## **E40D ('90 1-TON DUMP)**

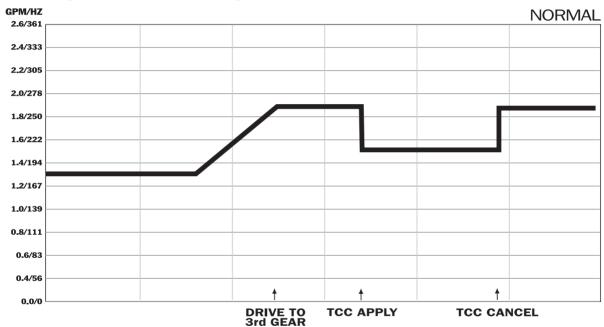
**Condition:** Normal for early pump.

Notes: Drilling line to lube across pump will increase flow. A stock worn, weak pump may flow down to .4 in reverse at idle.
