AXODE

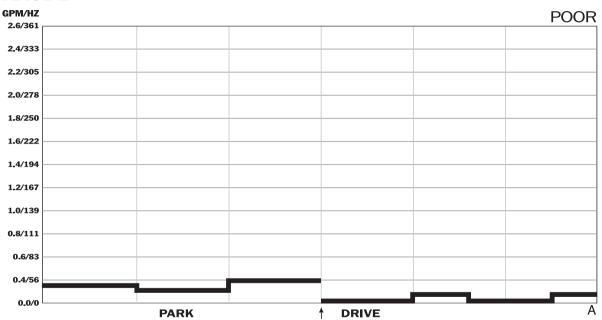
Condition: Incorrectly wired EPC and shift solenoids.

Notes: Notable "click-click" from side cover and 2nd gear shuttle.
