4L30-E ('90 TROOPER)

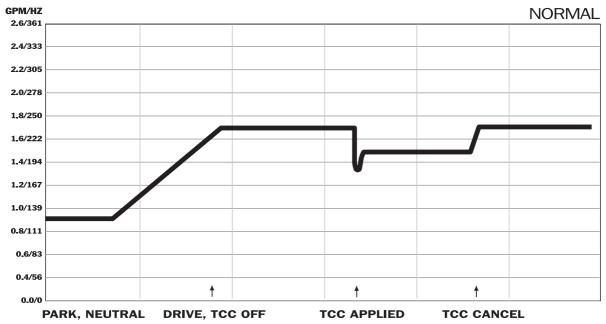
Notes: Vehicle had repetitive converter failure. TCC came on immediately at 35 mph, which loaded it heavily. Lift foot and TCC would come off. As soon as the throttle touched, TCC reapplied. The Bosch EDC solenoid will cycle a cleaning spike, which affects the flow.
