47RE ('97)

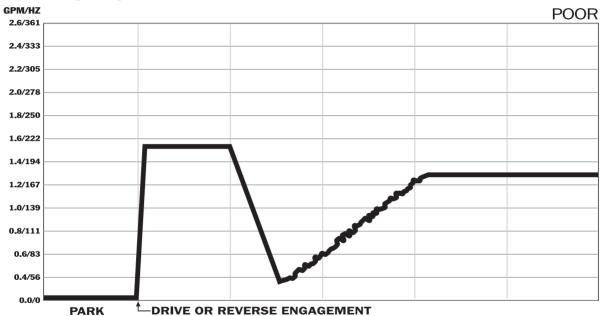
Condition: Weak pump, low volume, excess clearances. Vehicle had repeat converter failure.

Notes: Flow is 0 gpm in all rear-wheel-drive units.
