Building Inspection Report

Inspection Date: Tue, 18 Feb 2025

Property Address: 62 Hutt St, NORTHAM, WA, 6401, Australia

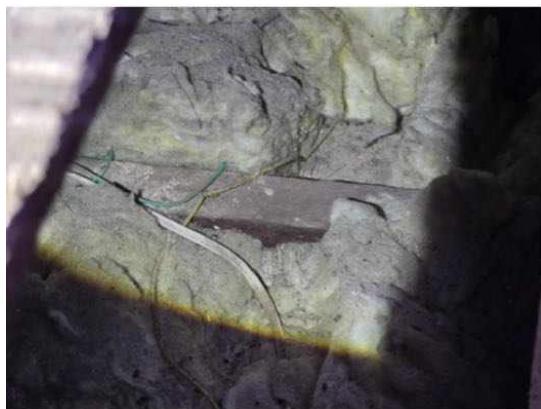
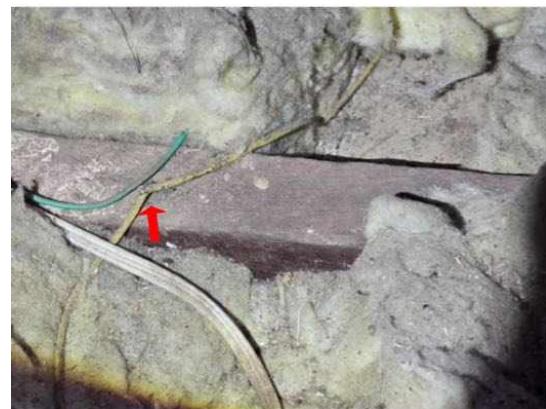
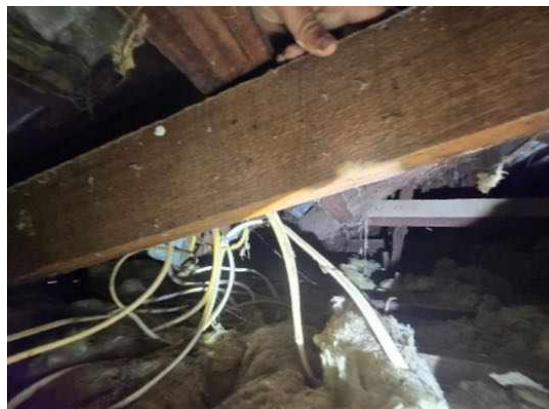
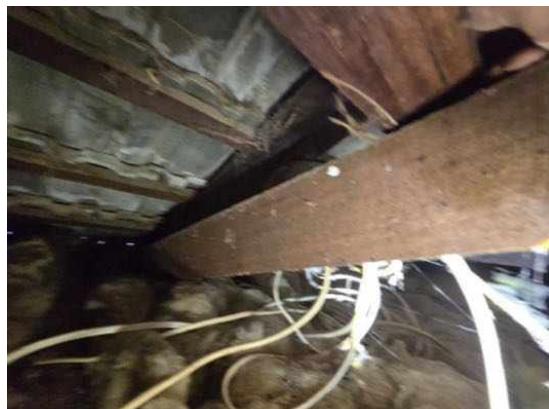
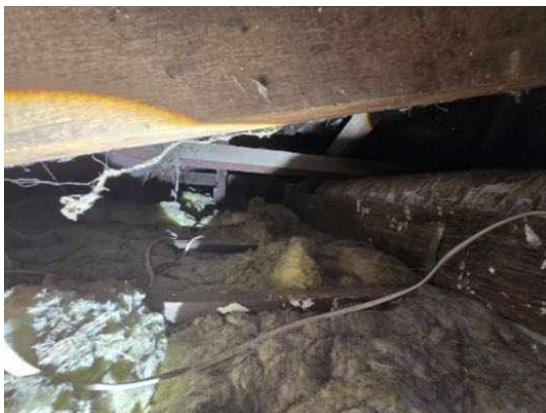
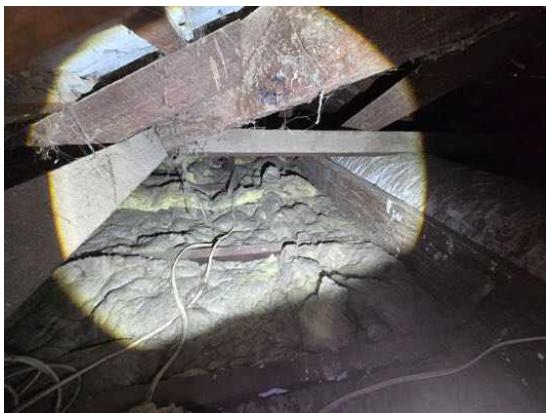
Defects 1.01

Building: Main Building
Location: Roof Void > Rear, Centre
Finding: Electrical wires exposed
Information: Exposed electrical wiring was identified. Exposed electrical wiring represents a potential safety hazard including for fire and personal contact. Contact a licensed electrician urgently for further inspection investigation and rectification.

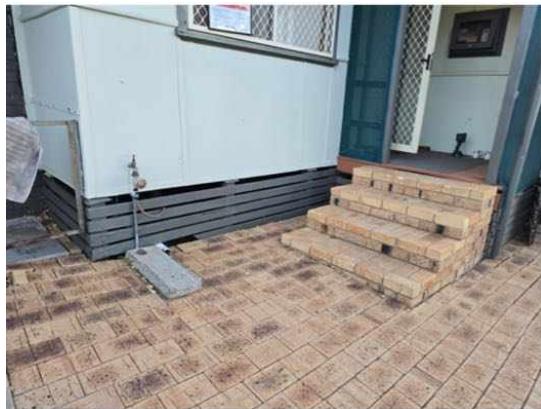
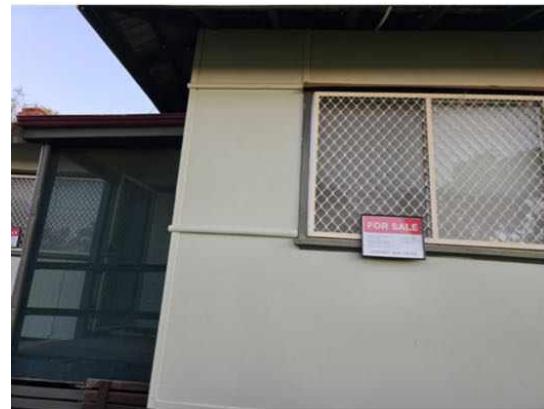
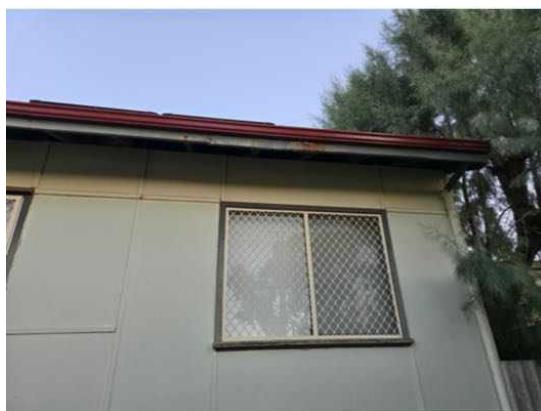
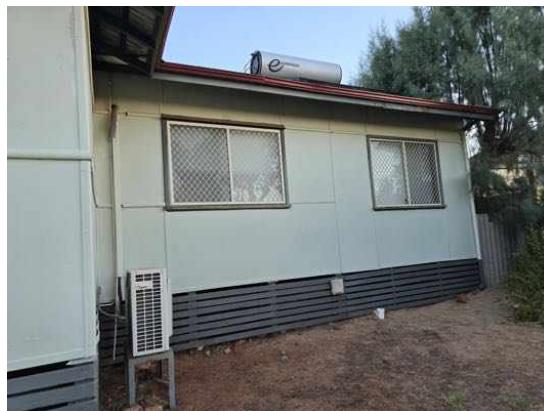
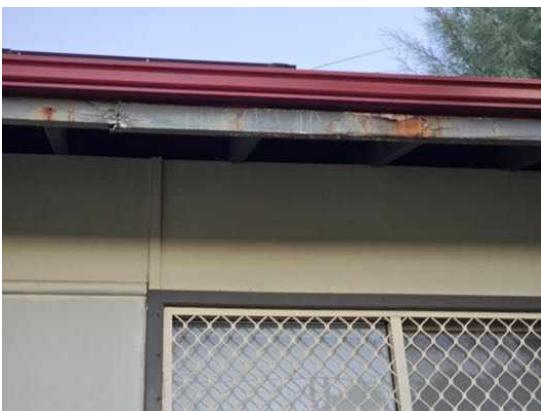
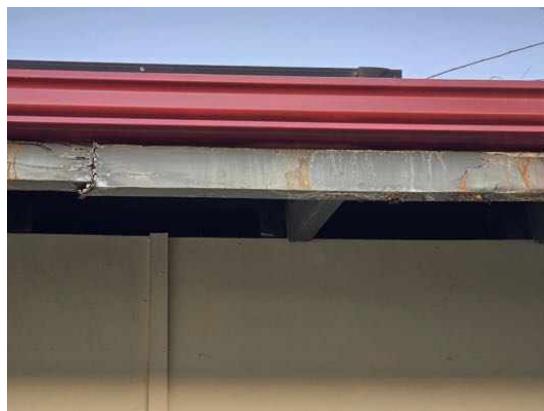
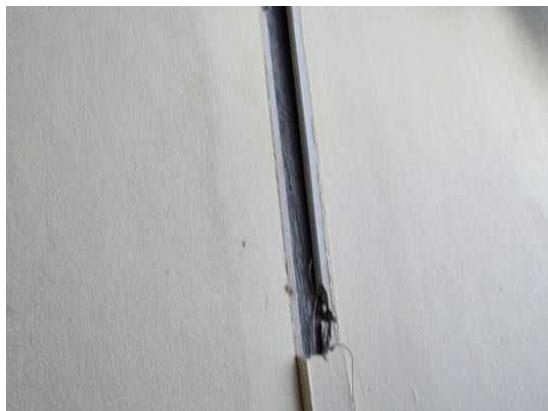
Defects 1.02

Building: Main Building
Location: Exterior Walls > All Areas
Finding: Asbestos - Suspected ACM Identified on Site
Information: Reporting on Asbestos is outside the Scope of this Report. This suspected defect is highlighted as a caution only. We suspect, based on our experience in the building industry, that there is a higher risk of the identified building element containing asbestos.

As Asbestos Reporting is outside the scope of this report, we advise that you consider a separate Asbestos Inspection and Condition Audit, which can include the taking of samples for definitive confirmation of the presence of Asbestos.

In the interim, the client is advised to act with caution, especially when considering any damage to building materials general wear and tear renovations extensions demolition and general maintenance activities due to the suspected presence of Asbestos.

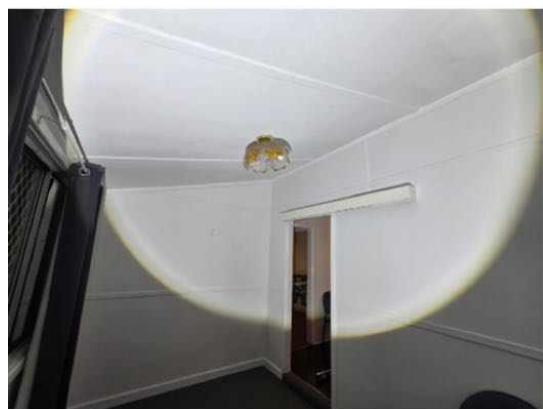
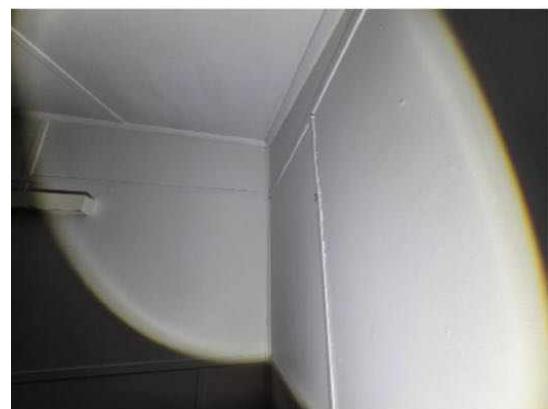
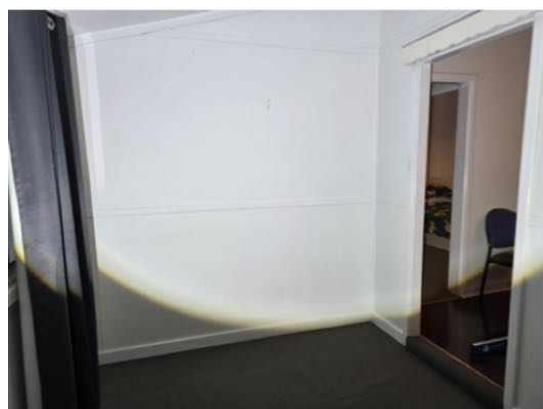
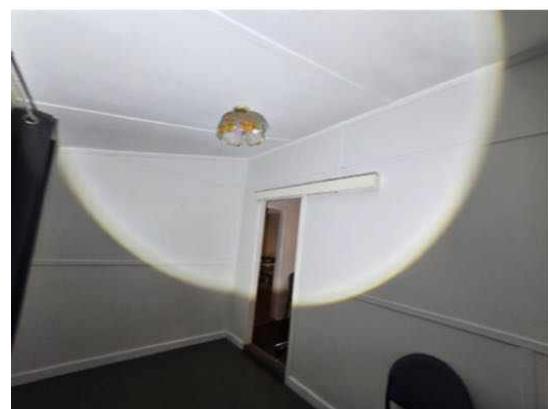
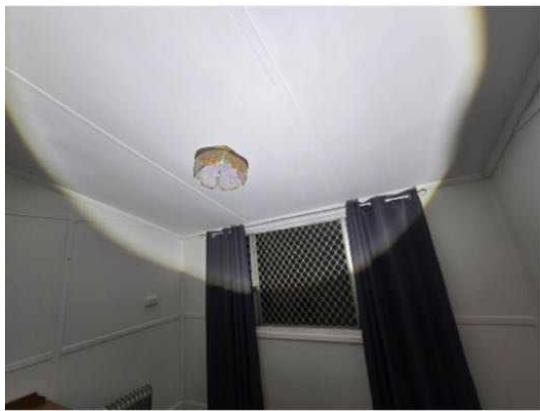
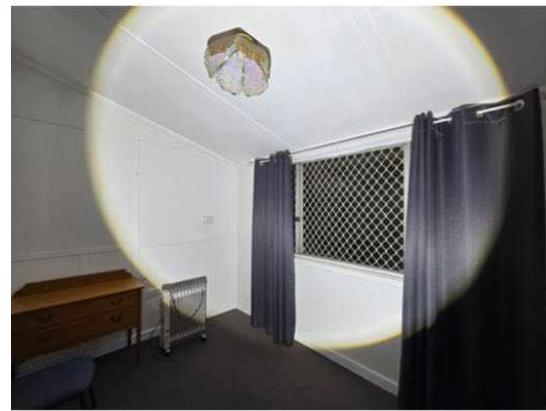
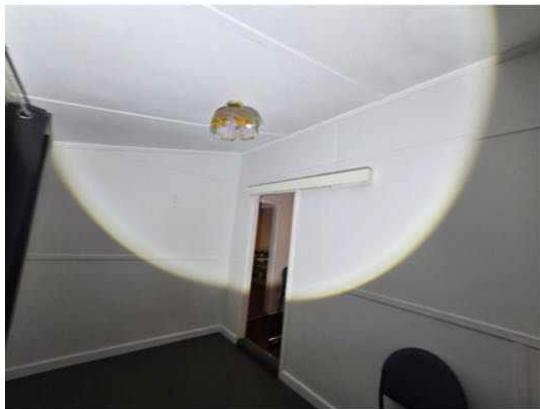
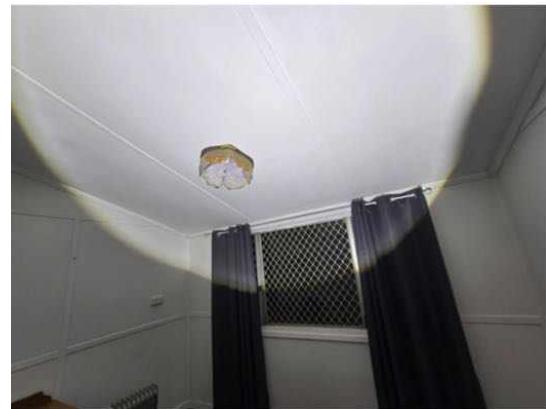
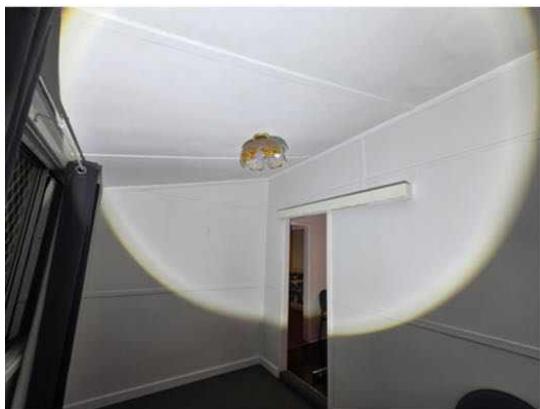
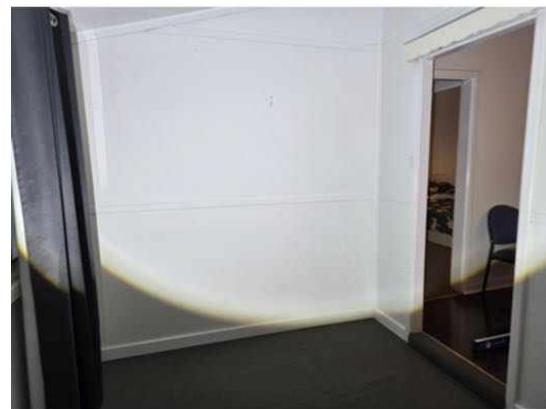
Defects 1.03

Building: Main Building
Location: Internal Walls > Centre Right,Rear Right
Finding: Asbestos - Suspected ACM Identified on Site
Information: Reporting on Asbestos is outside the Scope of this Report. This suspected defect is highlighted as a caution only. We suspect, based on our experience in the building industry, that there is a higher risk of the identified building element containing asbestos.

As Asbestos Reporting is outside the scope of this report, we advise that you consider a separate Asbestos Inspection and Condition Audit, which can include the taking of samples for definitive confirmation of the presence of Asbestos.

In the interim, the client is advised to act with caution, especially when considering any damage to building materials general wear and tear renovations extensions demolition and general maintenance activities due to the suspected presence of Asbestos.

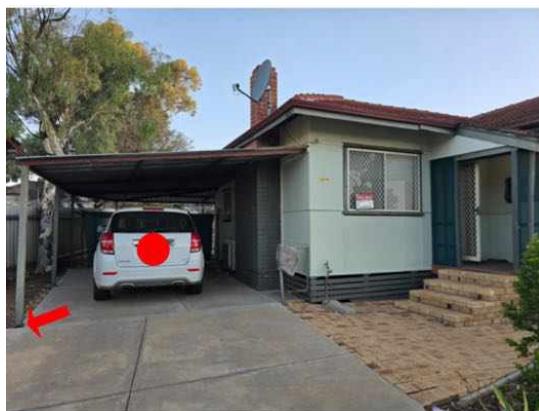
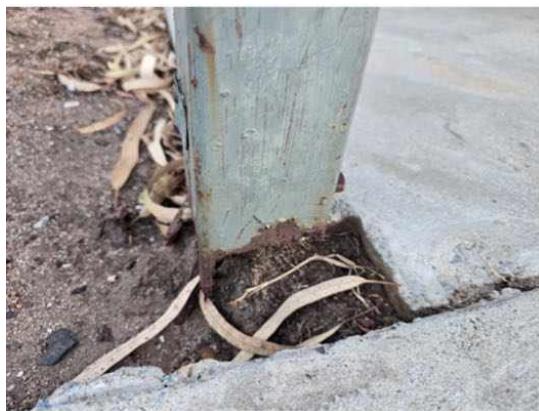
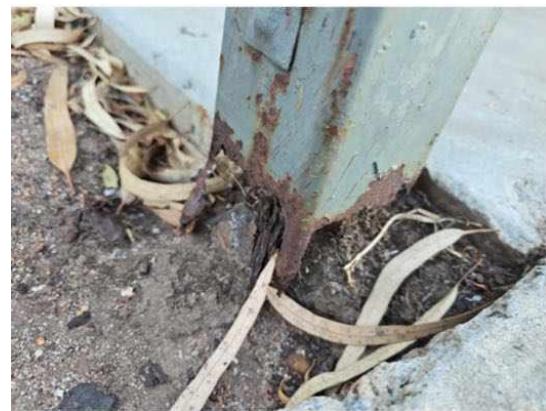
Defects 2.01

Building: Main Building
Location: Carport > Front Left
Finding: Post/Column - Severely Rusted or corroded at base (Carport)
Information: Post/Column of the carport shows evidence of severe rusting and corrosion, which is likely to have developed as a result of excessive exposure to moisture and/or inadequate coatings.

As surface rust provides no protection to the underlying iron, the deteriorating condition is likely to worsen structural integrity if not addressed in the short-term future.

Base of the column/post fully corroded away which requires replacement on urgent basis to restore the structural integrity.

Where possible, the use of galvanized (treated) metals or aluminium coated metals aid in rust prevention, as does regular general maintenance. Rust formation can be controlled with coatings, such as paint, that isolate the iron from the environment.

Rusting and corrosion should be managed by ideally removing or limiting the affected surface from exposure to moisture. A registered builder may be appointed to replace any building elements that have been severely affected by rust or water damage.

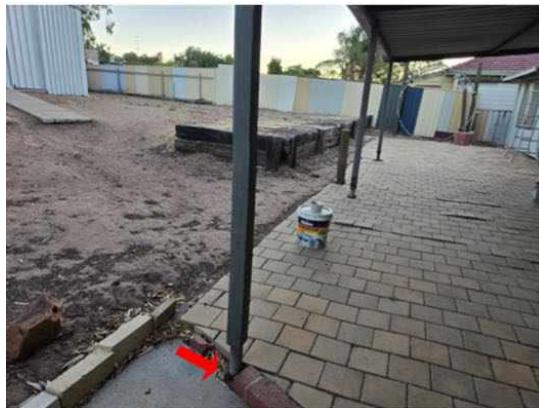
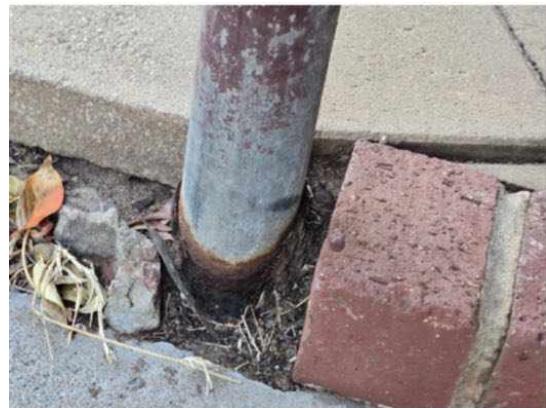
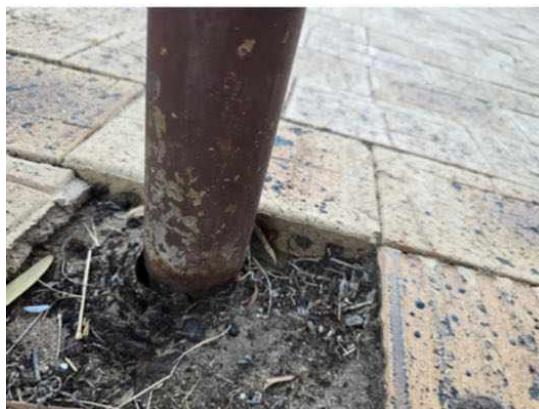
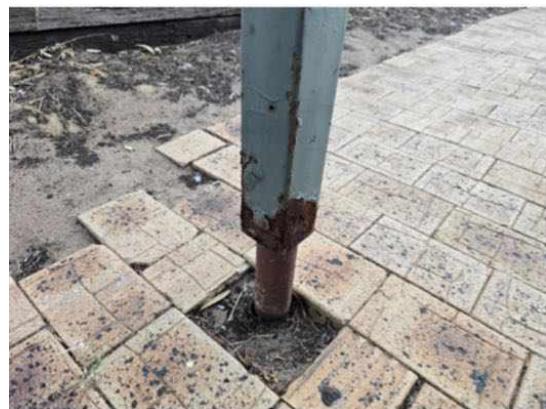
Defects 2.02

Building:	Main Building
Location:	Rear Patio > Rear Left
Finding:	Post/Column - Severely Rusted or corroded at base (rear patio area)
Information:	Post/Column of the rear Patio shows evidence of severe rusting and corrosion, which is likely to have developed as a result of excessive exposure to moisture and/or inadequate coatings.

As surface rust provides no protection to the underlying iron, the deteriorating condition is likely to worsen structural integrity if not addressed in the short-term future.

Base of the column/post fully corroded away which requires replacement on urgent basis to restore the structural integrity.

Where possible, the use of galvanized (treated) metals or aluminium coated metals aid in rust prevention, as does regular general maintenance. Rust formation can be controlled with coatings, such as paint, that isolate the iron from the environment.

Rusting and corrosion should be managed by ideally removing or limiting the affected surface from exposure to moisture. A registered builder may be appointed to replace any building elements that have been severely affected by rust or water damage.

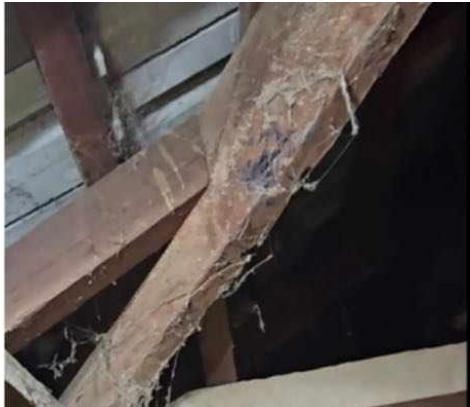
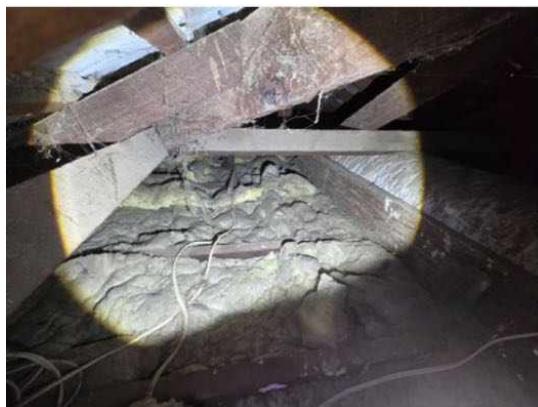
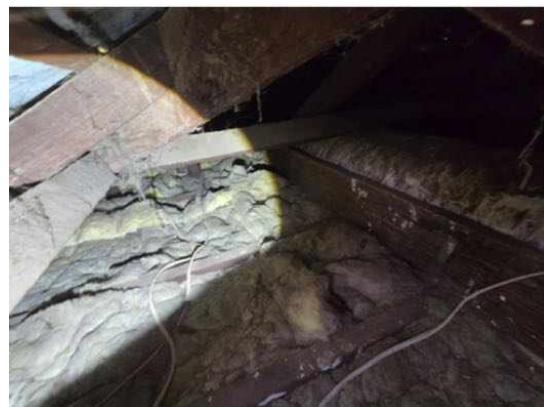
Defects 2.03

Building:	Main Building
Location:	Roof Void > Rear Right
Finding:	Timber Rafter - Crack or split (Major Structural)
Information:	It appears that the wooden rafter has sustained some form of damage. It looks like there is a crack or split in the beam. This type of damage can potentially weaken the structure over time, depending on the severity and the load the beam is bearing.

It is suspected that this is maybe caused by leaning large tree putting pressure & loads to the roof structure or maybe due to aging and possible under design of the rafter for intended roof loading .

Removal of the large tree may also be required to fix the issue, as the cause may be significant and may indicate a further structural defect which would require extensive works in the long-term future, including works to primary roof structures.

Further invasive inspection is required to determine the full extent of damage to the roof truss. If the damages are structural it is advisable that a Structural Engineer also inspects the building and provide remediation scope which require to be carried out by registered builders.

It would be wise to consult with a structural engineer or a professional contractor to assess the extent of the damage and recommend any necessary repairs. Depending on their evaluation, reinforcement, replacement, or other remediation steps might be needed to ensure the safety of the structure.

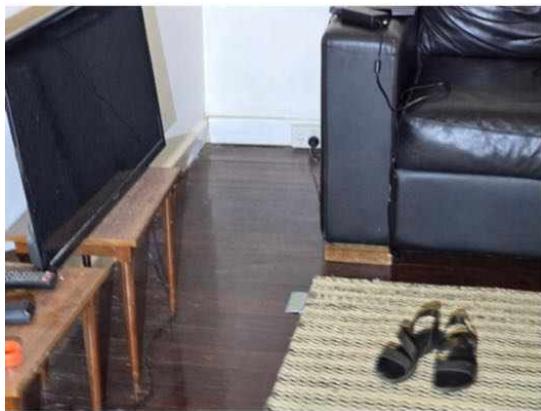
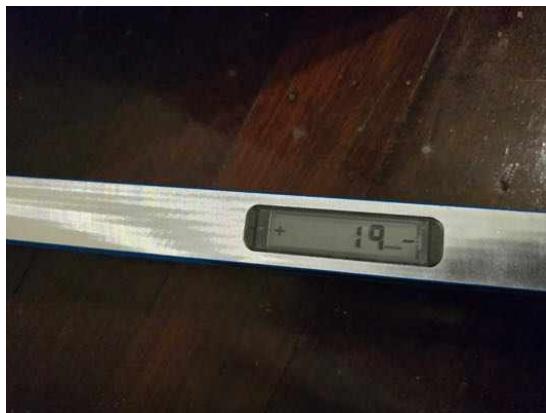
Defects 2.04

Building:	Main Building
Location:	Lounge Room > Front
Finding:	Settlement/sinking of Floor - Suspected Inadequate Subfloor support or settlement of Subfloor foundation

Information: Floor settlement/sinking were observed. Subfloor foundation was suspected to have inadequate support and inappropriately sub-base were moved underneath the pilasters. While this type of construction is common for the era of building, additional support or underpinnig may be required.

Lack of support subfloor structures are likely to create strain on associated building elements, creating potential for primary damage including the collapse of subfloor. The subfloor is also unlikely to have sufficient support, which may lead to further settlelement if left unmanaged.

- Measurements taken using a digital level indicate minor variations in the floor level is up to 19 mm/m slope, consistent with expected settlement over time.
- Cause: Likely due to Subfloor foundation settlement and/or inadequate support to floor.
- No major structural compromise such structural cracks on wall due to settlements was observed.

It is advised that a Structural engineer be appointed to provide remedial advice which then could then be carried out by a licensed builder.

While it would appear that this defect has been present for a long period of time repair is recommended in the short term to ensure the longevity and structural integrity of the dwelling.

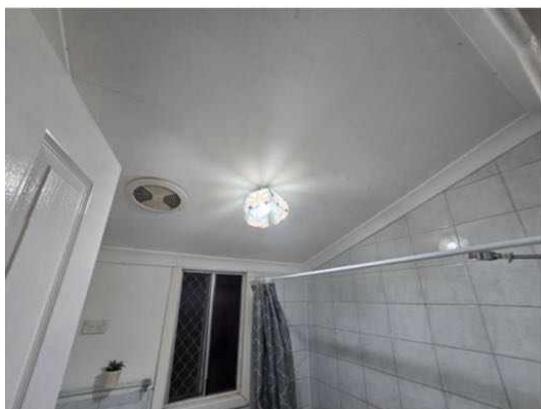
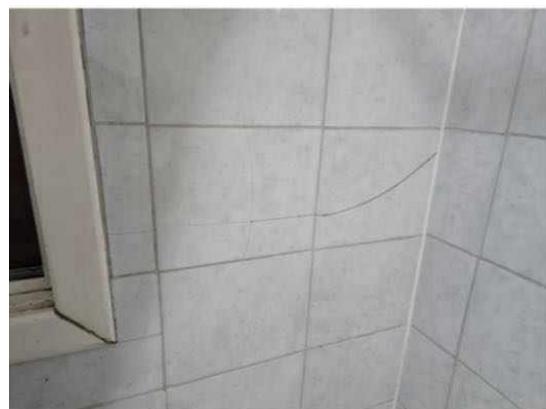
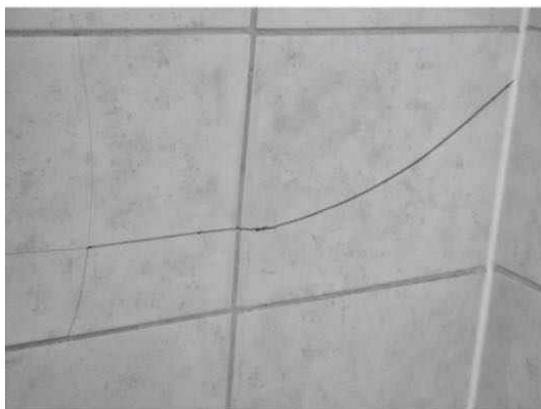
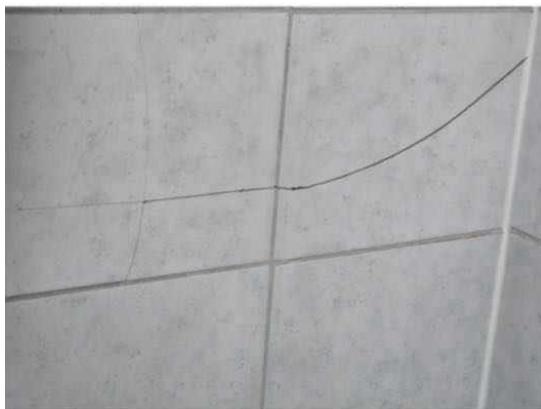
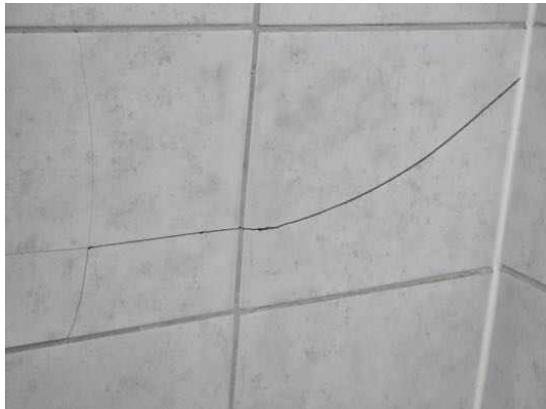
Defects 2.05

Building: Main Building
 Location: Bathroom > Centre
 Finding: Tile cracks in the bathroom - Differential settlement
 Information: Several Interior tile cracks in the bathroom were observed which indicate differential settlement of the floor. Subfloor foundation was suspected to have inadequate support and inappropriately sub-base were moved underneath the pilasters. While this type of construction is common for the era of building, additional support or underpinnig may be required.

Lack of support subfloor structures are likely to create strain on associated building elements, creating potential for primary damage including the collapse of subfloor. The subfloor is also unlikely to have sufficient support, which may lead to further settlelement if left unmanaged.

- Cause: Likely due to Subfloor foundation settlement and/or inadequate support to floor.

While it would appear that this defect has been present for a long period of time repair is recommended in the short term to ensure the longevity and structural integrity of the

dwelling.

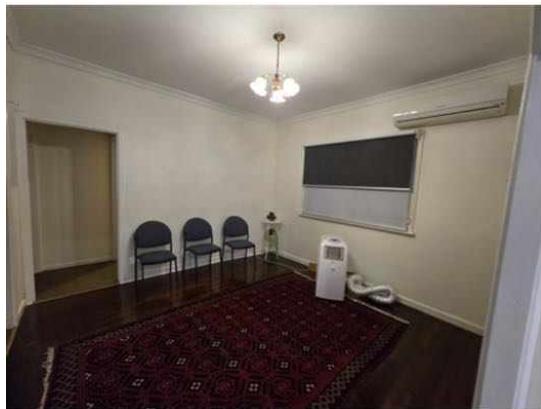
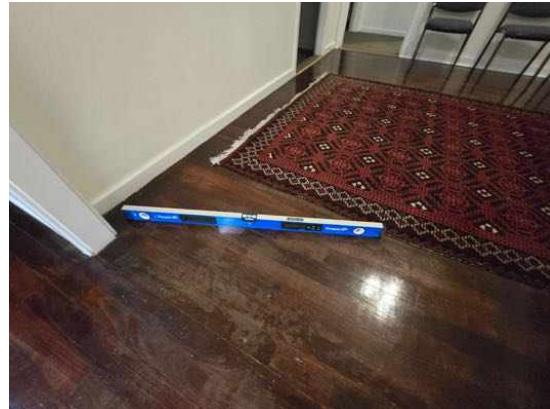
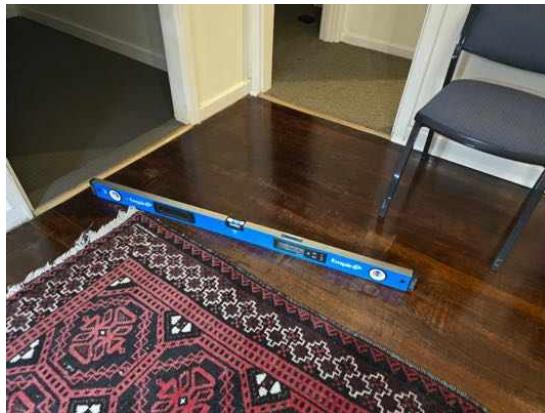
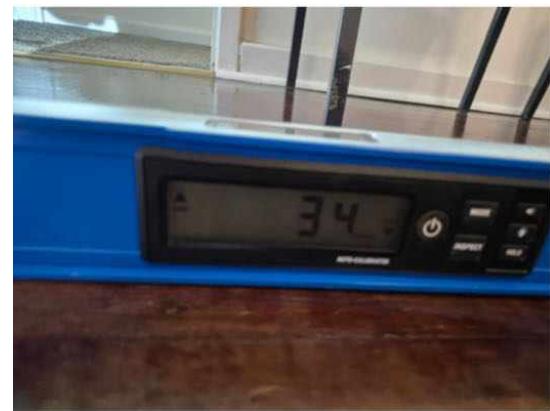
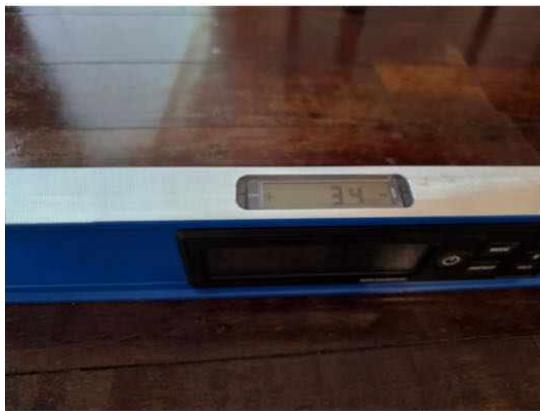
Defects 2.06

Building:	Main Building
Location:	Dining Room > Centre
Finding:	Settlement/sinking of Floor - Suspected Inadequate Subfloor support or settlement of Subfloor foundation
Information:	Floor settlement/sinking were observed. Subfloor foundation was suspected to have inadequate support and inappropriately sub-base were moved underneath the pilasters. While this type of construction is common for the era of building, additional support or underpinnig may be required.

Lack of support subfloor structures are likely to create strain on associated building elements, creating potential for primary damage including the collapse of subfloor. The subfloor is also unlikely to have sufficient support, which may lead to further settlement if left unmanaged.

- Cause: Likely due to Subfloor foundation settlement and/or inadequate support to floor.

- No major structural compromise such structural cracks on wall due to settlements was observed.

It is advised that a Structural engineer be appointed to provide remedial advice which then could then be carried out by a licensed builder.

While it would appear that this defect has been present for a long period of time repair is recommended in the short term to ensure the longevity and structural integrity of the dwelling.

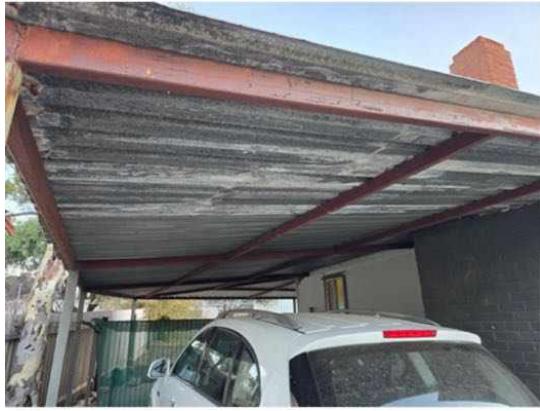
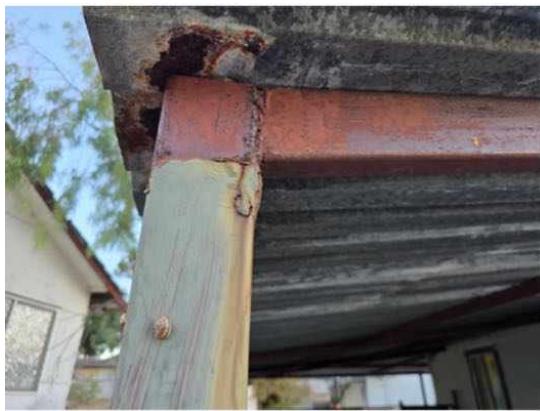
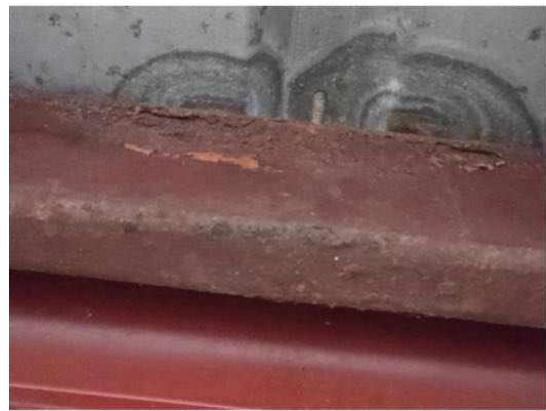
Defects 3.01

Building: Main Building
 Location: Carport > Front Left
 Finding: Carport Roof Steel Rafter - Rusted or corroded (non-severe)
 Information: Carport Roof Truss shows evidence of rusting and corrosion, which is likely to have developed as a result of excessive exposure to moisture and or inadequate coatings.

As surface rust provides no protection to the underlying iron, the deteriorating condition is likely to worsen if not addressed in the short-term future.

Where possible, the use of galvanized (treated) metals or aluminium coated metals aid in rust prevention, as does regular general maintenance. Rust formation can be controlled with coatings, such as paint, that isolate the iron from the environment.

Rusting and corrosion should be managed by ideally removing or limiting the affected surface from exposure to moisture. A registered builder may be appointed to replace any building elements that have been severely affected by rust or water damage.

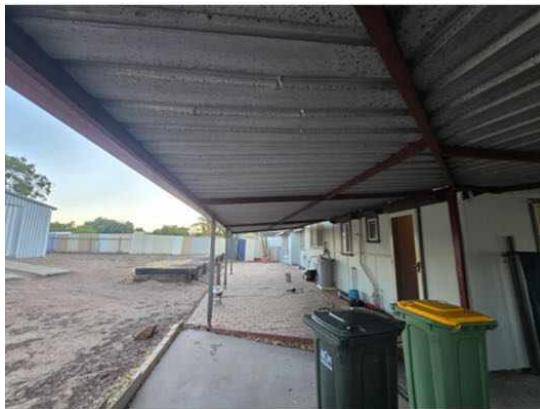
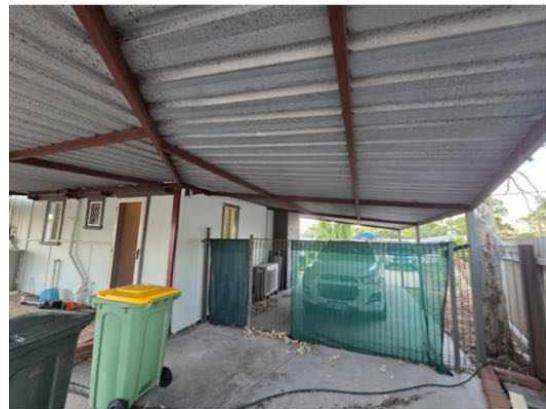
Defects 3.02

Building: Main Building
 Location: Rear Patio > Rear Left
 Finding: Patio Roof Truss - Rusted or corroded (non-severe)
 Information: Rear Patio Roof Steel Rafter shows evidence of rusting and corrosion, which is likely to have developed as a result of excessive exposure to moisture and or inadequate coatings.

As surface rust provides no protection to the underlying iron, the deteriorating condition is likely to worsen if not addressed in the short-term future.

Where possible, the use of galvanized (treated) metals or aluminium coated metals aid in rust prevention, as does regular general maintenance. Rust formation can be controlled with coatings, such as paint, that isolate the iron from the environment.

Rusting and corrosion should be managed by ideally removing or limiting the affected surface from exposure to moisture. A registered builder may be appointed to replace any building elements that have been severely affected by rust or water damage.

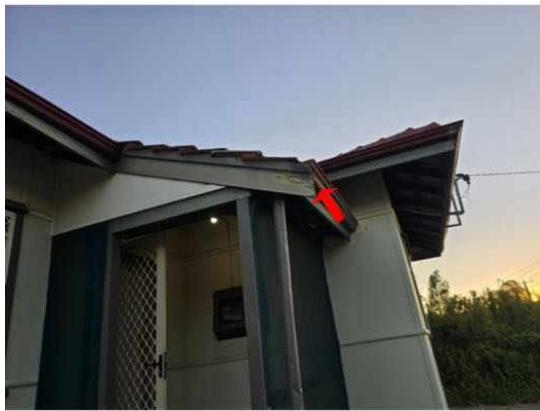
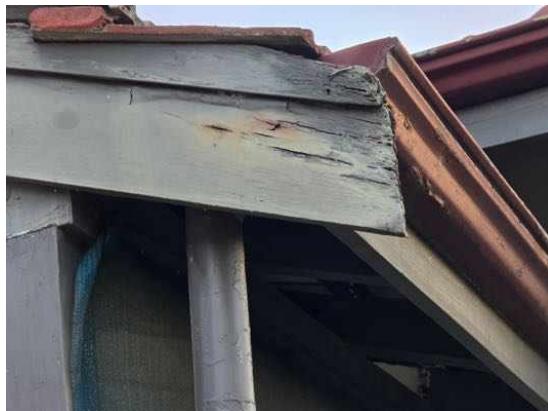
Defects 3.03

Building: Main Building
 Location: Front Porch > Front
 Finding: Timber fascia's - deteriorated due to exposed to weather
 Information: It appears that the wooden fascia's has sustained some form of damage from weathering. It looks like there is decaying or split on the fascia's timber. This type of damage can potentially weaken the structure over time, depending on the severity and the load the beam is bearing.

External timbers fascia's that are frequently exposed to harsh weather conditions require adequate protection in order to maintain their condition. Where timbers have not been painted or treated adequately, general deterioration is likely to occur at an accelerated rate.

If left unattended, replacement of these timbers is likely to be necessary in the short-term future. Adequate treatment of these timbers is required as soon as possible by a painting contractor or general handyman.

It would be wise to consult with a structural engineer or a professional contractor to assess the extent of the damage and recommend any necessary repairs. Depending on their evaluation, reinforcement, replacement, or other remediation steps might be needed to ensure the safety of the structure.

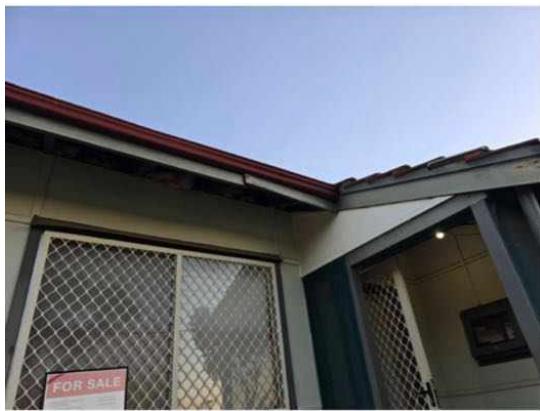
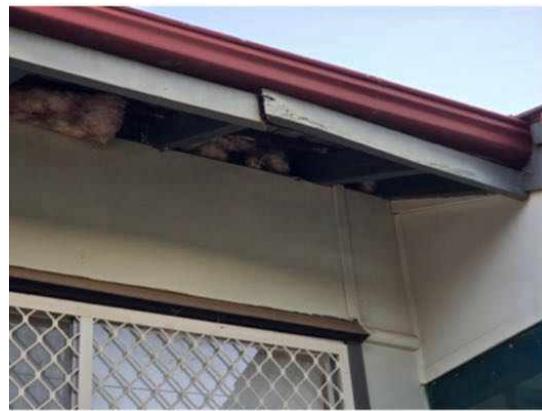
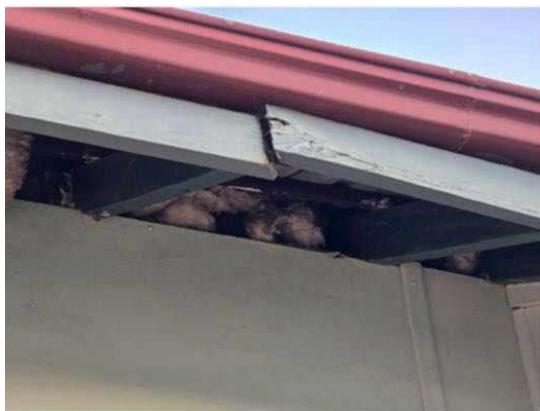
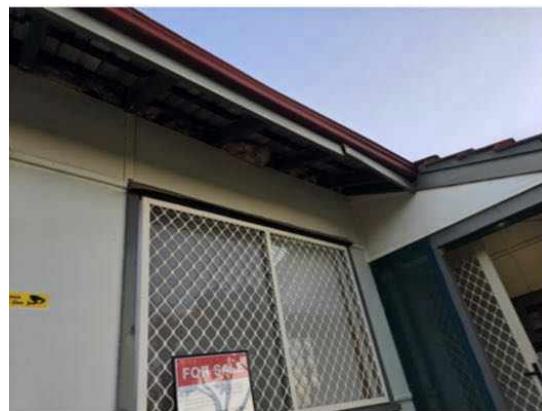
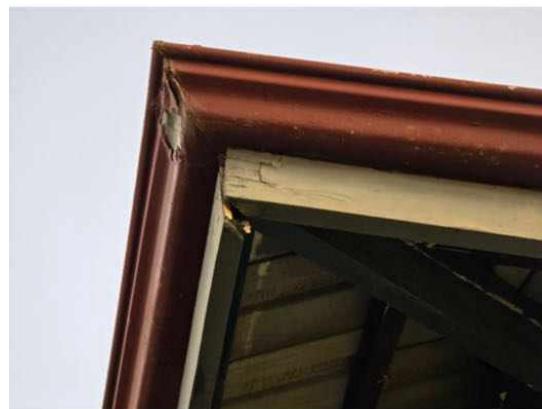
Defects 3.04

Building: Main Building
 Location: Front Elevation > Front,Front Left
 Finding: Front Fascia's - Deteriorated Connection
 Information: The Fascia's timber structures are showing signs of deterioration and loosening of connection with rafters timber. It is suspected that this defect has developed as a result of damp conditions or fascia's twisted under the load.

Damp conditions or sustained weathering cause the timbers to fail, resulting in the fascia's timber failing to bear the load (or weight) of the roof as originally intended. Without repairs and maintenance, including potential replacement of affected elements, it is likely that fall object hazard leading safety of the occupants will result, as well as an array of minor defects.

Rectification or replacement of the affected timber building element is required. Consultation with a roof carpenter or registered builder specialising in roof truss is highly advised as soon as possible

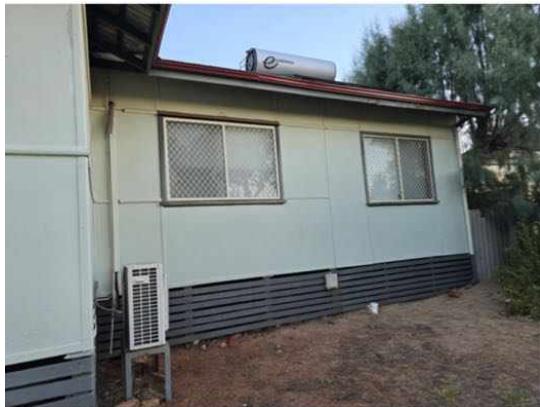
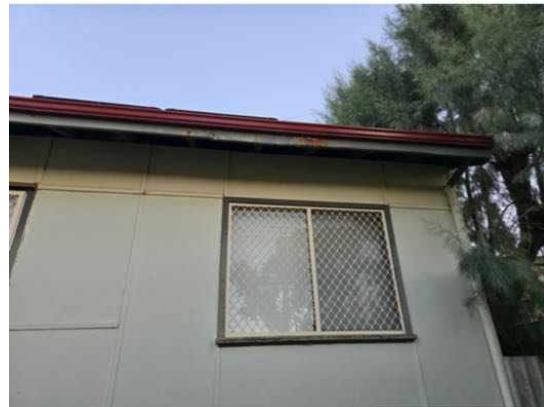
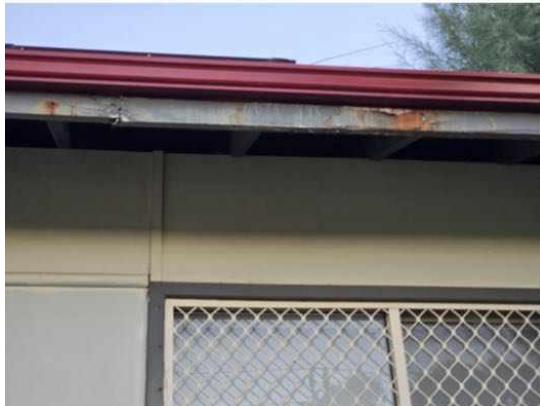
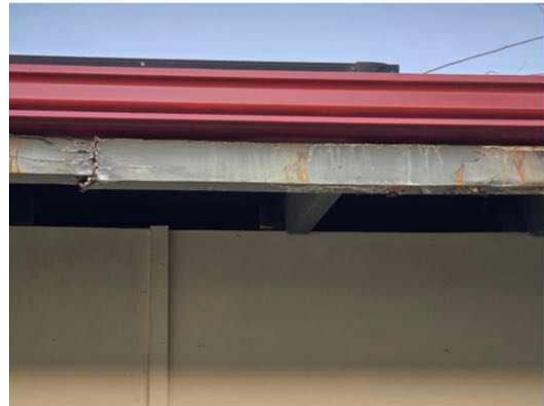
Defects 3.05

Building: Main Building
 Location: Front Elevation > Front,Front Left
 Finding: Front Timber fascia's - deteriorated due to exposed to weather
 Information: It appears that the wooden fascia's has sustained some form of damage from weathering. It looks like there is decaying or split on the fascia's timber. This type of damage can potentially weaken the structure over time, depending on the severity and the load the beam is bearing.

External timbers fascia's that are frequently exposed to harsh weather conditions require adequate protection in order to maintain their condition. Where timbers have not been painted or treated adequately, general deterioration is likely to occur at an

If left unattended, replacement of these timbers is likely to be necessary in the short-term future. Adequate treatment of these timbers is required as soon as possible by a painting contractor or general handyman.

It would be wise to consult with a structural engineer or a professional contractor to assess the extent of the damage and recommend any necessary repairs. Depending on their evaluation, reinforcement, replacement, or other remediation steps might be needed to ensure the safety of the structure.

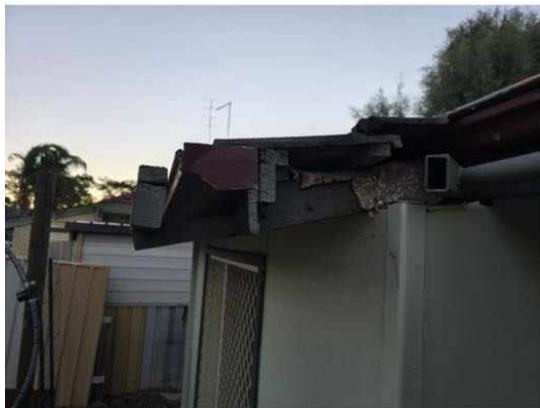
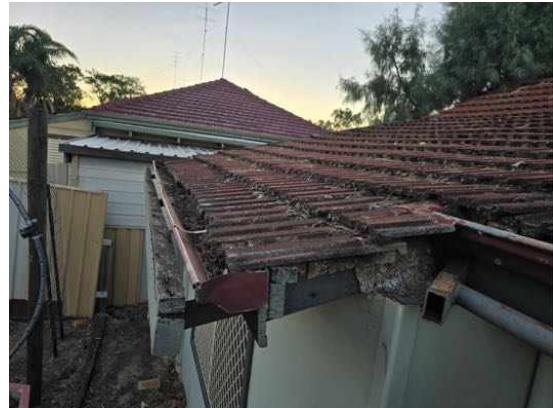
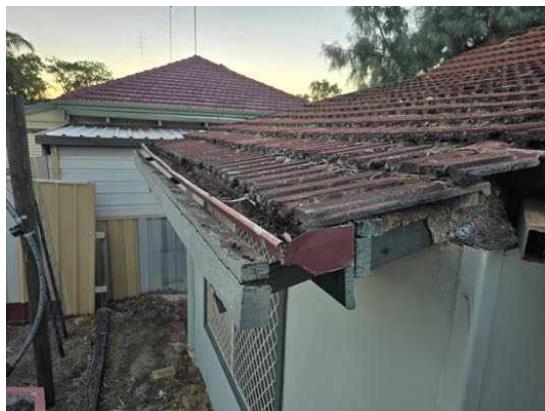
Defects 3.06

Building:	Main Building
Location:	Rear Elevation > Rear
Finding:	Rear Timber fascia's - deteriorated due to exposed to weather
Information:	It appears that the wooden fascia's has sustained some form of damage from weathering. It looks like there is decaying or split on the fascia's timber. This type of damage can potentially weaken the structure over time, depending on the severity and the load the beam is bearing.

External timbers fascia's that are frequently exposed to harsh weather conditions require adequate protection in order to maintain their condition. Where timbers have

not been painted or treated adequately, general deterioration is likely to occur at an accelerated rate.

If left unattended, replacement of these timbers is likely to be necessary in the short-term future. Adequate treatment of these timbers is required as soon as possible by a painting contractor or general handyman.

It would be wise to consult with a structural engineer or a professional contractor to assess the extent of the damage and recommend any necessary repairs. Depending on their evaluation, reinforcement, replacement, or other remediation steps might be needed to ensure the safety of the structure.

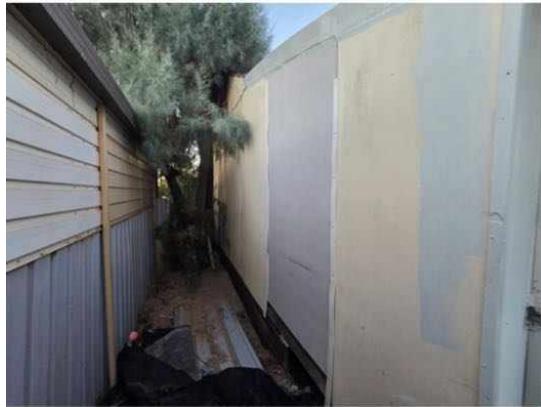
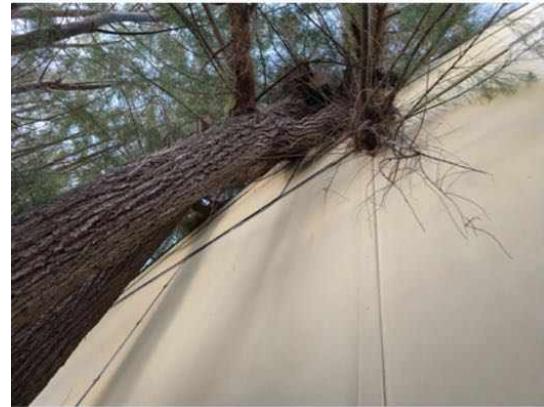
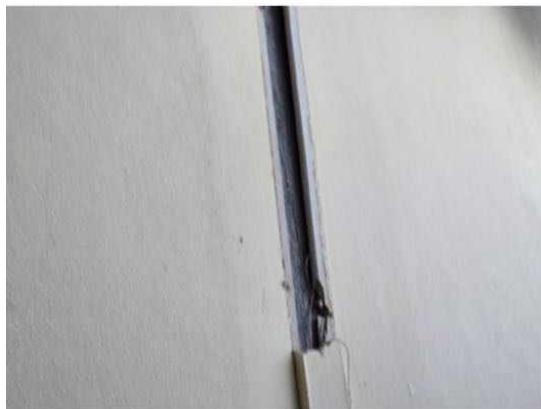
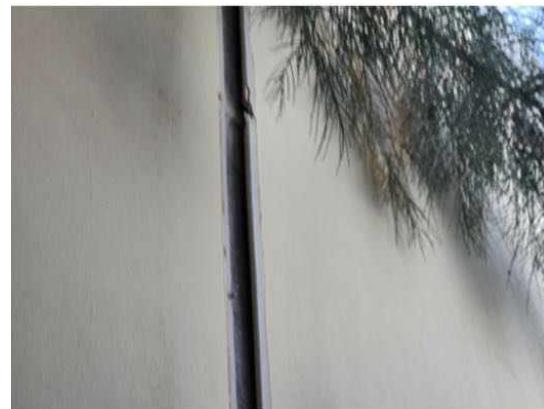
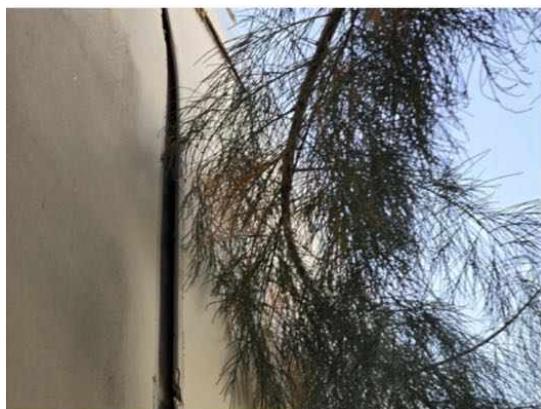
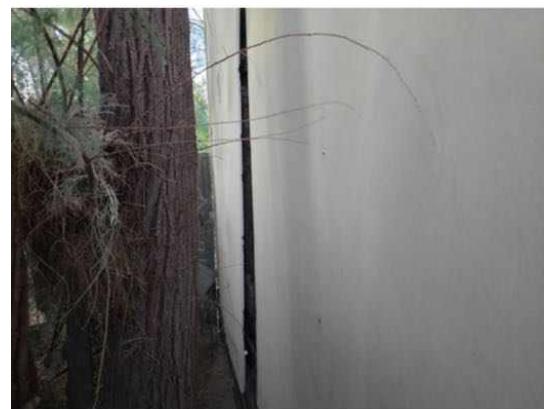
Defects 3.07

Building:	Main Building
Location:	Exterior walls - right side > Rear Right
Finding:	External walls cladding - Bulging, Detached & Nail popping
Information:	External walls cladding bulging, detached & nail popping was noted to right side wall. It is suspected that this bulging & detachment is caused by leaning large tree putting pressure & loads to the wall and lack of or failure in adhesion to framing a common indication of substandard workmanship during the installation phase.

Removal of the large tree & associated building works required to fix the bulging & detachment of the wall cladding should be completed, as the cause may be

significant and may indicate a structural defect which would require extensive works in the long-term future, including works to roof structures, wall frame structures, and associated finishes.

Further invasive inspection is required to determine the full extent of damage to the roof truss & wall frame structure. If the damages are structural it is advisable that a Structural Engineer also inspects the building and provide remediation scope which require to be carried out by registered builders.

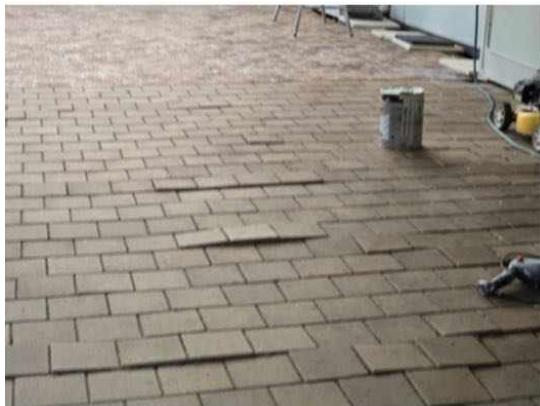
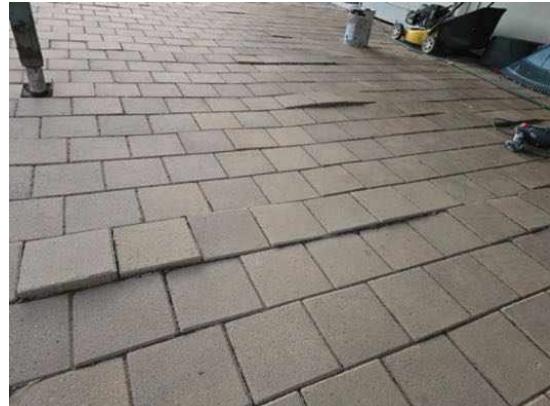
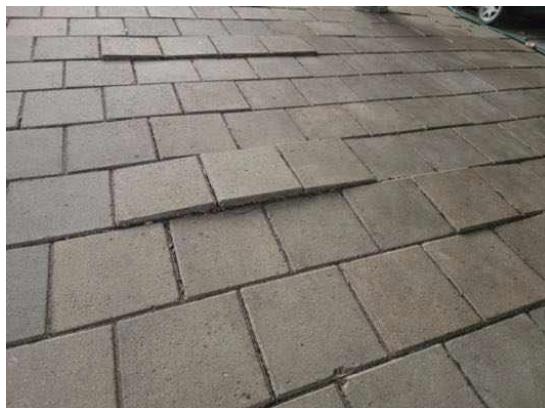
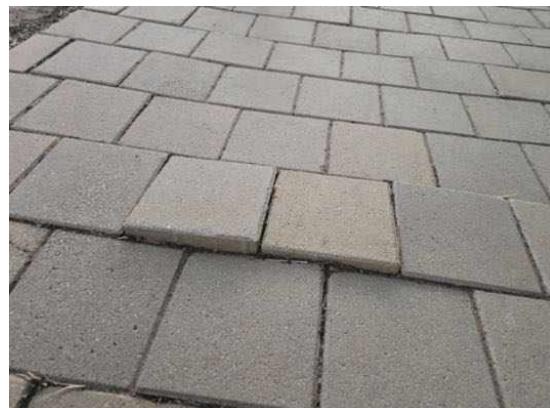
Defects 3.08

Building: Main Building
Location: Patio Paving > Rear
Finding: Paving - Uneven
Information: Sections of the external paved area are uneven, creating a potential trip hazard. It appears as though the area has been subject to rough installation, or that paving sections have lifted due to movements in the foundation of the property.

Where paving creates a trip hazard, personal injury may ensue if due caution is not taken by all persons within this area.

Re-paving of the area is required as soon as possible to remedy this situation. Further

consultation with a specialist concreter is advised.

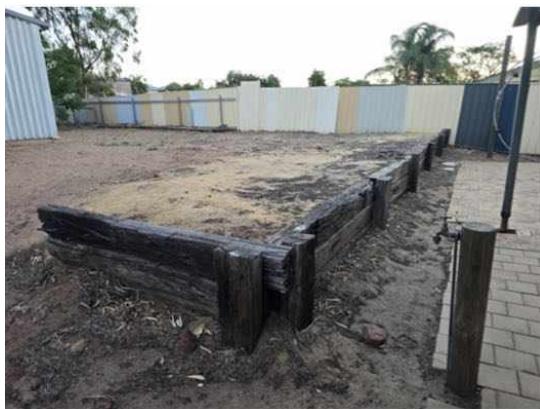
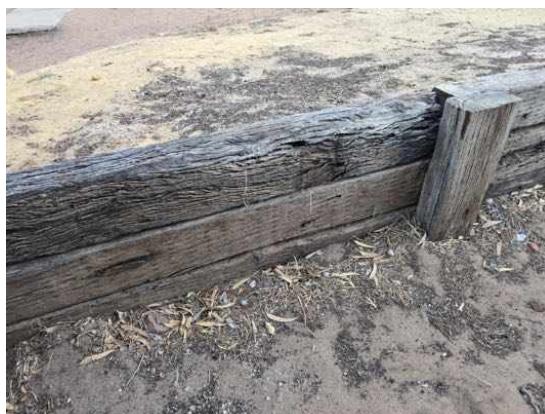
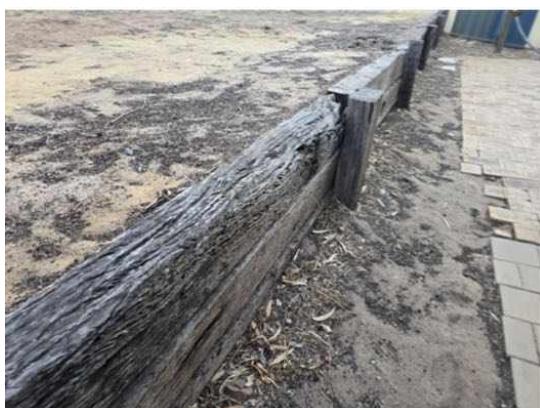
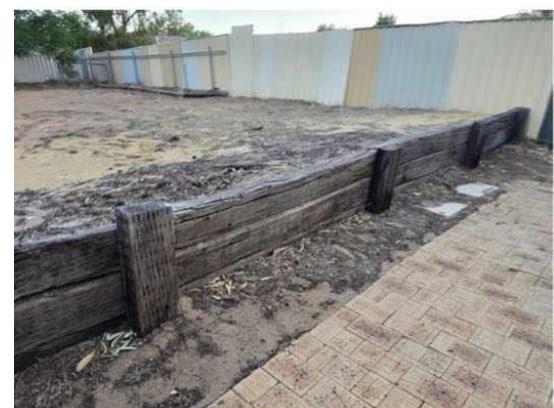
Defects 3.09

Building:	Main Building
Location:	Rear Retaining Wall > Rear
Finding:	Timber Retaining Wall - Exposed to weather / Wood rot
Information:	The timber retaining walls are showing signs of deterioration and wood rot (fungal decay) of the timbers. It is suspected that this defect has developed as result of general aging and excessive exposure to weather.

Damp conditions or sustained weathering cause the timbers to fail, resulting in the frame failing to bear the load (or weight) as originally intended. Without repairs and maintenance or replacement, it is likely that serious structural damage to the roof frame may occur.

As timber elements are in direct contact with the ground, concealed termite infestation is made possible. Such entry is made easier if the timbers become non-durable due to even slight wood rot.

Where wood rot is present to any timber, rectification or replacement of the affected timber building element is required. The adequate timeframe for such works are dependent on the severity of the rot. Where rot has developed to become widespread, replacement may be required. Consultation with a registered builder

specialising in window framing is highly advised.
