Building Inspection Report

Inspection Date: Tue, 18 Feb 2025

Property Address: 62 Hutt St, NORTHAM, WA, 6401, Australia

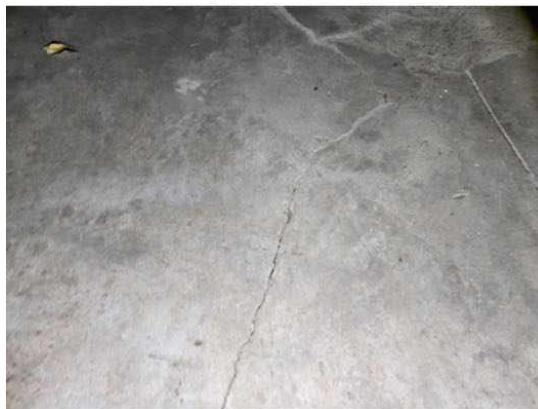
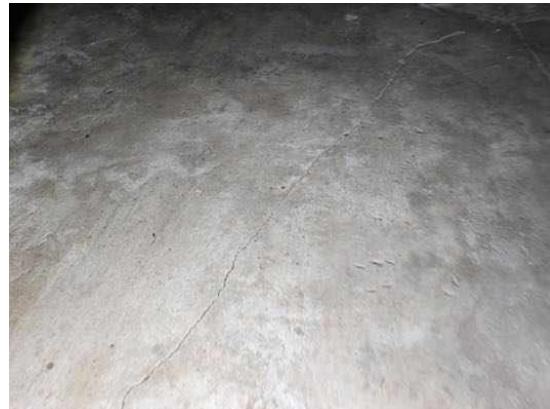
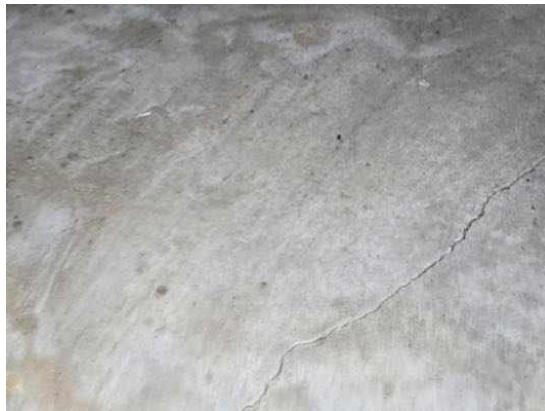
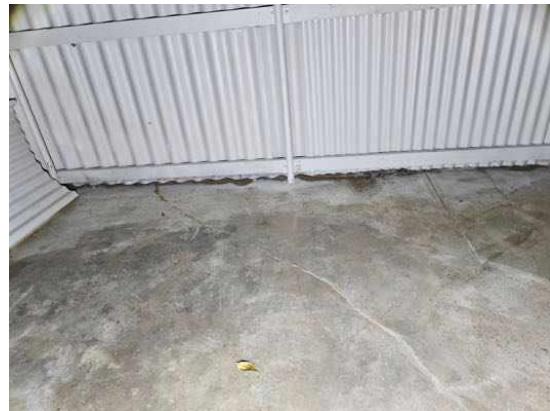
Defects 3.13

Building: Out Building
 Location: Shed > Rear
 Finding: Timber Purlins - Exposed to weather / Wood rot
 Information: The shed timber purlins are showing signs of deterioration and wood rot (fungal decay) of the timbers. It is suspected that this defect has developed as result of general aging and excessive exposure to weather.

Damp conditions or sustained weathering cause the timbers to fail, resulting in the frame failing to bear the load (or weight) as originally intended. Without repairs and maintenance or replacement, it is likely that serious structural damage to the roof frame may occur.

Where wood rot is present to any timber, rectification or replacement of the affected timber building element is required. The adequate timeframe for such works are dependent on the severity of the rot. Where rot has developed to become widespread, replacement may be required. Consultation with a registered builder specialising in window framing is highly advised.

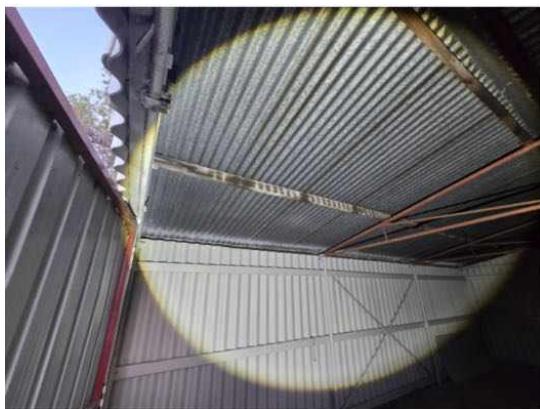
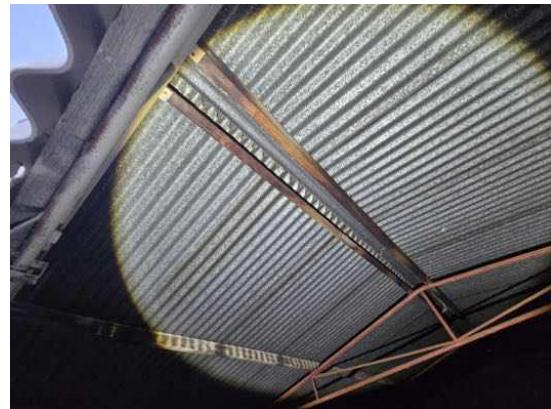
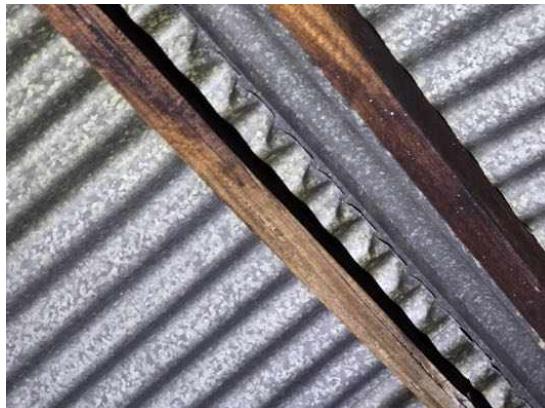
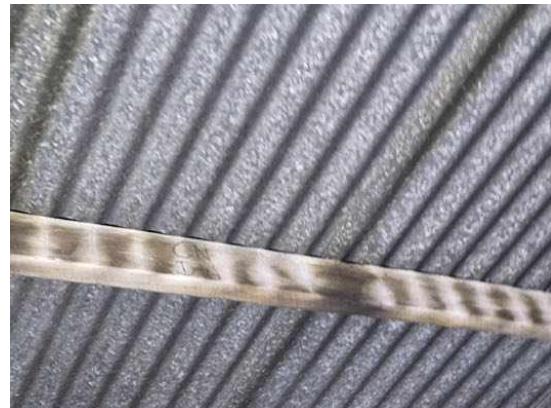
Defects 3.14

Building:	Out Building
Location:	Shed > Rear
Finding:	Shed Roof Truss - Rusted or corroded (non-severe)
Information:	Shed Roof Truss shows evidence of rusting and corrosion, which is likely to have developed as a result of excessive exposure to moisture and or inadequate coatings.

As surface rust provides no protection to the underlying iron, the deteriorating condition is likely to worsen if not addressed in the short-term future.

in rust prevention, as does regular general maintenance. Rust formation can be controlled with coatings, such as paint, that isolate the iron from the environment.

Rusting and corrosion should be managed by ideally removing or limiting the affected surface from exposure to moisture. A registered builder may be appointed to replace any building elements that have been severely affected by rust or water damage.

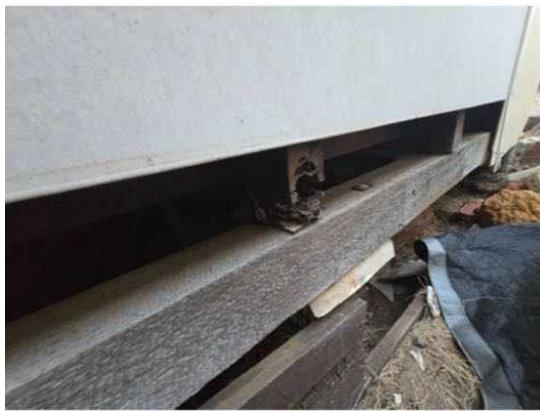
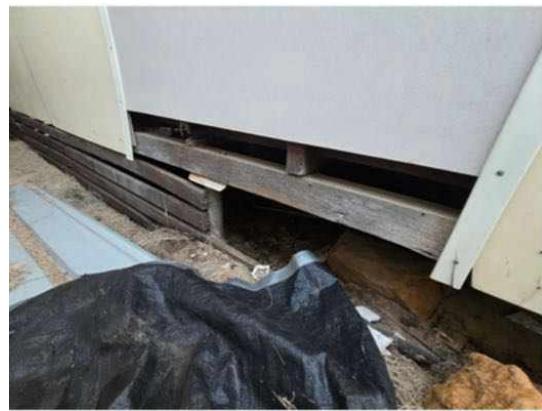
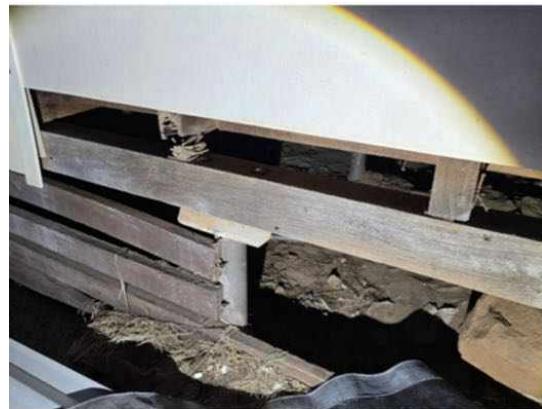
Defects 3.16

Building: Main Building
 Location: Subfloor > All Areas
 Finding: Subfloor Stump - Wood rot
 Information: Some of the subfloor timber stump are showing signs of deterioration and wood rot (fungal decay) of the timbers. It is suspected that this defect has developed as a result of damp conditions or weathered and the rafter twisted under the load.

Also it appears that some of the stump has sustained some form of damage. It looks like there is a crack or split in the stump. This type of damage can potentially weaken the structure over time, depending on the severity and the load the stump is bearing.

Damp conditions or sustained weathering cause the timbers to fail, resulting in the roof structures failing to bear the load (or weight) of the roof as originally intended. Without repairs and maintenance, including potential replacement of affected elements, it is likely that serious structural faults will result, as well as an array of minor defects.

The presence of wood rot to the roof structure is also conducive to termite infestation. As timber stumps are in direct contact with the ground, concealed termite is made possible. Such entry is made easier if the timbers become non-durable due to even slight wood rot.

Where wood rot is present to any structural timber, rectification or replacement of the

affected timber building element is required. The adequate timeframe for such works are dependent on the severity of the rot. Where rot has developed to become widespread, replacement of sections of the subfloor structure may be required. Consultation with a structural engineer or registered builder specialising in re-stumping is highly advised as soon as possible.

It would be wise to consult with a structural engineer or a professional contractor to assess the extent of the damage and recommend any necessary repairs. Depending on their evaluation, reinforcement, replacement, or other remediation steps might be needed to ensure the safety of the structure.

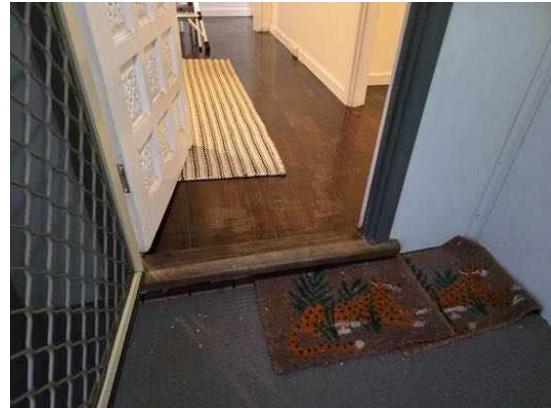
Defects 3.17

Building: Main Building
 Location: Entry Door > Front
 Finding: Entry Door Timber - exposed to weather
 Information: External timbers that are frequently exposed to harsh weather conditions require adequate protection in order to maintain their condition. Where timbers have not been painted or treated adequately, general deterioration is likely to occur at an accelerated rate.

If left unattended, replacement of these timbers is likely to be necessary in the short-term future. Adequate treatment of these timbers is required as soon as possible by a painting contractor or general handyman.

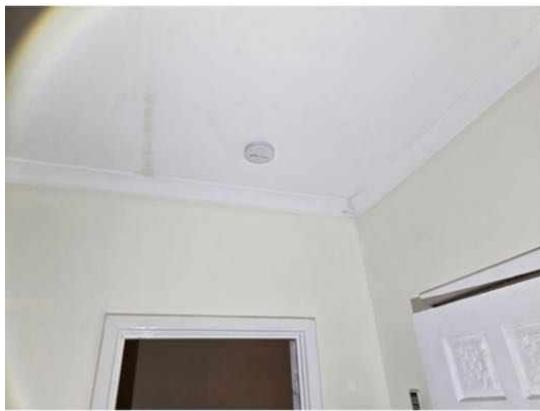
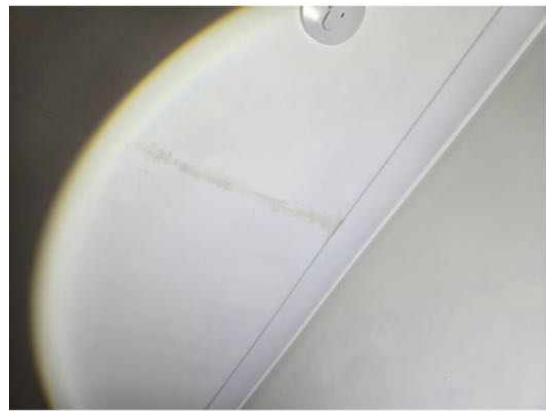
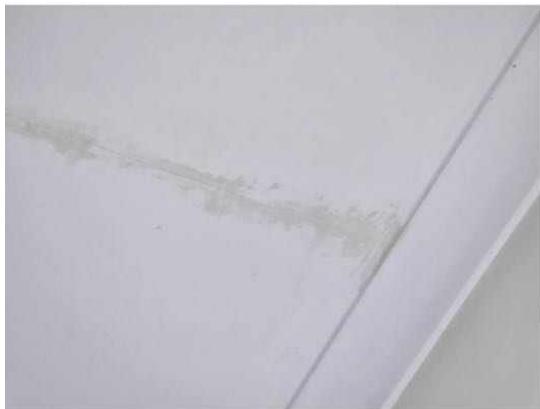
Defects 3.18

Building: Main Building
 Location: Lounge Room > Front
 Finding: Ceiling - Water stained
 Information: Water staining to ceiling linings in this area was evident at the time of inspection. Water staining indicates that surfaces have been exposed to excessive moisture over time. The minerals and other elements in the water lead to staining, which may graduate to corrosion and deterioration if left unmanaged.

While mostly an appearance defect, water staining can be indicative of more serious defects, which may be currently concealed by interior ceilings.

Where water staining is active, a licensed plumber must be consulted to identify the cause of the staining and to provide advice on any reparation works that may be required. Replacement of any damaged structures is advised.

Conversely, where water staining is old and inactive, affected building materials may be repaired or replaced at client discretion.

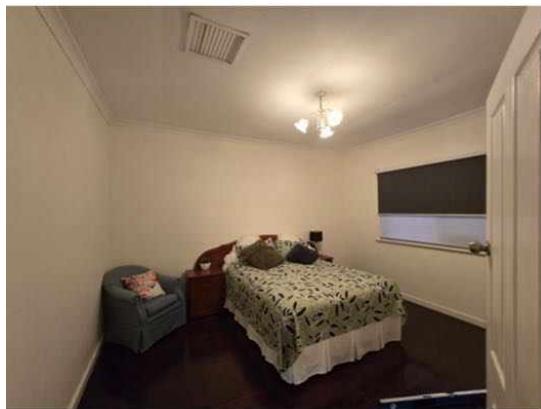
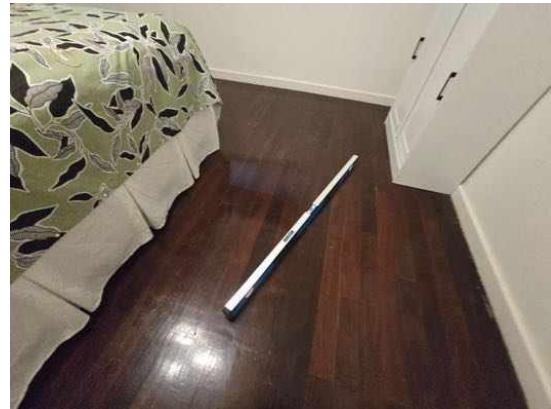
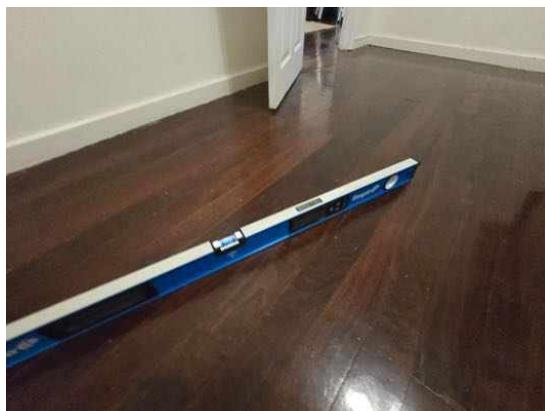
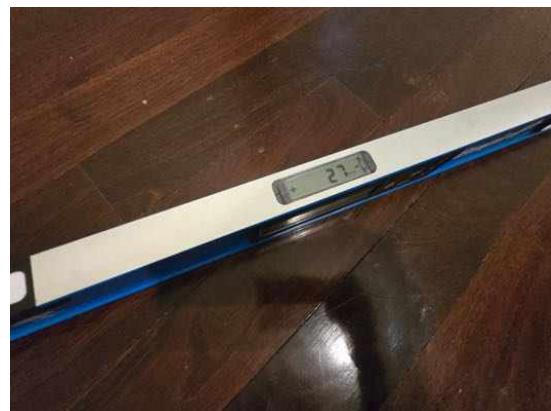
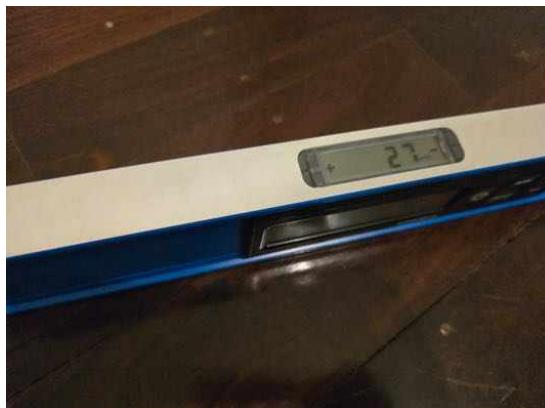
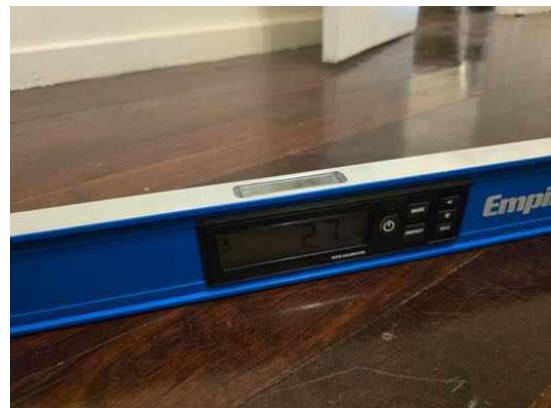
Defects 3.19

Building: Main Building
 Location: Bedroom 1 > Front Right
 Finding: Settlement/sinking of Floor - Suspected Inadequate Subfloor support or settlement of Subfloor foundation
 Information: Floor settlement/sinking were observed. Subfloor foundation was suspected to have inadequate support and inappropriately sub-base were moved underneath the pilasters. While this type of construction is common for the era of building, additional support or underpinnig may be required.

Lack of support subfloor structures are likely to create strain on associated building elements, creating potential for primary damage including the collapse of subfloor. The subfloor is also unlikely to have sufficient support, which may lead to further settlement if left unmanaged.

- Level Measurements:
 - Measurements taken using a digital level indicate minor variations in the floor level is up to 31 mm/m slope, consistent with expected settlement over time.
- Cause: Likely due to Subfloor foundation settlement and/or inadequate support to floor.

- No major structural compromise such structural cracks on wall due to settlements was observed.

It is advised that a Structural engineer be appointed to provide remedial advice which then could then be carried out by a licensed builder.

While it would appear that this defect has been present for a long period of time repair is recommended in the short term to ensure the longevity and structural integrity of the dwelling.

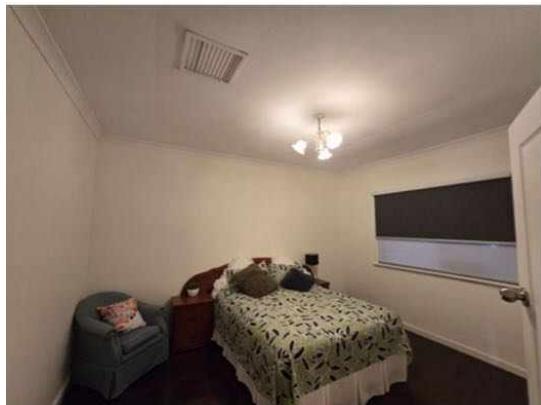
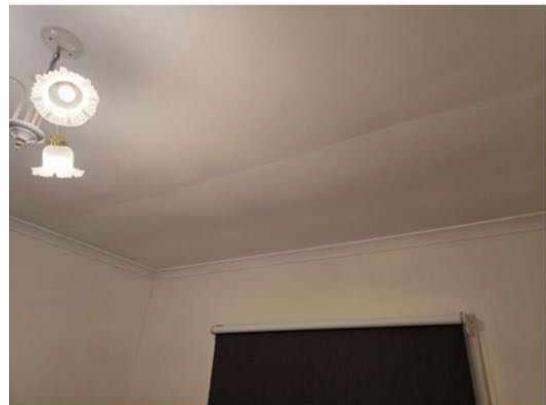
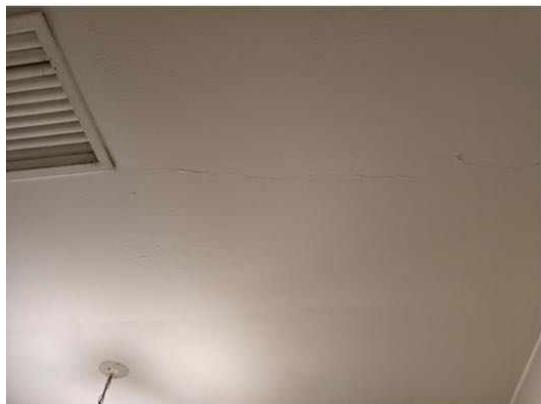
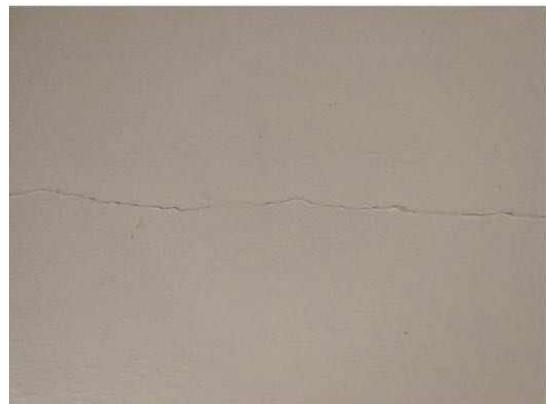
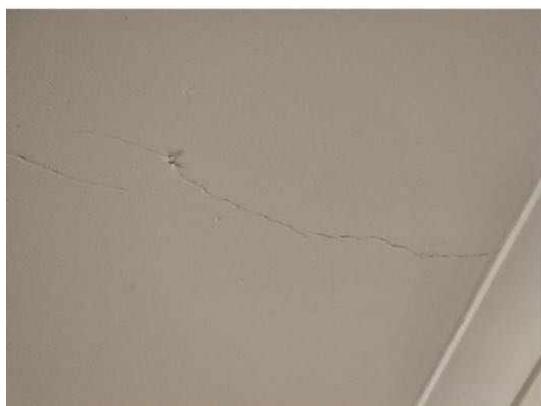
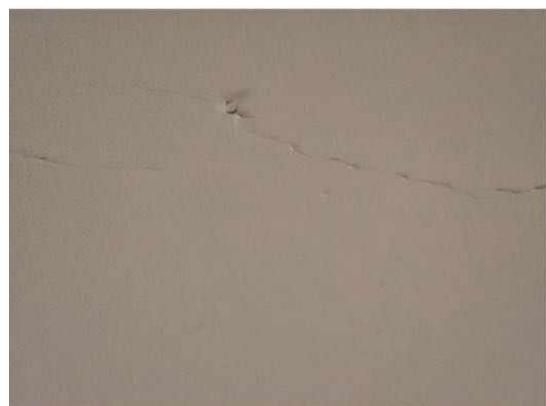
Defects 3.20

Building: Main Building
Location: Bedroom 1 > Front Right
Finding: Cracks to internal rendered surfaces (hairline)
Information: It has been observed that cracking to internal rendered surfaces has occurred. The degree of damage falls within Category 0, described as hairline cracks that do not require repair and which are less than 0.1mm in width limit.

Damage of this category is not considered a defect for rectification. Always contact your building inspector should cracks widen, lengthen, or become more numerous.

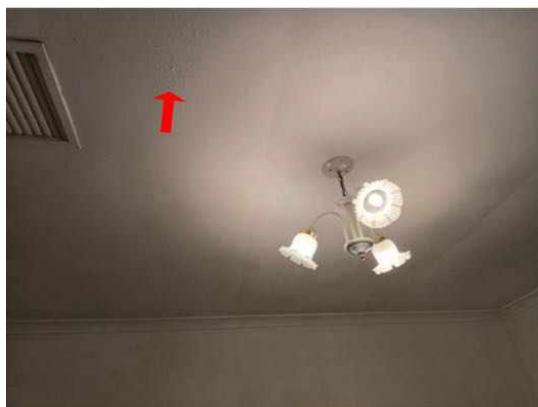
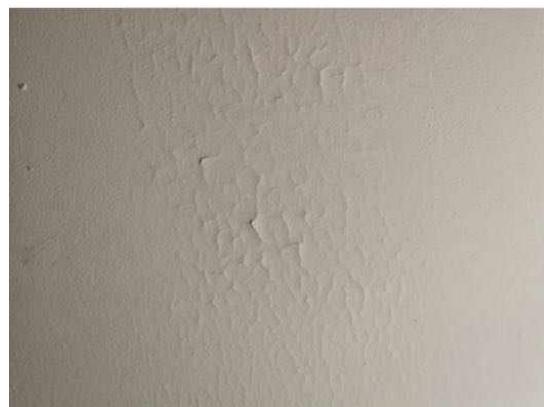
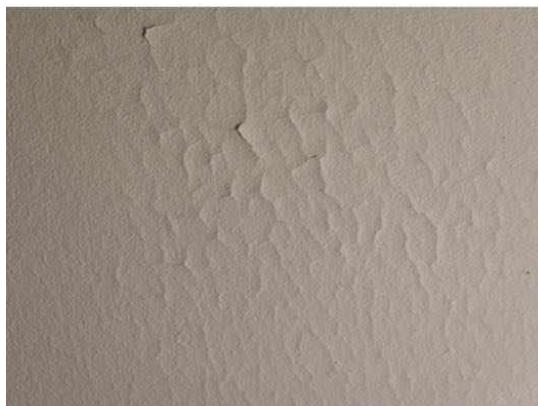
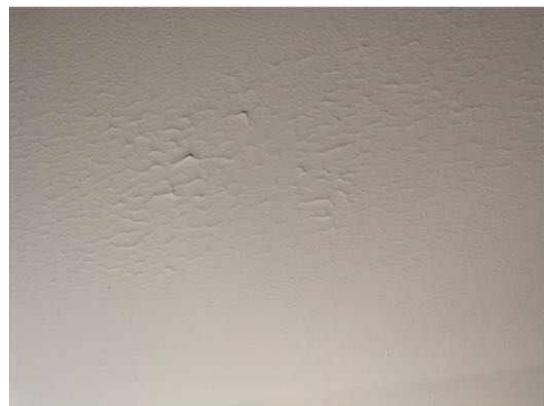
Defects 3.21

Building: Main Building
 Location: Bedroom 1 > Front Right
 Finding: Ceiling - Water damaged
 Information: Water damage to the ceiling lining is generally an indication of excessive moisture being present in the roof void, usually via a leak to the roof covering.

Where water damage is evident to the ceiling, the primary requirement is to identify and rectify the source of the leak. A roofing plumber should be appointed as soon as possible to identify the leak and perform rectification works as necessary, ensuring the water damage is restricted.

Once the leak is repaired, consultation with relevant tradespeople, including plasterers and painters, is advised. Rectification works may include replacement of ceiling lining or minor repainting, depending on the extent of the damage.

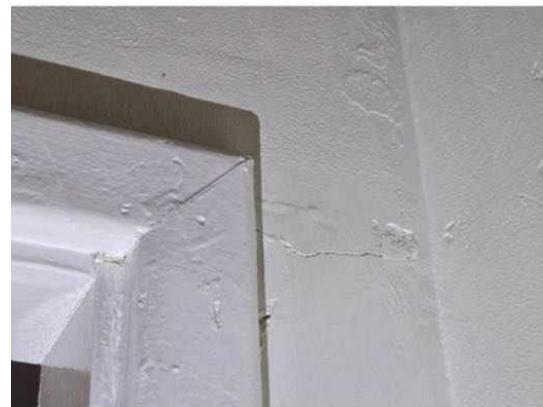
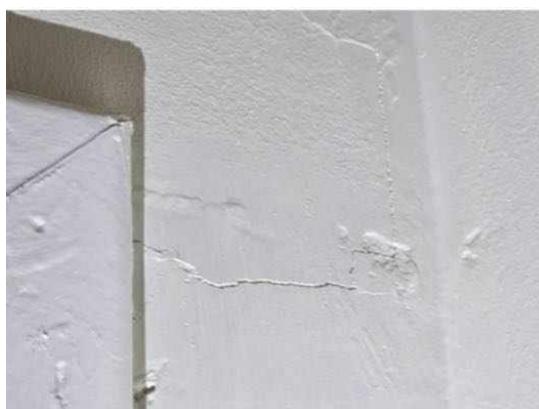
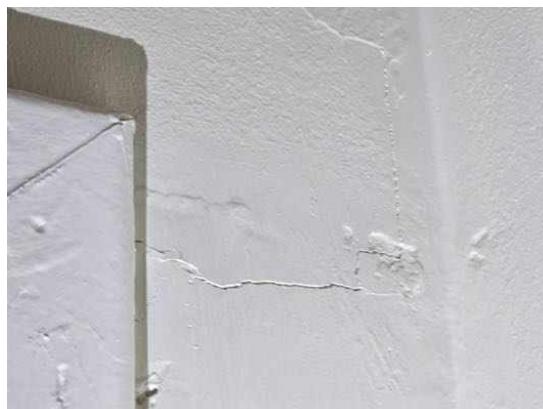
Defects 3.22

Building: Main Building
 Location: Dining Room > Centre
 Finding: Cracks to internal rendered surfaces - Category 1
 Information: It has been observed that cracking to internal rendered surfaces has occurred in this area. The degree of damage falls within Category 1, described as fine cracks that do not need repair and which are less than 1.0mm in width limit.

Damage of this category is not considered a defect for rectification. Always contact your building inspector should cracks widen, lengthen, or become more numerous.

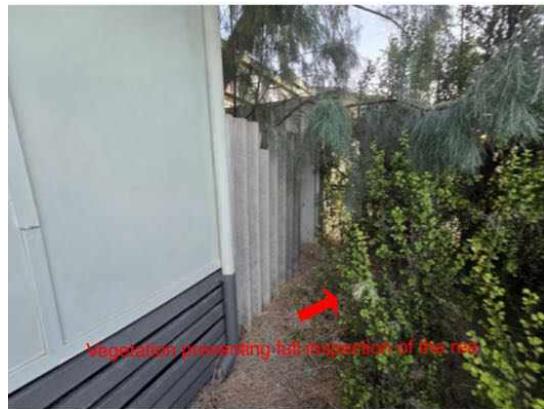
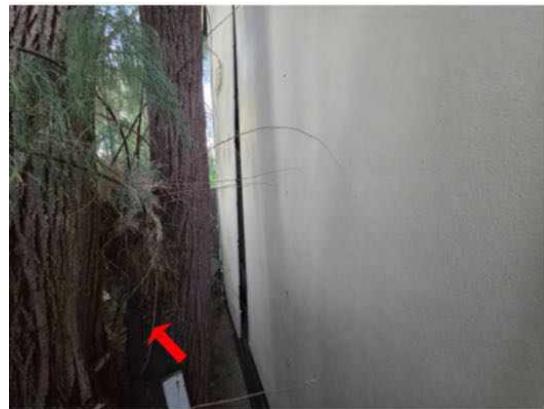
Building: Main Building
Location: All Areas > All Areas
Finding: Additional Photos - Obstructions and Limitations
Information: These photographs are an indication of the obstructions and limitations which impeded full inspection of the property at the time of inspection. These obstructions can hide an array of defects and should be removed to allow full inspection to be carried out. A re-inspection is recommended once the areas are made accessible.

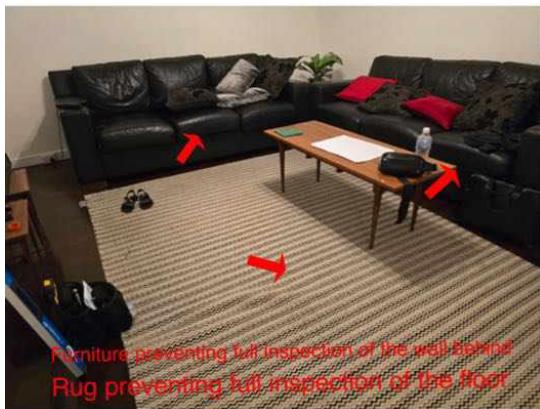
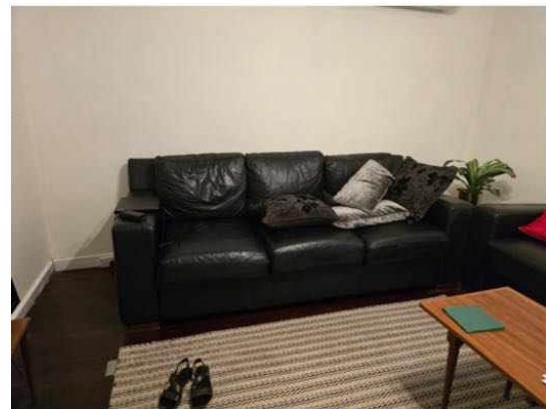
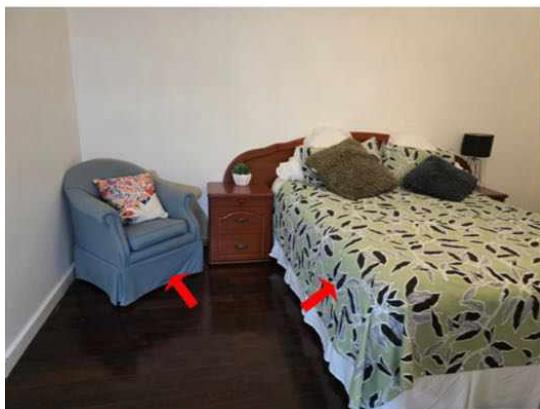
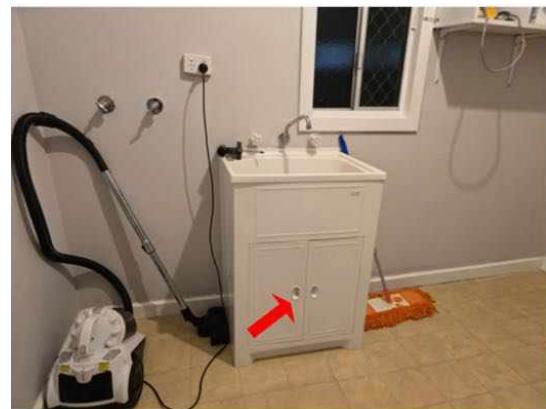
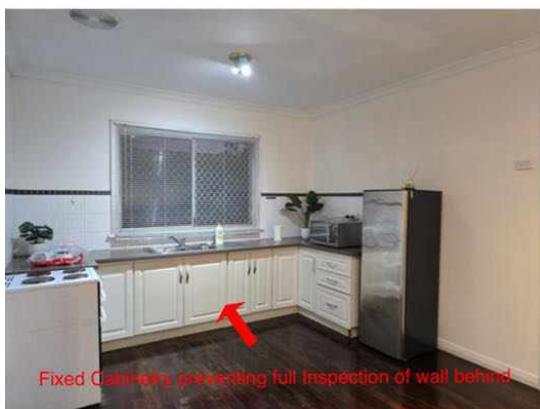
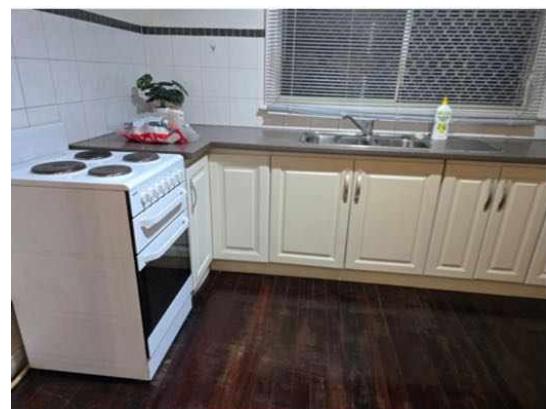
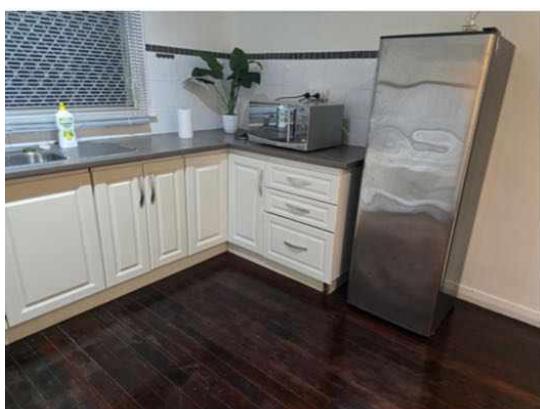
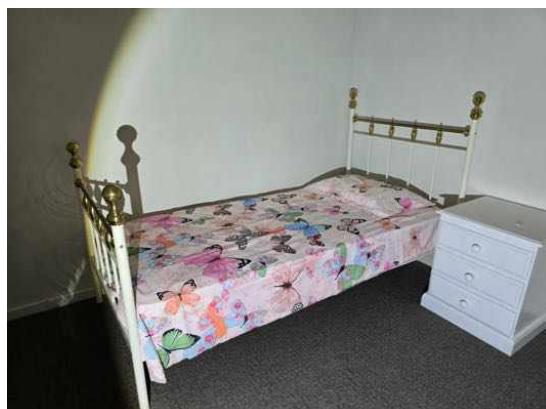
Building: Main Building
Location: All Areas > All Areas
Finding: Additional Photos - Obstructions and Limitations
Information: These photographs are an indication of the obstructions and limitations which impeded full inspection of the property at the time of inspection. These obstructions can hide an array of defects and should be removed to allow full inspection to be carried out. A re-inspection is recommended once the areas are made accessible.

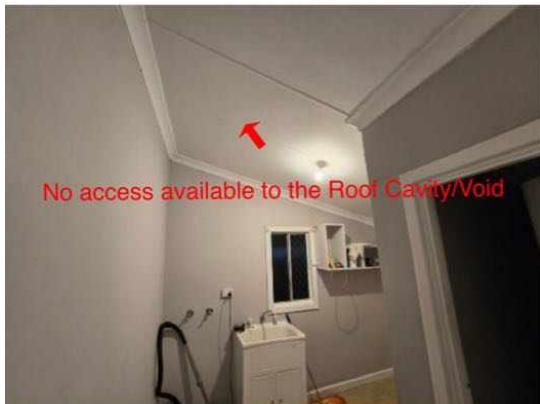
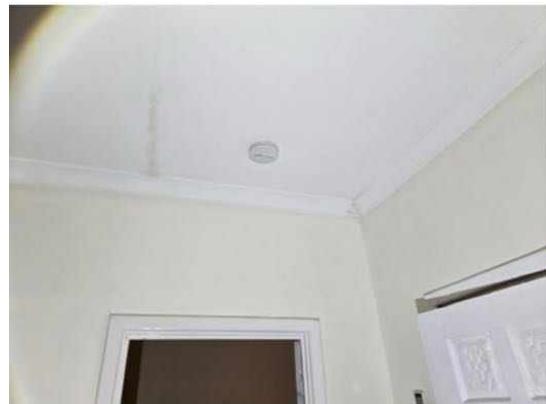
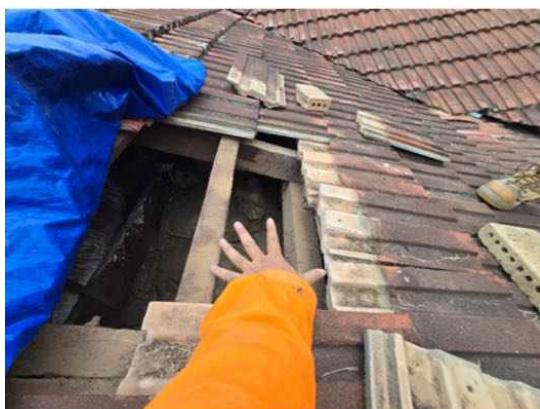
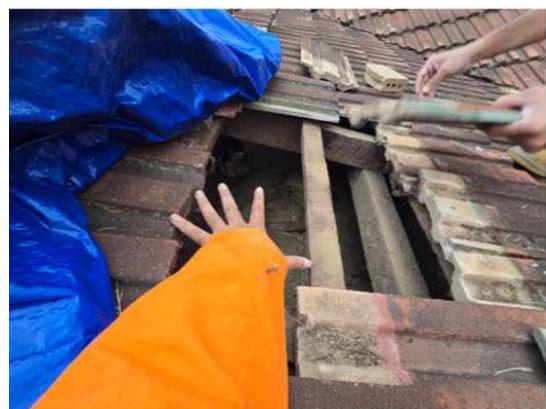
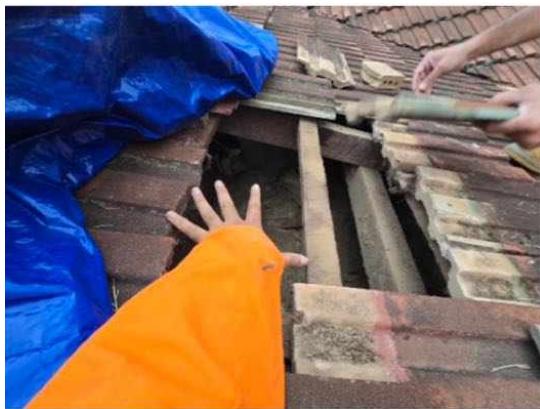
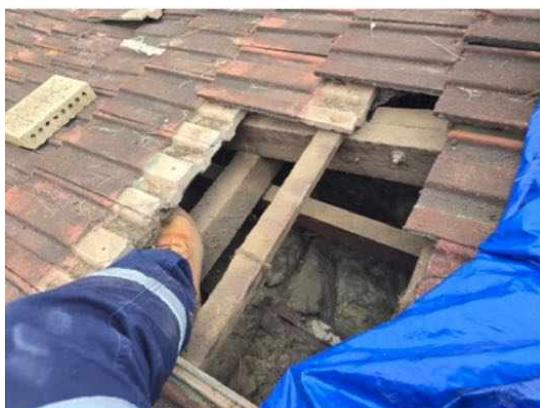
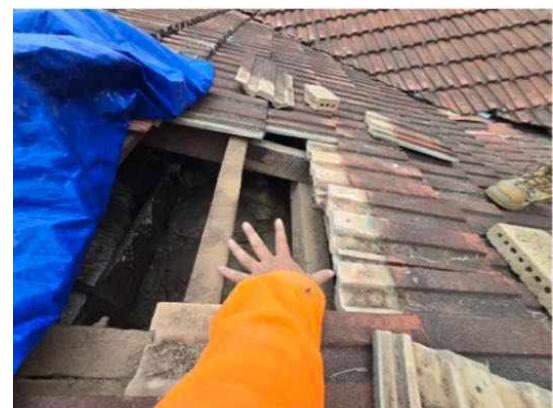
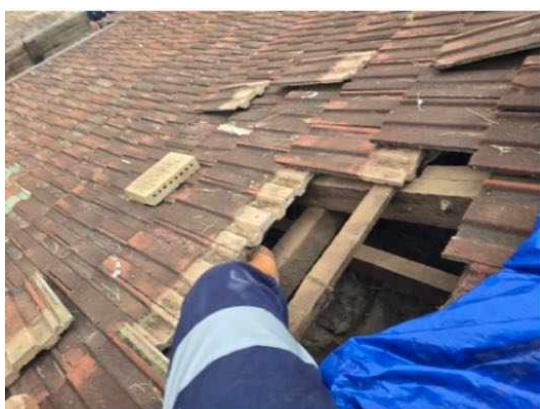
Building: Main Building
Location: Roof Void > All Areas
Finding: Obstructions and Limitations - Roof Cavity
Information: These photographs are an indication of the obstructions and limitations which impeded inspection of the Roof Cavity area at the time of inspection. These obstructions can hide an array of defects and should be removed to allow full inspection of the Roof Cavity to be carried out. A re-inspection is recommended once the areas are made accessible.

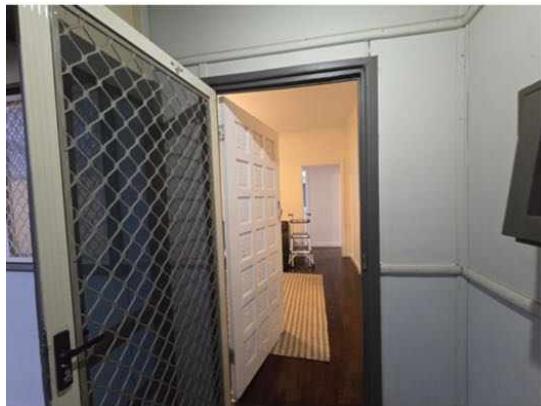
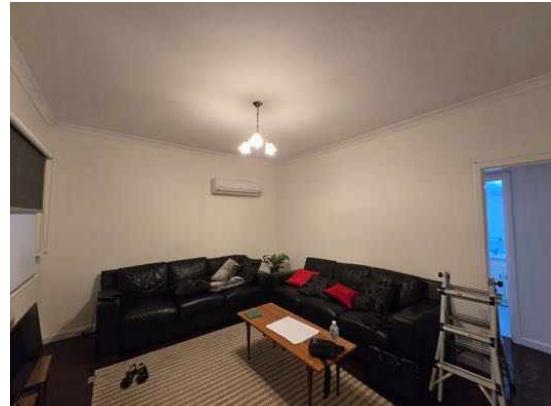
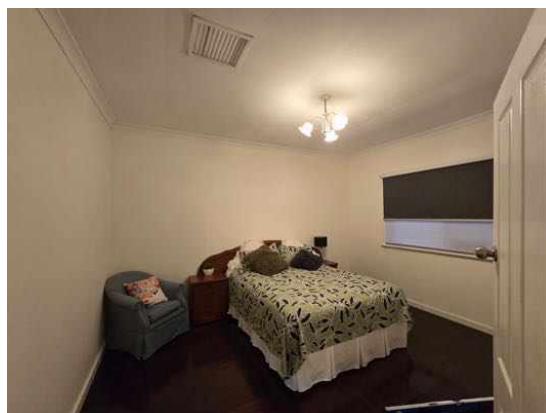
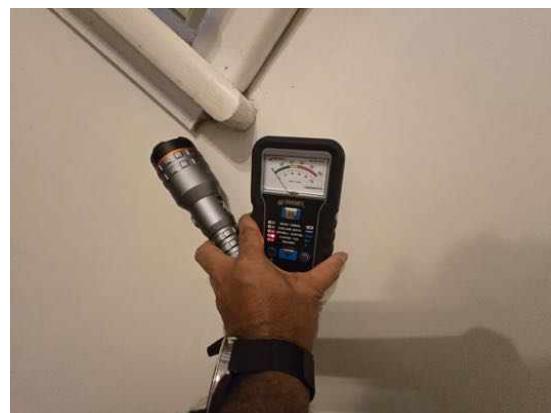
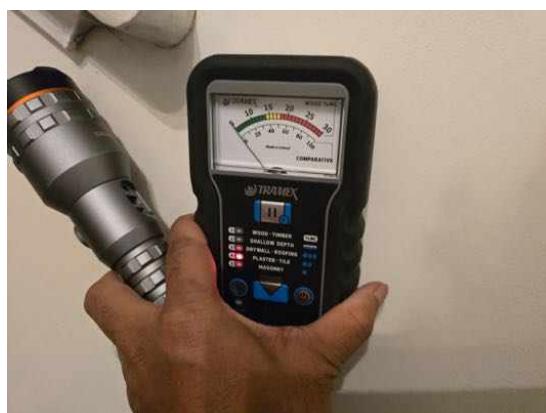
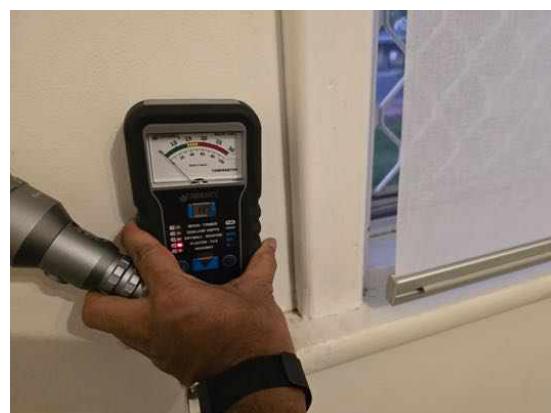
Building: Main Building
Location: All Areas > All Areas
Finding: Additional Photos
Information: Additional photos are provided for your general reference

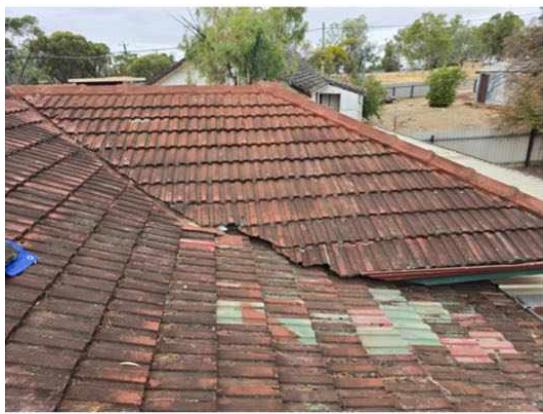
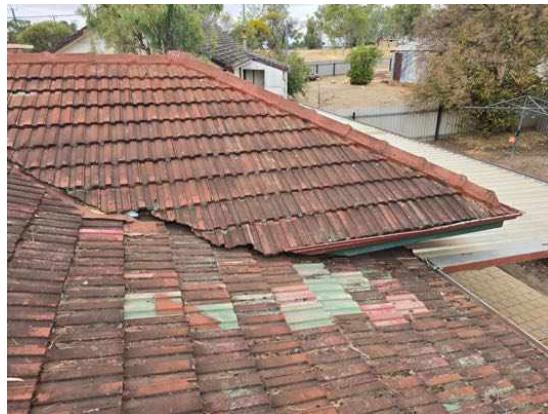
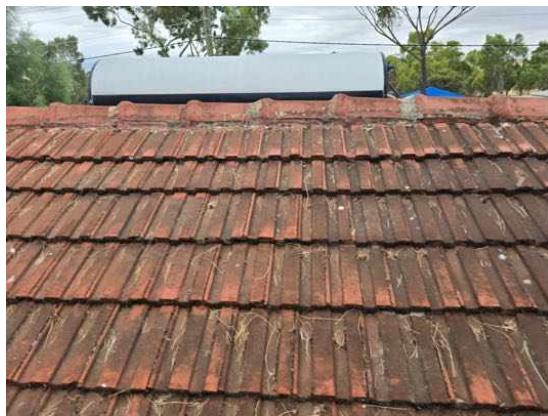
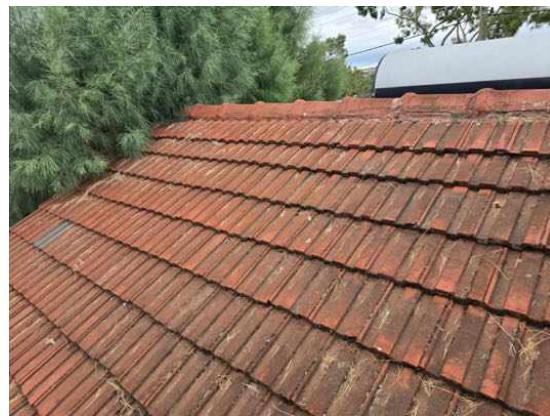
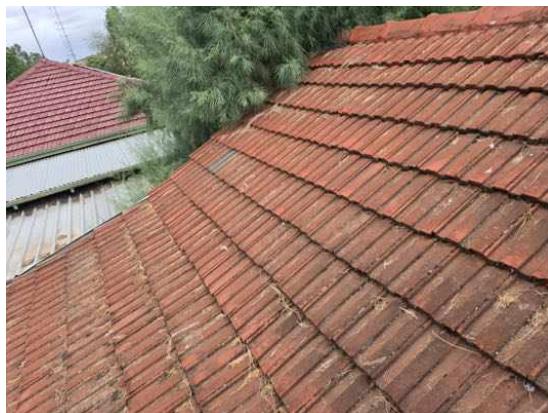
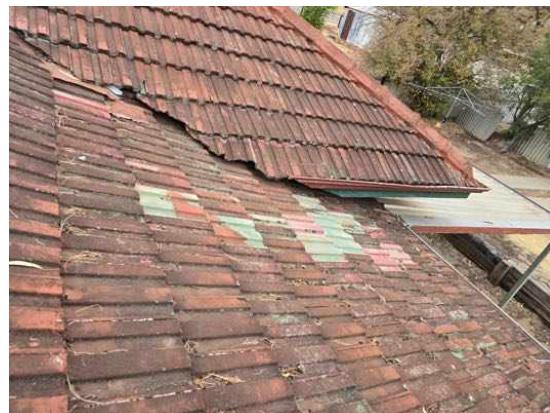
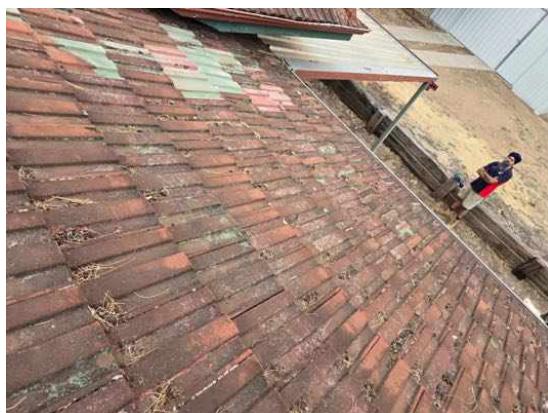
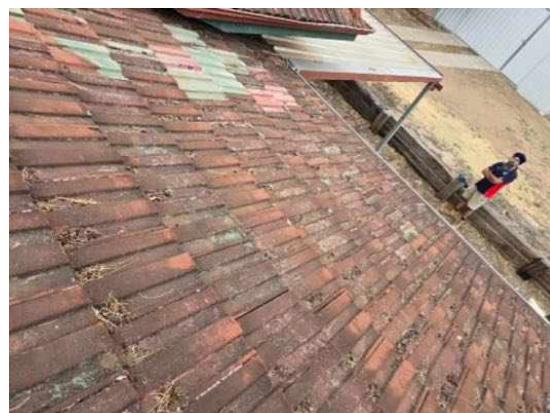
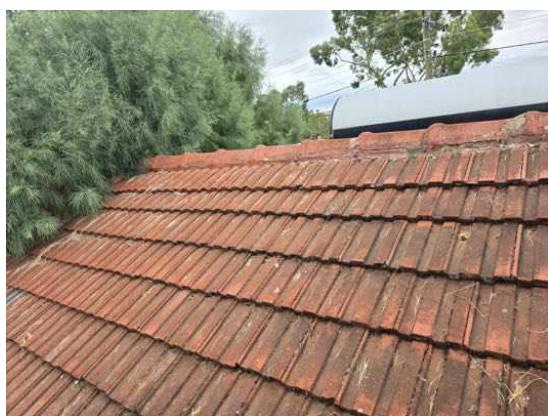
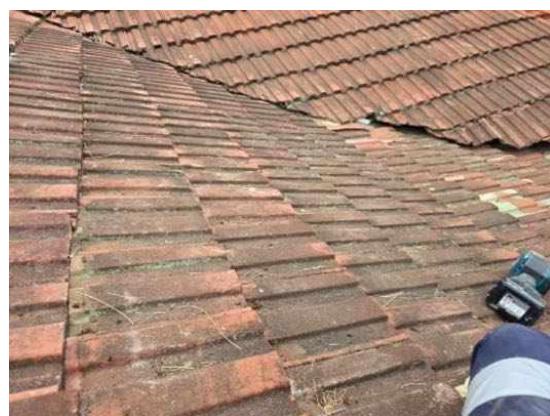
Noted Item

Building: Main Building
Location: Roof Exterior > All Areas
Finding: Additional Photos
Information: Additional photos are provided for your general reference

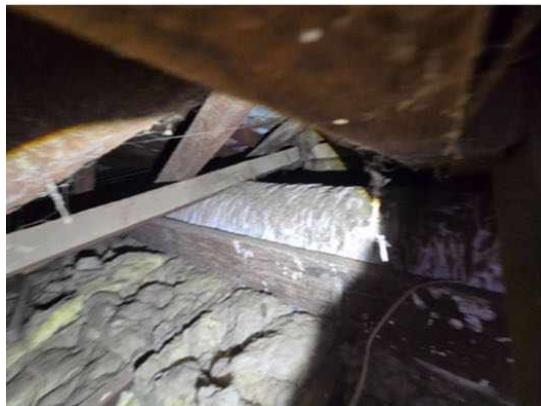
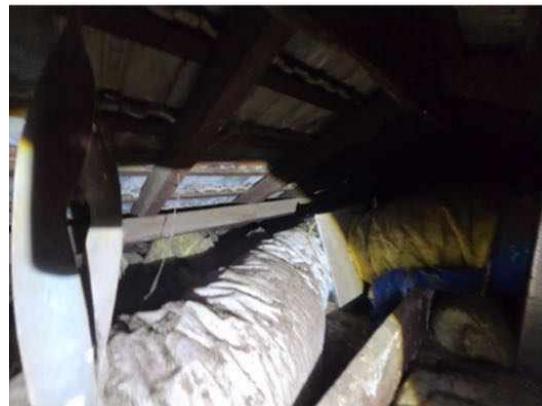
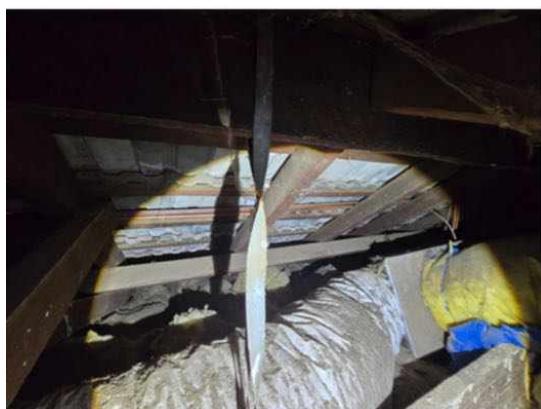
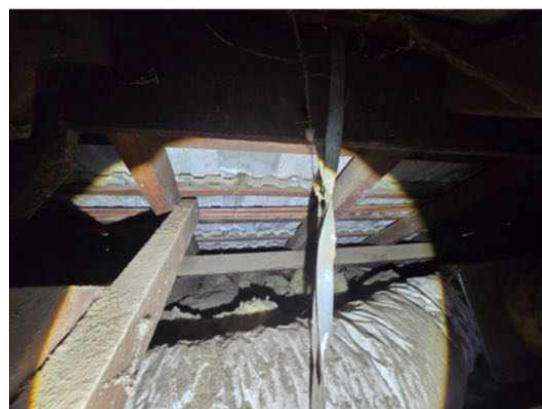
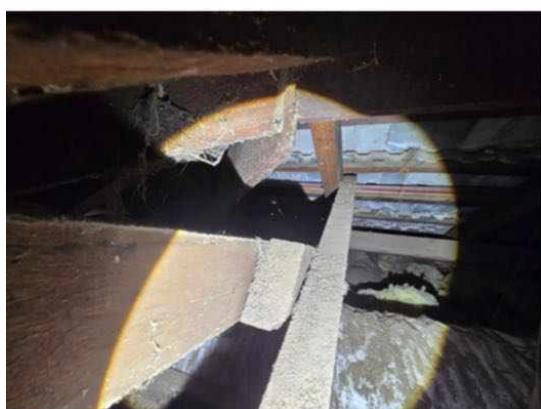
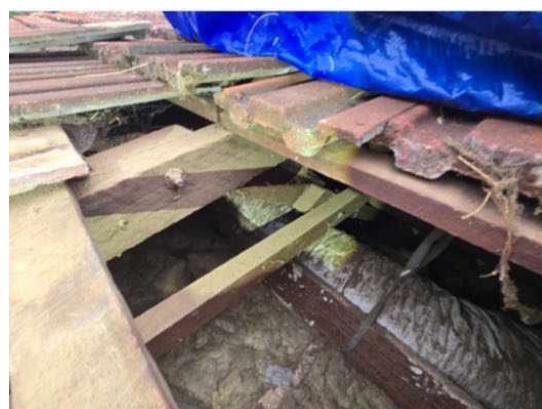
Noted Item

Building: Main Building
Location: Roof Void > Rear, Centre
Finding: Additional Photos
Information: Additional photos are provided for your general reference
