Safety Inspection Report

Annual Inspection

The Playground

21 November 2019

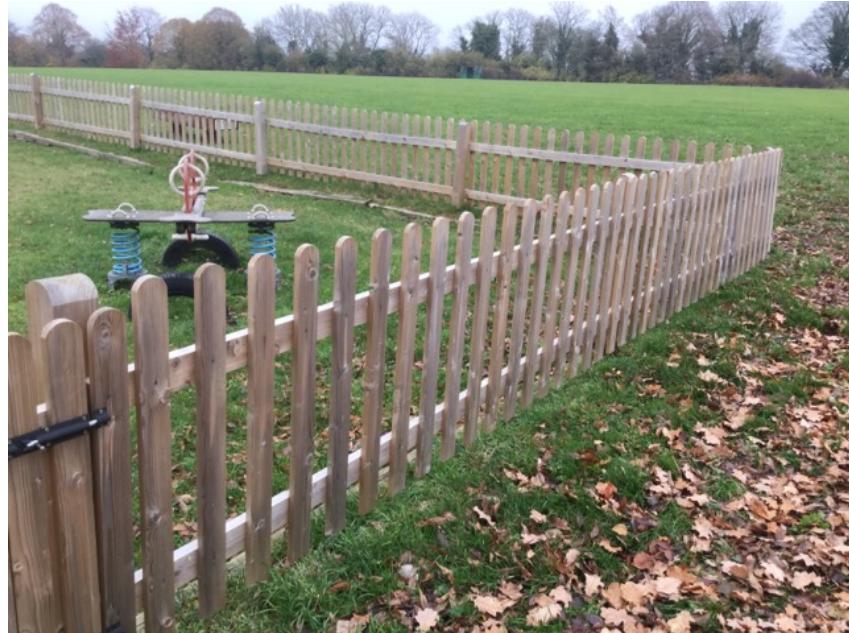
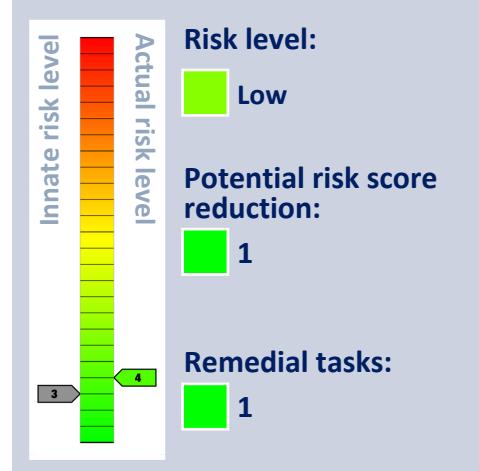
Fencing

Timber is decayed.

Low

Replace affected parts.

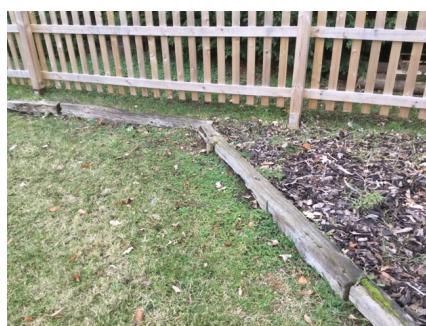
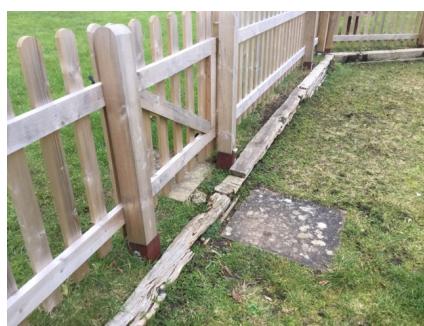
4

Sleeper retainers and posts.

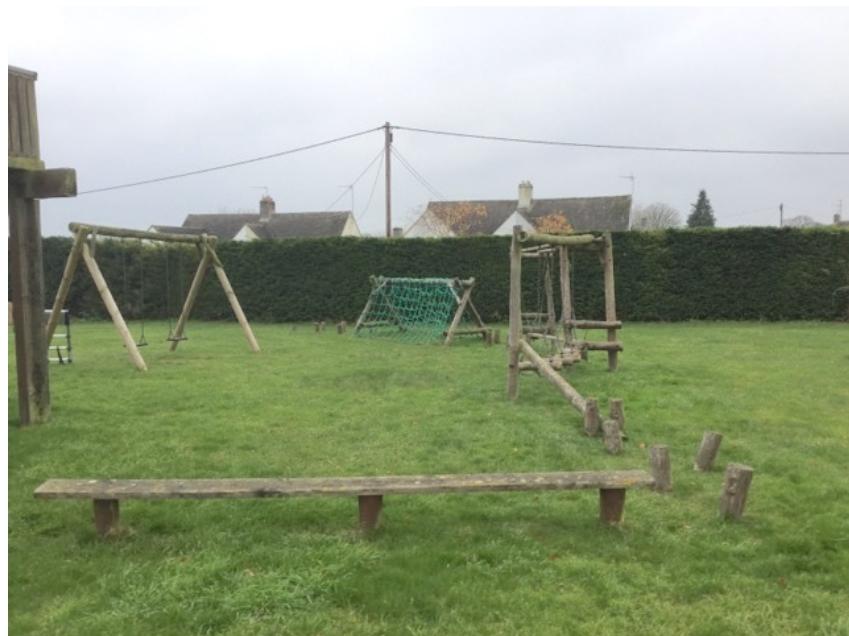
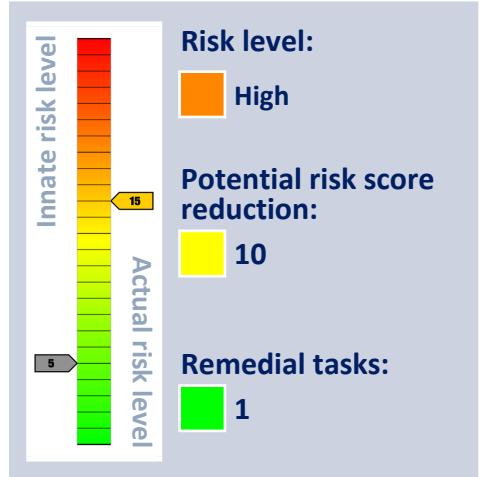
Agility Trail

Decay to parts throughout unit.

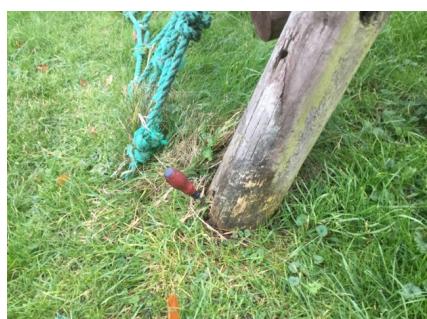
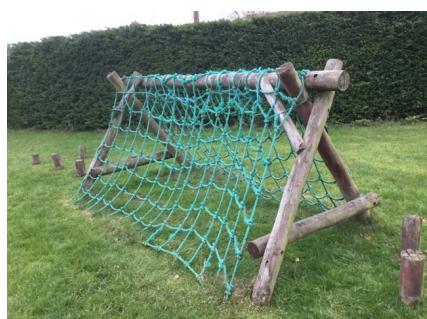
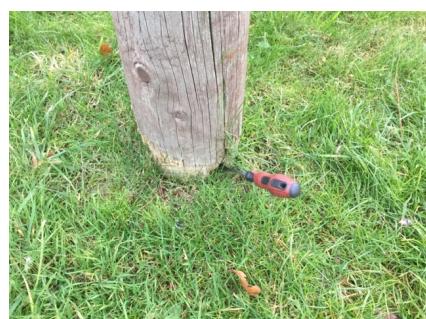
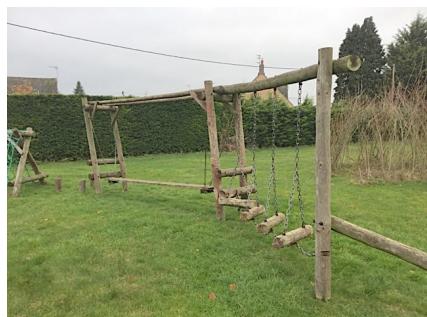
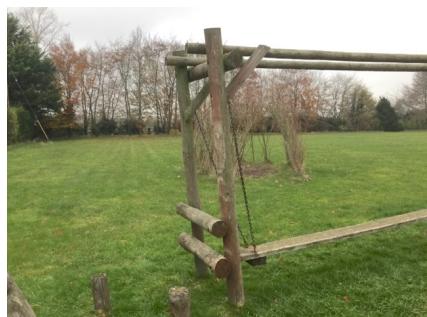
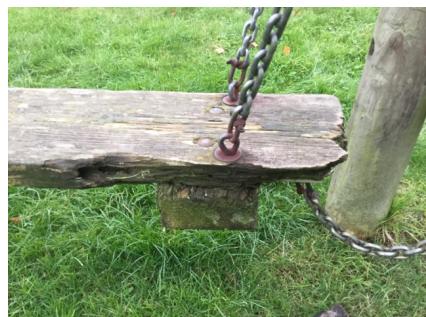
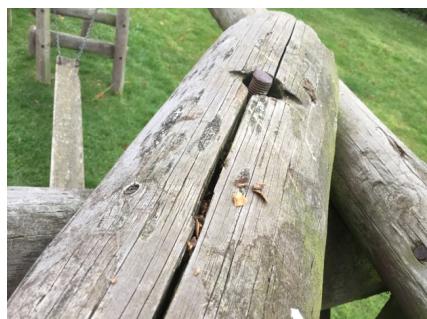
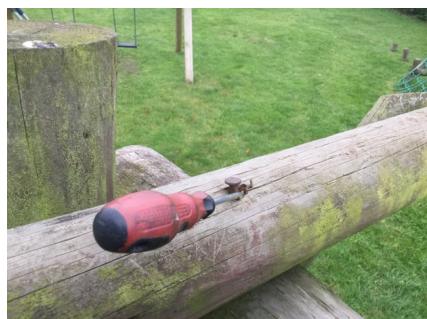
Item is at the end of its useful working life.

High

15

Swinging logs / suspended beam element is unstable.

Remove immediately.

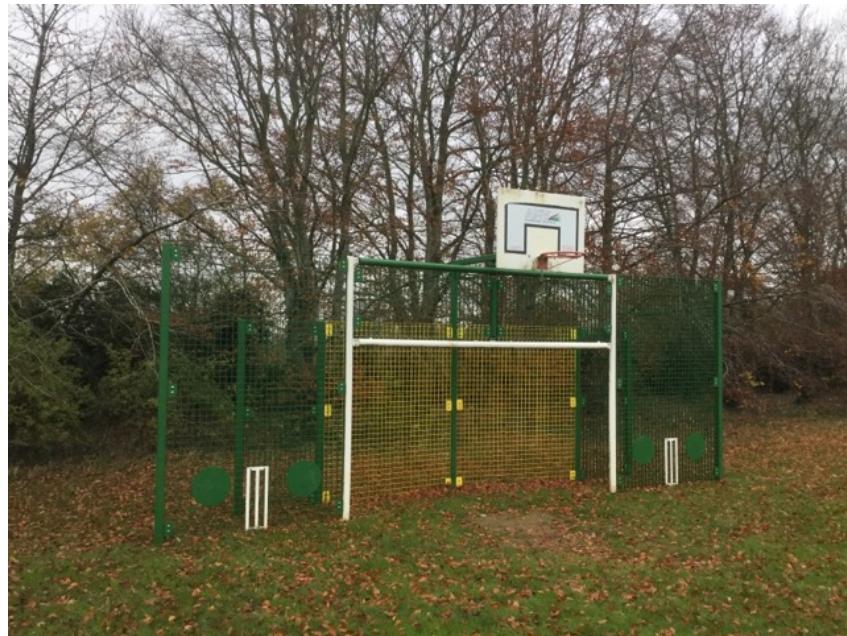
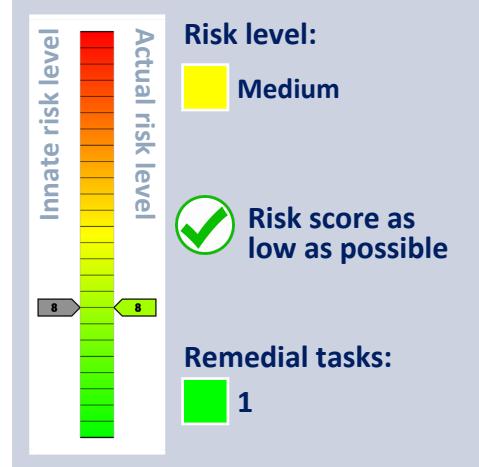
Combination Goal

Surface is wearing.

Repair.

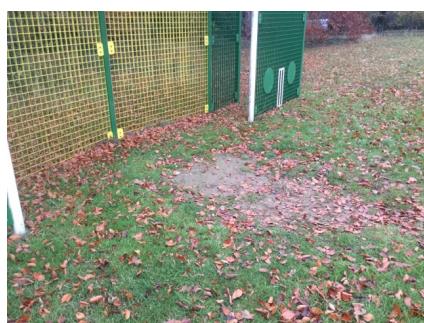
Low

4

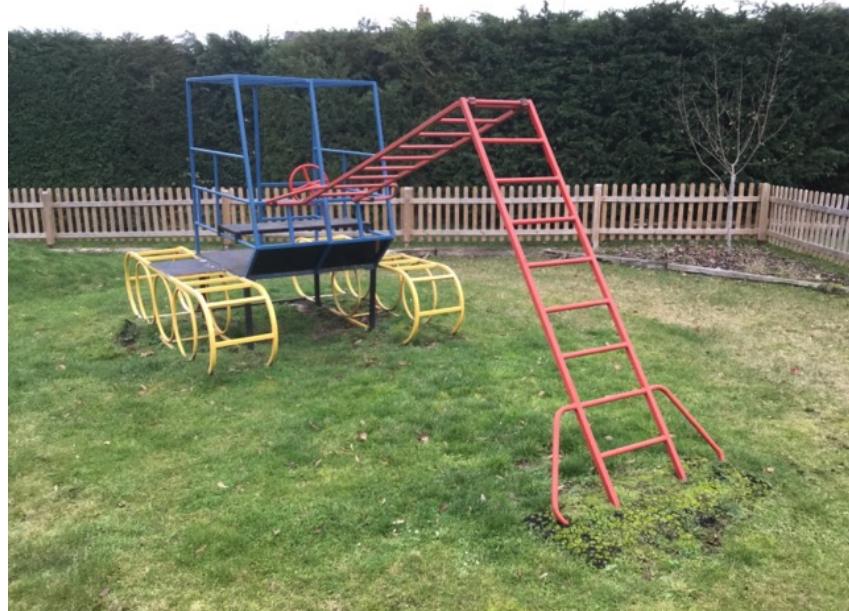
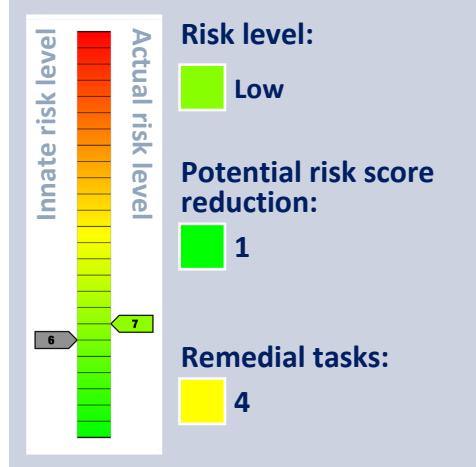
Multiplay - Tractor

There is significant corrosion on this item.

De-scale back to good metal and coat with lead free paint, using appropriate precautions. Repairs may be necessary where corrosion is severe.

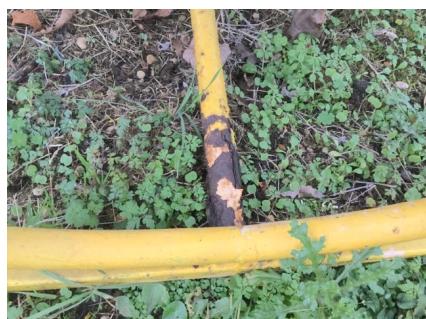
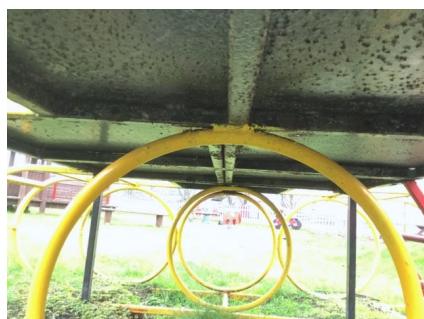
The item or its surfacing are not compliant with the requirements of the relevant standards.

Low

7

Under unit.

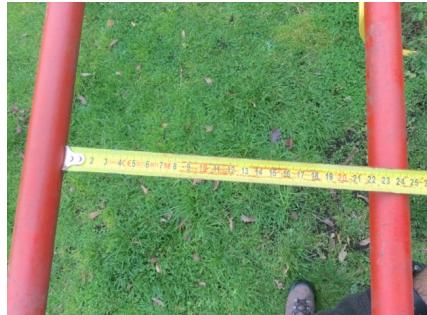
There is a head entrapment.

No reasonably practicable action is identified.

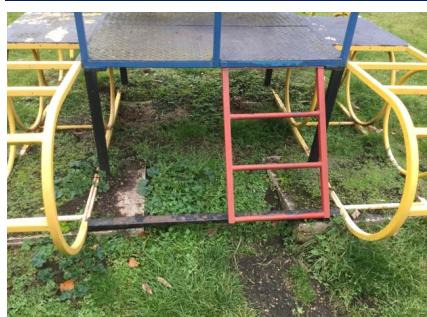
The safer surface has hard edging / foundation within the impact area.

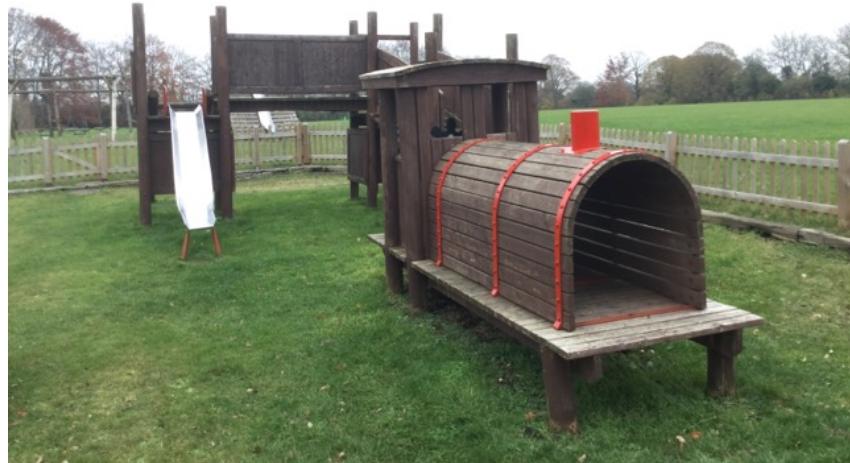
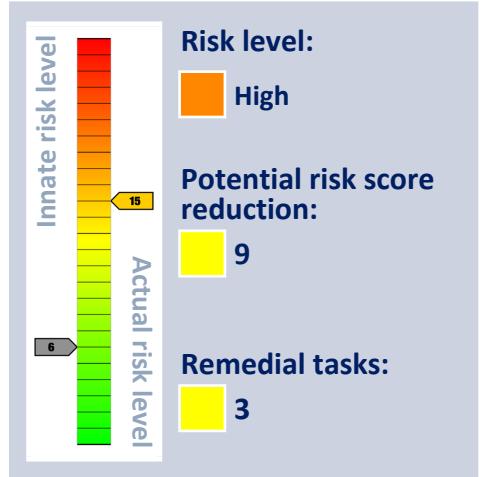
Multiplay - Train - With Slide

Decay throughout unit.

Timbers on platforms, barriers and steep play elements are worn.

Slide is loose in ground.

Programme early replacement.

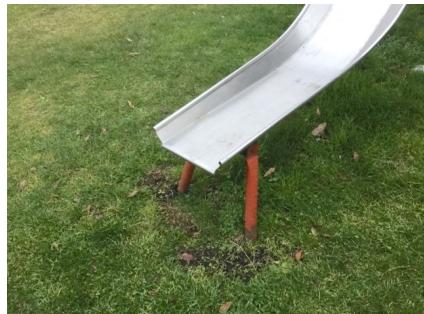
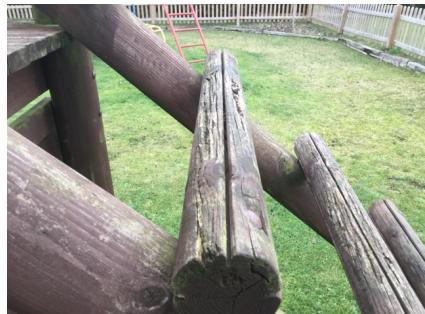
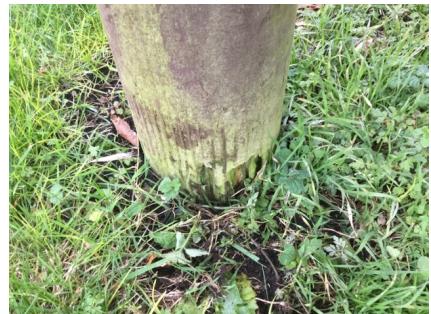
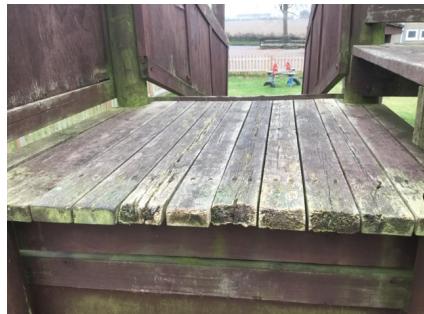
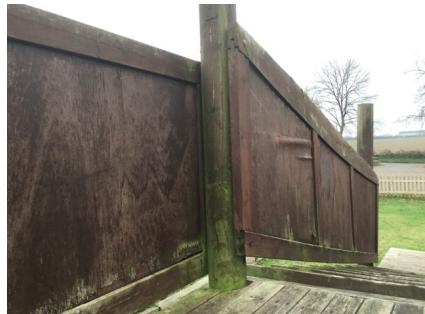
The item or its surfacing are not compliant with the requirements of the relevant standards.

Item is at the end of its useful working life.

Supports have not been set deep enough allowing item to rock excessively.

Lighter sections can be lifted out of surface.

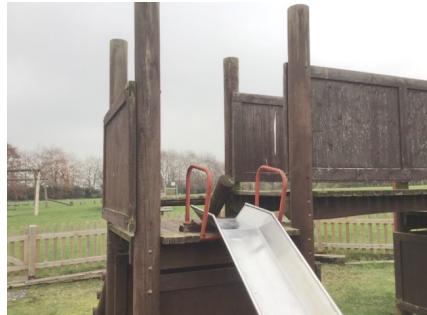
Slide bar not fitted across the access to the slide.

Very low

3

No reasonably practicable action is identified.

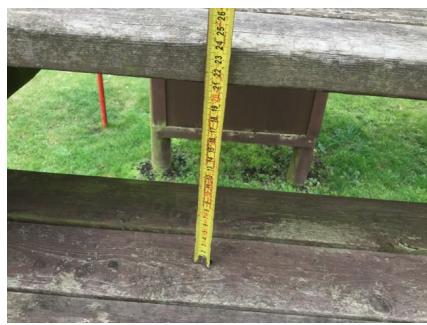
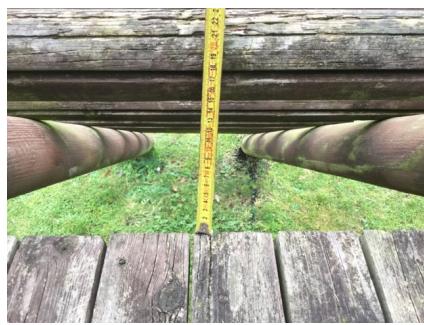
There is a head entrapment.

Low

5

Gaps from platforms to bridge as well as slide platform to ladder.

No reasonably practicable action is identified.

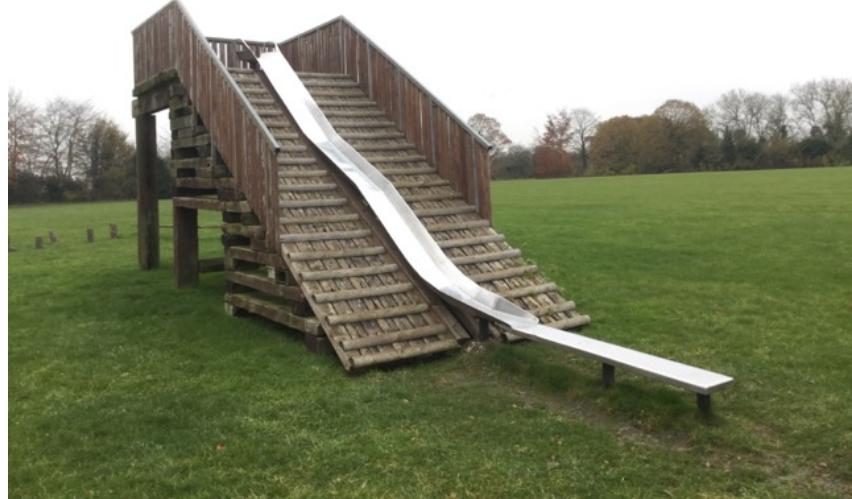
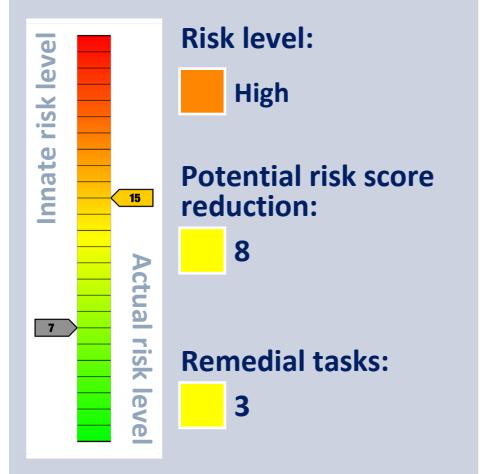
Slide

Decay throughout the unit.

Programme early replacement.

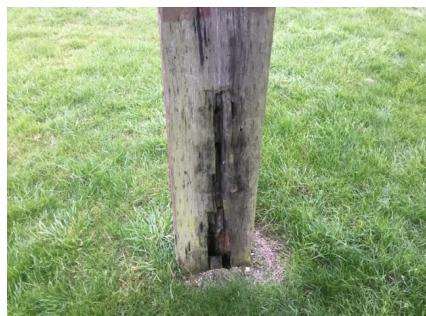
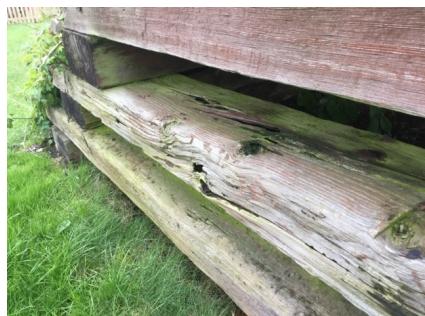
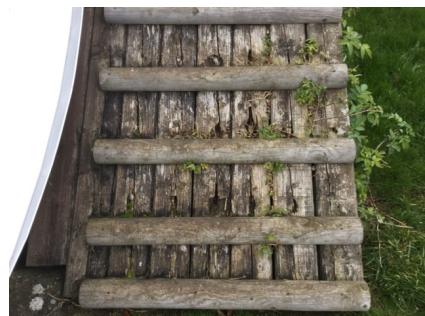
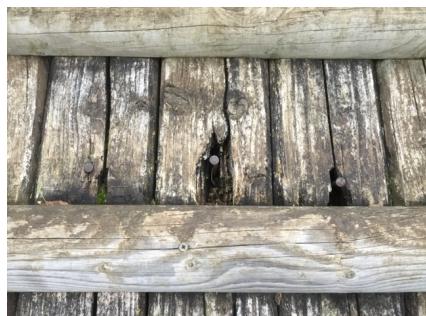
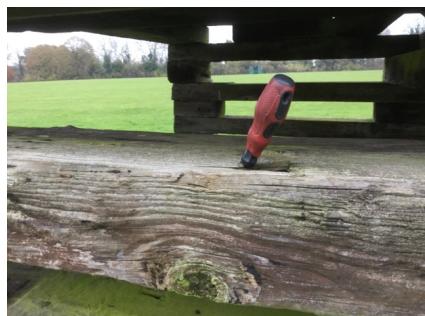
The item or its surfacing are not compliant with the requirements of the relevant standards.

Item is at the end of its useful working life.

High

15

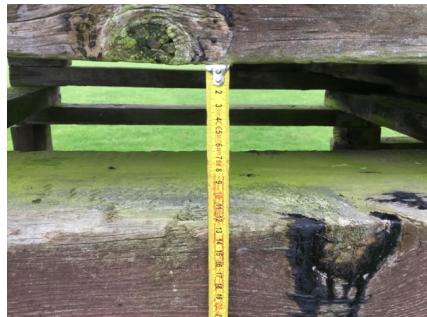
There is a head entrapment.

No reasonably practicable action is identified.

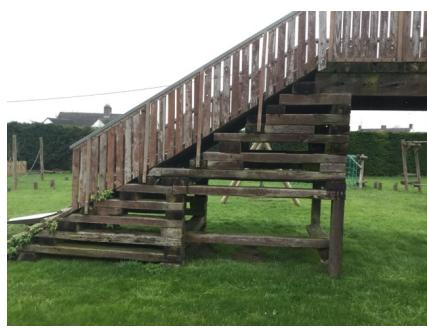
Sleepers encourage climbing of exterior of structure.

No reasonably practicable action is identified.

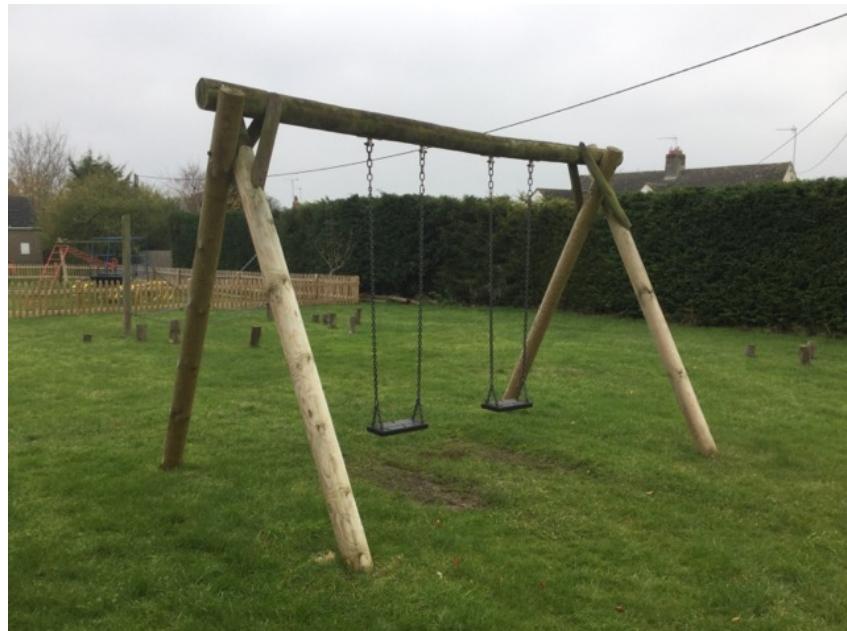
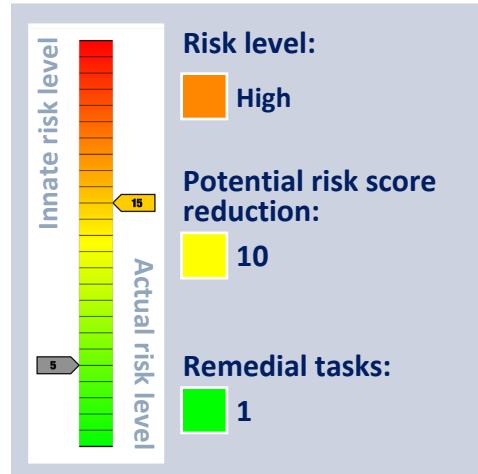
Swing - Junior - 1 Bay 2 Seat

Timber is decayed.

Top bar is old and sodden and should be replaced.

Replace affected parts.

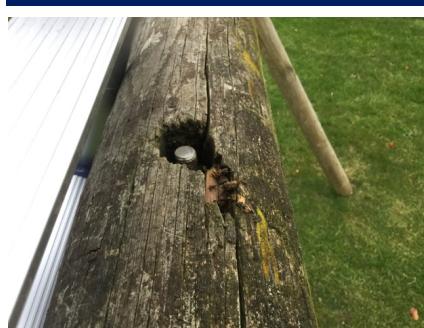
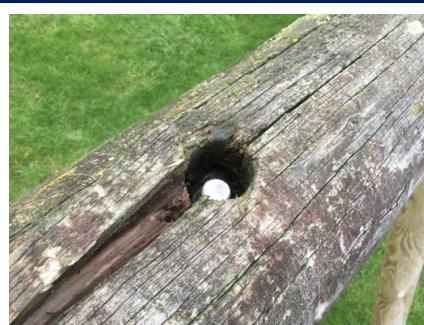
High

15

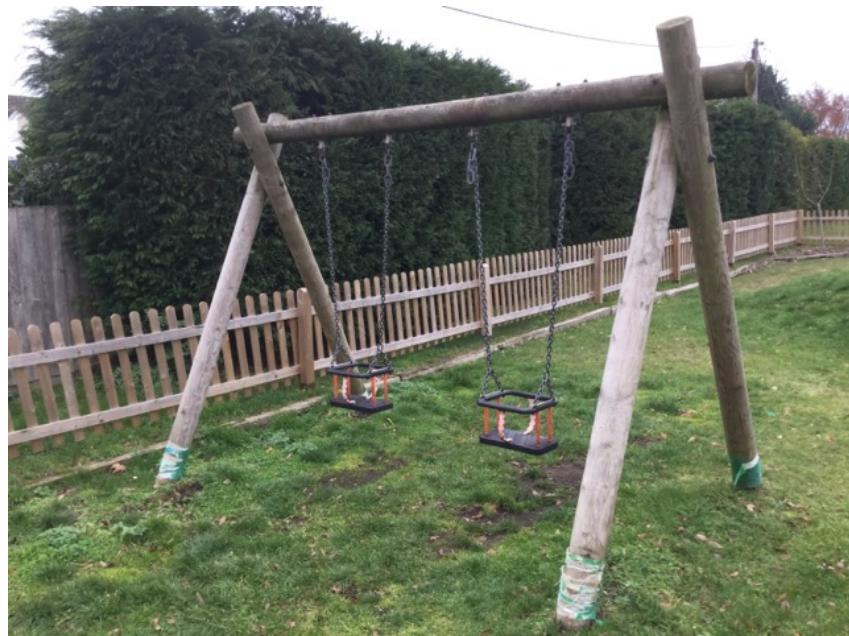
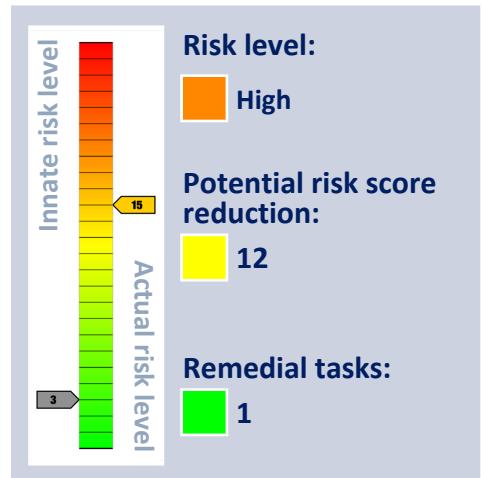
Swing - Toddler - 1 Bay 2 Seat

There is decay to timber components which may affect structural integrity. We do not recommend replacing rotten supports with timber posts which are directly set in the ground due to the increased problem of timber rot, especially in posts in contact with the ground.

Replace decayed components where possible and plan replacement of item.
Check on a routine basis, especially at ground or foundation level.

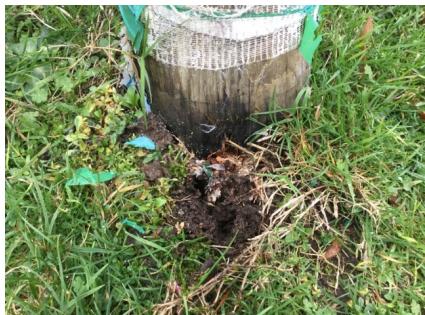
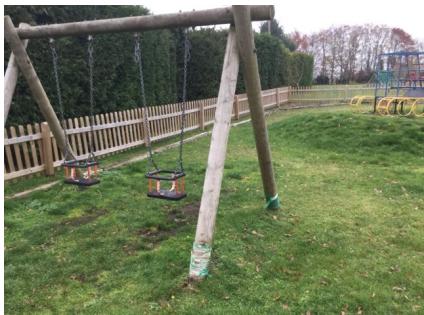
High

15

Support closest to picnic bench.

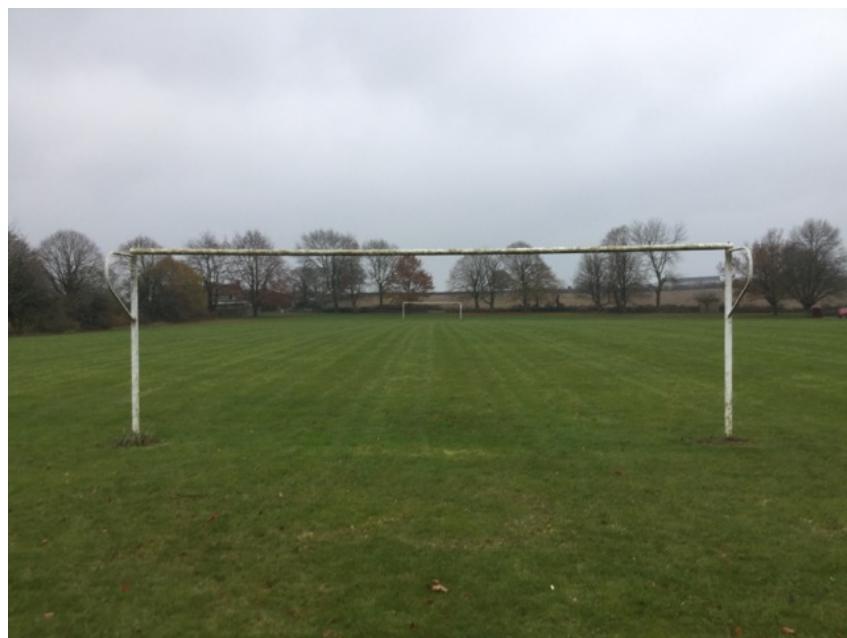
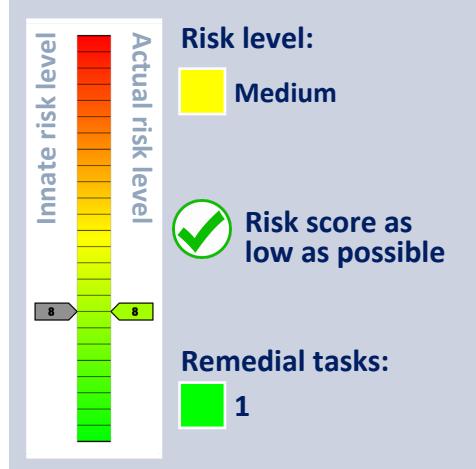
Goal Posts

Paintwork is in poor condition.

De-scale back to good base material and coat with lead free paint, using appropriate precautions. Repairs may be necessary where corrosion is severe.

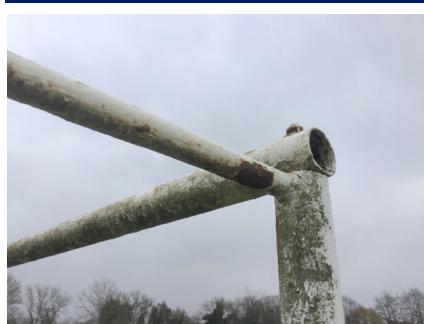
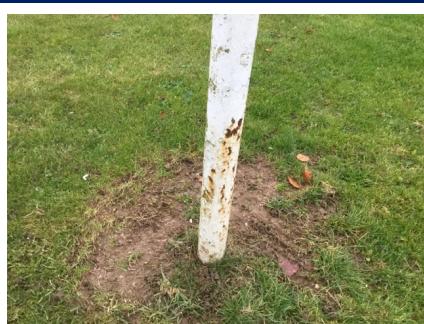
Low

5
