## **Raspberry Pi 5 Camera Not Detected – Fixed (IMX219 / Third-Party Cameras)**

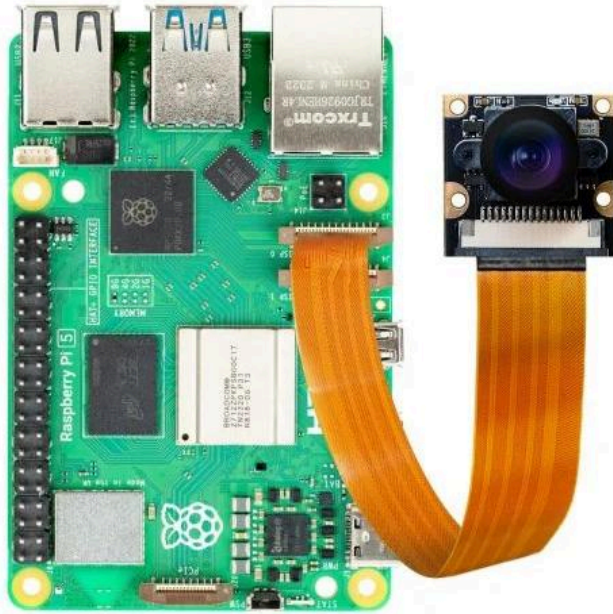
Connect the camera module:

1. Open the configuration file:

```
sudo nano /boot/firmware/config.txt
```

2. Disable camera auto-detection:

```
camera_auto_detect=0
```

3. Add this line at the bottom:

```
dtoverlay=imx219,cam0  
dtoverlay=imx219,cam1
```
