# Status of the Advanced Oxygen Generation Assembly

**Future Exploration missions will require an Oxygen Generation Assembly (OGA) to electrolyze water to supply oxygen for crew metabolic consumption. The system design will be based on the International Space Station (ISS) OGA but with added improvements based on lessons learned during ISS operations and technological advances since the original OGA was designed and built. The goal of these improvements will be to reduce spares mass and crew maintenance time while increasing reliability. Over the past year, the team has performed additional design reviews, testing and analysis in an effort to optimize upgrade efforts and achieve the best value that meets Exploration mission requirements. Upgrades that will be incorporated include: redesign of the electrolysis cell stack, redesign of the hydrogen dome, replacement of the hydrogen sensors, redesign of the recirculation loop deionizing bed, and incorporation of recirculation loop nitrogen purging and water flushing. The ISS OGA will be upgraded to an Advanced OGA (AOGA) configuration and its operation demonstrated in a relevant flight environment.**

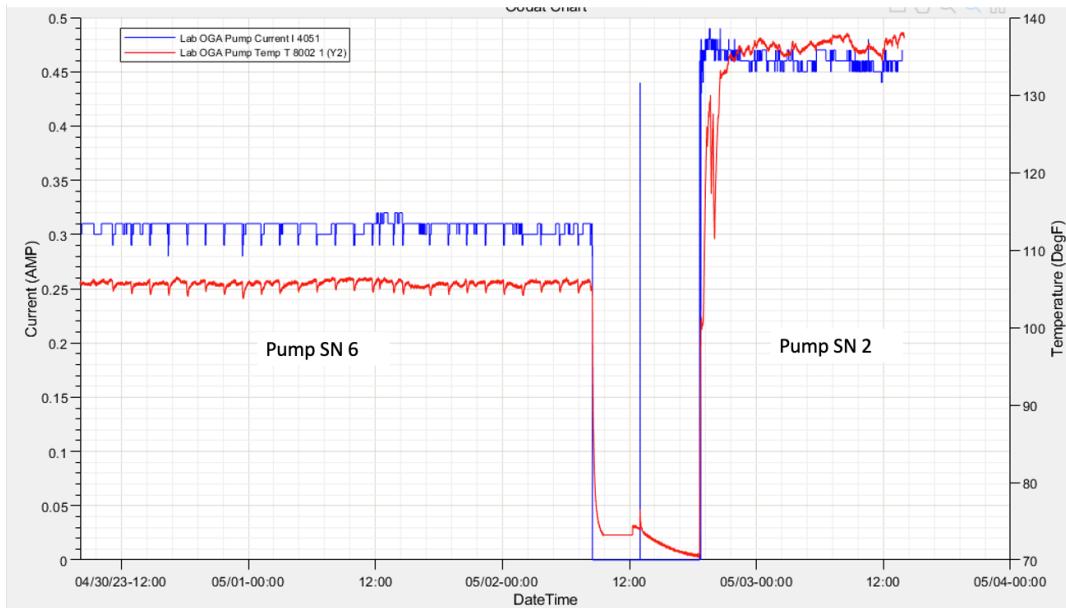
Because of the risk of lockup of new spare pump SN 2, SN 6 was removed from OGA, and SN 2 was installed on May 2, 2023. It started up without issue and continues to operate. As shown in Figure 4, pump SN 2 has a higher motor current than SN 6 (blue, 0.45 vs. 0.30 A) and a higher temperature (red, 135 vs. 105 F, 57 vs. 41 C). The high

**Figure 4. Pump SN 6 and SN 2 Current (blue) and Temperature (red)**

shutdown limit for pump current is 0.9 A. Pump SN 2 provides a slightly higher flow rate than SN 6 at the same speed (536 vs. 518 lb/hr, 243 vs. 235 kg/hr). It is theorized that pump SN 2 may have tighter gear tolerances than SN 6, resulting in a slightly higher flow rate, current and temperature. Finally, it was noted that the pump's delta pressure (DP) sensor has a -1.4 psid (72 mmHg) offset, which is within the sensor's accuracy specification. The OGA team will continue to monitor the pump's performance over time.

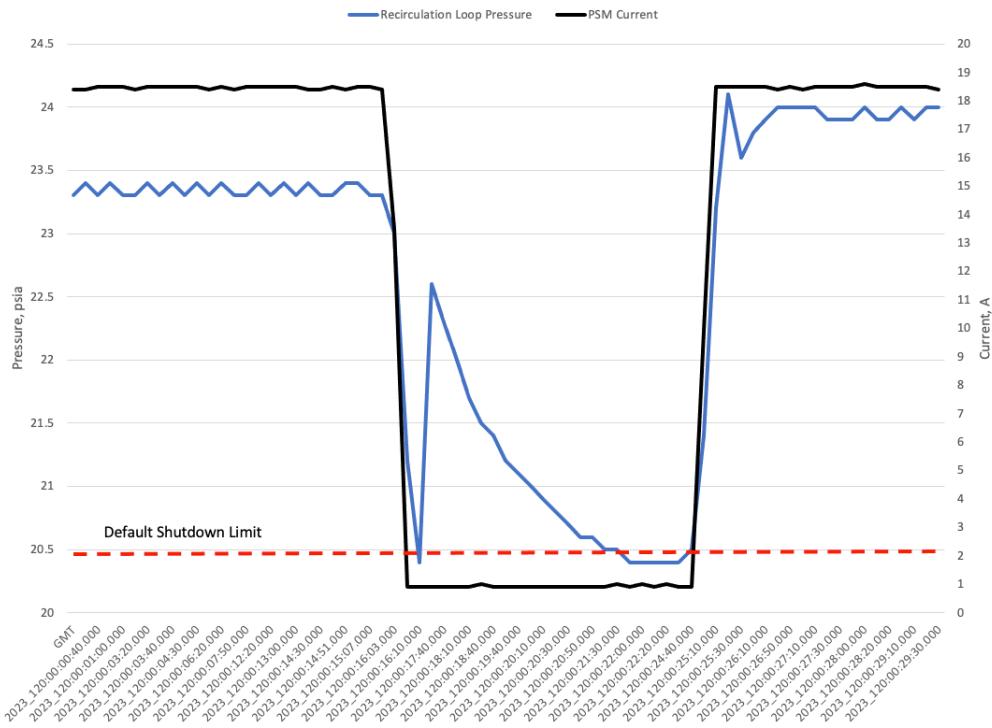
**Figure 5. Recirculation Loop Pressure Process/Standby/Process**

pressure has been consistently low with Hydrogen ORU SN 4 installed. Figure 5 shows a typical example of the recirculation loop pressure (shown in blue) dropping below the default low limit shutdown value when the system goes into Standby (current, shown in black, temporarily decreases to 1 A) every 100 minutes.

After Hydrogen ORU SN 3 was returned to the ground, the back pressure regulator was removed and has undergone performance testing, CT-scan, and a TT&E to determine the cause of the poor performance. Upon teardown, condensation and rust have been found in the parts that are wetted with hydrogen during operation. Condensation can be expected since the hydrogen gas is saturated with water when leaving the RSA, but the rust is concerning. The rust that was found is likely the cause of the erratic regulation seen in operation, interfering with the poppet operation. This has driven changes to the passivation method for the metal parts for AOGA back pressure regulators to help prevent this from happening in the future.

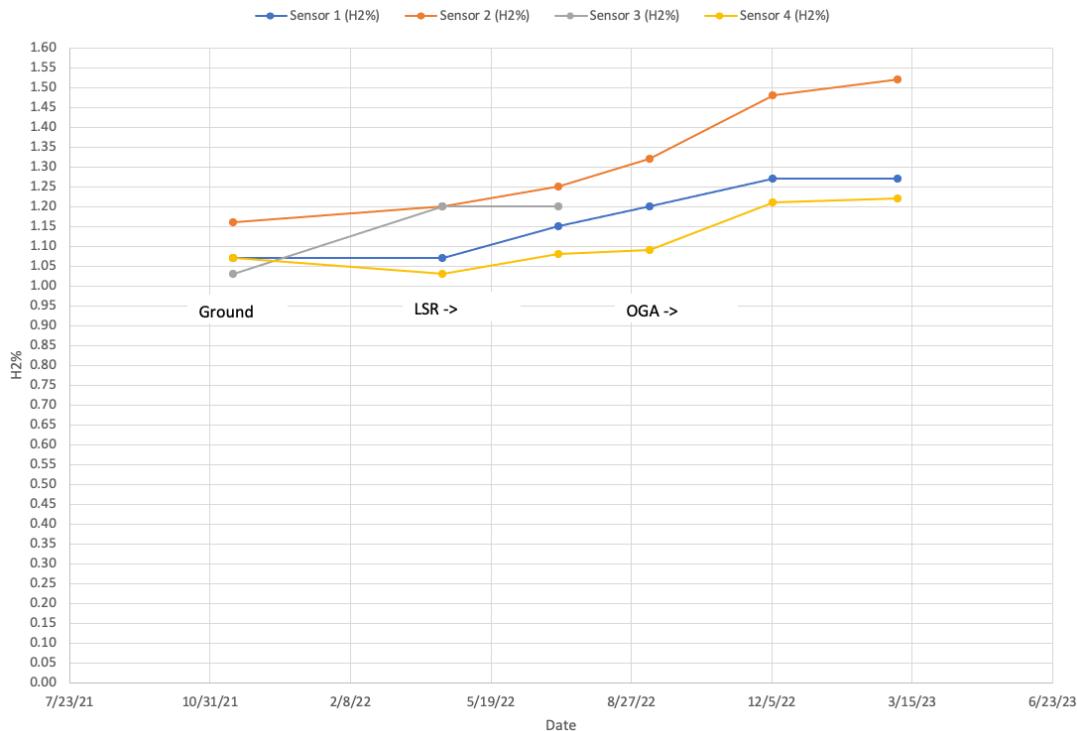
**Figure 11. H2ST Sensor Drift Checks**

Every 90 days, a drift check is performed: the crew flows calibration gas (1.0% H<sub>2</sub>/air) through the H2ST sensors for 1 minute, and the sensor response is recorded. There have been four drift checks performed so far. The upwards drift of the sensors over time is shown in Figure 11. This overreporting of H2% is conservative, although not desirable as it could eventually lead to nuisance shutdowns. The legacy ISS OGA hydrogen sensors are known to drift downwards over time (under-reporting H2%), limiting their installed time to 201 days. H2ST has been installed for over 400 days.

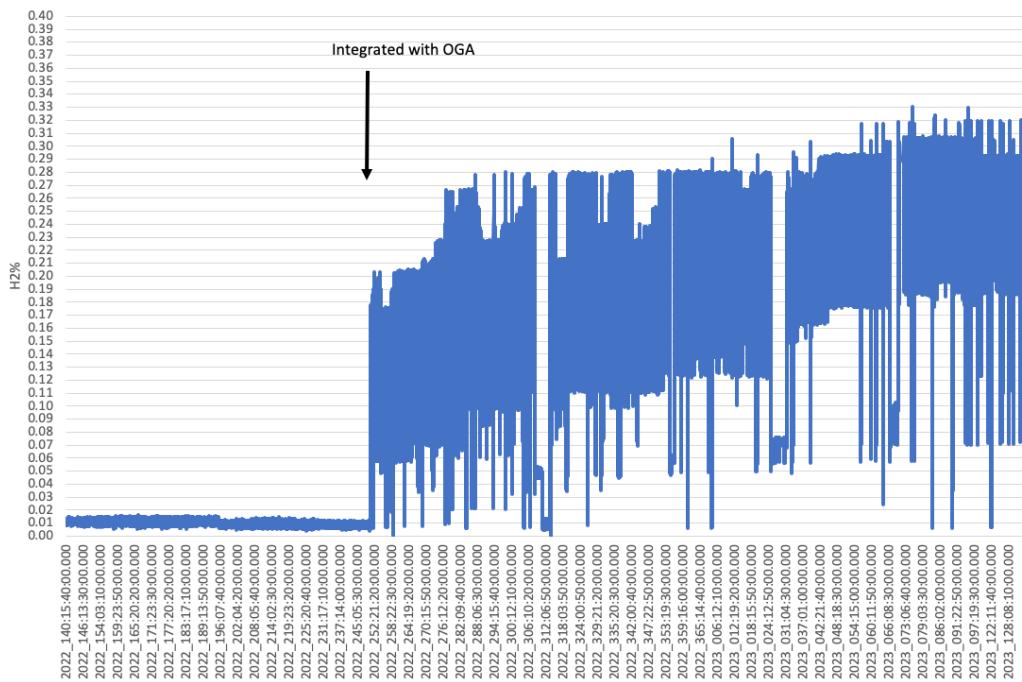
When OGA's product oxygen is flowing through H2ST (starting in September 2022), the sensors have been reporting between approximately 0.1 – 0.3% H<sub>2</sub>/O<sub>2</sub>, as shown in Figure 12. The wide band in readings is due to the Process/Standyby cycling that occurs every 100 minutes. Prior to integration with OGA, it was thought that the sensors would report close to 0% H<sub>2</sub>/O<sub>2</sub>, based on testing using a ground OGA test stand. The OGA specification allows up to 1% H<sub>2</sub>/O<sub>2</sub>. A review of cell stack acceptance test data was performed. The currently installed cell stack (SN 6) was tested in 2013, and 0.06% H<sub>2</sub>/O<sub>2</sub> was recorded. The on-orbit spare cell stack (SN 7) was tested in 2018, and 0.06% H<sub>2</sub>/O<sub>2</sub> was recorded. The previously installed cell stack (SN 4, installed from 2016 – 2021) was tested in

**Figure 12. Average H2ST Sensor Readings (5/20/22 – 5/14/23)**
