KRAKsat Satellite Mission – Lessons Learned [EN]

Technical Report · December 2019

KRAKsat Lessons Learned

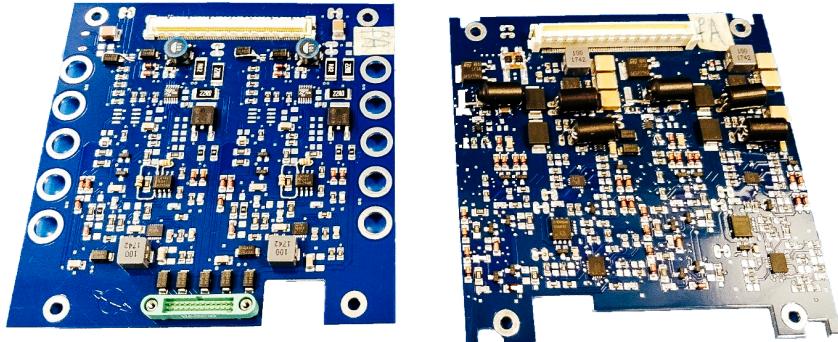
The EPS system consists of two PCBs used to manage the electric power in the satellite. The setup is responsible for the solar panels proper functioning, 3200 mAh battery charging and power supply of all satellite's modules with 12 V and 3.3 V voltage.

Figure 4: EPS [photo by SatRevolution]

A well-designed EPS should have a hysteresis loop implemented. The voltage level switching on the satellite should be significantly higher than the level switching it off. The missing hysteresis implementation caused an endless loop of satellite restarts when its voltage dropped below 9.5 V.

This critical error caused an irreversible blockage of the satellite in the restart loop. It became the key reason for the inoperability of the satellite after entering the third phase of the mission.

When designing a satellite, the largest possible safety reserve should be included in the energy budget. Such an approach would guarantee a positive energy balance on the orbit. Accurate tests must be carried out on the integrated device to check probable battery consumption by individual components in different lighting conditions.

There should be a hysteresis system implemented in the EPS. Voltage levels should be selected in a way that the switch-off level would protect the battery against damage, and the switch-on level would allow the satellite to function at least until the next communication session.

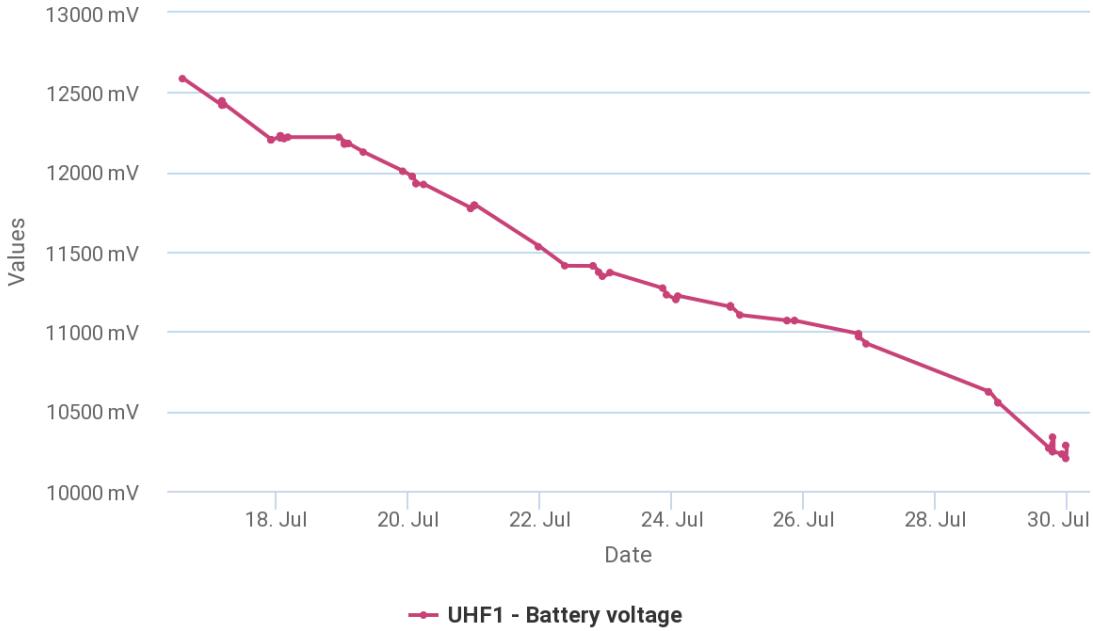
Figure 6: KRAKsat satellite power graph

In the second phase of the mission, the satellite's power supply system had a negative energy budget. On-board

devices used more energy than solar panels were able to provide. The attempt to completely turn off the device did not increase the battery voltage, keeping it on a similar or even lower level. Despite stable communication having been achieved, goals of the mission could not be fulfilled. Crucial errors found during the operation of the satellite prevented execution of the Ferrofluid Reaction Wheel experiment.

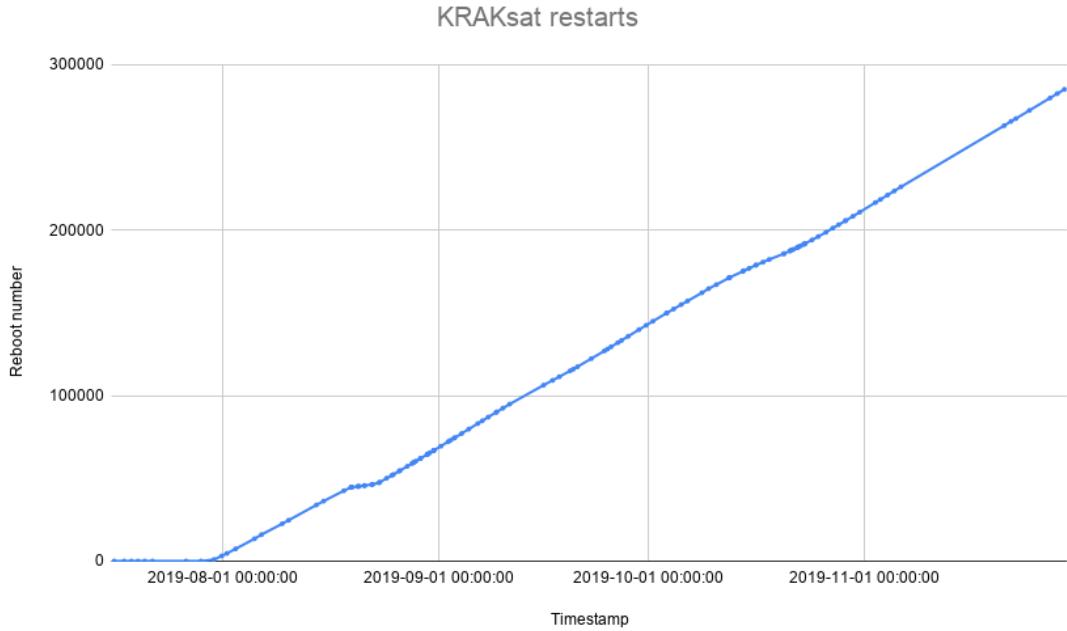
Figure 7: KRAKsat satellite reboots graph

On the 30th of July 2019, KRAKsat's power dropped to its limit value, causing all systems to shut down. Due to the lack of hysteresis implementation, turning off the device resulted in lifting voltage values, which then led to another restart of the satellite. Each time the KRAKsat is turned on, it should transmit information about radio activation, the reboot number and all status frames in the form of a beacon. Attempting such a transmission overloaded the devices EPS, causing the satellite to turn off, and several seconds later, when the voltage increased slightly, another start-up. The third phase restart loop was characterized by a relatively constant frequency of about 150 reboots on one orbit around the Earth. Between reboots of the UHF1 and the UHF2 radios, a very short time window took place in which it was possible to communicate with the satellite.

According to the data collected during the third phase of the mission, the KRAKsat probably only restarted in the sunlight - remaining turned off in the shadow. The restart loop was caused directly by the power dropping below the limit value and the lack of implementation of the hysteresis, which should have allowed the battery to charge to the level at which the satellite could work properly. Many time windows gave chances of communication with the satellite of which, few were used. The mission control team was able to shift the frequency of the KRAKsat broadcast by 2kHz to reduce jamming with the Świątowid satellite signal (operating in the same range of frequency), as well as receive a frame with information about the power supply
