PROPERTY WALK — STATUS MEMO

# Thirteen East

614 13th Avenue East · Capitol Hill · Seattle, WA 98112

Wednesday, May 20, 2026

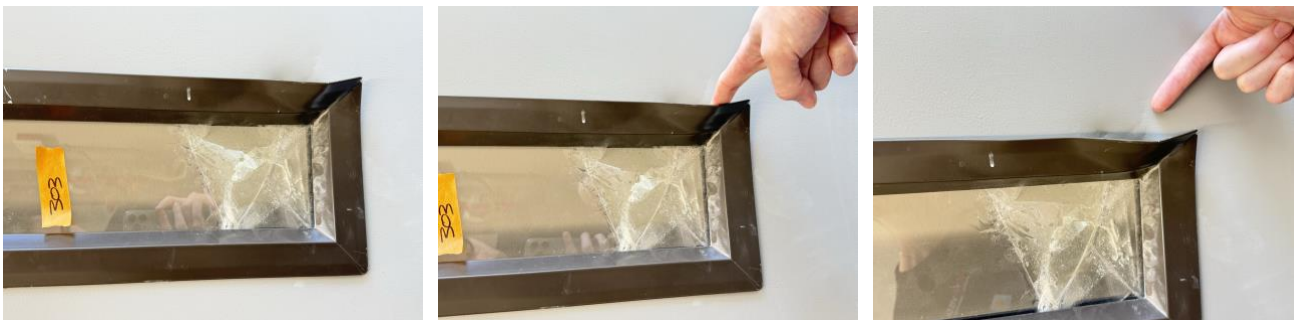
## Broken window, signs of pry-entry

A window on the third floor was found broken during the walk. The frame shows clear signs of having been pried — tool marks along the sash and deformation consistent with attempted forced entry. Vendor status is unknown; it is not confirmed whether a contractor has been notified or scheduled. Every unit aside from second-floor-and-up was found locked, so unauthorized access into the building below the affected level is limited, but the breach point itself remains open.

Third-floor window — broken pane and visible tool marks along the sash (3 angles).

- Confirm vendor engagement and ETA on glazing repair this week.
- Board-up the opening today as an interim measure if the glazier is more than 48 hours out.
- Add an exterior security presence (camera coverage or after-hours patrol) until the window is restored.
- Walk the rest of the third-floor envelope for other pry signs not visible from the street.

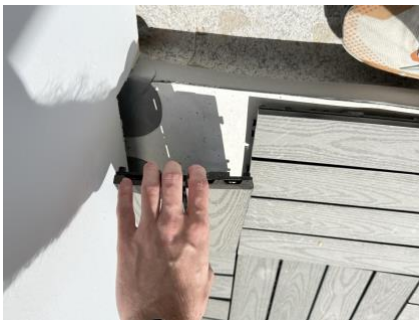
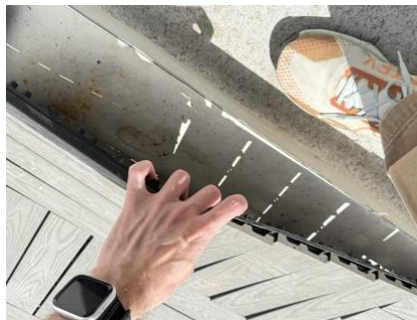
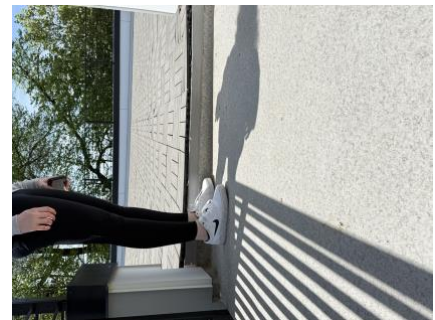
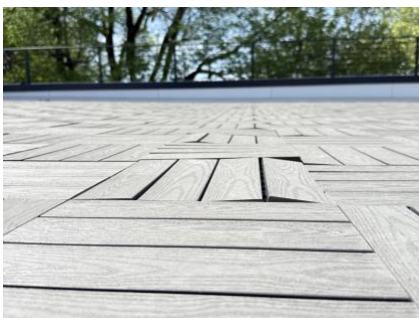
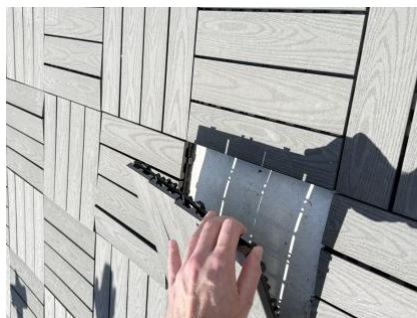
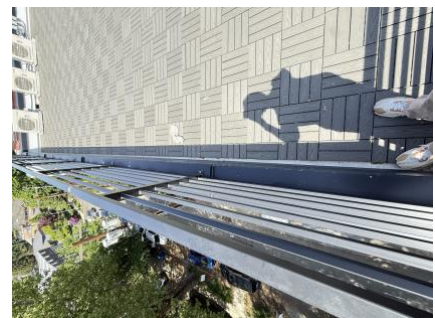
## Multiple safety + drainage issues

Several rooftop conditions warrant immediate attention. On entering the rooftop area there is an unmarked lip at the threshold and, immediately past it, a sudden dip in the deck — both unmarked and at a height differential significant enough to cause a fall. Decking tile in this transition zone is not secured and shifts underfoot. The roof field is not leveled, which compromises any furniture or amenity placement and indicates uneven structural loading.

Drainage is single-point — only one scupper/drain was observed across the entire roof — and there is no raised decking or sleeper system to lift the walking surface off the membrane. Standing water is present and pooling against the membrane will accelerate deterioration of both the membrane and the finishes; the wet decking also presents a slip hazard on top of the existing trip hazards.

Rooftop — threshold lip and dip, unsecured tiles, pooling water against the membrane.

- Tape off the rooftop or post a do-not-enter notice until the lip, dip, and loose tiles are remediated.
- Engage a roofing consultant this week for a written scope on: leveling, secondary drainage, raised decking / sleeper system.
- Mark the threshold lip with high-visibility nosing as an interim safety measure.
- Re-bed or replace loose tiles before any tenant-facing use of the roof resumes.

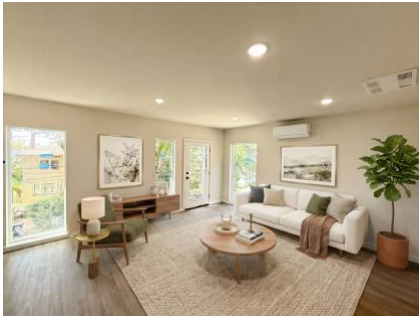
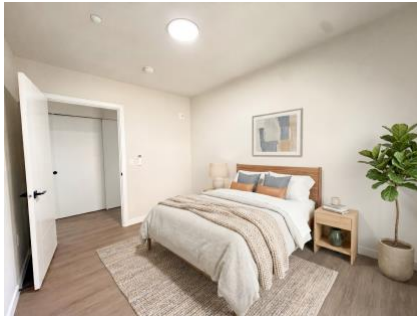
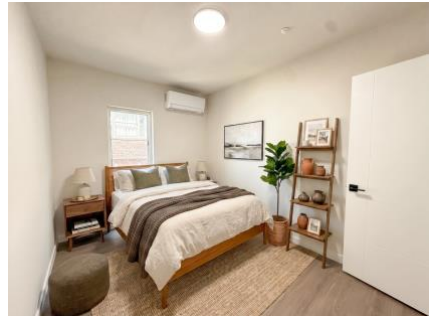
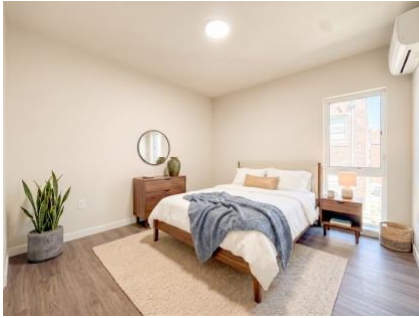
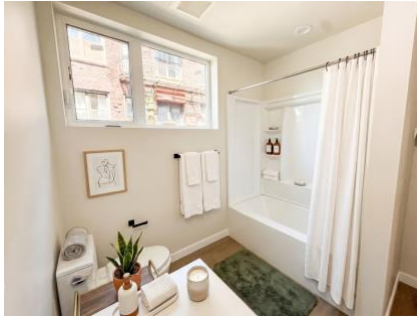
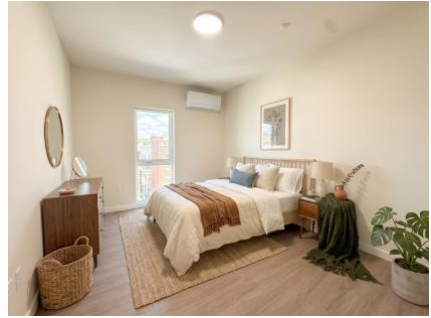
The top-floor units have been turned, cleaned, and staged. They are ready for marketing photography. To enable Regional to access the units for shoots and tours, keys to the staged units need to be handed off to Regional.

Top units — staged and photography-ready (6 of 10 shown).

- Provide keys for the newly staged top units to Regional this week.
