ON POINT HOME INSPECTIONS LLC

INSPECTION REPORT

1234 Main St.
Tucson, Az 85704

Buyer Name
07/21/2019 9:00AM

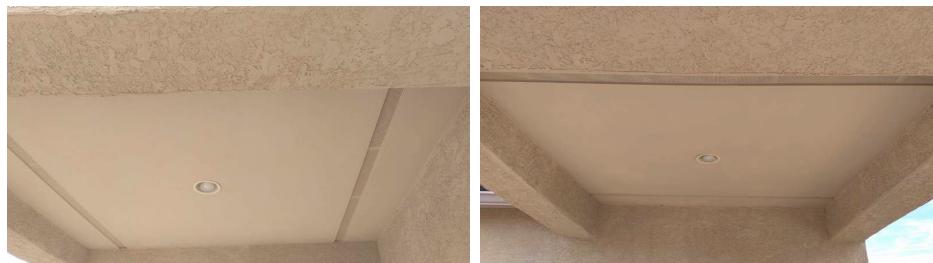
Eaves, Soffits & Fascia: Eaves, soffit and fascia

The house had a combination of parapet wall and wood fascia, soffit and eaves. These wood areas will need an occasional coat of paint. The paint acts as a protective layer against moisture intrusion, wood rot and deterioration.

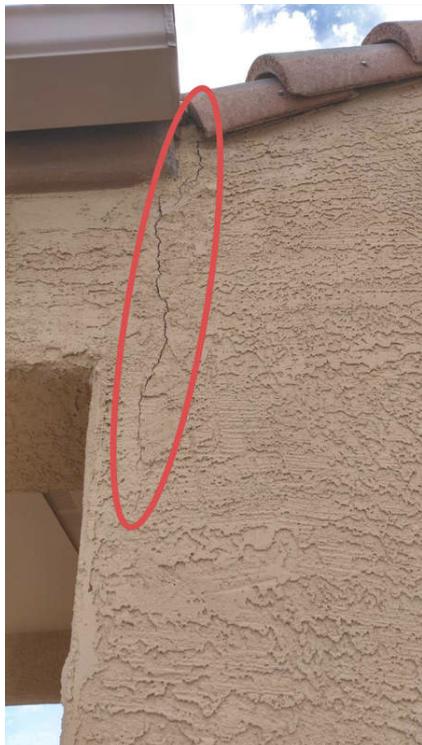
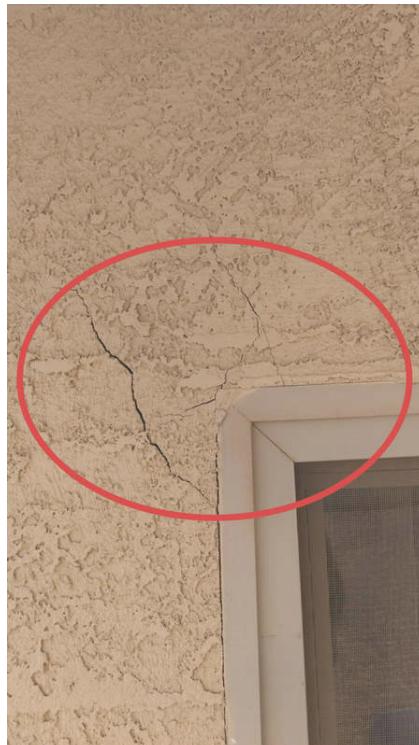
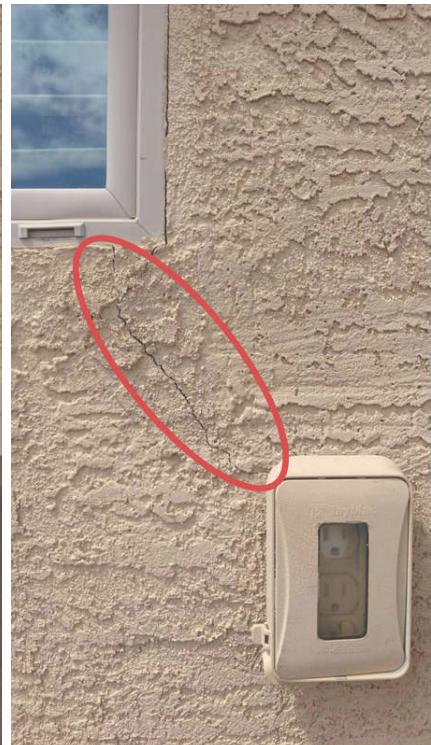
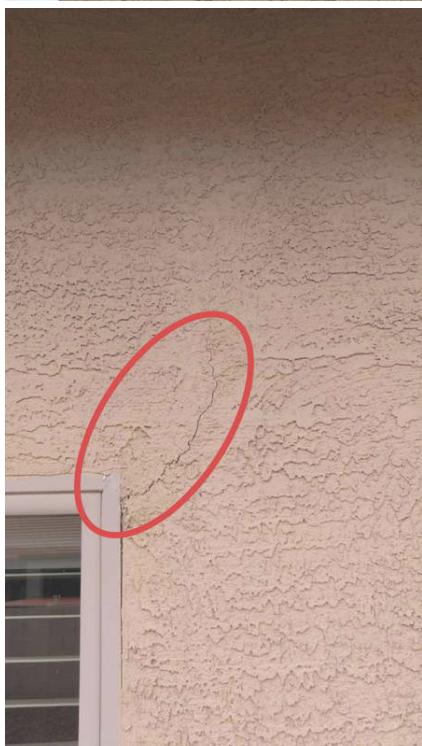
2.1.1 Siding, Flashing & Trim

CRACKING - MINOR

EXTERIOR (MOSTLY SOUTH FACING)

The stucco siding had some minor cracking in a few areas around the house. This can be common and often is a result of temperature changes, expansion/contraction and typical as homes with stucco age. I recommend having a qualified professional evaluate and seal these cracks to prevent moisture intrusion.

Contact a qualified professional.

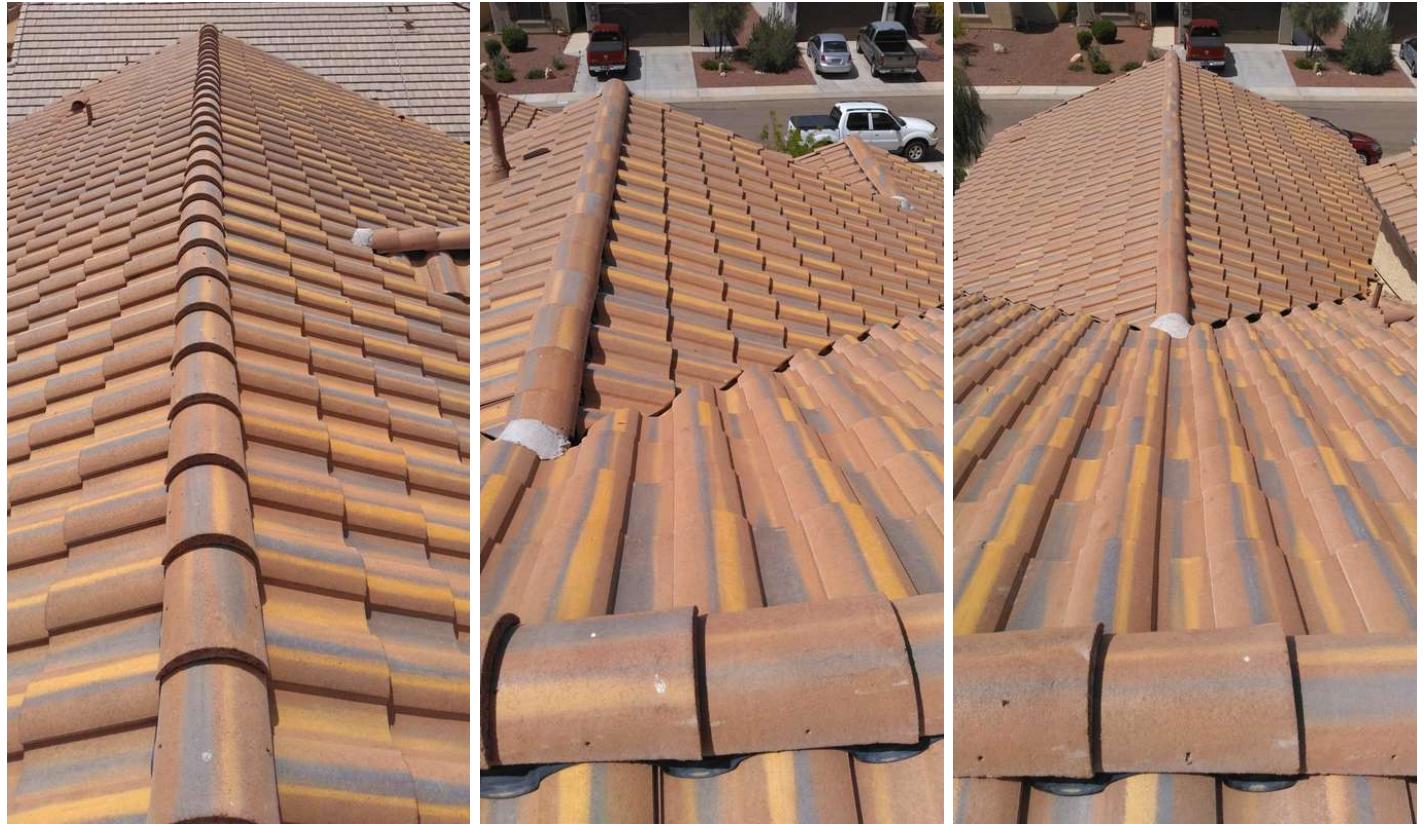
**Coverings: Material**

The house had concrete tile roof covering with rolled roofing on the low pitched back porch. The coverings are in overall good condition with a couple cracked tile noted. See the observation/summary section for more details.

The roof had cracked/broken tiles. I recommend having a qualified roofing professional evaluate and repair as needed prevent moisture intrusion.

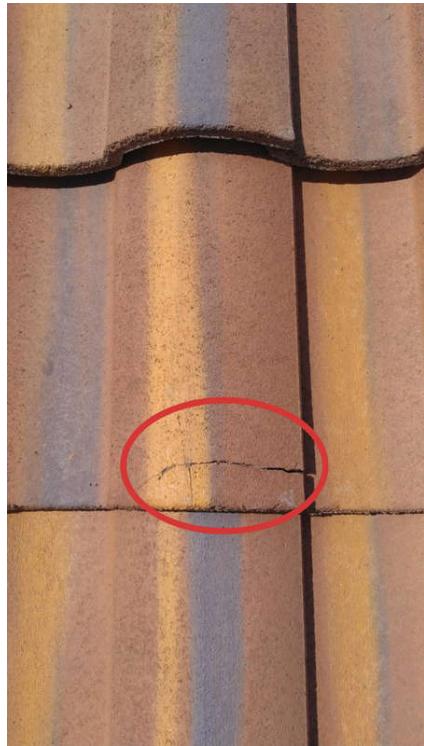
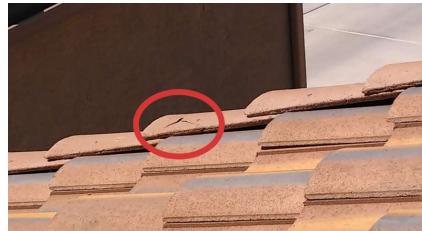
3.1.1 Coverings

TILES CRACKED/BROKEN

Contact a qualified roofing professional.

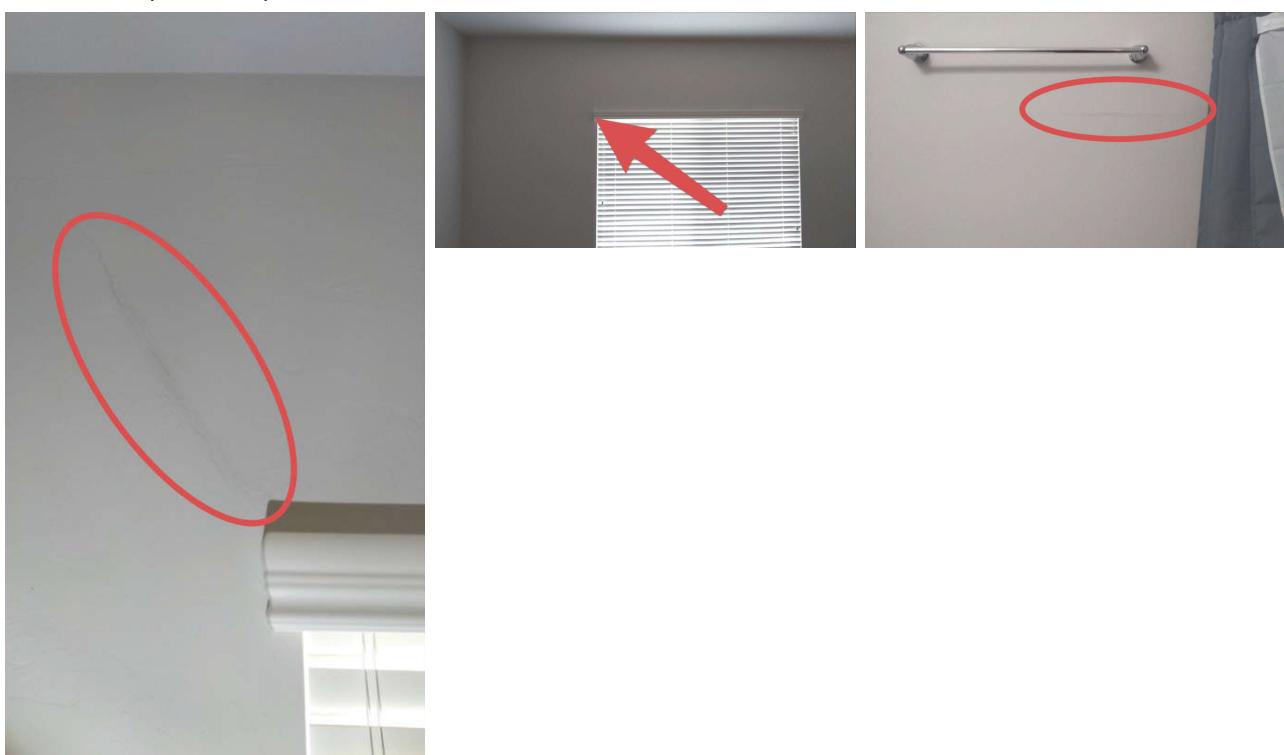
9.4.1 Walls

MINOR DRYWALL CRACKS

MASTER BEDROOM- GUEST BATHROOM

Minor cracks at the corners of doors and/or windows appeared to be the result of long-term, minor settling/movement. Some settling is not unusual in a home of this age and these cracks are not a structural concern. I recommend having these cracks repaired by a drywall professional.

Contact a qualified professional.

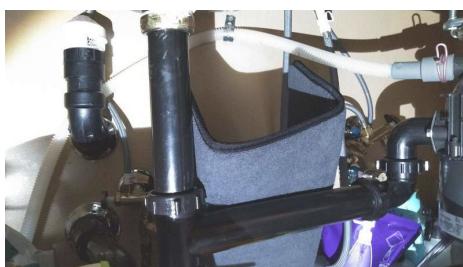
**Dishwasher: High Loop Present**

The dishwasher had a high loop installed in the drain line at the time of the inspection. The high loop is designed to prevent wastewater from contaminating the dishwasher. This is a proper condition.
