TOPNOTCH BUILDING INSPECTIONS

PRE-PURCHASE RESIDENTIAL

1234 Main St. Preston Victoria 3072

10/07/2020 9:00AM

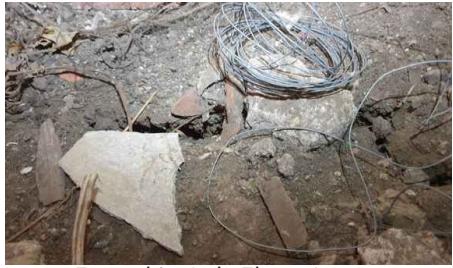
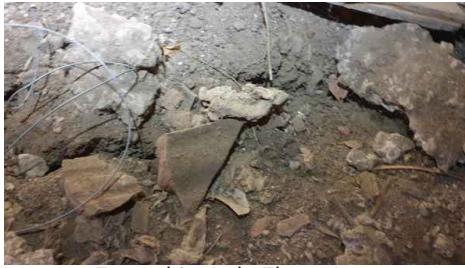
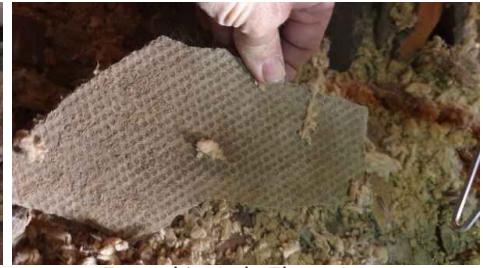
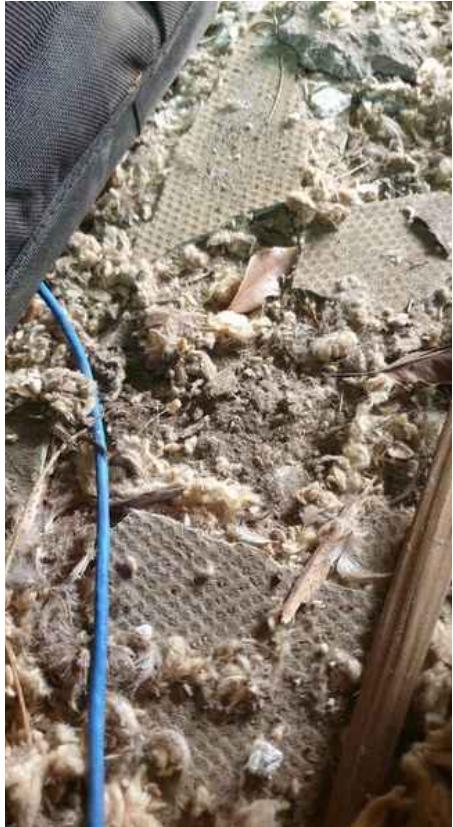
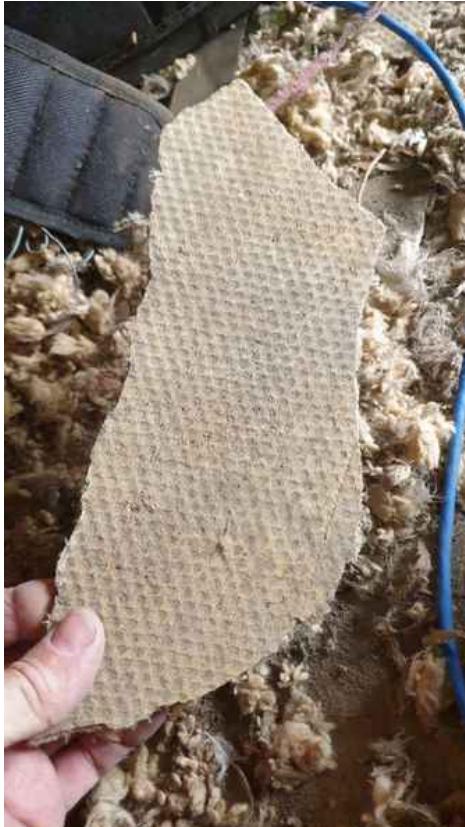
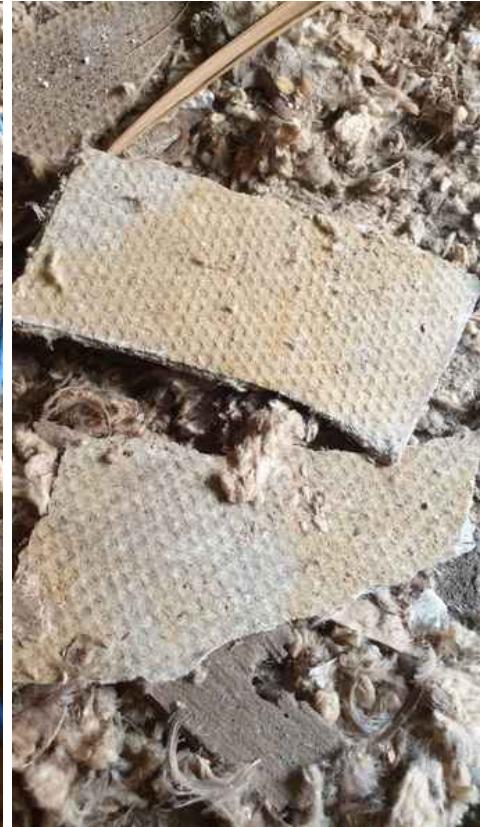
Found in Sub-Floor Area

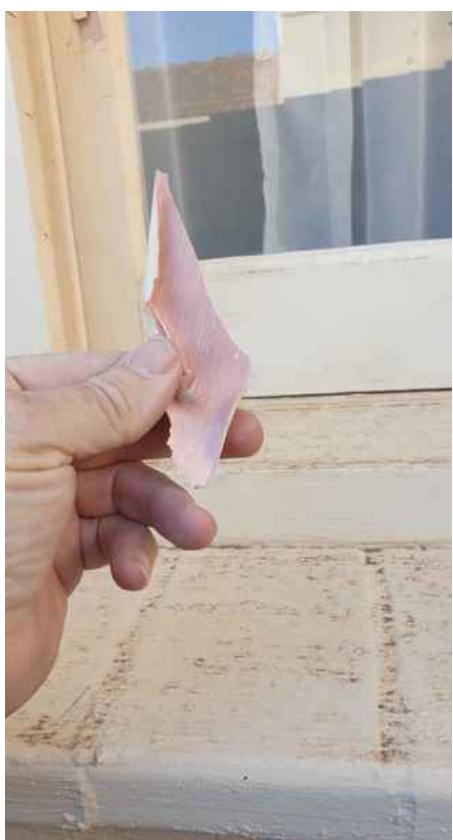
Suspected Lead Based Paint

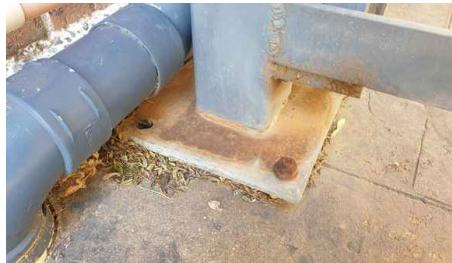
Degradation of fixings in base plate and missing fixing.

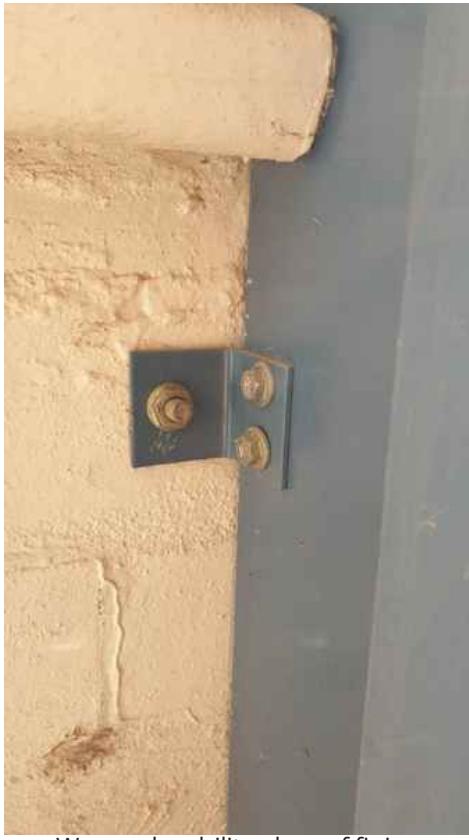
Wrong durability class of fixing

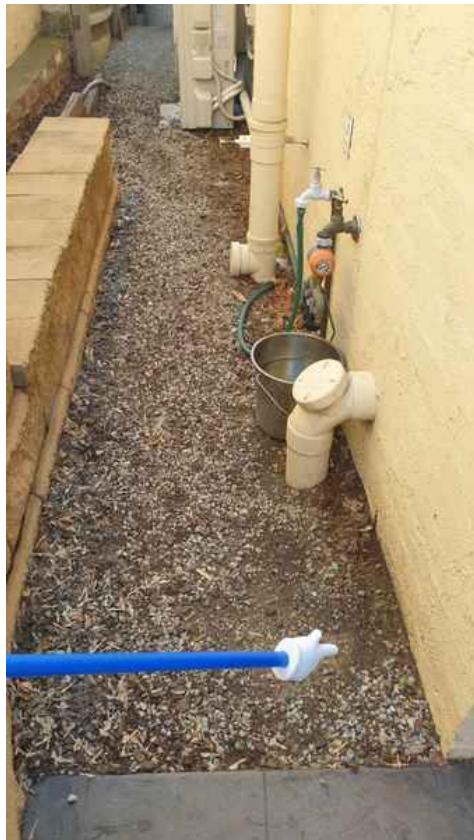
**3.4.2 Grading and Drainage****PAVING HIGH ON FOUNDATION WALL (SLAB)**

WESTERN SIDE (REAR) SOUTHERN END

Contact a qualified professional engineer

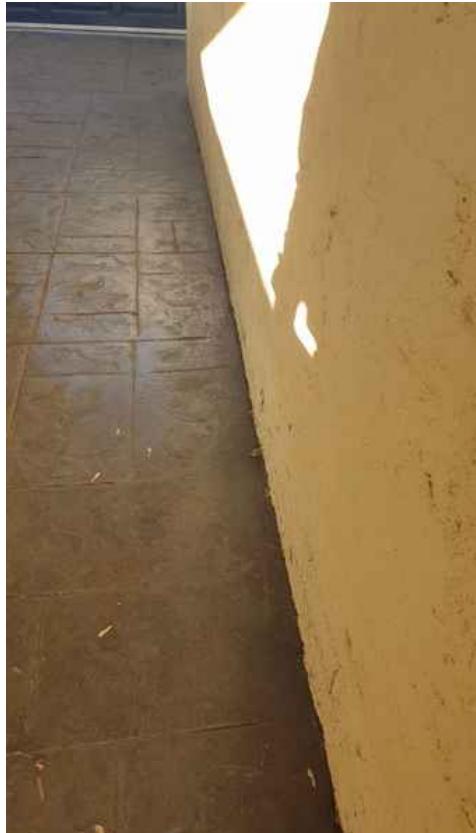
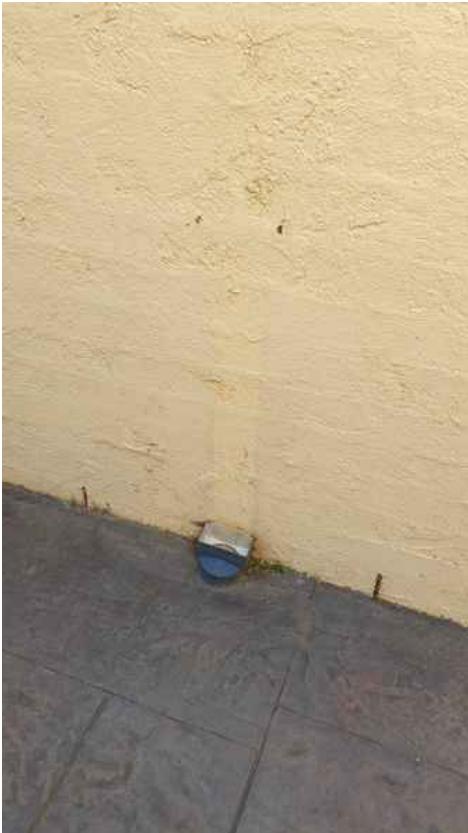
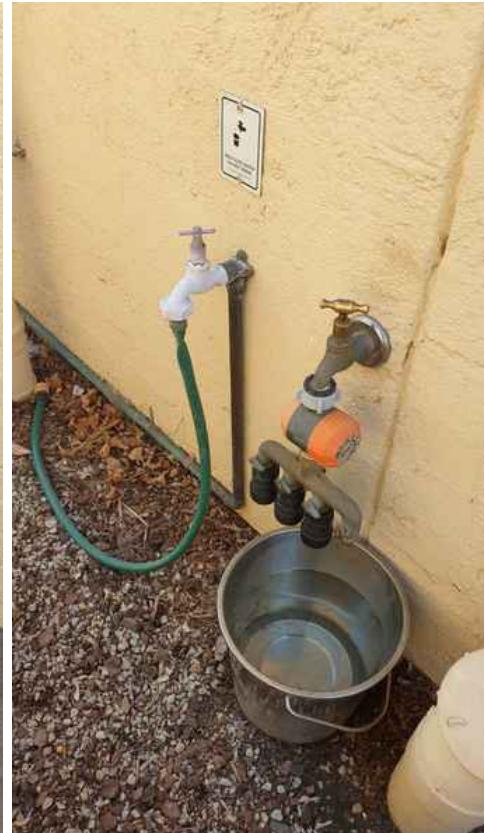
3.4.3 Grading and Drainage

SOIL HIGH ON FOUNDATION WALL (B/V)

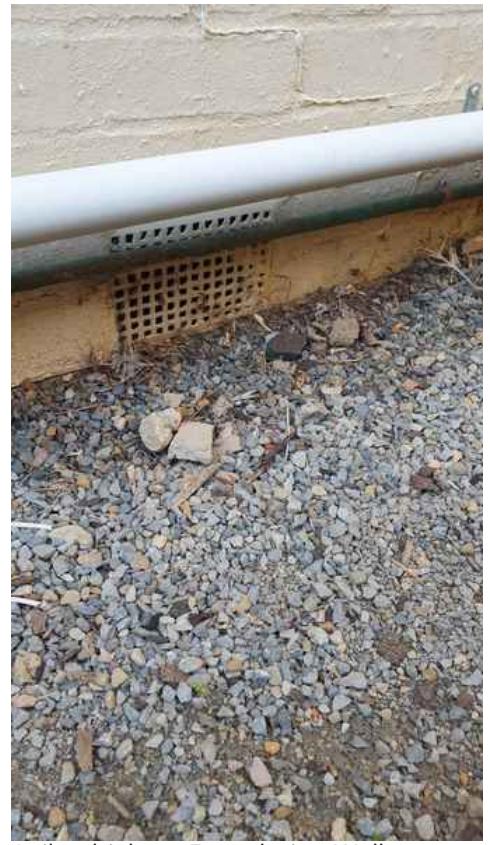
Soil to high on Foundation Wall, conducive to WDI and moisture intrusion.

Contact a qualified professional.

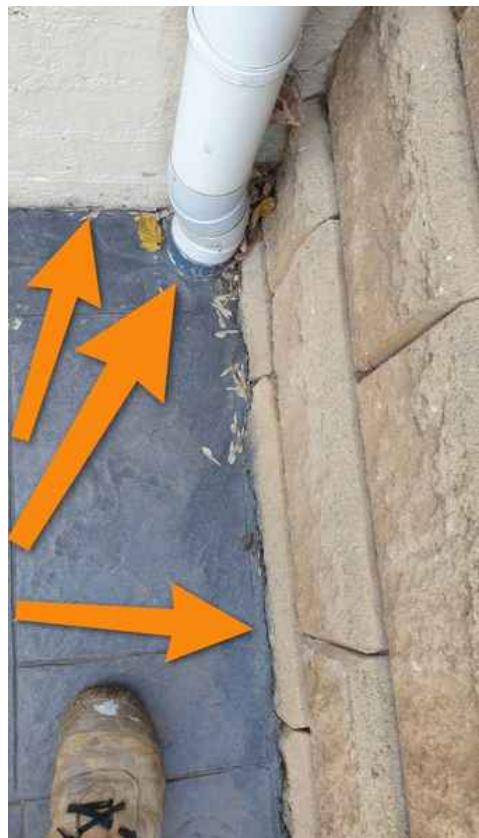
Missing Isolation Joint

Contact a qualified professional.

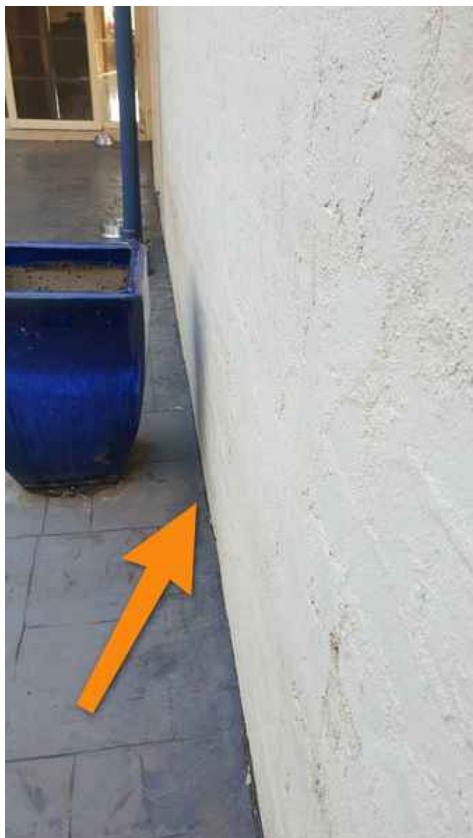
Missing Isolation Joint

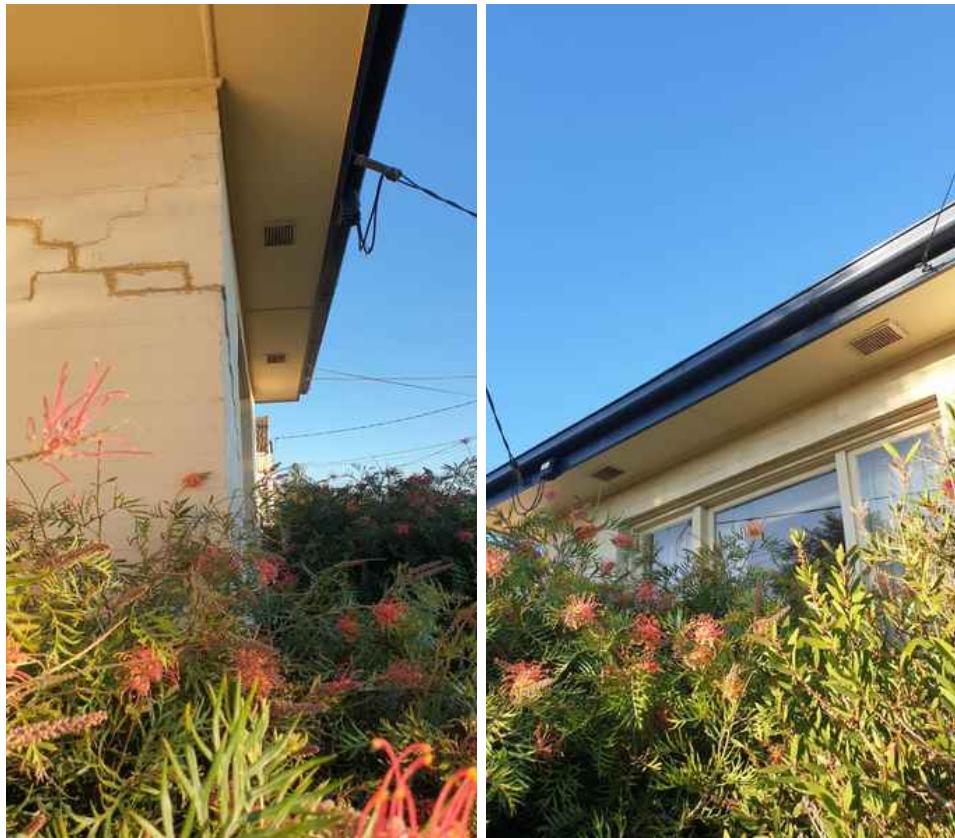
3.8.1 Vegetation / Trees

VEGETATION IN CONTACT WITH HOME

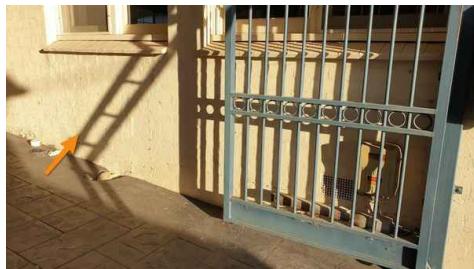
The foundation is poorly ventilated. Increased ventilation (introduction and movement of fresh air) is recommended.

Could add extra ventilation

Contact a qualified professional.

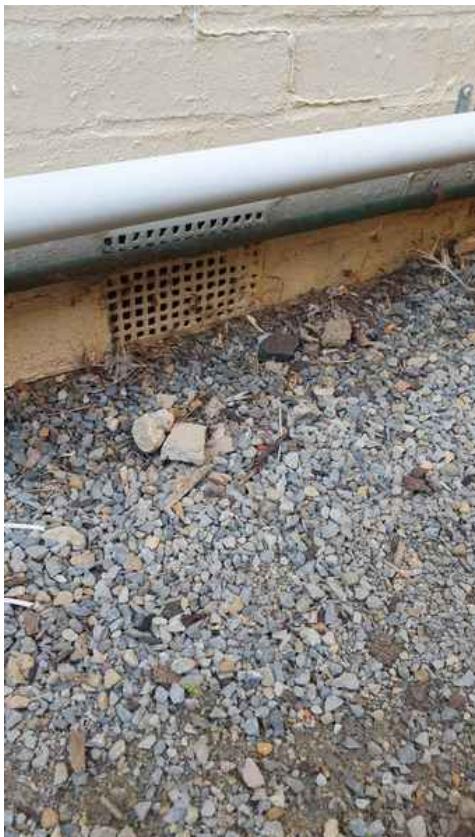
Partly obstructed and conducive to WDI

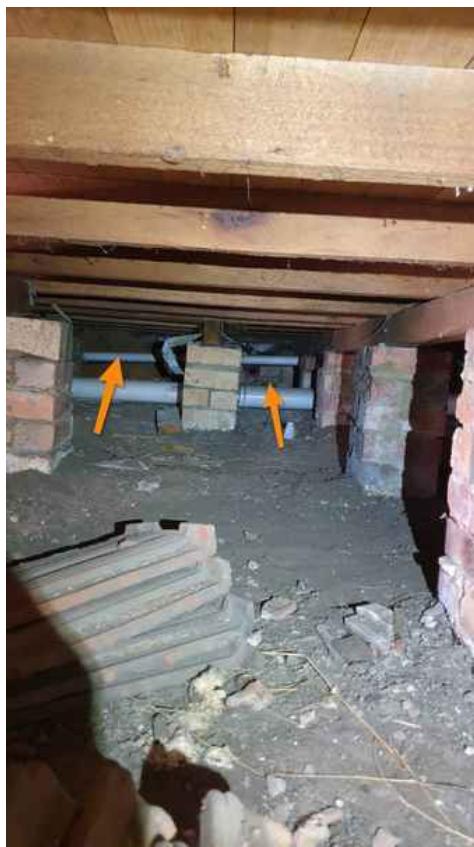
No cross ventilation due to new slab addition

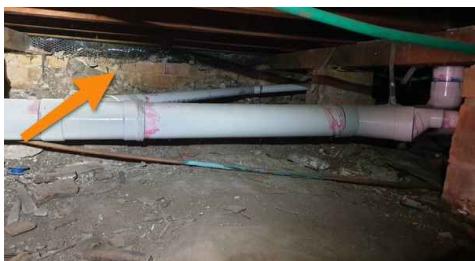
No cross ventilation due to new slab addition

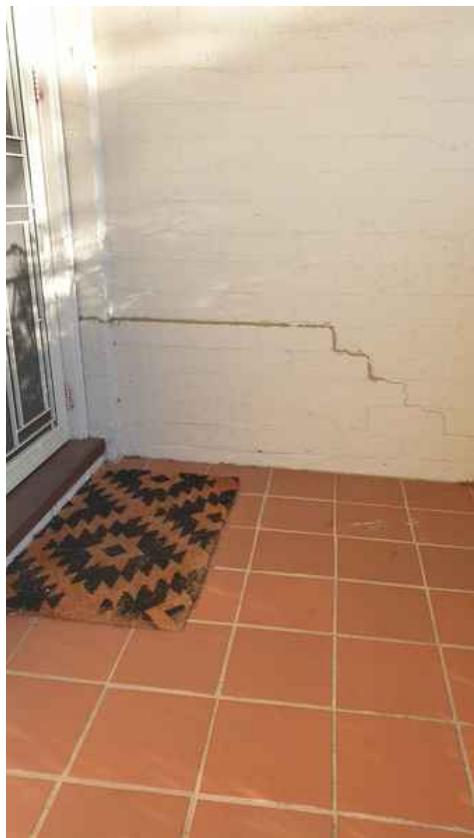
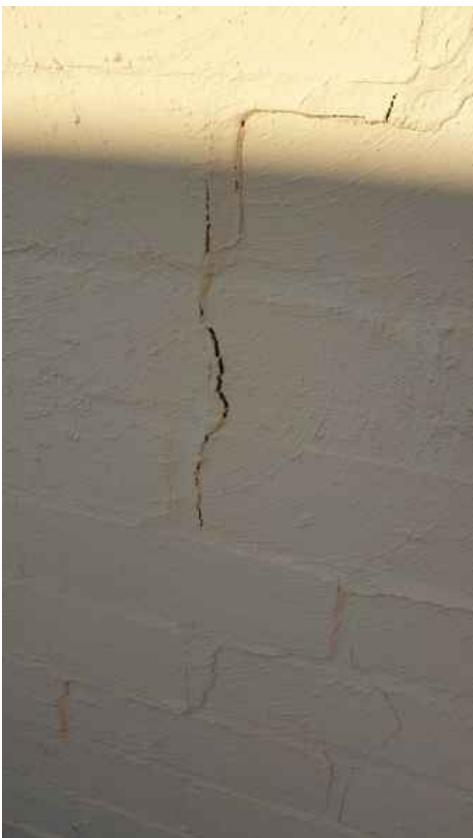
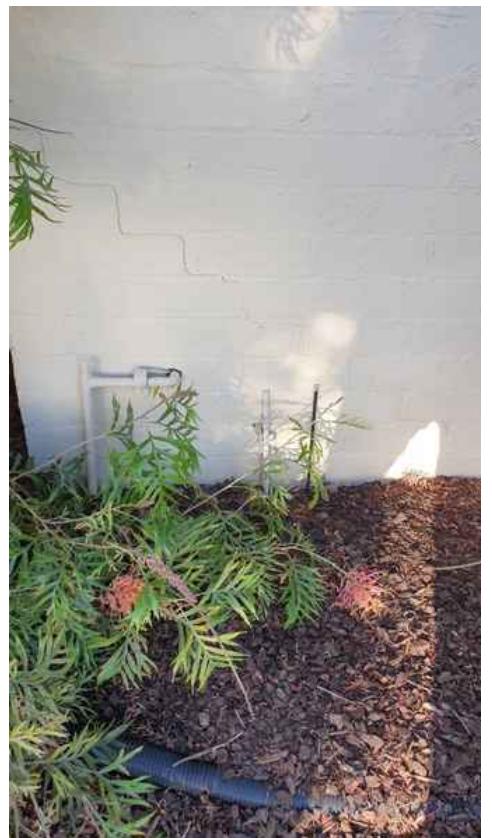
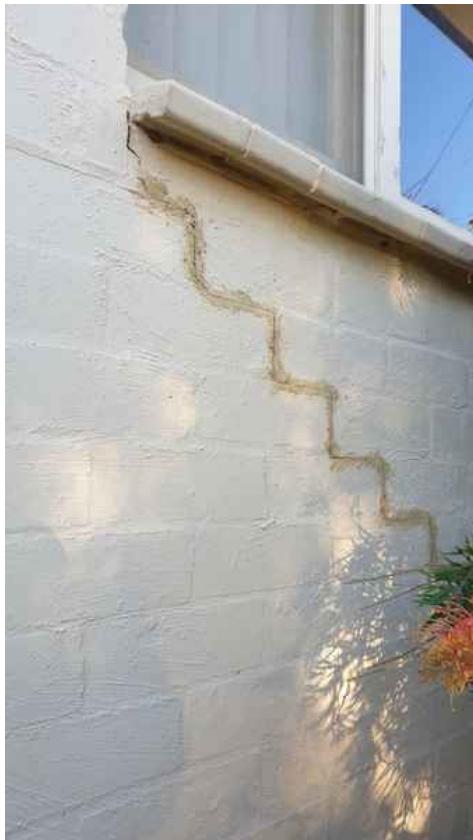
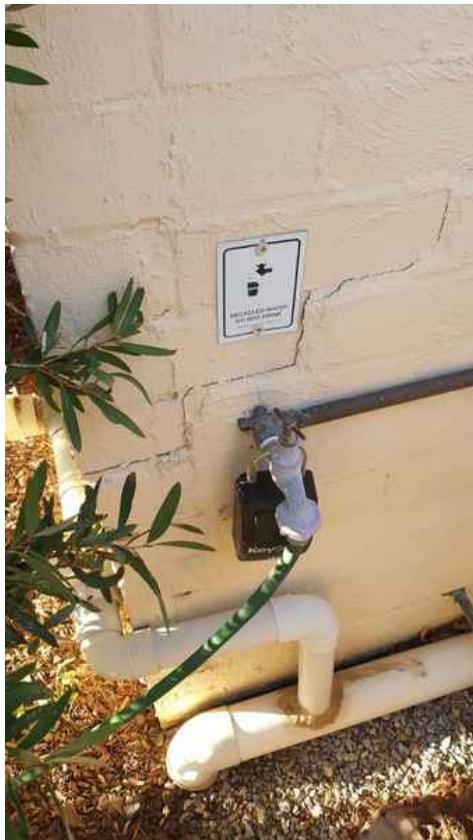
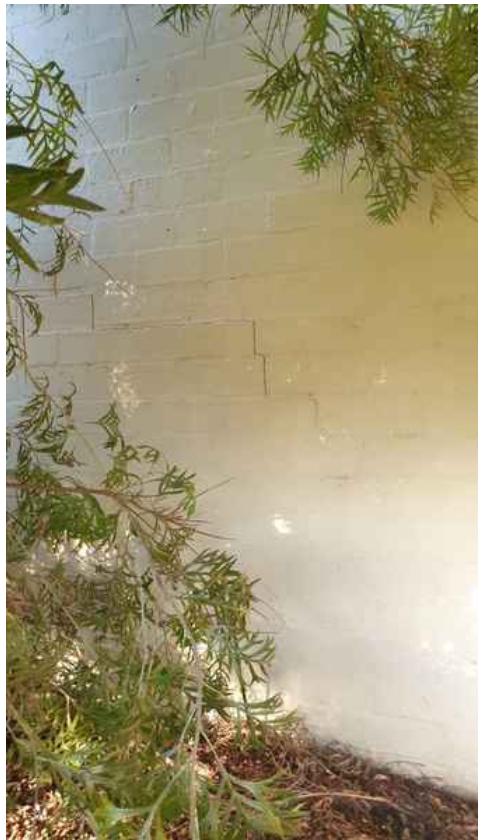
The masonry brickwork showed visible evidence of Cracks / Cracking.

Cracks are ≤ 5.0 mm in width with a Damage Category of 2, Slight, and are considered a defect and requires repair work such as repointing. These cracks are noticeable but easily filled. Common damage associated with these cracks may be doors and windows that stick slightly.

Recommendations:- Fill cracks and monitor for 12 months, should they become larger than 5.0mm in width contact a structural engineer for further advice.

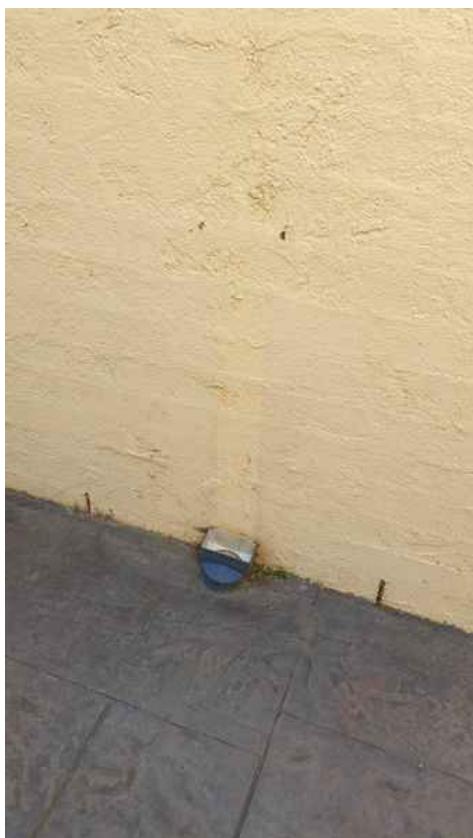
The weep hole of the external cladding were partly or fully covered which inhibits the proper function of the weep holes. Covering or partially covering the weep holes does not allow the wall cavity to ventilate and expel moisture from within the structure, furthermore the damp coarse has been bridged allowing for moisture to draw up the wall. Covering weep holes also invites termites and other unwanted insect or organisms to enter the wall cavity.

Weep hole partly covered rear of dwelling

Recommendations:- Reduce level below the bottom of the weep holes to allow for proper function.

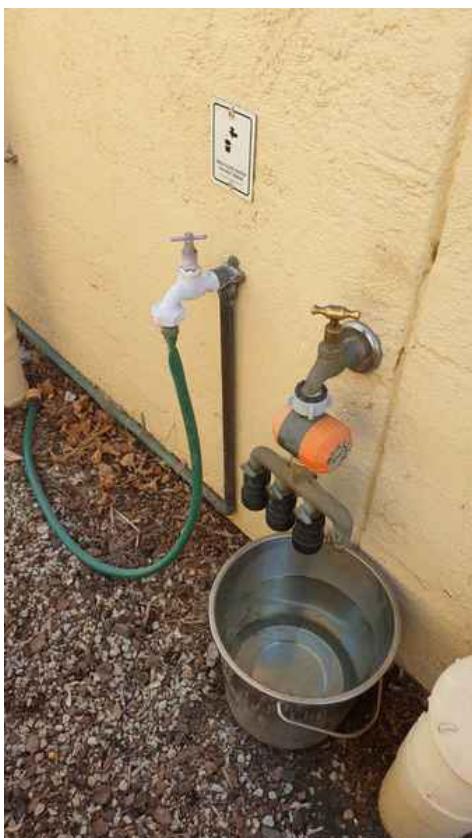
Weep hole partly covered Northern side of dwelling

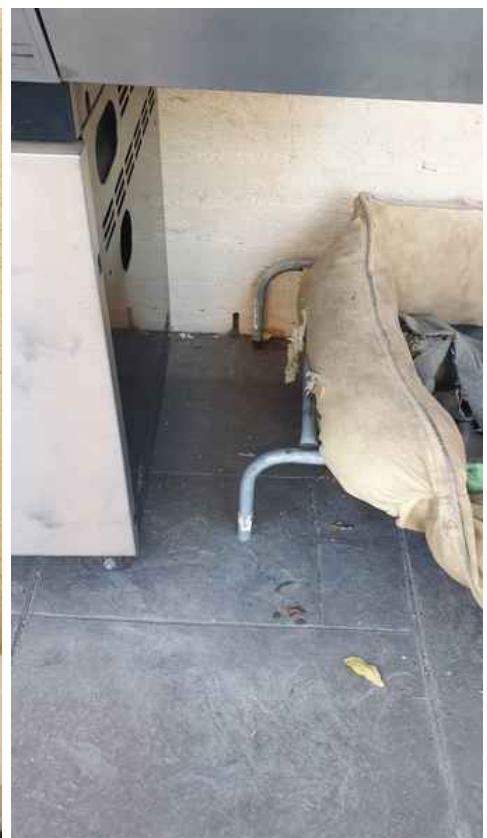
Weep hole partly covered rear of dwelling

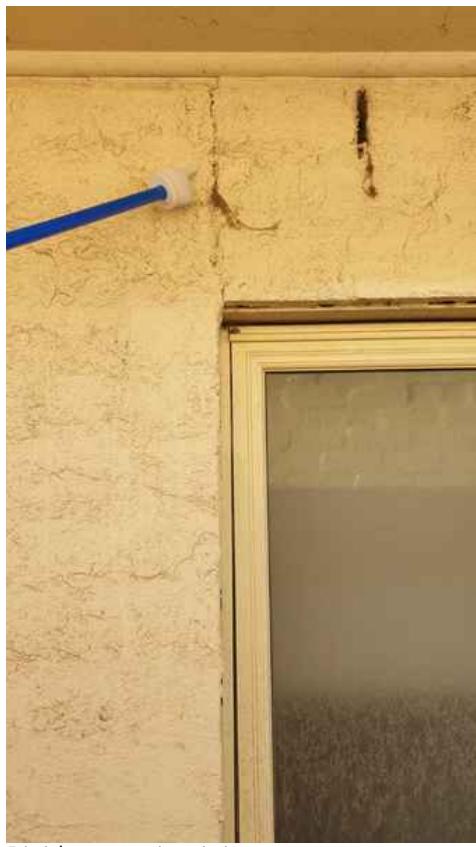
Rigid expansion joint

Contact a qualified professional.

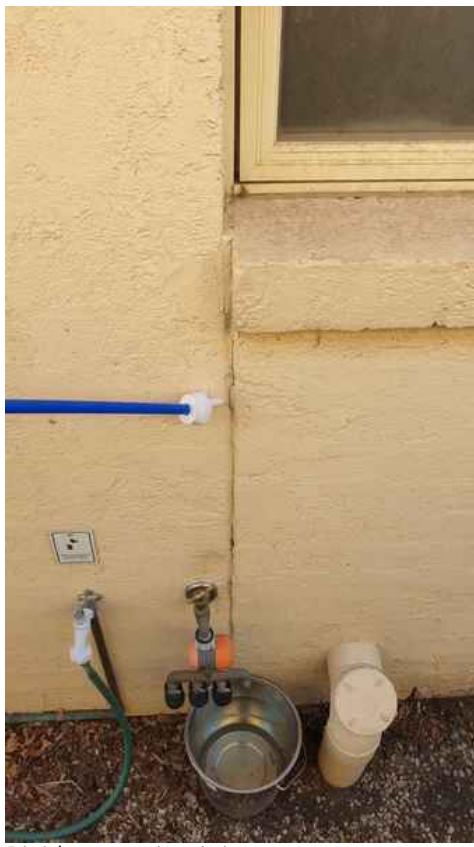
I observed a rigid expansion joint compound in one or more locations.

Rigid expansion joint

I recommend installing a flexible expansion joint compound to all expansion joints.

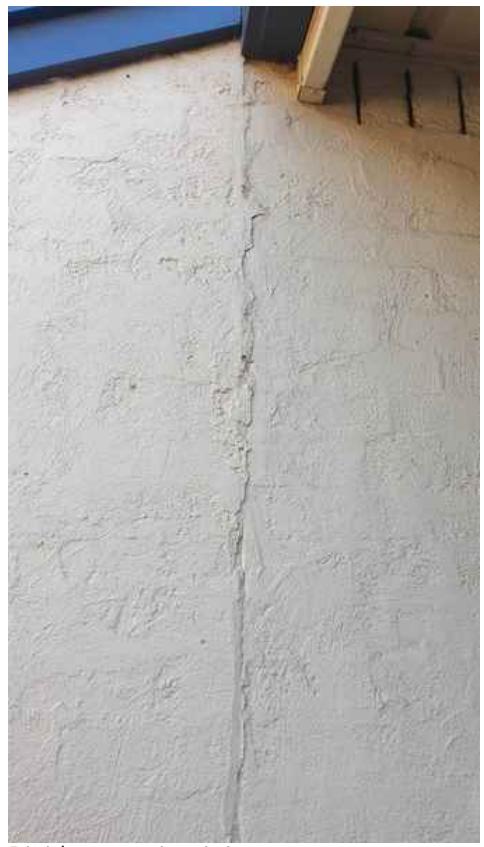
Rigid expansion joint

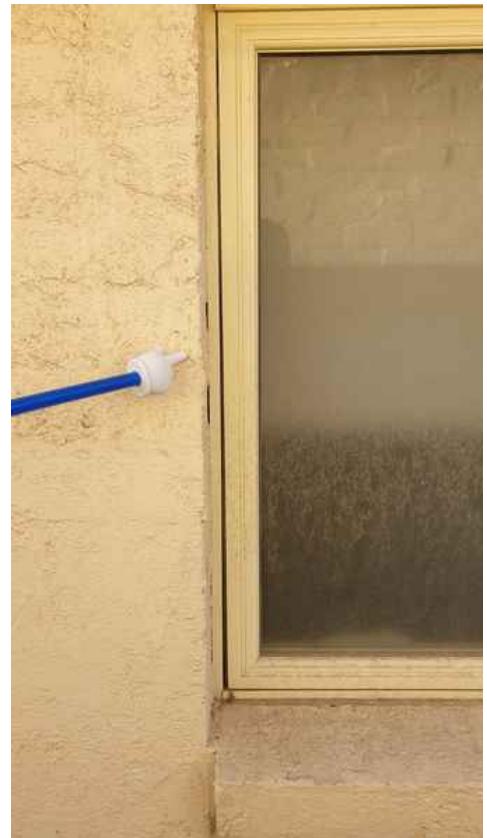
Missing expansion joint beside window

Contact a qualified professional.

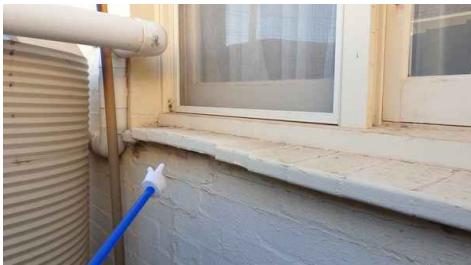
I observed bowing of brick window sills in one or more locations.

Bowing is usually caused by expansion of brickwork. Each brick can increase in size by up to 1/4 of a millimetre, that doesn't sound like much until you add all the bricks together and the brick wall can grow (increase in length) considerably. If inadequate (or no) expansion joints are installed to accommodate expansion, cracking, bowing and distorting brickwork can and will occur.

Bowing Masonry Window Sill

I recommend reinstalling the brick window sills and installing expansion joints as required to accommodate the naturally occurring expansion and contraction of the brickwork.

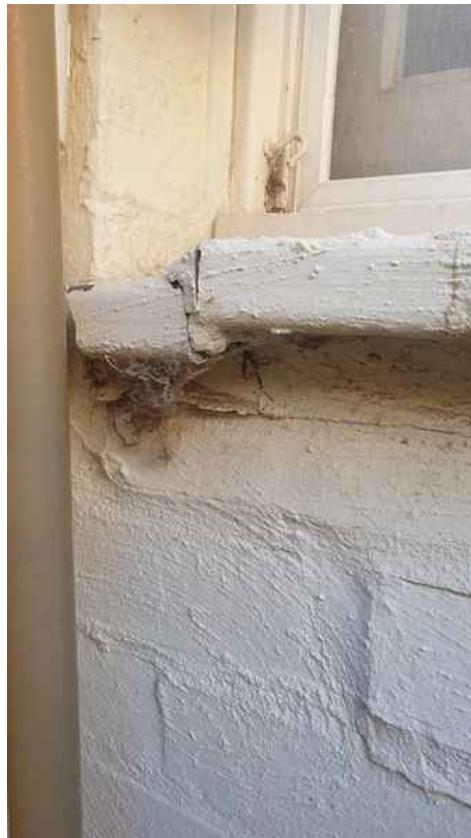
Bowing Masonry Window Sill

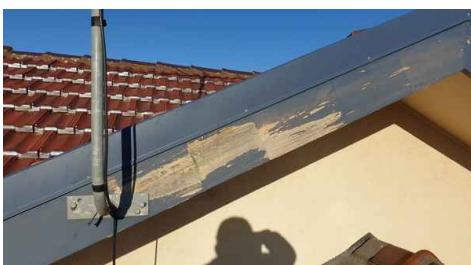
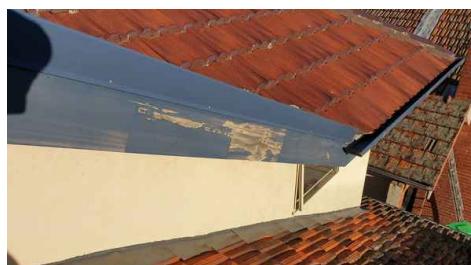
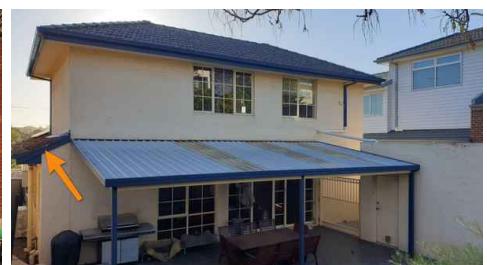
The paint or finish is failing. This can lead to deterioration and rot of the material.

Recommend that the areas be properly prepared and painted / finished.

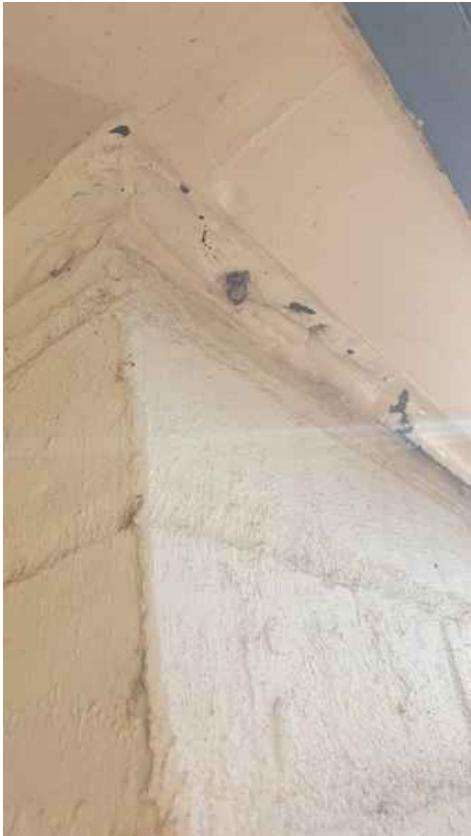
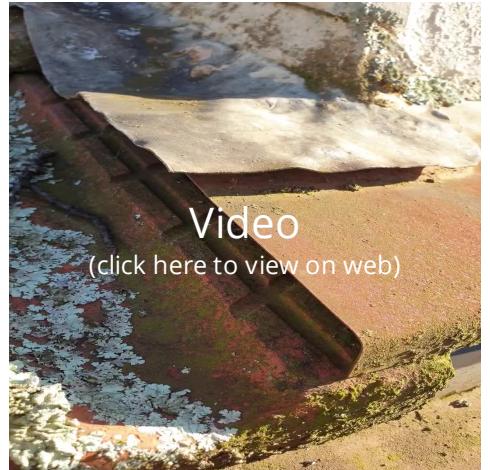
Water damage was present on the overhangs / fascia in areas. Repairs or replacement of any damaged wood is recommended by a qualified person.

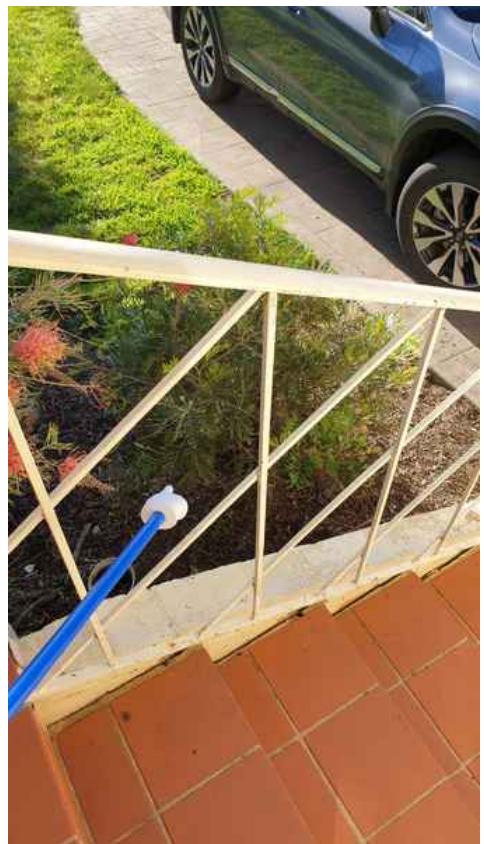
There is an unsafe opening in the railing. The spacing on the rail should not exceed 125mm. An opening greater than 125mm is a serious safety hazard especially for children as their head or other body part can become trapped.

Contact a qualified professional.

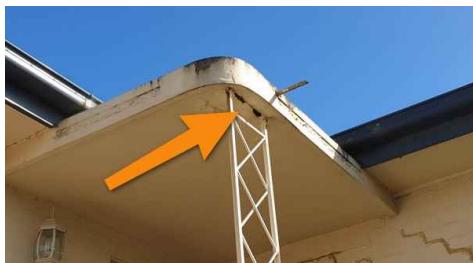
The steel support of the porch is rusting and requires maintenance / repair or replacement.
I recommend further investigation to establish an appropriate remediation / rectification or repair.
Recommendation
Contact a qualified professional.

Rusting

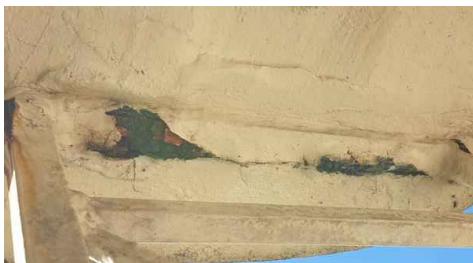
Rusting

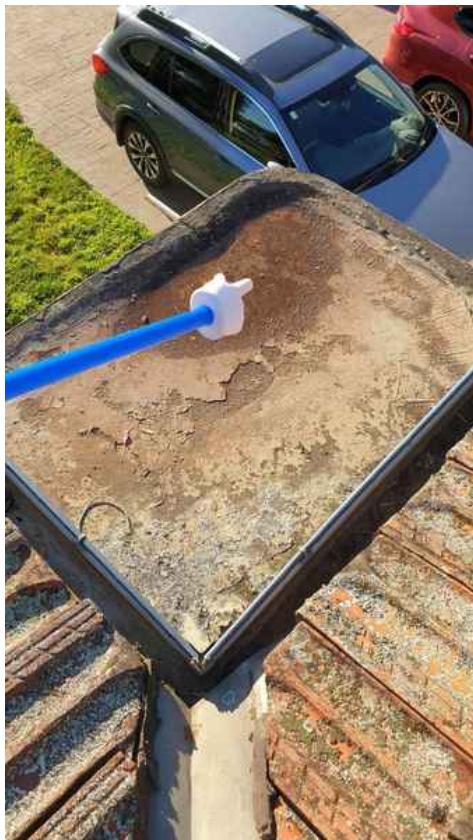
Ponding Water

Contact a qualified professional.

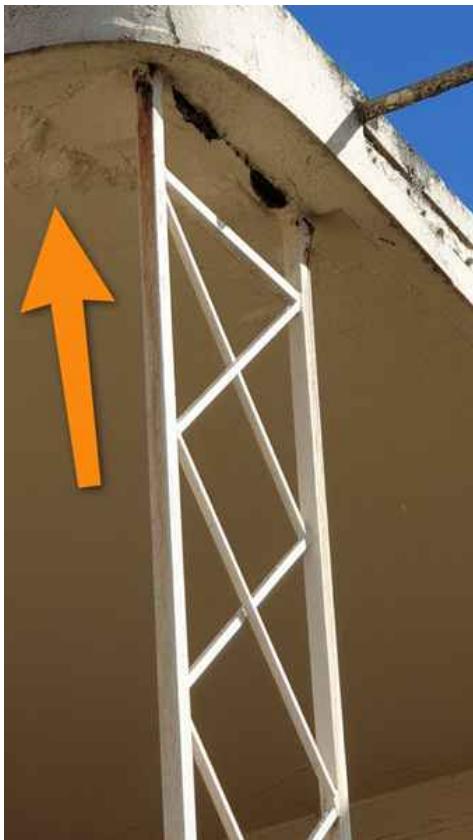
Moisture to Underside of Porch Roof

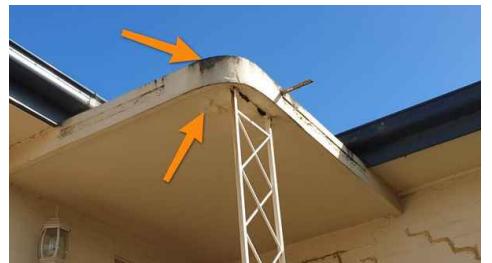
Porch Roof

Moisture or water penetration was evident on the underside or the porch roof.

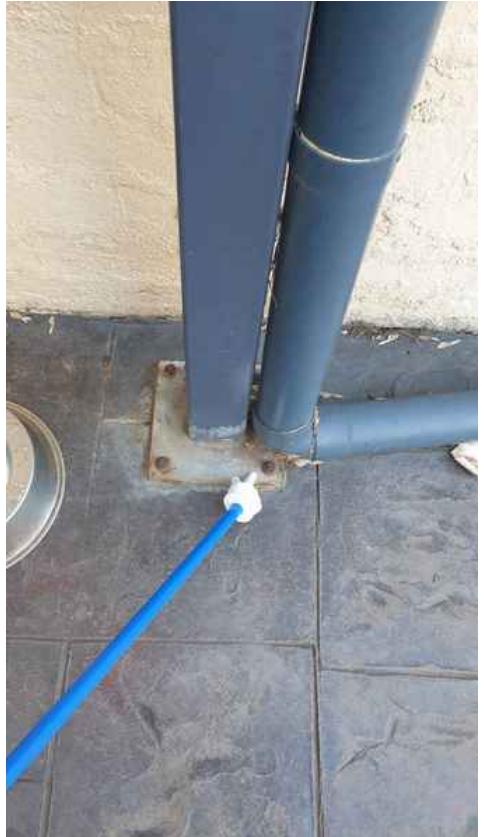
Rusting Hold Down Bolts

Contact a qualified professional.

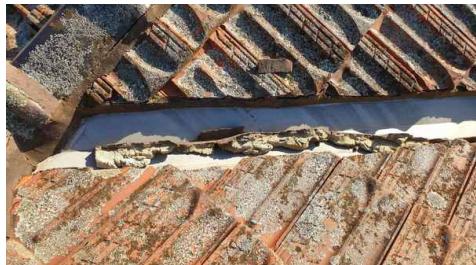
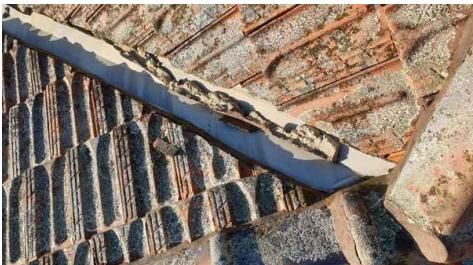
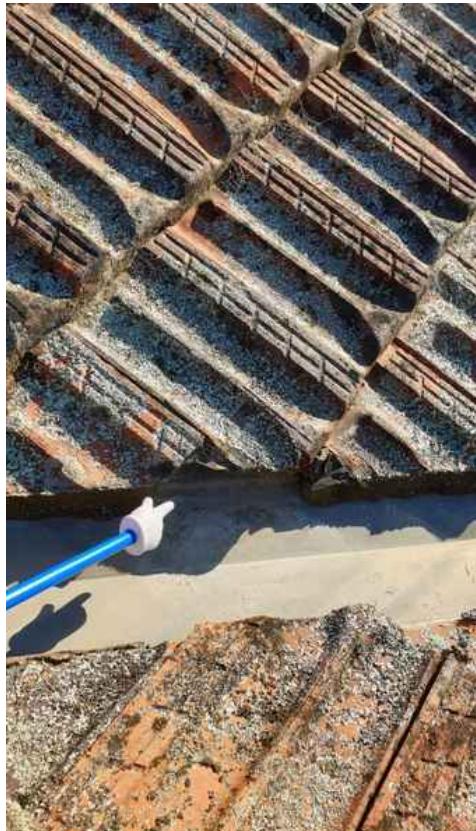
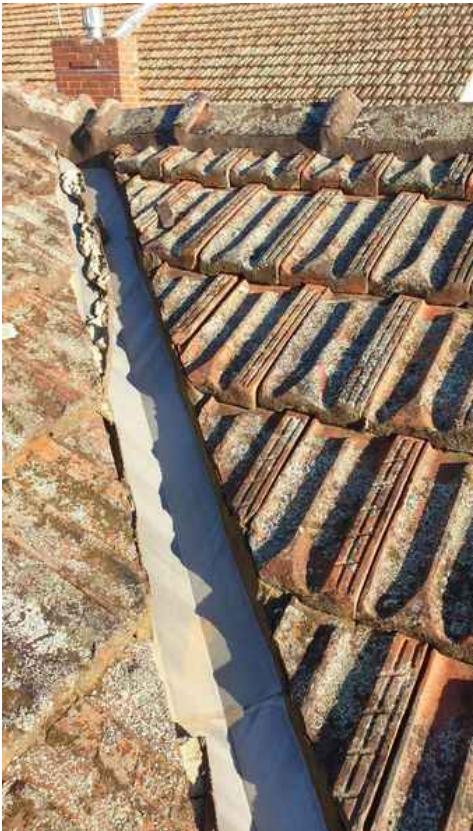
Areas of the roof valley have missing or dislodged pointing.

GF Roof Valley, Dislodged Pointing

GF Missing pointing

I recommend contacting a Qualified Roof Tiler to further evaluate and rectify.

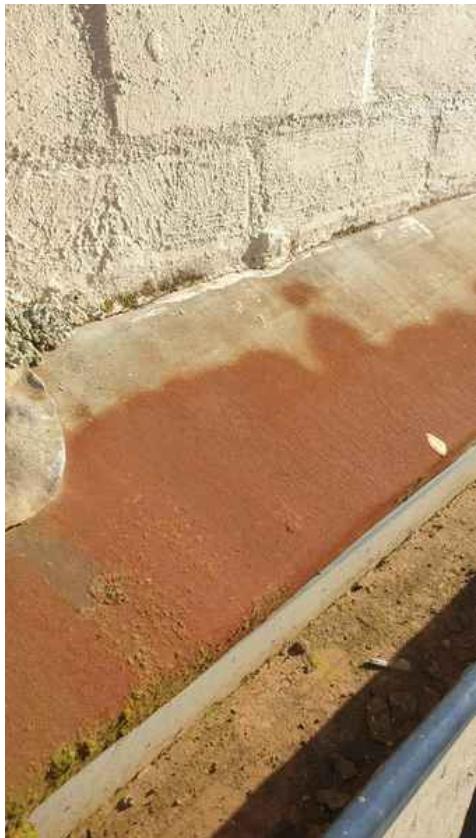
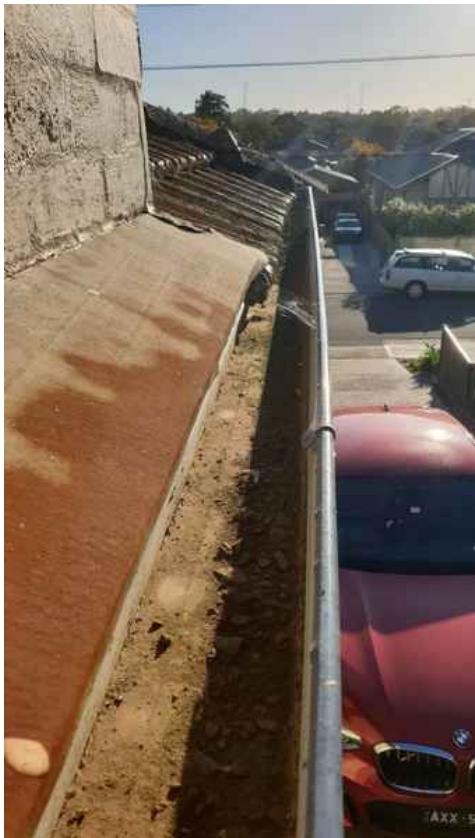
Rusting Chimney Flashing

Contact a qualified roofing professional.

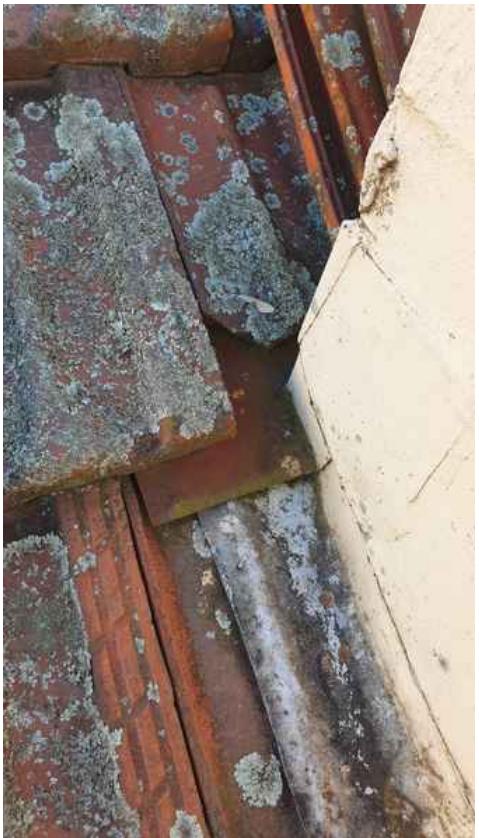
Lead Chimney Flashing

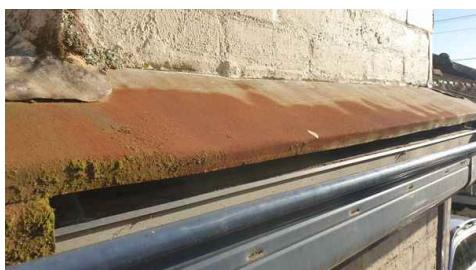
Roof flashing showed signs of corrosion, but are still in working condition. Flashing should be monitored to prevent severe corrosion leading to moisture intrusion.

Rusting Chimney Flashing

I recommend coating flashings with an appropriate epoxy coating to prolong the life of the flashings.

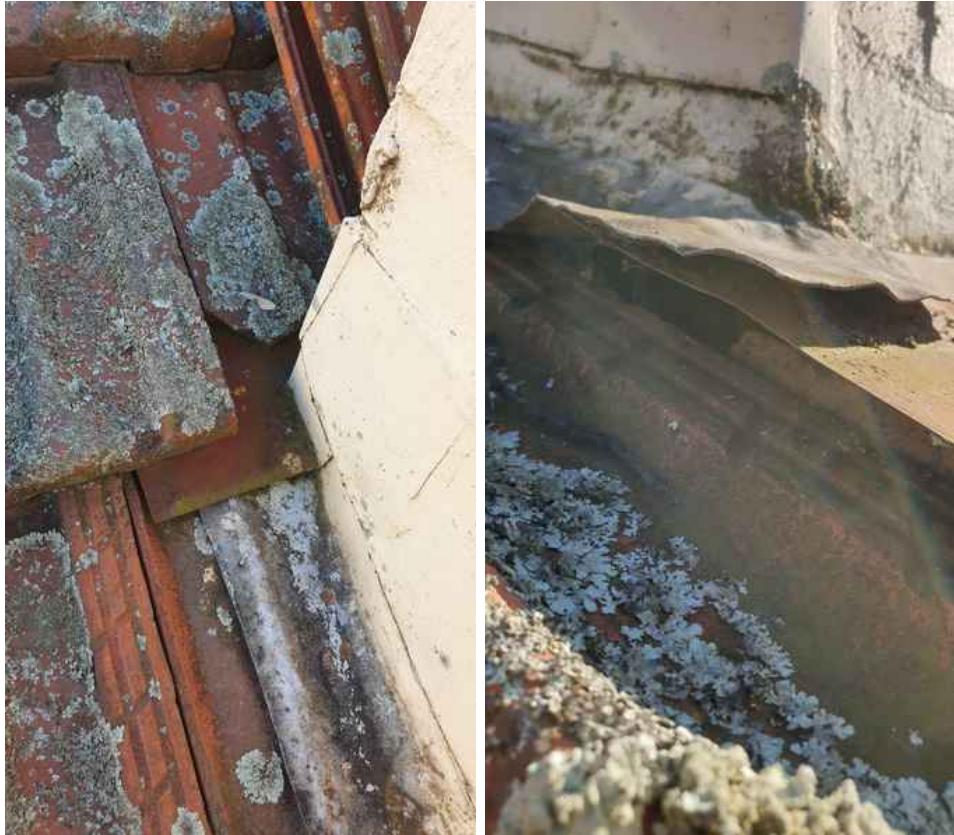
Areas of the chimney flashings have poor coverage which could lead to water or moisture ingress.

I recommend engaging a Qualified Roof Plumber to evaluate and repair.

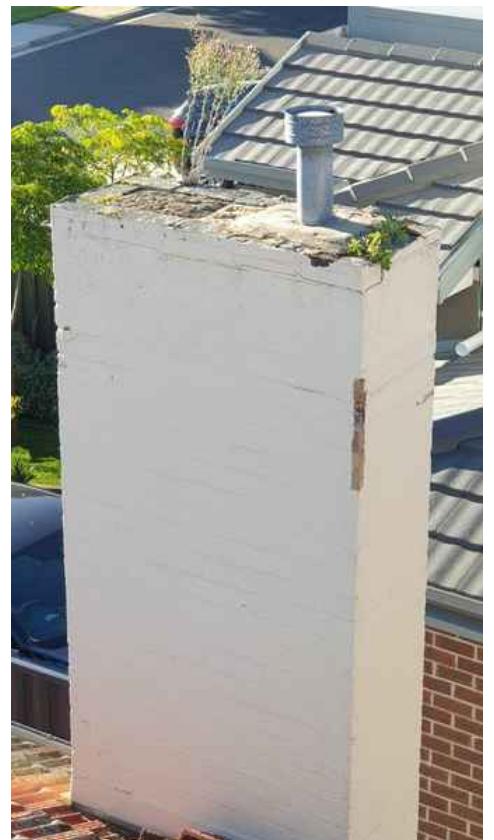
Chimney

The pointing on the top of the chimney is deteriorating, this could allow for water / moisture ingress and requires repairs.

I recommend engaging a qualified roofing contractor for further advice and repairs.

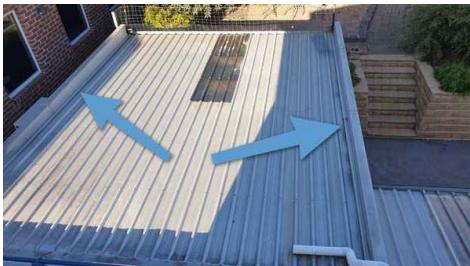
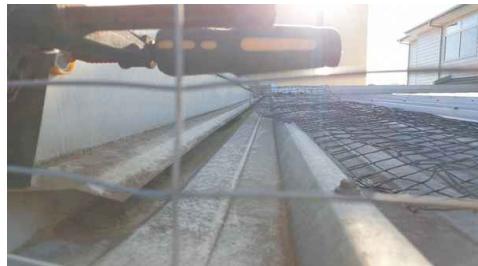
Apron Flashing

Apron Flashing Inadequate Coverage

Contact a qualified roofing professional.

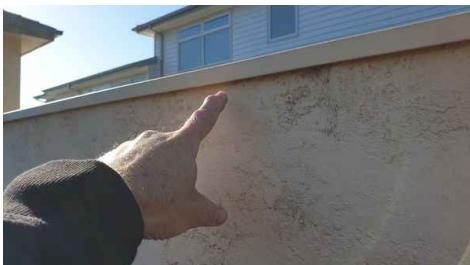
Minimum Turn Down is 50mm

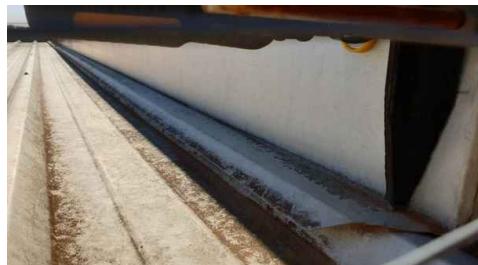
Apron Flashing Inadequate Coverage

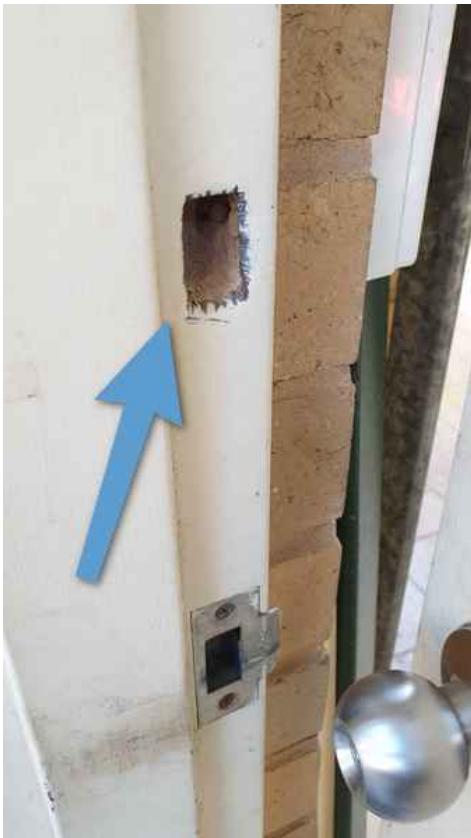
6.3.1 Pedestrian Door

The striker on the pedestrian garage door is missing.

Missing Dead Bolt Striker

I recommend installing a striker to suit.

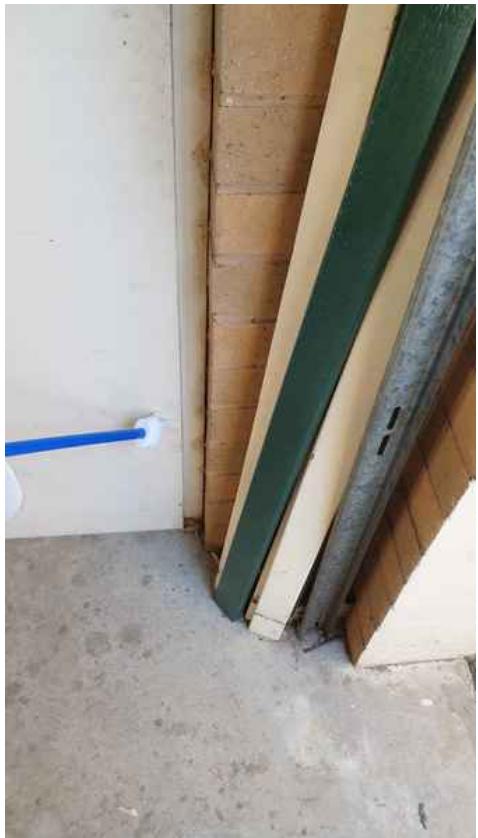
6.3.2 Pedestrian Door

The pedestrian garage door was binding at the time of the inspection. This is a relatively easy fix, the door needs to be planed to suit the opening. Remember to paint the edge of the door after rectifying to prevent water damage. This can be repaired by a Handyman, DIYer or Qualified Carpenter.

Door Binds

Contact a qualified carpenter.

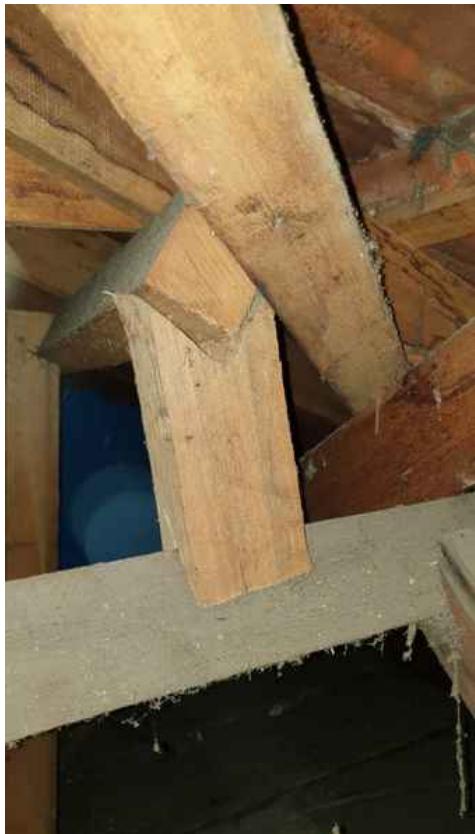
7.1.1 Roof Structure

A purlin prop supporting an *Underpurlin* was found to be inadequately founded. This may not yet have caused a problem, but it should be rectified to prevent possible roof and ceiling damage to the dwelling.

Poorly Installed Purlin Prop

I recommend founding the prop correctly, contact a qualified carpenter to rectify.
