TOPNOTCH BUILDING INSPECTIONS

PRE-PURCHASE RESIDENTIAL

1234 Main St. Preston Victoria 3072

10/07/2020 9:00AM

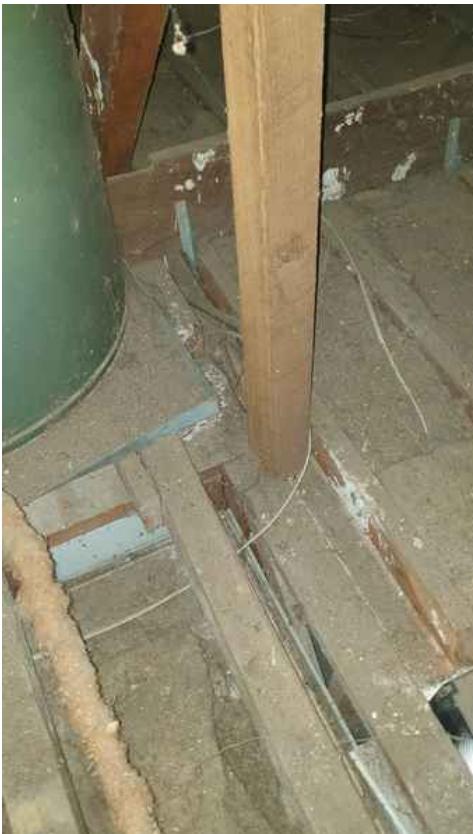
7.1.1 Roof Structure

A purlin prop supporting an *Underpurlin* was found to be inadequately founded. This may not yet have caused a problem, but it should be rectified to prevent possible roof and ceiling damage to the dwelling.

Poorly Founded Purlin Prop

I recommend founding the prop correctly, contact a qualified carpenter to rectify.

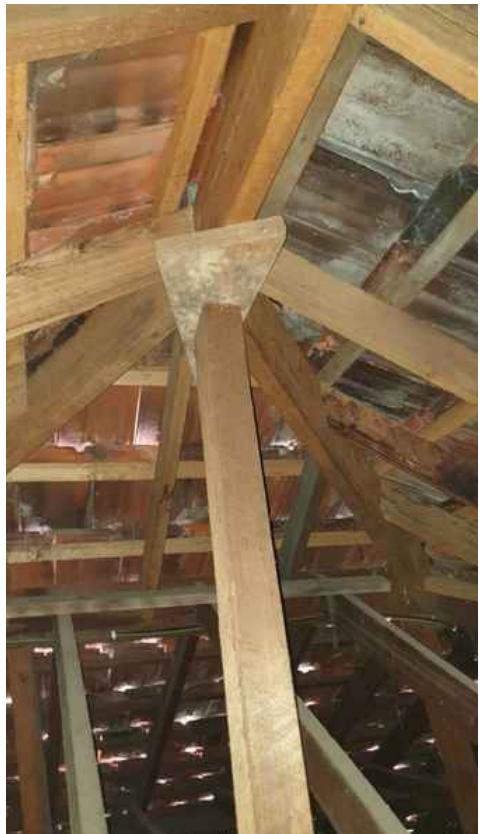
Poorly Installed Purlin Prop

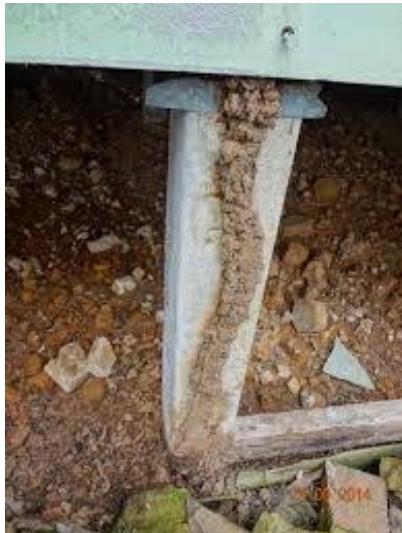
The stumps were missing or had no ant caps installed. Ant caps are a form of physical barrier to termites and are inserted between the lower floor framing timber and the supporting stumps, piers or masonry bases. They are usually made from galvanised sheet metal and are designed to force termites out into the open for detection during physical inspection.

Ant Caps Missing Throughout Entire Sub-Floor Area

Recommend installing ant caps to all stumps of the dwelling.

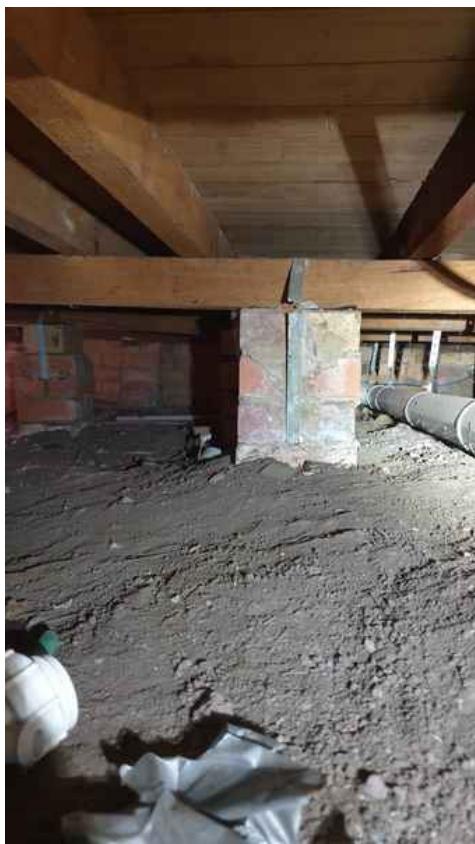
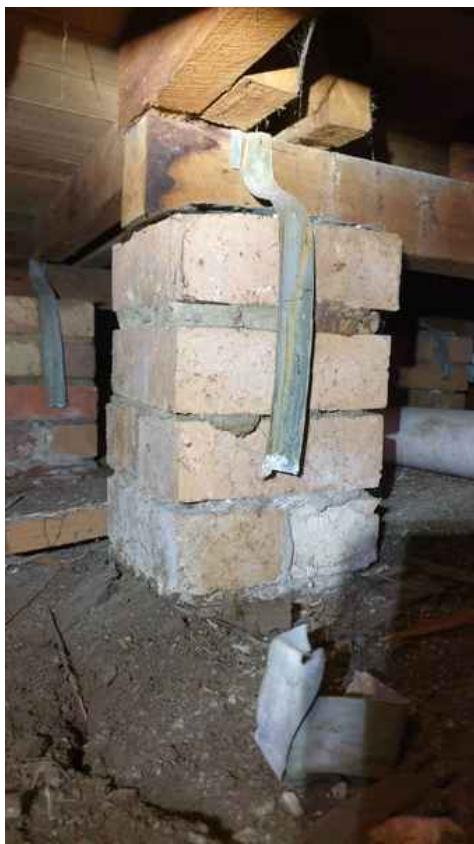
Ant Caps Missing Throughout Entire Sub-Floor Area

Contact a qualified professional.

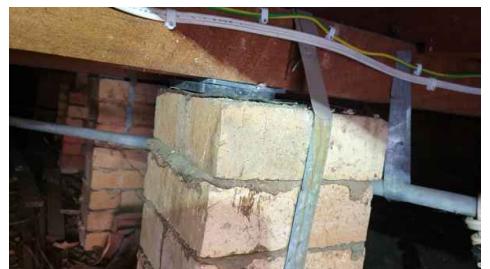
Ant Caps Missing Throughout Entire Sub-Floor Area

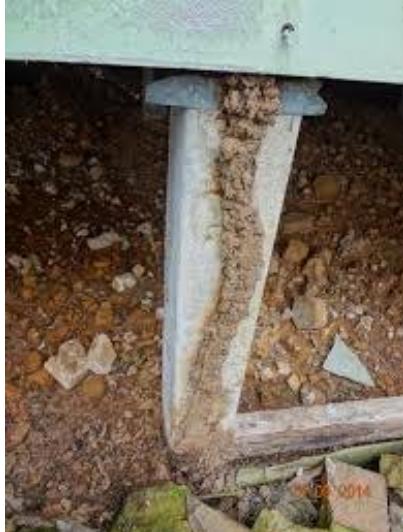
8.2.2 Crawlspaces

The stumps were missing or had no ant caps installed. Ant caps are a form of physical barrier to termites and are inserted between the lower floor framing timber and the supporting stumps, piers or masonry bases. They are usually made from galvanised sheet metal and are designed to force termites out into the open for detection during physical inspection.

Recommend installing ant caps to all stumps of the dwelling.

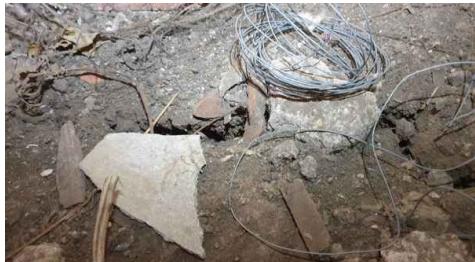
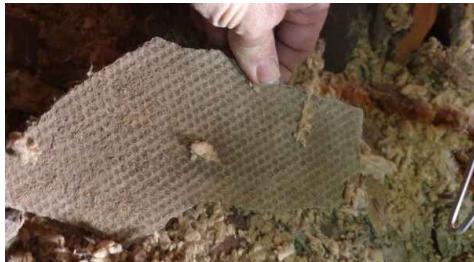
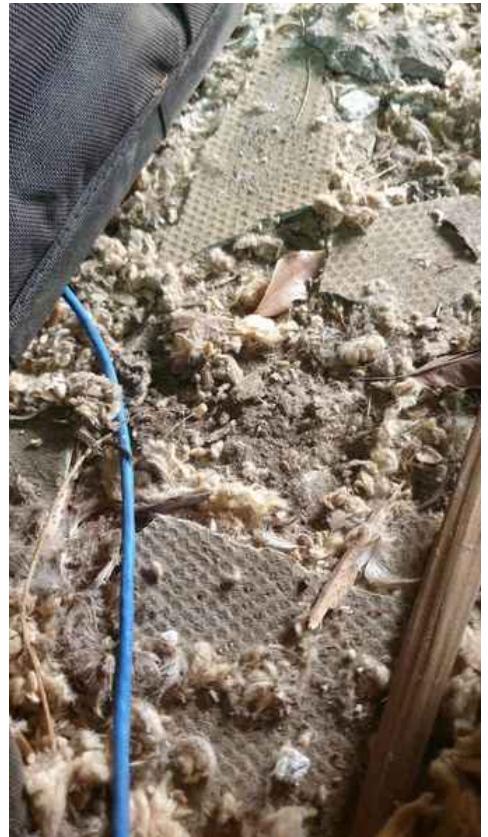
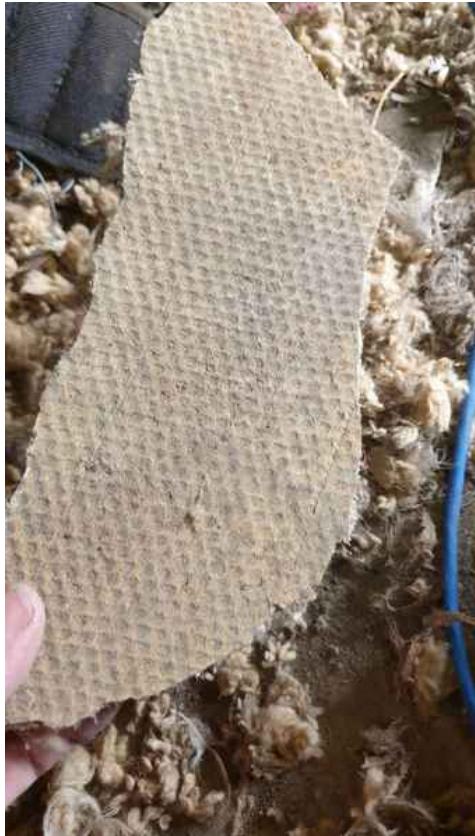
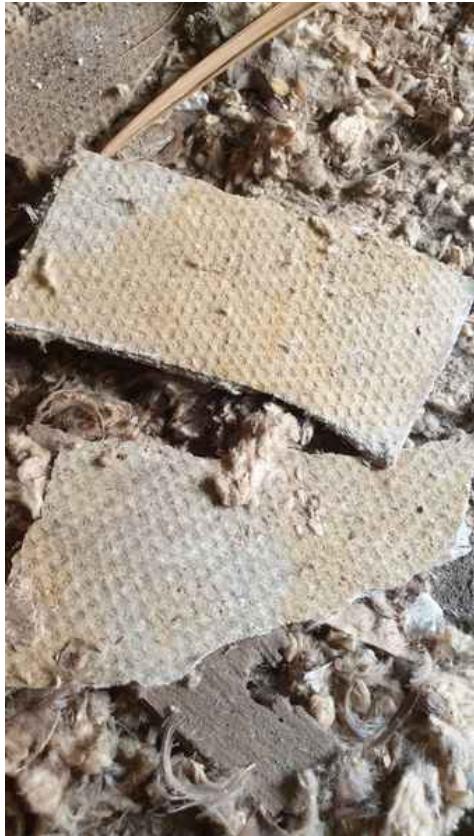
8.2.3 Crawlspaces

I observed what I believe to be Asbestos Containing Materials within the sub-floor area. Entering the sub-floor area could be a **Major Health Concern**.

Suspected Asbestos Containing Materials

I recommend not entering the sub-floor space, have a professional test the suspected material for asbestos and have it removed by a professional if it's found to contain asbestos.

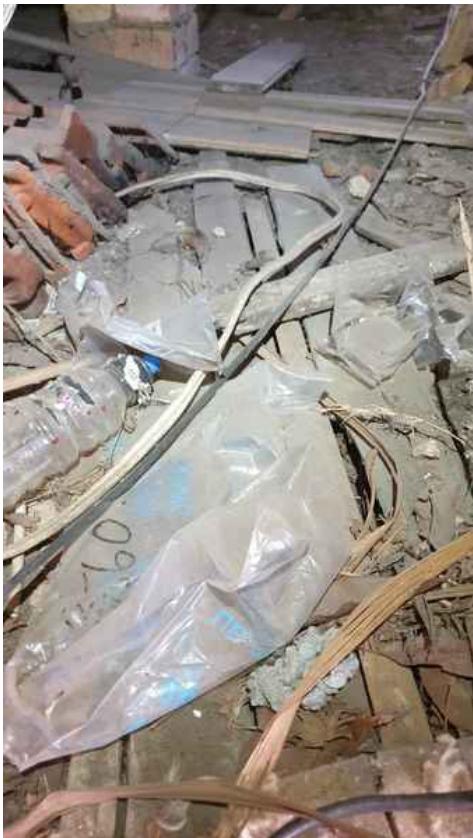
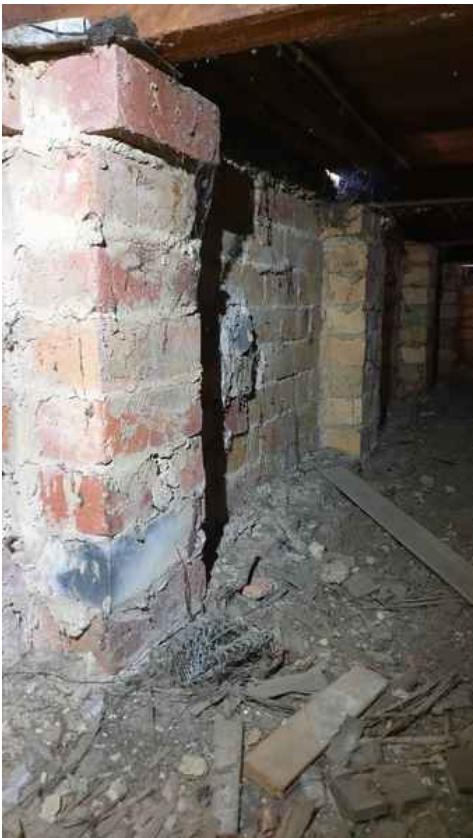
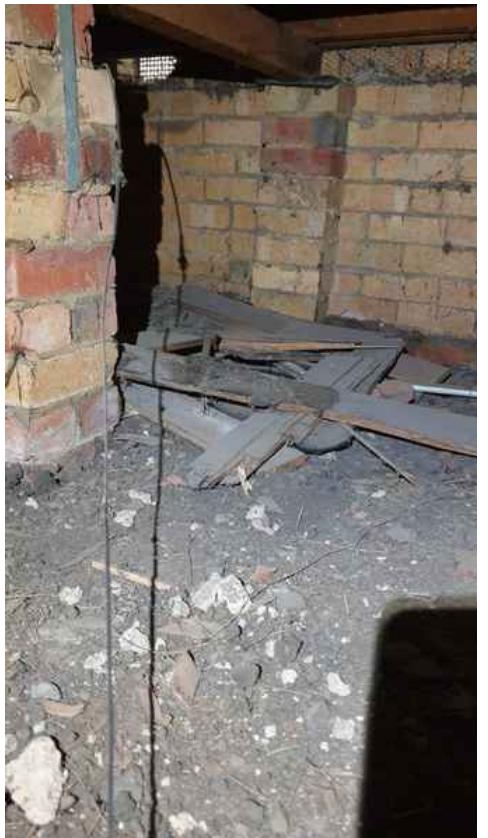
8.2.4 Crawlspaces

Building debris and other rubble was found in the sub-floor of the dwelling.

Sub-Floor Debris

I recommend cleaning all foreign matter and debris from the sub-floor area.

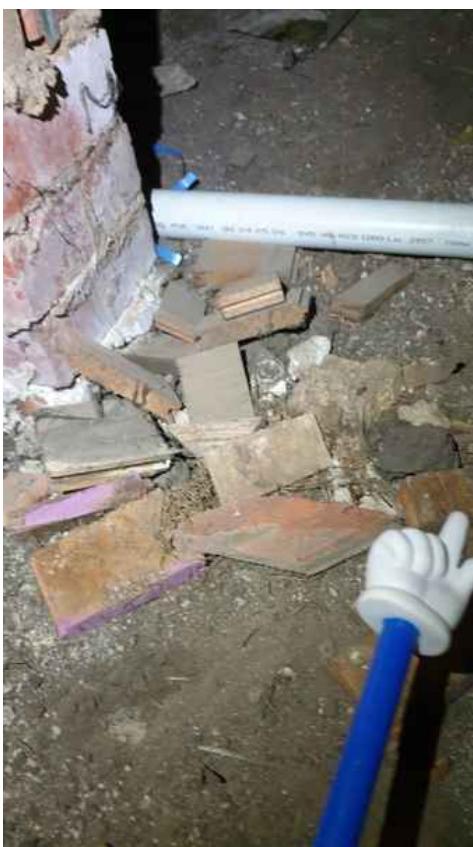
Sub-Floor Debris

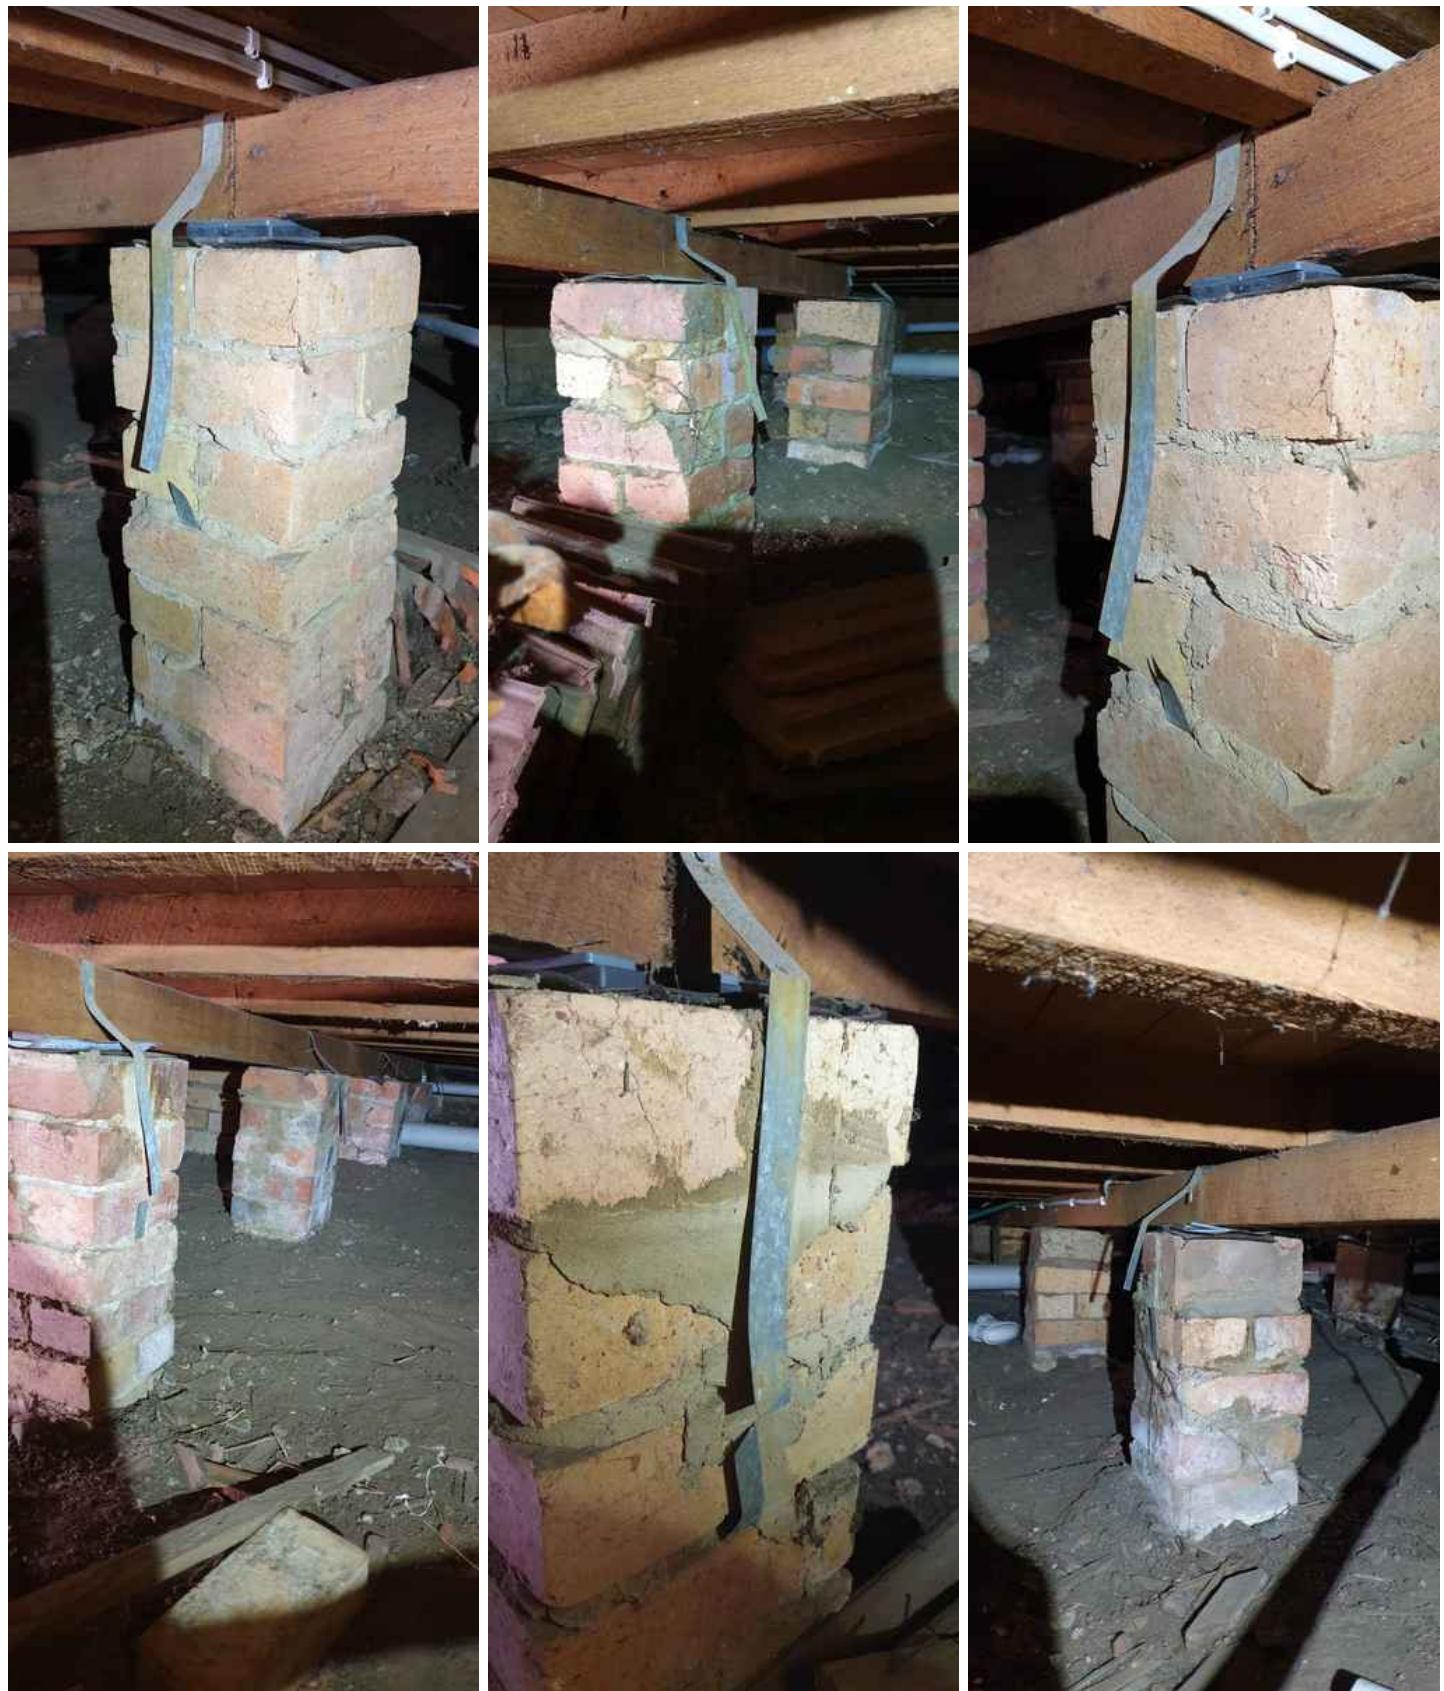
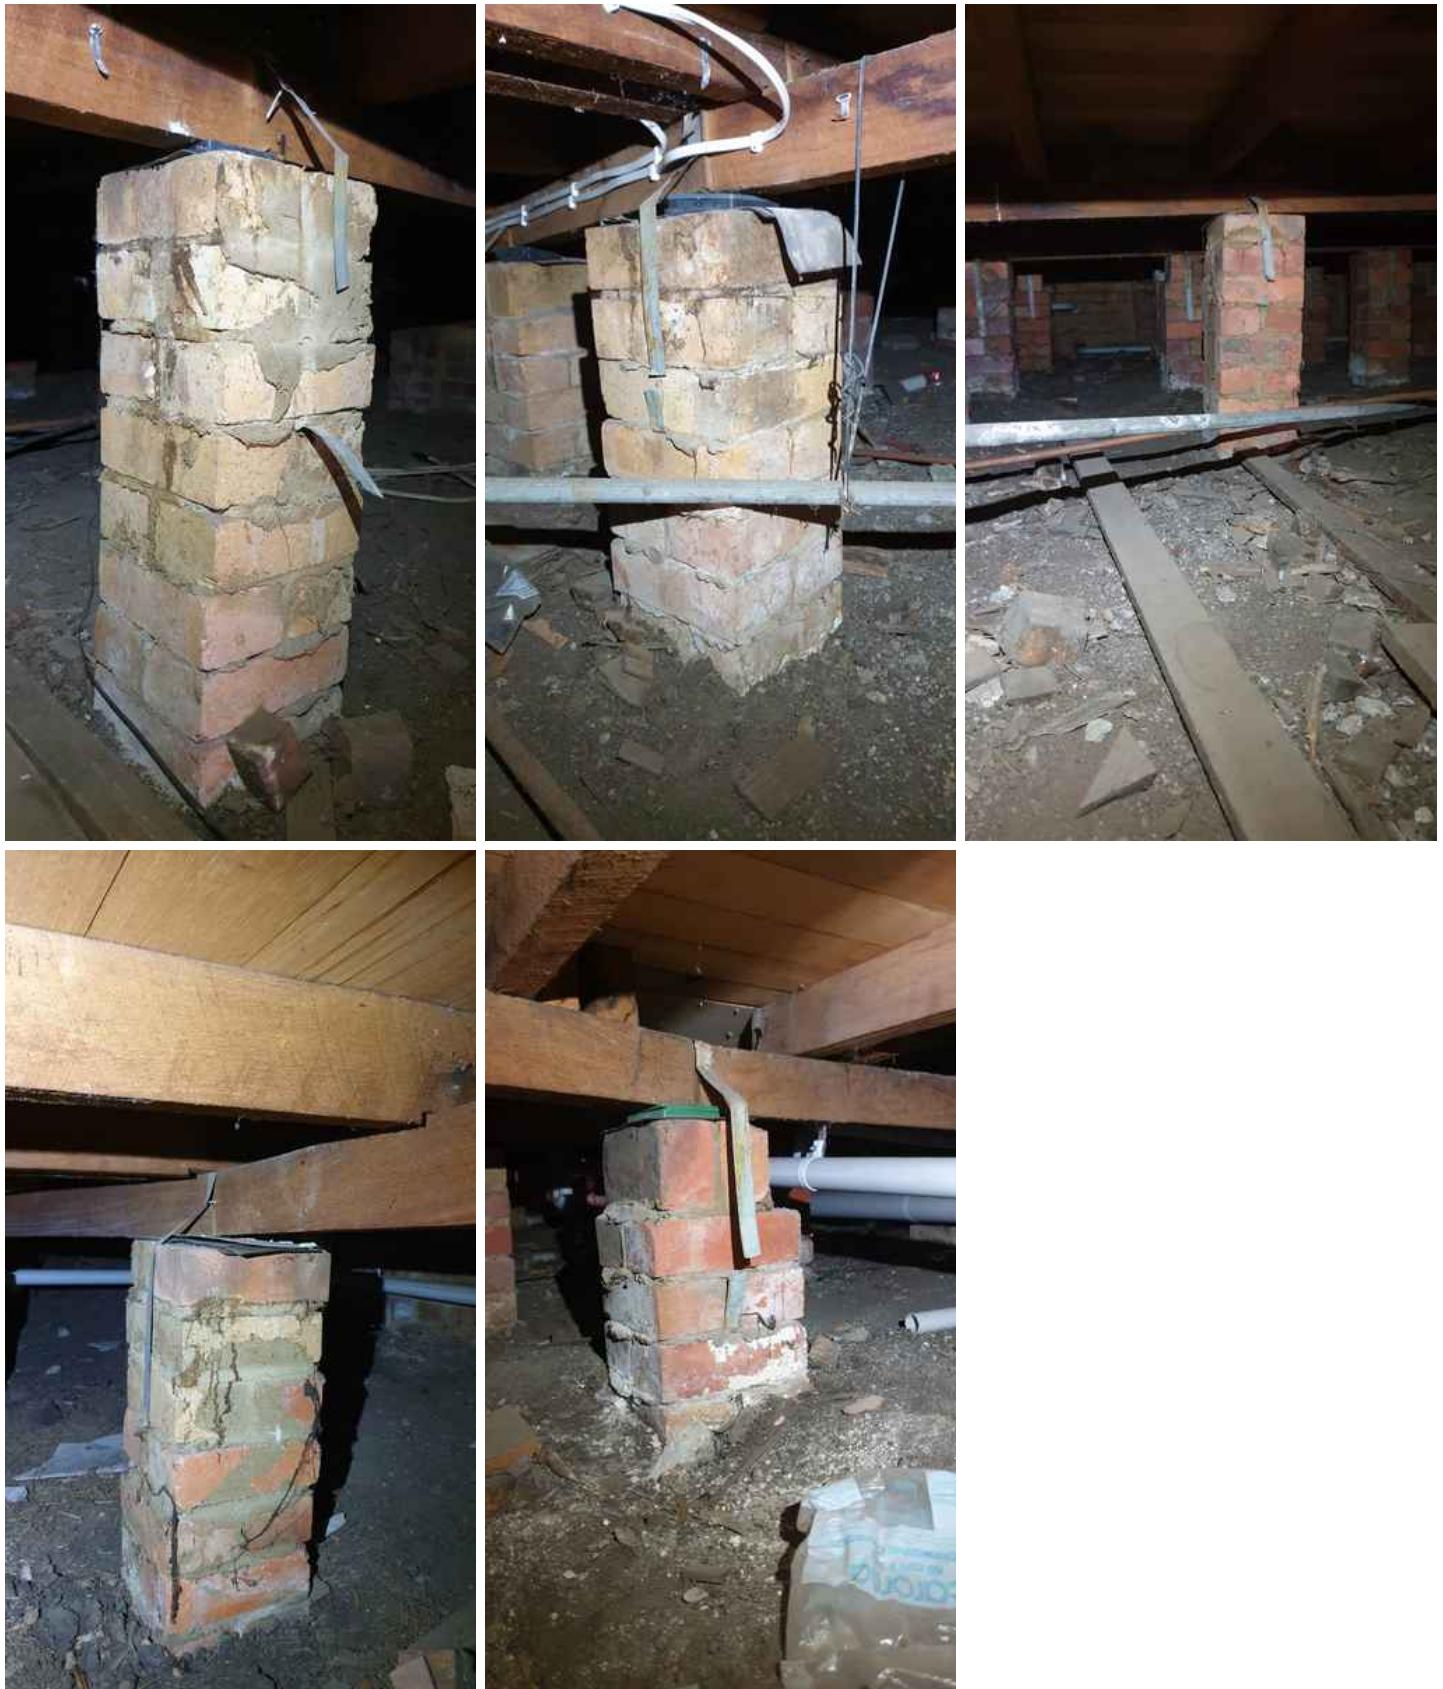
8.2.6 Crawlspaces

HOLD DOWN STRAPPING CUT

The hold down strapping of the bearers which are founded into and or under the brick piers have been cut! Hold down straps are designed to hold the bearer down to the pier to prevent a bouncing or springing floor and to transfer wind and racking forces through to the foundations.

I recommend engaging a licensed engineer for advice on remediation and rectification works.

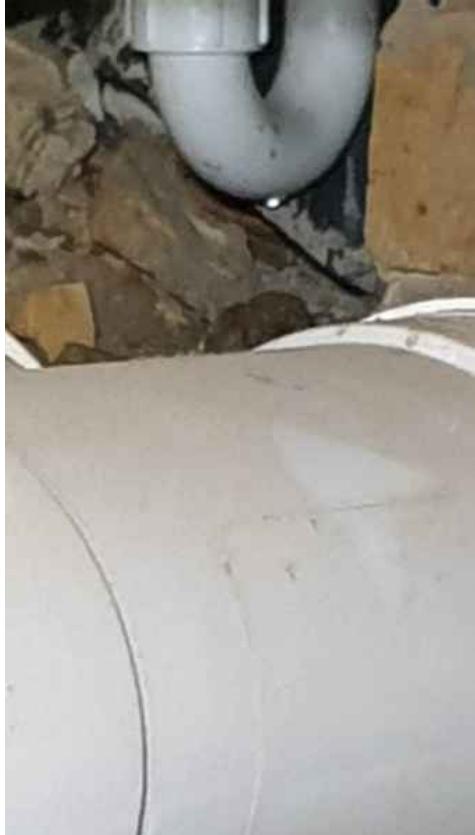
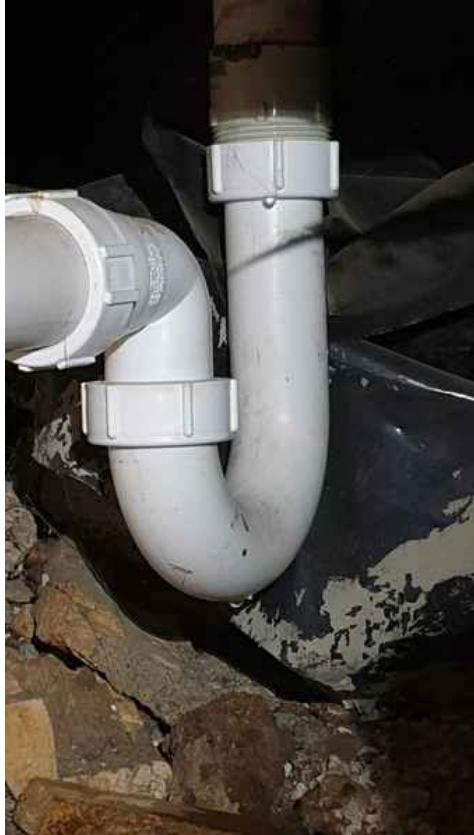
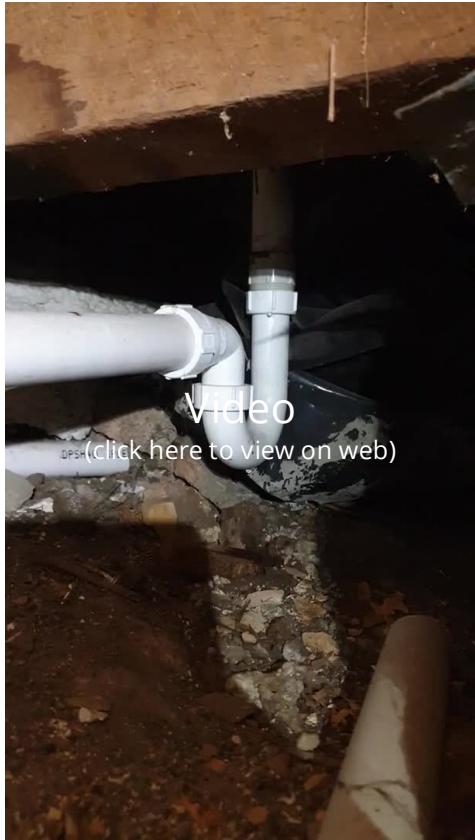
8.2.7 Crawlspaces

PLUMBING LEAKING (BATH TRAP)

Plumbing pipes were observed to be leaking at the time of the inspection.

I observed a leaking bath trap.

I recommend contacting a licensed plumber to assess and rectify.

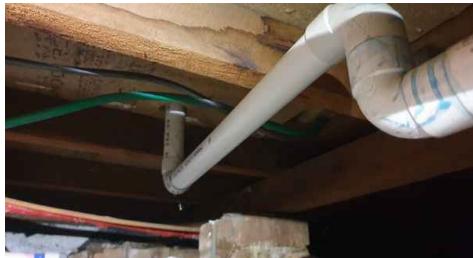
I observed negative fall on some parts of the sewer line as shown in the photographs.

Negative Fall

I recommend contacting a licensed plumber for repairs and rectification works.

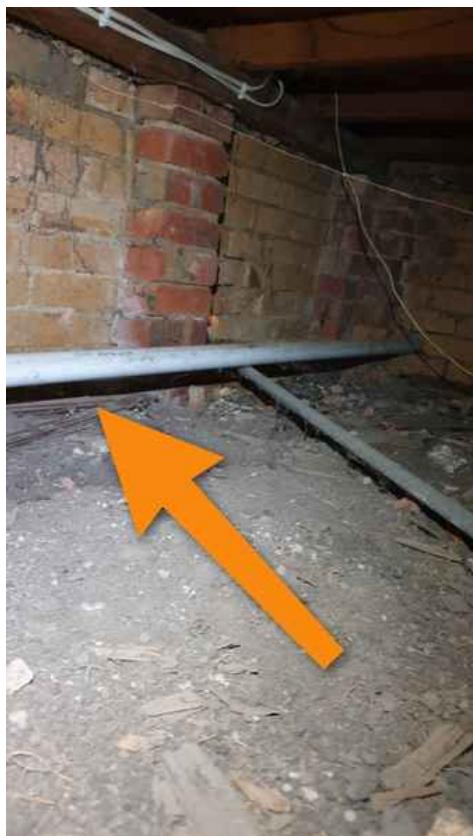
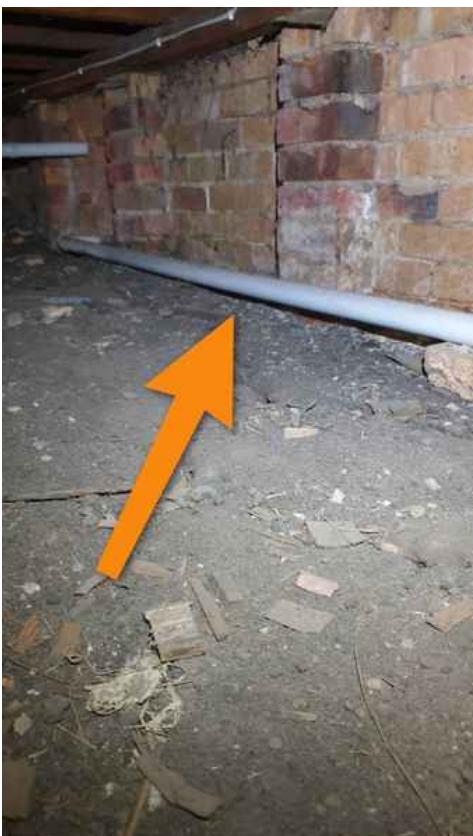
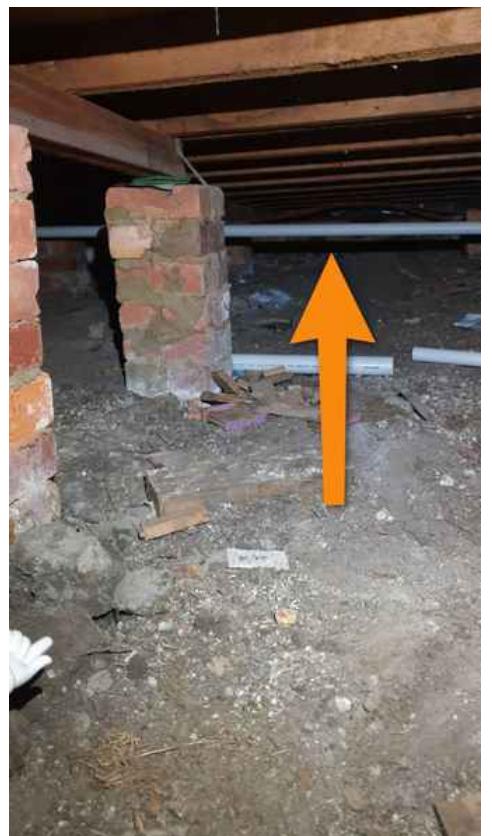
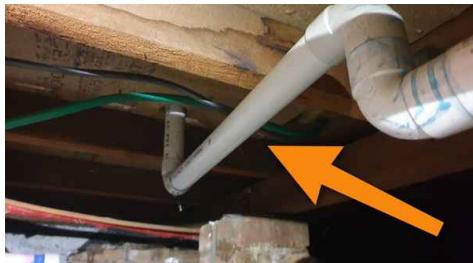
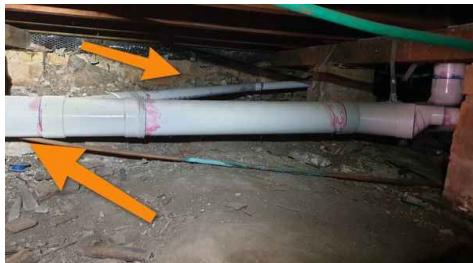
Unsupported Sewer Pipe

Contact a qualified plumbing contractor.

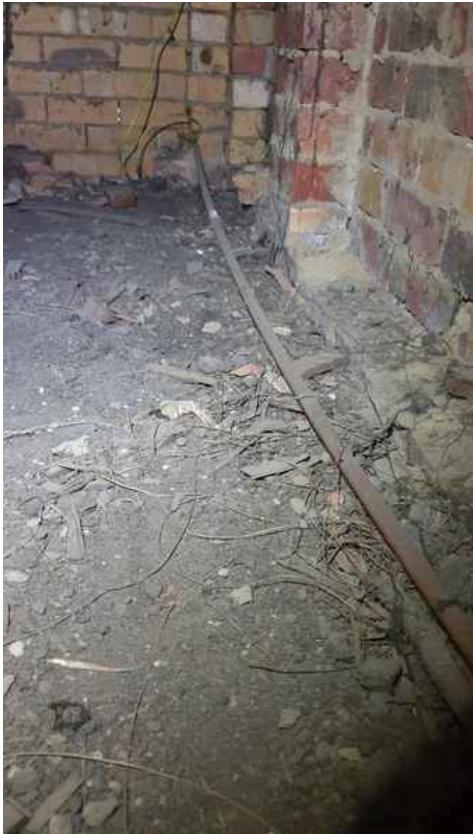
Unsupported Water Pipe

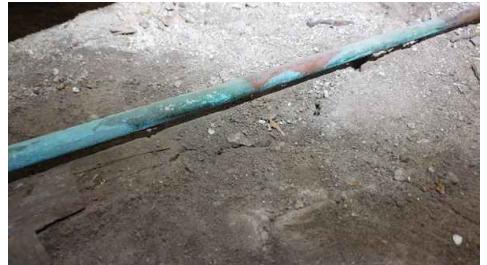
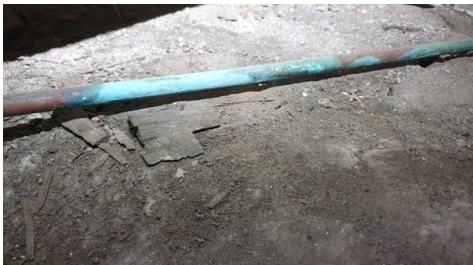
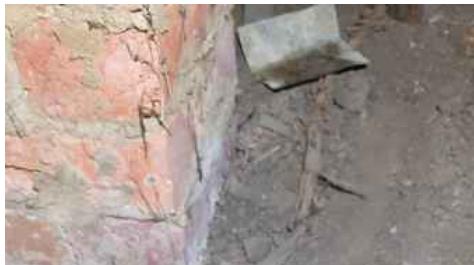
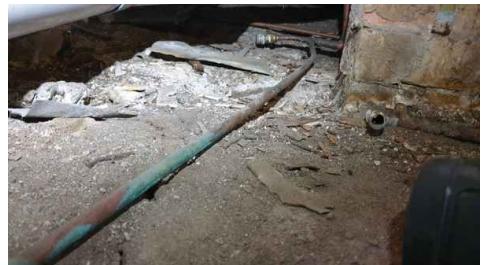
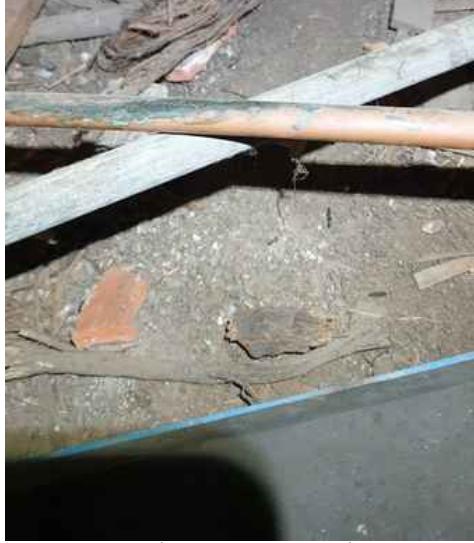
Unsupported Water Pipe

Unsupported Water Pipe and
Electrolysis

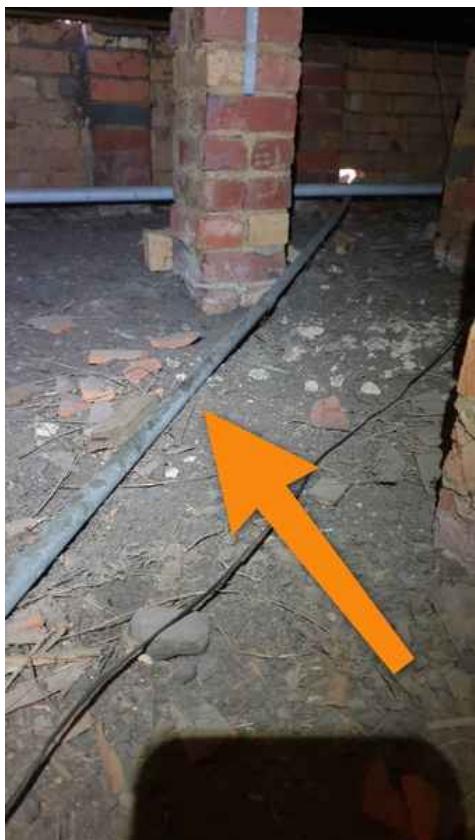
Unsupported Pipework

Recommendation
Contact a qualified plumbing contractor.

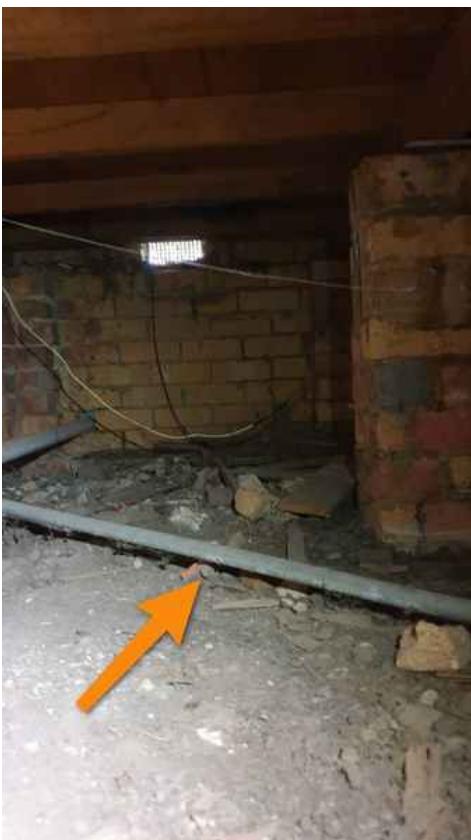
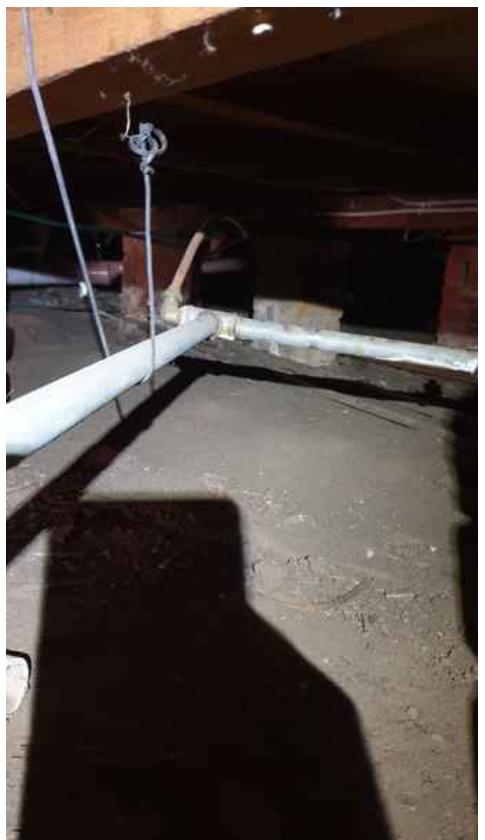
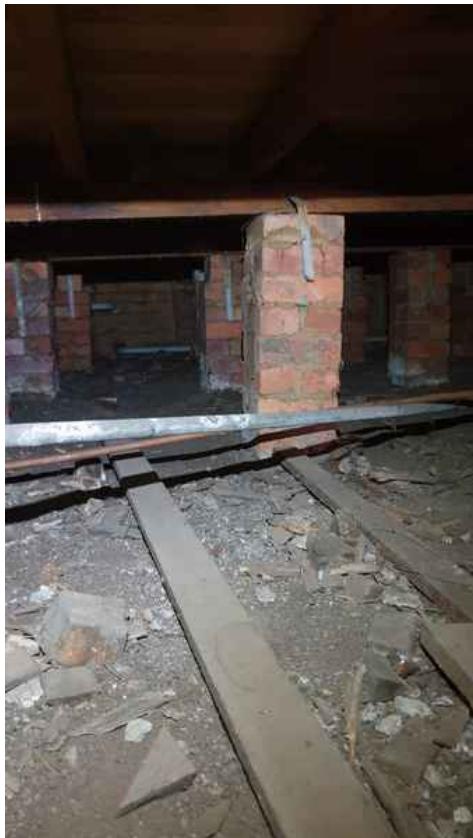
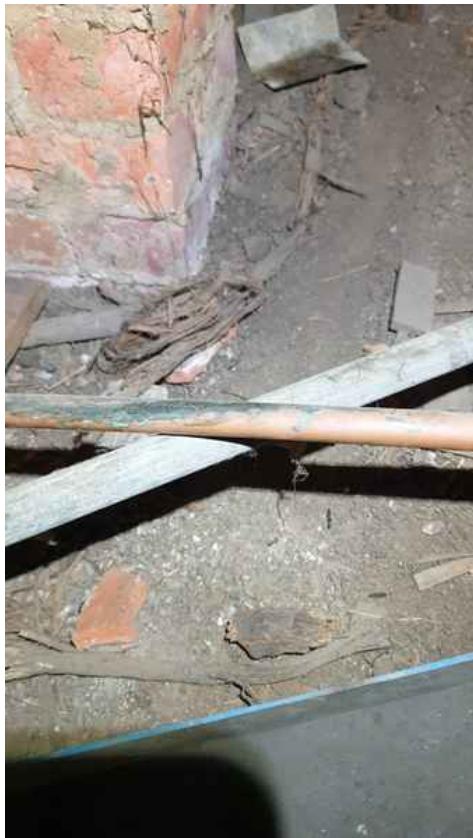
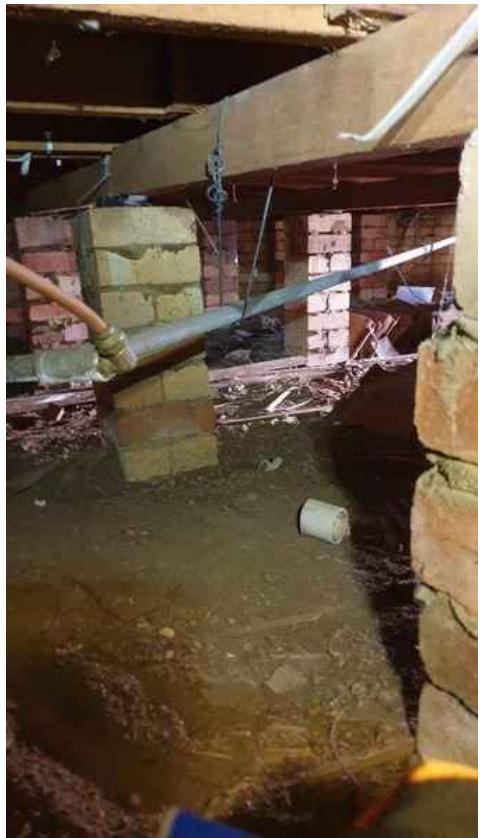
I observed unsupported galv' gas plumbing pipework in the sub-floor / crawlspace area.

Unsupported Pipework

Poorly Supported

Unsupported Pipes

Unsupported and Electrolysis

I recommend contacting a licensed plumber to rectify.

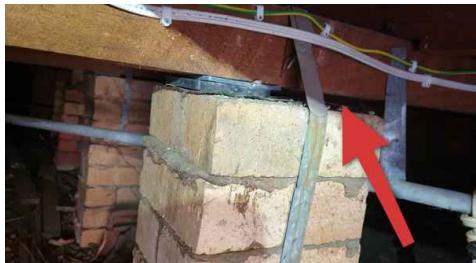
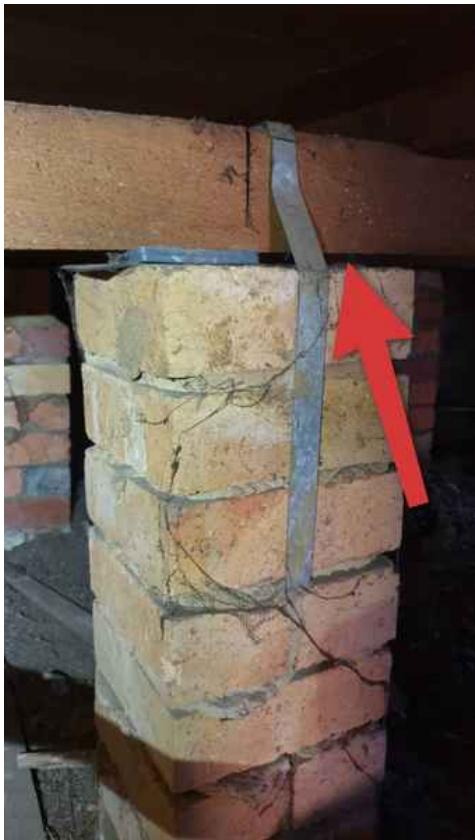
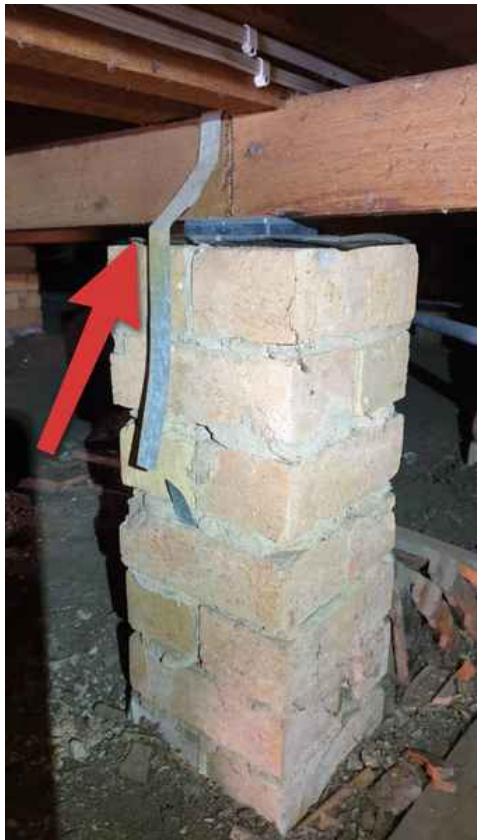
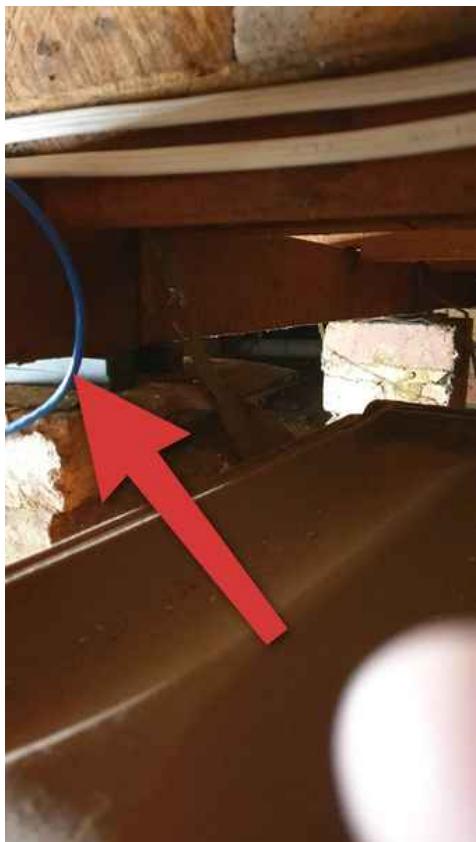
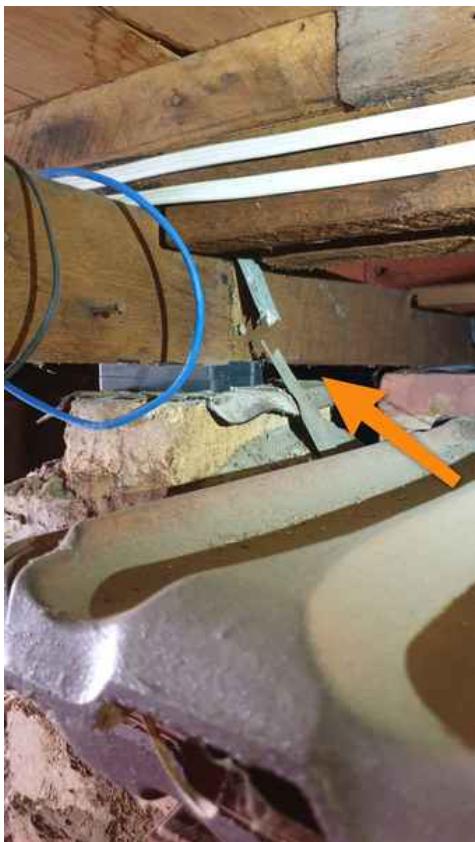
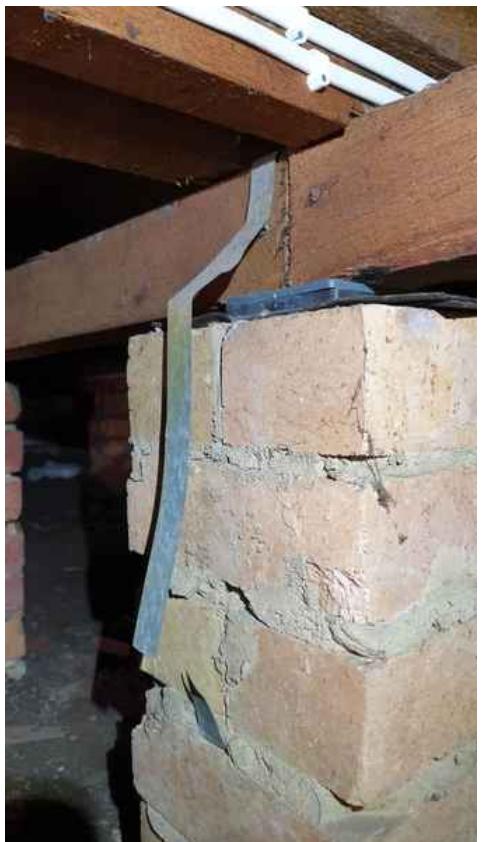
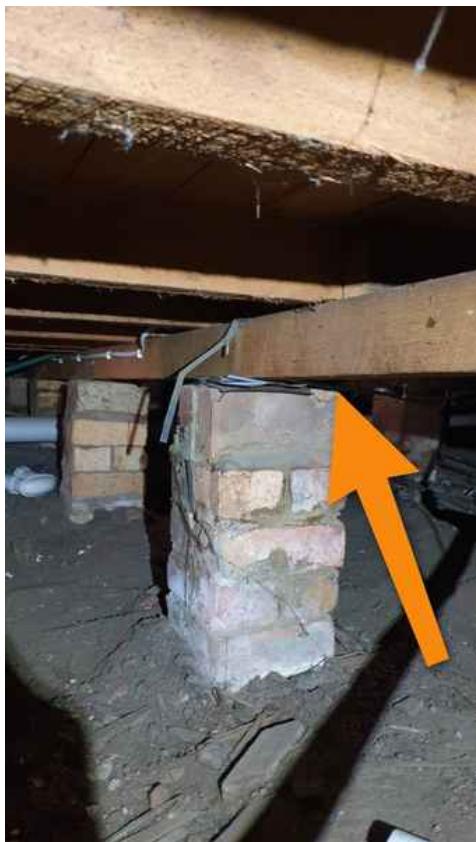
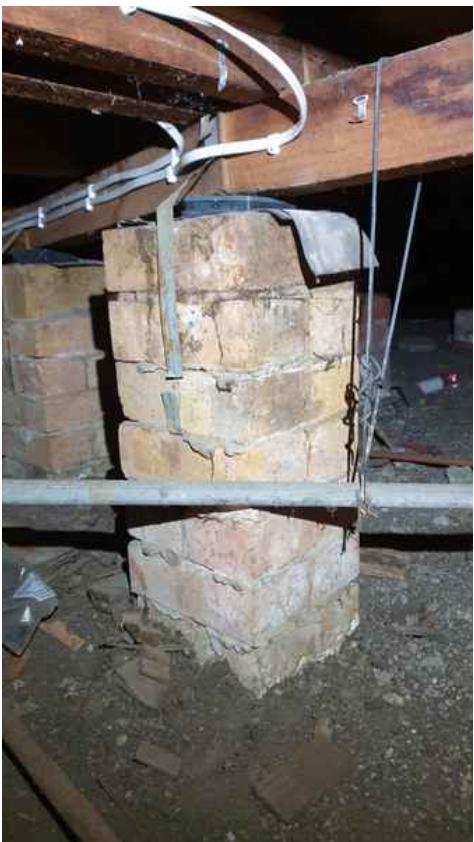
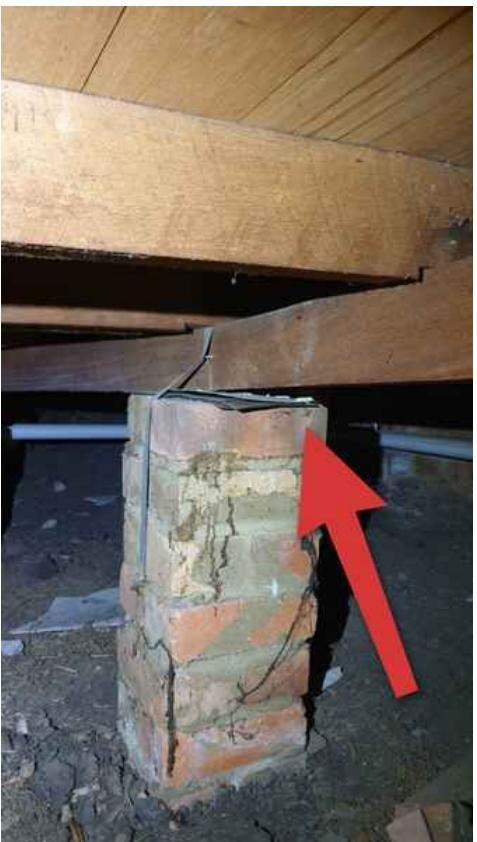
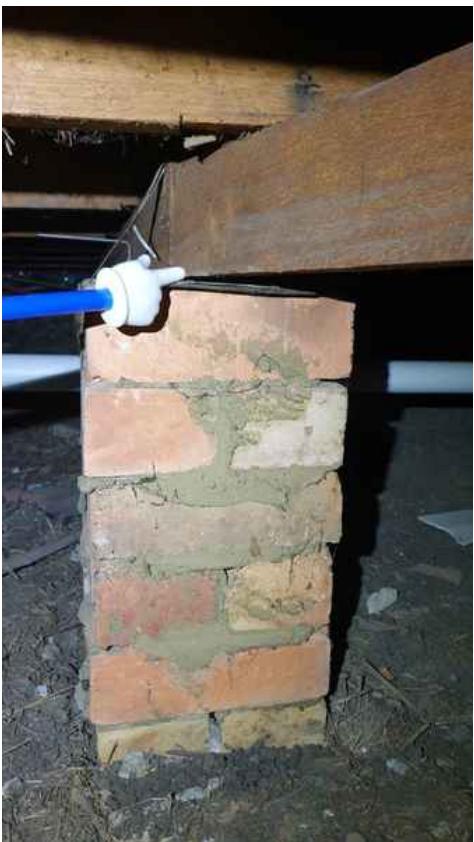
MAJOR DEFECT / SAFETY HAZARD

Poorly Supported

I recommend contacting a structural engineer for further evaluation and advice.

Contact a qualified carpenter.

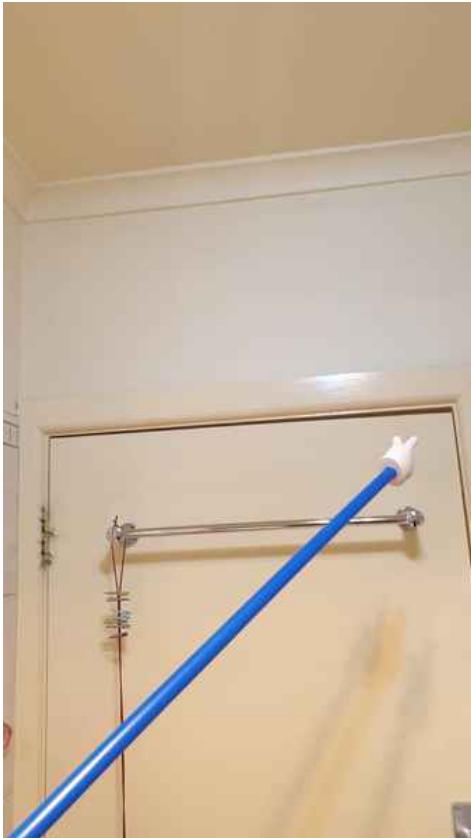
9.2.1 Doors

(MARGINS) INCONSISTENT

The door margins around the bathroom door are inconsistent, this is likely due to settlement / movement of the sub-floor structure.

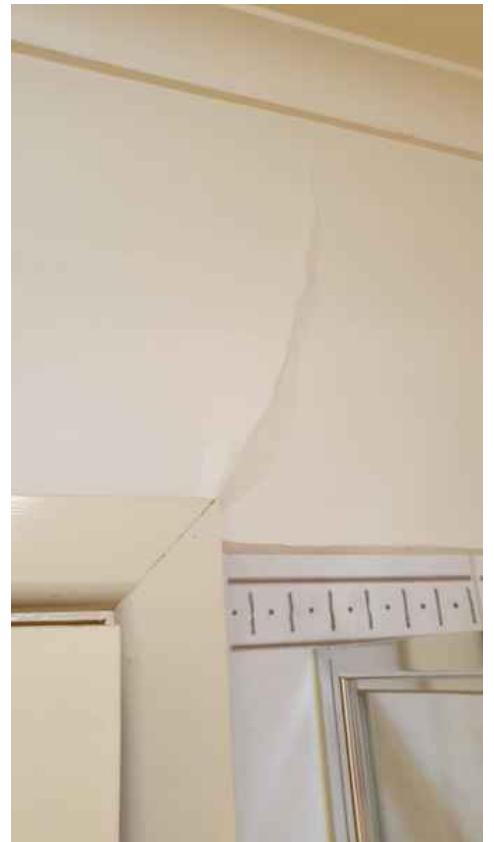
9.4.1 Walls

MINOR CRACKS

Minor cracks at the corners of doors in walls.

Some settling is not unusual in a home of this age and these cracks are not a structural concern.

Contact a qualified drywall contractor.

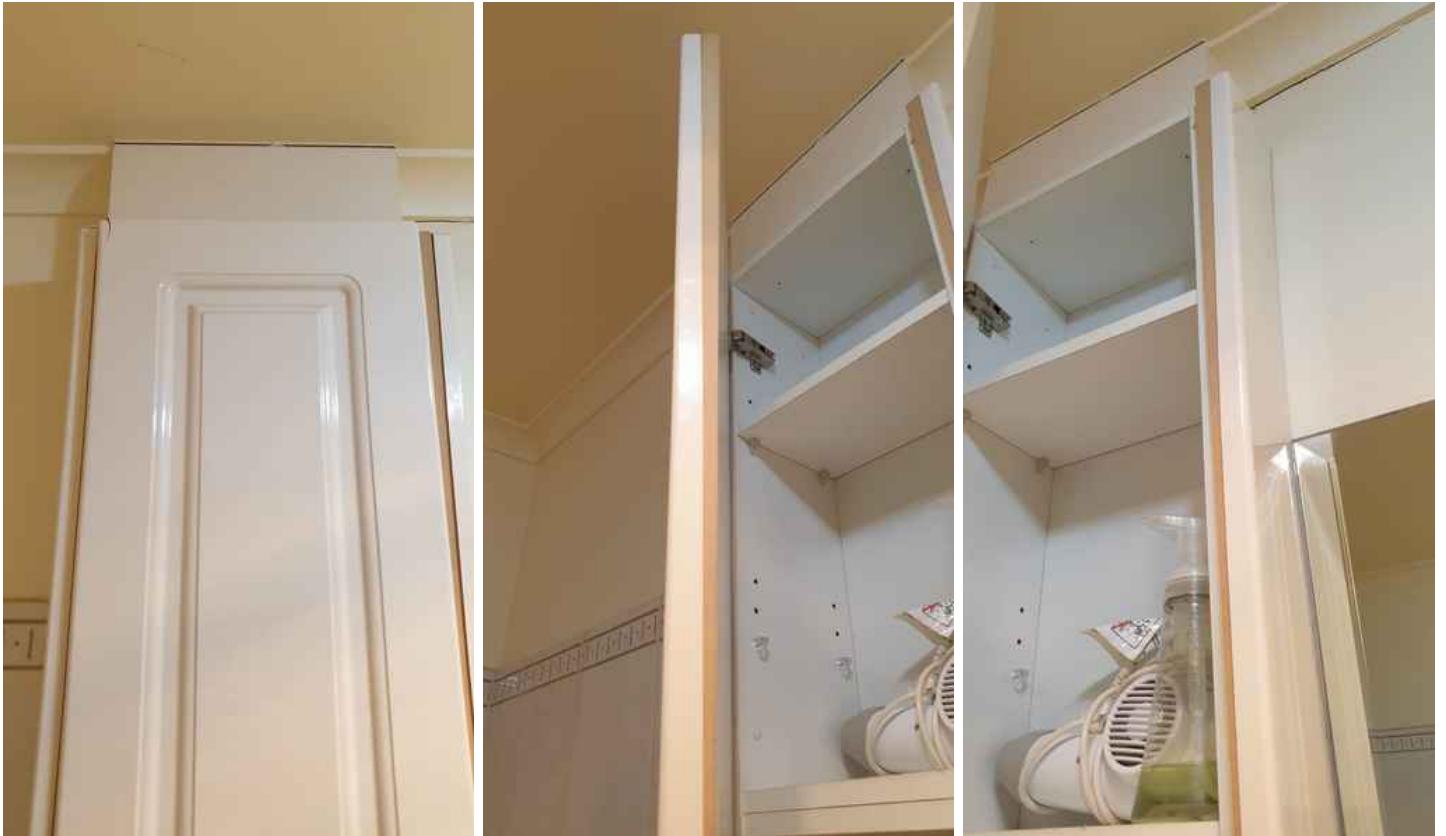
MINOR DEFECT

I recommend replacing cabinet doors, contact a Cabinetmaker for replacement.

Contact a qualified cabinet contractor.
