TOPNOTCH BUILDING INSPECTIONS

PRE-PURCHASE RESIDENTIAL

1234 Main St. Preston Victoria 3072

10/07/2020 9:00AM

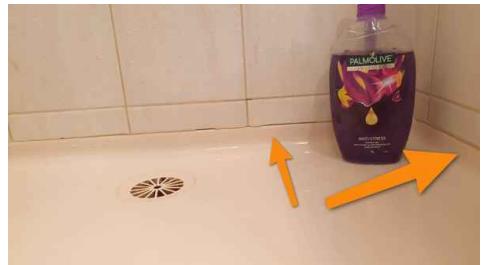
9.14.1 Shower **CAULKING / SILICONE**

MINOR DEFECT

I recommend caulking the shower base and walls to prevent water damage.

Contact a handyman or DIY project

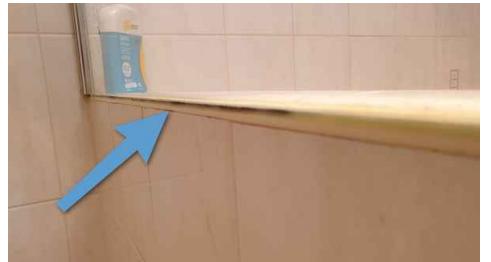
9.14.2 Shower **SEALANT MOULD (MINOR)**

Minor mould was observed in or on the sealant in the shower recess.

I recommend cleaning or removing the mould affected sealant and replace with new sealant. This can be undertaken by a handyman or DIYer

Contact a handyman or DIY project

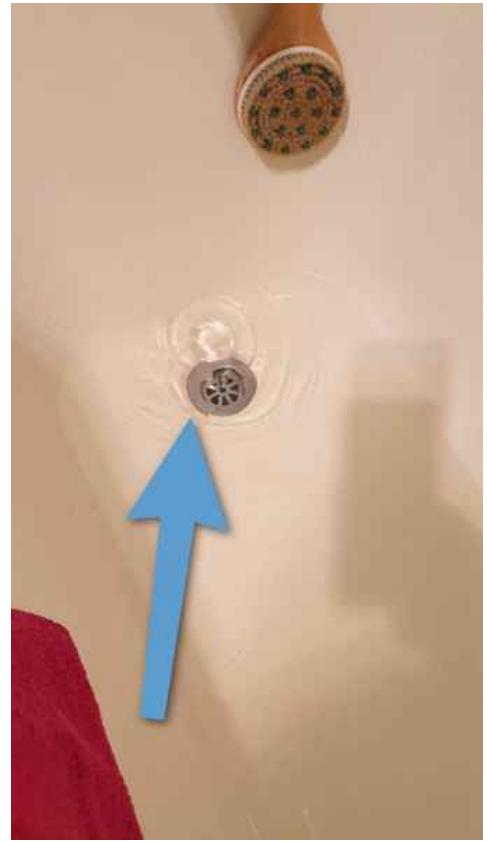
Surface Delamination

Contact a qualified professional.

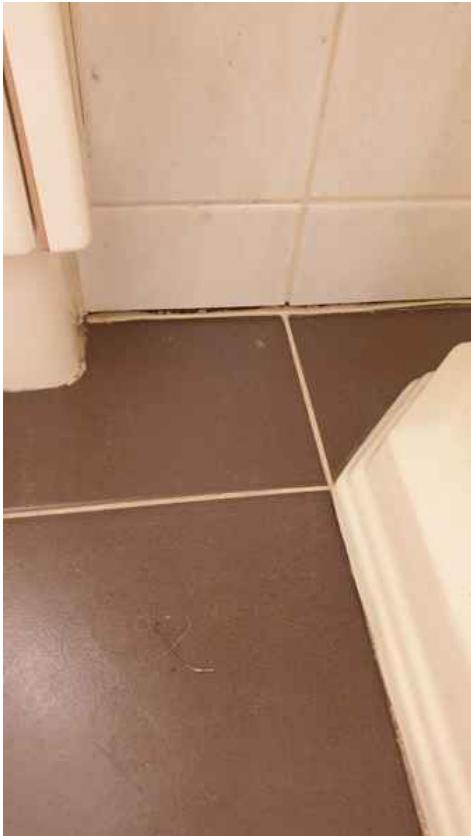
Behind Basin

Minor sealant works are required in the bathroom area as noted in the photographs.

I recommend sealing the bathroom as required.

Contact a handyman or DIY project

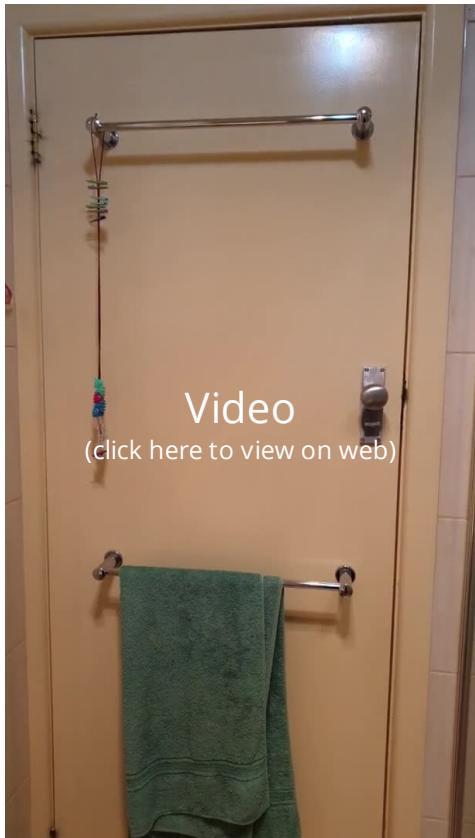
9.19.1 Ventilation

The bathroom exhaust fans ability to remove air from the bathroom was restricted when the bathroom door was closed. For air to be displaced, it must be able to be replaced. As there are no windows to facilitate additional airflow, I suggest creating additional ventilation within the door. This can be achieved by creating a clearance of approximately 20mm - 25mm under the door as this will create greater airflow in the bathroom.

- MINOR DEFECT

Contact a qualified carpenter.

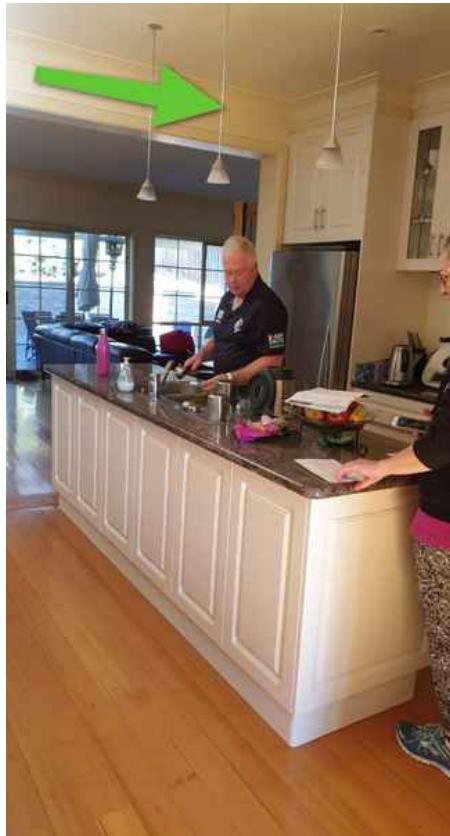
Some Island Bench Lights Not Working

I recommend changing the globes and or transformers as required. Contact a licensed electrician.

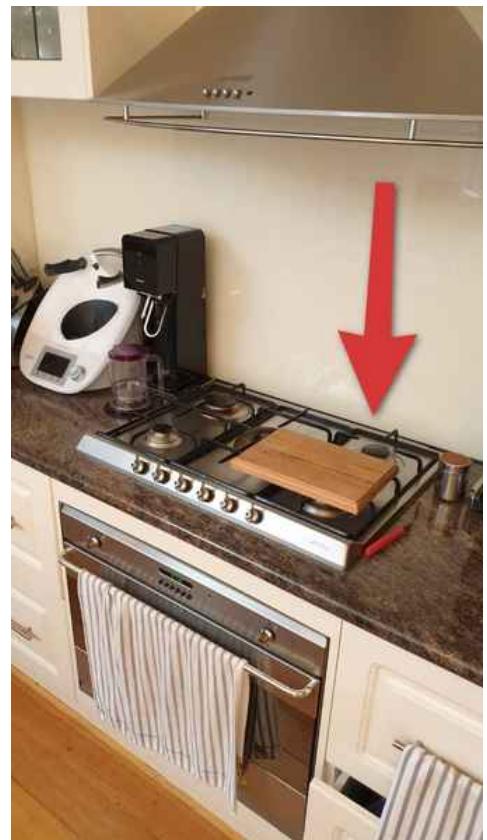
MAJOR DEFECT / SAFETY HAZARD

The gas cook-top does not achieve the minimum clearances to combustible materials and is a Safety Hazard.

A minimum clearance of 200mm is required when measured horizontally from the edge the nearest burner to any vertical combustible surface or conducting material, and the splashback must be a minimum of 150mm in height. Materials such as ceramic tiles less than 5mm thick, glass and stainless steel are not fire rated materials and require fire rated substrates behind them to be deemed to comply.

As this is a visual, non-invasive inspection, I can not determine the substrate used in this circumstance and recommends obtaining a certificate of compliance from the current home owner or contacting a licensed gas fitter for further advice and repair / rectifications.

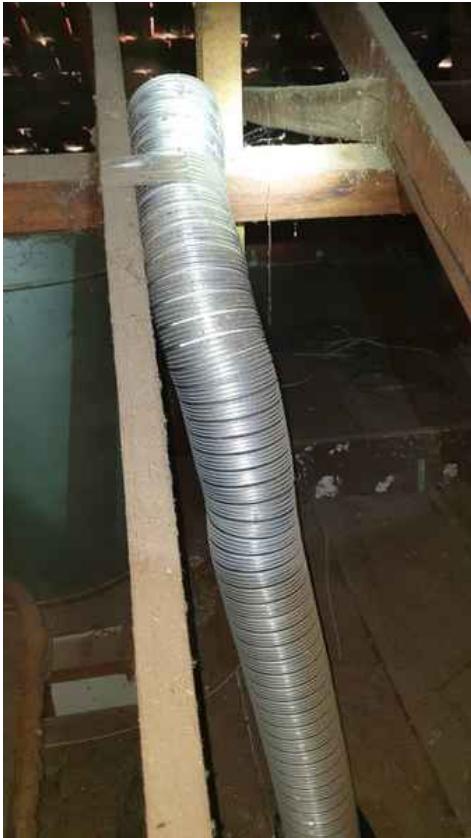
MINOR DEFECT

The kitchen range hood is currently vented to the roof space. Previously, a tiled roof was considered to be ventilated and therefore it was adequate to vent exhaust fans into this space. Currently, this has changed and new kitchens are required to be vented directly to atmosphere. Although not a defect when constructed / renovated years ago, it is good building practice and desirable to vent to atmosphere to avoid a build up of moist air in the roof space.

Range Hood Exhausting to Roof Space

Contact a qualified professional.

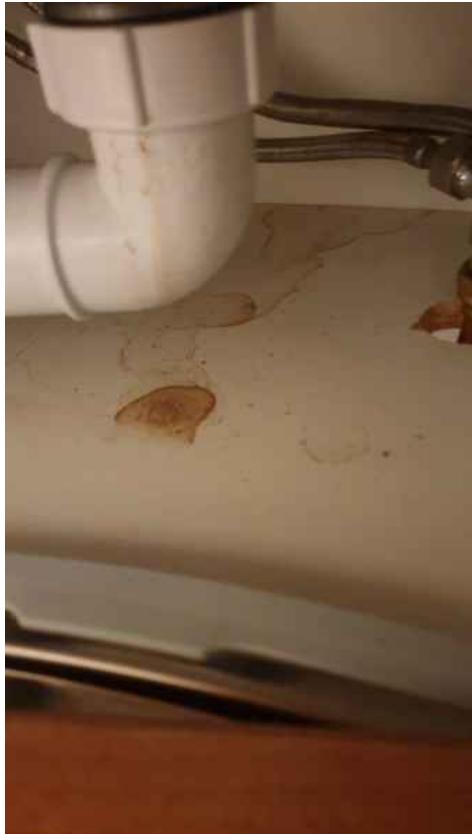
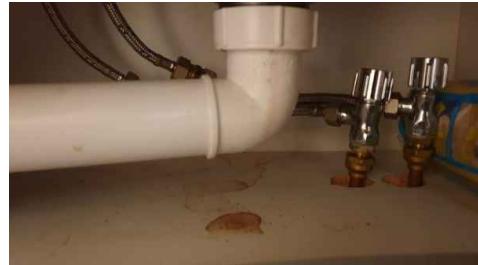
10.11.1 UNDER SINK PLUMBING

WATER LEAK STAINING (NOT ACTIVE)

A water leak stain was observed under the kitchen sink at the time of the inspection. The sink was tested for leaks and no leaks were found, I recommend to monitor the sink for leaks and if a leak occurs, contact a licensed plumber to rectify.

Water Staining

Recommend monitoring.

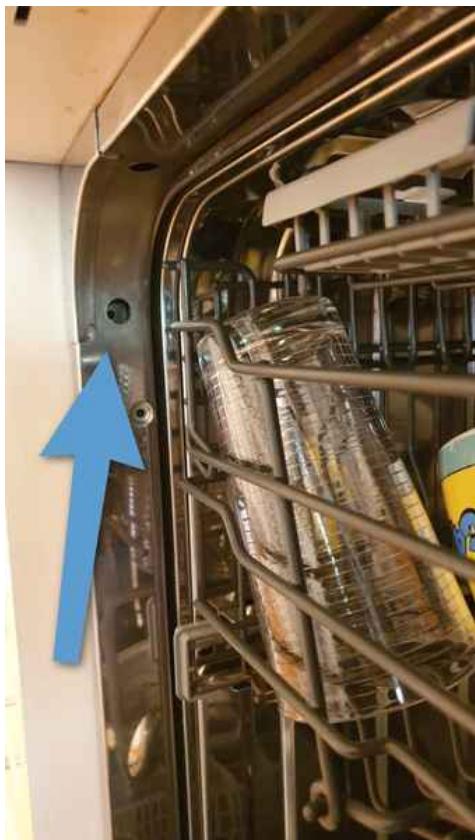
10.12.1 DISHWASHER **IMPROPER INSTALLATION**

Dishwasher Not Secured

I recommend aligning and securing the dishwasher as required.

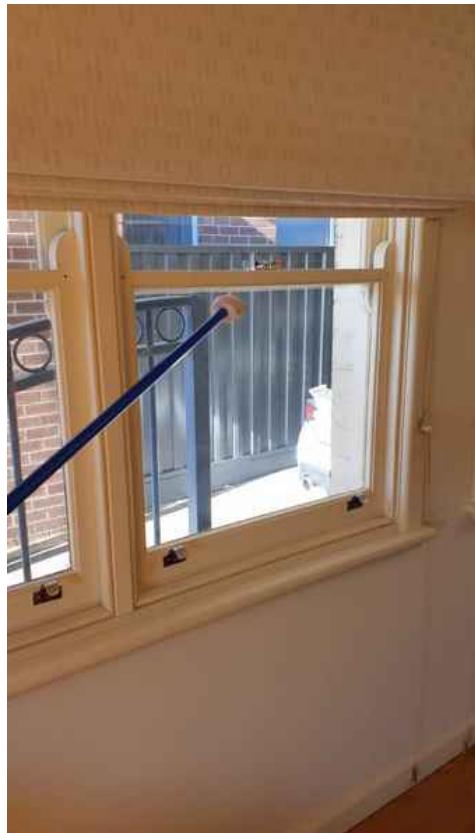
One of the double hung windows was difficult to open. A broken spiral balance is the likely cause.

Not meeting correctly and difficult to open

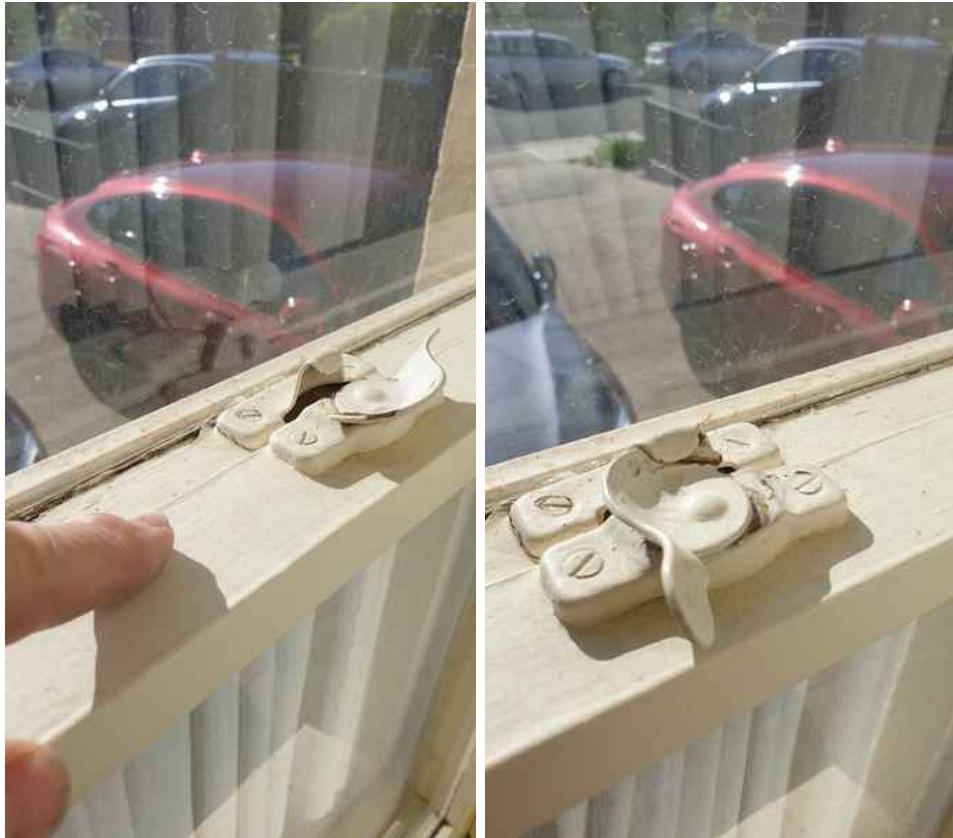
13.2.2 Window(s)

SASHES MISALIGNED

MAINTENANCE ITEM / GENERAL ADVICE

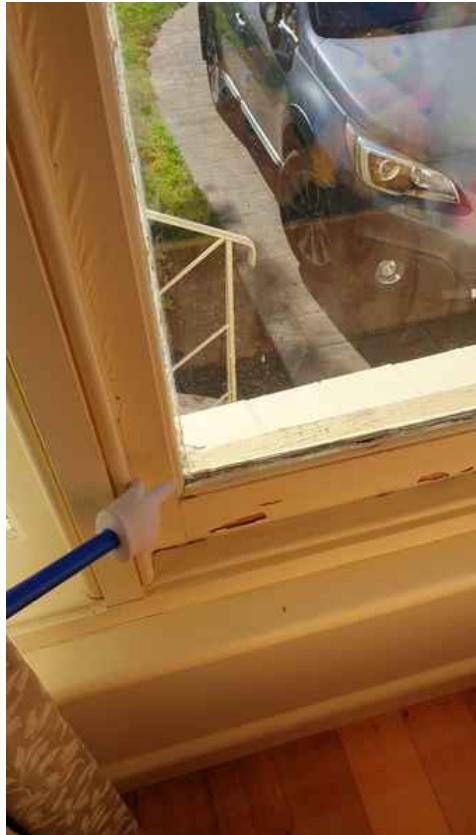
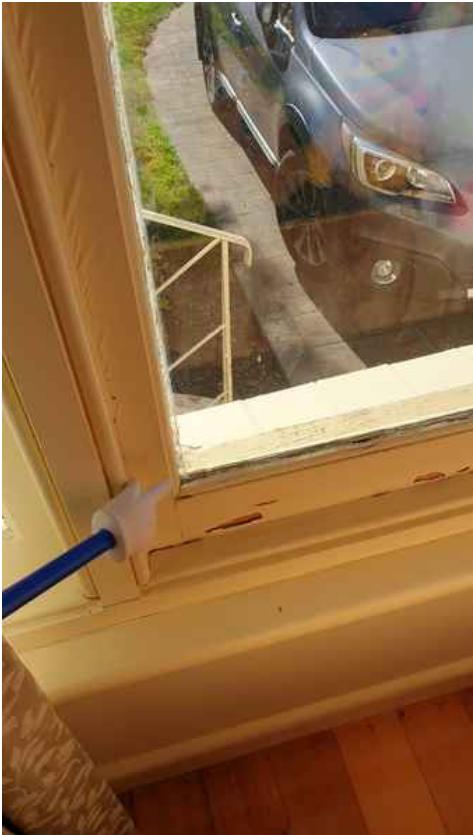
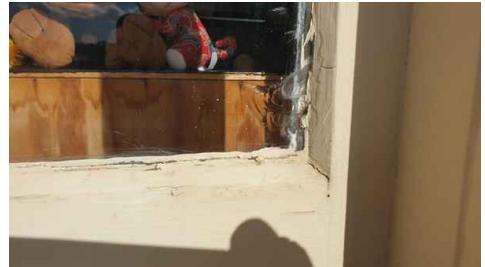
13.2.4 Window(s)

PAINT DETERIORATION

Contact a qualified professional.

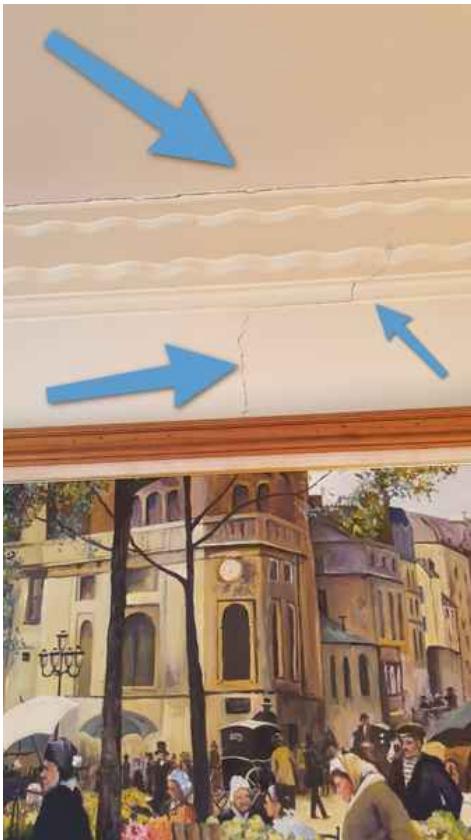
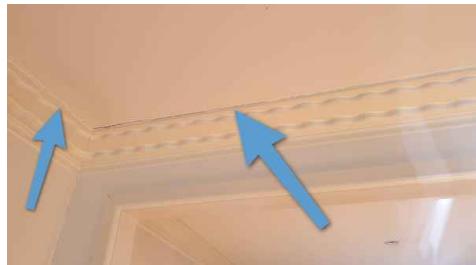
CRACKS CORNICE (MINOR)

Contact a qualified painting contractor.

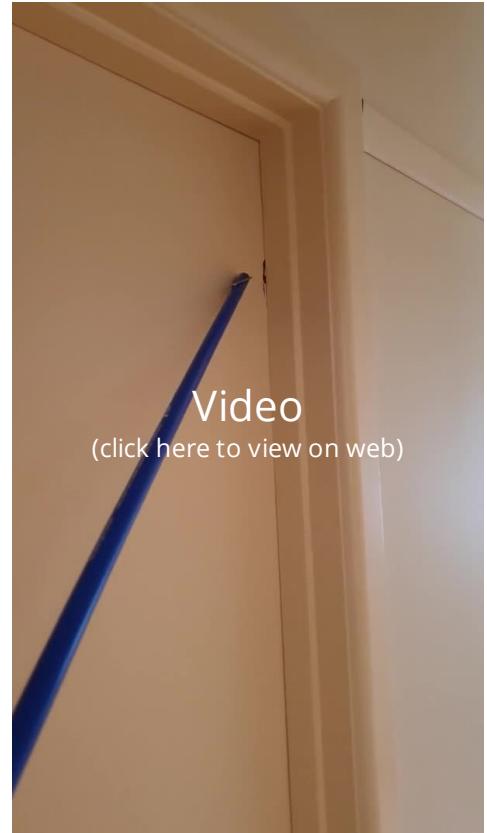
Although the Study door functions. I observed the door to be binding on the hinged side of the jamb. The door margins are inconsistent, this is likely due to poor installation at the time of construction. This is a typical find in a dwelling of this age, it is an easy fix for a qualified carpenter, however the door and jamb may be required to be repainted after the repairs.

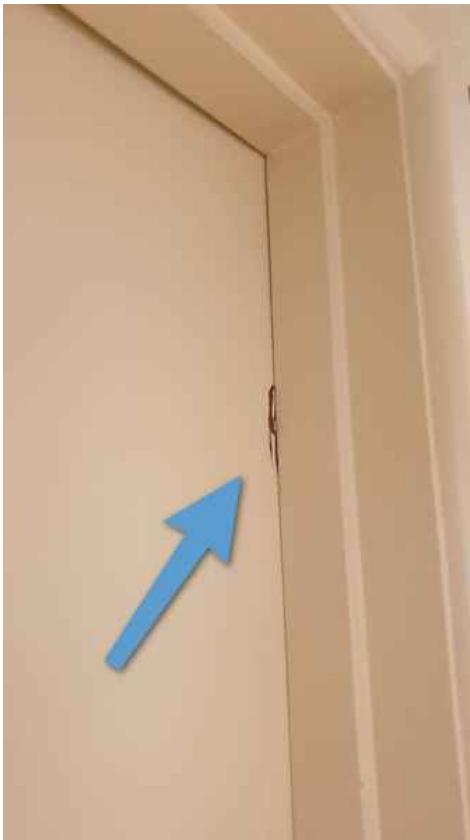
Minor surface damage to the study door is evident and requires repair.

Contact a qualified painting contractor.

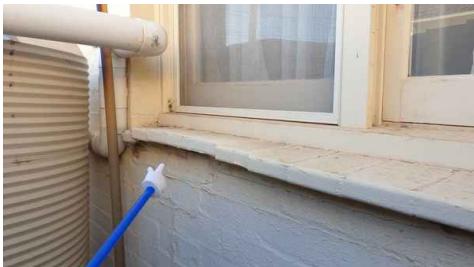
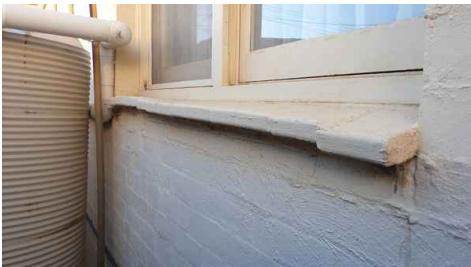
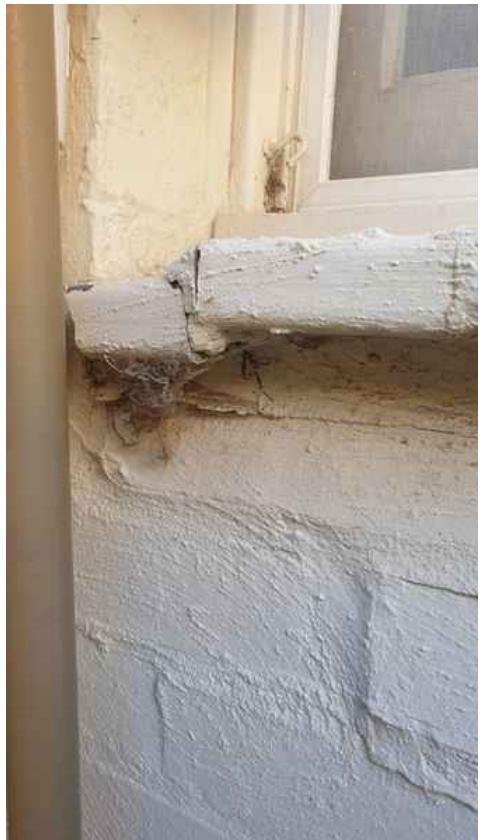
I observed bowing of brick window sills in one or more locations.

Bowing is usually caused by expansion of brickwork. Each brick can increase in size by up to 1/4 of a millimetre, that doesn't sound like much until you add all the bricks together and the brick wall can grow (increase in length) considerably. If inadequate (or no) expansion joints are installed to accommodate expansion, cracking, bowing and distorting brickwork can and will occur.

I recommend reinstalling the brick window sills and installing expansion joints as required to accommodate the naturally occurring expansion and contraction of the brickwork.

Contact a qualified masonry professional.

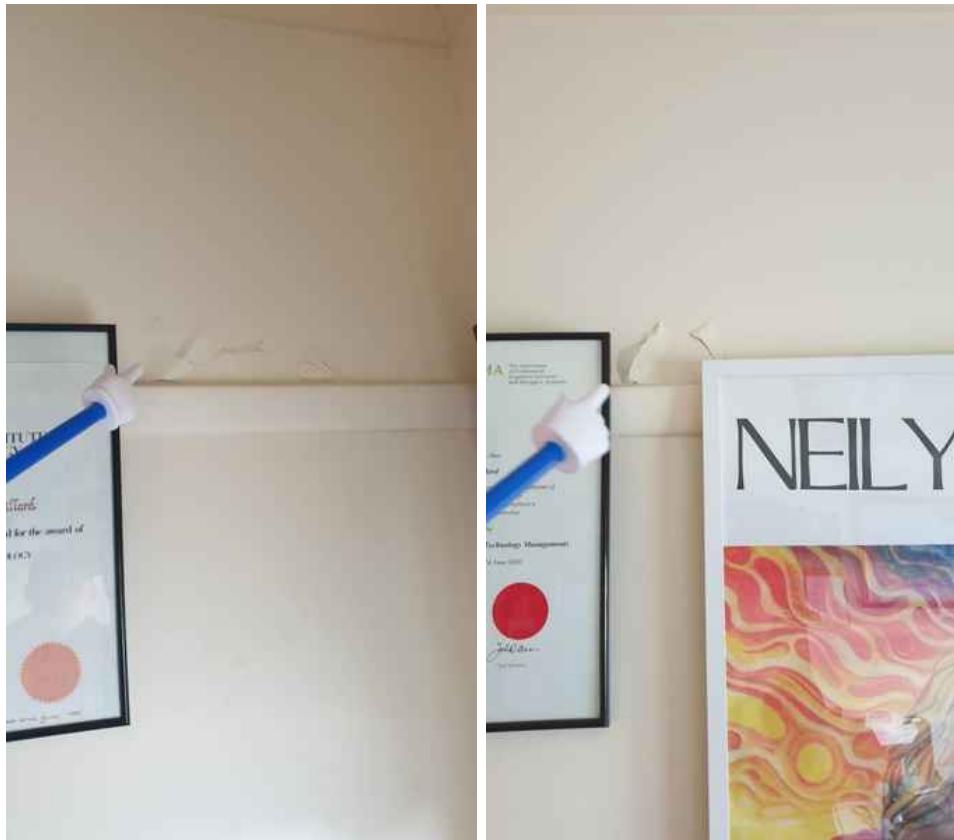
14.4.1 Walls

Some minor cracking of the walls was observed during my inspection. These cracks are often caused by settlement and movement of the dwelling.

I recommend to monitor the cracks for 12 months and repair if the cracks remain unchanged. If the cracking increases in size or quantity contact a licensed structural engineer to determine the cause of the movement of the dwelling and for further advice on rectification works required.

Recommend monitoring.

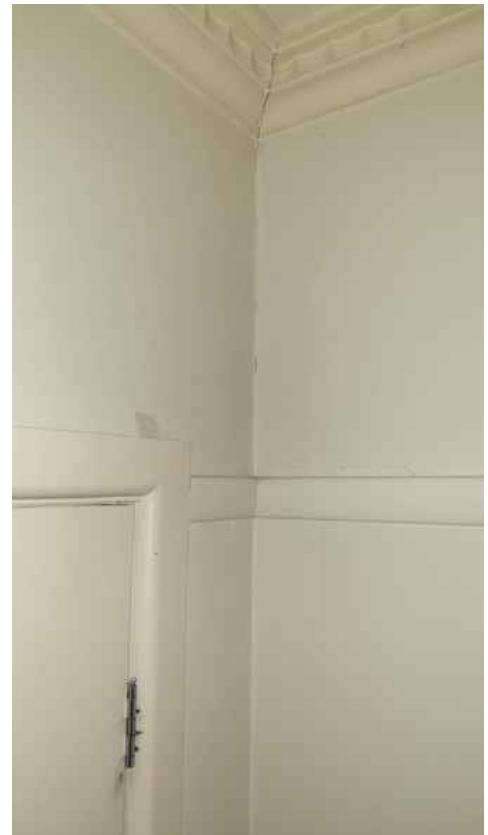
15.3.1 Walls

Some minor cracking of the walls was observed during my inspection. These cracks are often caused by settlement and movement of the dwelling.

I recommend to monitor the cracks for 12 months and repair if the cracks remain unchanged. If the cracking increases in size or quantity contact a licensed structural engineer to determine the cause of the movement of the dwelling and for further advice on rectification works required.

Recommend monitoring.

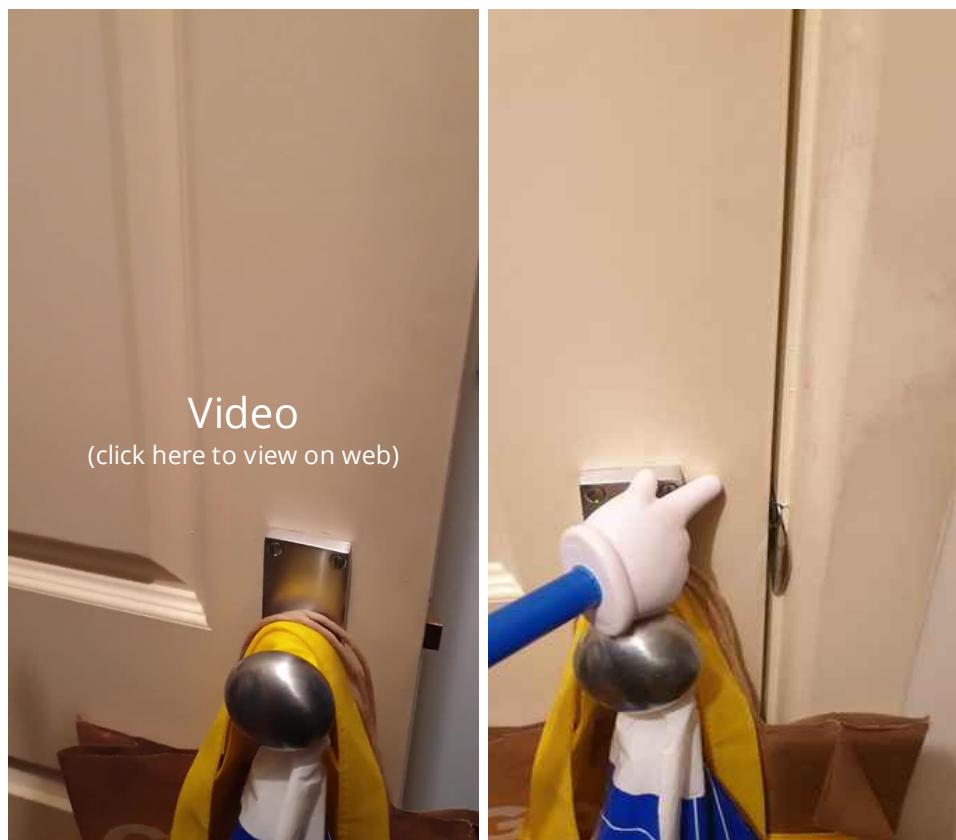
Door latch and/or strike plate is out of alignment. Recommend a handyman repair.

Contact a qualified door repair/installation contractor.

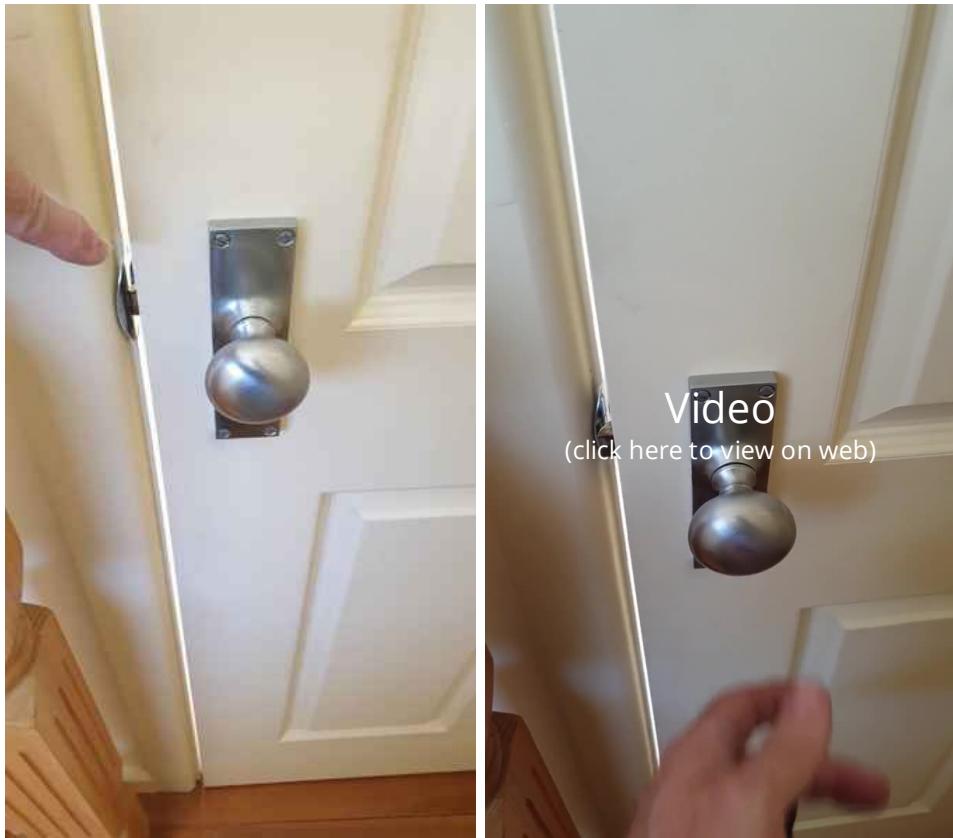
18.1.1 Door(s)

Door latch and/or strike plate is out of alignment. Recommend a handyman repair.

Contact a qualified door repair/installation contractor.

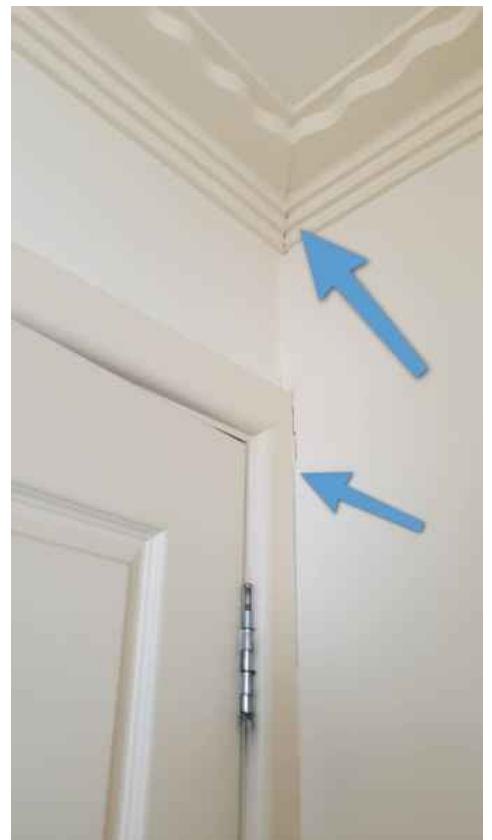
18.4.1 Walls

Some minor cracking of the walls was observed during my inspection. These cracks are often caused by settlement and movement of the dwelling.

I recommend to monitor the cracks and repair if they remain unchanged. If the cracking increases in size or quantity contact a licensed structural engineer to determine the cause of the movement of the dwelling and for further advice on rectification works required.

Contact a qualified painting contractor.

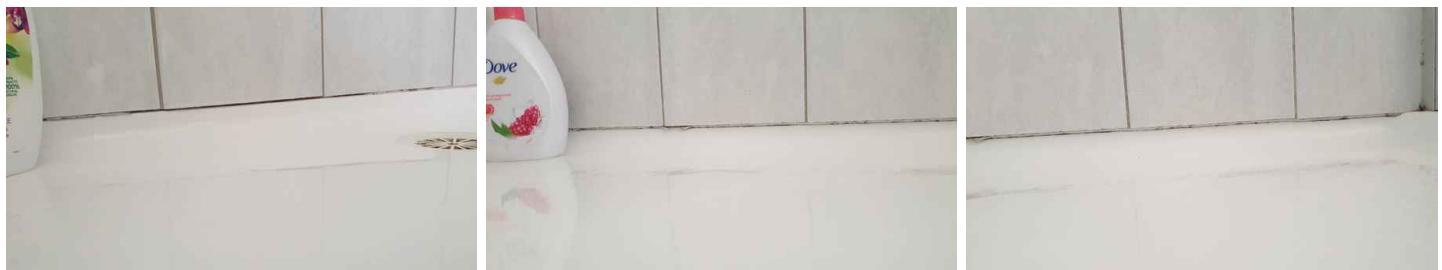
Minor mould was observed in or on the sealant in the shower recess.

I recommend caulking the shower base and walls to prevent water damage.

I recommend cleaning or removing the mould affected sealant and replace with new sealant. This can be undertaken by a handyman or DIYer

Contact a handyman or DIY project

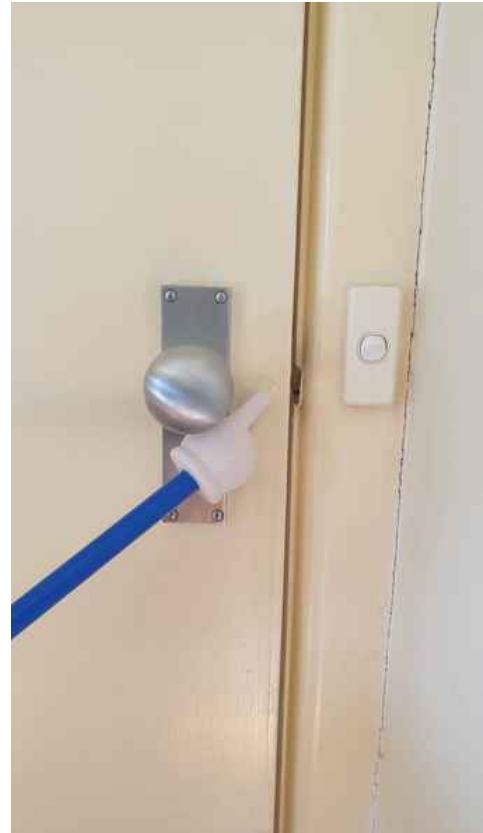
Door doesn't latch properly. Recommend handyman repair latch and/or strike plate.

Contact a qualified carpenter.

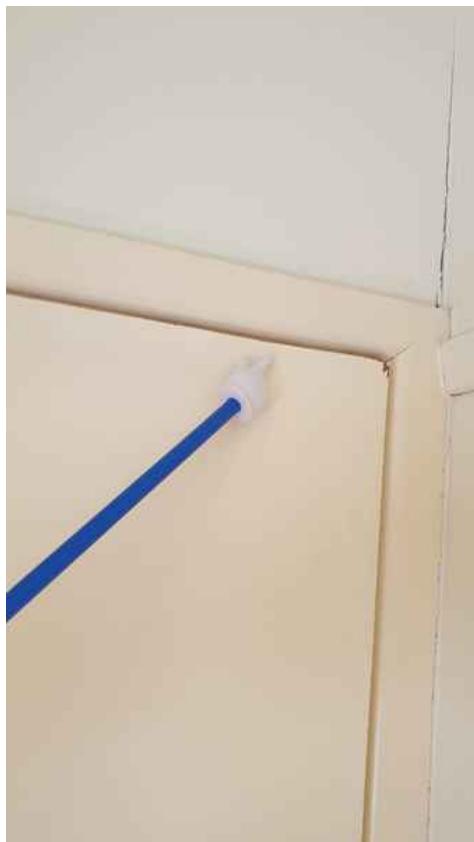
Bedroom 2 Door

The door margins around the bedroom door are inconsistent, this is likely due to settlement / movement of the sub-floor structure. Door margins can alter slightly with the changes of seasons due to soil heave and settlement, this would seem the likely cause in this case.

Monitor and repair as required.

Recommend monitoring.

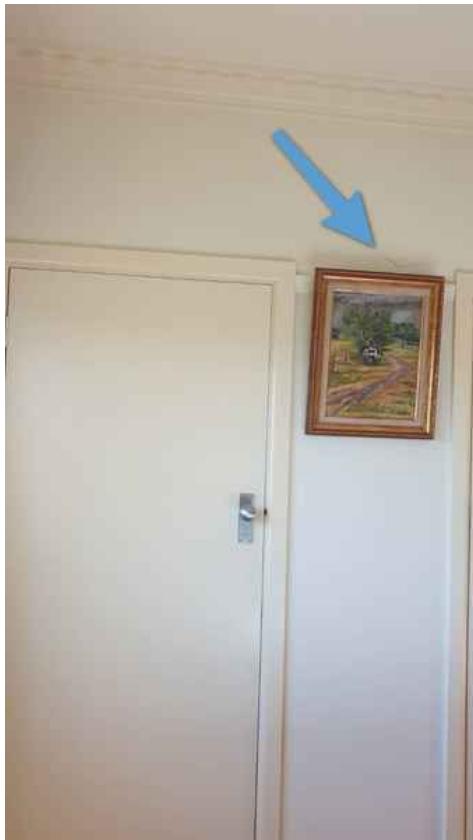
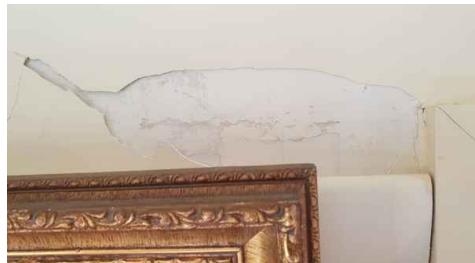
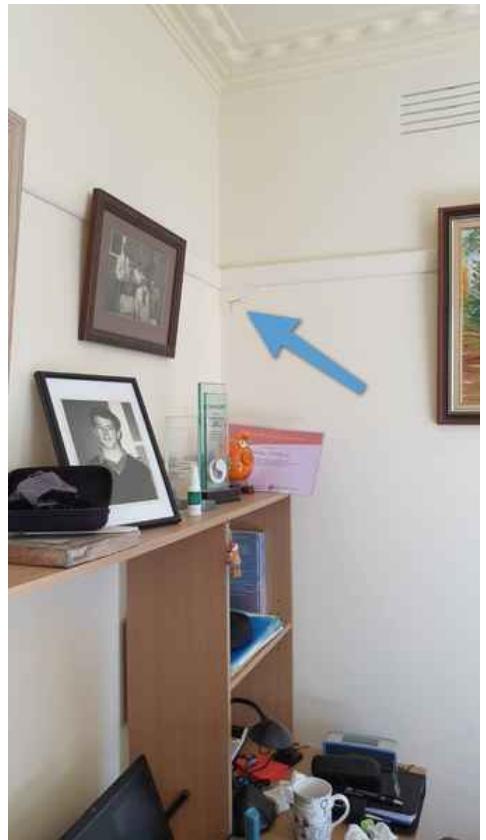
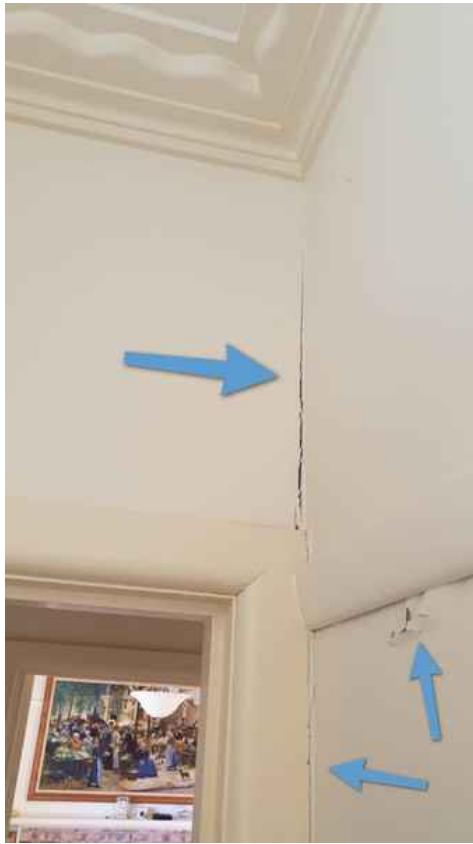
20.5.1 Walls

CRACKS (MINOR)

Some minor cracking of the walls was observed during my inspection. These cracks are often caused by settlement and movement of the dwelling.

I recommend to monitor the cracks for 12 months and repair if the cracks remain unchanged. If the cracking increases in size or quantity contact a licensed structural engineer to determine the cause of the movement of the dwelling and for further advice on rectification works required.

Recommend monitoring.

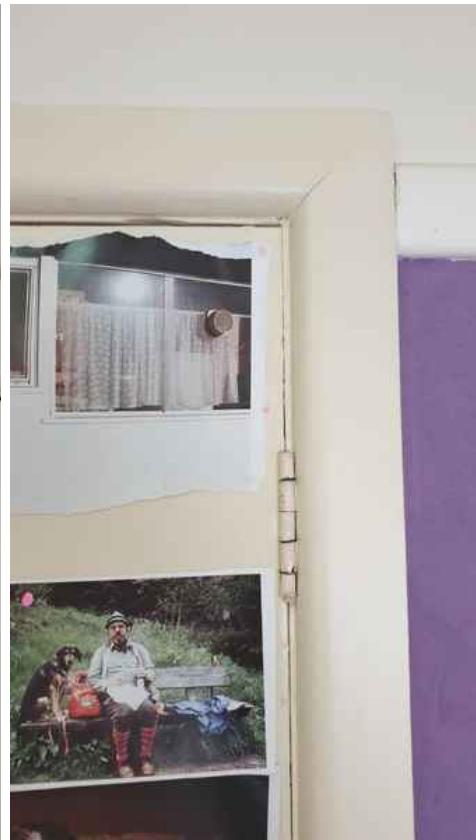
BEDROOM 3 DOOR

The door margins around the bedroom door are inconsistent, this is likely due to settlement / movement of the sub-floor structure. Door margins can alter slightly with the changes of seasons due to soil heave and settlement, this would seem the likely cause in this case.

Monitor and repair as required.

Recommend monitoring.

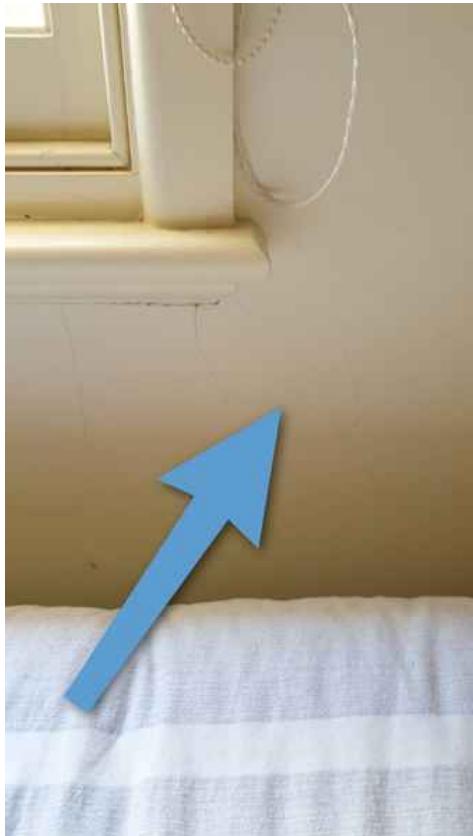
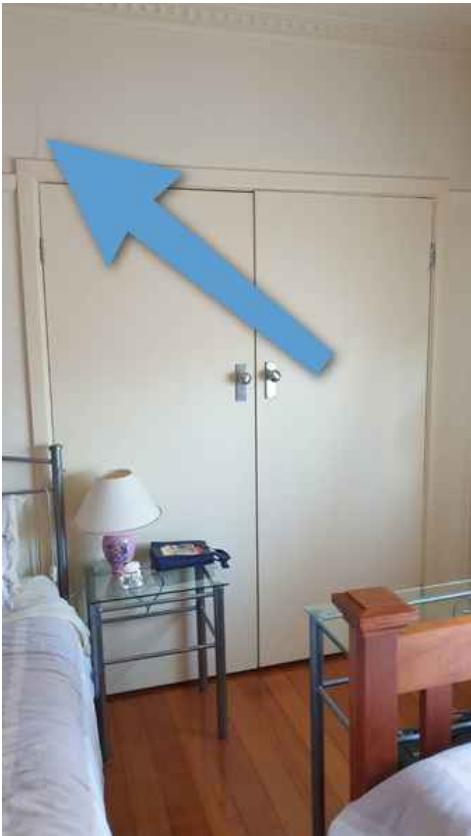
21.5.1 Walls

CRACKS (MINOR)

Some minor cracking of the walls was observed during my inspection. These cracks are often caused by settlement and movement of the dwelling.

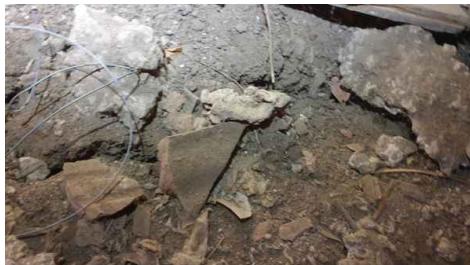
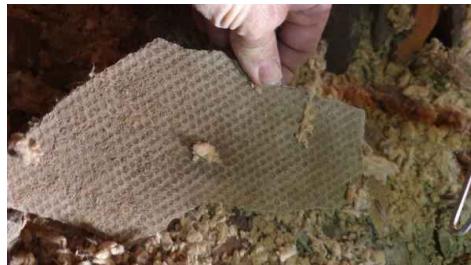
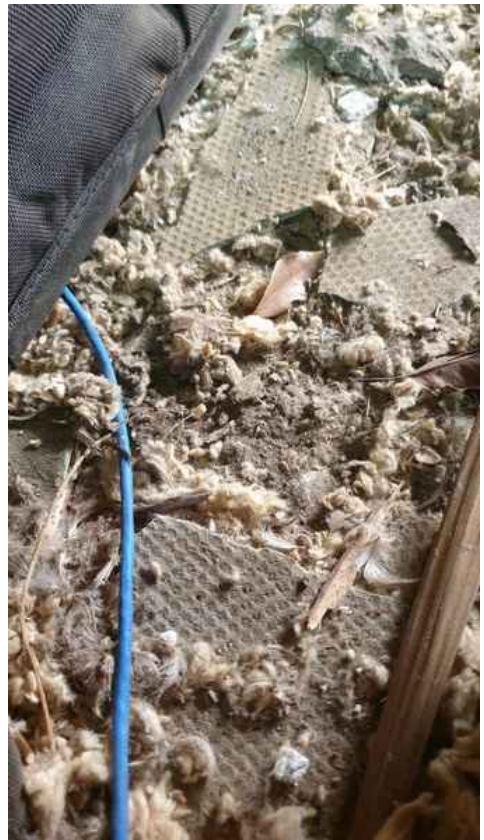
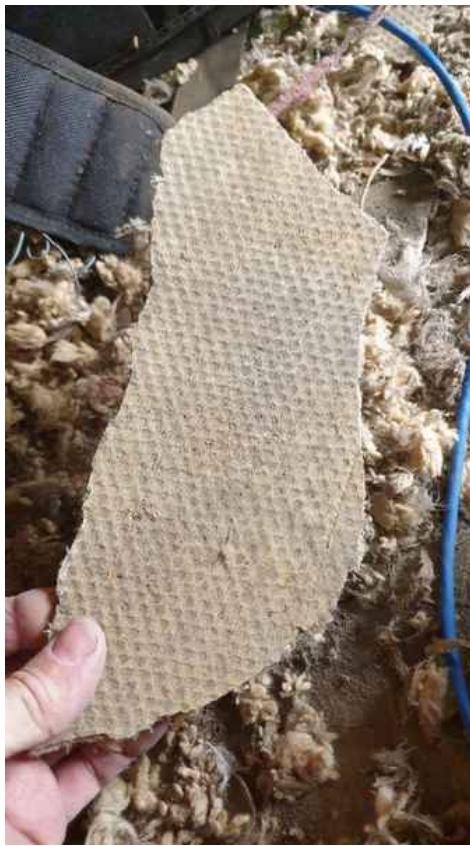
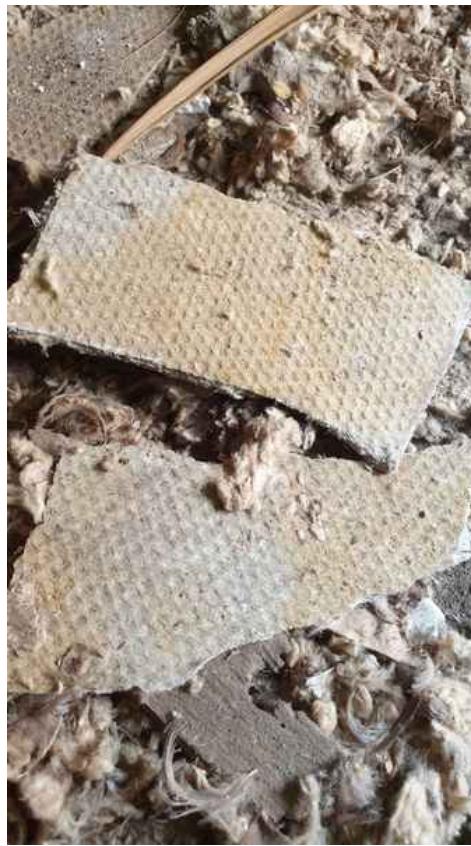
MAJOR DEFECT / SAFETY HAZARD

A material that may contain asbestos was observed in the sub-floor area of this dwelling.

- not to allow anyone to enter the sub-floor area without full Personal Protective Equipment (PPE).
- evaluation and testing of the material by an environmental contractor.
- if found to be an asbestos containing material, have it safely removed by a qualified asbestos removalist

Contact a qualified environmental contractor

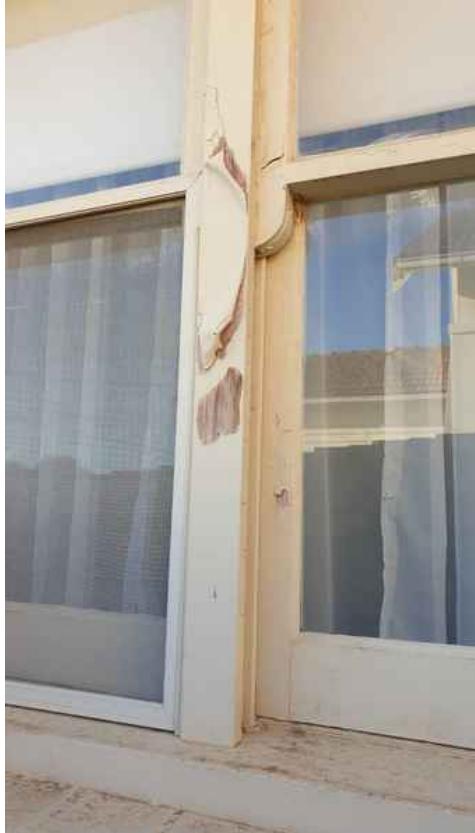
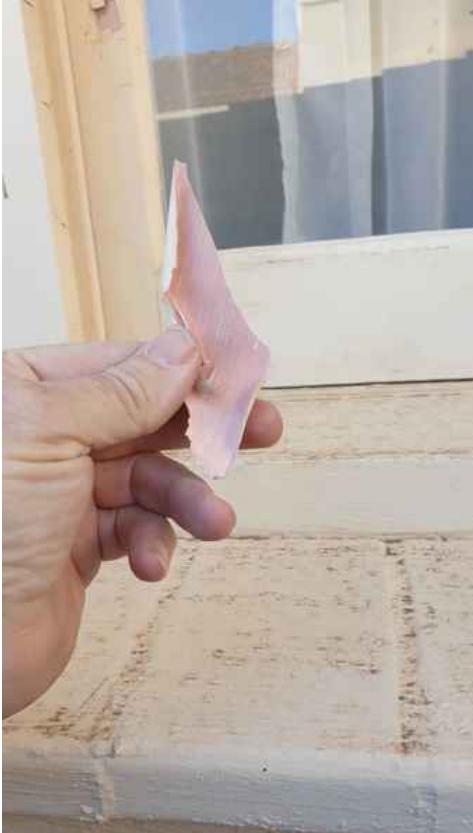
27.2.1 Lead Based Paint
POSSIBLE LEAD BASED PAINT
EXTERNAL WINDOW PAINT

MAJOR DEFECT / SAFETY HAZARD

Paint that may contain lead was observed on the external window frames of this dwelling.

Contact a qualified environmental contractor
