PGR HOME INSPECTIONS

RESIDENTIAL HOME INSPECTION REPORT

1234 Main St. Charleston SC 29414

03/01/2020 9:00AM

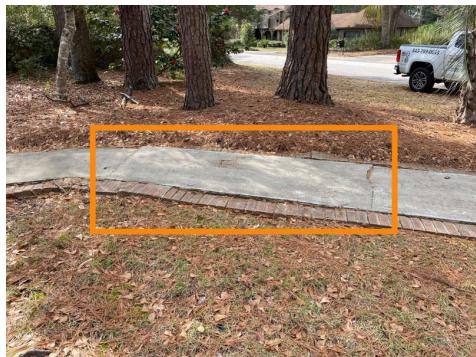
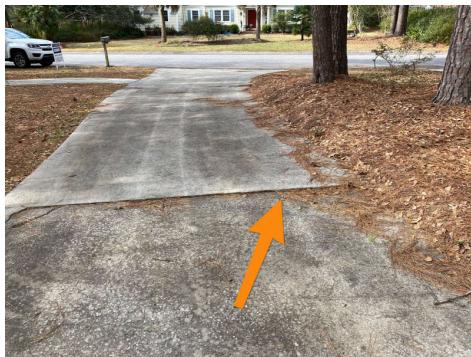
DRIVEWAY/WALKWAY: CRACKING

Moderate cracks, settlement/slab movement observed in the driveway and walkway due to underground tree roots that could be a potential trip hazard. Recommend repairing by a qualified concrete contractor.

Contact a qualified concrete contractor.

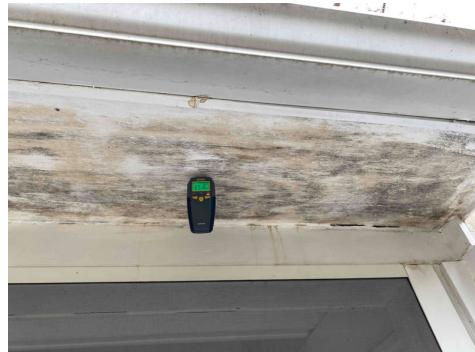
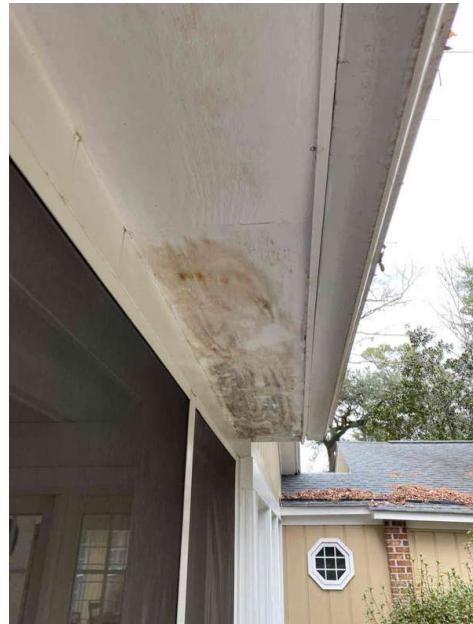
SOFFIT: ACTIVE MOISTURE INTRUSION

High moisture readings in the soffit on the back side of the home indicating active moisture intrusion is present from above. Recommend a qualified roofing professional evaluate and repair/ replace any damaged materials as needed.

Contact a qualified roofing professional.

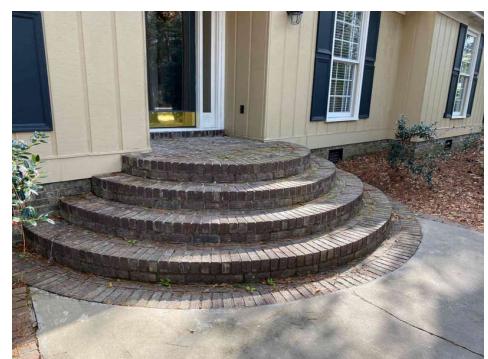
STEPS: NO HANDRAIL

The steps have 4 or more risers present with no handrail. This may or may not have been a requirement when the home was built, however it is recommended to have a handrail/guardrail installed for safety reasons by a qualified professional.

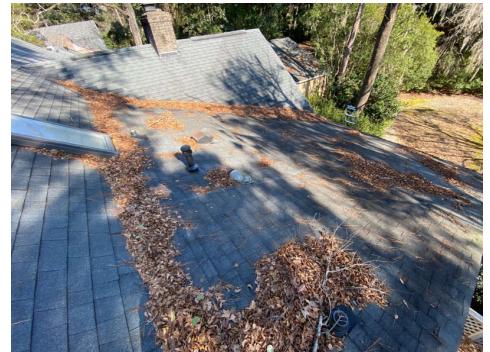
2.6.1 Vegetation, Grading,
Drainage**TREE DEBRIS ON ROOF**

Tree debris observed on roof. This can cause improper drainage and water retention on the roof that can eventually find its way through the roofing material causing damage to the roof decking below.

Recommend clearing debris.

Contact a handyman or DIY project

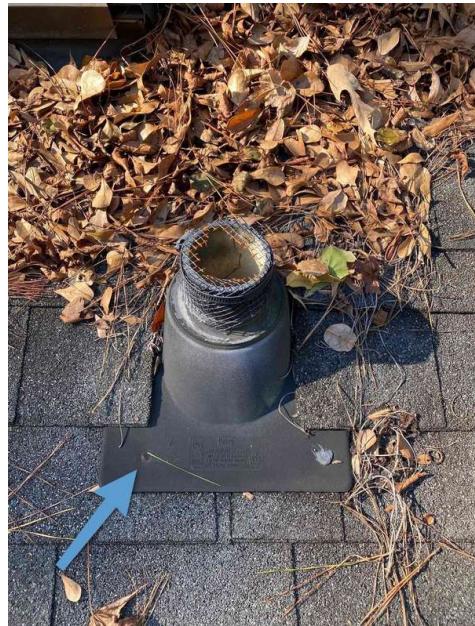
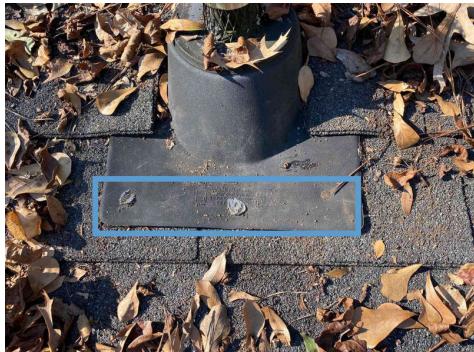
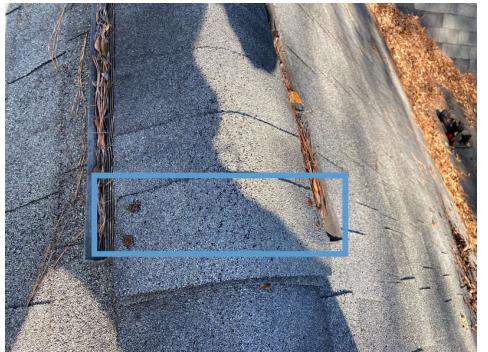
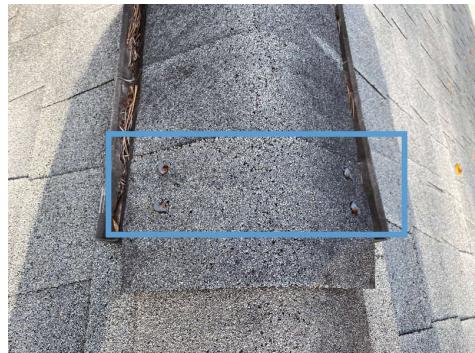
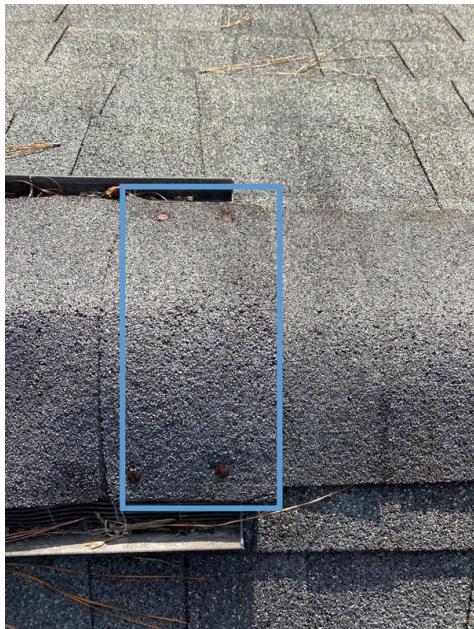
NAIL HEADS EXPOSED

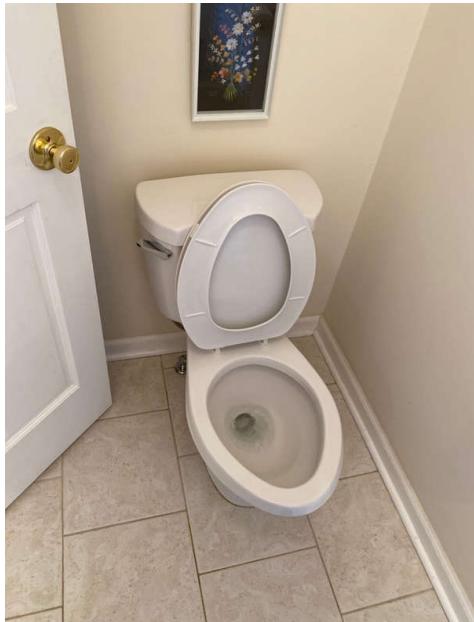
1st Floor Powder Room

TOILET LOOSE

Toilet is loose at the base. Recommend a qualified plumbing professional evaluate and repair. They may just need to be tightened at the anchor bolts or there may be an issue with the flange. No signs of leaking on the interior of the home observed at time of inspection.

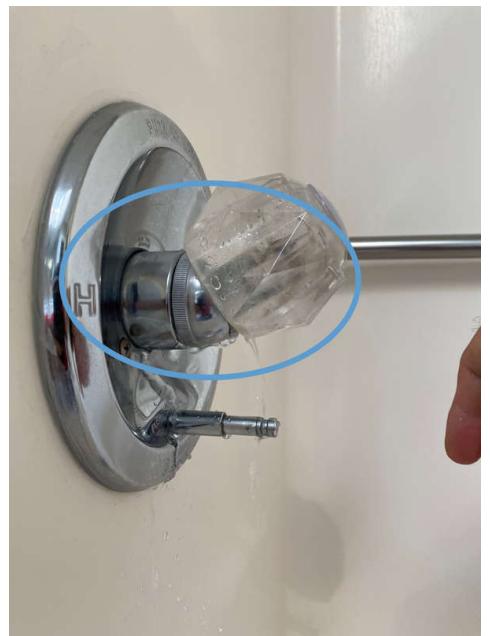
2nd Floor Guest Bathroom

7.2.2 Sinks, Tubs/Shower,
Toilets, Plumbing**BATHTUB: VALVE LEAKING**

The guest bathroom tub valve is leaking. Recommend a licensed plumbing professional repair or replace as needed.

Contact a qualified plumbing contractor.

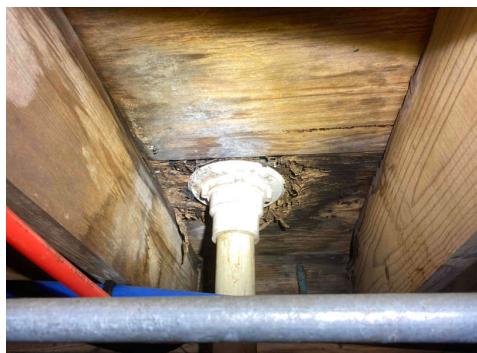
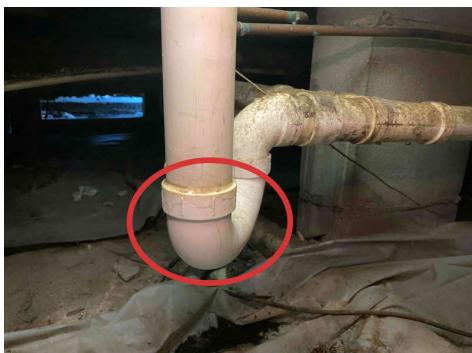
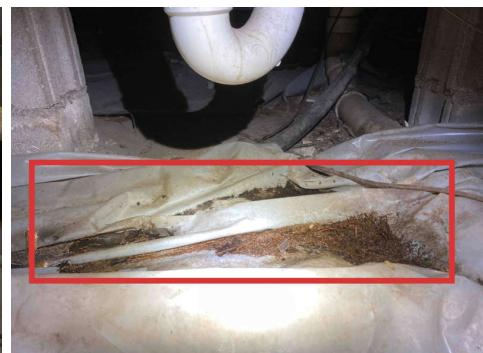
Standing water on ground

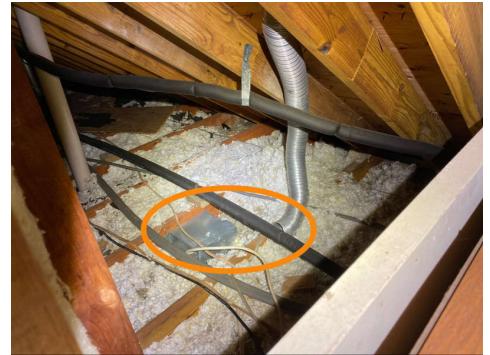
1st Floor Bathroom

Deficiencies/ Recommendations**EXHAUST FAN: VENTS INTO ATTIC**

Bathroom fan vents into the attic due to the disconnected exhaust duct , which can cause moisture, increased humidity and possible mold growth Recommend a qualified professional repair.

Contact a qualified professional.

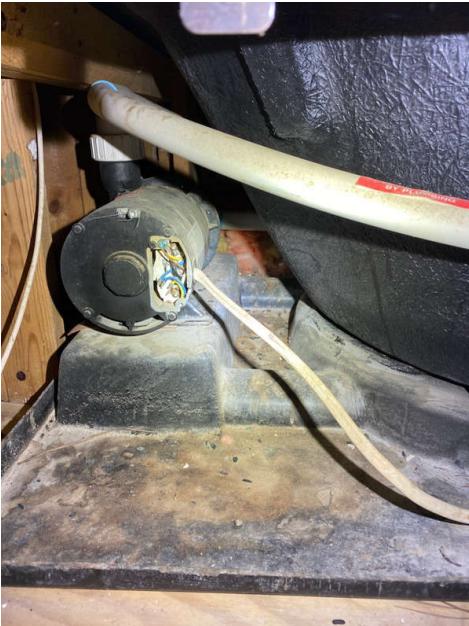
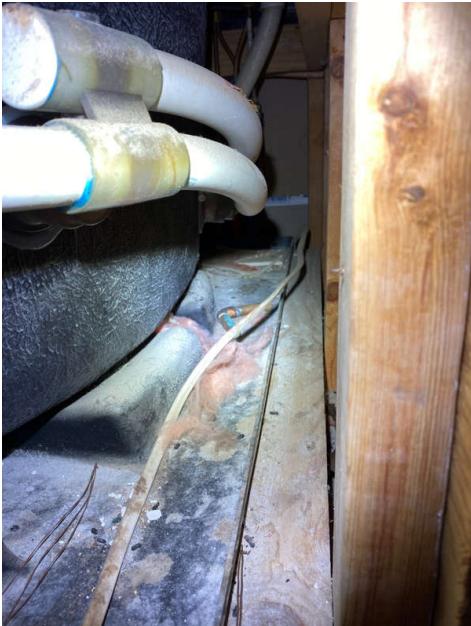
Deficiencies/ Recommendations**WHIRLPOOL: NO GFCI PROTECTION**

No visible GFCI (ground fault circuit interrupter) protection installed on the jetted tubs which is recommended to be installed. Recommend a qualified professional repair.

Contact a qualified professional.

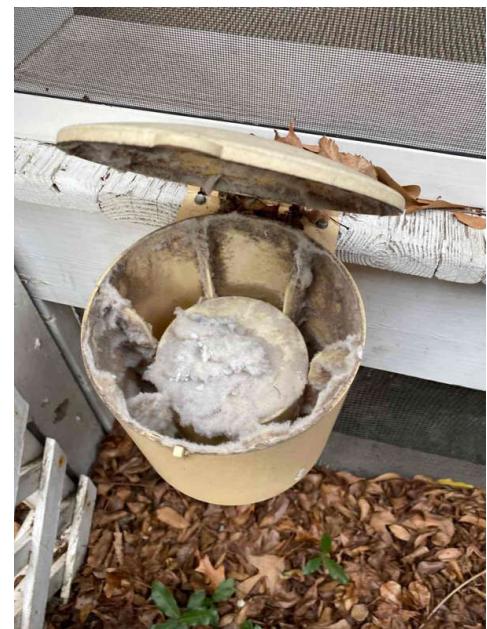
The dryer vented into a canister. To help prevent the buildup of lint and a potential hazard it is recommended to install a louvered termination cap instead. Any work should be performed by a qualified professional.

Contact a qualified professional.

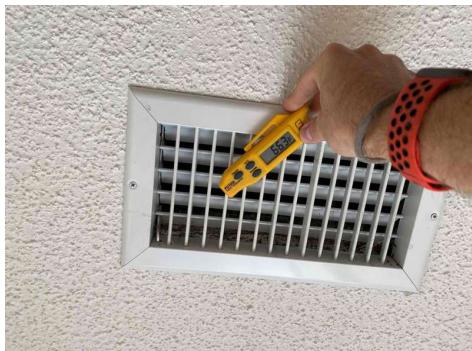
AC TEMPERATURE SPLIT: INADEQUATE/ TRANE SYSTEM

2nd floor air supply cooling temp

Contact a qualified HVAC professional.

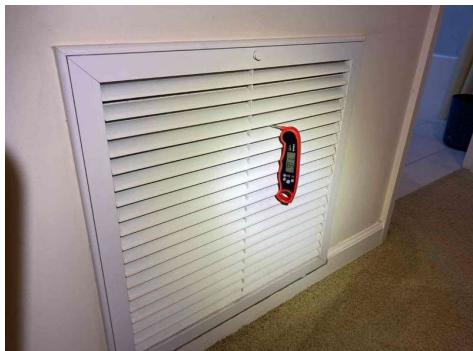
2nd floor return air temp

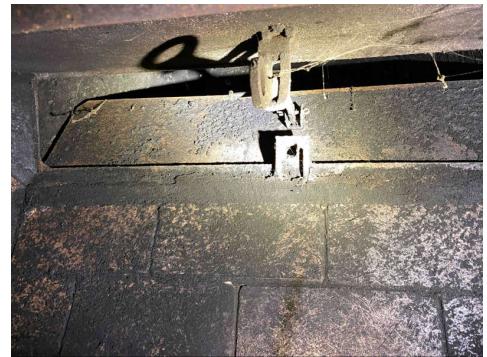
9.5.1 Gas/LP Firelogs & Fireplaces

There was creosote in the chimney flue/ firebox. Recommend a qualified fireplace or chimney contractor clean prior to first use and continue on an annual basis.

Contact a qualified chimney sweep.

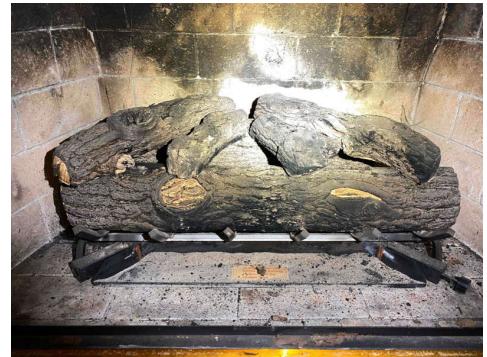
9.5.2 Gas/LP Firelogs & Fireplaces

The gas fireplace unit was not operational at time of inspection. Recommend receiving visual confirmation from the seller that the unit is functional and/or have a qualified professional evaluate and repair.

Contact a qualified fireplace contractor.

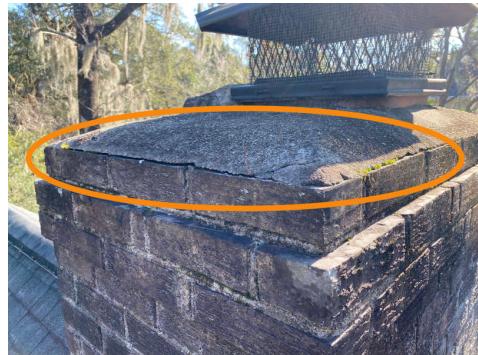
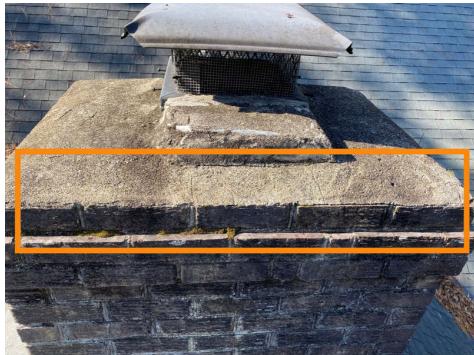
9.6.1 Chimneys, Flues

CHIMNEY CAP/CROWN: CRACKED

Chimney cap/crown was cracked/ not sealed well around the perimeter of the chimney chase allowing for moisture to enter, evidenced by the moss growth. Recommend a qualified chimney contractor evaluate and repair as needed.

Contact a qualified chimney contractor.

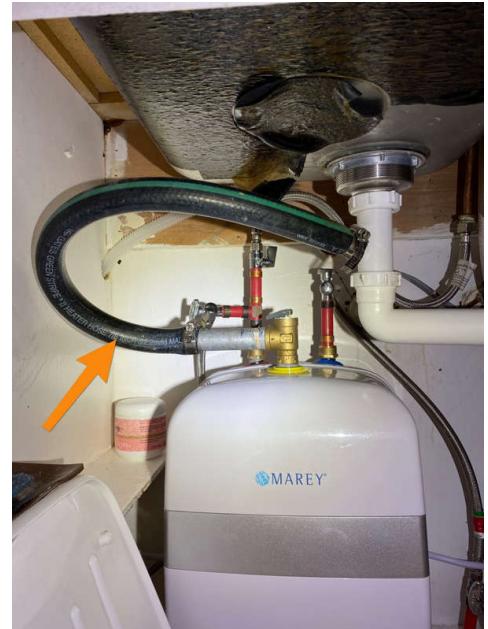
10.3.2 Water Heater

IMPROPER TPRV DISCHARGE PIPE SET UP

The Temperature Pressure Relief Valve (TPRV) discharge pipe is not properly set up. It should discharge to a drip pan or terminate to the exterior to a readily observable location no more than 6 inches off the ground and no less than 2 times the diameter of the pipe. Recommend a qualified plumber repair.

Contact a qualified plumbing contractor.

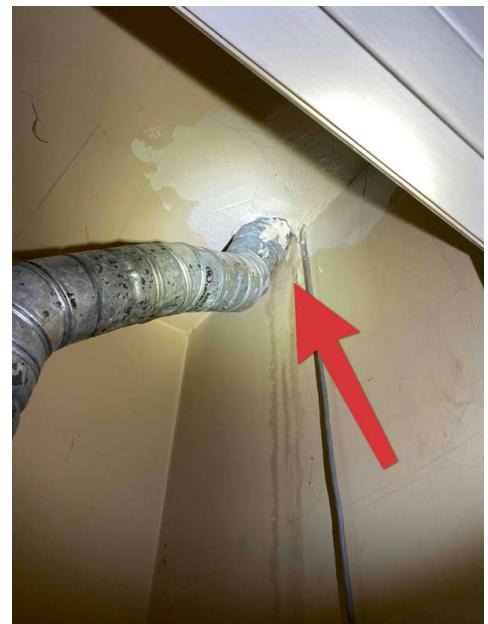
10.3.3 Water Heater

The B-vent serving as the water heater exhaust vent had inadequate clearance from combustible materials. B-vent requires a minimum 1-inch clearance from combustible materials. This condition is a potential hazard. Recommend that this condition be corrected by a qualified contractor.

Contact a qualified professional.

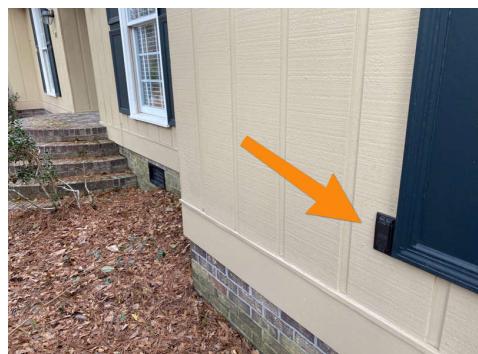
11.5.1 GFCI & AFCI

GFCI RECEPTACLE NOT FUNCTIONING PROPERLY

Contact a qualified electrical contractor.

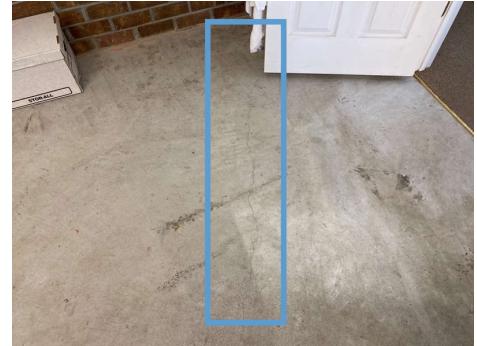
Floor: Cracking Present?

Yes, Cosmetic shrinkage crack likely formed during curing of the concrete
