TIM HEMM

Inspection Report

Property Address:
4115 Home Town Rd
Cathedral City CA 92545

Date: 10/12/2019	Time: 10:00 AM	Report ID: 20191012TLH2
Property: 4115 Home Town Rd Cathedral City CA 92545	Customer: Client is the most Important	Real Estate Professional:

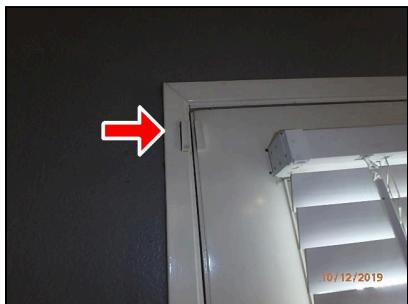
1.1 Item 1(Picture)

- 🏡 1.1 (1) The door alarms are non operational.

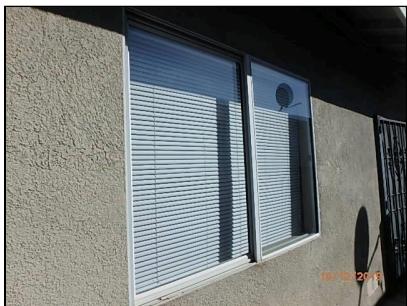
1.2 Item 1(Picture)

1.2 Screen(s) are missing at front and rear of home. A qualified person should repair or replace as needed.

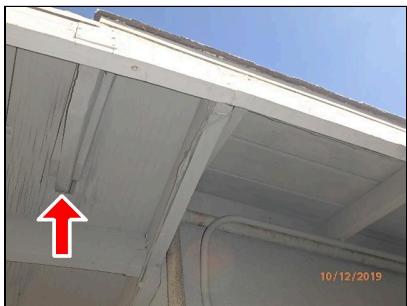
1.3 Item 1(Picture)

1.3 The Patio cover is weathered and the roof deck/sheeting at the rear of home is damaged and has been replaced. This damage should be repaired or replaced. A qualified contractor should inspect further and correct as needed.

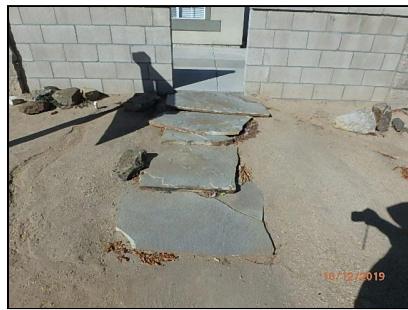
1.4 Item 1(Picture)

**1.4 (1)** The flag stone walkway at the front of the home (east side) is uneven and loose. A fall ,or injury can occur if Not connected. I recommend repairs by a qualified contractor.

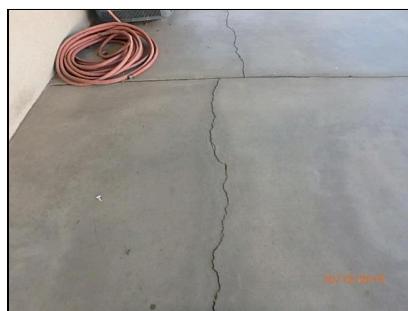
1.4 Item 2(Picture)

(2) The concrete on the patio at the (West side of home) has cracks and displacement, is uneven and may be a tripping hazard and Does not appear to drain water away from the foundation. There are a number of reasons that concrete cracks. I am unable to determine the cause of these cracks.. A qualified contractor should inspect further and correct as needed.

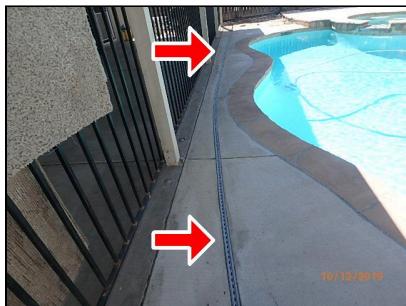
1.4 Item 3(Picture)

🏡 (3) There are surface drains installed at the west side of home. The condition of underground pipes can Not be judged.I recommend yearly maintenance to insure the drains function properly during periods of severe weather.

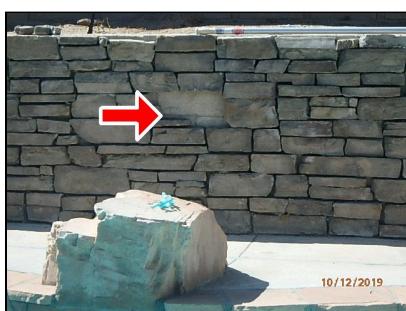
1.4 Item 4(Picture)

🏡 (5) The block retaining wall at the (West side of home) Cultured rocks are loose and missing.. A possible injury could occur if not secured. I recommend a qualified contractor evaluate and repair as necessary.

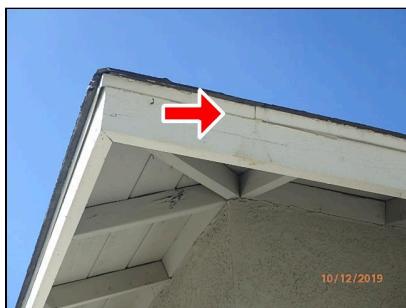
1.5 Item 1(Picture)

🏡 1.5 (1) Stains noted on fascia at the front of home indicate moisture could possibly be penetrating the Asphalt shingle roof and is draining on underlayment down to eaves. Recommend further evaluation by a licensed roofing contractor.

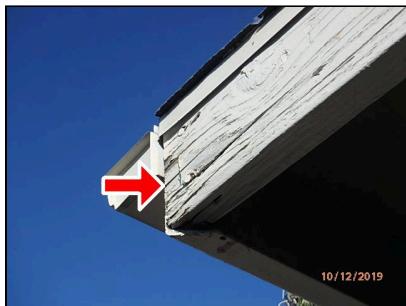
1.5 Item 2(Picture)

(2) The wood fascia at eave on the rear of home weathered and damaged. Further deterioration may occur if not repaired. A qualified contractor should inspect further and correct as needed.

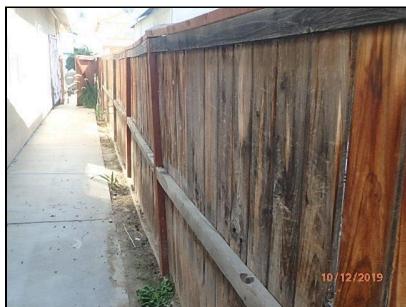
1.6 Item 1(Picture)

1.6 The posts at the wooden fence are loose and leaning. Injury or damage can occur if the fence falls. Recommend evaluations and repairs by a qualified person.

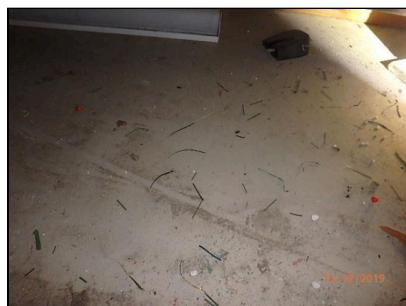
2.4 Item 1(Picture)

**2.4** Rodent droppings noted at various areas in attic (garage and home). We do not test for the presence of rodent or vermin infestations. I am un able to determine if there is an active problem, however we recommend further evaluation by proper specialist.

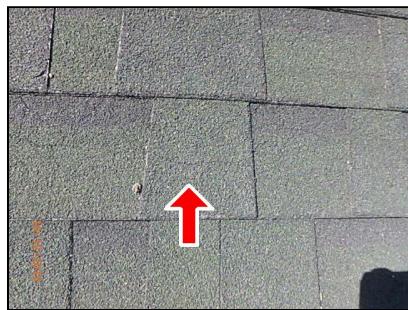
3.0 Item 8(Picture)

⚠ (2) Surface cracking noted at the shingles. Surface cracking is normally caused by excessive heat and poor or no ventilation of the attic or under the roof deck area. The cracking is an indication of possible pre mature failure of the shingles. I recommend a qualified licensed roofing contractor evaluate and estimate the remaining life of the roof covering.

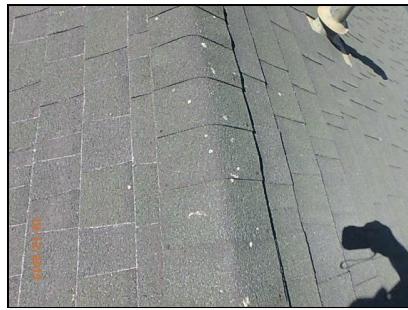
3.0 Item 17(Picture)

⚠ (3) The ridge/hip caps and roll roofing has exposed fasteners that breach the roofing material at "entire roof". Fasteners can loosen with age and allow moisture to penetrate roof. A qualified contractor should inspect further and correct as needed.

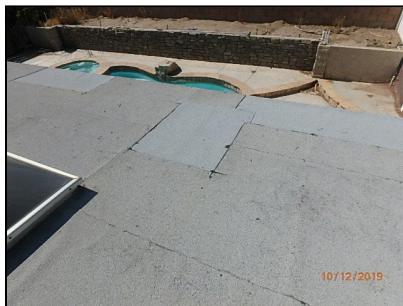
3.0 Item 20(Picture)

(4) The roll roofing is damaged and has been improperly repaired at patio cover. It should be replaced as soon as possible. A qualified contractor should inspect further and correct as needed.

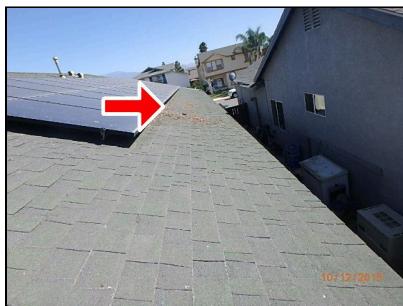
3.0 Item 24(Picture)

(5) Pigeon droppings noted at various areas. This can sometimes be a health hazard. Recommend proper specialist inspect further and correct as needed.

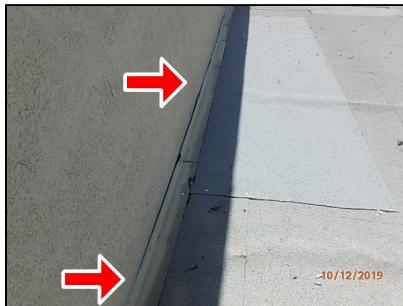
3.1 Item 1(Picture)

3.1 (1) The head wall flashing (patio cover) was Not installed under the wall cladding. Normally the flashing is installed prior to the wall cladding, to direct any water that gets under the cladding back onto the roof covering. Incorrectly installed flashing can allow moisture intrusion. Moisture intrusion will lead to structural damage and microbial growth. I recommend a qualified person seal the flashing (on a regular schedule) to help prevent future damage.

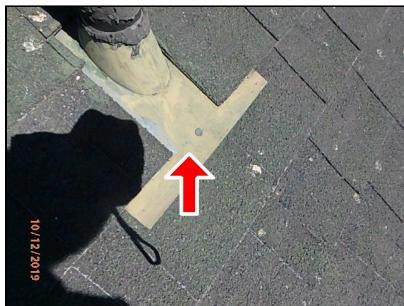
3.1 Item 3(Picture)

(2) Exposed fasteners at flashings. There should be No exposed fasteners at the flashings. All exposed fasteners are an potential leak. I recommend repairs by an qualified roofing contractor.

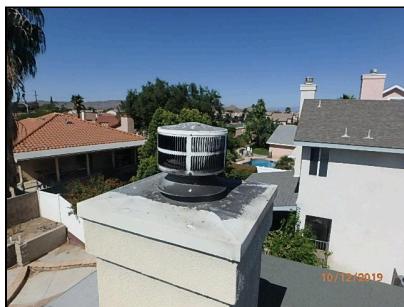
3.2 Item 1(Picture)

3.2 The paint is peeling on the chimney cap. The paint protects the metal from pre mature failure. I recommend a qualified contractor properly prepare the cap and paint to help prevent pre mature failure.

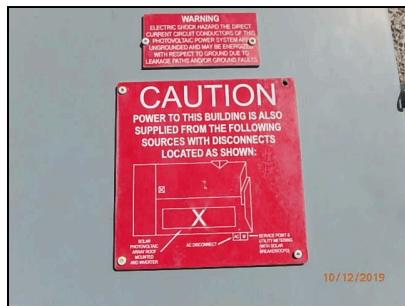
4.0 Item 1(Picture)

4.0 Electrical service is installed with a solar power unit that manages electricity for the home. Solar electric system is beyond the scope of the inspection. Solar electric system and components were not evaluated by my company. I recommend complete system evaluation by a qualified contractor.

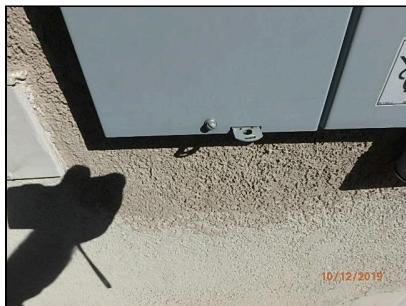
4.1 Item 1(Picture)

**4.1** (1) The missing seal on the service entrance conductor side of the main panel may be an indication of alterations or possible theft of electricity. I recommend contact the utility company for replacement of the seal.

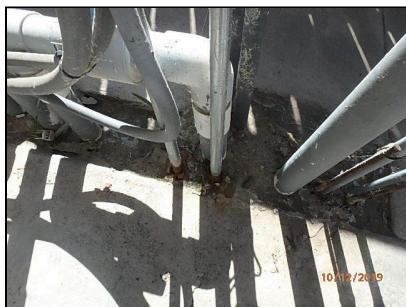
4.1 Item 2(Picture)

(2) The conduit that supports the sub panel is rusted and damaged. The panel is loose. This is a safety hazard. I recommend repairs by a qualified contractor.

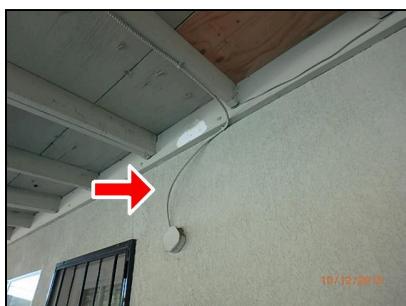
4.2 Item 1(Picture)

**4.2** (1) Problem(s) discovered with Branch Circuits such as non exterior rated conduit and any other problems that an electrician may discover while performing repairs need correcting. I recommend a licensed electrician inspect further and correct as needed.

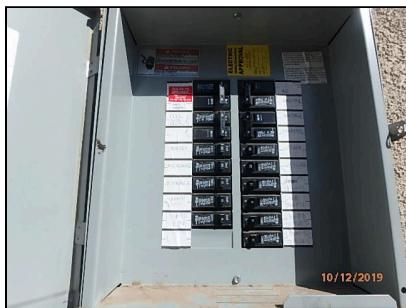
4.2 Item 2(Picture)

🏡 (2) There are No AFCI (arc fault circuit interrupter) breakers installed. Homes in California that have had permitted electrical alterations or up grades after 2005 are required to have AFCI safety breakers installed. I recommend a qualified electrical contractor evaluate and estimate the cost of installing AFCI breakers to meet the current safety standard.

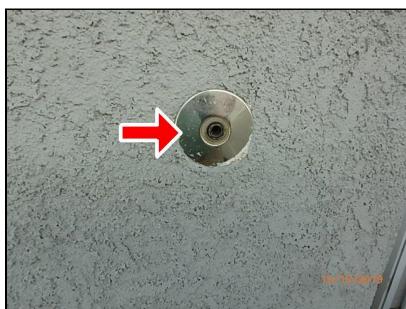
4.3 Item 1(Picture)

🏡 4.3 (1) Doorbell did not work. A qualified licensed electrician should perform repairs that involve wiring.

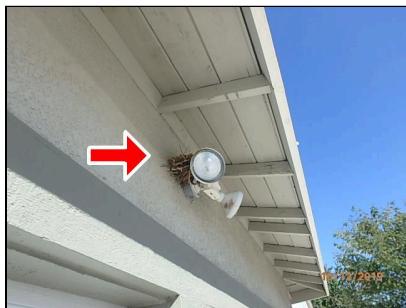
4.3 Item 2(Picture)

🏡 (2) I recommend remove the birds nest at the east side driveway light to help prevent fire.

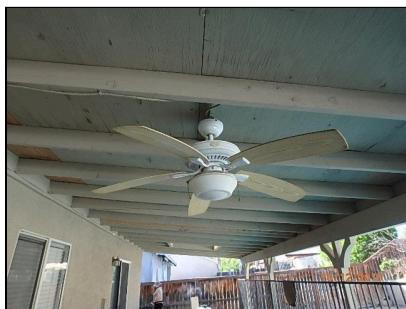
4.3 Item 3(Picture)

🏡 (3) All electrical fixtures (ceiling fans) installed outdoors must be rated for exposure.I recommend an qualified electrical contractor evaluate the ceiling fan(s) to determine if they are rated for exposure.

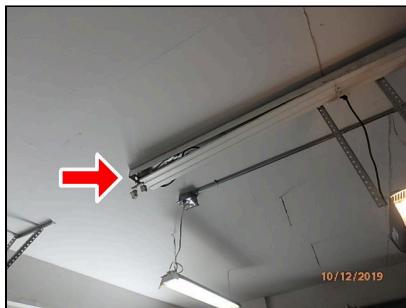
4.3 Item 4(Picture)

- 💡 (4) The light fixture is damaged at the garage. This is a safety issue that needs to be corrected. A qualified licensed electrician should inspect further and correct as needed.

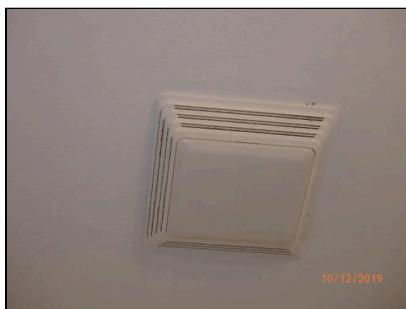
4.3 Item 5(Picture)

- 💡 (5) The light fixture did not work at the Hall Bath. A qualified person should test/verify operation.

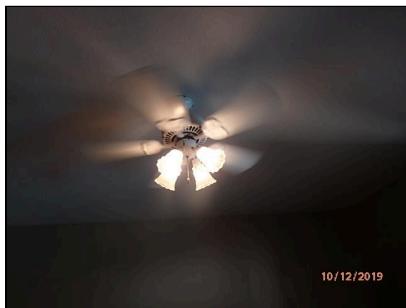
4.3 Item 6(Picture)

- 💡 (6) The light fixture at the master bedroom "flickers" when some thing is plugged in the guest bedroom. I recommend evaluation by a qualified electrical contractor.

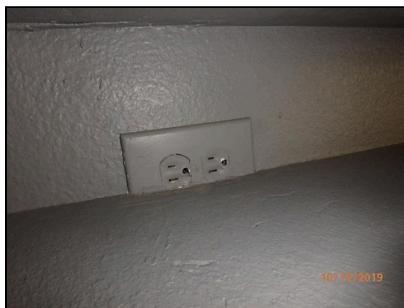
4.3 Item 7(Picture)

(7) At least one "three-prong" outlet is mounted in non-accessible locations and can not be properly accessed in the family room above the fireplace. This is a safety issue that needs to be corrected. A qualified licensed electrician should inspect further and correct as needed.

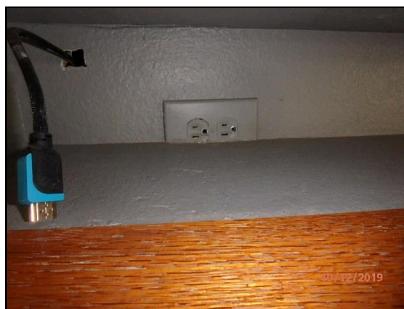
4.3 Item 8(Picture)

(8) We recommend replacement of All receptacle/outlets that have been painted.

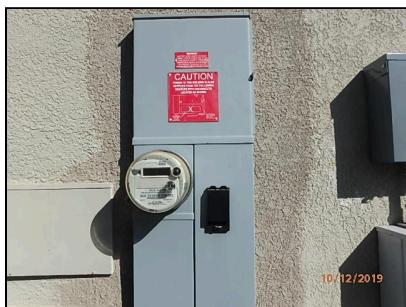
4.6 Item 1(Picture)

4.6 (1) The main panel box is located at the South side.

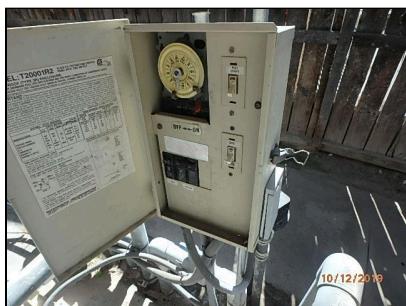
4.6 Item 3(Picture)

(2) The sub panel box is located at the pool/spa equipment.

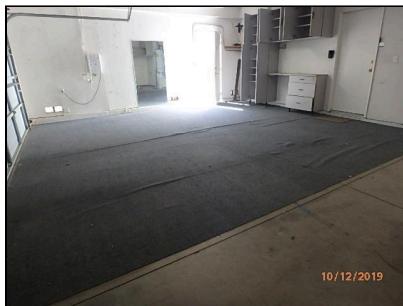
5.2 Item 1(Picture)

**5.2** Floors are not fully visible for inspection due to carpet. Carpet is flammable and should Not be installed on the garage floor. Recommend further evaluation by proper specialist.

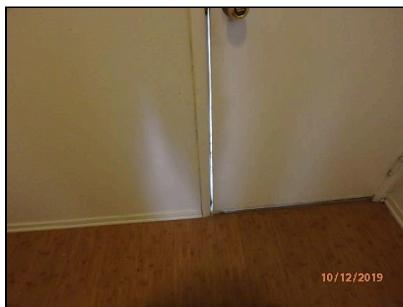
5.3 Item 1(Picture)

**5.3** The weather strip is damaged at the garage door (fire door) to the interior. Recommend proper licensed specialist inspect further and correct as needed.

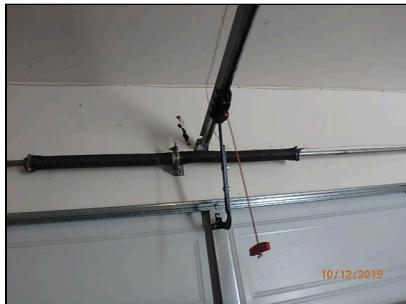
5.4 Item 1(Picture)

(2) The springs for garage door (s) at the front of home is missing the warning tag. Do Not attempt to adjust the spring. Tampering with the spring (s) can cause Bodily Injury or Death.

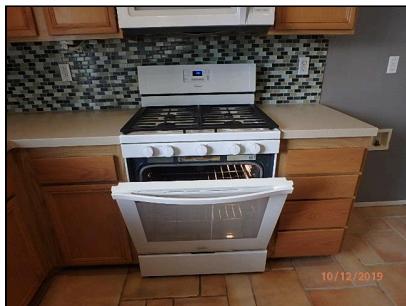
6.2 Item 1(Picture)

**6.2** No "anti tip" bracket installed on the stove/range to prevent unit from tipping over if oven door were to be used for a step. Recommend installation of "anti tip" bracket for safety.

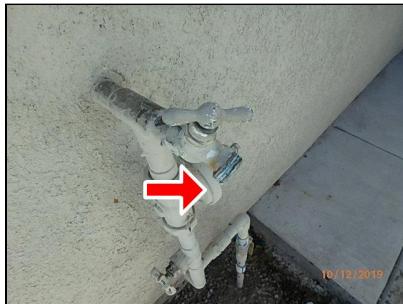
7.1 Item 1(Picture)

- 7.1 (1) Hose bibs at various locations are missing anti-backflow prevention devices(vacuum breakers). While this may be a newer requirement,I recommend installing vacuum breakers to prevent accidental contamination of water supply system

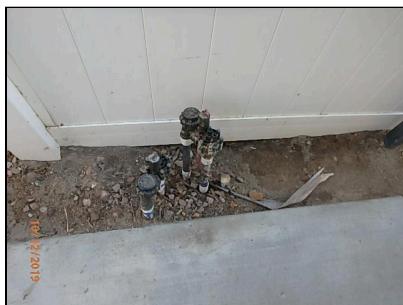
7.1 Item 2(Picture)

- 7.1 (2) Irrigation system was Not inspected. Recommend proper specialist inspect irrigation system further and verify that it meets all of the current water conservation requirements and is functioning correctly.

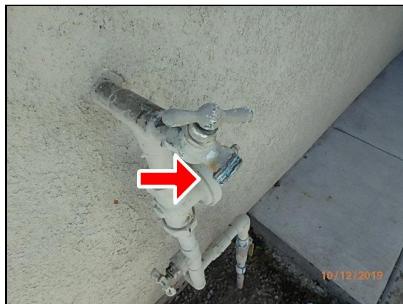
7.1 Item 4(Picture)

- 7.1 (3) The hose bib drips at knob when turned on at the (North side of home). Repairs are needed to help prevent wasting water. A qualified person should repair as necessary.

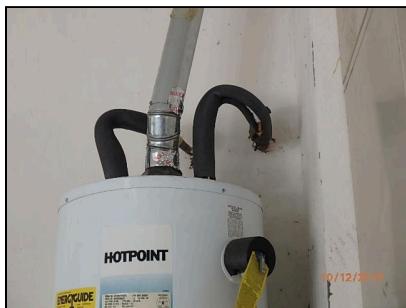
7.1 Item 7(Picture)

accidental electrocution if the pipes become "accidentally electrified". I recommend evaluation and repair by a qualified person.

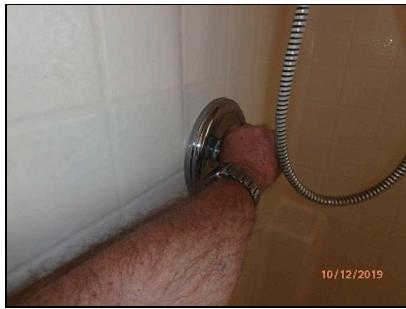
7.1 Item 8(Picture)

- ⬆️ (5) The shower valve and pipes are loose in the wall (master bathroom). I recommend a qualified person secure the pipes inside the wall to prevent damage to any concealed connections that may result in a leak. Water leaks can lead to structural damage and microbial growth. I recommend evaluation and repairs by a qualified contractor.

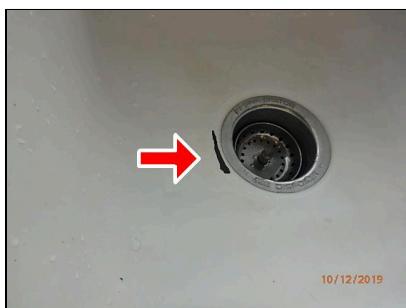
7.1 Item 10(Picture)

- ⬆️ (6) The sink finish is damaged at the kitchen. Repairs are needed. A qualified person should repair as necessary.

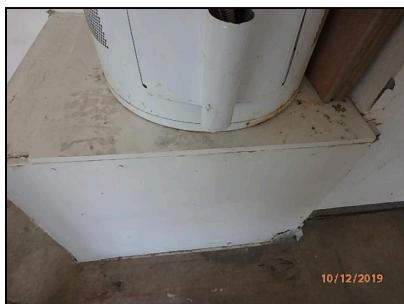
7.2 Item 2(Picture)

When a water heater is located where damage results from a leaking water heater, a watertight pan of corrosion-resistant materials shall be installed beneath the water heater with not less than three-quarters of an inch (20 mm) diameter drain to an approved location.

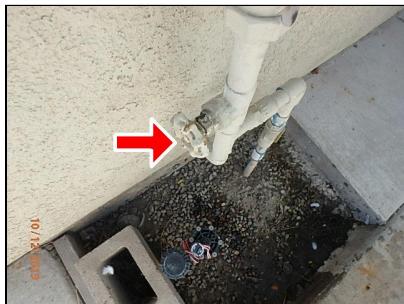
7.3 Item 1(Picture)

7.3 The main water shut off is the Tan knob located on North wall. This is for your information.

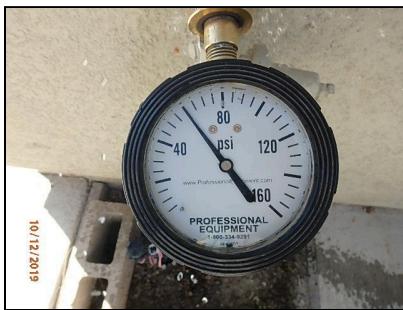
7.4 Item 1(Picture)

7.4 (1) Water pressure is 60 psi.

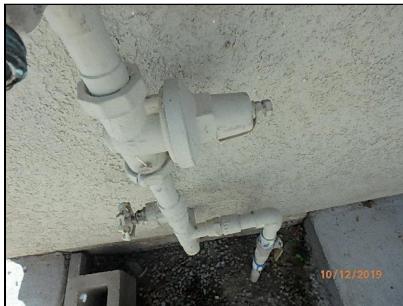
7.4 Item 2(Picture)

(2) No relief valve visible/installed

Excessive Water Pressure. Where static water pressure in the water supply piping is exceeding eighty (80) pounds per square inch (552 kPa), an approved-type pressure regulator preceded by an adequate strainer shall be installed and the static pressure reduced to eighty (80) pounds per square inch (552 kPa) or less. Pressure regulator(s) equal to or exceeding one and one-half (1 1/2) inches (38 mm) shall not require a strainer. Such regulator(s) shall control the pressure to all water outlets in the building unless otherwise approved by the Authority Having Jurisdiction. Each such regulator and strainer shall be accessibly located above ground or in a vault equipped with a properly sized and sloped bore-sighted drain to daylight, shall be protected from freezing, and shall have the strainer readily accessible for cleaning without removing the regulator or strainer body or disconnecting the supply piping. Pipe size determinations shall be based on 80 percent of the reduced pressure. An approved expansion tank shall be installed in the cold water distribution piping downstream of each such regulator to prevent excessive pressure from developing due to thermal expansion and to maintain the pressure setting of the regulator. The expansion tank shall be properly sized and installed in accordance with the manufacturer's instructions and listing. Systems designed by registered engineers shall be permitted to use approved pressure relief valves in lieu of expansion tanks provided such relief valves have a maximum pressure relief setting of one hundred (100) pounds per square inch (689 kPa) or less.

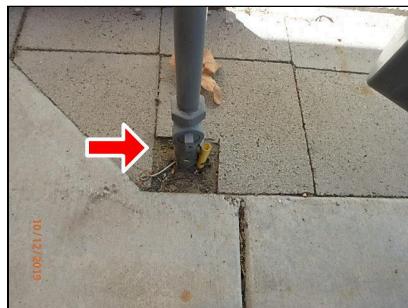
7.5 Item 1(Picture)

7.5 (1) The main fuel shut off is at gas meter outside at (South side of home). The valve will need a wrench to be operated. While not a requirement, in case of emergency, we recommend an earthquake style wrench with a chain be installed to aid shut off in the event of an emergency.

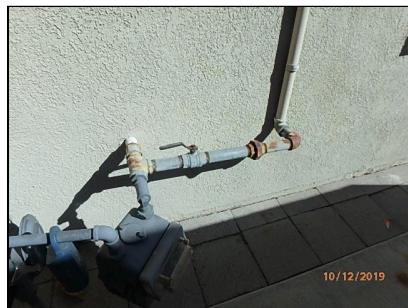
7.5 Item 3(Picture)

(2) The pipes are rusty and there is no automatic earthquake shutoff valve, at the gas meter. I recommend the rusty pipes be prepared and painted. There is no requirement for an automatic earthquake shutoff valve. It is a recommendation for a safety up grade, from the Home Inspector to you.

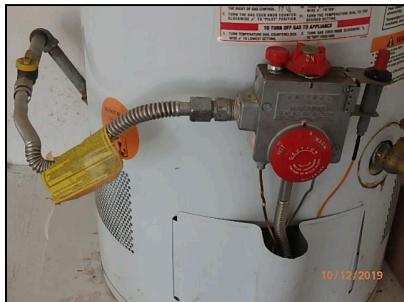
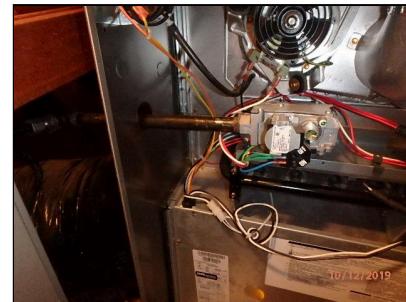
**7.6** No sediment traps noted at gas appliances. While local jurisdictional authorities may not require this, we recommend installation of sediment traps at gas appliances as per manufacturers installation instructions.

Sediment Trap. Where a sediment trap is not incorporated as a part of the gas utilization appliance, a sediment trap shall be installed downstream of the appliance shutoff valve as close to the inlet of the appliance as practical at the time of appliance installation. The sediment trap shall be either a tee fitting with a capped nipple in the bottom outlet, or other device recognized as an effective sediment trap. Illuminating appliances, ranges, clothes dryers, decorative vented appliances for installation in vented fireplaces, gas fireplaces, and outdoor grills shall not be required to be so equipped.

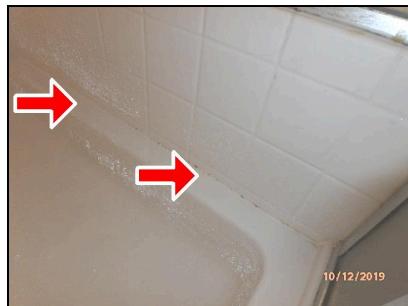
8.1 Item 1(Picture)

**8.1 (1)** The caulking at the Surround kit for shower on the wall is discolored at the master bath. Some shower surround manufacturers do Not recommend sealing these areas with silicone (or any other material).. Moisture that accumulates inside the wall cavity can lead to structural damage and microbial growth. A qualified contractor should inspect further and correct as needed.

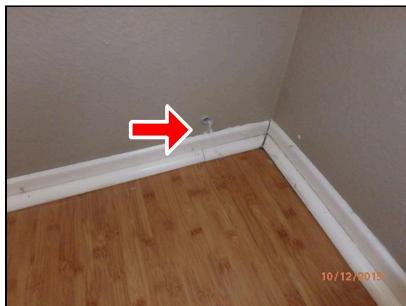
8.1 Item 2(Picture)

(2) The drywall and finish are damaged at a number of areas, most likely from missing door stops, pictures, bath accessories,cable installer or furniture. I recommend repairs by a qualified person.

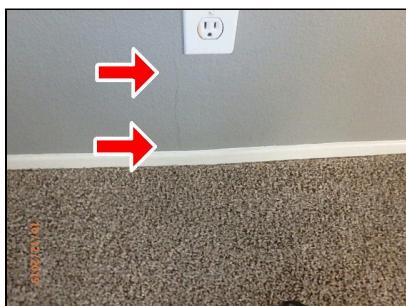
8.1 Item 5(Picture)

(3) The drywall on the wall is cracked at Living Room. Repairs are needed. A qualified contractor should inspect further and correct as needed.

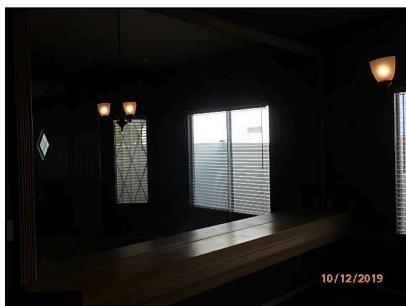
8.1 Item 6(Picture)

(4) I am unable to view the attachment system of the Wall mirror. Mirrors that are not mechanically attached/anchored(adhesive only) may become loose during an seismic event (earthquake) and can cause serious injury. I recommend evaluation by an qualified contractor.

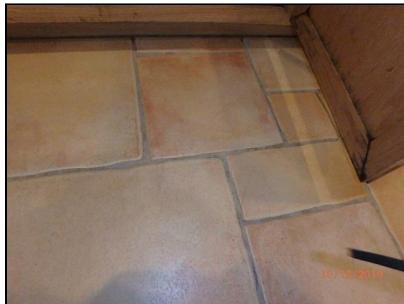
8.2 Item 1(Picture)

8.2 (1) Hollow sounding floor tiles are most likely loose/not correctly adhered to the concrete. These tiles will eventually break (if not repaired.) I recommend evaluation/repairs by a qualified person

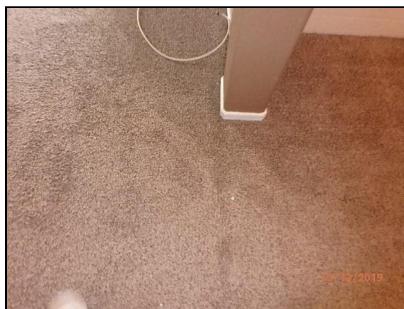
8.2 Item 4(Picture)

(3) The Carpet is loose at Master Bedroom. It may eventually become a trip hazard . A qualified contractor should inspect further and correct as needed.

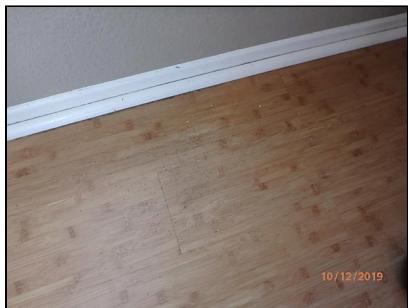
8.2 Item 5(Picture)

(4) Evidence of Pests noted at the guest bedroom. I am unable to determine if there is an active infestation. Roaches can carry diseases. I recommend complete evaluation by a qualified pest control operator.

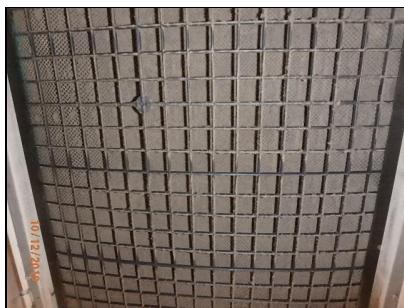
9.5 Item 1(Picture)

**9.5** I recommend clean or replace the filters a minimum of twelve (12) times a year to maintain system efficiency.

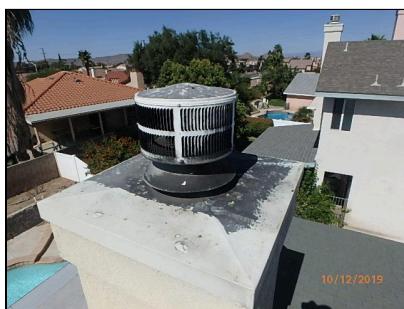
9.7 Item 1(Picture)

**9.7 (1)** The chimney, liner and all related components are not fully accessible for a visual inspection. It is recommended that a NFPA(National Fire Protection Association) 211(Standards for chimneys, Fireplaces, Vents and Solid Burning Appliances) level II inspection be performed by a proper licensed specialist for safety.Prior to the use of this fireplace.

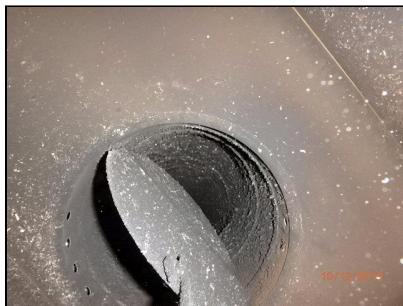
9.7 Item 2(Picture)

(2) I recommend install damper clamp to prevent the damper from fully closing and allowing products of combustion (carbon monoxide) entering into the living space and clean the chimney prior to the use of this fireplace.

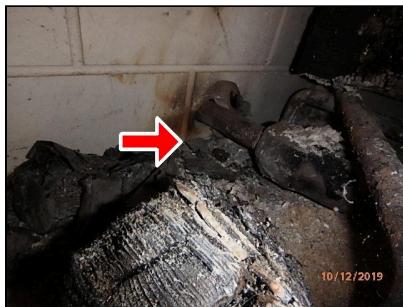
9.8 Item 1(Picture)

9.8 The fireplace refractory panel is Not sealed at the gas line. Excess gap can allow hot embers or gasses to enter the chase area around the fireplace and is considered a fire hazard. We recommend a qualified person seal the excess gap with a material that is approved for that use.

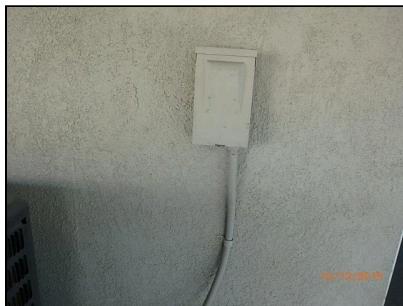
9.10 Item 1(Picture)

(2) I recommend lock or secure the AC disconnect cover to prevent accidental electrocution.

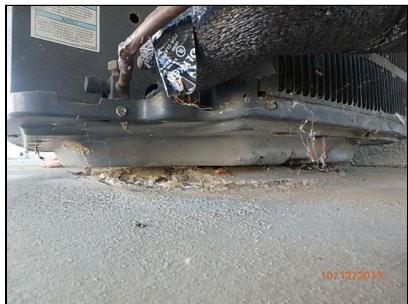
9.10 Item 2(Picture)

(3) We recommend anchor/secure the AC unit to the mounting pad and the pad is undersized. The unit should be anchored to resist movement during an seismic event. Anchorage of Appliances. Appliances designed to be

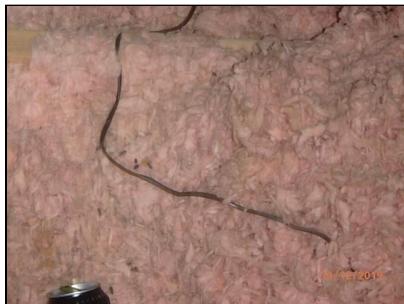
10.0 Item 1(Picture)

**10.0** (1) Insulation in the attic that is contaminated by rodents is considered an health safety hazard and should be removed and replaced. I recommend evaluation and cost estimation of replacement and upgrading to meet the current energy conservation standard.

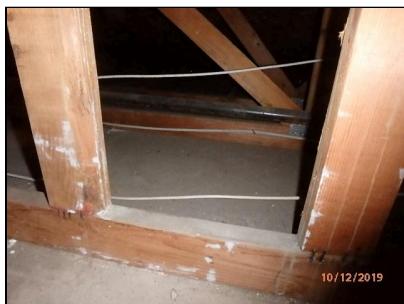
10.0 Item 2(Picture)

(2) The area above the garage is not required to be insulated. I recommend install insulation that meets current energy conservation standard. This should be considered an upgrade and will help reduce energy costs

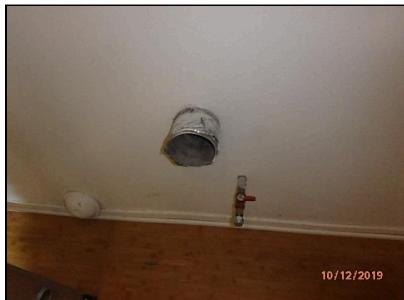
10.2 Item 1(Picture)

**10.2 (1)** The dryer vent terminates above the roof. This may allow dryer lint to accumulate inside the duct and become a fire hazard. We recommend cleaning the dryer vent duct yearly.

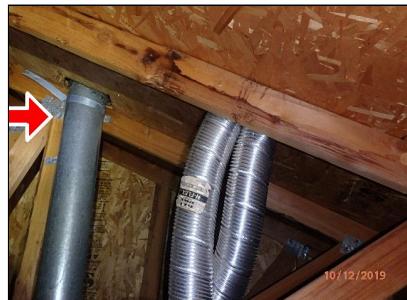
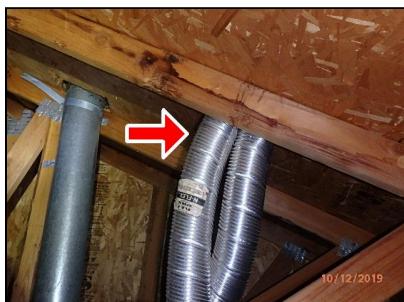
**(2)** The exhaust ducts in the attic (bath, laundry, Etc Etc.) are routed to one opening in the attic.. Vents are supposed to terminate to the exterior, one duct per opening. The duct tape is Not an approved support system. If the ducts fall they will be venting warm damp air into the attic. This will lead to excess moisture and possibly microbial growth. I recommend repairs by a qualified person

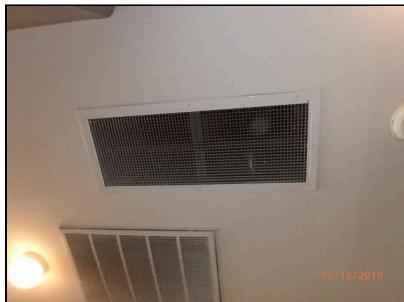
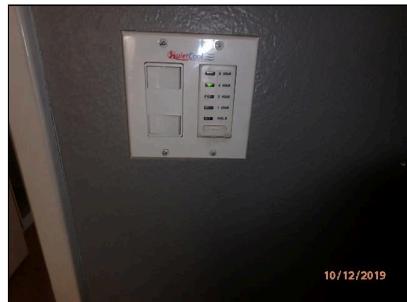
**10.7** Whole house fans are installed as an added energy saving feature. The fans should be equipped with fire sensor safety switches in the attic. The fan normally is operated in the evening or night time hours. The fan creates an negative pressure inside the home and exhausts in the attic. An window must be opened to allow outside air to be drawn in and cool the homes interior. Operation of the fan without an open window or door can draw ashes out of the fire place(s). The fan should not be operated when the HVAC system(s) are running. These systems are beyond the scope of this inspection and was not evaluated. I recommend regular inspection and maintenance by an qualified person.

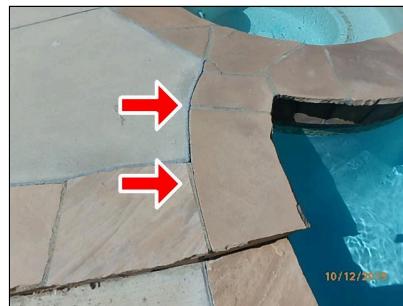
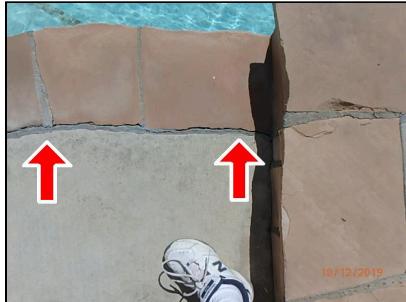
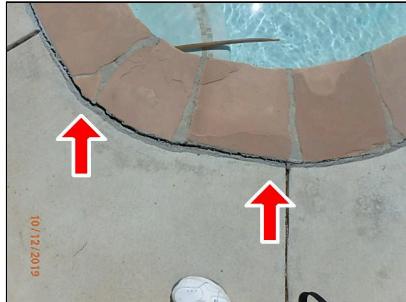
12.3 The deck seal is cracked at a number of locations. The seal helps to prevent water from seeping between the pool shell and the soil. Excess water in this area will have severe negative affects on the pool structure. I recommend repairs by a qualified person.

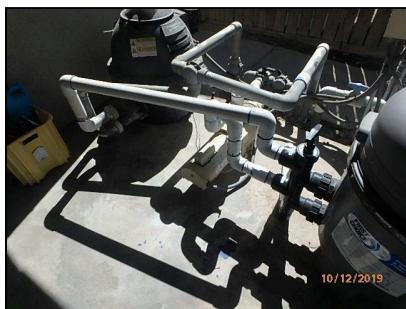
12.4 Item 1(Picture)

12.4 PVC pool and spa plumbing should be painted to avoid deterioration from sunlight.

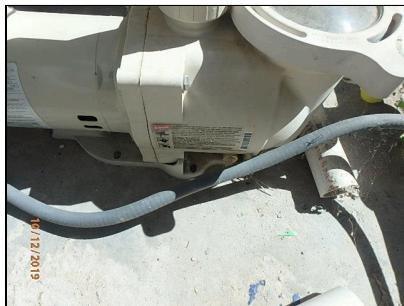
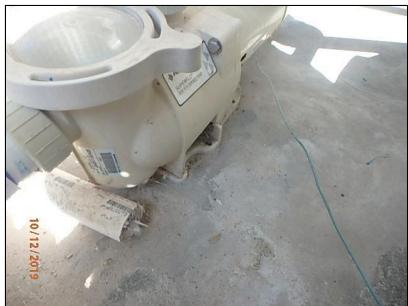
(2) Pool pump is not secured properly to pad. Opinions vary as to importance of this item. We recommend correcting for safety. Recommend further evaluation by a licensed pool technician.
