Inspection Report

Property Address:
22815 Miles Dr
Highland CA 92346

Date: 11/4/2019	Time: 10:30 AM	Report ID: 20191104TLH12
Property: 22815 Miles Dr Highland CA 92346	Customer: Donor Report	Real Estate Professional:

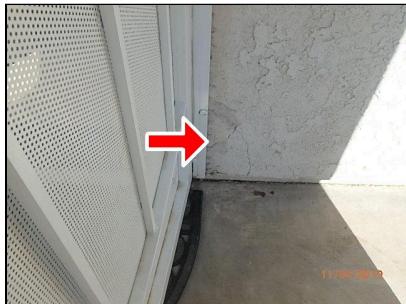
1.0 Item 1(Picture)

1.0 (1) Stucco coating at various areas of exterior is cracked. Recommend sealing of all cracks to prevent moisture intrusion and further deterioration. If these are areas of concern, recommend further evaluation by proper specialist be completed.

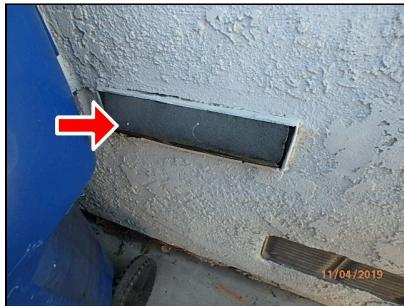
1.0 Item 2(Picture)

(2) Utility access cover is missing at (West side of home). This can allow moisture intrusion into the wall cavity. I recommend correct as necessary.

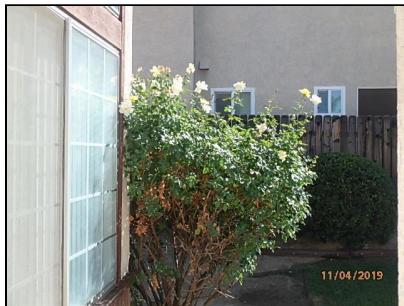
1.4 Item 1(Picture)

**1.4 (1)** Trees and vegetation planted next to home may cause foundation,plumbing drain and/or moisture problems on exterior wall covering and can allow rodents access to the attic and interior of home, if not moved. Recommend correct as necessary to avoid any possible future damage. Removal of the vegetation can lead to a Rodent infestation inside the home. Steps to prevent a possible infestation should be taken prior to removal of the vegetation.

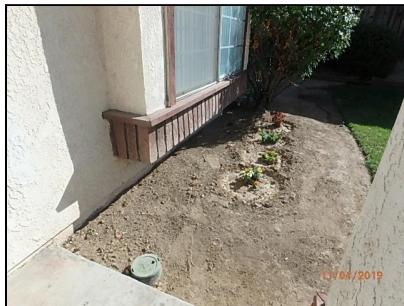
1.4 Item 2(Picture)

(2) There are several areas attached to the home (and away from the home). That do not appear to drain water to an approved location. Water that does not drain away from the home can lead to structural damage and microbial growth. I recommend correction of the grading and drainage by an qualified person.

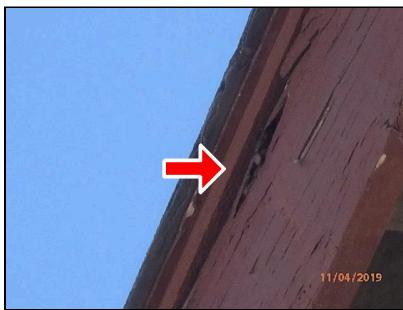
1.5 Item 1(Picture)

**1.5 (1)** The wood fascia at eave on the front,rear and sides is weathered. Further deterioration will occur if not repaired. A qualified contractor should inspect further and correct as needed.

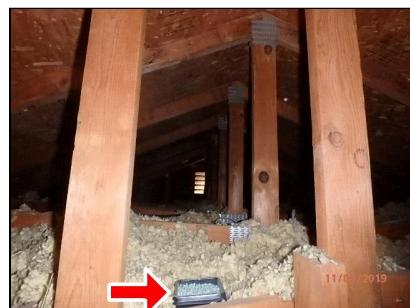
2.4 Item 1(Picture)

2.4 Rodent poison noted in attic. We do not test for the presence of rodent or vermin infestations. I am un able to determine if there is an active problem, however we recommend further evaluation by proper specialist.

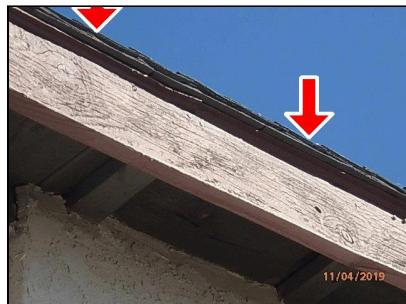
3.0 Item 1(Picture)

3.0 (1) Two layers of roof covering exist on roof. While most jurisdictions allow three layers. It is not usually recommended by roofing manufacturers. The top layer of shingles may not get adequate ventilation. This may result in pre mature failure of the shingles. The excess weight can lead to other negative impacts on the structural integrity of the home. When the current top layer of shingles needs to be replaced. I recommend a complete removal of all layers, and installation of an sheathing/ roof deck that is approved by the City and the Shingle Manufacturer.

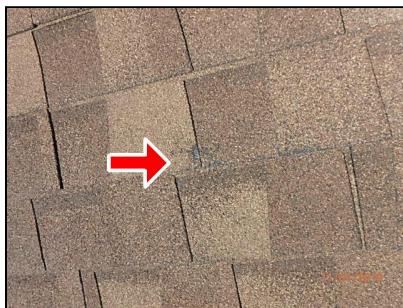
3.0 Item 5(Picture)

(2) The fiberglass composition shingles are damaged or "scuffed" at middle of home. I recommend repairs as soon as possible to help prevent pre mature failure of the roof covering. A qualified contractor should inspect further and correct as needed.

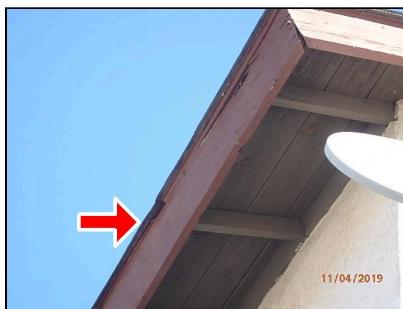
3.1 Item 1(Picture)

3.1 (1) Metal drip edge is missing along rake/eave at front of home and left side (facing front). This will eventually deteriorate the wood. A qualified roofing contractor should inspect further and correct as needed.

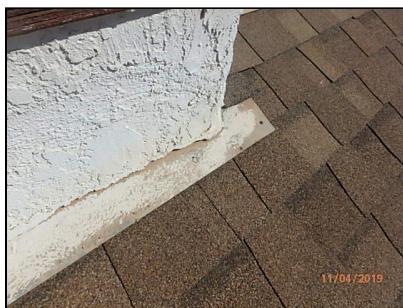
3.1 Item 4(Picture)

(2) Exposed fasteners at flashings. There should be No exposed fasteners at the flashings. All exposed fasteners are a potential leak. I recommend repairs by an qualified roofing contractor.

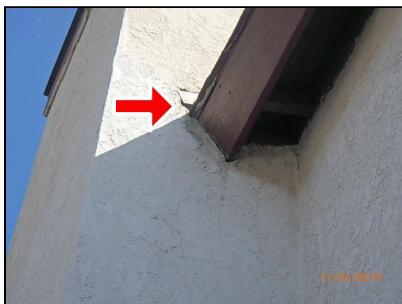
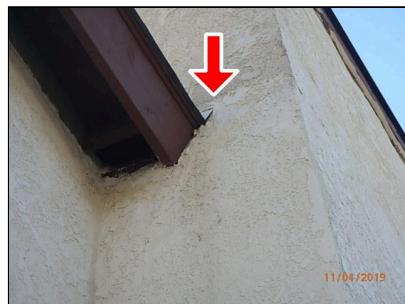
(3) There is no flashing kick out visible at the sides of the chimney where the roof slopes to the chimney(eave sides.) Water may not be diverted away from the chimney/wall and can saturate the stucco and lead to moisture intrusion. I recommend repairs by a qualified roofing contractor

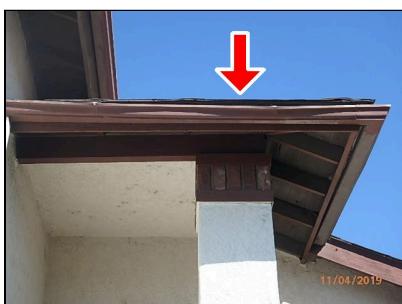
3.3 Item 1(Picture)

3.3 The gutter is damaged, is loose at the (South side of home). Gutters that drain poorly or clogged can lead to many costly problems such as deterioration of fascia, soffit or roof edge. It can also cause gutters to pull loose and lead to possible water intrusion. A qualified contractor should inspect further and correct as needed.

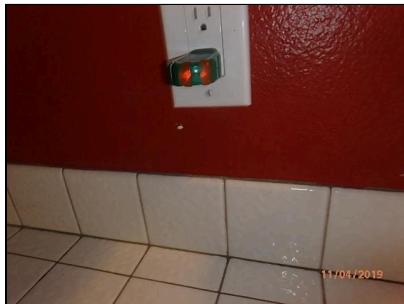
4.5 Item 1(Picture)

**4.5** "GFCI" protected outlets are not present at all kitchen countertop receptacles and peninsula. Some of these style outlets would have been required at the time of construction, we recommend consideration of upgrading to current standards for safety. Recommend a licensed electrician inspect further, evaluate and correct as necessary for safety.

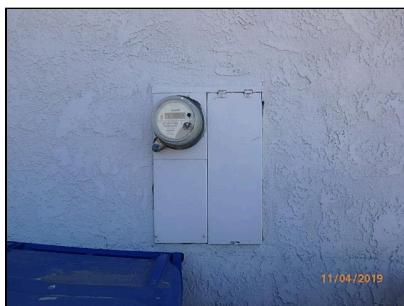
4.6 Item 1(Picture)

4.6 The main panel box is located at the West side.

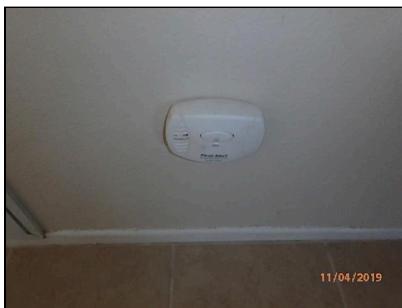
4.8 Item 1(Picture)

4.8 There are carbon monoxide detector/alarm(s) found in home. They were Not tested. It is recommended that they be installed and Tested according to the manufacturer's instructions. It is Now required by state law. I recommend install CO alarms in all of the locations that smoke alarms are Now required(each floor, every sleeping room,in the common hallway outside every sleeping room). This is recommend as an occupant safety up grade.

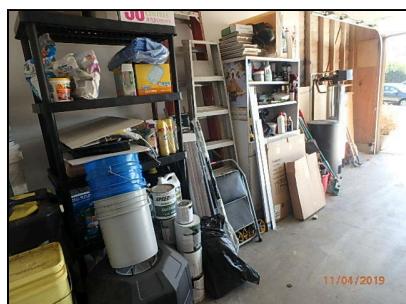
5.1 Item 1(Picture)

**5.1** (1) Walls are not fully visible for inspection due to occupants belongings. Recommend further evaluation by proper specialist.

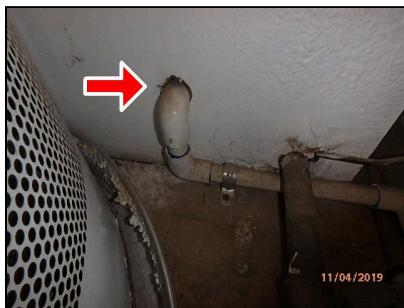
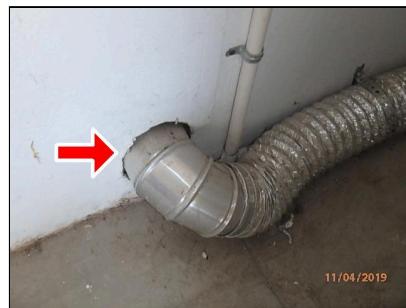
(2) The firewall/drywall that separates garage from heated space Not fully sealed at pipe penetration(s). This is

considered unsafe until corrected. A qualified person should correct for safety.

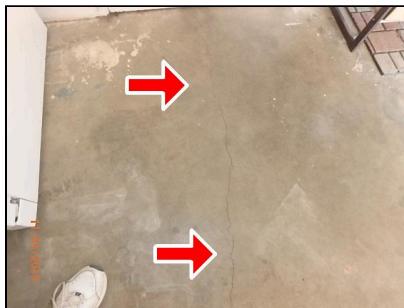
5.2 Item 2(Picture)

- (2) The concrete at the garage floor is cracked. We are unable to determine the cause of the cracks. We recommend evaluation by a qualified person.

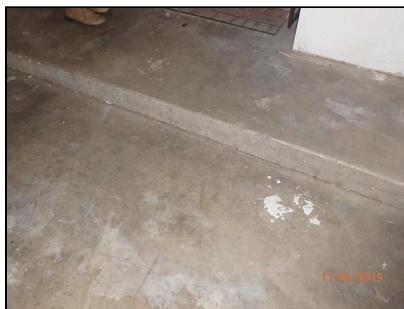
5.2 Item 3(Picture)

- (3) The small step up in the garage is a trip hazard. I recommend a qualified person paint or otherwise mark the step to help prevent fall injuries.

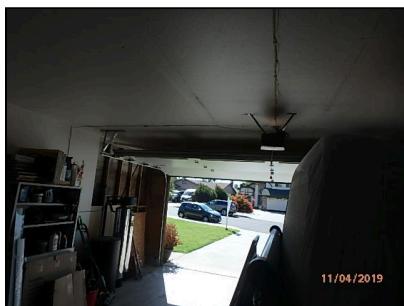
5.5 Item 1(Picture)

**5.5** The automatic opener for vehicle door at the (South side of home) does Not close door. This is a safety/security hazard. A qualified contractor should inspect further and correct as needed.

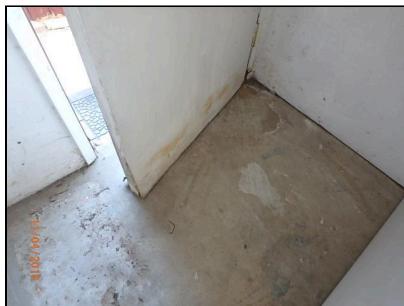
5.6 Item 1(Picture)

**5.6** (1) Moisture stains on the door jamb and around the door are an indication of moisture intrusion. Moisture intrusion will lead to structural damage and microbial growth. I recommend repairs by a qualified contractor.

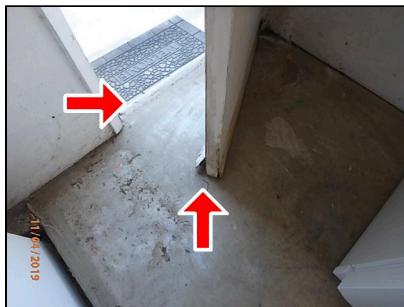
5.6 Item 3(Picture)

(2) There is damage and there is No threshold Installed at the door to the exterior. I recommend install a threshold to help prevent moisture intrusion. A threshold will also help prevent rodents and other pests from entering the Garage and House. I recommend a qualified person correct as necessary.

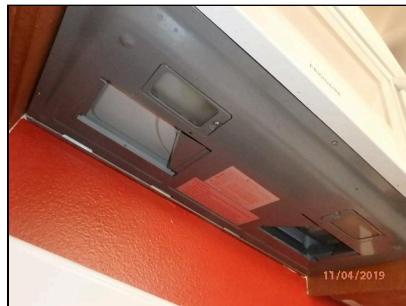
6.0 Item 1(Picture)

6.0 The range hood fan filters are missing. I recommend repair or replace as needed.

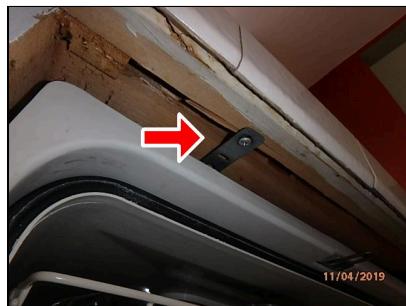
6.1 Item 1(Picture)

6.1 The dishwasher is loose. I recommend repair as necessary.

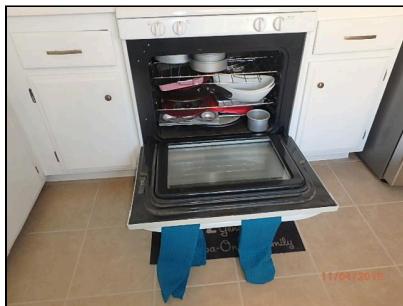
6.2 Item 1(Picture)

6.2 (1) No "anti tip" bracket installed on the stove/range to prevent unit from tipping over if oven door were to be used for a step. Recommend installation of "anti tip" bracket for safety.

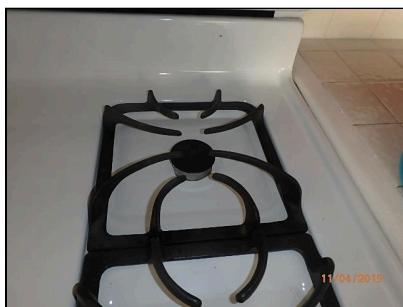
6.2 Item 2(Picture)

(2) The right rear burner (on range) did not respond to normal user controls. I recommend repair or replace as needed.

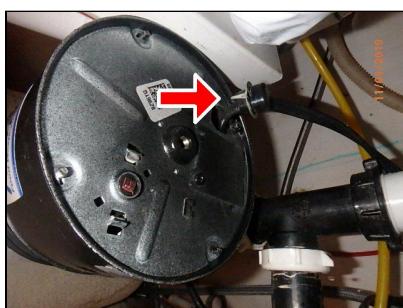
6.3 Item 1(Picture)

6.3 The food waste disposer wiring is has a loose romex connector. I recommend repair or replace as needed.

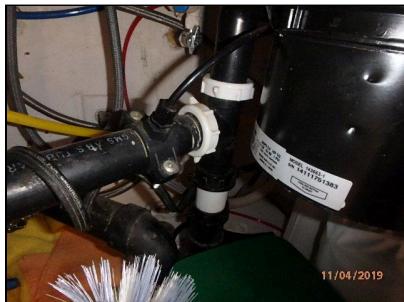
7.0 Item 1(Picture)

(2) Sink drain lines are not allowed to be tapped for discharge line connection. I recommend connect the discharge line to an approved location

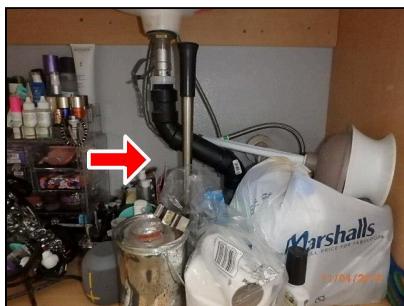
7.0 Item 2(Picture)

(3) Sink drain is improperly installed at upstairs bath. I recommend evaluation and repairs by a qualified licensed plumbing contractor

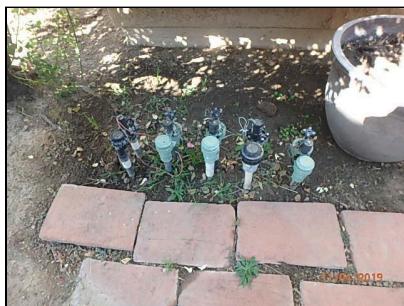
7.1 Item 1(Picture)

**7.1** (1) Irrigation system was Not inspected. Recommend proper specialist inspect irrigation system further and verify that it meets all of the current water conservation requirements and is functioning correctly.

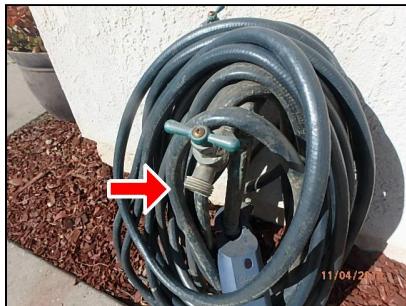
7.1 Item 2(Picture)

(2) Hose bibs at various locations are missing anti-backflow prevention devices(vacuum breakers). While this may be a

newer requirement, I recommend installing vacuum breakers to prevent accidental contamination of water supply system

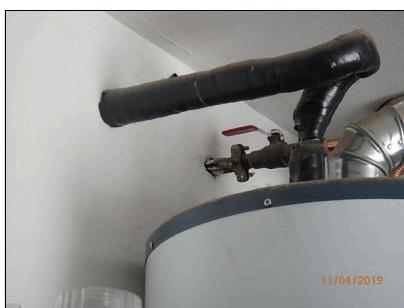
- ⚠ (3) There is no bond wire visible at the water heater pipes (hot and cold.) All metal pipes should be bonded together and the bond wire should be connected to the homes electrical grounding system. This is a safety requirement to prevent accidental electrocution if the pipes become "accidentally electrified". I recommend evaluation and repair by a qualified person.

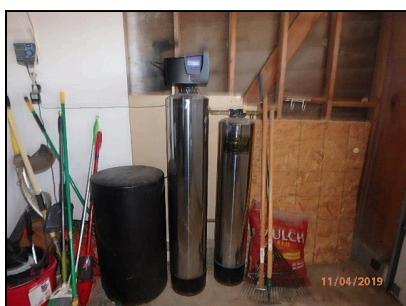
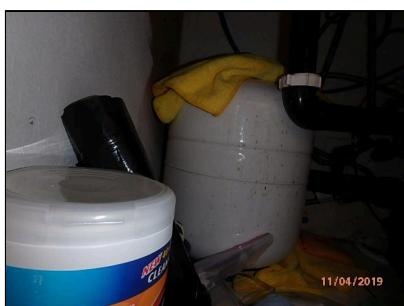
- ⚠ (4) Water softener and filter systems are beyond the scope of inspection and were not evaluated. Recommend proper specialist inspect further and evaluate.

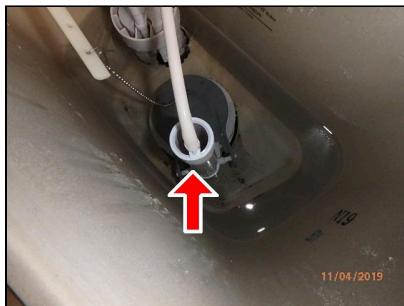
7.1 Item 9(Picture)

- ⚠ (5) Cross connections are present at the toilet filler hoses. The end of the hose should terminate 1" above the water level inside the tanks. I recommend correct as necessary to prevent accidental contamination of the plumbing system.

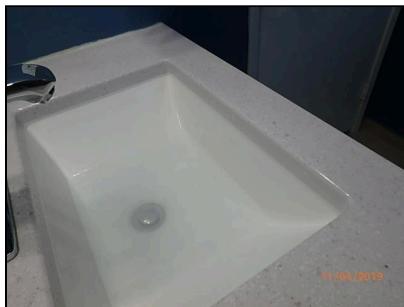
- ⚠ (6) The sink (s) do not have an overflow present at the downstairs and upstairs baths. A sink that is not designed with an overflow can cause accidental flooding of the home. I recommend install sinks with an overflow to help prevent accidental flooding.

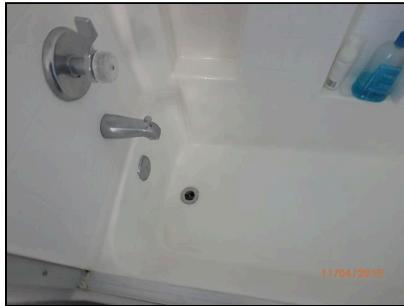
7.1 Item 12(Picture)

- ⚠ (7) The bath tub(s)and shower walls have been re surfaced. I am unable to determine the condition of the surface below the new finish. Sometimes refinishing can hide damage and prior repairs. I recommend complete evaluation of the tub and shower wall surfaces for hidden damage by a qualified person.

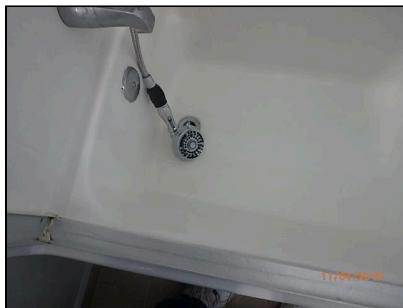
7.1 Item 13(Picture)

- 🏡 (8) Removable shower heads should be equipped with an air gap device or should terminate 1" above the flood rim of the shower. This is an requirement to help prevent accidental contamination of the homes plumbing system.

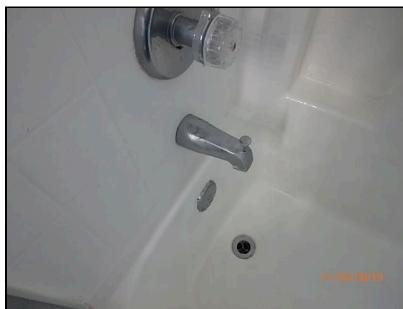
- 🏡 (9) The tub spout diverter does not operate at the upstairs bath. Repairs are needed. A qualified person should repair as necessary.

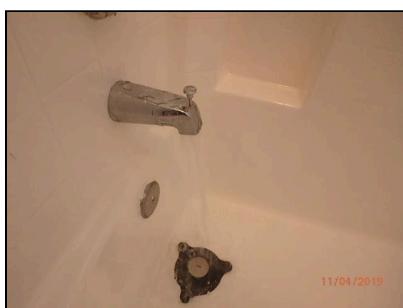
7.1 Item 16(Picture)

- 🏡 (10) The diverter valve leaks at the master bath. Repairs are needed to help prevent wasting water. A qualified person should repair as necessary.

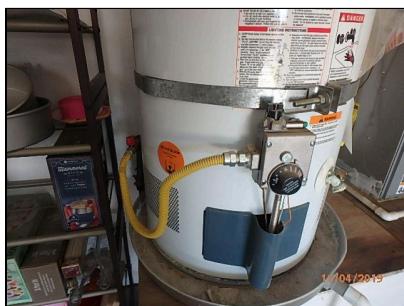
7.2 Item 2(Picture)

(2) The seismic straps are incorrectly spaced.

Protection from Seismic Damage. Water heaters shall be anchored or strapped to resist horizontal displacement due to earthquake motion. Strapping shall be at points within the upper one third (113) and lower one-third (113) of its vertical dimensions. At the lower point, a minimum distance of four (4) inches (102 mm) shall be maintained above the controls with the strapping.

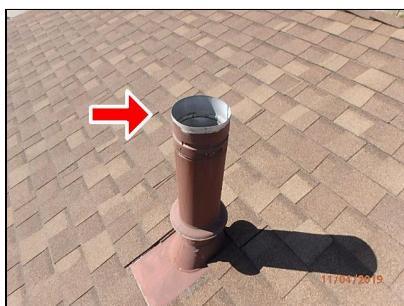
7.2 Item 3(Picture)

(3) The vent pipe for gas water heater cap is damaged/missing above the roof. This is a safety issue and should be corrected. I recommend a qualified licensed heat contractor inspect further and repair as needed.

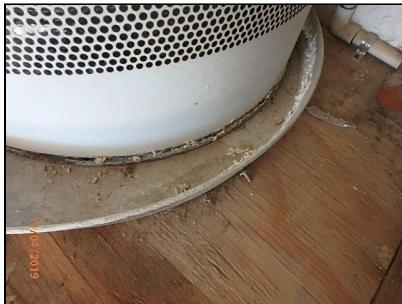
7.2 Item 4(Picture)

- 🏡 (4) Corrosion on the waterheater, drain valve and inside the catch pan may be an indication of a leak.I recommend evaluation by a qualified contractor.

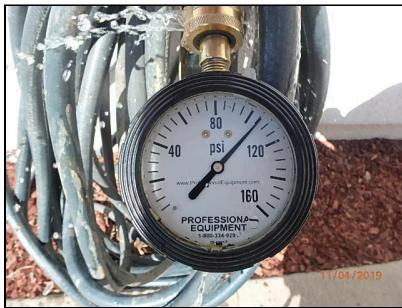
7.4 Item 1(Picture)

- 🏡 7.4 (1) Water pressure is 105 psi.

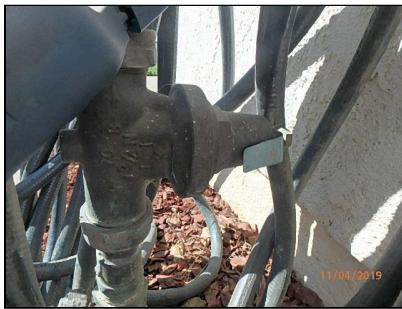
7.4 Item 2(Picture)

- 🏡 (2) Recommend adjustment of water pressure regulator so water pressure is 65-75 psi.

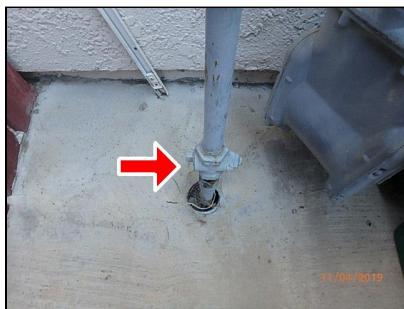
7.5 Item 1(Picture)

7.5 (1) The main fuel shut off is at gas meter outside at (West side of home). The valve will need a wrench to be operated. While not a requirement, in case of emergency, we recommend an earthquake style wrench with a chain be installed to aid shut off in the event of an emergency.

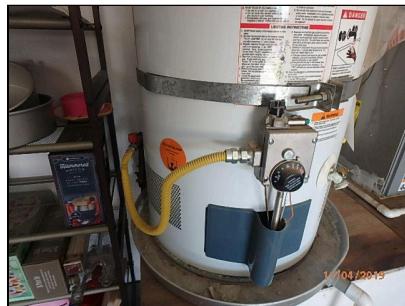
**7.6** (1) No sediment traps noted at gas appliances. While local jurisdictional authorities may not require this, we recommend installation of sediment traps at gas appliances as per manufacturers installation instructions.

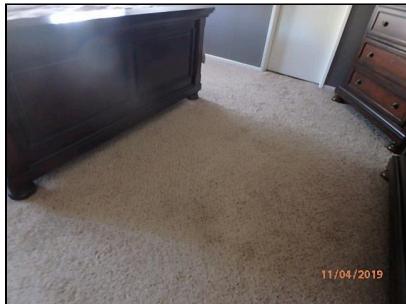
8.2 Item 1(Picture)

**8.2** (1) There are floor "squeaks" at a number of locations. The only way to determine the cause of the squeaks is to remove the carpet/floor covering. We recommend repair as desired.

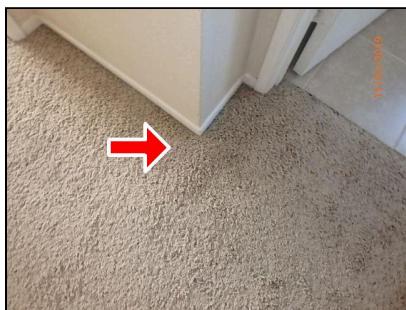
8.2 Item 3(Picture)

(2) The Carpet is loose at upstairs. It may eventually become a trip hazard . A qualified contractor should inspect further and correct as needed.

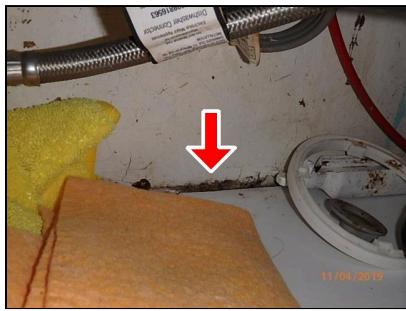
8.4 Item 1(Picture)

**8.4** (1) Unknown black staining present at the under sink at bottom shelf (from a previous leak) . We did not inspect, test or determine if this growth is or is not a health hazard. The underlying cause is moisture. I recommend you contact a proper specialist or expert for investigation and/or correction if needed.

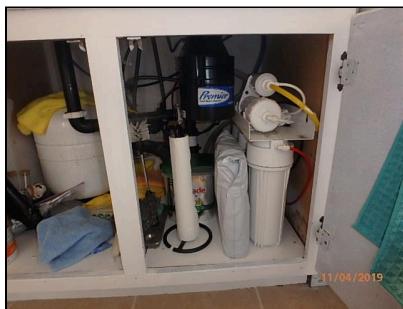
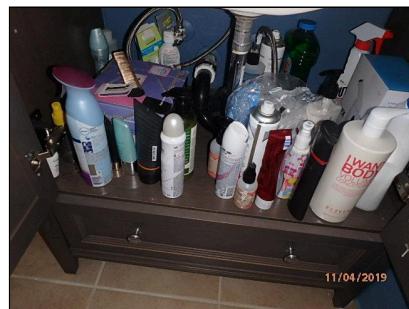
- 🏡 (3) Occupants belongings stored under the sinks block access. I was unable to fully evaluate the condition of cabinets or plumbing (supply/DWV) under the sinks. I recommend complete evaluation by a qualified contractor after occupants belongings have been moved.

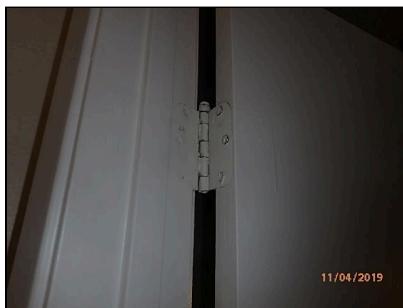
8.5 Item 1(Picture)

- 🏡 8.5 (1) The Privacy door has a loose hinge at Master Bedroom. Further deterioration may occur if not repaired. A qualified person should repair or replace as needed.

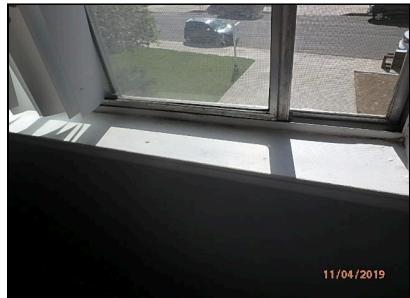
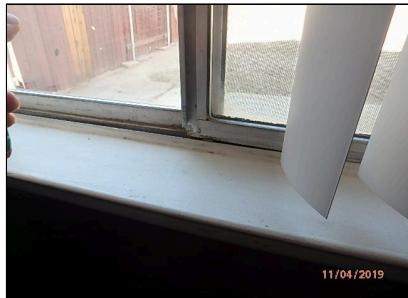
**8.6** Several windows are difficult to operate at various rooms. A repair is needed. A qualified contractor should inspect further and correct as needed.

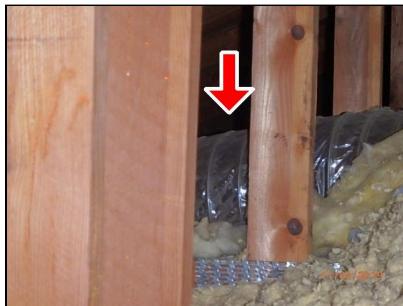
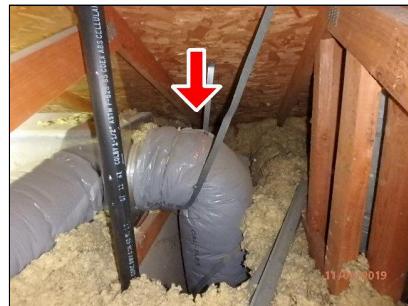
**9.3 (1)** The supply and return is starting to deteriorate and insulation is coming loose in the attic. The grey ducts do not meet the current energy conservation requirement. A qualified HVAC person should inspect further and repair or replace as needed.

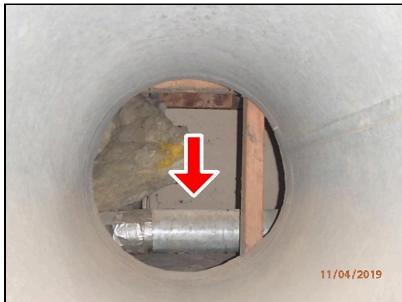
9.6 Item 1(Picture)

**9.6** When this home was constructed it was an acceptable practice to route the dryer vent duct through the return air chamber. That practice has been discontinued due to the possibility of the duct leaking warm moist air into an concealed area (the return air chamber). Warm moist air will promote microbial growth. I recommend an qualified person re route the dryer vent duct and seal the openings.

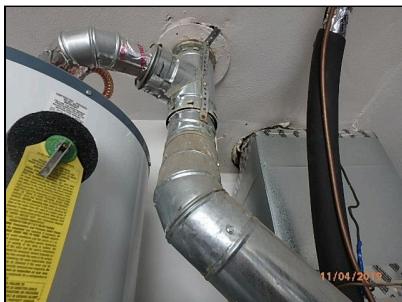
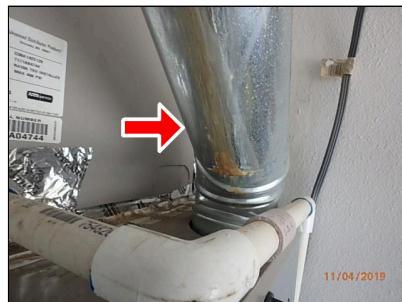
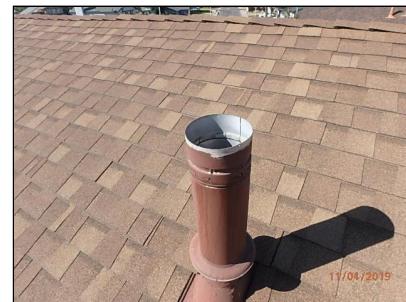
**9.7** (1) The vent pipe for gas furnace is rusty/old and is missing a cap above roof line. This is a safety issue and should be corrected. I recommend a qualified licensed heat contractor inspect further and repair as needed.

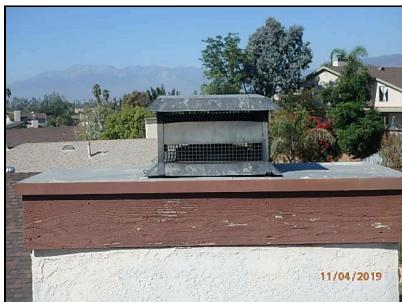
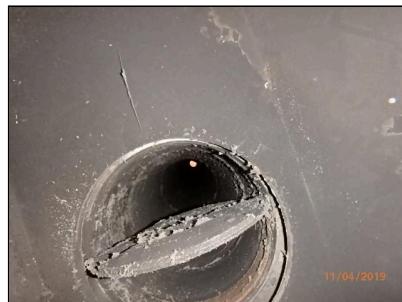
(2) The chimney, liner and all related components are not fully accessible for a visual inspection. It is recommended that a NFPA(National Fire Protection Association) 211(Standards for chimneys, Fireplaces, Vents and Solid Burning Appliances) level II inspection be performed by a proper licensed specialist for safety.Prior to the use of this fireplace.

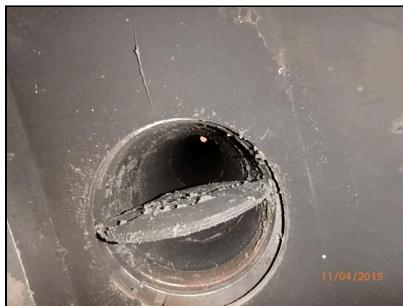
9.7 Item 6(Picture)

(3) I recommend install damper clamp to prevent the damper from fully closing and allowing products of combustion (carbon monoxide) entering into the living space and clean the chimney prior to the use of this fireplace.

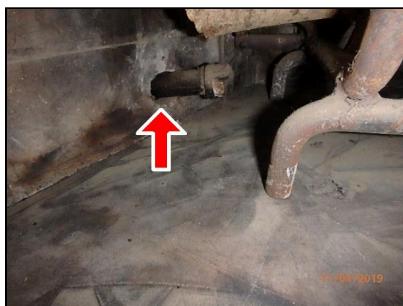
9.8 Item 1(Picture)

9.8 The fireplace refractory panel is Not sealed at the gas line. Excess gap can allow hot embers or gasses to enter the chase area around the fireplace and is considered a fire hazard. We recommend a qualified person seal the excess gap with a material that is approved for that use.

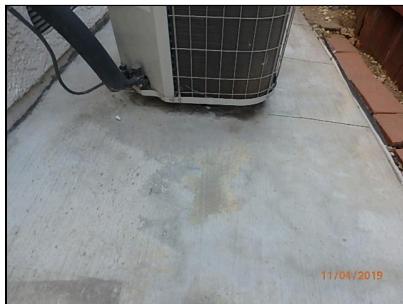
9.10 Item 2(Picture)

(2) We recommend anchor/secure the AC unit to the mounting pad. The unit should be anchored to resist movement
