# AWESOME DAY HOME INSPECTIONS, LLC

## RESIDENTIAL HOME INSPECTION

934 Valley-Westside Rd  
Colville WA 99114

Pamina J Hofer  
APRIL 13, 2019

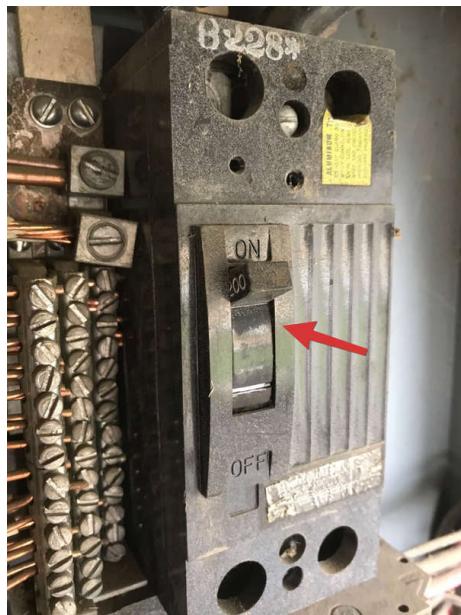
#### Electrical Shutoff

2nd Floor outside porch South

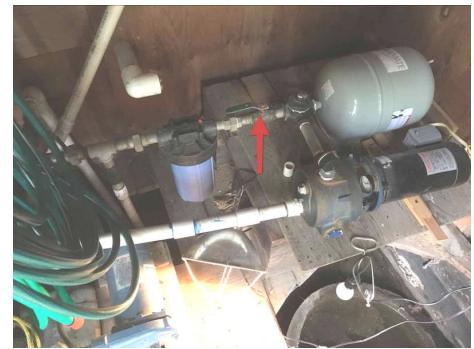
#### Water Shutoff

East well house

Private well water supply

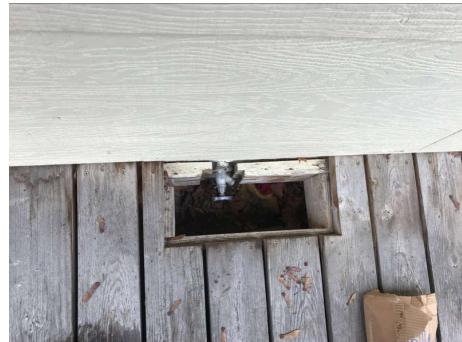
West

Hose bib was tested and operated correctly.

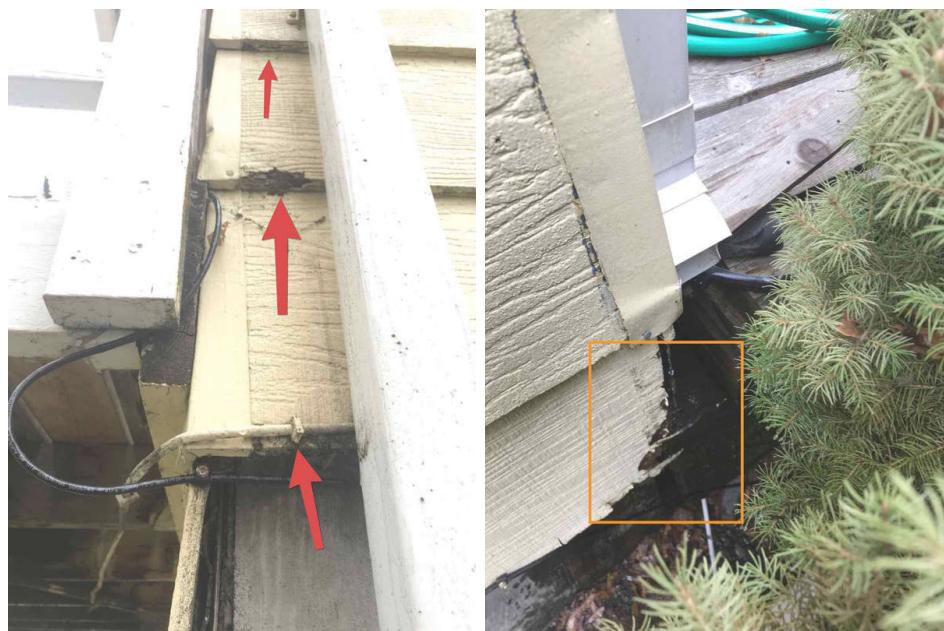
### 3.1.1 Wall Cladding

#### MOISTURE DAMAGE AND ROT

The exterior wall cladding had damage and/or deteriorated areas noted from moisture intrusion at the time of the inspection. Recommend qualified professional evaluate and repair as needed to prevent further damage. The damage was caused by downspouts.

Contact a qualified professional.

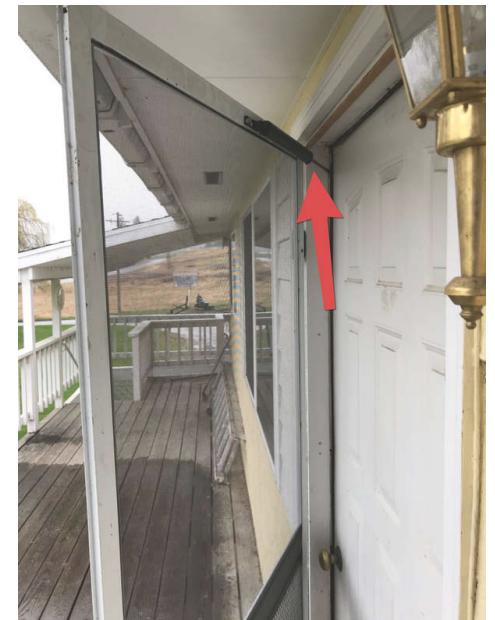
### 3.4.1 Screen/Storm Door(s)

#### SCREEN DOOR DAMAGE

One or more screen doors were damaged at the time of inspection. Repairs recommended.

Contact a qualified professional.

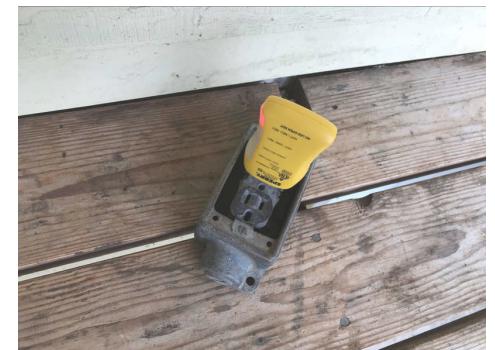
### 3.7.1 Exterior Outlets

#### **UNSAFE OUTLET**

This receptacle is unsafe. Recommend a total replacement.

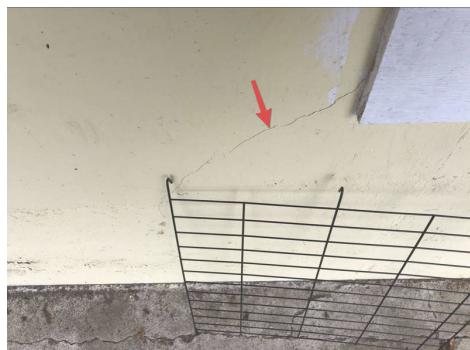
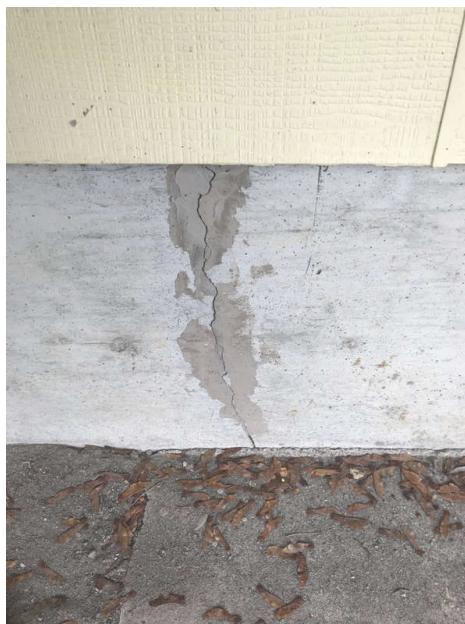
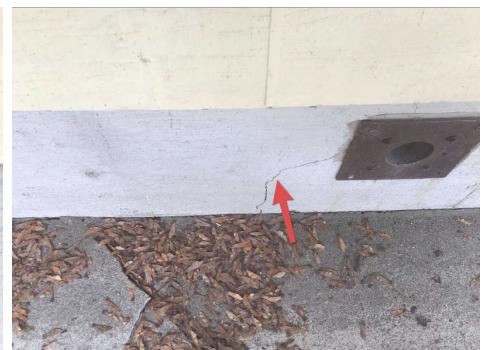
#### 4.1.1 Foundations and Floors (Structural)

#### COMMON CRACKS

Common cracks were visible in the floor slab. This type of cracking can have several causes...concrete shrinkage, which is a normal part of the concrete curing process and not a structural concern post-construction settling due to incomplete compaction of the soil beneath the slab during construction. This also is not an unusual condition and typically would not continue. heaving of the soil due to the presence of expansive soils. Determining the cause of cracking lies beyond the scope of the General Home Inspection.

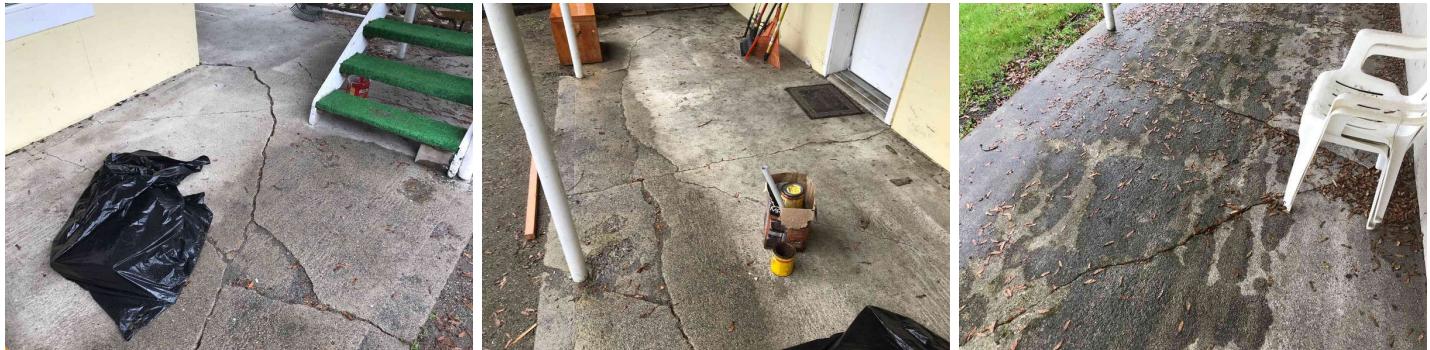
#### SIGNIFICANT CRACKS

Moderate Concern

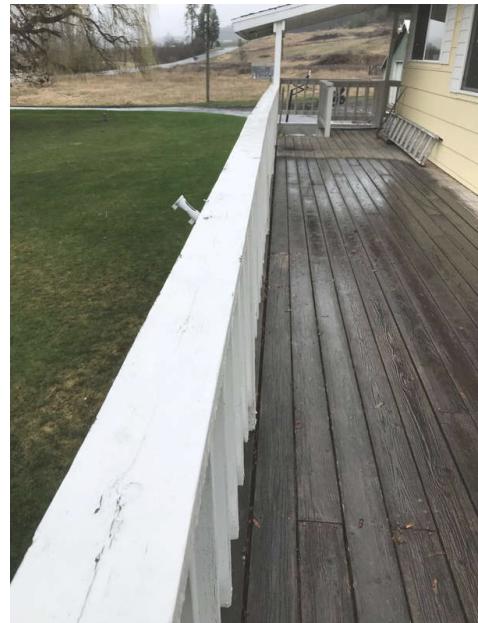
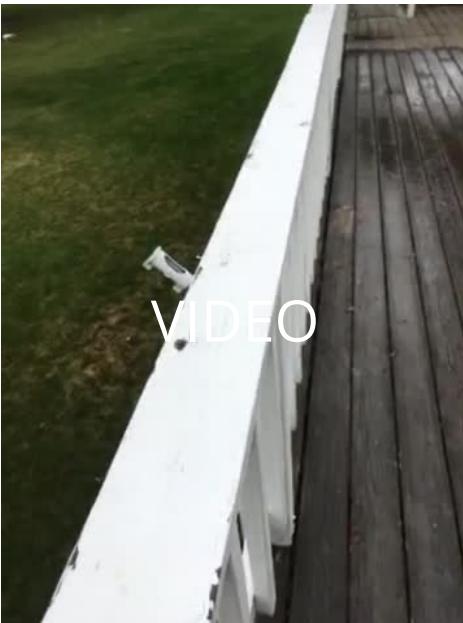
## 5.5.1 Steps, Stairs and Handrails

**HANDRAIL NOT LEVEL OR SECURE**

Moderate Concern

Contact a qualified professional.

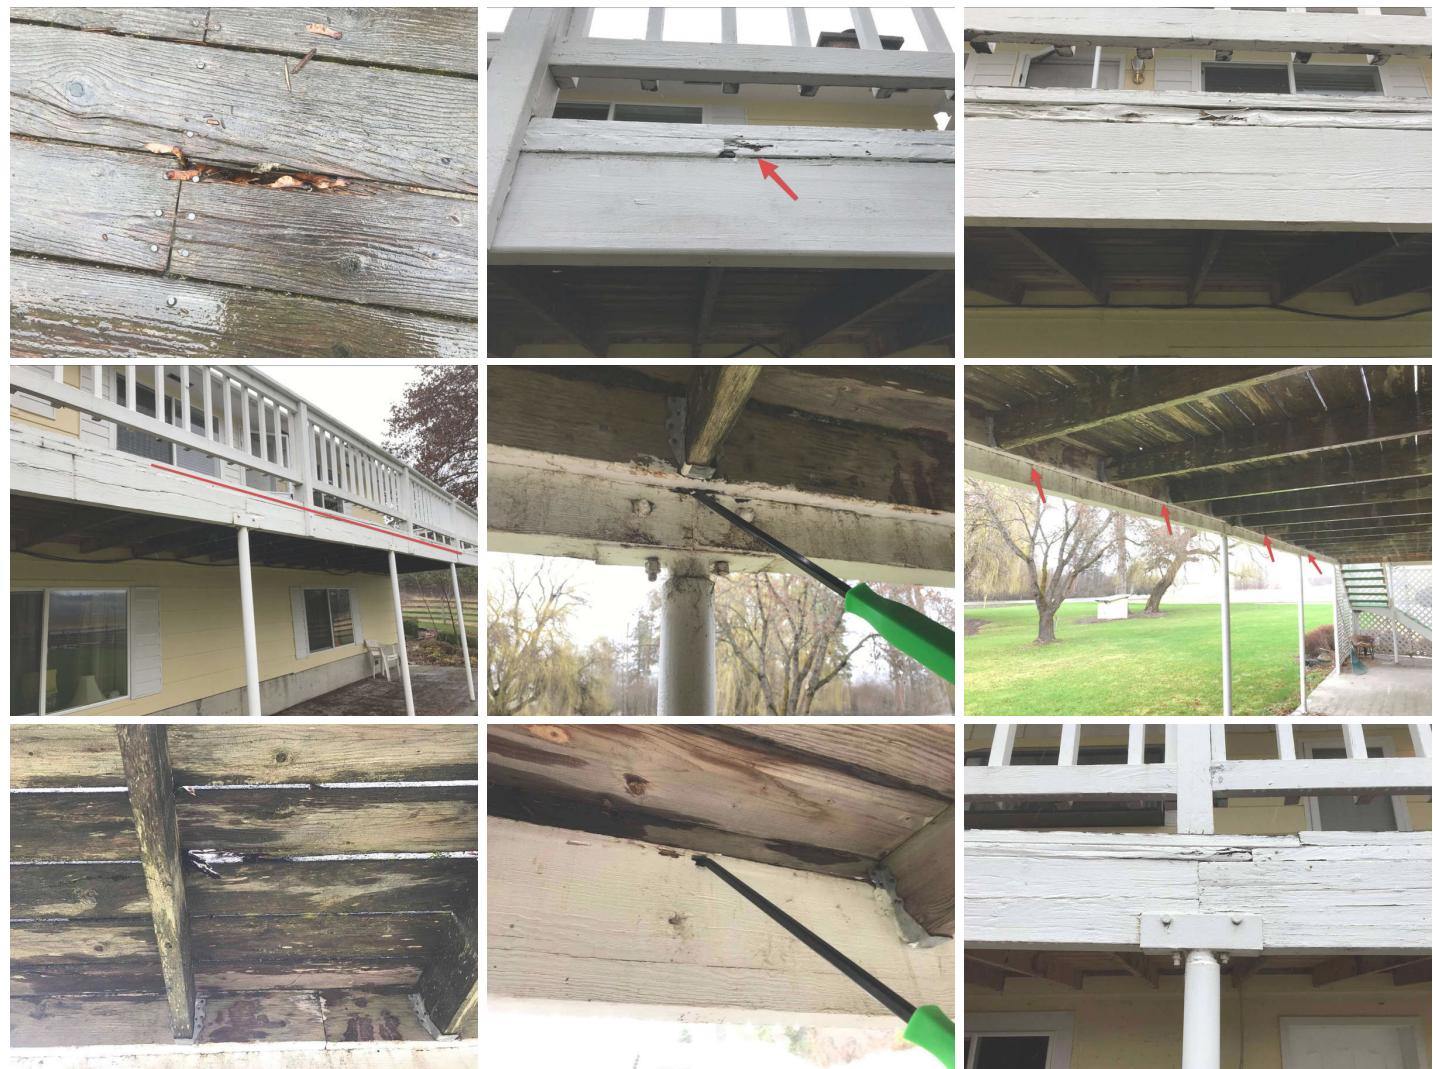
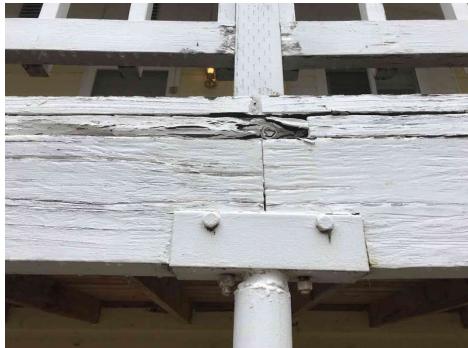
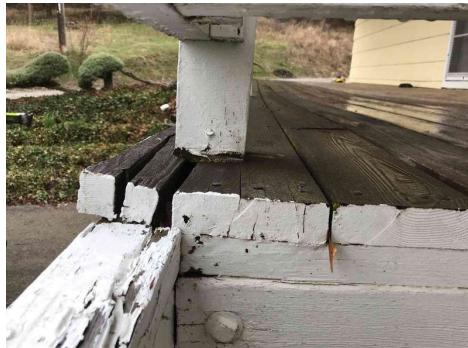
### 5.6.1 Porch Observations

#### ADVANCED DECAY

Probing multiple areas of this porch revealed the presence of advanced wood decay. Wood decay significantly weakens framing. This is Wood Rot Fungi. Often I could push the probe almost completely through. All of this rot was painted over. Recommends having the affected areas replaced by a qualified professional.

Contact a qualified professional.

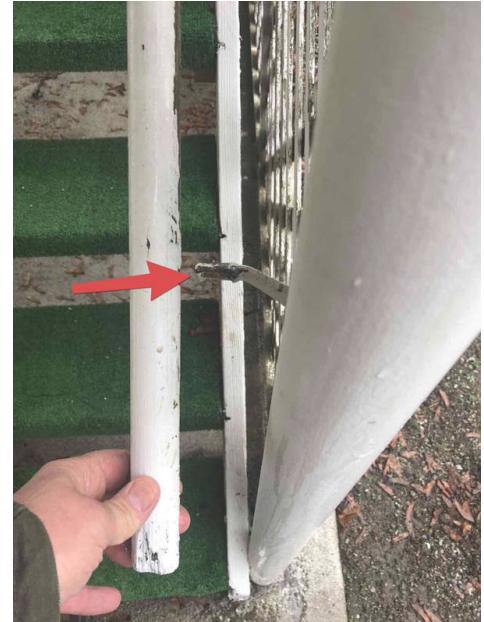
#### 5.6.2 Porch Observations

#### **LOOSE HANDRAIL**

##### SOUTHEAST

The porch stair handrail was loose and needed re-fastening. This condition is a potential fall hazard. The Inspector recommends repair by a qualified contractor.

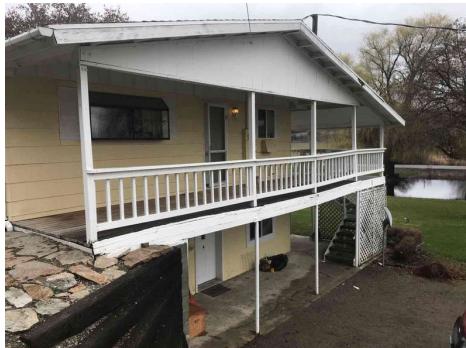
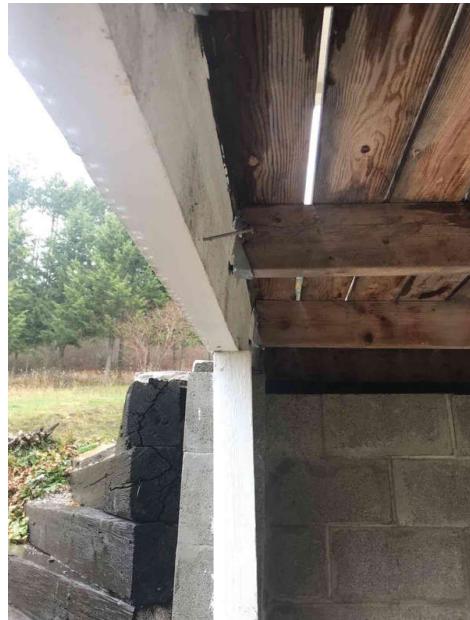
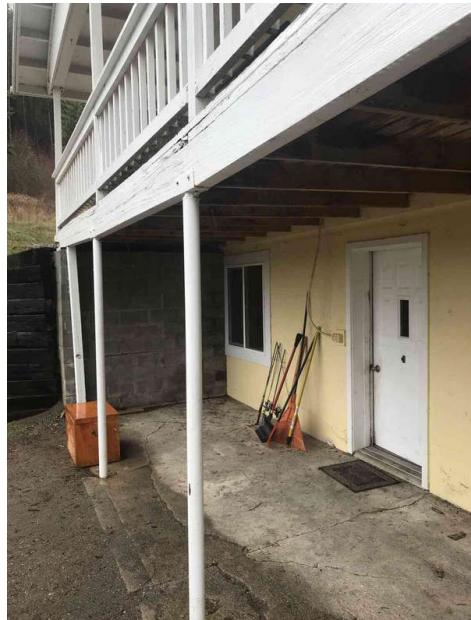
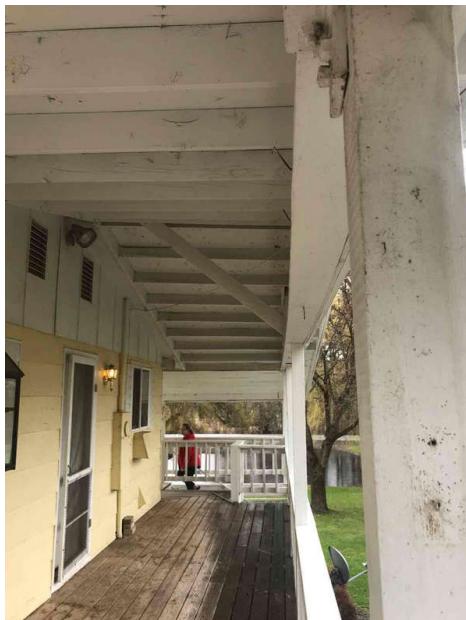
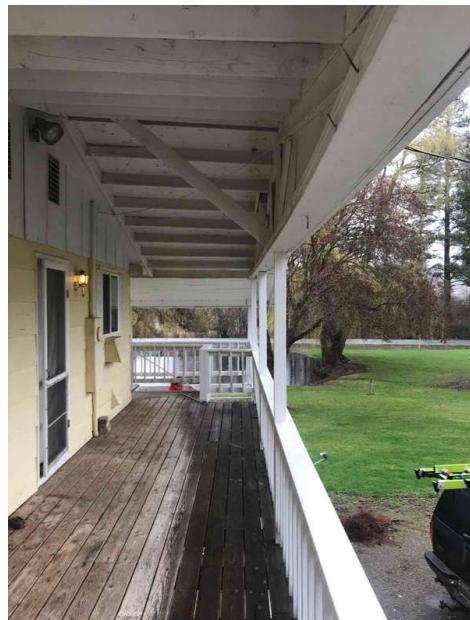
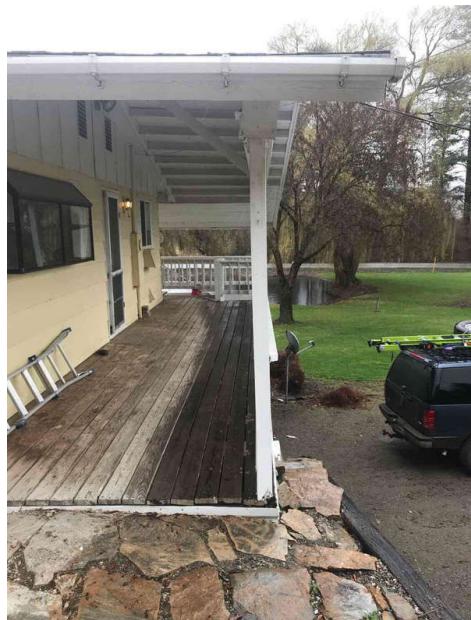
1. There is a large ripple in the roof where porch connects to the main house. This could be poor construction from the original edition of the porch to the home or could be the byproduct of the sinking posts.
2. Original ledger board bolts were taken out. This significantly weakens the whole system.
3. The wood rot in the center of the horizontal support beams.

Contact a qualified structural engineer.

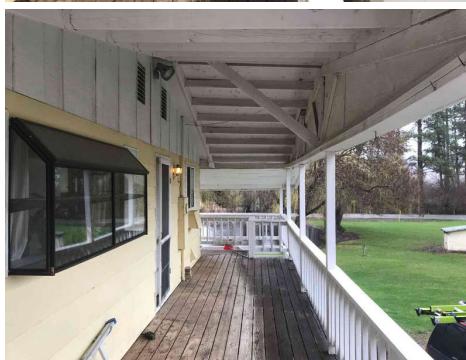
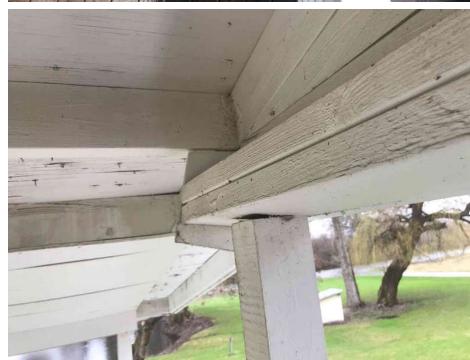
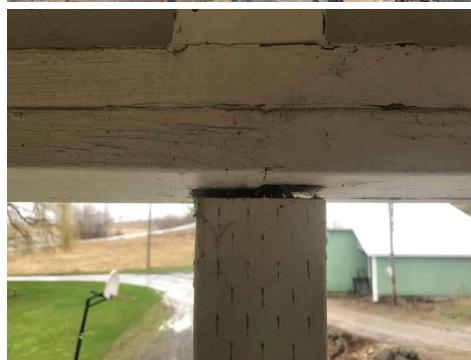
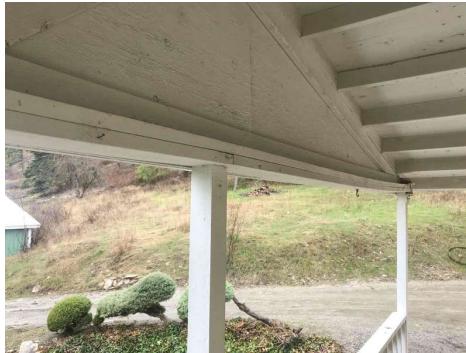
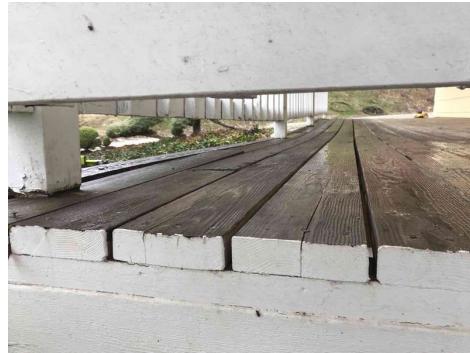
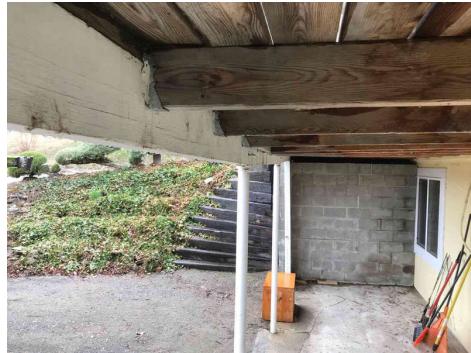
#### 5.6.4 Porch Observations

### MAJOR STRUCTURAL PROBLEM

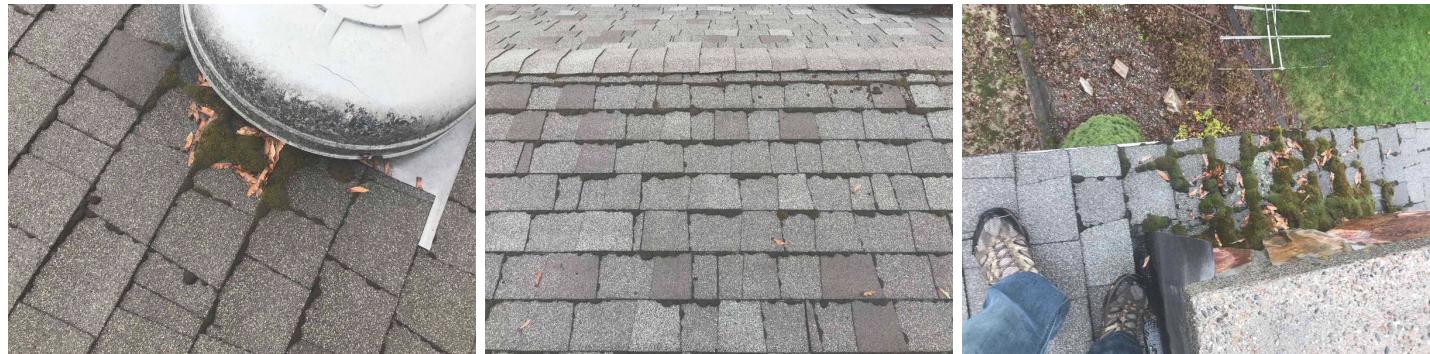
Moss accumulated on the roof at the time of the inspection may damage and/or shorten the life expectancy of the roof covering materials by retaining moisture. Clearing the roof of moss should be included in annual maintenance to ensure proper roof drainage and prevent possible damage to roofing materials.

Contact a qualified professional.

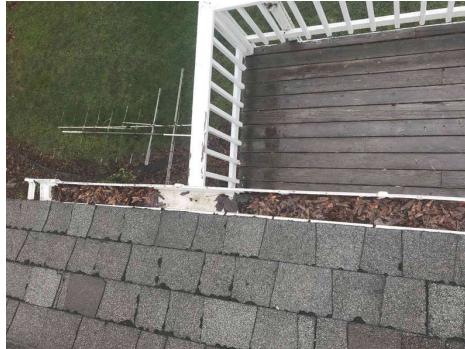
#### 6.5.1 Roof Drainage Systems

Debris has accumulated in the gutters. Recommend cleaning to facilitate water flow.

Recommended DIY Project

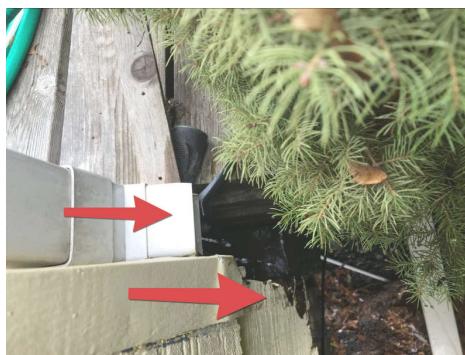
#### 6.5.2 Roof Drainage Systems

#### DOWNSPOUT DISCHARGE CONCERN

Downspouts which discharge onto the ground - above grade - should discharge a good distance away from the house -- four (4) to six (6) feet or more, if possible. The slope of the ground in this area should be away from the house to direct water away from the foundation.

Recommended DIY Project

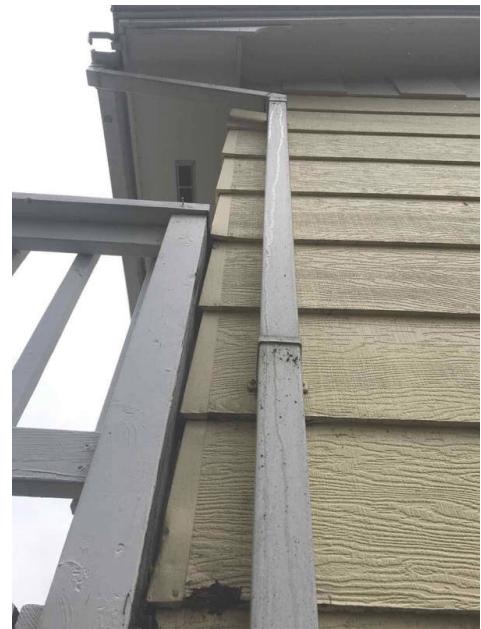
## 6.5.3 Roof Drainage Systems

**DEBRIS BLOCKED DOWNSPOUT**

The downspout was blocked and leaking water down the siding. This could be one of the reasons the siding is rotting in this area. Recommend cleaning of this downspout.

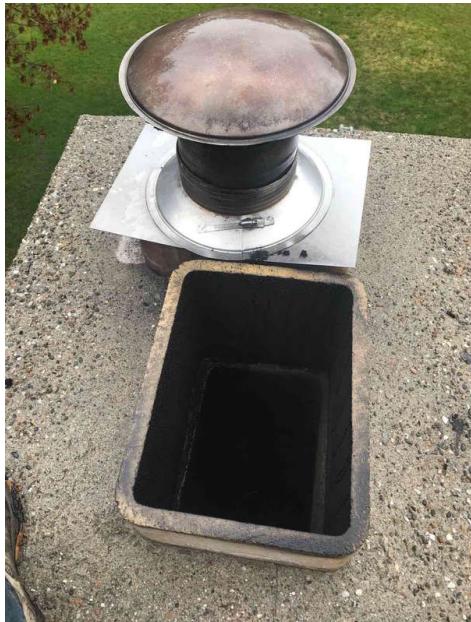
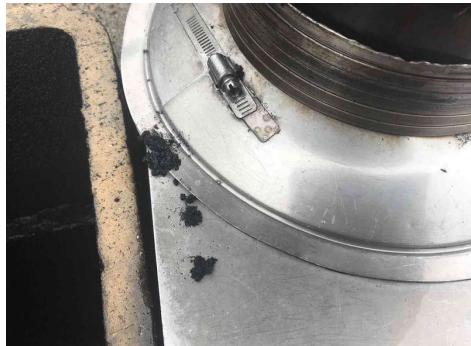
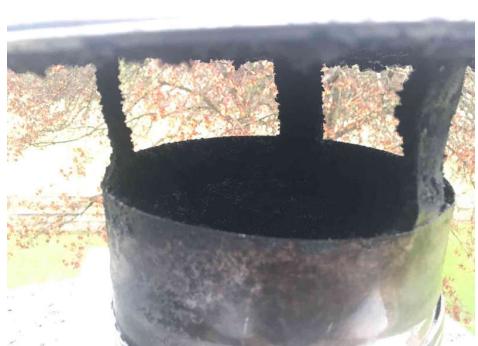
## 6.6.2 Chimney(s)

**CHIMNEY AND FIREPLACE VENT NEED CLEANING**

Moderate Concern

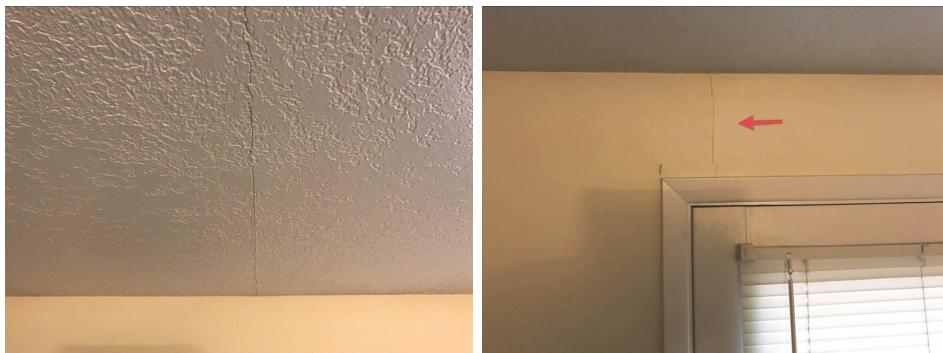
#### HAIRLINE CRACKS (COSMETIC)

One or more areas of the ceiling had hairline cracks or minor damage (cosmetic) noted.

Monitor these areas in case these cracks widen or get longer. These are normal settlement cracks.

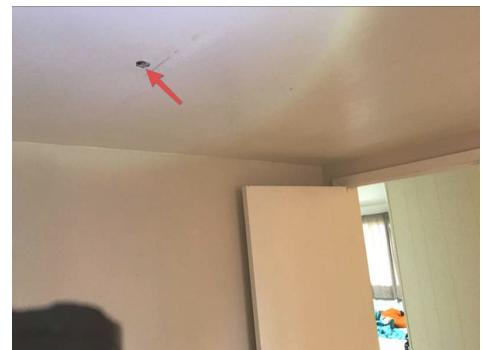
### 7.2.2 Ceilings

#### MINOR DAMAGE

Minor damage or deterioration to the ceiling was visible at the time of the inspection. Recommend patching this area.

Contact a qualified professional.

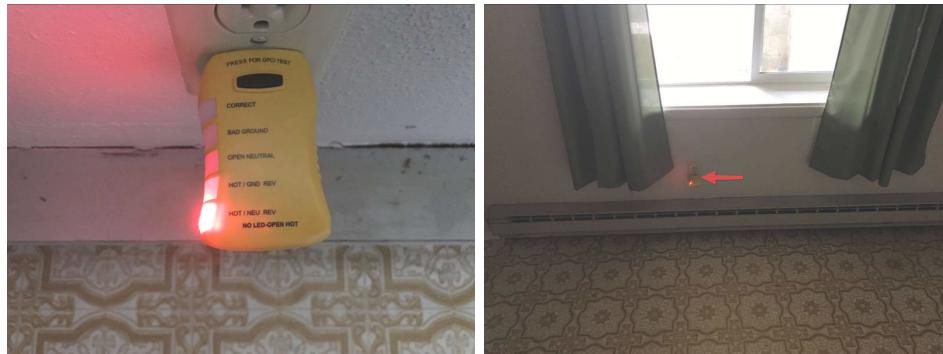
### 7.8.1 Outlet Observations

#### TESTED HOT & NEUTRAL REVERSED

One or more electrical outlets when tested indicated hot and neutral wires reversed. This is a safety issue that needs to be corrected. I recommend a qualified licensed electrical contractor should correct as needed.

Contact a qualified professional.

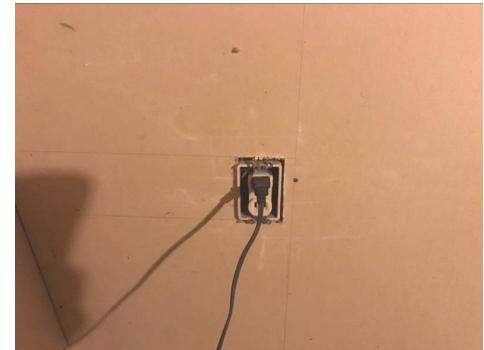
## 7.8.2 Outlet Observations

**MISSING COVER PLATE**

One or more electrical outlets was missing a cover plate. This condition left energized electrical components exposed to touch. This is safety hazard should be corrected by a qualified electrical contractor.

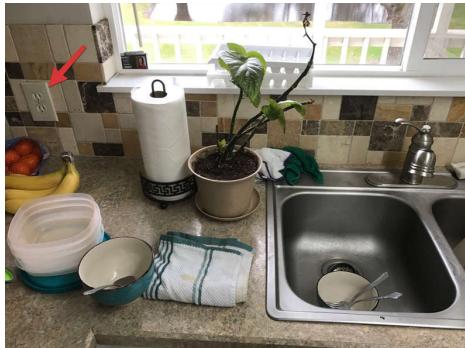
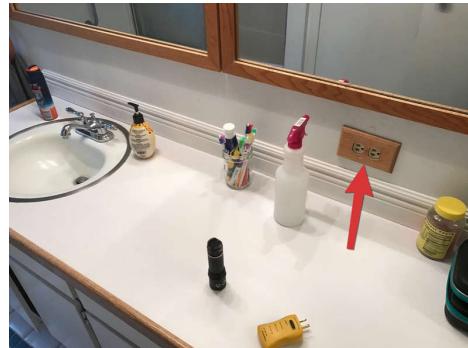
## 7.8.3 Outlet Observations

**GFCI UPGRADE RECOMMENDED**

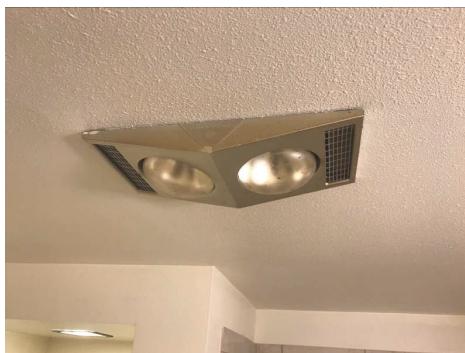
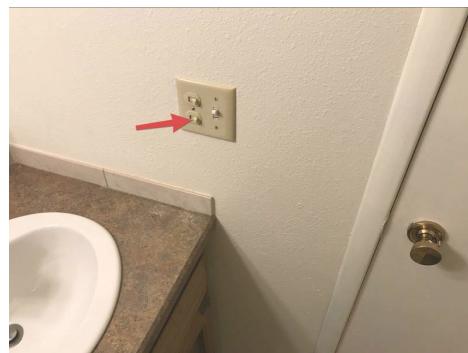
Moderate Concern

Contact a qualified professional.

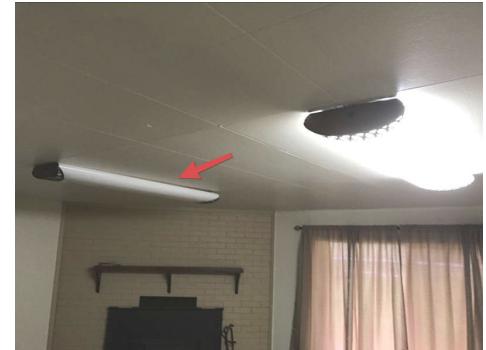
#### 7.10.1 Light Fixture Observations

### INOPERABLE LIGHTS

Moderate Concern

Contact a qualified electrical contractor.

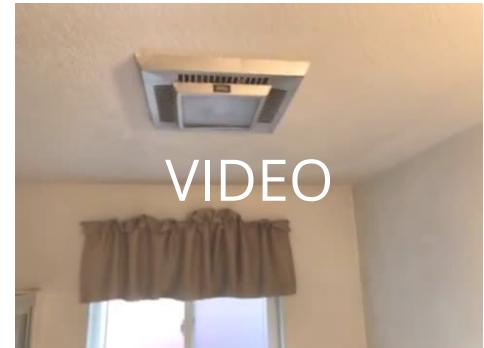
A ceiling fan was noisy during operation. This condition is typical of deteriorated fan components. Consider fan repair or replacement.

Contact a qualified electrical contractor.

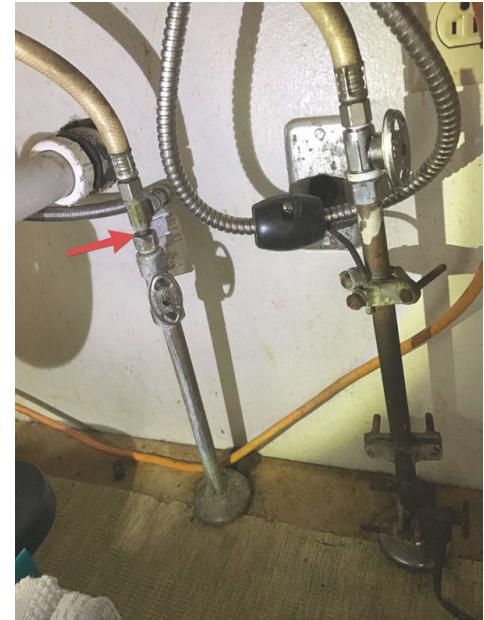
## 7.13.1 Lavatories / Sinks Observations

**LEAK NOTED**

A small leak noted under sink at the time of inspection. Recommend repair.

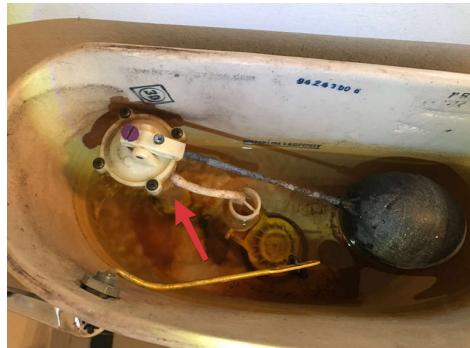
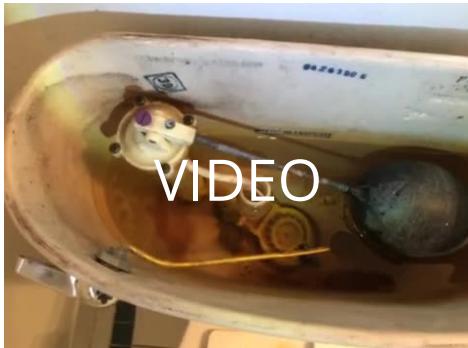
Moderate Concern

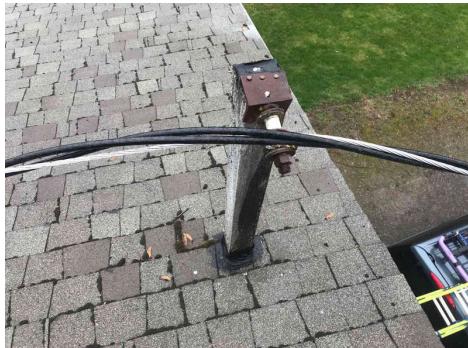
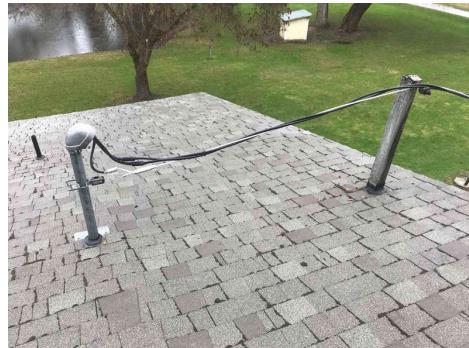
Wire support system is older and wires are not secure. A high wind could drop the wires onto the roof. Recommend a new support system.

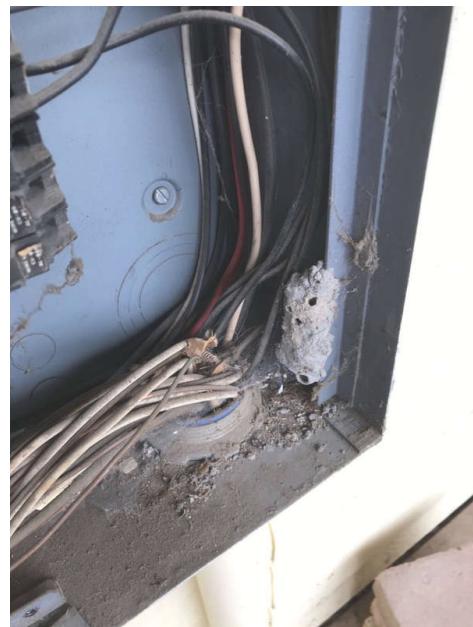
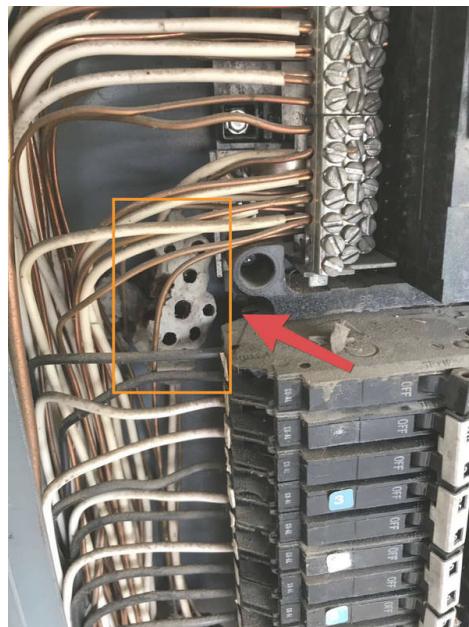
The interior of the service panel was dirty and needed cleaning. This condition may affect the ability of electrical components within the service panel to function as they were designed. The Inspector recommends that the service panel be cleaned by a qualified electrical contractor.

Contact a qualified professional.

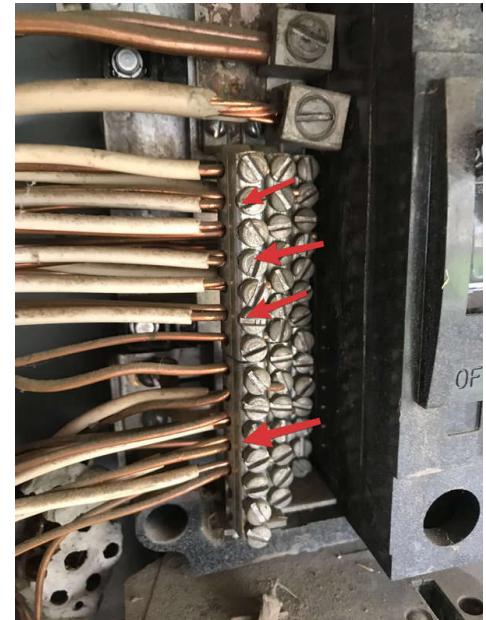
### 8.3.2 Electric Panel

#### DOUBLE TAP, NEUTRAL BAR

Neutral wires were doubled or bundled together under the same lug on the neutral bus bar in panel. This is a potential safety hazard in the event that one of the circuits needs to be isolated during servicing. For one neutral to be disconnected, other neutrals from energized circuits sharing the same lug will be loosened. Power surges may result on the energized circuits and result in damage or fire. Also, multiple wires under the same lug may not be secure, resulting in loose wires, arcing, sparks and fire. Recommend that a qualified electrician repair per standard building practices.

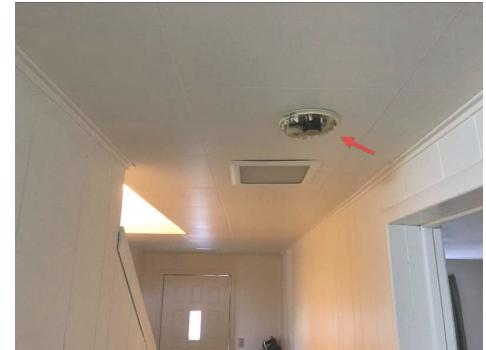
### 8.6.1 Smoke Detectors

#### ADD SMOKE DETECTORS

Recommend installing at least one smoke detector on each level of the home and one in each bedroom to bring up to modern safety standards.

Contact a handyman or DIY project

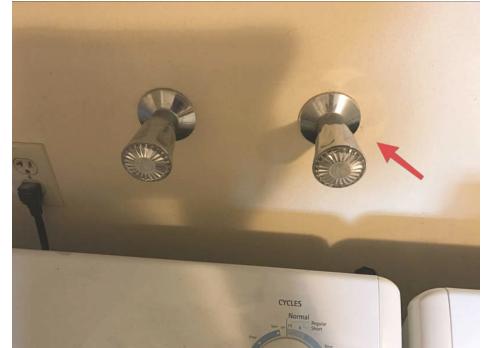
**10.5.1 Washer Machine Connections**
**LEAKING VALVE**

A washing machine supply line valve appeared to be leaking at the time of the inspection. Repairs are recommended by a qualified person.

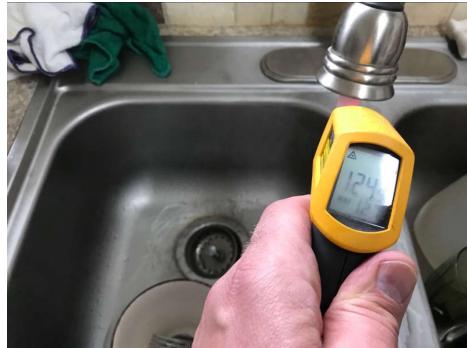
The generally accepted safe water temperature is one hundred twenty degrees Fahrenheit or less.

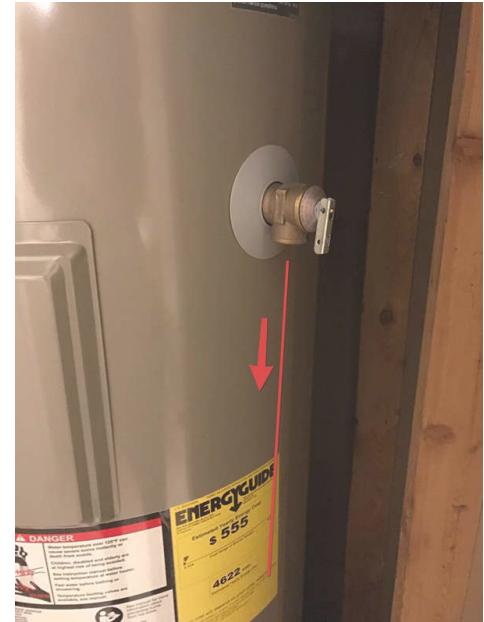
11.2.1 TPR valve - Pressure Relief

The temperature/pressure relief (TPR) valve had no discharge pipe installed. If the valve were to activate while a person was nearby, that person could be badly burned. The Inspector recommends that a properly-configured TPR discharge pipe be installed by a qualified plumbing contractor. The TPR V ALVE SHOULD NOT BE TESTED UNTIL A PROPER DISCHARGE PIPE HAS BEEN INSTALLED

Contact a qualified professional.

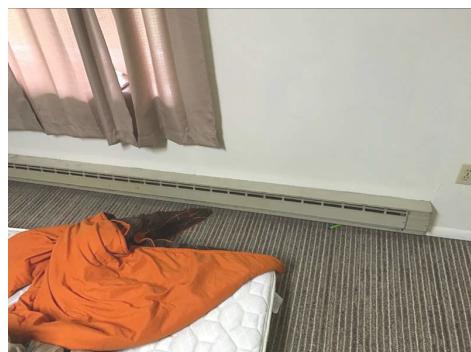
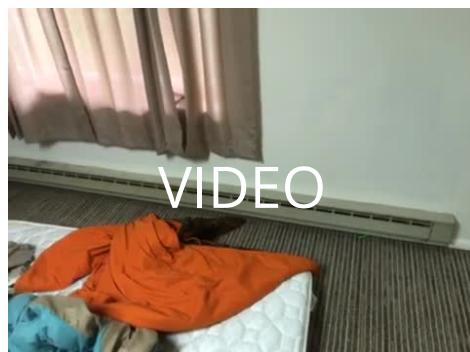
This heater was bussing. Recommend HVAC professional to evaluate.

Contact a qualified HVAC professional.

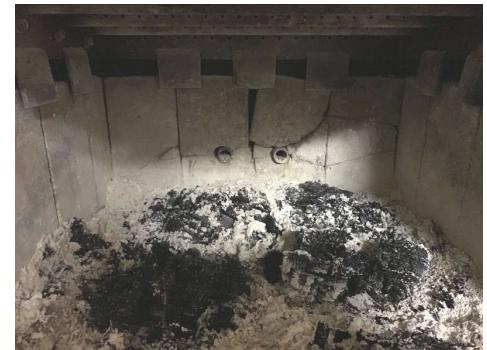
#### 12.3.1 Fireplaces, Stoves & Inserts

### FIREWALL CRACKED

The brick lining of the fireplace was cracked in one or more places, which could lead to chimney damage or toxic fumes entering the home. Recommend a qualified fireplace contractor evaluate and repair.

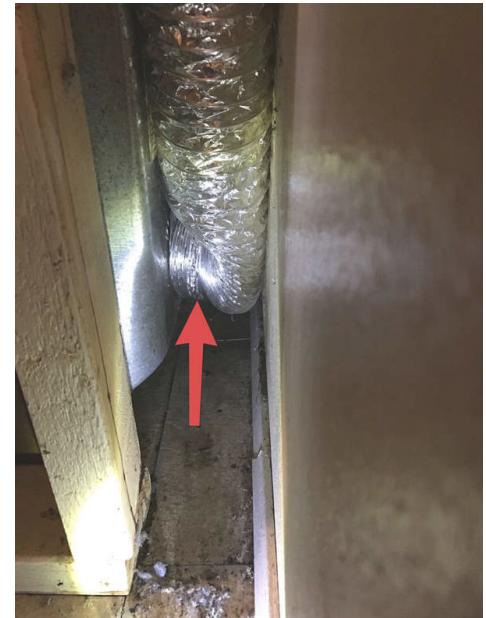
#### 13.1.1 Dryer Vent and Cover

The dryer vent was kinked and/or crushed where it exited the back of the dryer. Space limitations made proper venting difficult. Special hardware is available which will allow proper venting in areas with space limitations. I recommend installation of hardware which will not restrict dryer exhaust air flow, the restriction of which can result in lint accumulation or vent blockage which can cause the dryer to overheat; a potential fire hazard and a condition which will shorten the dryer's lifespan.

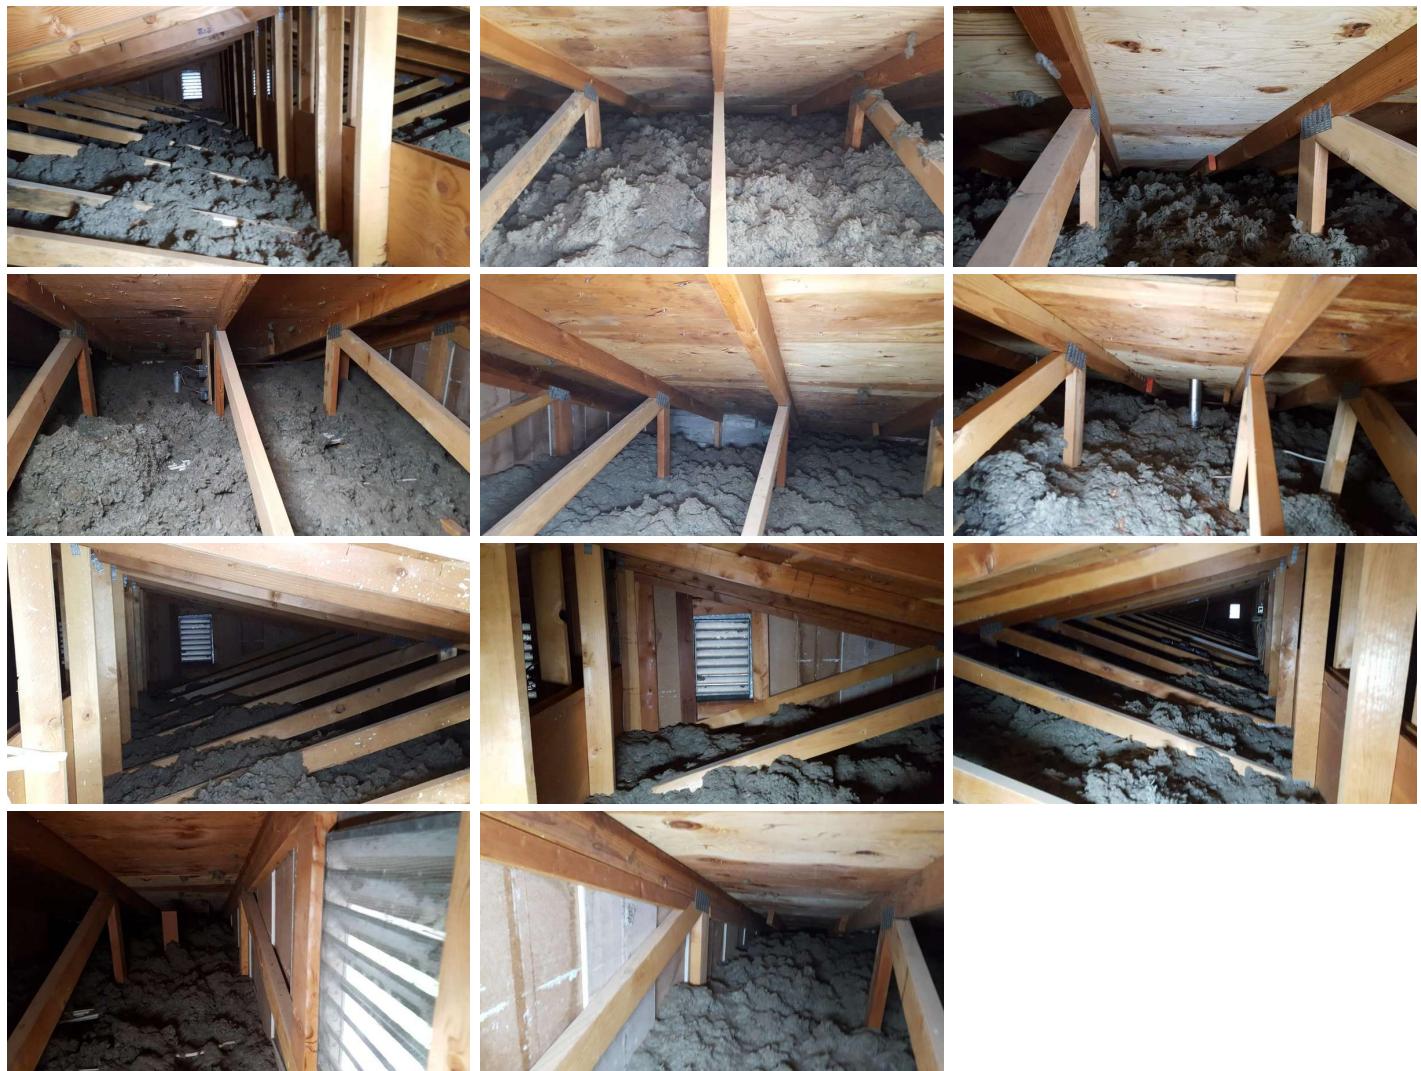
This Attic was very clean. I did not see any leaking anywhere that I could physically crawl.

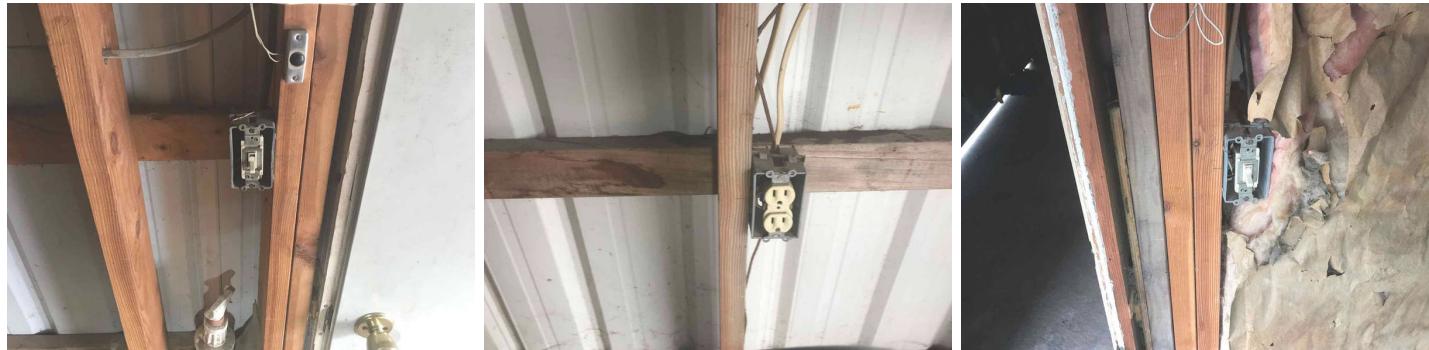
#### MISSING RECEPTACLE COVER PLATES

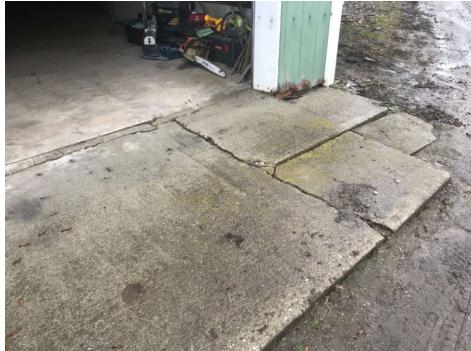
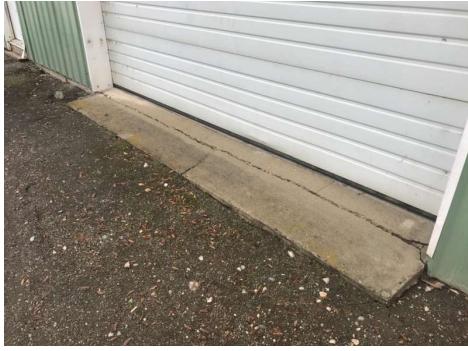
### 16.1.3 General

#### CRACKS IN CEMENT ENTRYWAYS

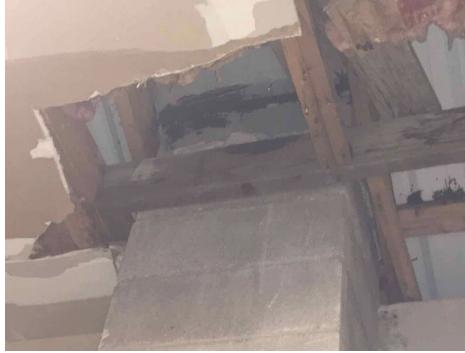
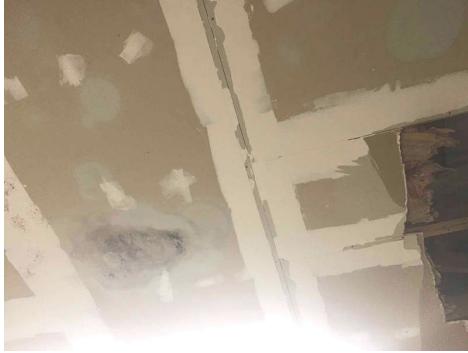
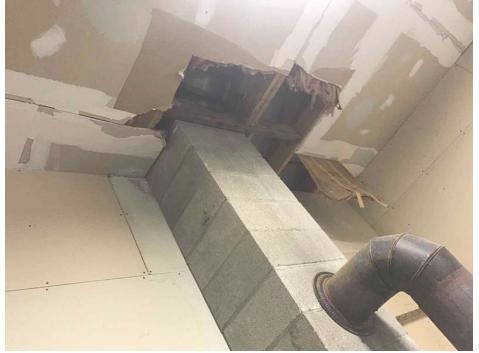
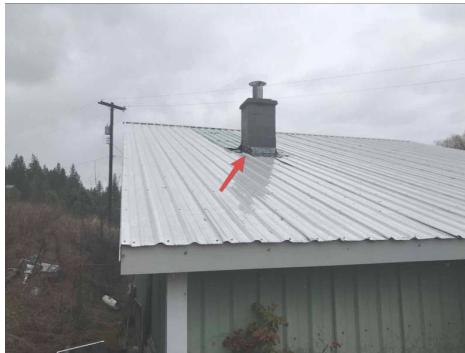
## 16.1.4 General

**PAST ROOFING LEAK AT CHIMNEY**

Contact a qualified professional.

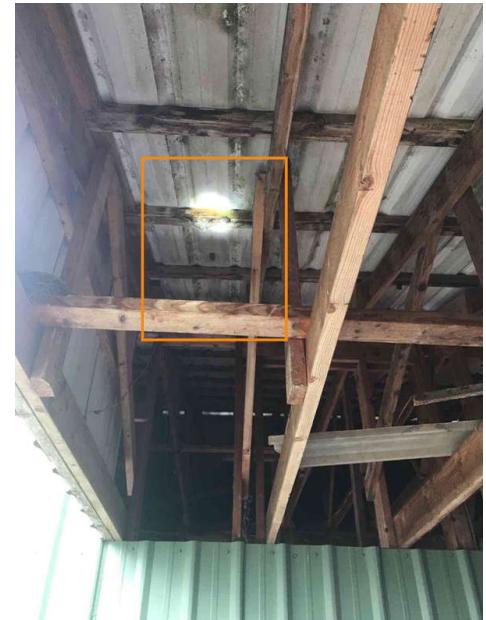
**ROOF LEAKING**

Contact a qualified professional.

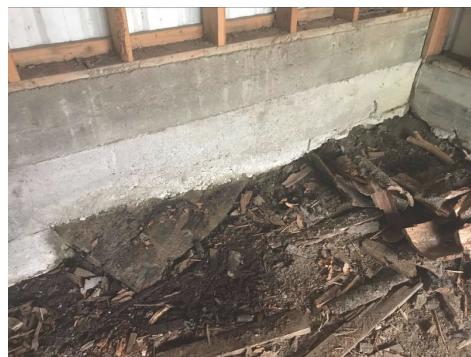
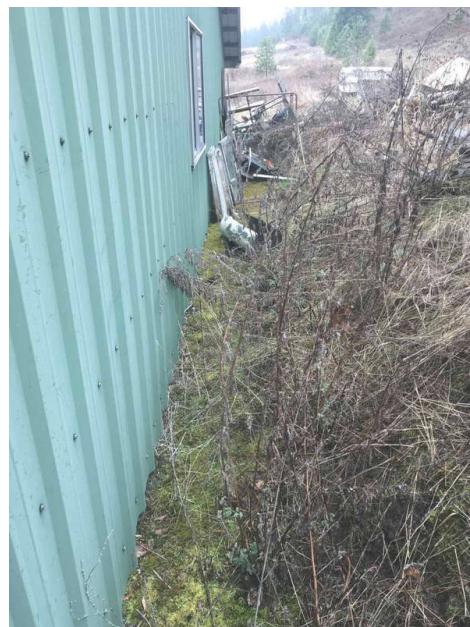
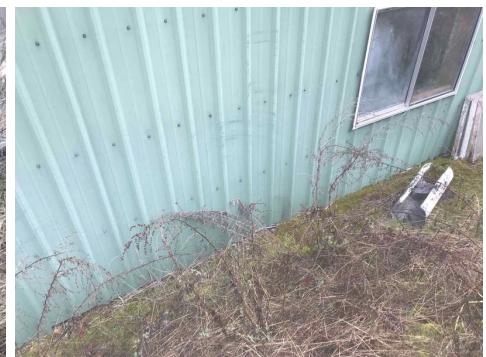
**WASHED-OUT OR UNDERMINED (REPAIR)****GARAGE / OUTBUILDING**

The concrete foundation has washed-out or undermined area(s) at the time of the inspection. Many locations on the west side of the garage has had erosion of the hillside pushing dirt and rock up against the garage. Also, frost heave and pressure from dirt are creating horizontal cracks in the foundation walls. This area needs to be excavated to stop the negative grade from bringing water into the garage and causing problems with foundation walls.

Contact a qualified professional.

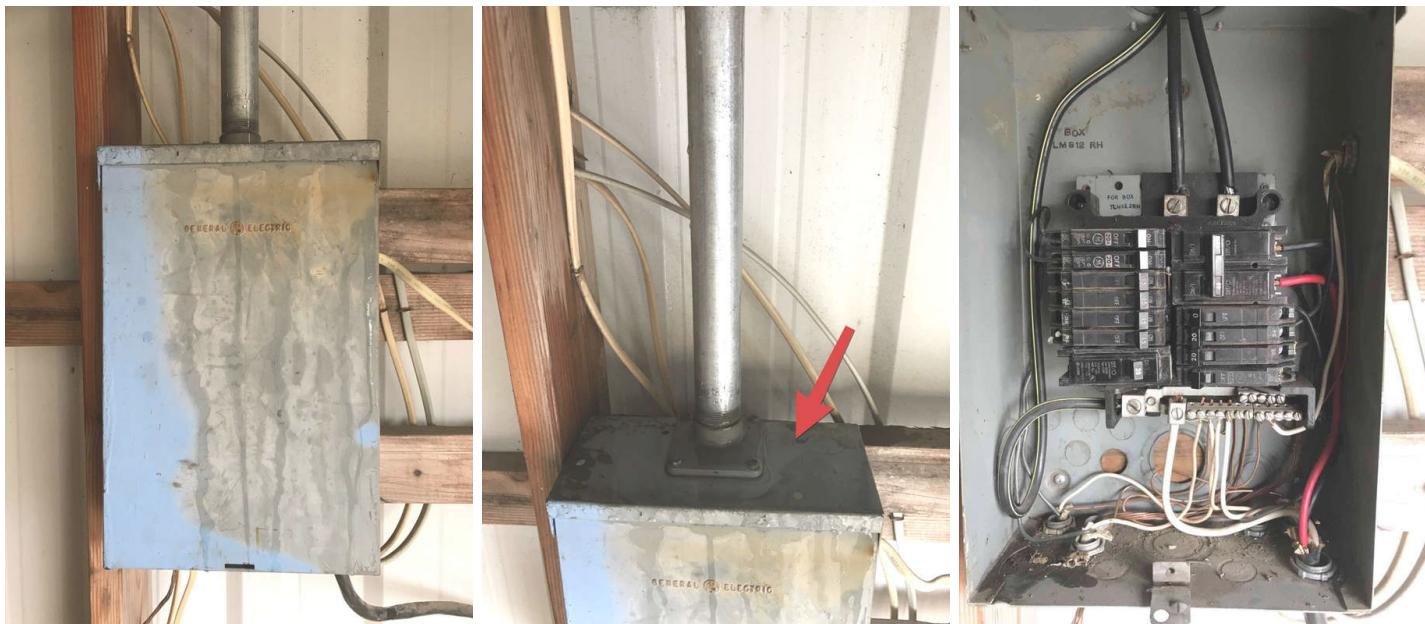
## 16.2.1 Sub-Panel

While it was raining, at the time of inspection, water was moving down electrical conduit and on to sub panel box. Water is dangerous around electricity. I did not see any water entering the panel and onto the breakers. Electrical conduit on the roof should be booted or flashed to keep water from entering. When repairing this defect on top of the garage, all other roof penetrations should be inspected and repair any other defects.

Contact a qualified professional.
