# AWESOME DAY HOME INSPECTIONS, LLC

## RESIDENTIAL HOME INSPECTION

934 Valley-Westside Rd  
Colville WA 99114

Pamina J Hofer  
APRIL 13, 2019

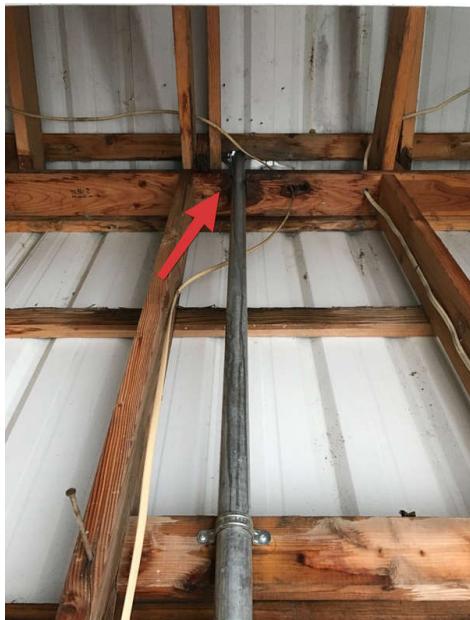
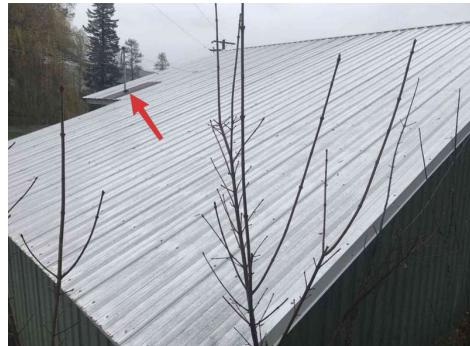
## 16.2.1 Sub-Panel

⚠️ Major Concern**WATER DRAINING DOWN ELECTRICAL PANEL**

While it was raining, at the time of inspection, water was moving down electrical conduit and on to sub panel box. Water is dangerous around electricity. I did not see any water entering the panel and onto the breakers. Electrical conduit on the roof should be booted or flashed to keep water from entering. When repairing this defect on top of the garage, all other roof penetrations should be inspected and repair any other defects.

Contact a qualified professional.

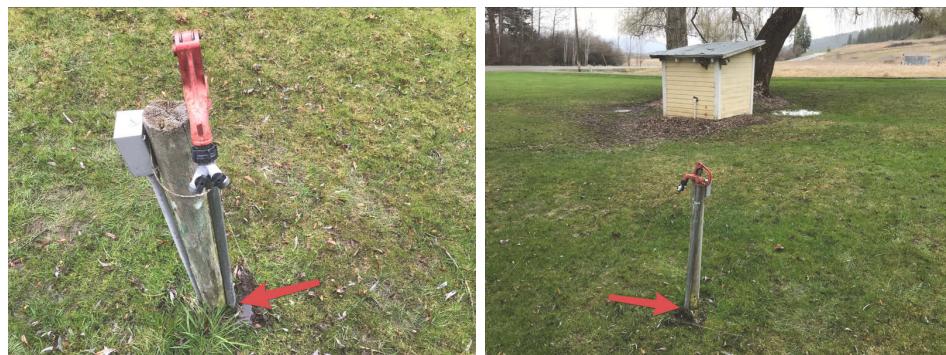
#### LEAKING

One or more leaks were found in pipes and/or fittings. A qualified well or plumbing contractor should evaluate and repair as necessary.
