YOUR HOME INSPECTION

1234 Main St.
Garland, Texas 75043

PROPERTY INSPECTION REPORT

Concerning:1234 Main St. Fort Worth Tx 76137

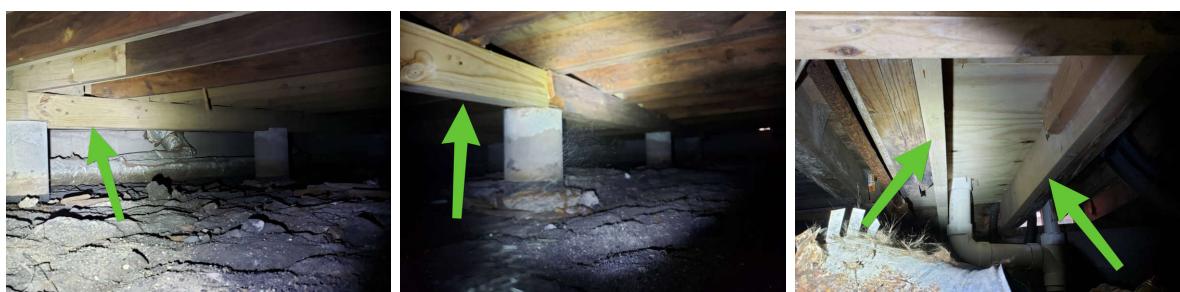
Pier and Beam Foundation - Prior Repairs Noted:

Previous repairs to the foundation components were observed.

The homeowner should be consulted on the previous foundation work performed and possible warranty information that may apply.

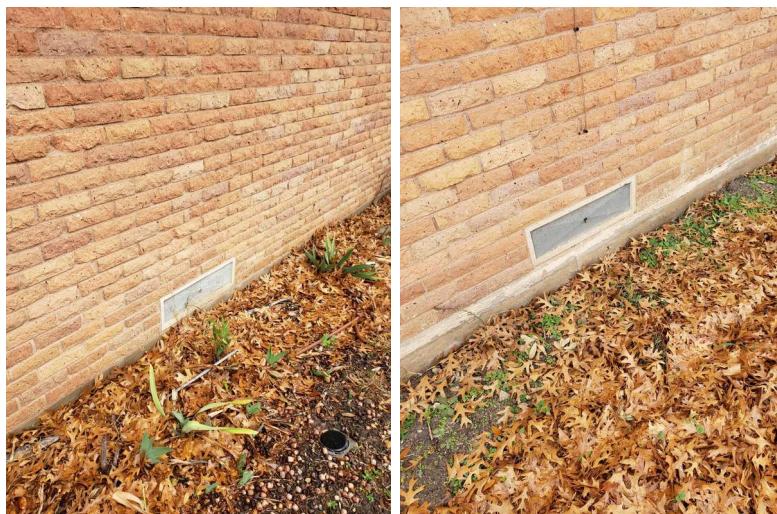
Right Side & Back

*Remove Crawl Space Debris:*

All wood debris and/or trash should be removed from the crawl space.

*Vent screen damage:*

Crawlspac e vent screens damaged.

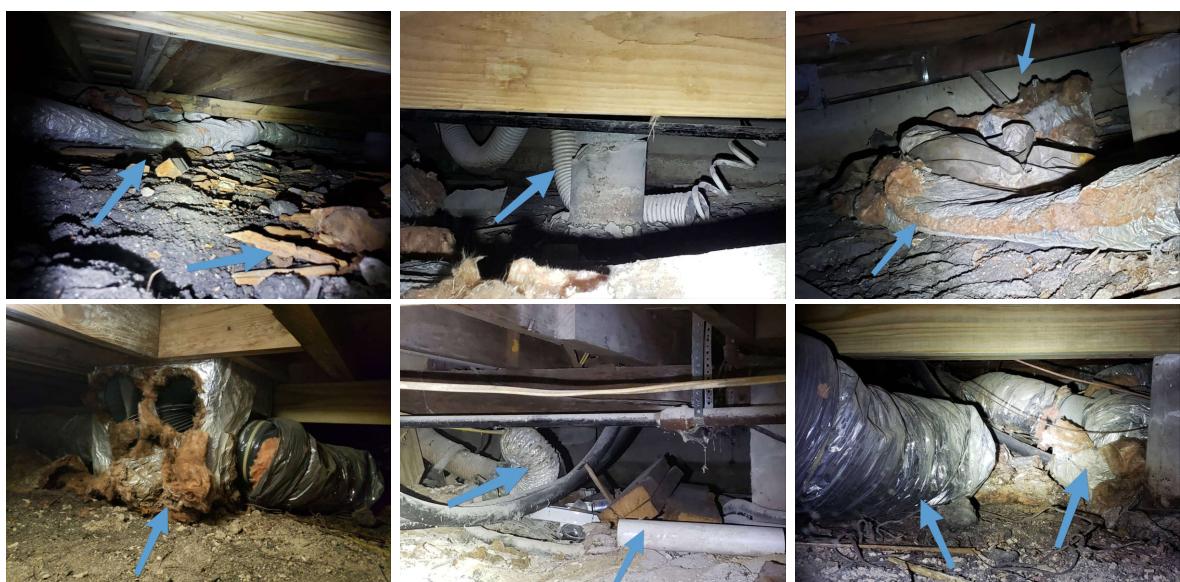
Some of the pier and beam foundation structural components appear to have deficiencies that are beyond normal.

The Buyer should have the cause and remedy investigated by an Engineer of your choosing.

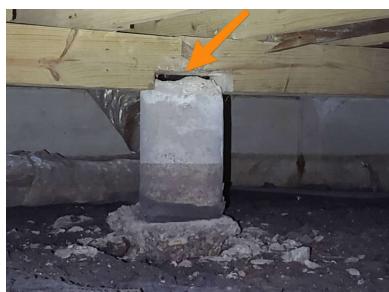
One or more of the support piers are not properly installed. Recommend further evaluation and correct as necessary.

Recommendation: Contact a qualified structural engineer.

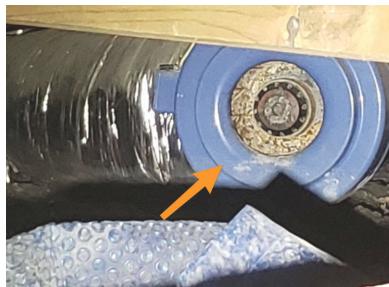
Crawlspace

**2: Crawl space exhaust fan not working****⊖ Minor Deficiency and Cosmetic Items**

Recommendation: Contact a qualified professional.

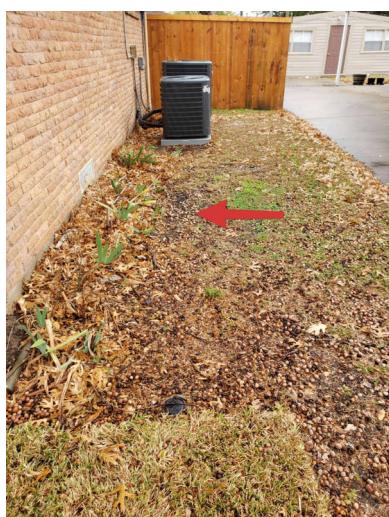
Grading is sloping towards the home in some areas. This could lead to water intrusion and foundation issues. Recommend qualified landscaper or foundation contractor regrade so water flows away from home.

[Here is a helpful article](#) discussing negative grading. There have been previous repairs in what appears to be an attempt to resolve water intrusion into the home. Further evaluation is recommended.

Recommendation: Contact a qualified grading contractor.

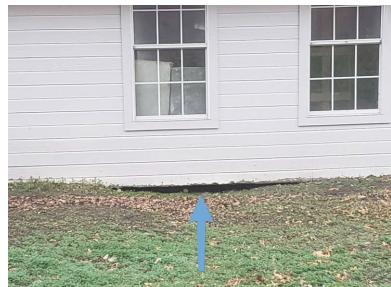
Fill dirt is needed. The low spots in the finished grade (ground) adjacent to the foundation perimeter wall need to be filled in to help prevent water from standing and/or ponding next to the foundation area.

Recommendation: Contact a qualified landscaping contractor

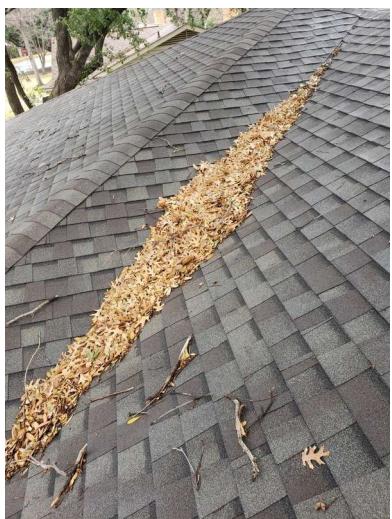
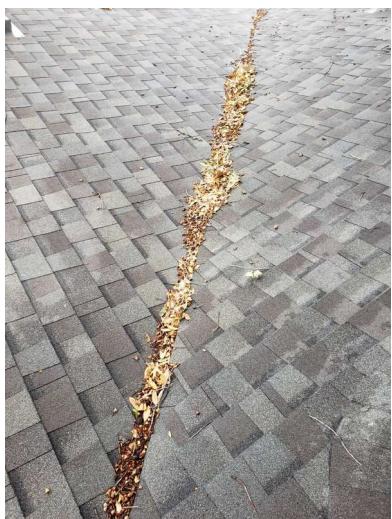
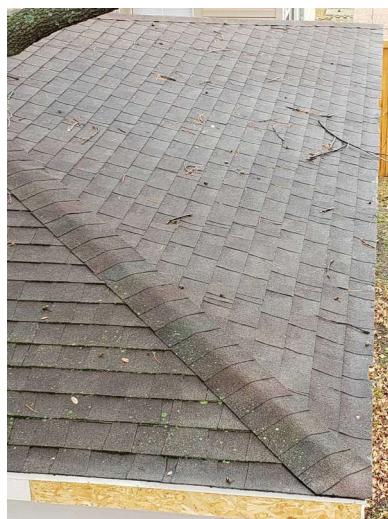
Remove Debris:

All debris, such as leaf's and branches, should be removed from the roof surface.

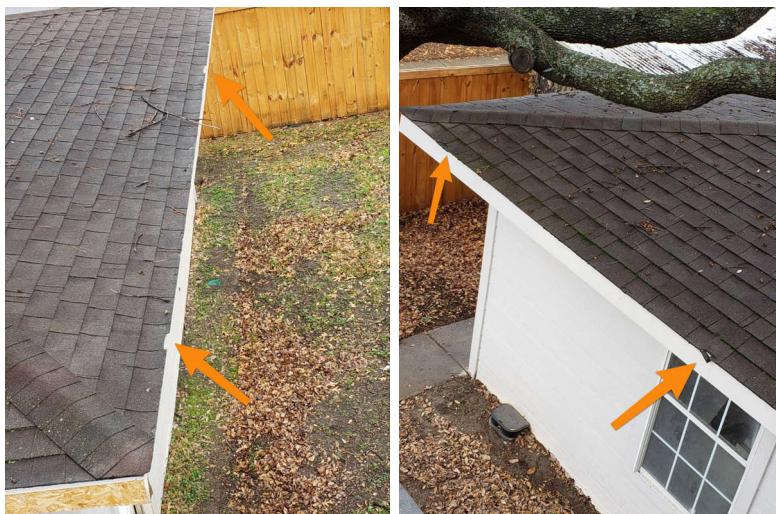
I NI NP D**1: Damaged Coverings****⊖ Minor Deficiency and Cosmetic Items**

Roof coverings exhibited general damage that could affect performance. Recommend a qualified roofer evaluate and repair.

Recommendation: Contact a qualified roofing professional.

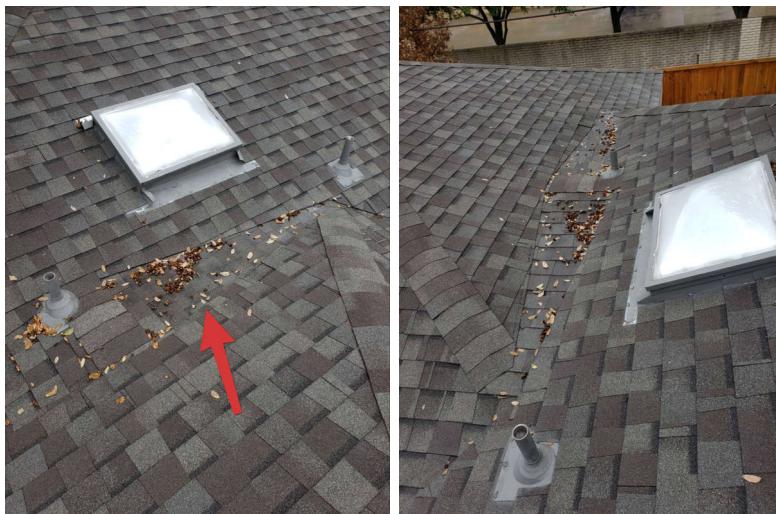
**2: Ponding****⚠ Major Deficiency, Essential and Safety Items**

Observed ponding in one or more areas of roof. Ponding can lead to accelerated erosion and deterioration. Recommend a qualified roofing contractor evaluate and repair.

Recommendation: Contact a qualified roofing professional.

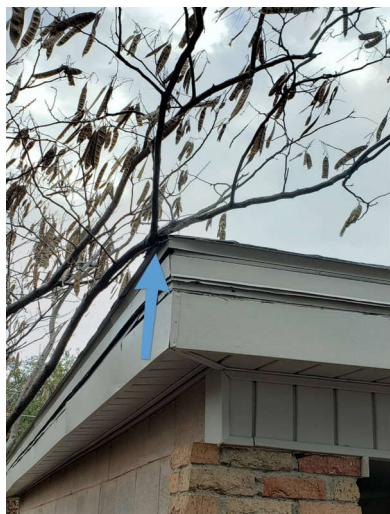
Left Side carport

**3: Trim trees now****☛ Observation and Maintenance Items**

Recommendation: Contact a qualified professional.

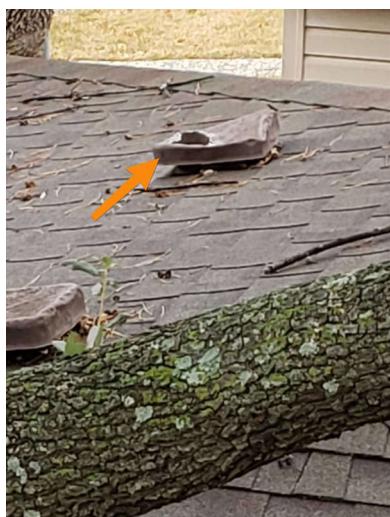
Outbuilding

**4: Vents or flashing impact damage****⊖ Minor Deficiency and Cosmetic Items**

The home inspector observed at the time of the inspection impact damage or damage from improper installation on vents or flashing.

Recommendation: Contact a qualified professional.

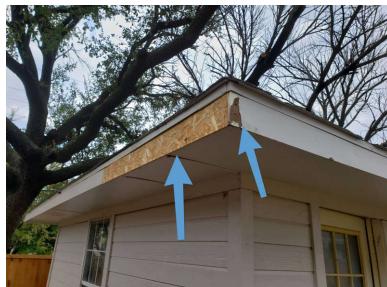
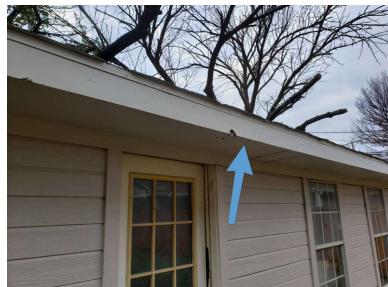
1: Fascia Board Damage

Recommendation: Contact a qualified carpenter.

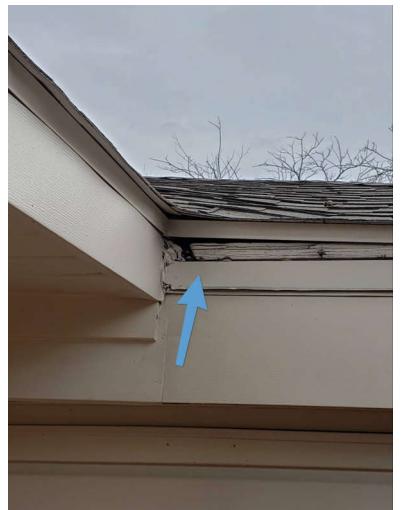
The fascia board material has some deterioration and/or damage.

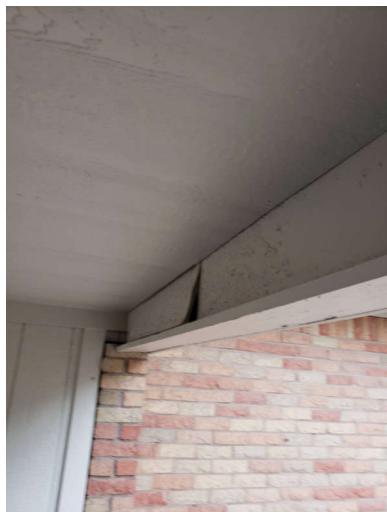
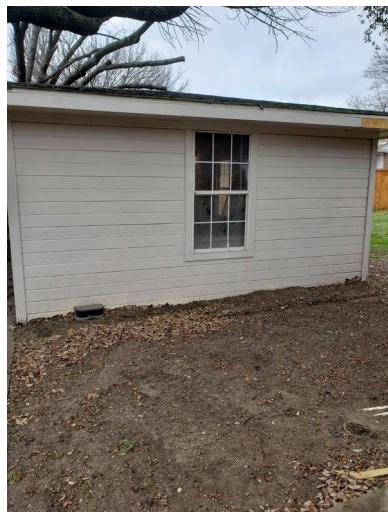
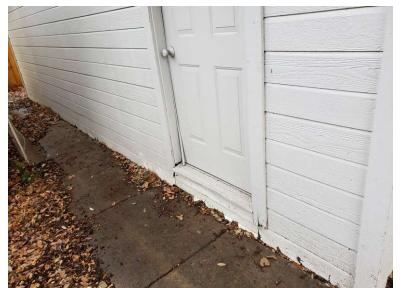
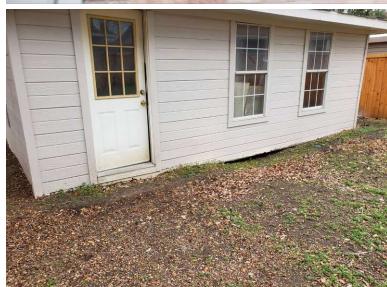
**2: Siding damaged or deteriorated****🔗 Observation and Maintenance Items****Carport & Outbuilding**

The exterior siding is damaged and or deteriorated in one or more locations.

Recommendation: Contact a qualified professional.

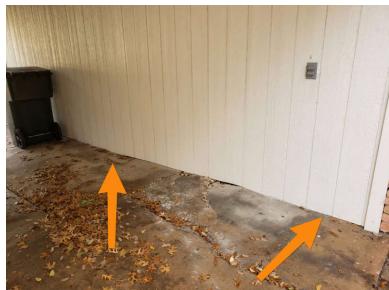
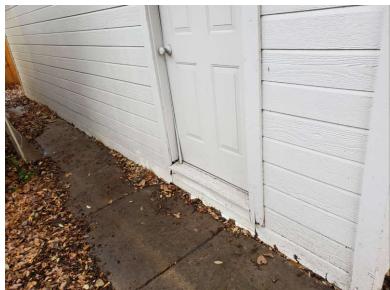
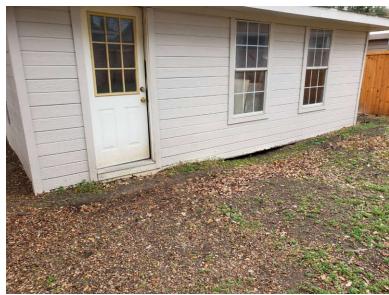
**3: Wood to Ground****● Minor Deficiency and Cosmetic Items****Carport & Outbuilding**

All wood to ground contact at the base of the siding should be eliminated. Rotted or damaged siding that is uncovered should be repaired.

Recommendation: Contact a handyman or DIY project

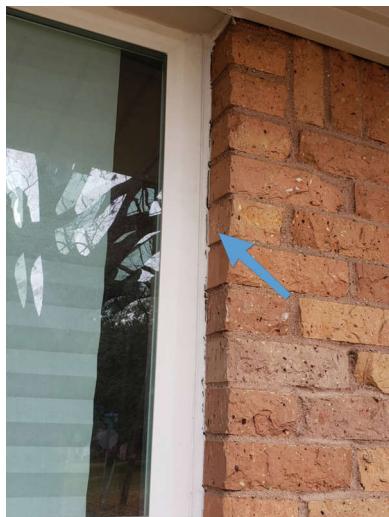
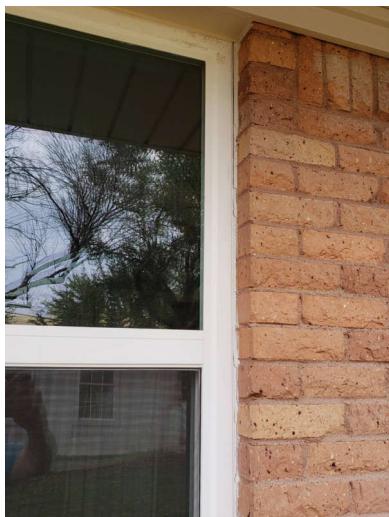
4: Seal Penetrations

It is recommended to use elastomeric caulking.

Recommendation: Contact a handyman or DIY project

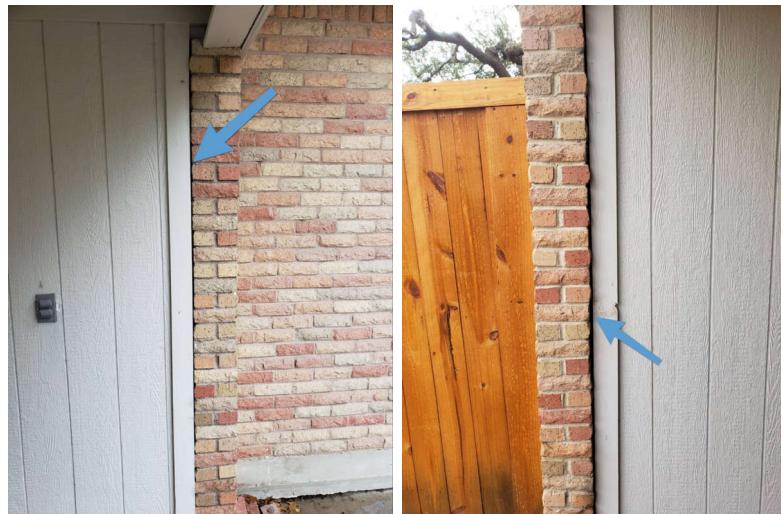
I NI NP D**5: Seal Transition**

The transition from wood veneer to brick veneer needs to be better sealed.

Recommendation: Contact a handyman or DIY project

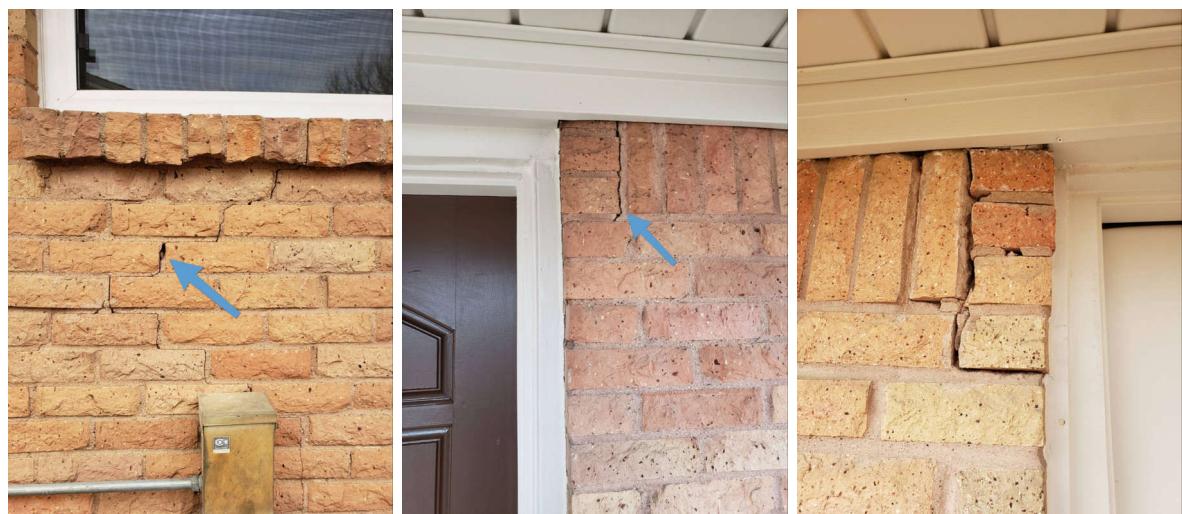
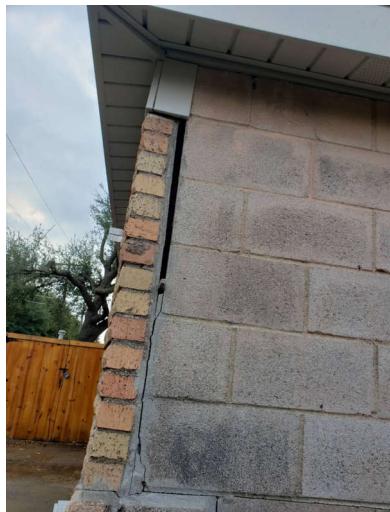
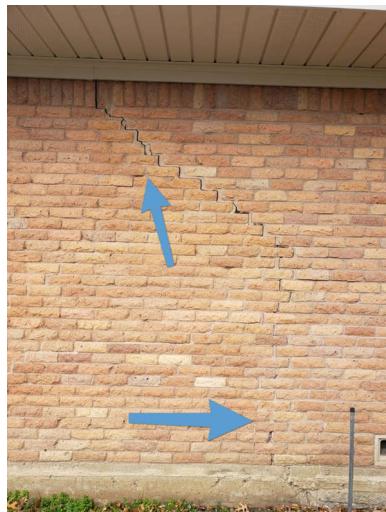
6: Mortar Improvements

Mortar improvements are recommended for the exterior masonry veneer

Recommendation: Contact a qualified masonry professional.

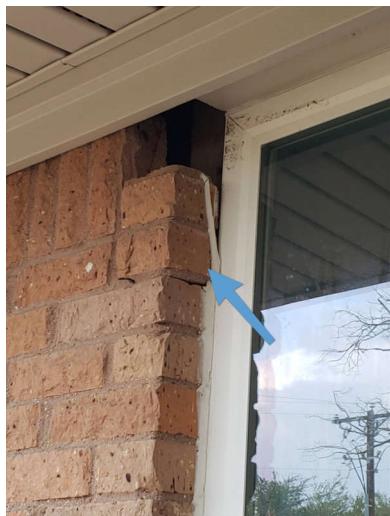
7: Loose Solider Brick

The soldier bricks were observed to be loose. Some improvements are recommended.

Recommendation: Contact a qualified masonry professional.

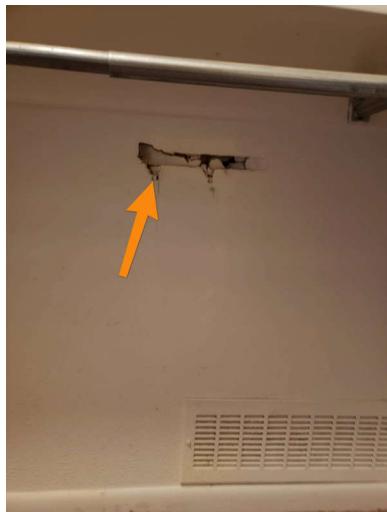
Drywall wall damage was observed.

Recommendation: Contact a qualified professional.

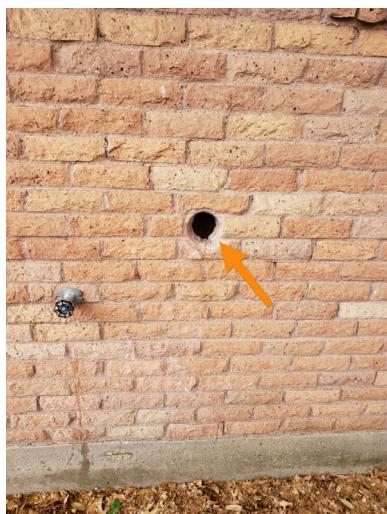
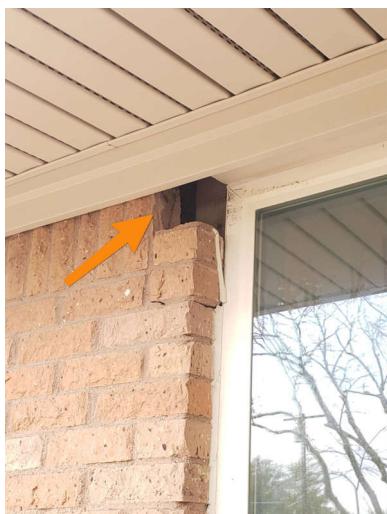
**9: Damaged or missing bricks****⊖ Minor Deficiency and Cosmetic Items**

Damaged or missing bricks were observed at time of inspection. Further evaluation recommended and repairs necessary.

Recommendation: Contact a qualified professional.

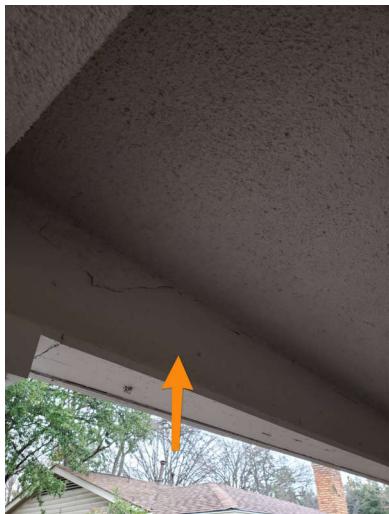
I NI NP D**1: Damaged Texture****⊖ Minor Deficiency and Cosmetic Items**

The ceiling texture has some deterioration and/or damage.

Recommendation: Contact a qualified drywall contractor.

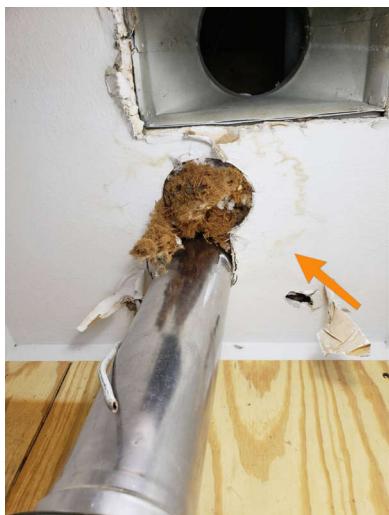
Laundry room closet

**2: Water Stain at WH Flue****⊖ Minor Deficiency and Cosmetic Items**

Recommendation: Contact a qualified drywall contractor.

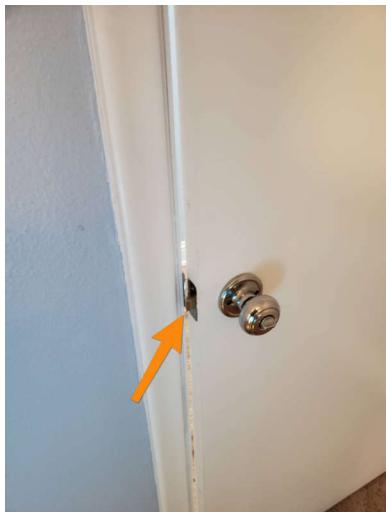
Door(s) not latching properly.

Recommendation: Contact a qualified door repair/installation contractor.

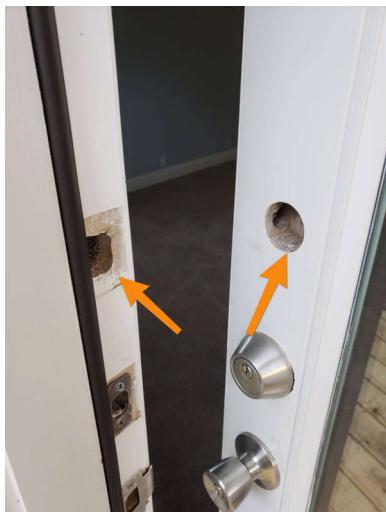
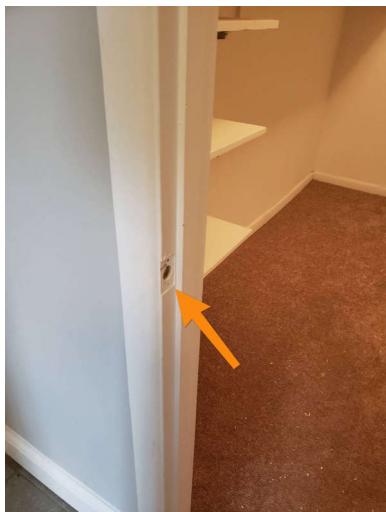
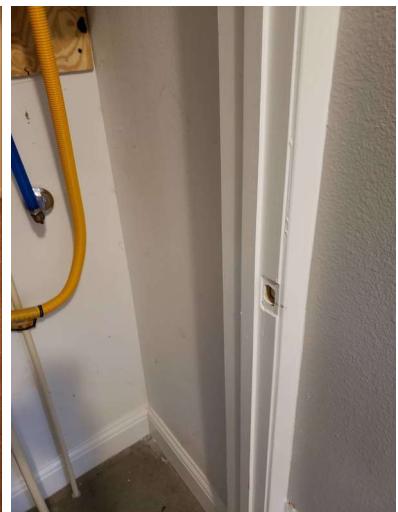
The door hardware is missing.

Recommendation: Contact a qualified door repair/installation contractor.

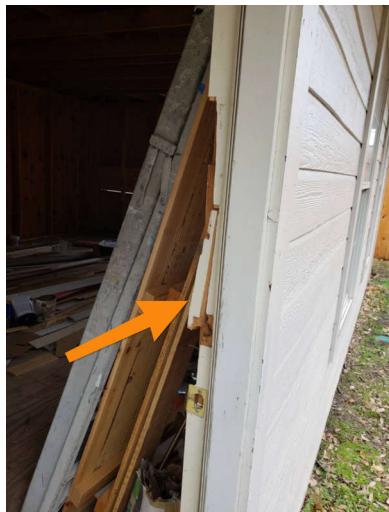
Outbuilding

**3: Frame Damage****⊖ Minor Deficiency and Cosmetic Items**

The door frame has some damage.

Recommendation: Contact a qualified door repair/installation contractor.

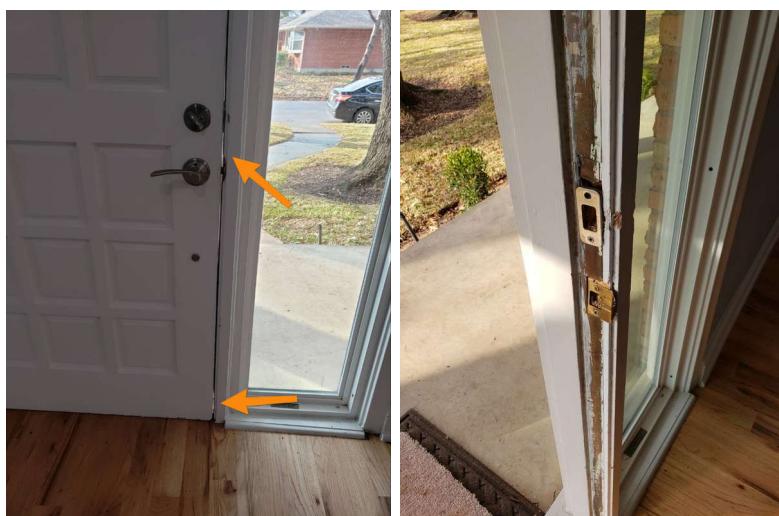
**4: Weather Stripping****⊖ Minor Deficiency and Cosmetic Items**

Weather-stripping improvements are recommended for the exterior doors.

Recommendation: Contact a qualified handyman.

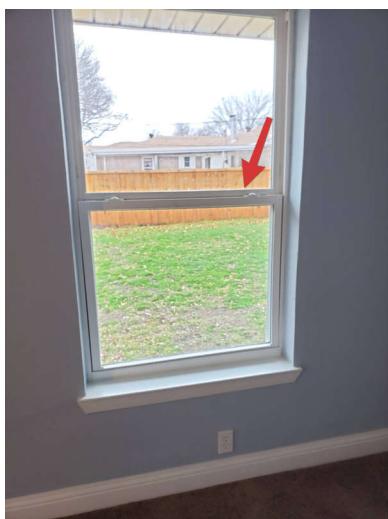
Window wont open

Recommendation: Contact a qualified professional.

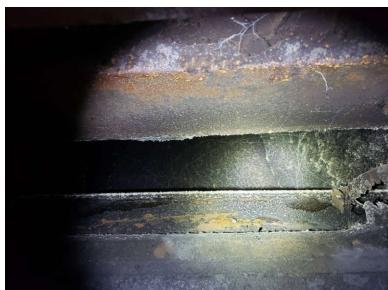
1: Dirty Flue**⊖ Minor Deficiency and Cosmetic Items**

The chimney flue needs to be cleaned by a Qualified Chimney Sweep. A creosote / soot build-up was observed in the visible flue area.

Recommendation: Contact a qualified chimney sweep.

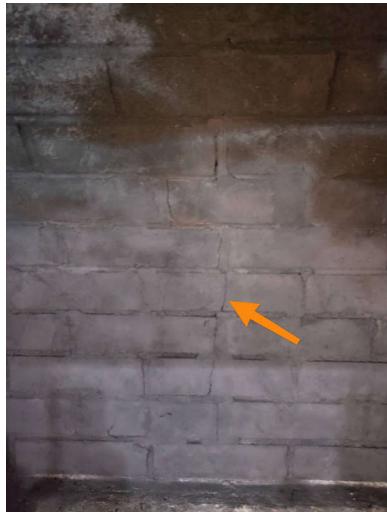
**2: Back Panel Cracked****⊖ Minor Deficiency and Cosmetic Items**

The back panel in the firebox was observed to be cracked and/or damaged. This condition should be further evaluated and corrected as necessary.

Recommendation: Contact a qualified fireplace contractor.

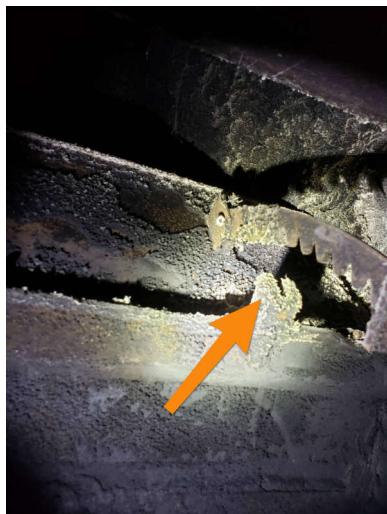
**3: Damper damage****⊖ Minor Deficiency and Cosmetic Items**

Damper has some damage and or corrosion

Recommendation: Contact a qualified professional.

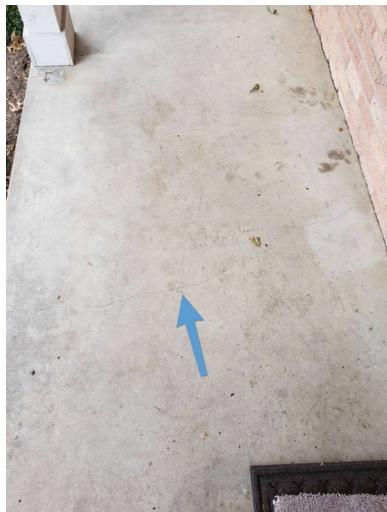
1: Minor porch cracks**↙ Observation and Maintenance Items**

There are cracks in the porch flat work.

Recommendation: Contact a qualified professional.

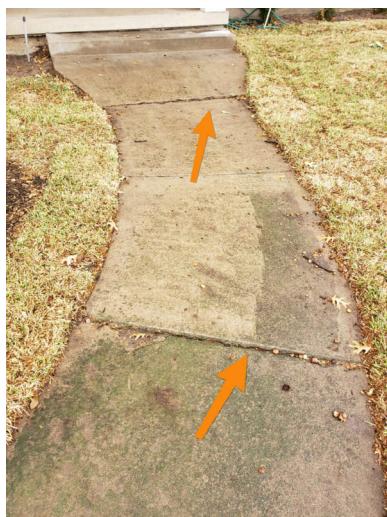
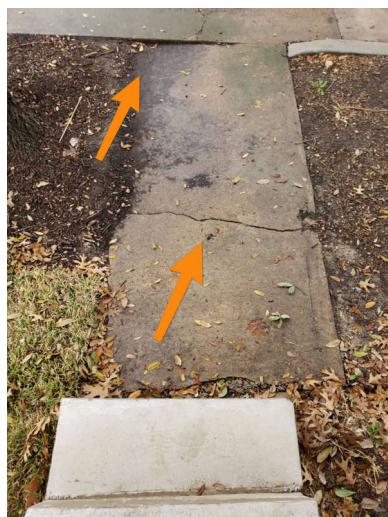
Front & Left Side

**2: Sidewalk Settled****⊖ Minor Deficiency and Cosmetic Items**

The sidewalk has settled somewhat. If this condition persists or if the sidewalk becomes a trip hazard, improvements should be undertaken.

Recommendation: Contact a qualified concrete contractor.

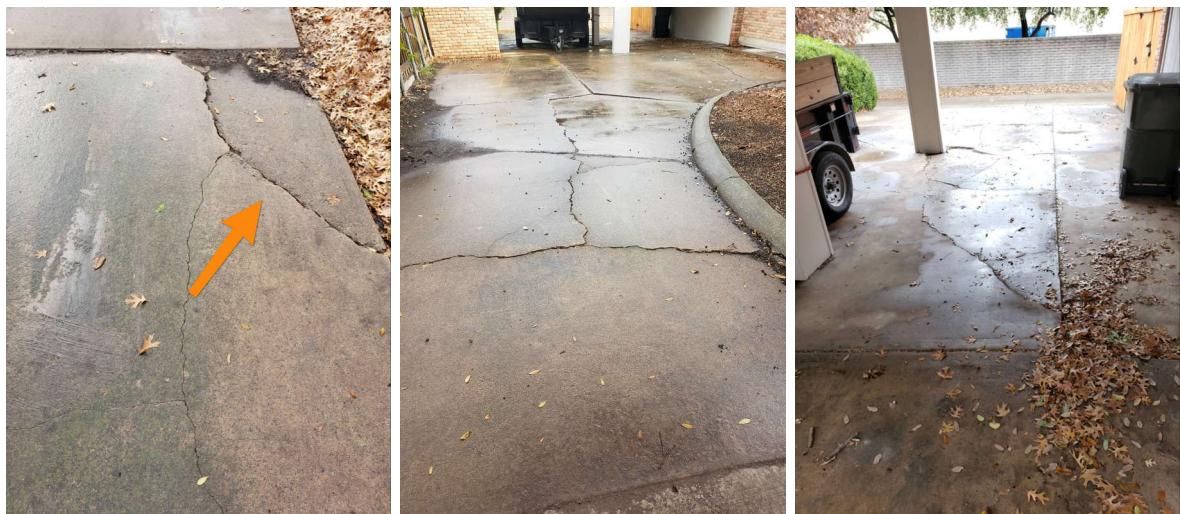
**3: Major Driveway Cracks****⊖ Minor Deficiency and Cosmetic Items**

Larger than typical cracks and/or deficiencies were observed in the driveway.

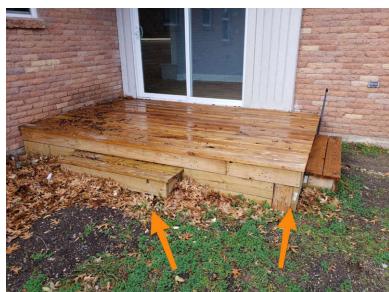
**4: Deck has wood to ground contact****⊖ Minor Deficiency and Cosmetic Items**

The deck has been built with wood to ground contact. This may cause premature wood rot in most cases.

Recommendation: Contact a qualified professional.

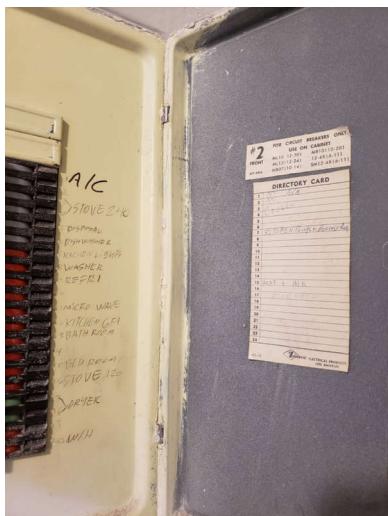
The breakers (overcurrent devices) in the electrical panel are not properly labeled. Every circuit shall be legibly identified as to its clear, evident, and specific purpose or use. The identification shall include sufficient detail to allow each circuit to be distinguished from all others.

Recommendation: Contact a qualified electrical contractor.

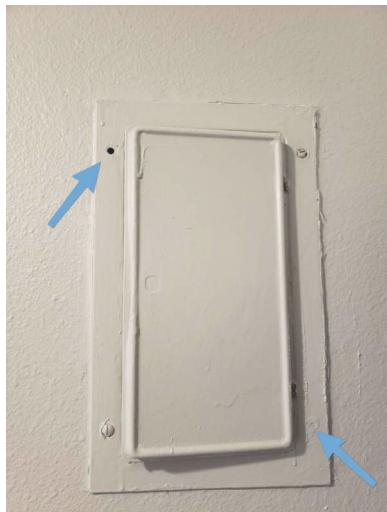
2: Cover Screw Missing

One or more of the cabinet cover plate screws are missing and need to be replaced.

Recommendation: Contact a qualified electrical contractor.

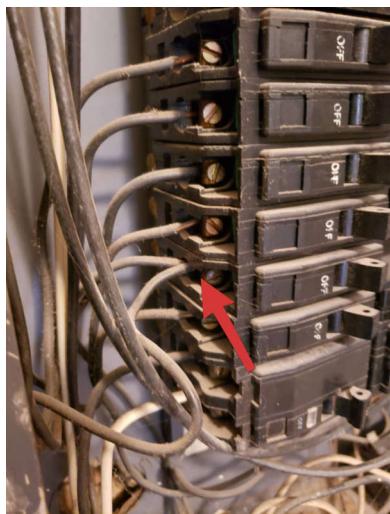
1: Double Tap Breaker**▲ Major Deficiency, Essential and Safety Items**

One or more of the breakers in the electrical cabinet were observed to be double lugged (i.e. two wires under one screw). The breakers in place are not listed or labeled for this type of installation and should be corrected as necessary.

Recommendation: Contact a qualified electrical contractor.

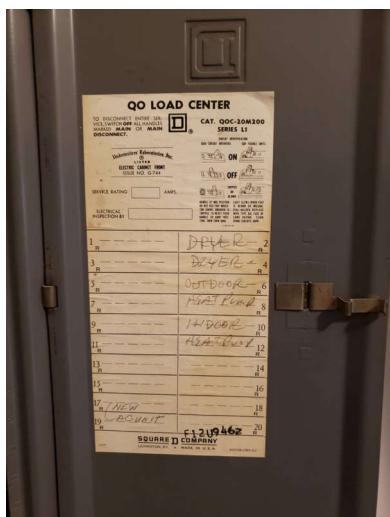
**2: Not Labeled Properly****🔧 Observation and Maintenance Items**

The breakers (overcurrent devices) in the electrical panel are not properly labeled. Every circuit shall be **legibly identified** as to its clear, evident, and specific purpose or use. The identification shall include sufficient detail to allow each circuit to be distinguished from all others.

Recommendation: Contact a qualified electrical contractor.

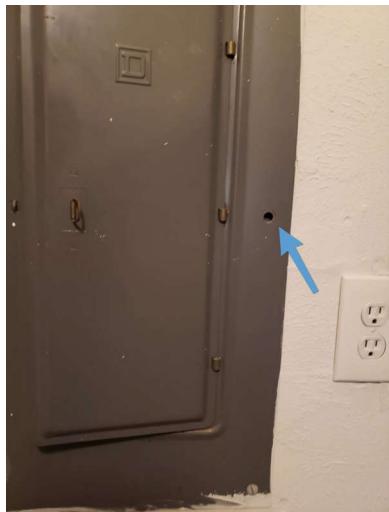
**3: Cover Screw Missing****🔧 Observation and Maintenance Items**

One or more of the cabinet cover plate screws are missing and need to be replaced.

Recommendation: Contact a qualified electrical contractor.

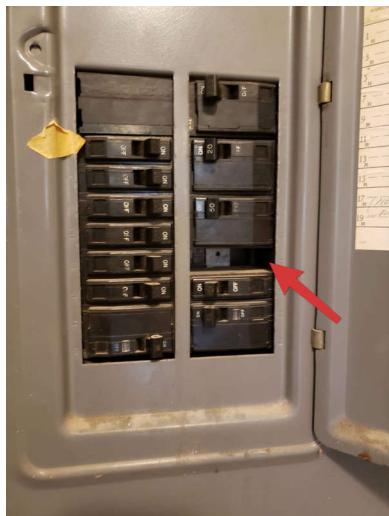
**4: Blank Spaces****▲ Major Deficiency, Essential and Safety Items**

All blank spaces in the electrical cabinet cover plate (dead front) and /or cabinet need to have fillers.

Recommendation: Contact a qualified electrical contractor.

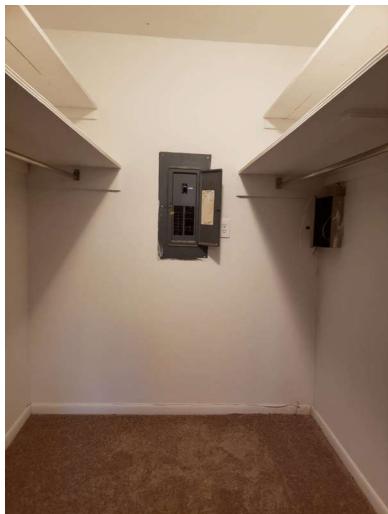
**5: Panel in Clothes Closet****▲ Major Deficiency, Essential and Safety Items**

The electrical panel is located in a clothes closet. Under current electrical standards, this is no longer an accepted practice. This is an as-built condition but Per TREC standards of practice we are required to report this condition as a deficiency.

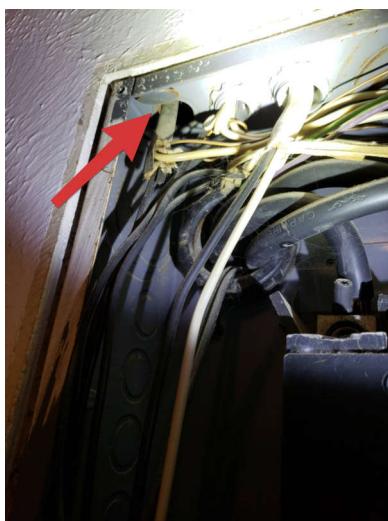
**6: Protect Wires From Cabinet****▲ Major Deficiency, Essential and Safety Items**

The wires entering the electrical cabinet are not properly secured or protected from the sharp edges of the cabinet. Non-metallic cable passed through knock-outs in the main electrical service panel which had no bushing installed. Bushings are electrical connectors designed to protect conductors where they pass through sheet metal. Without bushings, the sharp edges of sheet metal may damage the conductors. Bushings also include clamps which prevent any pressure on conductors from being transferred to circuit breaker connections.

Recommendation: Contact a qualified electrical contractor.

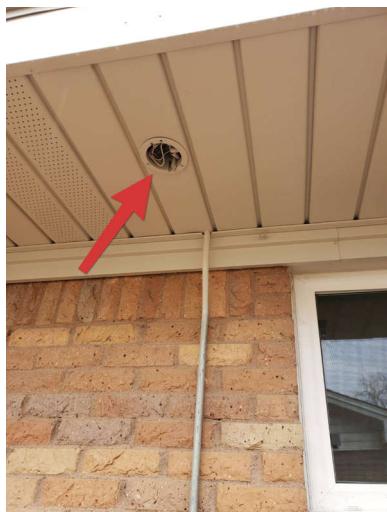
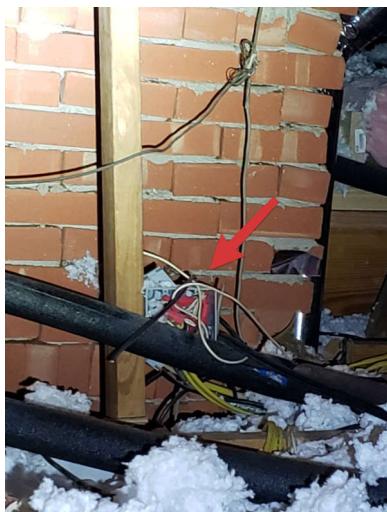
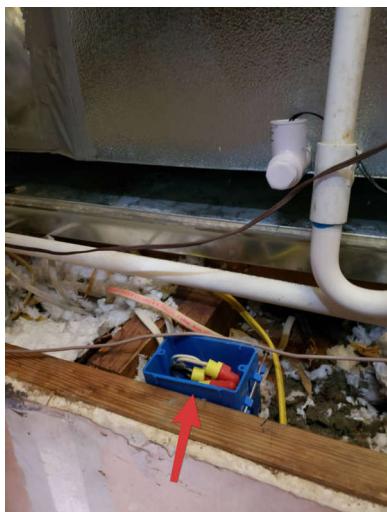
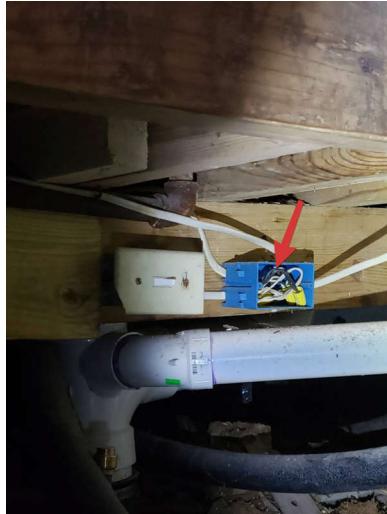
**7: Open J-Box****▲ Major Deficiency, Essential and Safety Items**

An open junction box was observed. A junction box cover should be installed for reasons of safety.

Recommendation: Contact a qualified electrical contractor.

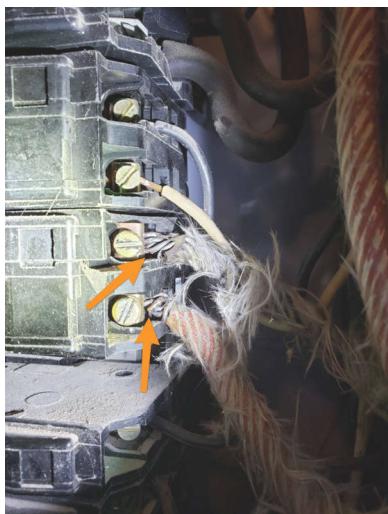
Main

9: Stranded wire trimmed**⊖ Minor Deficiency and Cosmetic Items**

The stranded wire is trimmed which is an improper method of termination. Further evaluation recommended.

Recommendation: Contact a qualified professional.

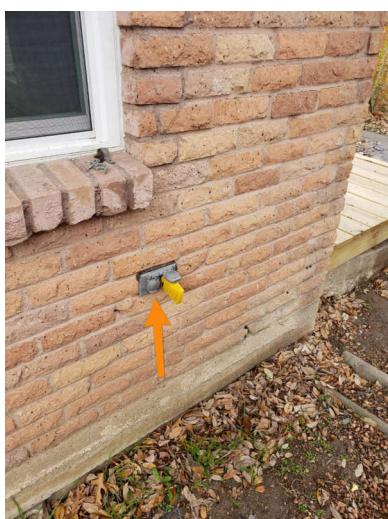
2: Open Ground**⊖ Minor Deficiency and Cosmetic Items**

One or more of the receptacles were observed to have an open ground connection.

Recommendation: Contact a qualified electrical contractor.

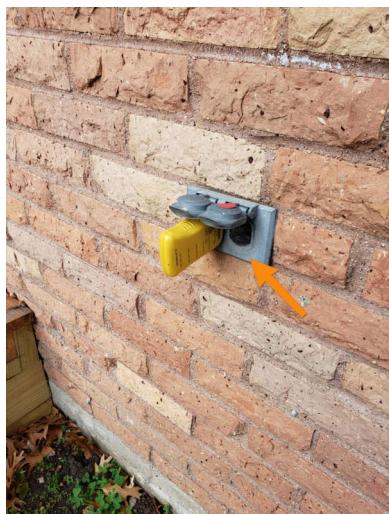
Back exterior

I NI NP D**3: reversed polarity****⊖ Minor Deficiency and Cosmetic Items**

One or more of the receptacles appear to have reversed polarity (i.e. it is wired backwards). This receptacle(s) and the circuit should be investigated and improved as necessary.

Recommendation: Contact a qualified electrical contractor.

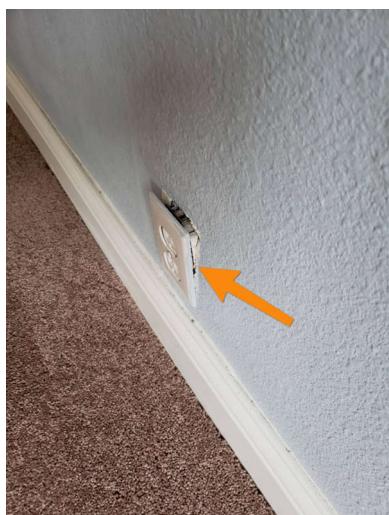
**4: Missing / damaged cover plate****⊖ Minor Deficiency and Cosmetic Items**

One or more of the receptacles was noted to have missing or damaged cover plate.

Recommendation: Contact a qualified electrical contractor.

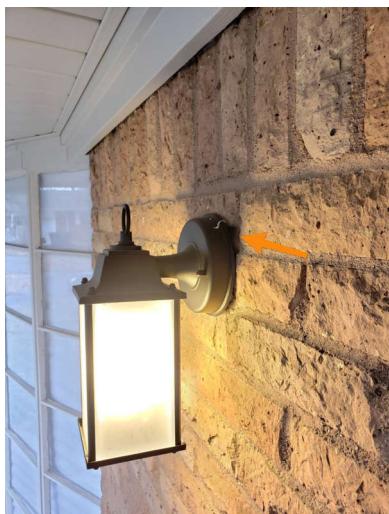
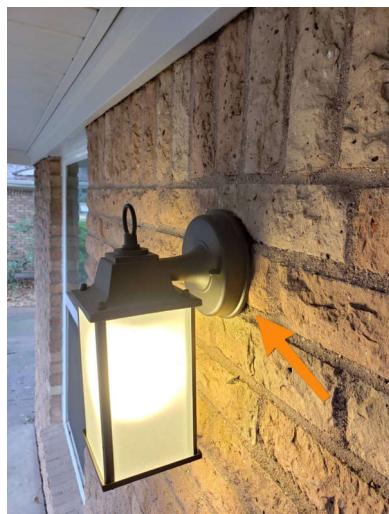
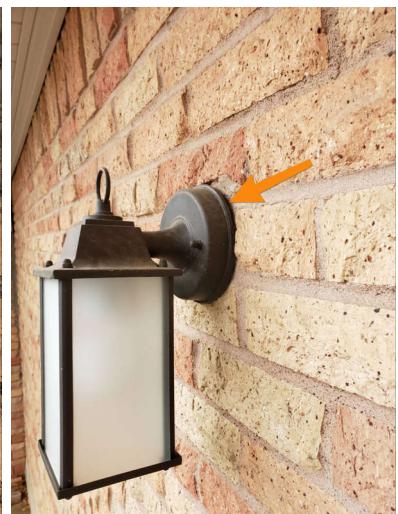
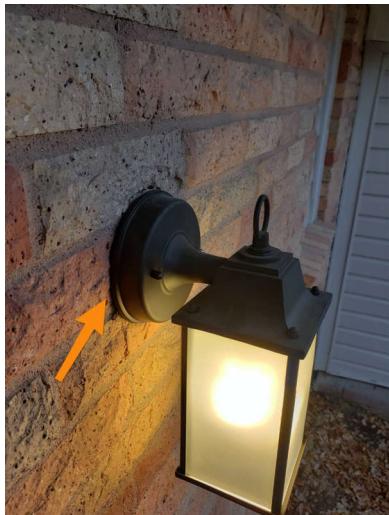
I NI NP D**6: Seal exterior fixture****⊖ Minor Deficiency and Cosmetic Items**

The exterior fixtures should be properly sealed to the wall to avoid water intrusion behind the fixture.

Recommendation: Contact a handyman or DIY project

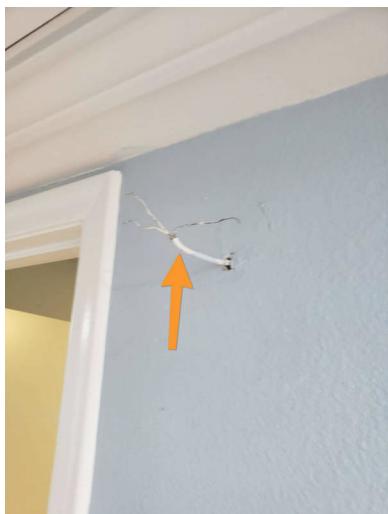
I NI NP D**8: No chime****⊖ Minor Deficiency and Cosmetic Items**

The doorbell chime does not appear to be functioning properly.

Recommendation: Contact a handyman or DIY project

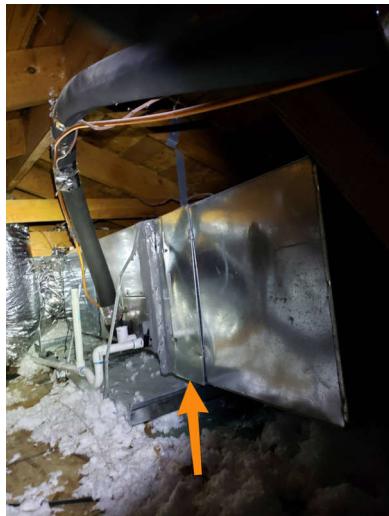
The air filter is missing and needs to be replaced.

Recommendation: Contact a qualified professional.

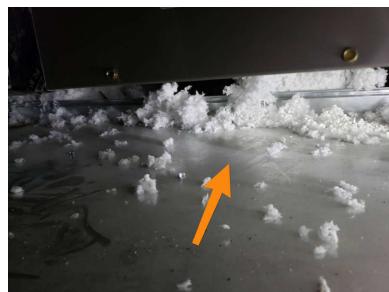
The auxiliary/secondary drain pan under the coil housing should be free of all debris. The debris in the pan could clog the drain line and cause water to leak to the interior of the house.

Recommendation: Contact a qualified professional.

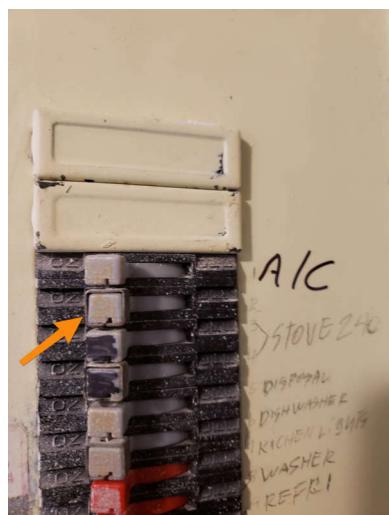
40 amp

**4: Wrong size breaker****⊖ Minor Deficiency and Cosmetic Items**

The manufacturers listing plate on the outside condenser/coil lists the maximum over current device (breaker) to be used. The breaker in place does not meet the manufacturers listing plate requirements.

Recommendation: Contact a qualified professional.

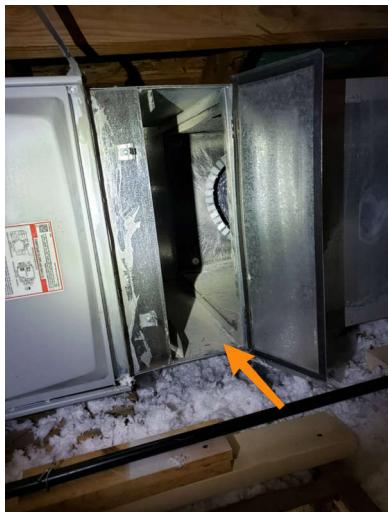
1: No filter**⊖ Minor Deficiency and Cosmetic Items**

The air filter is missing and needs to be replaced.

Recommendation: Contact a qualified professional.

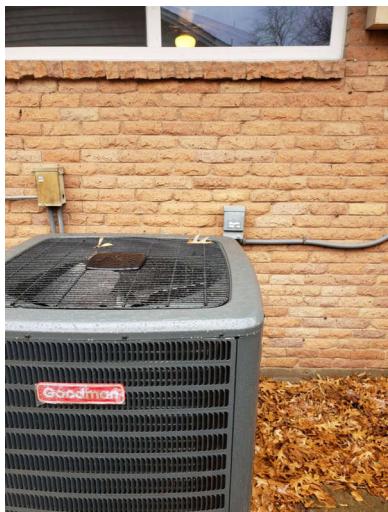
**2: Disconnect behind unit****⊖ Minor Deficiency and Cosmetic Items**

The electrical service disconnect is installed behind the outside condenser/coil. This does not meet the clearance requirements of the National Electrical Code or the International Residential Code and should be corrected as necessary.

Recommendation: Contact a qualified professional.

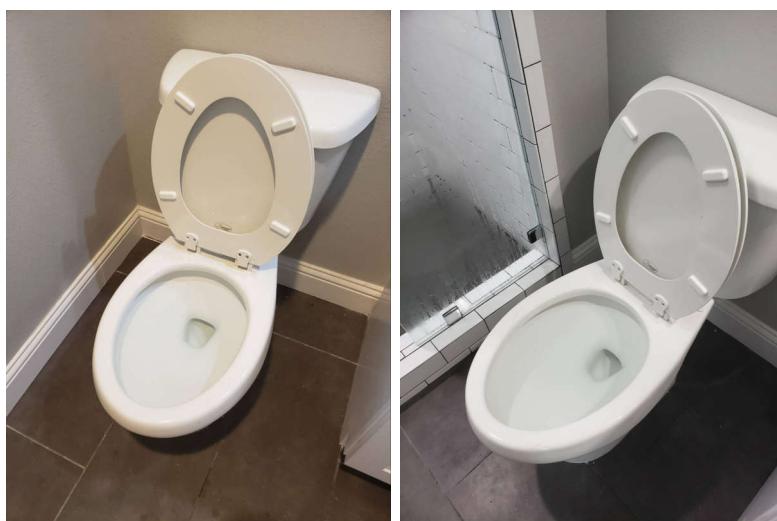
*Comments:***1: No drain proper****● Minor Deficiency and Cosmetic Items**

The commode does not drain properly when flushed, suggesting that an obstruction may exist. This condition should be further evaluated and corrected as necessary.

Recommendation: Contact a qualified plumbing contractor.

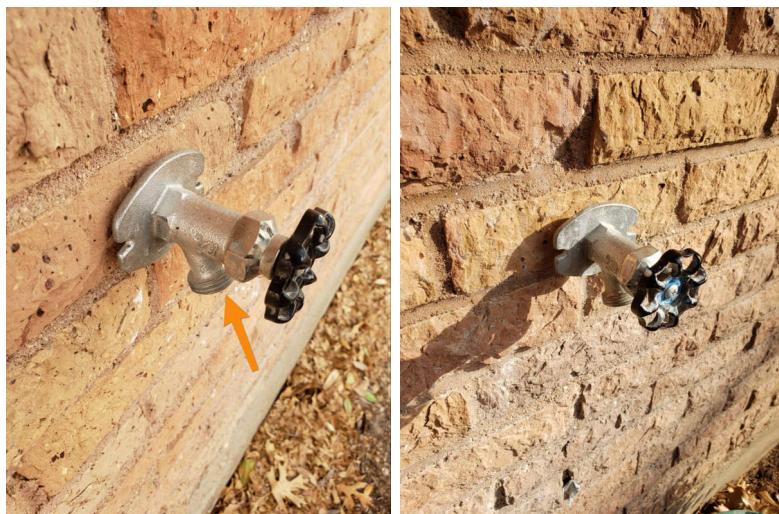
I NI NP D**2: Backflow missing****⊖ Minor Deficiency and Cosmetic Items**

One or more of the exterior water hose bibbs (faucet) do not have a back-flow or anti-siphon device (Vacuum Breakers) in place. Note: This is not uncommon to observe with a home of this age.

Recommendation: Contact a handyman or DIY project

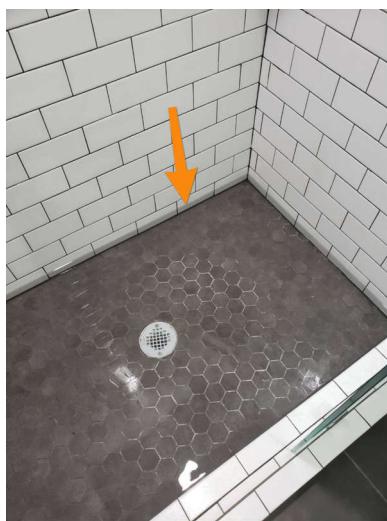
Guest Bathroom Shower

**1: Slow drain = Shower****● Minor Deficiency and Cosmetic Items**

The shower was observed to drain slowly, suggesting that an obstruction may exist.

Recommendation: Contact a qualified plumbing contractor.

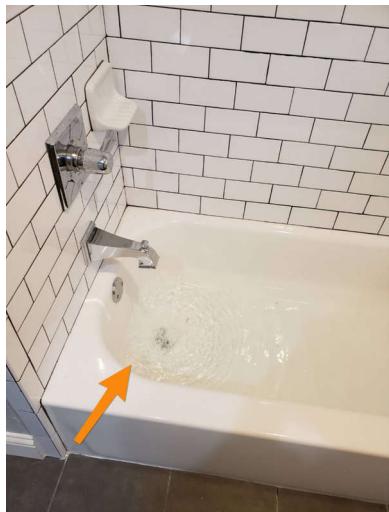
Hall Bathroom Bathtub

**2: Slow drain = Tub****● Minor Deficiency and Cosmetic Items**

The bathtub was observed to drain slowly, suggesting that an obstruction may exist.

Recommendation: Contact a qualified plumbing contractor.

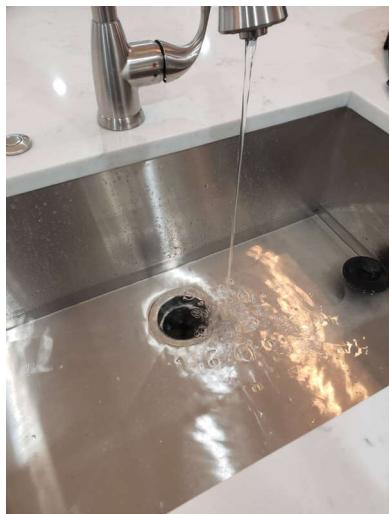
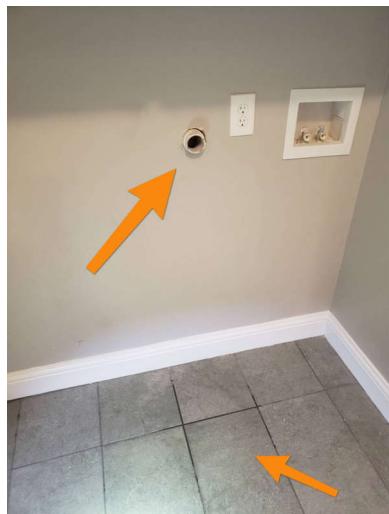
Kitchen

**3: Slow drain = Sink****⊖ Minor Deficiency and Cosmetic Items**

The sink was observed to drain slowly, suggesting that an obstruction may exist.

Sink water blew out drain line.

Recommendation: Contact a qualified plumbing contractor.

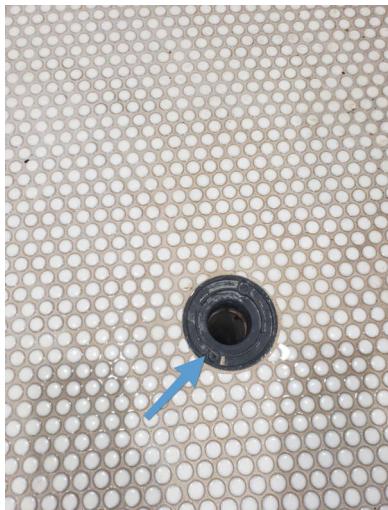
4: Drain screen missing**🔧 Observation and Maintenance Items**

The drain screamer in the shower is missing.

Recommendation: Contact a qualified professional.

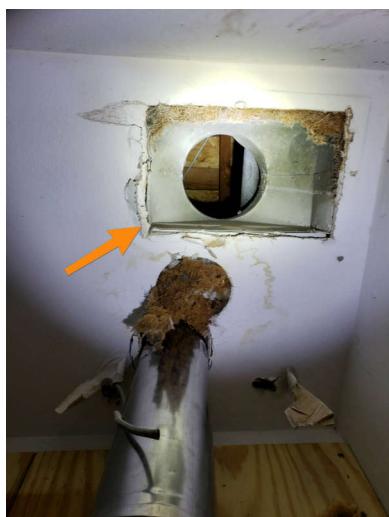
2: combustible clearance

The water heater flue (vent pipe) has inadequate clearance from combustible materials. Double walled vent pipes should have at least 1-inch of clearance and single walled vent pipes should have at least 6-inches of clearance from combustible material.

Recommendation: Contact a handyman or DIY project

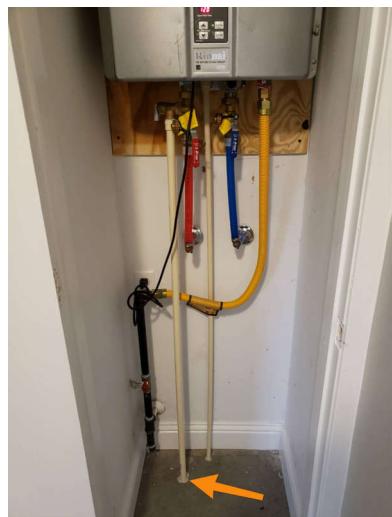
4: TPR terminates in crawlspace**⊖ Minor Deficiency and Cosmetic Items**

TPR terminates in crawlspace.

Recommendation: Contact a qualified professional.
