YOUR HOME INSPECTION

1234 Main St.
Garland, Texas 75043

PROPERTY INSPECTION REPORT

Concerning:1234 Main St. Fort Worth Tx 76137

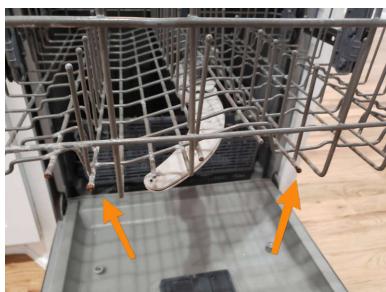
1: rust**⊖ Minor Deficiency and Cosmetic Items**

Some rusting of the dishwasher interior components was observed.

Recommendation: Contact a qualified appliance repair professional.

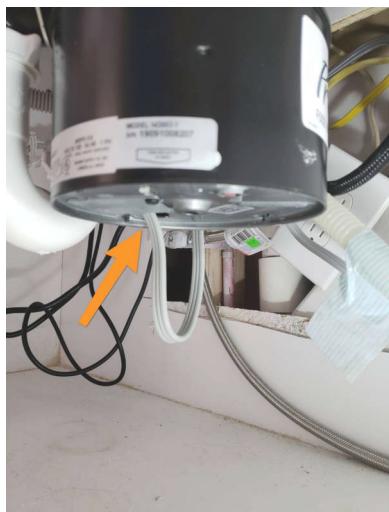
1: Wire not secure

Recommendation: Contact a qualified appliance repair professional.

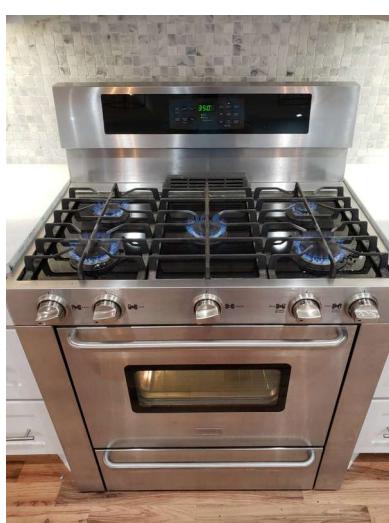
1: No Anti-Tip**⊖ Minor Deficiency and Cosmetic Items**

The range can be easily tipped over and should be equipped with an anti-tip device, for safety. This may be an as-built condition but Per TREC standards of practice we are required to report this condition as a deficiency.

Recommendation: Contact a handyman or DIY project

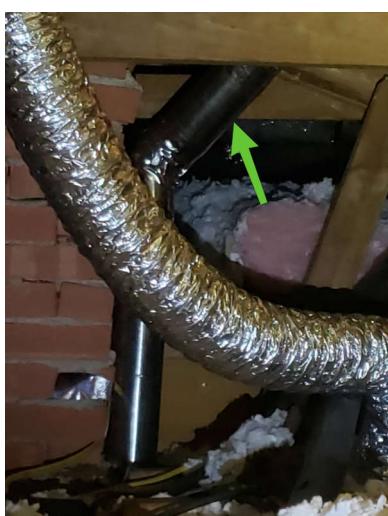
The dryer vent was observed to terminate through the roof. For reasons of safety it is advised that this type of dryer vent be professionally cleaned at least every three years.
