ON POINT HOME INSPECTIONS LLC

INSPECTION REPORT

1234 Main St.
Tucson, Az 85704

Buyer Name
01/08/2020 9:00AM

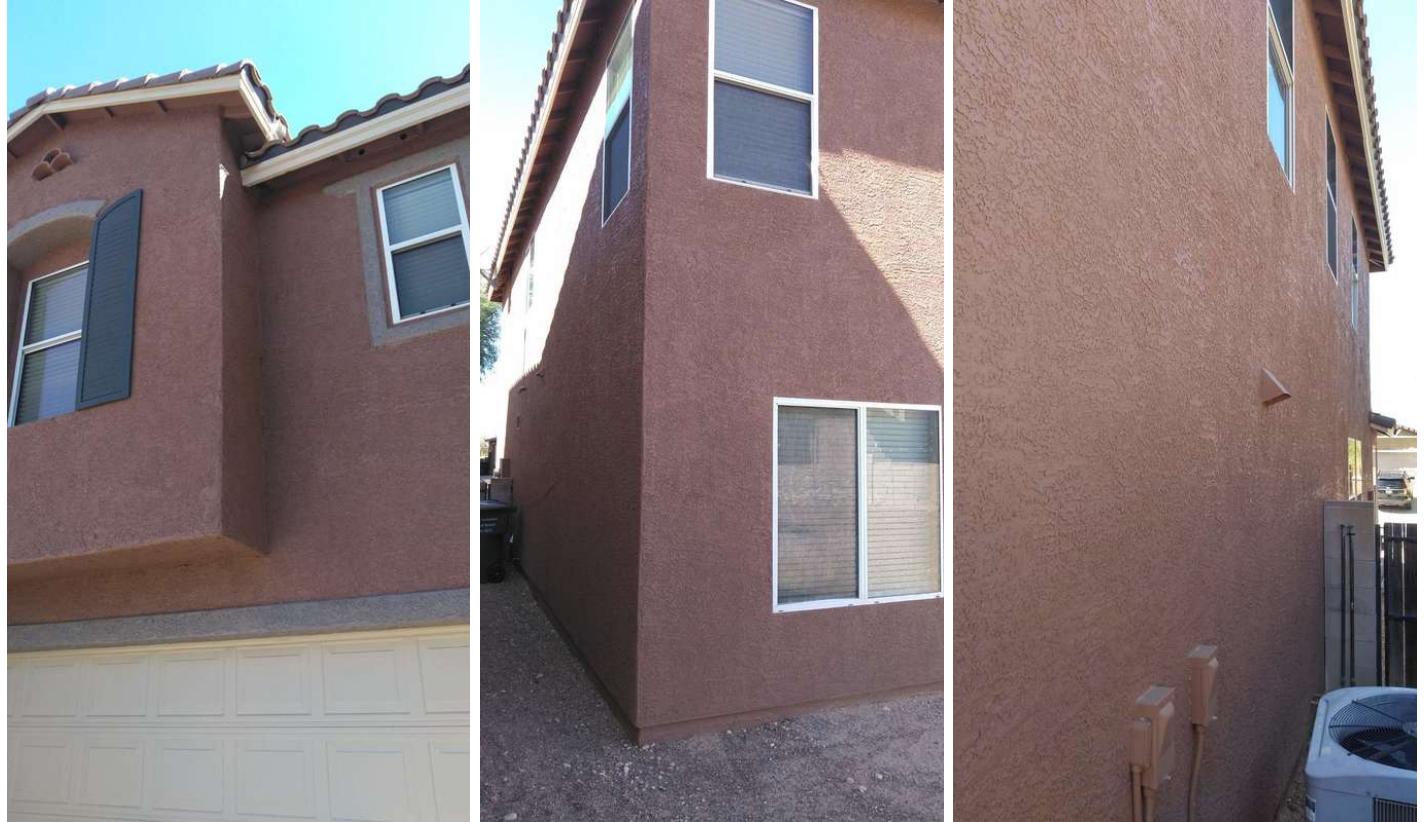
**Siding, Flashing & Trim: Stucco siding condition-Good**

The stucco siding was in overall good condition with minor/hairline cracks observed. These hairline cracks are normal and generally the result of minor settling or expansion/contraction from temperature change. These minor/hairline cracks are not a structural concern but should be filled to seal against moisture intrusion.

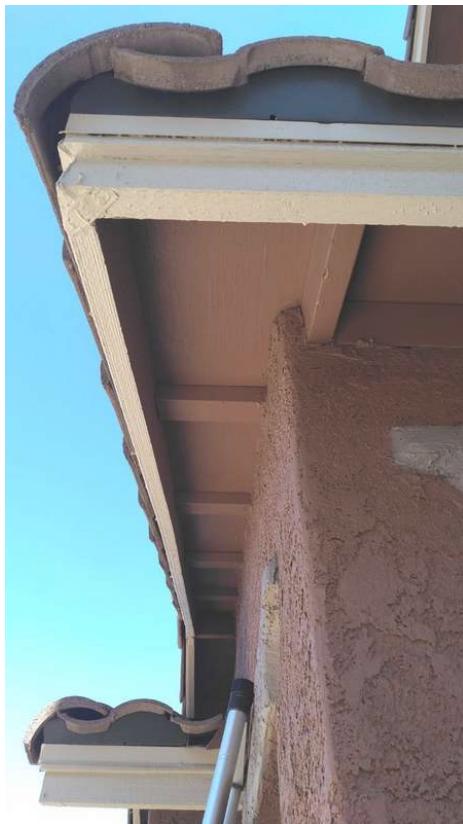
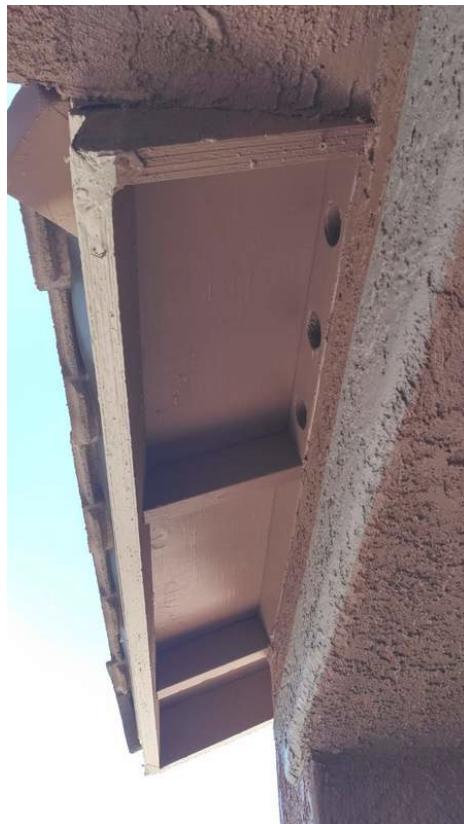
Eaves, Soffits & Fascia: Wood maintenance Item

The eaves, soffit and fascia are wood material. As a maintenance item these areas need an occasional coat of paint to protect the wood from moisture intrusion, deterioration and rot.

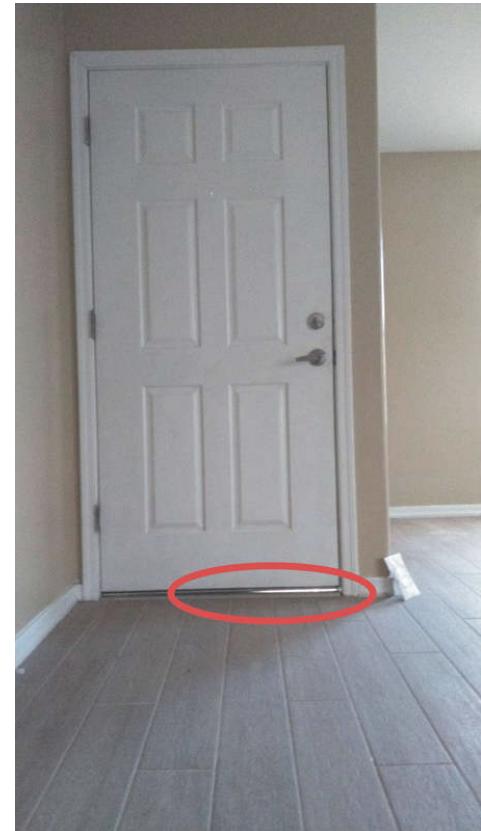
2.2.1 Exterior Doors

GAP IN WEATHER STRIPPING

FRONT DOOR

The front door had a gap in the threshold weather stripping which allows conditioned air to escape lowering the homes efficiency. Lack of weather stripping can also allow pests to enter the home. I recommend having a qualified professional adjust the door and / or replace the missing sections of weather stripping properly seal the door and prevent these issues.

Contact a qualified professional.

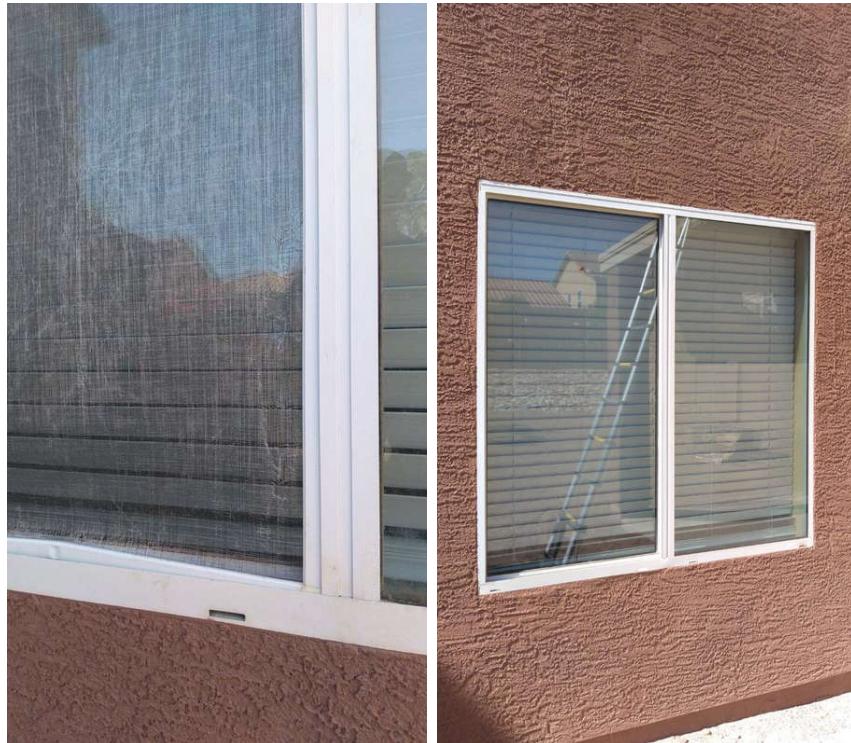
2.3.1 Windows

MISSING/DAMAGED SCREEN

EXTERIOR WINDOWS

At the time of inspection I observed various windows with damaged or missing screens. I recommend replacing damaged/missing window screens to prevent pests, birds and bugs from entering the home when windows are open.

Contact a qualified window repair/installation contractor.

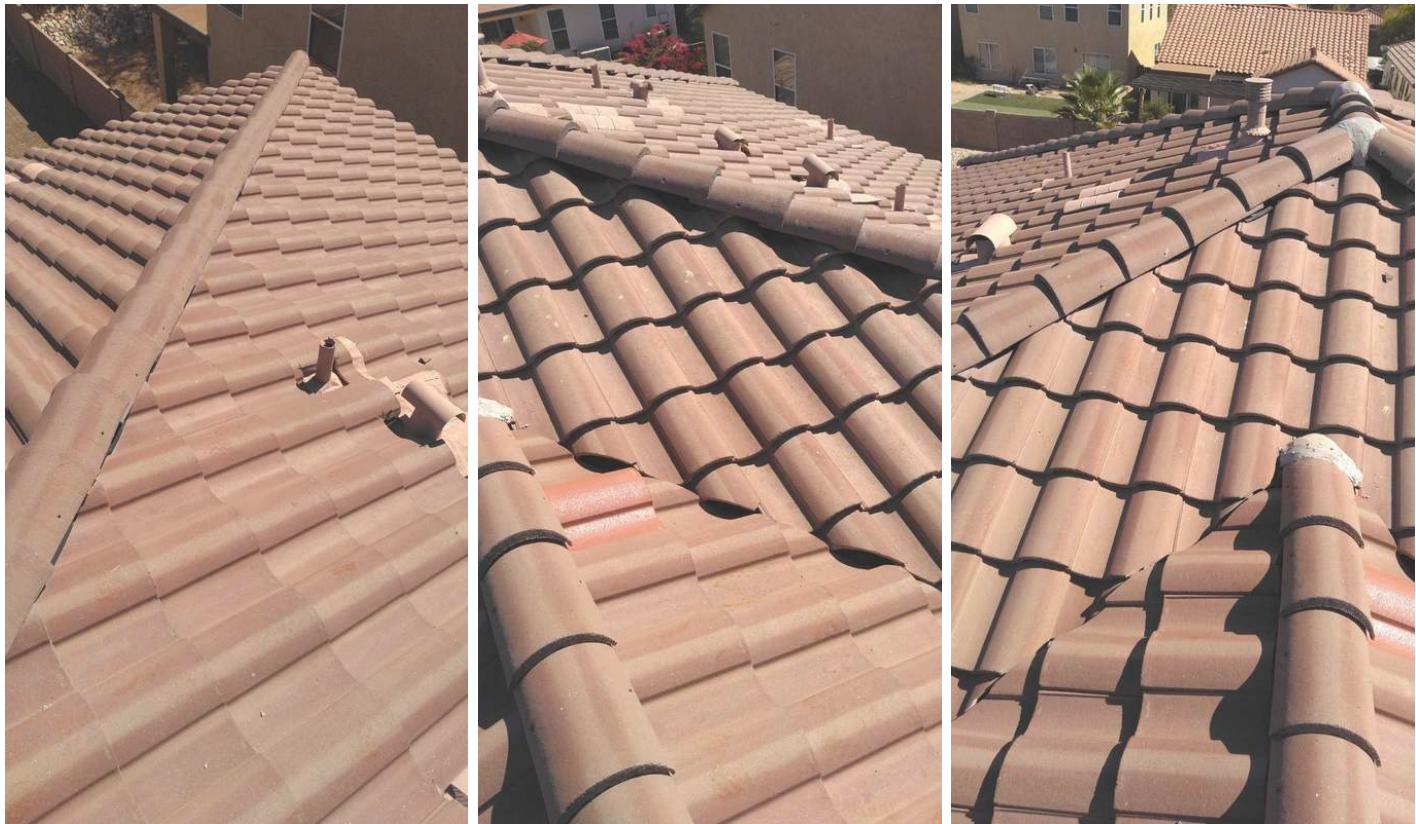
**Roof condition-Good**

The roof was in overall good condition with no signs of moisture intrusion. Any specific defects or observations will be noted in the observation/summary section.

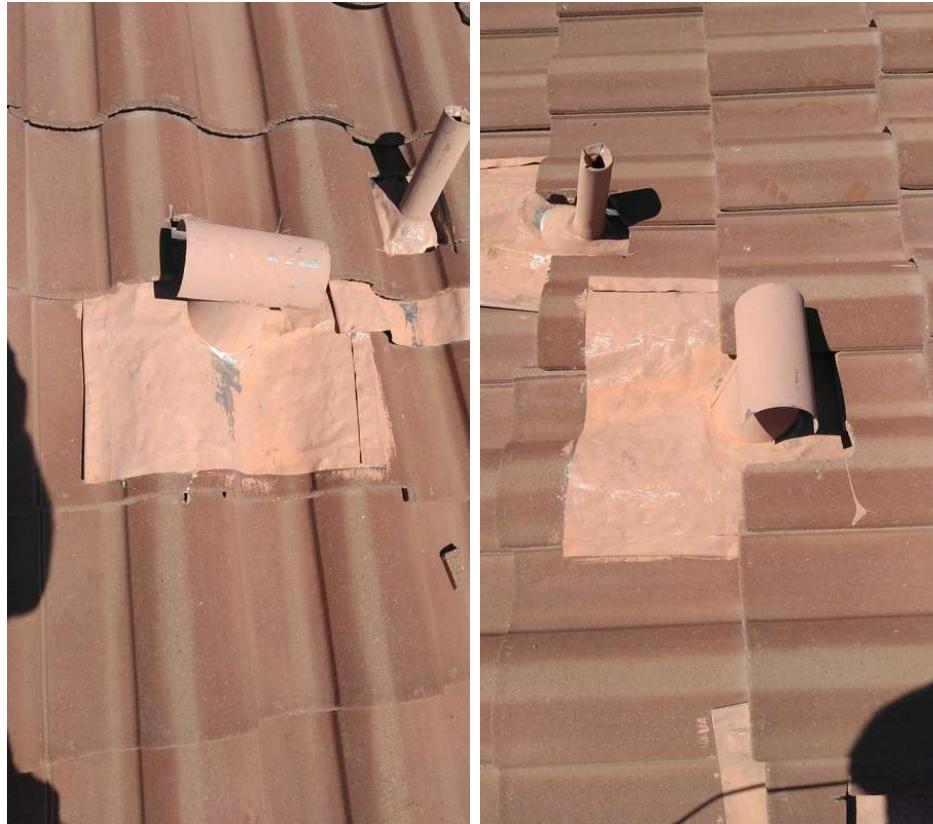
**Roof Penetrations, Skylights, Chimneys: Roof penetrations**

The roof penetrations consist of drain / wastewater venting, moisture venting, gas appliance venting, roof venting, ECT. No signs of moisture intrusion around the roof penetrations at the time of inspection.

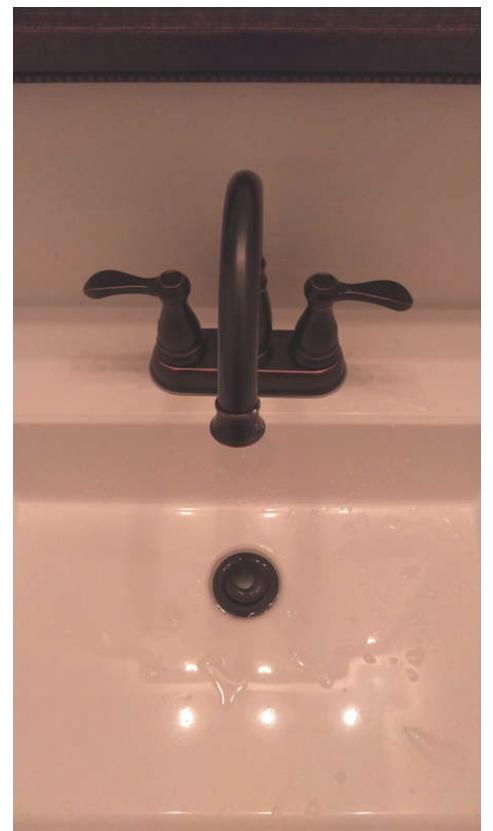
5.2.1 Drain, Waste, & Vent Systems

**SINK - PLUNGER MISSING / NOT
FUNCTIONING PROPERLY**

DOWNSTAIRS BATHROOM

The sink plunger (stopper) was not functioning properly at time of inspection. The plunger does not move with the rod. I recommend having a qualified professional evaluate and repair as needed for proper operation.

Contact a qualified professional.

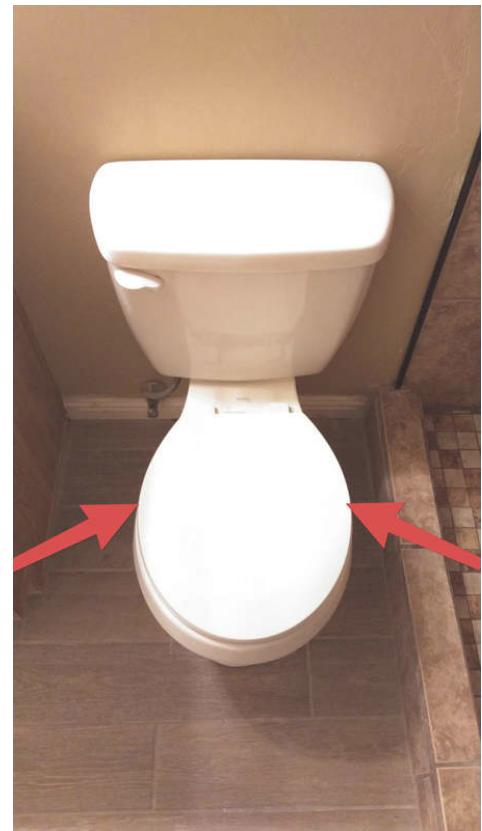
5.2.2 Drain, Waste, & Vent Systems

TOILET - LOOSE AT THE BASE

UPSTAIRS LOFT BATHROOM

At the time of inspection I observed a toilet that was loose at the base. A loose toilet can leak from the base wax ring/gasket. I recommend having a plumbing professional evaluate and secure / repair as needed to prevent leaking.

Contact a qualified plumbing contractor.

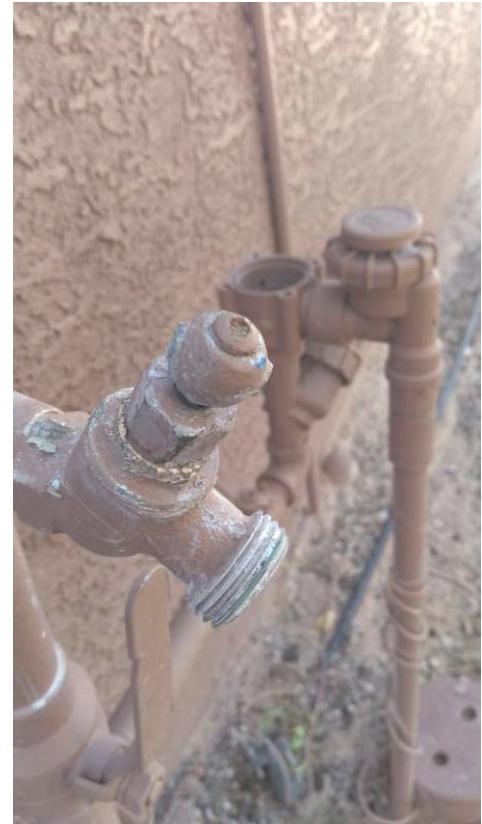
5.3.1 Water Supply, Distribution Systems & Fixtures

HOSE BIB HANDLE BROKEN

NORTH SIDE YARD (NEAR THE MAIN WATER SHUT OFF)

At the time of inspection I observed a broken hose bib handle. I recommend having a qualified professional repair or replace as needed for proper function.

Contact a qualified professional.

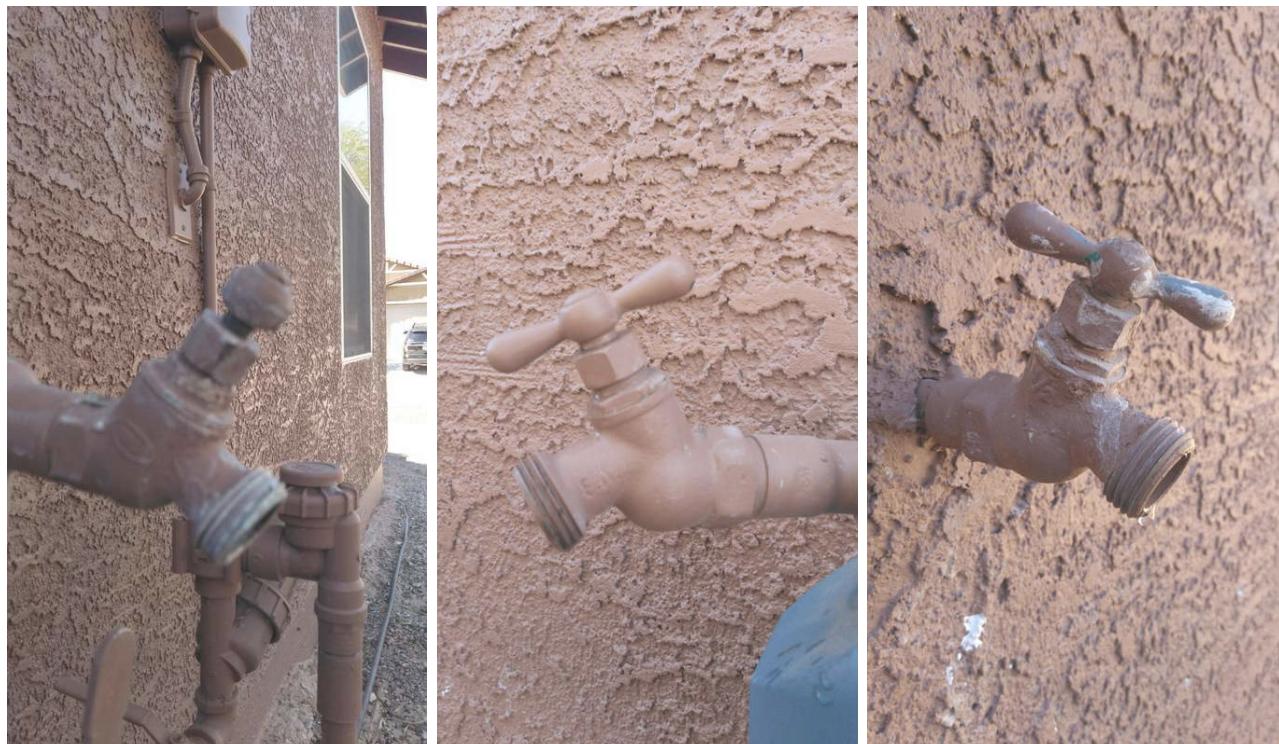
5.3.2 Water Supply, Distribution Systems & Fixtures

NO ANTI-SIPHON DEVICE ON EXTERIOR HOSE BIB(S)

EXTERIOR HOSE BIBS

At the time of inspection there was no anti-siphon device on the exterior hose bib(s). I recommend having an anti-siphon device installed to prevent the possibility of contamination.

Contact a qualified professional.

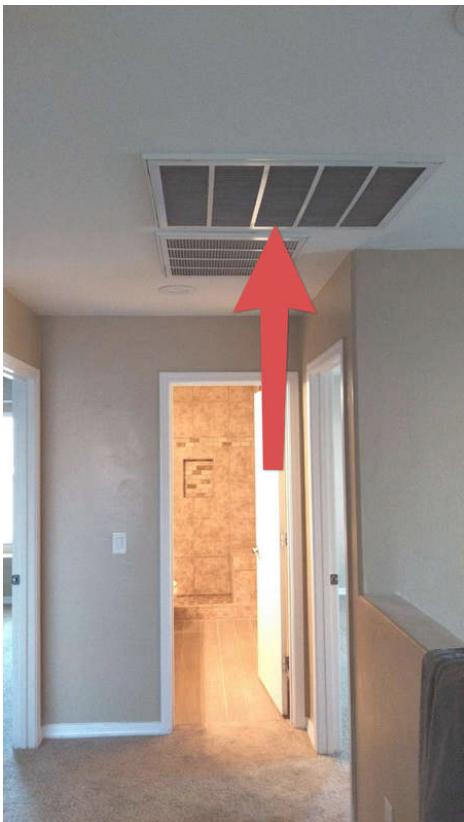
A/C temperature Splits: Normal temperature split reading

The AC system had normal temperature splits at the time of inspection. Temperature split was measured by taking temperature readings at the return air duct and Supply air duct, the difference is the temperature split. Acceptable temperature split ranges between 14 F and 24 F, with 18 F to 20 F being ideal.

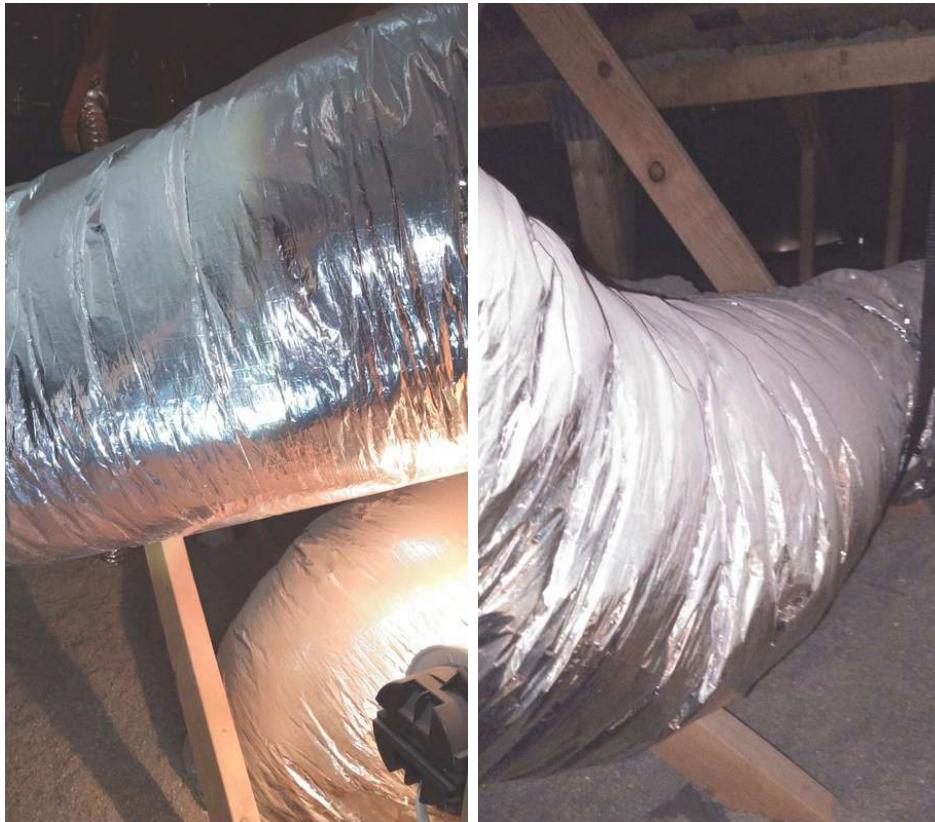
Distribution System: Ductwork

The visible sections of ductwork are insulated

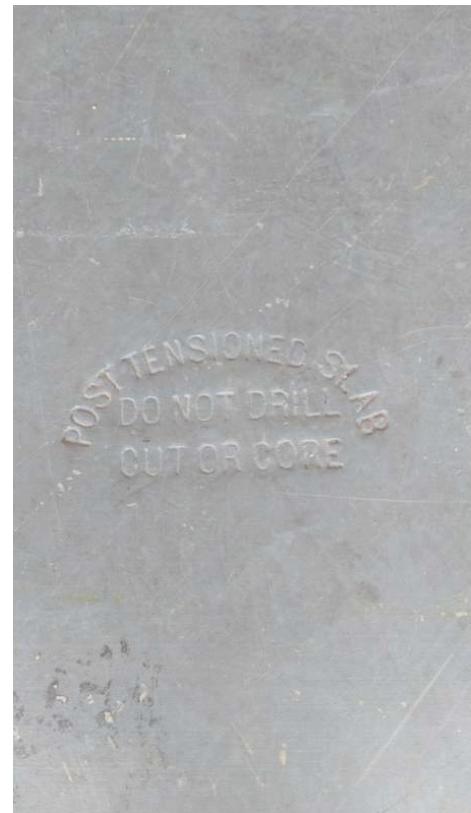
Floor Structure: Material

Post tension concrete

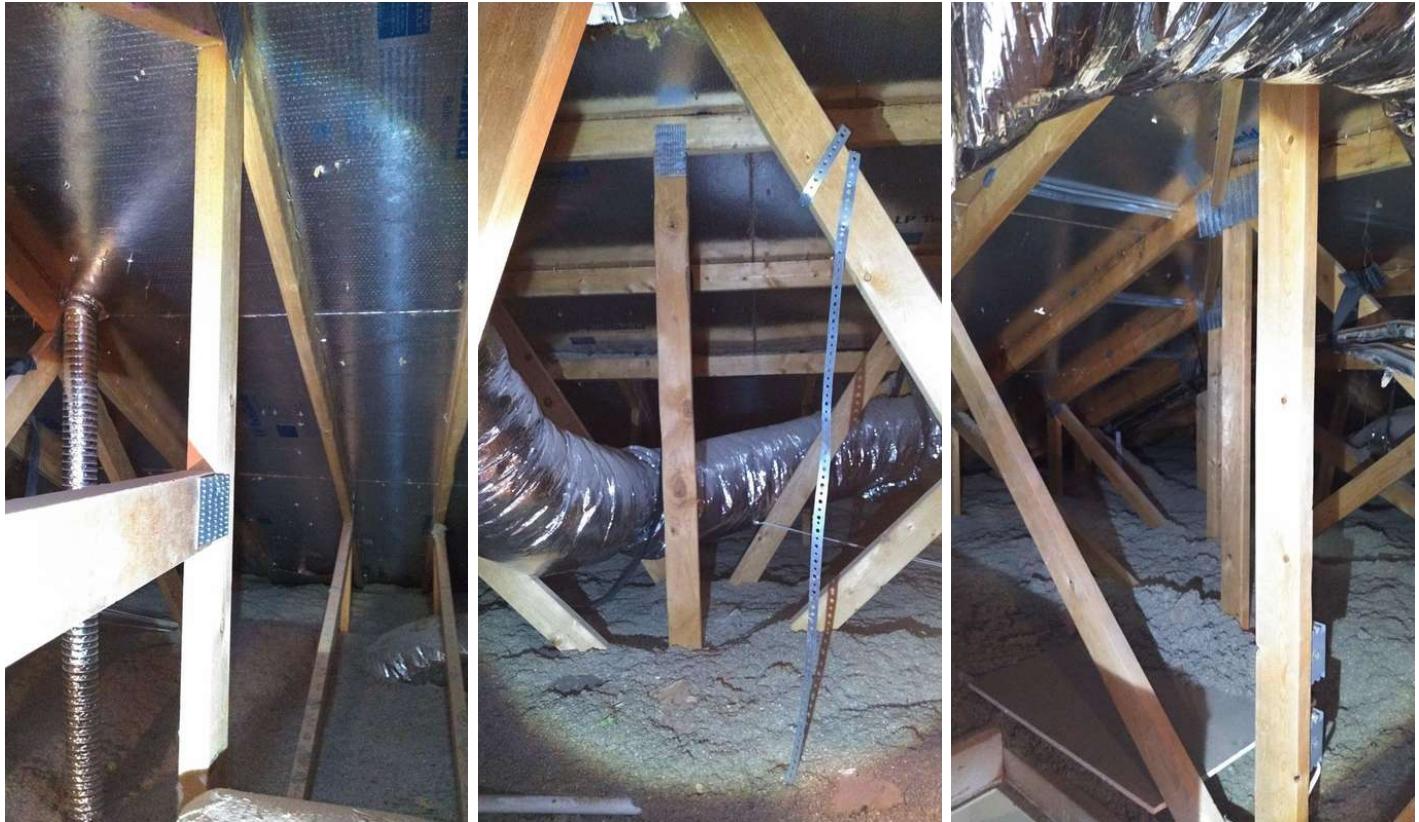
Ceiling Structure: Ceiling structure

Wood trusses

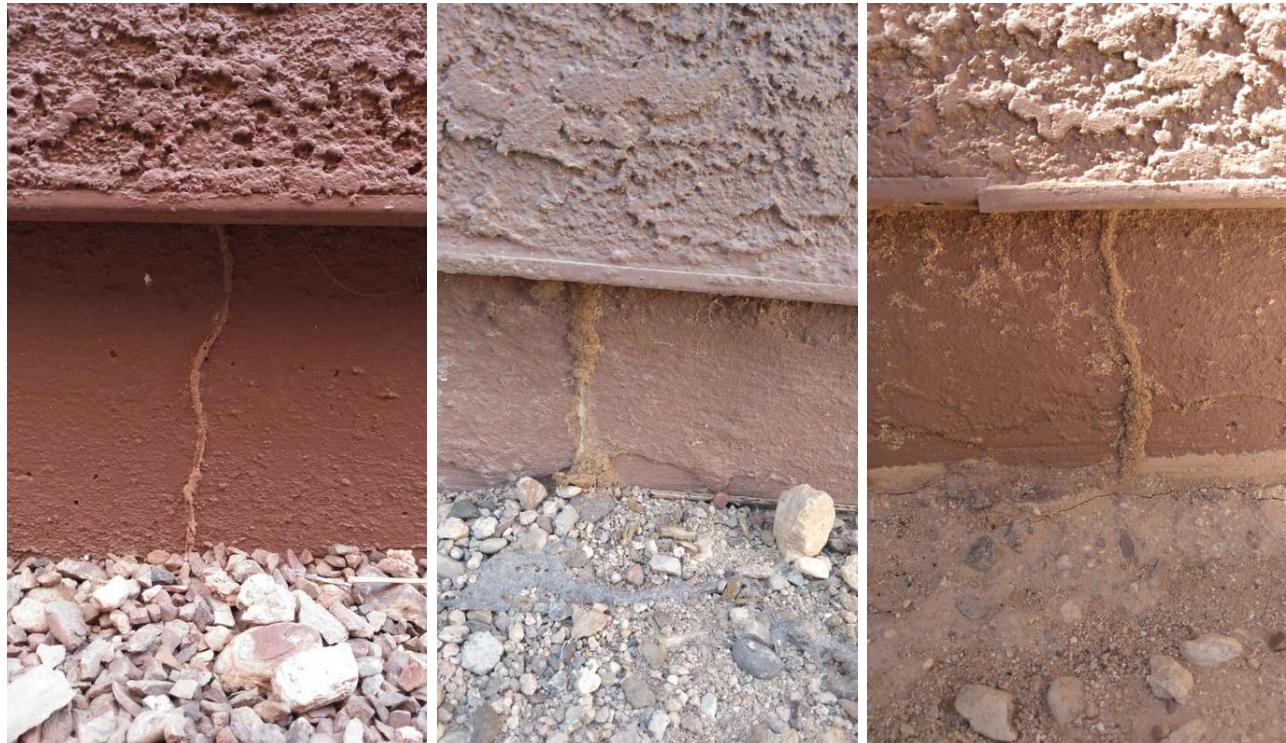
There is evidence of wood destroying organisms in the homes foundation/floor structure. The home inspector is permitted to report damage/evidence caused by insects, but may not identify or attempt to identify the type of pest causing the damage. I recommend having a pest control professional evaluate and discuss a treatment plan as needed.

Contact a qualified pest control specialist.

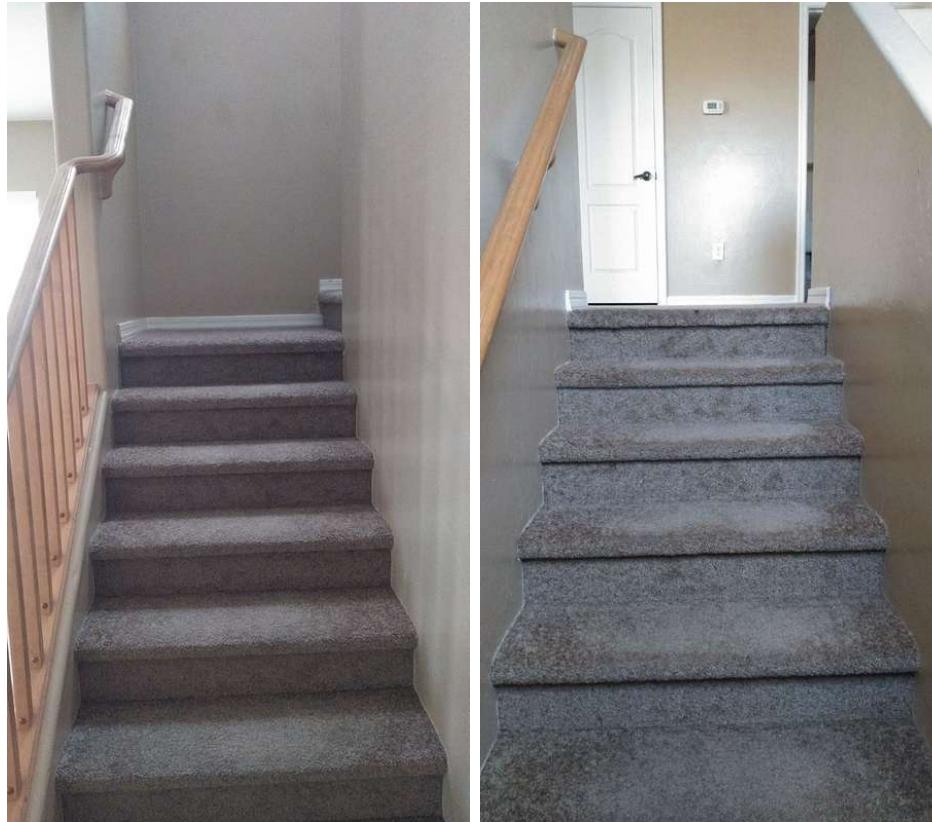
Steps, Stairways & Railings: Steps, Stairs, Railing

Safe secure hand railing, Proper Tread height and depth

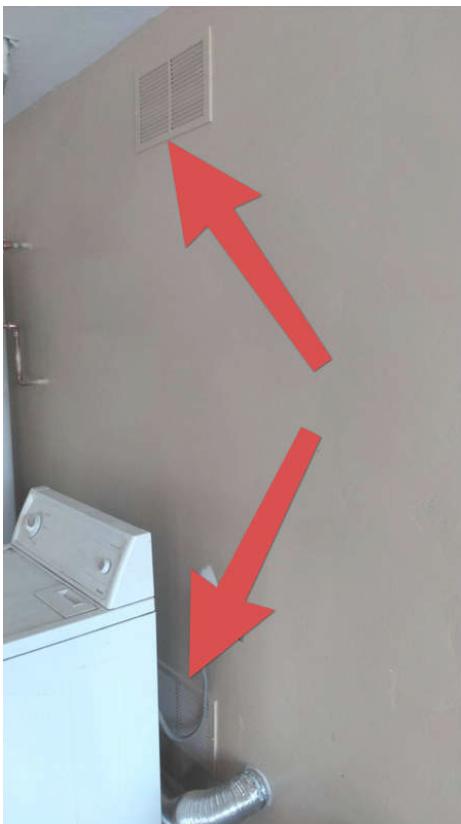
**Ventilation: High/low venting**

The High/Low venting is in place to provide gas appliances combustible air needed for proper combustion. Keep the vents clear and unobstructed for proper ventilation.

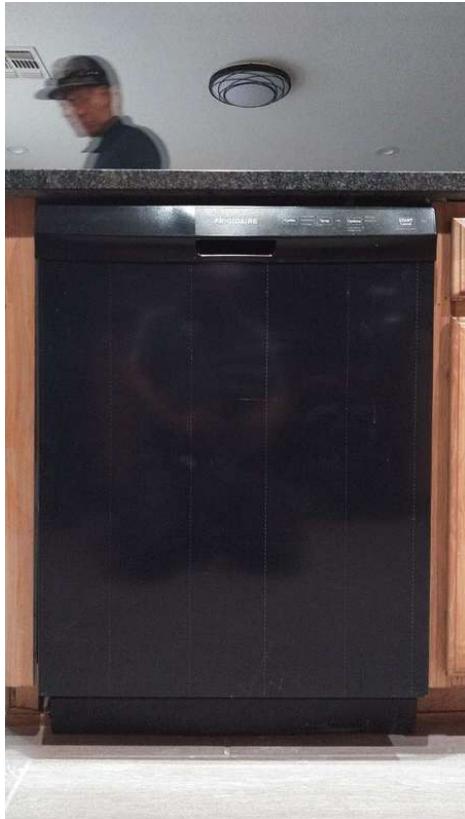
Dishwasher: Brand

Frigidaire

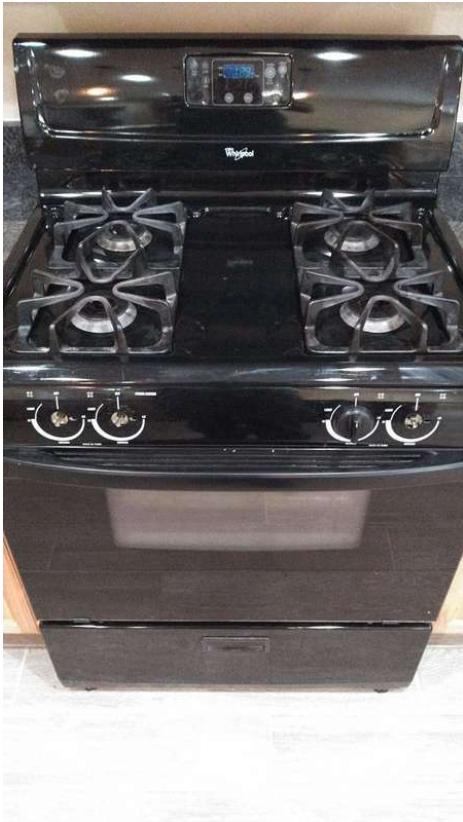
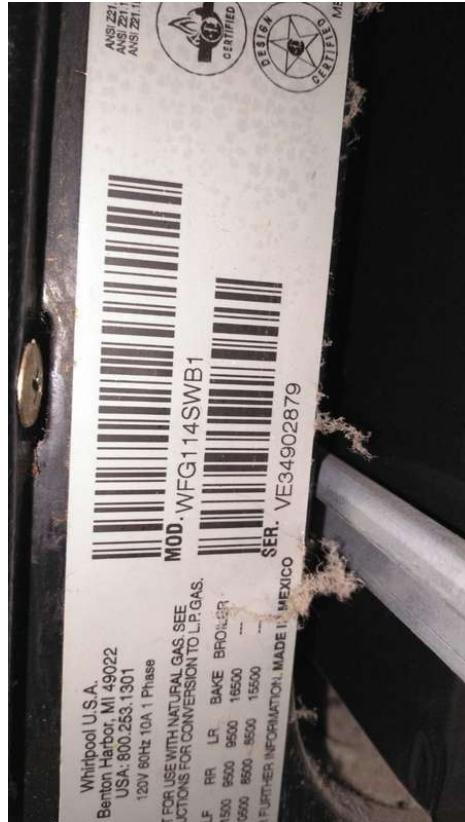
Range/Oven/Cooktop: Range/Oven Brand

Whirlpool

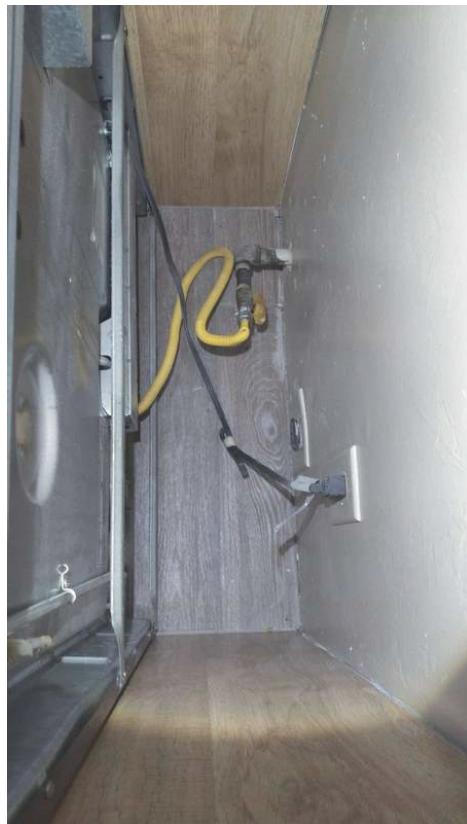
**Range/Oven/Cooktop: Anti-tip device**

Not present

There was no anti-tip devise present at the time of inspection. The anti tip devise is a metal bracket mounted to the floor or the wall behind a free standing range to prevent it from tipping if weight is applied to the open door. I recommend installation of an anti-tip device to eliminate this hazard.

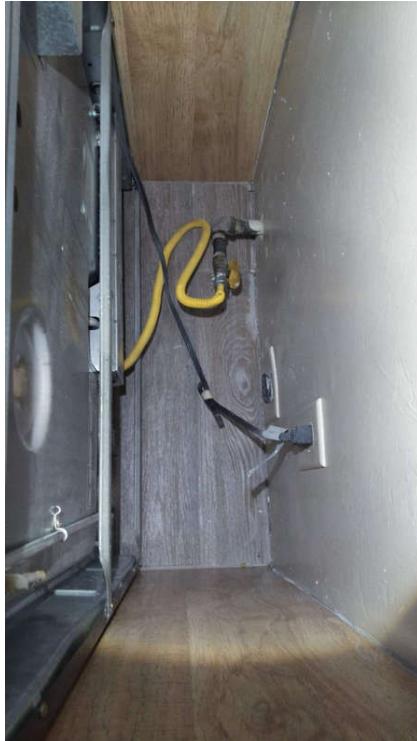
10.3.1 Range/Oven/Cooktop

NO ANTI-TIP DEVISE PRESENT

Contact a qualified professional.

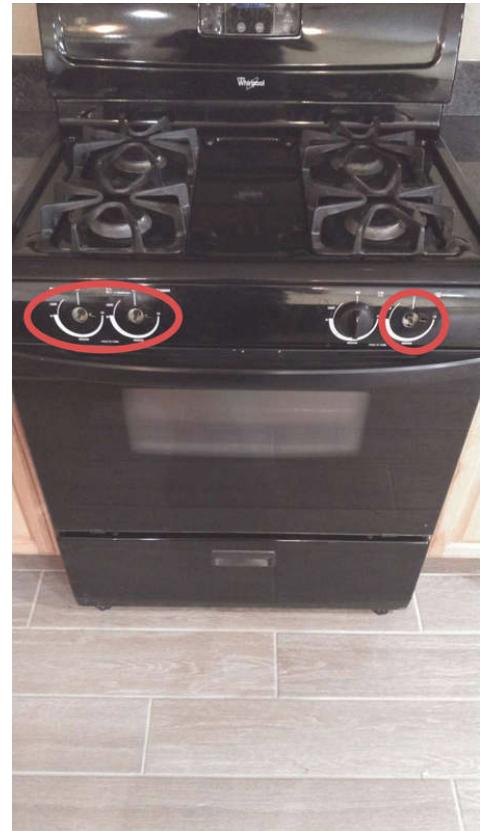
10.3.2 Range/Oven/Cooktop

MISSING KNOBS

At the time of inspection the stovetop controls were missing 3 knobs.
I recommend installing the proper knobs as needed.

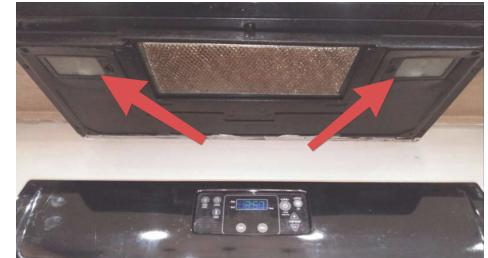
10.6.1 Built-in Microwave

STOVETOP LIGHTS - NOT OPERATIONAL

At the time of Inspection the stove top lights were not operational. This could be due to a number of issues such as a bad bulb, faulty switch or another issue. I recommend replacing the bulb, if the lights still don't work have an appliance repairman evaluate and repair as needed.

Contact a qualified appliance repair professional.
