TOPNOTCH BUILDING INSPECTIONS

FRAME STAGE INSPECTION

1234 Main St. Preston Victoria 3072

25/07/2020 9:00AM

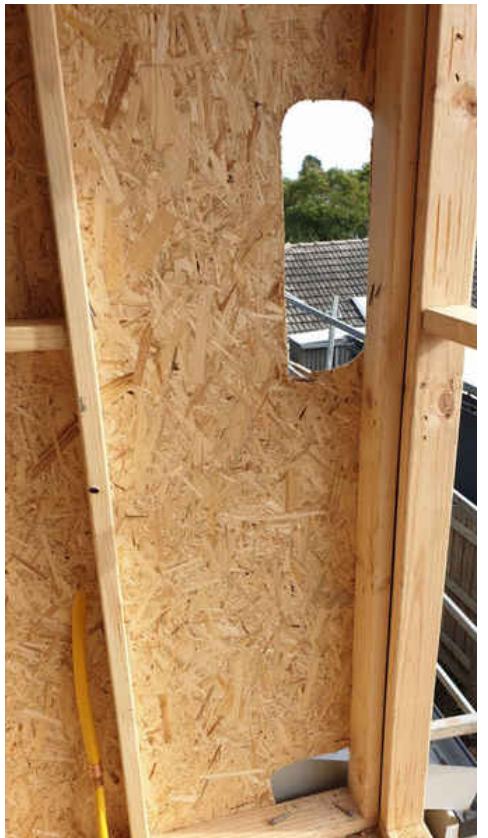
Bedroom 4 West

It was observed that some of the wall framing studs have not been laminated with the minimum required fixings / nails as required by Australian Standard 1684.2 - 2010

Recommendation
Contact your builder.

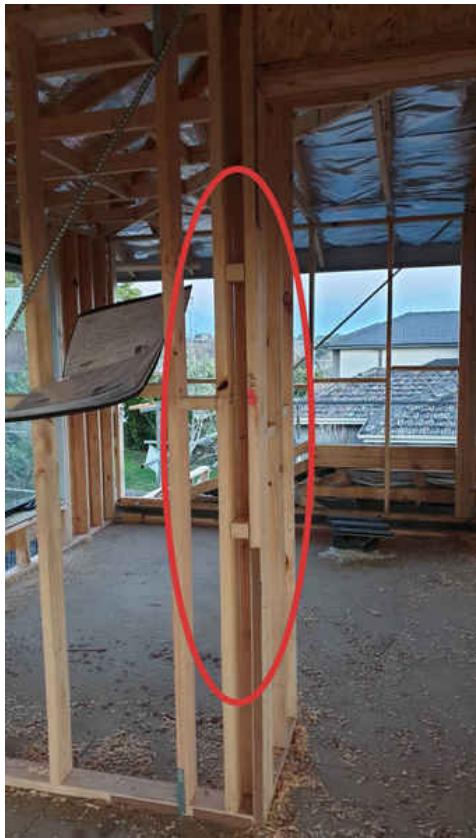
Master Bedroom / WIR

Blocking at intersecting walls - Insufficient / non-existent wall blocking was observed at intersecting walls in the nominated locations throughout the Structure.

It is noted, Engineering Drawings by Structerre Consulting, Project Number 116578, sheet Number S-600 requires blocking to be provided at a maximum 800mm centres as detailed on Engineering Drawings.

I recommend all wall intersections are fixed as per AS1684.2 - 2010

Contact your builder.

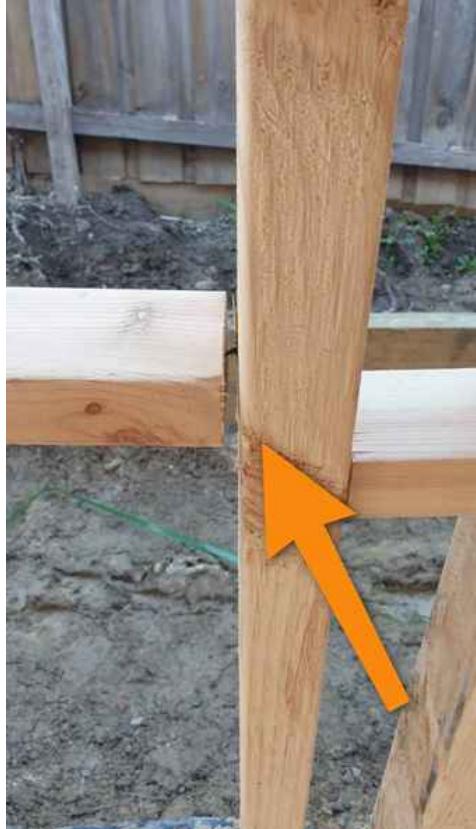
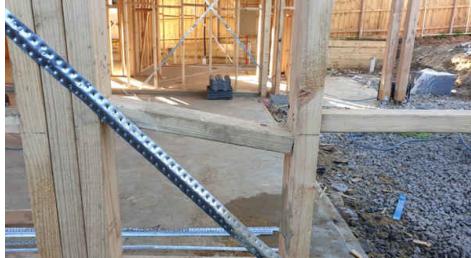
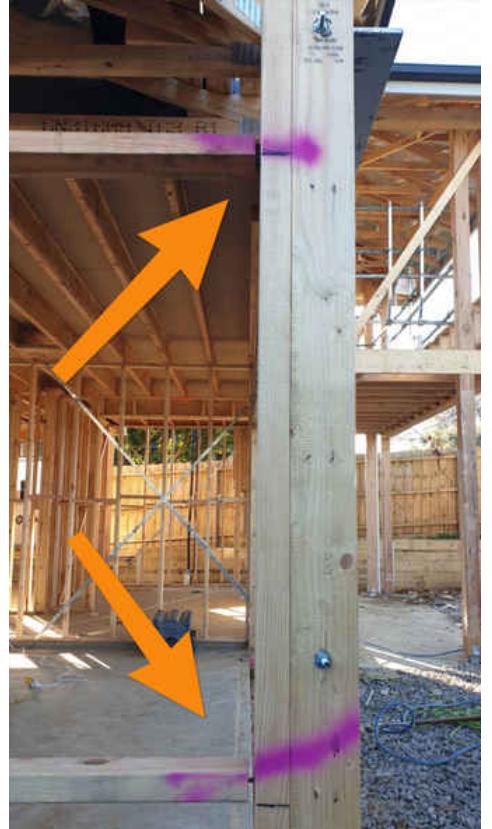
Noggings in one or more locations were observed to have been poorly fixed or installed.

South Garage, Noggings are required to be fixed with 2 fixings each end

I recommend installing noggings in compliance with AS1684.2 - 2010

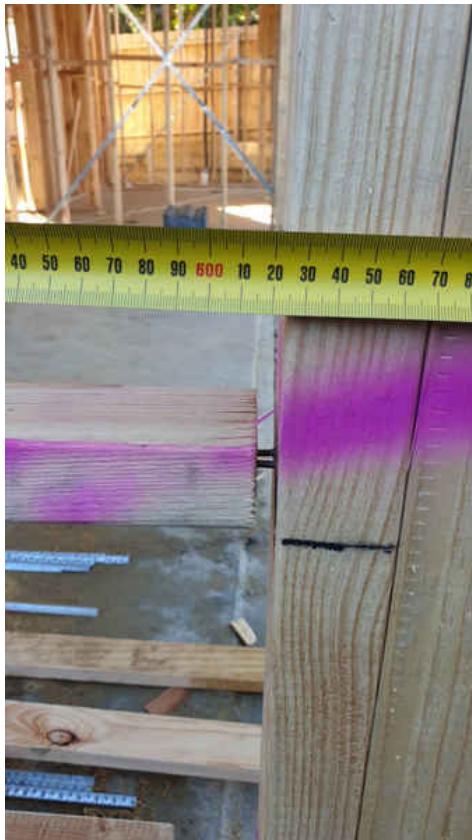
Garage, South East Corner

Major Defect / Safety Hazard

I recommend installing another stud to reduce the stud spacings.

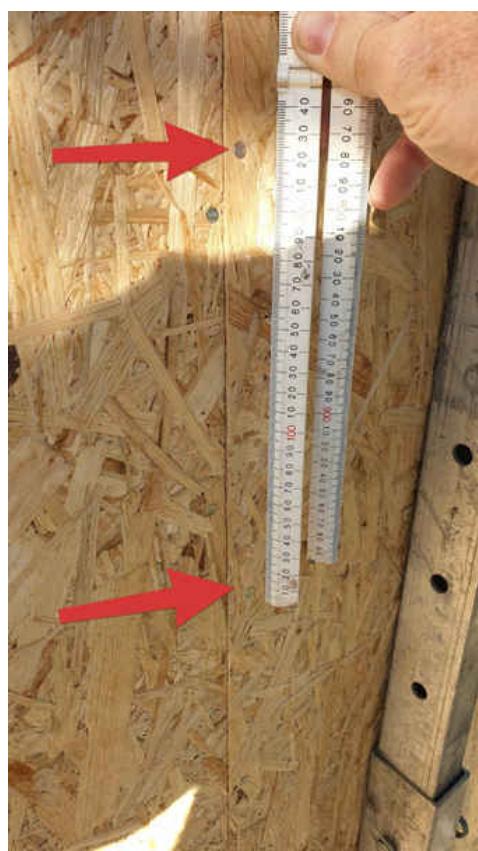
Exterior West Living Room

Insufficient fixings / defects were observed in the BR5 Bracing units required by Structerre Consulting, Sheet No. S-500 and S-602.

I recommend the builder rectifies all defects and ensures the BR5 bracing units are in compliance with the Engineering Drawings with particular attention to fixing spacings, fixings to noggings and ensure the bracing is fixed to **all studs** within the bracing unit.

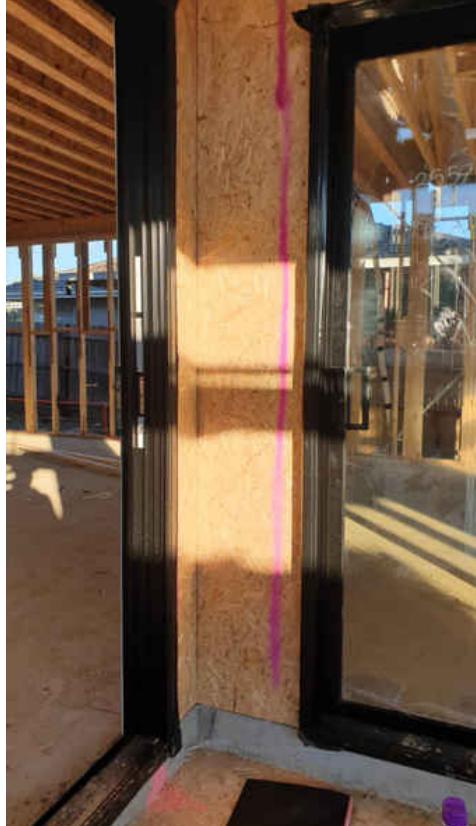
Exterior North Alfresco

Insufficient fixings / defects were observed in the BR4 Bracing units required by Structerre Consulting, Sheet No. S-500, S-501 and S-602.

I recommend the builder rectifies all defects and ensures the BR4 bracing units are in compliance with the Engineering Drawings with particular attention to fixing spacings, fixings to noggings and ensure the bracing is fixed to **all studs** within the bracing unit.

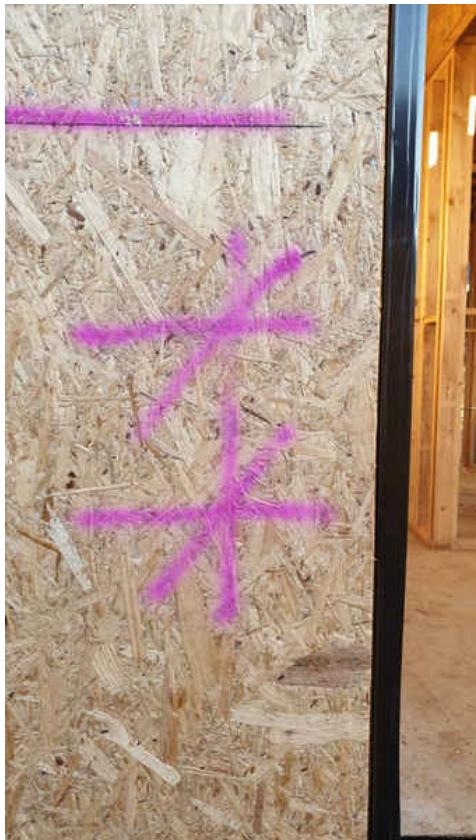
External North Theatre check all

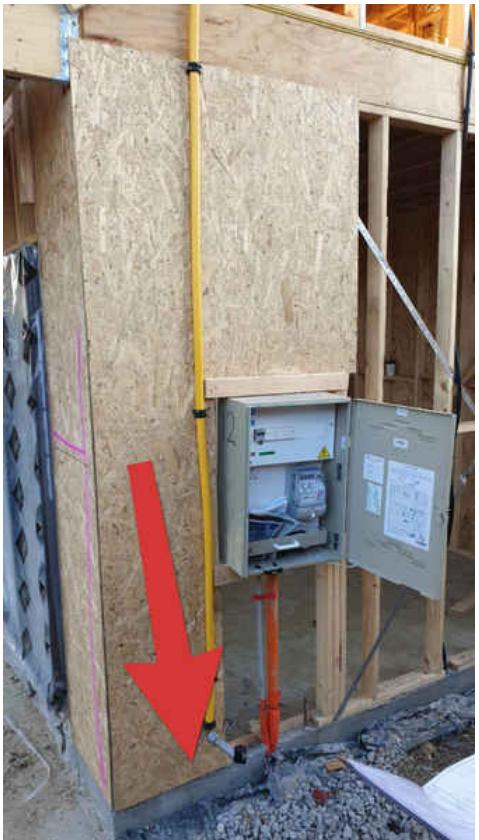
Exterior North Study Bottom of Ply not fixed

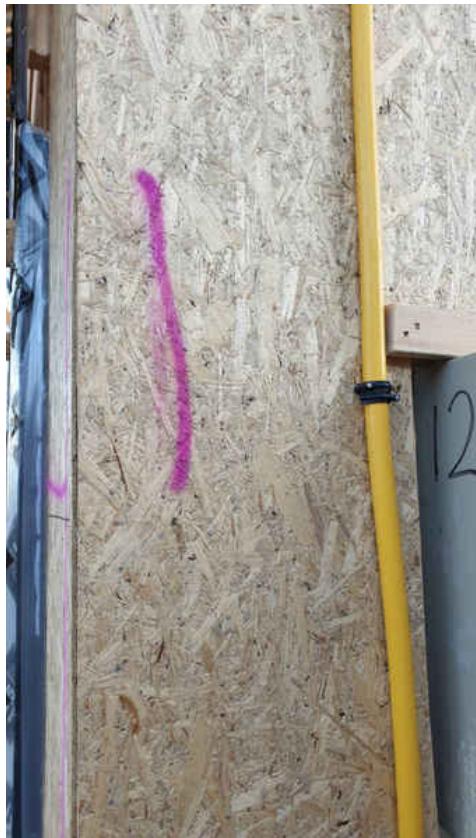
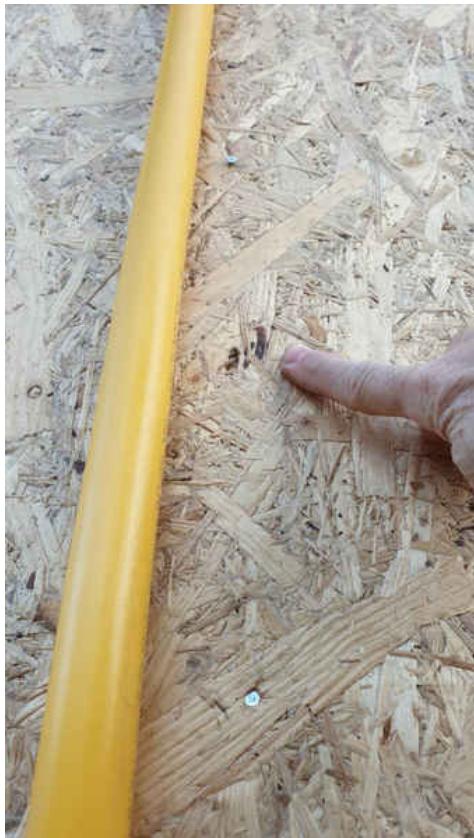
Exterior North Study, Nails driven under.

Exterior East Study, Fixings in excess of required spacing of 150mm

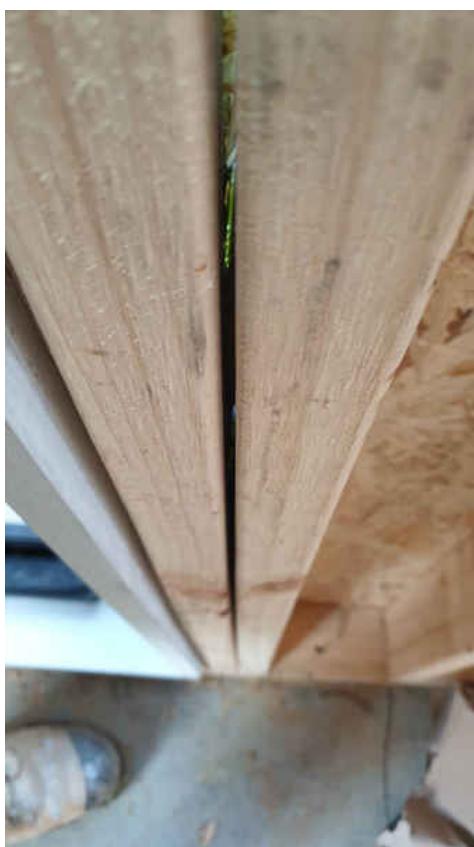
East Study BR4 Bracing Nails

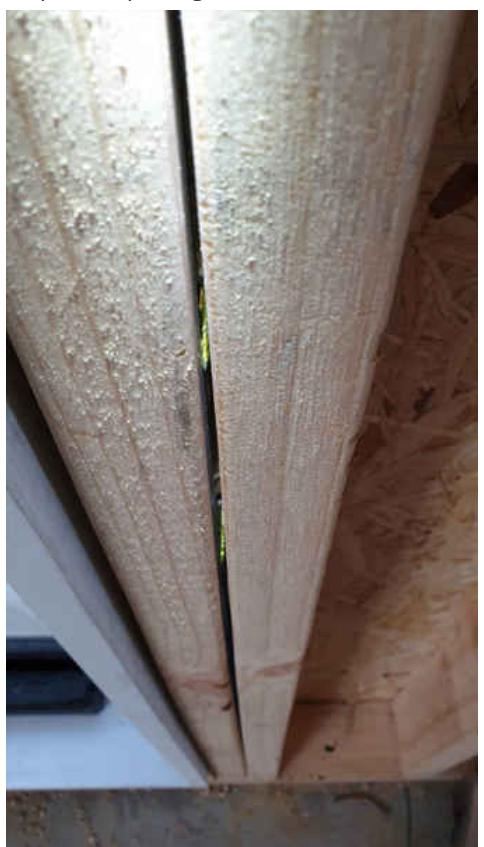
East Study BR4 Bracing Nails

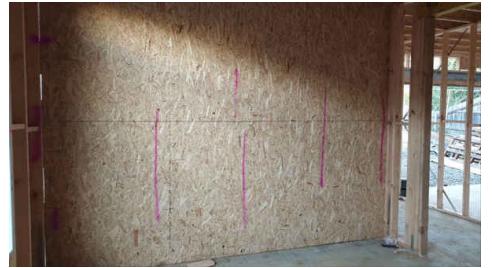
Theatre East

Theatre Room Ply Bracing in general,
check all to ensure it complies. Note
Fixings required at 150 mm centres

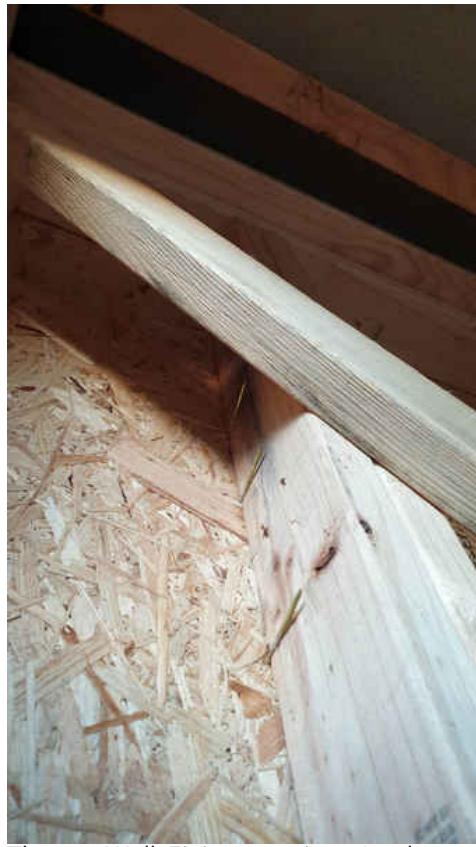
Theatre Wall, Fixings not into Stud

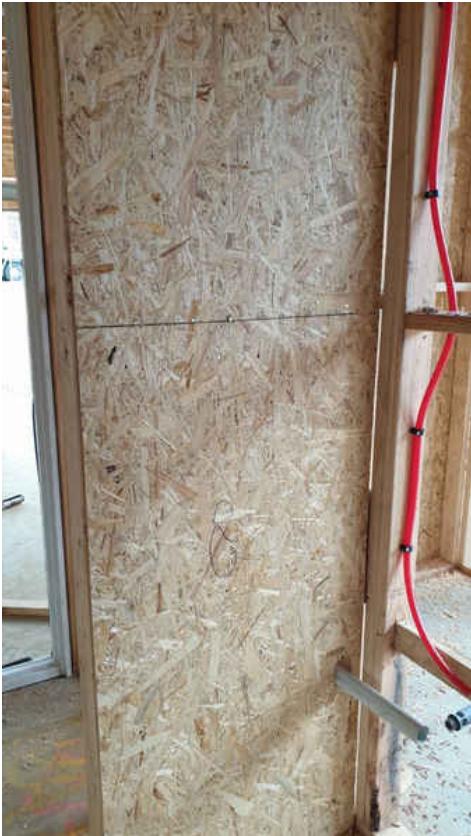
Ground floor Powder Room, BR4
Bracing not nailed at 150mm centres in
some locations, check Fixings

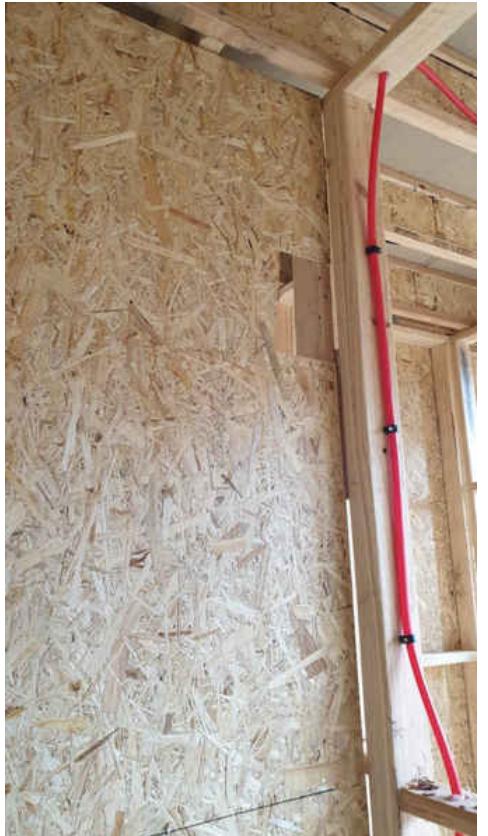
Powder room BR4 Bracing cut out not
blocked and fixed.

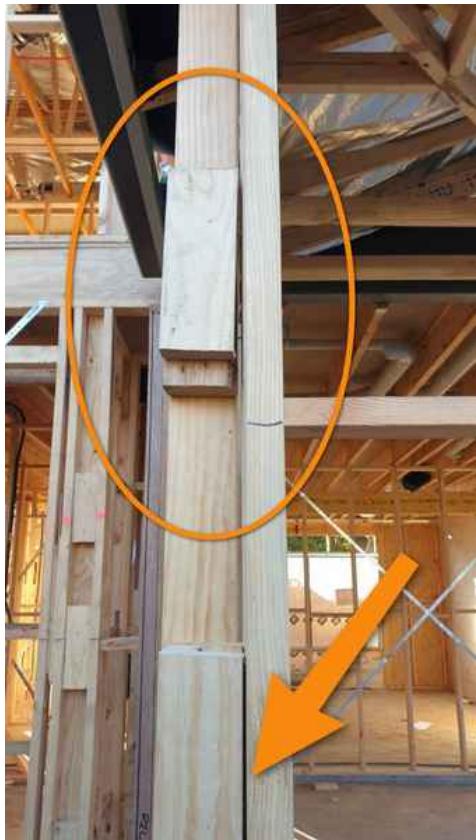
South Garage

I observed one or more locations of poor workmanship.

I recommend these items are rectified and comply with AS1684.2 - 2010

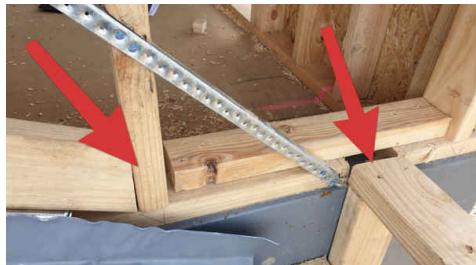
Master Bedroom WIR South, Missing Tie Down

I recommend installing metal strapping and nails in accordance with the Engineers detail BR2 Option B on S-601

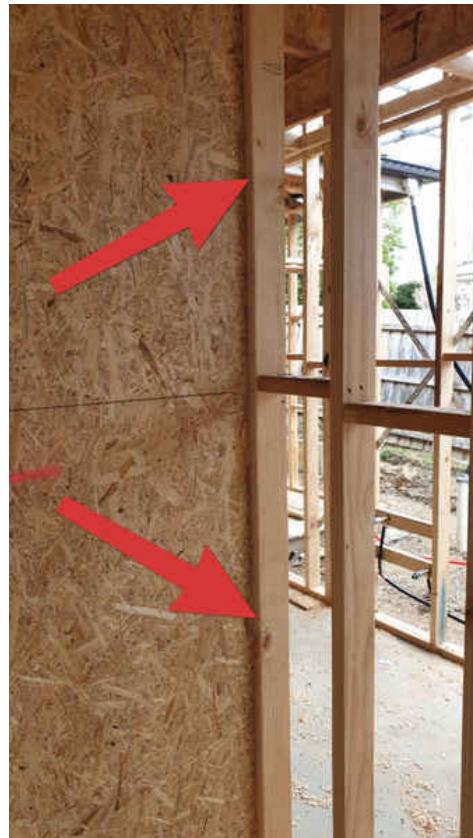
Fridge Area, Walls not yet fixed

I recommend all wall intersections are fixed as per AS1684.2 - 2010
Note not all locations were photographed.

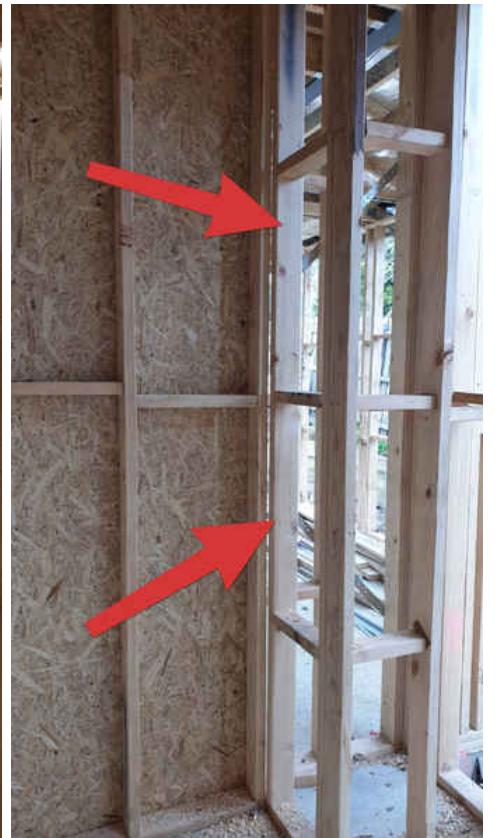
Butlers Pantry

During my inspection, I observed Macsim Window Horse Shoe packers were installed as packing. These packers provide little in the way of bearing capacity to support the concentrated loads. Solid plastic shims are available and recommended for use in these situations.

I recommend the builder confirms with the relevant engineer as to the adequacy of the installed window horseshoe packers or replace the packers with solid shims.

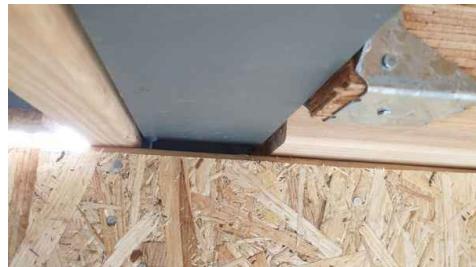
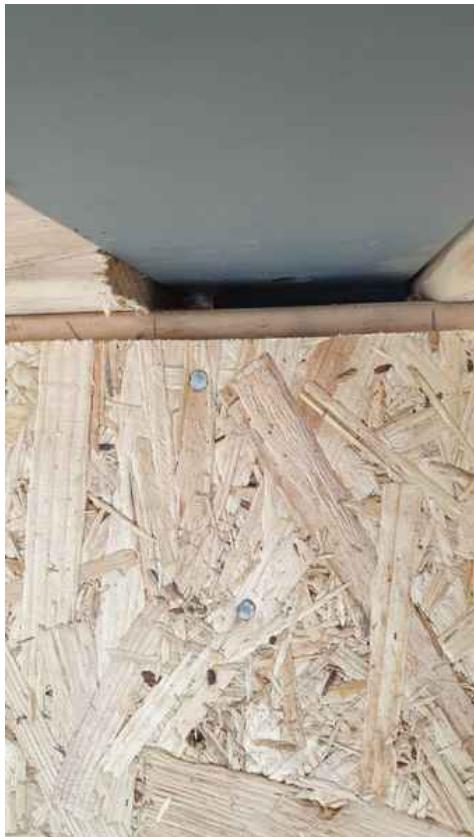
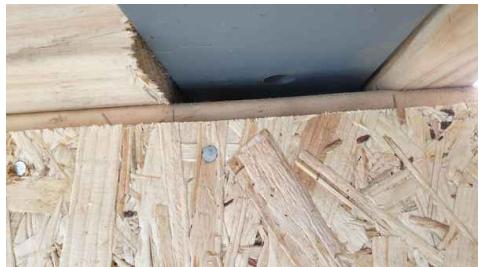
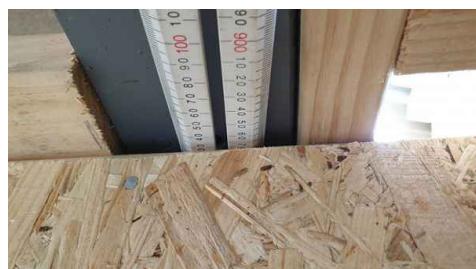
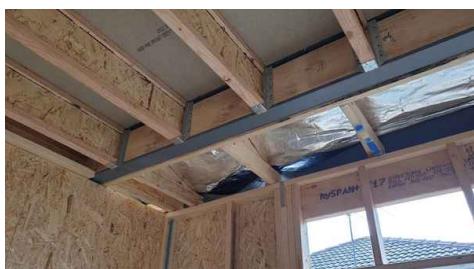
Note not all hold down / fixing details were able to be fully inspected due to the construction and this was a limitation to my inspection.

Contact a qualified structural engineer.

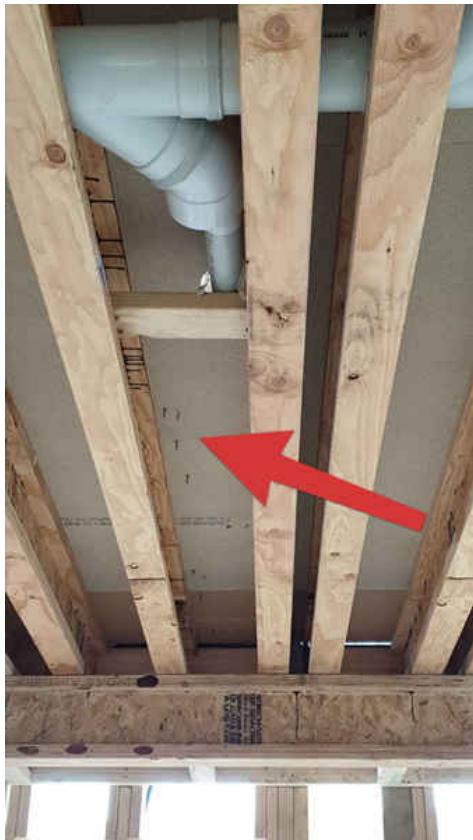
1st Floor, Floor Frame, Bracing Wall Not Tied to Floor structure. (Bathroom Wall)

I recommend further advice from a Structural Engineer or Dindas Engineer.

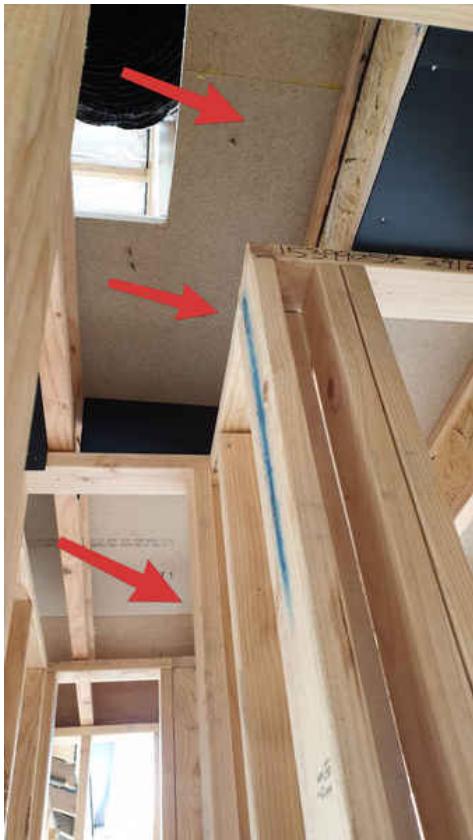
1st Floor, Master Ensuite Bracing wall not tied to Floor Frame

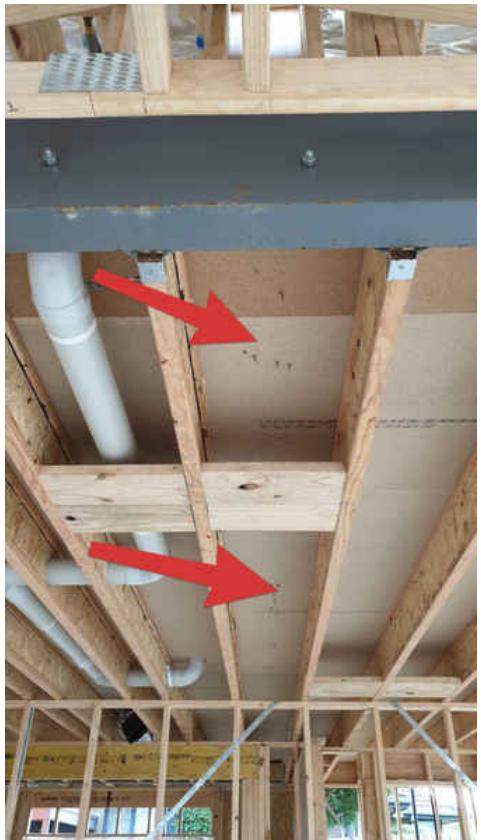
1st Floor, Master Bed WIR / Ensuite BR4 Bracing wall not tied to Floor Structure

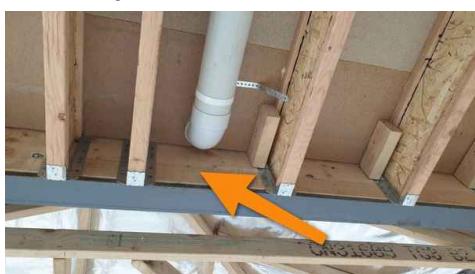
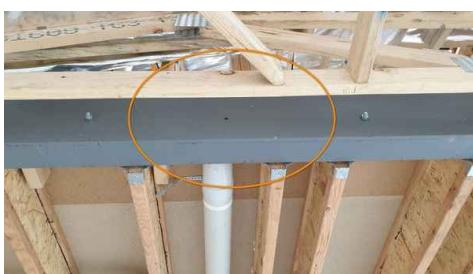
A bolt was observed not to have been installed or removed in the garage steel beam that supports the WIR and Ensuite (Southern) First floor Wall.

I recommend installing new bolt as required.

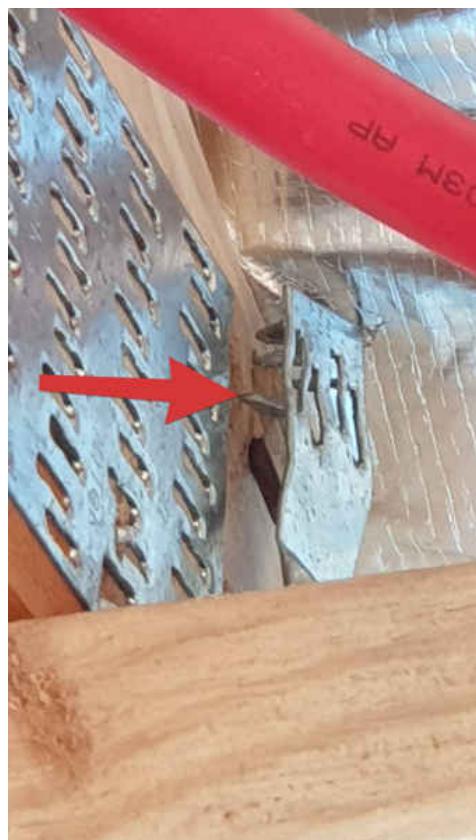
South Master Ensuite

Some truss tie downs were observed to have been not installed or removed.

I recommend installing truss tie downs as per the truss makers recommendations.

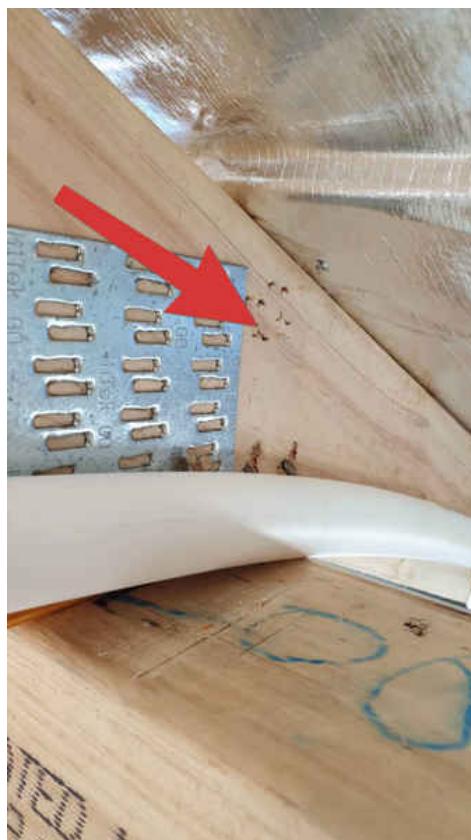
South Bedroom 2 Tie Down removed

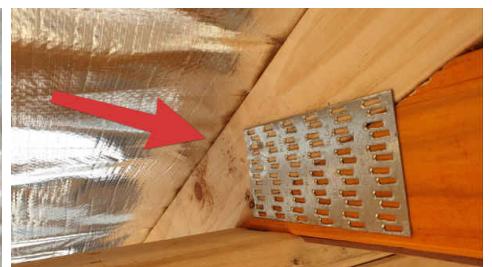
North Activities Room, Tie Down Removed

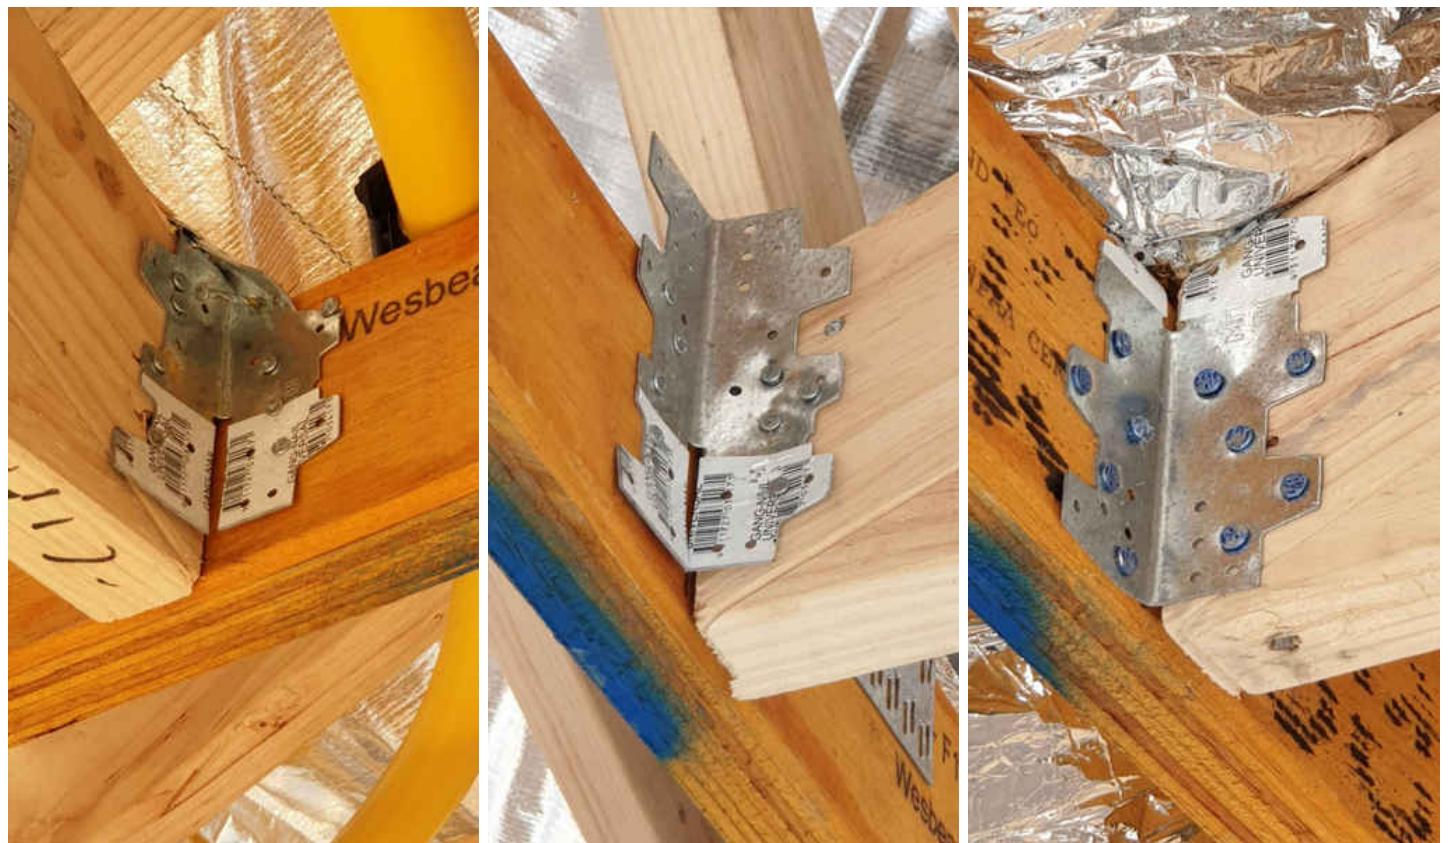
Master Bedroom

Universal Trip-L-Grips require 5 / 30 x 2.8mm Mitek nails to each face or receiving member as detailed by Mitek see [link here](#).

Furthermore, check the orientation of the brackets. Note some brackets have been installed upside down. I recommend installing additional fixings and re-orientating / replace brackets as required.

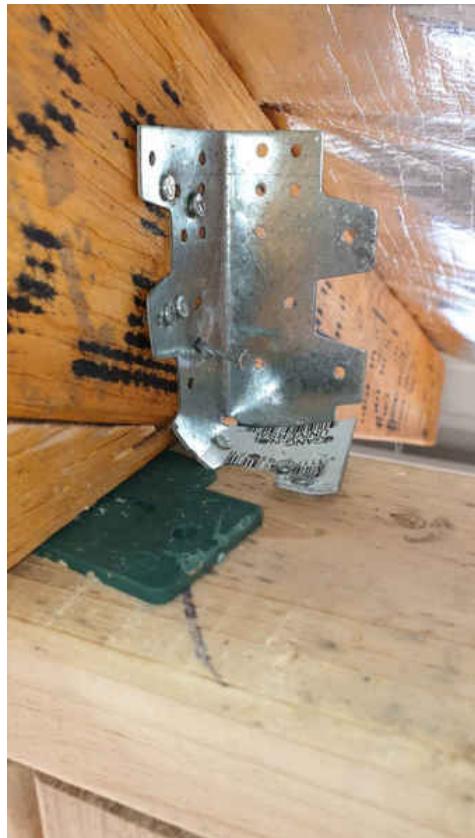
North Bedroom 4 Truncated Truss

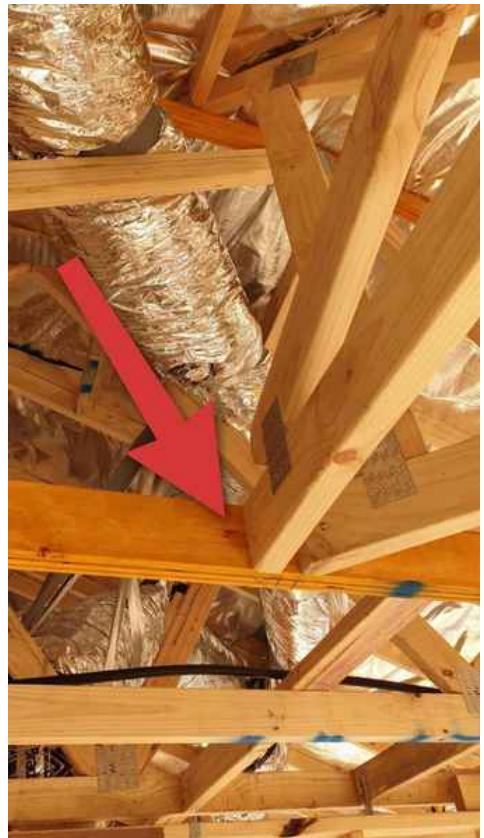
Bracket required in this location, check truss makers drawings for more information.
