ARK HOME INSPECTIONS LLC

## PROPERTY INSPECTION REPORT

1234 Main St. Clarkston Washington 99403

Buyer Name  
03/03/2021 9:00AM

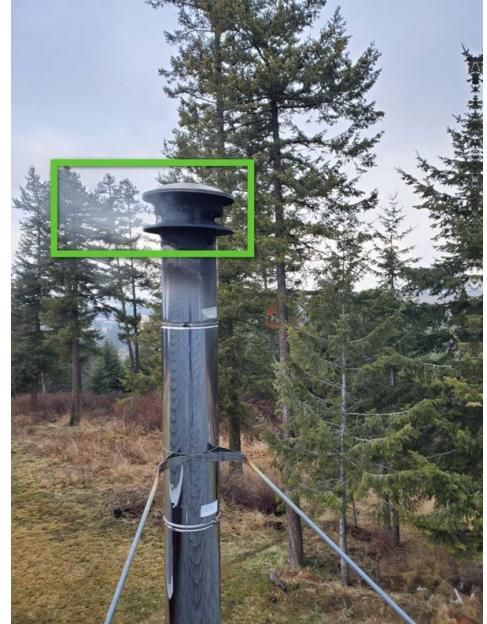
**IN USE**

The interior of the flue was not visible or accessible as it was in use at the time of inspection. Recommend regular cleaning and inspection as needed.

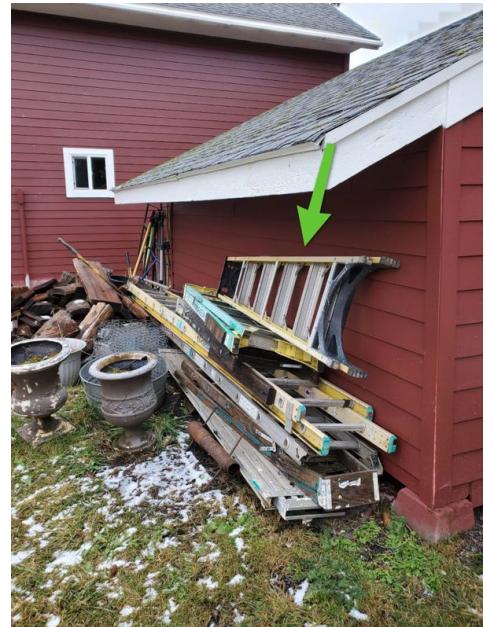
## NORTH/EAST SIDES HOUSE

**PERSONAL ITEMS**

Please note that I was not able to fully access several areas of the siding due to personal items present. Large or high amounts of items are not moved as part of this inspection.

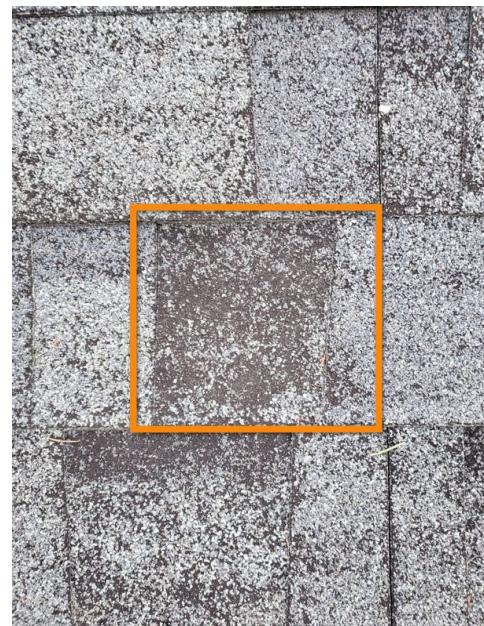
## 2.1.1 Roof Covering

There are several areas showing granule loss (appears to be normal aging). No major areas of missing granules observed. Recommend monitoring.

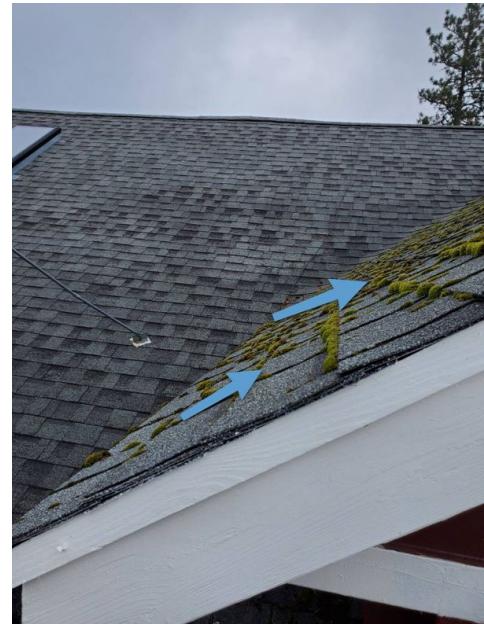
## 2.1.2 Roof Covering

**MOSS GROWTH--MINOR**

Moderate moss/algae growth present. This can be removed as needed to prevent moisture retention.

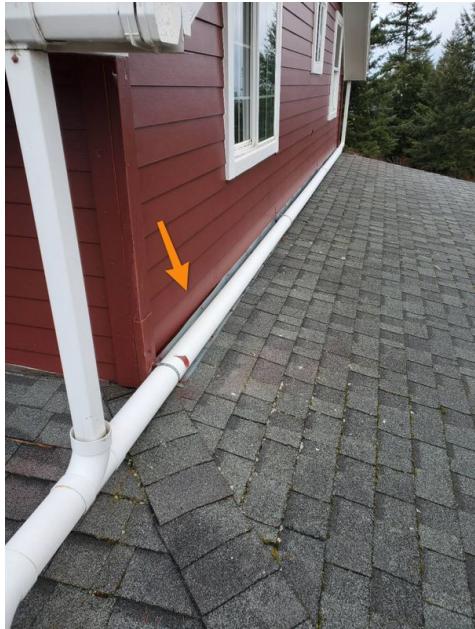
**LOOSE/SEPARATED**

Flashings observed to be loose or separated, which can lead to water issues. Recommend repair.

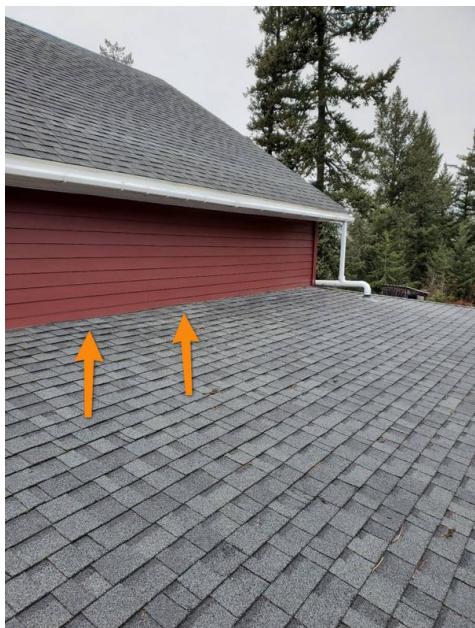
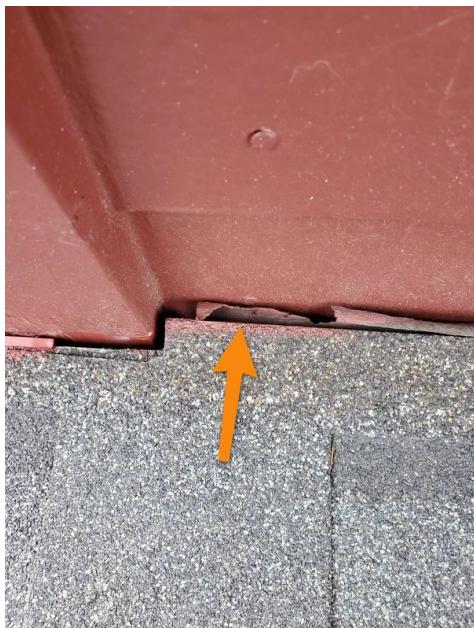
## 2.2.3 Flashing

**ROOF/SIDEWALL--MISSING**

There was no visible roof to side wall flashing observed. Installing proper flashing will help prevent moisture penetration.

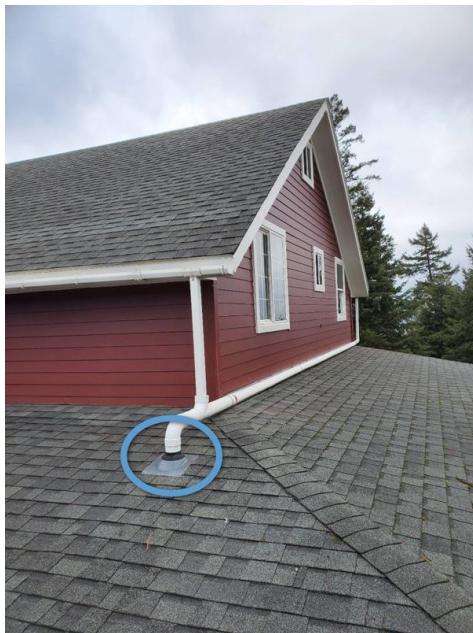
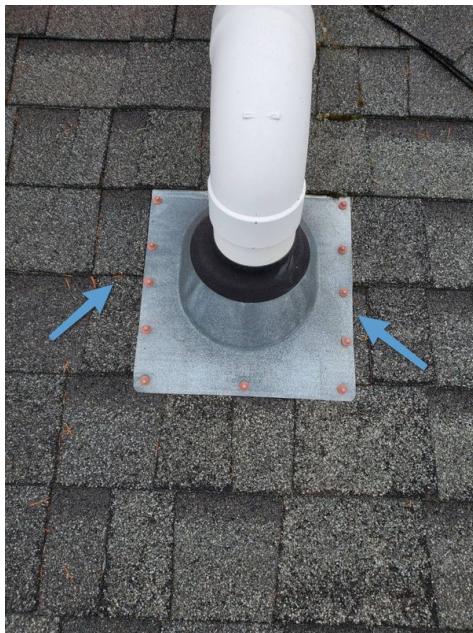
## 2.3.2 Plumbing Vent Pipes

**IMPROPER INSTALLATION**

The vent flashing does not appear to be properly installed. Ideally the top and side flashing should be installed under the roofing to prevent moisture intrusion. The top appears fine at this time, but most of the sides are exposed. Recommend further evaluation for repair as needed though to prevent possible moisture intrusion.

Contact a qualified roofing professional.

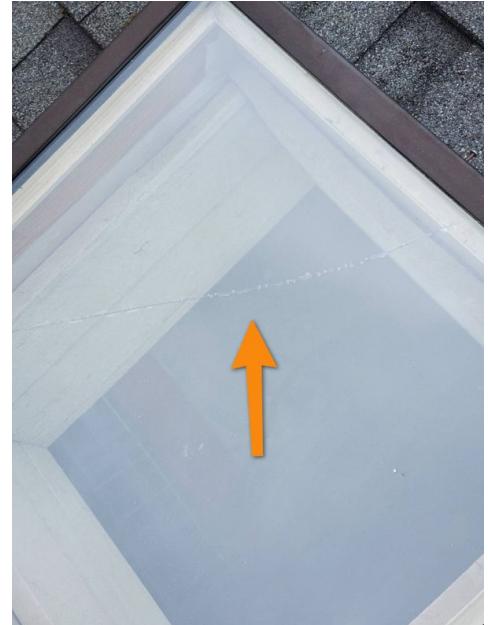
## 2.4.1 Skylights

**SKYLIGHT CRACKED**

NORTH SLOPE

Skylight was cracked in one or more places. Recommend a qualified roofing contractor repair.

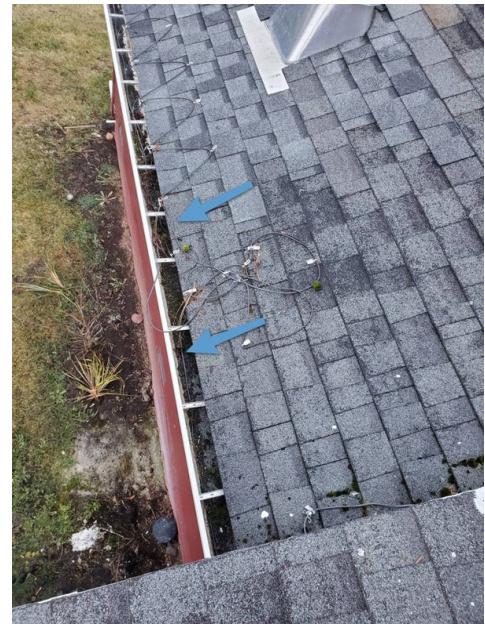
## 2.5.1 Gutters

**CLEANING RECOMMENDED**

The gutters have debris present. Regular cleaning is recommended.

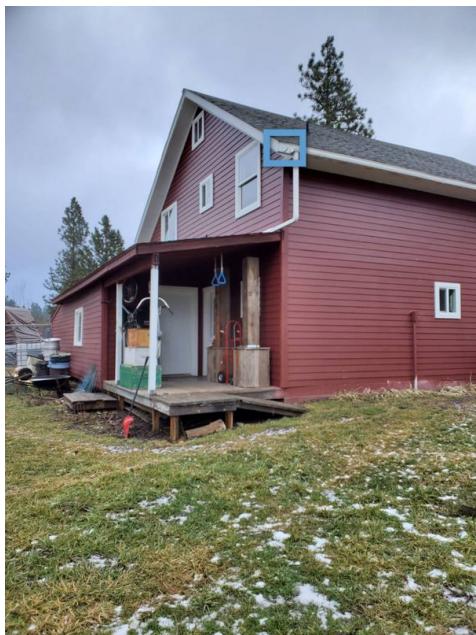
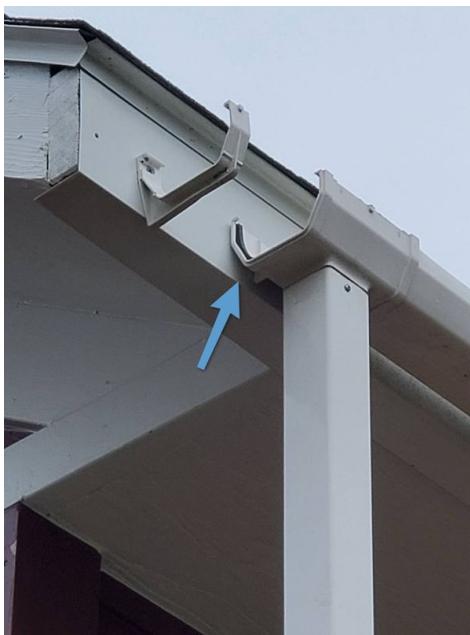
## 2.5.2 Gutters

**END CAP****WEST SIDE GARAGE**

Damaged/missing end cap(s) gutter section observed. Recommend repair/replacement to prevent moisture running out the end of the gutter(s).

Contact a qualified gutter contractor

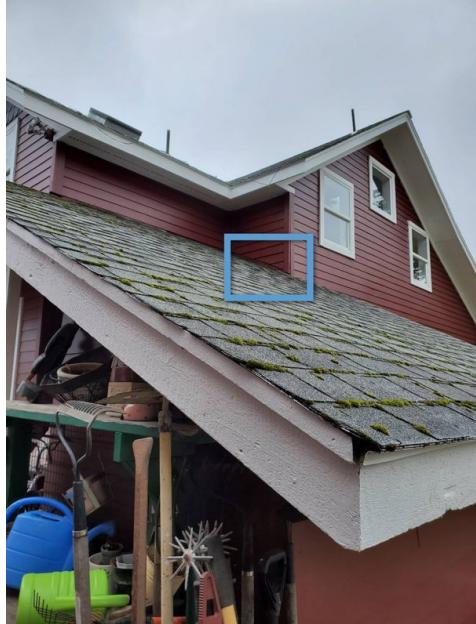
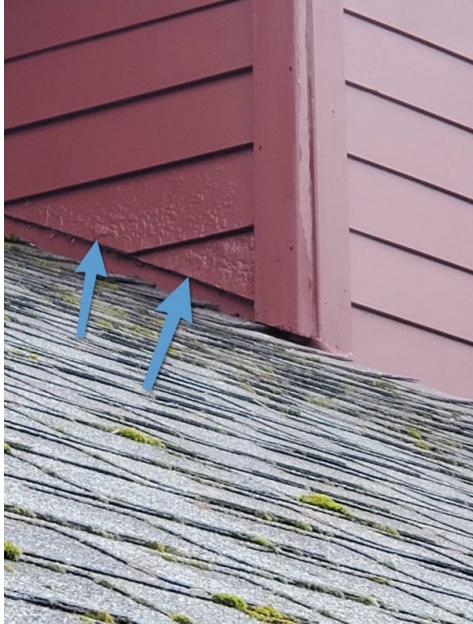
## 2.7.1 Siding

**BUBBLED PAINT**

Bubbled and cracked paint observed in various locations. These areas can be scraped and repainted as needed.

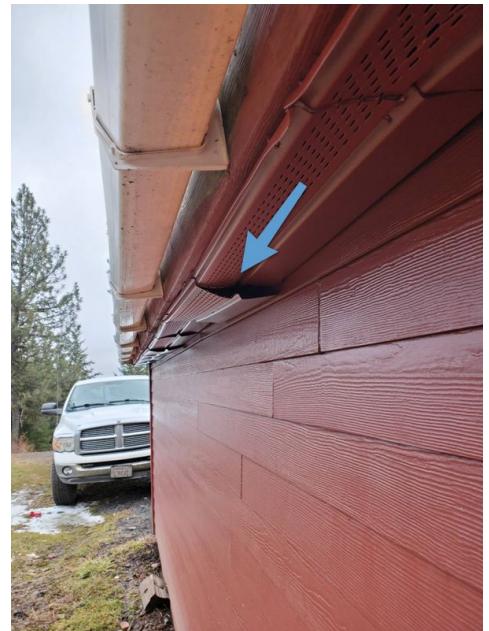
## 2.9.1 Fascia/Soffits

**LOOSE SOFFIT**

There are one or more loose soffits. Recommend repair/replacement as needed.

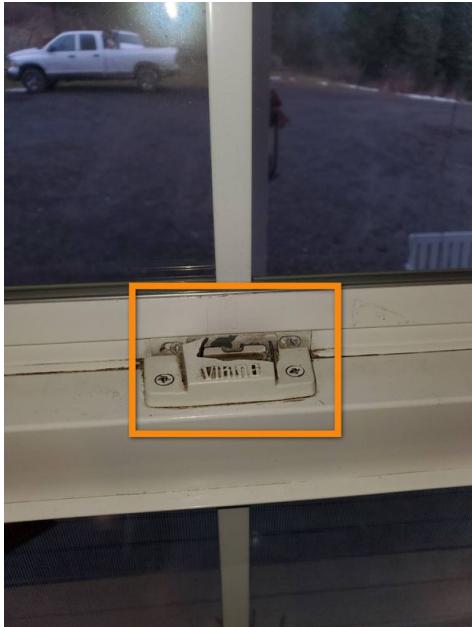
## 2.10.1 Windows

**BROKEN LOCK/LATCH**

There are one or more windows with broken latches. Recommend repair as needed.

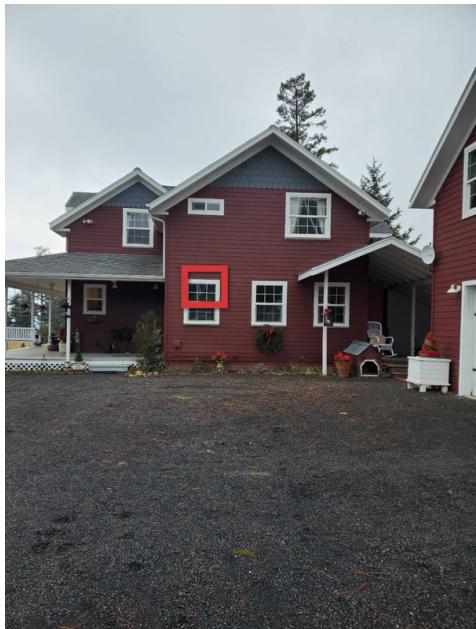
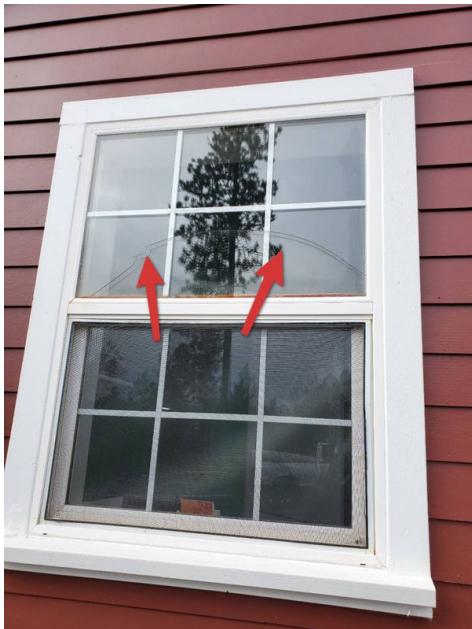
## 2.10.2 Windows

**CRACKED/BROKEN PANE**

Observed cracked/broken panes that should be replaced. Recommend qualified window contractor evaluate & replace.

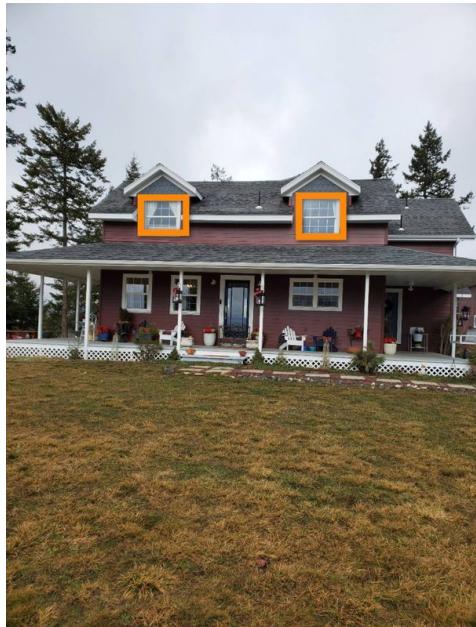
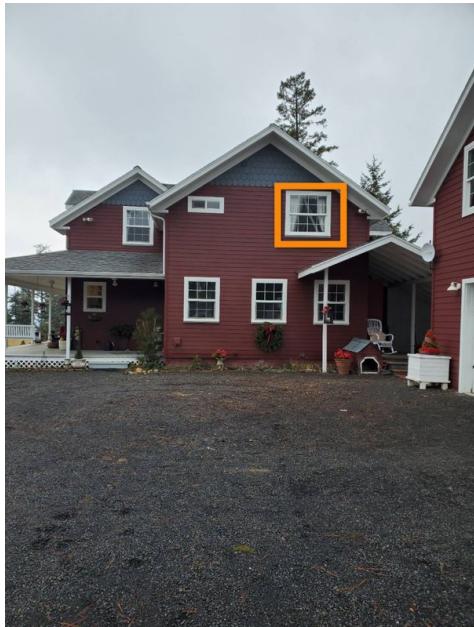
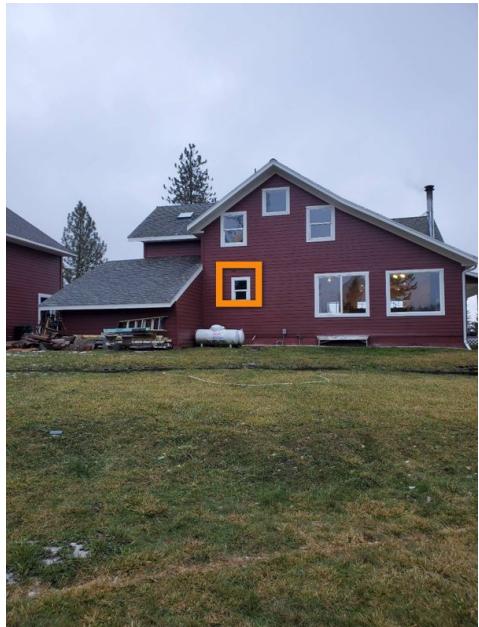
## 2.10.3 Windows

**FAILED SEAL**

There are windows with stains present between the panes which may indicate a failed insulative seal.  
Further evaluation of all windows is recommended to verify and for repair or replacement as needed.

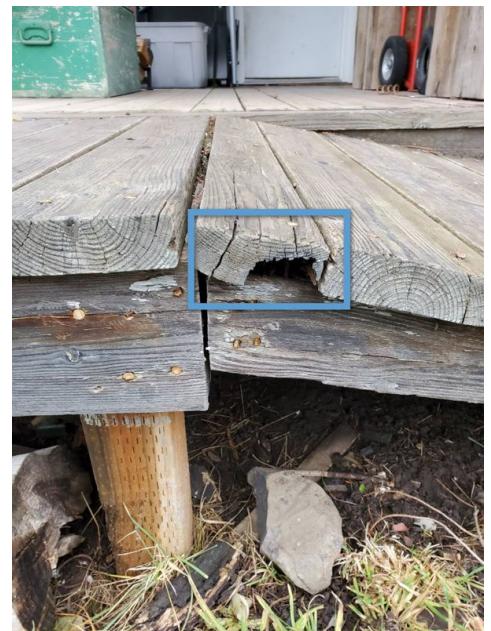
## DETERIORATION

GARAGE RAMP

Deterioration observed. Recommend repair of all issues as needed.

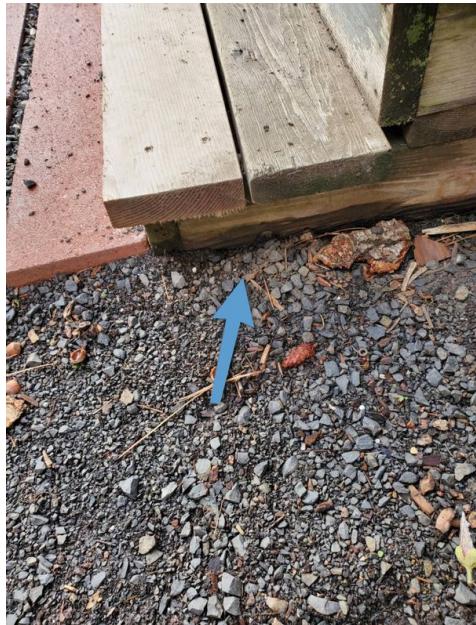
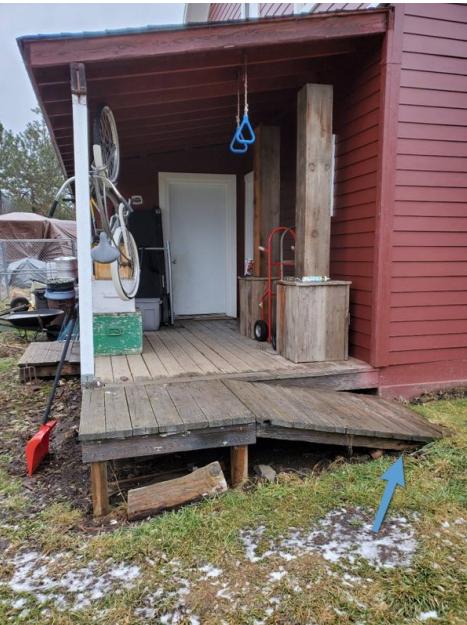
## 3.2.2 Steps/Stoops

**GROUND CONTACT**

EAST ENTRANCE NEAR THE GARAGE, WEST RAMP AT THE GARAGE

The wood is in contact with the ground. Ideally the wood should be on concrete or block to prevent deterioration and to eliminate conducive conditions for wood destroying organisms.

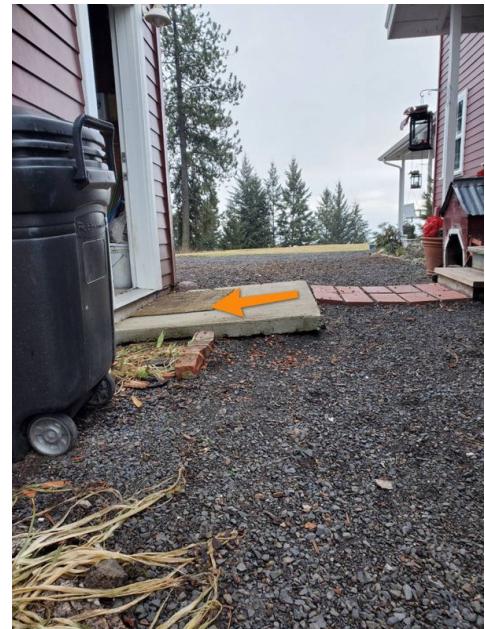
## 3.2.4 Steps/Stoops

**SETTLING/SLOPING**

Settling and sloping observed. Suspect that this may be a past issue, but I was not able to verify. Ideally the slope should be away from the structure to prevent moisture flowing toward the structure. Recommend repair as needed.

Recommend sealing the steps/stoops at the foundation connections to prevent moisture intrusion.

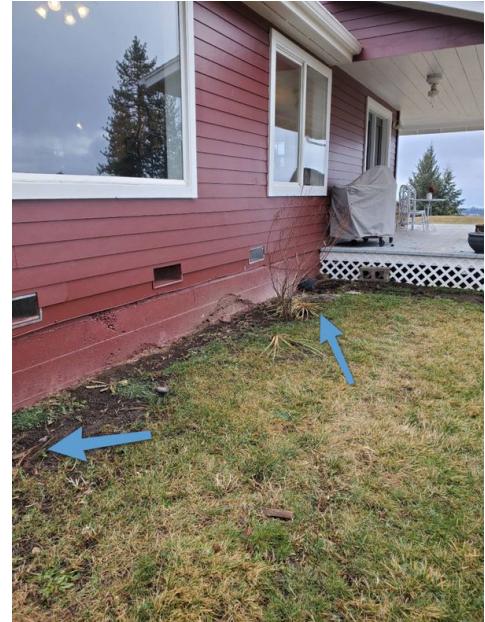
## 3.4.1 Grading

**LOW SPOTS**

There are some areas with unevenness and low spots near the foundation. Recommend adding dirt where needed to provide proper slope away from the home.

Contact a handyman or DIY project

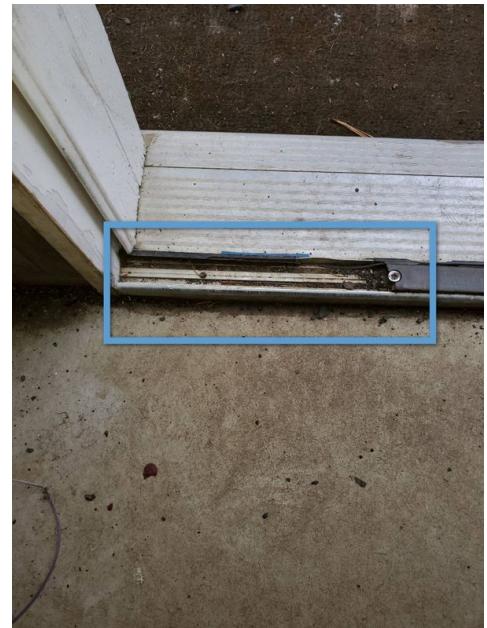
The threshold seal is damaged/missing. Recommend replacement as needed.

Contact a qualified professional.

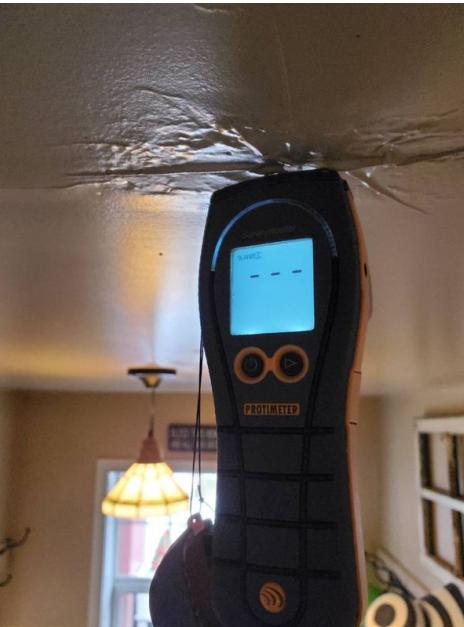
## MAIN FLOOR NE ENTRY

Bubbled paint observed in the ceiling in spots. Appears to be from past issues. No moisture observed when tested with a moisture meter at the time of inspection. Recommend monitoring.

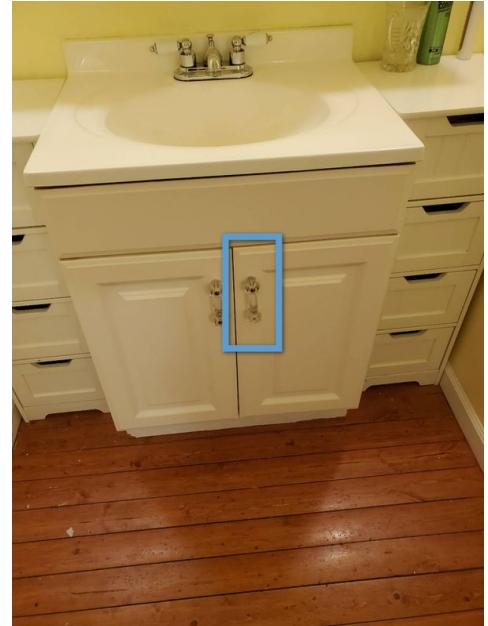
**LOOSE DOOR HANDLE**

The door handle is loose and needs repair.

Contact a handyman or DIY project

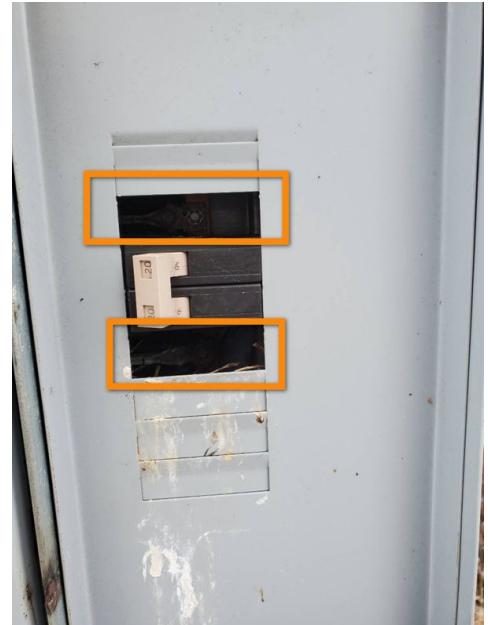
## 7.3.2 Electrical Panel

**OPEN BREAKER SLOTS**

Open breaker slots should be covered to prevent anyone reaching inside the box. This is considered a potential shock hazard.

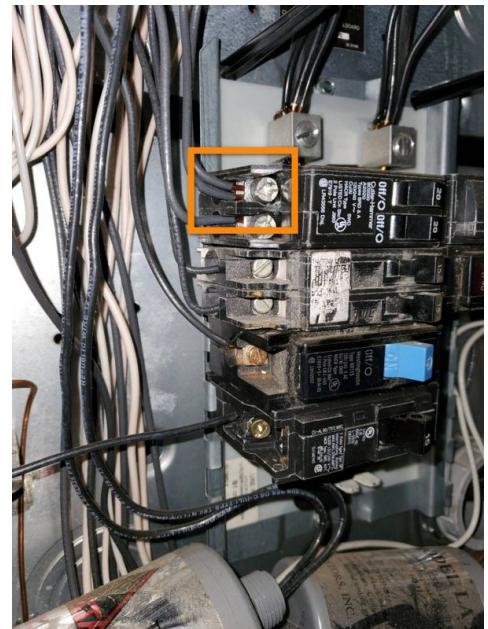
## 7.4.1 Garage Sub Panel

**DOUBLE TAPPED BREAKER(S)**

Double tap wiring observed. This means more than one wire is attached to a breaker or breakers. This can potentially cause an overload situation to a breaker because too much power will be pulled through the breaker. This should be evaluated and possibly repaired as needed.

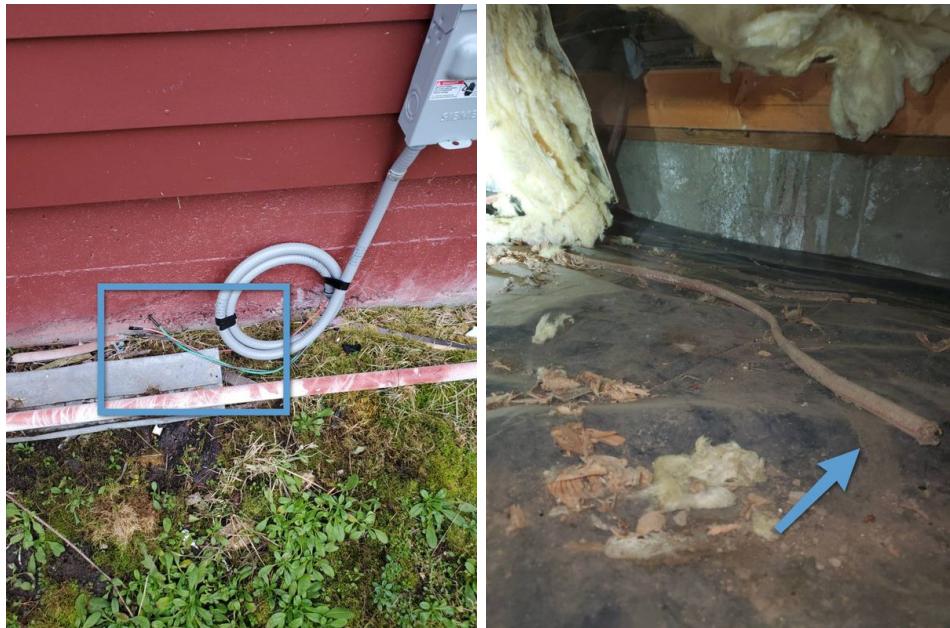
Observed extra or abandoned wires that are not in use that can be capped and contained, or removed as needed.

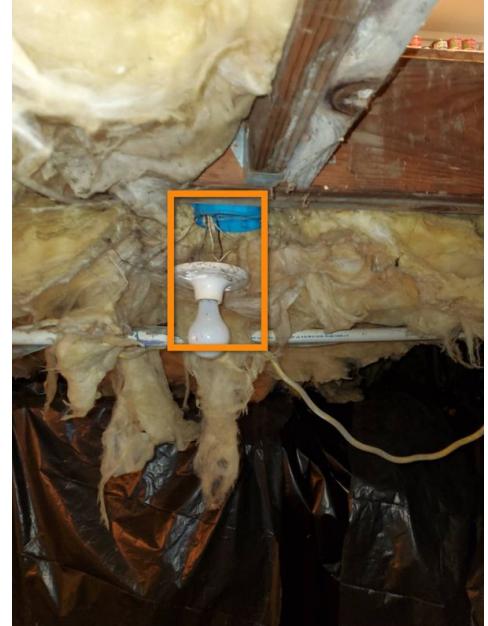
## 7.8.2 Lighting/Switches

**LOOSE FIXTURE**

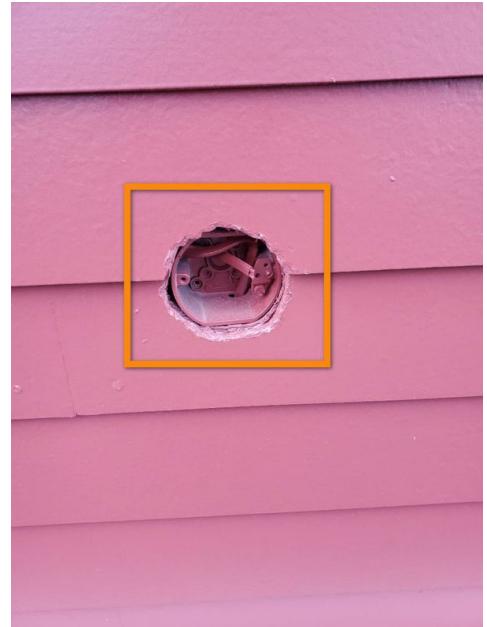
## 7.8.3 Lighting/Switches

**MISSING FIXTURE**

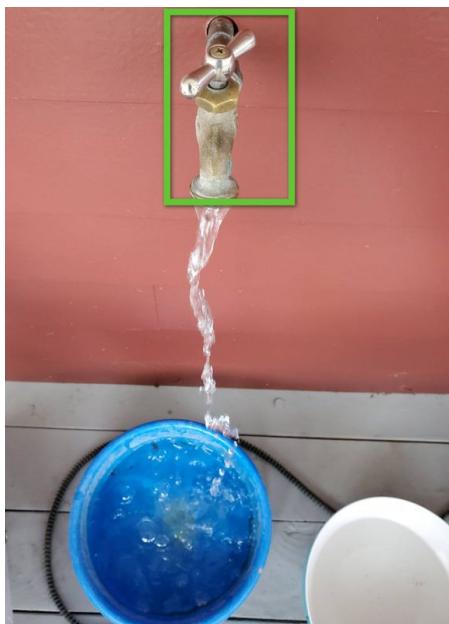
**Hose Bibs:** Hose Bibs--Not Frost Free  
South porch

These do not appear to be frost-proof faucets. This means that you will need to figure out how to turn off and drain these faucets in the winter time to prevent freezing pipes.

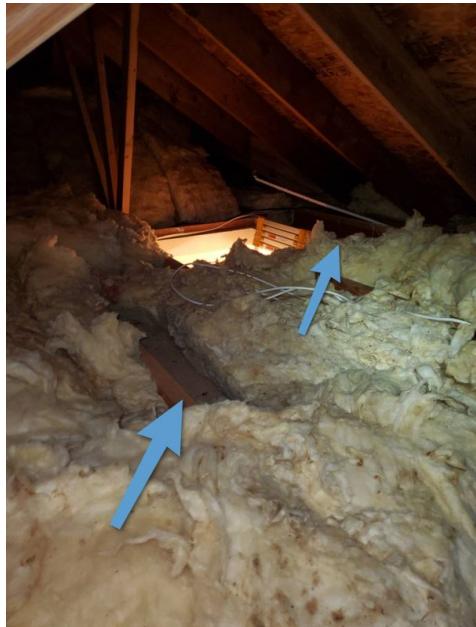
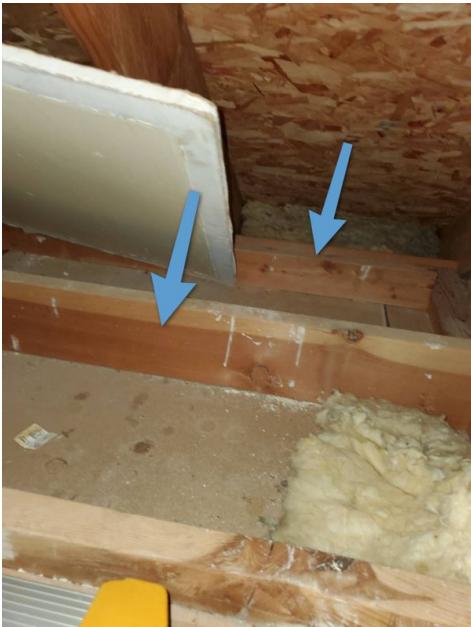
## 10.4.1 Ventilation

**ATTIC VENTILATION INSUFFICIENT**

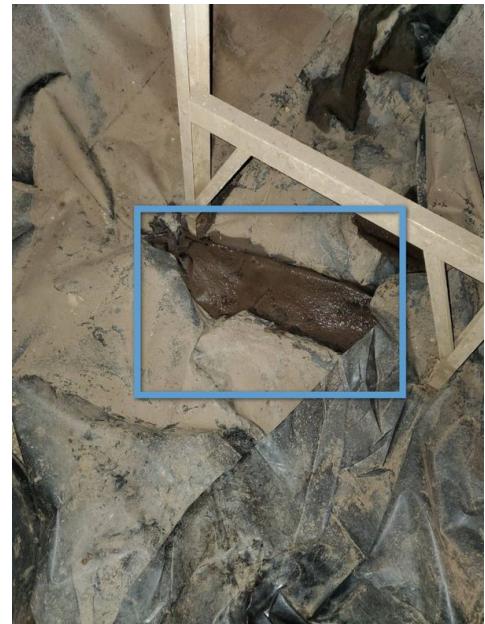
**MOISTURE PRESENT WITH  
SUMP PUMP**

Moisture was observed on and under the plastic. This appears to be ground water and sump pump is functioning. Recommend further evaluation to verify for any needed repairs.

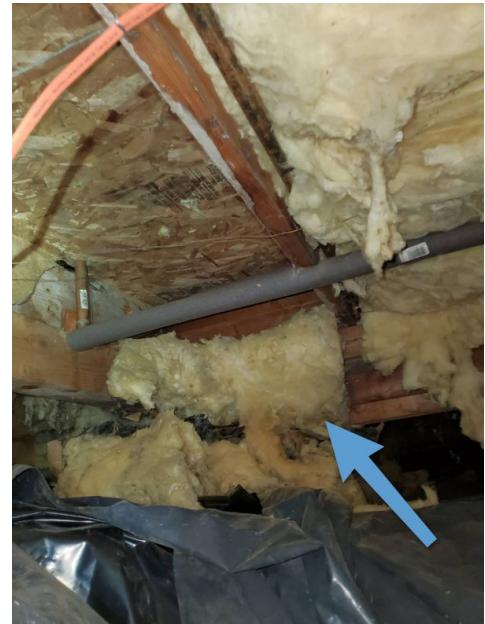
## 11.2.1 Insulation

VARIOUS LOCATIONS

Observed a few areas where the insulation has fallen and is missing. Recommend reinstalling as needed for efficiency.
