# PEACH Inspections

## THE HOME INSPECTION REPORT

07083102B - [REDACTED]

[REDACTED] Drive, Lansdale, PA 19446

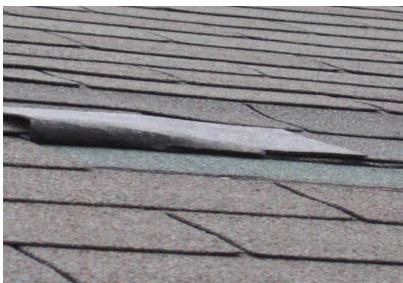
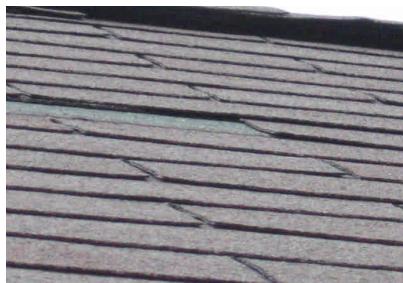
There are a few cracked and missing shingles. Prone to leaking. Located at the left-side of the front dormer. Correction and further evaluation by a professional roofer is recommended.

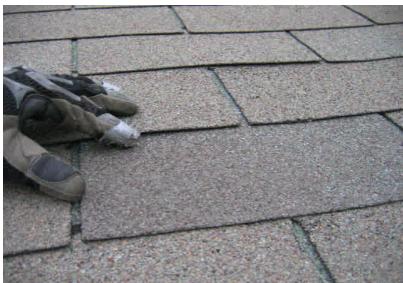
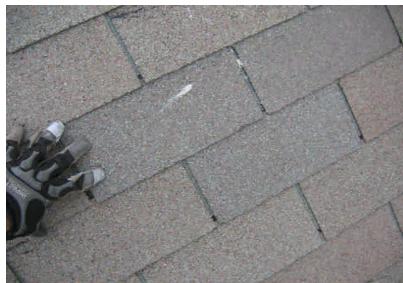
There have apparently been several repairs made on the roof. Repairs to the shingles are visible. Recommend asking the seller about the repairs to the roof.

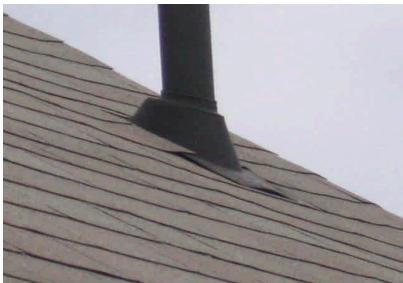
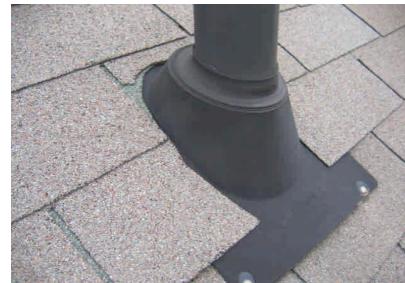
### Flashings

The flashing around the vent stacks coming through the roof appear to be in good condition. Good.

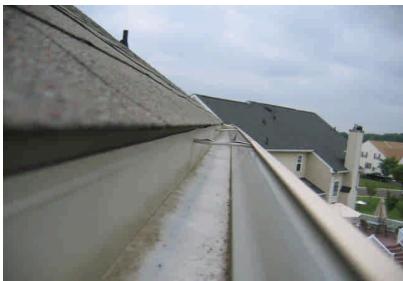
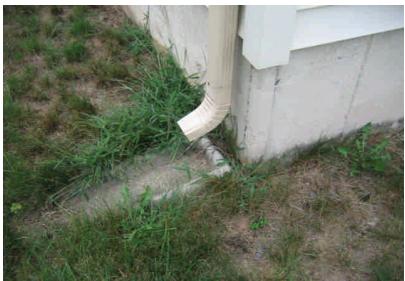
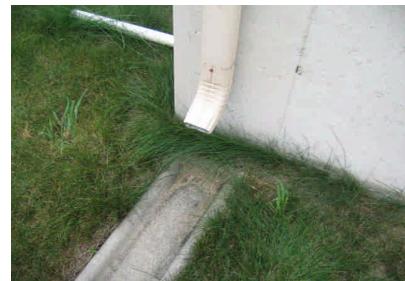
#### Gutters & Downspouts

The gutters and downspouts appear to be in functional condition. Good.

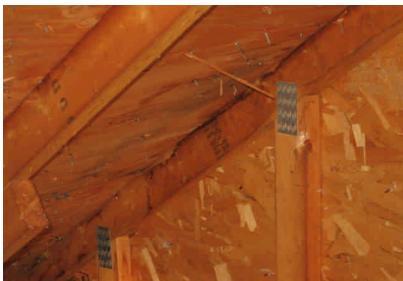
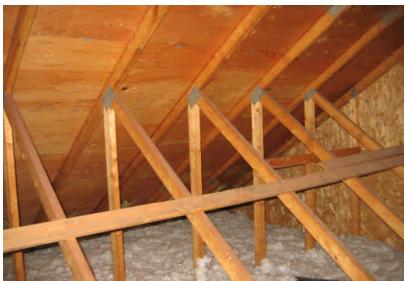
#### Active roof leak

There are water marks visible from the attic. Possibly indicating an active roof leaks. Located at the rear right corner of the attic. And at the front left area, below the missing shingles.

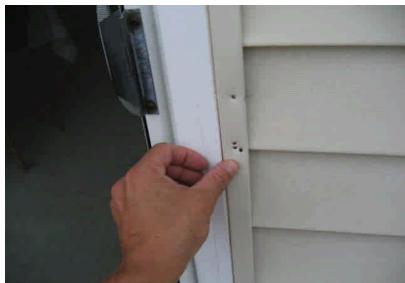
The vinyl siding trim at the rear slider door has some screw holes. Minor.

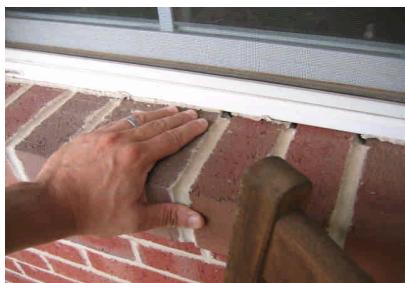
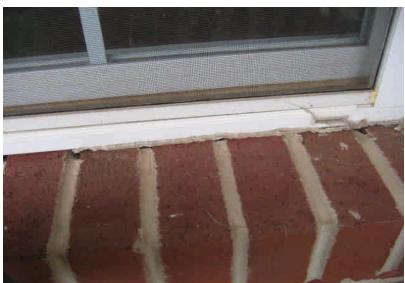
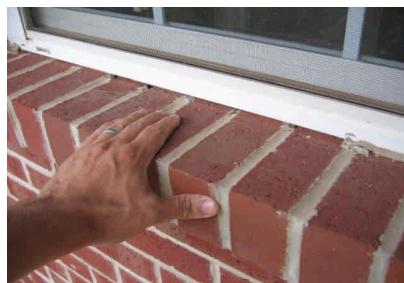
Open spaces at the window sills. Prone to water penetration. Front windows at porch, with brick exterior. Missing flashing, missing sealant.

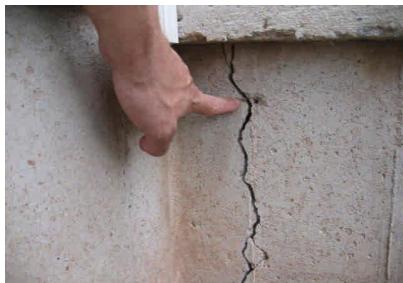
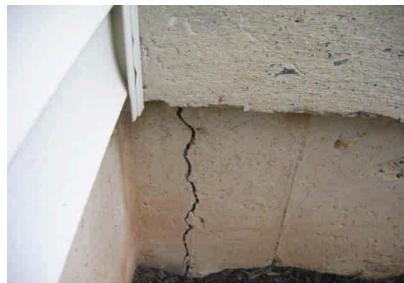
There is a crack in the exposed porch foundation. Located on the left-side. Apparently from settlement. Sealing or patching the crack with structural epoxy is recommended.

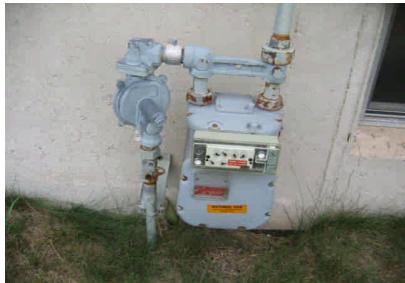
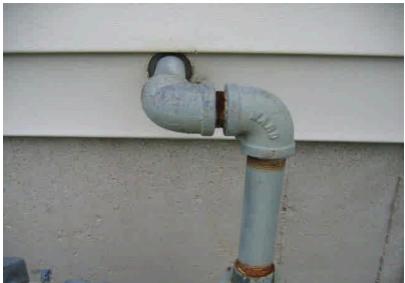
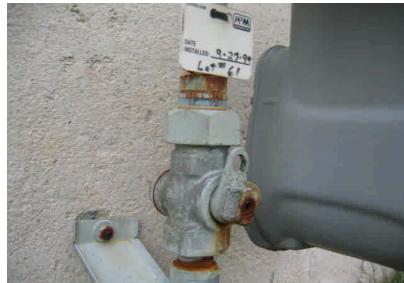
The main gas shut-off valve is located near the gas meter at the side of the house.

The gas meter has some surface rust on it.

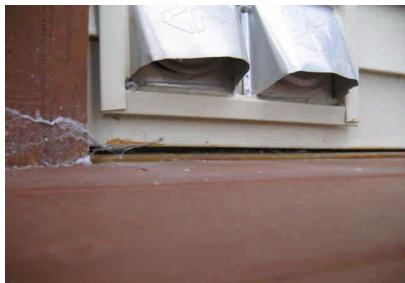
The dryer exhaust hood appears functional. No damage to hood or damper. No major lint build-up. We recommend inspecting and cleaning the dryer's exhaust pipe every year.

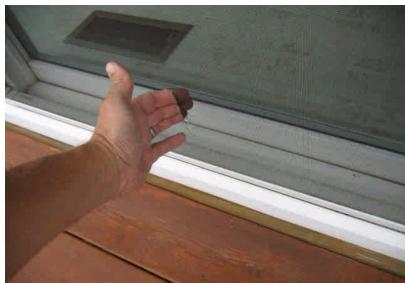
There is a screen door at the rear slider. The screen is torn or damaged. Repair or replacement of the screen material itself is recommended. This is a common problem.

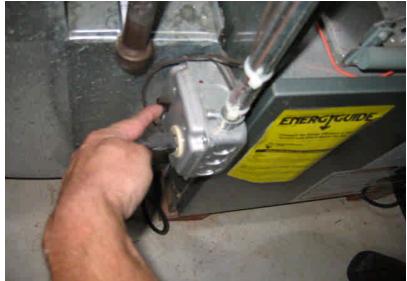
There is an electrical shut-off switch located on the side of the heating system.

The electrical shut-off switch functioned. Good. I would use this switch when inspecting the air filter.

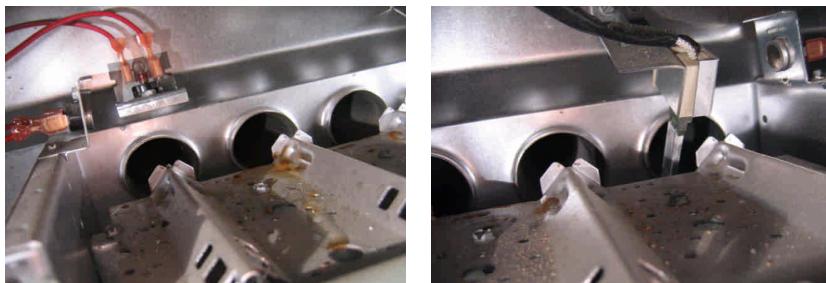
The gas burners of the heating system appear relatively clean. Good.

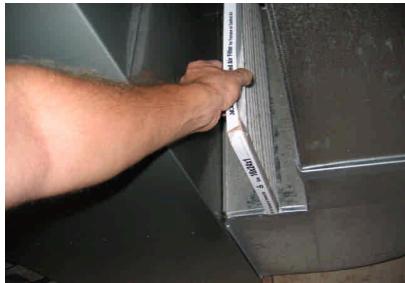
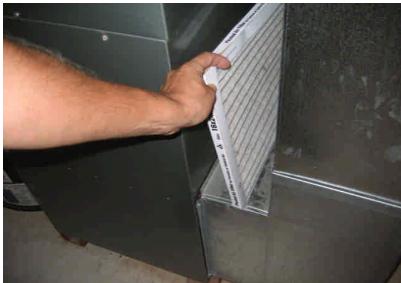
The air filter is disposable and clean. Good. Check the filter every 30 days. Replace when necessary.

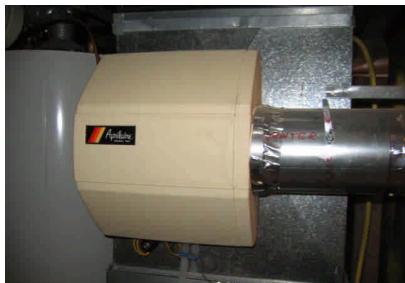
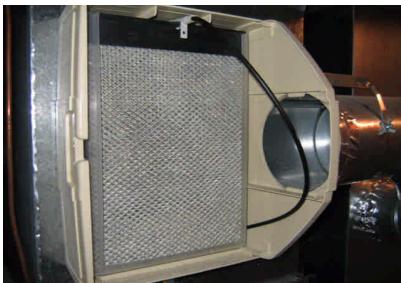
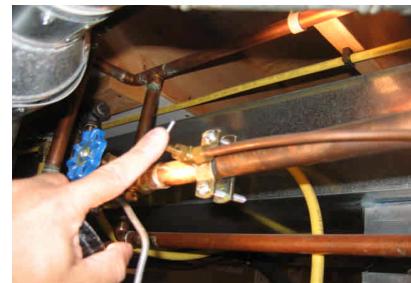
The by-pass humidifier needs to be serviced and cleaned every year. In the wintertime, when not in use, turn off the water valve, shut the damper closed, and turn off the humidity level control.

The humidifier appears functional. Good.

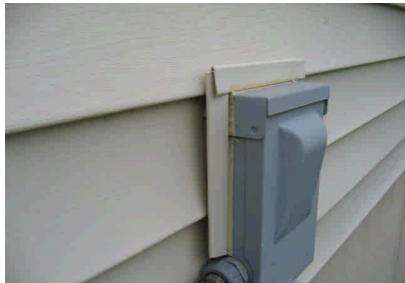
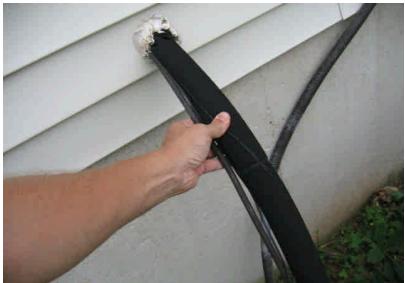
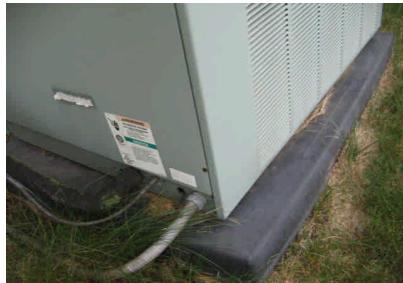
The estimated age of the exterior condenser unit is 8 years old. Middle of service life.

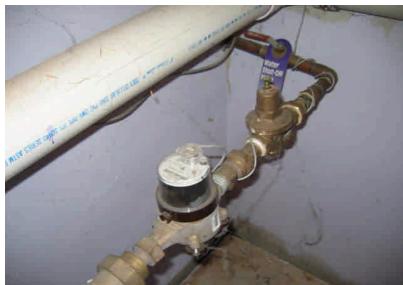
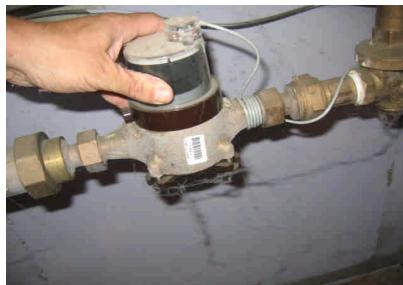
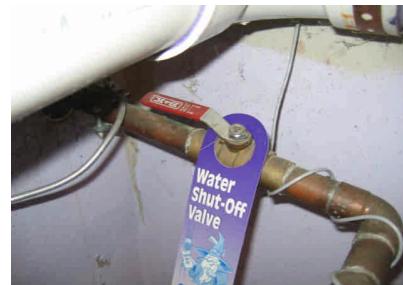
The main water shut-off valve is located in the basement.

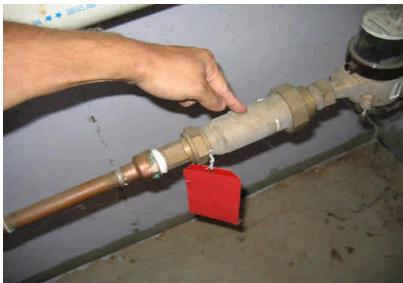
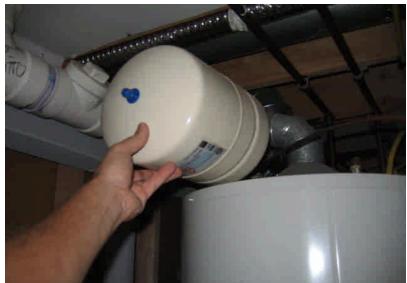
### **Check Valve & Expansion Tank**

The water line has an expansion tank installed on it. There is a back-flow check-valve installed on the water supply line coming into the house. This back-flow valve prevents water from flowing back out to the street, and makes the plumbing system a closed water system. When the water heater makes hot water, the water in the system expands. The expansion of the warm water increases the pressure on the homes water pipes. The expansion tank absorbs the extra pressure. The action of the expansion tank reduces knocking of the pipes and wear and tear on the faucets and shut-off valves in the home. Good.

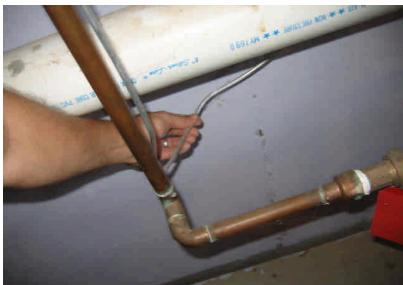
### **Jumper Cable at Meter**

There is a jumper cable installed over the water meter - Good.

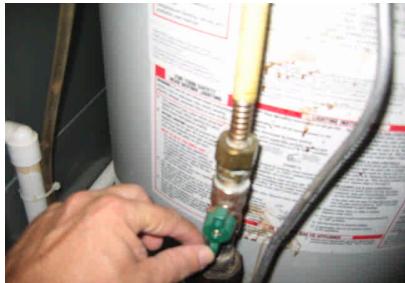
### **Gas Shut-Off Valve**

The gas shut-off valve at the water heater is installed within reach of the tank. This valve turns off the gas supply to the tank. Good.

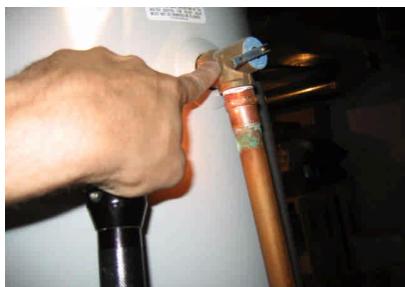
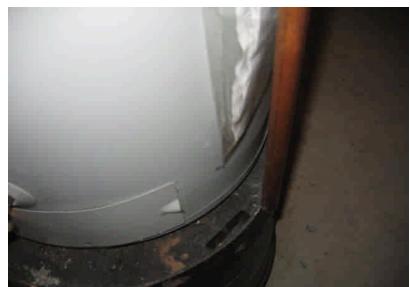
### **Relief Valve & Discharge Pipe**

The water heater is equipped with a pressure-temperature relief valve. The pipe is extended to the floor. For safety. Good.

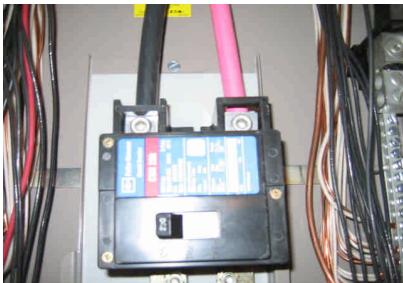
The main disconnect is installed.

The main electrical panel appears to be 200-amps.

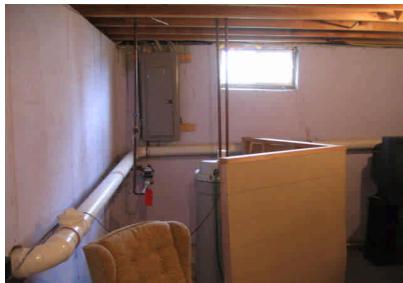
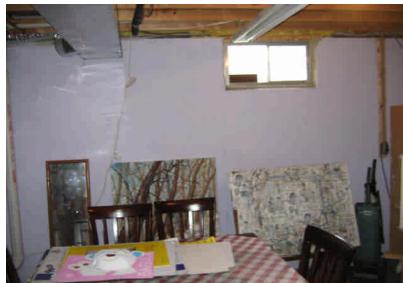
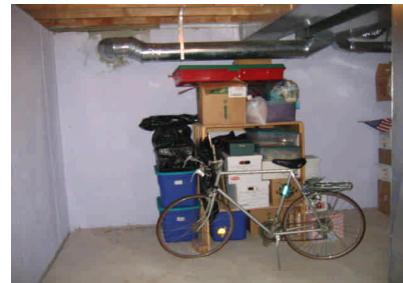
There is insulation at the band or rim joist areas, which is above the foundation wall, at the outer perimeter of the floor system. This insulation restricts the visual inspection of those areas considerably.

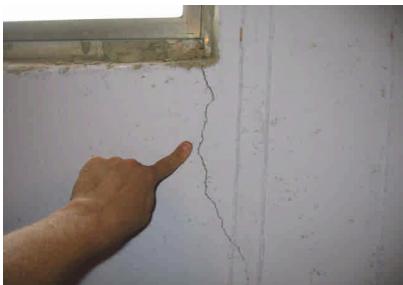
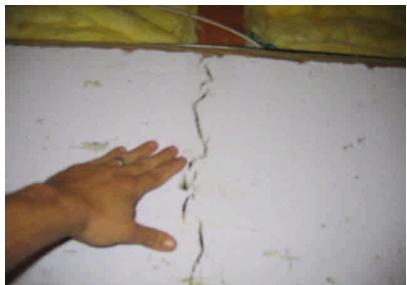
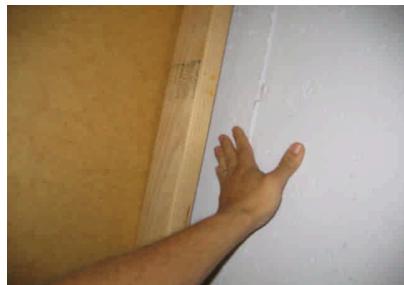
There are cracks in the foundation that is visible. Located on the right-side wall, left-side wall near window, and rear wall near stud board.

Foundation cracks can be repaired using an epoxy ejection method. Epoxy ejections are considered affordable and effective. Epoxy ejections make a bond between the cracked sections of the foundation that is actually stronger than the concrete itself. Further evaluation and correction to the foundation cracks by a professional (one familiar with epoxy injection repairs) is recommended.

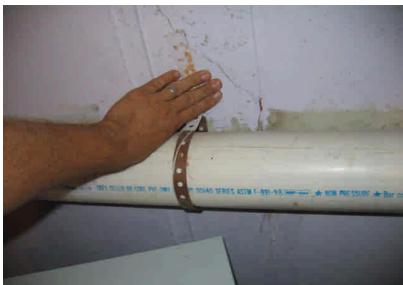
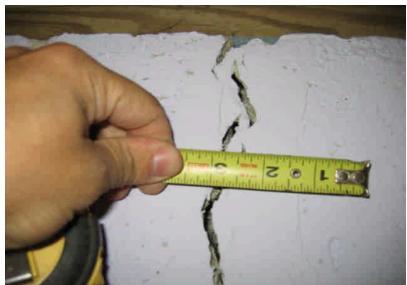
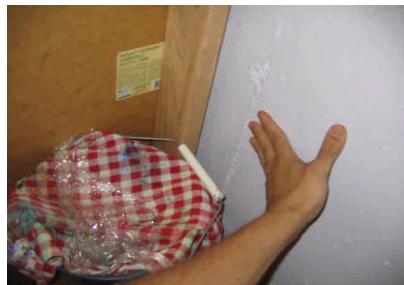
There is a patch in the right-side foundation wall. The patch appears to be in poor condition. Does not appear to be a structural repair. May have been patched because of water penetration. Cracked open. May not be reliable. Recommend a correction of the crack with an injection of epoxy.

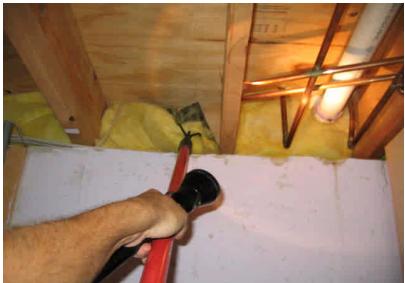
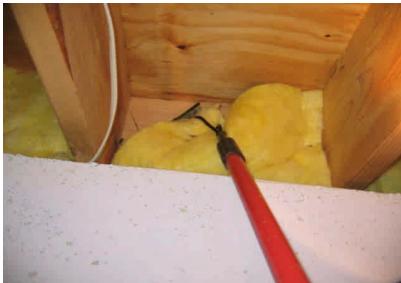
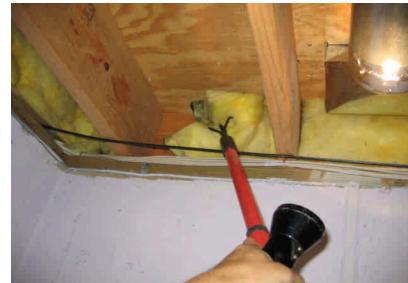
The floor joists are made of dimensional wood lumber - 2x10s.

I walked around, probed, checked the floor as best as I could. No material defects apparent. No major structural defects found. Recommend asking the seller if any repairs have been made to the floor structure in the past.

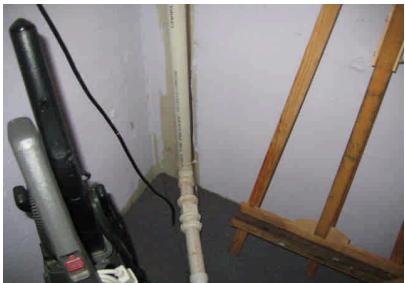
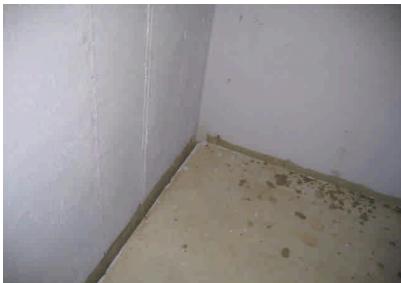
There are no signs of active, wet ground water penetration in the basement. The lowest living level appears dry today. Monitoring during a heavy rain storm or snow melt is recommended. Consult with the seller's disclosure.

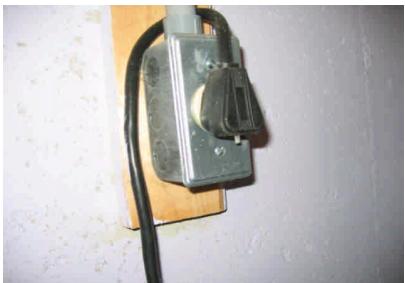
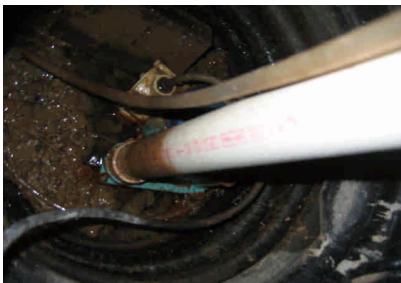
There is a sump pump being used. Recommend asking the seller why a sump pump has been installed. Has there been water penetration problems that required the pump to be installed?

There is water in the sump pit.

The pump turned on.

Discharged water.

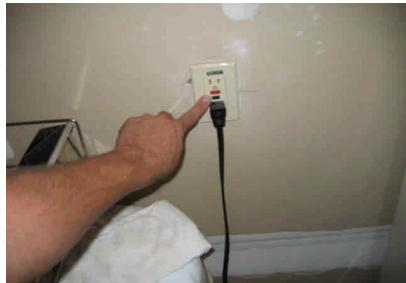
There is a fridge plugged into a GFCI-protected receptacle in the garage. A bad idea. If or when the GFCI trips off, no one would know until the fridge door is opened.

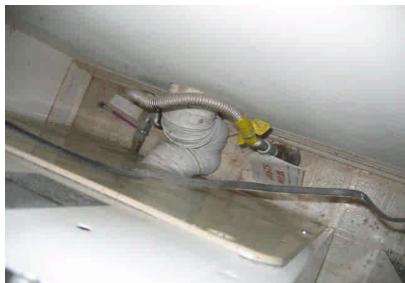
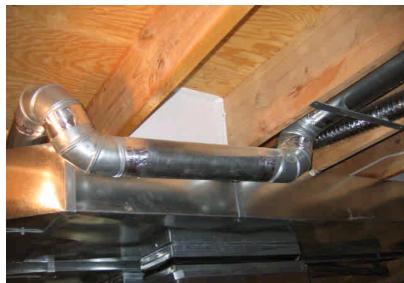
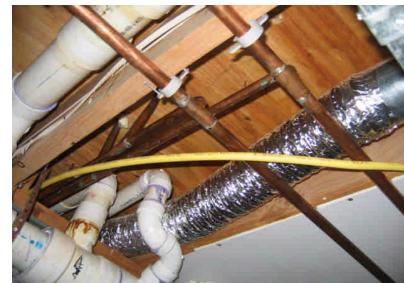
The dryer exhaust pipe is too long. The current standard limits the length of the dryer exhaust to 25 linear feet. For every 90 degree bend, minus 5 feet. Presently, the length of the dryer exhaust pipe is about 15 feet. With four 90 degree bends. Therefore, the length of the dryer exhaust pipe should be only 5 feet. Presently the dryer vent pipe is too long.

If the dryer exhaust pipe stays the way it is installed presently, being too long, then it needs to be inspected and cleaned every 6 months (twice a year). To prevent lint from building up and clogging the pipe. And to prevent fire hazards from developing in a clogged pipe.

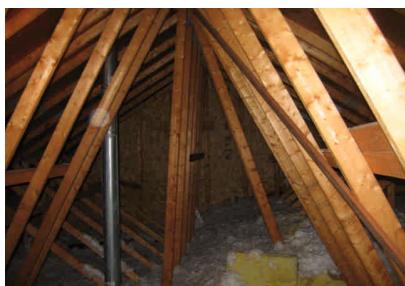
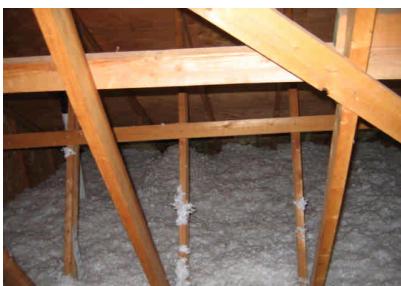
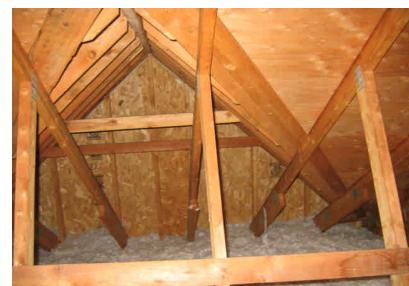
We inspected the attic by entering it. But there is no flooring, and the insulation is covering the joists. I am unable to safely move all around the attic space completely. Inspection restrictions.

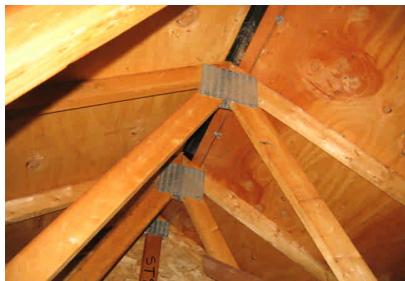
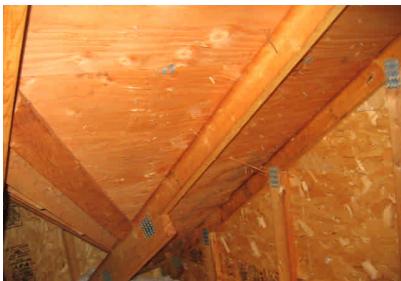
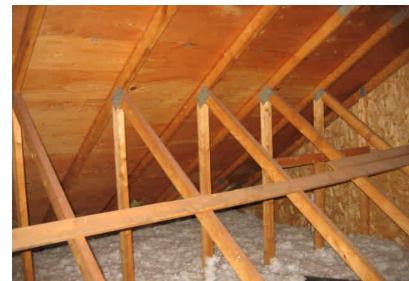
Attic roof leaks visible from attic.

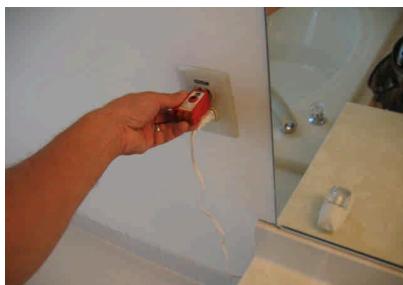
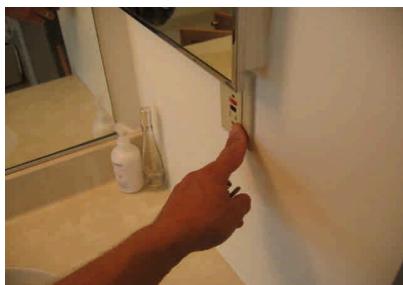
#### Master Bath Receptacles

The receptacles are testing functional and include ground-fault protection (GFCI). Good.

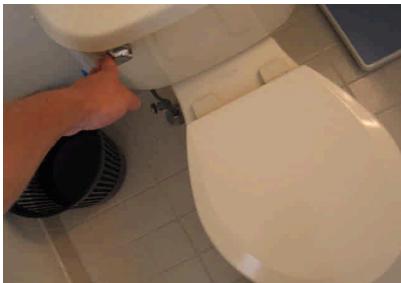
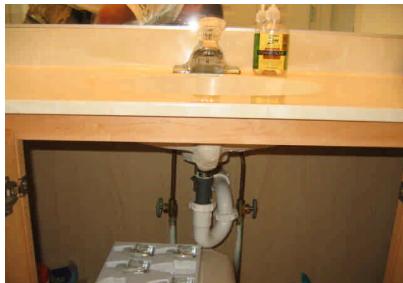
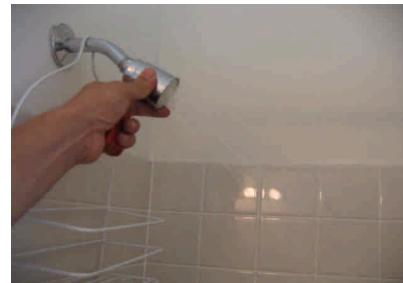
We inspected the bathroom, and found no major defects. Toilet flushed a couple times. Running water at the sink. Sink drained. The tub/shower functional. No active leaks.

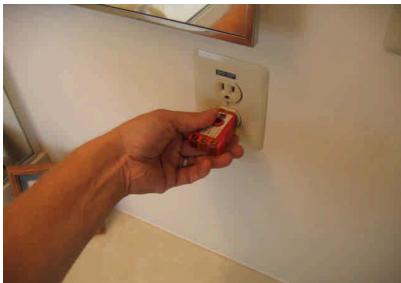
## **2nd Floor Bath Receptacles**

The receptacles are testing functional and include ground-fault protection (GFCI). Good.

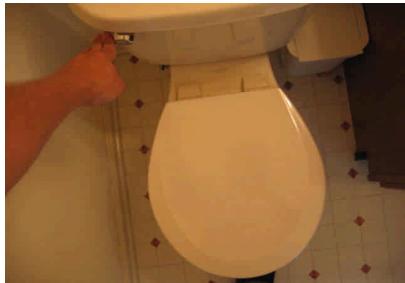
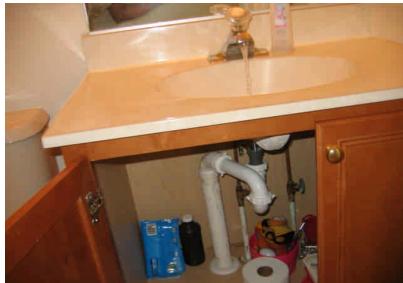
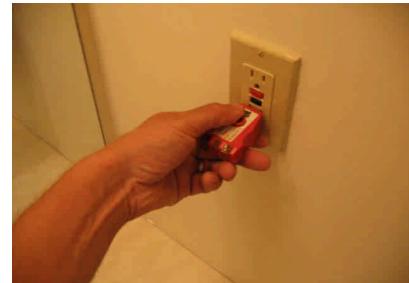
We inspected the 1/2 bathroom, and found no major defects. Running water at the sink. Toilet flushed a couple times. Sink drained. No active leaks.

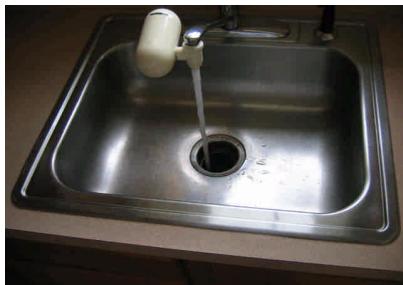
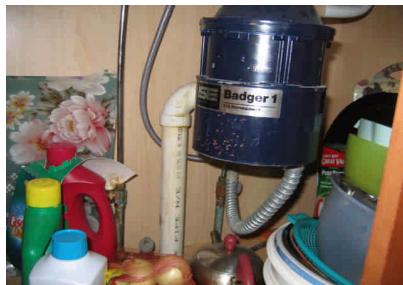
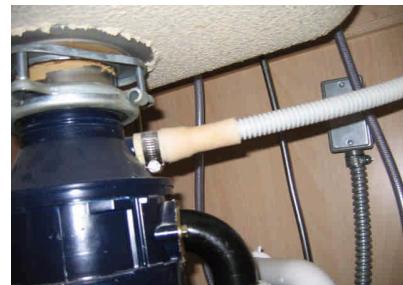
### The Kitchen Faucet

The sink faucet is functional. No active leaks seen.

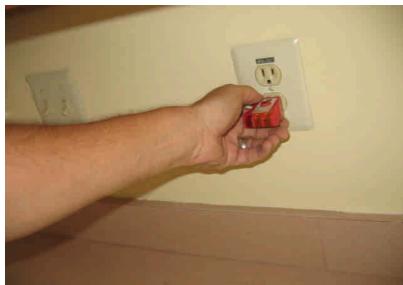
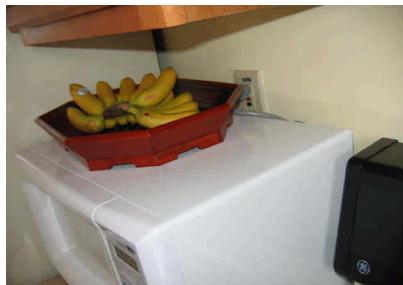
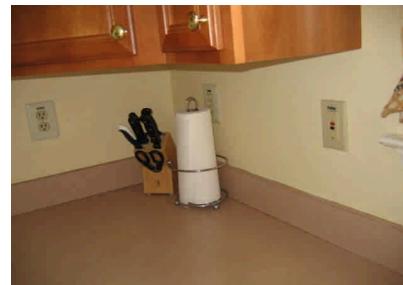
### **Receptacles and GFCI**

The visible counter receptacles that were tested are functional and include ground-fault protection. Good.

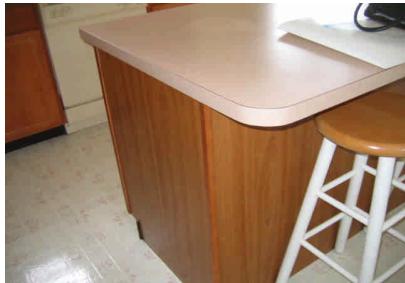
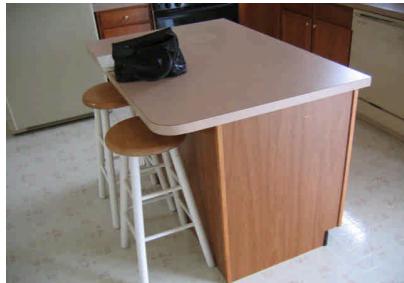
There is no outlet serving the island which is recommended, and should have ground fault protection.

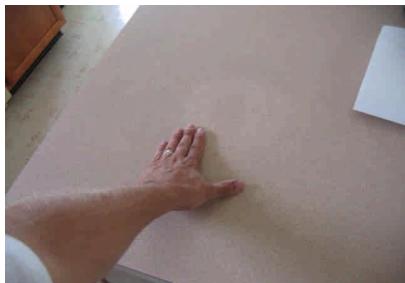
### Sink Surface & Countertop

The sink and countertop are functional. Apparent stain on island.

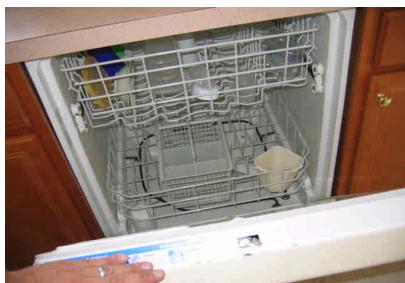
### Dishwasher

Ran a short cycle with no leaks. (This is no guarantee against future problems.)

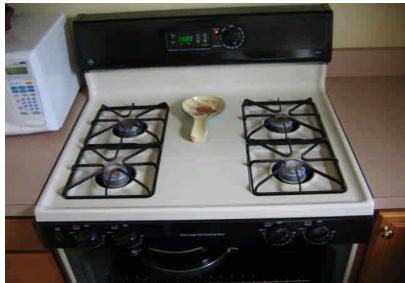
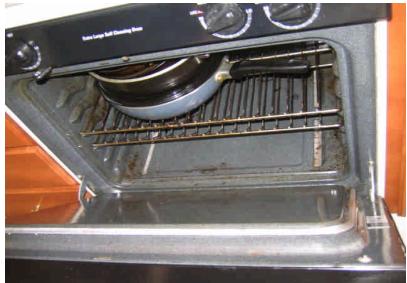
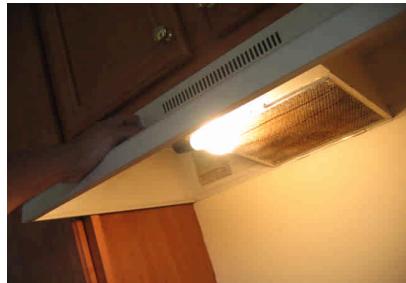
### Gas Cooktop

The gas cook top elements turned on.

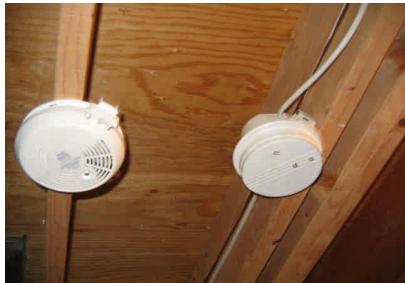
There is a fuel burning fireplace in the house. Carbon monoxide detector needed.

Recommend asking the seller if there are carbon monoxide detectors installed in the house that will be staying with the house. Recommend installing new detectors in the house, according to the manufacturer's recommendation.

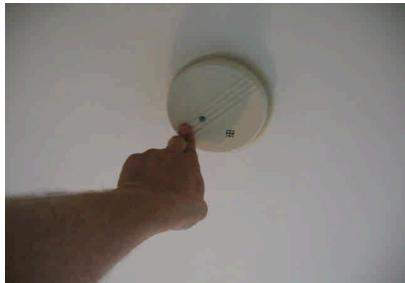
One detector didn't test functional. Front corner bedroom. Recommend installing new detectors throughout the house. For your own peace of mind.

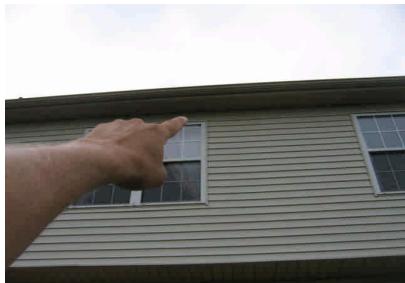
### Cracked Windows

There is one cracked window. Replacement needed. Located at the 2nd floor rear bedroom.

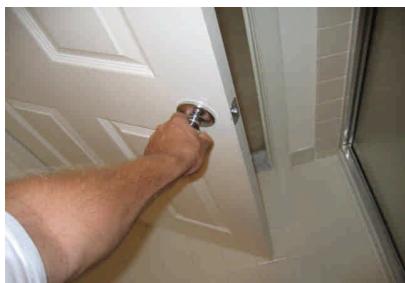
## Doors

The condition of the doors that I inspected seemed functional.

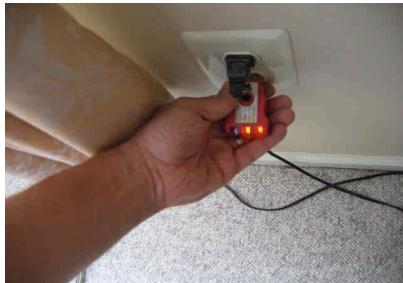
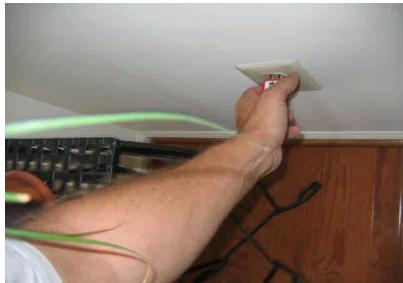
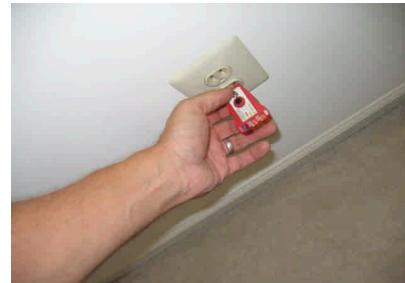
## Receptacles Observations

The ones that I tested seemed to be wired functional.
