HOME INSPECTION REPORT

1234 Main St.
Colleyville, Texas 76034

Buyer Name
08/25/2020 9:00AM

By:Chip Irving - Certified Master Inspector TREC #20489

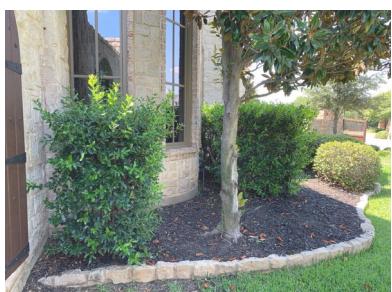
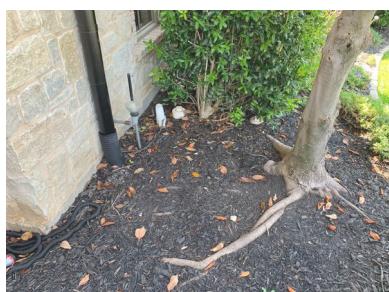
1: Trees Close to Foundation

NORTHWEST , WEST

Note: Tree(s) in close proximity of the foundation were observed. Client should consider the installation of a root barrier to reduce the possibility of damage to the foundation from tree roots and moisture removal.

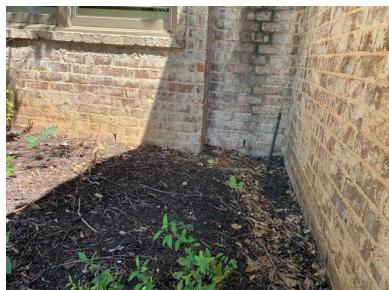
SOUTHEAST

**2: Excessive vegetation****⊖ Recommendation**

Vegetation was too close to, touching, or growing on exterior walls and roof. Condition can promote excessive damage and deterby movement of branches, root growth and/or attachment, and moisture retention, and can promote pest infestations. Recommend having vegetation trimmed or removed from affected areas, and regular homeowner monitoring and maintenance thereafter.

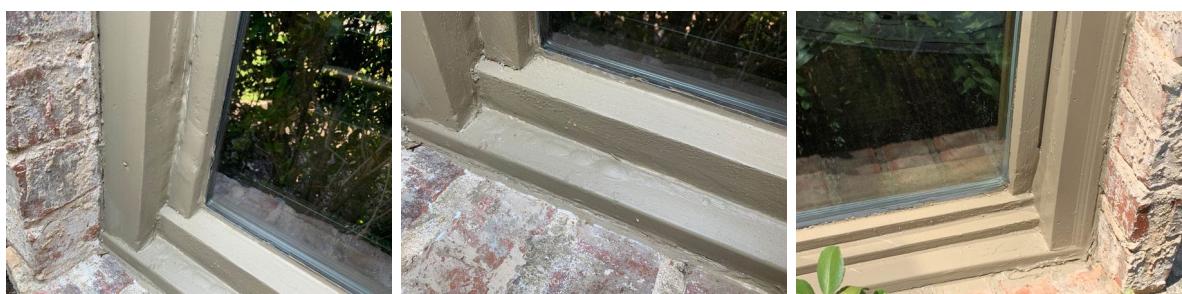
Prior repairs visible some blistering paint:

Prior repairs were visible around the window frames at the north west corner of the home. All appeared to be intact at the time of the inspection but some blistering of paint was noted.

WEST , EAST

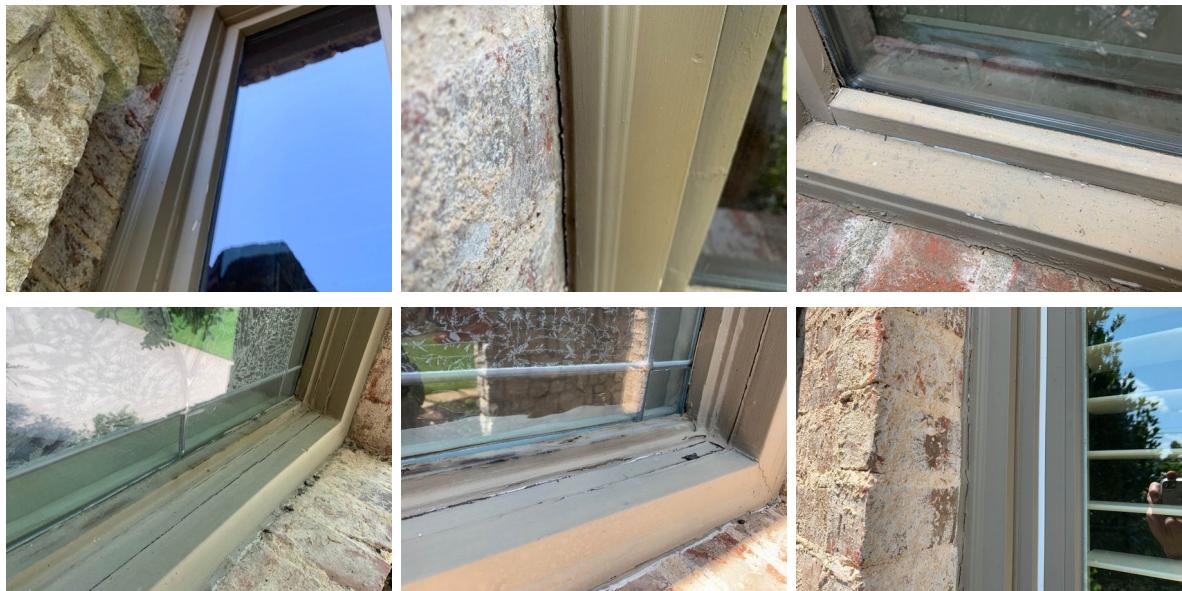
1: Exterior: Area Veneer Window/Door-Need Sealing

Caulking improvements are recommended for the area between the exterior veneer and the window and door frames. It is recommended to use elastomeric caulk.

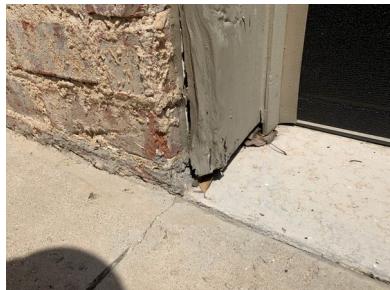
**3: Exterior: Garage Trim Damage @ Bottom****⊖ Recommendation**

The garage door trim had some deterioration and/or damage at the bottom.

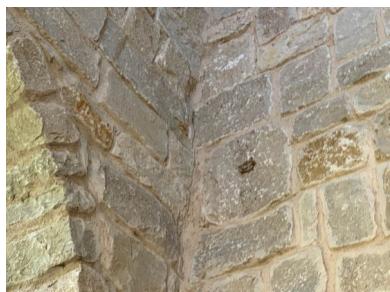
**4: Exterior: Mortar/Brick Cracks****⊖ Recommendation**

WEST

Minor mortar and/or brick cracks were observed in the exterior veneer.

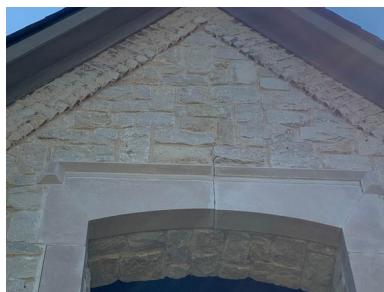
WEST , NORTH

5: Exterior: Mortar Improvements Needed

Mortar improvements are recommended for the exterior masonry veneer.

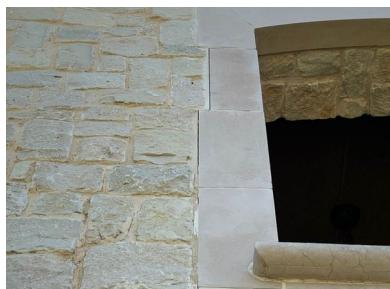
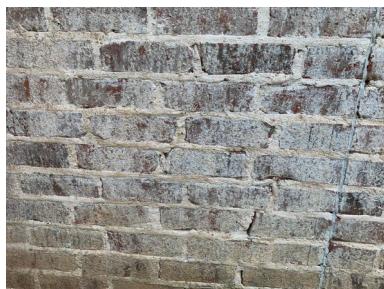
WEST

6: Exterior: Openings/Penetrations need sealing

All openings/penetrations at the exterior walls should be properly sealed to prevent moisture intrusion and/or rodent or insect entry.

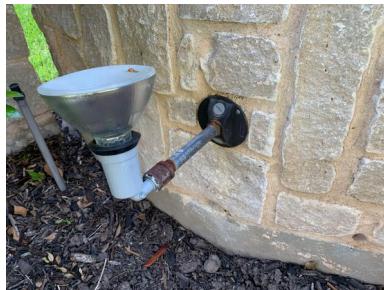
7: Exterior: Algae staining

Algae staining was observed at the exterior wall as a result of splash back from roof runoff. This is mostly a cosmetic concern that can be treated with an algaecide; however, this condition will reoccur if gutter are ninstalled to direct the flow of water off of the roof.

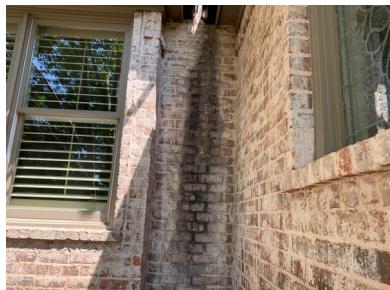
SOUTHEAST

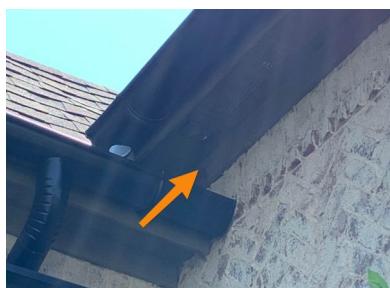
**10: Trim boards pulling loose****⊖ Recommendation**

Siding trim boards are visible pulling loose at the roof level on the east side of the home. Proper repairs are recommended.

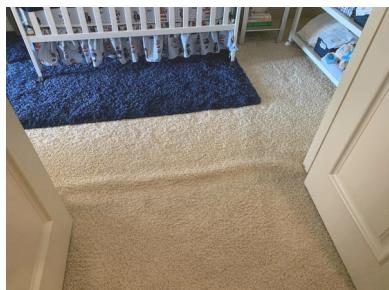
Game room

The door was sticking/rubbing against the frame.

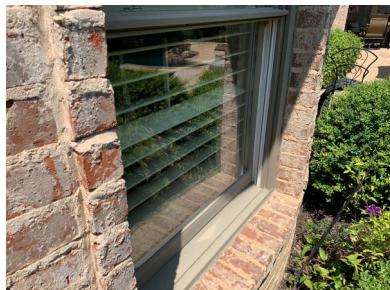
I NI NP D**3: Screens: Missing****⊖ Recommendation**

One or more of the window screens were observed to be missing. The screens appeared to be in the garage.

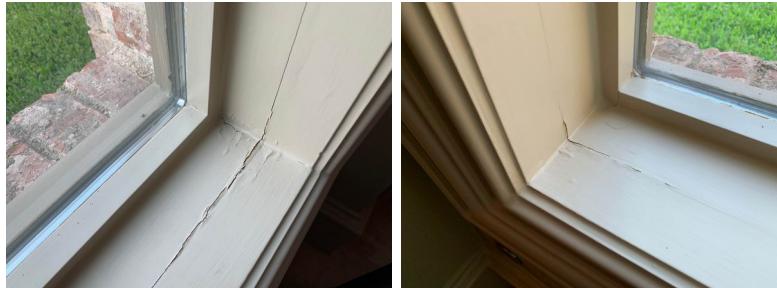
**4: Windows: Sill Deterioration/damage-Interior****⊖ Recommendation**

Living room

The interior window sill(s) had some deteriorated and/or damaged. This may be from condensation or prior water intrusion. Further evaluation may be needed.

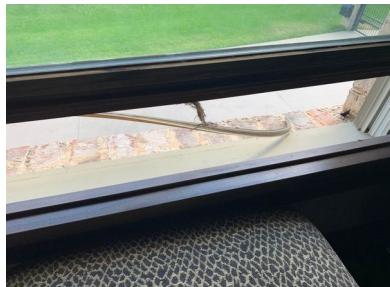
Game room

The window weather-stripping was damaged and/or missing at one or more of the windows and improvements are recommended.

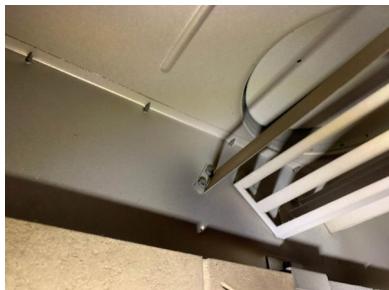
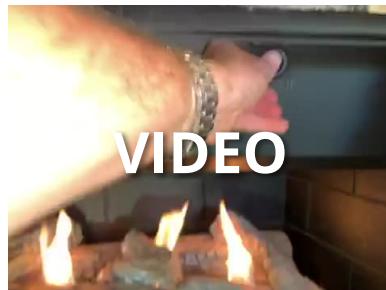
1: Gas Log: Shut off switch inoperative

All interior fireplaces were equipped with a shutoff switch that would trigger/shut off the gas supply if the damper was closed. The one in the family room was not functioning properly and the gas to the unit would continue to run. Repairs are needed for safety.

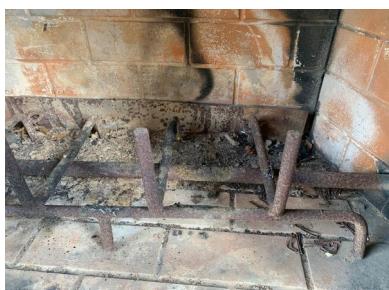
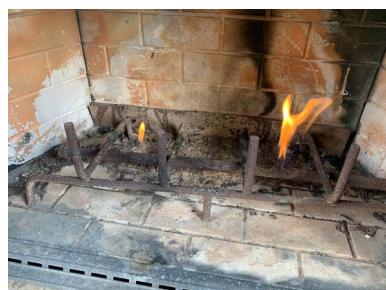
Outdoor fireplace

**2: Excessive rust visible at starter bar****⊖ Recommendation**

Excessive rust was visible at the exterior starter bar. Repairs are needed to prevent further corrosion and to allow gas to travel properly through the ports in the bar.

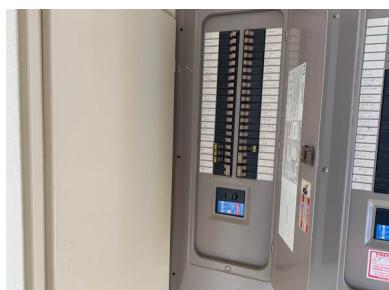
**2: Poor Clearance @ Cabinet****⌚ Recommendation**

The panel box did not have proper clearance in front of the cabinet. The panel box cover plate (Dead Front) and/or cabinet should be readily accessible and cover easily removable at all times. Under current electrical standards, the accessible workspace around the panel box should be at least 36-inches in depth in front of the cabinet and 30-inches in width or the width of the equipment. Clothes, shelves, cabinets, foliage, etc should not block the workspace in front of the cabinet.

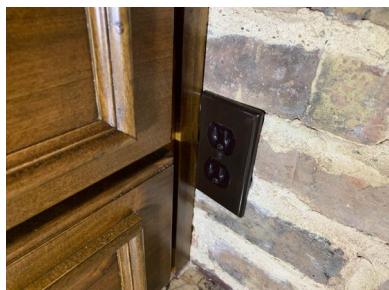
1: Receptacles: Loose

Butler's pantry

One or more of the receptacles were observed to be loose at the wall mount.

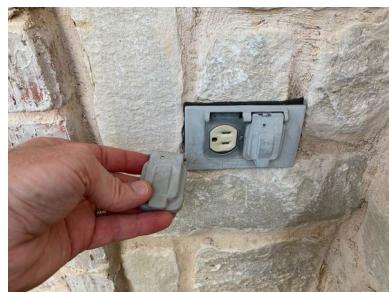
2: Receptacles: Exterior cover damaged/missing

WEST

All exterior receptacles should have weather tight covers. The receptacle weather cover plate was damaged and/or missing.

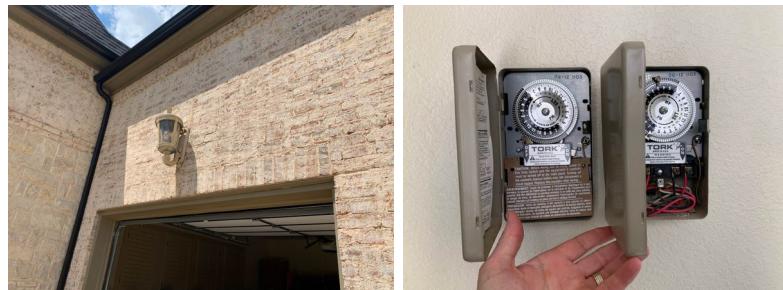
4: Fixtures: Exterior Light Fixture Inoperative**🔧 Maintenance Item**

One or more of the exterior light fixtures appeared to be inoperative. This may be due to a bad or missing bulb, a photocell that could not be operated or some other unknown condition. These should be further evaluated and corrected as necessary.

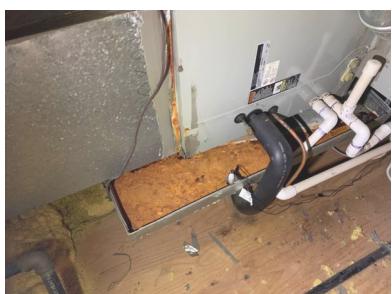
**1: Drain pan: Rust present****➡ Recommendation**

Note: The auxiliary/secondary drain pan under the coil housing had some water staining and/or a rust build-up. This would indicate that the pan has held water in the past and should be closely monitored.

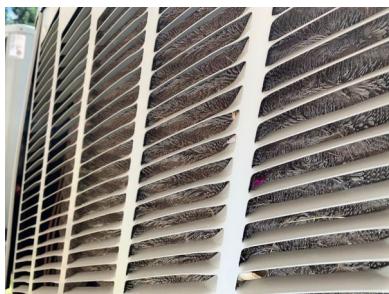
1: Condenser: Fins dirty

Dirt/debris was visible at the fins of the outdoor condensing unit. Proper cleaning is needed.

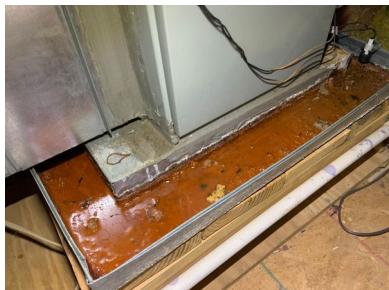
3: Secondary Pan: Holding water**⊖ Recommendation**

The auxiliary drain pan under the coil housing was holding water at the time of this inspection. Water was actively leaking from the unit or secondary drain. The primary line may be clogged and water may be backing up into the system. The exact cause and remedy should be further evaluated by a licensed HVAC technician and corrected as necessary.

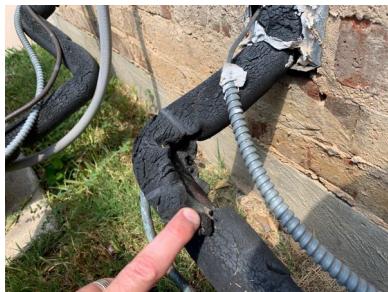
I NI NP D**1: Refrigerant Lines: Damaged insulation****⊖ Recommendation**

Damaged, deteriorated and/or missing insulation on the refrigerant lines. Refrigerant insulation areas area(s) should be repaired or replaced as necessary.

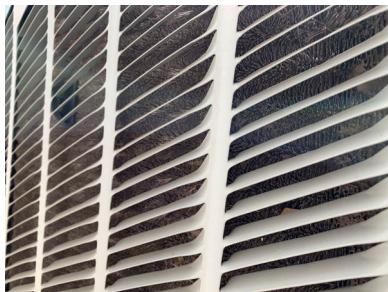
**2: Condenser: Fins dirty****⊖ Recommendation**

Dirt/debris was visible at the fins of the outdoor condensing unit. Proper cleaning is needed.

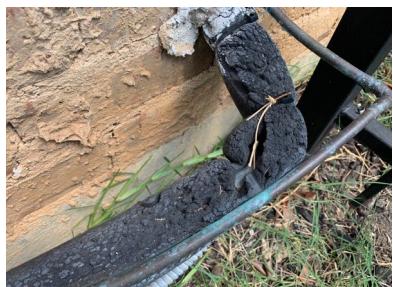
1: Refrigerant Lines: Damaged insulation

Damaged, deteriorated and/or missing insulation on the refrigerant lines. Refrigerant insulation areas area(s) should be repaired or replaced as necessary.

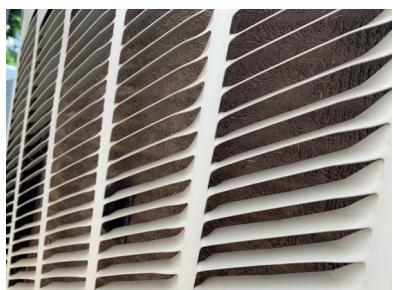
Dirt/debris was visible at the fins of the outdoor condensing unit. Proper cleaning is needed.

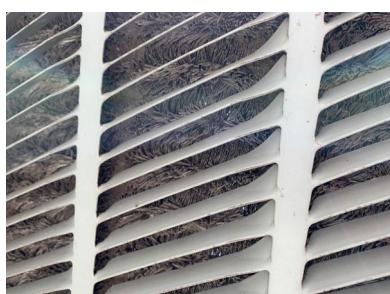
**1: Condenser: Fins dirty****⊖ Recommendation**

Dirt/debris was visible at the fins of the outdoor condensing unit. Proper cleaning is needed.

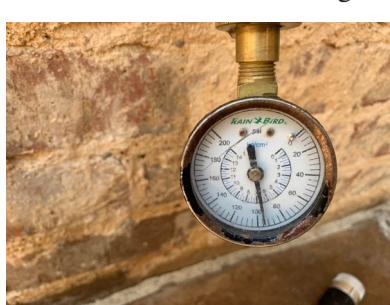
Static Water Pressure Reading: 90

**1: General: High Pressure-80+psi****➡ Recommendation**

The water pressure was observed to be above 80 psi at the time of this inspection. Under current plumbing standards the maximum water pressure should be 80 psi. This condition should be further evaluated and corrected as necessary.

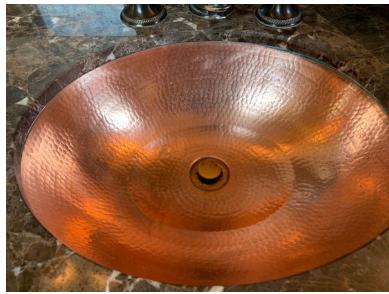
**2: Sink: Slow draining****➡ Recommendation**

The sink was observed to drain slowly, suggesting that an obstruction may exist.

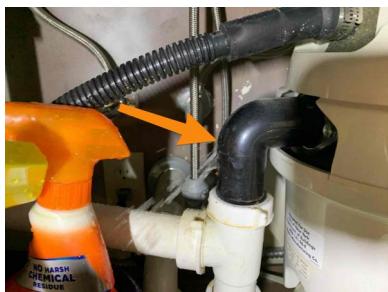
**3: Sink: Drain Leaks in Cabinet****➡ Recommendation**

KITCHEN

The sink drain leaked water into the cabinet when drained under pressure with a volume of water. Repair is needed.

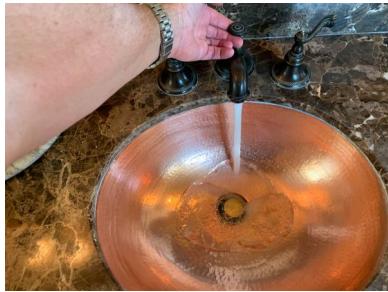
**4: Sink: Drain stopper adjustment****⊖ Recommendation**

MASTER ,Upstairs front bedroom bath

The sink stopper(s) did not appear to be functioning properly and repairs are recommended.

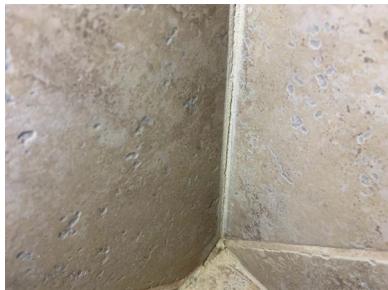
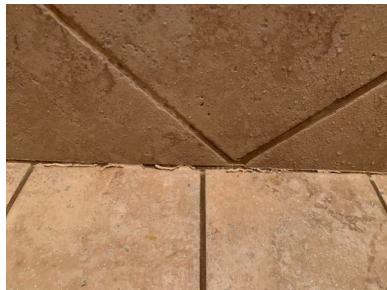
Upstairs front bedroom shower,Upstairs side bedroom bath, upstairs hall bath

**5: Shower: Caulking improvements needed****⊖ Recommendation**

Cracked, deteriorated and/or missing shower stall grout and/or caulking should be repaired or replaced as necessary.

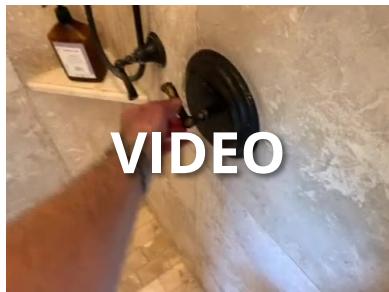
**6: Faucet: Fixture was loose****⊖ Recommendation**

Master shower

The faucet assembly was loose.

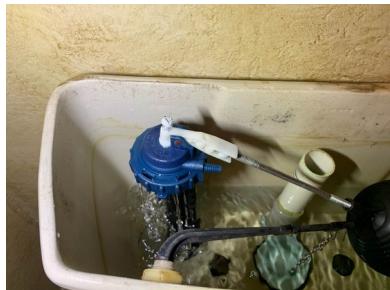
Upstairs hall bathroom

8: Commode: Ballcock leak at head seal**⊖ Recommendation**

The commode tank valve (ballcock assembly) was leaking at the head seal when flushed.

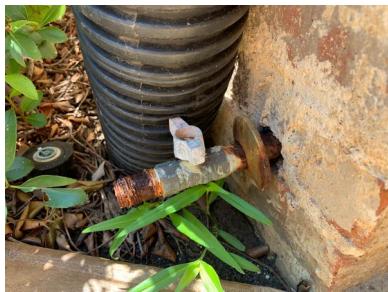
**11: Distribution: Surface rust visible****⊖ Recommendation**

Note: Rust was visible on the exterior natural gas piping. This is a natural occurrence based on the nature of the material, but preventative maintenance is recommended by removing surface rust and applying a protective coat of rust inhibiting paint.

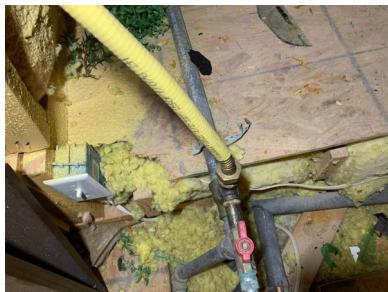
**12: Distribution: CSST present notice****⊖ Recommendation**

Notice: A gas piping system called CSST (corrugated stainless steel tubing) is present in this home. CSST is used to distribute gas in residential, commercial and industrial structures. Ideally it should be properly grounded and bonded. The inspector was unable to verify if these components meet the current installation safety standards recommended and further evaluation is recommended by a licensed electrician. For more information, go to <http://www.csstfacts.org>

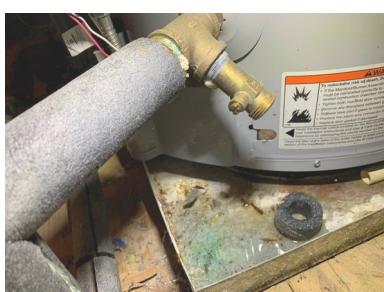
**1: Leak: Drain plug/line to circulation pump Leaking****► Recommendation**

The lower drain plug/lime to the circulation pump on the water heater was observed to be leaking and repairs are necessary. Excessive corrosion was visible.

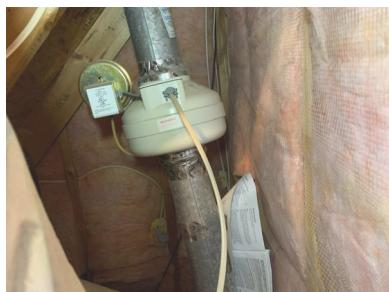
**E. Microwave Ovens***Comments:**Brand Name:* MAYTAG **F. Mechanical Exhaust Vents and bathroom Heaters***Comments:* **G. Garage Door Operators***Comments:* **H. Dryer Exhaust System***Comments:***1: Note: exhaust blower added to the system** **Maintenance Item**

A blower was added to the system to assist in pushing the lint through the ductwork out through the roof. These systems should be checked periodically as they can clog over time.

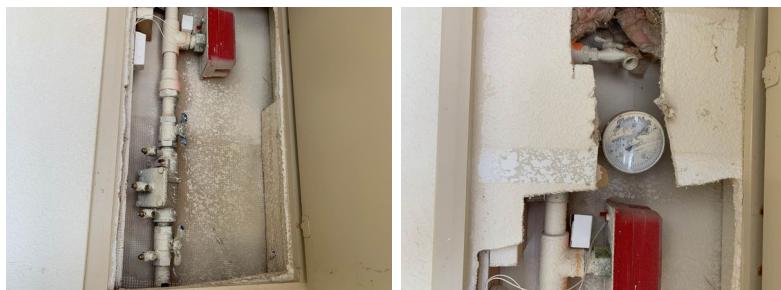
**I. Other***Comments:**Fire Suppression (Sprinkler) System - Not Inspected:*

The fire suppression system cannot be inspected as it falls outside the scope of a standard home inspection. Proper licensing and equipment is necessary to operate and test these components. Buyer should inquire with seller regarding the maintenance history of the equipment. Further evaluation is recommended.

- Note: Sprinkler heads should never be painted. Items should never be stacked close to the sprinklers as this may reduce their heat sensitivity. Tops of storage or furniture should be at least 18" below sprinklers. Never hang anything from any part of a fire sprinkler system.

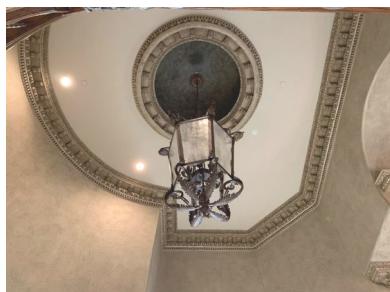
The motor and cable assembly that lowers.raises the main entry chandelier was making unusual sounds when tested. The sellers noted that they had never tried operating the unit. Further evaluation of the motor and cable system is recommended in the attic area. Lubrication may be needed. I was unable to reach it in the attic area at the time of the inspection so I am unable to verify if the system is sealed or the cable is exposed in the attic area. Note: The unit was not fully lowered at the time of the inspection.

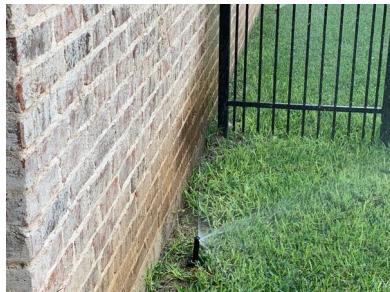
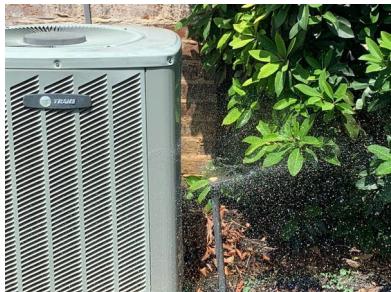
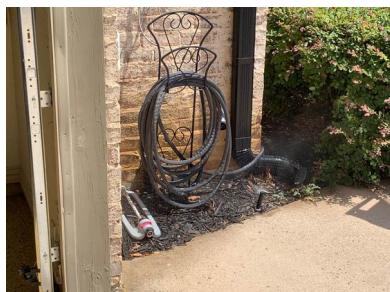
1: Sprays onto Walls/Windows**➡ Recommendation**

One or more of the sprinkler heads need to be adjusted so not to spray water onto the exterior walls, surfaces and/or windows.

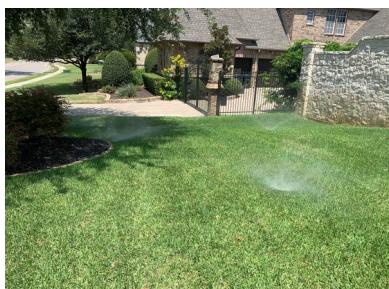
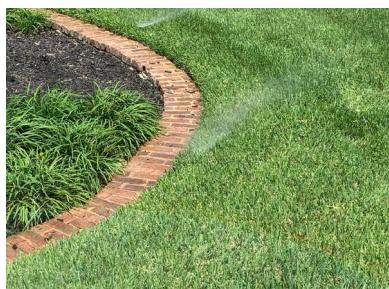
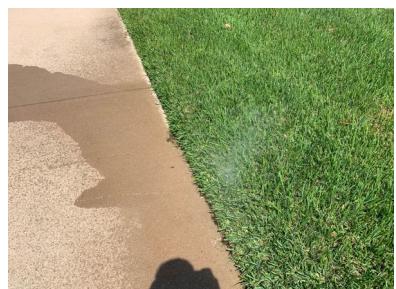
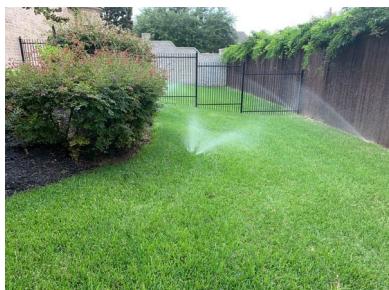
Zone 3,5,6,8 ,9,10

**3: Did not pop up high enough****● Recommendation**

One or more of the sprinkler heads did not pop-up high enough to disperse water properly.
