TOPNOTCH BUILDING INSPECTIONS

PRE-PURCHASE RESIDENTIAL

1234 Main St. Preston Victoria 3072

24/03/2021 9:00AM

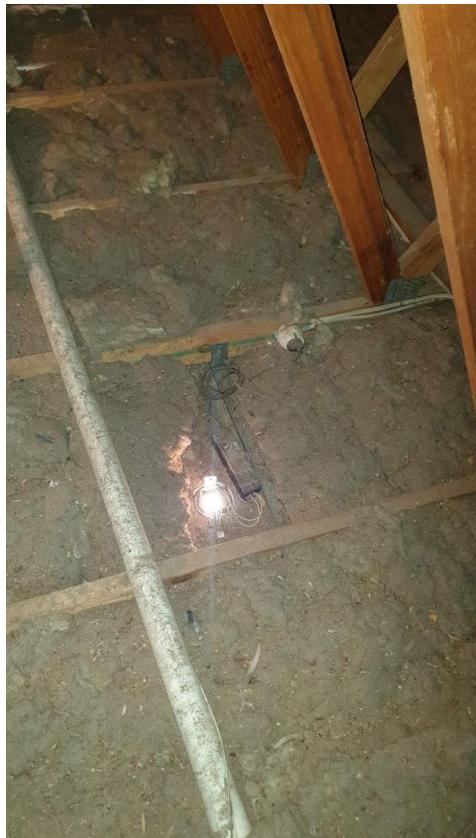
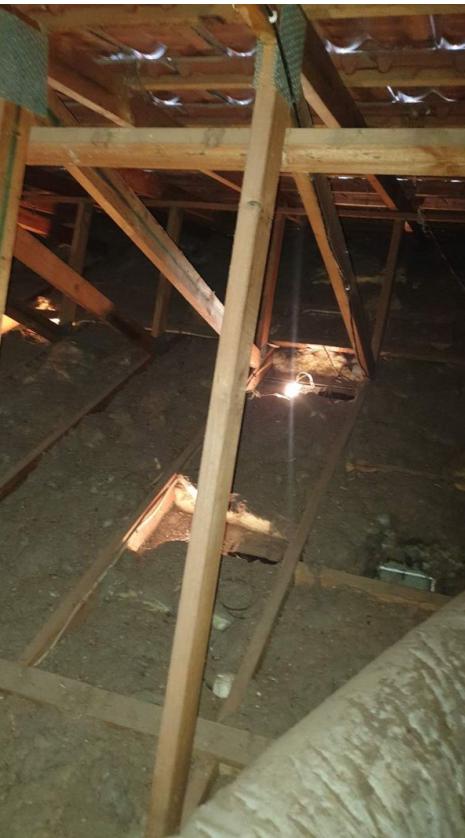
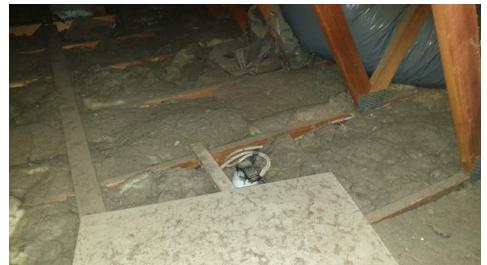
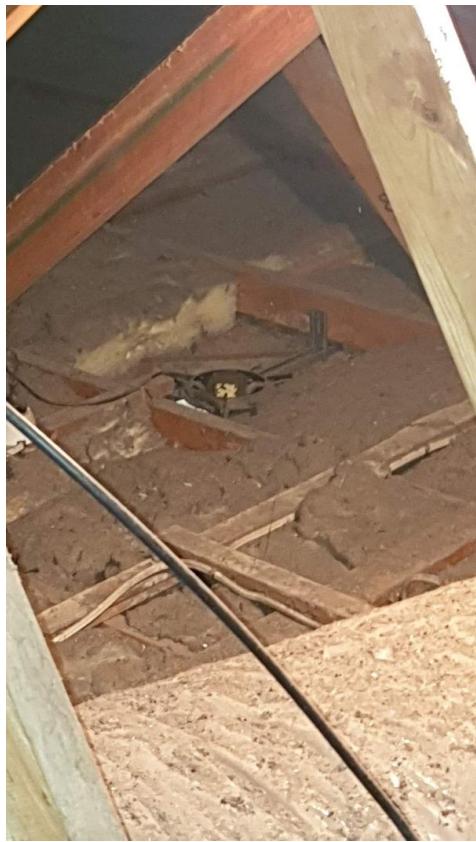
Downlights were observed without downlight protection or in close proximity to non-fire rated materials.

This is a major fire hazard.

⚠ MAJOR DEFECT / SAFETY HAZARD

I recommend contacting a licensed electrical contractor to install downlight protection throughout the house

Contact a qualified professional.

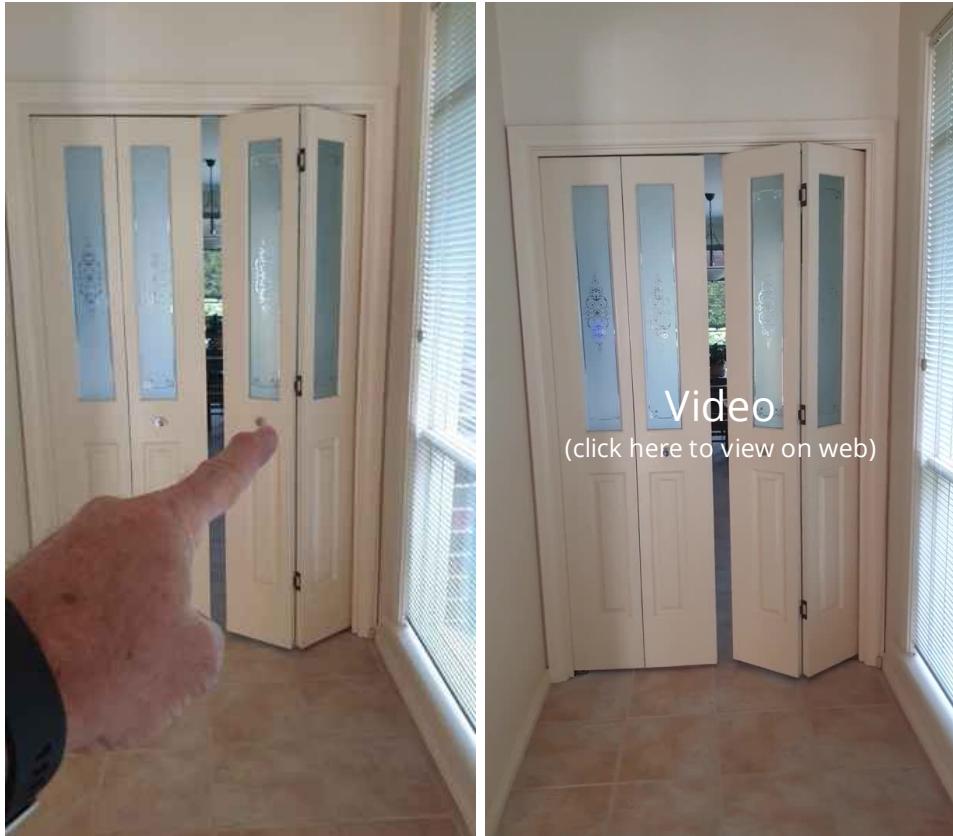
8.3.1 Doors

Although one set of the doors functions, I observed one set of bi-fold doors to be binding. The door margins are inconsistent, this is likely due to some minor movement or normal wear and tear over time.

MAINTENANCE ITEM / GENERAL ADVICE

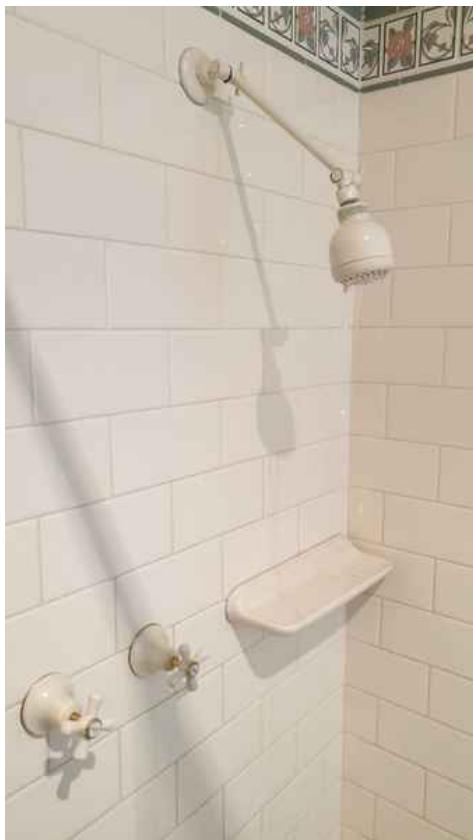
13.16.1 Bath

MINOR DEFECT

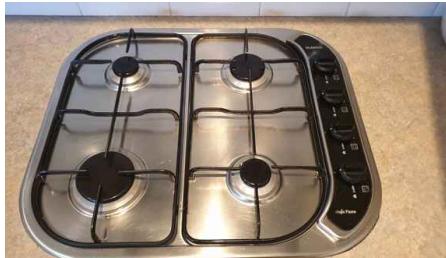
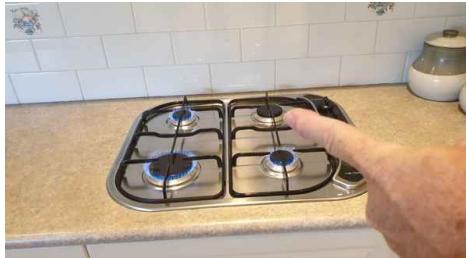
Back Right would not function using normal operations

One or more heating elements did not heat up when turned on.
Recommend qualified professional evaluate & repair.

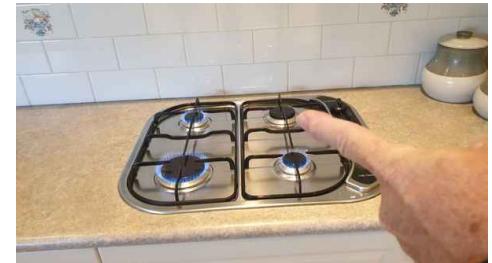
17.2.2 OVEN / COOKTOP / RANGE

EXHAUST FAN VENTED TO ROOF SPACE

The kitchen range hood is currently vented to the roof space. Previously, a tiled roof was considered to be ventilated and therefore it was adequate to vent exhaust fans into this space. Currently, this has changed and new kitchens are required to be vented directly to atmosphere. Although not a defect when constructed / renovated years ago, it is good building practice and desirable to vent to atmosphere to avoid a build up of moist air in the roof space.

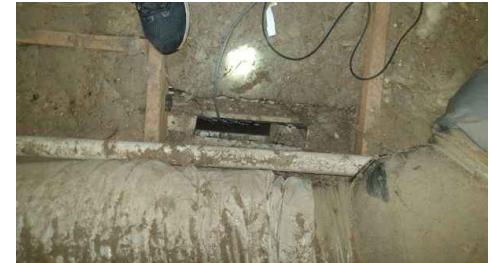
Rangehood venting into roof space

Recommendation

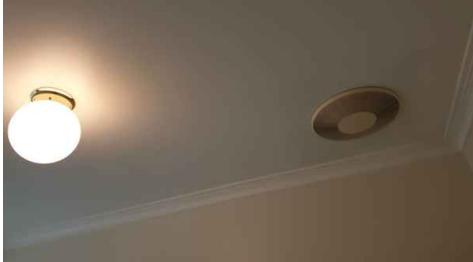
18.20.1 Ventilation

EXHAUST VENTED TO ROOF SPACE (TILED)

MINOR DEFECT

The bathroom exhaust fan is vented directly to the roof space. Previously, a tiled roof was considered to be ventilated and therefore it was adequate to vent exhaust fans into this space. Currently, this has changed and new bathrooms are required to be vented directly to atmosphere. Although not a defect when constructed / renovated years ago, it is good building practice and desirable to vent to atmosphere to avoid a build up of moist air in the roof space.

Recommendation

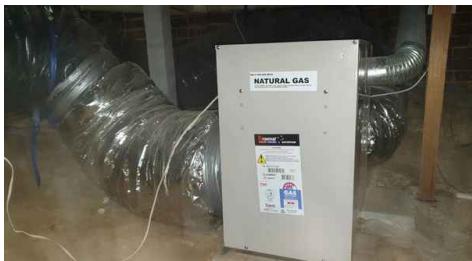
25.1.1 Heating

One of the duct joints was beginning to come apart.
I recommend taping the joint as required to prevent air loss.

Recommendation

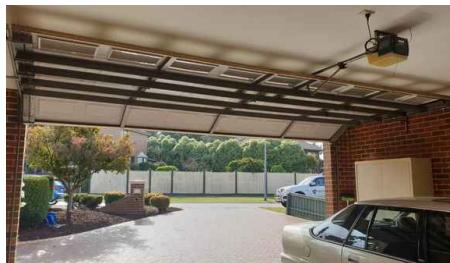
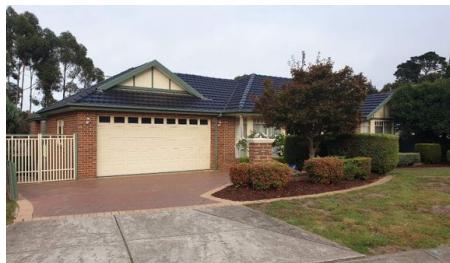
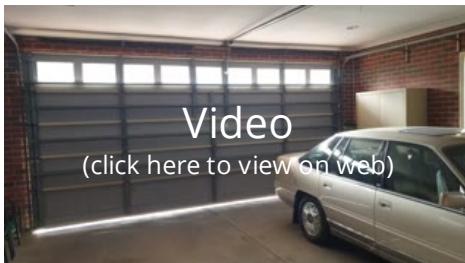
**General: Typical settlement / Shrinkage Cracking**

Typical settlement / shrinkage cracks were present on the garage concrete slab (<5mm wide). These cracks can be caused by admixtures used in the concrete mix when the slab was poured, the lack of expansion or control joints, or standard settlement. If a concern, have a concrete contractor to evaluate.

Any references to cracks in garage concrete slabs will need to be sealed with an appropriate material by a qualified person at a minimum, regardless of the cracks size. This will prevent the possibility of moisture/water infiltration rising through the crack(s) during periods of heavy rainfall.
