# Inspection Report

**Property Address:**  
114623 Golf Center PKWY  
Indio CA 92203

Date: 11/16/2019	Time: 10:30 AM	Report ID: 20191116TLH2
Property: 114623 Golf Center PKWY Indio CA 92203	Customer: Repeat Client	Real Estate Professional:

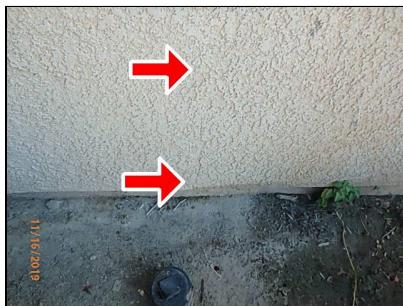
1.0 Item 1(Picture)

1.0 (1) Stucco coating at various areas of exterior is cracked and chipped. Recommend sealing of all cracks to prevent moisture intrusion and further deterioration. If these are areas of concern, recommend further evaluation by proper specialist be completed.

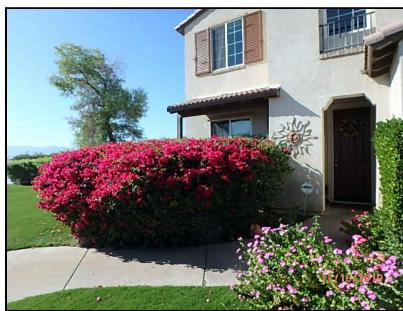
1.0 Item 8(Picture)

- (2) The shrubbery growing on exterior wall covering can cause moisture issues and damage if not removed. Damage can be hidden from view and may not be detected during the inspection. Recommend proper specialist evaluate further and correct as necessary.

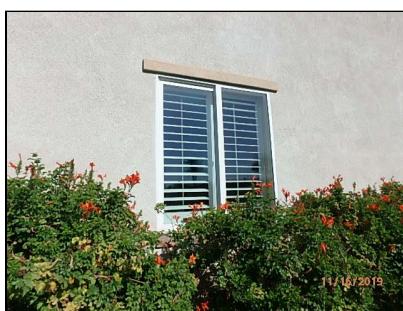
1.2 Item 1(Picture)

- 1.2 Screen(s) are missing at front,rear and side. A qualified contractor should inspect and repair as needed.

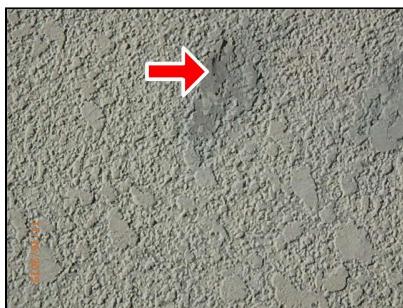
1.3 Item 1(Picture)

**1.3** The Waterproof coating on the upper level deck at the (West side of home) Has a prior repair. I am unable to determine the reason for repair(s). I recommend a qualified contractor evaluate and repair as necessary.

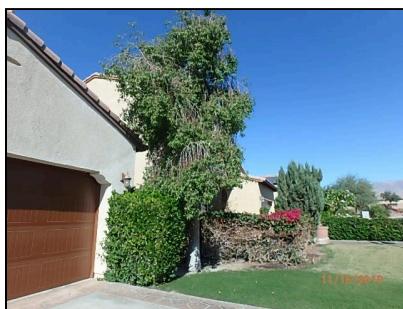
1.4 Item 1(Picture)

**1.4** (1) Trees and vegetation planted next to home may cause foundation,plumbing drain and/or moisture problems on exterior wall covering and can allow rodents access to the attic and interior of home, if not moved. Recommend correct as necessary to avoid any possible future damage. Removal of the vegetation can lead to a Rodent infestation inside the home. Steps to prevent a possible infestation should be taken prior to removal of the vegetation.

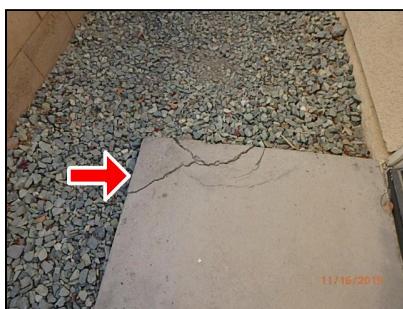
1.4 Item 5(Picture)

(2) The concrete at the driveways walkways/hard scape is cracked and deteriorated at a number of areas. We are unable to determine the cause of the cracks. We recommend evaluation by a qualified person

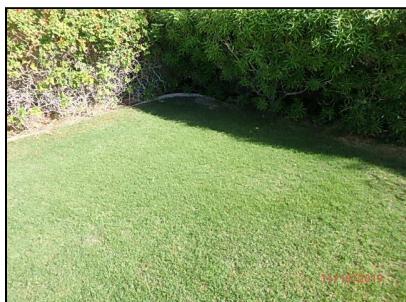
1.4 Item 11(Picture)

(3) There are several areas attached to the home (and away from the home). That do not appear to drain water to an approved location. Water that does not drain away from the home can lead to structural damage and microbial growth. I recommend correction of the grading and drainage by an qualified person.

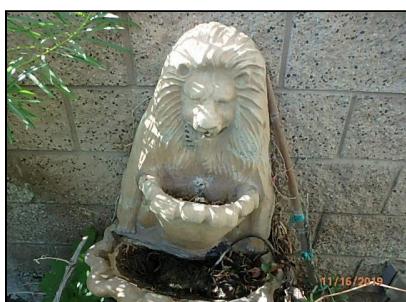
1.4 Item 15(Picture)

(4) Un anchored fountains are considered a child safety hazard. Fountains are beyond the scope of this inspection. I recommend evaluation by a qualified person

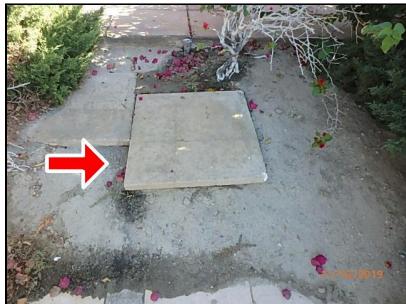
1.4 Item 16(Picture)

🏡 (5) The loose flag stone at the path to the dock is a trip hazard. I recommend repairs by a qualified person to help prevent injury.

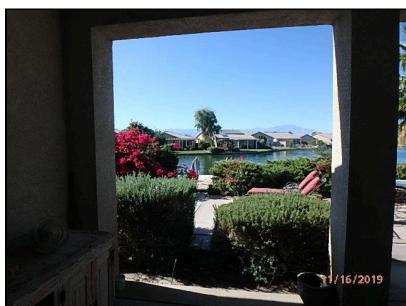
1.6 Item 1(Picture)

🏡 1.6 There is No perimeter fence installed. There is No safety barrier between the Home and The Lake. I recommend install a safety barrier to help prevent accidental drowning.

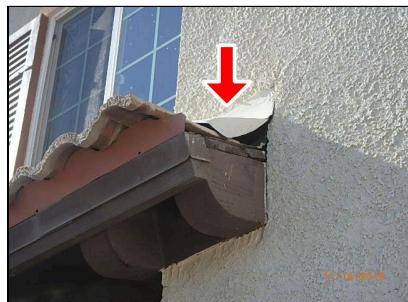
**3.0** (1) There are a number of slipped/loose, damaged or missing tiles. The roof protects the structure, it's contents and occupants. A leaking roof can lead to structural damage and microbial growth. We recommend a qualified roofing contractor fully evaluate the entire roof and repair.

3.0 Item 1(Picture) Missing rake tile

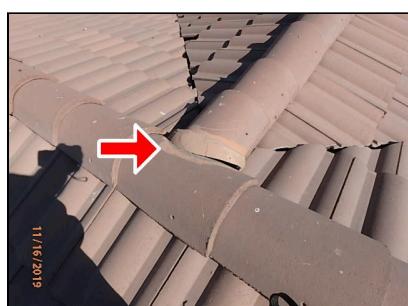
3.0 Item 4(Picture)

(2) The mortar/concrete used as weather block is cracked at a number of locations. These cracks will eventually allow moisture intrusion and need replacement. We recommend replacement of the mortar/concrete with a pre manufactured "weather block" material by a qualified roofer.

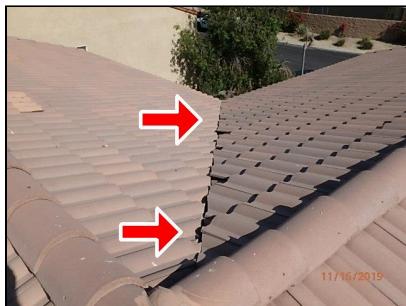
3.0 Item 5(Picture)

(3) Close cut tiles at valleys are an acceptable installation. The tiles do trap debris and prevent water from flowing freely off of the roof. I recommend yearly maintenance/cleaning to help prevent moisture intrusion.

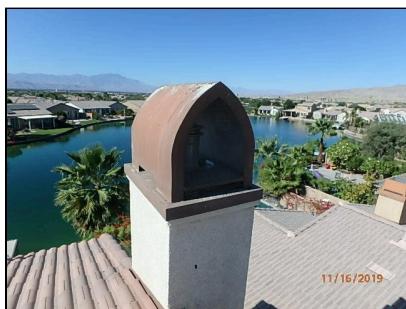
3.2 Item 1(Picture)

**3.2** The chimney, liner and all related components are not fully accessible for a visual inspection. It is recommended that a NFPA(National Fire Protection Association) 211(Standards for chimneys, Fireplaces, Vents and Solid Burning Appliances) level II inspection be performed by a proper licensed specialist for safety.Prior to the close of this transaction and the use of this fireplace.

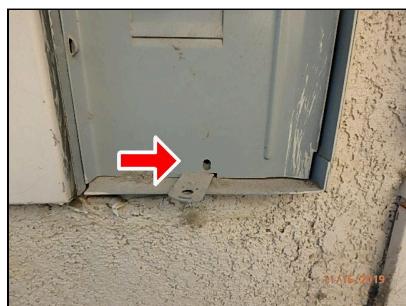
4.1 Item 1(Picture)

**4.1** The problem(s) discovered in the panel such as dead front anchor screw missing and any other problems that an electrician may discover while performing repairs need correcting. I recommend a licensed electrician inspect further and correct as needed.

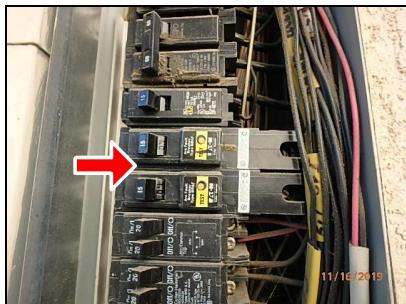
4.2 Item 1(Picture)

4.2 (1) The "AFCI" breakers were not tested due to possible damage to electrical equipment (computers, alarm clocks, etc.etc) connected to those circuits (bedrooms). I recommend an qualified person test/trip off the "AFCI" breakers in the sub panel and verify that all circuits that supply the bedrooms are properly connected to "AFCI" breakers. After the occupants belongings have been moved and prior to occupying the home.

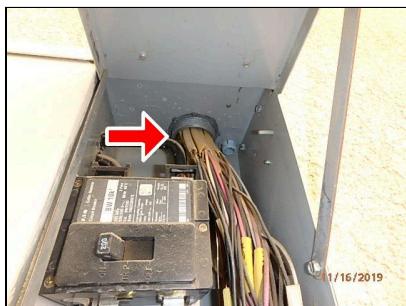
4.2 Item 2(Picture)

(2) When this home was constructed it may have been an acceptable practice to route all of the conductors through one conduit at the main panel. This practice has been discontinued due to overheating of the wires. The only way to determine if there is an problem is to turn on all of the electrical appliances and measure the temperature at the wires in the conduit.

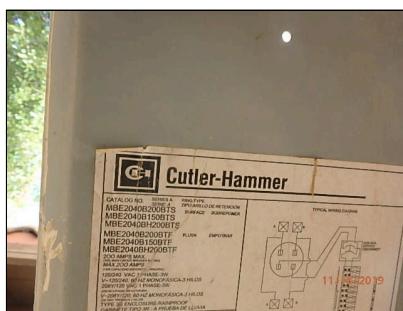
(3) At least one 15 amp circuit breaker in main panel is of a different brand than panel manufacturer. The manufacturer requires that in order for the panel to be safe, only their brand is allowed to be used inside the panel. Even though these circuit breakers are all "UL approved," they are not approved to be used in panels of different manufacturers unless so indicated on the panel label.

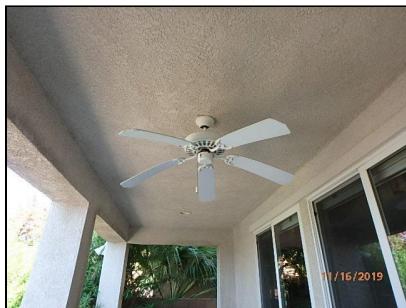
4.3 Item 1(Picture)

4.3 (1) All electrical fixtures (ceiling fans) installed outdoors must be rated for exposure. I recommend an qualified electrical contractor evaluate the ceiling fan(s) to determine if they are rated for exposure.

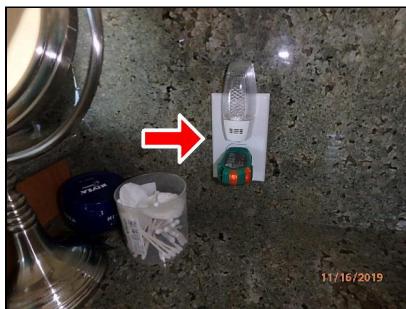
4.3 Item 2(Picture)

(2) At least one "three-prong" outlet is loose in wall/box in the master bath. This is a safety issue that needs to be corrected. A qualified licensed electrician should inspect further and correct as needed.

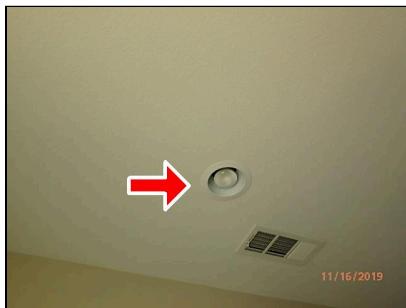
(3) The light fixture do not work at the various rooms. A qualified person should test/verify operation. .

4.3 Item 3(Picture) Master bedroom

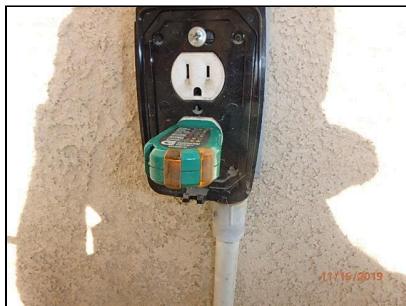
4.4 Item 1(Picture)

**4.4** The exterior receptacle/outlet at the front of home did not work or there is no power to outlet. Electrical issues are considered a hazard until repaired. A qualified licensed electrician should inspect further and correct as needed.

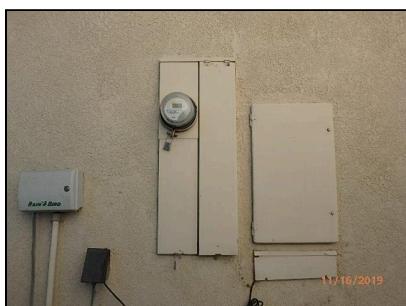
**4.6** The main panel box is located at the North side.

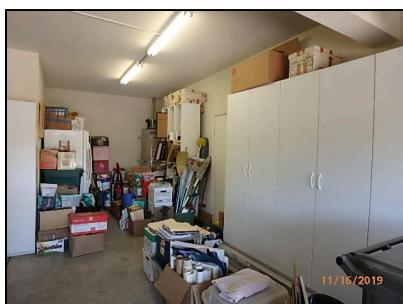
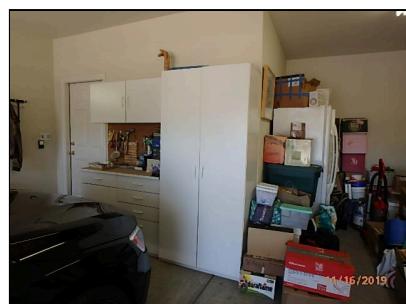
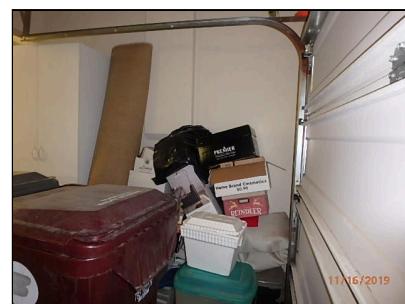
5.1 (1) Walls are not fully visible for inspection due to occupants belongings. Recommend further evaluation by proper specialist.

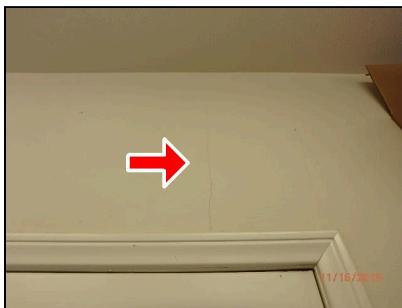
5.1 Item 4(Picture)

(2) The drywall on the wall is cracked at garage. Repairs are needed. A qualified contractor should inspect further and

correct as needed.

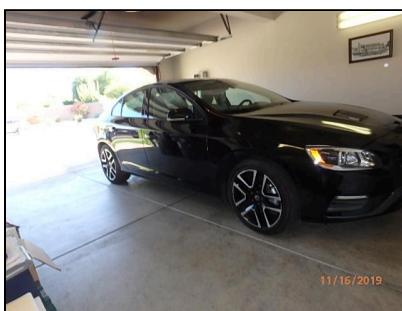
5.2 Item 1(Picture)

- 5.2** Floors are not fully visible for inspection due to occupants belongings. Recommend further evaluation by proper specialist.

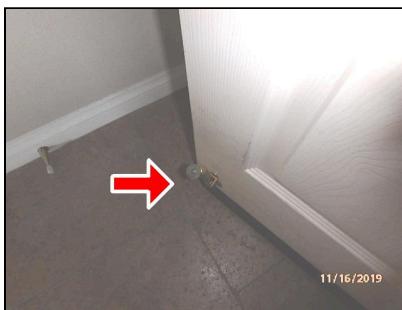
5.3 Item 1(Picture)

- 5.3** The door stop may prevent the door from fully closing and can compromise the doors ability to function as designed. We recommend removal of the door stop.

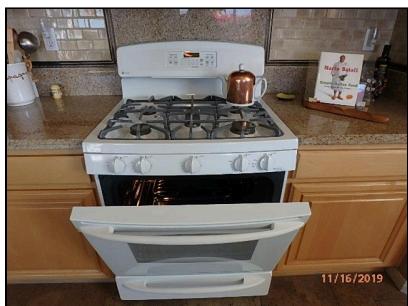
6.2 Item 1(Picture)

**6.2** No "anti tip" bracket installed on the stove/range to prevent unit from tipping over if oven door were to be used for a step. Recommend installation of "anti tip" bracket for safety.

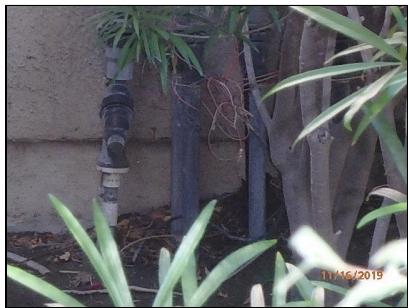
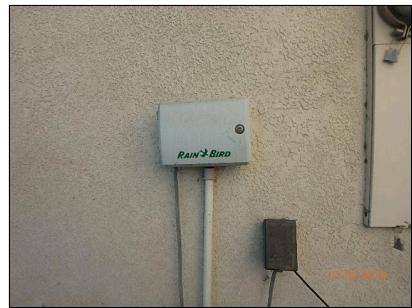
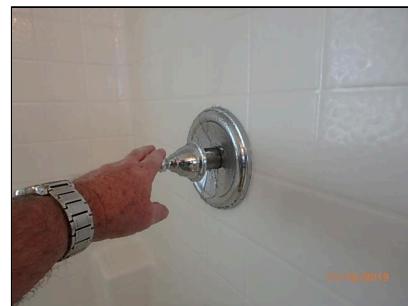
**7.1** (1) Irrigation system was Not inspected. Recommend proper specialist inspect irrigation system further and verify that it meets all of the current water conservation requirements and is functioning correctly.

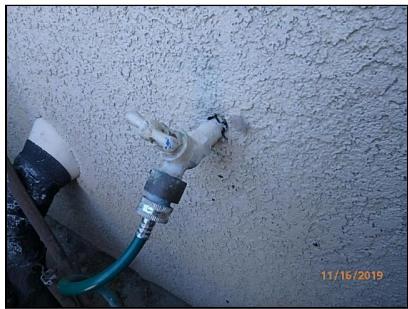
7.1 Item 3(Picture)

(2) The hose faucet pipe at the west side is loose in the wall. I recommend a qualified person secure the pipe inside the wall to prevent damage to any concealed connections that may result in a leak. Water leaks can lead to structural damage and microbial growth

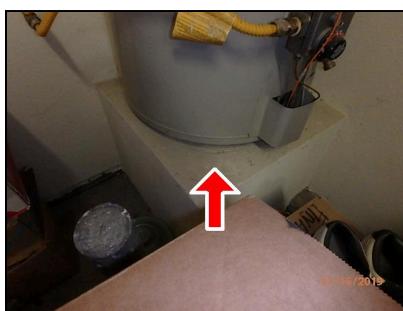
7.2 Item 2(Picture)

When a water heater is located where damage results from a leaking water heater, a watertight pan of corrosion-resistant materials shall be installed beneath the water heater with not less than three-quarters of an inch (20 mm) diameter drain to an approved location.

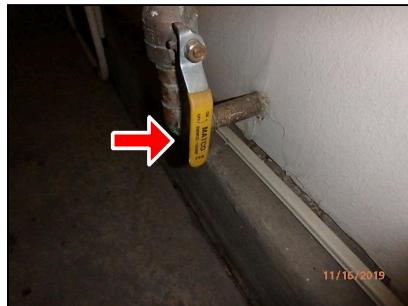
7.3 Item 1(Picture)

**7.3** The main water shut off is the yellow lever located in the garage. This is for your information.

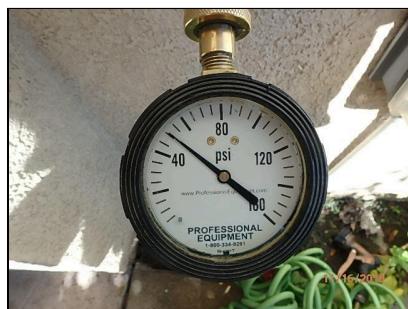
7.4 Item 1(Picture)

**7.4 (1)** Water pressure is 50 psi.

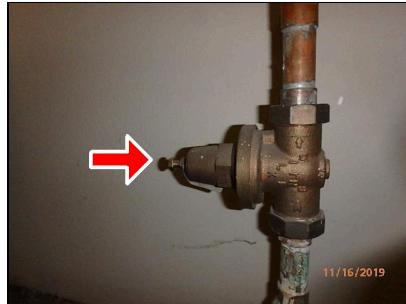
7.4 Item 2(Picture)

## (2) No relief valve visible/installed

Excessive Water Pressure. Where static water pressure in the water supply piping is exceeding eighty (80) pounds per square inch (552 kPa), an approved-type pressure regulator preceded by an adequate strainer shall be installed and the static pressure reduced to eighty (80) pounds per square inch (552 kPa) or less. Pressure regulator(s) equal to or exceeding one and one-half (1 1/2) inches (38 mm) shall not require a strainer. Such regulator(s) shall control the pressure to all water outlets in the building unless otherwise approved by the Authority Having Jurisdiction. Each such regulator and strainer shall be accessibly located above ground or in a vault equipped with a properly sized and sloped bore-sighted drain to daylight, shall be protected from freezing, and shall have the strainer readily accessible for cleaning without removing the regulator or strainer body or disconnecting the supply piping. Pipe size determinations shall be based on 80 percent of the reduced pressure. An approved expansion tank shall be installed in the cold water distribution piping downstream of each such regulator to prevent excessive pressure from developing due to thermal expansion and to maintain the pressure setting of the regulator. The expansion tank shall be properly sized and installed in accordance with the manufacturer's instructions and listing. Systems designed by registered engineers shall be permitted to use approved pressure relief valves in lieu of expansion tanks provided such relief valves have a maximum pressure relief setting of one hundred (100) pounds per square inch (689 kPa) or less.

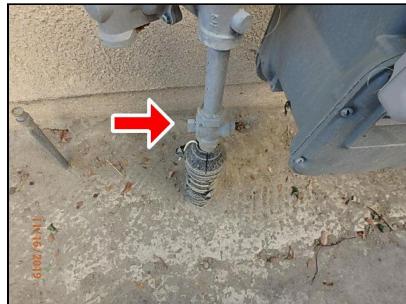
7.5 Item 1(Picture)

**7.5 (1)** The main fuel shut off is at gas meter outside at (North side of home). The valve will need a wrench to be operated. While not a requirement, in case of emergency, we recommend an earthquake style wrench with a chain be installed to aid shut off in the event of an emergency.

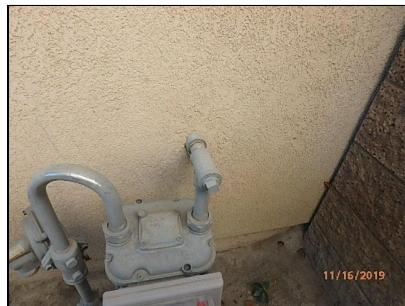
7.5 Item 3(Picture)

(2) There is no automatic earthquake shutoff valve, at the gas meter. There is no requirement for an automatic earthquake shutoff valve. It is a recommendation for a safety up grade, from the Home Inspector to you.

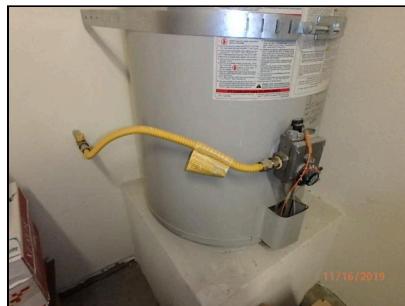
7.6 Item 1(Picture)

**7.6** No sediment traps noted at gas appliances. While local jurisdictional authorities may not require this, we recommend installation of sediment traps at gas appliances as per manufacturers installation instructions.

Sediment Trap. Where a sediment trap is not incorporated as a part of the gas utilization appliance, a sediment trap shall be installed downstream of the appliance shutoff valve as close to the inlet of the appliance as practical at the time of appliance installation. The sediment trap shall be either a tee fitting with a capped nipple in the bottom outlet, or other device recognized as an effective sediment trap. Illuminating appliances, ranges, clothes dryers, decorative vented appliances for installation in vented fireplaces, gas fireplaces, and outdoor grills shall not be required to be so equipped.

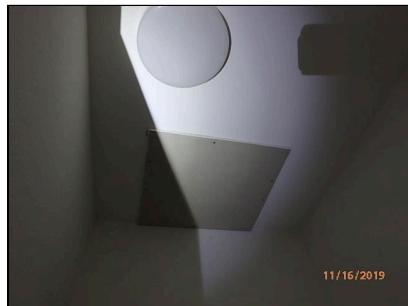
8.0 Item 1(Picture)

**8.0** The Drywall on the ceiling shows repair signs at Guest Bedroom closet. Repairs are needed. A qualified contractor should inspect further and correct as needed.

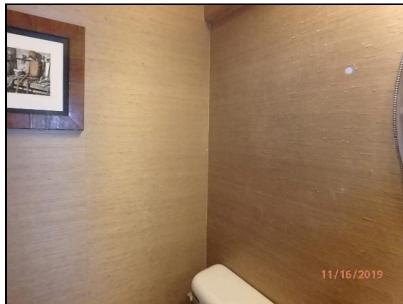
8.1 Item 1(Picture)

**8.1** It should be noted that bathrooms are wallpapered which can sometimes cause bio organic growth to form. Wallpaper is peeling in areas. It is recommended to remove wallpaper to avoid moisture problems.

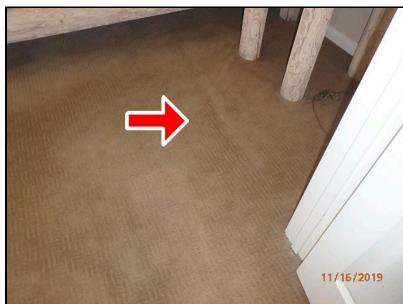
8.2 Item 1(Picture)

**8.2 (1)** The Carpet is loose at upstairs and stairwell. It may eventually become a trip hazard . A qualified contractor should inspect further and correct as needed.

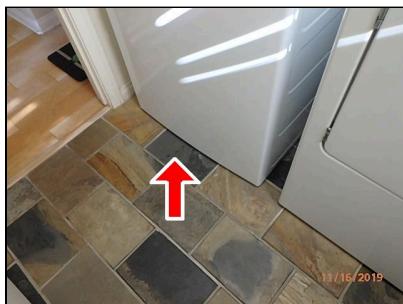
**(2)** PVC clothes washer catch pans become brittle and break with age. We recommend install a metal catch pan at the laundry floor.

8.2 Item 3(Picture) No catch pan below the upstairs clothes washer.

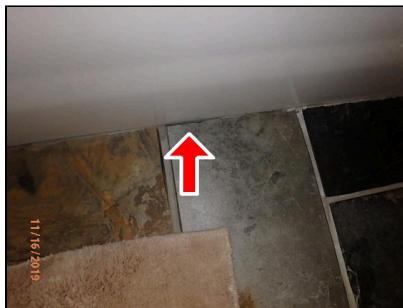
8.2 Item 4(Picture)

(3) The grout/caulking is missing at the upstairs bath. The grout/caulking helps prevent moisture from penetrating below the tiles. A qualified person should repair or replace as needed.

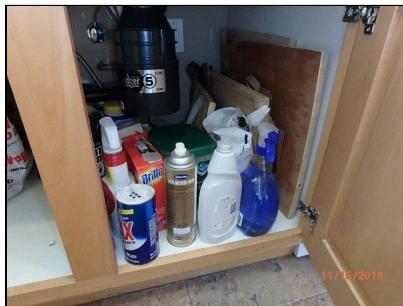
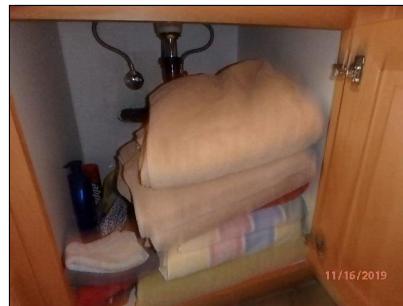
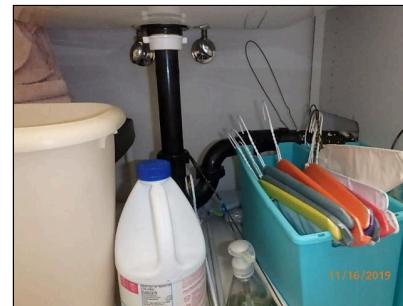
8.4 (1) Occupants belongings stored under the sinks block access. I was unable to fully evaluate the condition of cabinets or plumbing (supply/DWV) under the sinks.I recommend complete evaluation by a qualified contractor after occupants belongings have been moved.

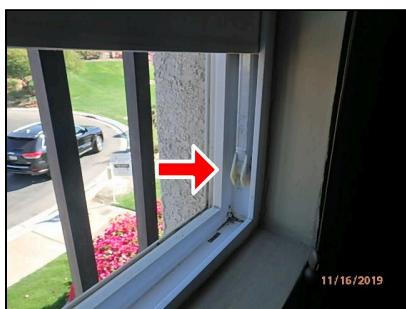
8.6 Item 1(Picture)

**8.6** The window sash spring is loose at the guest bedroom. Damaged springs will eventually have a negative affect on the safe operation of the window. I recommend evaluation and repair by a qualified contractor or window specialist

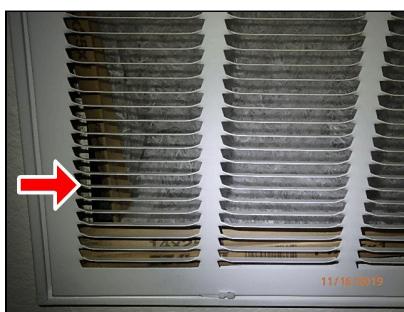
9.5 Item 1(Picture)

**(2)** The filter at the down stairs does not fully filter the return air. Unfiltered air will contaminate the evaporator coils and reduce system efficiency and reduce the life expectancy of the unit. I recommend use only filters that fill the opening and are not easily damaged.

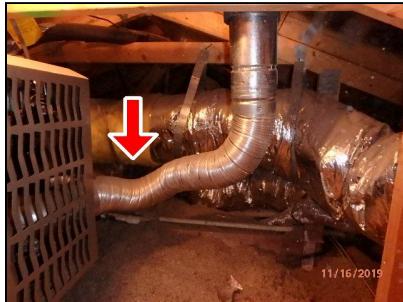
9.7 Item 1(Picture)

**9.7** (1) The chimney, liner and all related components are not fully accessible for a visual inspection. It is recommended that a NFPA(National Fire Protection Association) 211(Standards for chimneys, Fireplaces, Vents and Solid Burning Appliances) level II inspection be performed by a proper licensed specialist for safety.Prior to the close of this transaction and the use of this fireplace.

(2) The vent pipe for gas furnace does Not have a 1/4 slope up for the full length of the horizontal pipe. This is a safety issue and should be corrected. I recommend a qualified licensed heat contractor inspect further and repair as needed.

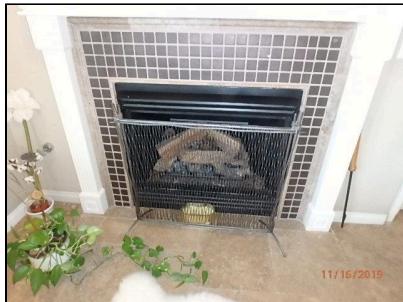
9.9 Item 1(Picture)

**9.9** The screen curtains at fireplace in the Living room are missing. I recommend repair as needed.

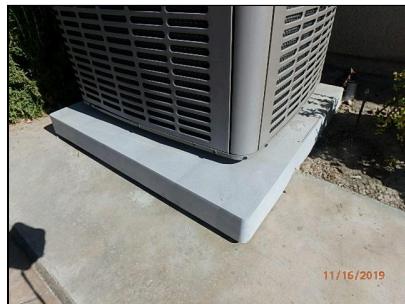
9.10 Item 3(Picture)

(2) We recommend anchor/secure the AC unit to the mounting pad. The unit should be anchored to resist movement

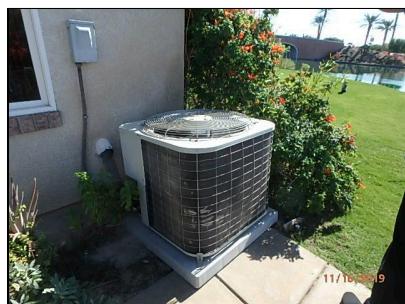
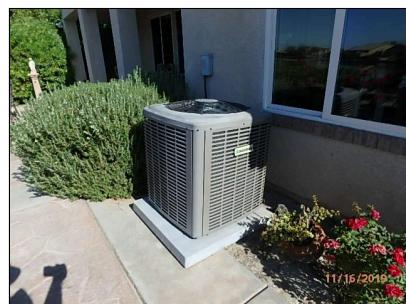
- ⚠️ (3) The AC units are Not level. This may cause the units to wear and prematurely fail. We recommend evaluation and repairs by a qualified HVAC contractor.

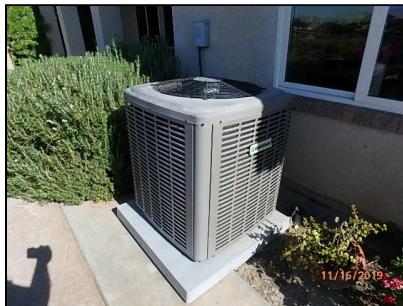
9.10 Item 8(Picture)

(6) I am unable to determine if the air conditioner condenser (guardian) is compatible (correctly sized) for the existing furnace. If the units are not compatible The systems will result in increased energy consumption and decreased system life. I recommend an licensed HVAC contractor fully evaluate the AC compressors and furnaces.

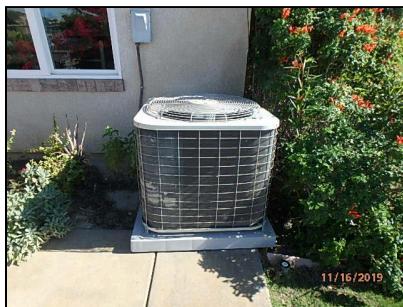
9.10 Item 10(Picture)

(7) Access to the AC electrical disconnect is blocked by the condenser. There should be 36" clearance at the front of the disconnect for the safety of service personnel. We recommend evaluation and repair by a qualified HVAC or electrical contractor

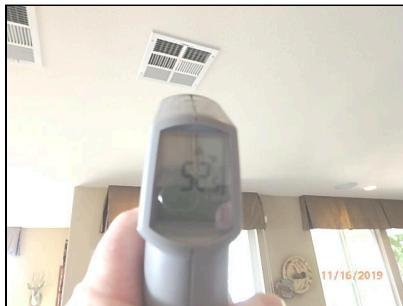
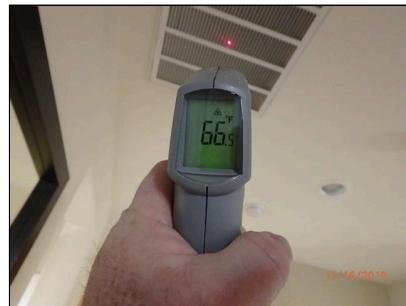
(8) The ambient air test was performed by using thermometers on the supply and return air registers of Air conditioner (down stairs) to determine if the difference in temperatures of the supply and return air are between 16 degrees and 22 degrees which indicates that the unit is cooling as intended. The supply air temperature on your system read 52 degrees, and the return air temperature was 66 degrees. This indicates that the unit is **not** cooling properly and a licensed Heat/Air contractor should inspect for cause or problem.

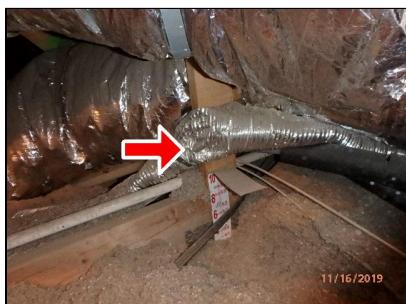
10.2 Item 1(Picture)

**10.2 (1)** The Exhaust fan duct is damaged at the upstairs bath. Vent pipes that are damaged in attic space can sometimes cause moisture that can lead to mold or cause condensation. Eventually a general replacement may be desired.

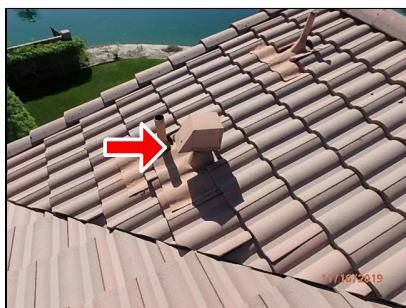
10.2 Item 2(Picture)

(2) The dryer vent terminates above the roof. This may allow dryer lint to accumulate inside the duct and become a fire hazard. We recommend cleaning the dryer vent duct yearly.
