FOREVER HOME INSPECTION - OKLAHOMA

## RESIDENTIAL REAL ESTATE INSPECTION REPORT

1234 Main St. Tulsa OK 74114

06/12/2021 9:00AM

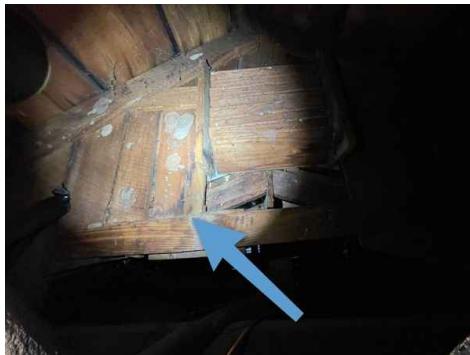
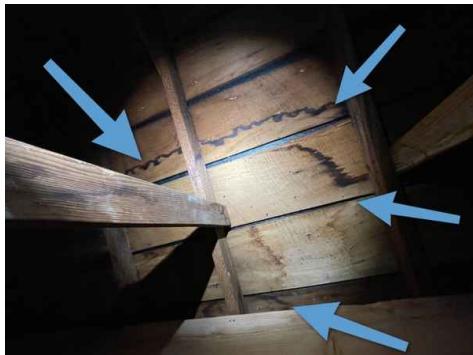
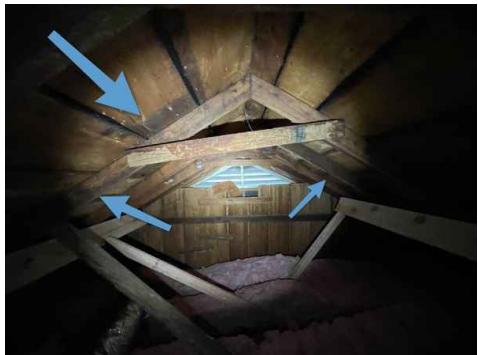
#### INDICATIONS OF PAST/PRESENT LEAKING PRESENT

There were indications of leak(s) on the rafters and/or decking in the attic. The conditions can only be reported as they existed and can not confirm if this is from a past or present leak. Evaluation is recommended to be conducted by a qualified roofing contractor with repairs made as needed, if needed.

Maintenance Item - Low Concern

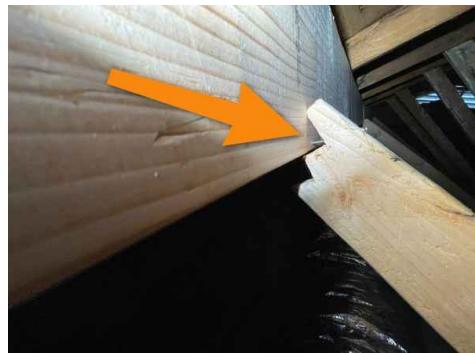
West Attic

Purling bracing was present that was supporting the rafters in their span. This bracing was installed in an unconventional manner in comparison with today's standards. Evaluation and replacement or repairs of this bracing as needed is recommended by a qualified contractor.

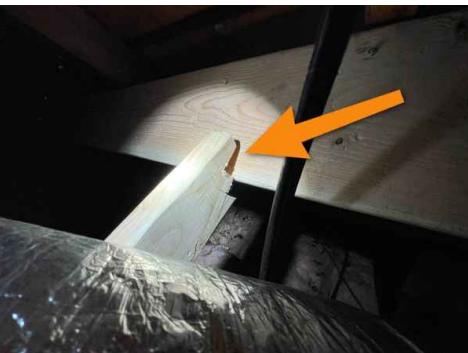
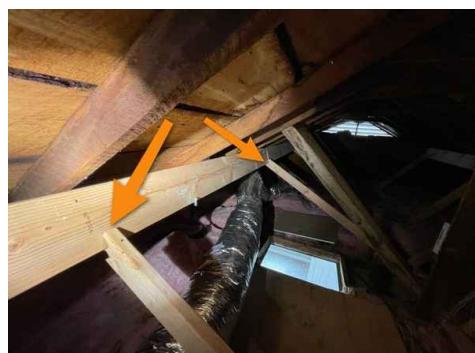
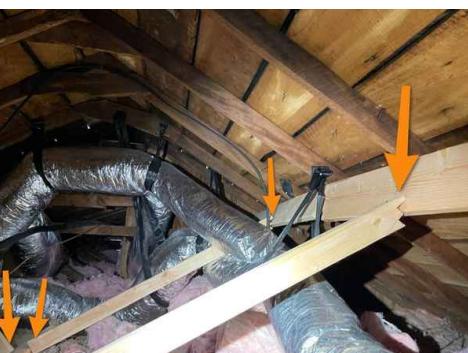
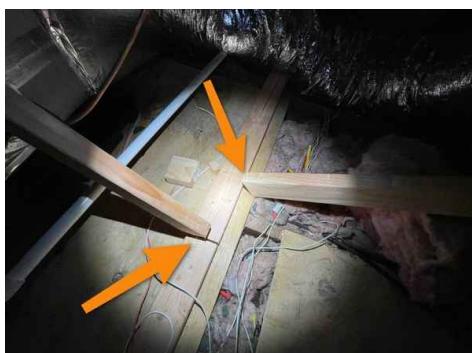
Defect - Medium Concern

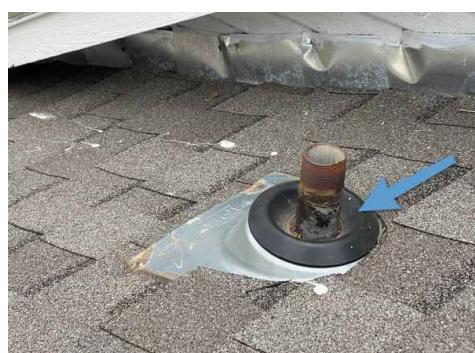
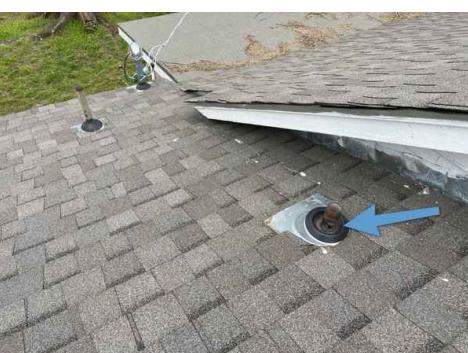
**BOOT-CRACKED / DAMAGED**

There were vent boot(s) that were cracked and/or damaged, this can allow rain water to infiltrate the attic area. Repairs or replacement of the boot(s) is recommended to be conducted as needed by a roofing contractor.

Maintenance Item - Low Concern

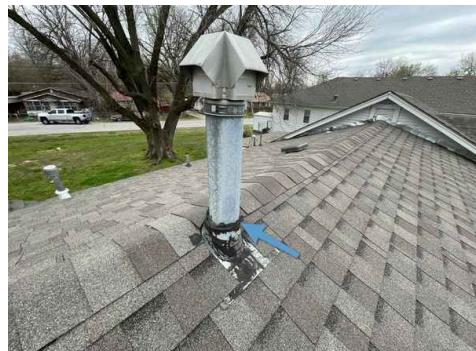
East

There were flashing boot(s) present that were heavily sealed in a possible attempt to correct or prevent a leak, this is a temporary fix. Flashing boots when installed properly do not need to rely on heavy sealant to prevent leaks. Further evaluation of the flashing boots with repairs or replacement made as deemed necessary is recommended to be performed by a qualified roofing contractor.

Contact a qualified roofing professional.

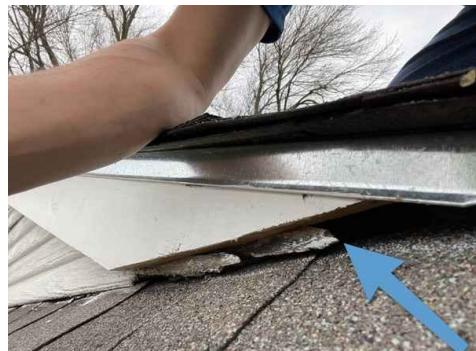
East

The flashing was observed to be loose, lifted, and/or separated from the roof surface, which can allow for rainwater infiltration under the flashing. Further evaluation for repairs to the lifted flashing(s) is recommended by a qualified roofing contractor.

Contact a qualified roofing professional.

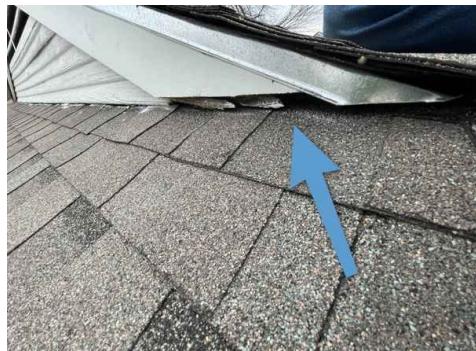
East

**FLASHING-LOOSE/SEPARATED**

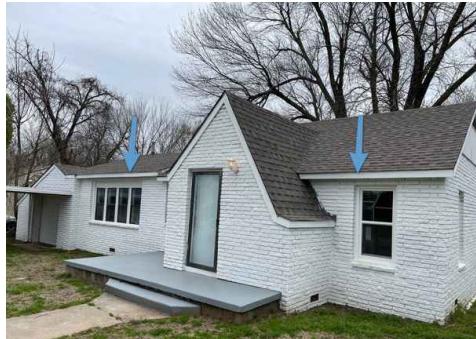
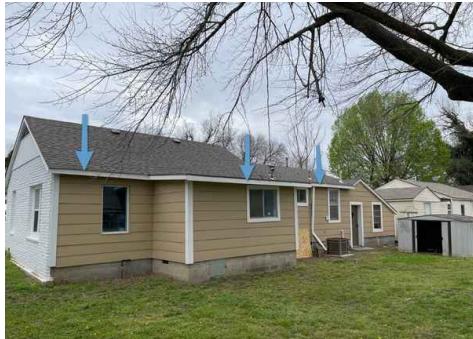
There were no gutters present for the roof. Without guttering present, the grounds surrounding the foundation will become saturated allowing moisture to infiltrate into areas below grade, potentially allowing for the settlement of the home. The installation of guttering is recommended by a qualified guttering contractor.

Contact a qualified gutter contractor

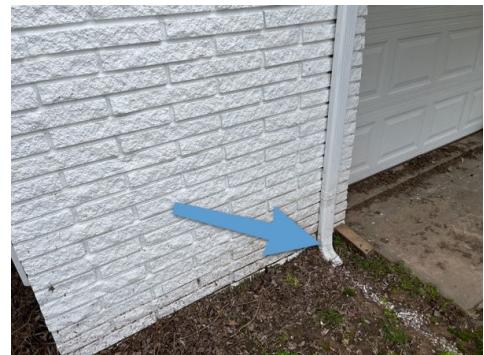
Northeast

There were downspouts present that were discharging next to the foundation of the home. It is recommended they divert away from the foundation to prevent gradient erosion and/or potential foundation issues over time. Installation of downspout extensions are recommended by a qualified person where needed.

Contact a qualified gutter contractor

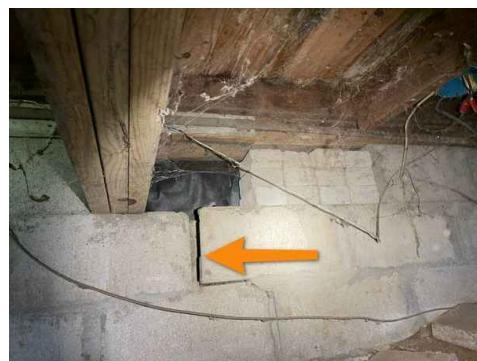
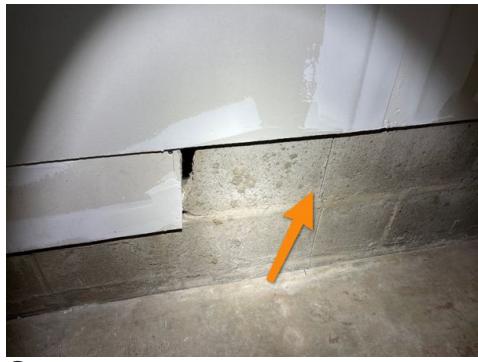
### **STRUCTURE - MAJOR CRACKING PRESENT**

Major cracks were present in the foundation at the referenced areas.

Evaluation and repairs are recommended as needed by a structural contractor.

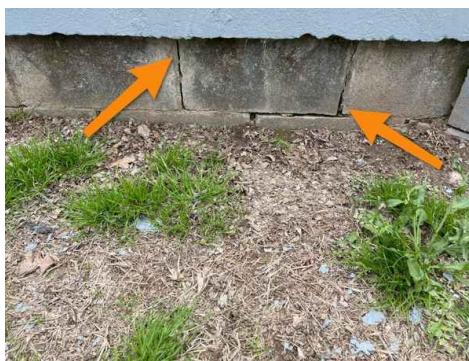
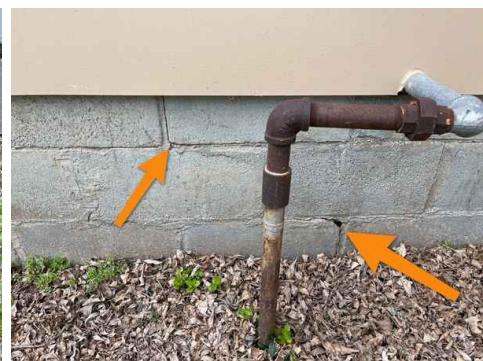
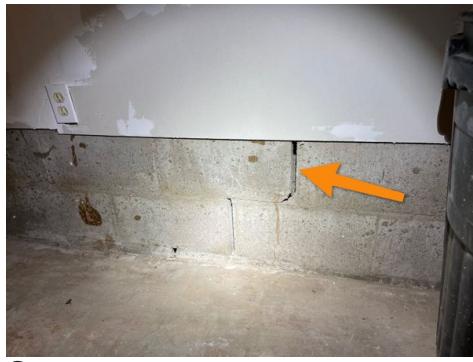
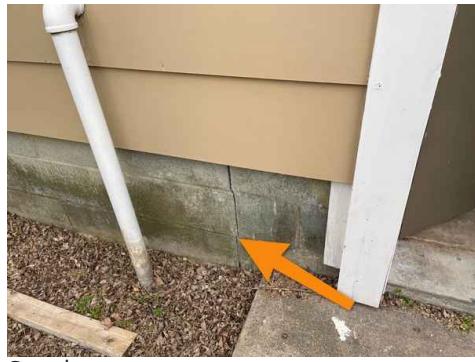
Defect - Medium Concern

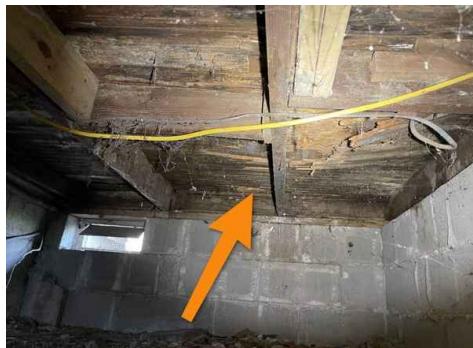
**SUBFLOOR MOISTURE DAMAGE**

Moisture damage to the subfloor was present below the East Bedroom Closet. Repairs are recommended to be conducted as needed to any damaged areas of the subfloor by a qualified contractor.

Defect - Medium Concern

Contact a qualified flooring contractor

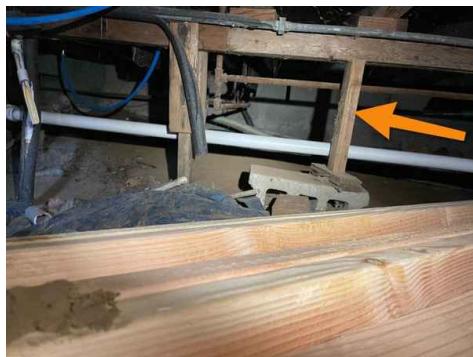
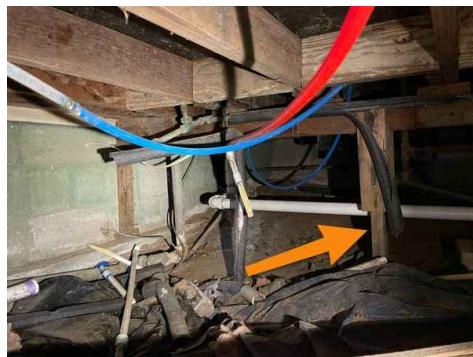
East

**UNCONVENTIONAL/INADEQUATE SUPPORT PRESENT**

Several areas of inadequate and unconventional floor support methods were present. Including 2X lumber stood vertically and stacked lumber, stone, etc. supporting beam(s), girder(s), and joists in their span. None of these unconventional supports were set on footings. A full evaluation of the floor structure's support system is recommended by a qualified contractor with repairs made as needed for proper support of the floor structure.

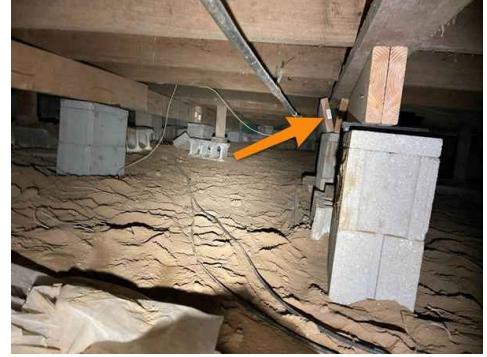
West

One of the built-up girders (two 2x8s) that supports the floor structure was rotated and not providing any support. It is recommended to have a foundation contractor evaluate and repair the girder as necessary.

Contact a foundation contractor.

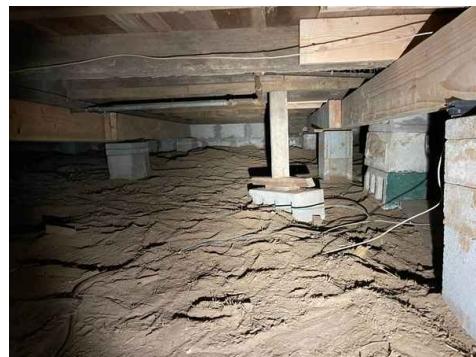
West Crawl Space

**VAPOR BARRIER MISSING**

A vapor barrier was not present in the crawl space. A vapor barrier is recommended to cover the soil as several gallons of water may evaporate from the earth/soil daily, adding moisture, humidity, and condensation to the crawl space area. This can lead to the formation of fungal growth on framing components and other moisture related deficiencies. The installation of a minimum of a 6 mil poly vapor barrier is recommended to be conducted by a qualified person.

Contact a foundation contractor.

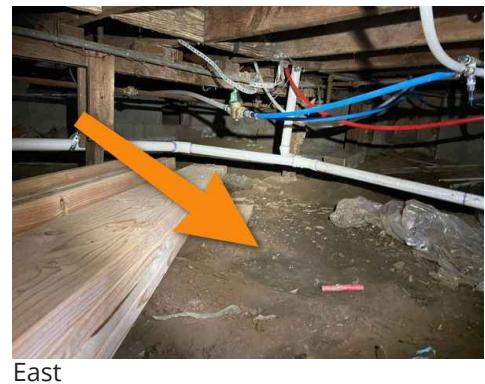
East

**MOISTURE PRESENCE-DAMP AND/OR WET EARTH PRESENT**

Damp earth and mud was present in areas of the crawl space. This is an indicator of moisture infiltrating into the crawl space area below grade. An evaluation by a foundation or grading contractor is recommended to be performed with repairs made as needed to prevent moisture infiltration into the crawl space.

Contact a qualified grading contractor.

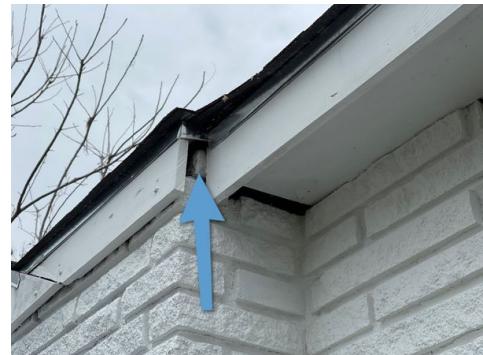
North

### **MISSING FASCIA CLADDING**

There was fascia cladding that was missing at the referenced area(s). The installation of proper cladding is recommended here by an exterior contractor to protect the exposed fascia board.

Contact a qualified handyman.

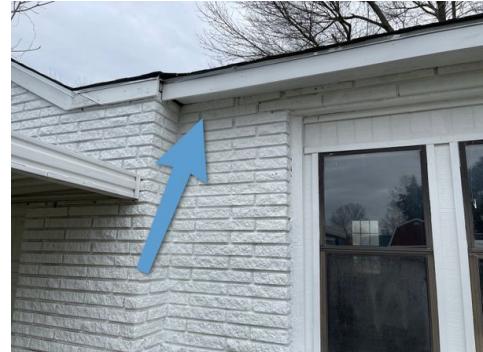
North

### **CRACKING PRESENT**

Cracking was present in the referenced area(s). Further evaluation is recommended by a qualified masonry contractor with sealing or repairs made as deemed necessary.

Contact a qualified masonry professional.

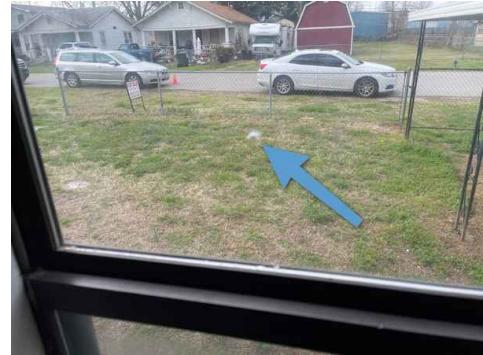
North

### **DAMAGED GLASS**

Damage was present to the referenced windows. Recommend a qualified window contractor repair as necessary.

Contact a qualified window repair/installation contractor.

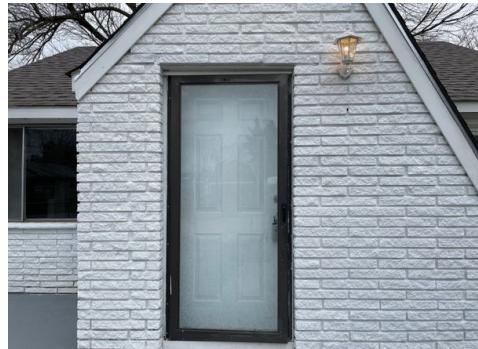
North

**STORM DOOR DAMAGE**

Storm doors are not inspected during a home inspection, but due to heavy damage and other deficiencies present, an evaluation of the doors with repairs or replacement made as needed for proper operation is recommended by a qualified person.

Contact a qualified door repair/installation contractor.

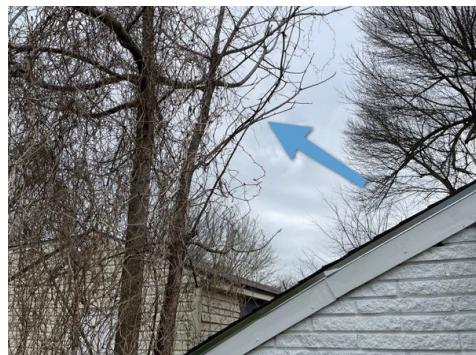
Northeast

Tree limbs were observed to be covering portions of the roof surface or overhanging the roof. Tree limbs within 10 feet of the roof should be trimmed away to provide air and sunlight to the roof, allowing the roof surface to adequately dry after rainfall events. Leaves/debris from overhanging trees can also clog downspouts and gutters allowing them to overflow. Trimming or removal of the offending branches/limbs as needed is recommended to be conducted by a tree trimming company.

Contact a qualified tree service company.

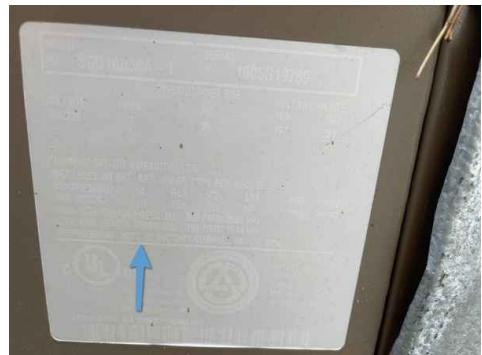
South

The home's HVAC system currently uses R-22 type refrigerant. In 2010 the Environmental Protection Agency banned the manufacture of new HVAC systems utilizing R-22 refrigerant. General phase out of R-22 refrigerant has been estimated to be completed by the year 2020. Existing units using R-22 can continue to be serviced with R-22 but the cost of doing so has been increasing as R-22 becomes more and more difficult to obtain. New systems utilize non-ozone-depleting refrigerants such as 410-A. This may increase the cost of repairs or cause you to have to replace equipment that could have been repaired if R-22 was not being phased out. Although drop-in replacement refrigerants such as RS-44, R407c, etc. are available, they may not perform as efficiently as R-22 and may shorten the life of the system. I recommend consulting with an HVAC contractor if more information is desired.

Contact a qualified heating and cooling contractor

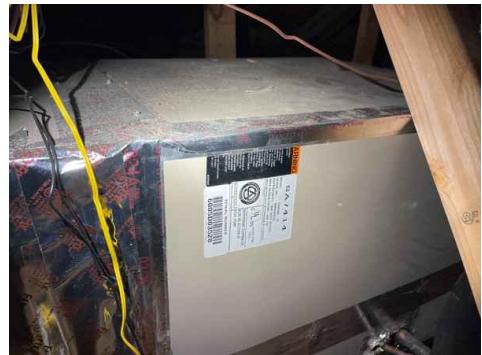
Attic

The unit was nearing, at, or past its typical service life. Repairs or replacement should be anticipated in the future due to the age of the unit(s) alone. Depending on prior maintenance and other factors the unit could last anywhere from months to years, the remaining life is undeterminable. Due to its age servicing is recommended to be conducted by an HVAC contractor. A typical life expectancy chart can be found here:<http://prohitn.com/component-life-expectancies/>

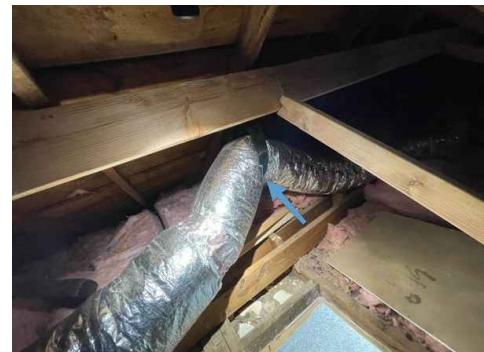
West

Portions of the flexible ductwork (takeoffs) were compressed or kinked. This kinking cuts down the inner diameter of the duct and doesn't allow it to provide the airflow it was designed to deliver to its respective register(s). This kinking or compression of the duct can also create other problems. Evaluation and repairs are recommended by an HVAC contractor as needed.

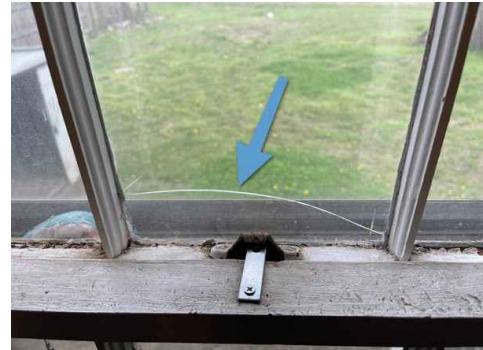
Laundry Room

### WINDOWS - BROKEN GLASS PRESENT

Broken glass was present on the referenced window(s). Replacement of the glass or window as needed is recommended to be performed by a window company or glazing contractor.

Contact a qualified window repair/installation contractor.

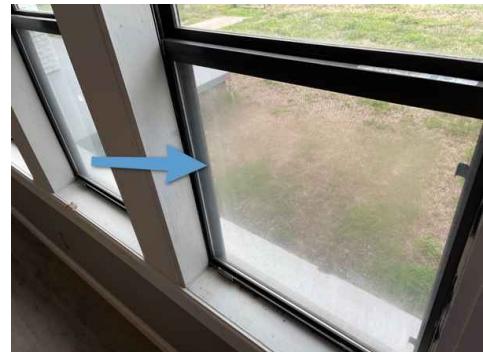
Living Room

Condensation was present on the glass of several windows. This is typically indicative of high humidity in the home. Excessive condensation can allow for the formation of fungal growth and can damage surrounding drywall. Locating the source of excessive humidity with modifications made to control it is recommended to be conducted by a qualified person.

Contact a qualified window repair/installation contractor.

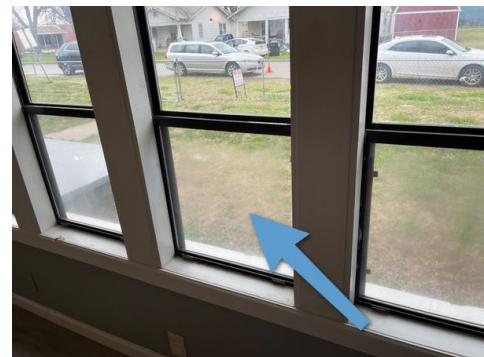
The window(s) in the referenced area(s) were difficult to operate (raise and lower). Repairs or replacement of the window(s) is recommended to be performed by a qualified person as needed for proper operation.

When a property lacks means of egress it present a safety hazard to the occupants as it limits escape from a property during an emergency.

Contact a qualified window repair/installation contractor.

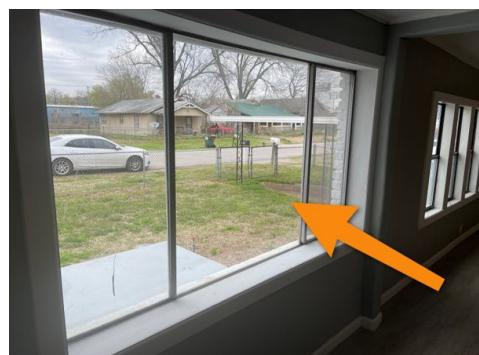
Living Room

### **WINDOWS - NOT LATCHING / LOCKING PROPERLY**

There were window(s) present in the referenced area(s) that were not latching and/or locking properly. Repairs are recommended to be conducted as needed for proper operation by a qualified person.

Contact a qualified window repair/installation contractor.

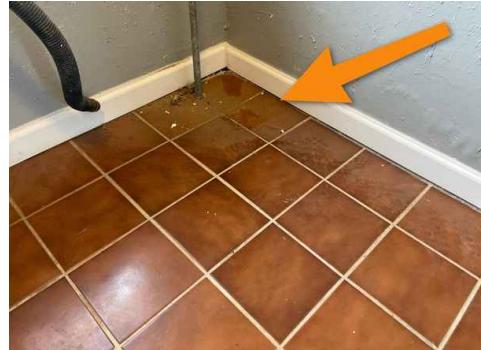
Laundry Room

The floor was settled, sunken, and/or sloping at the referenced area(s). An evaluation of the floor structure to determine the cause of settlement is recommended to be conducted by a qualified contractor or structural engineer with repairs made as deemed necessary.

Contact a qualified structural engineer.

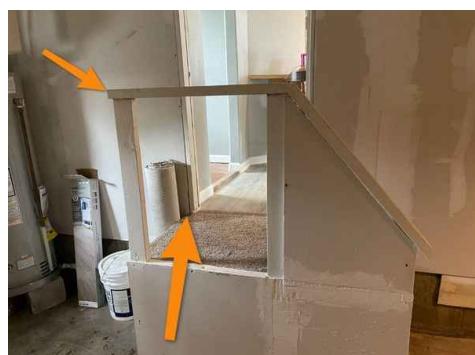
Garage

**GUARDRAIL MISSING**

A guardrail / fall protection was not present on the floor at the referenced area(s). This is a safety hazard. The installation of a proper guardrail is recommended to be conducted by a qualified person.

Contact a qualified handyman.

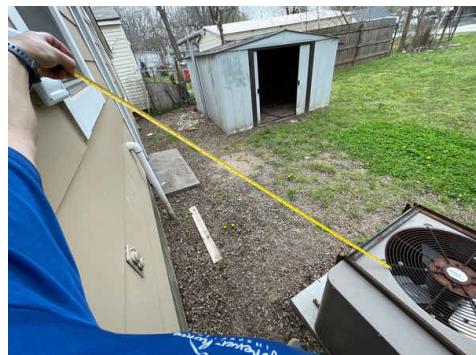
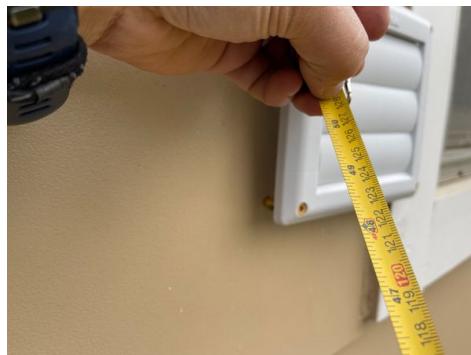
South

The dryer vent was located within five feet of the exterior HVAC unit. This can allow lint to clog the cooling fins of the unit, and affect the efficiency of the unit due to the warm air exiting from the vent. At least five feet of clearance is recommended here. Repairs to achieve the proper clearance is recommended to be conducted by a qualified person.

Contact a qualified handyman.

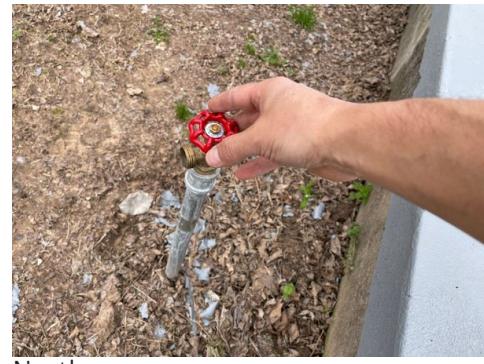
North

There were water valve(s) present in the referenced area(s) that were not functional at the time of inspection. Repairs are recommended to be conducted as needed for proper operation by a plumbing contractor.

Contact a qualified plumbing contractor.

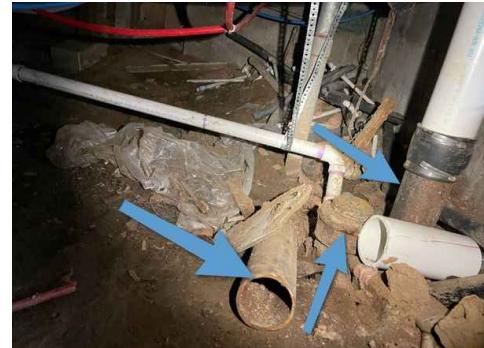
East Crawl Space

Cast iron and/or galvanized drain, waste, and vent pipes were present. These pipes typically have a 50 - 60 year life and will eventually develop inner corrosion that will affect the draining functionality of the system, and cause failure. These pipes will need to be monitored for performance, with the understanding that major repairs or replacement will be needed at some point in the future due to their age. The remaining life is undeterminable. A sewer camera inspection of the pipes is highly recommended due to their age.

Contact a qualified plumbing contractor.

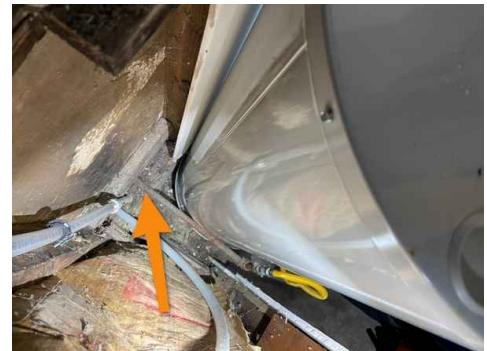
Garage

### HEAVILY CORRODED

The gas line for the water heater was heavily corroded. Evaluation and replacement as needed is recommended by a licensed plumber.

Contact a qualified plumbing contractor.

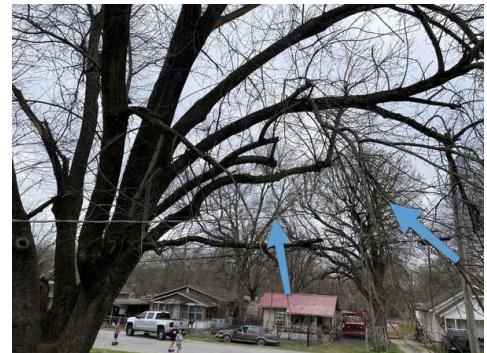
South

Tree branches were in contact with the service drop. Recommend removal of surrounding branches by a tree trimming company or other qualified person.

Contact a qualified tree service company.

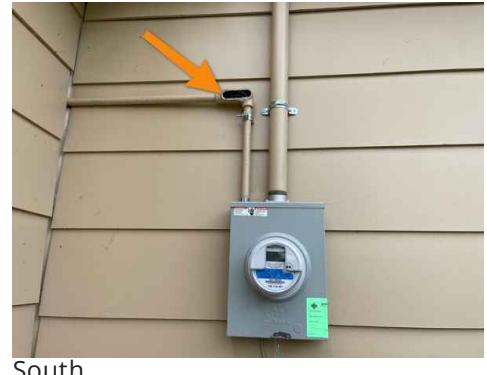
South

There was an open conduit cover with conductors running through it down to the meter. This opening could allow rain to run down into the meter. It is recommended to have the conduit cover repaired by an electrical contractor.

Contact a qualified electrical contractor.

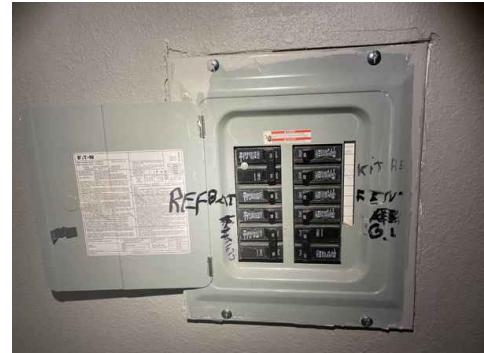
East Bedroom

### **INCOMPLETE, INCORRECT, OR MISSING LEGEND**

The legend for the electrical panel was missing, incomplete, or incorrect. A proper legend is required so that breakers are properly labeled, ensuring correct circuits are shut off in case of the need of service, etc. Properly labeling the breakers is recommended to be conducted by a licensed electrician.

Contact a qualified electrical contractor.

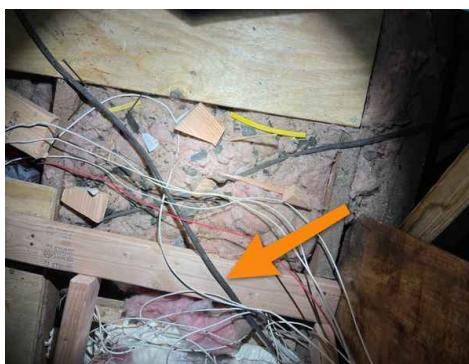
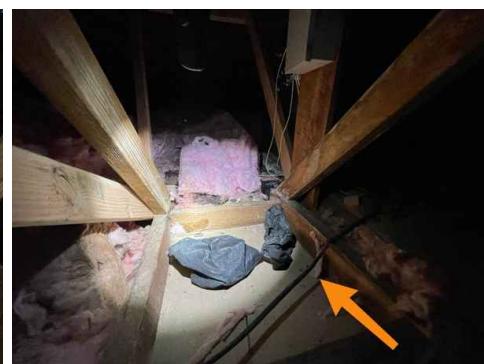
Braided cloth NM wiring was present in this home. This is the predecessor for today's polyvinyl chloride (Romex-like) wiring. This wiring's insulating jacket, both external, and the individual jackets covering the conductors themselves become brittle with age, and can be damaged easily, particularly at securement points to studs and joists, in hot attics, and at bend points in the wiring. Typically this form of wiring does not contain an EGC (ground wire). Replacement of this wiring is recommended to be considered due to its age alone. For safety, AFCI breakers are recommended to protect the circuits with braided cloth NM wiring, as the breaker would trip if a damaged section of the wiring were to arc. I also recommend that any electrical conductors over 40 years of age be evaluated by a licensed electrician to ensure they are performing safely and as intended. Below is a link to a great document by the Casualty Underwriters Association of America.<https://www.cauinsure.com/Include/Documents/P11%20-%20Aging%20Electrical%20Systems.pdf>

Contact a qualified electrical contractor.

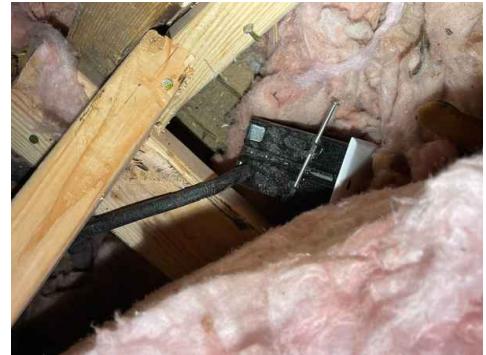
Attic

There were unsecured electrical box(es) present. Proper securement of any electrical box is recommended by a licensed electrician to protect the wiring from damage should the box be moved/disturbed.

Contact a qualified electrical contractor.

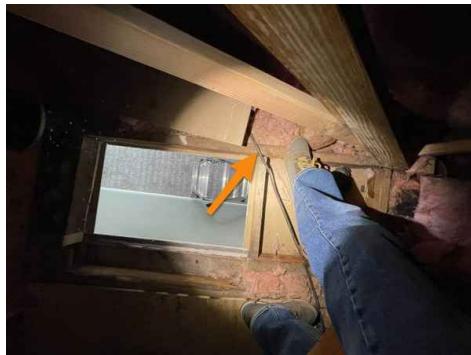
Unprotected wiring was present within 6' of the attic access. Any wiring within 6' of the access needs to be protected from damage with the use of guard strips at least the height of the cable. Evaluation of the wiring with the installation of protection as needed is recommended by a licensed electrician.

Contact a qualified electrical contractor.

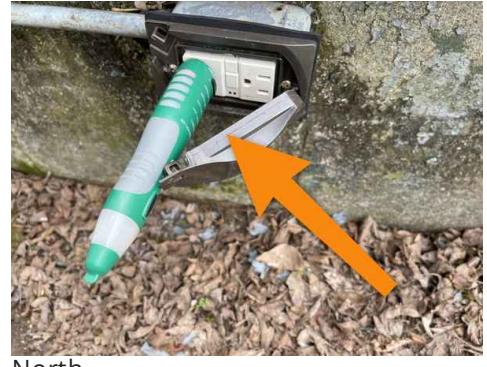
North

There were receptacle(s) present that tested as being ungrounded. This is a potential safety and electronic equipment hazard. Evaluation and repairs as needed is recommended to be conducted by a licensed electrician to obtain grounding protection.

Contact a qualified electrical contractor.

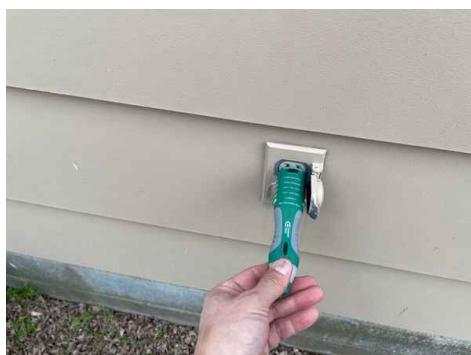
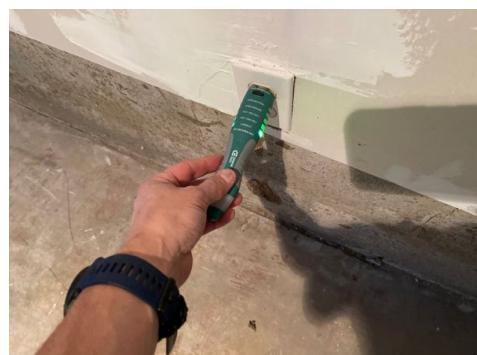
There were receptacle(s) present that were loose in the wall. Proper securement of any loose receptacles is recommended to be conducted by a licensed electrician to prevent loose wire connections.

Contact a qualified electrical contractor.

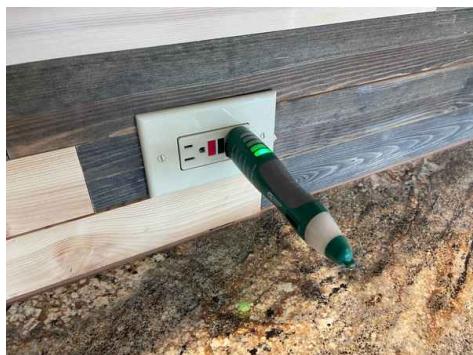
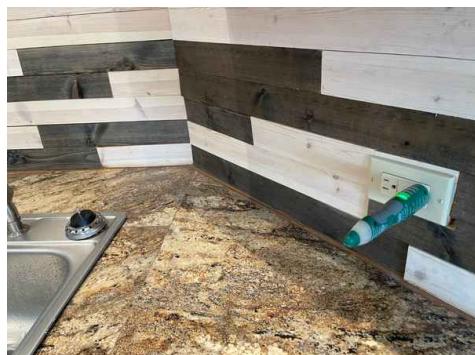
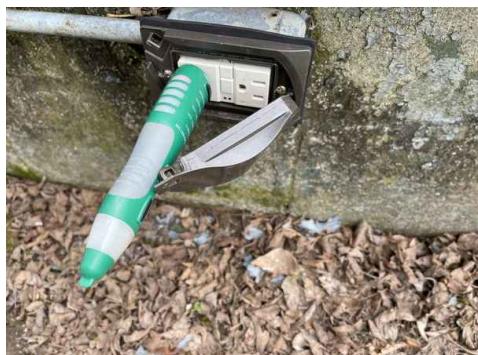
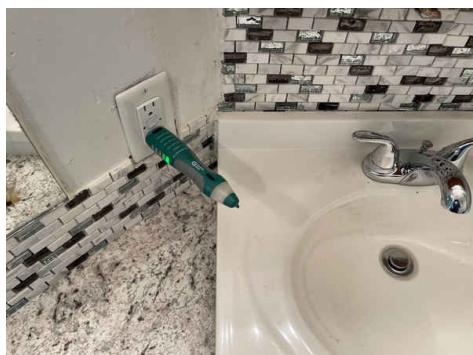
GFCI protection was not functional on the receptacle, due to it not tripping when depressing the "test" button. This is a safety hazard. Replacement of the receptacles is recommended to be performed by a licensed electrician for safety.

Contact a qualified electrical contractor.

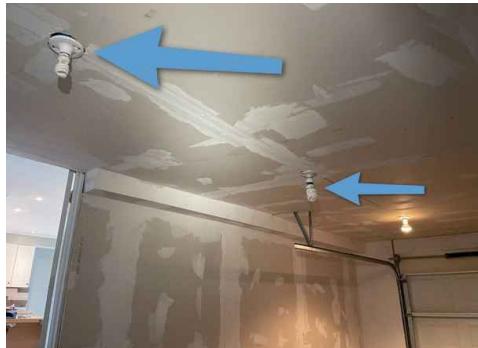
Garage

There were light(s) present that were not functional. This could be something as simple as a burned out bulb. I recommend confirming proper operation with the sellers prior to the end of your inspection contingency period. If these lights can not be verified to be functional prior to closing, evaluation and repairs as needed for proper operation is recommended to be conducted by a licensed electrician.

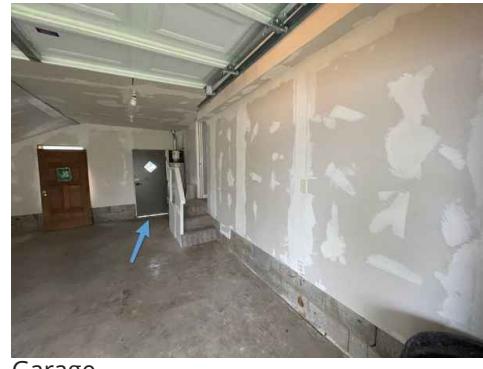
Garage

Light was visible around the door while in the closed position. Repairs / adjustments are recommended to be conducted as needed for a proper fit, and to eliminate any visible light by a qualified person.

Contact a qualified door repair/installation contractor.

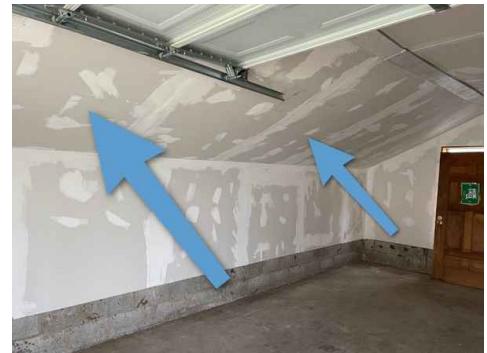
Garage

The ceiling was sloping or sagging in the referenced area. The cause of this cannot be confirmed. If a concern, have a qualified contractor to evaluate further.

Contact a qualified drywall contractor.

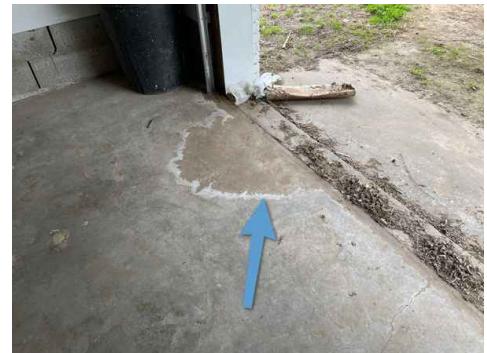
Garage

Evidence of water intrusion was present on portions of the insulation. This may be from a past leak. I recommend consulting with the sellers about the stains and/or evaluation by a roofing contractor.

Contact a qualified professional.

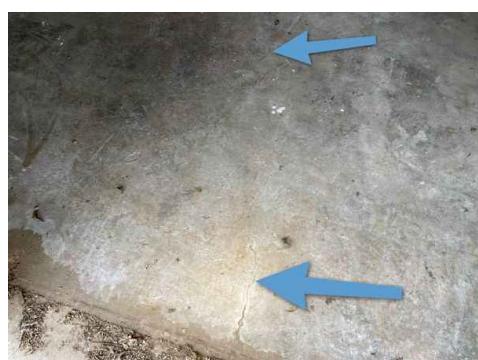
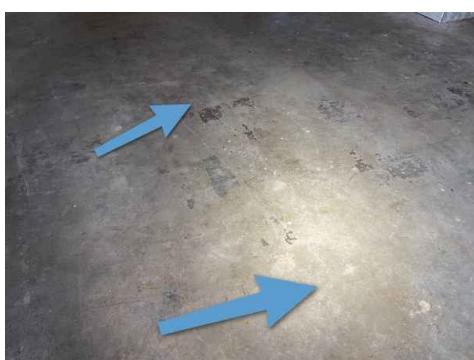
Typical settlement / shrinkage cracks were present on the garage concrete slab (<1/4" wide). These can be caused by admixtures used in the concrete mix when the slab was poured, the lack of expansion or relief joints, or standard settlement. If a concern, have a concrete contractor to evaluate.

Contact a qualified concrete contractor.

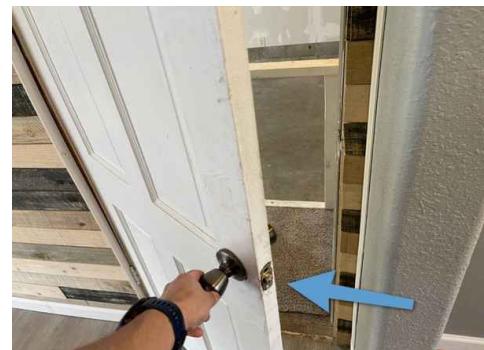
Kitchen / Garage

There was no lock present on the door from the garage to the interior of the house. It is recommended to have a lock installed on the door for security as necessary by a qualified professional.

Contact a qualified handyman.

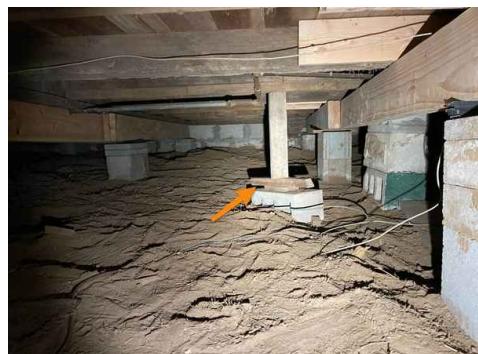
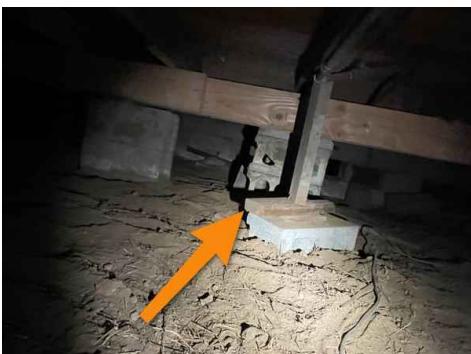
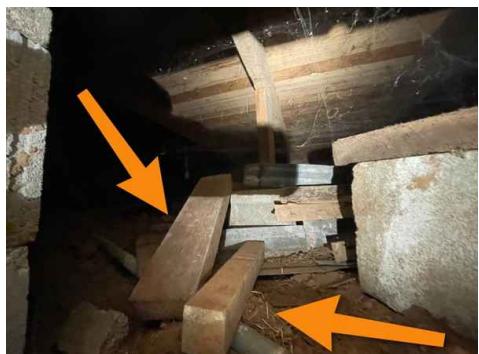
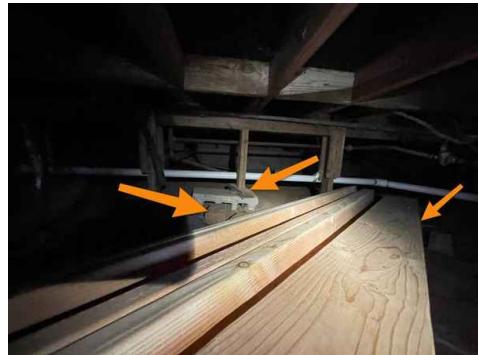
Conducive conditions to wood destroying organisms/termites were present in the referenced areas.

Contact a qualified professional.

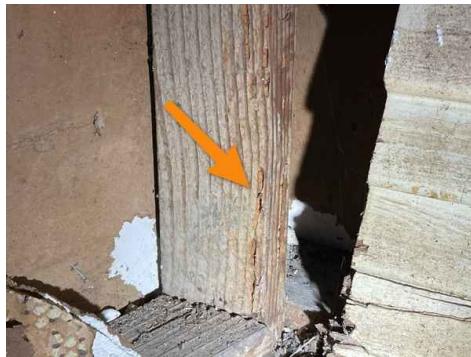
Kitchen

### **VISIBLE EVIDENCE OF TERMITE DAMAGE**

Contact a qualified pest control specialist.

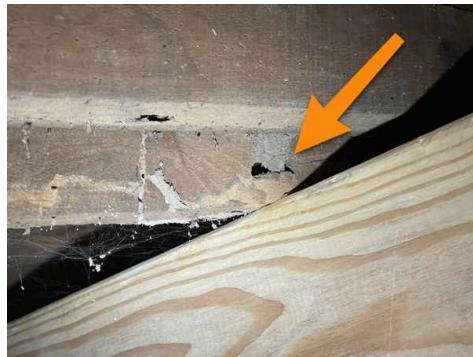
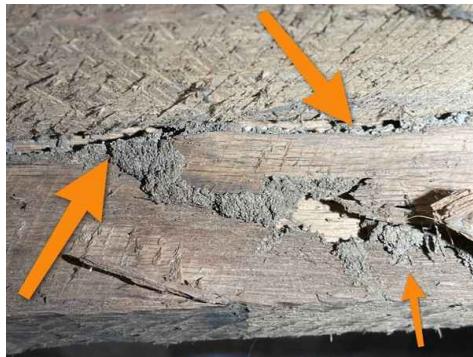
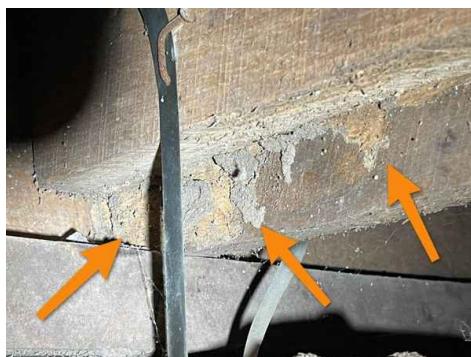
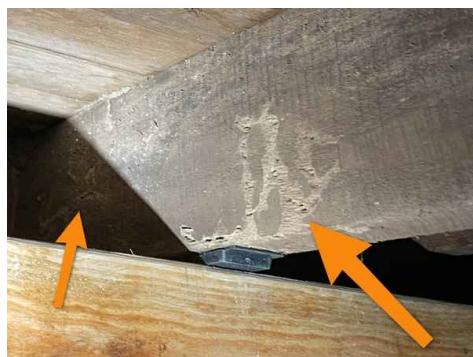
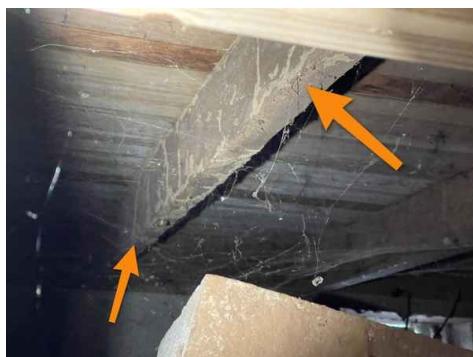
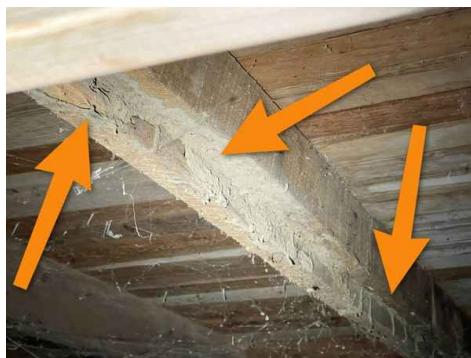
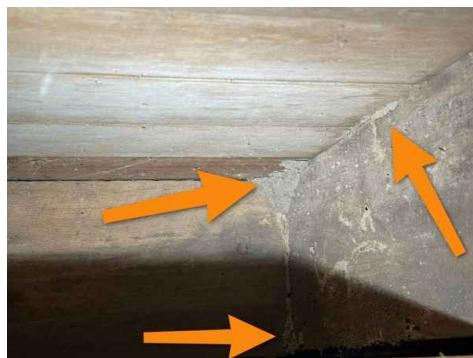
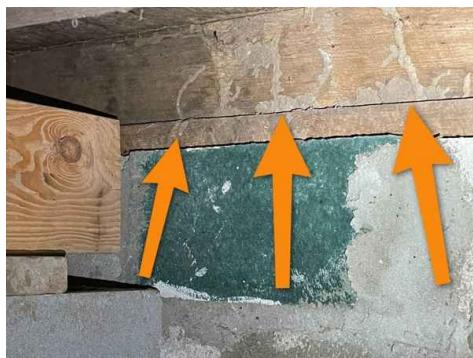
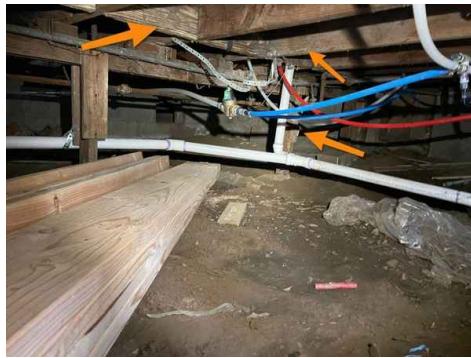
Visible evidence of termite damage was found in the referenced areas.

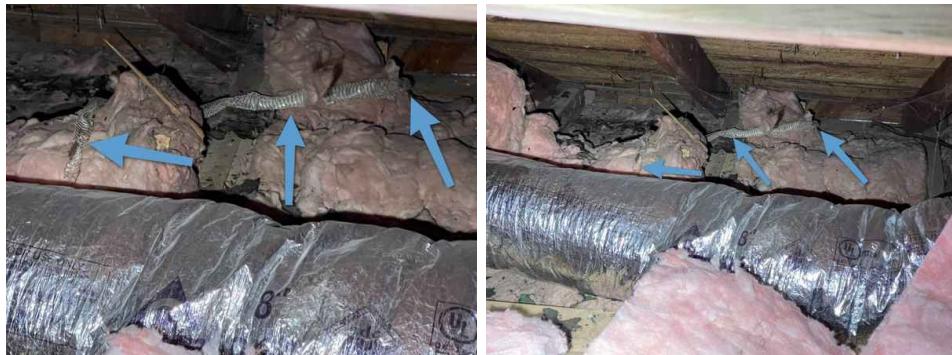
There was a large molted snake skin present in the attic. Removal of the snake is recommended to be conducted by a wildlife removal company as desired.
