# TOPNOTCH BUILDING INSPECTIONS

## PRE-PLASTER INSPECTION

1234 Main St. Preston Victoria 3072

12/03/2021 9:00AM

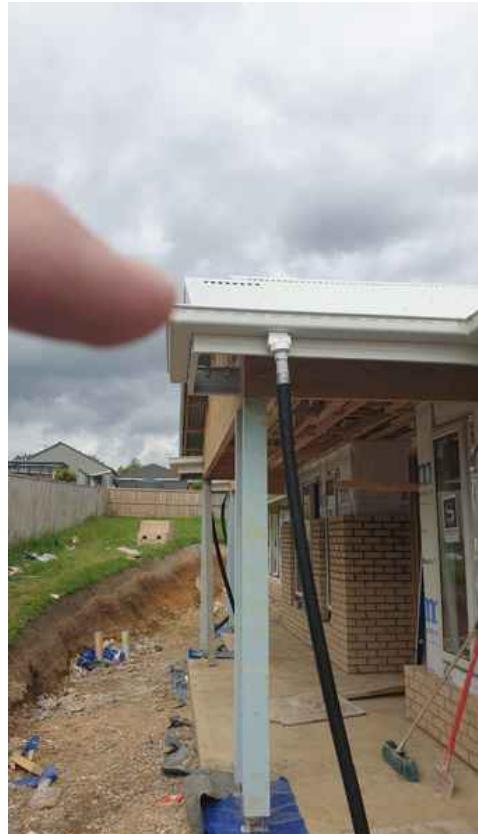
#### FASCIA - DAMAGED

One or more sections of the fascia are damaged.

Recommend qualified roof plumber to evaluate & repair.

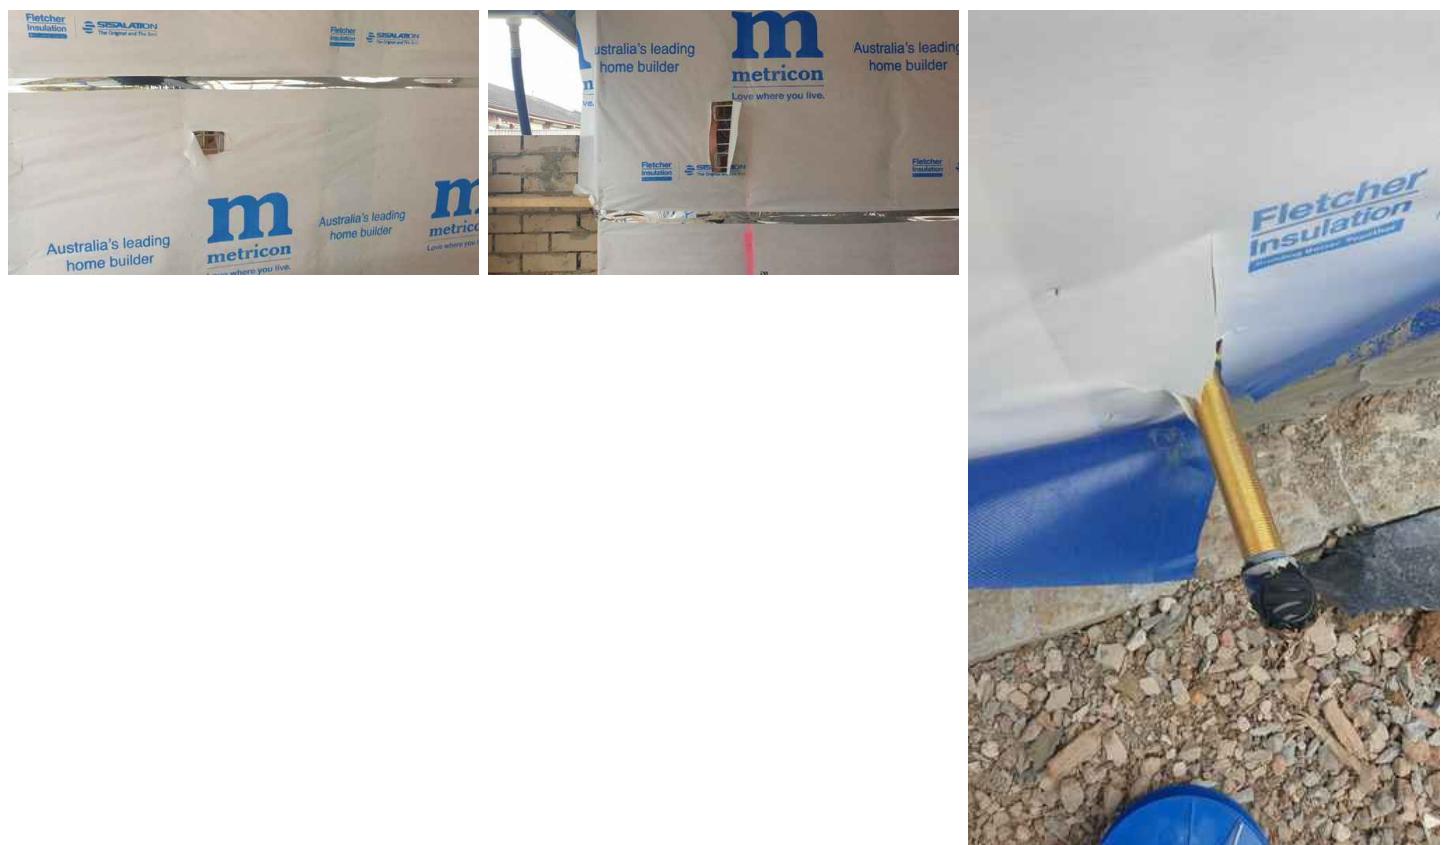
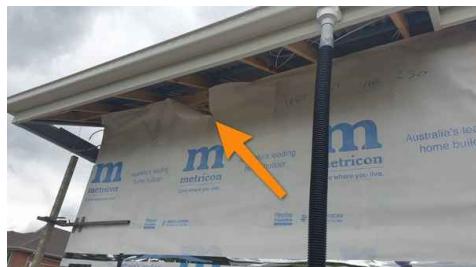
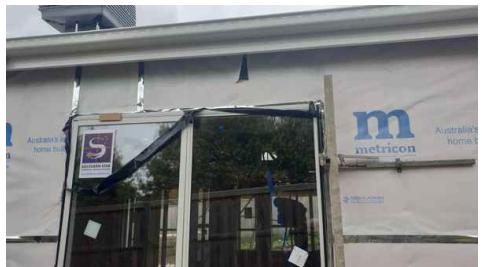
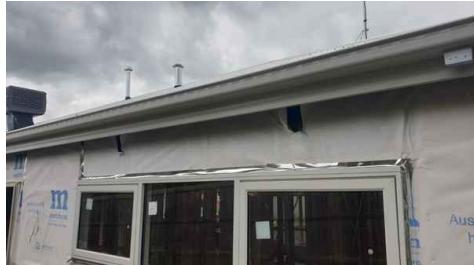
### 6.1.1 Pliable Membrane Walls

Perforations were observed in the house wrap throughout the structure.

Contact your builder.

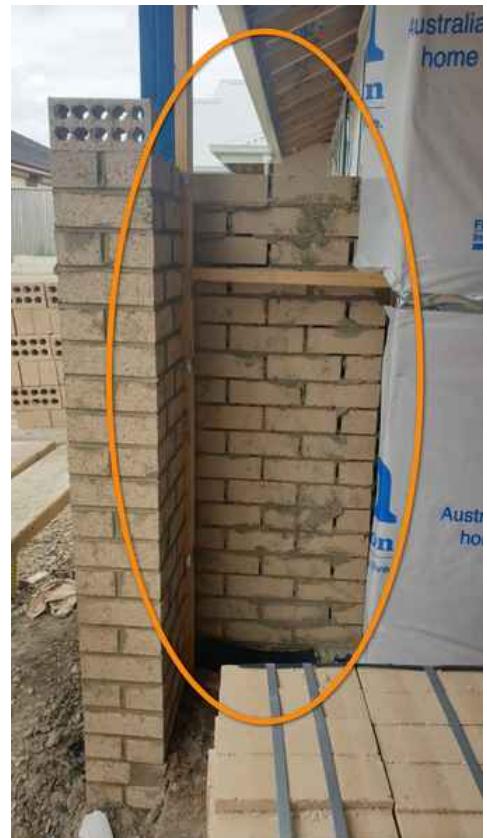
## 6.1.2 Pliable Membrane Walls

### MISSING HOUSE WRAP

The House Wrap has not been completed. We recommend to inspect and install.

I recommend installing permeable membranes throughout the entire structure and in strict compliance with AS4200.2-2017.

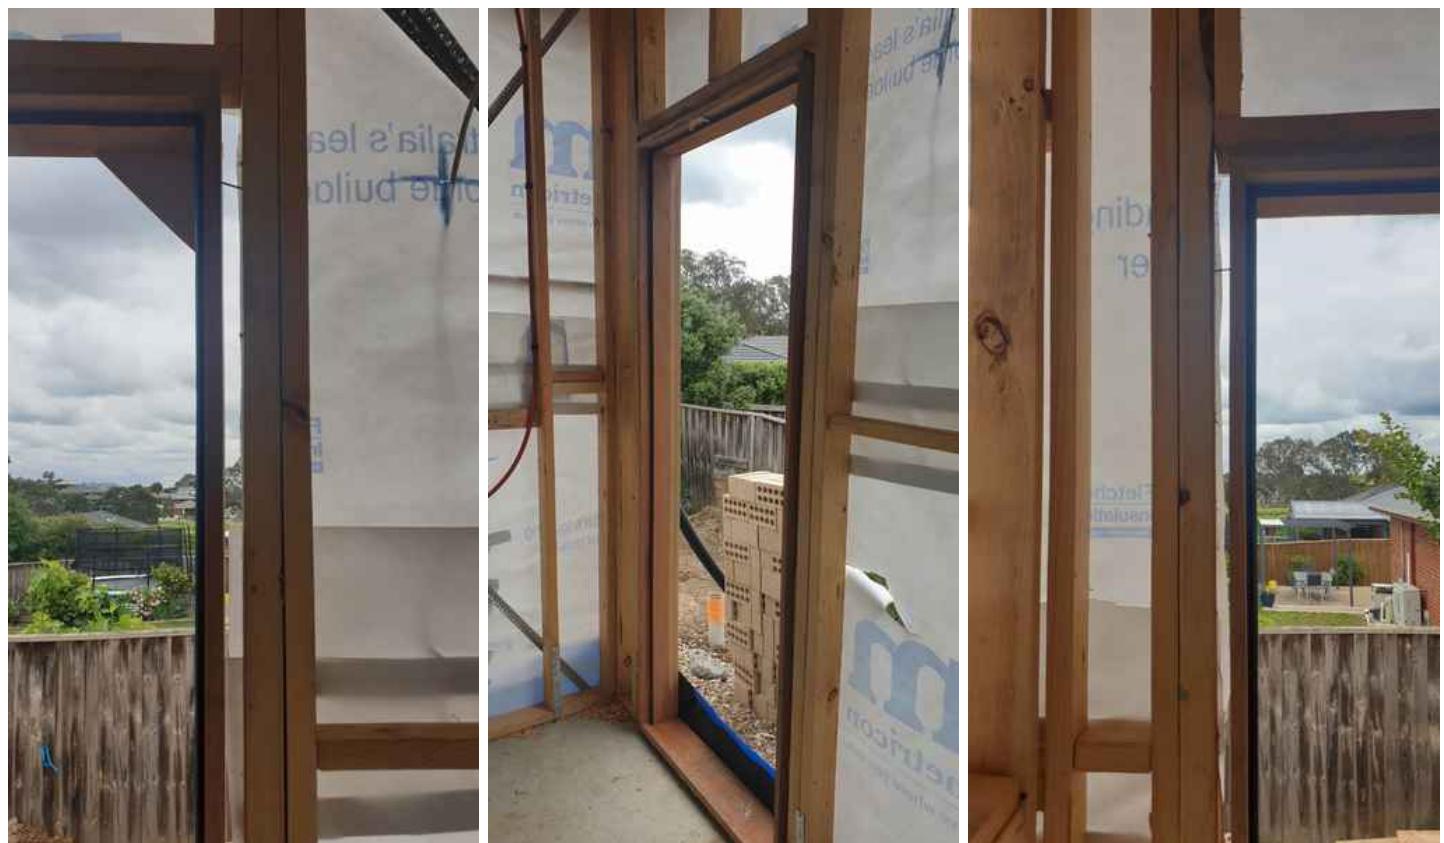
## 6.2.1 Windows

### WINDOW TAPE

I recommend checking all windows, doors, joints and penetrations throughout the structure are sealed in strict compliance with AS4200.2-2017

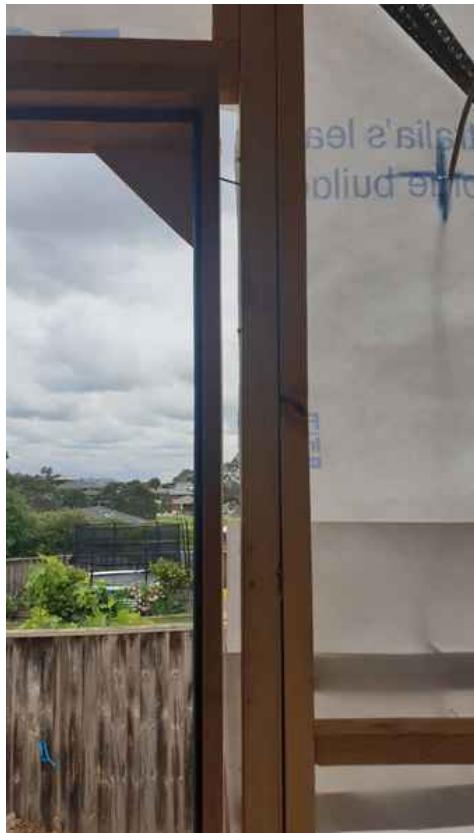
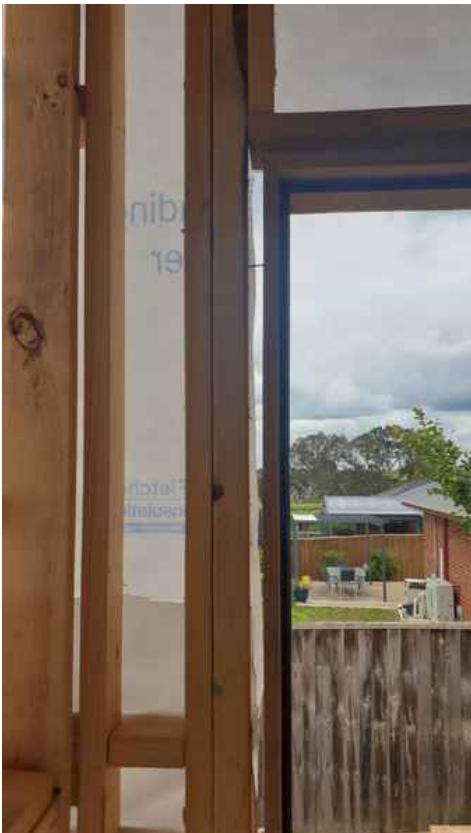
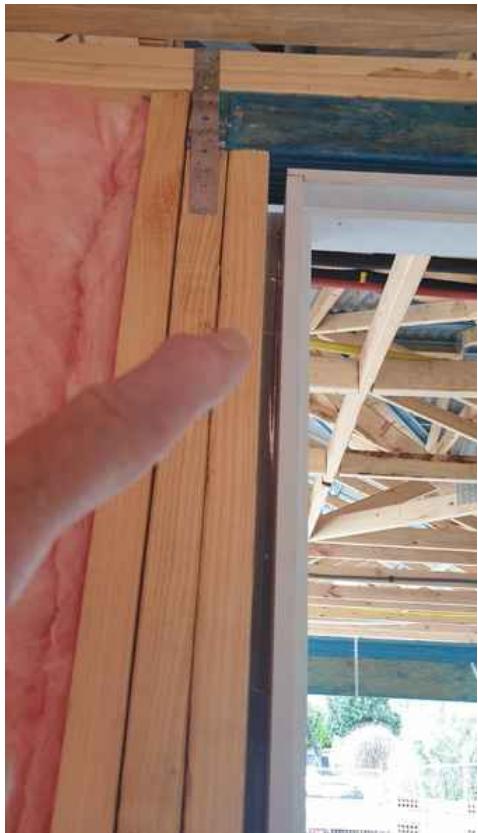
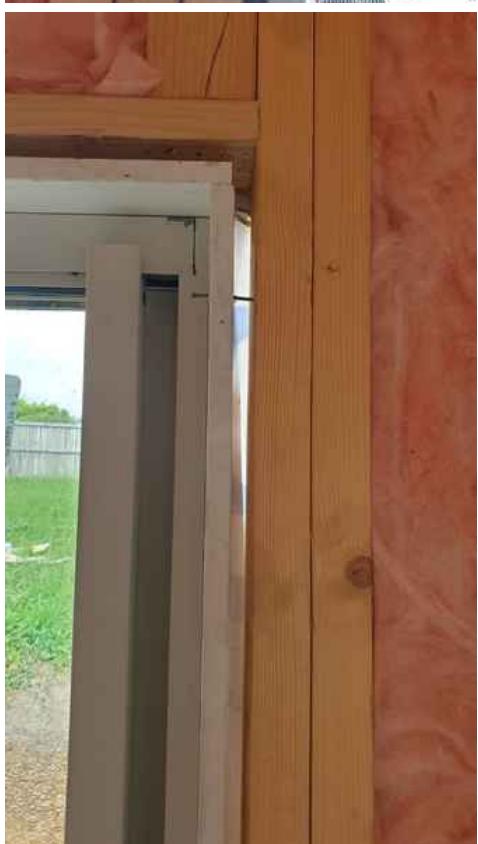
### 6.3.1 Exterior Doors **FRAMES NOT FIXED**

The external door frames have not been installed as per the manufacturers recommendations.

I recommend installing the external door frames as per the manufacturers recommendations and in-line with the Industry Guide To The Correct Installation Of Windows And Doors. [See link here](#)

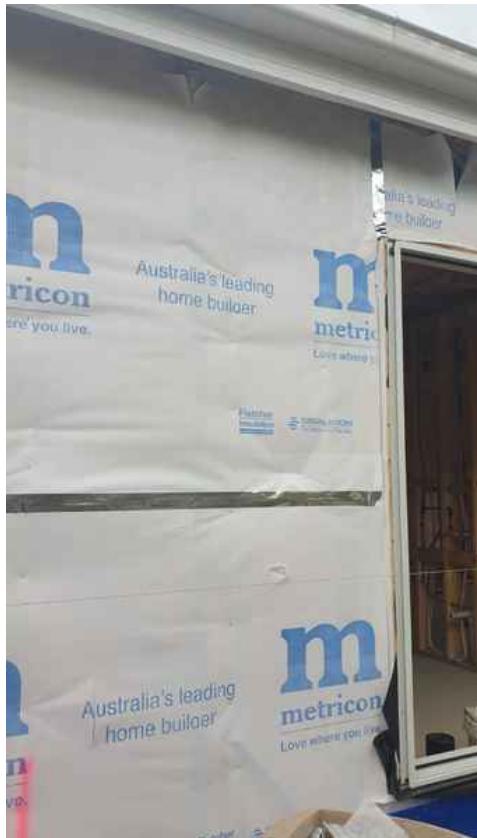
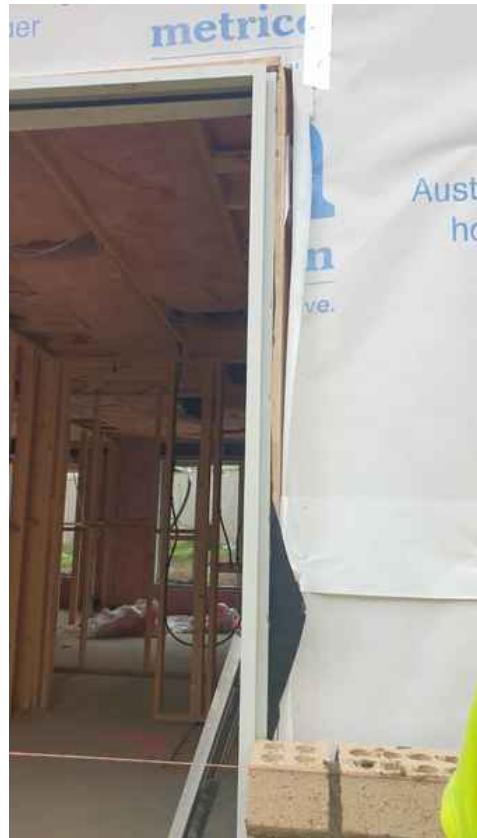
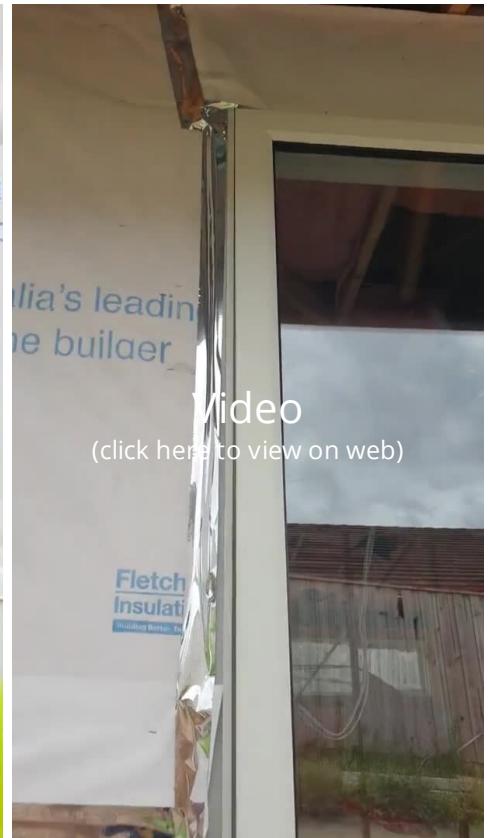
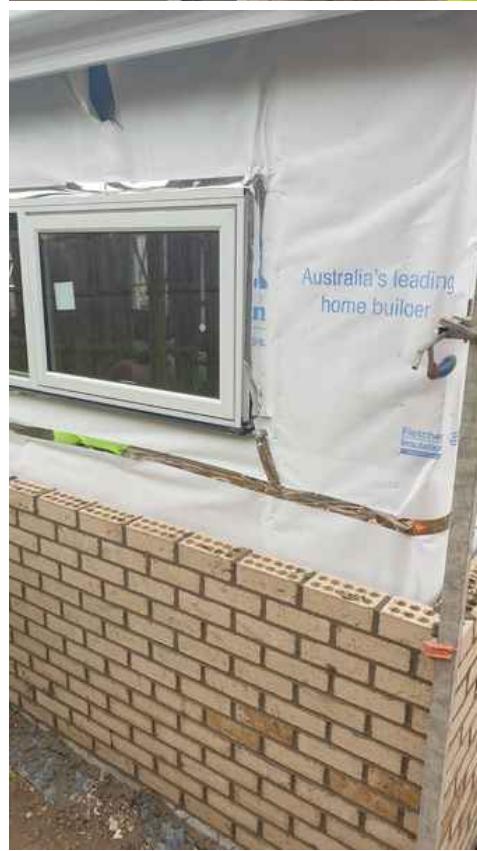
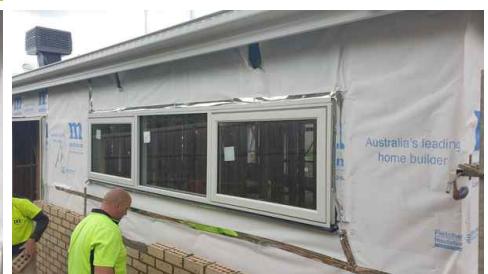
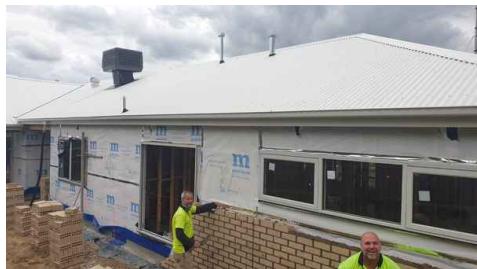
6.5.1 Porches, Patios, Decks and  
Balconies

## BINDERS

Contact your builder.

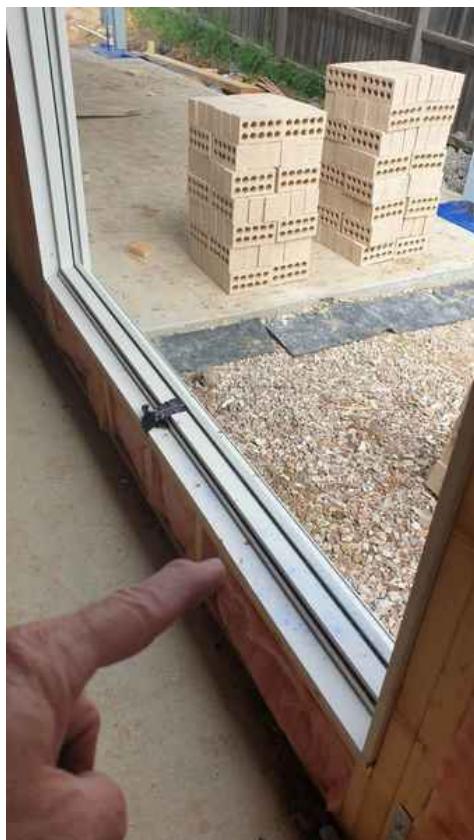
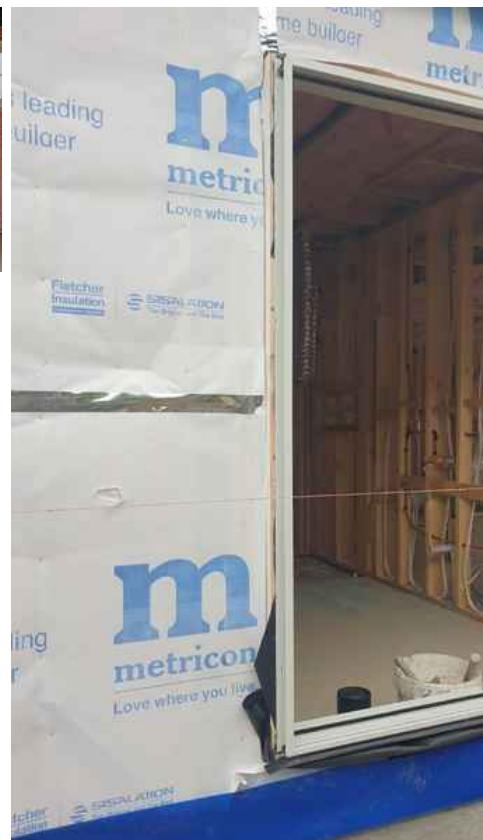
## 7.1.2 Windows

**PROTECTION OF WINDOWS**

Install and provide adequate protection for all windows and external doors to protect them from being damaged.

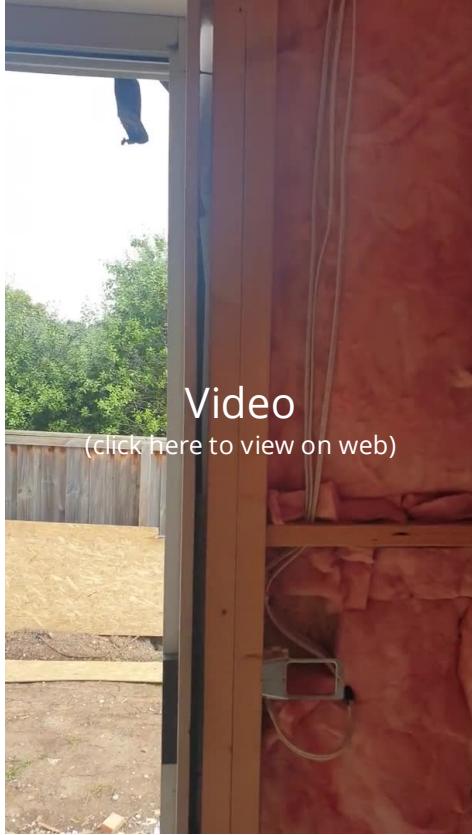
The window frames have not been installed as per the manufacturers recommendations.

I recommend installing all of the window frames as per the manufacturers recommendations and in-line with the Industry Guide To The Correct Installation Of Windows And Doors. [See link here](#)

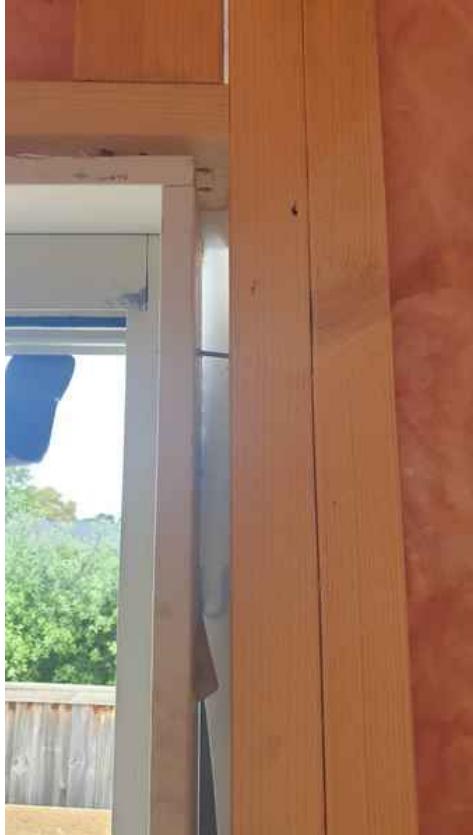
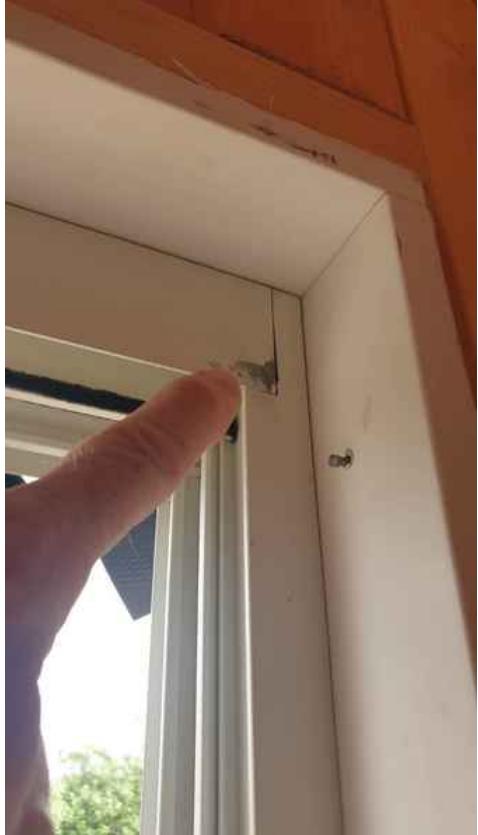
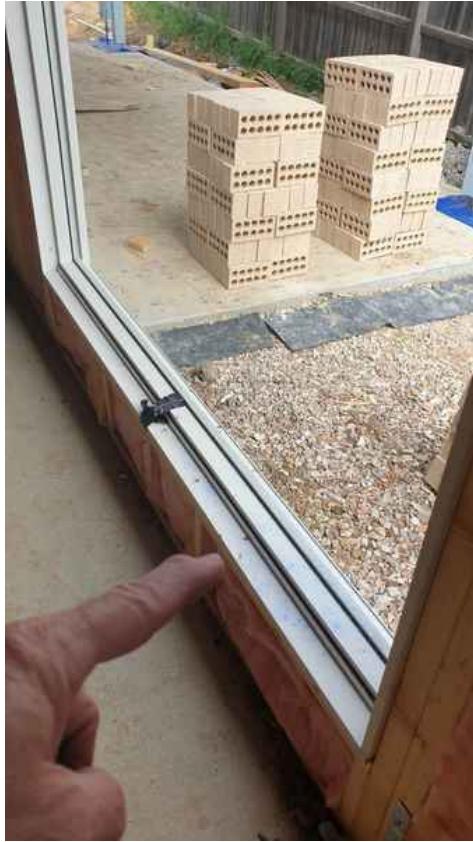
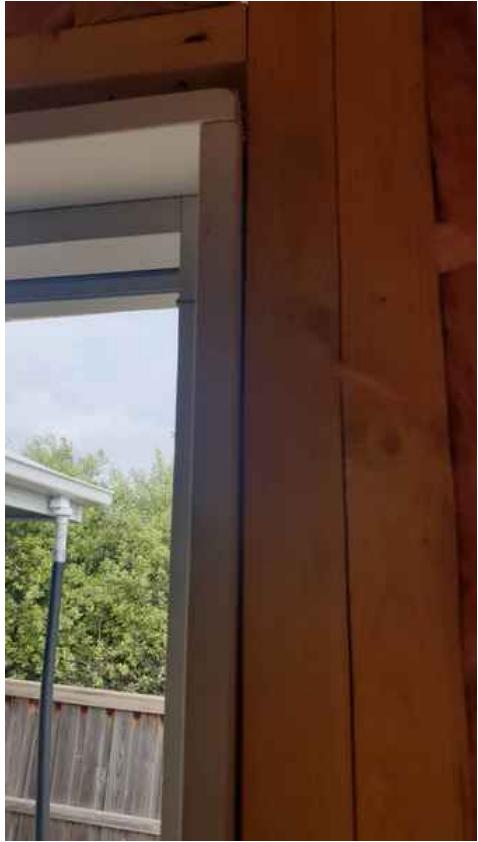
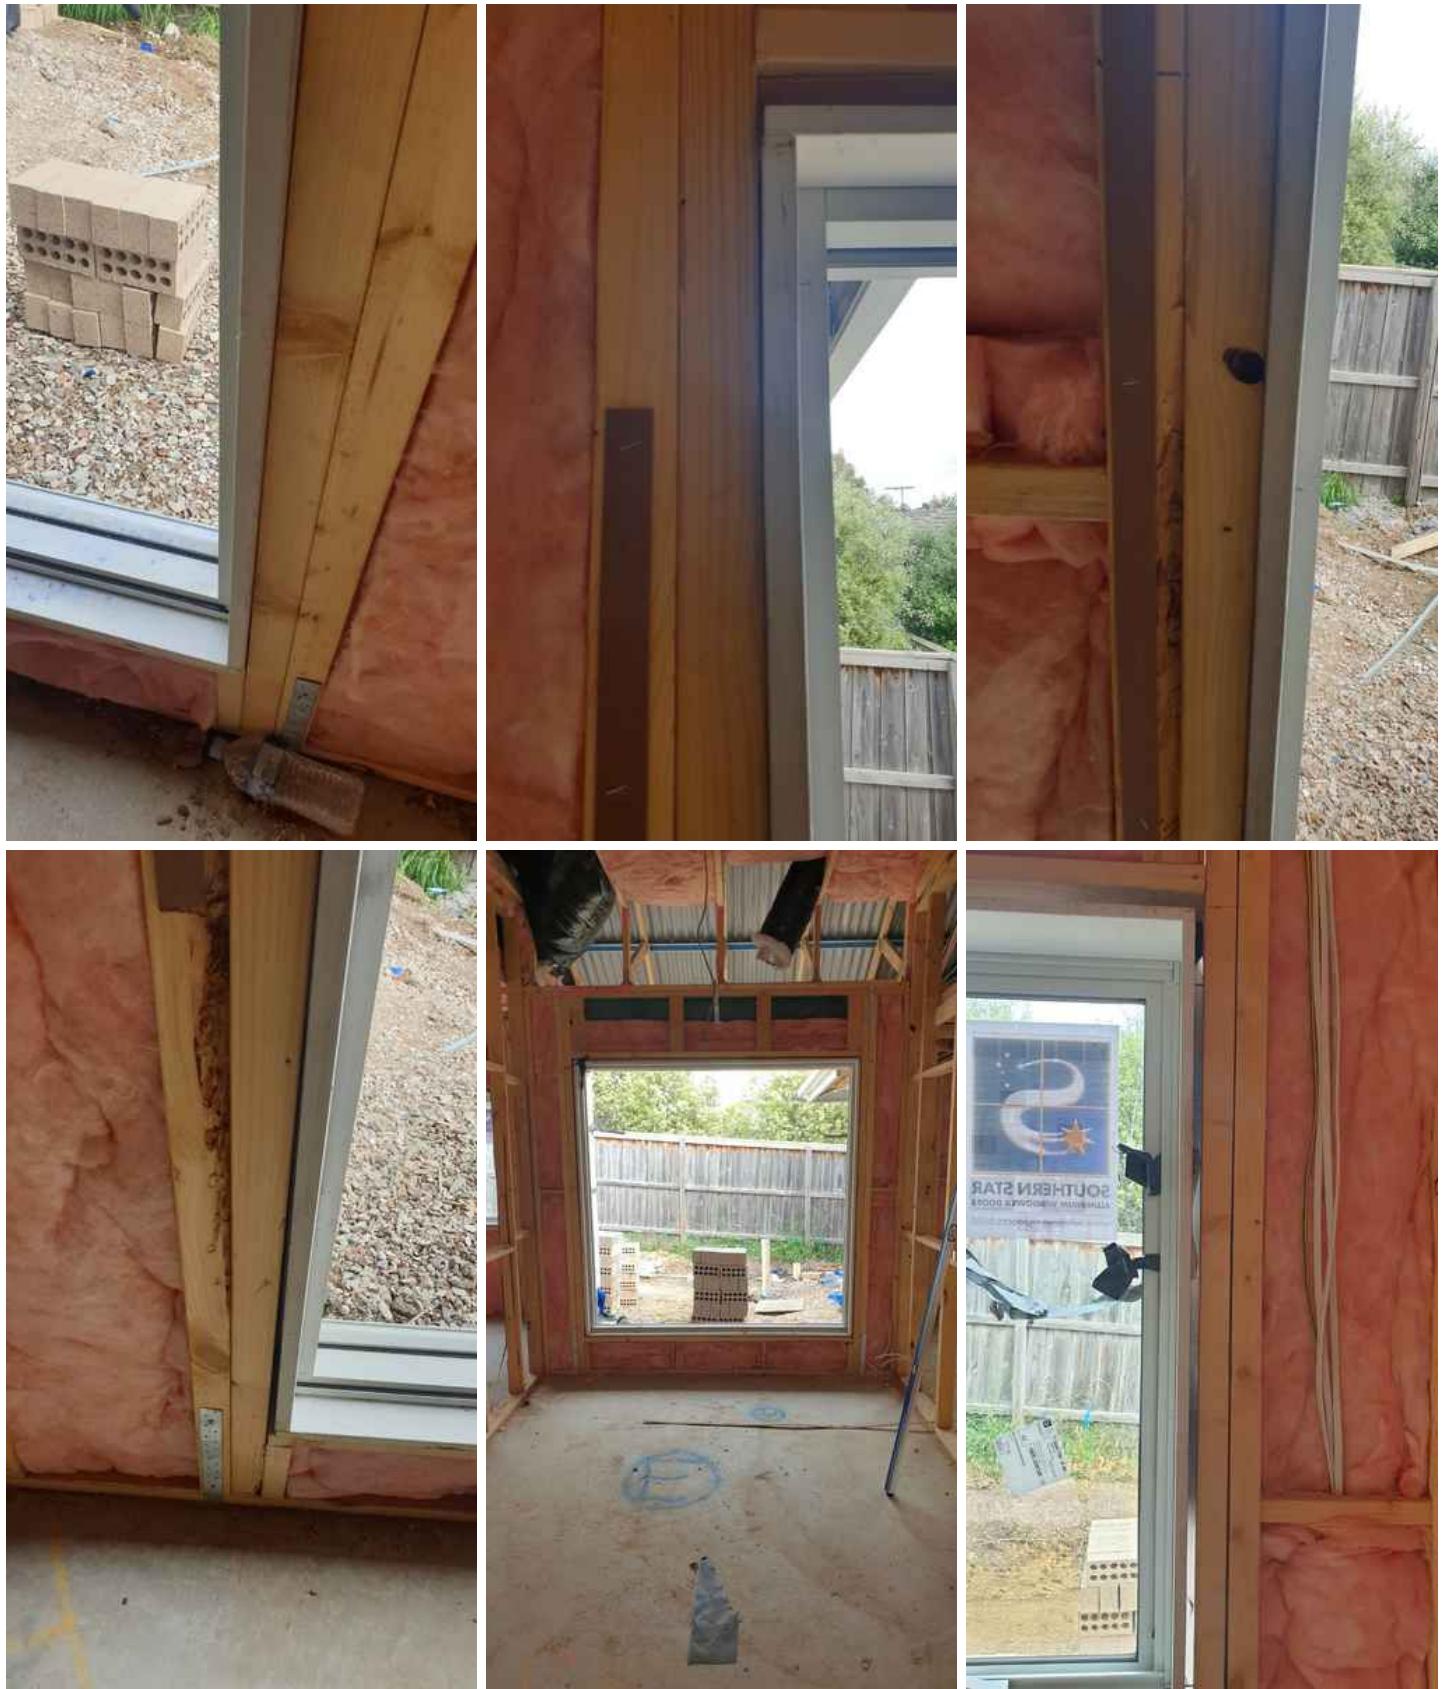
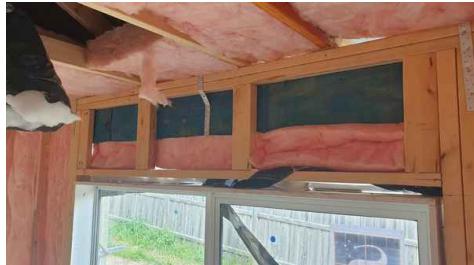
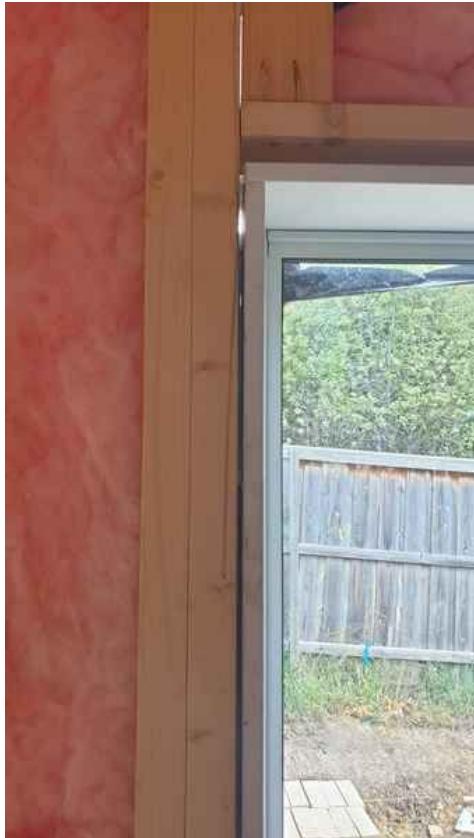
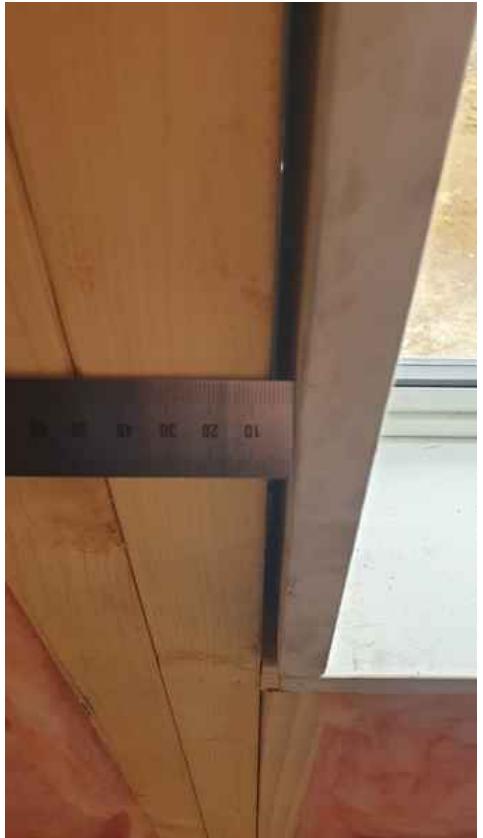
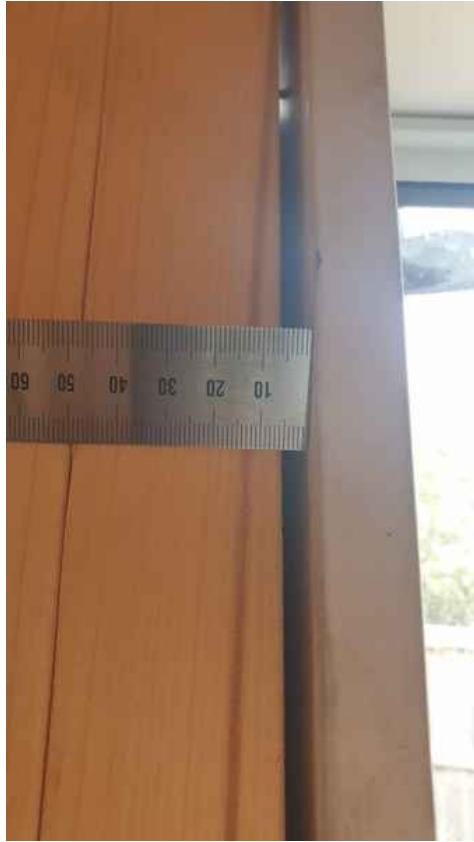
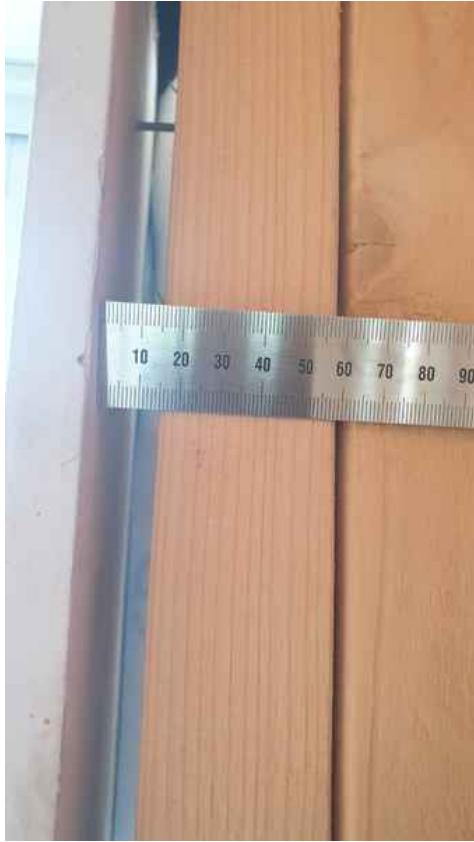
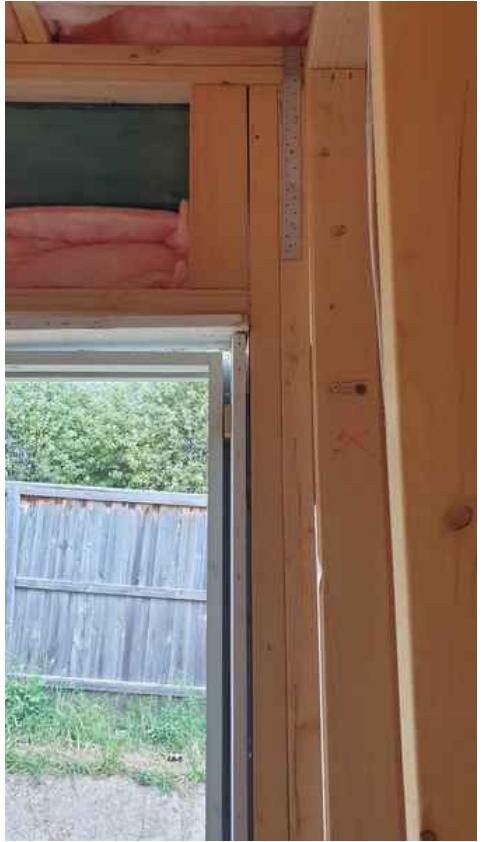
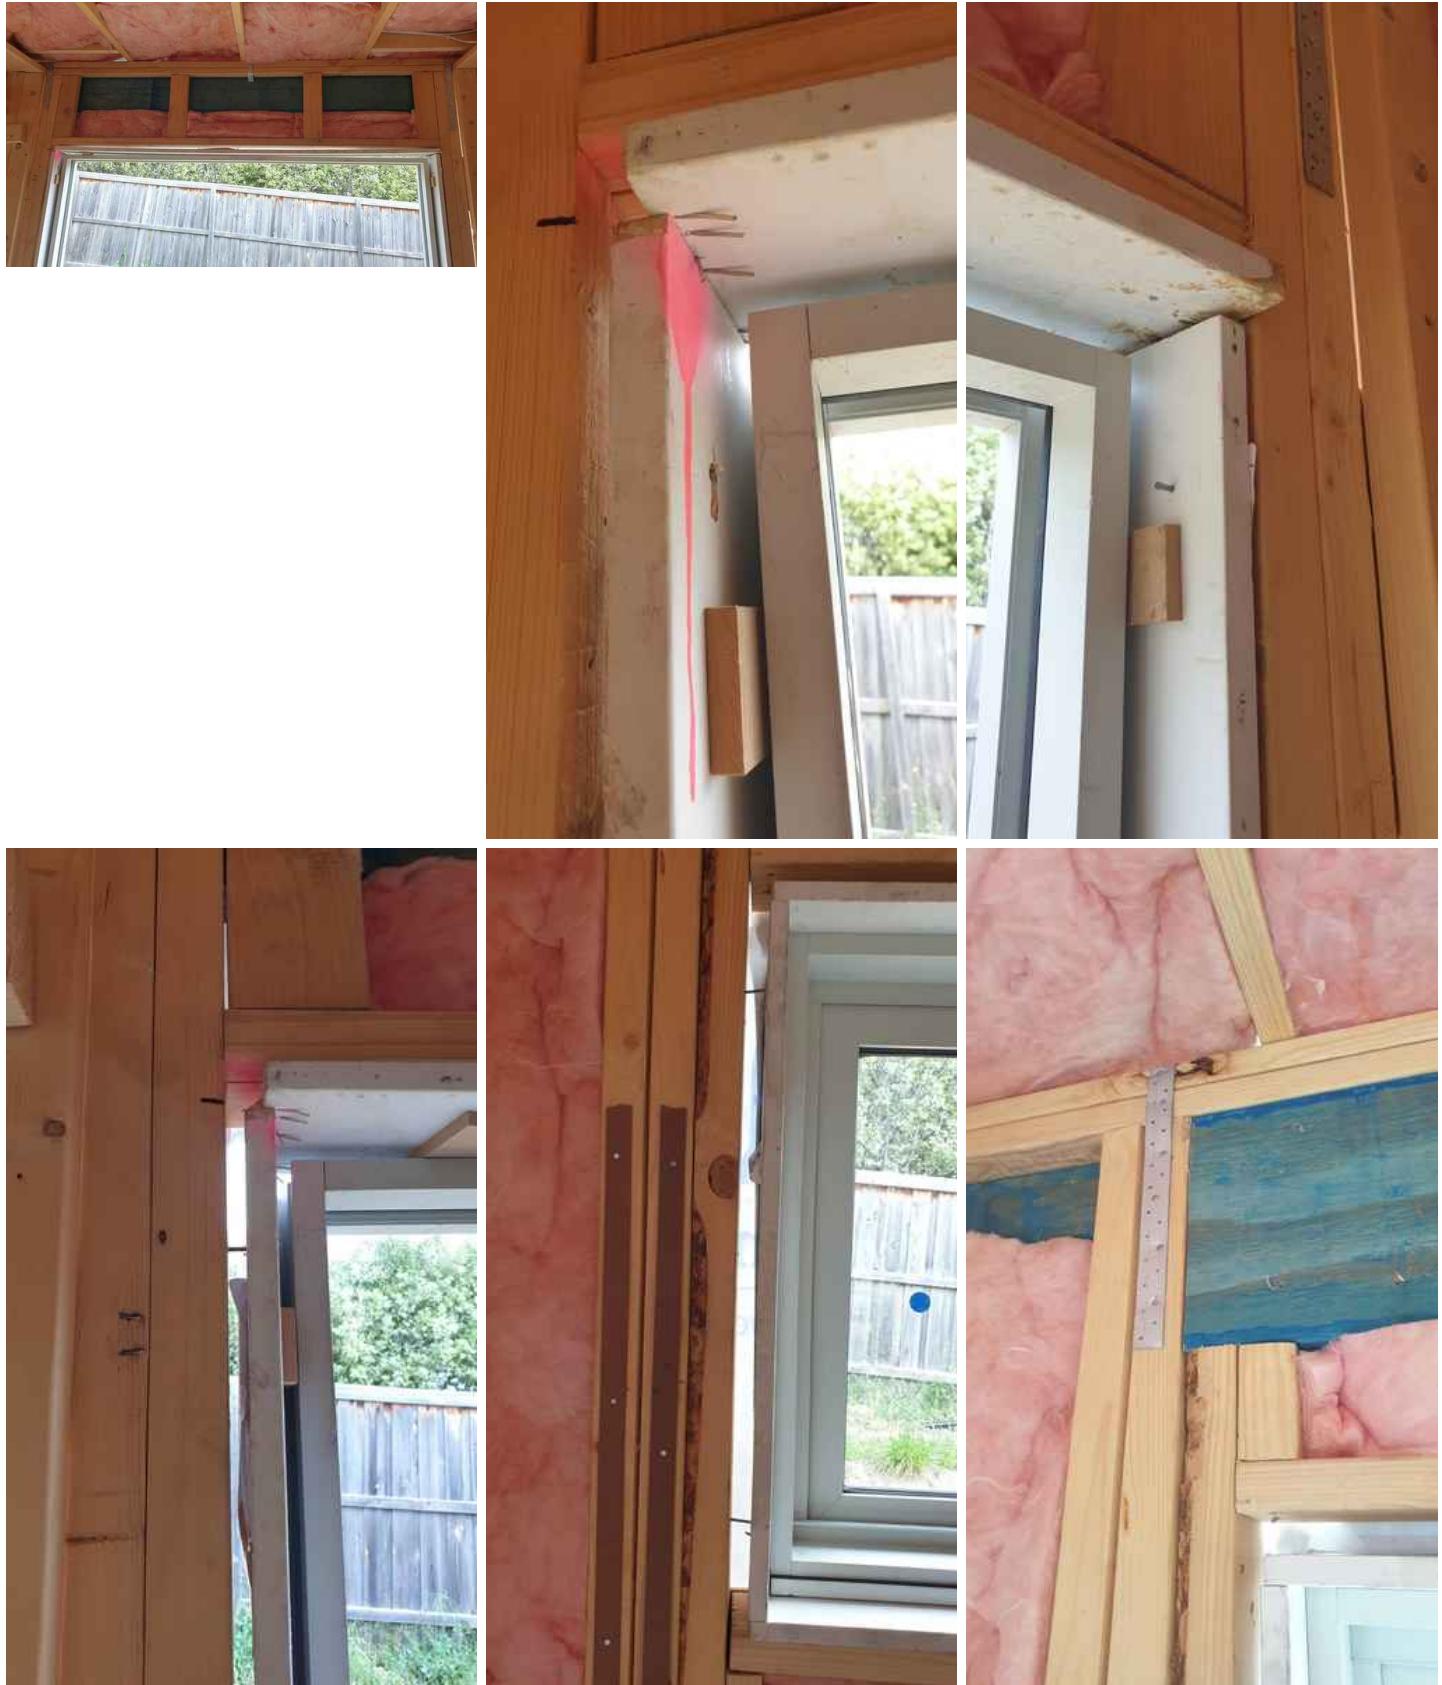
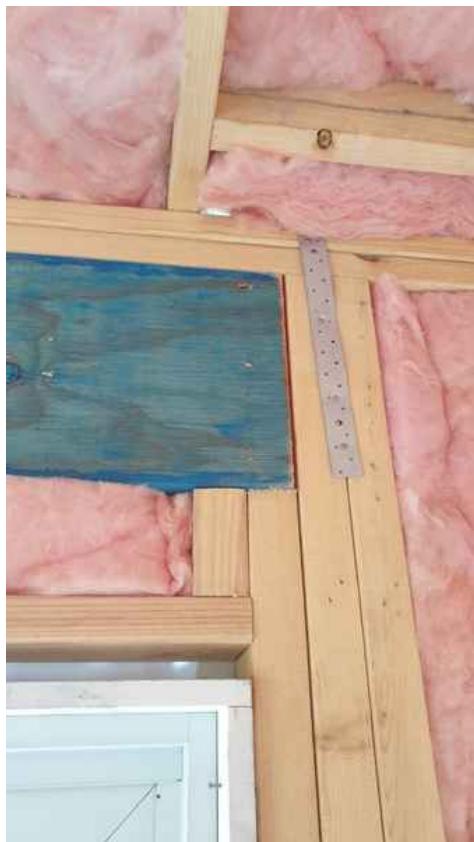
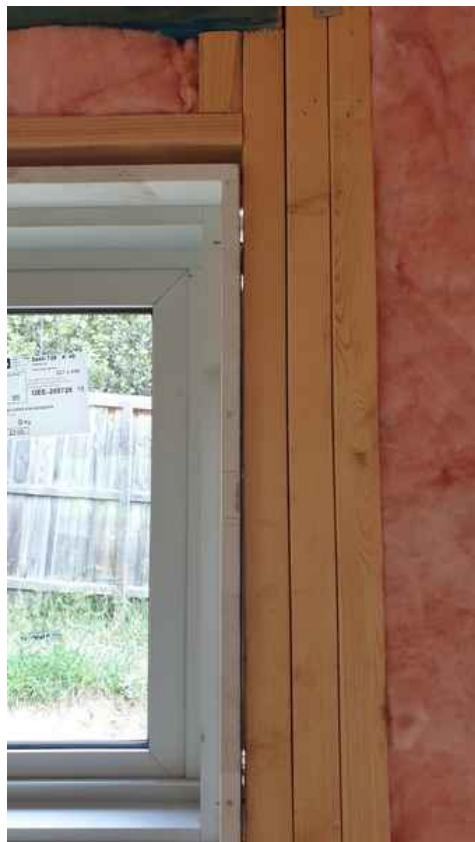
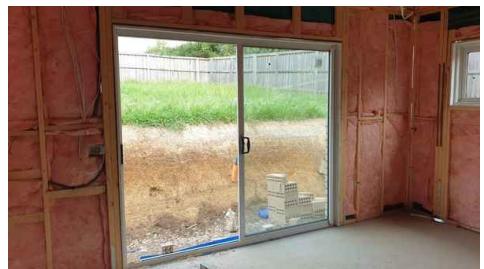
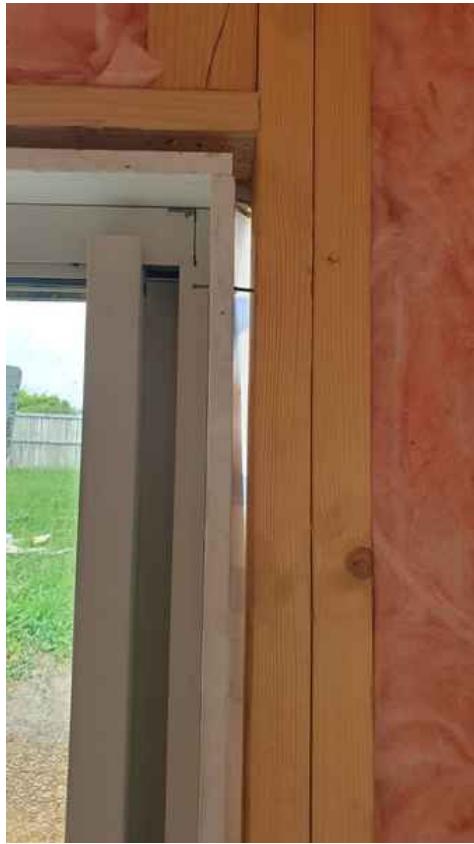
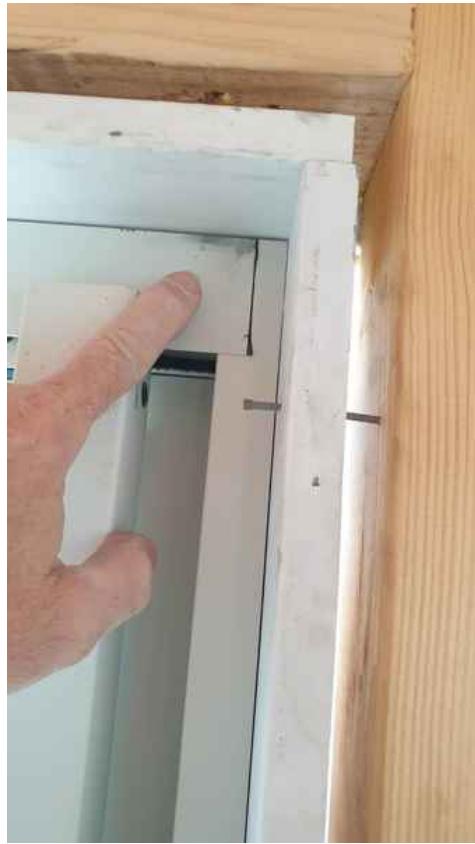
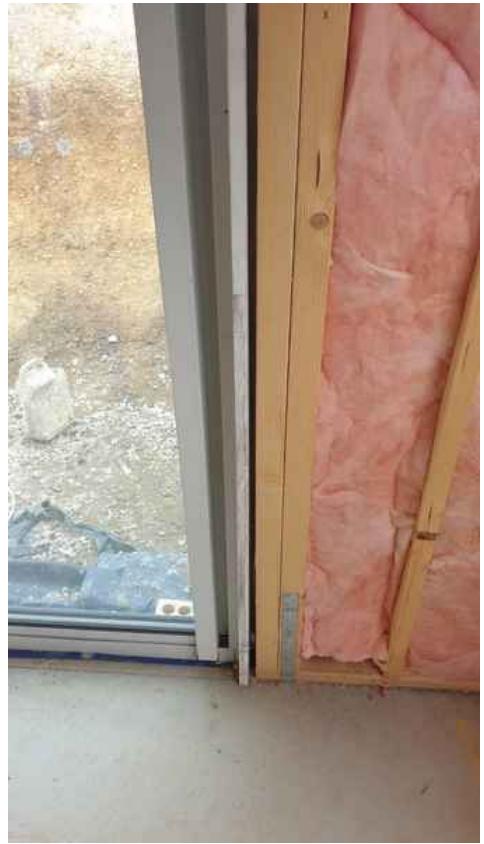
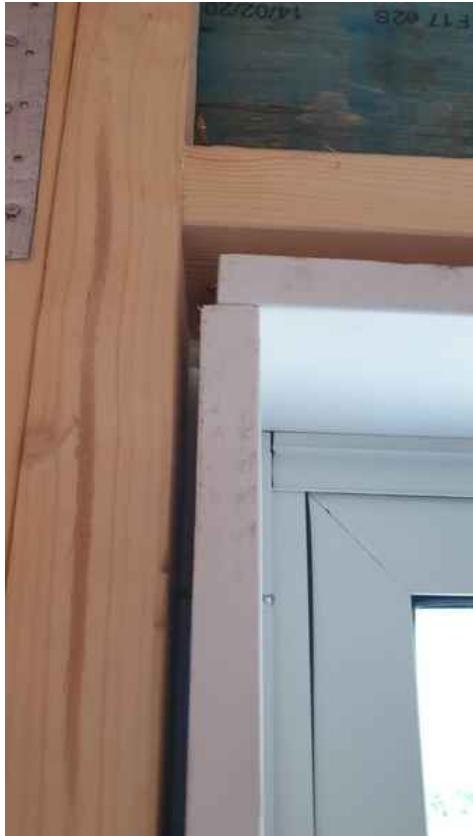
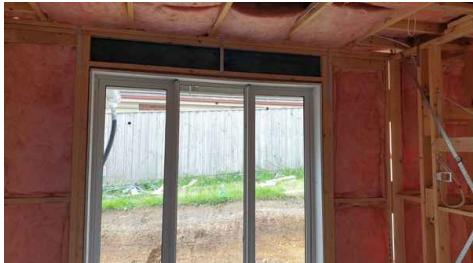
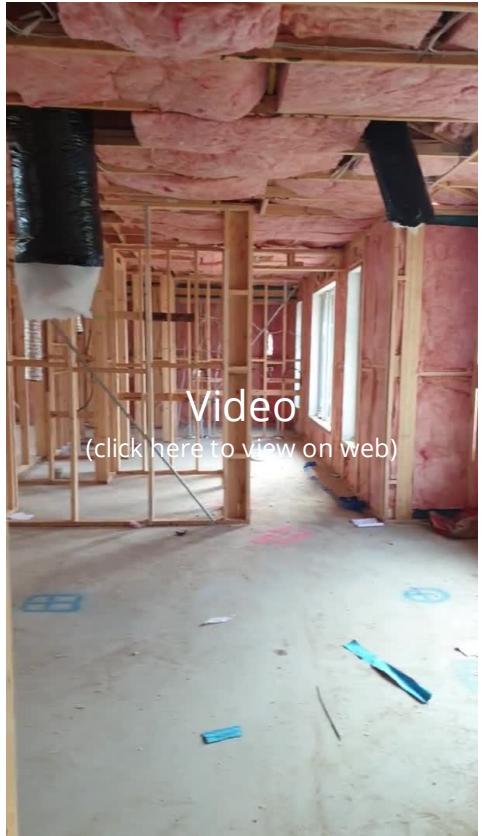
**Major Defect / Safety Hazard**
