# TOPNOTCH BUILDING INSPECTIONS

## PRE-PLASTER INSPECTION

1234 Main St. Preston Victoria 3072

12/03/2021 9:00AM

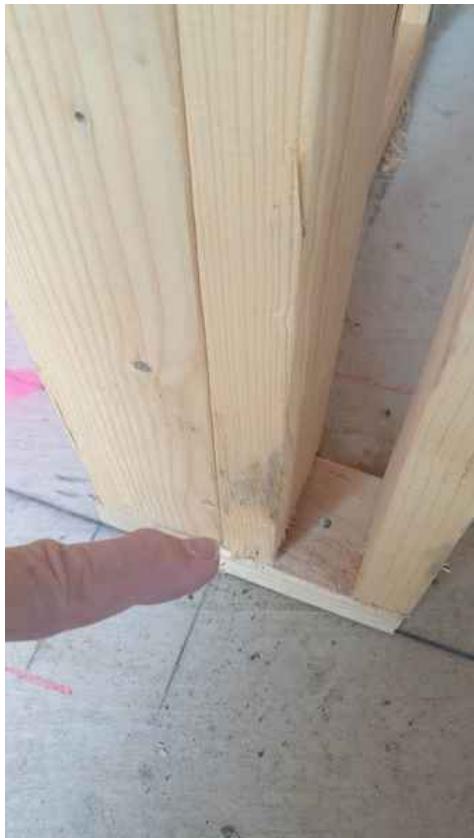
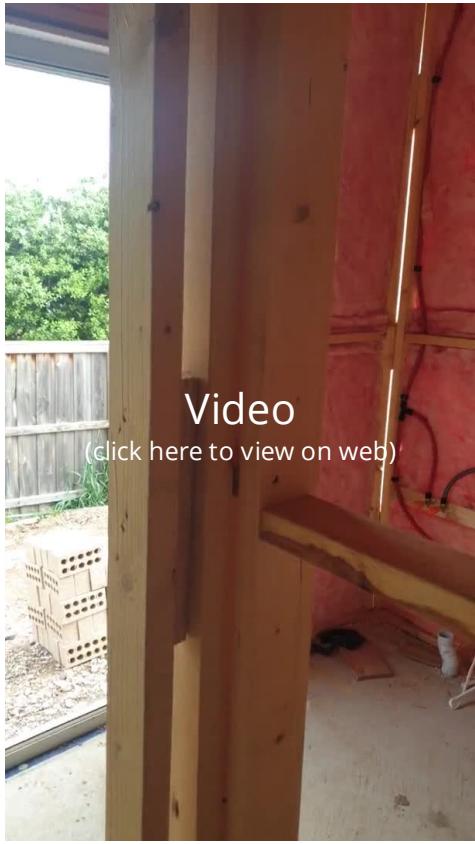
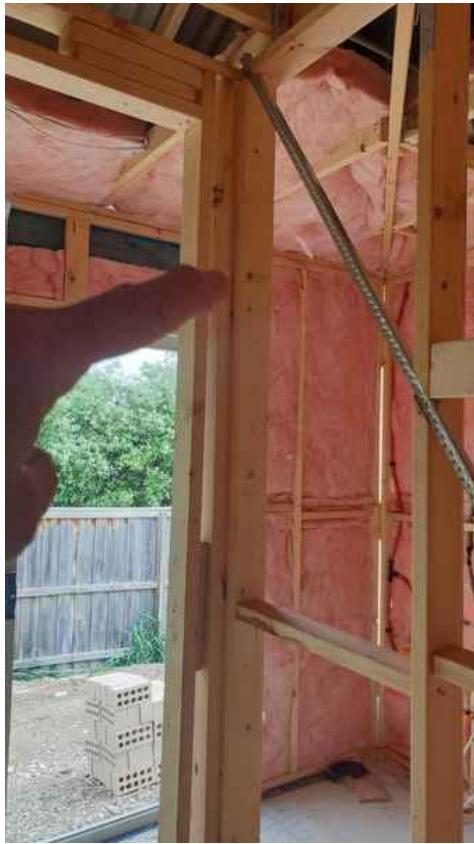
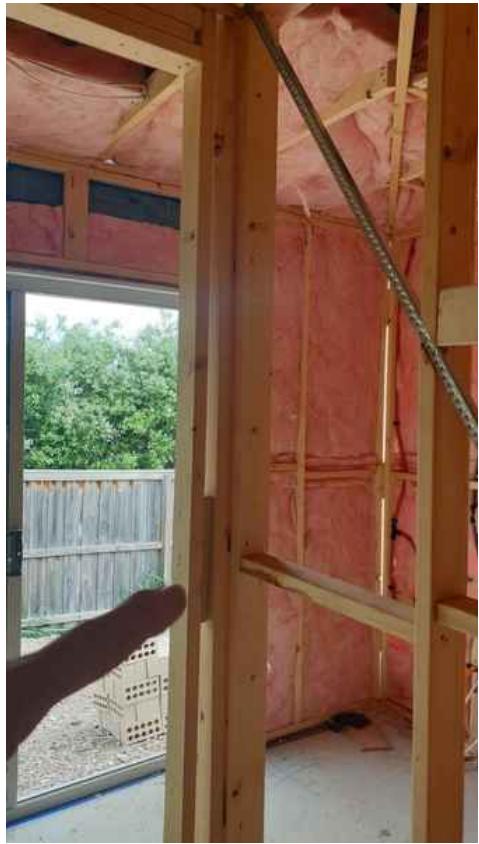
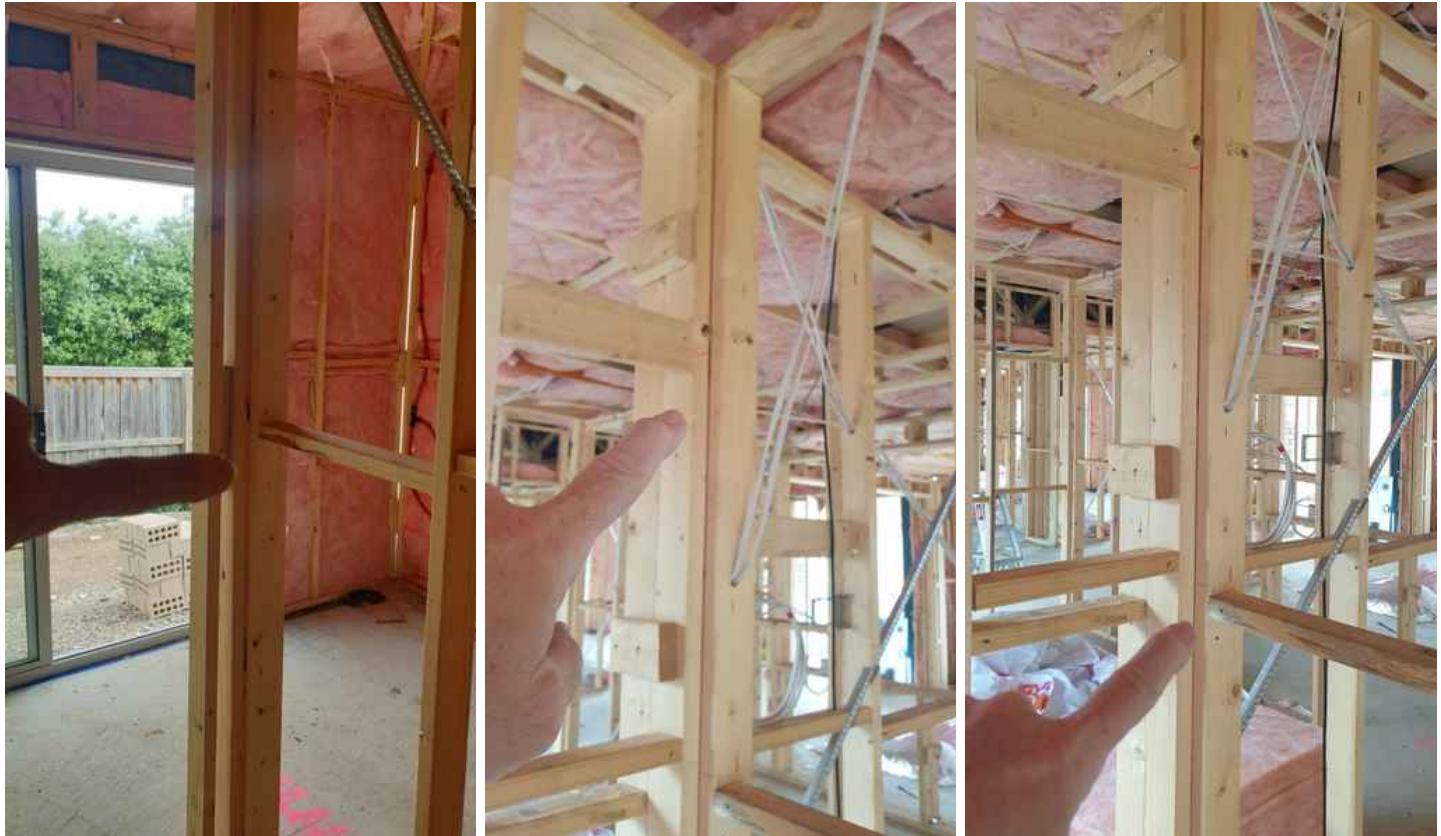
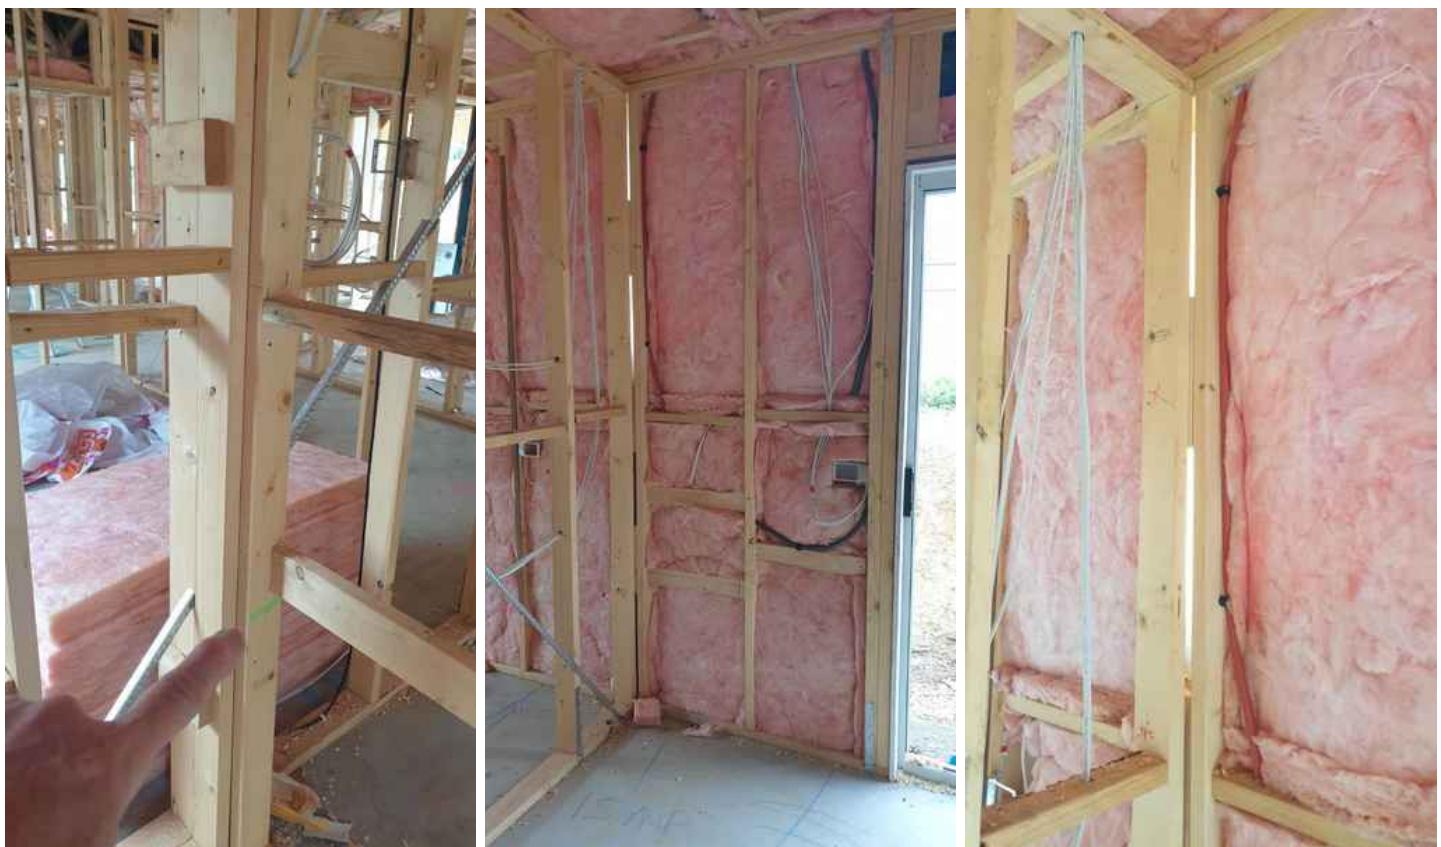
It was observed that intersecting walls were not fixed, or fixed correctly in the nominated locations throughout the structure.

I recommend fixing all wall intersections in compliance, and as required by AS:1684.2

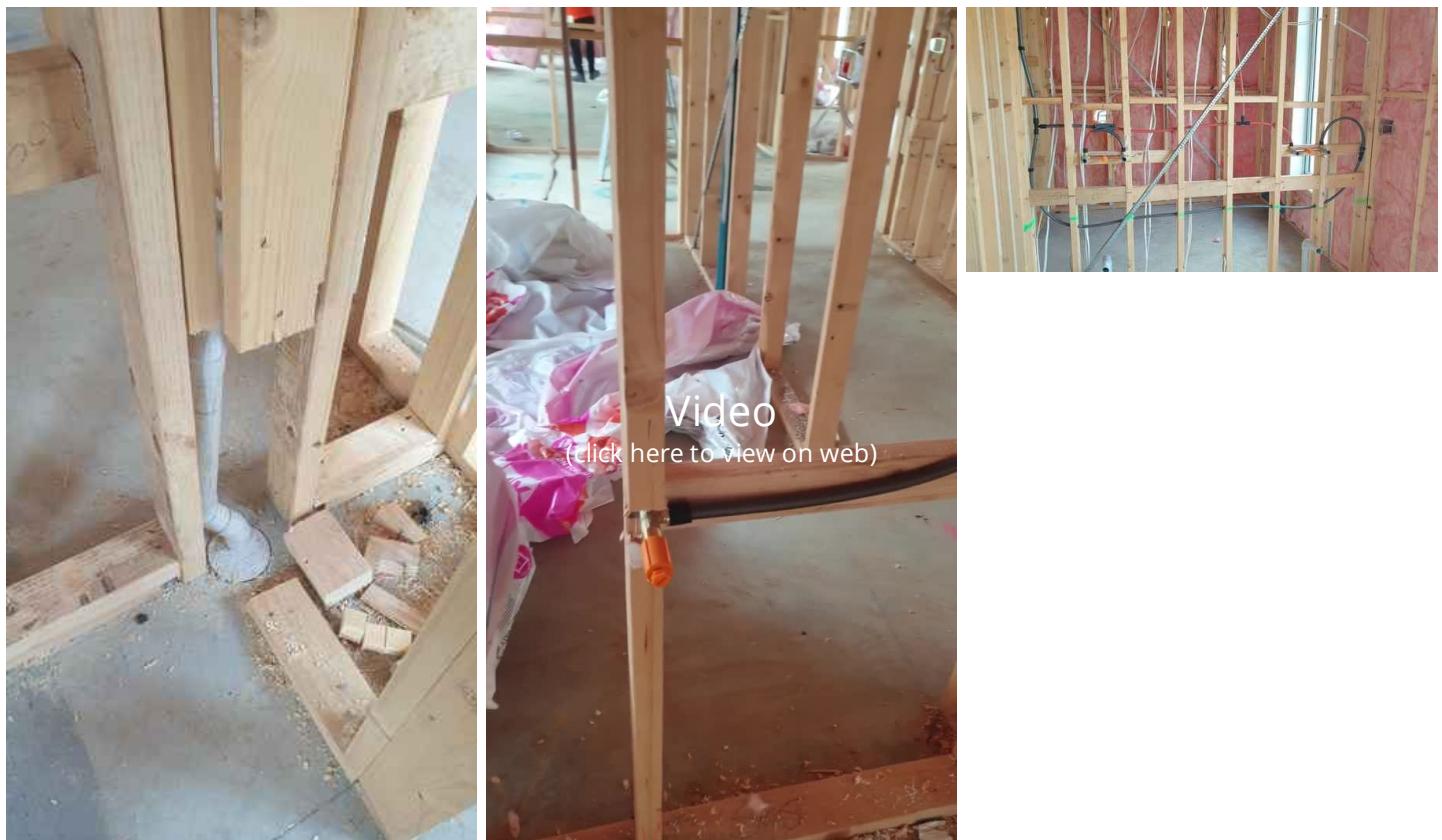
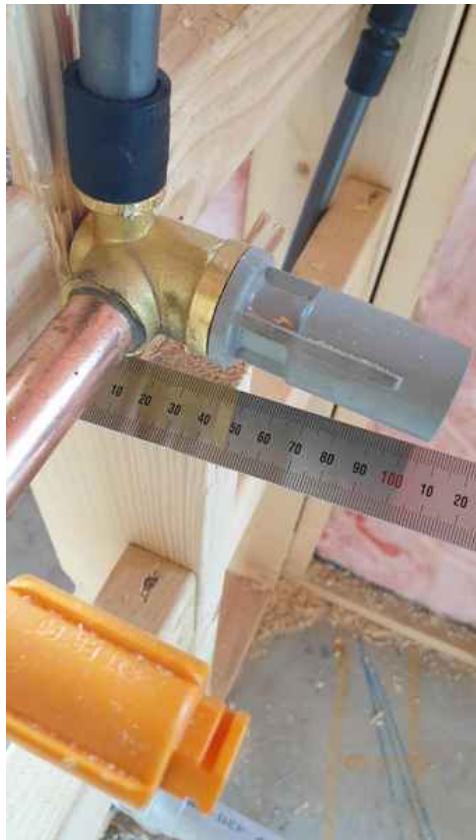
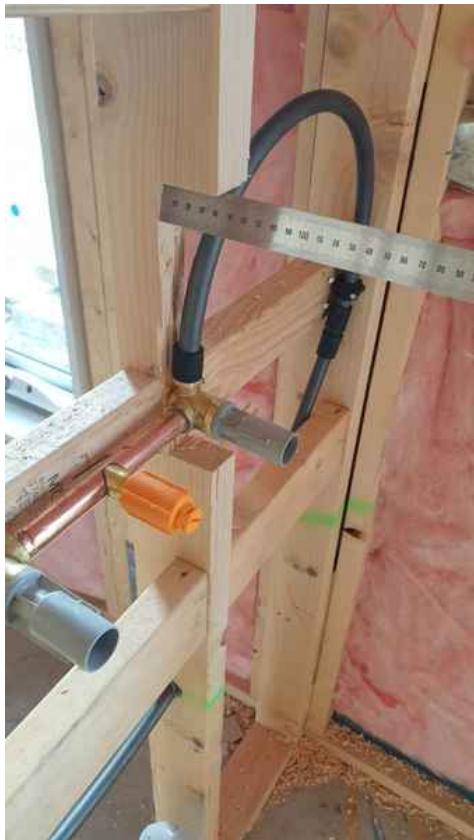
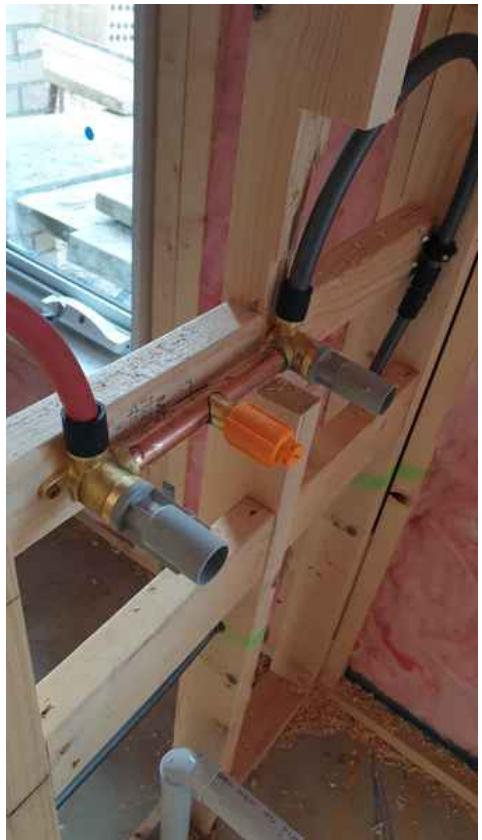
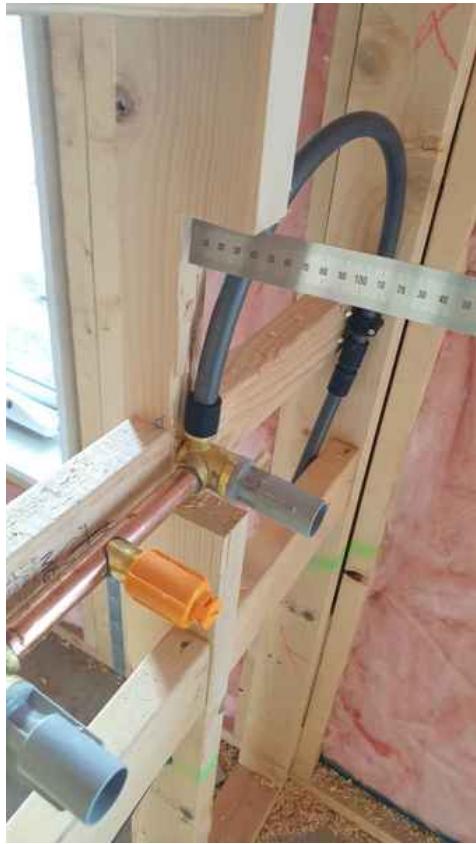
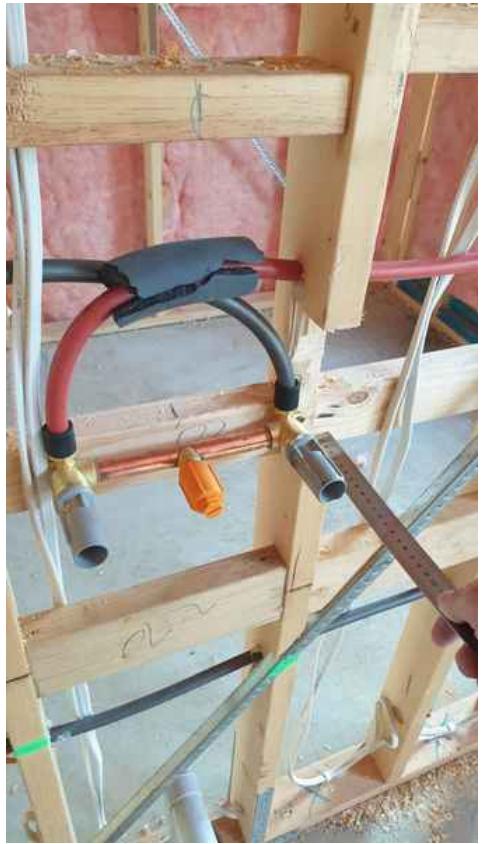
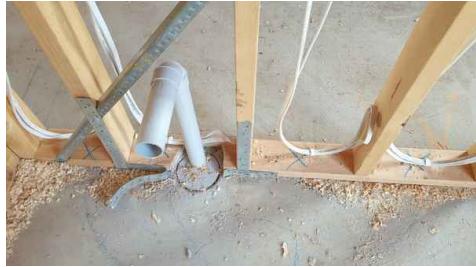
## 9.1.2 Wall Framing

**NOTCHING OF STUDS**

I recommend removing the effected studs and replacing with new studs to comply with AS1684.2-2010

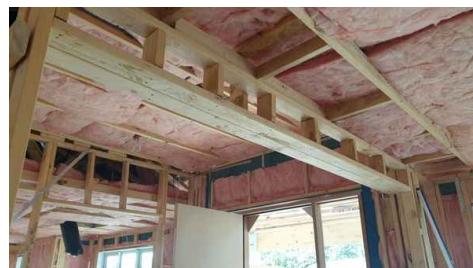
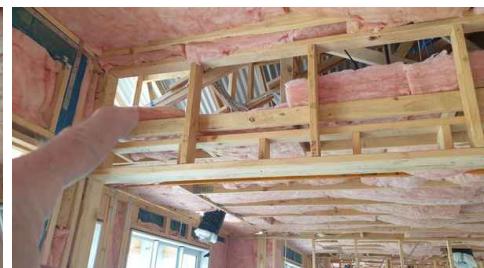
### 9.1.3 Wall Framing

## JACK STUDS IN OPENINGS

It was observed that openings framed with Jamb studs and lintels, had "Jack" studs installed with an incorrect orientation.

**I recommend installing jack studs in compliance and as required by AS1684.2:2010 throughout the structure.**

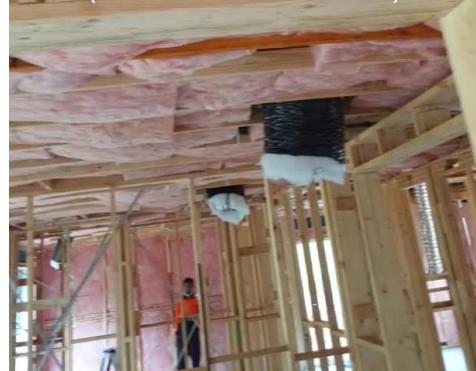
Major Defect / Safety Hazard

I recommend checking the standard for the appropriate lintel size and install new lintels into the non-loadbearing walls as required.

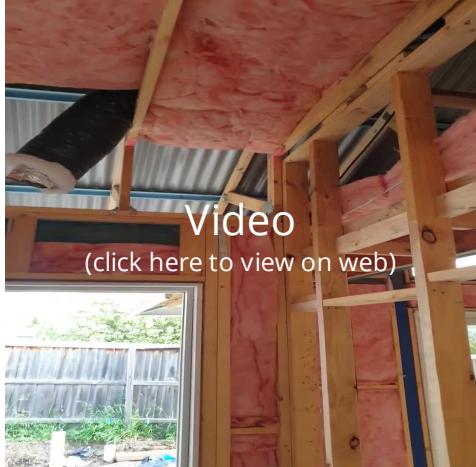
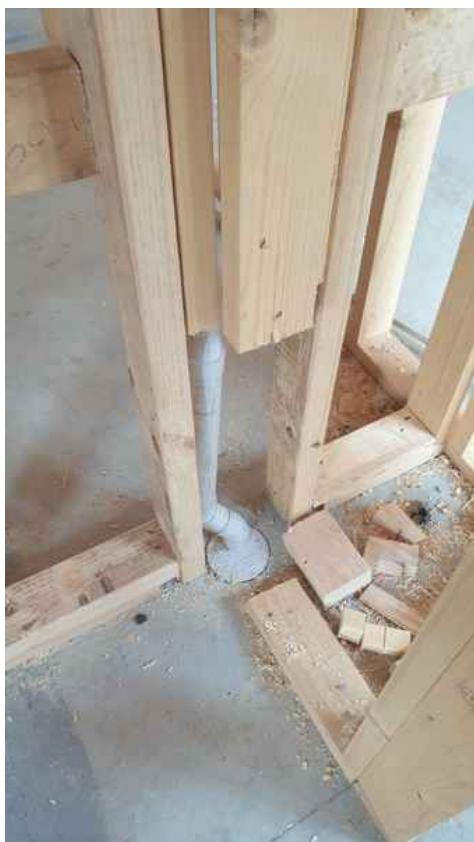
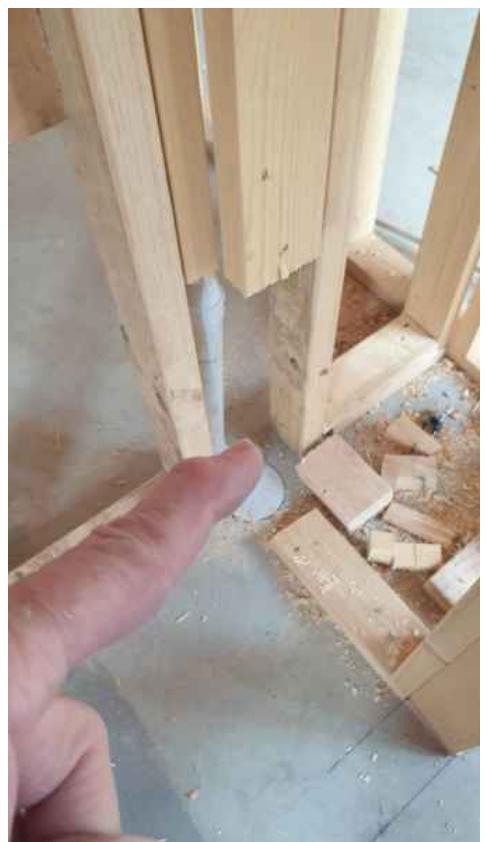
## 9.1.5 Wall Framing

### MISSING FRAMING TO PICK UP PLASTER

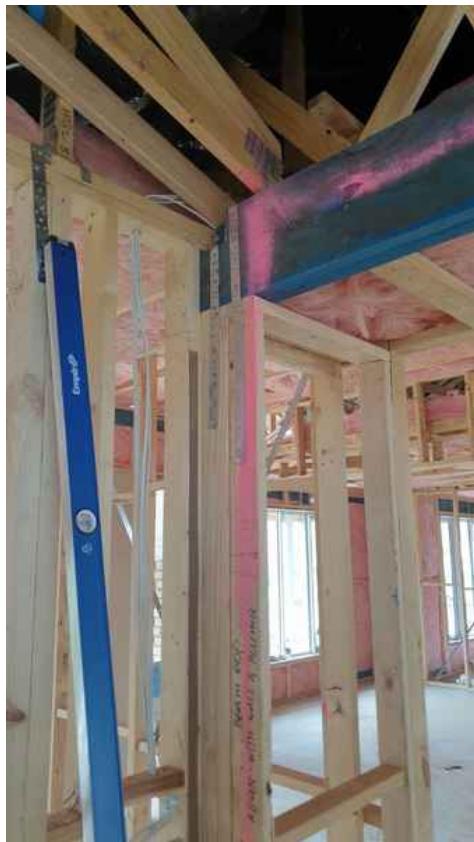
9.1.6 Wall Framing  
**WALLS NOT PLUMB**

Minor Defect

I recommend checking all walls to ensure they have been installed straight and plumb as required.

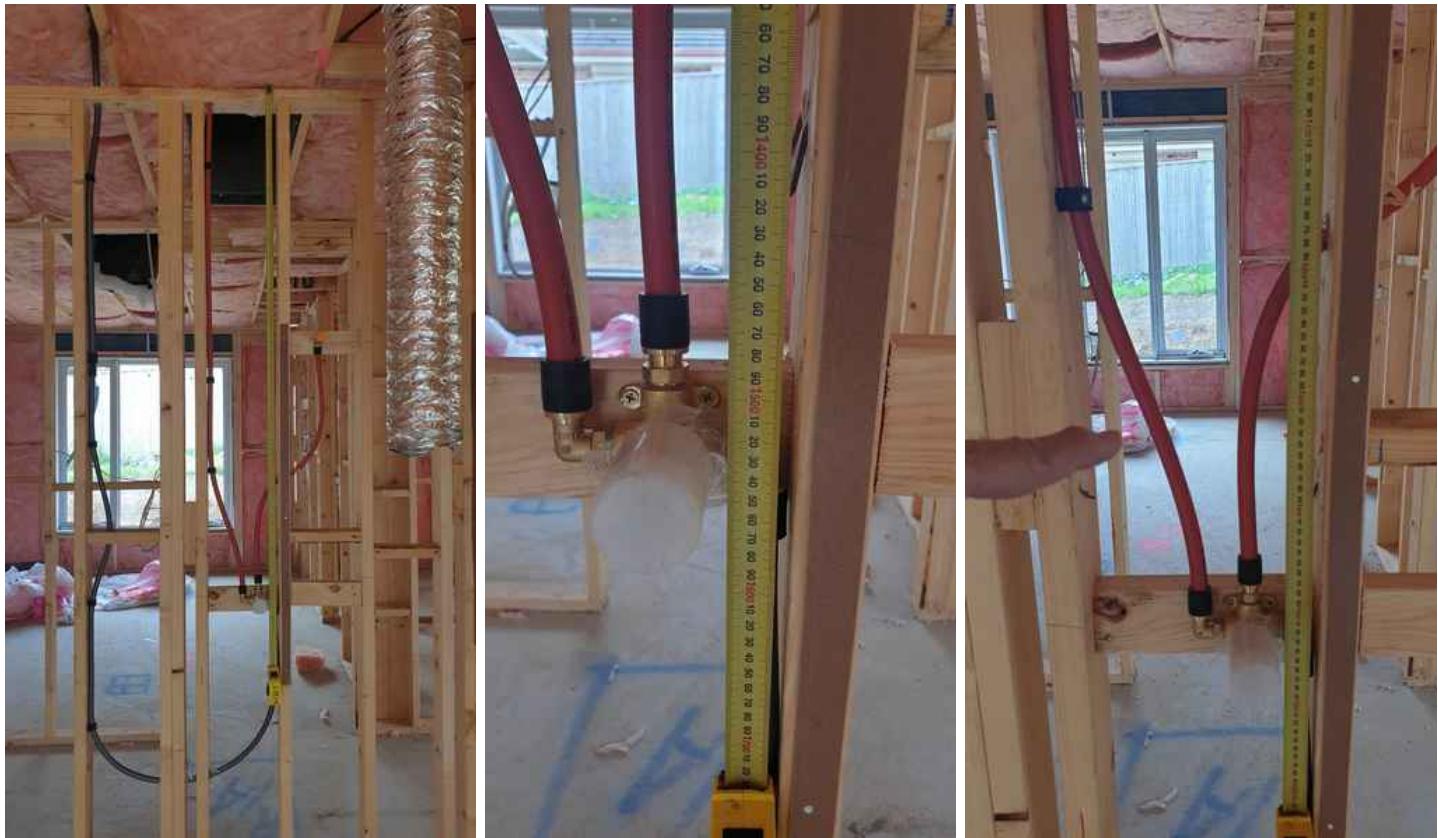
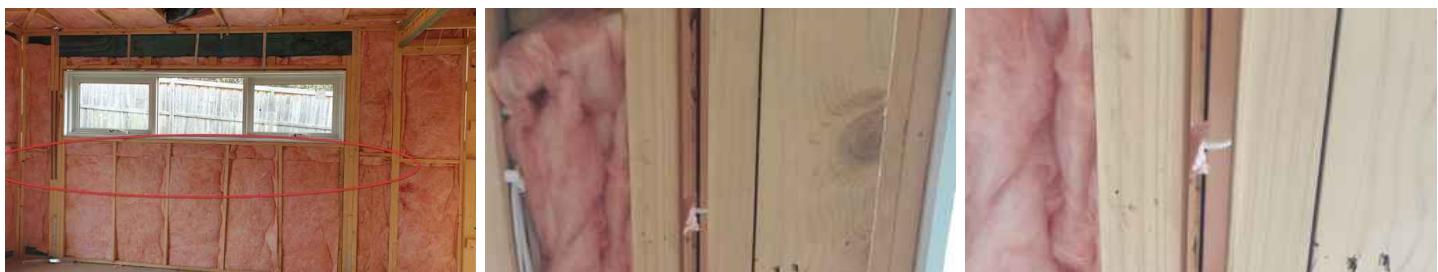
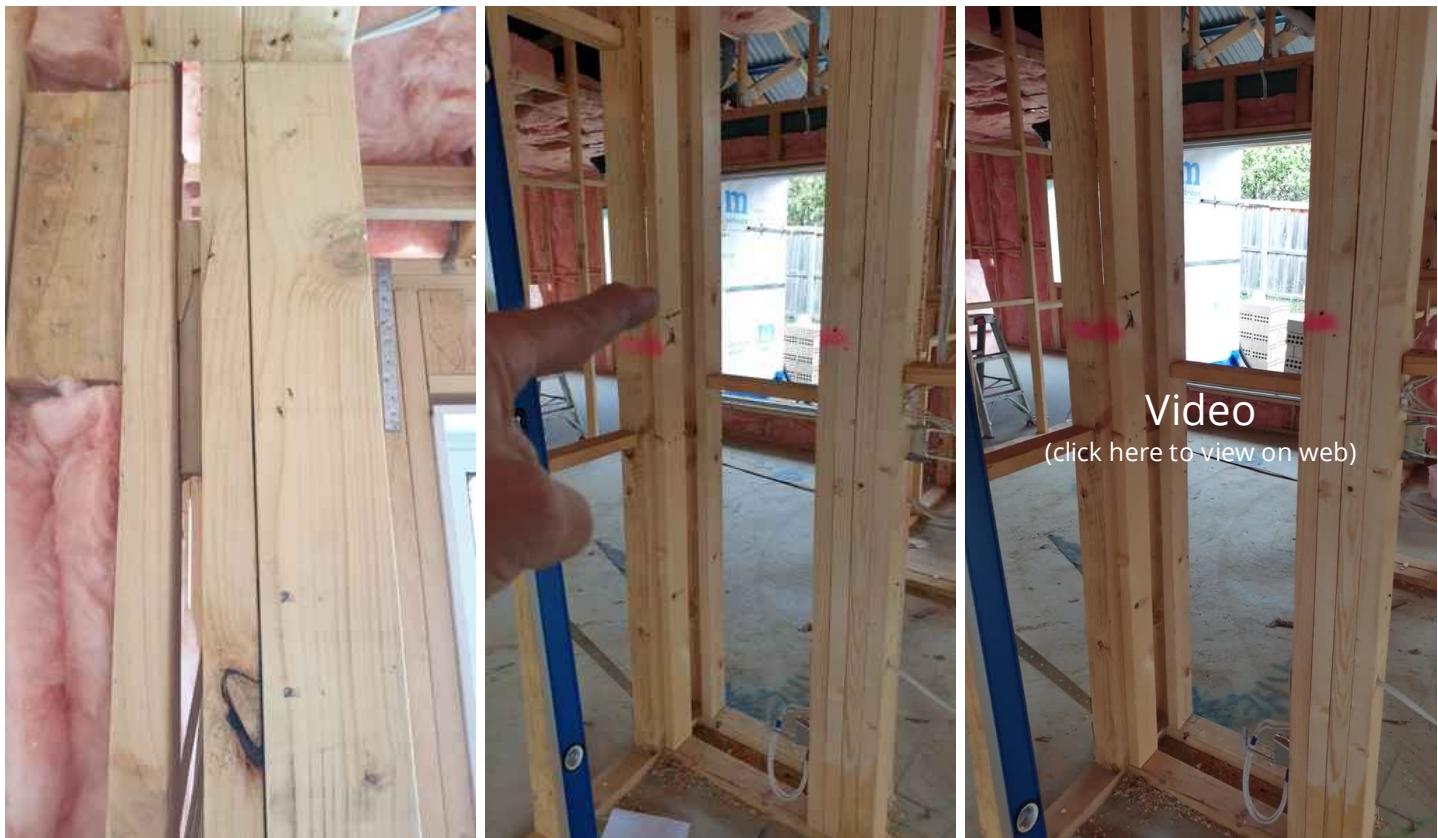
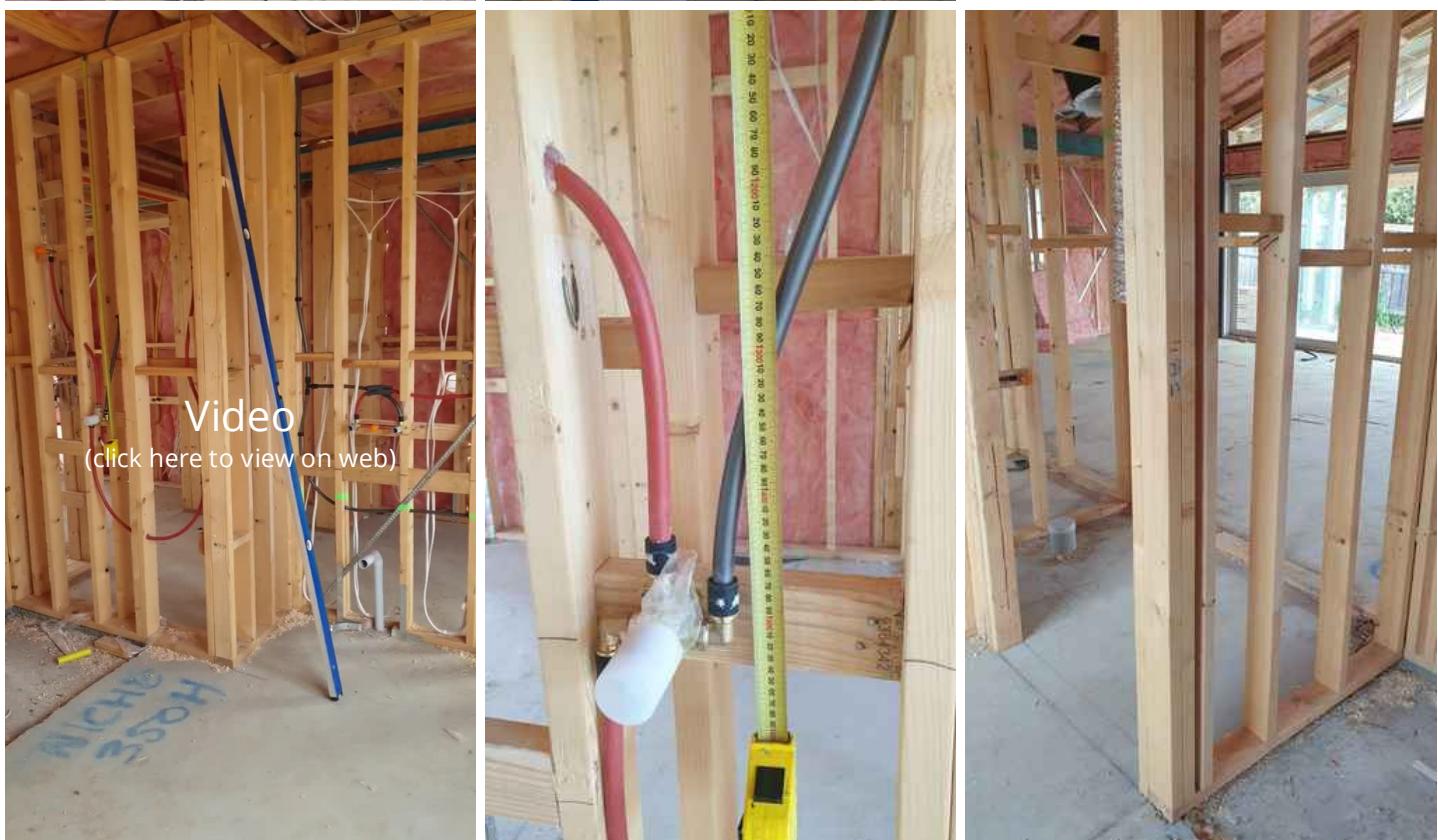
It was observed that some noggings have been not been installed as required by **AS1684.2:2010** or they have been removed.

Noggings in excess of max 1350mm  
spacings

**I recommend all noggings are installed to ensure compliance with Australian Standard 1684.2:2010**

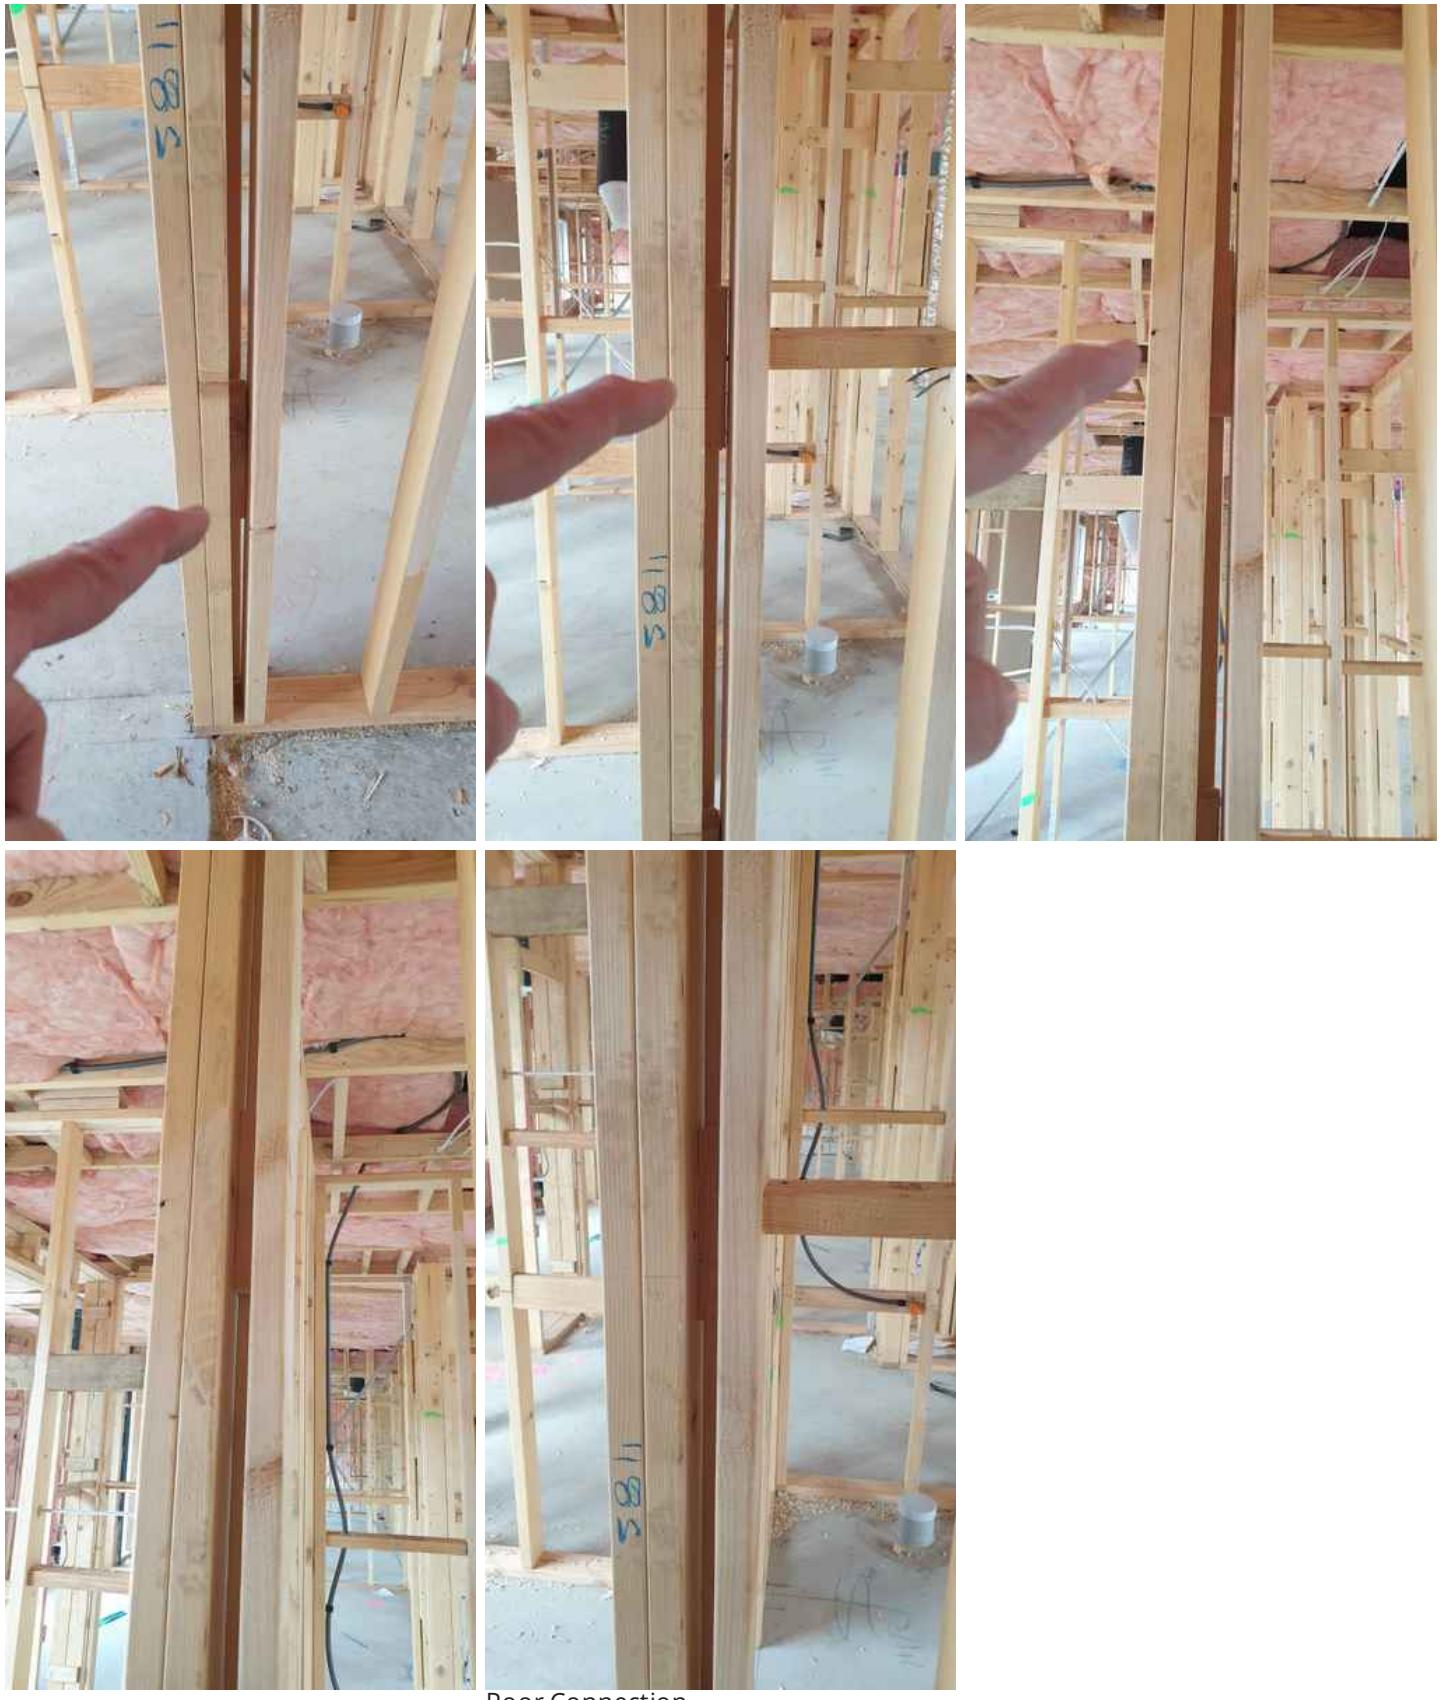
Poor Connection

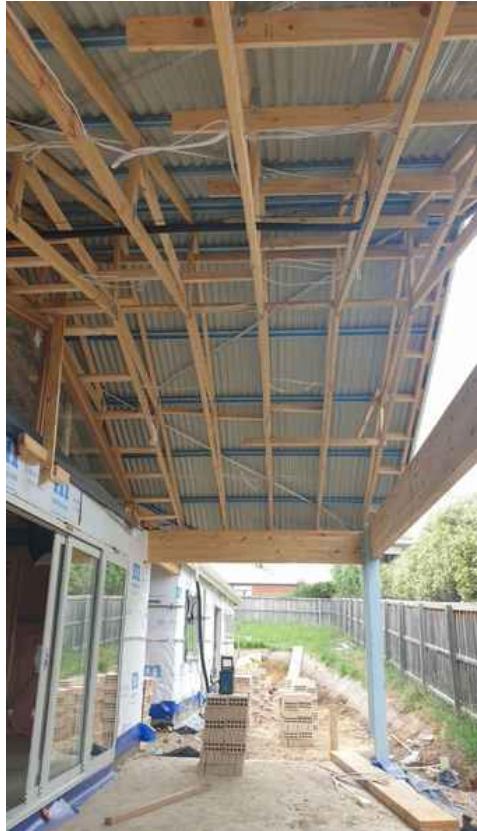
Bottom Chord restraints required at  
4.0m Maximum spacings

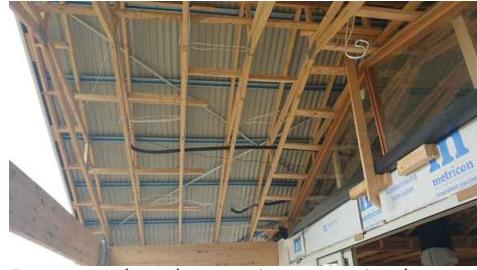
Bottom Chord restraints required at  
4.0m Maximum spacings

I recommend installing bottom chord ties in compliance with AS4440-2004

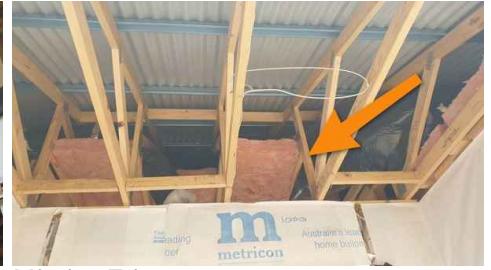
Missing Trimmer

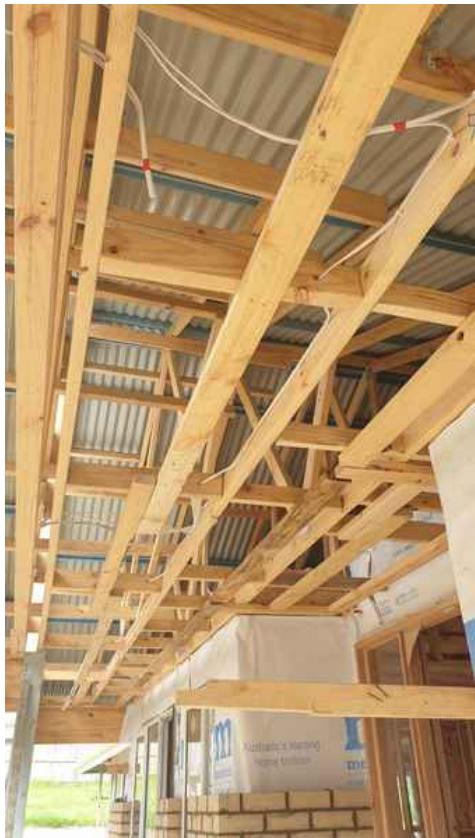
Bottom Chord restraints required at 4.0m Maximum spacings and Binders have not been installed.

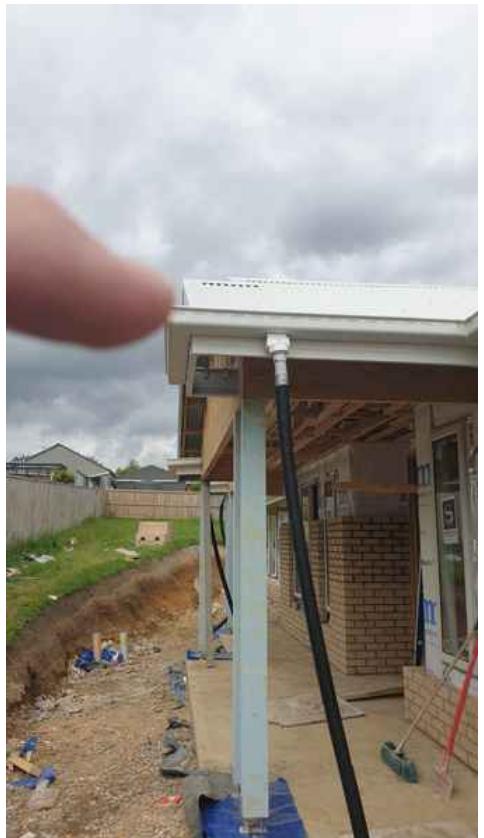
Bent fascia

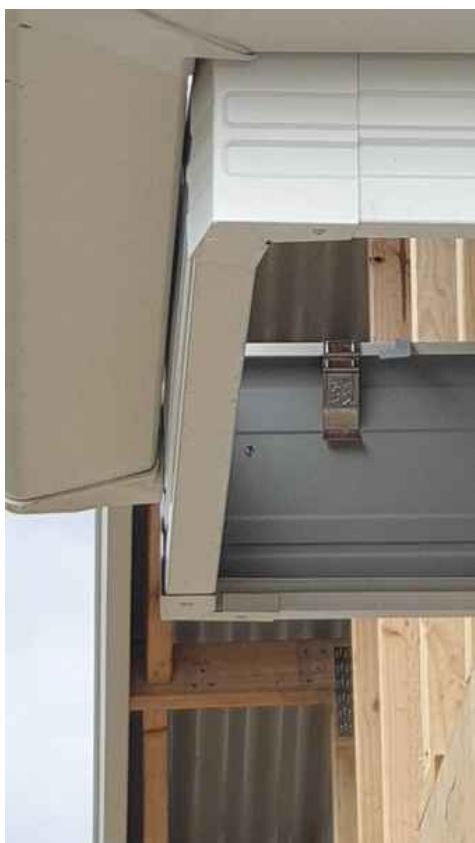
Bent fascia

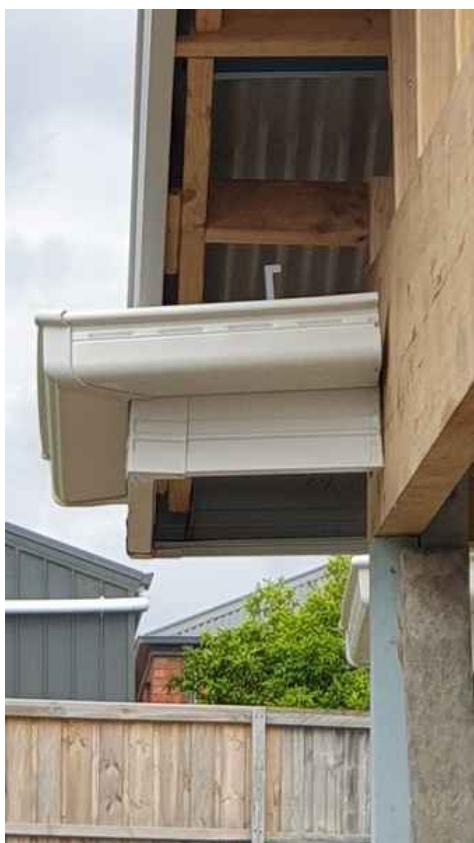
Gutter Obviously Exaggerated Fall

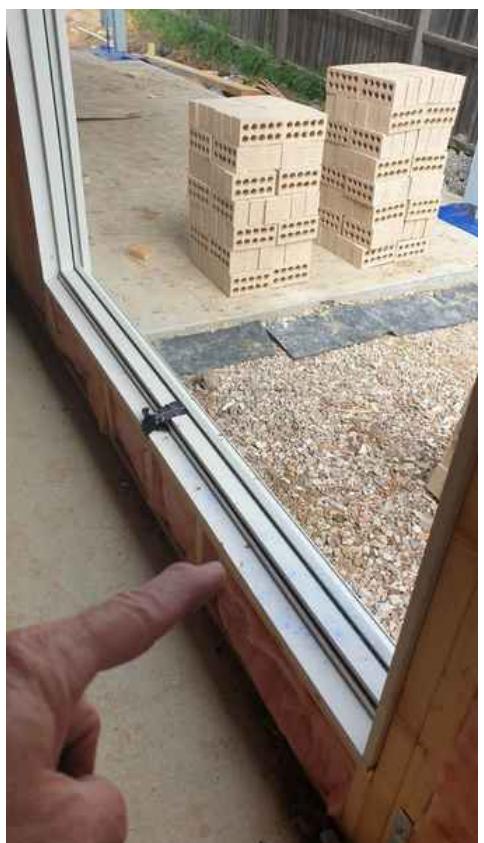
No window sill protection or means of preventing access

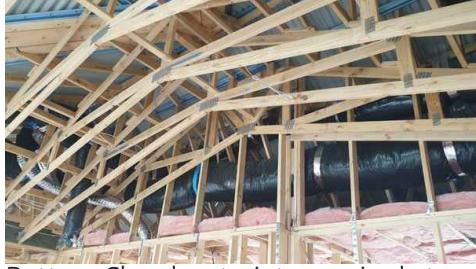
Bottom Chord restraints required at 4.0m Maximum spacings

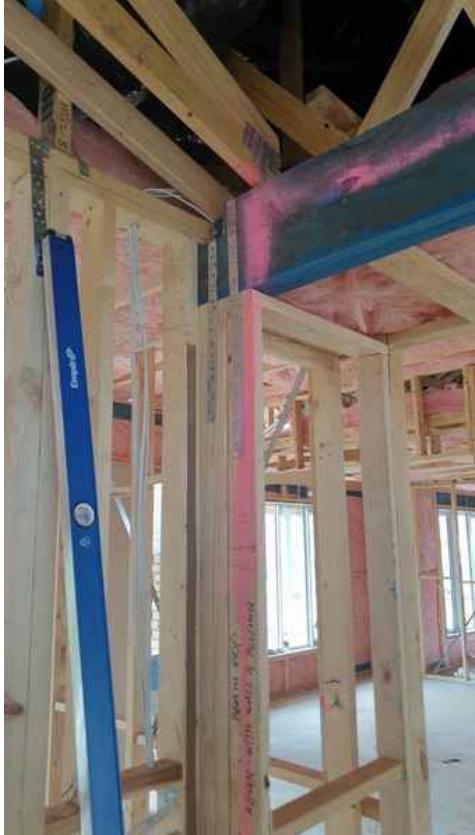
Beam and wall out of alignment

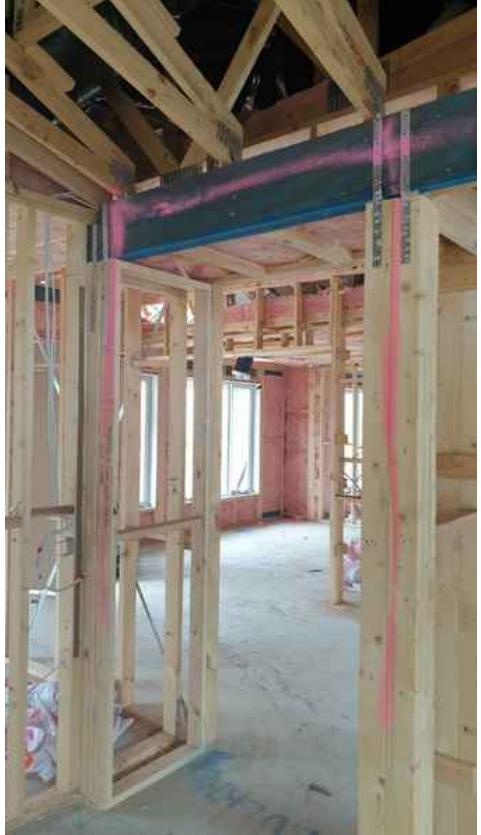
Beam and wall out of alignment

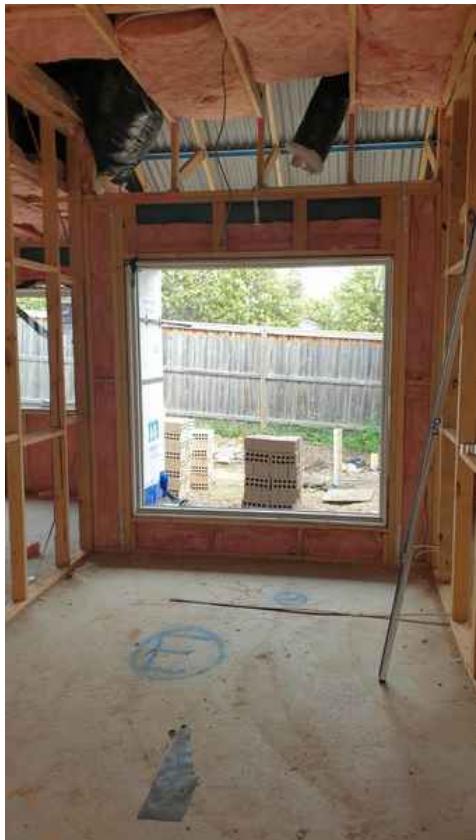
Missing framing members for plasterboard

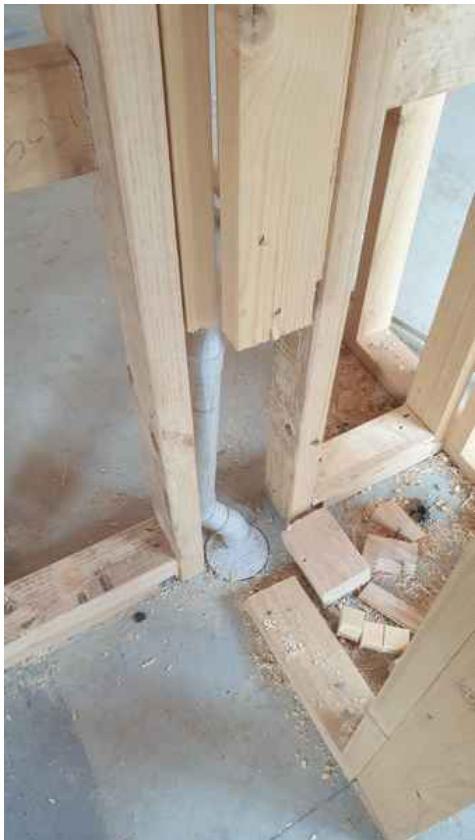
Cut stud work

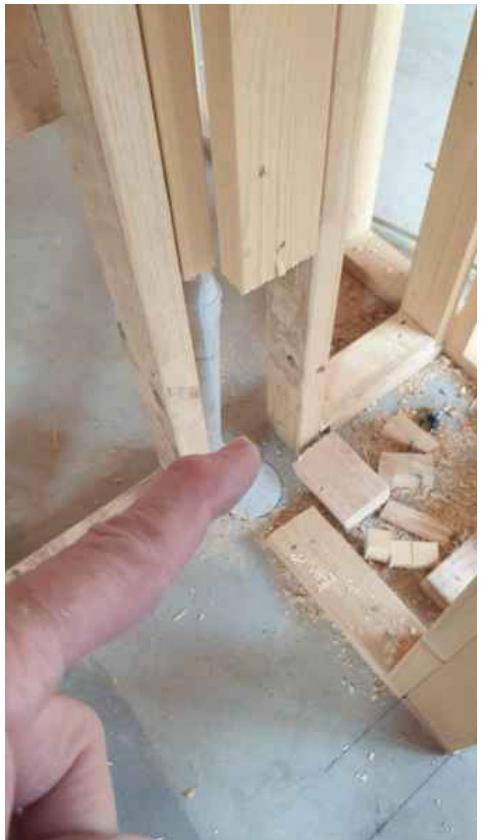
Missing Noggings

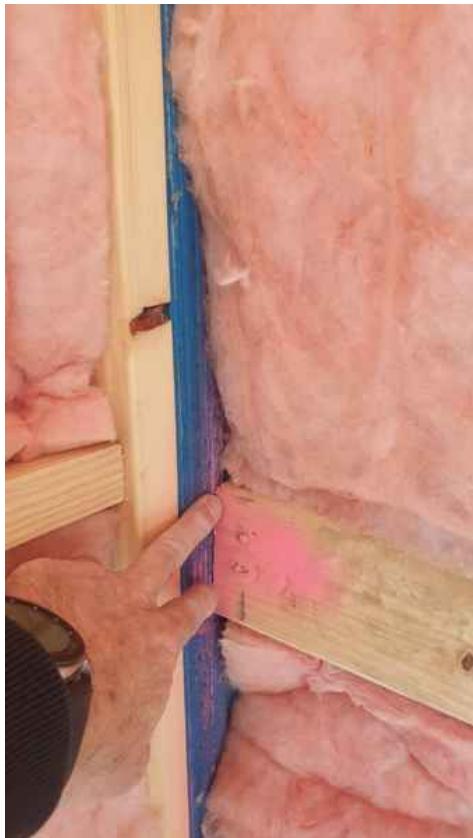
Missing Stud

I recommend to complete work in a professional and workmanlike manner and in strict compliance with the Building Code.

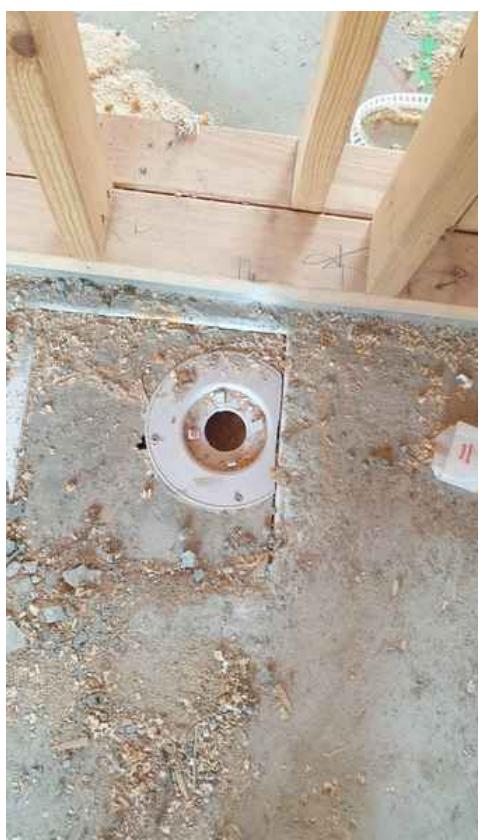
Poor Workmanship

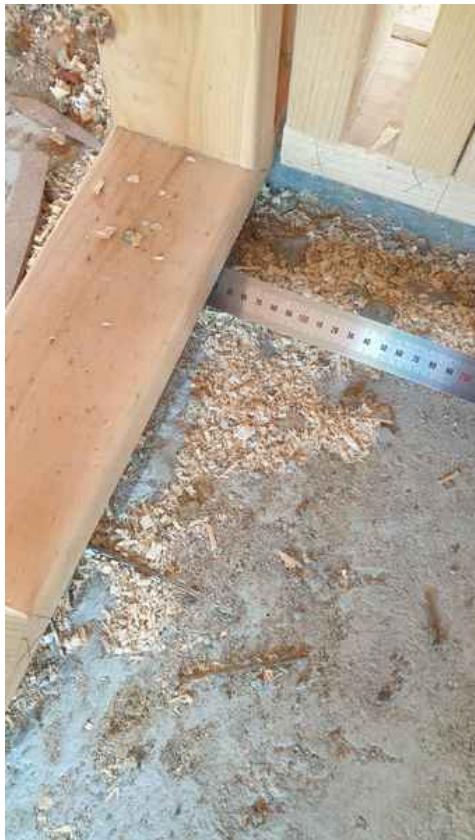
Modified leak control flange.

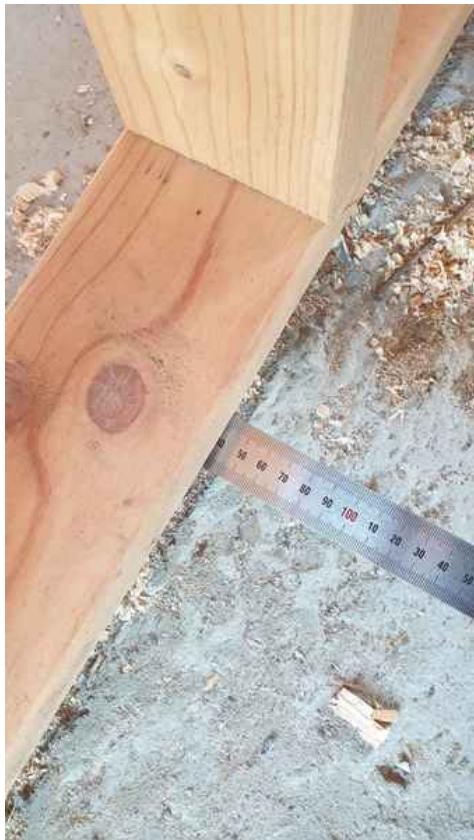
Master Ensuite Wall Not Fully Supported

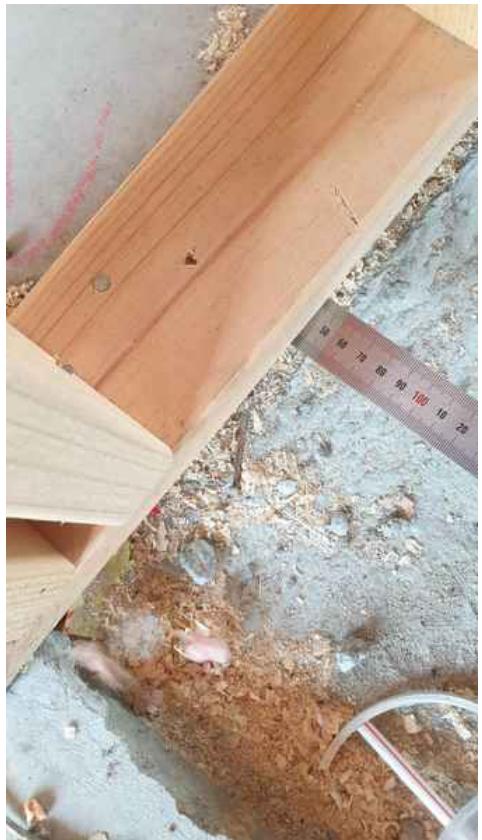
Master Ensuite Wall Not Fully Supported

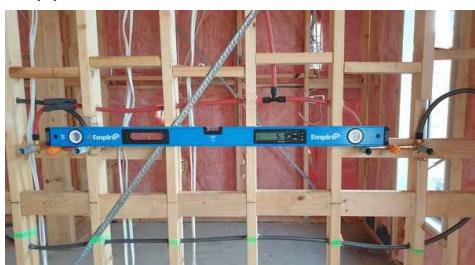
Breaches Not Level In Master Ensuite
