# TOPNOTCH BUILDING INSPECTIONS

## PRE-PLASTER INSPECTION

1234 Main St. Preston Victoria 3072

12/03/2021 9:00AM

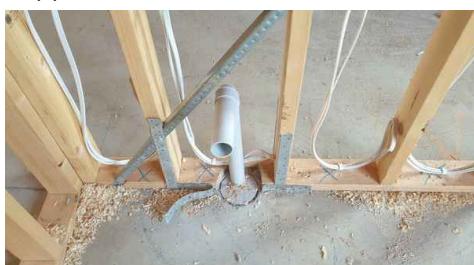
Bottom plate cut in bracing wall, requires rectification

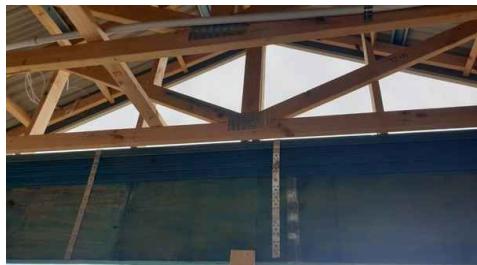
Missing Binders in Garage

Recommendation  
Contact your builder.

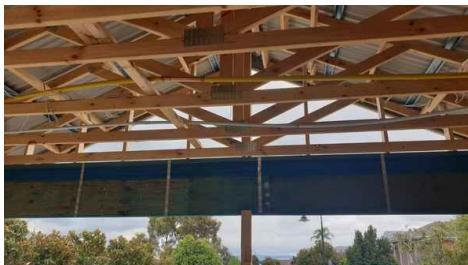
Missing Binders in Garage

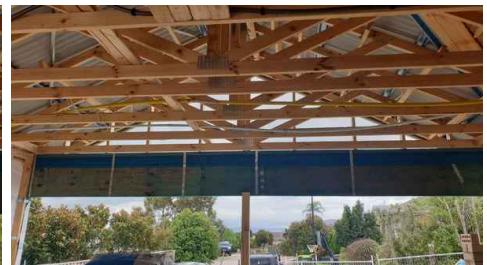
Missing Binders in Garage

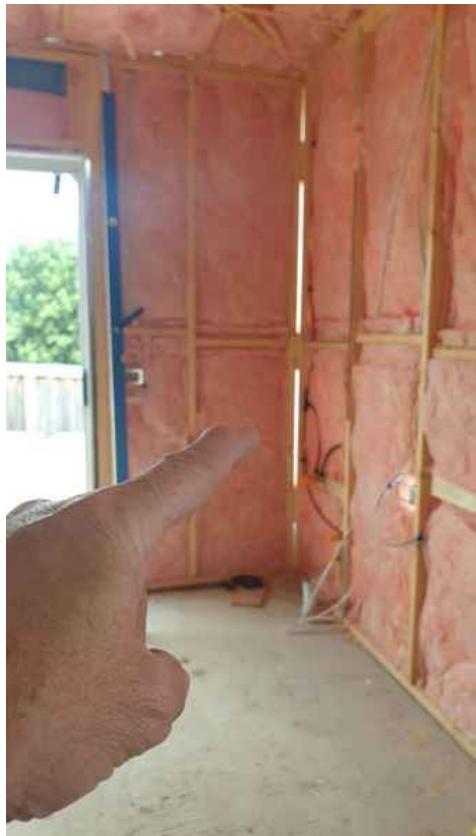
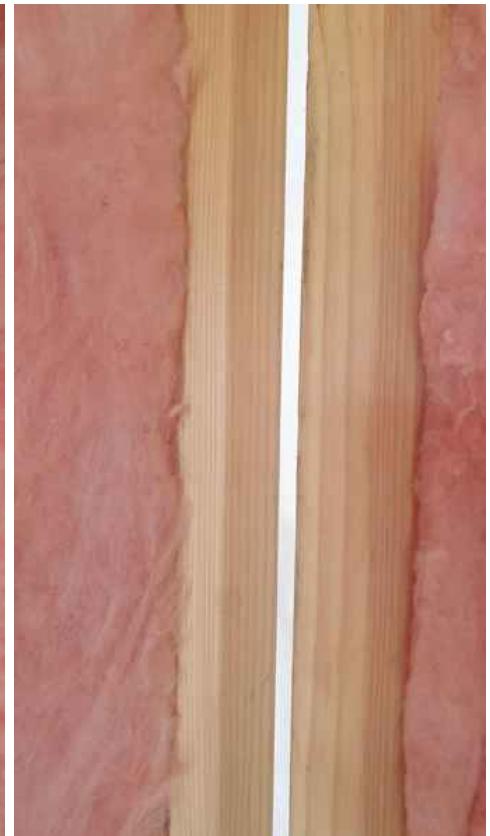
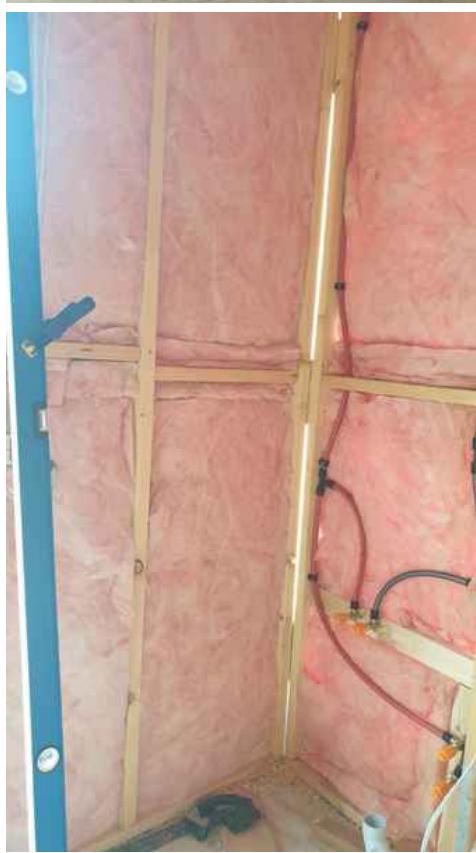
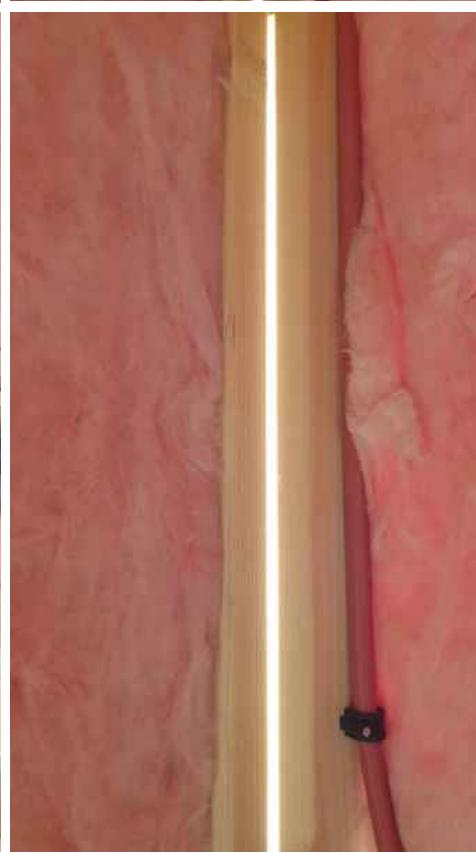
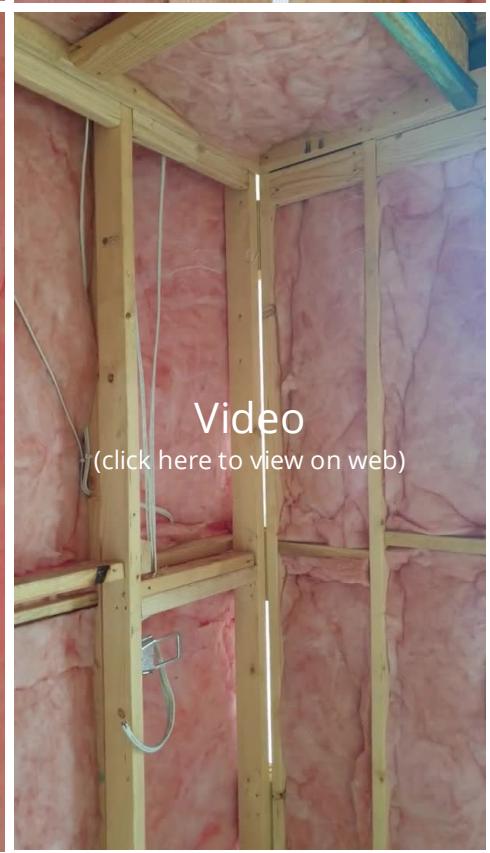
- Minor Defect

I recommend installing insulation into the external wall junctions to provide continuity, and in strict compliance with the manufacturers recommendations and AS3999-2015 to ensure effectiveness.

Contact a qualified insulation contractor.

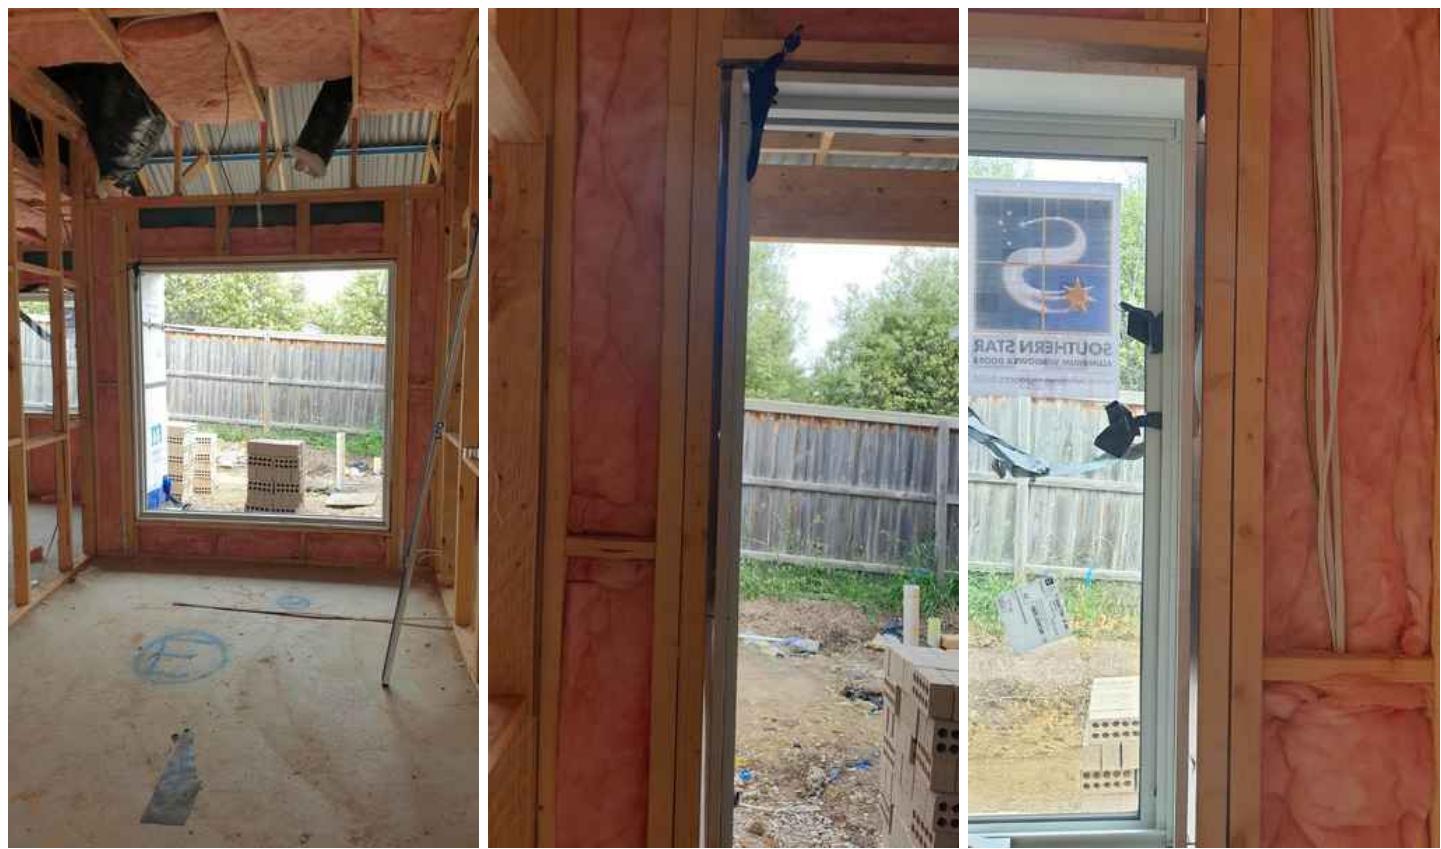
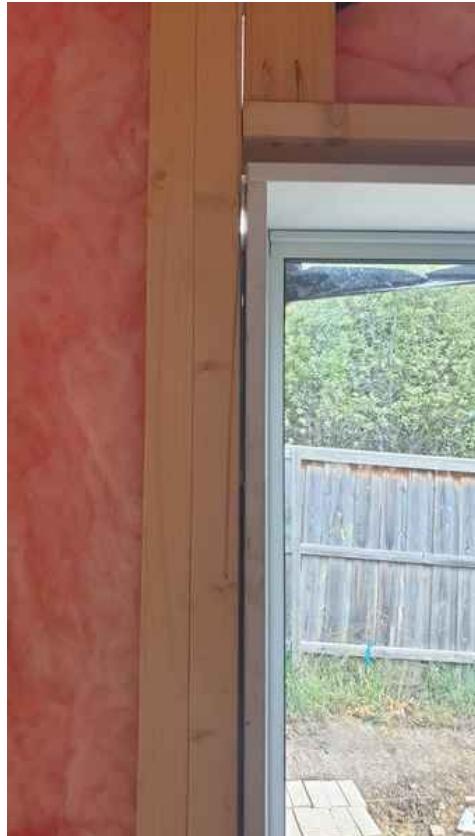
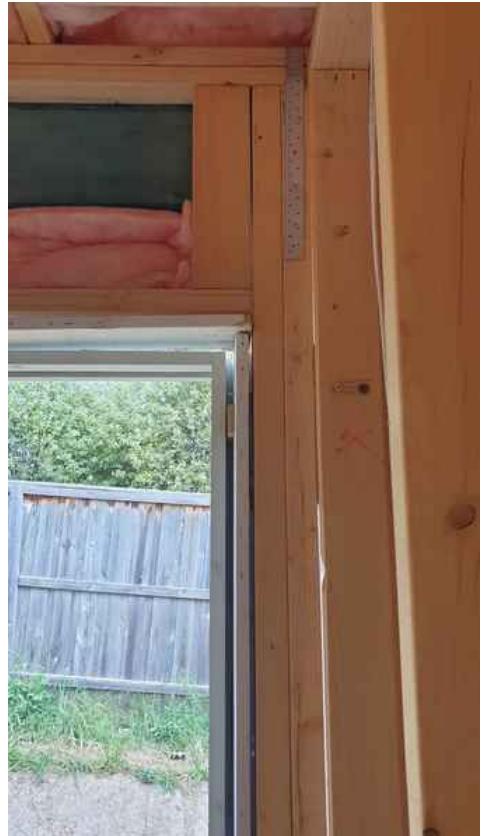
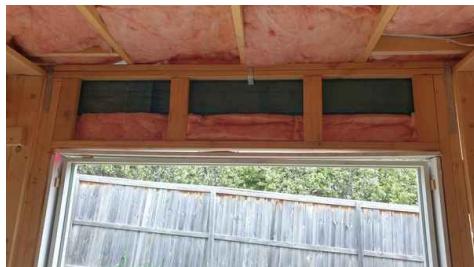
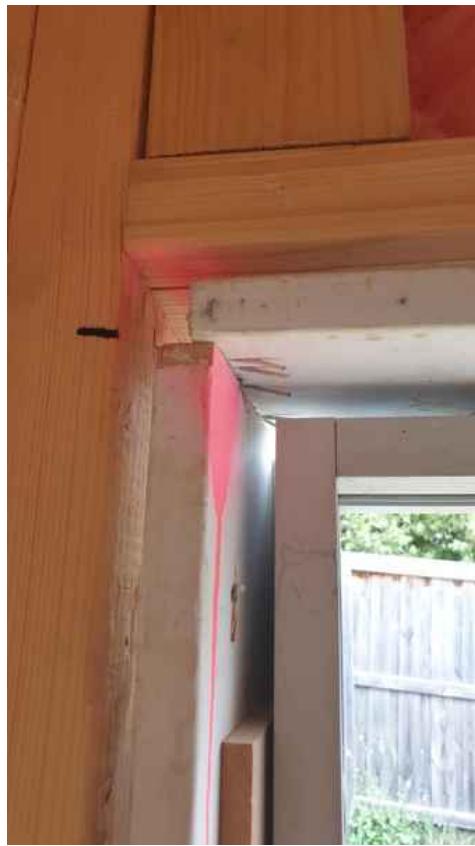
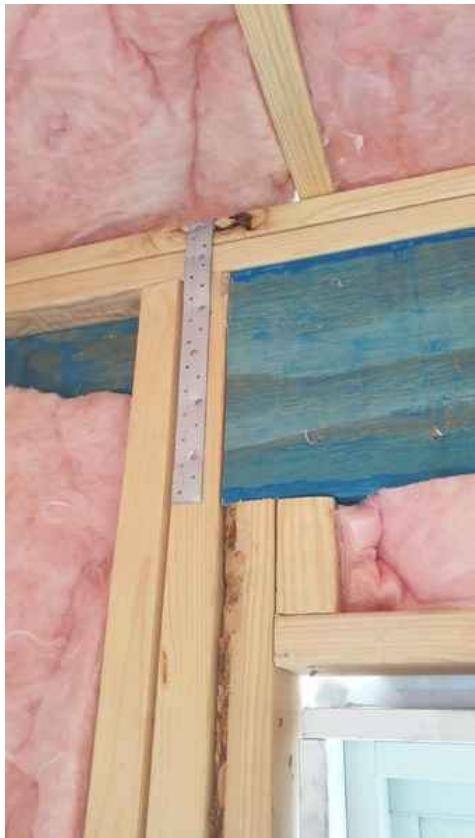
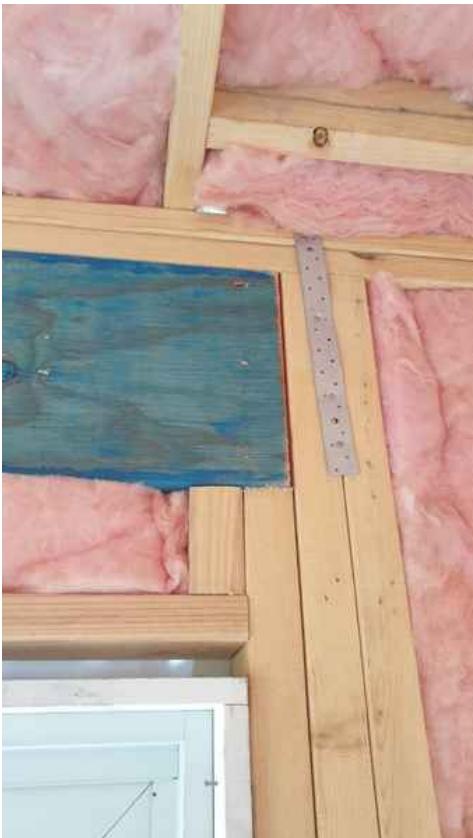
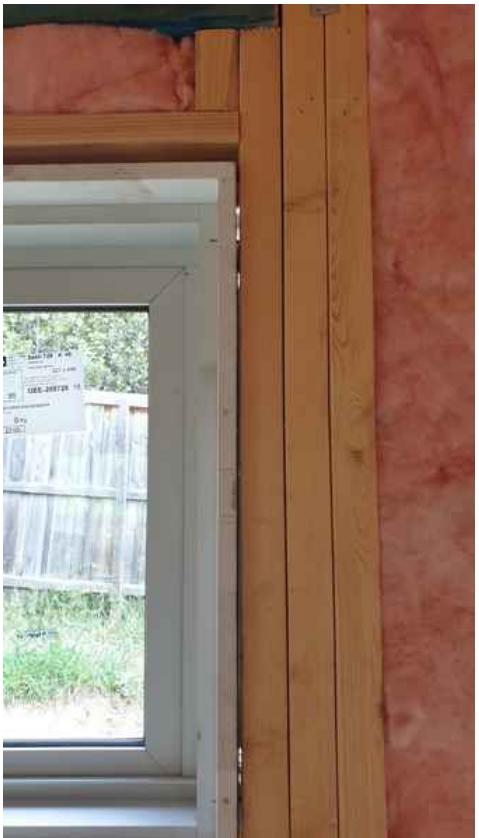
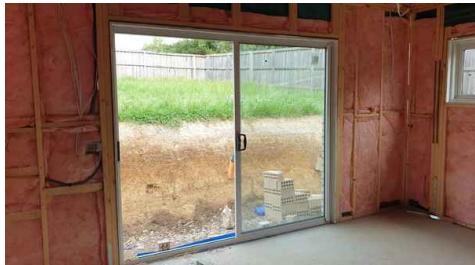
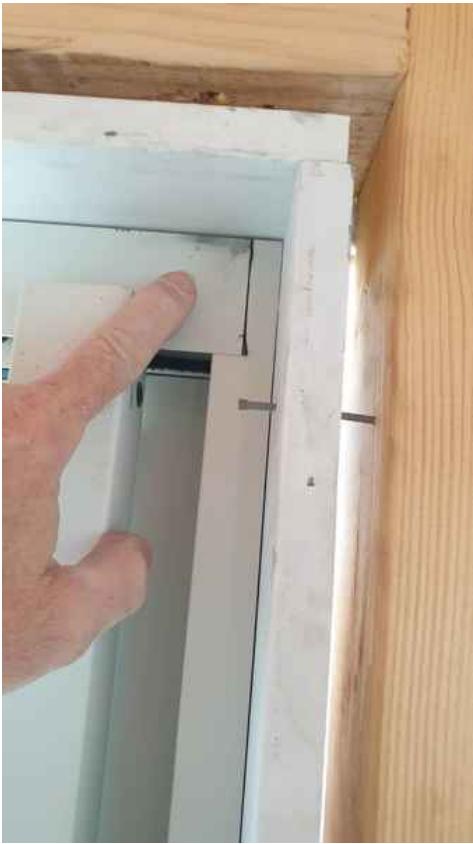
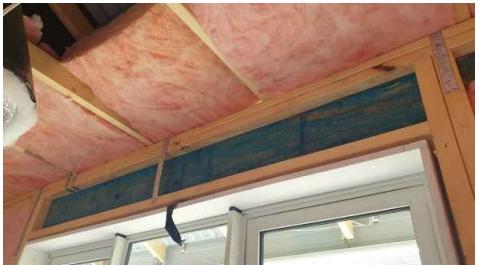
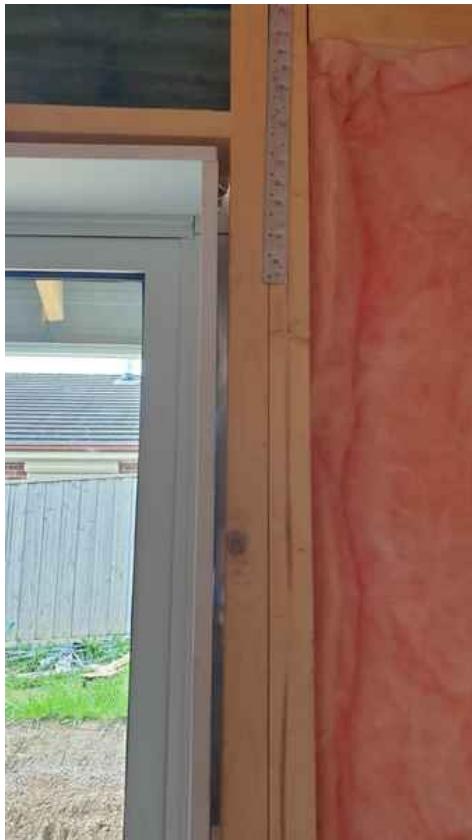
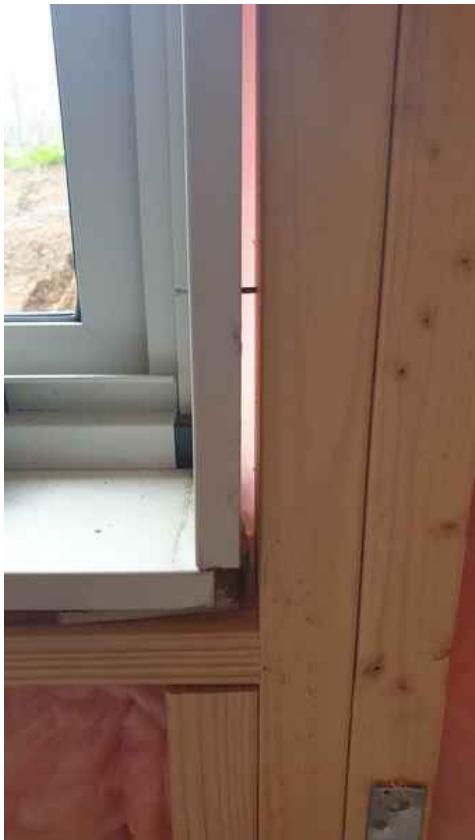
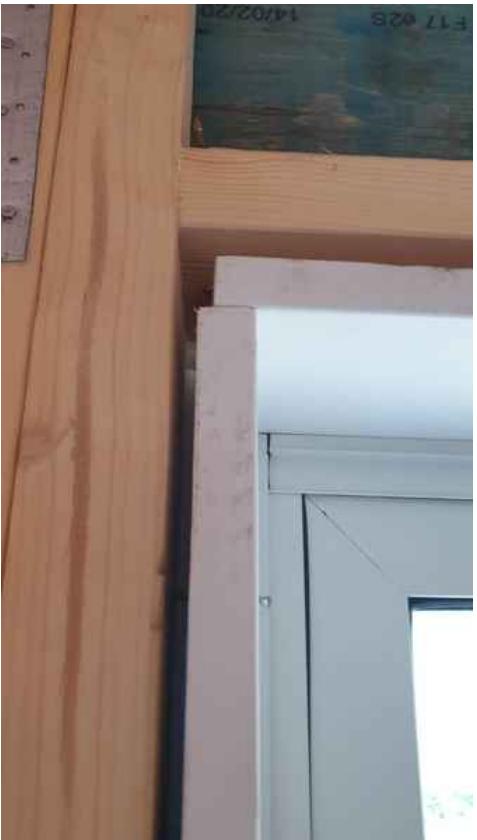
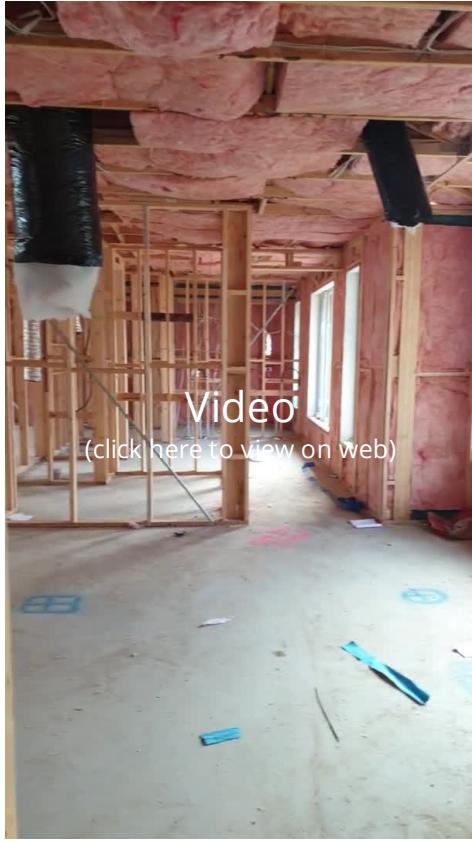
## 10.1.3 Wall Insulation

**AREAS NOT INSULATED OR COMPLETED**

Minor Defect

I recommend installing insulation into wall structure to provide continuity, and in strict compliance with the manufacturers recommendations and AS3999-2015 to ensure effectiveness.

Recommendation  
Contact a qualified insulation contractor.

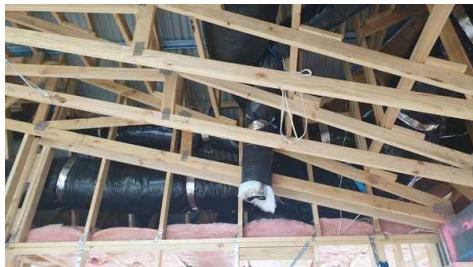
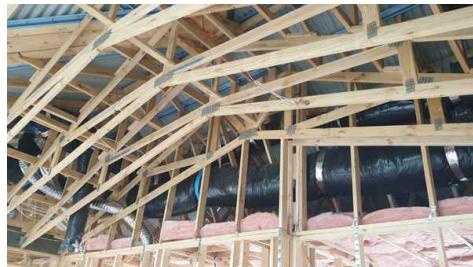
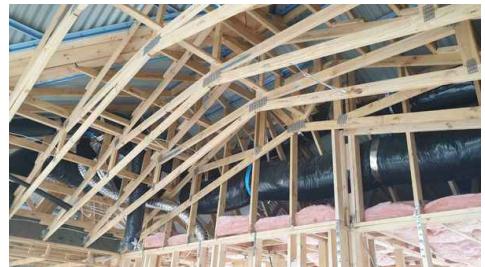
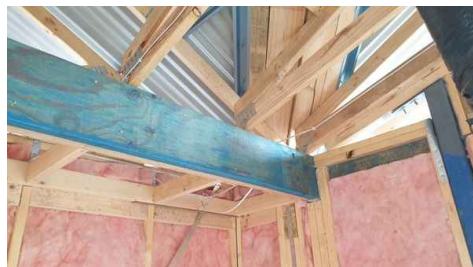
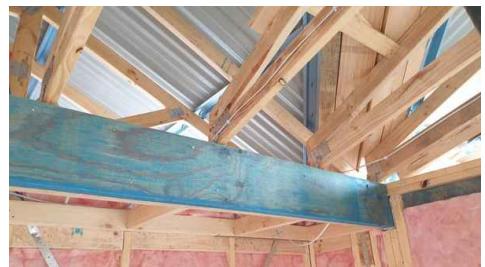
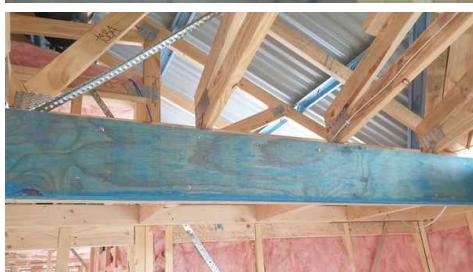
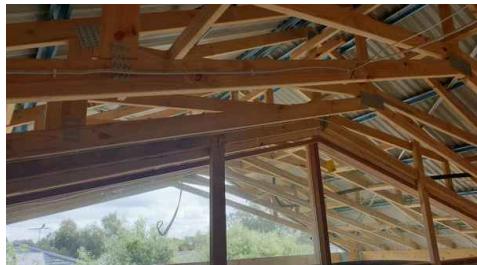
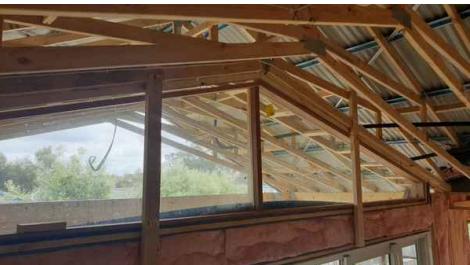
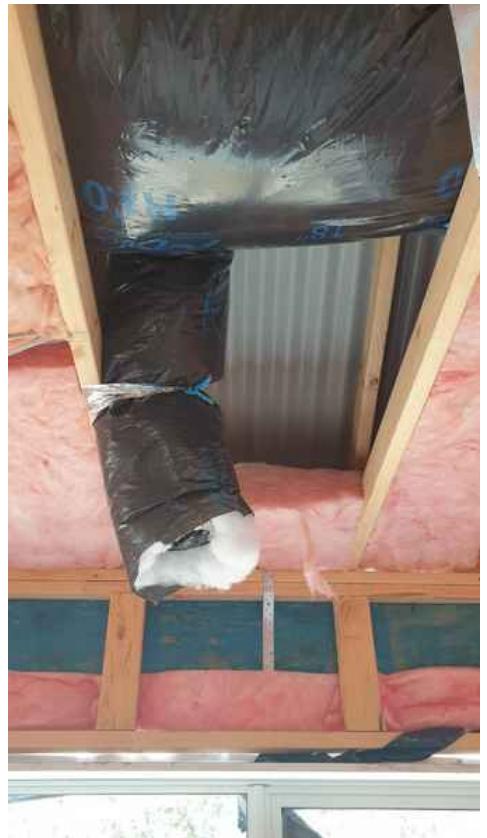
## 10.2.1 Ceiling Insulation

**MISSING OR NOT COMPLETE INSULATION**

- Minor Defect

I recommend installing insulation into wall structure to provide continuity, and in strict compliance with the manufacturers recommendations and AS3999-2015 to ensure effectiveness.

Recommendation  
Contact a qualified insulation contractor.
