# TOPNOTCH BUILDING INSPECTIONS

## PRE-PURCHASE RESIDENTIAL

1234 Main St. Preston Victoria 3072

21/07/2020 9:00AM

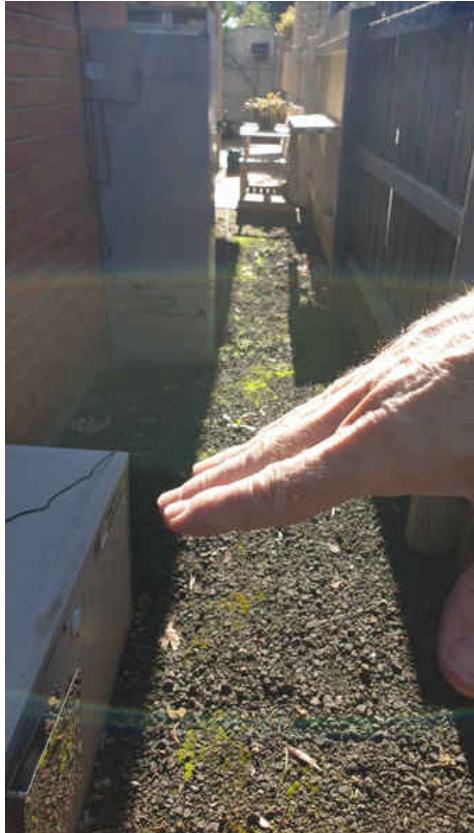
Negative Grading

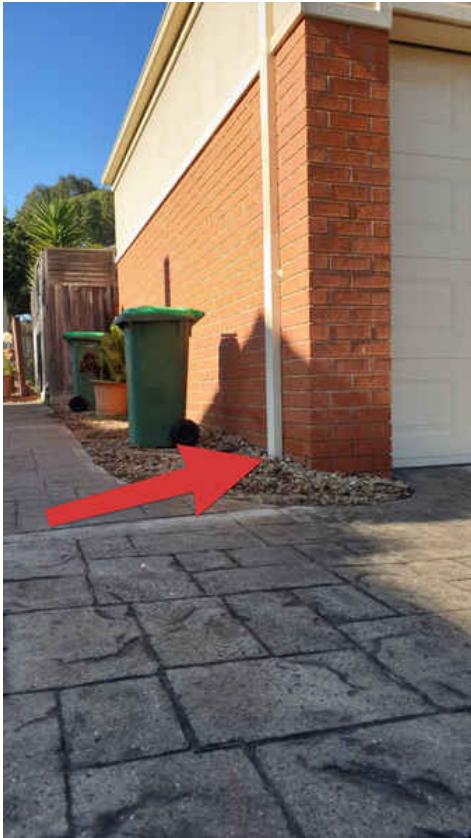
### 3.4.2 Grading and Drainage **SOIL HIGH ON FOUNDATION (SLAB)**

Recommendation

Contact a qualified professional.

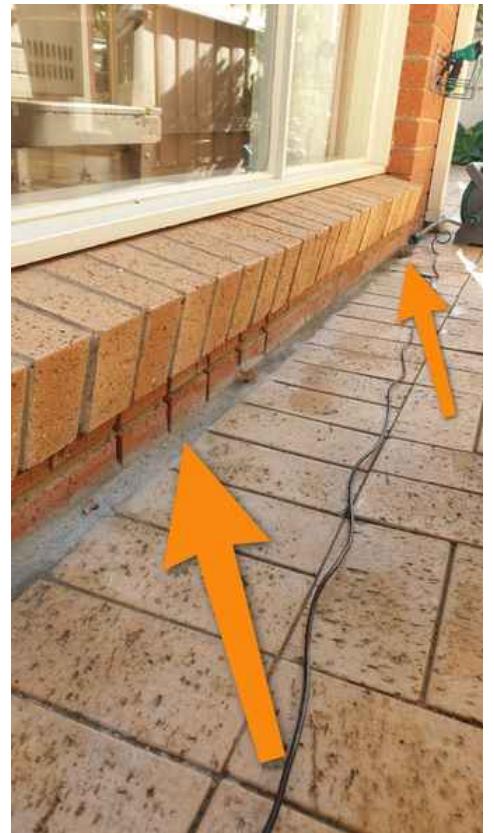
## 3.4.3 Grading and Drainage

**PAVING HIGH ON FOUNDATION WALLS (BV)**

Paving Partially Covering Subfloor Ventilation

Recommendations: Consulting a qualified engineer for advice and recommendations.

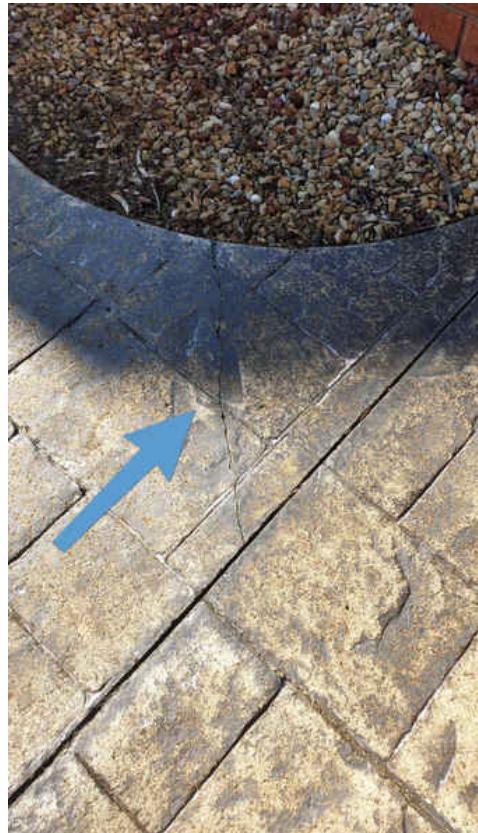
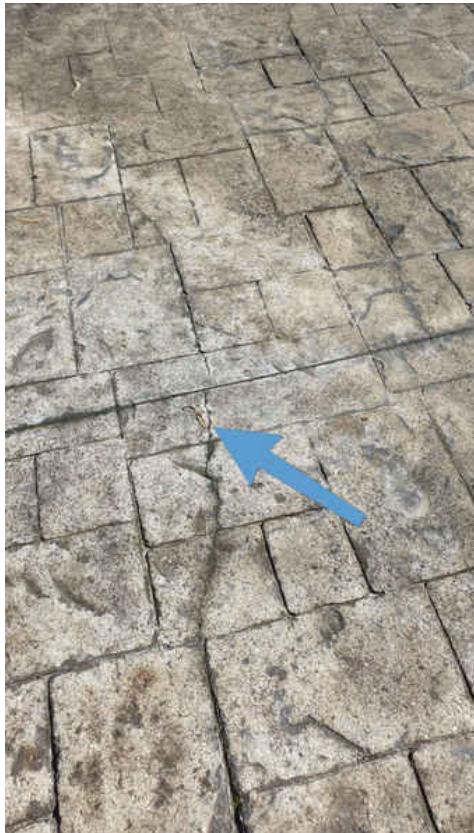
## 3.5.1 Driveway

Recommendation

Recommend monitoring.

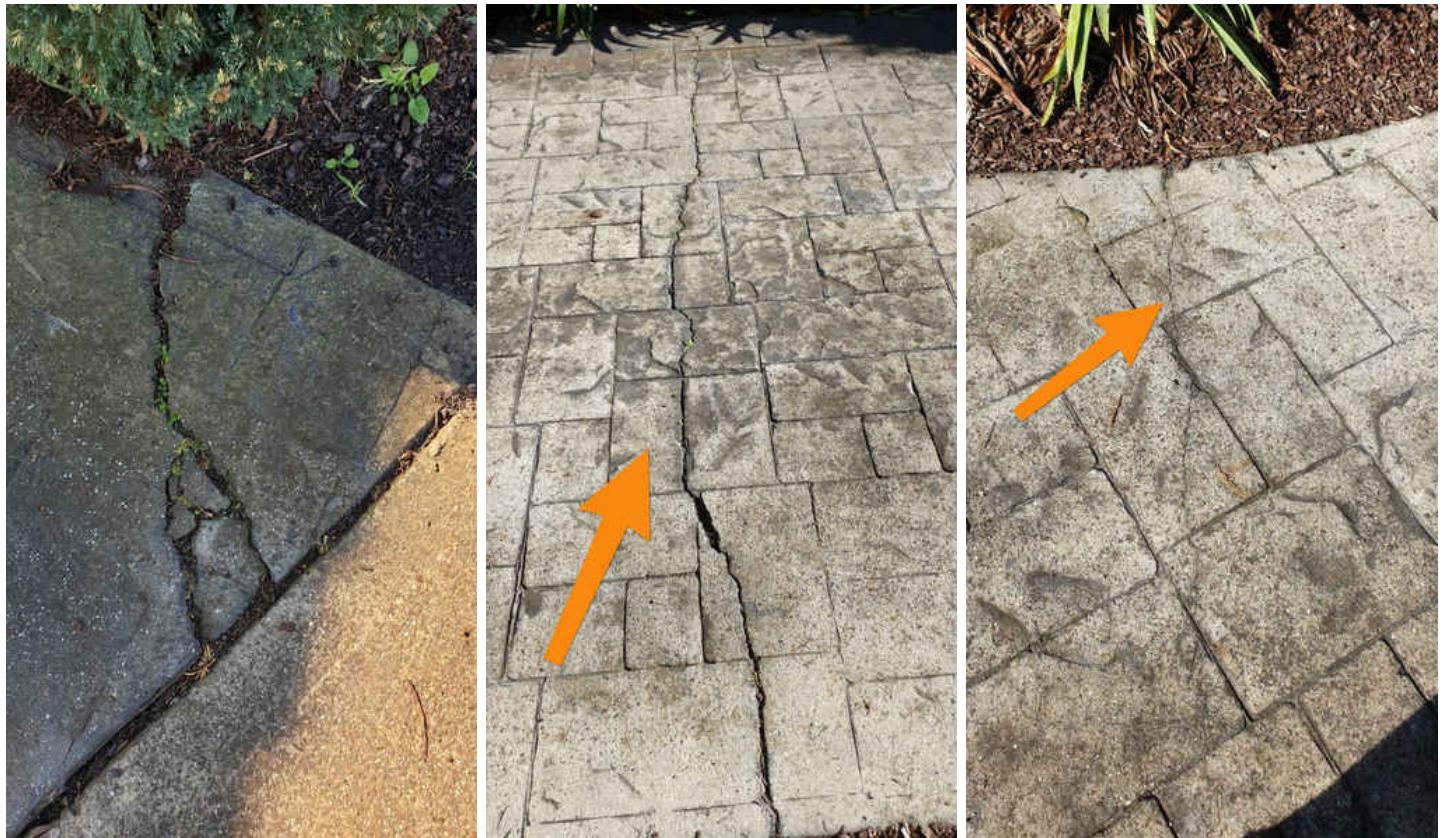
## 3.5.2 Driveway

Recommendation

Contact a qualified professional.

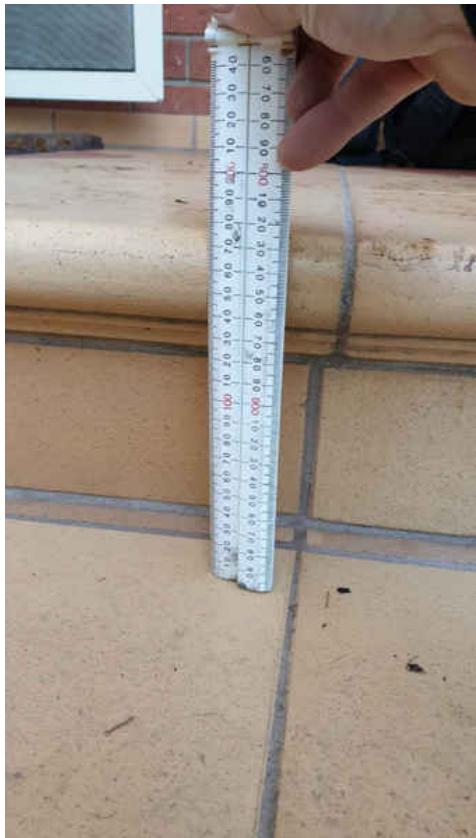
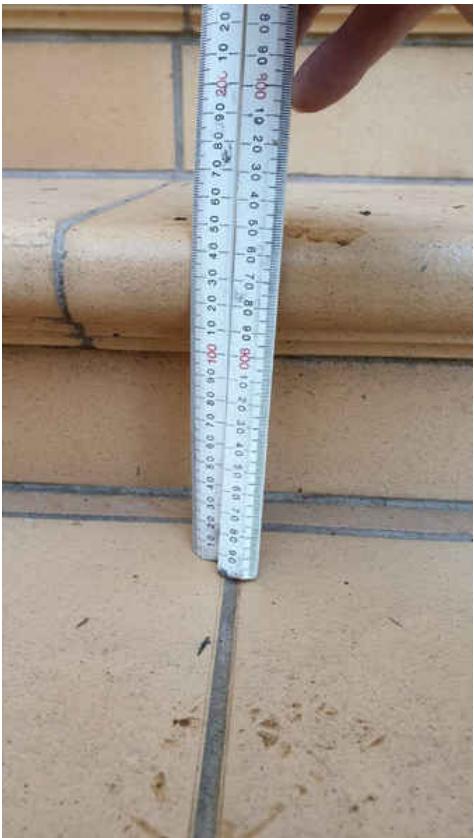
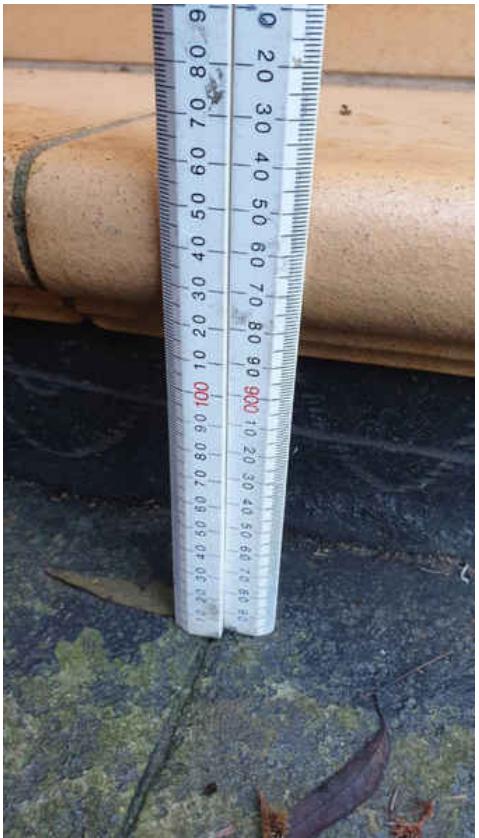
## 3.7.1 Steps

**RISER HEIGHTS INCONSISTENT**

Inconsistent Riser Heights, Safety / Trip Hazard

Contact a qualified professional.

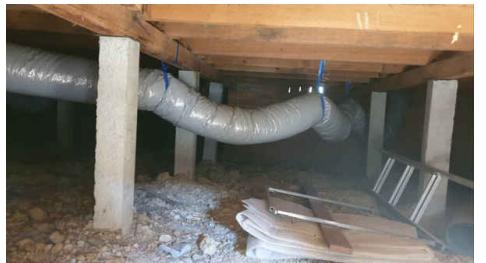
Subfloor Area, Stored Materials

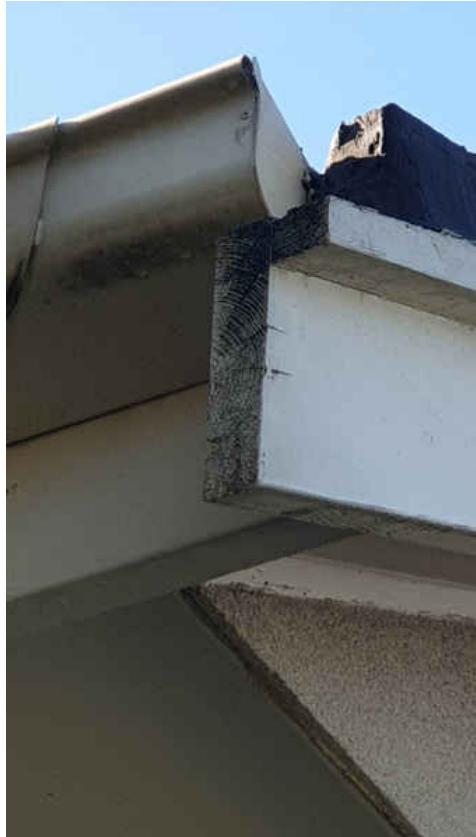
Front of Dwelling Gable End

4.4.1 Eaves, Soffits & Fascia

Recommendation

Contact a qualified painting contractor.

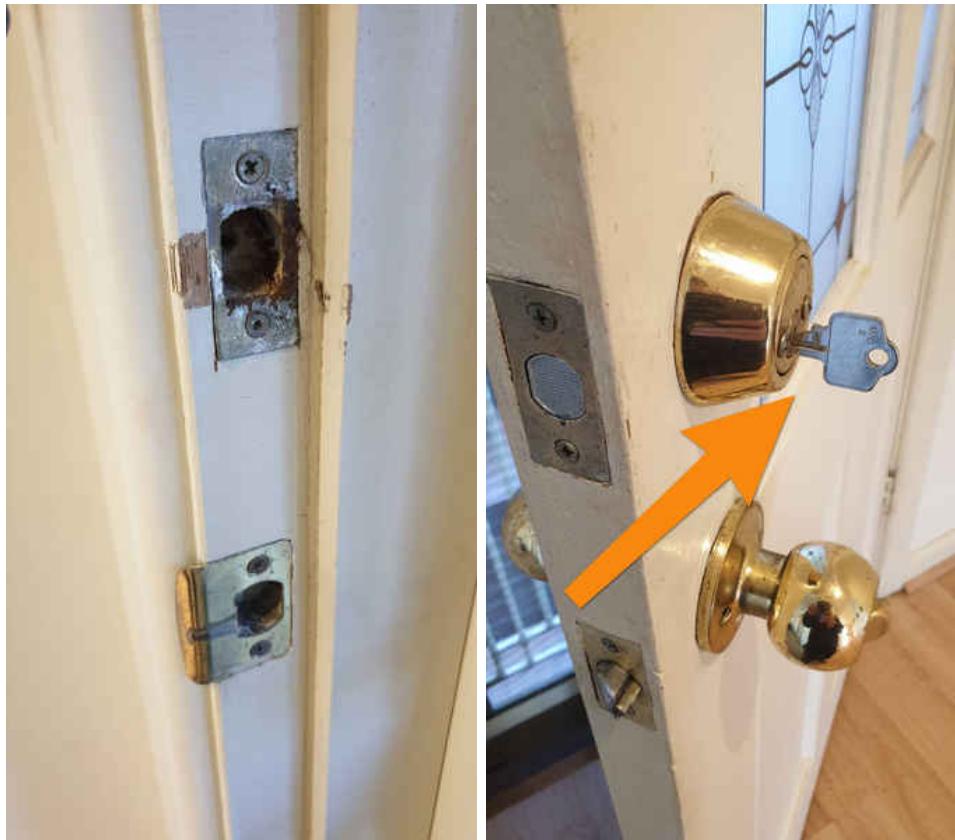
Front door lock latch.

Recommended DIY Project

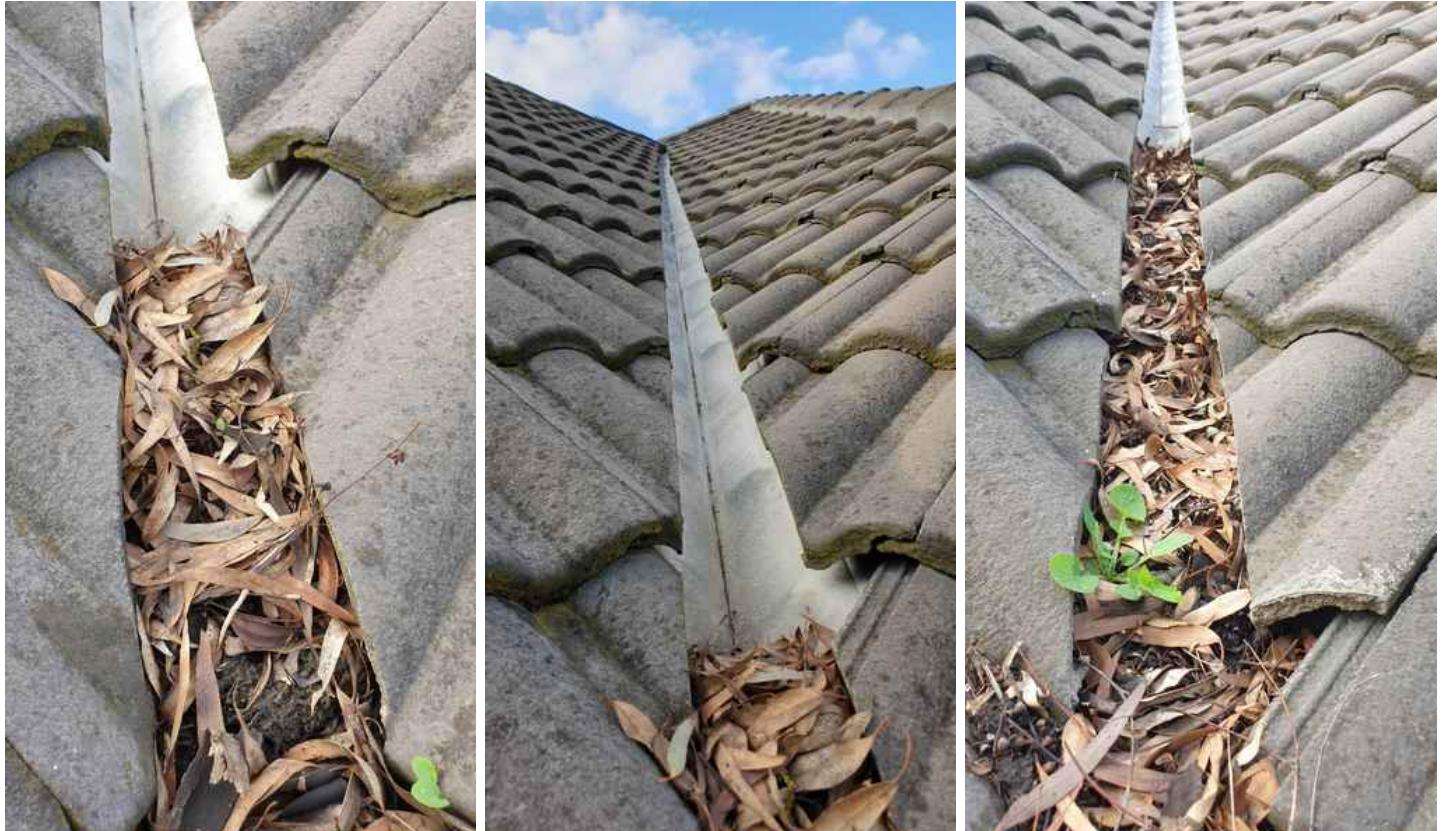
Broken Roof Tile and Debris in Valley

Debris and leaf litter were observed in the valleys of the roof.

Excessive debris can cause water intrusion into the roof space and into the dwelling.

Some roof tiles were found to be cracked / broken tiles in one or more locations. This is typical of both concrete and terracotta roof tiles, but requires immediate action to be taken by the home owner.

I recommend regularly cleaning the roof valleys from debris and leaf litter to help prevent water intrusion.

Recommend: a qualified roof contractor replace cracked or broken roof tiles to prevent water damage to the roof and ceiling structure. Water leaks can cause rot, decay, mould, health issues and lead to structural failures.

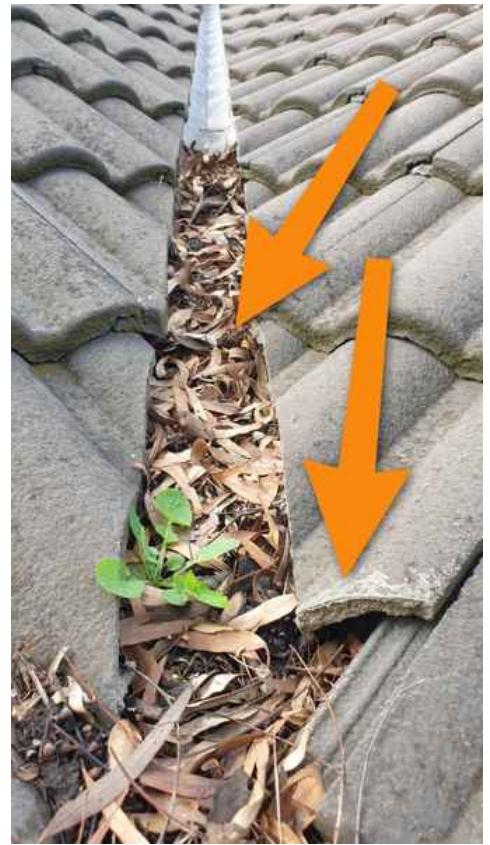
#### 5.2.2 Roof Coverings

#### **TILES - CRACKED / BROKEN**

Recommendation

Contact a qualified roofing professional.

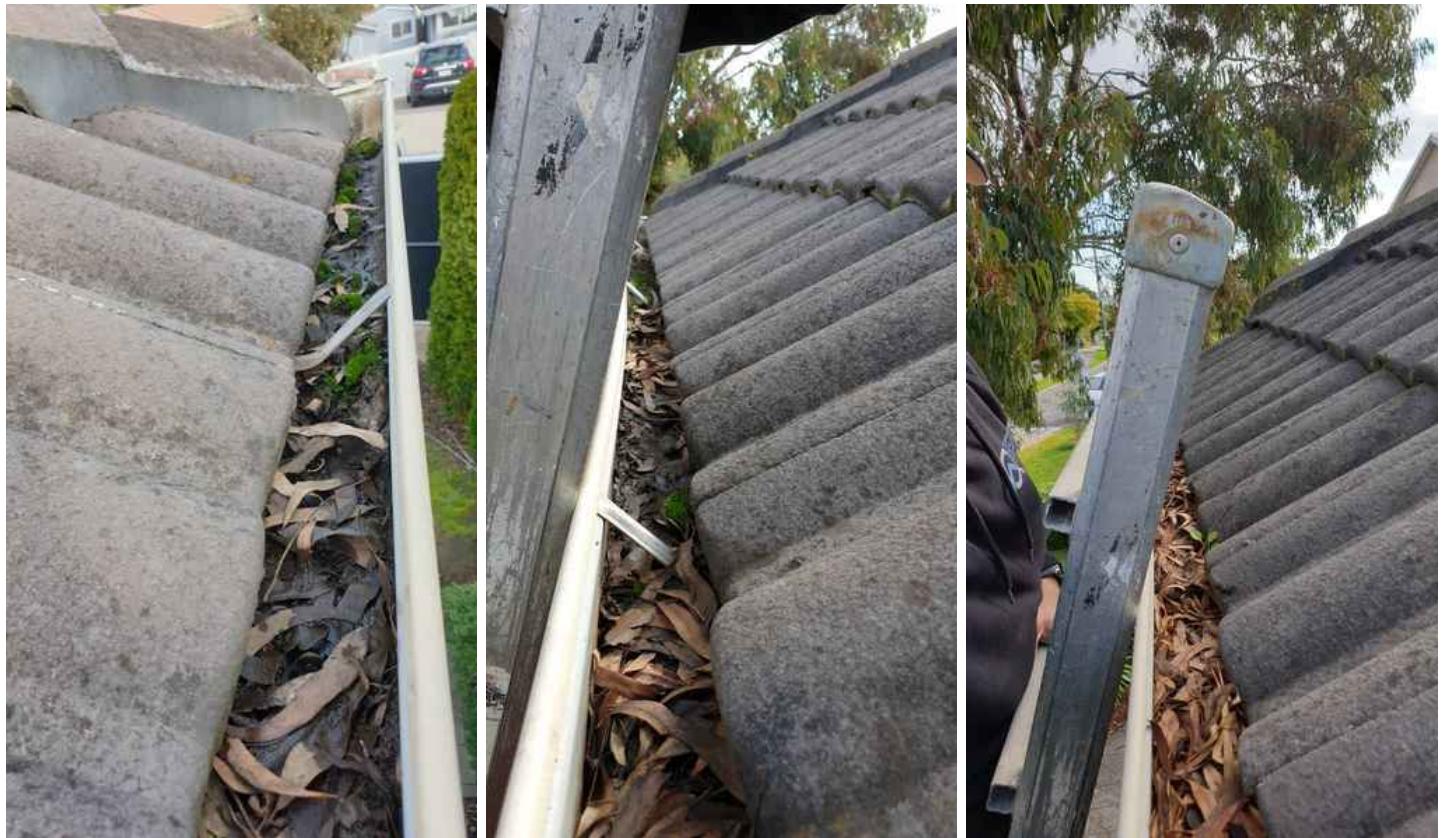
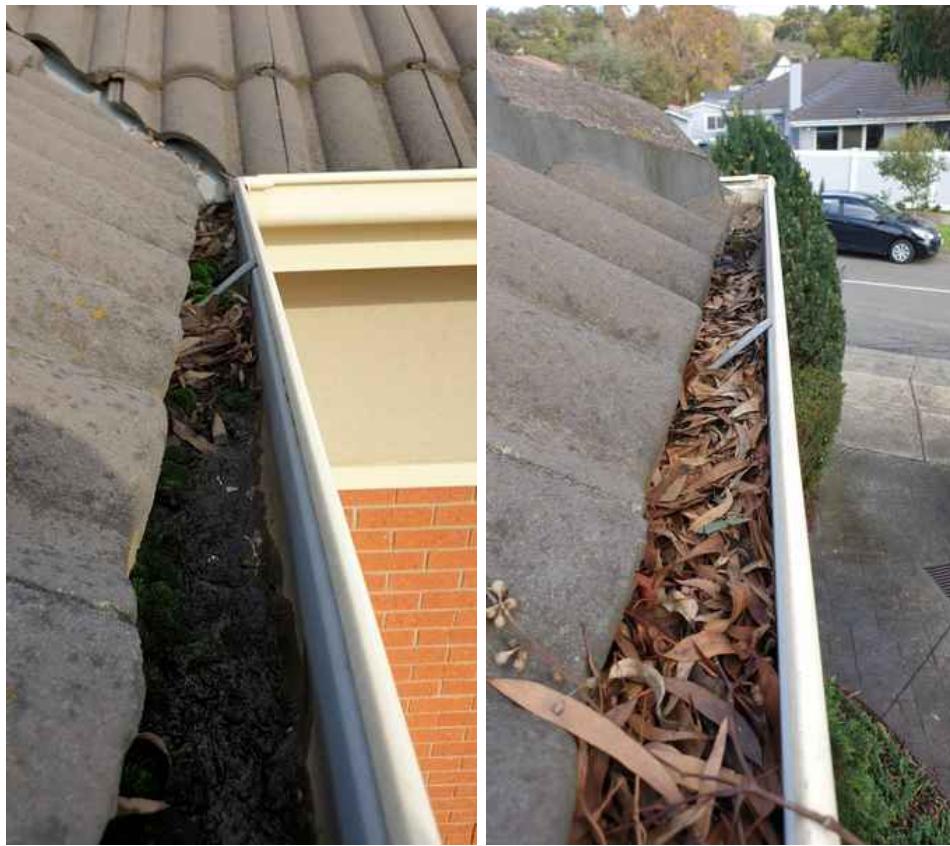
#### 5.3.1 Gutters / Downpipes

Recommendation

Contact a handyman or DIY project

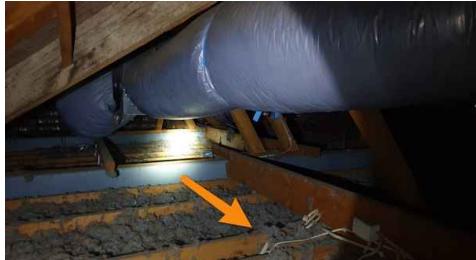
Downlights were observed without downlight protection or in close proximity to non-fire rated materials.

##### This is a major fire hazard.

Missing Downlight Protection

I recommend contacting a licensed electrical contractor to install downlight protection throughout the house

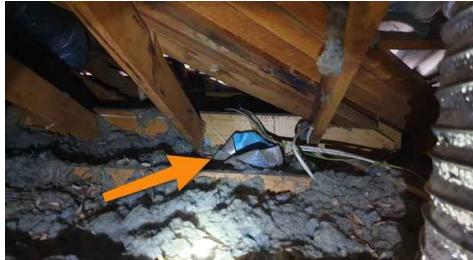
Poorly Installed Downlight Protection

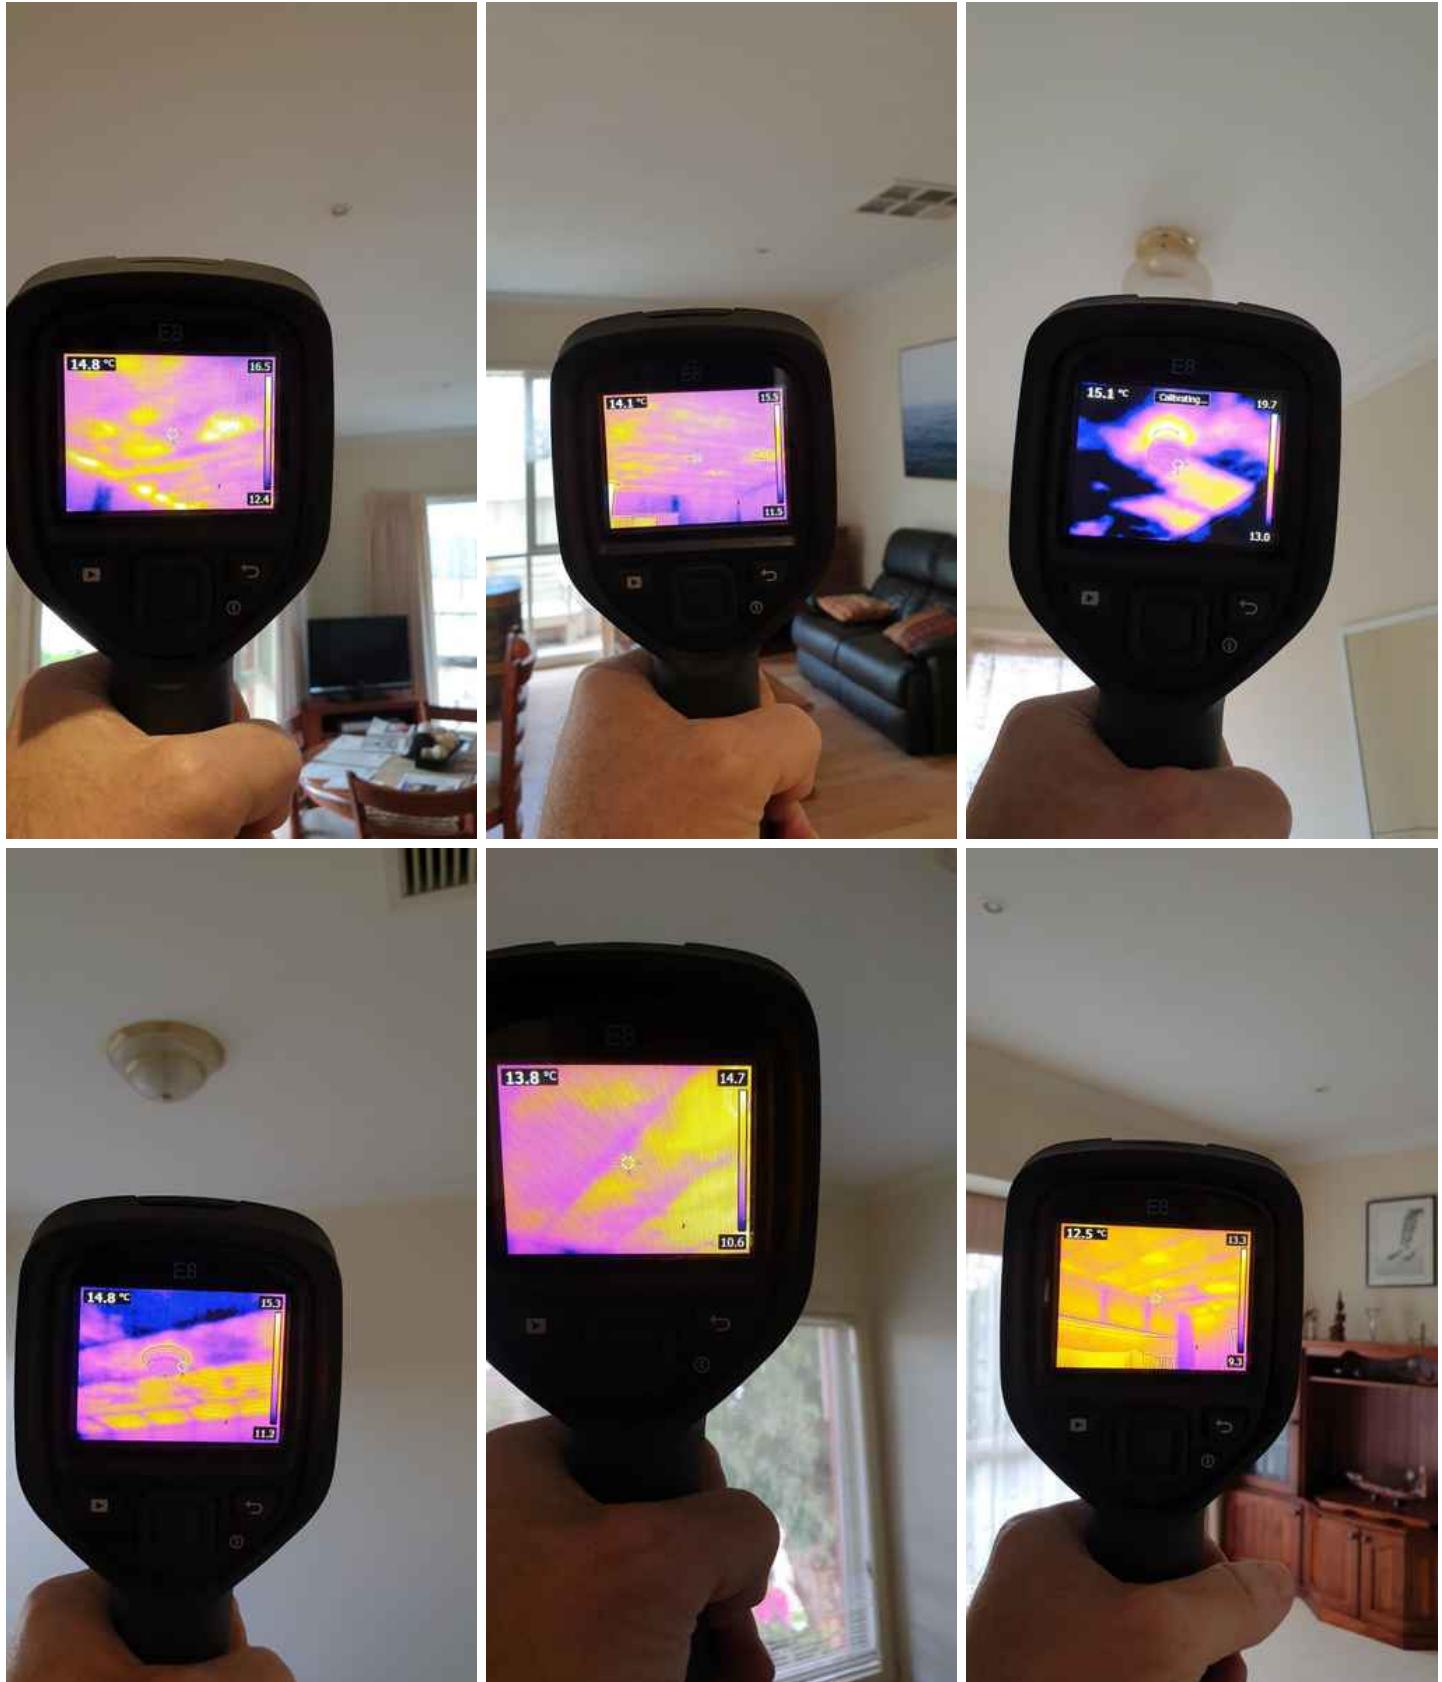
Insulation depth was inadequate. Recommend a qualified attic insulation contractor install additional insulation.

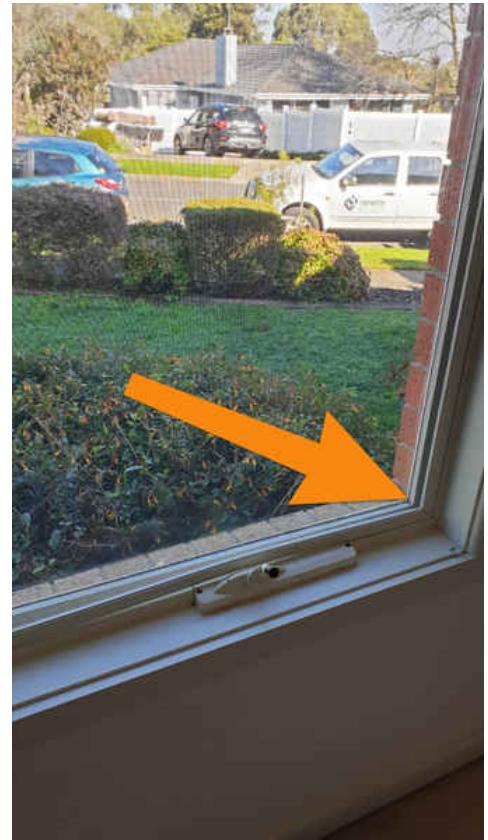
Master bedroom East Window Binding

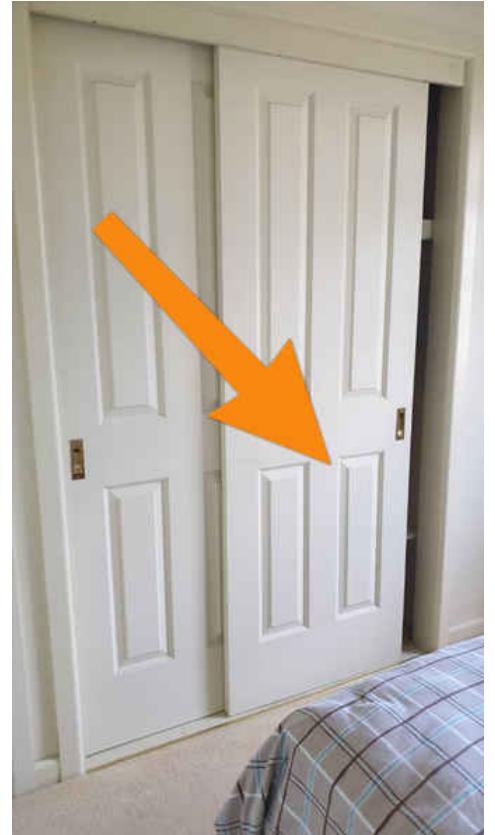
10.3.1 WIR Door

Recommendation

Contact a qualified professional.

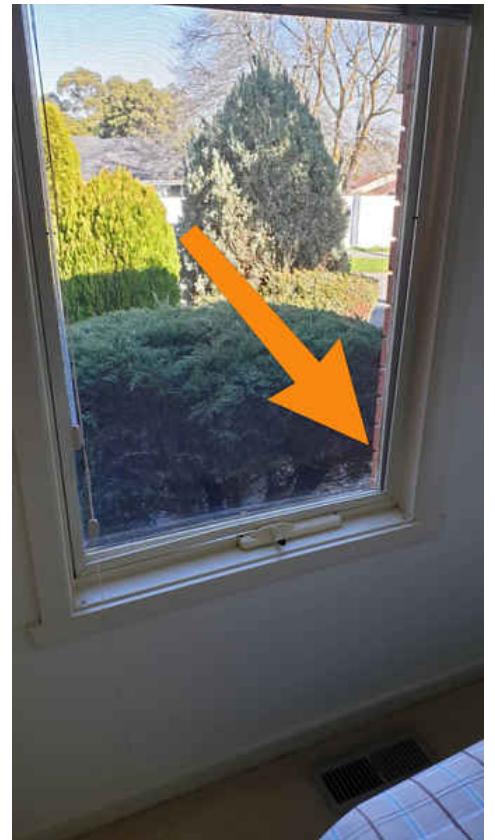
10.6.1 Windows

Recommendation

Contact a qualified window repair/installation contractor.

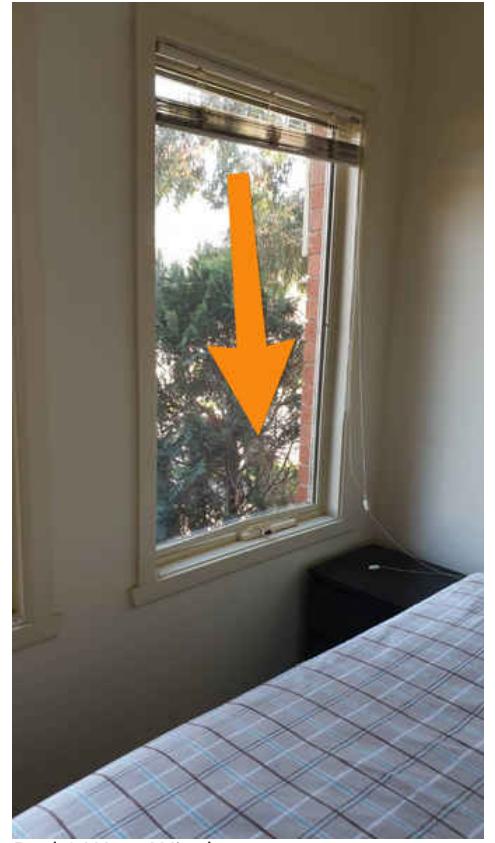
Bed 2 West Window

10.6.2 Windows

### DIFFICULT TO OPEN

Recommendation

Contact a qualified professional.

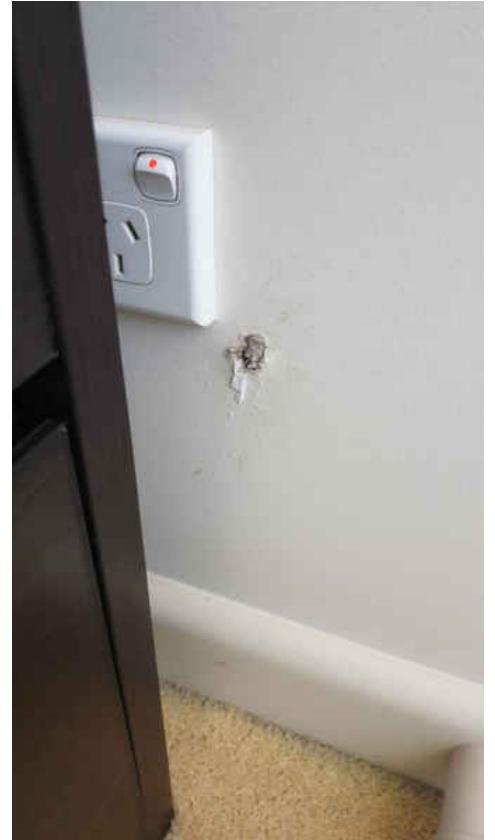
10.8.1 Walls

Recommendation

Contact a qualified professional.

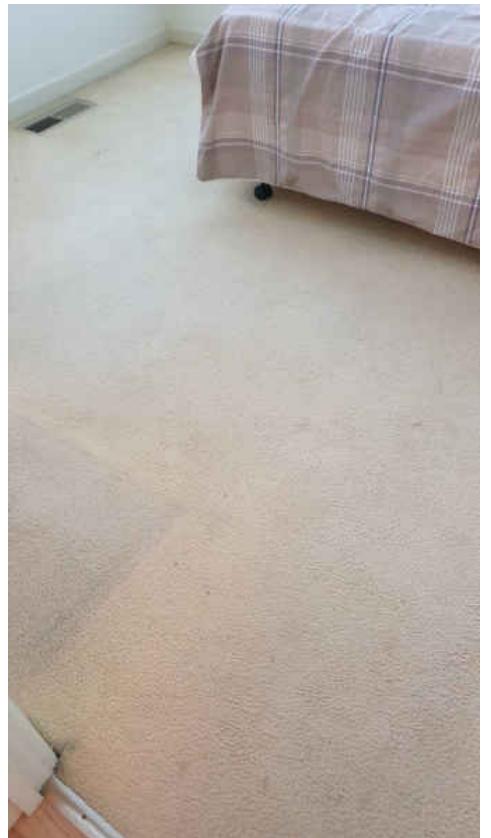
### 11.4.1 Floors

Recommendation

Contact a qualified cleaning service.

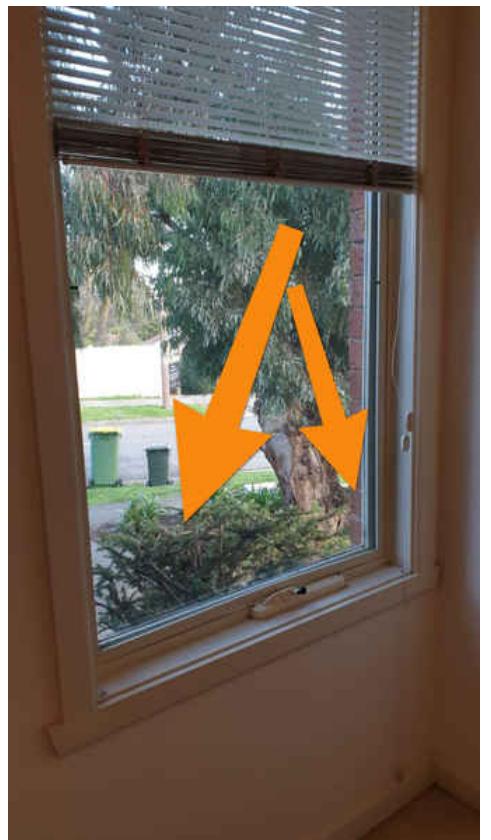
Bed 3 West Window

### 11.6.1 Windows

#### BINDING

Recommendation

Contact a qualified window repair/installation contractor.

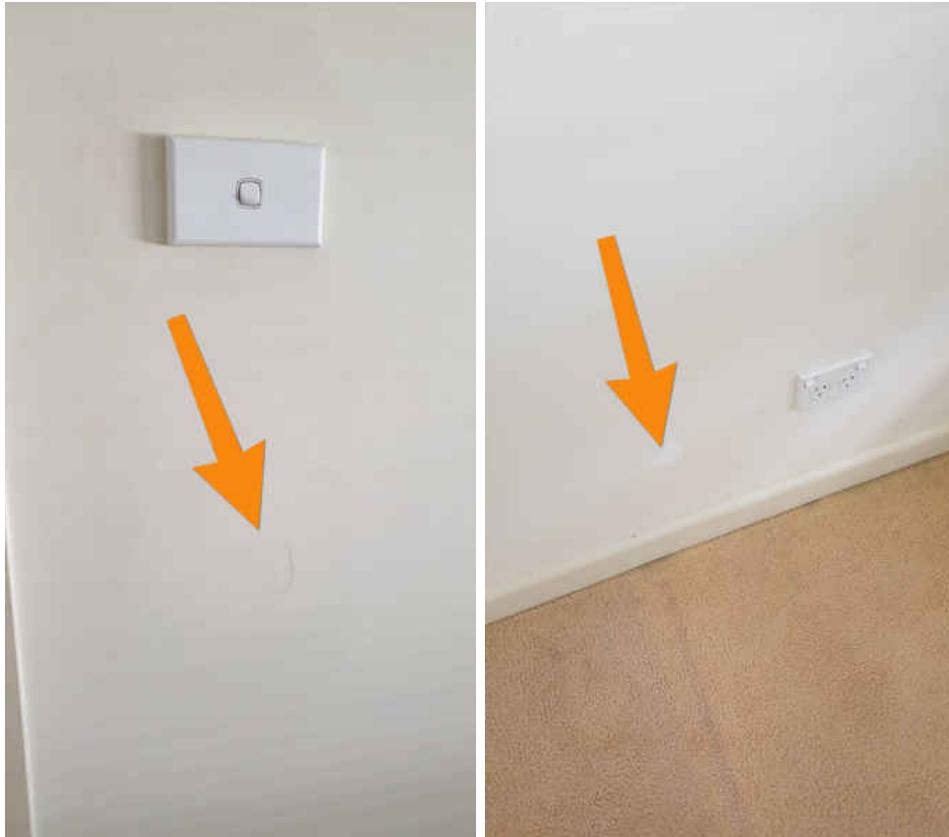
## 11.8.1 Walls

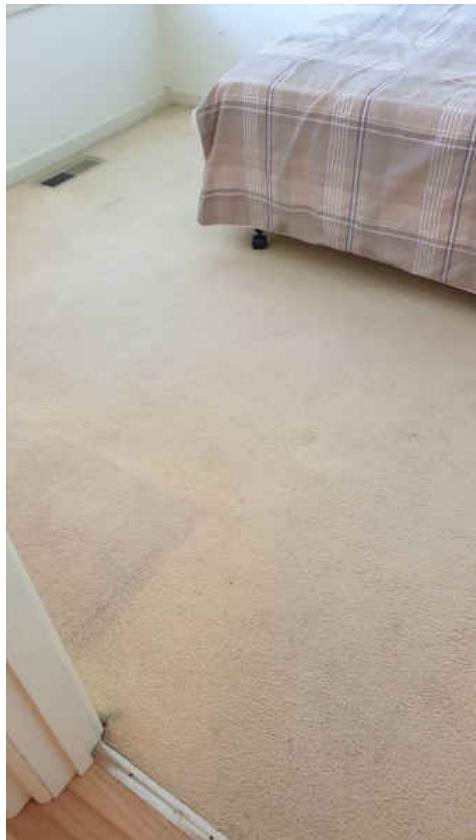
## 11.9.1 Floors

**AGE**

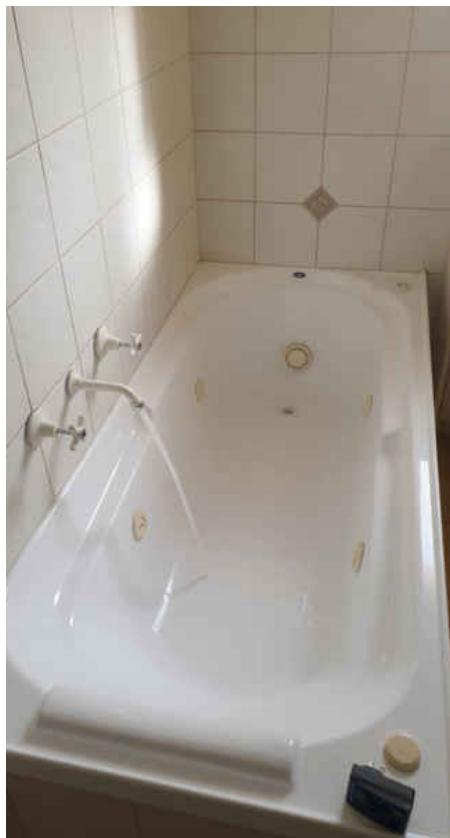
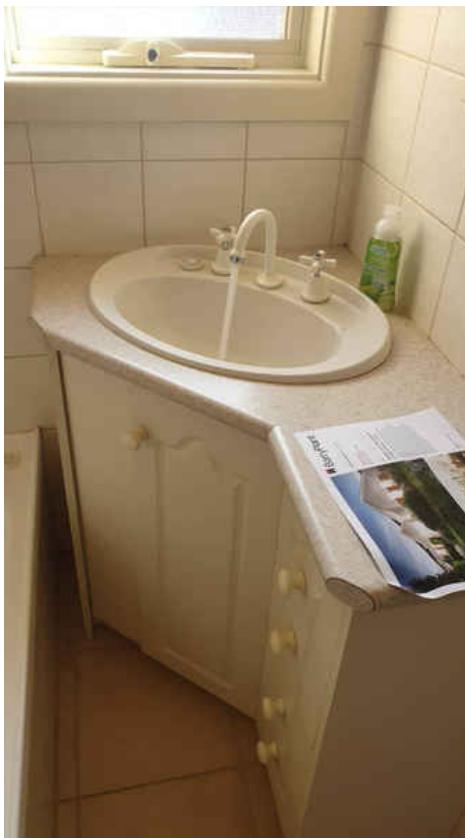
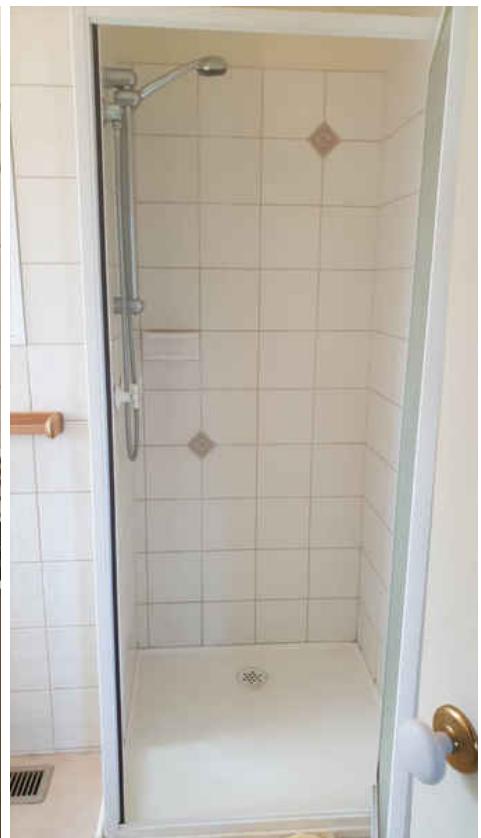
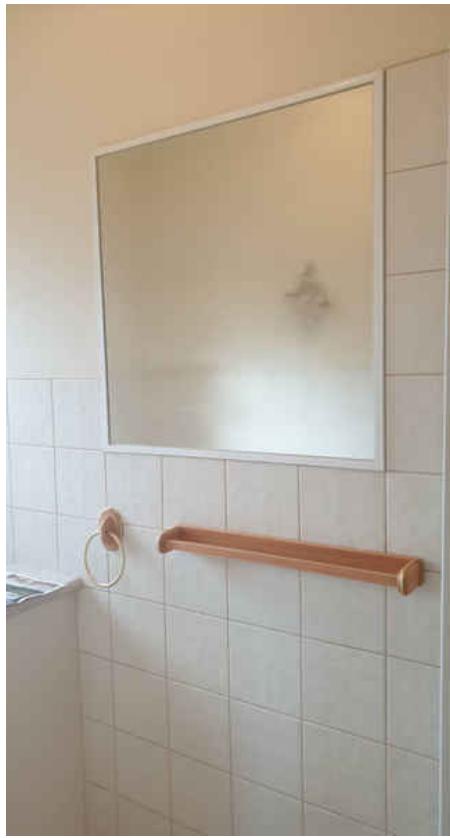
**General: GENERAL VIEW (Photos)****MAIN BATHROOM**

General view of the Main Bathroom at time of inspection.

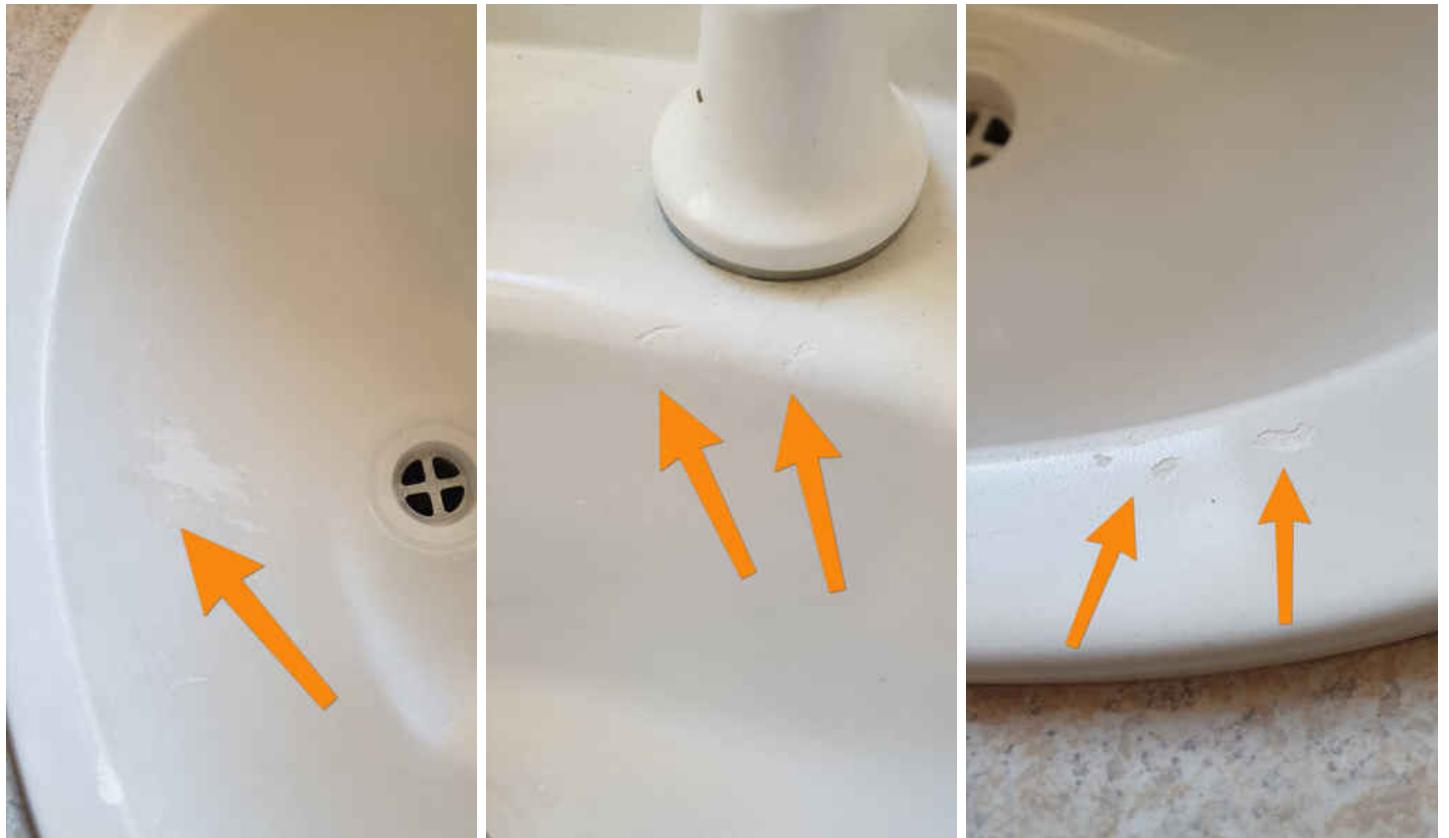
## 16.10.1 Basin

Recommendation

Contact a qualified professional.

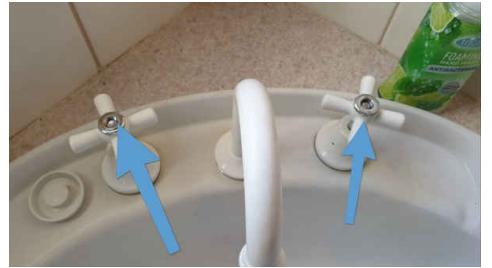
16.11.1 Basin Tap  
**MISSING TAP  
BUTTONS**

MAINTENANCE ITEM / GENERAL ADVICE

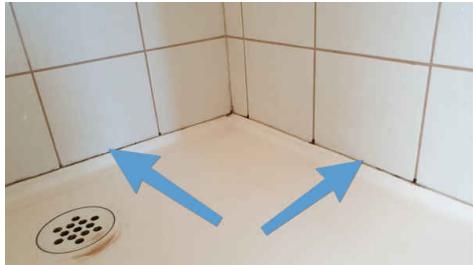
16.15.1 Shower  
**SEALANT MOULD (MINOR)**

Minor mould was observed in or on the sealant in the shower recess.

I recommend cleaning or removing the mould affected sealant and replace with new sealant. This can be undertaken by a handyman or DIYer

Contact a handyman or DIY project

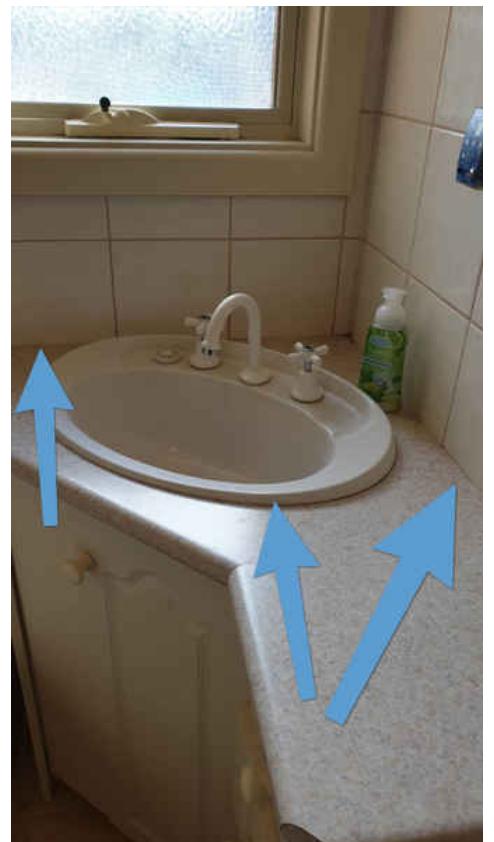
## 16.17.1 Sealants

Recommendation

Contact a handyman or DIY project

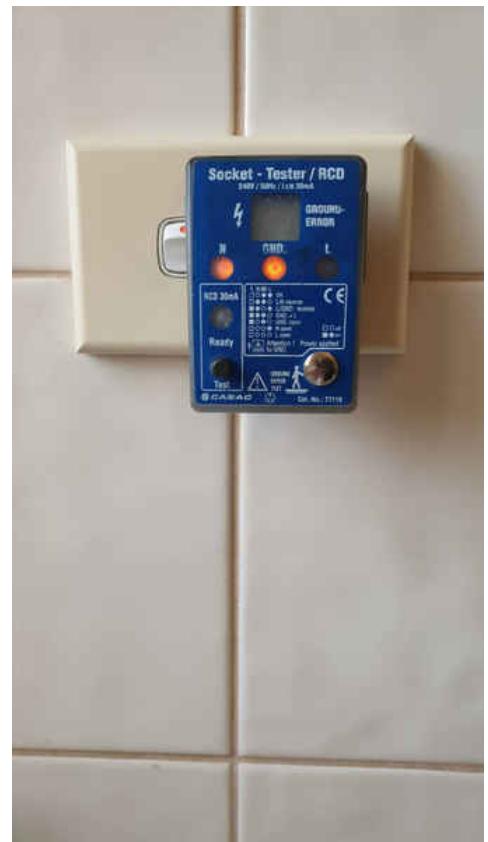
## 16.19.1 Lighting Fixtures, Switches &amp; Power Outlets

Recommendation

Contact a qualified electrical contractor.

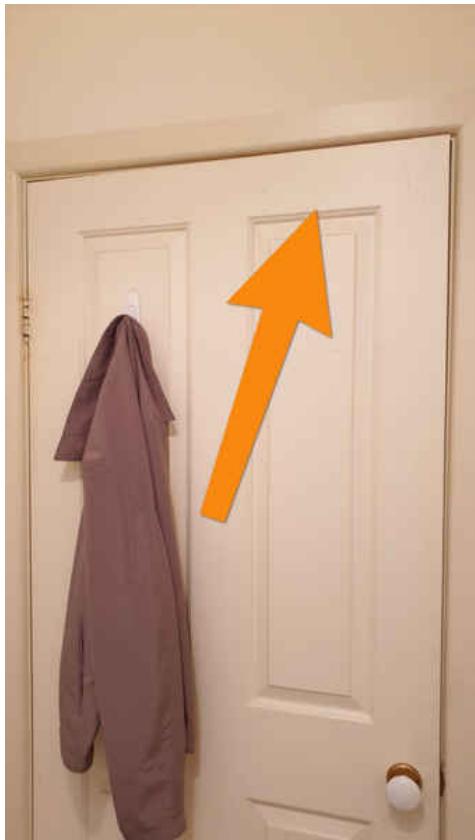
### 17.2.1 Doors

Door sticks and is tough to open. Recommend sanding down offending sides.

MINOR DEFECT

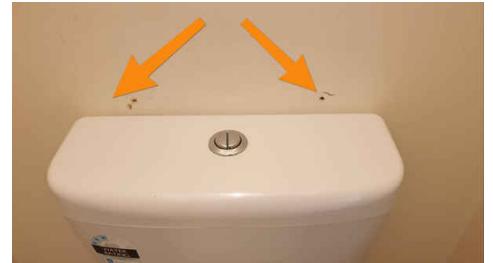
### 18.5.1 Walls

#### **PLASTER DAMAGE**

Incomplete detach or plaster damage

Contact a qualified professional.
