TREC REI 7-5

1234 Main St.
Mckinney , Texas 75071

PROPERTY INSPECTION REPORT

Concerning: 1234 Main St. McKinney Texas 75071

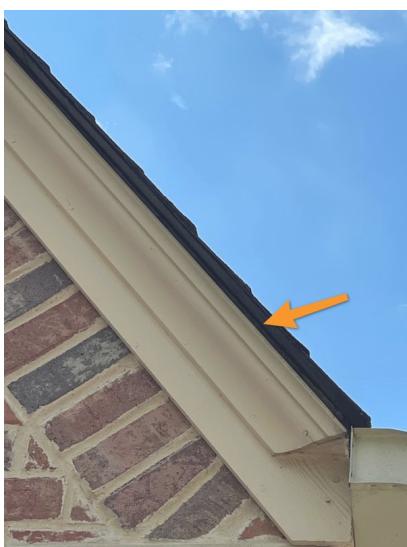
1: Missing drip edge flashing

Missing roof drip edge flashing on the side of the roof. Recommend qualified roofer for repair.

Southeast. Missing drip edge flashing in some areas

Recommendation: Contact a qualified roofing professional.

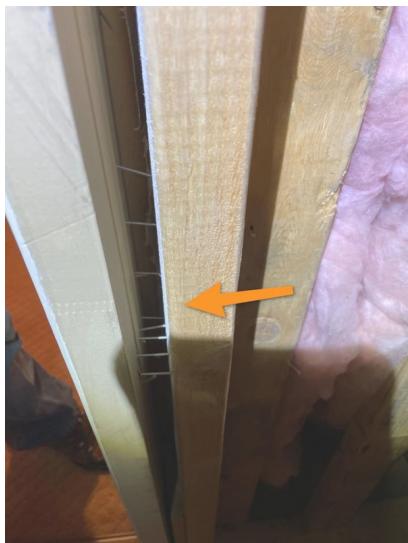
Attic and entrance off bedrooms

1: Insulation on door frame recommended

The attic door frame needs insulated around for energy efficiency. Recommend adding insulation around door

Recommendation: Contact a handyman or DIY project

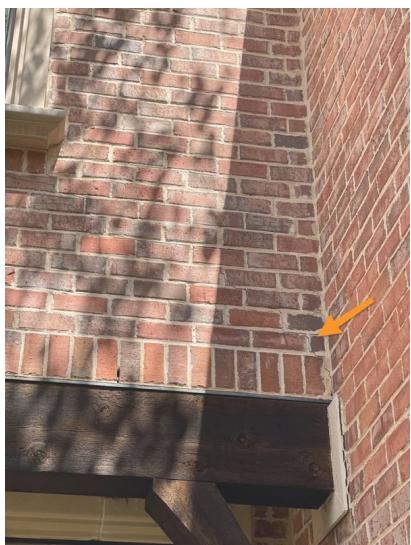
2: Moderate cracking**⊖ Recommendation**

Moderate cracking observed in the wall structure. This appears to be an indication of soil movement/settlement of the foundation that may need repair now or in the future. Maintaining moisture content during dry seasons is important in preventing further movement. Cracks can also be cosmetically filled and repainted as needed

Front of house mortar crack only

Recommendation: Contact a qualified professional.

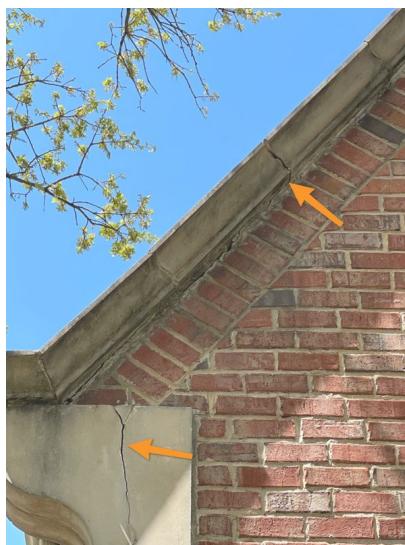
Southeast corner may need repair

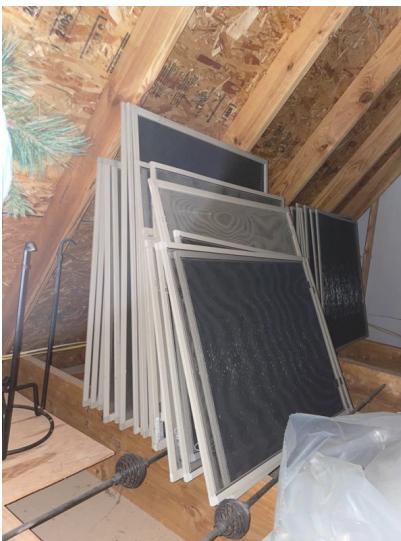
1: Missing Screen(s)**– Recommendation**

One or more windows are missing a screen. Recommend replacement if desired.

Most windows do not have screen

Some stored in the garage attic

Recommendation: Contact a qualified window repair/installation contractor.

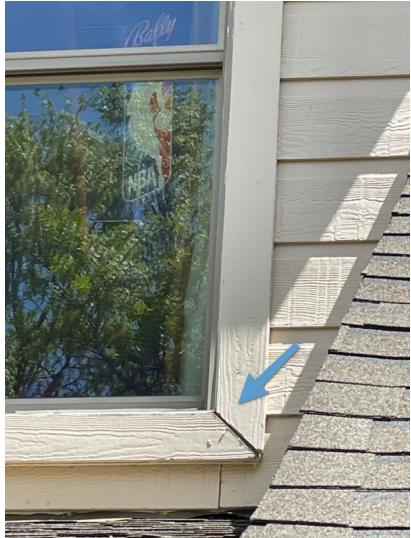
2: Missing or insufficient caulk**🔧 Maintenance Item**

Need maintenance caulking around one or more windows. Recommend caulking around windows where needed.

Recommend sealing around windows where needed

Recommendation: Contact a handyman or DIY project

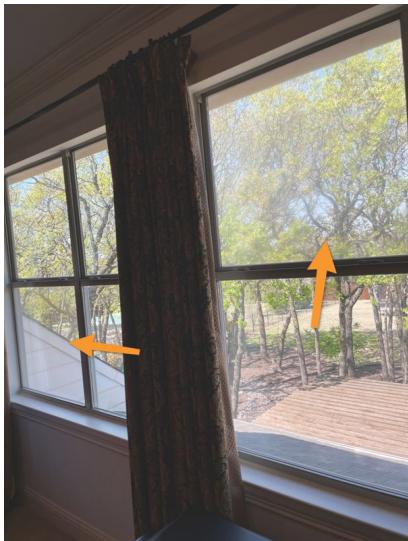
2nd Floor Living Room

3: Voided seal**🔴 Recommendation**

One or more windows throughout home appears to have a voided seal. These can worsen over time when condensation builds up. Individual glass panes can usually be replaced if needed. Windows pictured may not be all inclusive as it is difficult to determine when windows are dirty etc.

Recommendation: Contact a qualified professional.

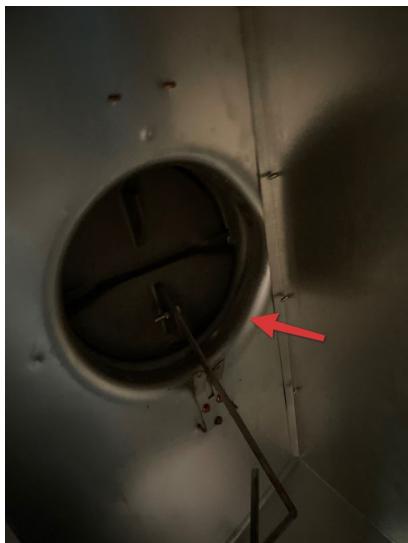
Formal living room

1: Missing damper clamp**⚠ Safety Hazard**

No fireplace flue damper clamp installed. Recommend installing to reduce accidental spillage of carbon monoxide into the living space. This clamp is approximately \$15 and can be easily installed. Note: TREC standards of practice require a damper block be installed on the fireplace flue damper when gas is present to fireplace.

Recommendation: Contact a qualified professional.

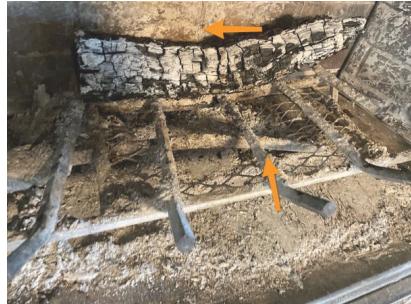
2: Gas port problems**● Recommendation**

The gas valves, bar ports and/or starter bars do not appear to be working as intended. Recommend further evaluation for repair or replacement.

Living Room. Gas starter is operational but has some damage as well as minor crack in firewall

Recommendation: Contact a qualified fireplace contractor.

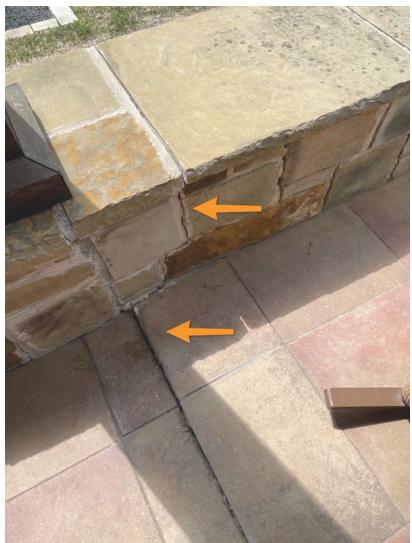
K. Porches, Balconies, Decks, and Carports*Comments:***1: Cracks in driveway or patio****● Recommendation**

Cracks in one or more areas on the driveway, walkway or patio. This is a common area to see cracks or damage. Recommend repair if desired

Back patio movement at joint

Recommendation: Contact a qualified professional.

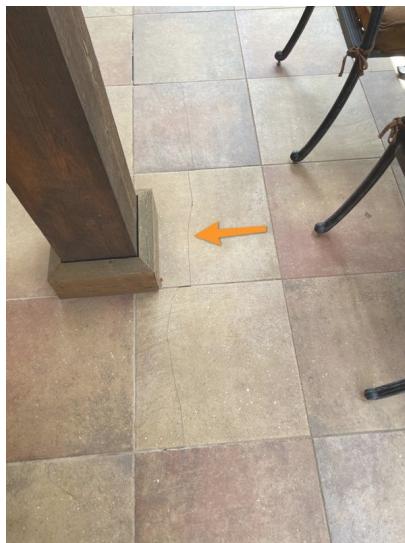
Back patio tile cracks

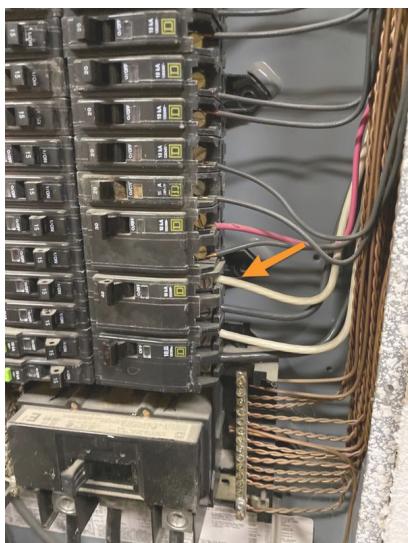
1: Hot wires not properly labeled

There are white wires in the panel that should be labeled as hot wires. Recommend correction by properly labeling wire ie. Black electrical tape on end

Recommendation: Contact a qualified electrical contractor.

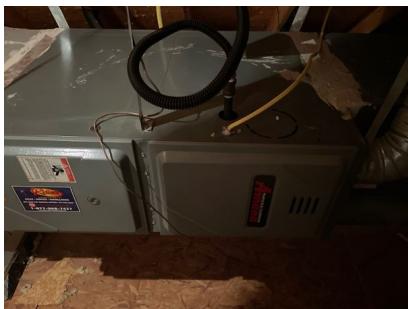
1: Heating system age**● Recommendation**

The heating system appears to be nearing the end of its serviceable life expectancy and recommend it be further evaluated by a licensed HVAC technician due to age. However heating unit is still operational at this time.

Master Bedroom Unit is Functioning but appears 2005 unit and may need replacement soon

Recommendation: Contact a qualified HVAC professional.

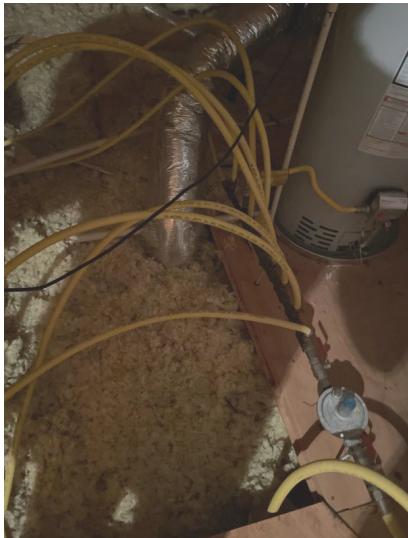
2: CSST piping observed

CSST {Corrugated Stainless Steel Tubing} was observed and this piping is required to be properly grounded and bonded to the electrical system to avoid energized charges caused by indirect lightning strikes. This piping is prone to develop pinholes on an energy strike and cause gas leakage possibly resulting in a fire and/or other catastrophic situation. It is recommended that a licensed electrician be consulted for further evaluation. Additional information can be found at {www.csstsafety.com} sponsored by the National Association of State Fire Marshals

CSST piping for gas observed

Recommendation: Contact a qualified electrical contractor.

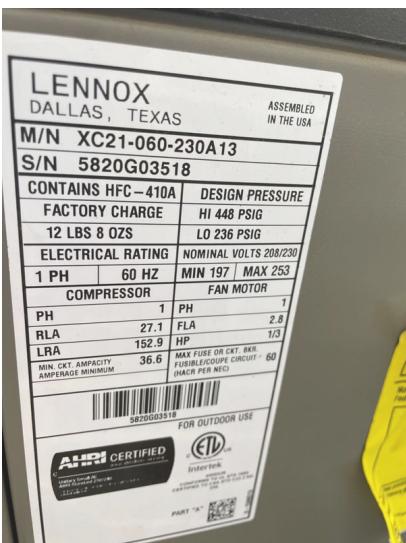
1st Floor 2020

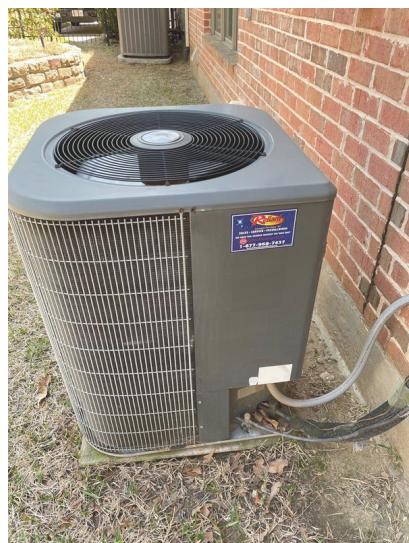
Master Bedroom. Appears 2005 unit

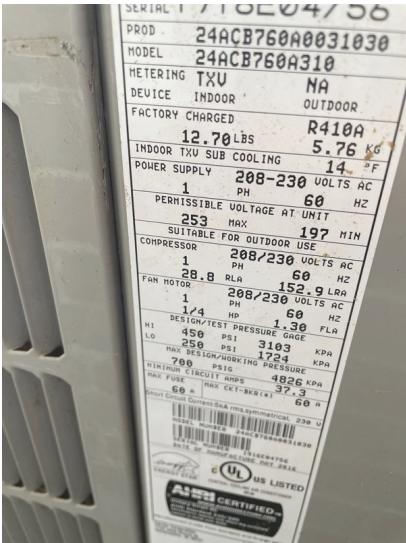
2nd Floor 2016

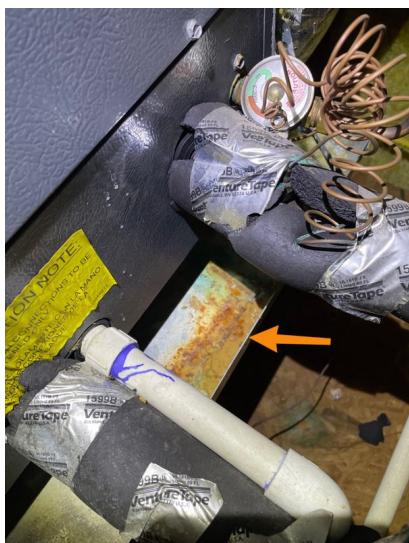
Type of system: Central air conditioning**1: Corrosion in drain pan****● Recommendation**

Corrosion observed in the bottom of the AC condensate drain pan(s). Recommend painting with a pan sealer. Recommend service of the unit by HVAC professional.

Master Bedroom Unit some corrosion

Recommendation: Contact a qualified professional.

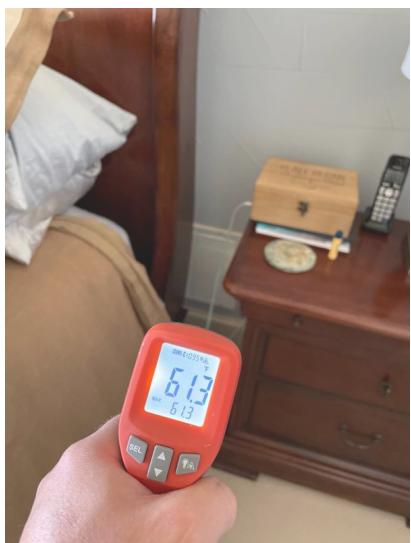
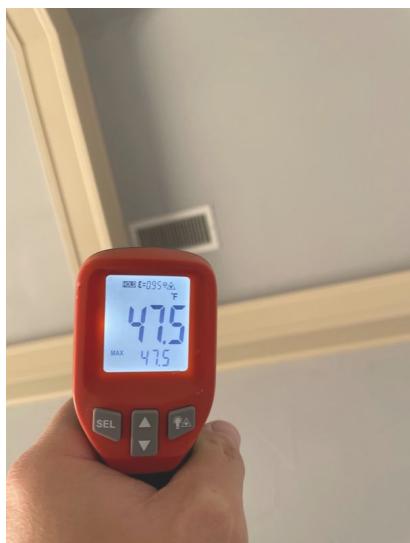
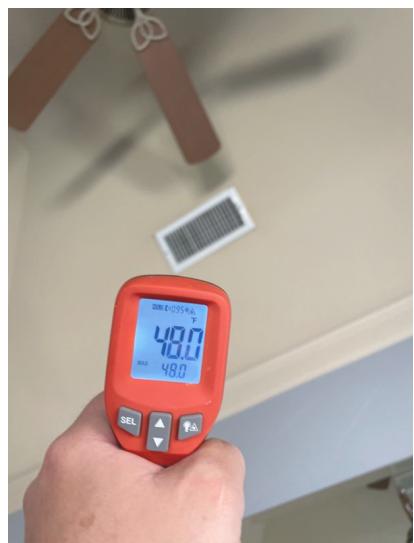
2: Temperature difference did not meet minimum standard**● Recommendation**

Temperature differential should be between 16-22 degrees greater than supply air. System did not met this requirement at time of inspection. Recommend evaluation by HVAC specialist

(Master bedroom unit 14 degree difference avg. Unit appears to be 2005 and may need replacement soon)

Recommendation: Contact a qualified professional.

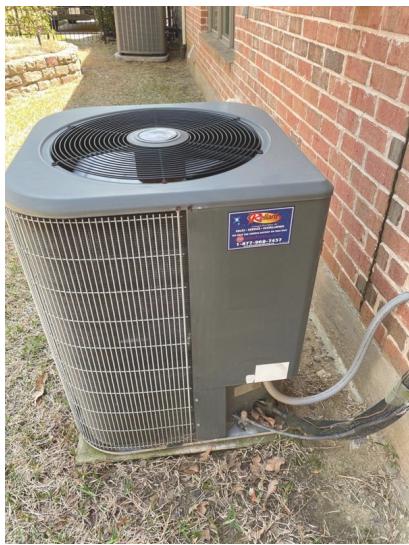
Appears to be original to the home
appears to use r22 coolant

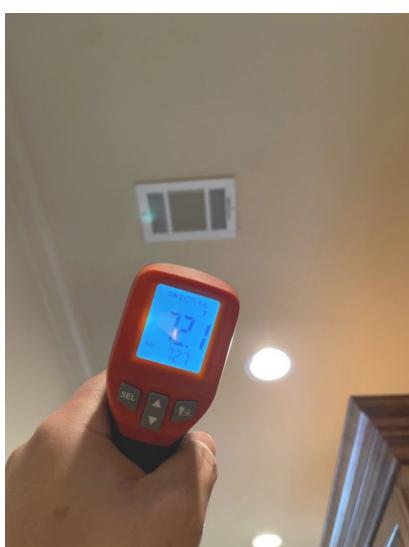
1: Vent not connected

Vent in one or more areas does not appear to be connected to the HVAC system. Recommend evaluation and repair as needed by a qualified professional

Hallway/mudroom vent does not appear
to be connected

Recommendation: Contact a qualified professional.

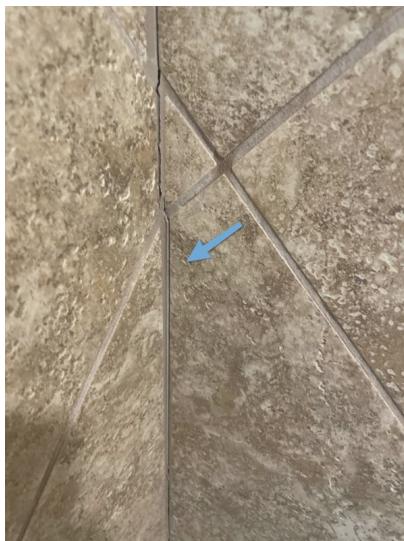
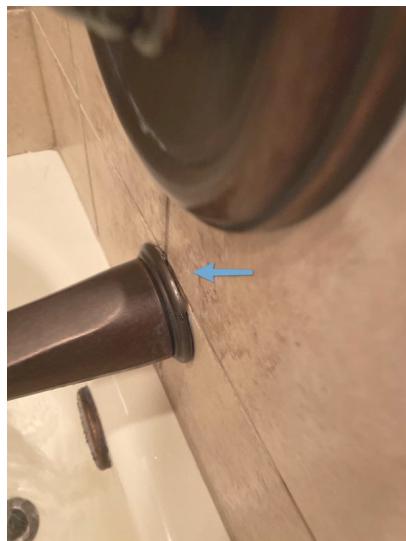
1: Seal/caulking around tub missing or loose

Seal/caulking around tub or shower missing, loose or inadequate in one or more areas. Recommend caulking to prevent water intrusion

Recommendation: Contact a qualified professional.

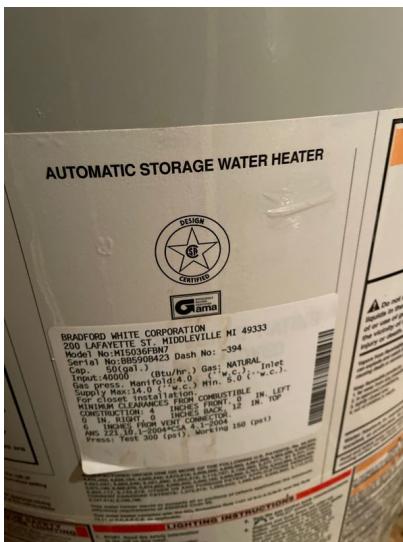
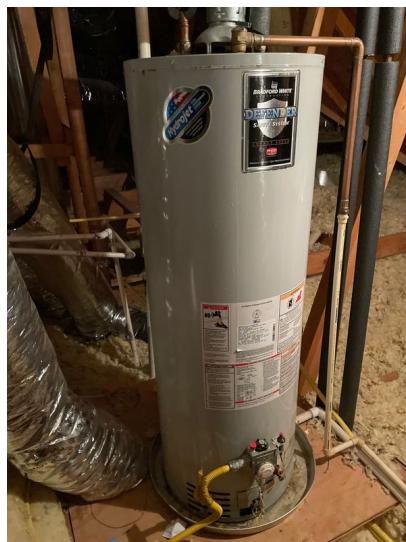
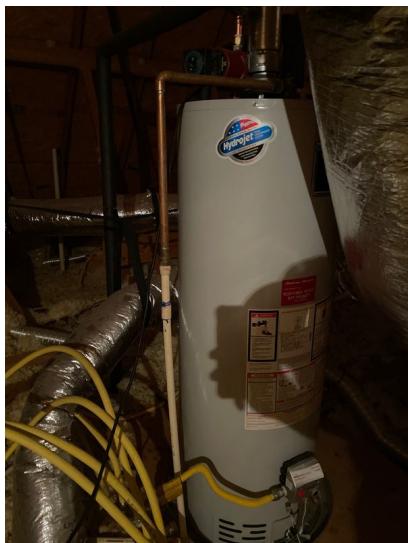
1: Corrosion around pipe or fitting**● Recommendation**

Corrosion around the pipe fitting in one or more areas. Not currently leaking but may become a problem in time

Recommendation: Contact a qualified professional.

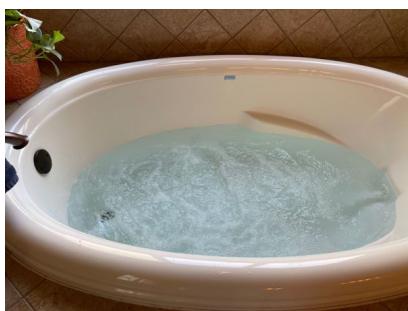
**1: Access panel missing****● Recommendation**

It was observed that no access panel{s} were readily available to view the motor and/or equipment lines. This

does not meet current building standards recommend correction as needed

Recommendation: Contact a qualified professional.

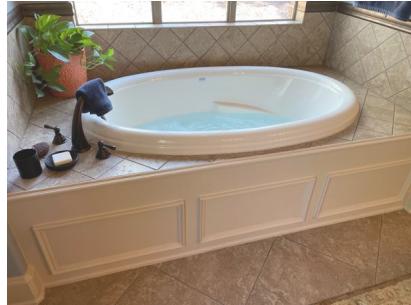
Master Bathroom. Would need to create an access panel if there was a problem

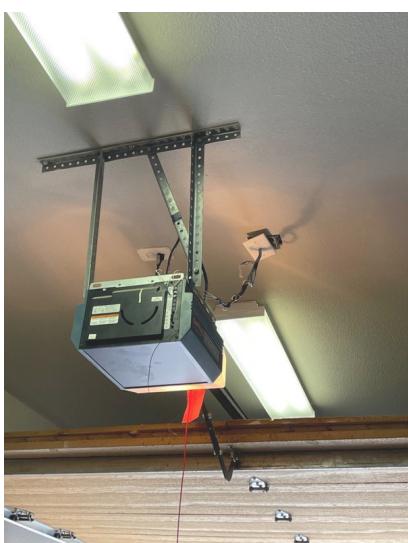
Single car garage

The garage door did NOT automatically reverse under reasonable resistance. This is a safety hazard to children and pets. Recommend adjusting the pressure sensitivity switch on the back of the garage door opener.

Recommendation: Contact a qualified professional.

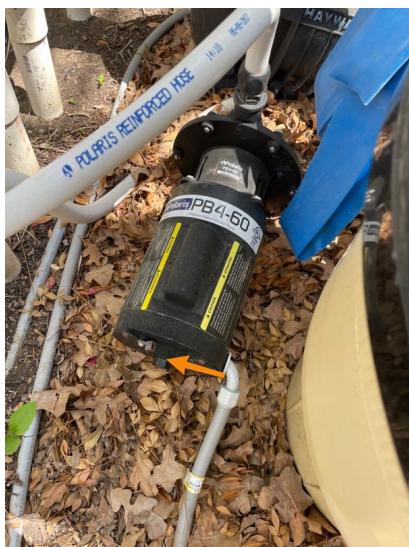
2: Improper bonding

The bonding connection is not tied into the bonding system for the equipment in one or more areas

Two motors missing bonding wire

Recommendation: Contact a qualified professional.

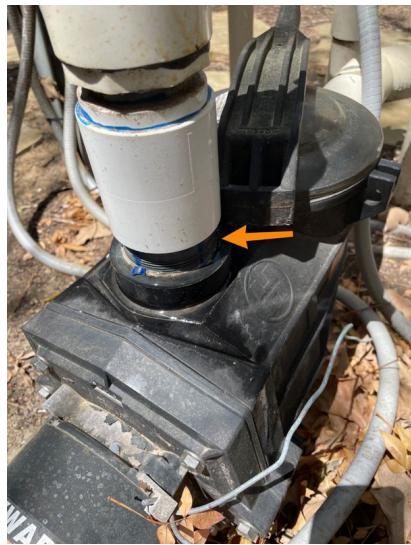
3: Plumbing leak

Plumbing leak observed at time of inspection in one or more areas. Recommend a qualified professional to repair leak.

Minor leak

Recommendation: Contact a qualified professional.

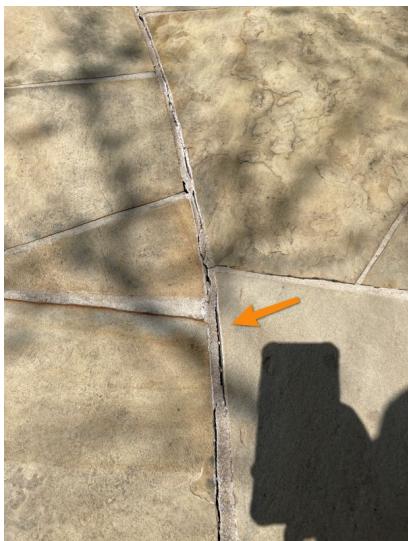
4: Reseal coping

The seal between the deck and coping or the coping and pool tile is missing or deteriorating in one or more areas. Recommend resealing to prevent water from leaking behind the pool walls.

Openings in some areas

Recommendation: Contact a qualified professional.

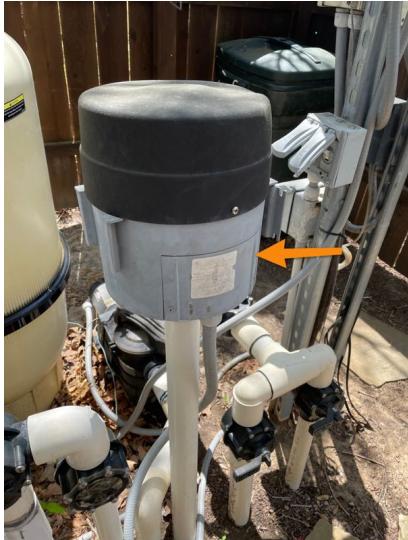
5: Pool/spa blowers

Pool or spa blower does not appear to be operational recommend evaluation and repair as needed by qualified professional

Recommendation: Contact a qualified professional.

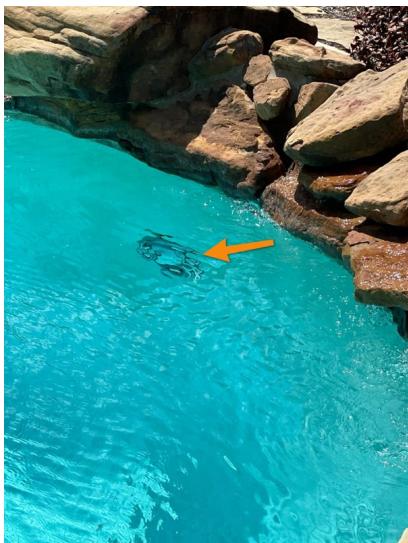
6: Pool light

One or more lights in the pool is not functioning. Recommend repair or replacement of bulb

Pool lights did not appear to be functional

Recommendation: Contact a qualified professional.

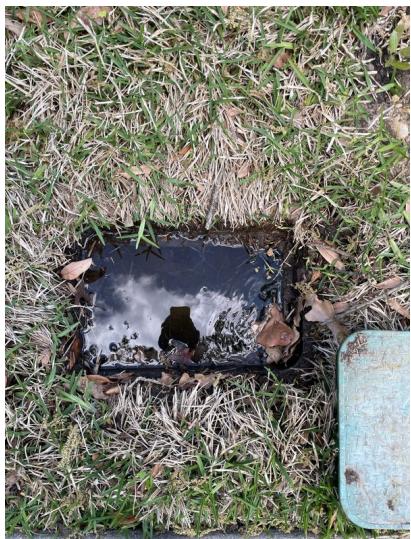
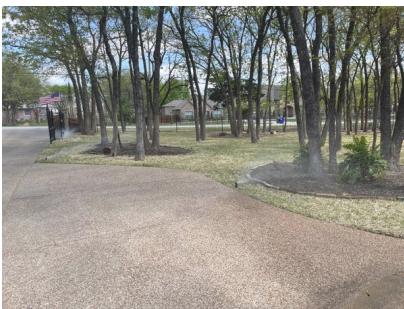
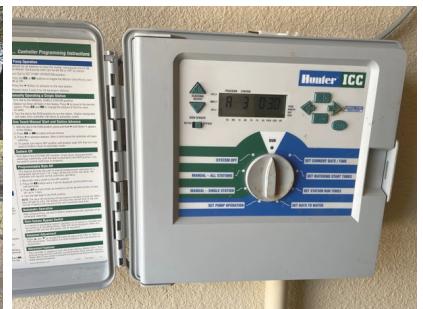
1: Missing rain or moisture sensor**● Recommendation**

Missing, damaged or unable to find the rain or moisture sensor. Recommend consulting with irrigation system contractor to install or locate and test the sensor.

Recommendation: Contact a qualified professional.

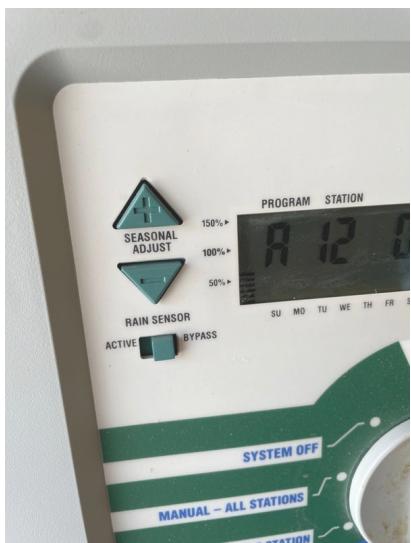
Could not locate and sensor was bypassed
