TRANSPARENT PROPERTY INSPECTIONS

PA - FULL RESIDENTIAL INSPECTION COPY

1234 Main St. ERIE PA 16509

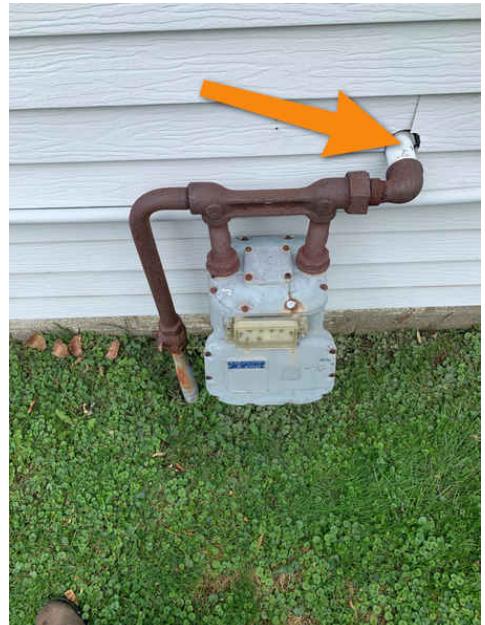
Gas line can use additional sealant where it enters home.

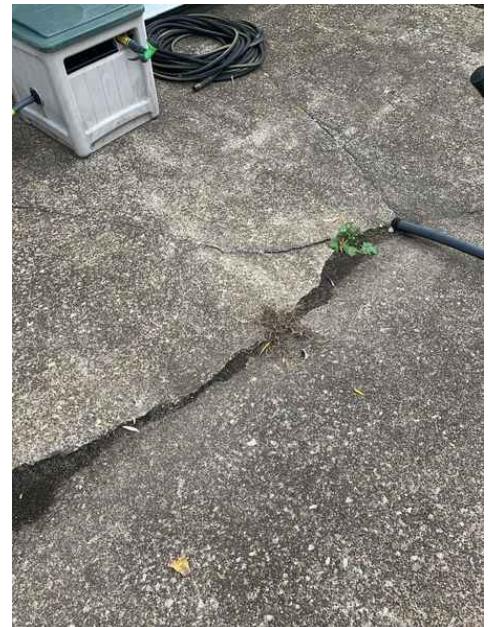
2.6.3 Patio

SEAL SLAB TO HOME

Recommendation

Contact a handyman or DIY project

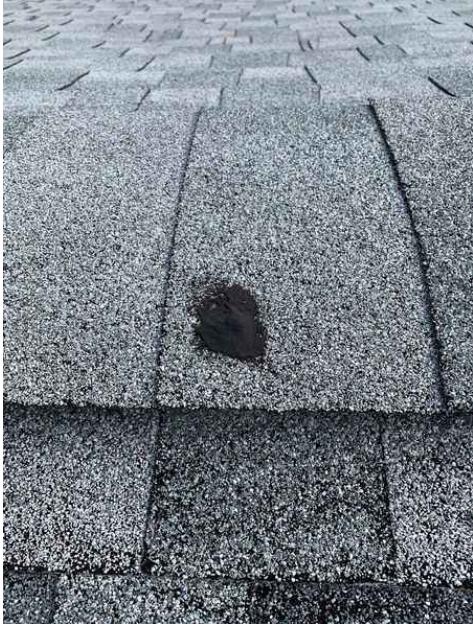
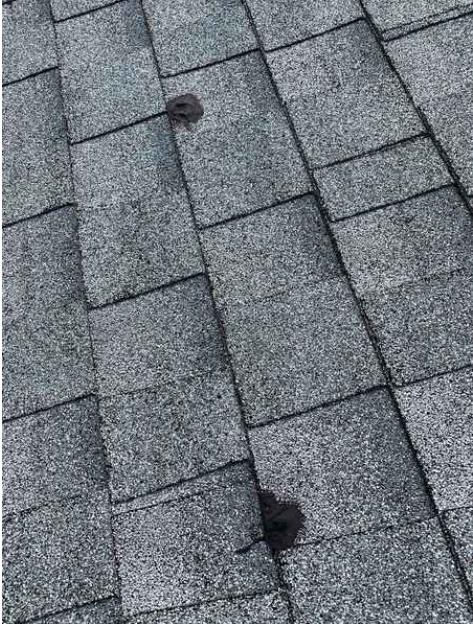
3.3.2 Roof Surface Condition

MISSING SHINGLES

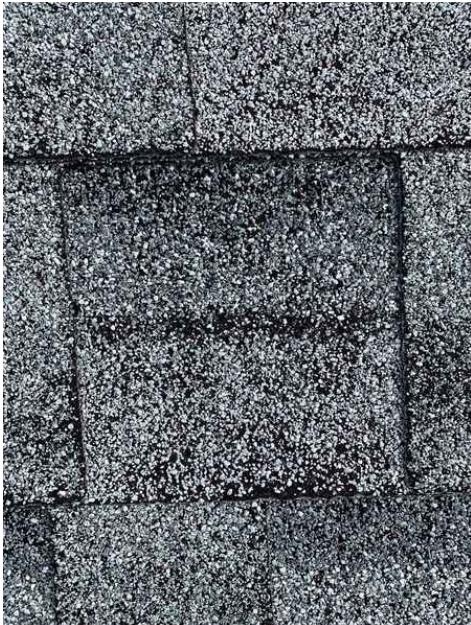
3.3.3 Roof Surface Condition

GRANULE LOSS IN AREAS

Contact a qualified professional.

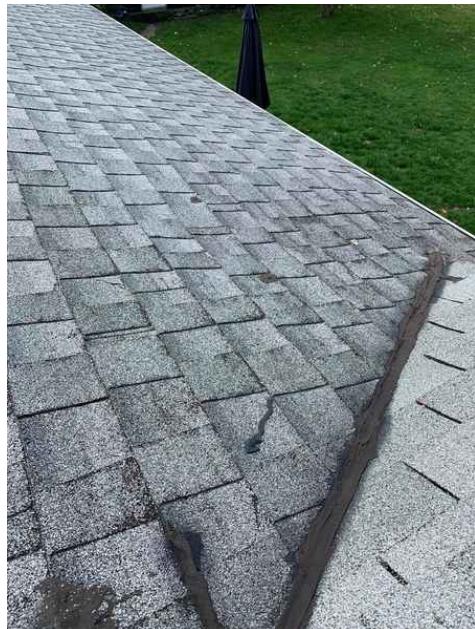
3.4.1 Vents / Penetrations

FLASHING BOOT(S) HEAVILY SEALED- Marginal

Recommendation

Contact a qualified roofing professional.

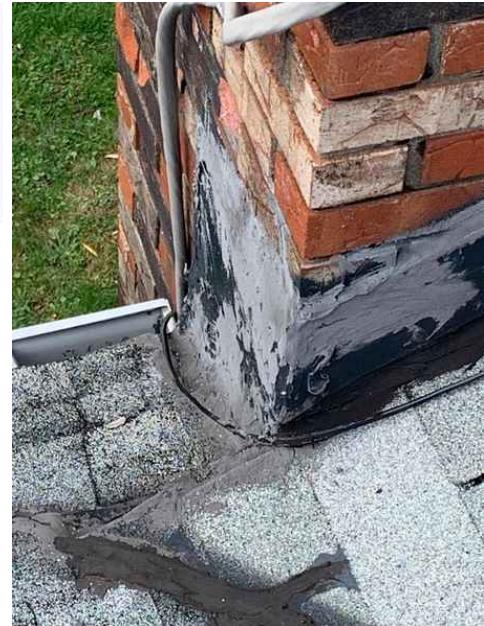
3.6.1 Chimney

COUNTER FLASHING SEALED - HEAVILY

Contact a qualified chimney contractor.

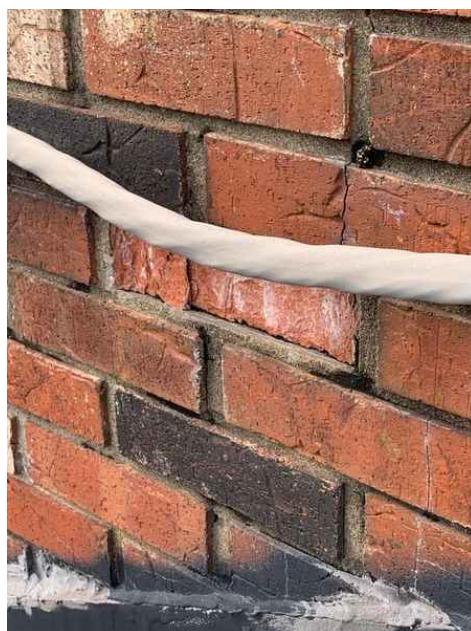
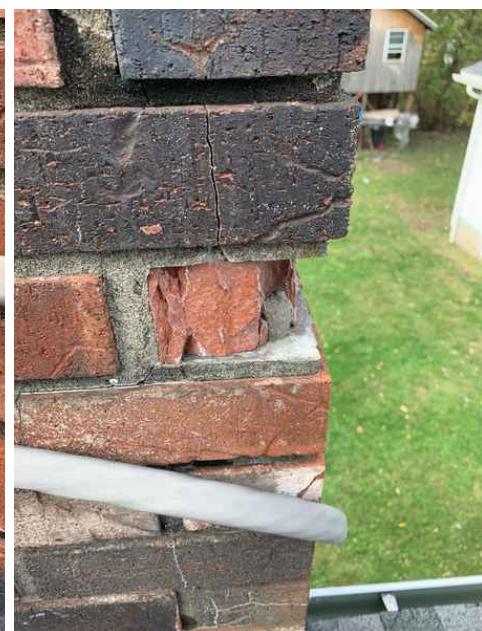
3.6.2 Chimney

HEAVY BRICK SPALLING

Contact a qualified masonry professional.

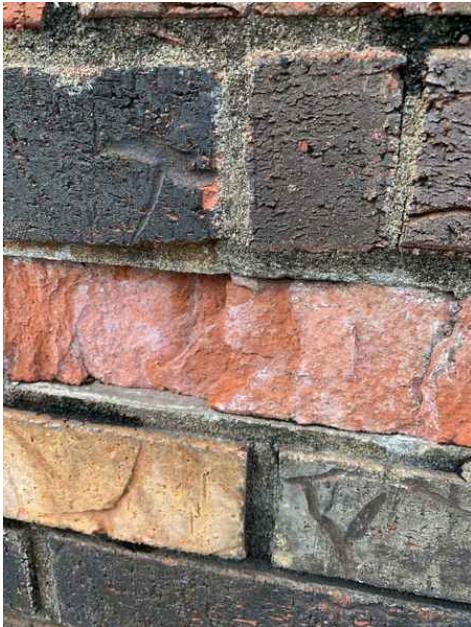
3.6.3 Chimney

EFFLORESCENCE ON BRICK

Contact a qualified masonry professional.

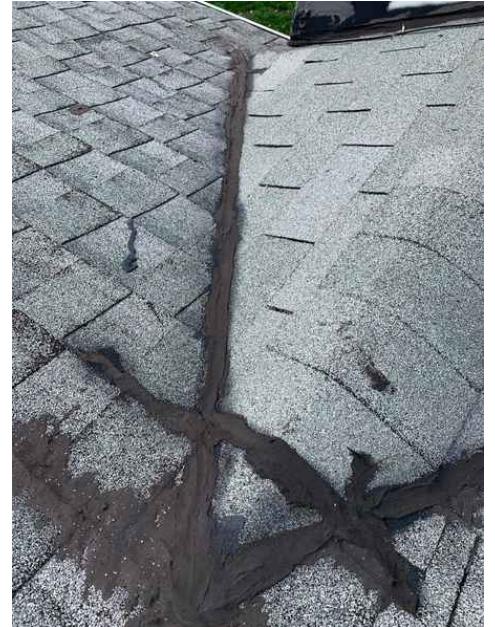
3.6.4 Chimney

HEAVY SEALANT AT CRICKET AREA

Contact a qualified roofing professional.

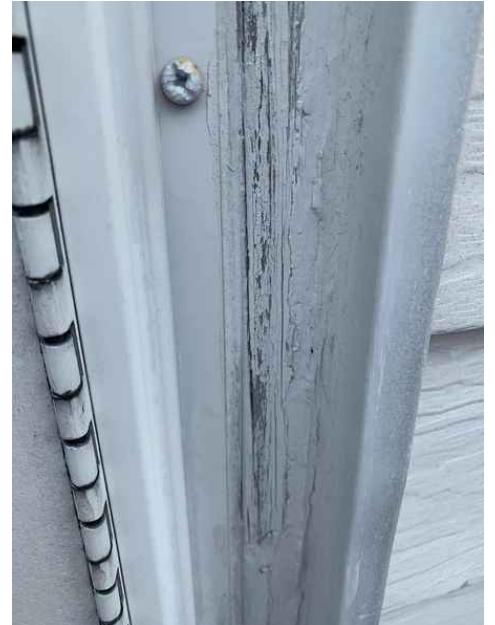
4.6.2 Sealant / Paint Overall

SEALANT NEEDED

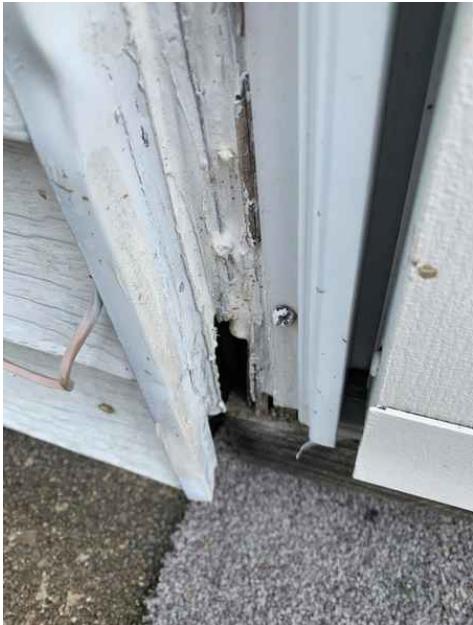
4.7.1 Exterior Doors / Doorbell

WATER DAMAGE TO WOOD

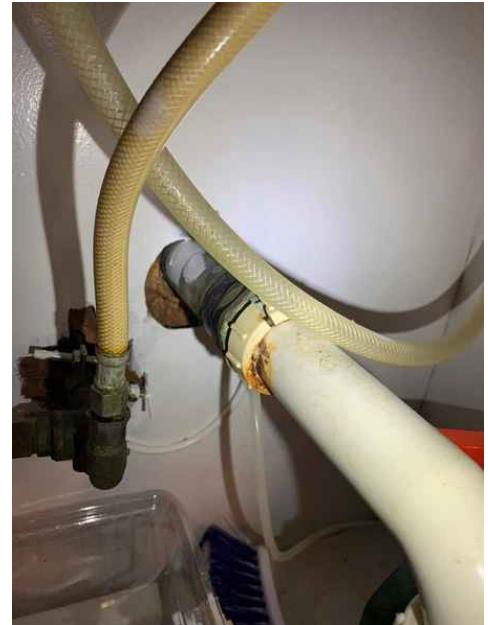
5.6.2 Undersink Plumbing - Kitchen

RUST/CORROSION PRESENT ON PIPES

Contact a qualified plumbing contractor.

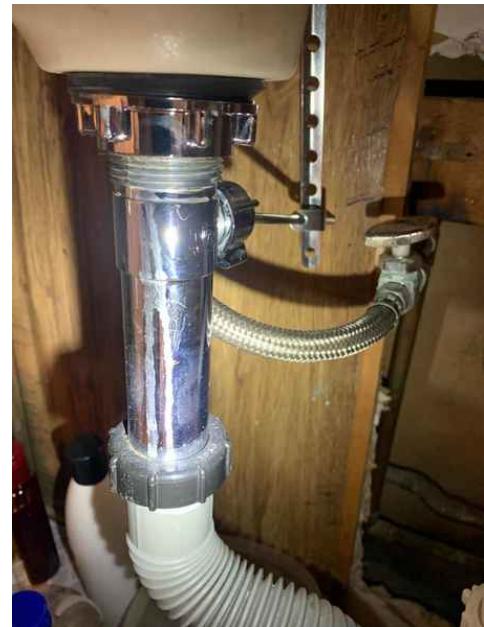
6.6.2 Undersink Plumbing - Bathroom

FLEX DRAIN PIPE PRESENT

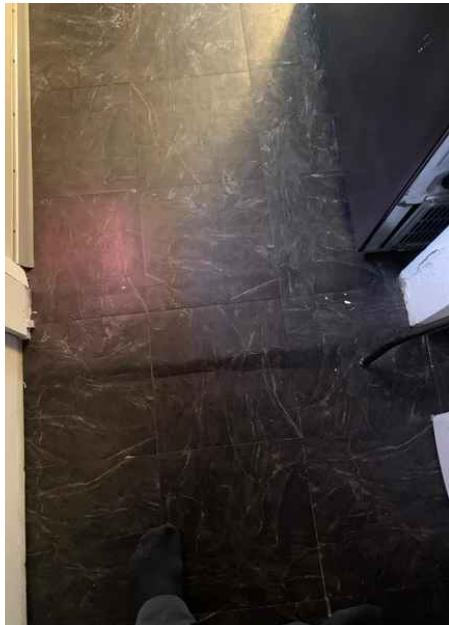
Laundry to kitchen

Floor Condition: Deflection Present

Deflection was noticed while walking the floors in areas. If a concern have a structural engineer or contractor to evaluate further as this is beyond the scope of a home inspection.

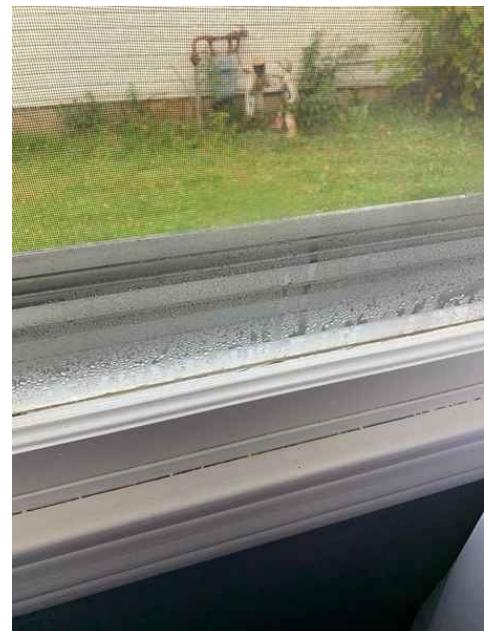
8.2.1 Windows

Condensation was present on the glass of several windows. This is typically indicative of high humidity in the home. Excessive condensation can allow for the formation of fungal growth and can damage surrounding drywall. Locating the source of excessive humidity with modifications made to control it is recommended to be conducted by a qualified person.

Contact a qualified professional.

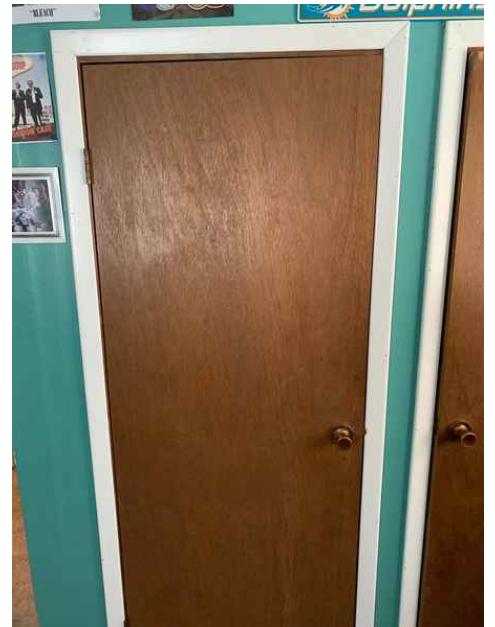
8.3.1 Closets

DOOR BINDING

Contact a qualified handyman.

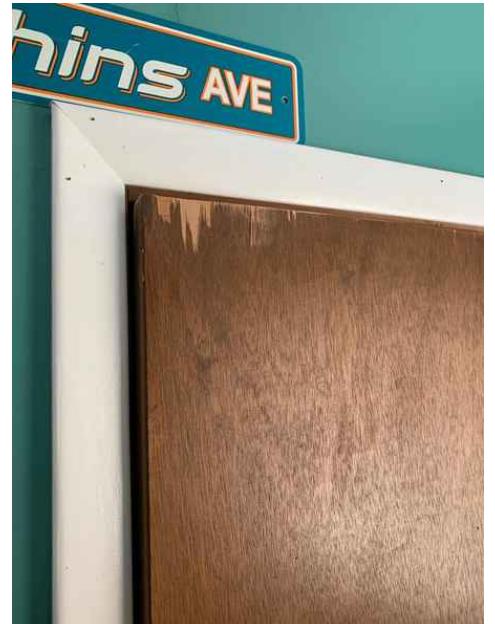
8.3.2 Closets

CLOSET DOOR DAMAGED

Contact a qualified handyman.

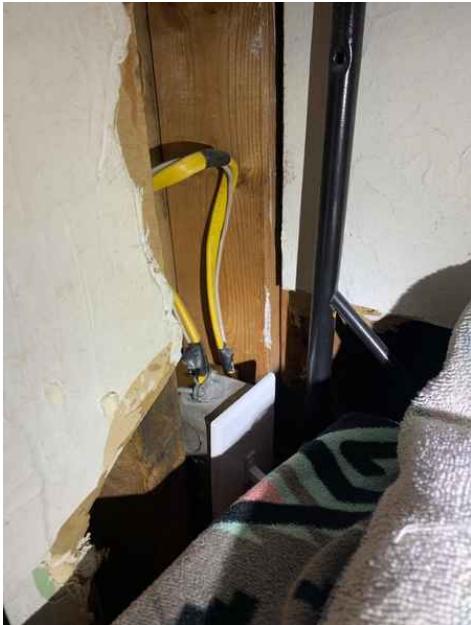
8.8.1 Wall Condition

DRYWALL DAMAGE

Contact a qualified drywall contractor.

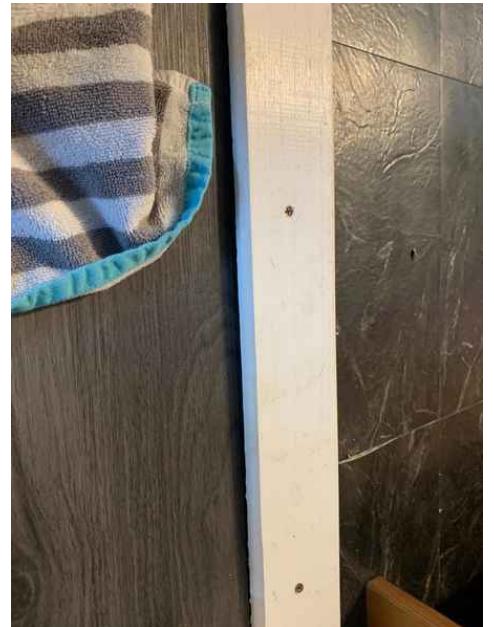
8.10.1 Floor Condition

TRIP HAZARD(S) PRESENT

Changes in elevation between adjacent floor covering materials, transition strips, or other items were present at the referenced area(s) resulting in trip hazards. Repairs are recommended to be conducted at these area(s) as needed for safety by a qualified contractor.

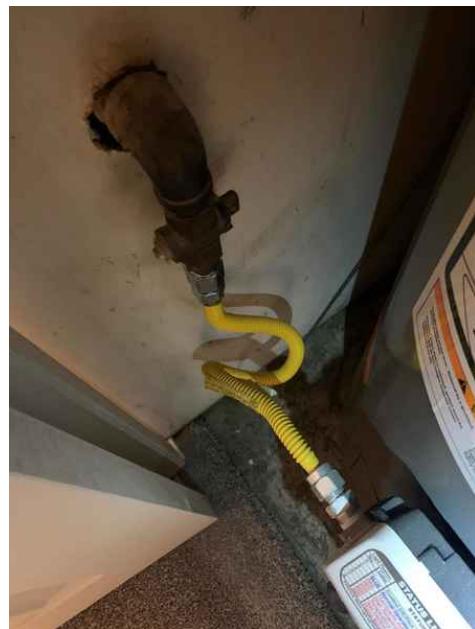
12.4.1 Gas Pipe

SEDIMENT TRAP MISSING

the sediment trap (drip leg/dirt pocket/drip) serves as a collection area for sediment to reduce the chance of clogged gas valves or burners
