Inspection Report

Property Address:
36206 Main St
Yucaipa CA 92399

| Date: 10/19/2019 | Time: 08:00 AM | Report ID: 20191019TLH2 |

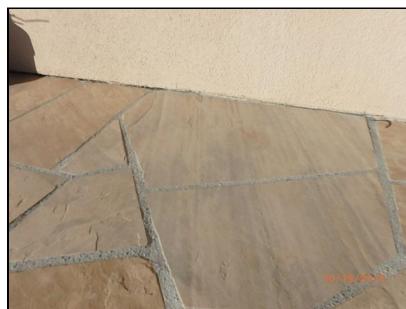
1.0 Item 1(Picture)

**1.0** (1) The minimum allowed weep space below the "stucco weep screed" to concrete/hard scape is 2" the space at exterior wall and patio surface is less than that. The wall may not drain correctly and moisture intrusion may occur. I am unable to determine if there has been any moisture accumulation inside of the wall(s.) I recommend evaluation by a qualified person.

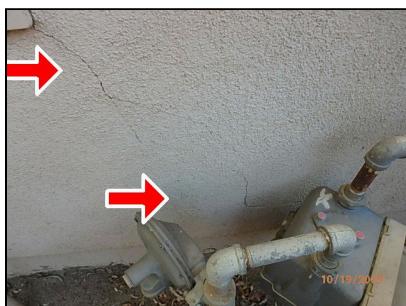
1.0 Item 4(Picture)

⚠ (2) Stucco coating at various areas of exterior is cracked or chipped. Recommend sealing of all cracks/chips to prevent moisture intrusion and further deterioration. If these are areas of concern, recommend further evaluation by proper specialist be completed.

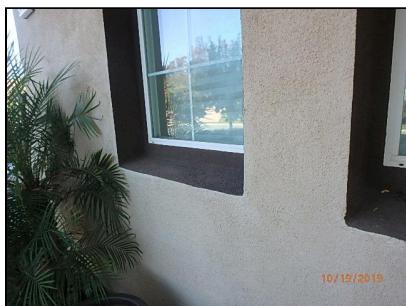
1.0 Item 8(Picture)

⚠ (3) Horizontal areas known as "pot shelves" are prone to moisture intrusion. Moisture intrusion can lead to structural damage and microbial growth. I recommend yearly maintenance(sealer) to help prevent moisture intrusion.

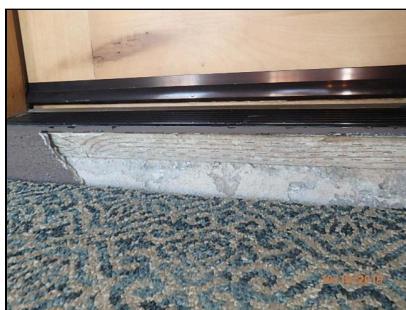
1.0 Item 12(Picture)

4 (4) The stucco coating has flaked off below the entry door threshold. I recommend repairs by a qualified contractor.

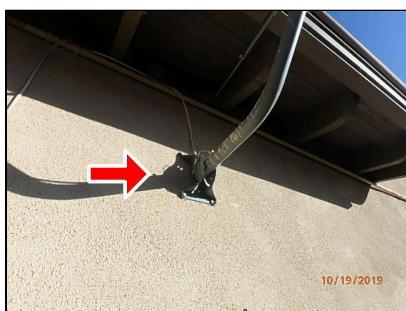
1.0 Item 14(Picture)

5 (5) The satellite dish anchored through the wall cladding will eventually leak and possibly damage the wood they are anchored to. I recommend an qualified person re locate the satellite dish and seal the wall.

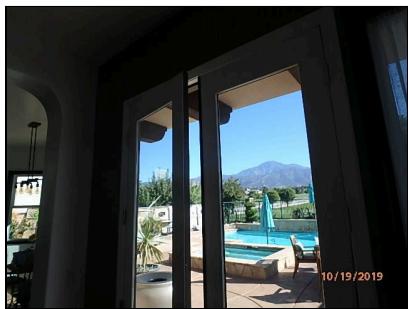
1.1 Item 1(Picture) No alarms on the doors

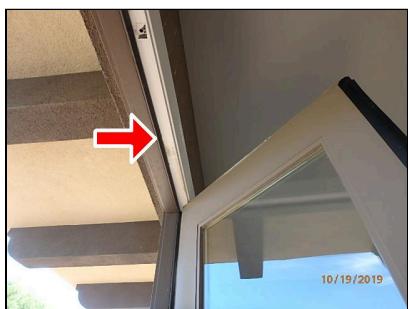
1.1 Item 2(Picture)

(3) The french doors T door rubs at jamb/frame when closing. An adjustment/repair is needed. A qualified contractor should inspect further and correct as needed.

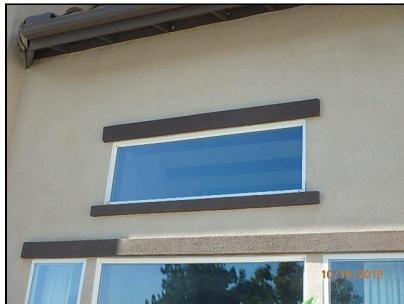
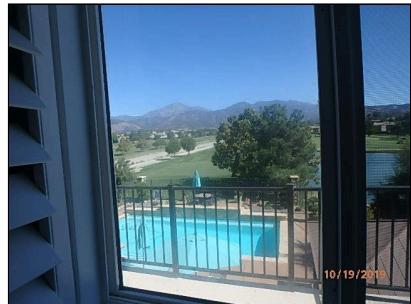
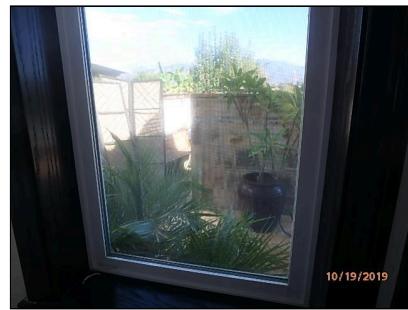
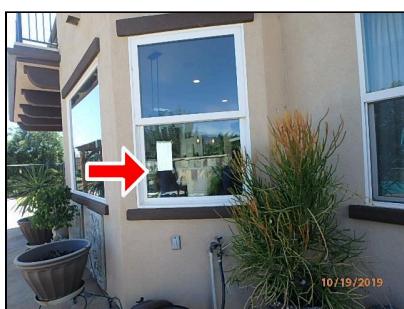
1.2 (1) Cloudy glass is an indication of a damaged seal. A window with a damaged seal has lost its insulation value and its energy efficiency. I recommend a qualified person evaluate and repair

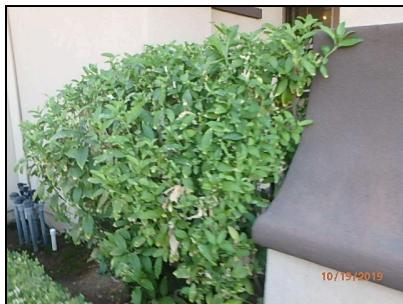
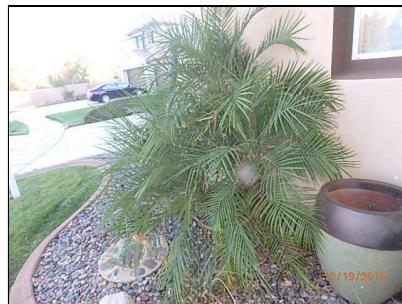
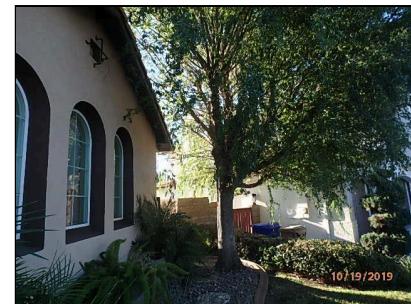
1.4 (1) Trees and vegetation planted next to home may cause foundation,plumbing drain and/or moisture problems on exterior wall covering and can allow rodents access to the attic and interior of home, if not moved. Recommend correct as necessary to avoid any possible future damage. Removal of the vegetation can lead to a Rodent infestation inside the home. Steps to prevent a possible infestation should be taken prior to removal of the vegetation.

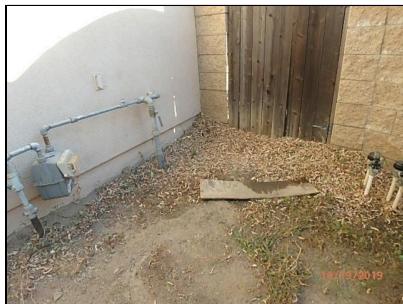
1.4 Item 4(Picture)

(2) There are several areas attached to the home (and away from the home). That do not appear to drain water to an approved location. Water that does not drain away from the home can lead to structural damage and microbial growth. I recommend correction of the grading and drainage by an qualified person.

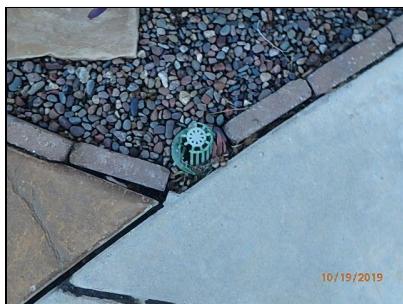
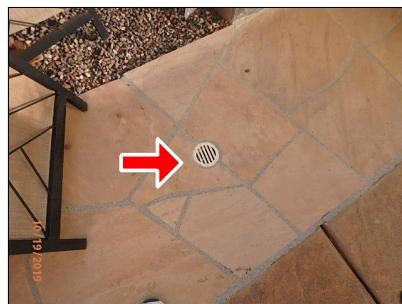
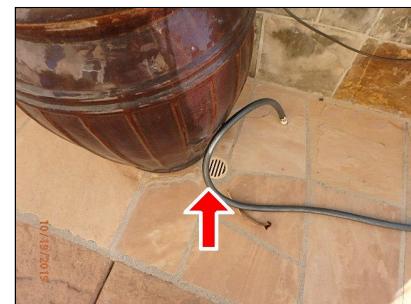
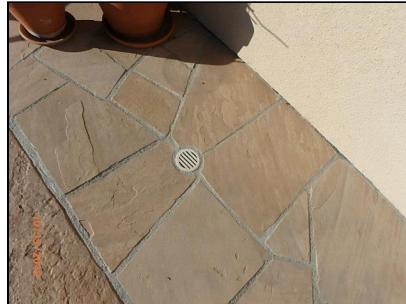
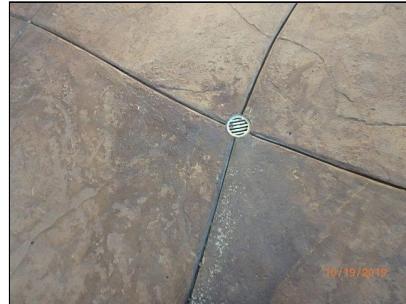
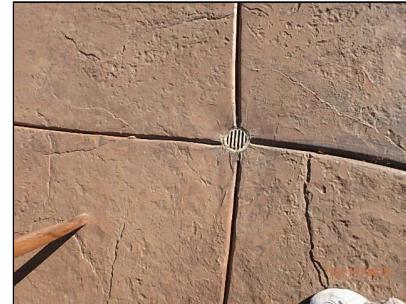
(3) There are surface drains installed at the west,north and east sides of home. The condition of underground pipes can Not be judged.I recommend yearly maintenance to insure the drains function properly during periods of severe weather.

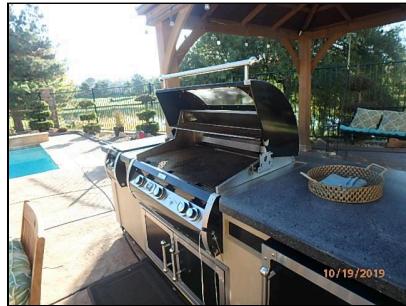
1.4 Item 11(Picture)

- ⬆️ (4) The BBQ burners did Not function when tested. I recommend repairs by a qualified contractor.

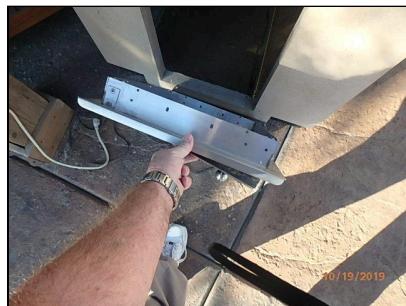
1.4 Item 12(Picture)

- ⬆️ (5) The end access door at the patio island is Not anchored and is an injury hazard. I recommend repairs by a qualified contractor.

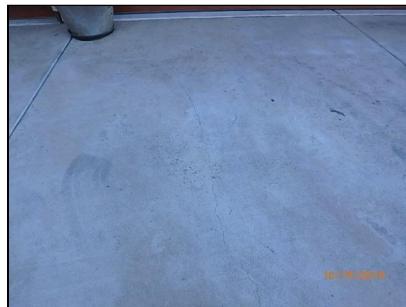
1.4 Item 13(Picture)

- ⬆️ (6) The concrete at the driveway/hard scape is cracked. We are unable to determine the cause of the cracks. We recommend evaluation by a qualified person

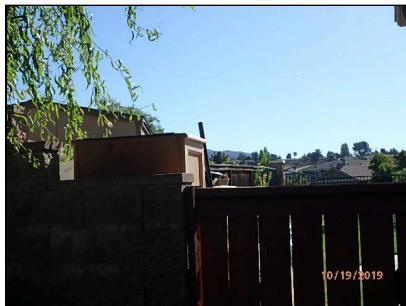
- 🏡 (7) There appears to be a beehive in the neighbors yard.

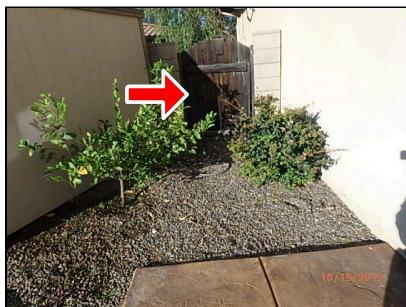
1.6 Item 2(Picture)

- 🏡 (2) The south gate is non operational. I recommend repairs by a qualified contractor.

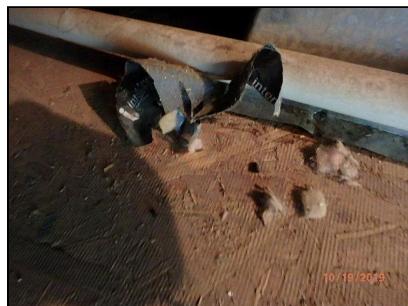
2.4 Item 1(Picture)

**2.4** (1) Rodent droppings noted at various areas in attic. We do not test for the presence of rodent or vermin infestations. I am un able to determine if there is an active problem, however we recommend further evaluation by proper specialist.

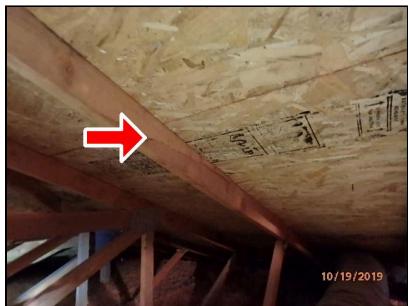
2.4 Item 3(Picture)

(2) There are moisture stains in the attic at numerous areas. I am unable to determine the cause or if the leak has been repaired. I recommend further evaluation by a qualified person.

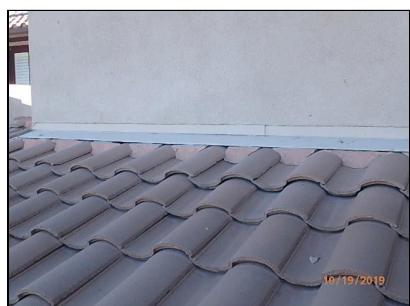
3.0 Item 1(Picture)

- 3.0 (1) The concrete roof tiles are slipped, damaged, chipped and cracked has been repaired at a number of areas. I recommend repairs as soon as possible to help prevent pre mature failure of the roof covering. A qualified contractor should inspect further and correct as needed.

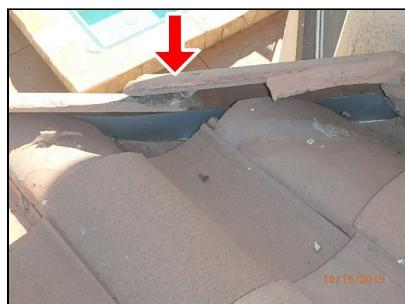
3.0 Item 8(Picture)

- (2) The rake tiles are improperly installed at the splayed rake (east side). The rake tiles should be laying flat and sealed to prevent water from entering at the open areas. I recommend repairs by a qualified roofing contractor.

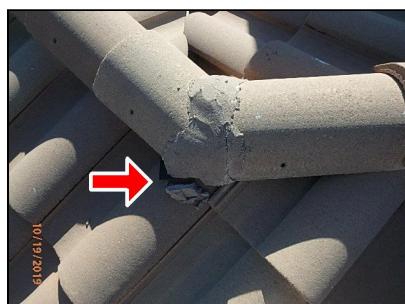
3.0 Item 9(Picture)

- (3) The mortar/concrete used as weather block is cracked at a number of locations. These cracks will eventually allow moisture intrusion and need replacement. We recommend replacement of the mortar/concrete with a pre manufactured "weather block" material by a qualified roofer.

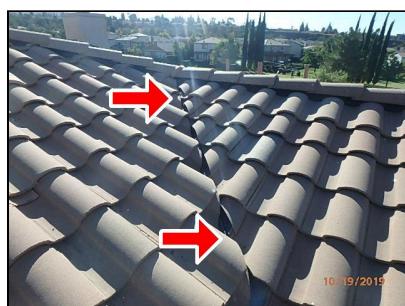
3.0 Item 10(Picture)

- (4) Close cut tiles at valleys are an acceptable installation. The tiles do trap debris and prevent water from flowing freely off of the roof. I recommend yearly maintenance/cleaning to help prevent moisture intrusion.

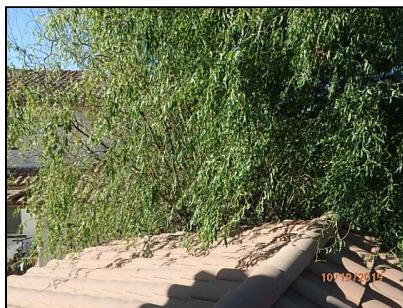
3.0 Item 12(Picture)

🏡 (5) The tree limbs that are in contact with roof or hanging near roof should be trimmed. Sometimes vegetation can cover roof covering and may conceal hidden damage. Recommend proper licensed specialist inspect further and correct as necessary.

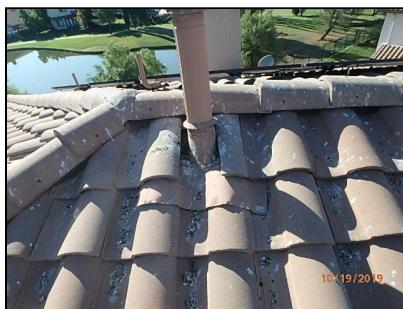
3.0 Item 13(Picture)

🏡 (6) Pigeon droppings noted at various areas. This can sometimes be a health hazard. Recommend proper specialist inspect further and correct as needed.

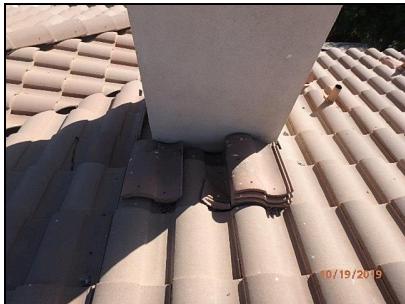
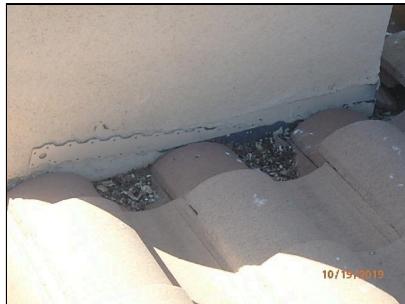
**3.2** There is no cricket/saddle flashing installed on the upper side of the chimney. A cricket/saddle flashing is peaked in the middle and will prevent water from ponding on the upper side of the chimney. Water that does not easily flow off of the roof can lead to moisture intrusion, structural damage and microbial growth. I recommend a licensed roofing contractor evaluate further.

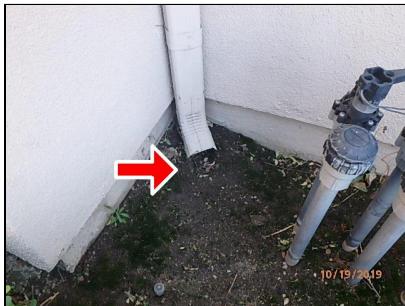
3.3 Item 1(Picture)

**3.3** The downspout does Not terminate 5' from house/foundation at the (East side of home). Down spouts should terminate to an location that directs water away from the home and walkways. A qualified contractor should inspect further and correct as needed.

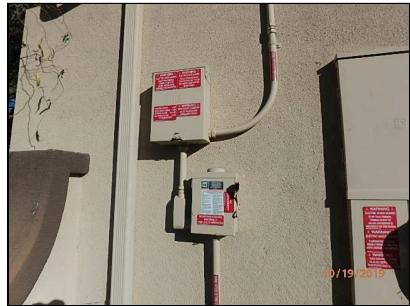
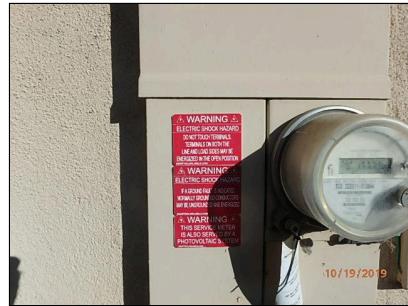
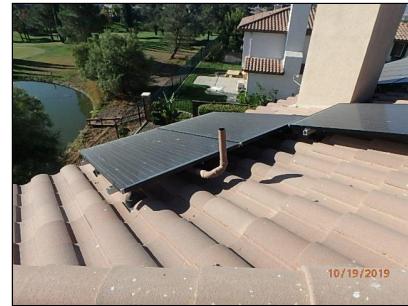
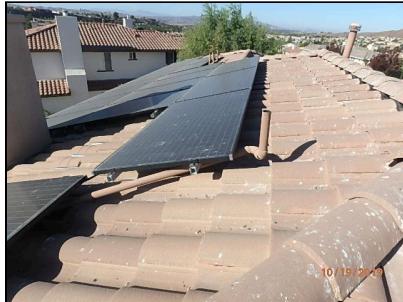
4.0 Electrical service is installed with a solar power unit that manages electricity for the home. Solar electric system is beyond the scope of the inspection. Solar electric system and components were not evaluated by my company. I recommend complete system evaluation by a qualified contractor. I recommend contact a qualified solar installer and inquire about a maintenance contract.

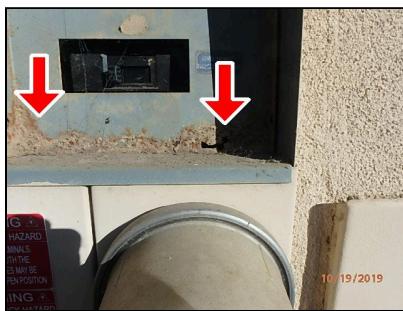
4.1 Item 1(Picture)

**4.1** The problem(s) discovered in the panel such as dead front cover rusty/damaged, deadfront cover anchor screws missing and any other problems that an electrician may discover while performing repairs need correcting. I recommend a licensed electrician inspect further and correct as needed.

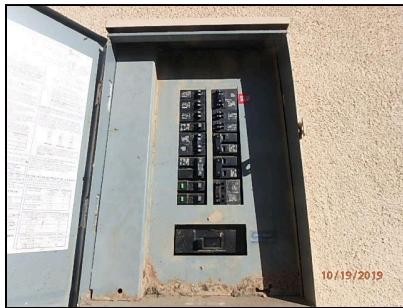
4.2 Item 1(Picture)

**4.2 (1)** Problem(s) discovered with Branch Circuits such as circuits not labeled or identified and doubled wiring at circuit(s), exposed wires subject to damage inside kitchen island and any other problems that an electrician may discover while performing repairs need correcting. I recommend a licensed electrician inspect further and correct as needed.

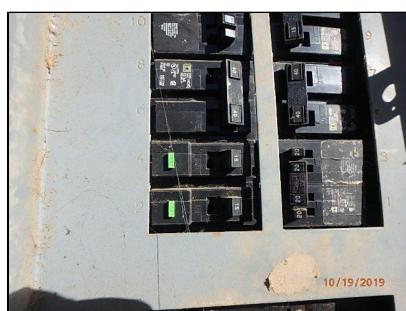
4.2 Item 5(Picture)

(2) The "AFCI" breakers were not tested due to possible damage to electrical equipment (computers, alarm clocks, etc.etc) connected to those circuits (bedrooms). I recommend a qualified person test/trip off the "AFCI" breakers in the sub panel and verify that all circuits that supply the bedrooms are properly connected to "AFCI" breakers. After the occupants belongings have been moved and prior to occupying the home.

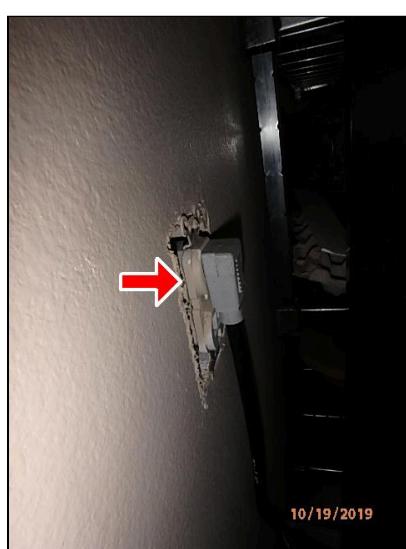
4.3 Item 1(Picture)

4.3 (1) At least three "three-prong" outlets are missing the cover-plate in the garage and master closet. This is a safety issue that needs to be corrected. I recommend a qualified person install the cover (s).

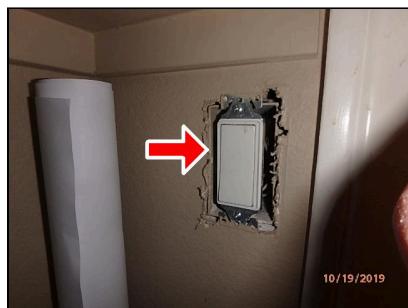
4.3 Item 3(Picture)

- ⚠ (2) The light switch is missing "cover-plate" at the closet. This is a safety issue that needs to be corrected. I recommend a qualified person install the cover.

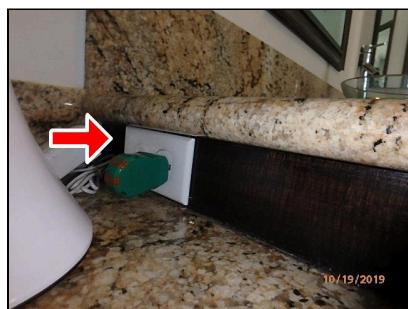
4.3 Item 4(Picture)

- ⚠ (3) At least one "three-prong" outlet is loose in wall/box in the master bath. This is a safety issue that needs to be corrected. A qualified licensed electrician should inspect further and correct as needed.

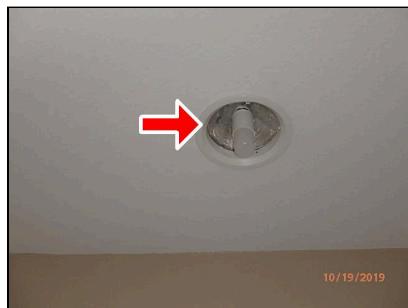
4.3 Item 5(Picture)

- ⚠ (4) The light fixture not currently approved for use in a shower/wet location at the jack and jill bathroom. This is a safety issue that needs to be corrected. A qualified licensed electrician should inspect further and correct as needed.

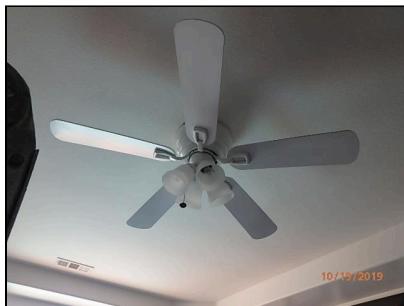
4.3 Item 6(Picture)

(5) The ceiling fan did not work when tested in the master bedroom. Electrical issues are considered a hazard until repaired. Recommend seller or proper specialist verify operation.

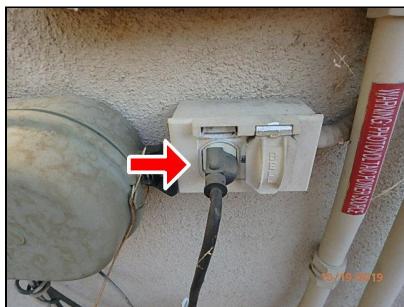
4.4 Item 1(Picture)

4.4 (1) The exterior receptacle/outlet at the (South side of home) is missing a weatherproof cover. This is a safety issue that needs to be corrected. I recommend a qualified person install cover(s) that are rated for exterior application.

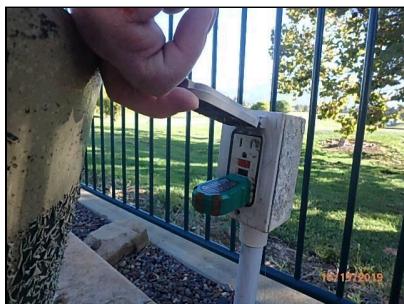
4.4 Item 3(Picture)

(2) The exterior receptacle/outlet at the rear of home did not work or there is no power to outlet. This is a safety issue that needs to be corrected. A qualified licensed electrician should inspect further and correct as needed.

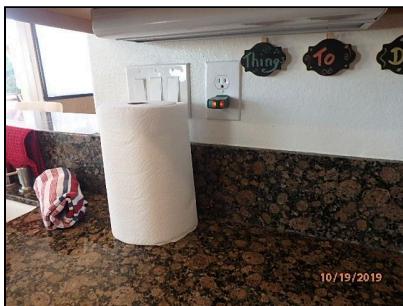
4.5 Item 1(Picture)

**4.5** "GFCI" protected outlets are not present at kitchen sink, kitchen island and, peninsula. Some of these style outlets may not have been required at the time of construction, however we recommend consideration of upgrading to current standards for safety. Recommend a licensed electrician inspect further, evaluate and correct as necessary for safety.

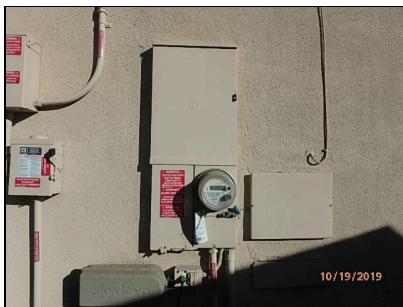
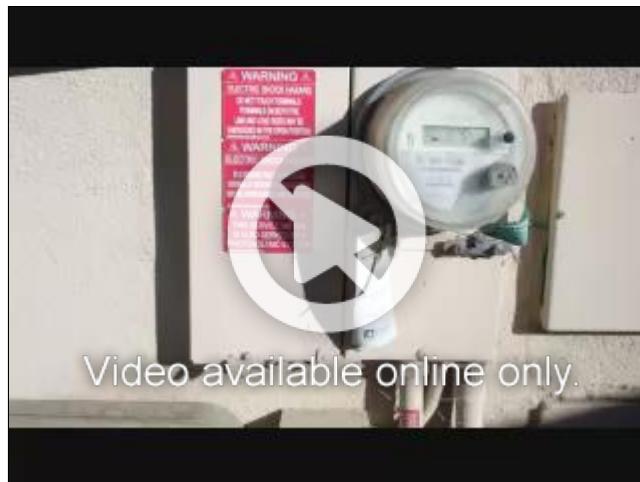
4.6 The main panel box is located at the South side.

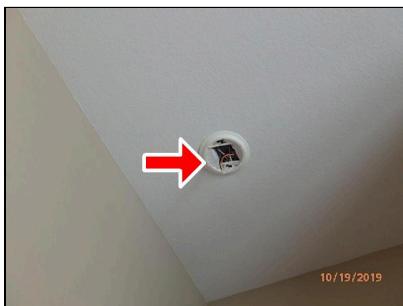
4.7 Item 1(Picture)

(2) The smoke alarm is missing at one or more required locations. Smoke alarms are a life saving safety device and are required in all bedrooms,common hallways to bedrooms and on every floor/story. I recommend install smoke alarms at all of the currently required locations.

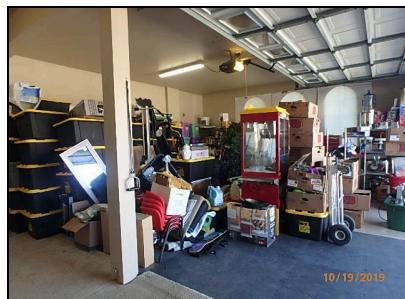
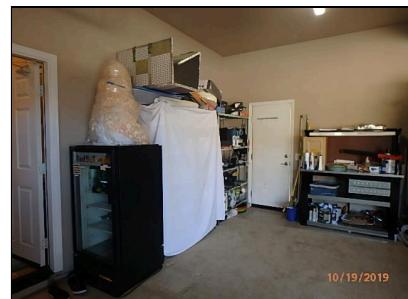
**5.1** Walls are not fully visible for inspection due to occupants belongings. Recommend further evaluation by proper specialist.

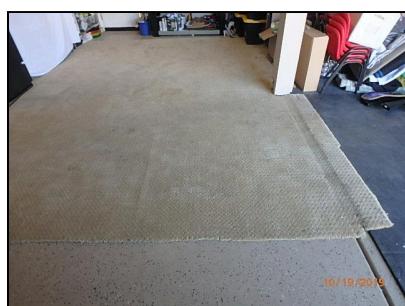
5.2 Item 1(Picture)

**5.2** Floors are not fully visible for inspection due to occupants belongings carpet and floor mat. Carpet is flammable. Recommend further evaluation by proper specialist.

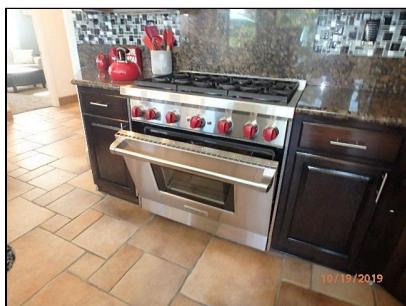
6.2 Item 1(Picture)

**6.2** No "anti tip" bracket installed on the stove/range to prevent unit from tipping over if oven door were to be used for a step. Recommend installation of "anti tip" bracket for safety.

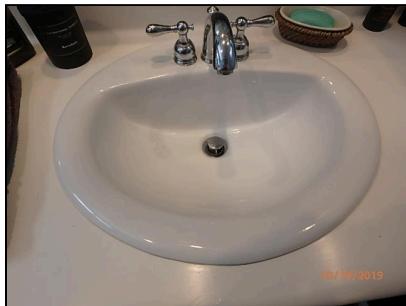
7.0 Item 1(Picture)

(2) Sink drain stopper is non operational at guest bath. A qualified person should repair as necessary

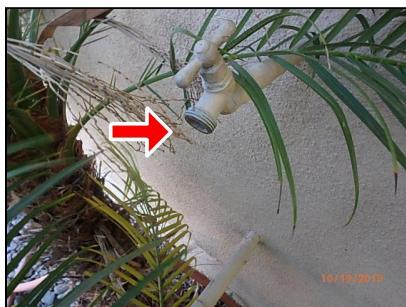
7.1 Item 1(Picture)

**7.1** (1) Hose bibs at various locations are missing anti-backflow prevention devices(vacuum breakers). While this may be a newer requirement,I recommend installing vacuum breakers to prevent accidental contamination of water supply system

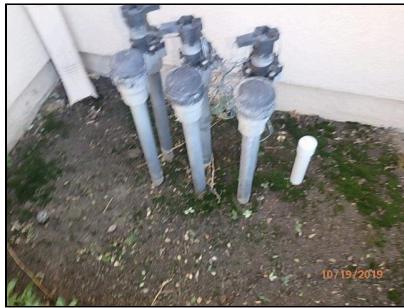
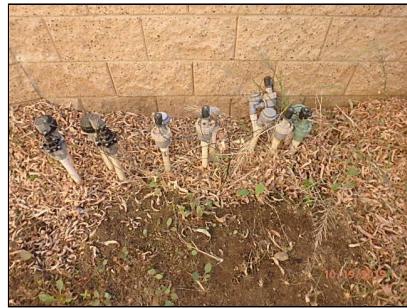
(2) Irrigation system was Not inspected. Recommend proper specialist inspect irrigation system further and verify that it meets all of the current water conservation requirements and is functioning correctly.

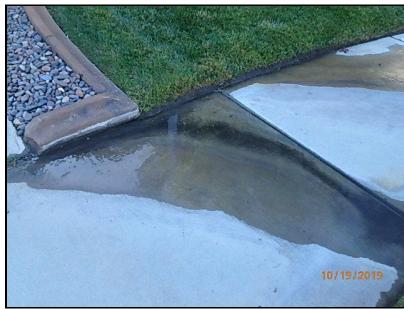
7.1 Item 7(Picture)

(3) Standing water on the sidewalk may be an indication of an incorrectly functioning anti siphon valve. I recommend repairs by a qualified contractor.

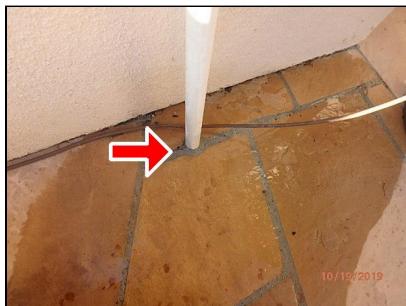
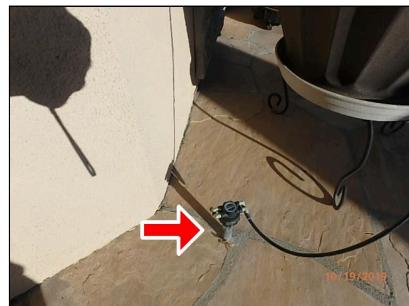
4) Pipes not wrapped at the patio.

Pipes passing through concrete or cinder walls and floors or other corrosive material shall be protected against external corrosion by a protective sheathing or wrapping or other means that will withstand any reaction from the lime and acid of concrete, cinder or other corrosive material. Sheathing or wrapping shall allow for expansion and contraction of piping to prevent any rubbing action. Minimum wall thickness of material shall be 0.025 inch (0.64 mm).

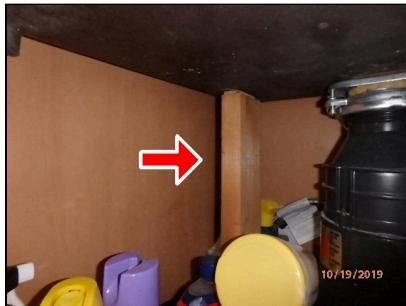
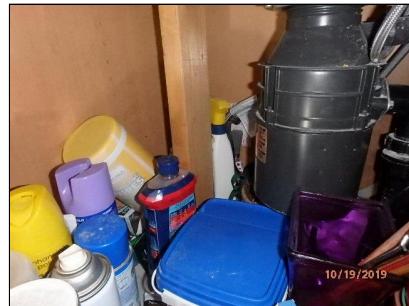
5) The kitchen sink has an extra support under it. This is for your information. I recommend evaluation by a qualified contractor.

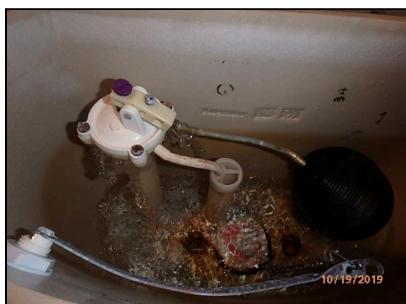
7.1 Item 13(Picture)

⚠ (6) Cross connections are present at the toilet filler hoses and the filler valves leak. The end of the hose should terminate 1" above the water level inside the tanks. I recommend correct as necessary to prevent accidental contamination of the plumbing system.

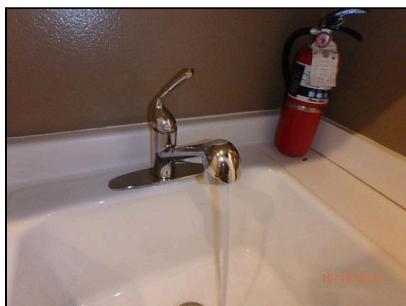
7.1 Item 18(Picture)

⚠ (7) The sink faucet is loose at the laundry room. loose pipes are easily damaged. I recommend evaluation and repairs by a qualified licensed plumbing contractor.

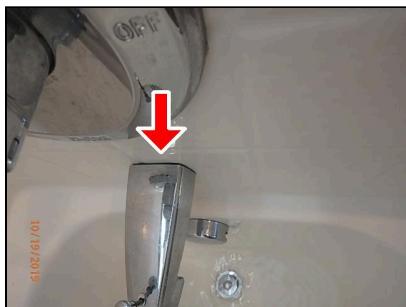
7.1 Item 19(Picture)

⚠ (8) I recommend seal the shower head pipes and shower/tub valves and spouts, at the walls with a suitable caulking to help prevent moisture intrusion into the wall(s.) Moisture intrusion can lead to structural damage and microbial growth.

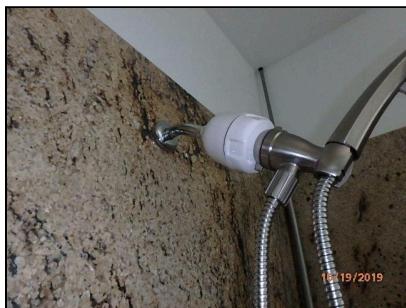
7.1 Item 20(Picture)

(9) The shower pipe is loose in the wall(master bath). I recommend a qualified person secure the pipes inside the wall to prevent damage to any concealed connections that may result in a leak. Water leaks can lead to structural damage and microbial growth. I recommend evaluation and repairs by a qualified contractor.

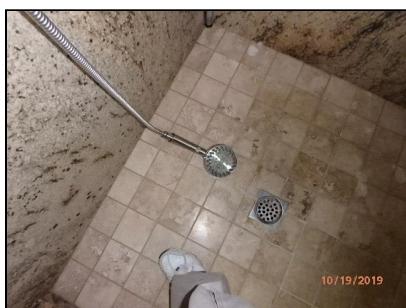
7.1 Item 21(Picture)

(10) Removable shower heads should be equipped with an air gap device or should terminate 1" above the flood rim of the shower. This is an requirement to help prevent accidental contamination of the homes plumbing system.

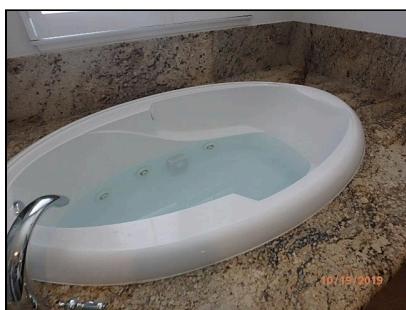
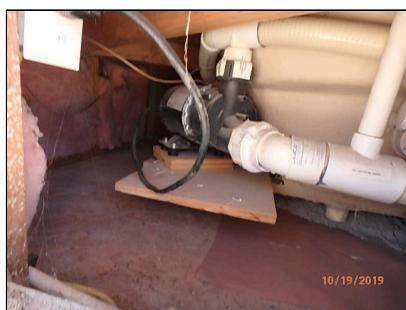
(11) Whirlpool tub at master bath did not function when tested. A qualified contractor should inspect further and correct as needed.

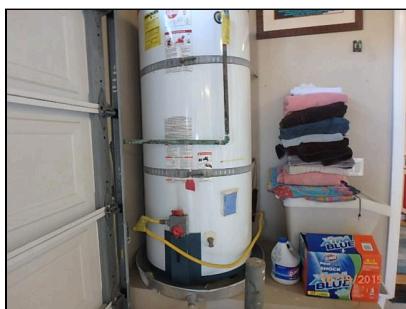
7.2 Item 2(Picture)

(2) Some jurisdictional authorities require three (3) or an engineered strapping system for water heaters 75 gal or more. I am unable to determine if the straps installed meet the local requirements. I recommend contact the local authority having jurisdiction regarding strapping requirements for 75 gal unit.

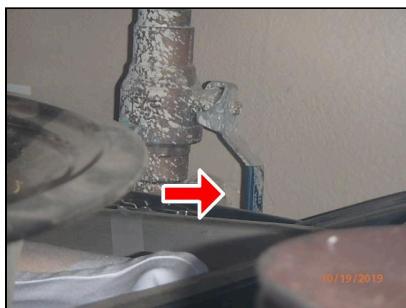
7.3 Item 1(Picture)

7.3 The main water shut off is the blue lever located in the garage. This is for your information.

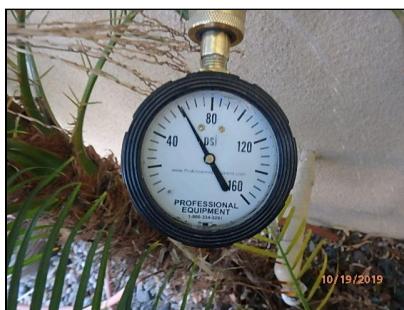
7.4 Item 1(Picture)

7.4 (1) Water pressure is 60 psi.

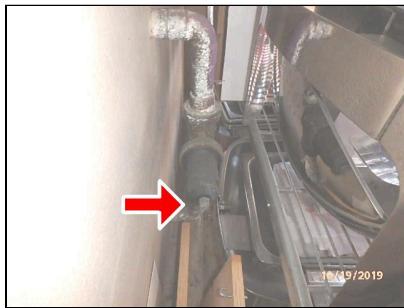
7.4 Item 2(Picture)

(2) No relief valve visible/installed

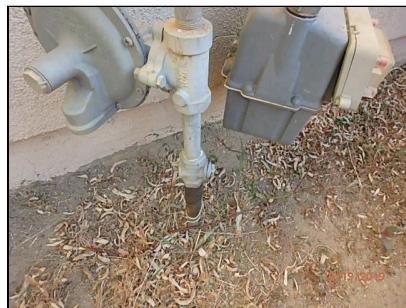
7.5 (1) The main fuel shut off is at gas meter outside at (South side of home). The valve will need a wrench to be operated. While not a requirement, in case of emergency, we recommend an earthquake style wrench with a chain be installed to aid shut off in the event of an emergency.

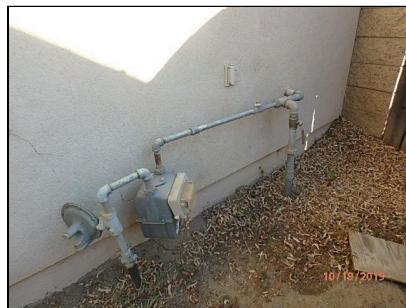
7.5 Item 3(Picture)

(2) The pipes are rusty and there is no automatic earthquake shutoff valve, at the gas meter. I recommend the rusty pipes be prepared and painted. There is no requirement for an automatic earthquake shutoff valve. It is a recommendation for a safety up grade, from the Home Inspector to you.

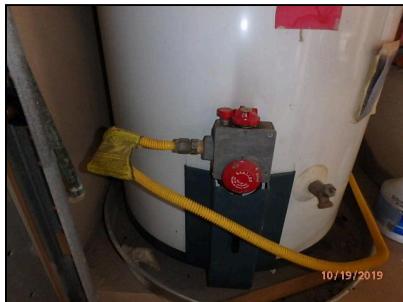
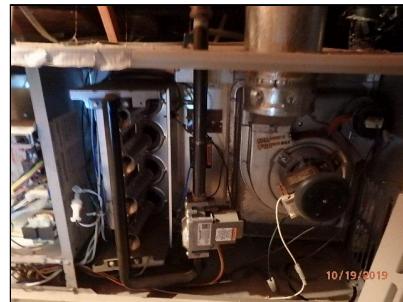
**7.6** (1) No sediment traps noted at gas appliances. While local jurisdictional authorities may not require this, we recommend installation of sediment traps at gas appliances as per manufacturers installation instructions.

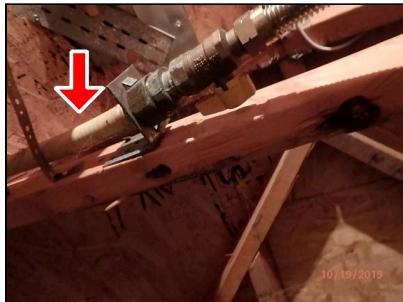
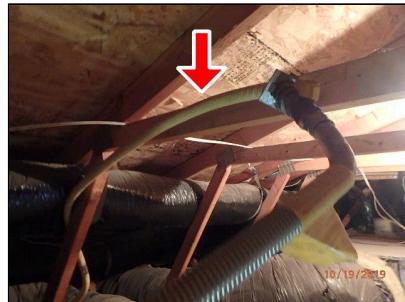
(2) There is CSST (corrugated stainless steel tubing) gas line in this Home. New California law Requires Home Inspectors to report the presence of this material/gas line. The law also states that Home inspectors are Not qualified to determine if it is properly bonded to the home's electrical system. The Only Person Qualified to determine if the CSST is Properly Bonded is a Licensed Electrical Contractor. An Electrical Contractor Must inspect to determine if the CSST is correctly Bonded Prior To The Close Of This Transaction.

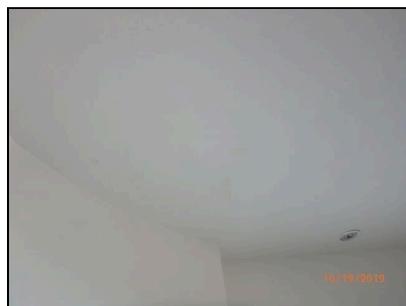
**8.0** The Drywall on the ceiling reveals a water stain/damage indicating a leak did or still exists at family room and upstairs. Moisture intrusion will lead to structural damage and microbial growth. A qualified contractor should inspect further and correct as needed.

8.0 Item 1(Picture) Above stairs

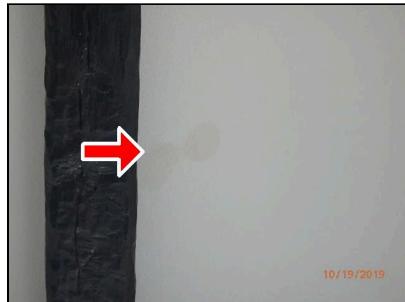
8.0 Item 3(Picture) Family room

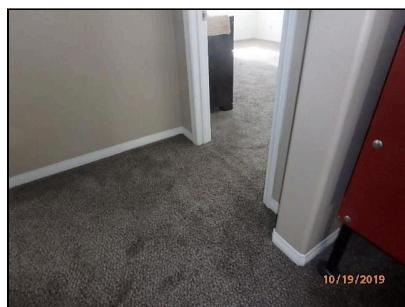
8.2 Item 1(Picture)

- 8.2** The Carpet is loose at the upstairs. It may eventually become a trip hazard . A qualified contractor should inspect further and correct as needed.

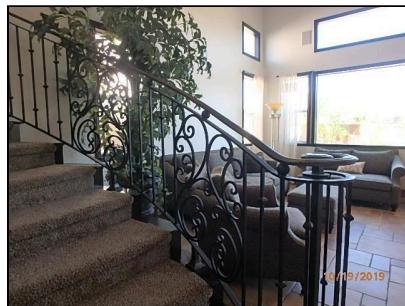
- 8.3** The hand/guard rail for the upstairs and loft does not meet current standard and is considered climbable . A fall or injury could occur if not corrected. I recommend a qualified contractor install an handrailing that meets the current safety standard as an upgrade.

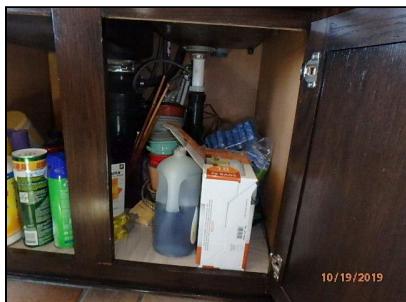
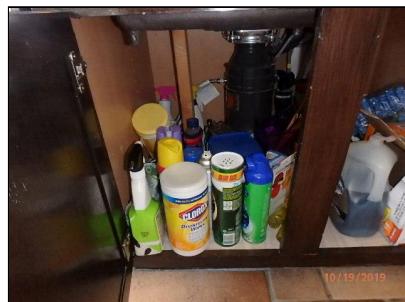
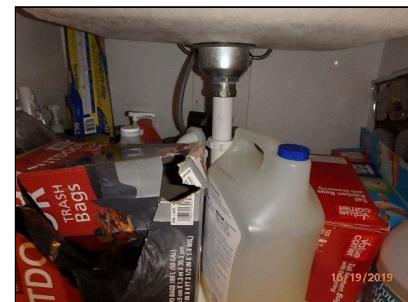
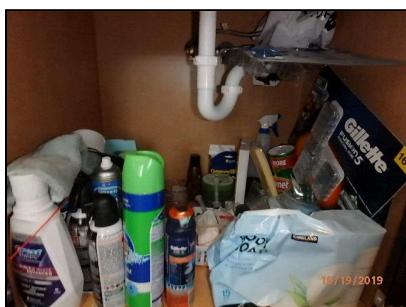
8.4 (1) Occupants belongings stored under the sinks block access. I was unable to fully evaluate the condition of cabinets or plumbing (supply/DWV) under the sinks.I recommend complete evaluation by a qualified contractor after occupants belongings have been moved.

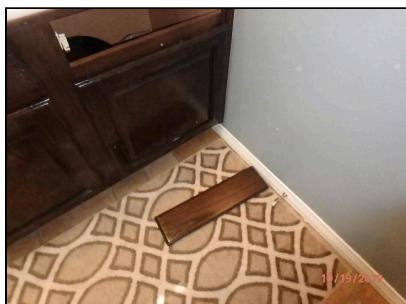
8.4 Item 5(Picture)

(2) Drawer face in guest bath is loose(fell off). This is a maintenance issue and is for your information. A qualified contractor should inspect further and correct as needed.

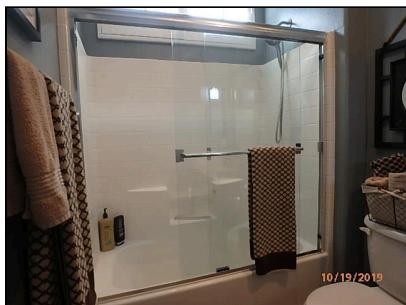
8.5 Item 1(Picture)

8.5 (1) The Shower door falls out of track when opened at Guest bath. This is considered Un safe. A qualified contractor should inspect further and correct as needed.

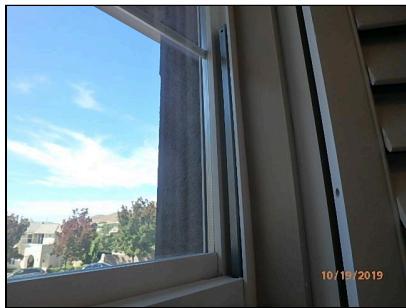
8.6 Item 1(Picture)

8.6 (1) The window sash springs/balancers are loose at a number of areas. Damaged springs will eventually have a negative affect on the safe operation of the window. I recommend evaluation and repair by a qualified contractor or window specialist

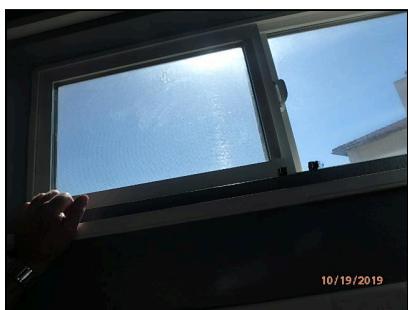
8.6 Item 5(Picture)

(2) One window difficult to operate at the Guest bath. This is a maintenance issue and is for your information. A qualified contractor should inspect further and correct as needed.

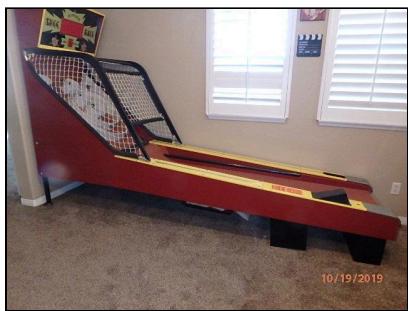
8.6 Item 6(Picture)

(3) Some windows were blocked by occupants belongings and could not be tested for proper operation.

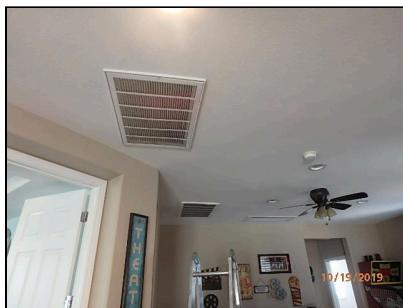
9.6 Item 1(Picture)

9.6 Return air gills not installed down stairs (or separated). Un even cooling (or heating) may be possible. Normally the return air grilles are separated to circulate the air in the whole house. The system may not function or perform to it's design potential. I recommend evaluation by an licensed HVAC contractor.

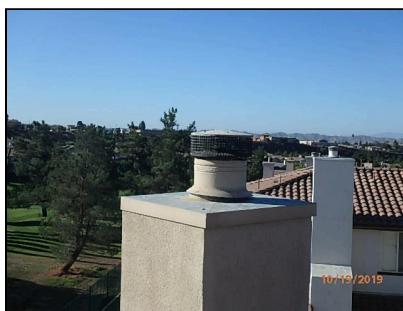
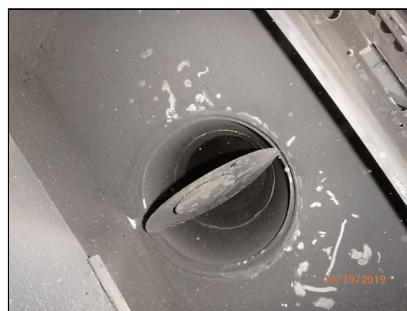
**9.7** (1) The chimney, liner and all related components are not fully accessible for a visual inspection. It is recommended that a NFPA(National Fire Protection Association) 211(Standards for chimneys, Fireplaces, Vents and Solid Burning Appliances) level II inspection be performed by a proper licensed specialist for safety.Prior to the use of this fireplace.

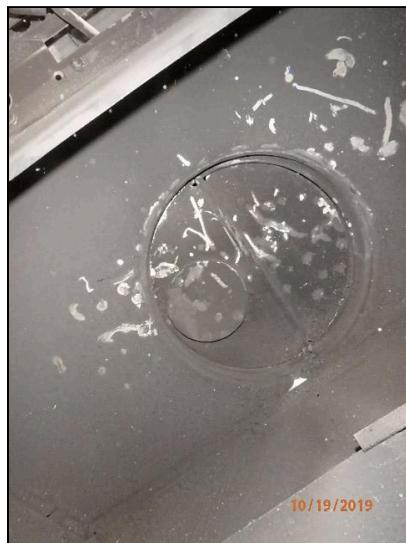
9.7 Item 3(Picture)

(2) I recommend install damper clamp to prevent the damper from fully closing and allowing products of combustion

(carbon monoxide) entering into the living space and clean the chimney prior to the use of this fireplace.

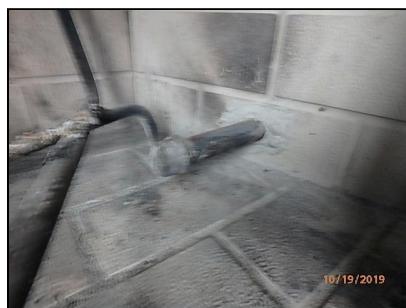
9.9 Item 1(Picture)

**9.9** Gas line in fireplace(s) is capped, and gas logs were missing or inoperable. We can not verify if gas is present at fireplace.

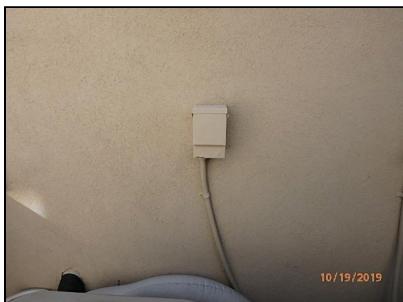
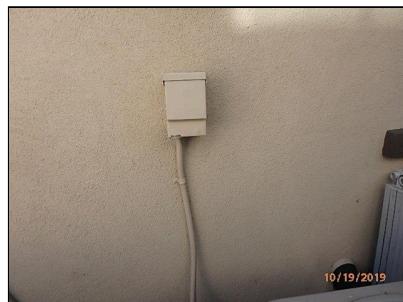
(2) Access to the AC electrical disconnect is blocked by the condenser. There should be 36" clearance at the front of the disconnect for the safety of service personnel. We recommend evaluation and repair by a qualified HVAC or electrical contractor

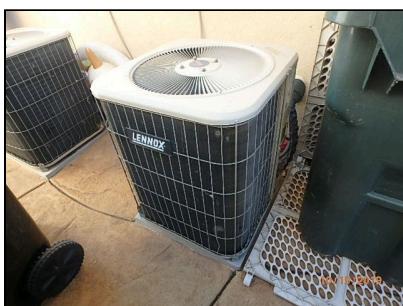
(3) The cooling fins are bent/damaged at the units outside. Bent or damaged cooling fins restrict air flow and reduce the efficiency of the units. I recommend a qualified HVAC technician correct as necessary

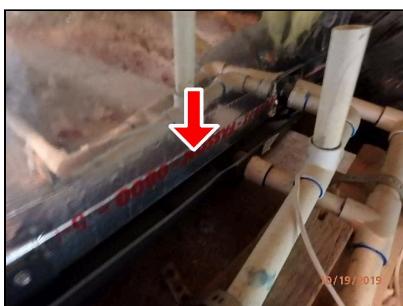
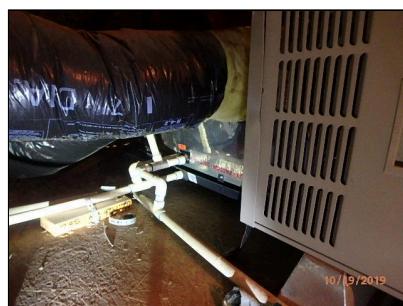
(4) I recommend install moisture sensor safety switches in the condensation catch pan(s) in the attic. This is a recommendation for a safety upgrade from the Home Inspector to You.

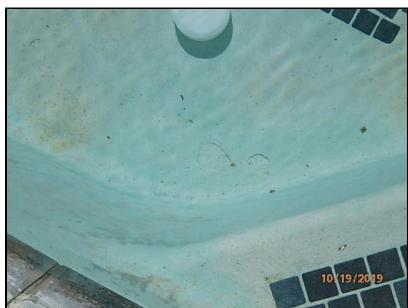
12.1 Item 1(Picture)

12.1 The pool and spa plaster are discolored and chipped at a number of areas. I can not judge the remaining life of the plaster. I recommend evaluation and estimation of the remaining life and replacement cost by a licensed pool plaster contractor.

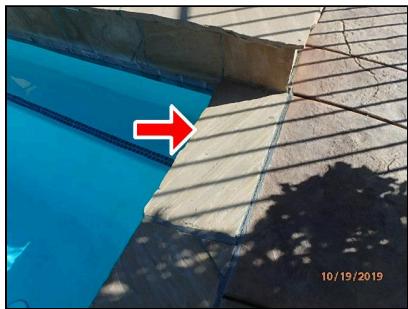
12.3 Item 1(Picture)

12.3 Pool coping feels loose. I recommend repairs by a qualified pool contractor.

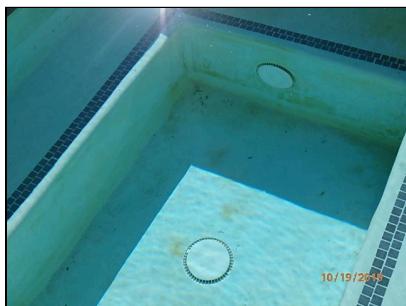
12.4 Item 1(Picture)

12.4 (1) The pool and spa bottom drains lack an approved cover. The current safety standard requires an anti entrapment type cover that complies with the Virginia Graham Baker Law. I recommend an qualified pool contractor install all of the currently required safety equipment. These are some safety guidelines,

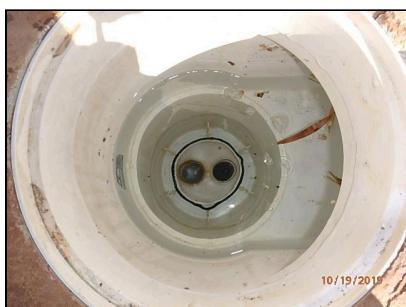
12.4 Item 2(Picture)

(2) The diverter/safety valve is missing in the skimmer. This valve prevents damage to the equipment when the water level drops below the skimmer intake. I recommend installation of an diverter/safety valve.

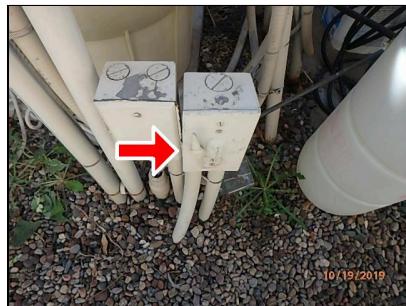
12.4 Item 4(Picture)

(4) This electrical switch is damaged. I was unable to determine what it controls. I recommend repairs by a qualified contractor.

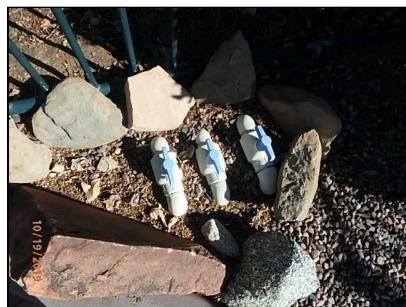
12.4 Item 5(Picture)

(5) PVC pool and spa plumbing should be painted to avoid deterioration from sunlight.

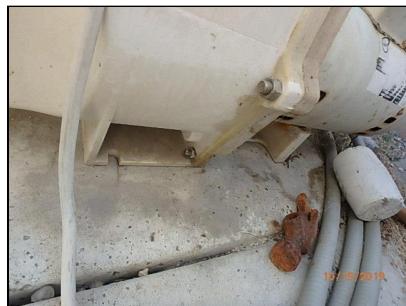
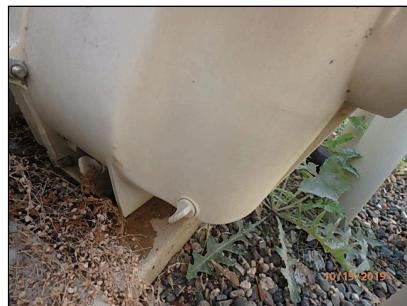
(2) Pool pump is not secured properly to pad. Opinions vary as to importance of this item. We recommend correcting for safety. Recommend further evaluation by a licensed pool technician.

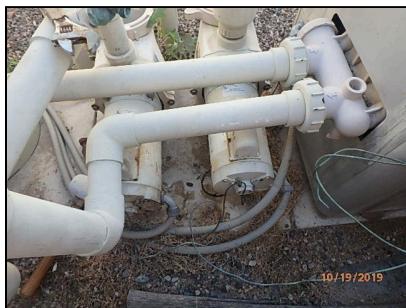
12.5 Item 3(Picture)

(3) I recommend up grade the pool pump motor to meet the current energy conservation variable speed standard.

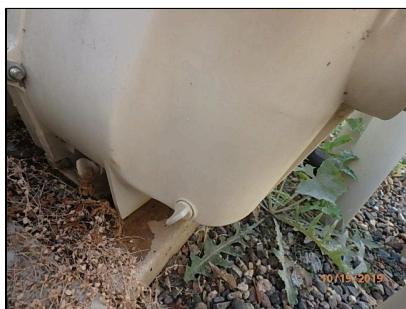
12.5 Item 4(Picture)

(4) The waterfall pump is leaking. I recommend repairs by a qualified contractor.

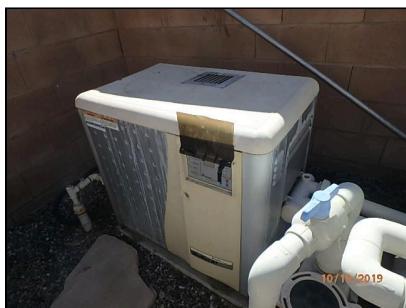
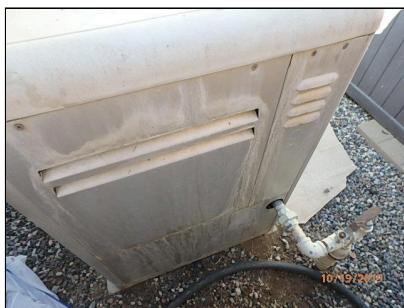
12.7 Gas-fired Pool Heater would not respond to normal user controls. Staining on the unit and wet soil around the unit may be an indication of a leak. Recommend further evaluation by a licensed pool technician..

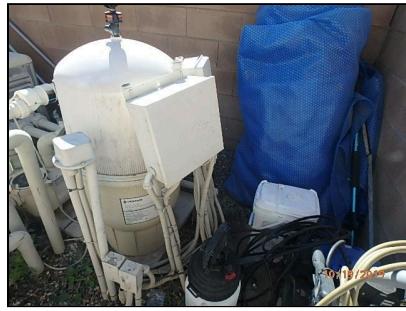
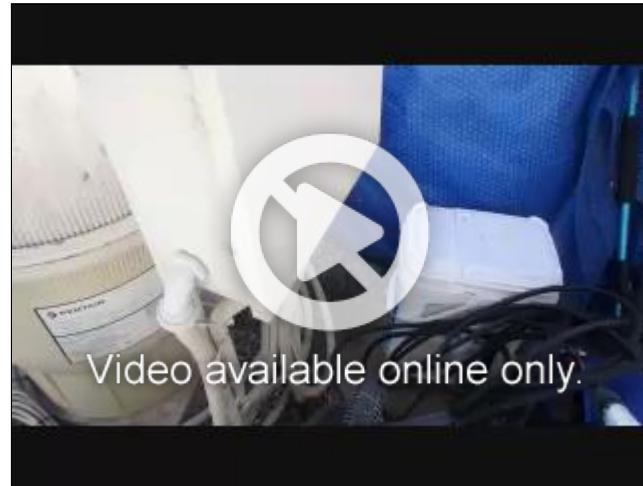
(2) The conduit that supports the pool pump timer and salt system control box is rusted and damaged. The equipment is loose. This is a safety hazard. I recommend repairs by a qualified contractor.

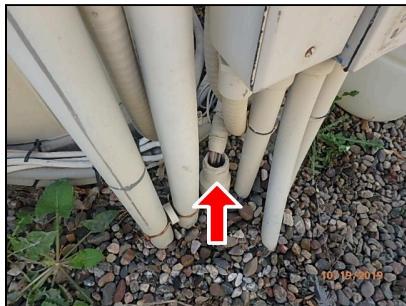
12.8 Item 4(Picture)

(3) Exposed wiring in pool equipment area. Recommend correct as necessary.

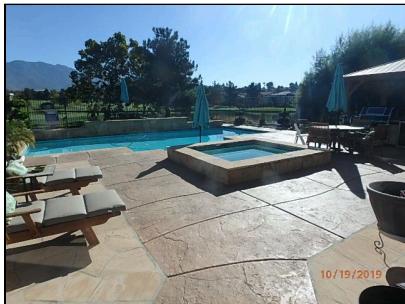
12.9 Item 1(Picture)

12.9 There are None of these safety features installed.

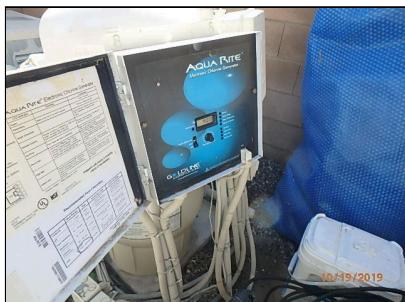
12.10 Salt/Chlorinator systems are beyond the scope of this inspection. Operation of salt/chlorinator system or water chemistry was not tested. I recommend evaluation by an qualified swimming pool technician.
