PGR HOME INSPECTIONS

RESIDENTIAL HOME INSPECTION REPORT

1234 Main St.
Charleston, SC 29407

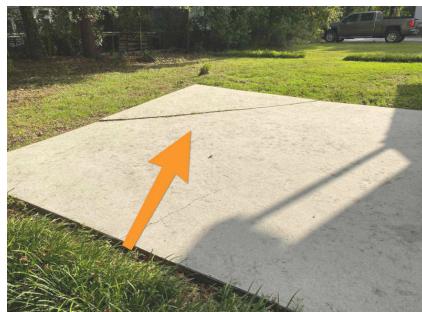
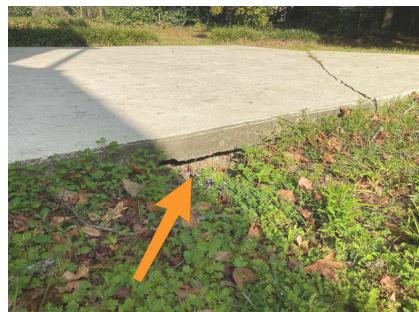
PATIO: CRACKED

Significant crack in the patio slab possibly due to soil erosion or poor soil conditions. Recommend a qualified professional evaluate the void present under the slab and repair as needed.

Contact a qualified professional.

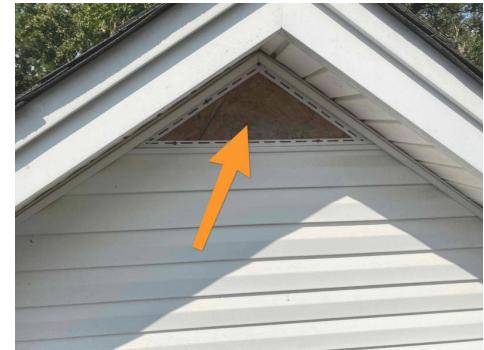
2.2.1 Exterior Components

SIDING: MISSING

One small section of vinyl siding was found to be missing. Recommend having a qualified siding contractor match to the existing siding and replace.

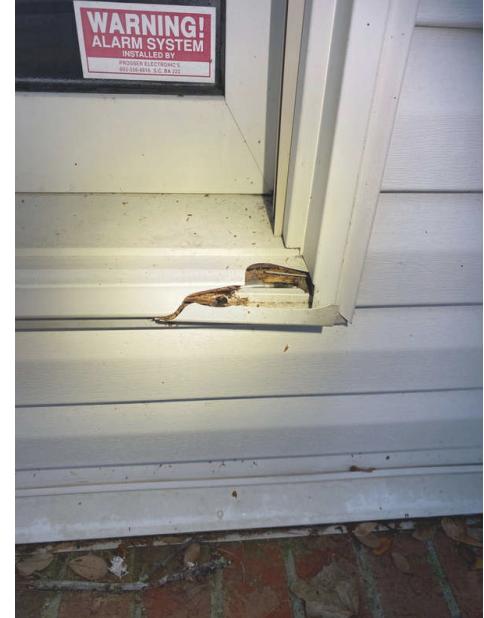
Left side of home

WINDOW DAMAGE: WOOD ROT

Damage to one of the windows exposing the framing below which has resulted in wood rot. Recommend a qualified professional remove the damaged portion and evaluate the extent of the damage and repair as needed.

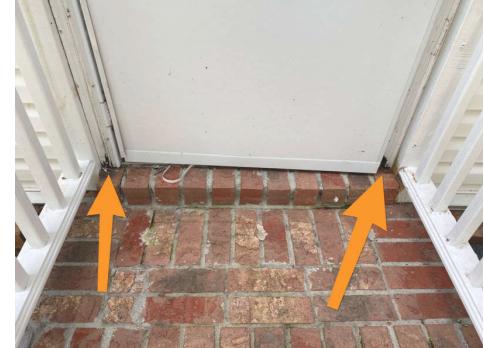
Back of the home

TRIM/ JAMB: ROT

Wood rot along the bottom portions of the trim/door jam in one or more locations. (Locations notes on picture) Recommend repairing/replacing to prevent further damage and to help prevent the attraction of wood destroying insects.

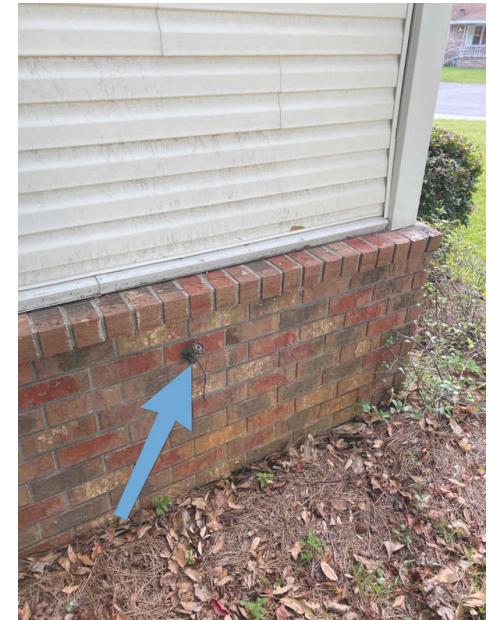
Left side of home

One of the hose bibs was not operational. Recommend consulting with the seller for more information and/or have a qualified plumbing professional evaluate and repair.

Contact a qualified professional.

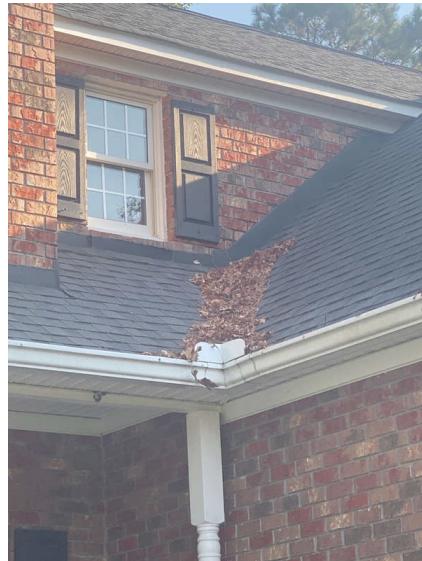
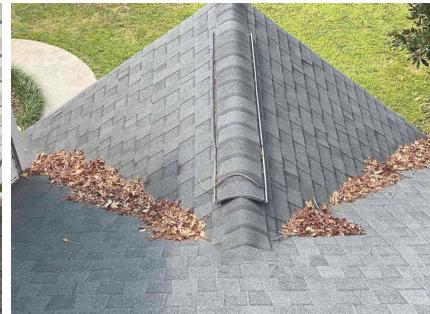
3.2.1 Gutters, Downspouts

GUTTERS: SIGNIFICANT DEBRIS

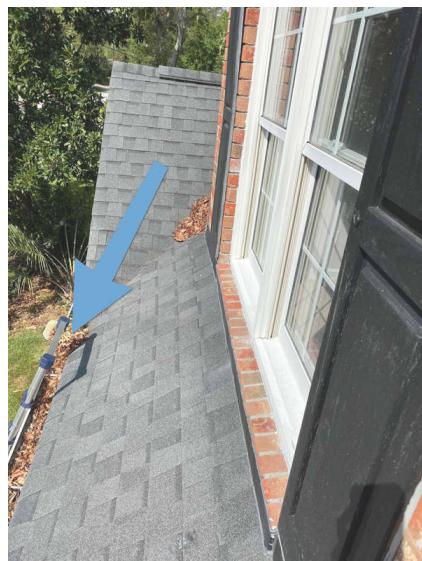
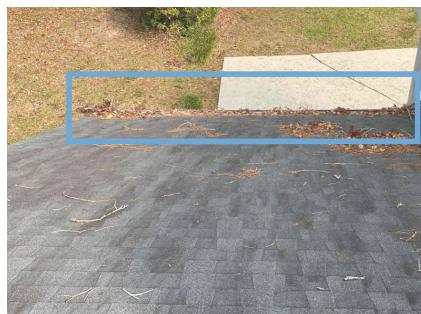
3.2.2 Gutters, Downspouts

DOWNSPOUT LOOSE

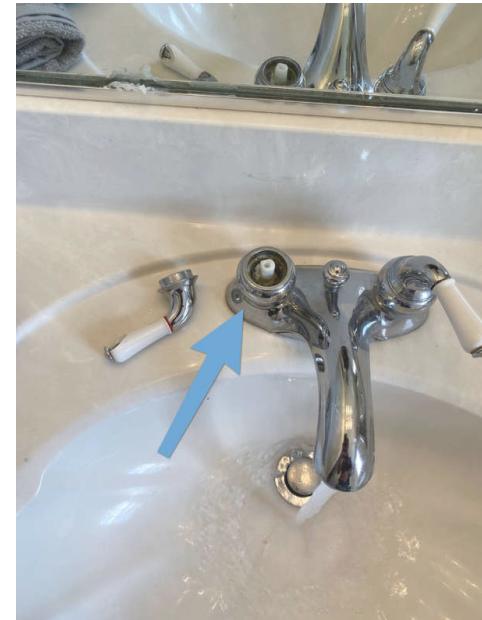
2nd Floor Guest Bathroom

7.2.2 Sinks, Tubs/Showers,
Toilets, Plumbing

Contact a handyman or DIY project

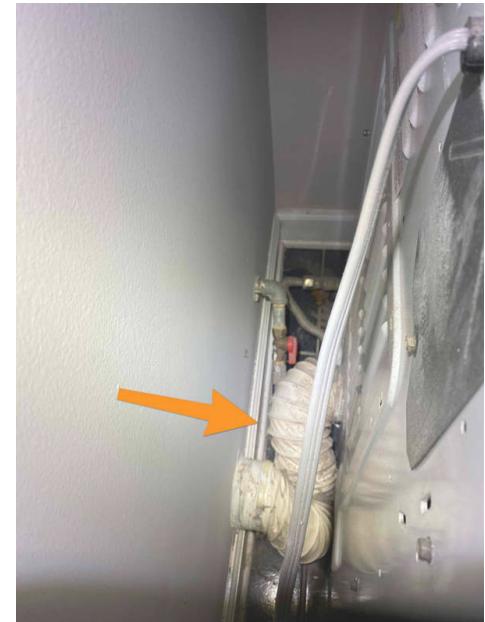
Deficiencies**DRYER EXHAUST DUCT: FLEXIBLE PLASTIC EXHAUST DUCT**

The dryer exhaust was discharged using a flexible, ribbed plastic duct that is not approved by the Underwriter's Laboratory (UL). This type of dryer exhaust duct is more likely to accumulate lint than a smooth metal vent, creating a potential fire hazard. Excessive lint accumulation can also increase drying time and shorten the dryer's lifespan. Recommend replacing this plastic duct with a properly-installed, UL-approved dryer duct.

Contact a qualified professional.

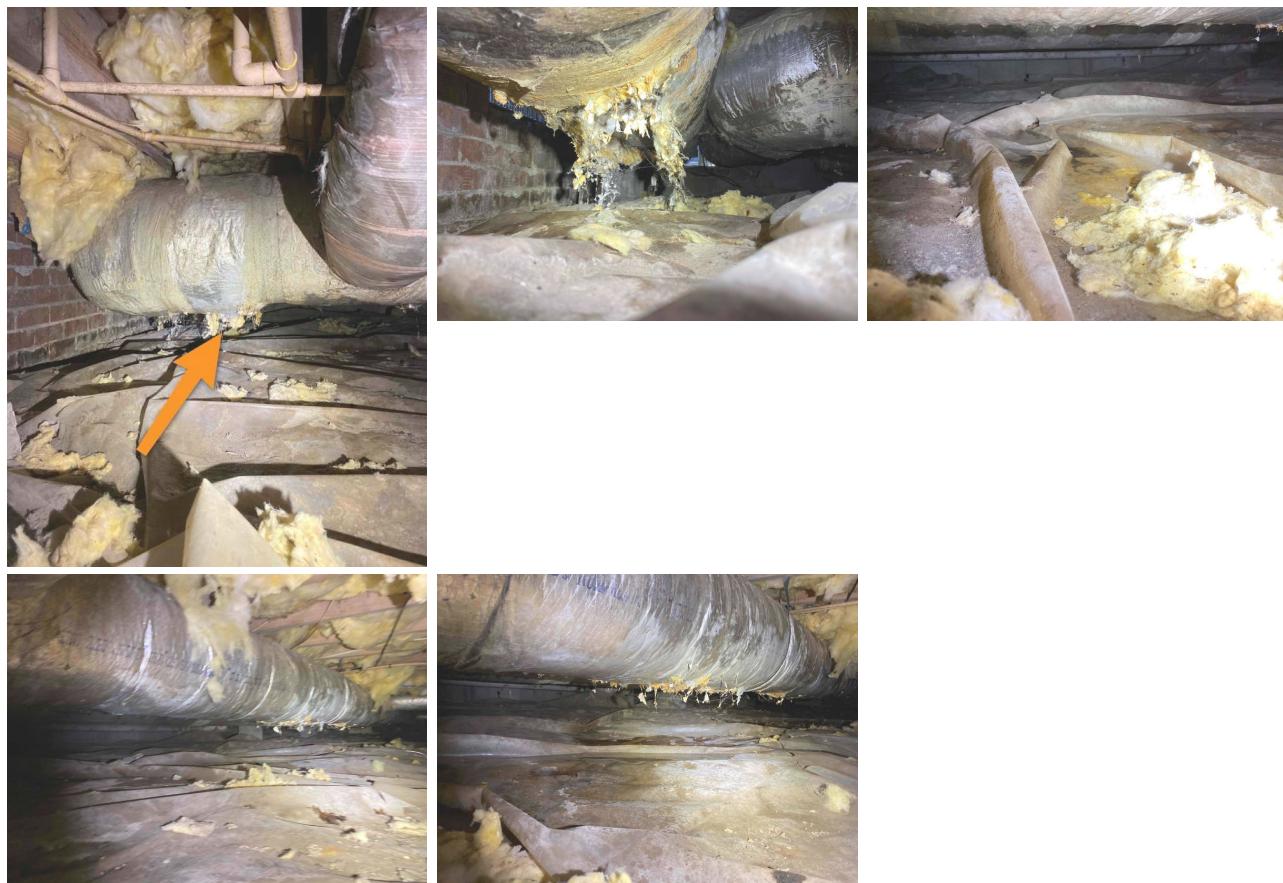
DUCTWORK CRAWLSPACE: DUCT INSULATION DAMAGED/ MODERATE SWEATING

- Several areas of duct insulation was damaged, exposing the duct beneath.
- Many sections of ductwork were sweating, resulting in standing water on top of the vapor barrier. While not uncommon to find sweating ductwork in crawlspaces on a hot day, this can potentially indicated areas of air leakage at the seams.

Recommend a qualified hvac contractor evaluate and repair or replace.

Contact a qualified HVAC professional.

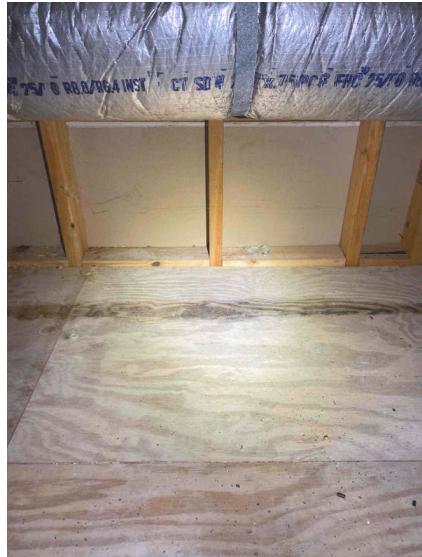
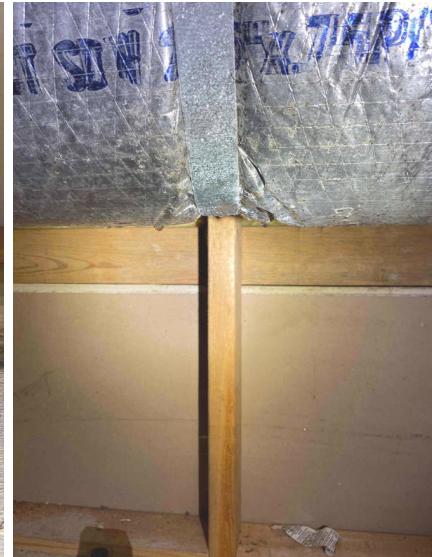
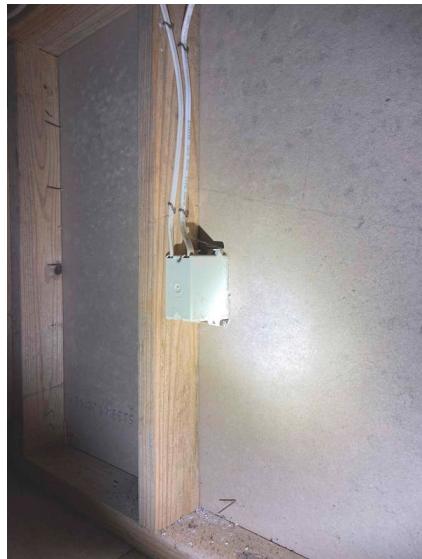
9.3.2 Distribution System

DUCTWORK ATTIC: SWEATING CAUSING MOISTURE DAMAGE**- Deficiencies**

Contact a qualified professional.

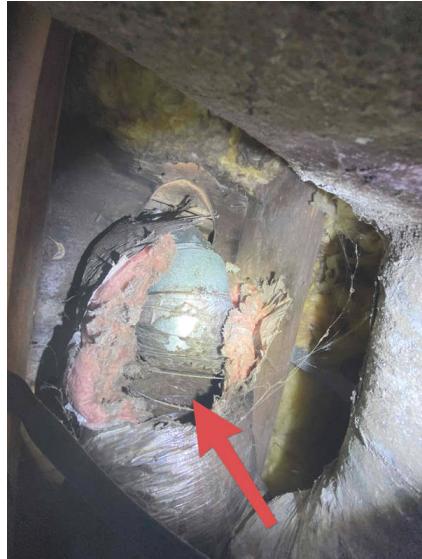
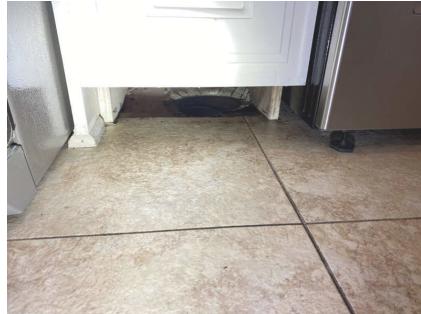
Kitchen

**SUPPLY DUCT: DAMAGE/ SIGNIFICANT HOLE
VENTING INTO CRAWLSPACE**

Contact a qualified HVAC professional.

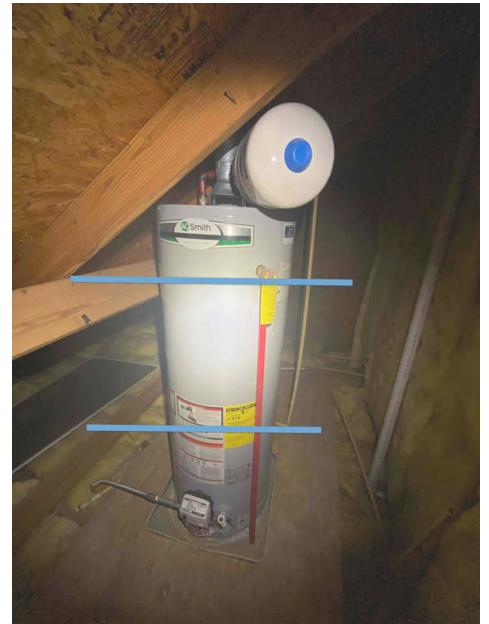
Water heater flame is yellow and irregular. Yellow flames can be caused by multiple variables, including but not limited to:

- Lack of combustion air
- Clogged main burner
- Flue blocked possibly

Because of this the unit was manually turned off. Recommend a licensed plumber evaluate and repair.

SEISMIC STRAPS MISSING

Water heater is missing seismic straps which are recommended for the area. Recommend a qualified professional install on the top and bottom third of the tank.

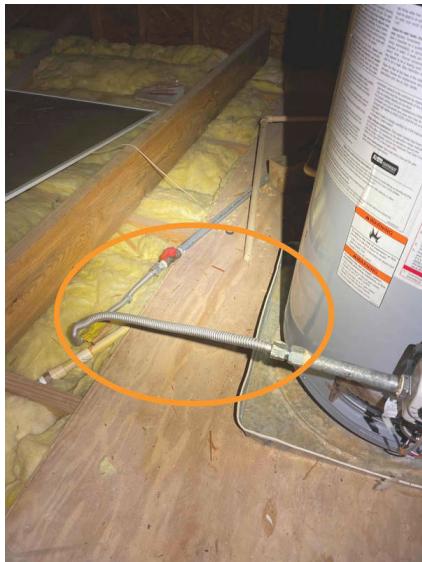
10.4.1 Fuel Shut Off

There is not a proper sediment trap located behind the shut off valve. These help catch and prevent sediment in the gas from entering the unit potentially causing damage. Recommend a licensed plumbing professional repair.

Contact a qualified plumbing contractor.

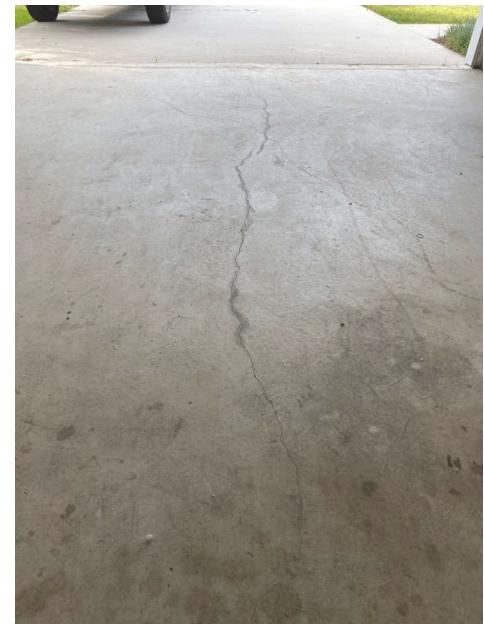
SLAB: MINOR CRACK

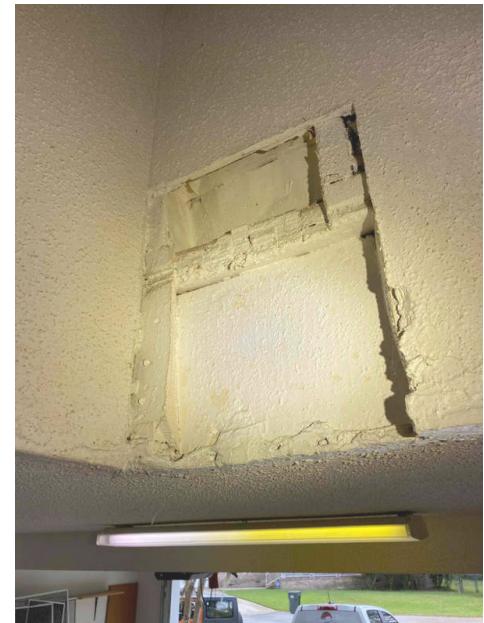
12.4.1 Ceiling, Walls & Firewalls

WALL: INCOMPLETE FIREWALL

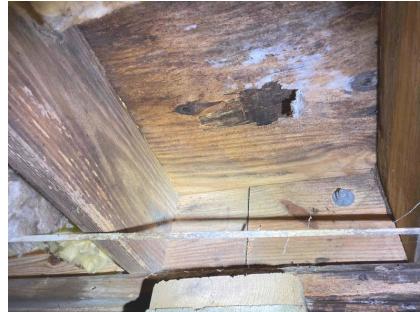
Far right side of the crawl

SUBFLOOR/ JOISTS: HIGH MOISTURE/ ORGANIC GROWTH/ DAMAGE

Several areas in the crawlspace exhibited high moisture from outside moisture intrusion, air leakage, possible leaking resulting in possible organic growth (lab analysis required to confirm) and rot. Recommend a qualified contractor correct the moisture intrusion points/ cause of excess moisture, evaluate the extent of the damage to the joists and subfloor, repair as needed, and remediate any growth as needed.
