FRAME STAGE INSPECTION

1234 Main St. Preston Victoria 3072

26/10/2020 9:00AM

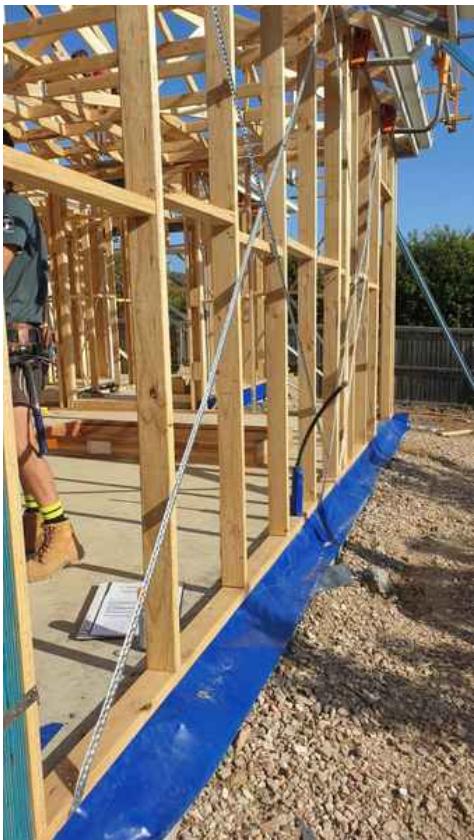
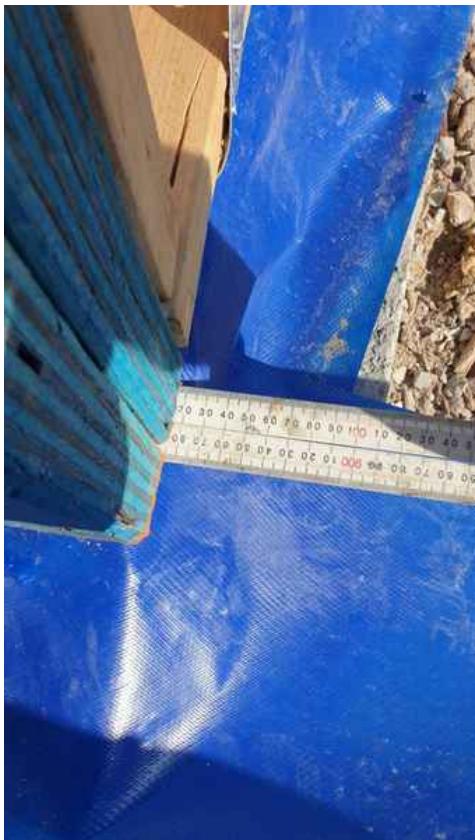
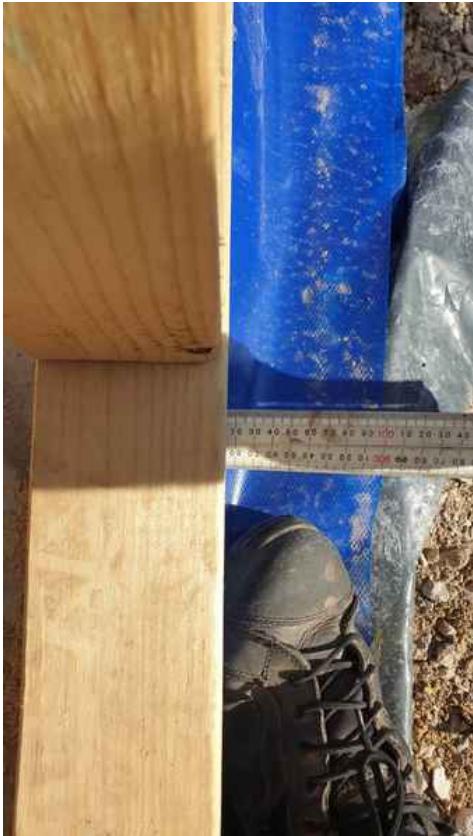
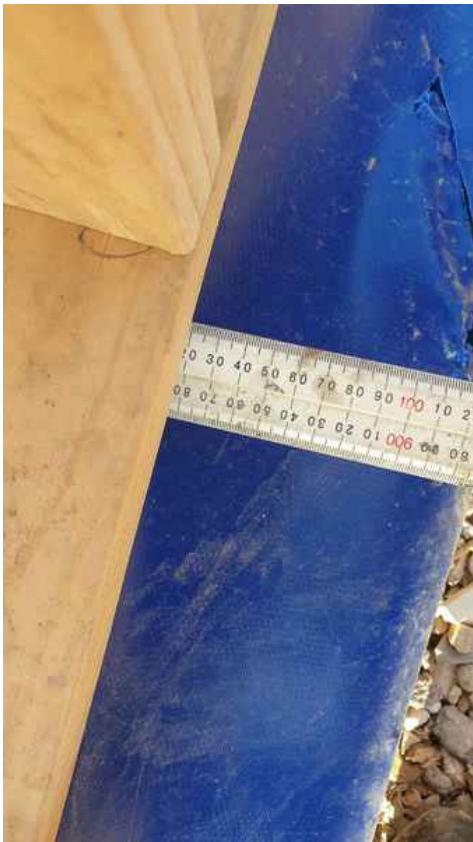
Garage Exterior Wall

Recommendation
Contact your builder.

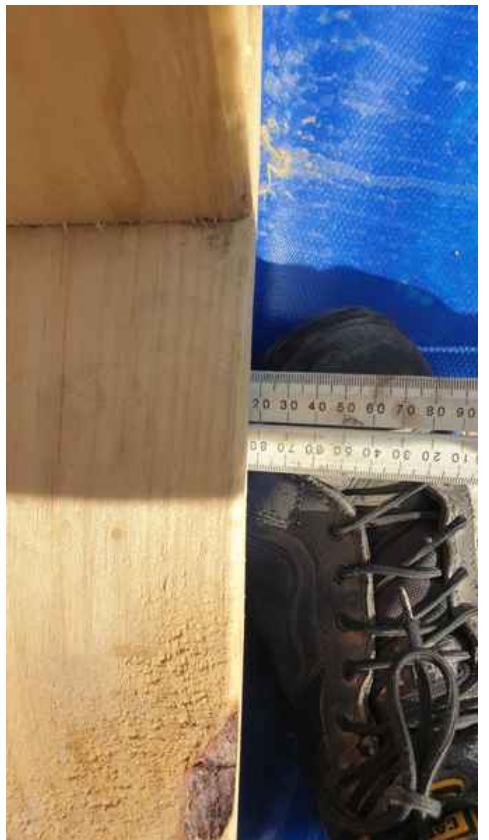
Garage Exterior Wall

The bottom plates of the external wall frames were overhanging the slab in excess of the maximum 10mm allowance and is deemed to be defective.

I recommend contacting the project engineer and confirm in writing a design resolution.

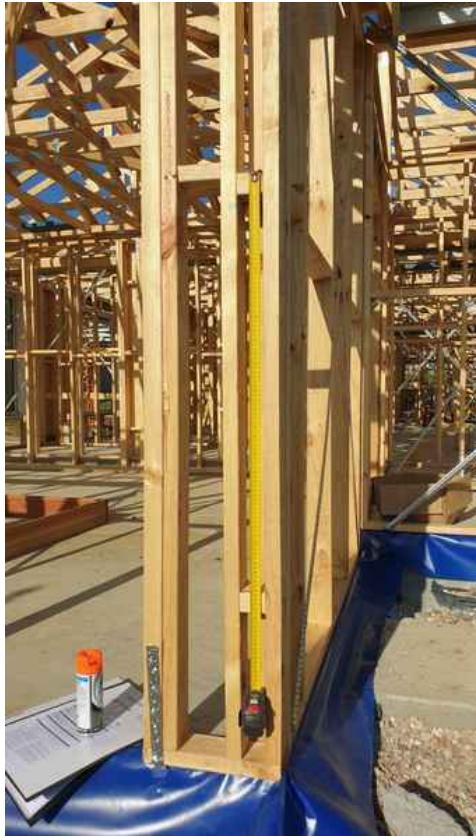
Garage Exterior Wall

The bottom plates of the external wall frames were overhanging the slab in excess of the maximum 10mm allowance and is deemed to be defective.

I recommend contacting the project engineer and confirm in writing a design resolution.

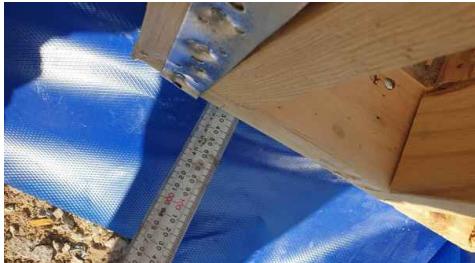
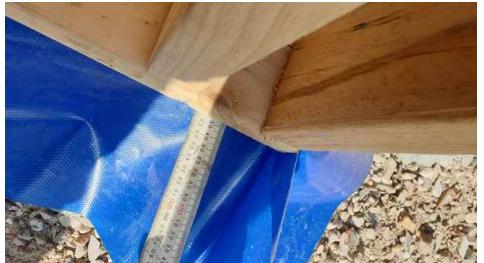
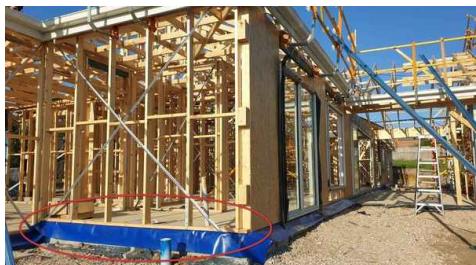
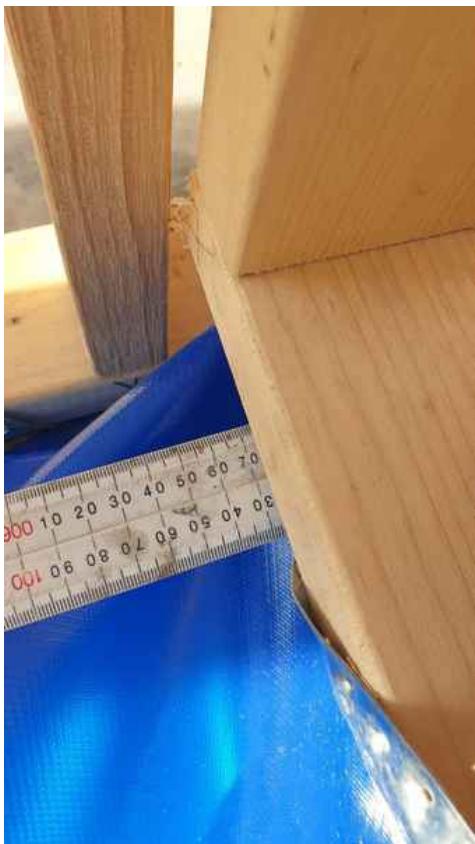
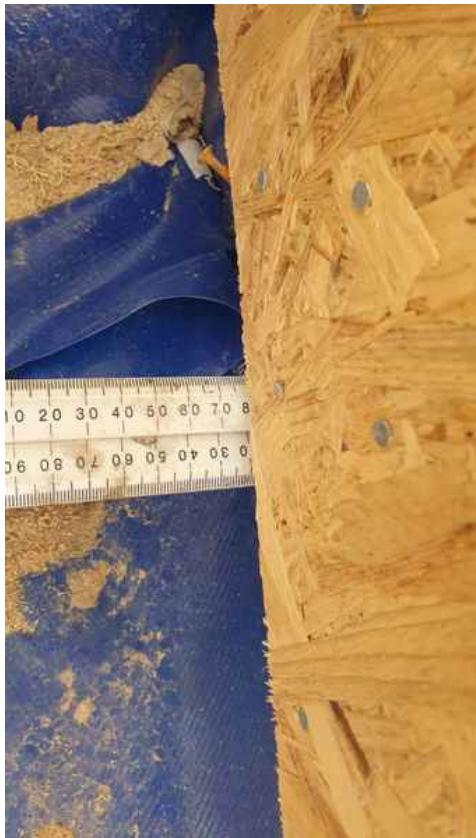
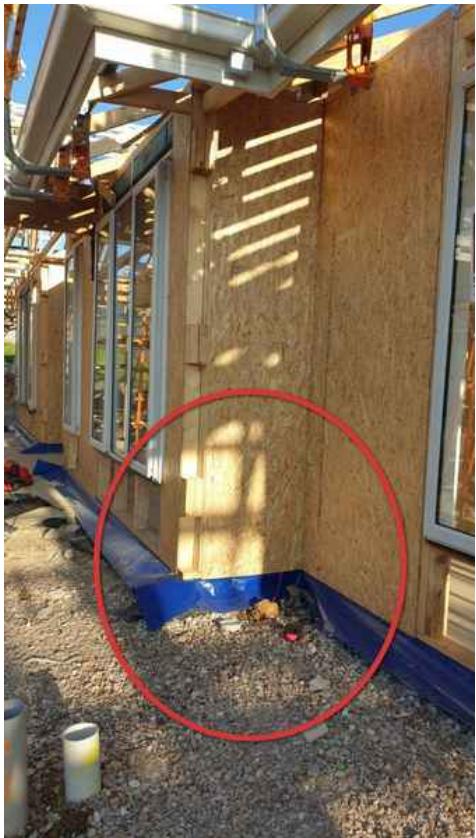
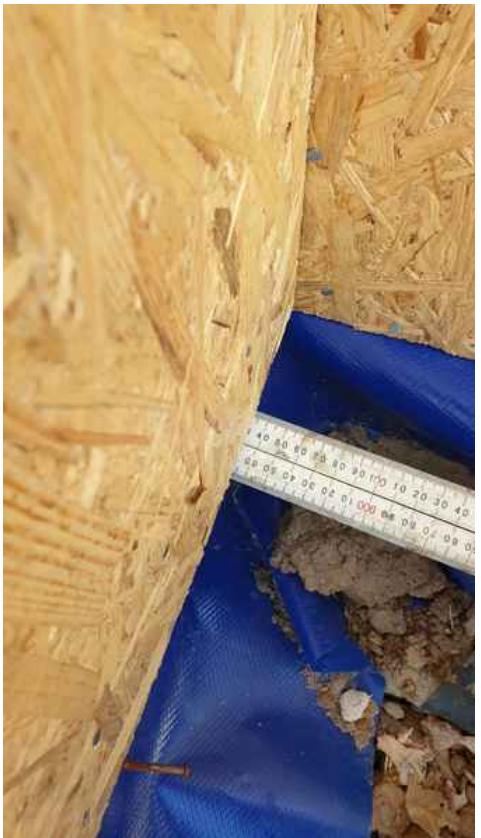
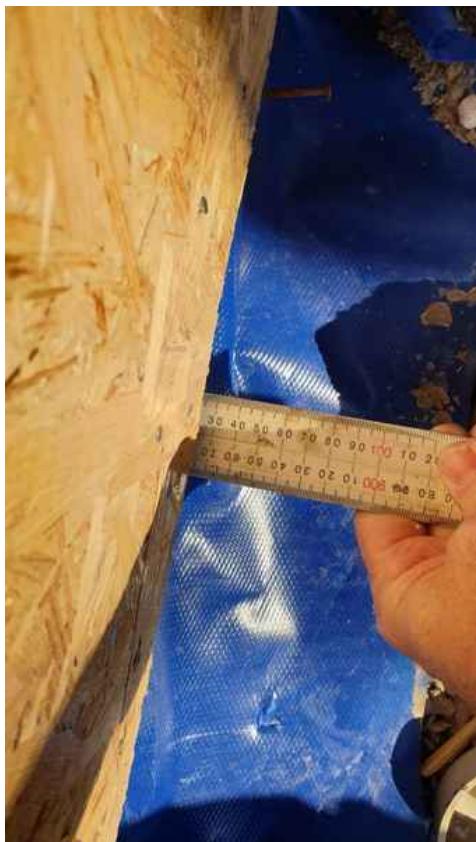
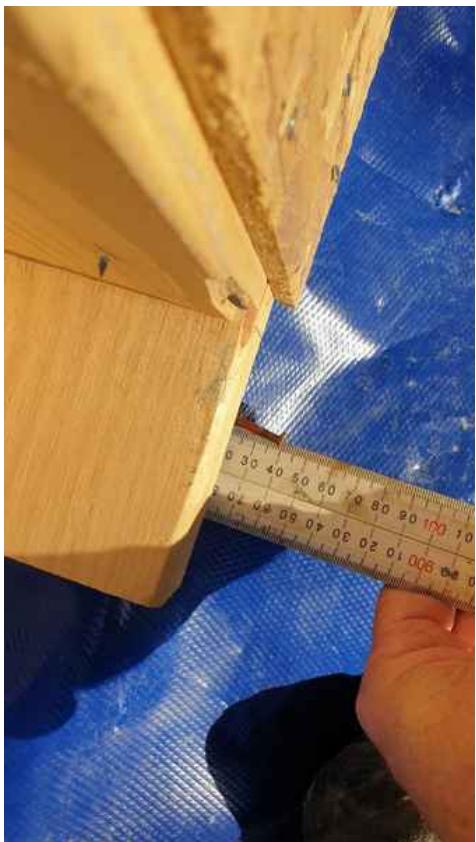
Garage Exterior Wall

Contact a qualified professional engineer

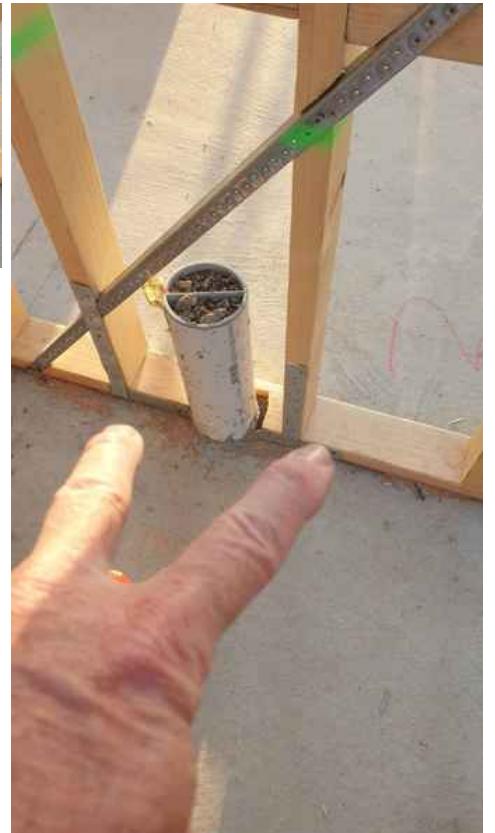
Additional bottom plate fixings required

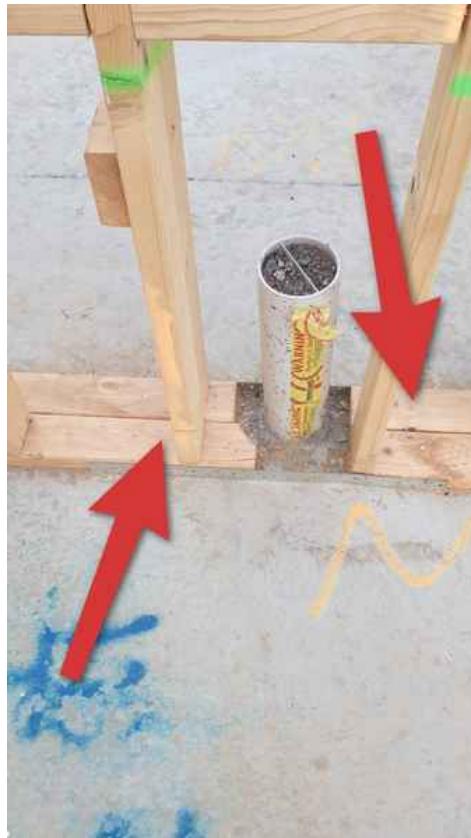
Additional bottom plate fixings required

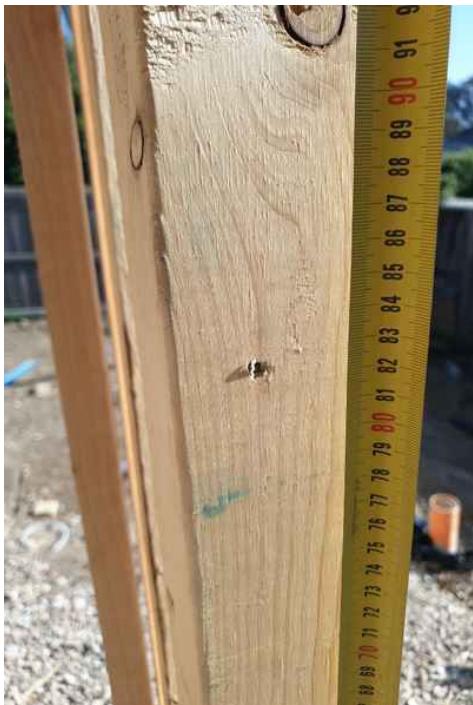
Garage Wall, Studs Laminated at approx 800mm centres, 600mm is the requirement.

Contact your builder.

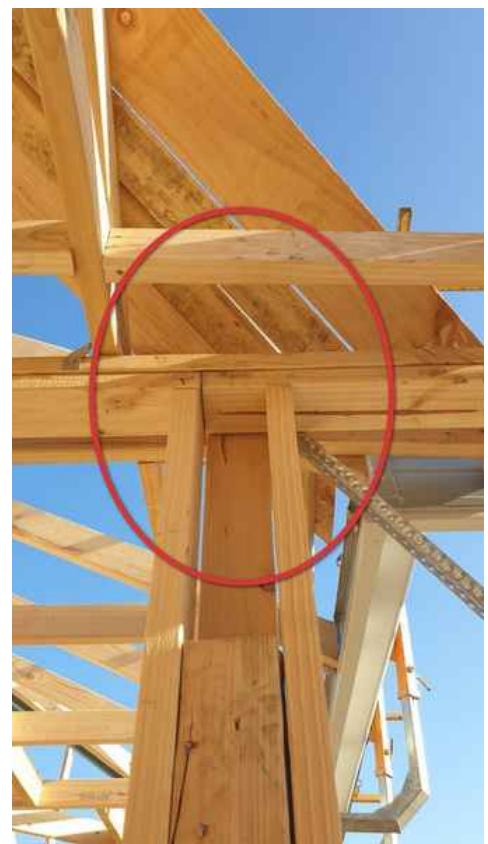
It was observed that the Top Plate(s) in one or more locations, have not been joined in compliance with Australian Standard 1684.2:2010

Garage / Laundry Wall Junction. Provide Top Plate Jointing as Required by AS1684.2:2010 Part 6.2.2.4 and Section 9

I recommend joining all Top Plate(s) as

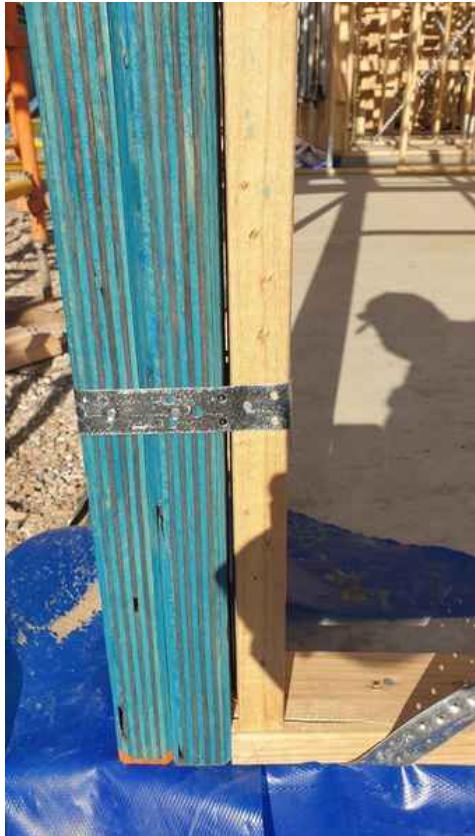
Insufficient or non-existent wall blocking was observed at intersecting walls in the nominated locations throughout the structure.

Garage Exterior, Wall Junction not tight and securely fixed. This workmanship can lead to cracking plasterboard of the internal junctions.

I recommend fixing all wall junctions in compliance with AS1684.2:2010

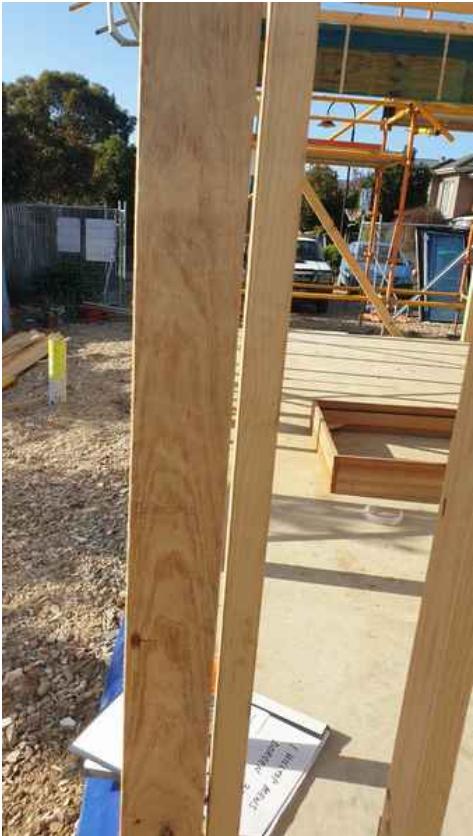
Garage Exterior, Wall Junction not tight and securely fixed. This workmanship can lead to cracking plasterboard of the internal junctions.

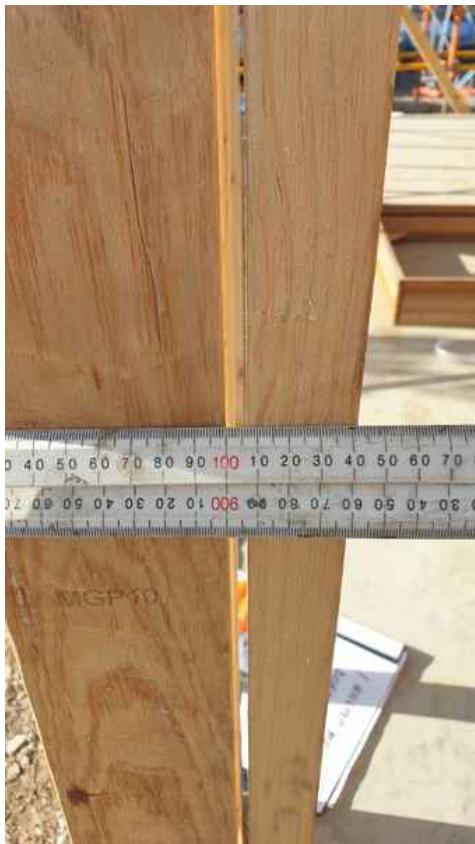
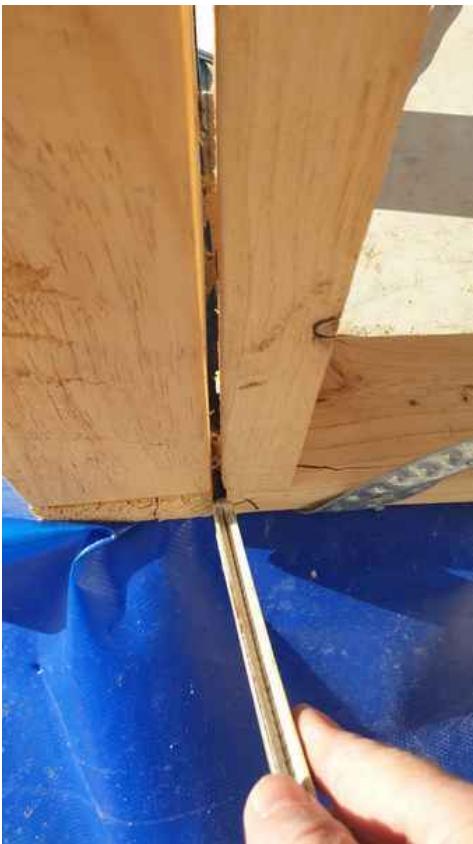
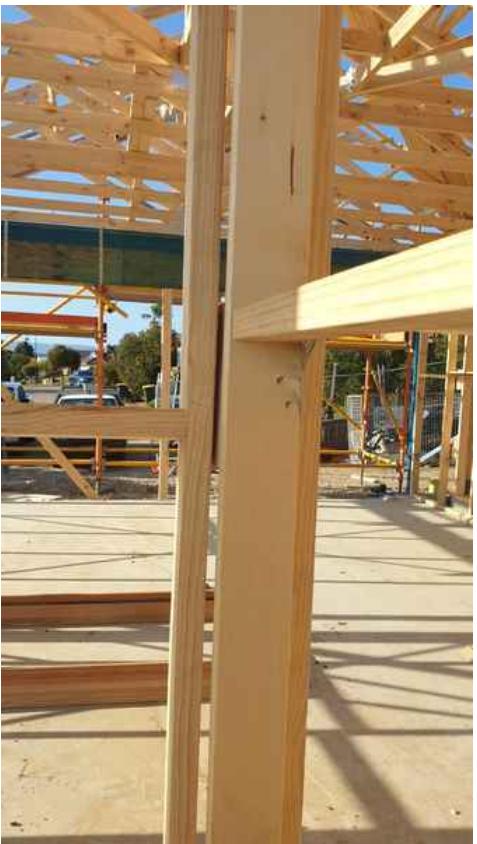
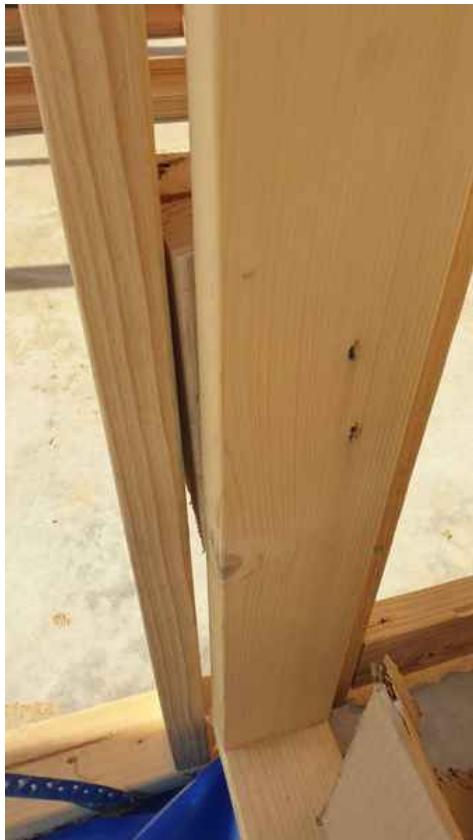
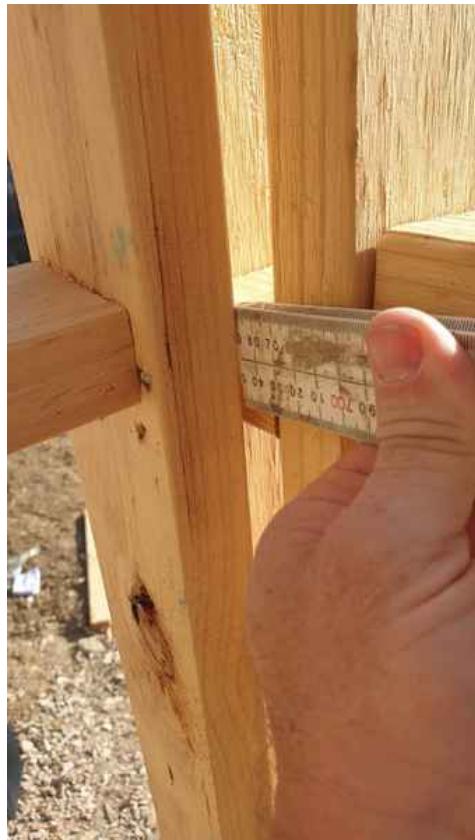
Garage Exterior

Recommendation
Contact your builder.

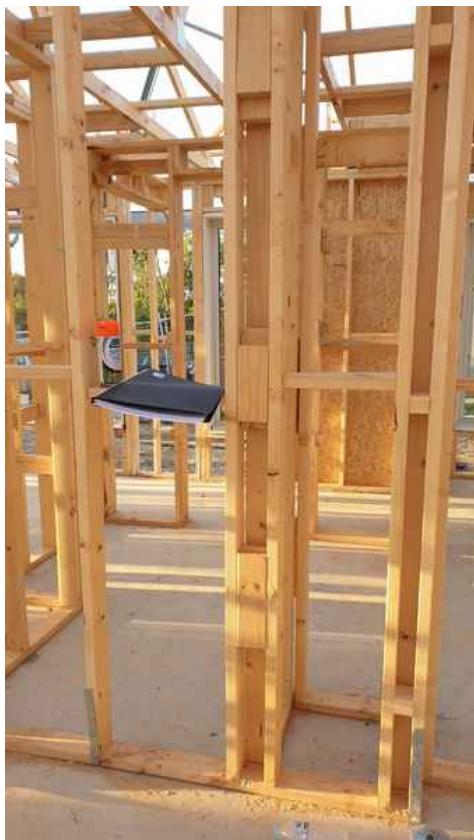
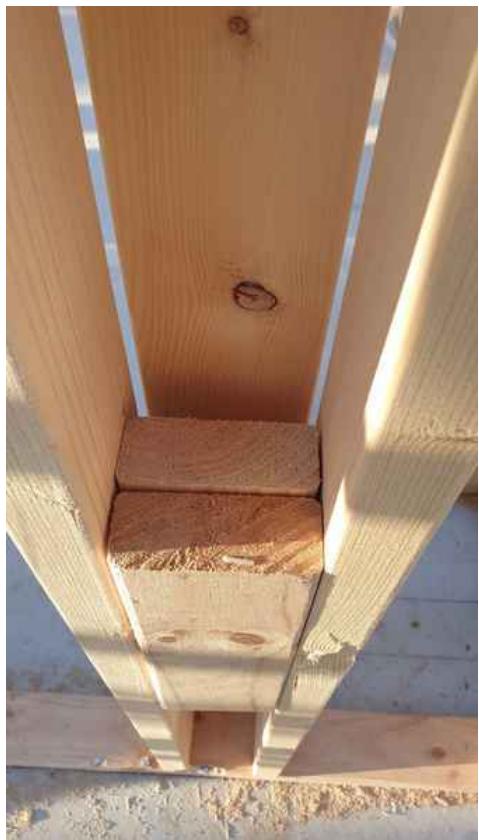
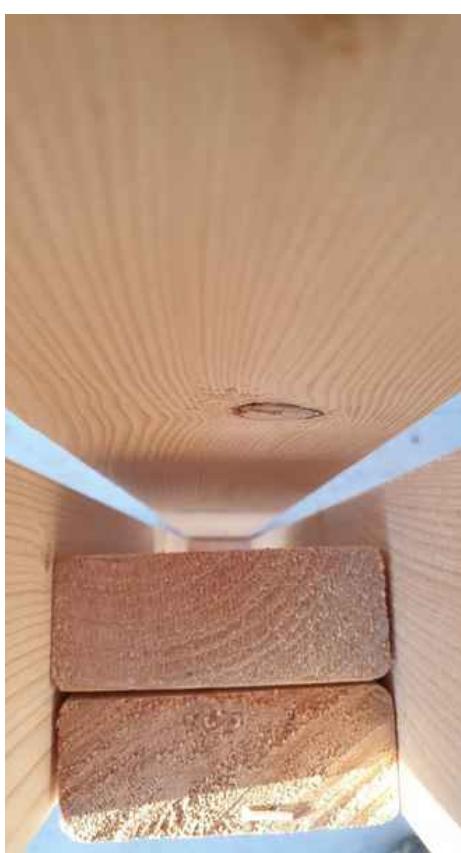
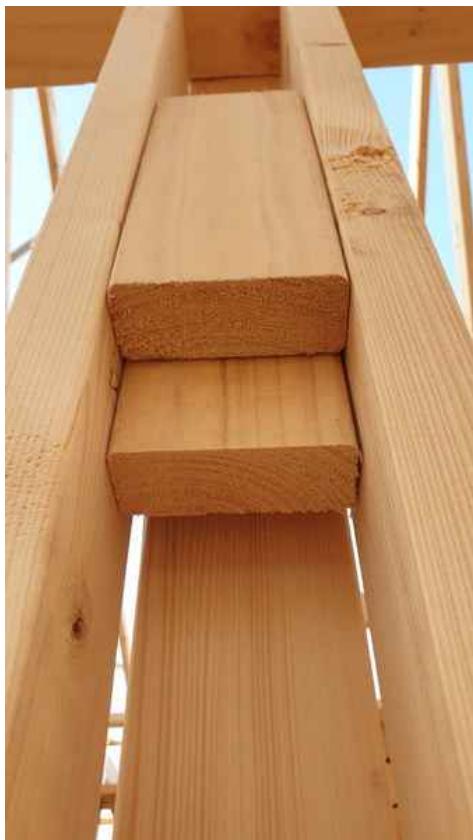
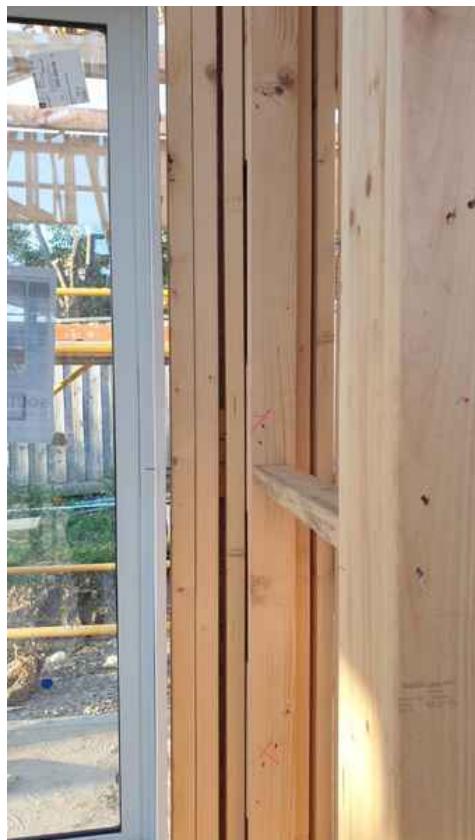
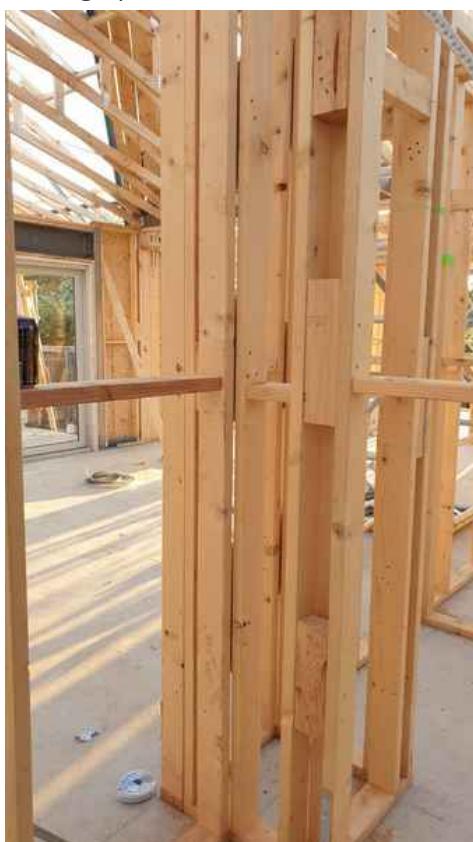
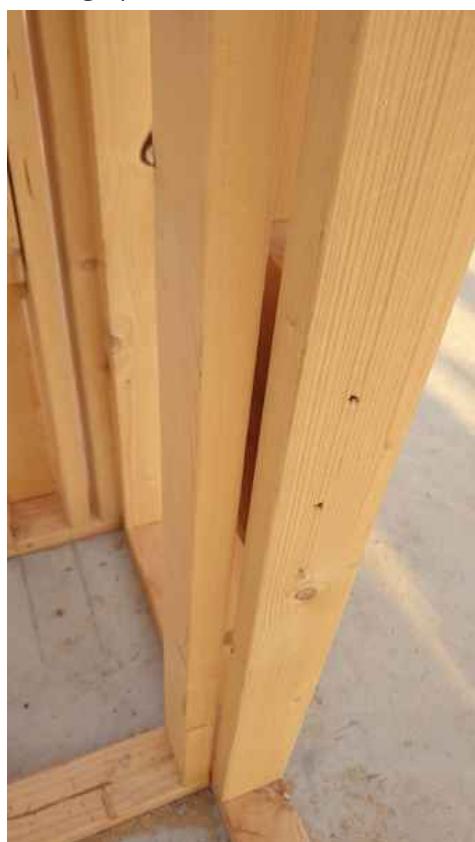
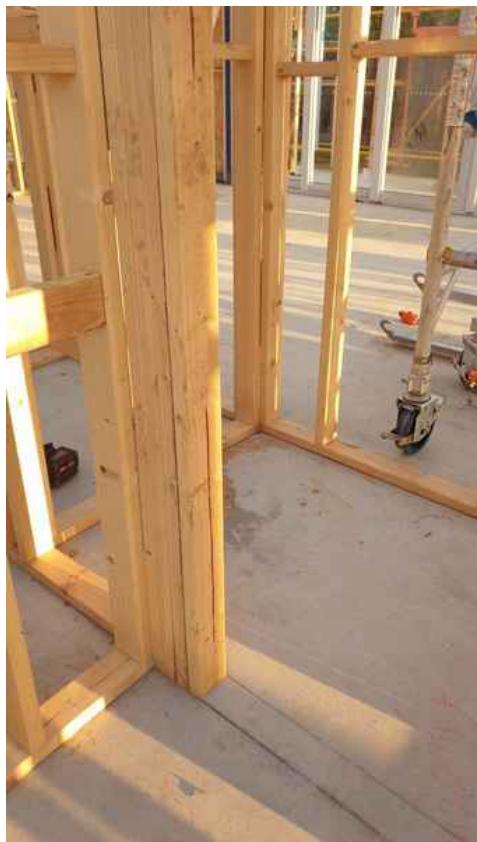
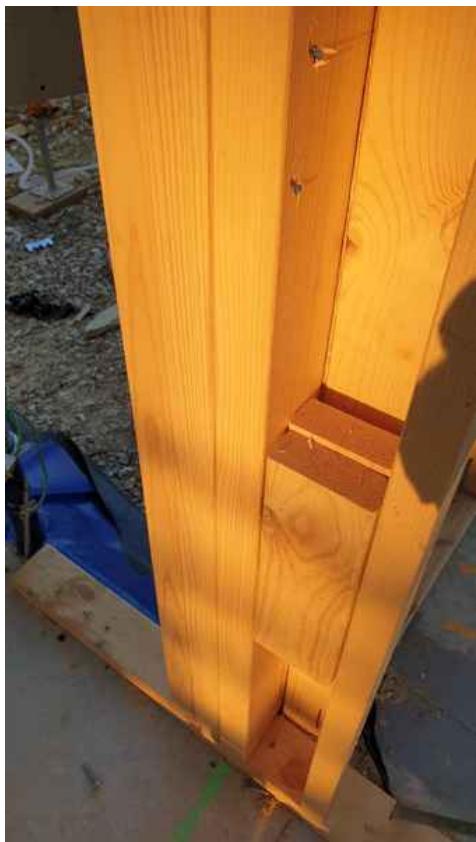
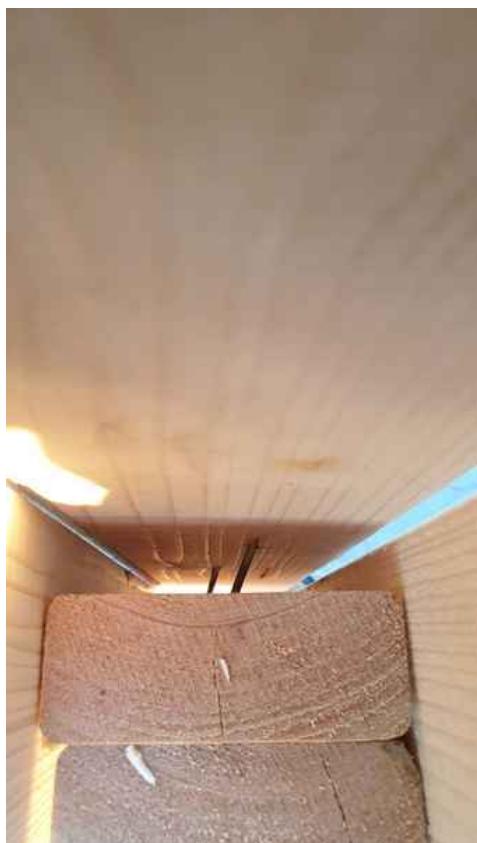
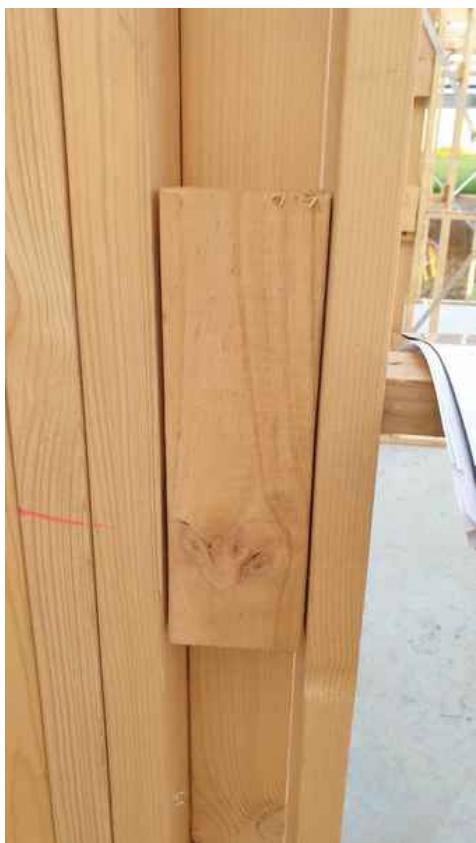
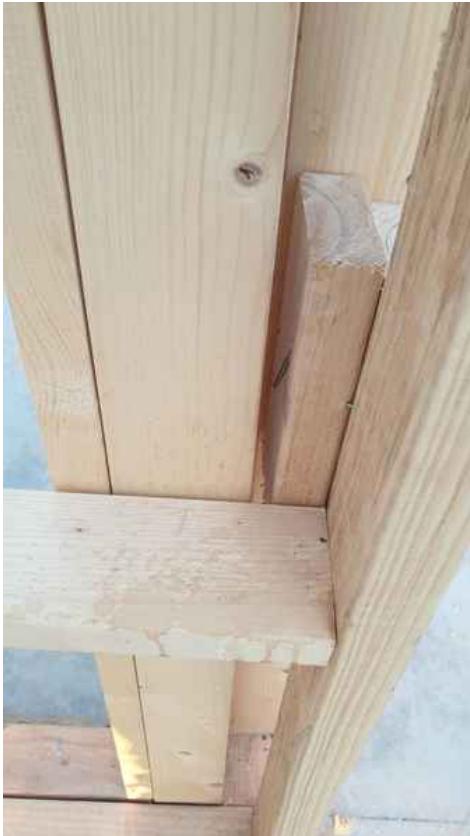
Internal wall Junction Sample Photographs

The builder may claim that the internal connections will be undertaken at lockup stage, however, this procedure fails to take into account, what holds the dwelling up in the time between now and lockup stage completion?

I recommend fixing all wall junctions as required by AS1684.2:2010

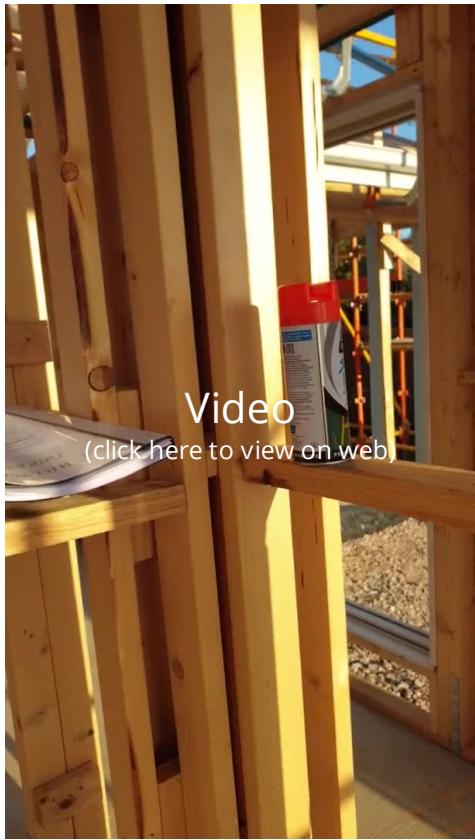
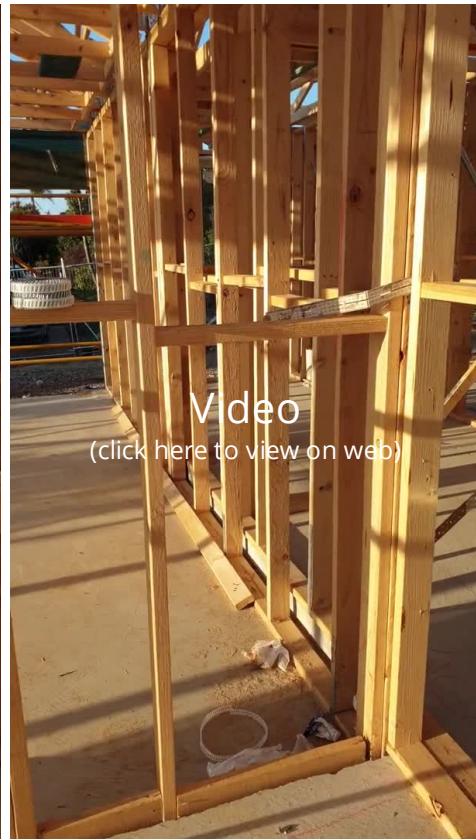
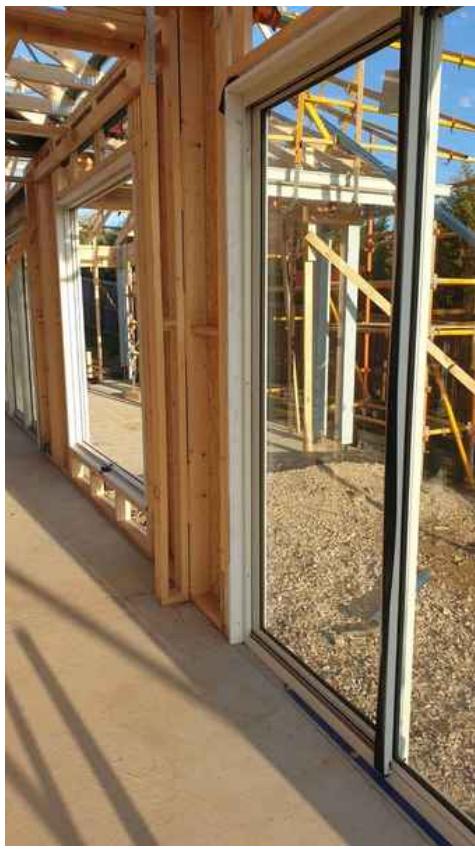
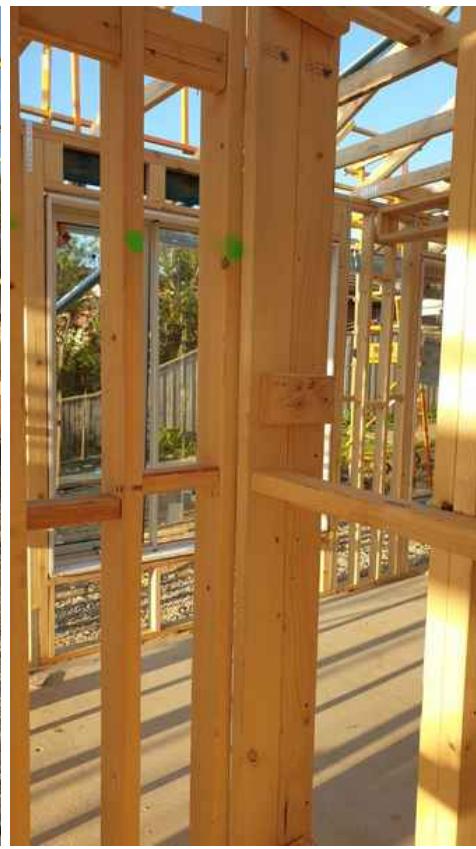
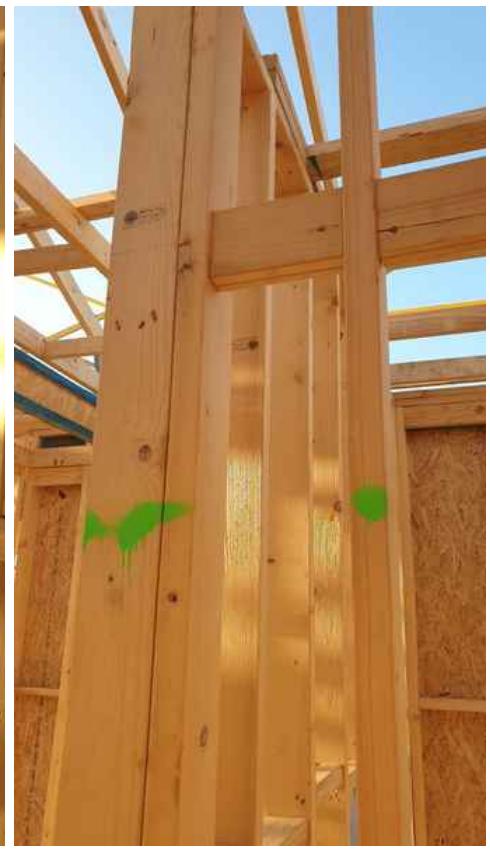
Stud spacing in one or more locations was observed to be greater than the maximum of 600mm centres.

I recommend installing extra studs as required to reduce spacings to a maximum of 600mm centres.

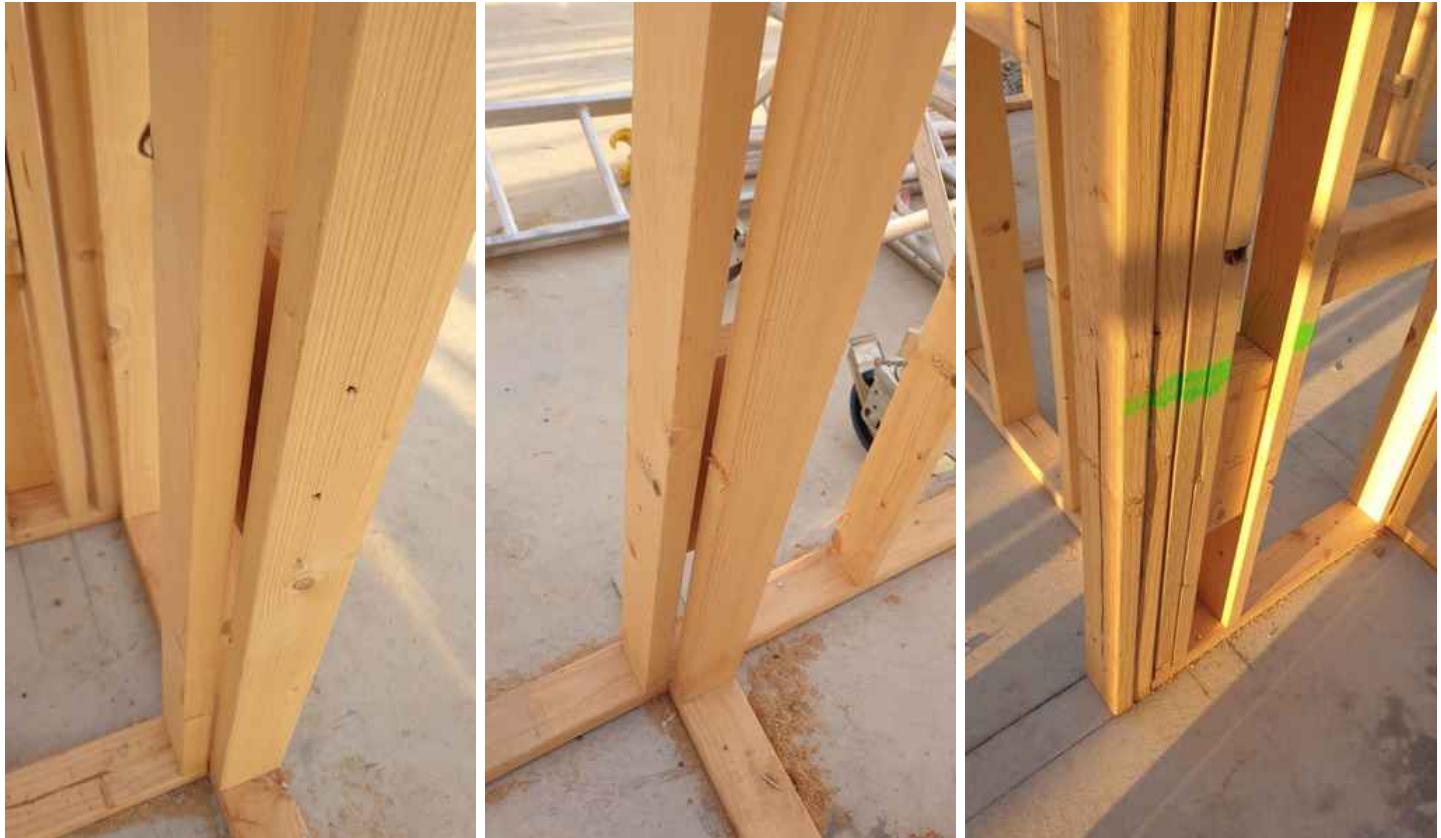
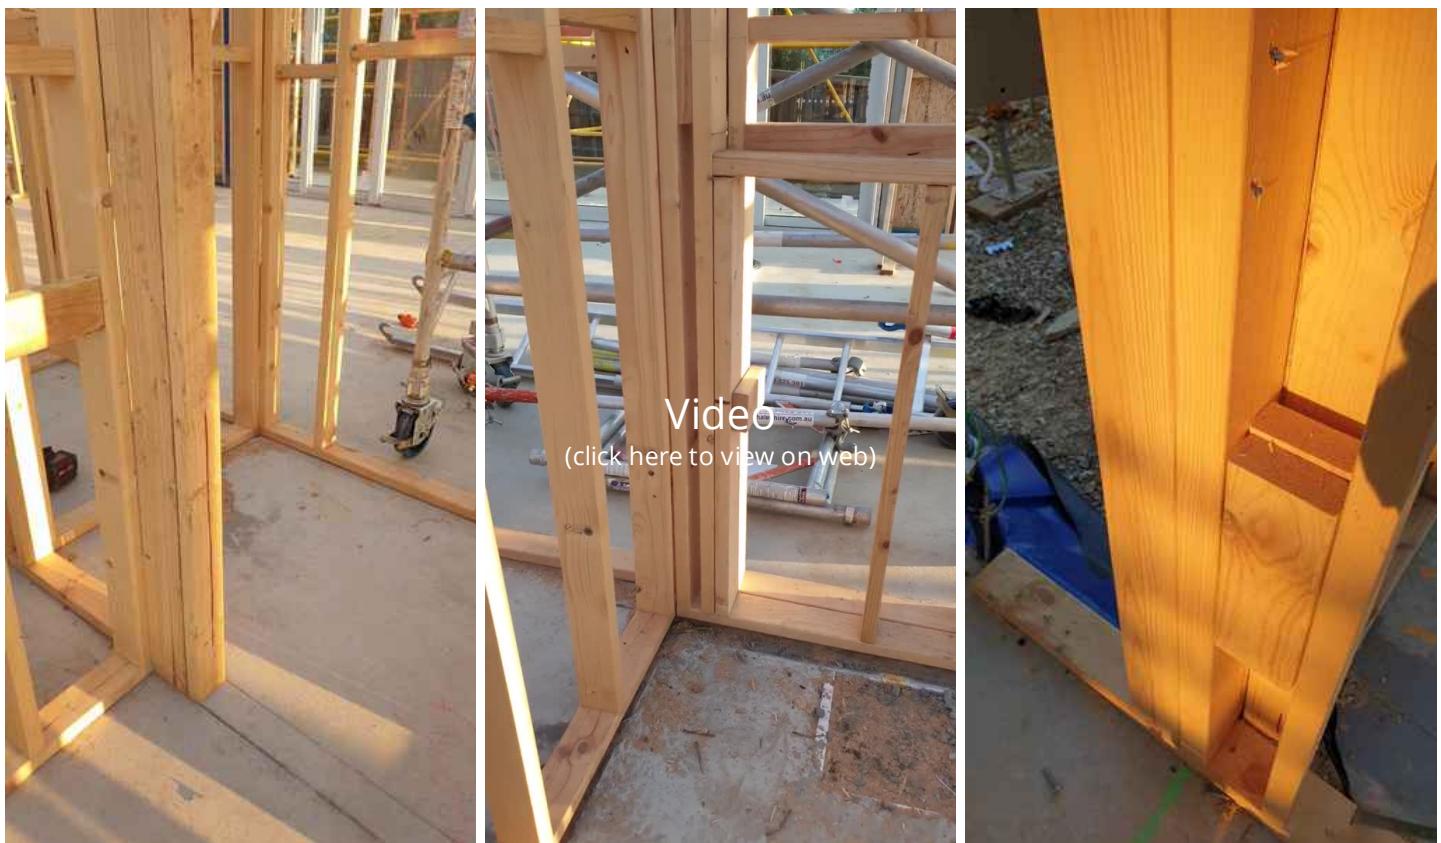
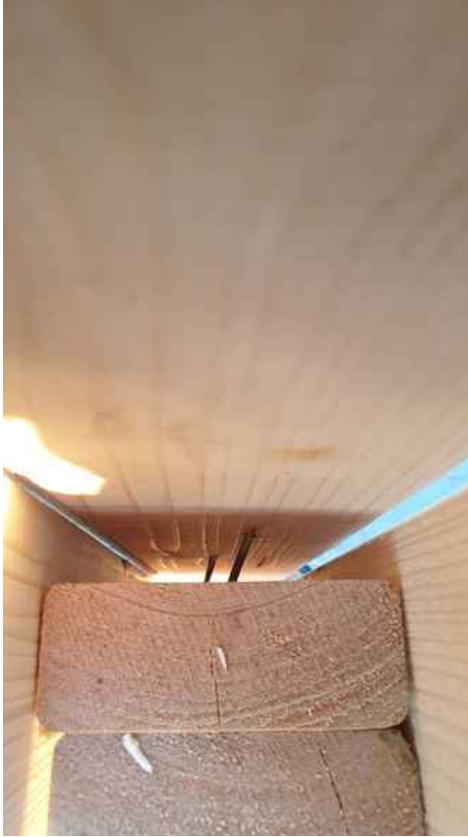
5.2.7 Wall Framing **STUD CENTRES**
