FRAME STAGE INSPECTION

1234 Main St. Preston Victoria 3072

26/10/2020 9:00AM

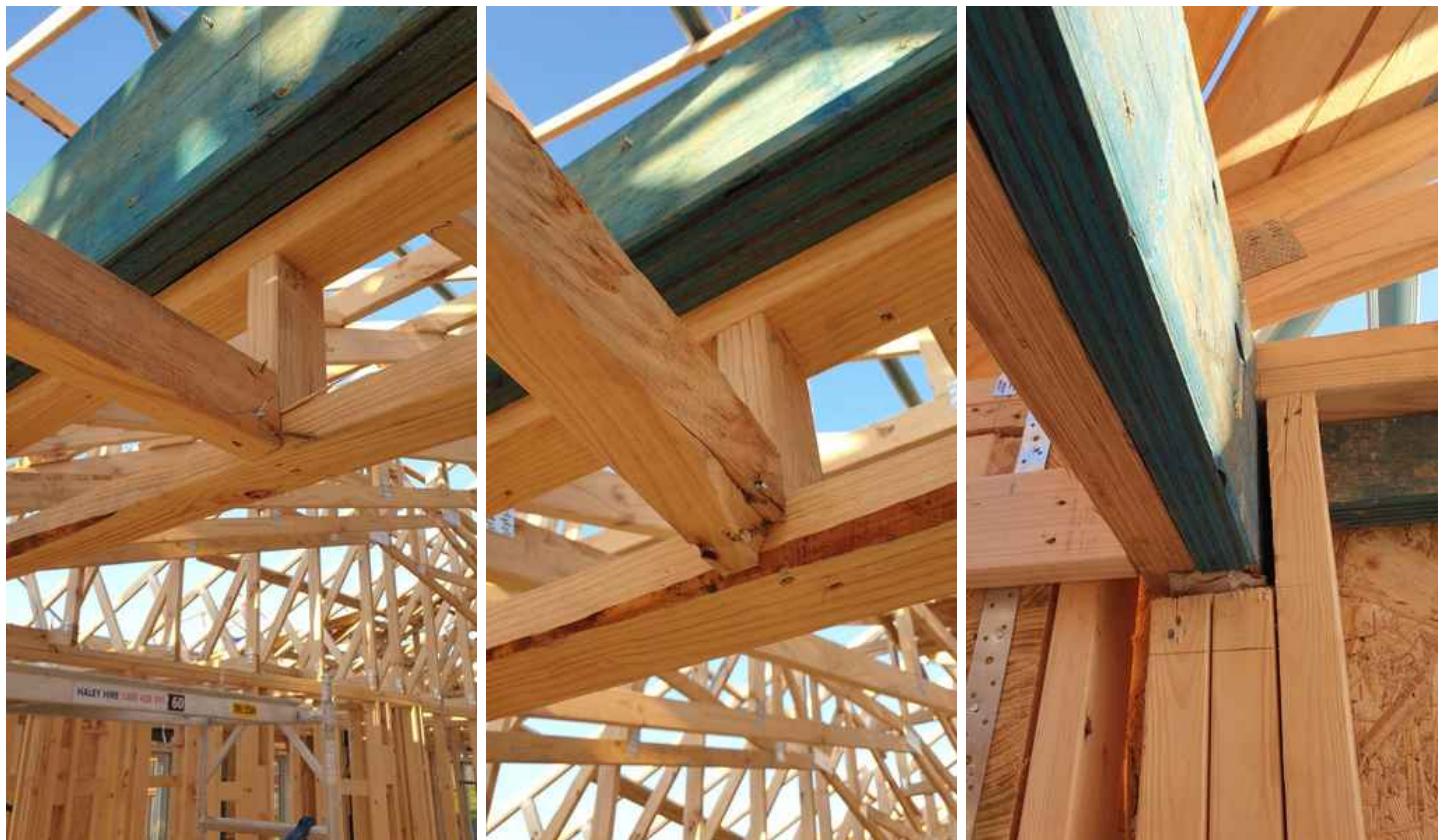
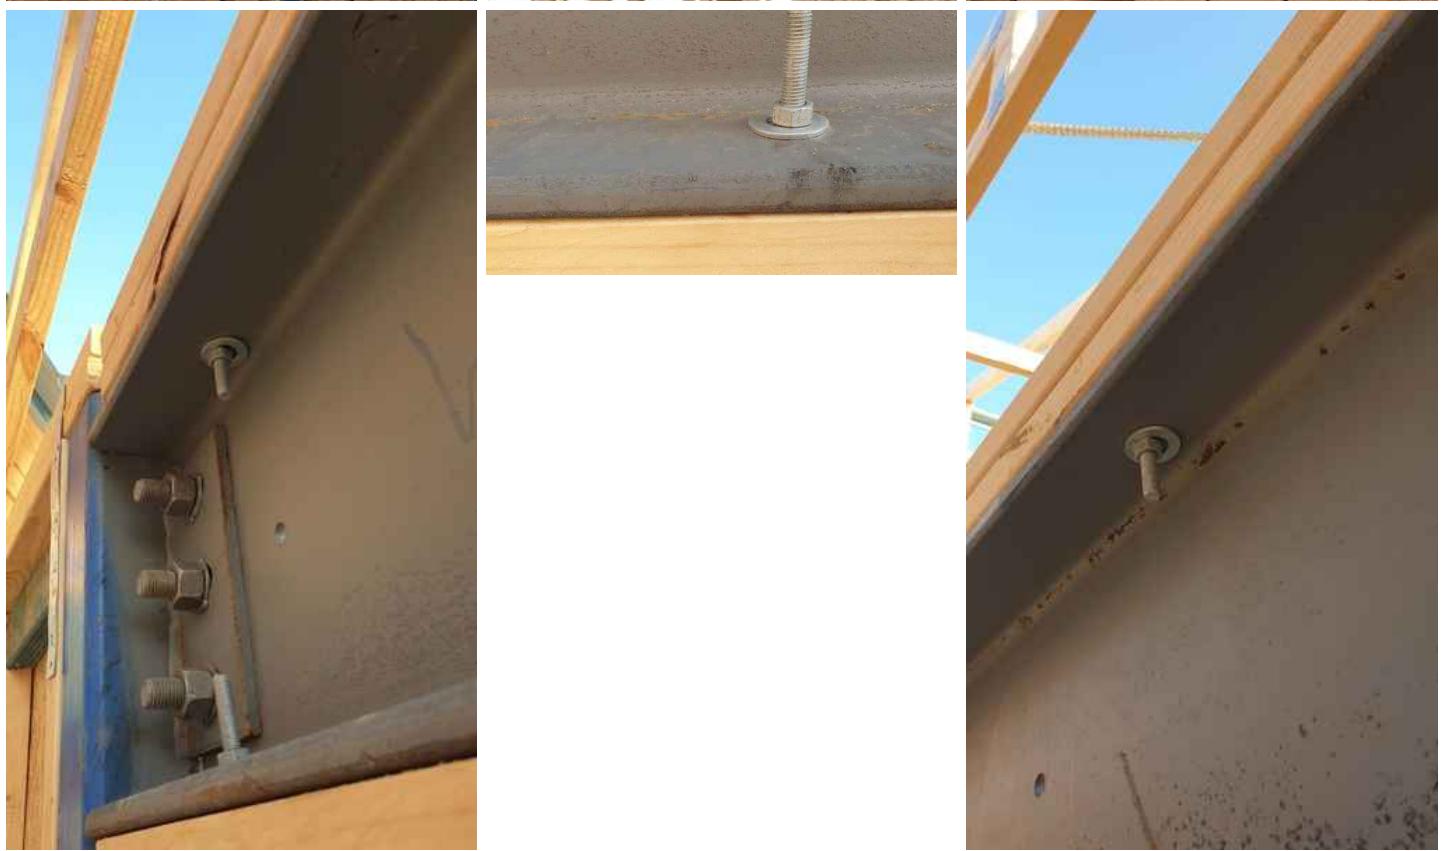
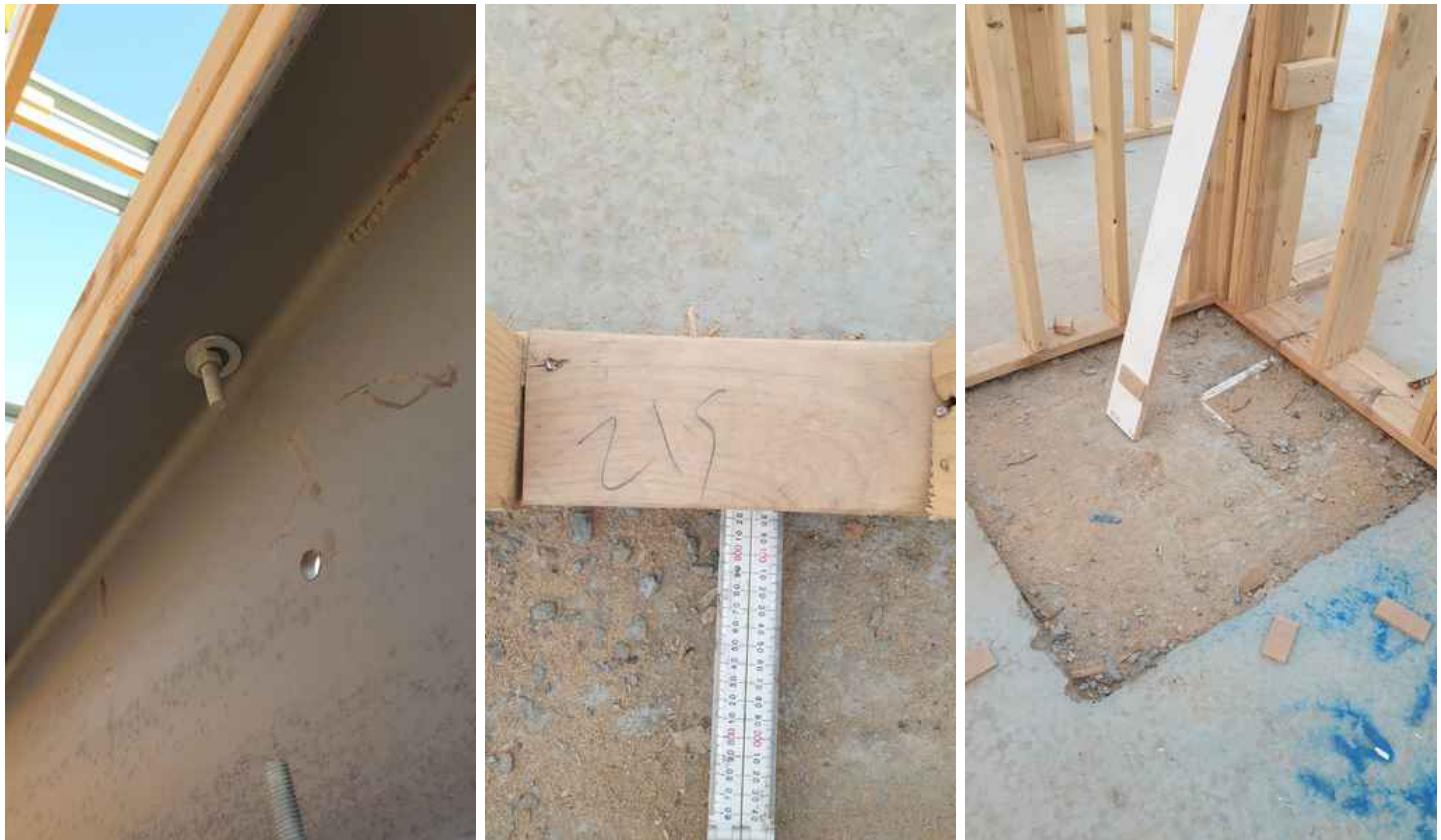
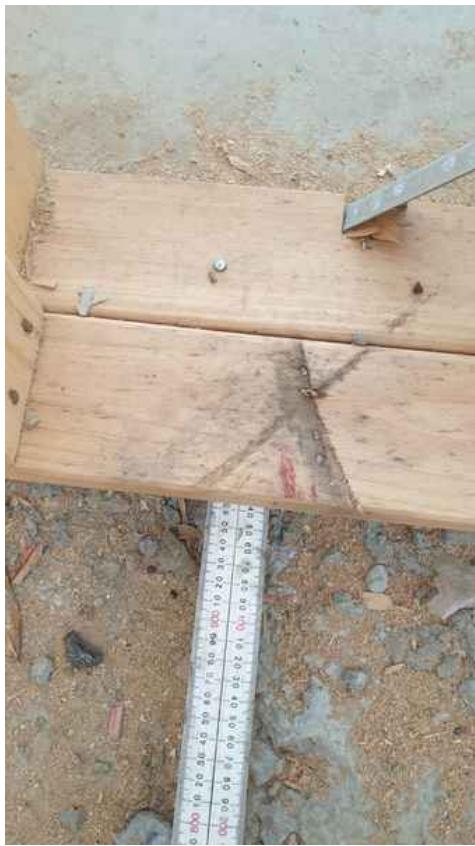
5.2.9 Wall Framing **UNSUPPORTED LOAD BEARING STUDS**

A section of wall framing was found to be inadequately support and fixed to the concrete slab.

I recommend fully supporting the bottom plates with particular care taken at concentrated load bearing points.

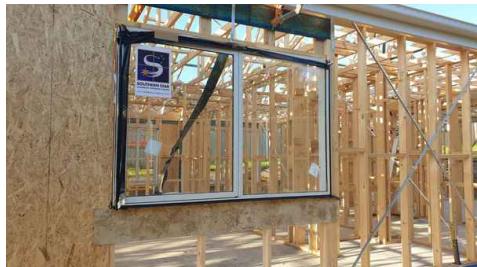
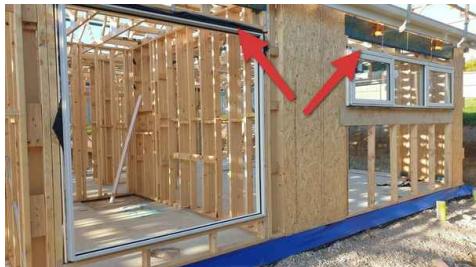
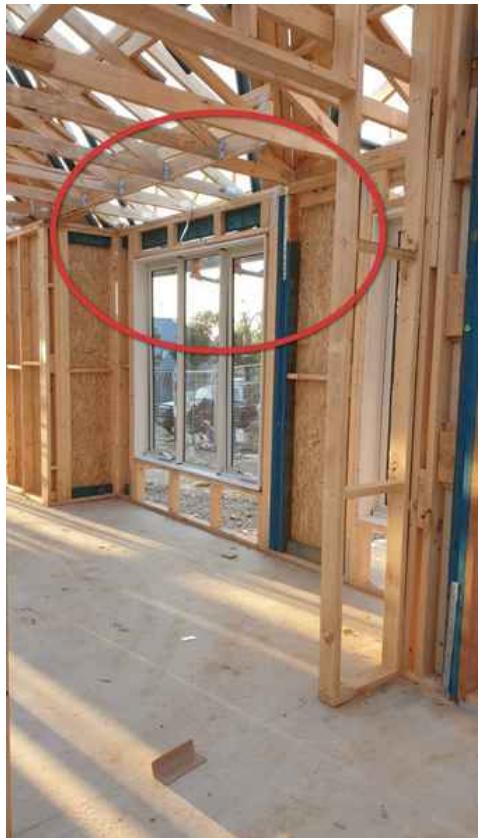
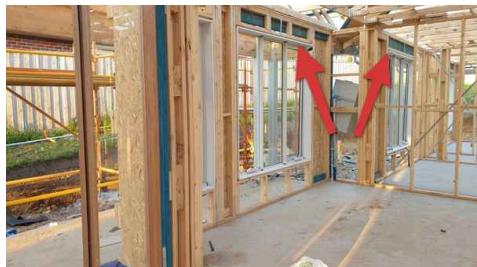
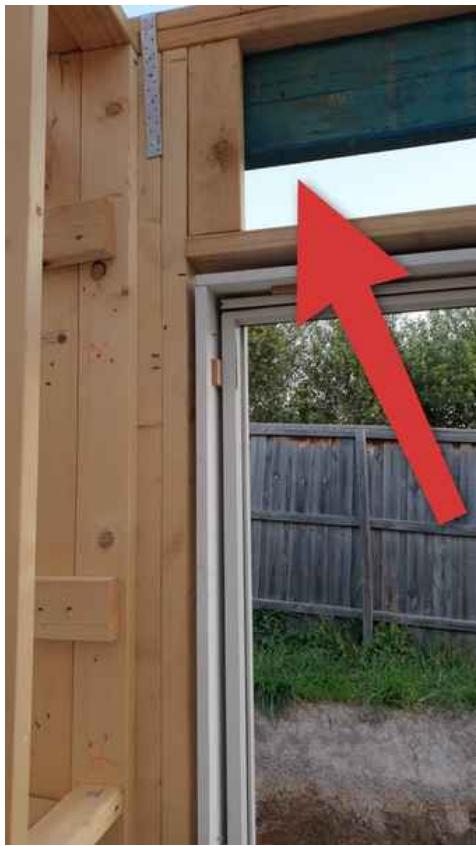
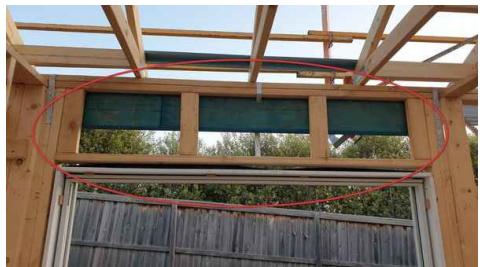
Missing Jack Studs

I recommend installing jack studs in compliance and as required by AS1684.2:2010 throughout the structure.

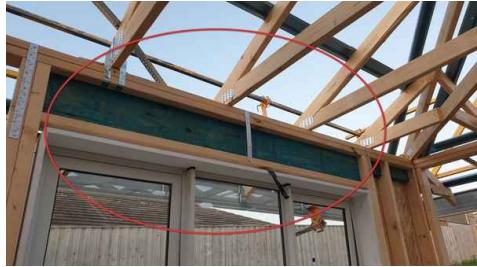
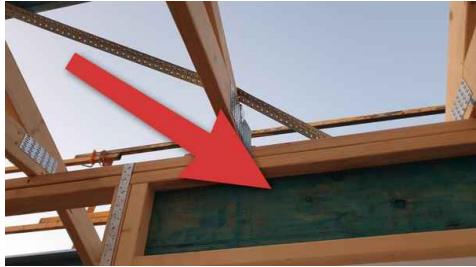
It was observed that openings framed with Jamb studs and lintels, had "Jack" studs installed with an incorrect orientation or not installed at all.

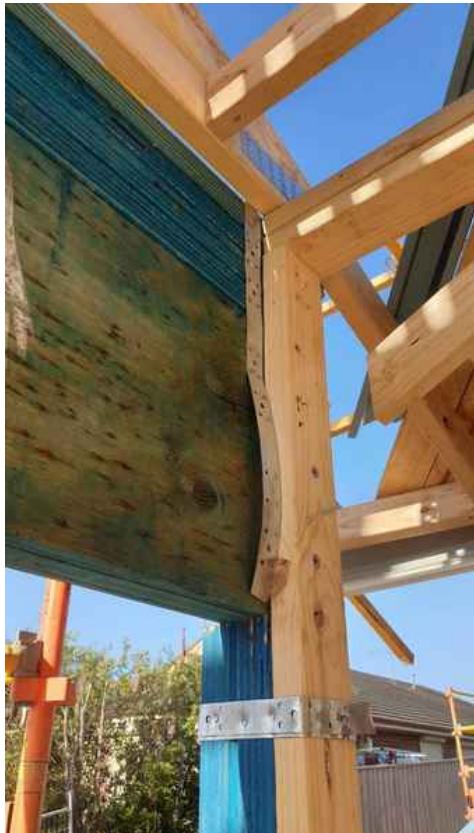
Garage

Tie-down fixing was observed to be incomplete in one or more locations.

I recommend completing tie-down fixing in compliance with AS1684.2:2010.

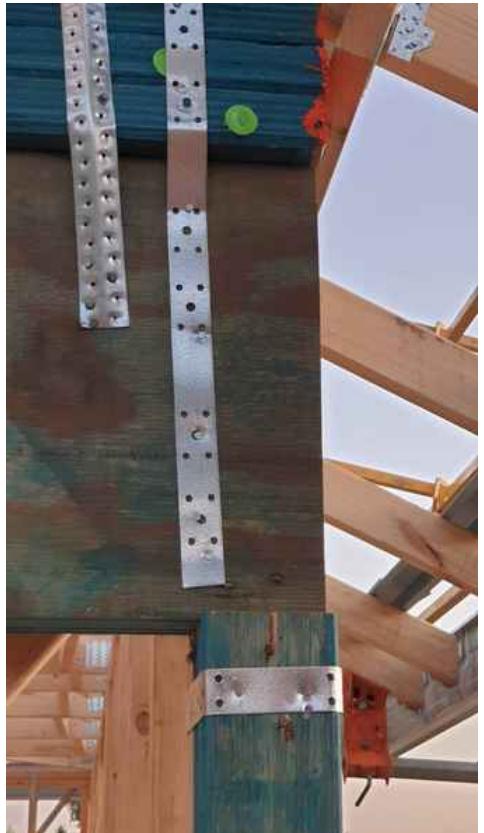
Garage lintel not tied to stud

I recommend tying the garage lintel to the roof structure as required the truss manufacturer installation guide and by Australian Standard 4440:2004

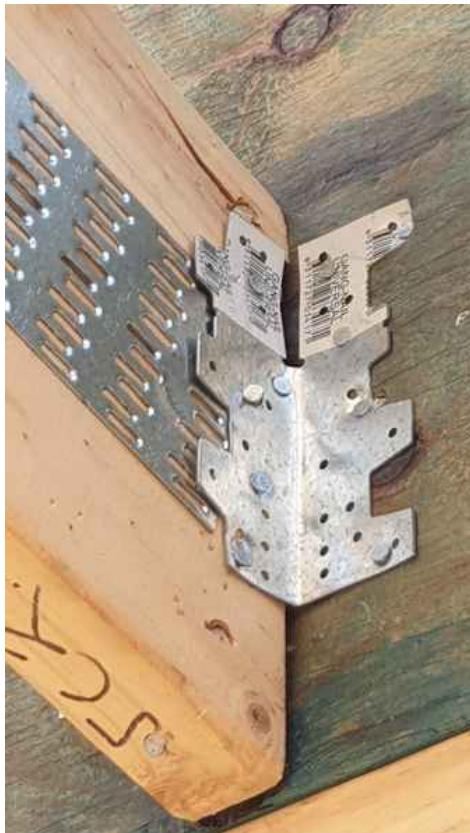
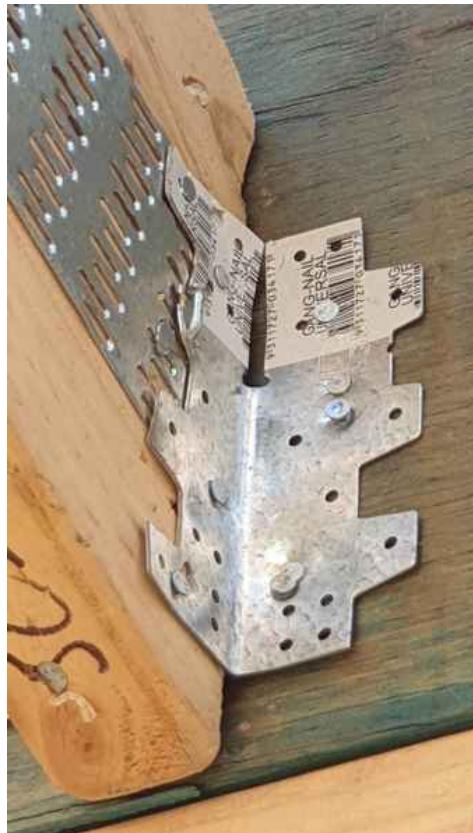
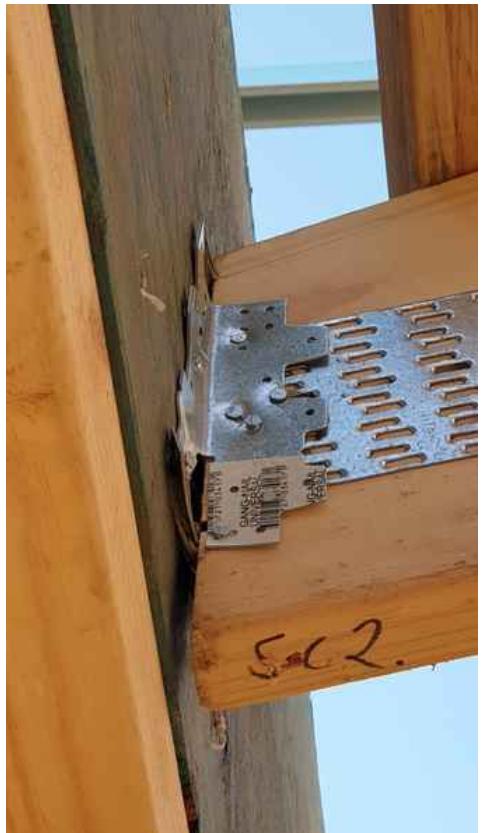
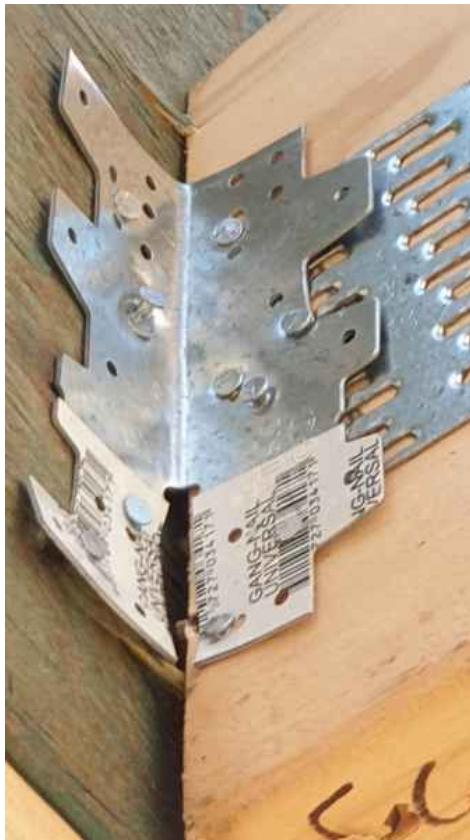
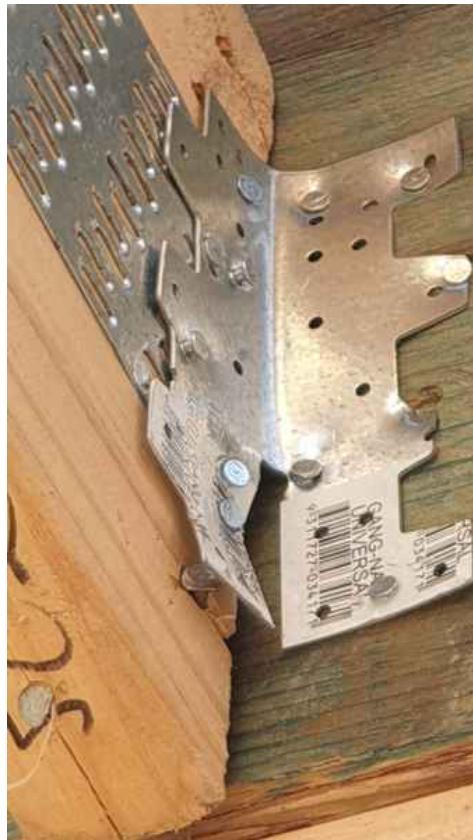
The nail brackets used to fasten truss details have not been installed in compliance with the manufacturers recommendations and technical reports.

Non-compliant Fixing of Brackets

I recommend fixing all brackets in strict compliance with the manufacturers recommendations.

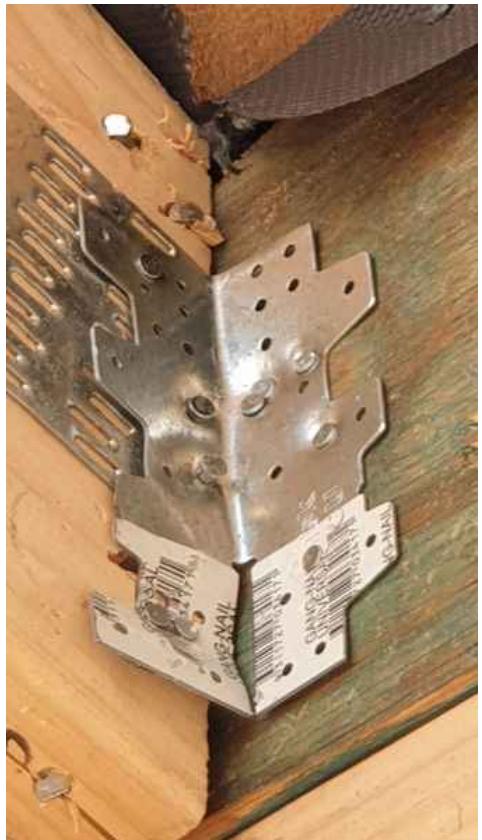
Non-compliant Fixing of Brackets

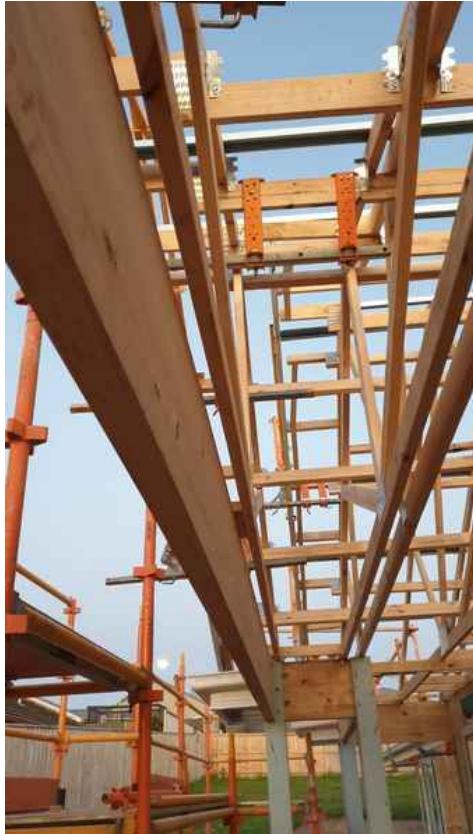
Porch Lintel

MISSING STUD

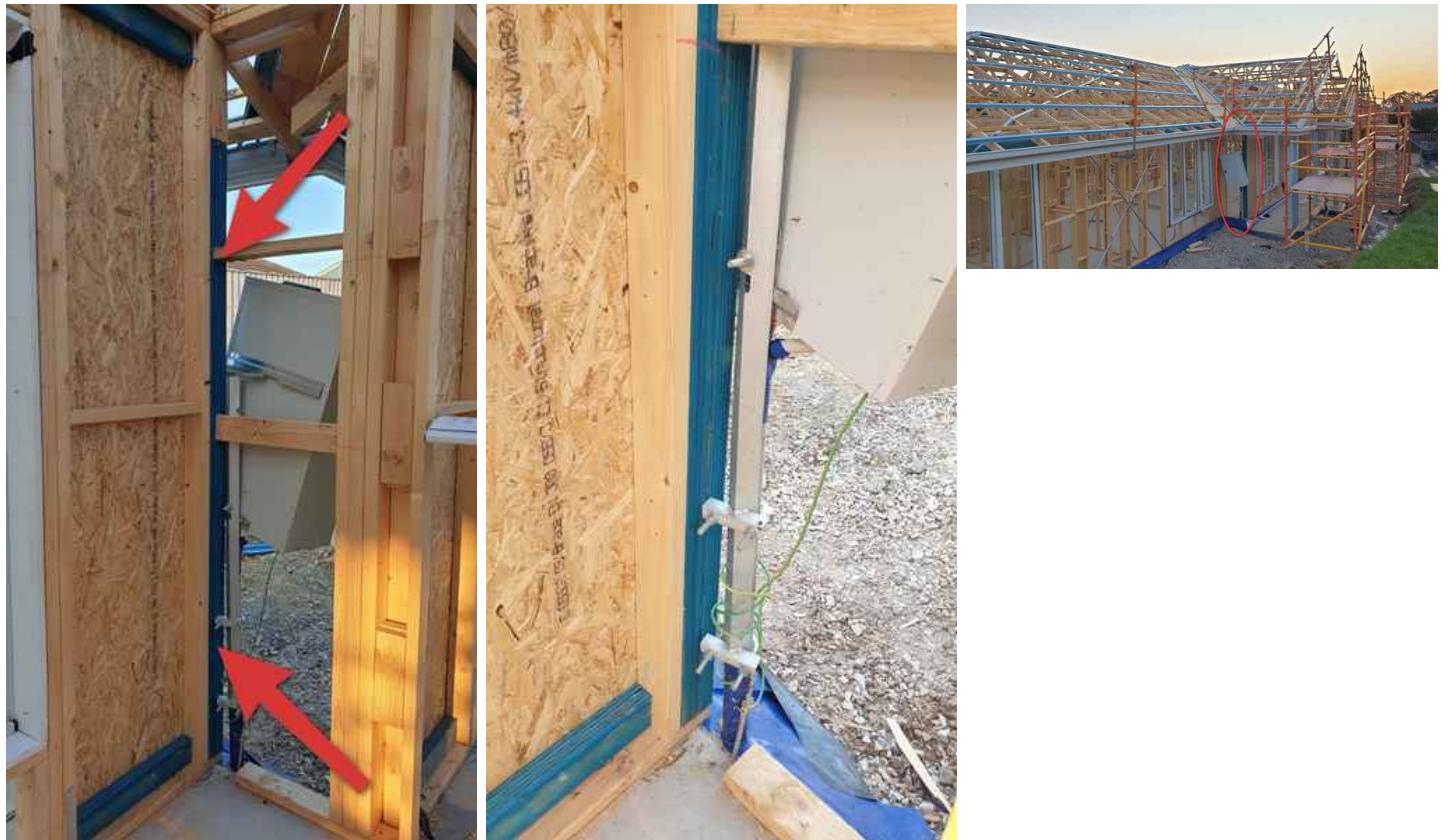
OPENING LINTEL- Minor Defect

I recommend installing a lintel into this opening so that the opening is not reliant on the roof truss.

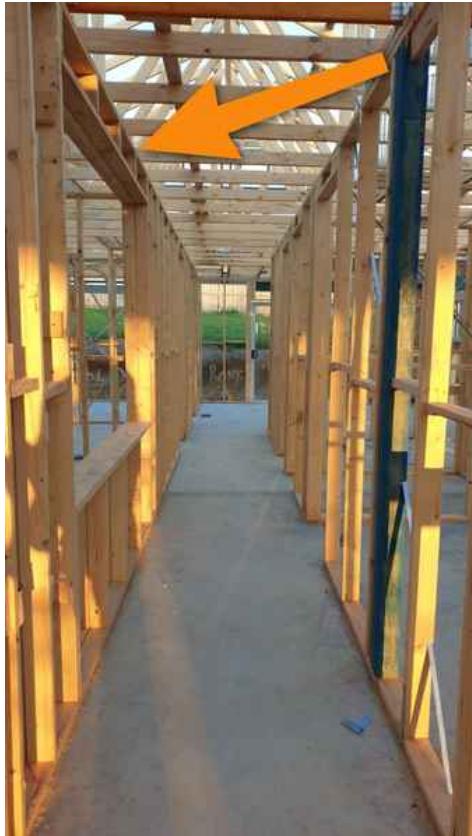
Install Lintel to Opening

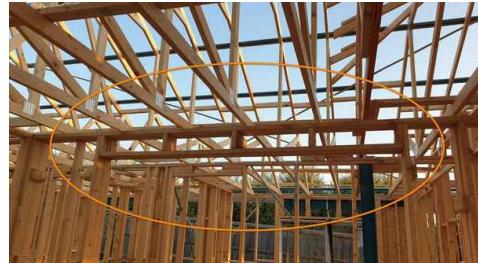
Install Lintel To Opening

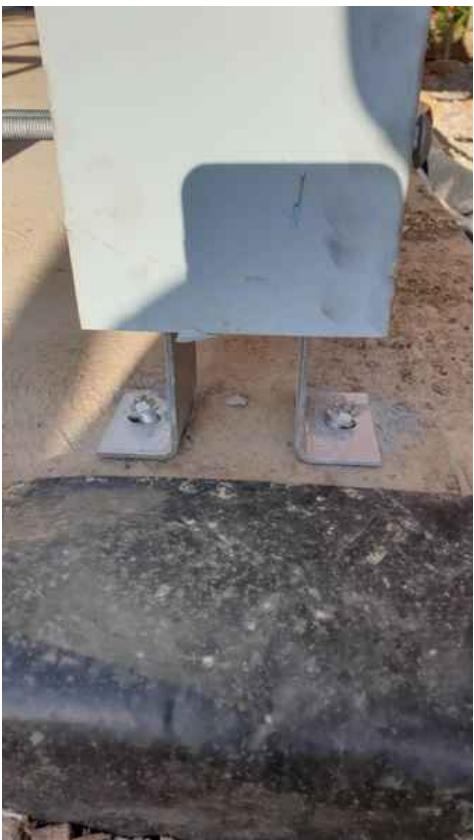
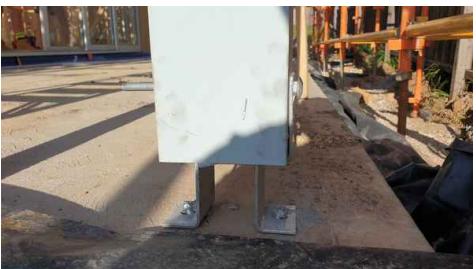
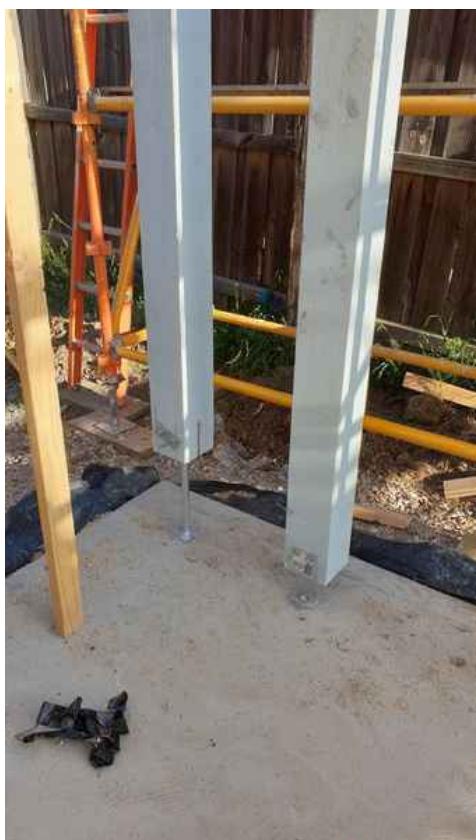
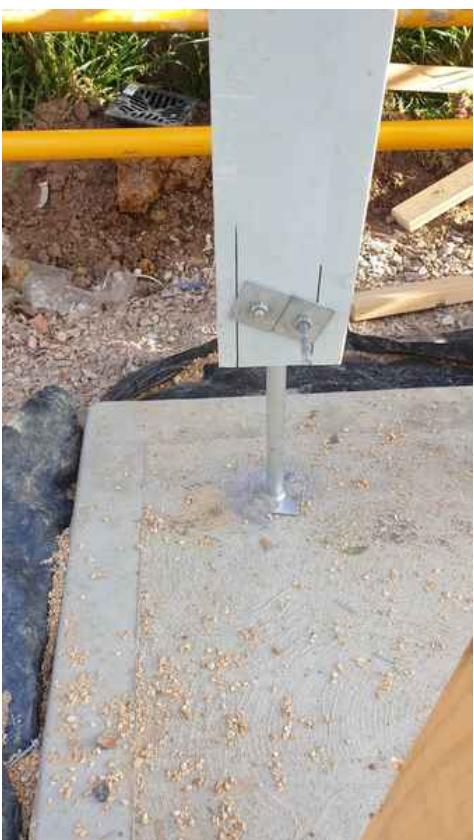
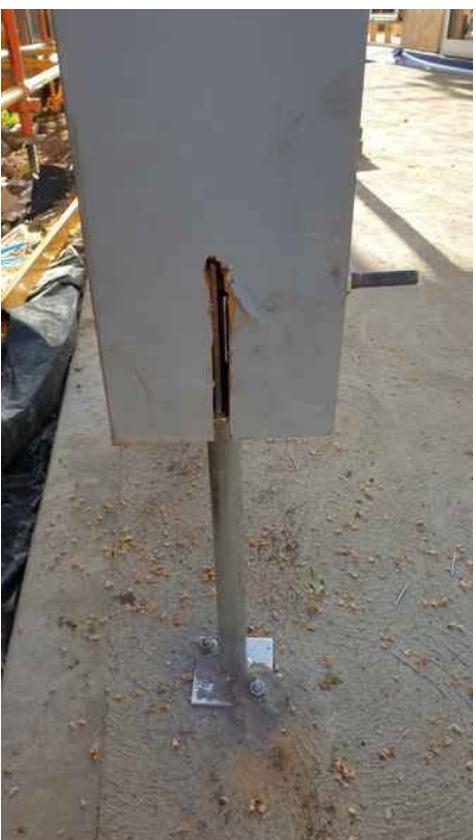
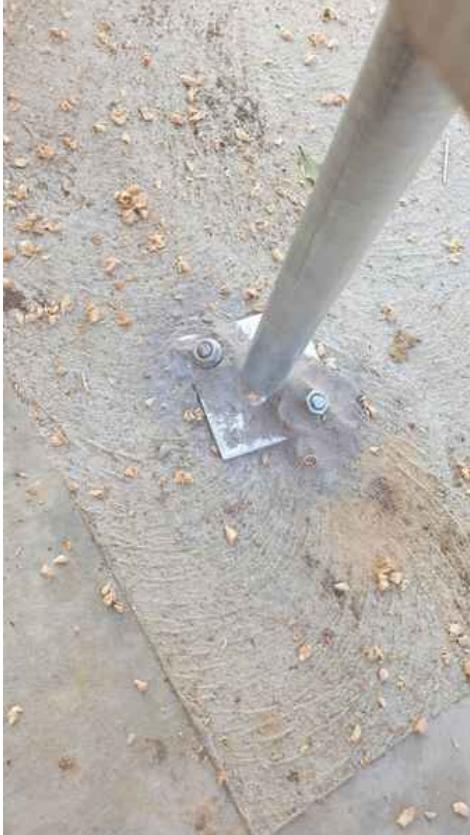
Grand Outdoor Room

The corrosion protection of bolts used to fasten the stirrup(s) into concrete in one or more locations is not in compliance with the manufacturers recommendations.

Yellow Zinc fixings have low anti-corrosion properties, they are generally used as a temporary fixing or in an internal (protected environment) and are not suitable for use for external conditions.

I recommend replacing all external bolts / fixings with either a fixing suitable for use in external conditions such as "Hot Dipped Galvanised" or "Stainless Steel" fixings.

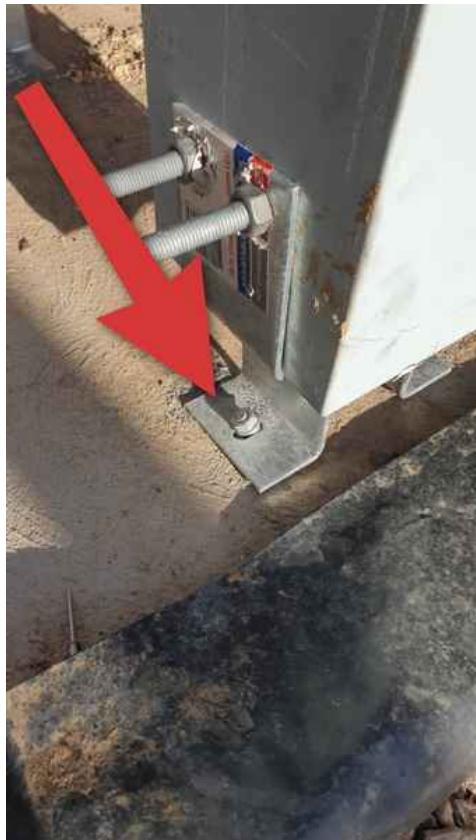
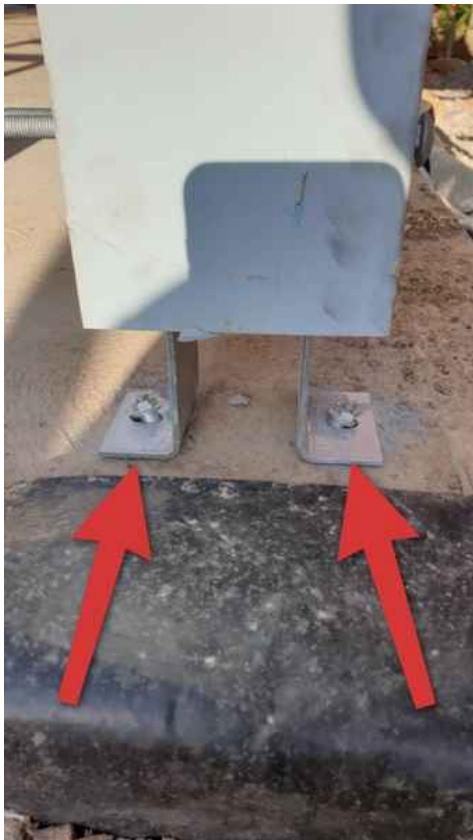
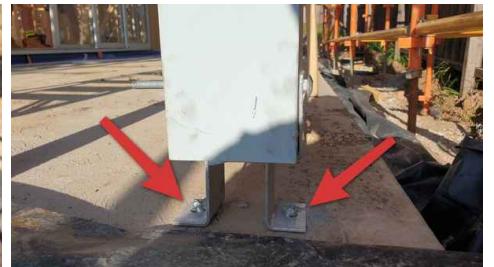
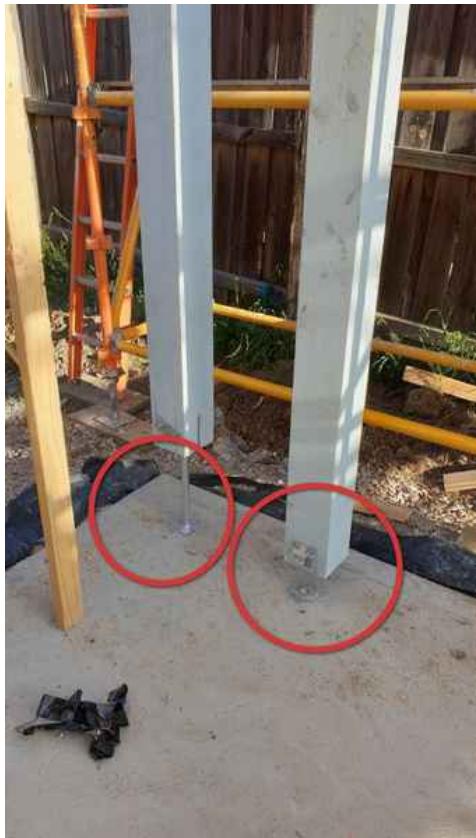
Grand Outdoor Room

The "Dynabolts" used to fix the post anchor stirrups have been poorly installed and are not in contact with the fixture as recommended by Ramset.

As per the manufacturers recommendations, the DynaBolt™ Plus is to be inserted through the fixture and driven with a hammer until the washer contacts the fixture.

I recommend installing fixings that are suitable for external use and installed as per the manufacturers installation guide.

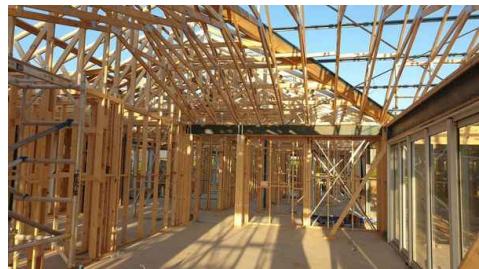
Requires Bottom Chord Restraints

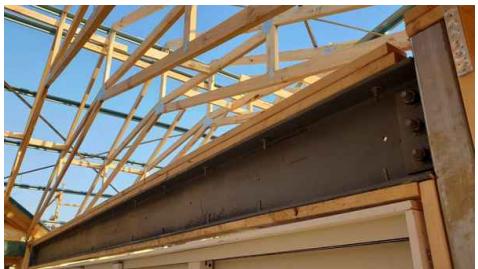
Bottom chord restraints are required to be installed in compliance with the truss makers recommendations and AS4440:2004

I recommend installing bottom chord restraints to prevent possible structural and plasterboard failure in the future.

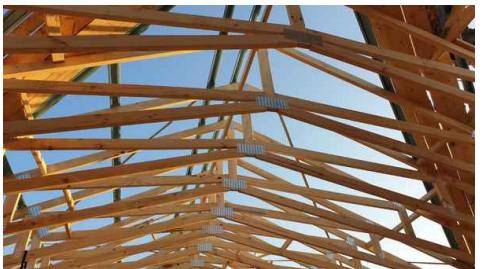
Requires Bottom Chord Restraints

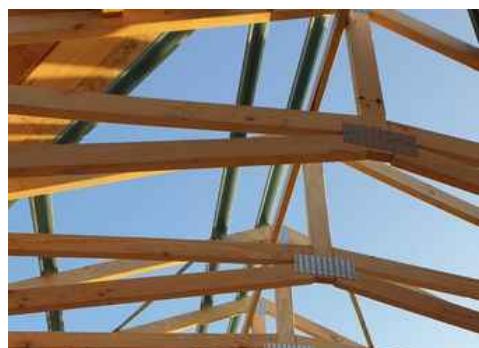
Requires Bottom Chord Restraints

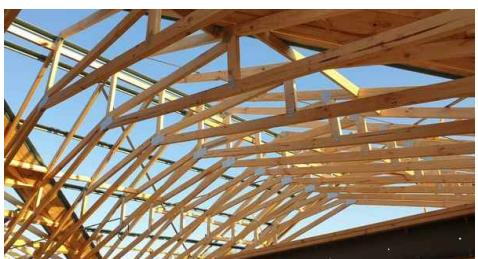
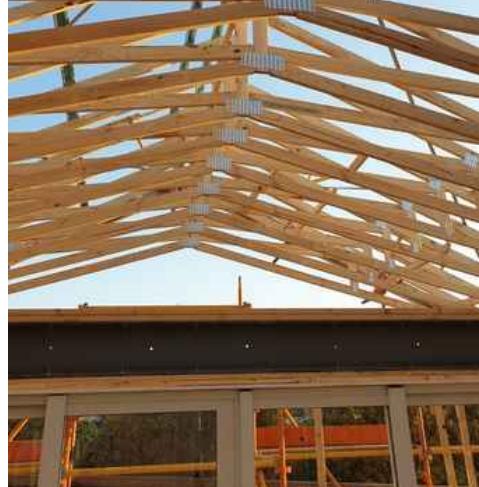
Requires Bottom Chord Restraints
