HOME INSPECTION REPORT

1234 Main St.
Colleyville, Texas 76034

09/03/2019 9:00AM

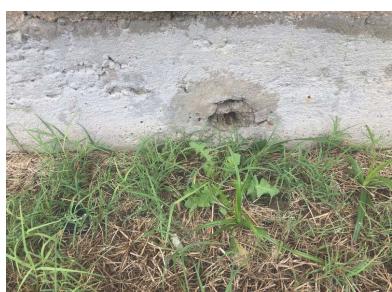
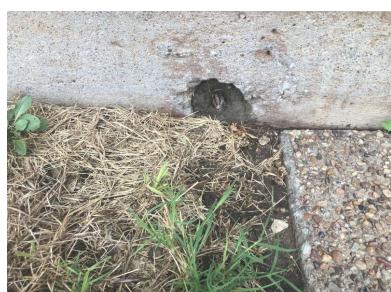
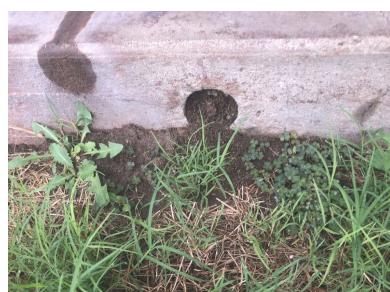
Rear right rear middle

One or more of the post tension cable ends were exposed and need to be properly sealed.

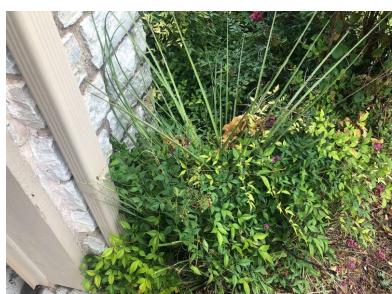
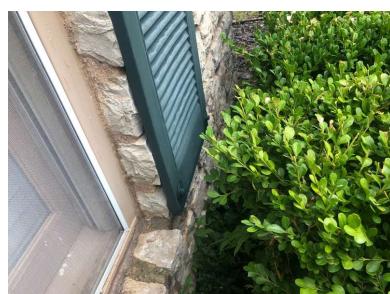
MULTIPLE LOCATIONS

1: Excessive vegetation

Vegetation was too close to, touching, or growing on exterior walls and roof. Condition can promote excessive damage and deterby movement of branches, root growth and/or attachment, and moisture retention, and can promote pest infestations. Recommend having vegetation trimmed or removed from affected areas, and regular homeowner monitoring and maintenance thereafter.

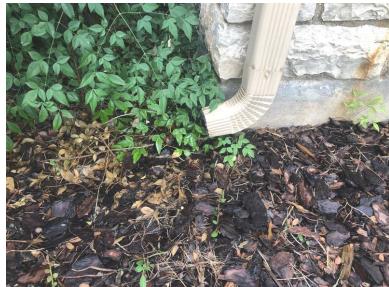
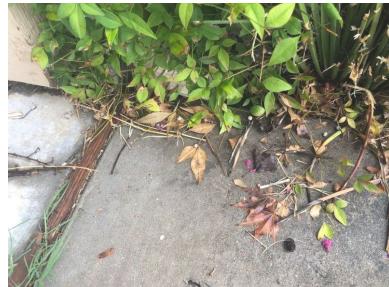
FRONT LEFT, FRONT RIGHT

I NI NP D**2: Gutters: Redirect Downspout Elbow****⊖ Recommendation**

Gutter downspout elbow was directing water near the foundation. The elbow should be turned so that storm water is encouraged to flow away from the structure at the points of discharge.

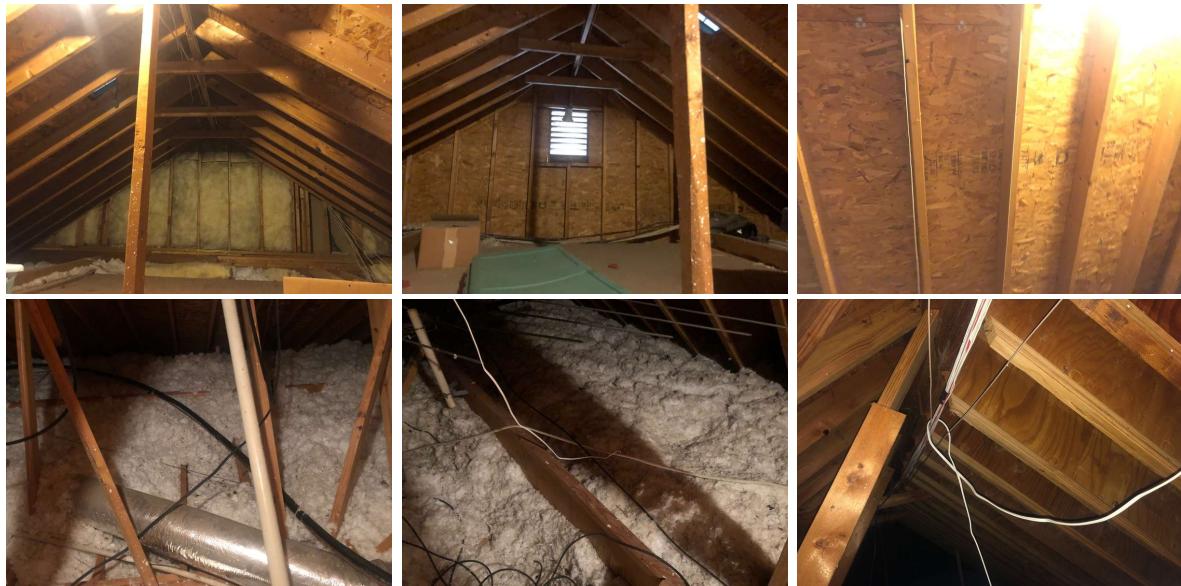
Note: Visible evidence of rodent activity was observed in the attic area. It is recommended to have a Pest Control Operator further evaluate this condition and make corrections as necessary. All vermin/pest entry points to the attic area should be properly sealed.

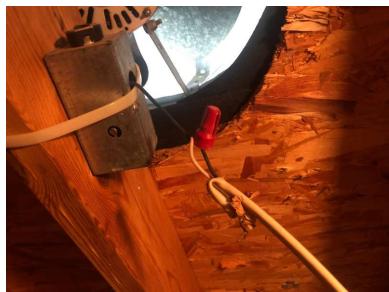
Upper attic

**3: Power vent: Spliced Wires @ Controls****⊖ Recommendation**

The spliced wires at the attic power ventilator(s) needed to be properly enclosed in a junction box(es).

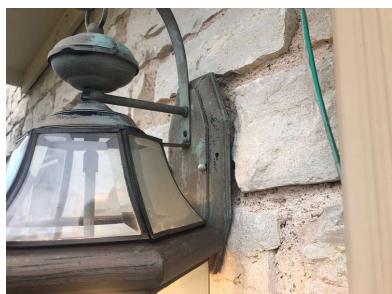
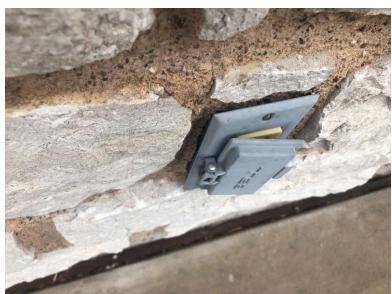
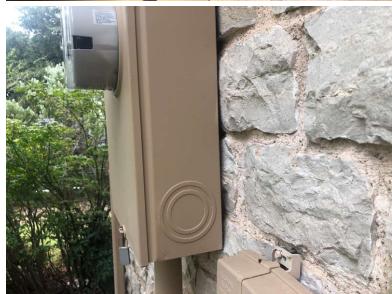
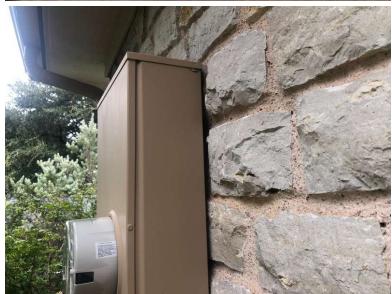
EXTERIOR FIXTURES

*Comments:**Type(s) of Exterior Cladding::* Stone masonry veneer**1: Exterior: Re-caulking needed****⊖ Recommendation**

Many areas of the house needed re-caulking due to settlement and deteriorated caulking. Recommend re-examination of all windows, doors and vertical joints between the trim and brick veneer. All

openings should be sealed/caulked to prevent water penetration and further deterioration/damage.

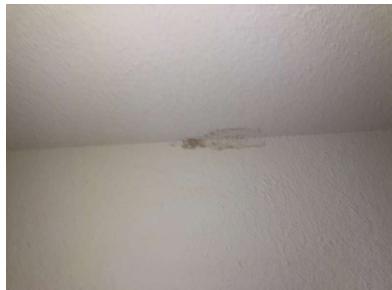
Upstairs rear left bedroom closet

2: Interior: Water stained wall(s)

Water stains were observed on the walls. The cause and remedy should be further evaluated and corrected as necessary.

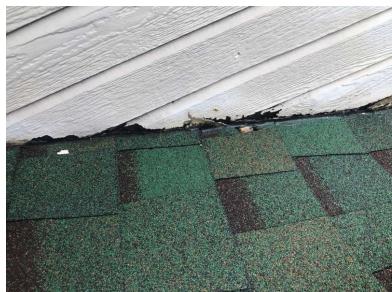
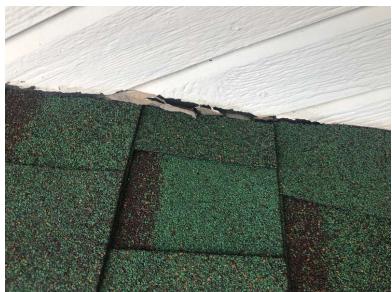
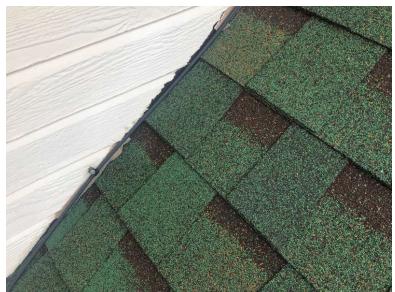
ROOF/SIDING

3: Exterior: Minor siding damage

Minor damage to the siding material was observed.

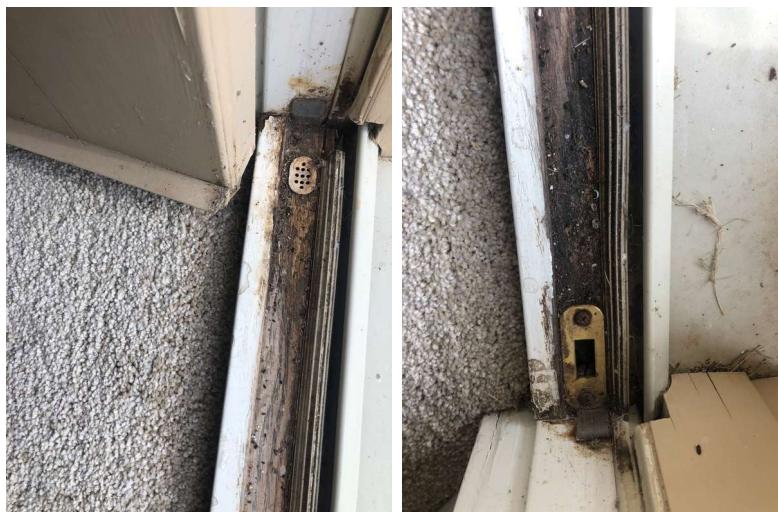
Master bedroom rear entry

**2: Exterior door/frame deterioration****⊖ Recommendation**

The exterior door / frame had some deterioration and/or damage.

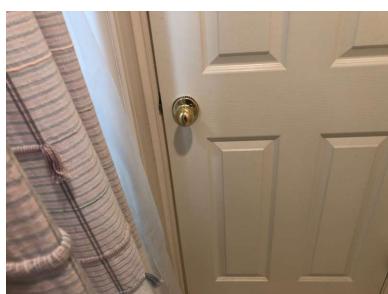
Upstairs Jack and Jill right side door

**3: Doors: Not Latching Properly****⊖ Recommendation**

The door would not latch/catch properly at the areas noted above.

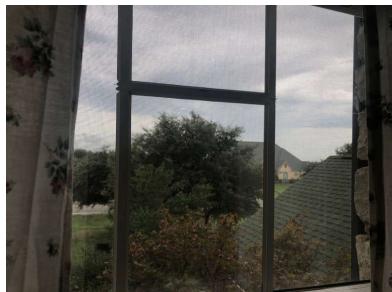
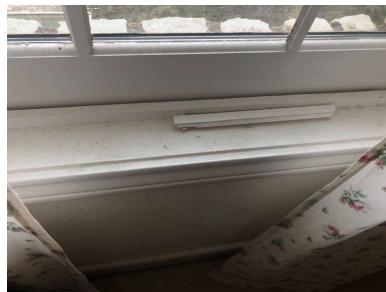
Upstairs front middle bedroom grids in the windows damaged

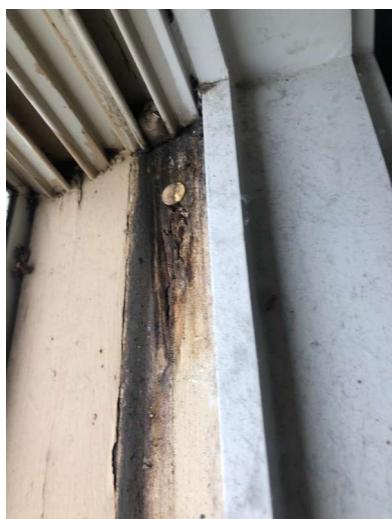
Upstairs middle bedroom and the side window right about

Wood rot inside the window sill.

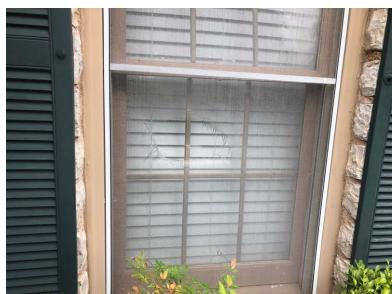
**1: Screens damaged****➡ Recommendation****MULTIPLE LOCATIONS**

One or more of the window screens were observed to be damaged.

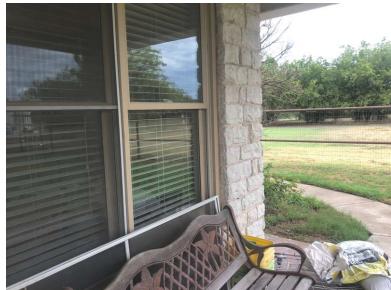
Rear of the house

**2: Screens: Missing****➡ Recommendation**

One or more of the window screens were observed to be missing.

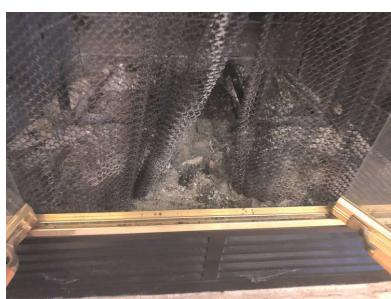
Office

1: Creosote Buildup/Clean**➡ Recommendation**

Creosote / soot build-up was observed in the visible flue area. The chimney flue should to be cleaned by a Qualified Chimney Sweep.

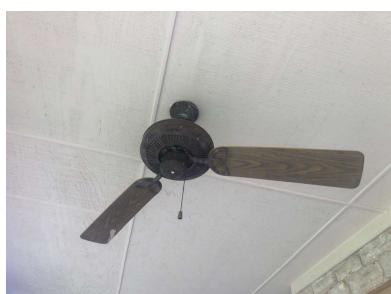
Rear patio

2: Fixtures: Fan blade damaged**⊖ Recommendation**

One or more of the ceiling fan blades are damaged.

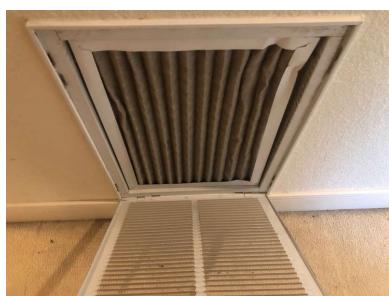
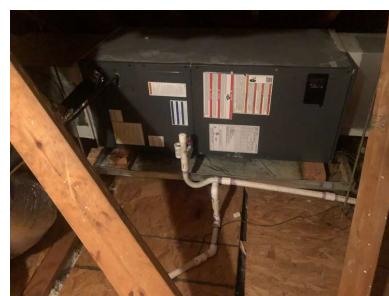
ATTIC

**1: Filter: Dirty****⊖ Recommendation**

Upstairs wall filters.

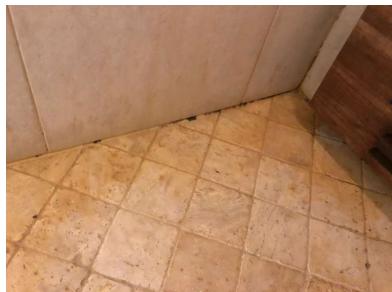
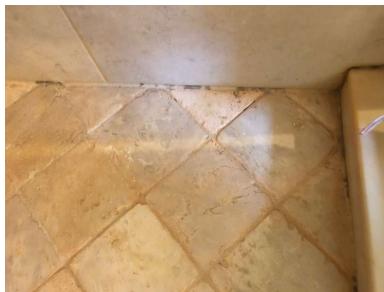
Master bathroom

**1: Shower: Caulking improvements needed****⊖ Recommendation**

Cracked, deteriorated and/or missing shower stall grout and/or caulking should be repaired or replaced as necessary.

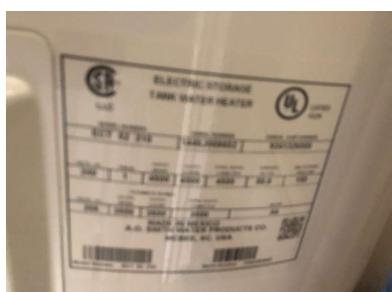
I NI NP D**1: TPR Line: Runs upward****⊖ Recommendation****GARAGE**

The temperature and pressure relief (TPR) valve discharge pipe was running in an upwards direction in one or more locations. The TPR discharge pipe should run gravitationally downwards at all points.

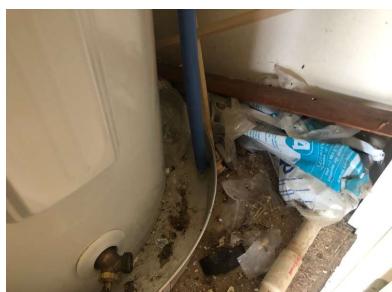
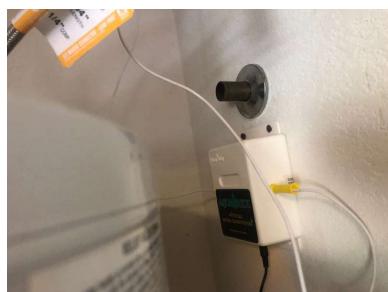
2: TPR: Terminated into pan**⊖ Recommendation****Garage closet**

The temperature and pressure relief discharge pipe was terminating into the water heater drain pan. Under current building standards, this discharge pipe should run downward to the exterior of the structure, turn and terminate within 6-inches of the ground.

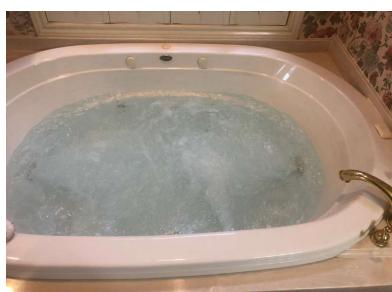
**1: No/limited access to motor****⊖ Recommendation****MASTER BATHROOM**

The access to the hydro-massage therapy equipment motor was not readily accessible and inspection of the equipment lines and motor could not be performed. This does not meet current installation standards.

I was unable to locate a ground fault circuit interrupter (GFCI) receptacle or breaker for the hydro-massage therapy equipment. The homeowner should be consulted on the location of this GFCI device. If there is no GFCI device installed on the hydro-massage therapy equipment circuit, a GFCI receptacle or breaker should be installed for reasons of safety. \

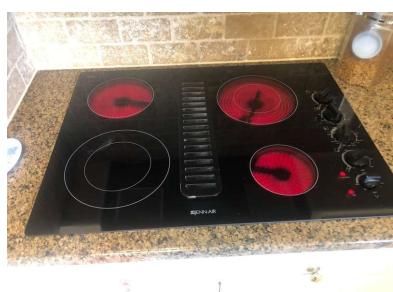
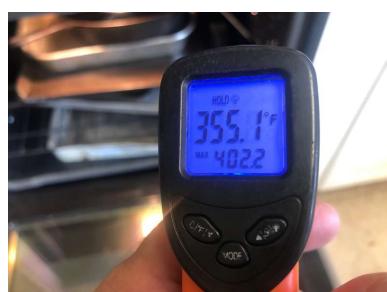
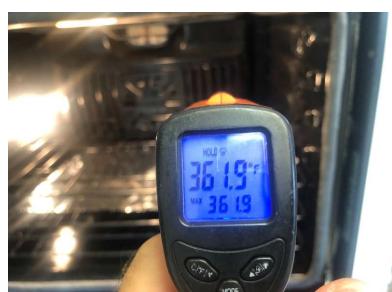
Front left burner

**1: Burner No Function Properly****► Recommendation**

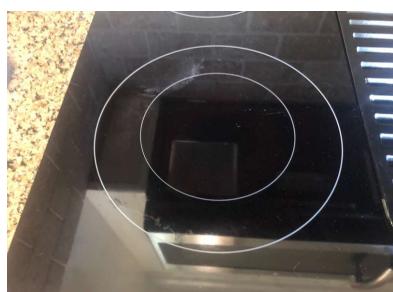
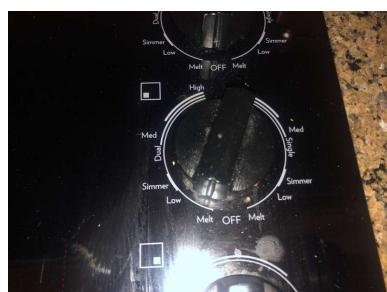
One or more of the burners did not function properly and should be further evaluated.

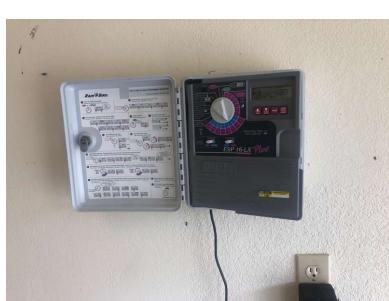
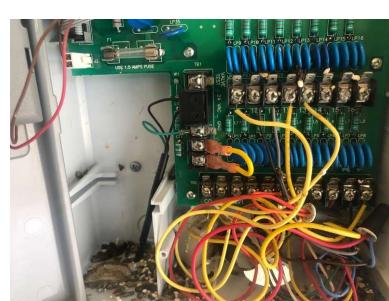
**1: Control panel not functioning properly****⊖ Recommendation****GARAGE**

The sprinkler system control panel did not appear to be functioning properly. The cause and remedy should be further evaluated and corrected as necessary.

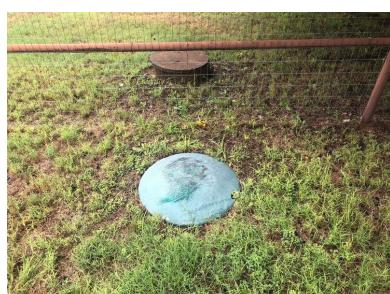
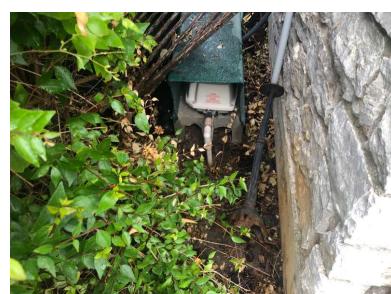
E. Private Sewage Disposal (Septic) System

*Type of System:: Aerobic**Drainage Field Location:: West side of structure*
