STATEWIDE FLORIDA HOME INSPECTIONS, INC.

ROOM-BY-ROOM RESIDENTIAL

1234 Main St.
Homestead, Florida 33033

Buyer Name
09/04/2019 9:00AM

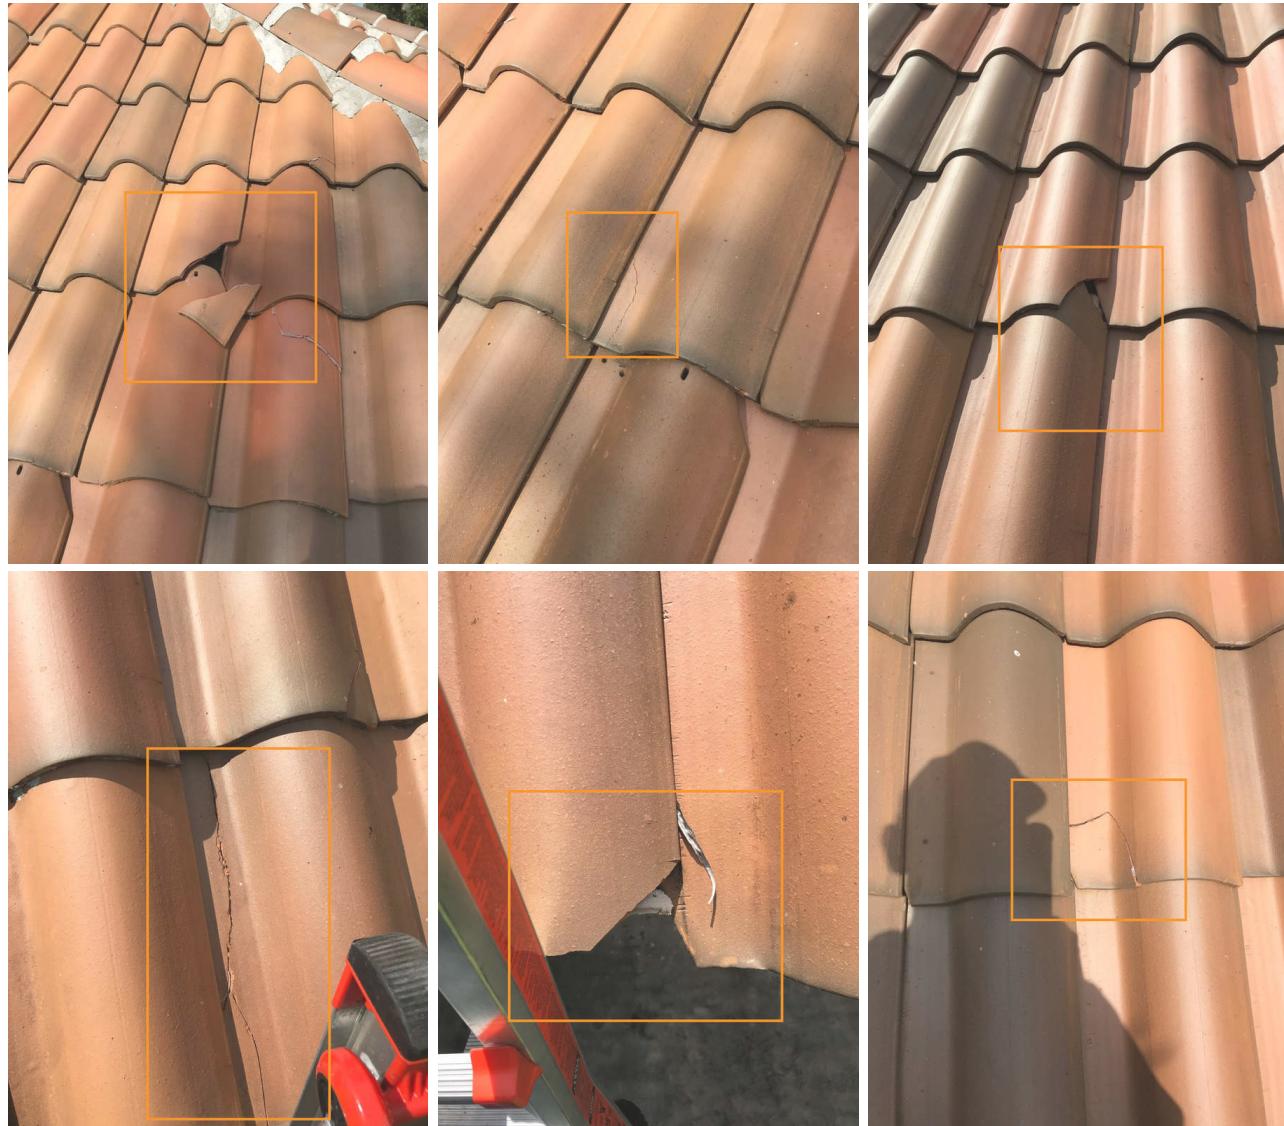
2.1.1 Coverings

TILES CRACKED/BROKEN

Roof had cracked/broken tiles. Recommend a qualified roof contractor repair or replace to prevent moisture intrusion and/or mold.

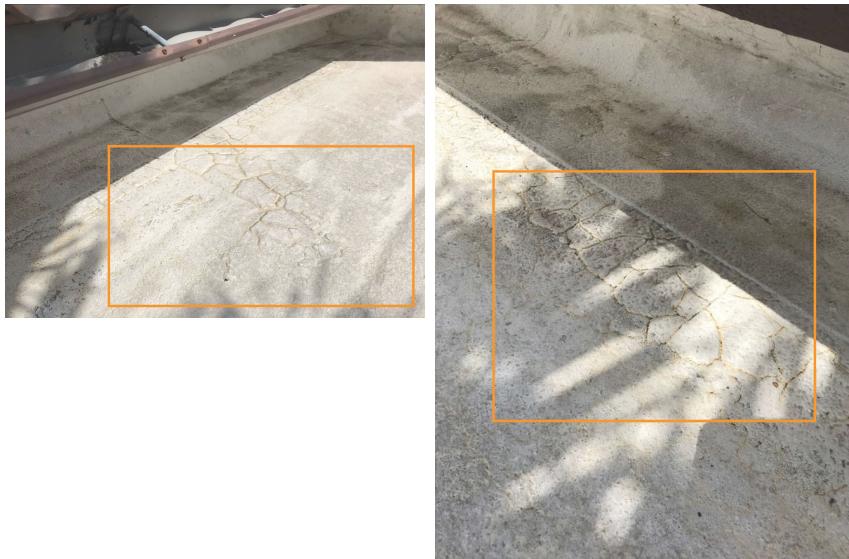
2.1.2 Coverings **ALLIGATORING**

Alligator is cracking of the surfacing bitumen on a bituminous roof producing a pattern of cracks similar to an alligator's hide. The cracks may not extend completely through the surfacing bitumen or coating. When left unattended, cracks and splits eventually develops. Recommend further evaluation from a licensed roofing contractor.

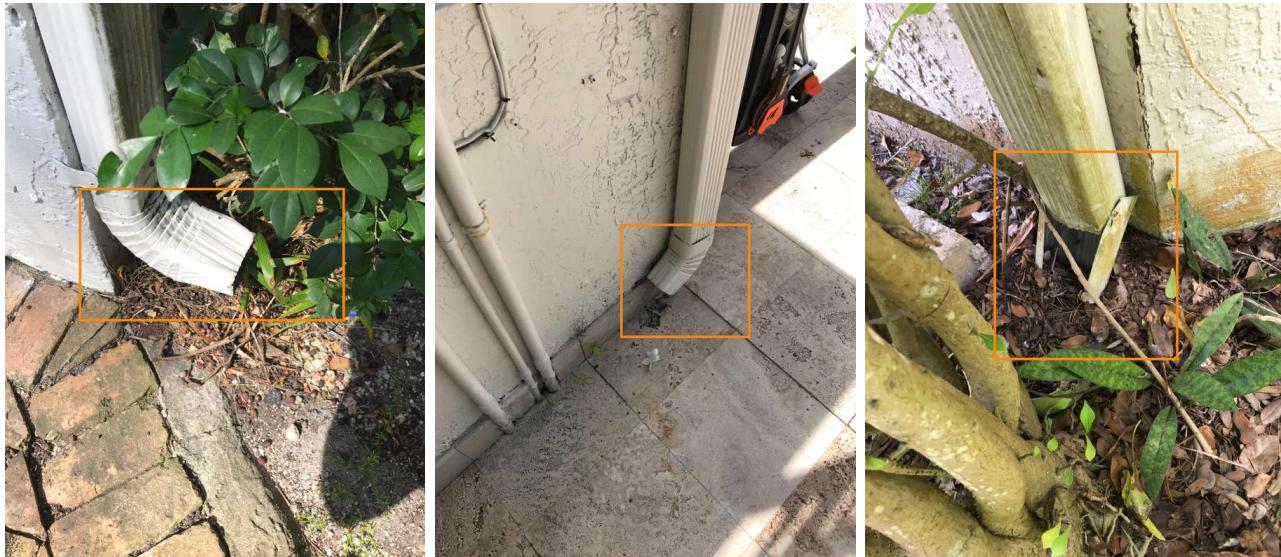
2.2.1 Roof Drainage Systems

DOWNSPOUTS DRAIN NEAR HOUSE

One or more downspouts drain too close to the home's foundation. This can result in excessive moisture in the soil at the foundation, which can lead to foundation/structural movement. Recommend a qualified contractor adjust downspout extensions to drain at least 6 feet from the foundation.

Contact a qualified roofing professional.

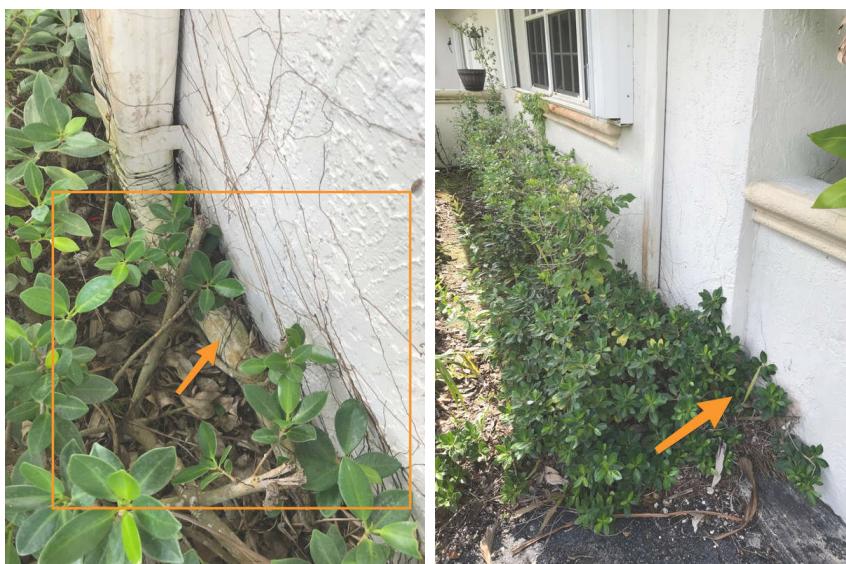
2.2.2 Roof Drainage Systems

GUTTER DAMAGED

Gutters were damaged. This can result in excessive moisture in the soil at the foundation, which can lead to foundation/structural movement. Recommend a qualified contractor evaluate and repair.

Contact a qualified roofing professional.

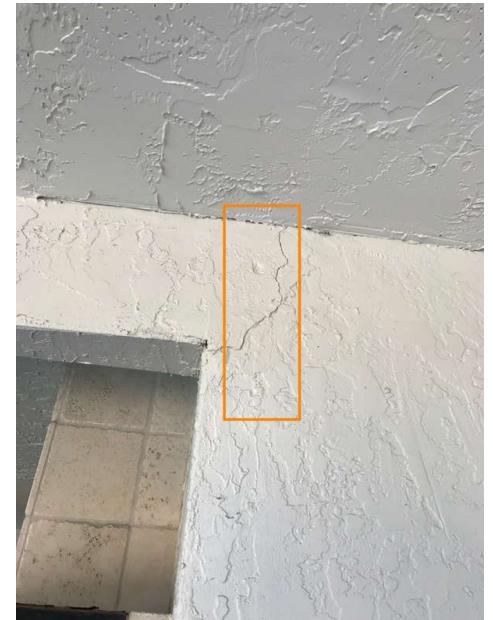
3.2.1 Siding, Flashing & Trim

CRACKING - MINOR

Siding showed cracking in one or more places. This is a result of temperature changes, and typical as homes with stucco age. Recommend monitoring.

Recommended DIY Project

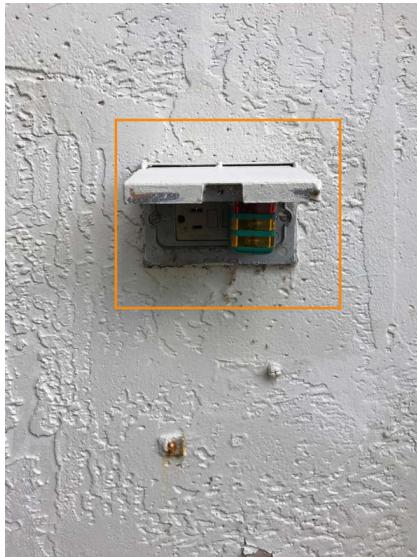
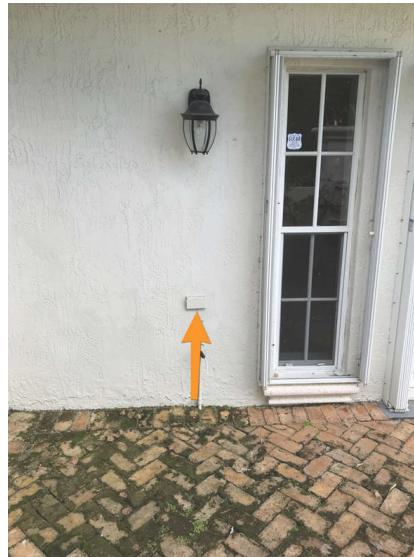
#1

FAULTY GFCI FOUNDATIONAL OUTLET

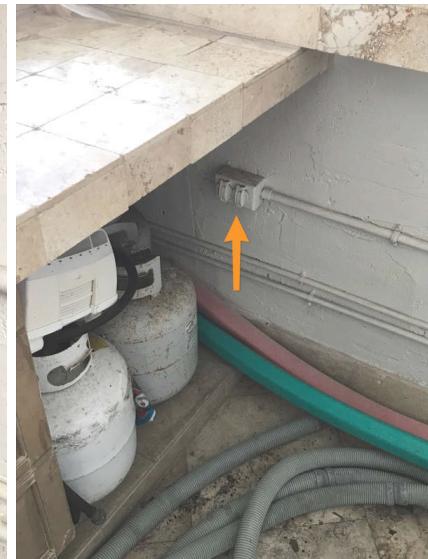
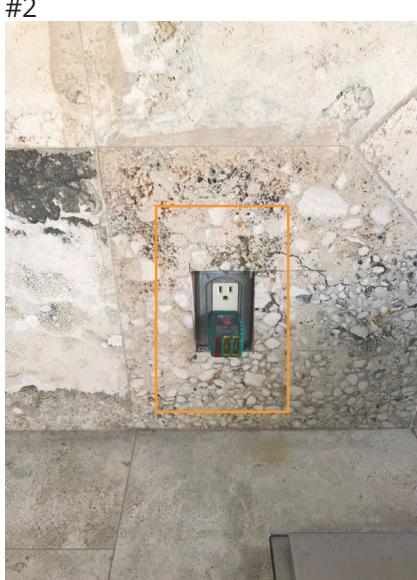
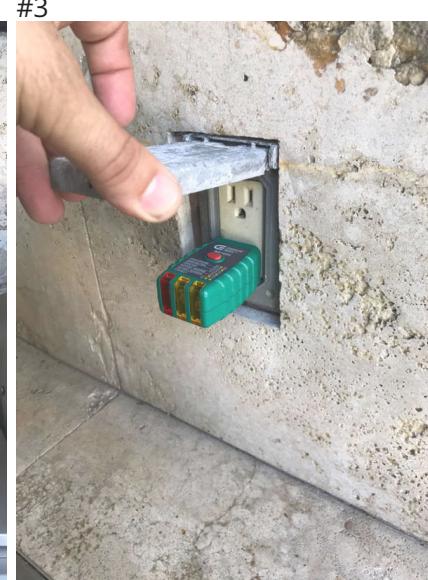
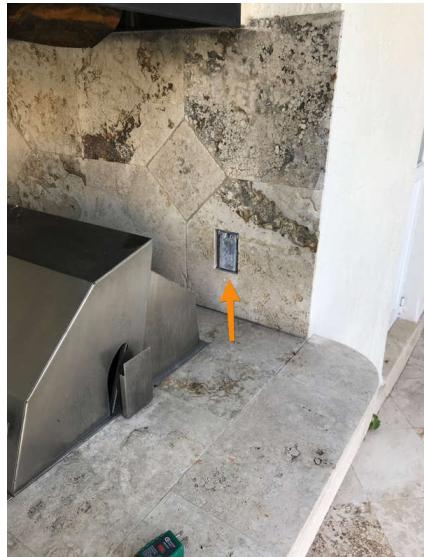
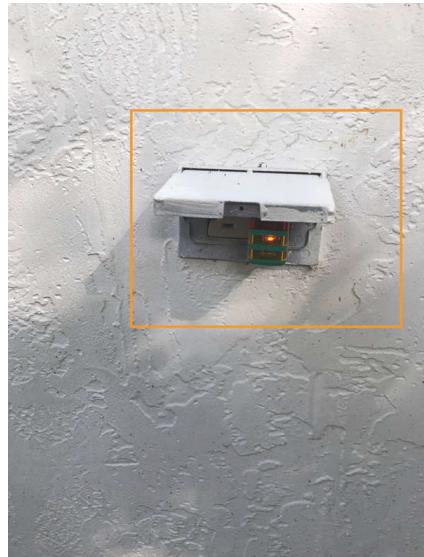
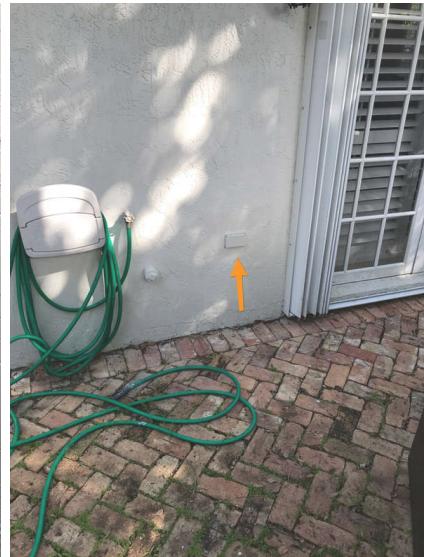
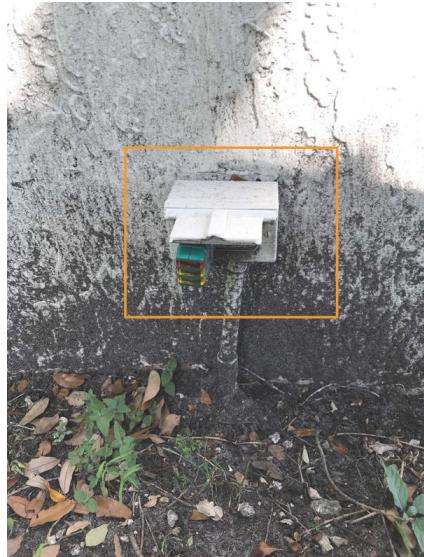
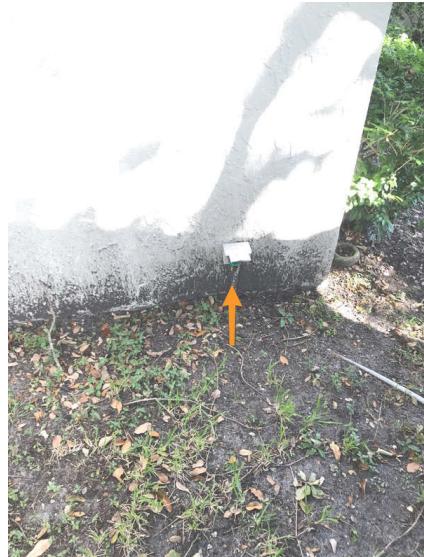
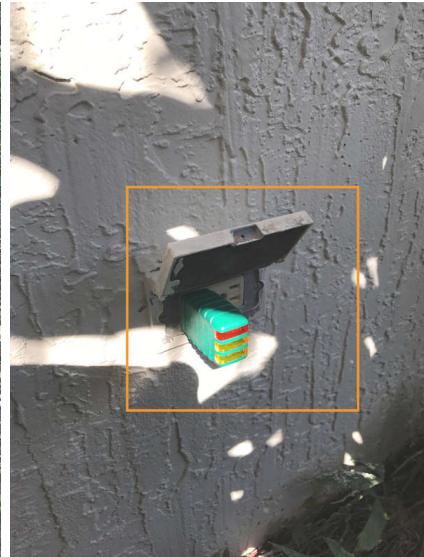
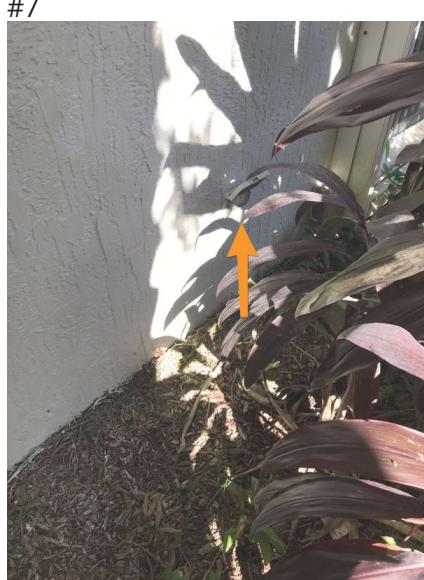
Observed one or more GFCI rated outlets with a fault of no power, does not trip, or has an open ground. An open ground is a potential shock hazard, a safety concern, and any device plugged into outlet may be damaged. In many cases, the open ground on one outlet is the result of a disconnected wire at another outlet. Recommend further evaluation from a licensed electrician.

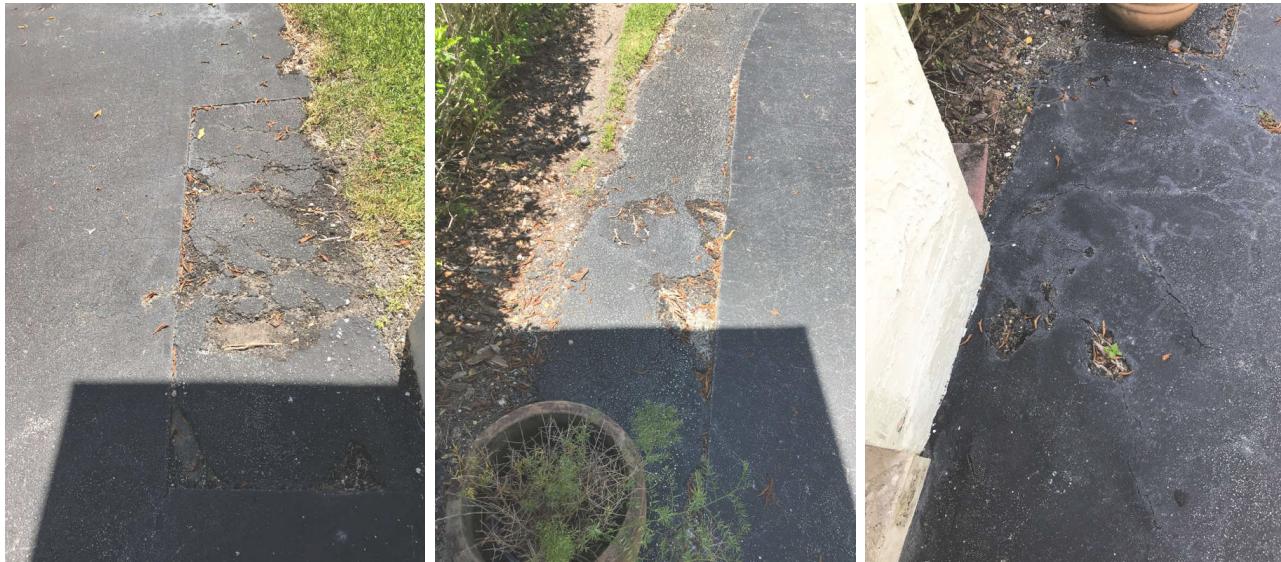
3.4.1 Walkways, Patios & Driveways

DRIVEWAY CRACKING - MINOR

Minor cosmetic cracks observed, which may indicate movement in the soil. Recommend monitor and/or have concrete contractor patch/seal.

Contact a qualified concrete contractor.

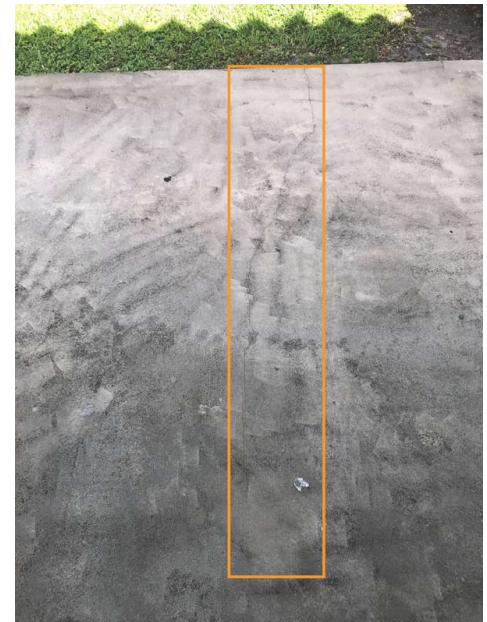
WALKWAY CRACKING - MINOR

Minor cosmetic cracks observed. Recommend monitor and/or patch/seal.

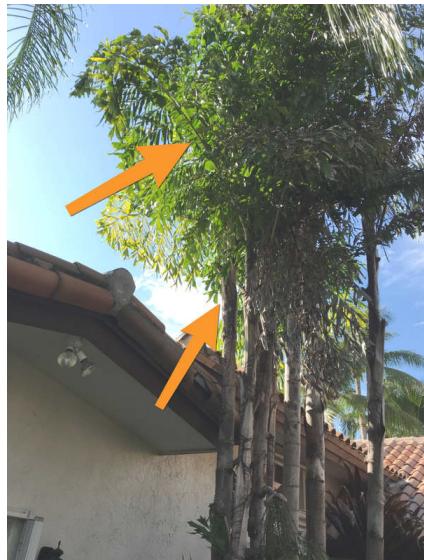
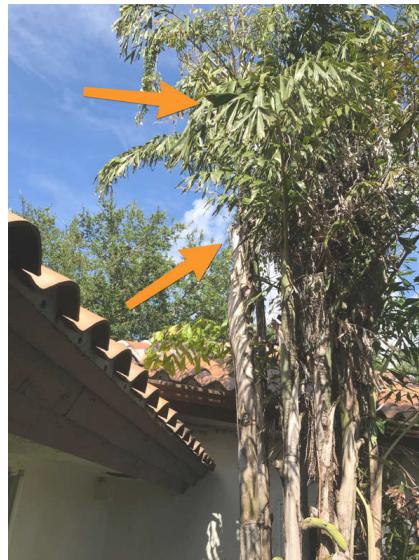
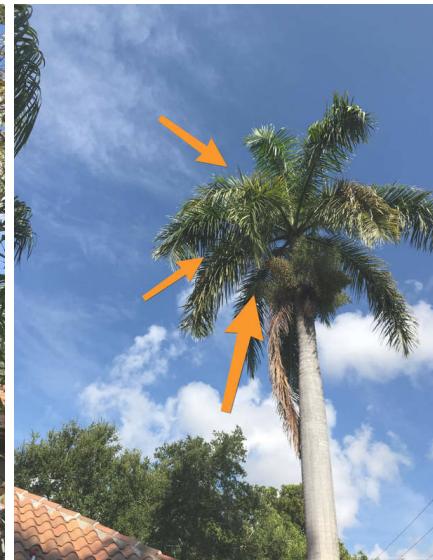
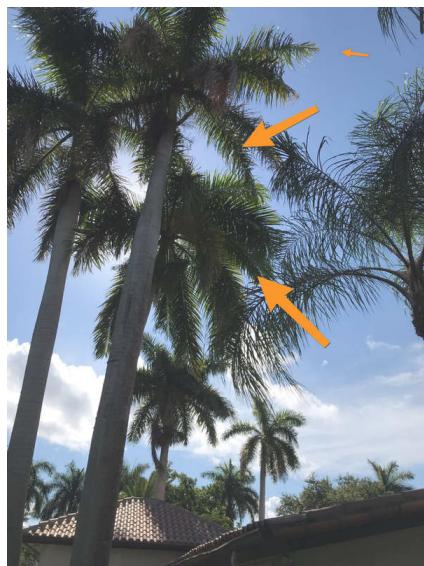
TREE OVERHANG

Trees observed overhanging the roof. This can cause damage to the roof and prevent proper drainage. Recommend a qualified tree service trim to allow for proper drainage.

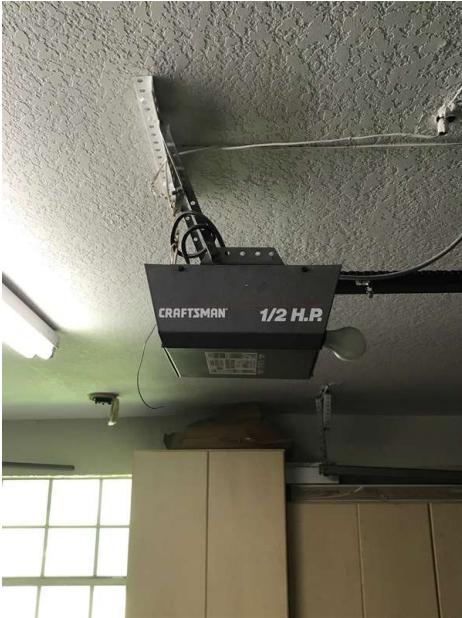
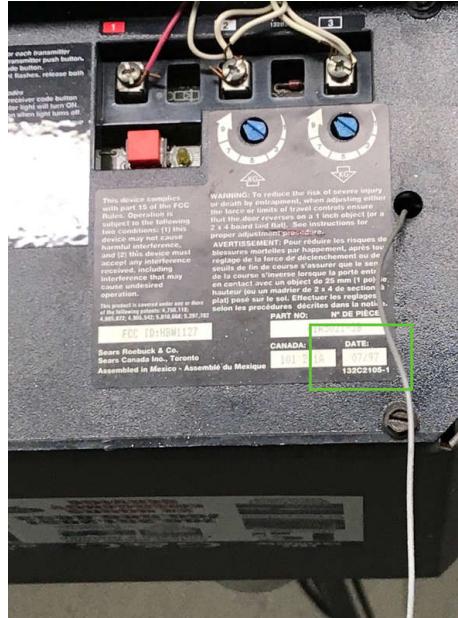
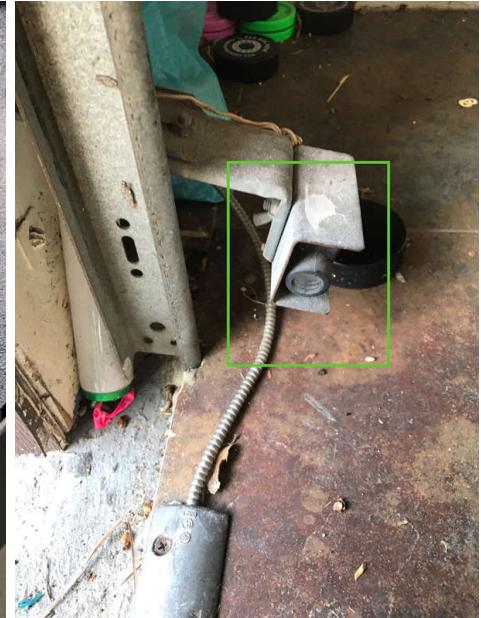
Manufacturer: Craftsman 1/2 H.P.

Date of manufacture: 07/1997

Average life expectancy of a garage door opener is between 10-12 years. This unit is past its life expectancy.

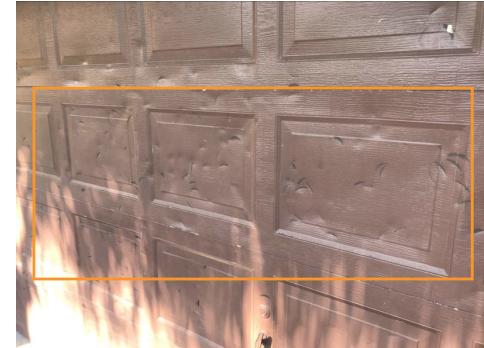
PANEL DAMAGE

Garage door panel is damaged and may need repair/replacement.
Recommend a qualified garage door contractor evaluate.

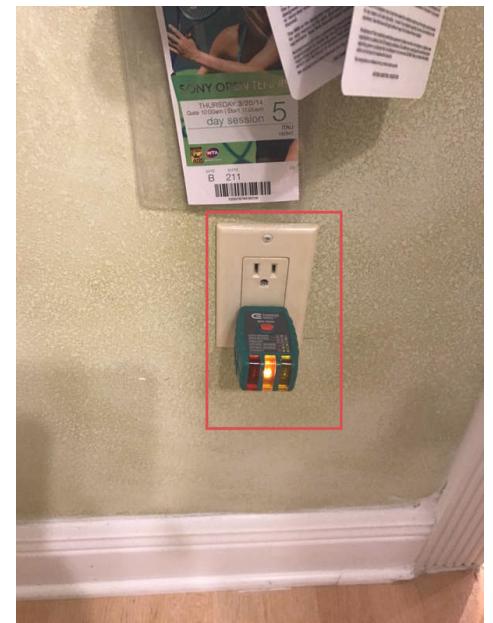
6.7.1 Lighting Fixtures, Switches & Receptacles

Observed a fault of open ground at outlet next to the bathroom door. An open ground is a potential shock hazard, a safety concern, and any device plugged into outlet may be damaged. In many cases, the open ground on one outlet is the result of a disconnected wire at another outlet. Recommend further evaluation from a licensed electrician.

Recommendation

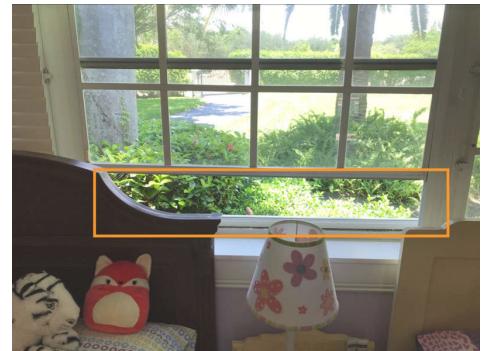
8.3.1 Windows

MISSING SCREEN

Window missing screen. Recommend replacement.

Contact a qualified window repair/installation contractor.

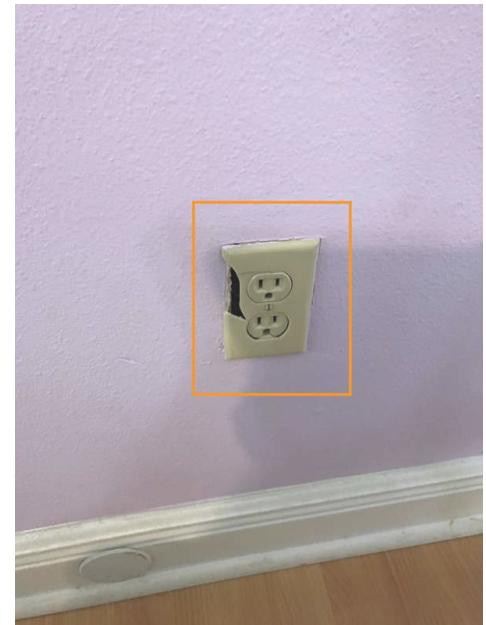
COVER PLATES DAMAGED

One or more receptacles have a damaged cover plate. Recommend replacement.

Contact a qualified electrical contractor.

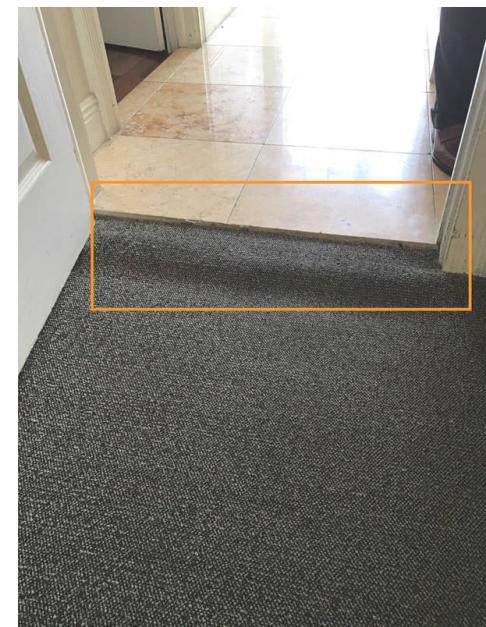
9.4.1 Floors

MISSING THRESHOLD

Observed no threshold between the carpet and tile. This is a tripping hazard. Recommend installing one. Recommend further evaluation from a licensed flooring contractor.

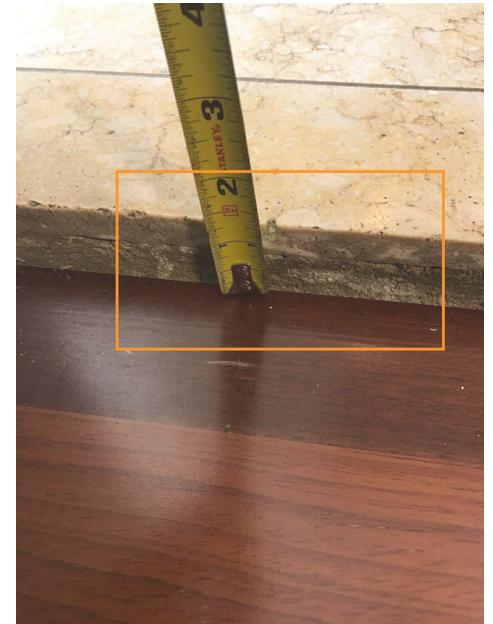
MISSING THRESHOLD/UNEVEN FLOOR

Observed no threshold between tile and laminate flooring. Observed a more than one inch difference in height. This is a safety and tripping hazard. Recommend further evaluation from a licensed flooring contractor.

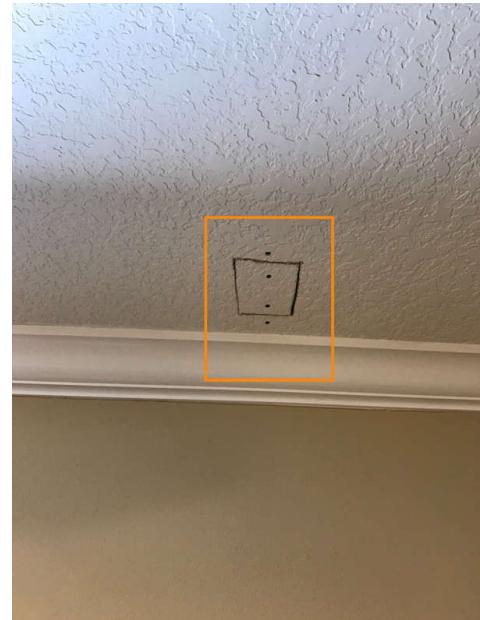
MINOR DAMAGE

Minor damage or deterioration to the ceiling was visible at the time of the inspection.

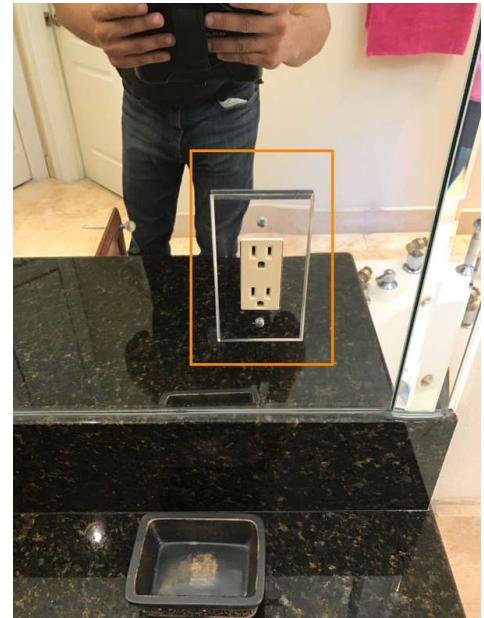
11.3.1 GFCI & AFCI

No GFCI protection present in all locations. Recommend licensed electrician upgrade by installing ground fault receptacles in all locations.

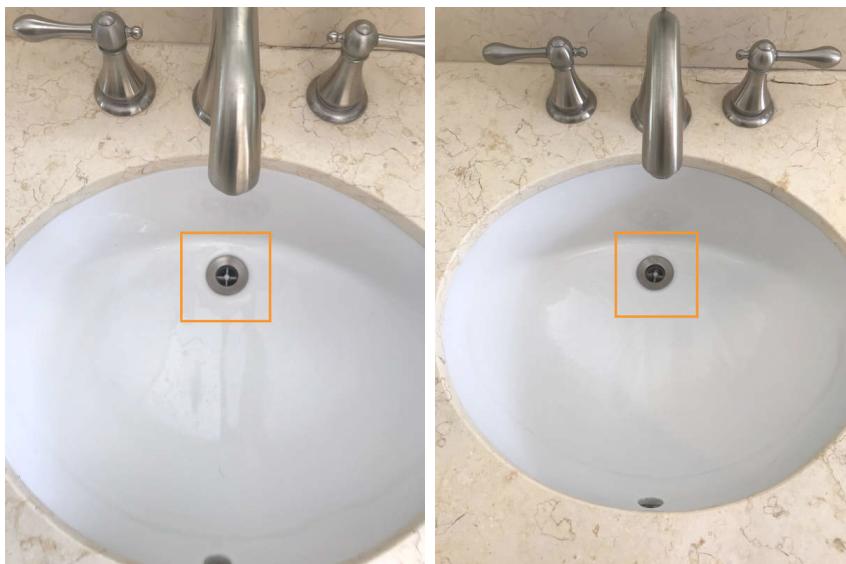
MISSING SINK STOPPER

Observed no sink stoppers at both sinks. Recommend installing new ones. Recommend further evaluation from a licensed plumber.

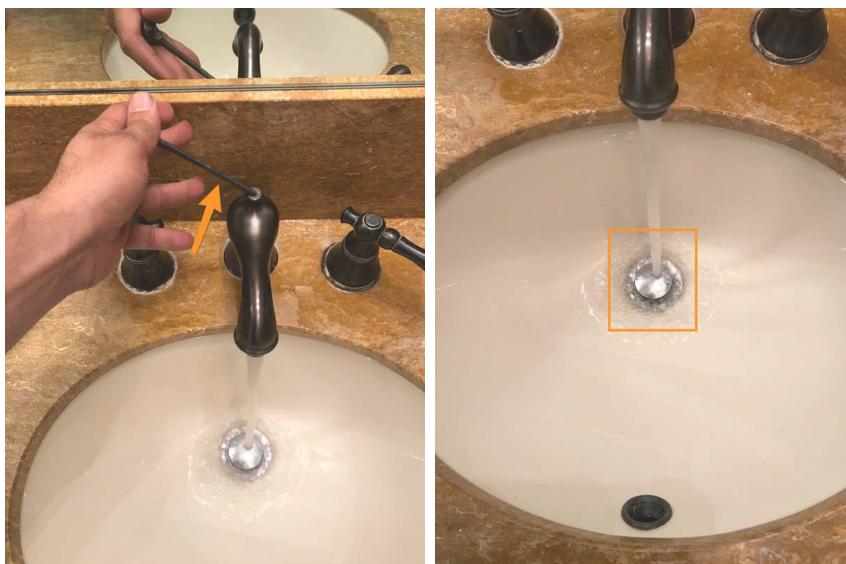
15.1.1 General

Observed the sink stopper broken. Recommend further evaluation from a licensed plumber.

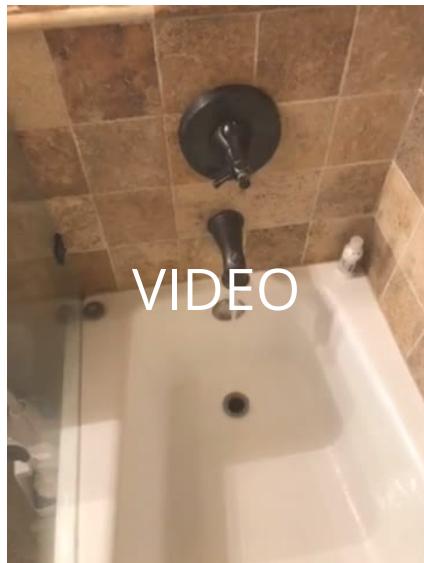
15.1.3 General

FAULTY SHOWER DIVERTER

Observed no pressure at the lower faucet. Recommend further evaluation from a licensed plumber.

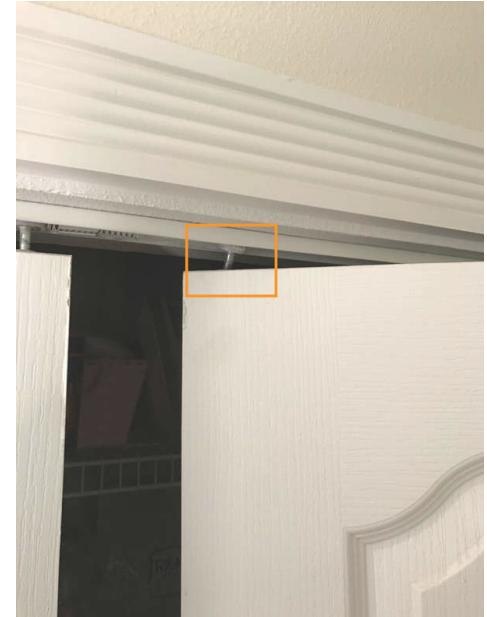
West Hallway Closet

HARDWARE IN NEED OF REPLACEMENT

Right side closet door in west hallway had broken hardware (top roller). Recommend replacing. Recommend further evaluation from a licensed carpenter or a handyman.

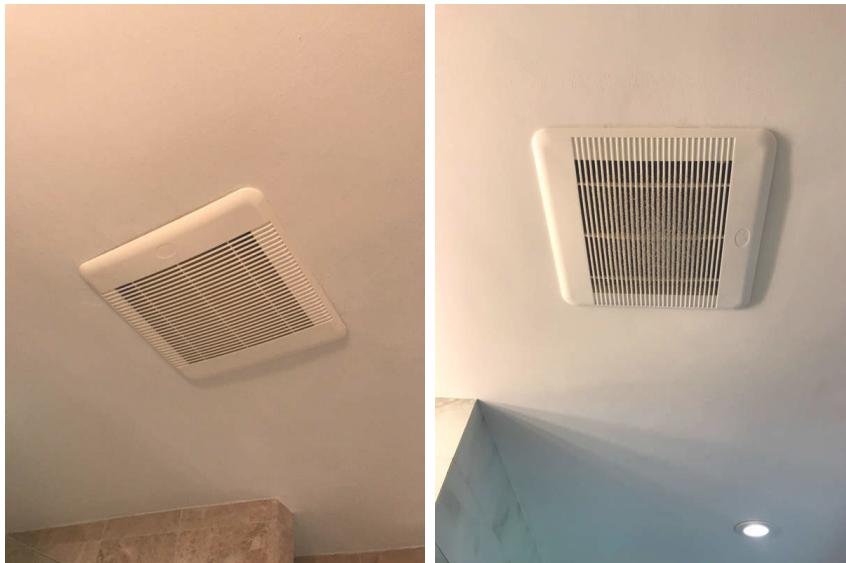
17.3.1 Exhaust Systems

Observed the vent fan in bathroom 4 & bathroom 3 were non functional (kids bathrooms). A bathroom vent fan is a common and effective way to circulate air in a small or confined space, allowing for circulation and lower humidity. A proper operating vent fan can help prevent future mold or water damage issues. Recommend further evaluation from a licensed electrician.

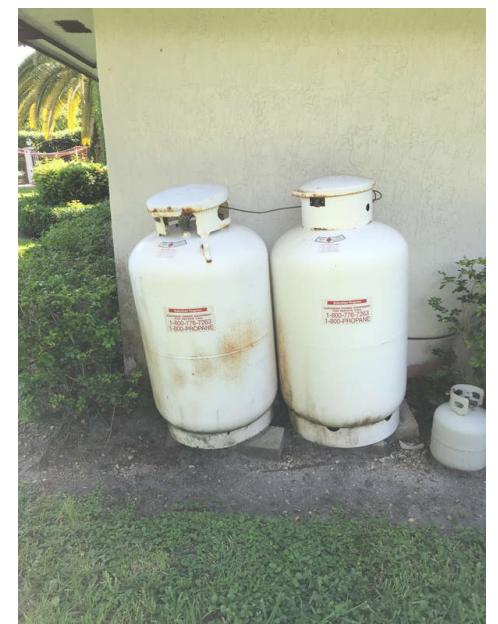
17.5.1 Fuel Storage & Distribution Systems

IMPROPER INSTALLATION

Observed the propane tanks not level. Recommend leveling floor. Gas supply or distribution pipes were improperly installed. Recommend a qualified contractor or local utility company evaluate and properly install pipes up to standards.

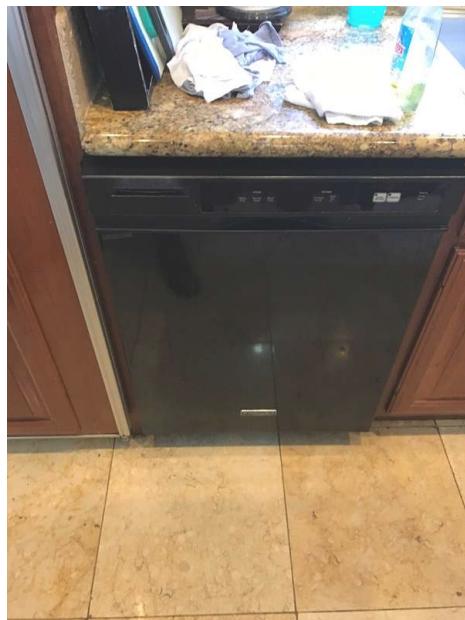
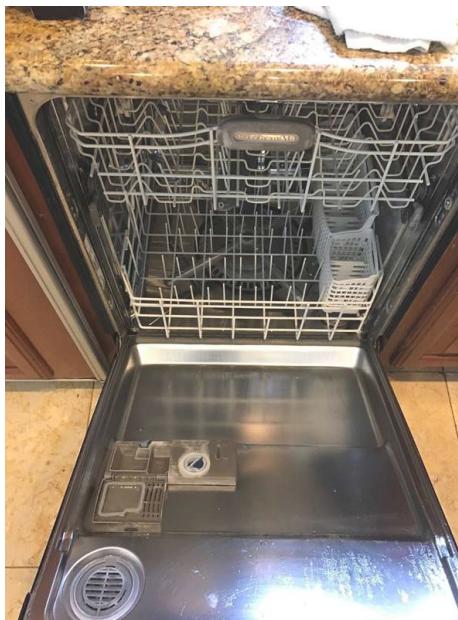
Dishwasher: Life Expectancy

Date of manufacture: 07/2008

Average life expectancy of a dishwasher is between 7-12 years. This unit is nearing the end of its life expectancy.

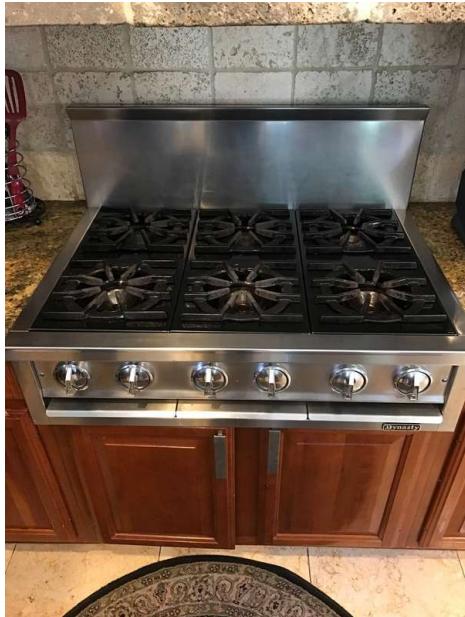
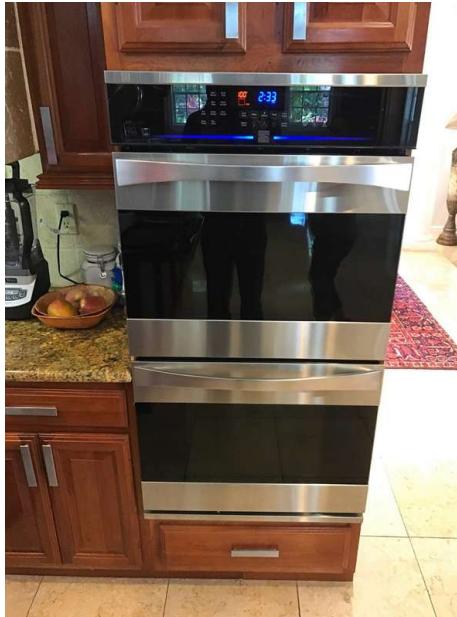
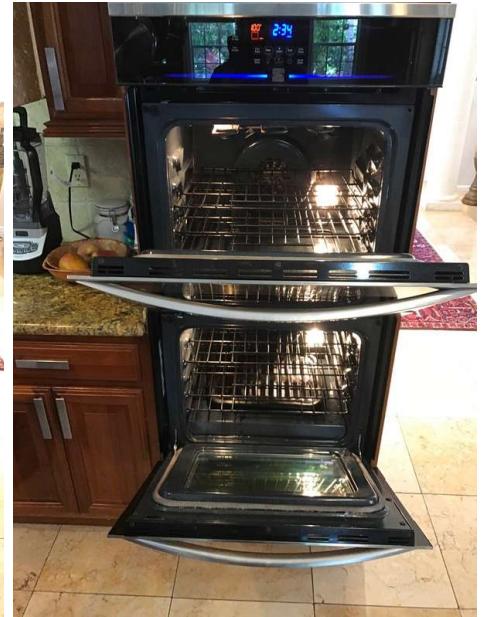
**Range/Oven/Cooktop: Life Expectancy**

Date of manufacture: 04/2014

Average life expectancy of a stove is between 13-15 years. This unit is still within its life expectancy.

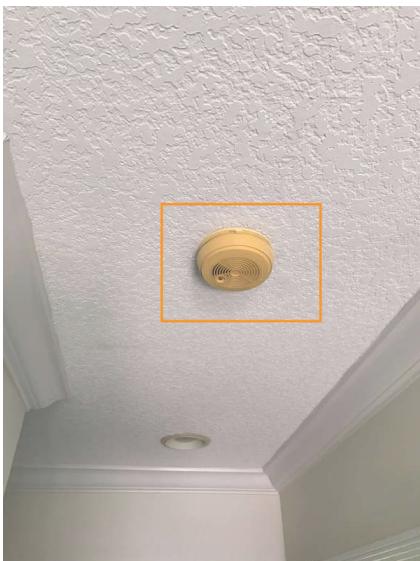
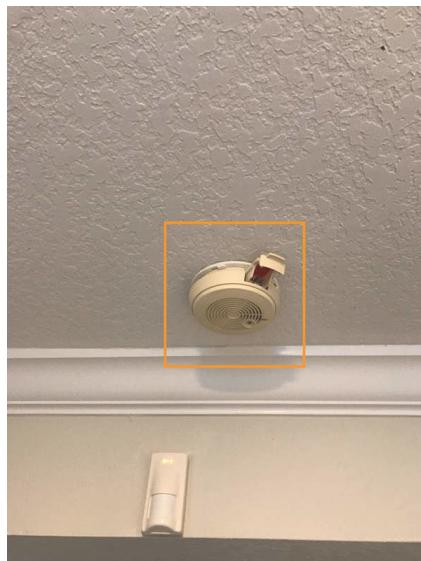
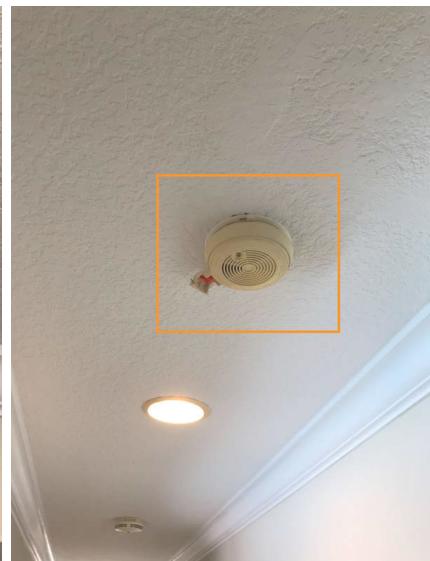
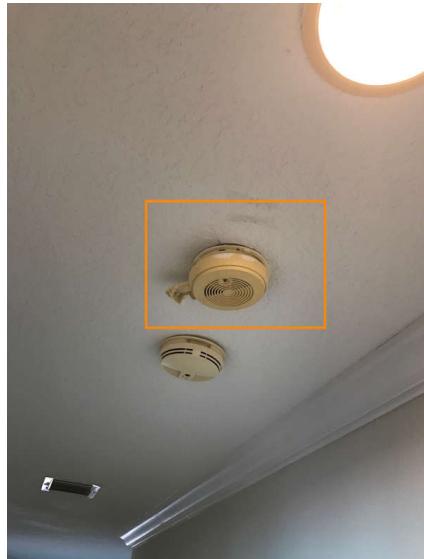
19.2.1 Smoke Detectors

One or more smoke detectors failed to respond when tested. Recommend battery be replaced in all smoke detectors.

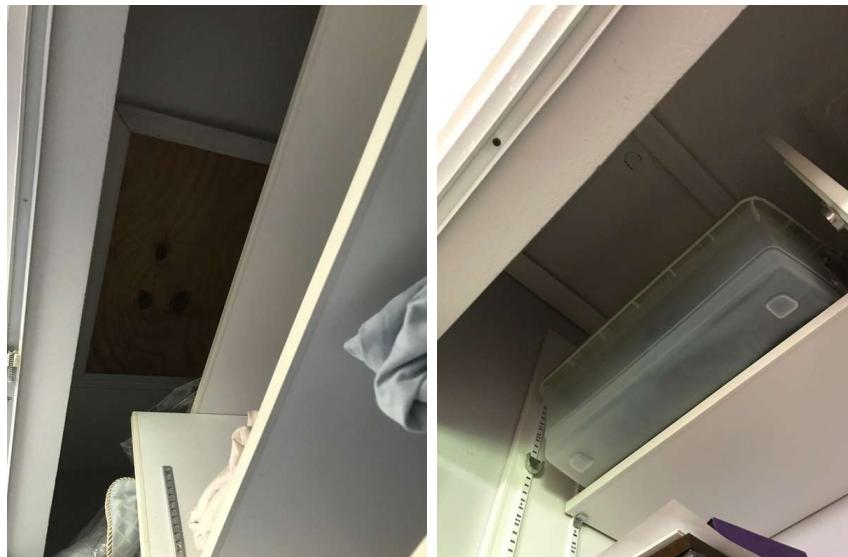
INACCESSIBLE

Attic access in bedroom 4 & 5 are inaccessible.

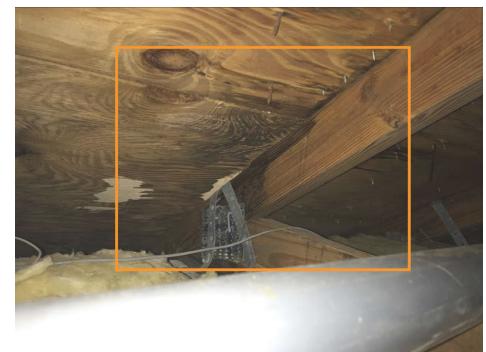
20.3.1 Roof Structure & Attic

MOISTURE DAMAGE

One or more areas of the sheathing showed signs or moisture damage. This appears to be from a prior leak. No evidence that it is from an active leak. Recommend further evaluation from a licensed roofing contractor to evaluate severity of damage and cost of repair/replacement.

Contact a qualified roofing professional.

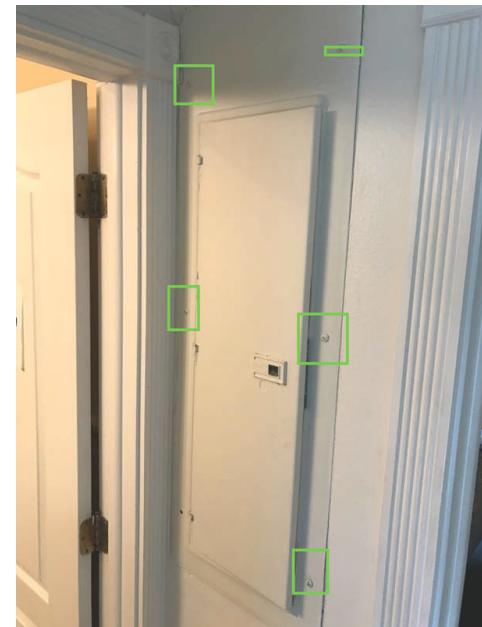
PANEL SCREWS STRIPPED

Unable to remove panel screws at the main panel. Recommend further evaluation from a licensed electrician to remove and replace panel screws and evaluate condition of panel.

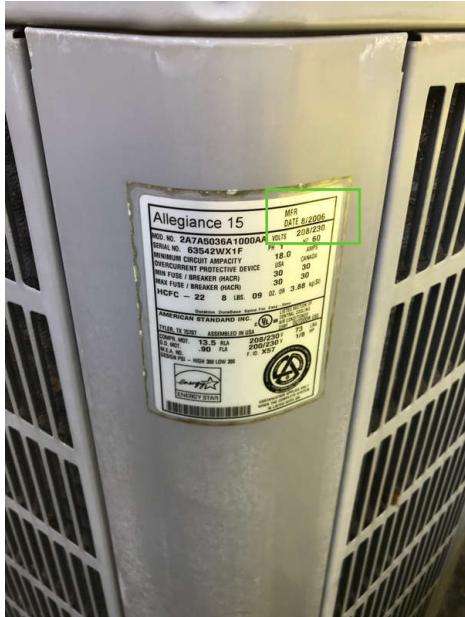
A/C Unit #1

Average life expectancy of an air conditioning unit is between 10-15 years. Unit #1 is nearing the end of its life and unit #2 & #3 are still within their life expectancies.

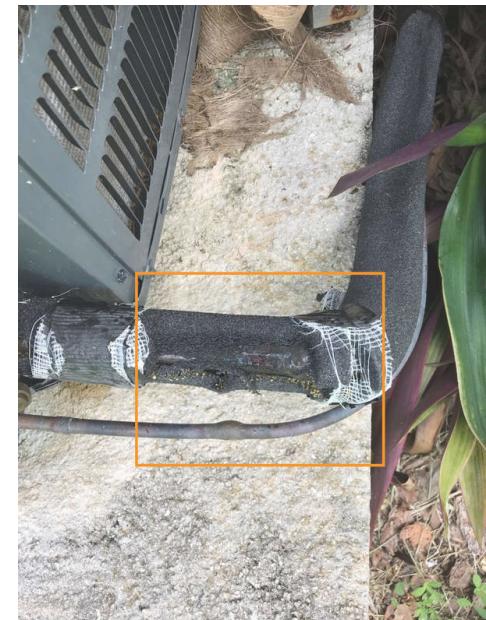
A/C Unit #2

INSULATION MISSING OR DAMAGED

Observed missing or damaged insulation on refrigerant line on A/C unit #2, which can cause energy loss and condensation. Recommend further evaluation from a licensed air conditioning contractor.
