# SLAB TO SHINGLE INSPECTIONS PLLC

# TREC REI 7-5

1234 Main St. Mckinney , Texas 75071

# PROPERTY INSPECTION REPORT

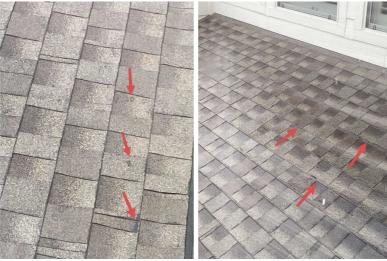
Backside of home

### 1: Damaged Coverings

Roof coverings exhibited general damage that will affect performance. Appears to have had hail damage and granular loss. Did not see any leakage. Would consult qualified roofer to evaluate if this is of concern. Owner commented she had roof inspected approximately 2 years ago and roofer said it had hail damage but not bad enough for insurance to pay for a new roof.

Recommendation: Contact a qualified roofing professional.

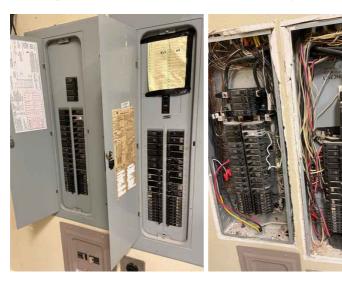
Location: Garage

This inspection covers the service entrance wiring, electrical panels and subpanels.

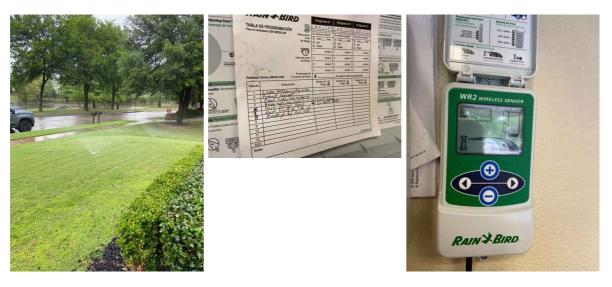
# 1: Zone Not Working

One or more zones was observed to not be working. May be buried soaker and unseen. Recommend a qualified contractor check for issues on bad zones.

Recommendation: Contact a qualified professional.
