PGR HOME INSPECTIONS

RESIDENTIAL HOME INSPECTION REPORT

1234 Main St. Charleston SC 29414

12/21/2020 9:00AM

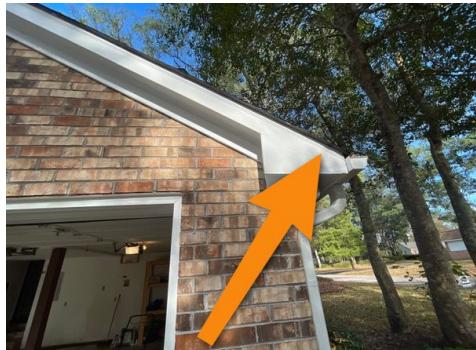
Front left corner

FASCIA: WOOD ROT

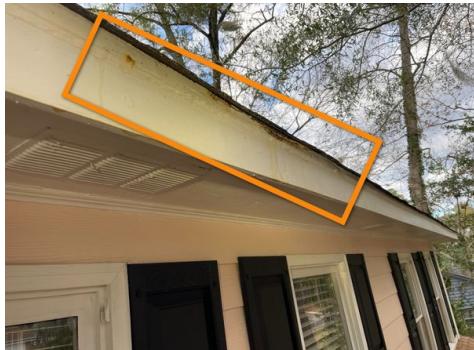
Front of the home

2.2.2 Exterior Components

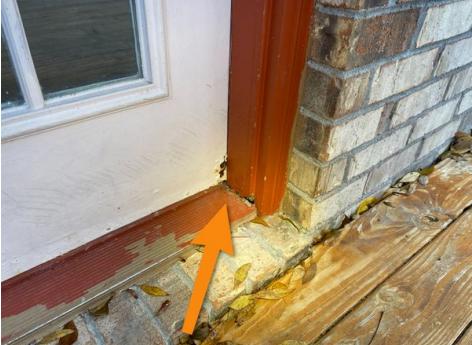
Back door

2.4.1 Decks, Porches, Steps

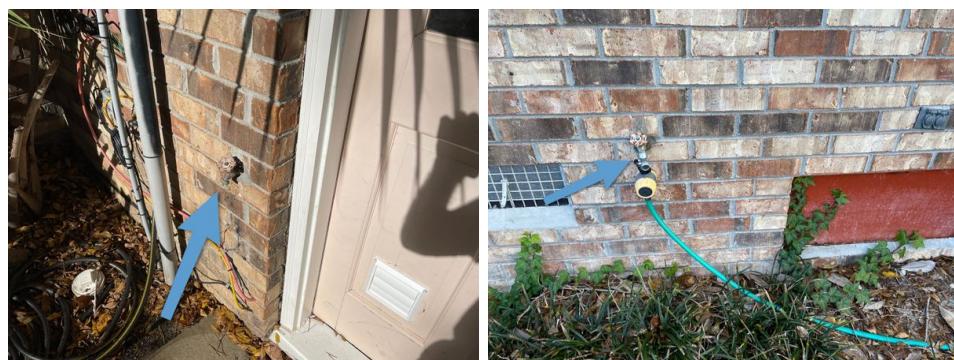
Left side of home

2.5.1 Hose Bibs

HOSE BIB: LOOSE/ NOT SECURED WELL

Contact a qualified professional.

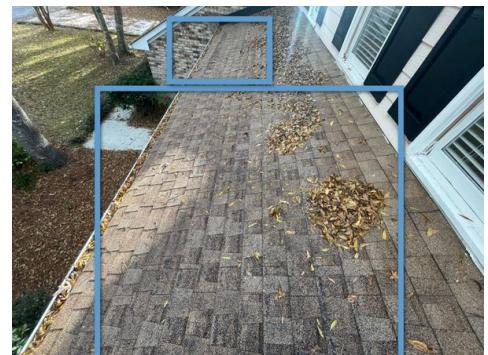
SHINGLES: FIBERGLASS EXPOSED/ MODERATE GRANULE LOSS

The asphalt composition shingles exhibited moderate granule loss throughout several areas. the roof. Several areas have widespread fiberglass exposure, which once exposed accelerates deterioration of the shingle. No signs of moisture intrusion in these areas at time of inspection. Recommend monitoring for future issues and budget for replacement in the future.

Recommend monitoring.

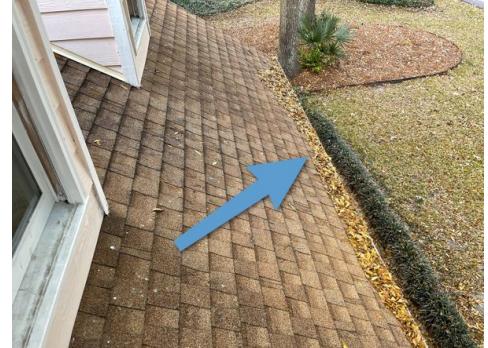
3.3.1 Flashings

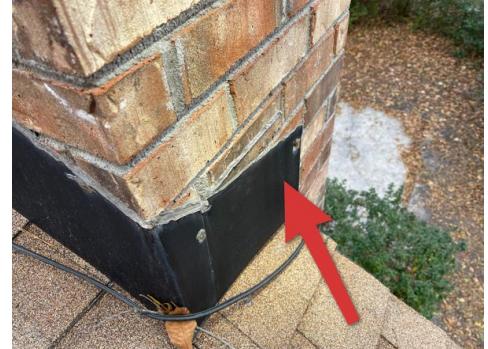
3.4.1 Vents, Other Roof Protrusions

NAIL HEADS EXPOSED

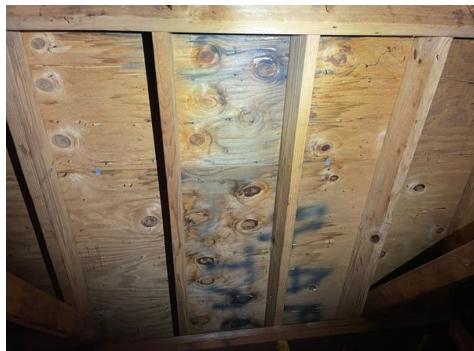
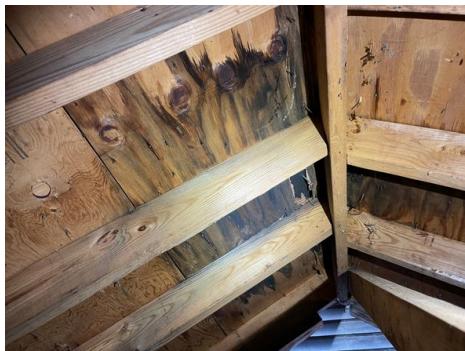
4.1.2 Roof Structure & Attic

Recommendation

Contact a qualified roofing professional.

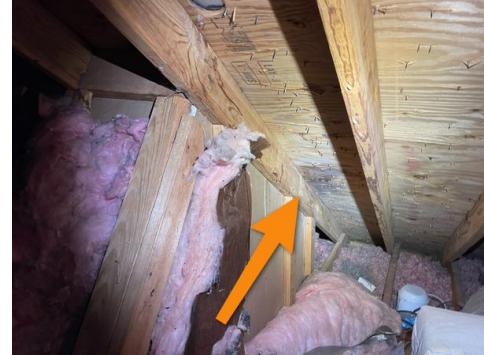
4.1.3 Roof Structure & Attic

ROOF DECKING: DAMAGED/ ROT**Deficiencies/ Recommendations**

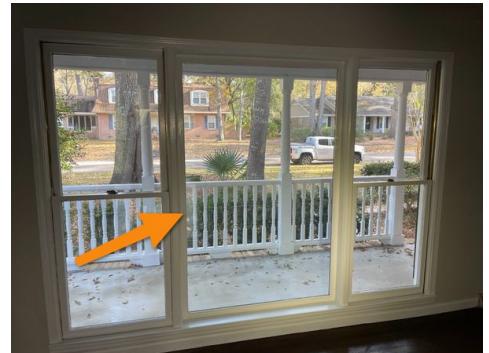
5.2.3 Windows

WINDOWS: UNABLE TO OPEN

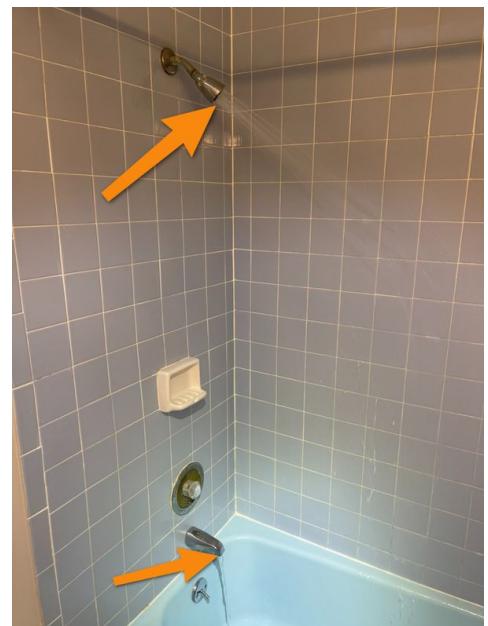
The 2nd floor bathroom has a leaky shower diverted valve resulting in water waste. Recommend repair or replacing the tub diverter by a qualified professional.

Contact a qualified plumbing contractor.

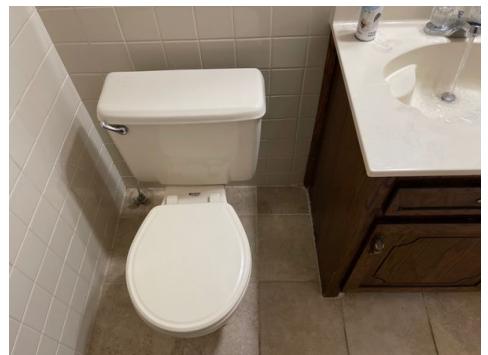
Toilet is loose at the base. Recommend a qualified plumbing professional evaluate and repair. It may just need to be tightened at the anchor bolts or there may be an issue with the flange. No signs of leaking on the interior of the home observed at time of inspection.

Contact a qualified plumbing contractor.

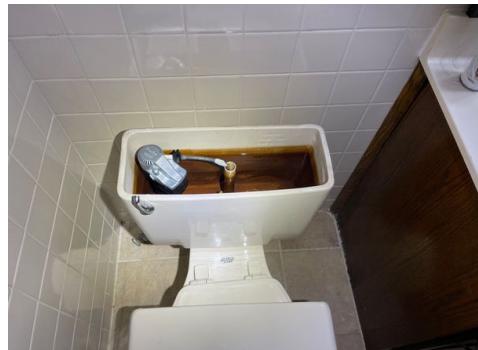
Toilet was running during time of inspection which may indicate a defective fill valve or flapper. Recommend a qualified professional evaluate and repair as needed.

Contact a qualified professional.

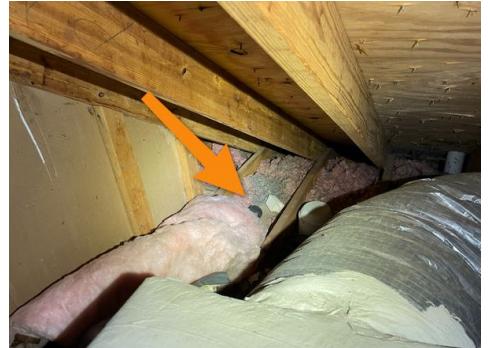
Master Bathroom

7.3.1 Exhaust Fans

EXHAUST FAN: VENTS INTO ATTIC

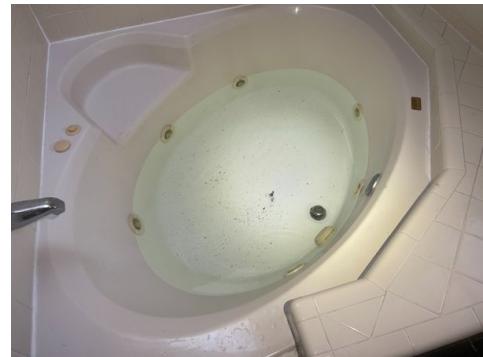
WHIRLPOOL TUB: SLOW DRAINAGE/ DEFECTIVE STOPPER

The whirlpool bathtub was draining extremely slow at time of inspection. When attempting to fill the tub the stopper was very difficult to engage therefore the issue may lie with the tub stopper. It is possible the stopper is defective and would not open properly in order to drain. Recommend a qualified plumbing professional evaluate further and repair as needed.

Contact a qualified plumbing contractor.

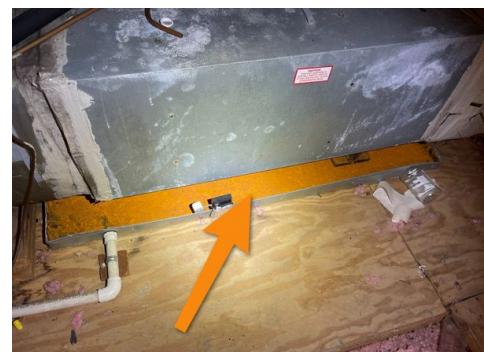
DRAIN PAN: HEAVY RUST

Heavy rust present in a the drain/overflow pan. No signs of leaking current leaking, however over time pinhole leaks could develop. Due to the age of the system, servicing is recommended Recommend monitoring the pan and ceiling below it for future issues and budget for replacement in the future.

Contact a qualified HVAC professional.

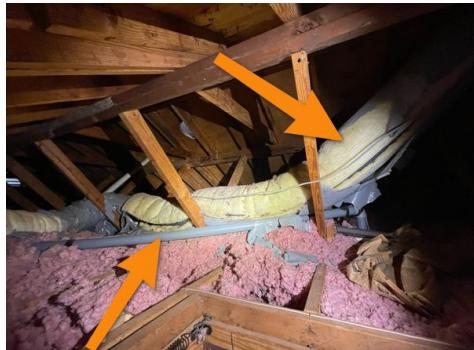
SW portion of attic. Above room over the garage

9.3.1 Distribution System

DUCT INSULATION: DAMAGED

Contact a qualified professional.

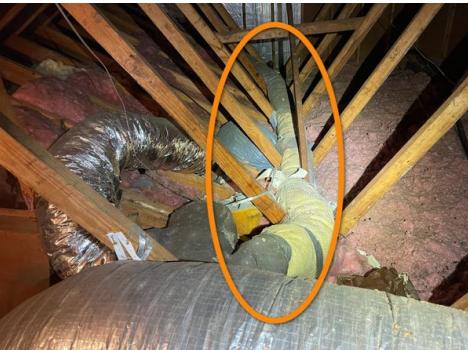
Above Master Bedroom

Duct insulation is damaged in the attic around multiple supply ducts. This can result in increased sweating and reduce efficiency. Recommend a qualified professional repair as needed.

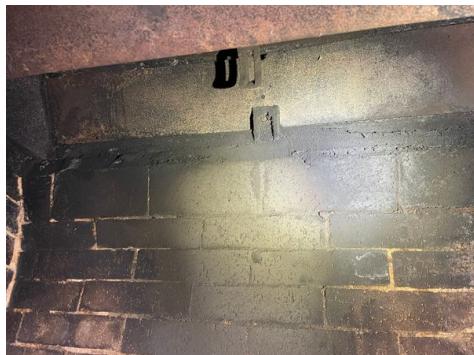
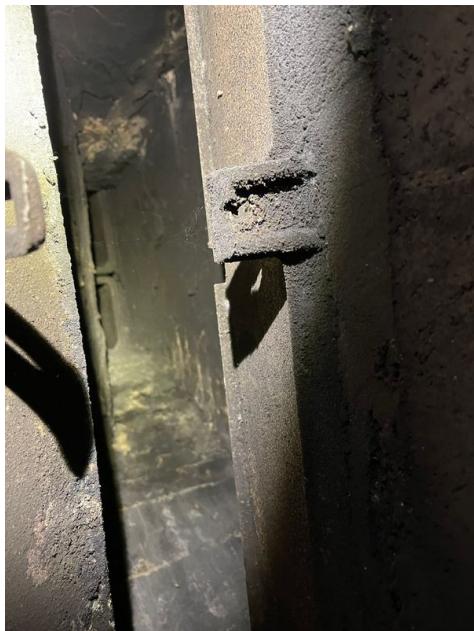
There was creosote in the chimney flue and firebox. Recommend a qualified fireplace or chimney contractor clean prior to first use and continue on an annual basis.

Contact a qualified chimney sweep.

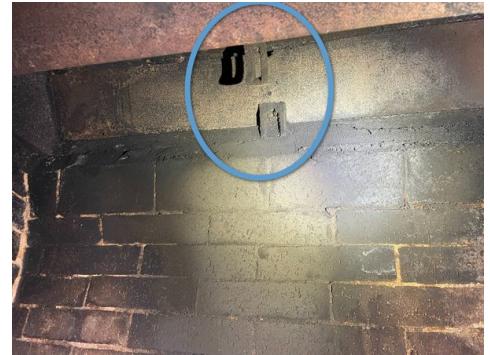
FIREPLACE: DAMPER HANDLE MISSING

The fireplace damper handle is missing. Recommend installing a new handle to improve functionality.

Contact a qualified professional.

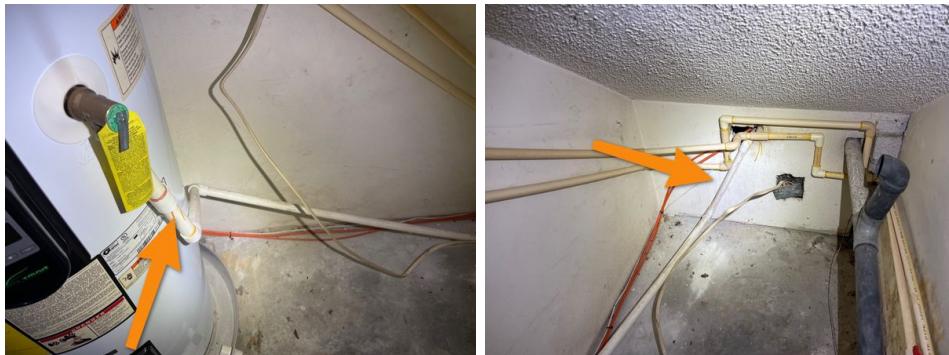
10.1.4 Water Heater

TPRV DISCHARGE PIPE: IMPROPER MATERIAL AND INSTALL**Deficiencies/ Recommendations**

**P2906.5 Water Distribution Pipe**

Water distribution piping within *dwelling units* shall conform to NSF 61 and shall conform to one of the standards indicated in Table P2906.5. Water distribution pipe and tubing shall have a pressure rating of not less than 100 psi at 180°F (689 kPa at 82°C).

Contact a qualified plumbing contractor.

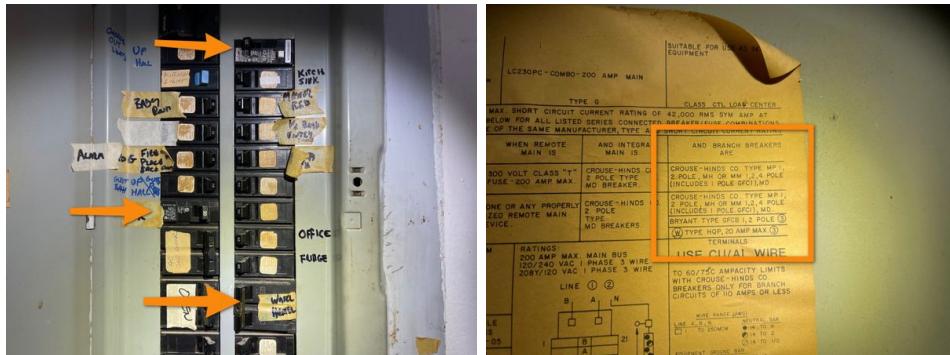
11.3.2 Branch Wiring Circuits, Breakers & Fuses

BREAKERS: IMPROPER BRAND/ NOT APPROVED FOR USE IN PANEL ACCORDING TO LABEL

Contact a qualified electrical contractor.

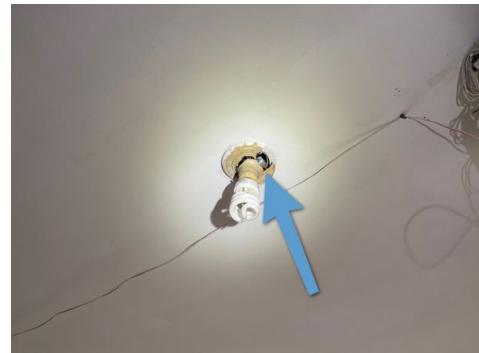
11.3.3 Branch Wiring Circuits, Breakers & Fuses

DOUBLE LUGGED NEUTRALS

Contact a qualified professional.

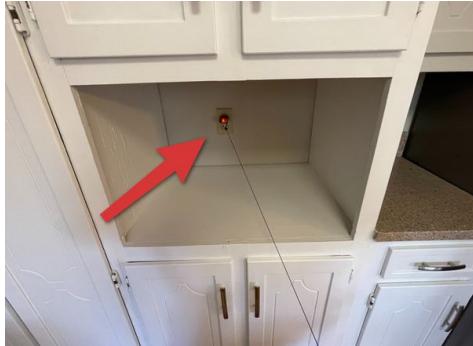
Left of refrigerator

11.4.2 Receptacles & Switches & Lights

RECEPTACLE(S): OPEN GROUND - 3 PRONG

Contact a qualified electrical contractor.

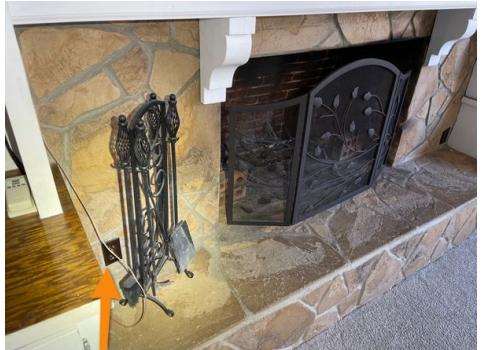
One receptacle was not functioning at time of inspection. All nearby switches were on to test if it is a switched receptacle. Recommend a licensed electrician evaluate and repair as needed.

Contact a qualified electrical contractor.

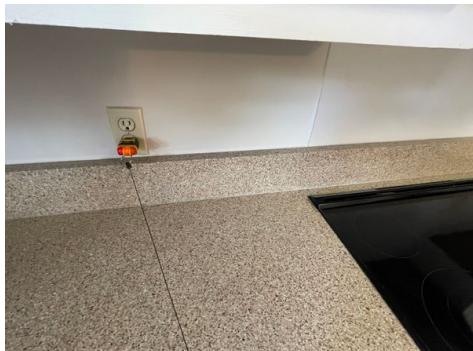
Kitchen left of range

11.4.4 Receptacles & Switches & Lights

RECEPTACLES: REVERSE POLARITY (HOT AND NEUTRAL REVERSED)

Contact a qualified electrical contractor.

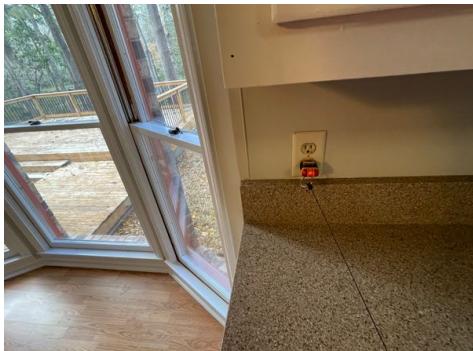
Multiple receptacles were found with reverse polarity meaning the Hot and Neutral conductors are reversed. Receptacles with reverse polarity pose a risk of shock and injury. Recommend a licensed electrician repair.

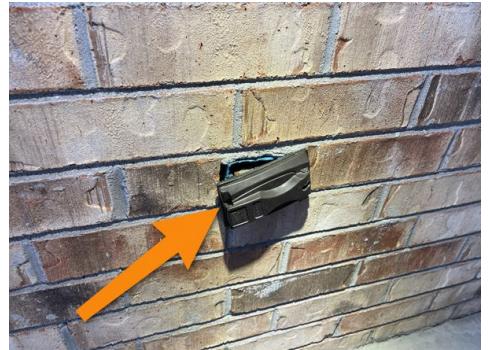
Front porch

The weatherproof cover on the front porch receptacle is partially detached which can allow for unwanted moisture intrusion into the gang box. Recommend a qualified professional repair.

Contact a qualified professional.

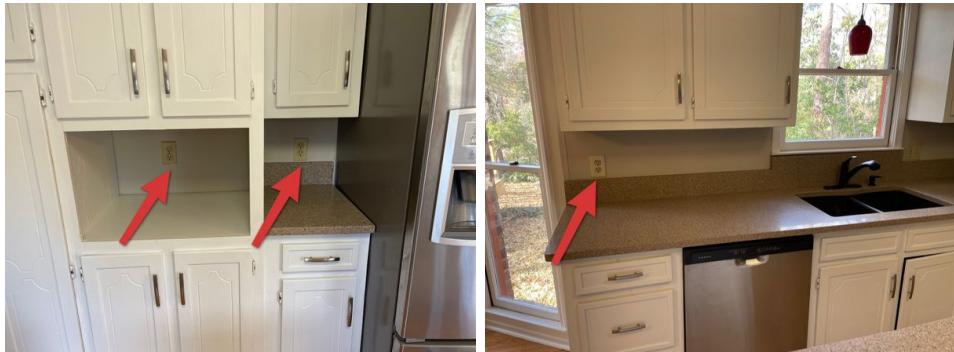
GFCI (Ground Fault Circuit Interrupter) protection was not present in the KITCHEN receptacles shown. To help protect against possible shock and/or damage to equipment recommend a licensed electrician install proper GFCI protection.

Contact a qualified electrical contractor.

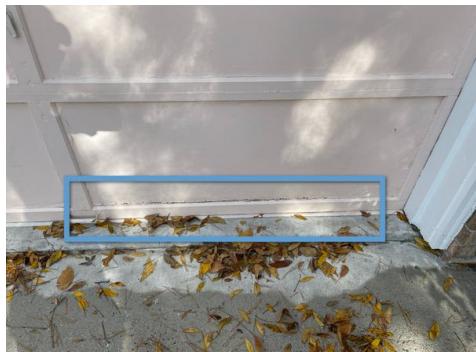
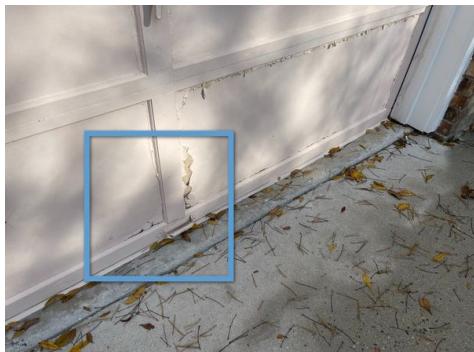
GARAGE DOOR: PANEL DAMAGE

Multiple garage door panels have minor moisture damage. The damage does not affect functionality of the garage door. Recommend monitoring for future issues and/or have a qualified professional repair as needed.

Recommend monitoring.

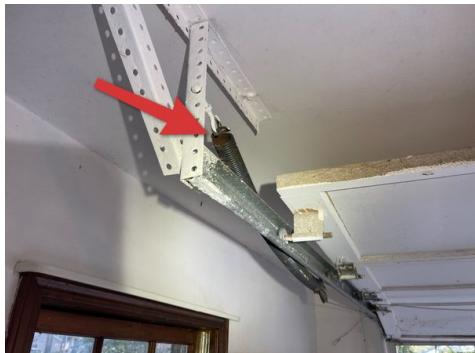
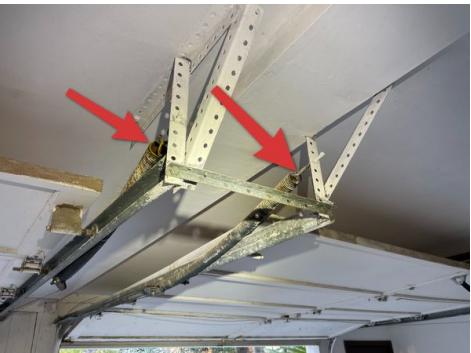
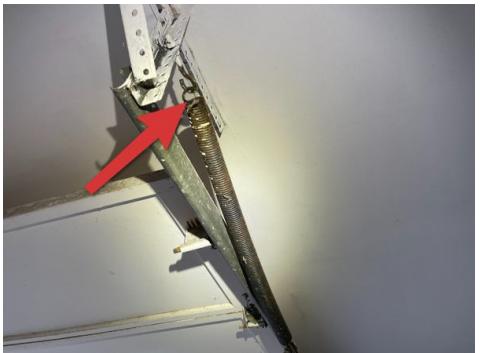
12.1.3 Garage Door/ Door Opener

GARAGE DOOR: SPRING CONTAINMENT CORDS MISSING

Contact a qualified professional.

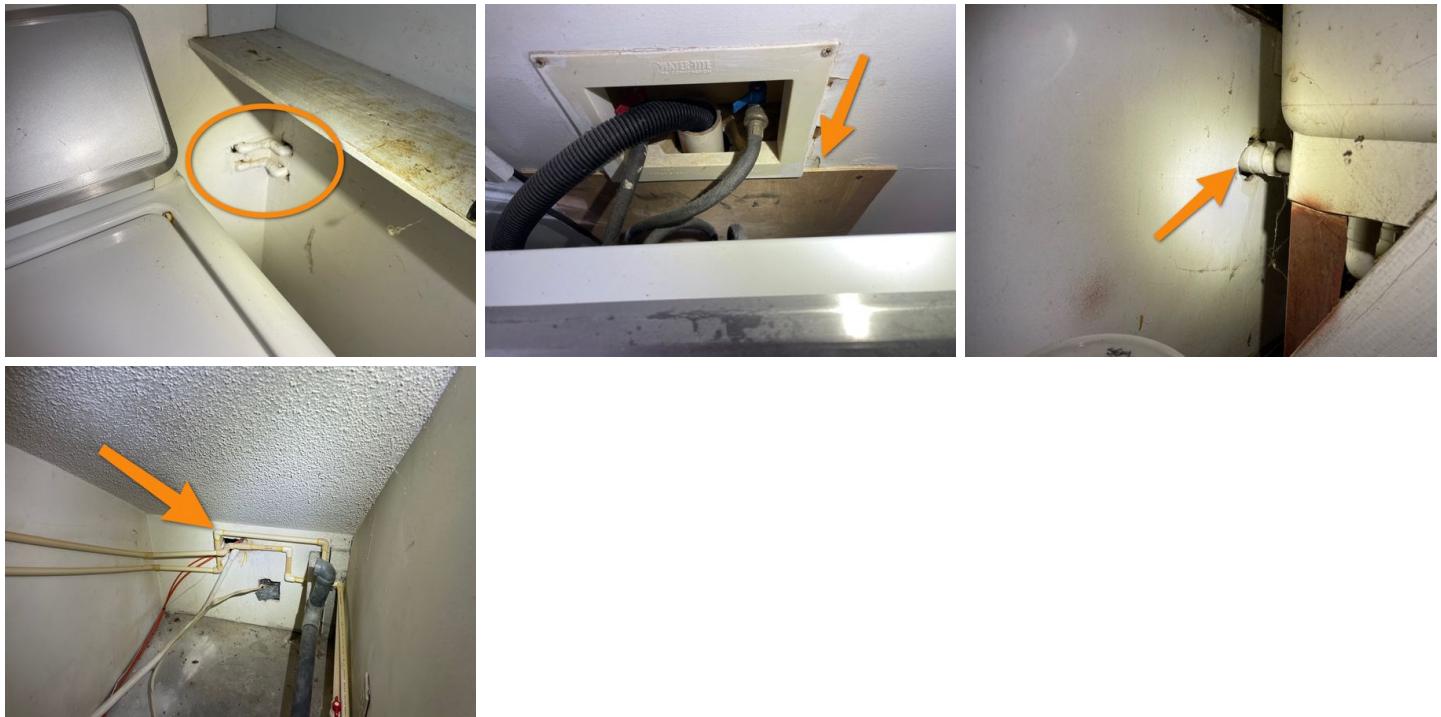
WALLS/ CEILING: INCOMPLETE FIRE SEPARATION - PLUMBING/WIRING

Break in the proper fire separation between the garage and living space where plumbing penetrate the wall and ceiling and drywall was removed near the laundry plumbing and replaced with thin wood paneling. Recommend installing the appropriate fire block sealant around the plumbing penetrations and installing proper fire rated drywall where the wood paneling is present to help reestablish the fire separation.

Contact a qualified professional.
