Pait Home Inspections of North Carolina, LLC

Home Inspection Report

Property Address:
123 Street Name
Louisburg, NC 27549

Inspected on Mon, Nov 4 2019 at 9:31 AM

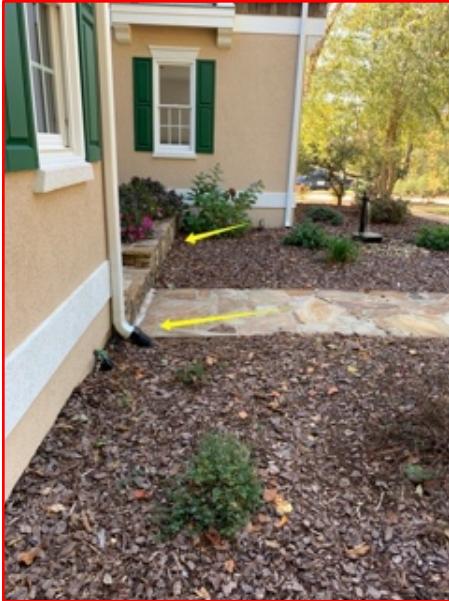
Figure 1-1

1) Comment 1: The site grading in multiple areas slopes toward the homes foundation. It is recommended that grading slopes away from the foundation 6 inches in the first 10 feet. This will prevent water intrusion into the foundation and deterioration of materials. Raising the grade or sloping these areas is recommended.

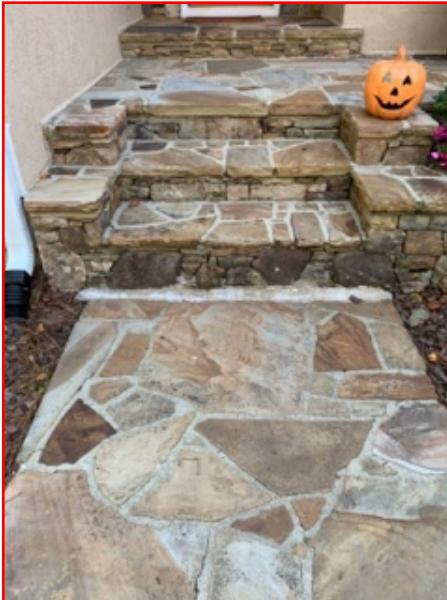
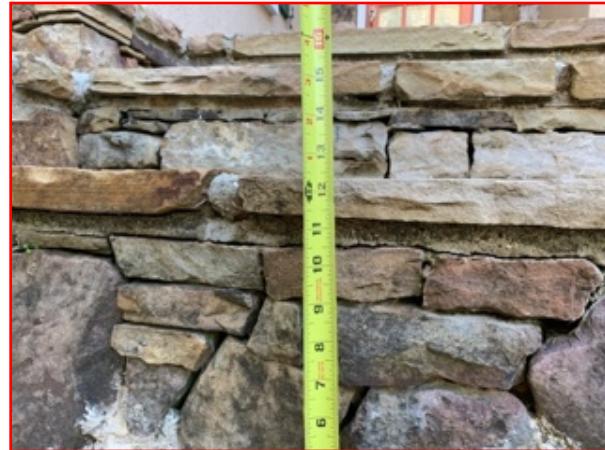
2) Comment 3: The front entry steps do not meet current building guidelines in regards to total riser height and riser height differential. It is considered a fall/trip hazard. 7 3/4" max height and no more than 3/8" difference in height or depth is allowed.

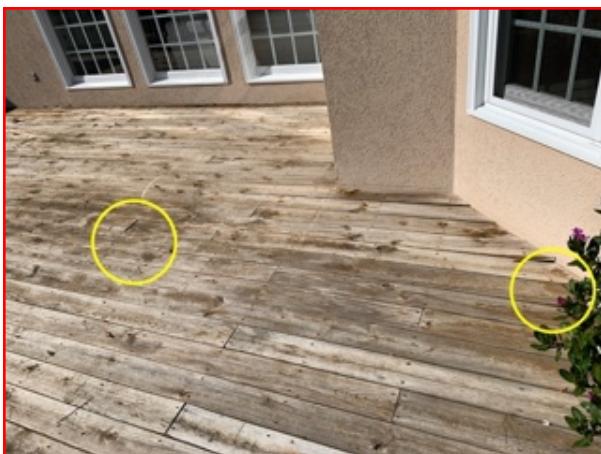
Figure 4-1

3) Comment 4: The back deck and back deck stairs have loose/damaged boards. Replacement/repair of the boards is recommended to prevent failure.

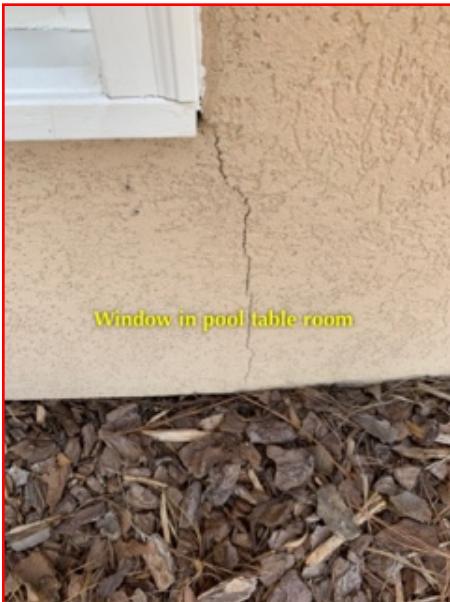
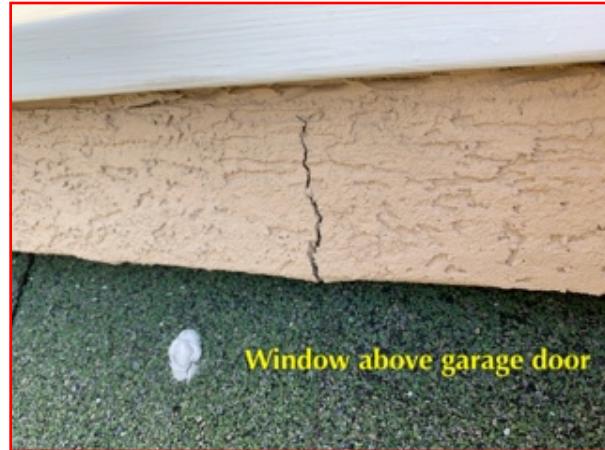
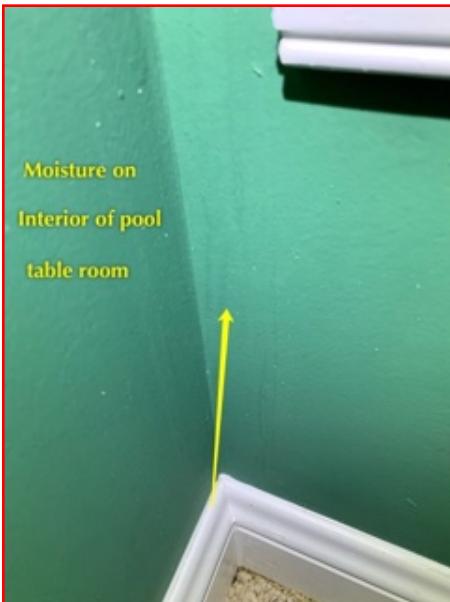
4) Comment 7: There are multiple hairline cracks in the exterior synthetic stucco. Evaluation, sealing and repairing the cracks by a qualified stucco professional is recommended to prevent water entry.

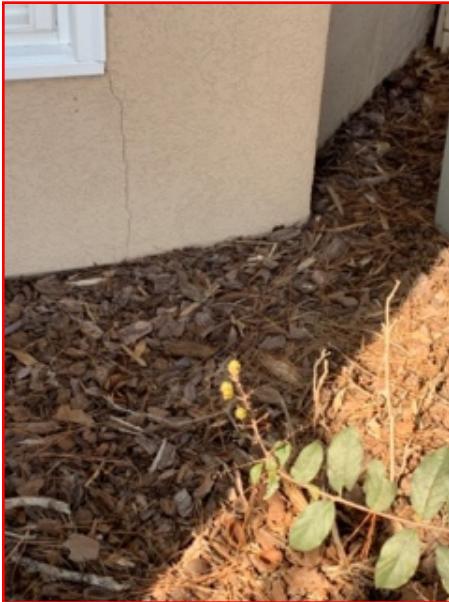
Figure 8-1

5) Comment 8: Synthetic stucco should not come into contact with the exterior grade. There should be approximately 6" between grade and the stucco to help prevent moisture related issues.

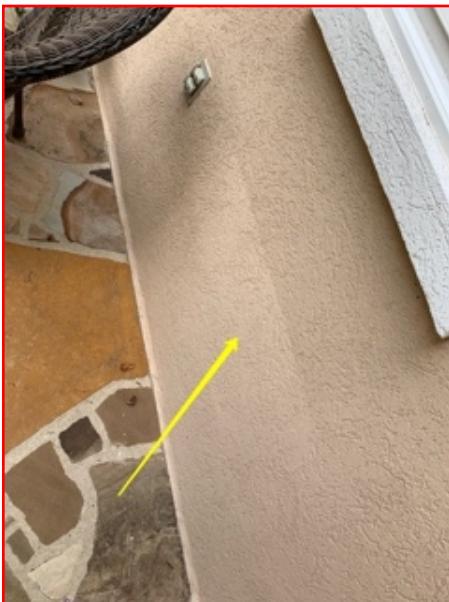
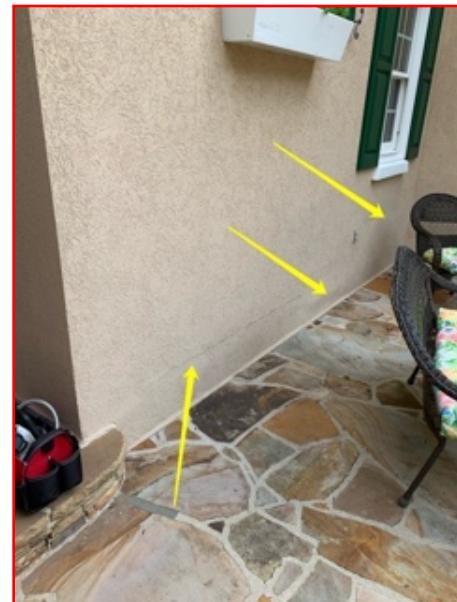
6) Comment 9: There is damage to the stucco on the lower wall of the front porch. There is a horizontal crack and the stucco is bowed out in multiple locations. Further evaluation and repair by a qualified stucco professional is recommended to prevent further damage.

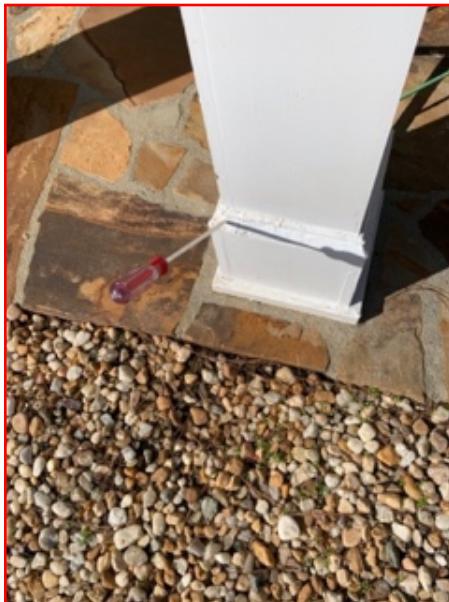
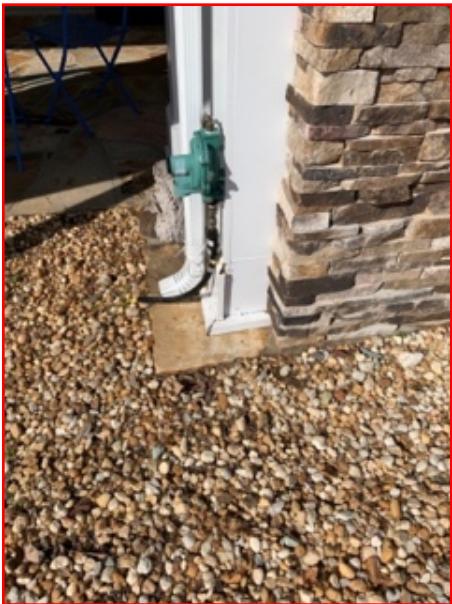
7) Comment 10: There is wood rot at multiple back porch columns. Repair by qualified carpenter is recommended to prevent further deterioration or damage to surrounding components.

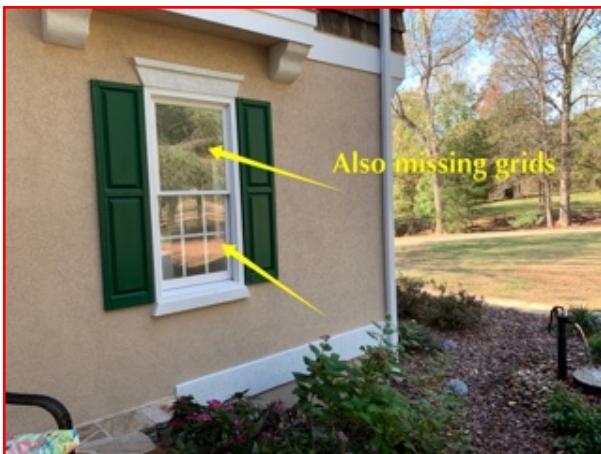
Figure 12-1

8) Comment 12: There are multiple windows whose hermetic seals are broken and moisture has entered between the two glass panes. This reduces the window's insulation ability. Evaluating all of the windows and replacing any failed windows is recommended.

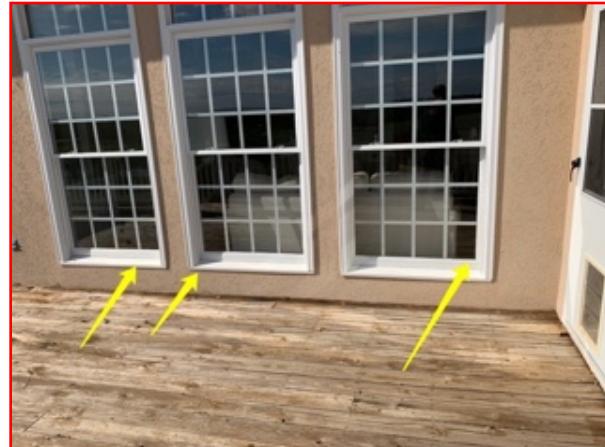
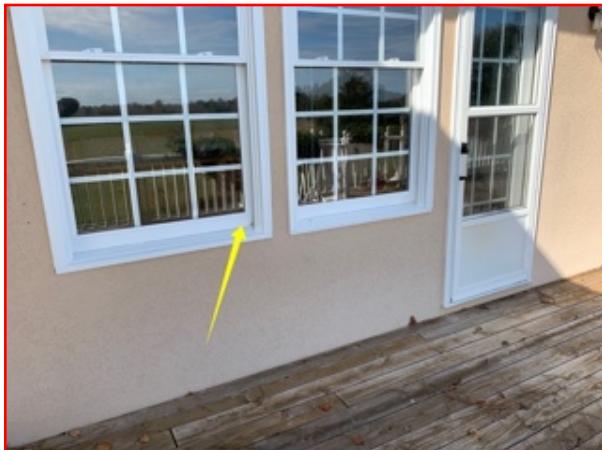
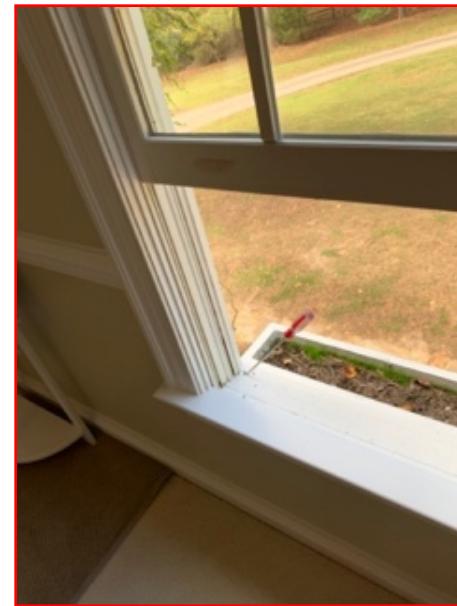
9) Comment 13: There are multiple windows that have water damage or show signs of beginning damage to rails or stiles of the window. Evaluation of all windows and repair or replacement by a licensed window contractor is required to prevent further damage.

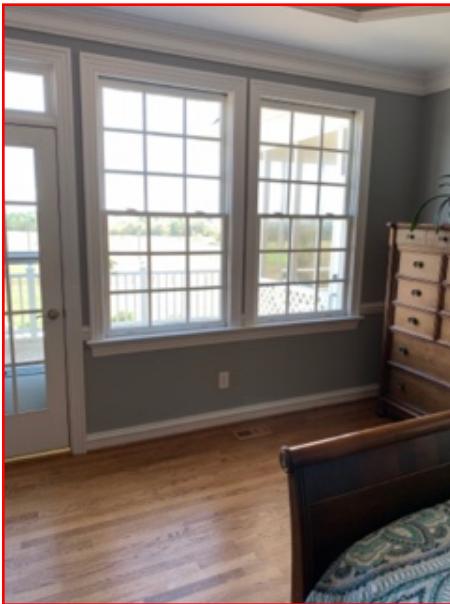
Figure 15-1

10) Comment 15: The windows in the master bedroom were difficult to open. The sash on the right wouldn't open (possible painted shut) and both windows are loose and came detached from the side channel when attempting to open them. Evaluation by a qualified professional is recommended.

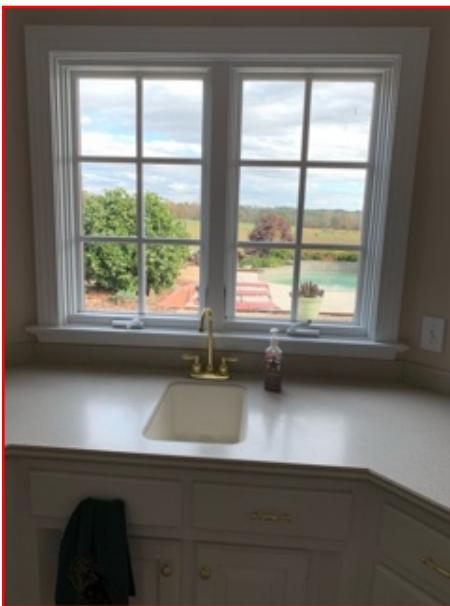
Figure 17-1

11) Comment 17: The casement windows in the basement kitchen were unable to be opened. Evaluation and repair by a qualified professional is recommended. (Possibly painted shut)

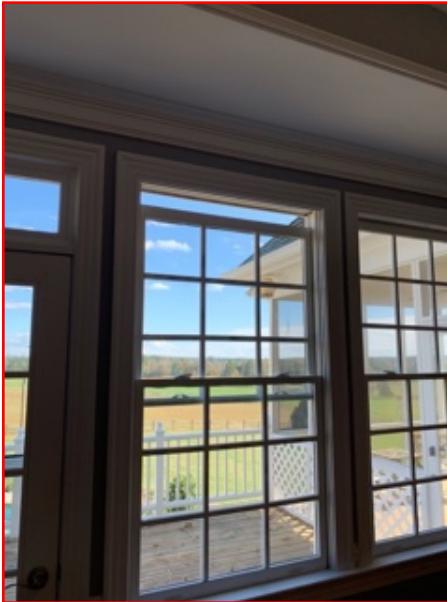
Figure 18-1

12) Comment 18: On several windows, the top sash drops several inches when the bottom sash is unlocked. Repair for proper function is recommended and to prevent further loosening of the top sash.

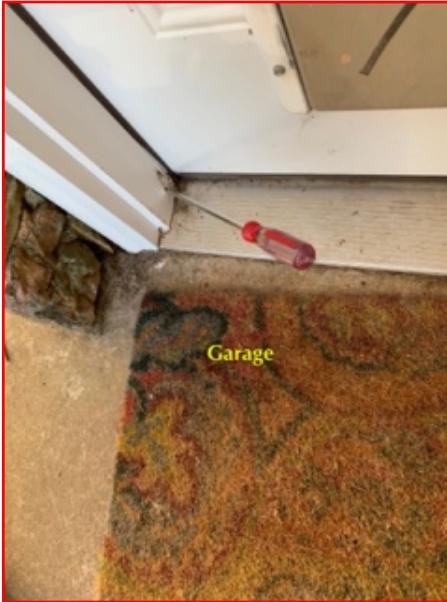
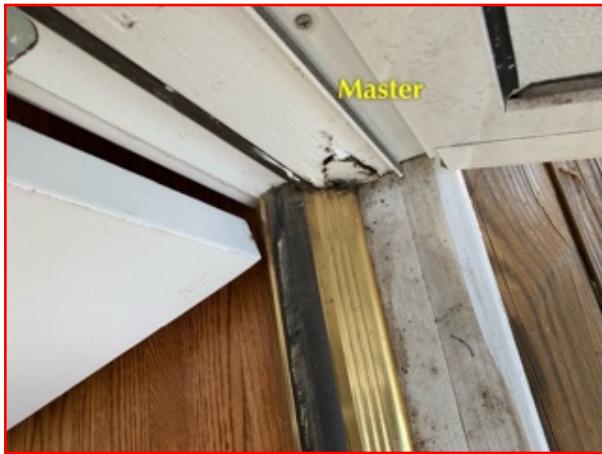
13) Comment 19: Multiple exterior doors have wood rot to the jamb. Repairing the affected area is recommended to prevent further damage.

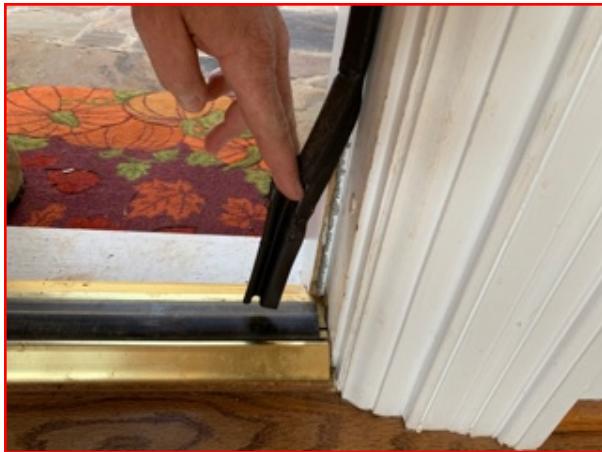
Figure 20-1

14) Comment 20: The front exterior door weatherstripping is torn. Replacing the weatherstripping is recommended.

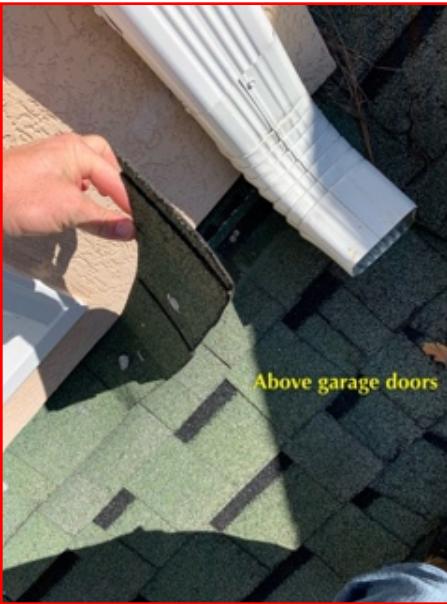
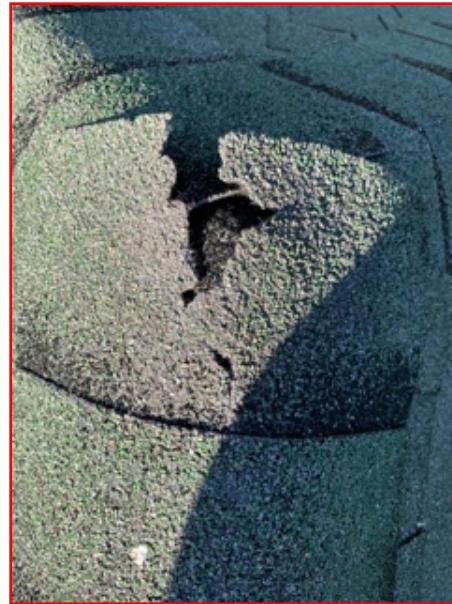
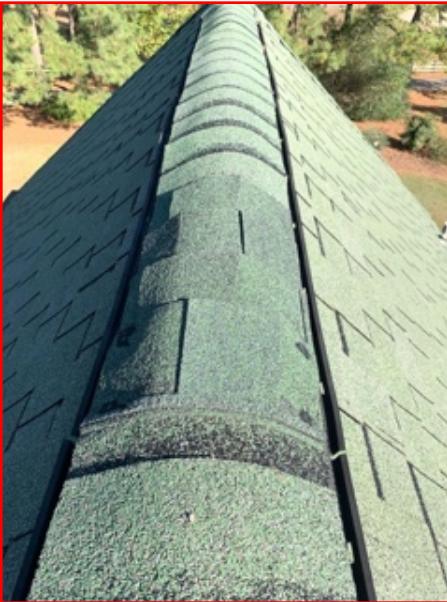
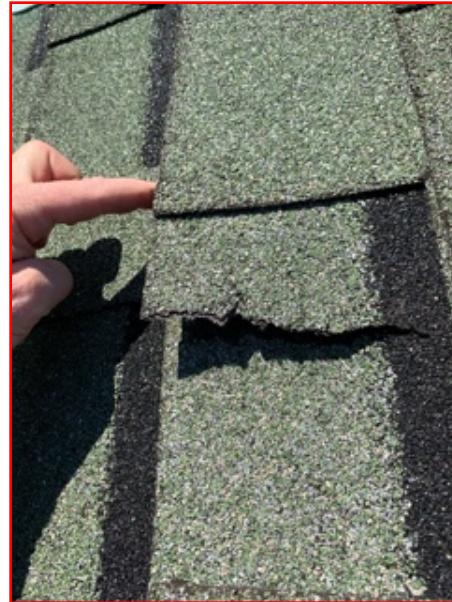
15) Comment 23: Due to the number of deficiencies with the roofing system, a complete evaluation by a licensed roofer is required. Some deficiencies include but are not limited to missing/detached shingle tabs, torn shingles, lifted flashing, signs of leaking and improper ridge cap repair.

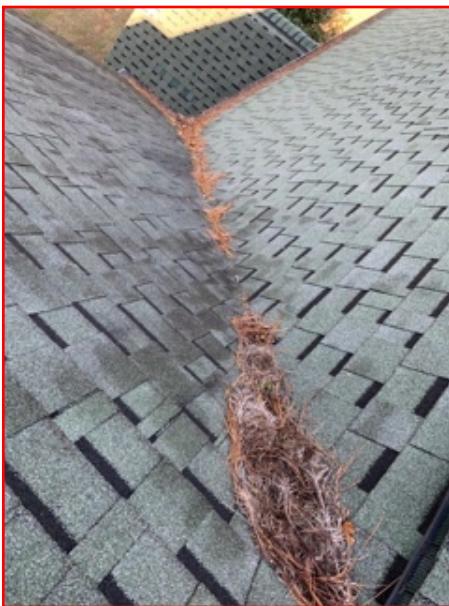
Figure 25-1

16) Comment 25: There is debris from trees and surrounding vegetation on the roof. This causes water to back up under the roofing materials and could lead to water leaking and damage to surrounding components. Periodic cleaning of the roof is required.

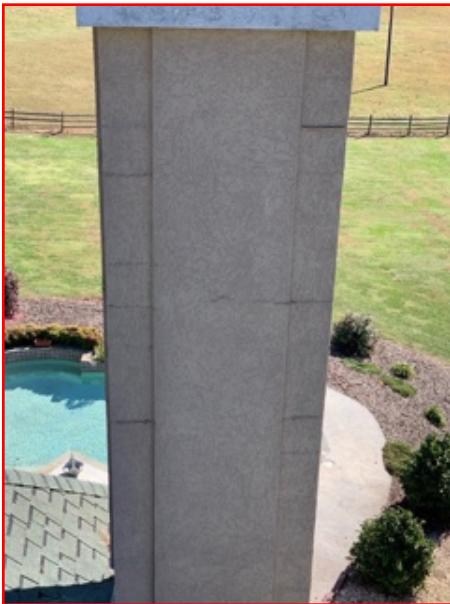
Figure 26-1

17) Comment 26: The stucco coat applied to the chimney block has come loose/been damaged. Evaluation and repair by a qualified contractor is recommended to prevent moisture entry.

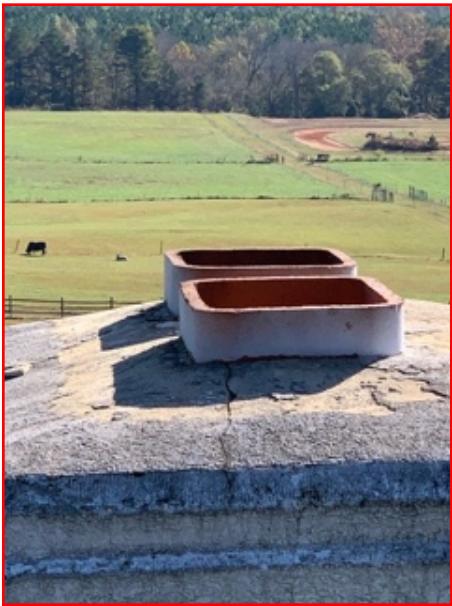
Figure 27-1

18) Comment 27: The mortar on the chimney cap has multiple cracks and is deteriorated. This could allow water to enter into the chimney chase. A qualified professional should repair the mortar chimney cap before using the fireplace. There is also no spark arrestor/rain cap.

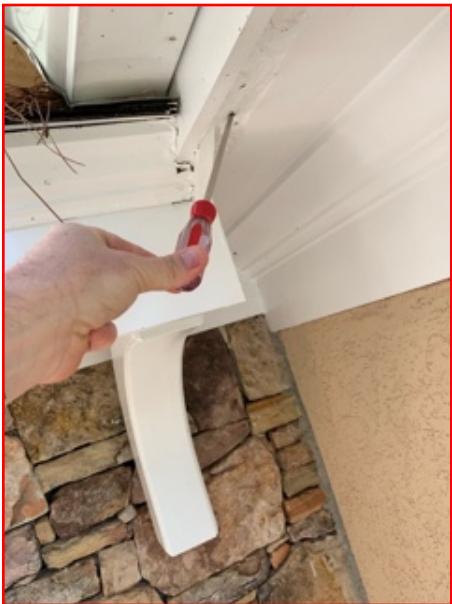
Figure 28-1

19) Comment 28: The soffits, fascia and crown molding above the garage entry door have moisture damage and are deteriorated. Further evaluation of the cause of the leak and replacing any moisture damage wood is recommended.

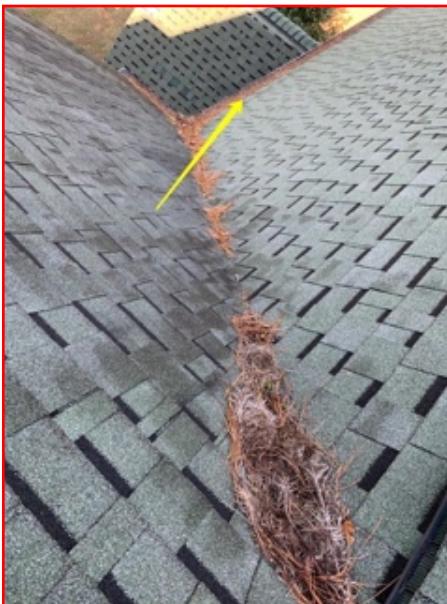
Figure 29-1

20) Comment 29: The gutters/gutter guards, in multiple locations, are filled with debris which will prevent water from exiting into the downspouts. This could cause water runoff in areas that could present moisture problems. Cleaning out the gutters and ensuring functional flow out of the downspouts is recommended.

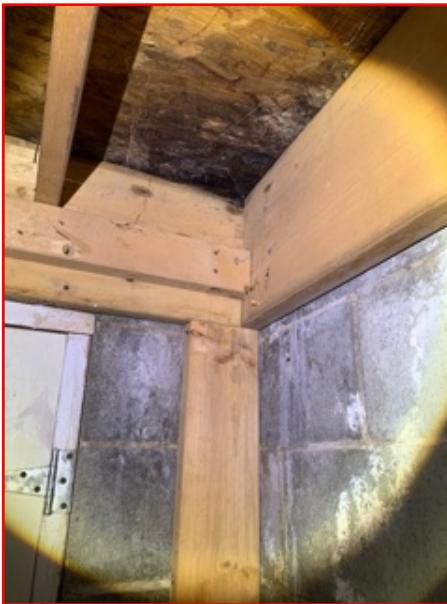
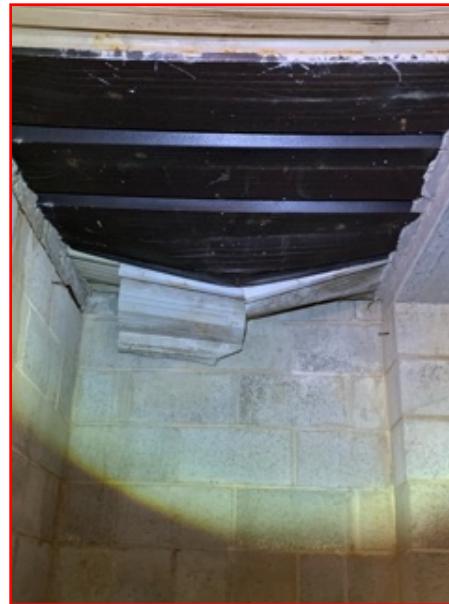
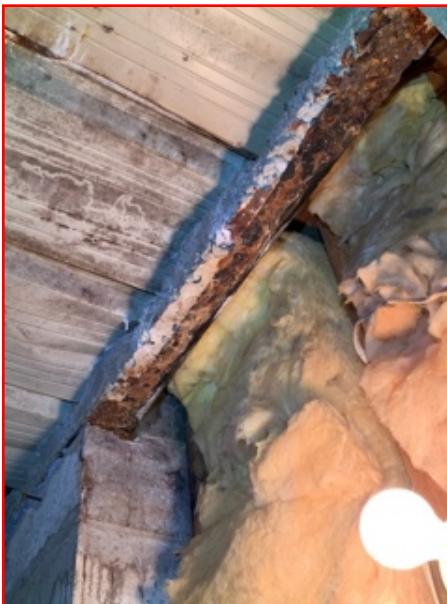
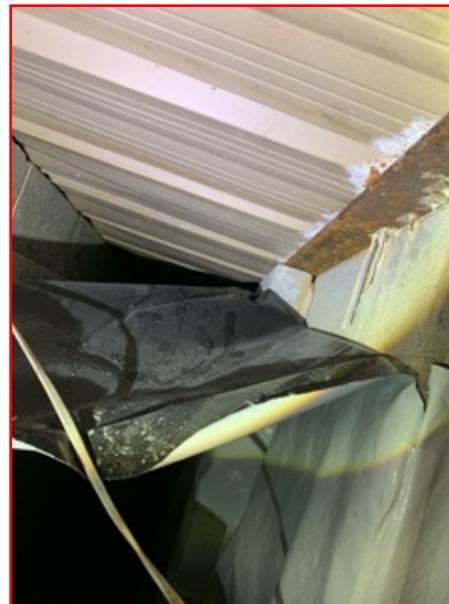
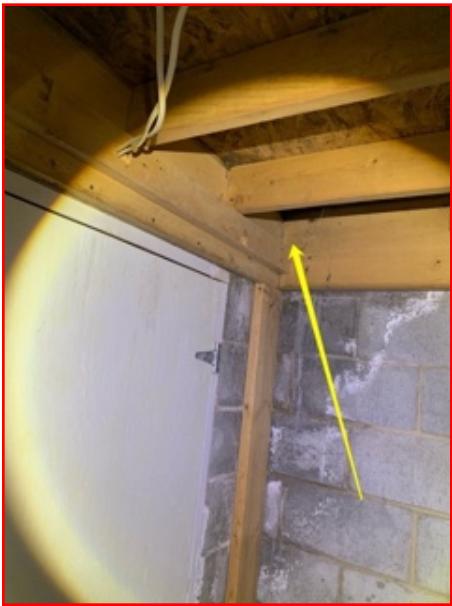
22) Comment 31: There are multiple indications of moisture/water entry into the foundation including but not limited to efflorescence, staining to masonry block and wood framing members, and rust to lentils. Further evaluation by a qualified professional is recommended.

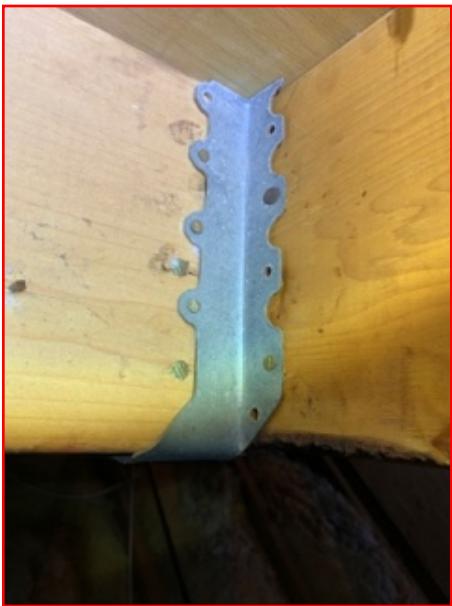
Figure 32-1

23) Comment 32: The attic joist hangers were not installed using the manufacturer's required fasteners. Galvanized common nails are required for installation of these hangers to ensure proper load support and to reduce galvanic corrosion between dissimilar metals. In addition, the manufacturers require all holes be filled with a fastened. Further evaluation by a licensed contractor is required.

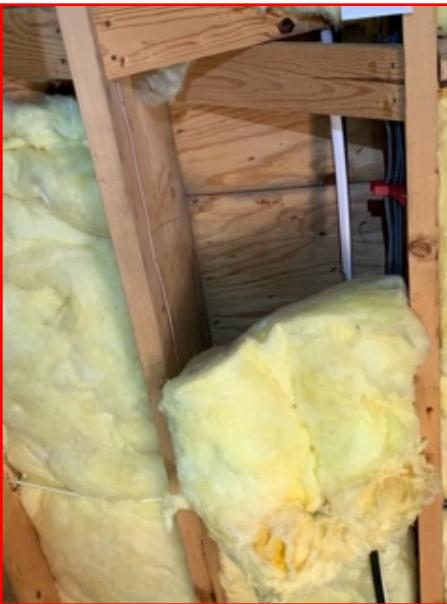
Figure 38-1

25) Comment 38: There are several areas of the utility room with missing or damaged insulation. This leads to excessive conditioned air exiting the livable space, as well as moisture intrusion. Having insulation installed/replaced in these areas is recommended.

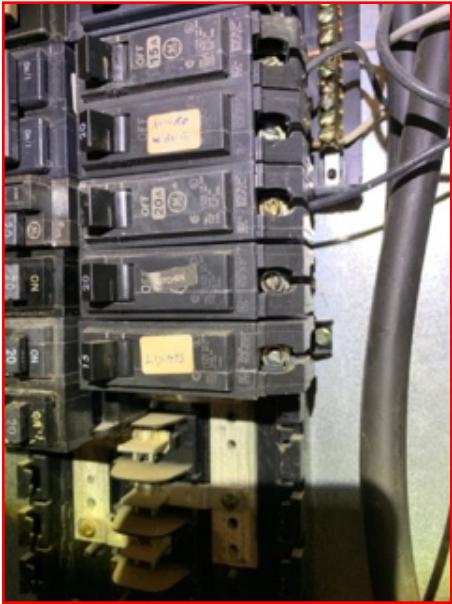
Figure 39-1

26) Comment 39: Unused breakers are required to be removed and replaced with a blank or they are required to be labeled "spare" on the breaker legend. There are multiple unused breaker in the utility room electrical panel that should be removed or labeled appropriately.

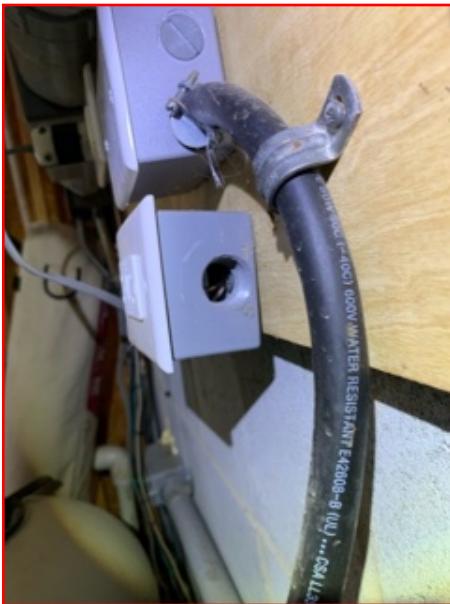
Figure 47-1

30) Comment 47: There is an open knockout to a receptacle in the utility room. This is a safety hazard and should be plugged to prevent accidental electrocution.

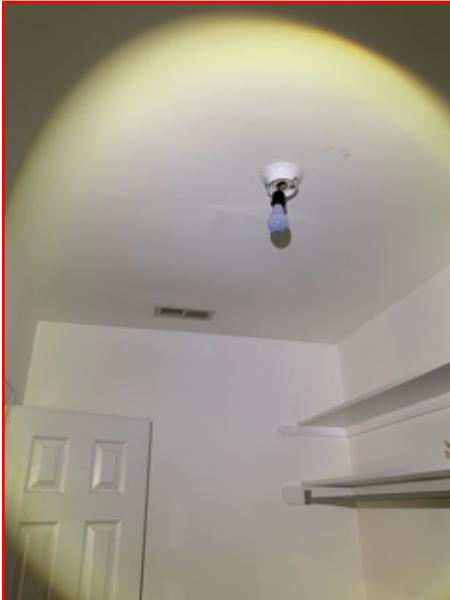
Figure 51-1

32) Comment 51: The ceiling fixture in the tanning bed room is broken. Replacement/repair is recommended by a licensed electrician.

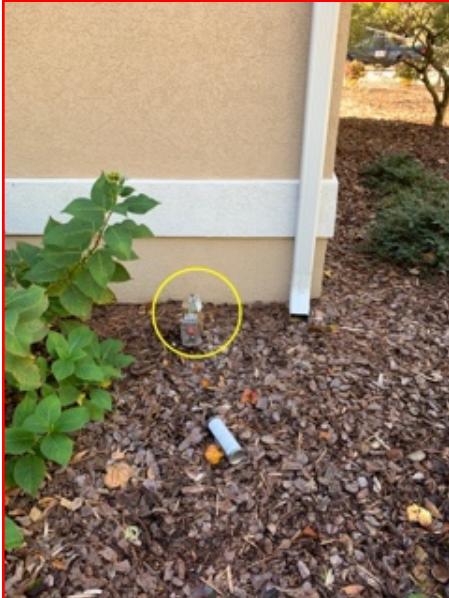
Figure 55-1

33) Comment 55: The exterior receptacles are not GFCI protected. A licensed electrician should replace all non-protected exterior circuits with a GFCI protected circuit.

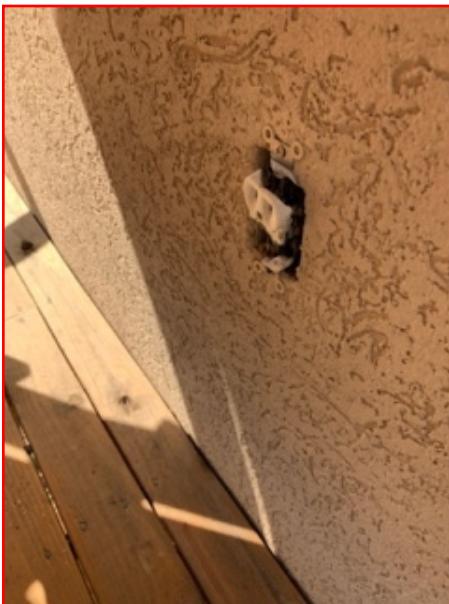
Figure 57-1

34) Comment 57: There is a broken receptacle located in the deck screened porch Replace this receptacle to prevent accidental electrocution and for proper function of all receptacles on this circuit.

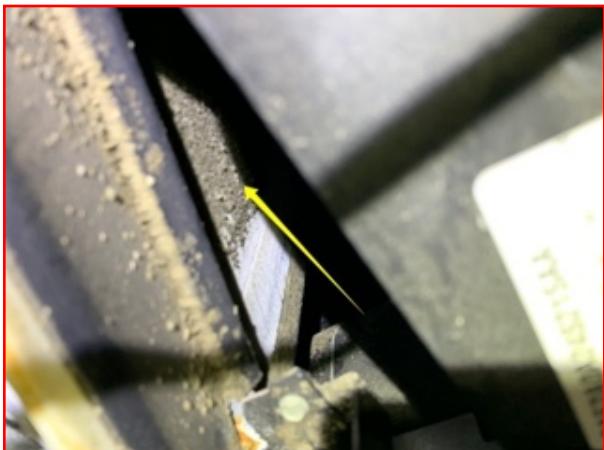
Figure 59-1

35) Comment 59: There is excess debris inside the utility room air handler unit. Evaluation and cleaning by a licensed HVAC technician is required.

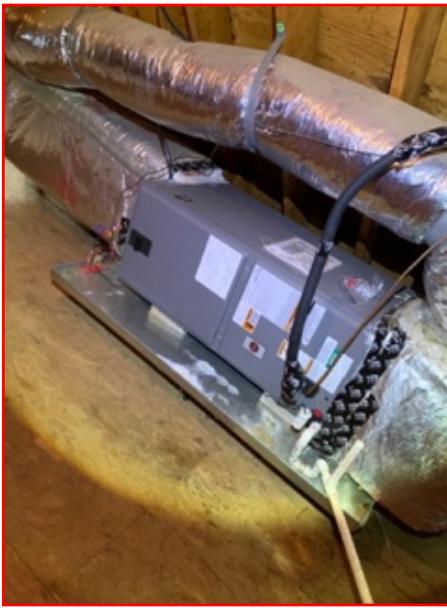
Figure 60-1

36) Comment 60: The heat pump air handler located in the attic of the second floor is not properly working. The intake and the output air were the exact same for over 15 min. Once the heat was produced, the output temp was only 11° differential. Further evaluation by licensed HVAC technician is required.

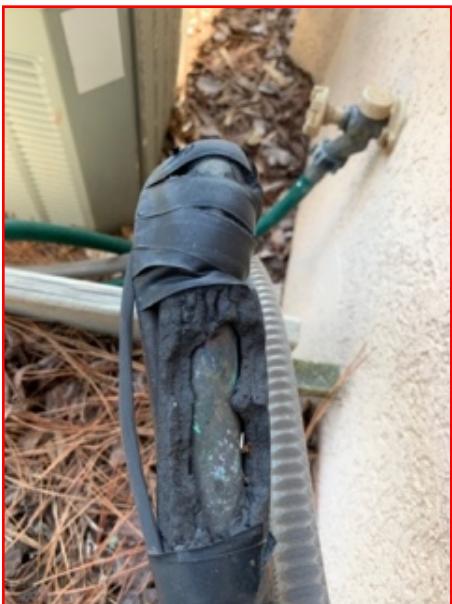
Figure 63-1

37) Comment 63: The insulation on the compression lines for the HVAC condenser unit is dry rotted and partially missing. This could allow inefficient heating and cooling, as well as damage to the condenser line. Install the appropriate condenser line insulation.

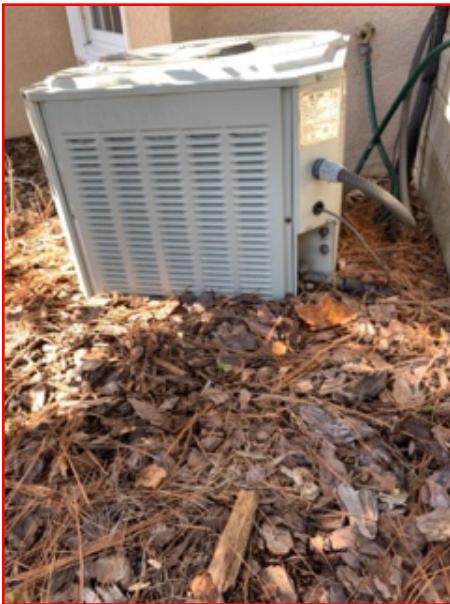
Figure 64-1

38) Comment 64: Exterior HVAC condenser units are required to have 3 inches of clearance to grade to prevent debris blocking coils and possibly causing damage to the condenser unit. A licensed HVAC technician is required to re-set the condensers with proper height clearance, as well as being plumb and level for proper efficiency.

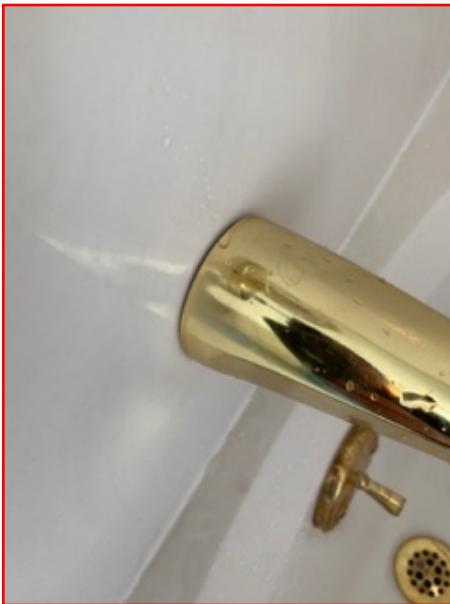
Figure 67-1

39) Comment 67: All tub spouts and valve escutcheons should be sealed where they contact the tub or shower surround to prevent water penetration through the plumbing supply opening. It is recommended to seal this gap with a 100% silicone sealant.

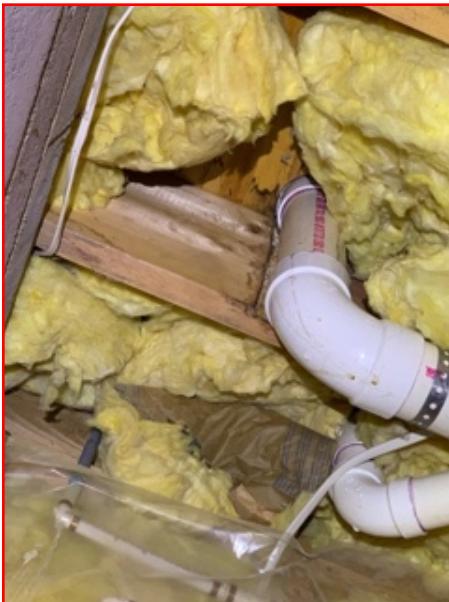
Figure 68-1

40) Comment 68: The subfloor and framing, located underneath the water closet in the first floor powder room, show signs of a possible leak. Further evaluation and repair by licensed plumber is recommended.

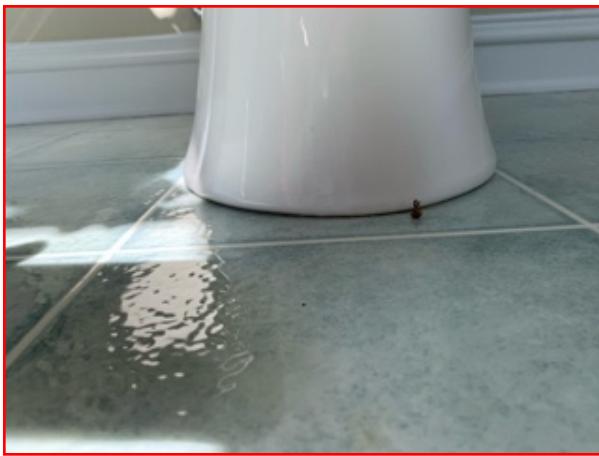
Figure 69-1

41) Comment 69: All toilet bases should be sealed to the floor to prevent excess movement as well as prevent sewer gases from entering the livable space. Sealing with grout or 100% silicone sealant is recommended.

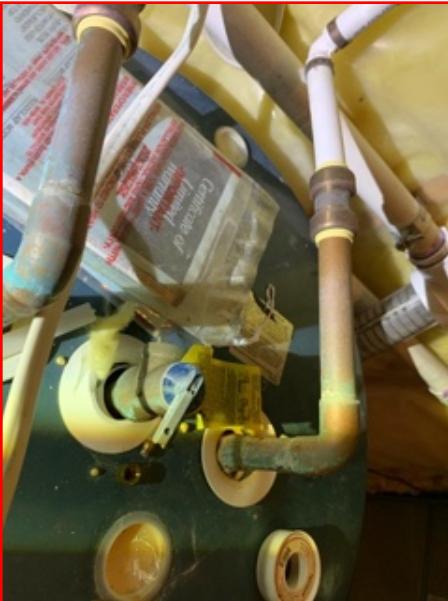
Figure 70-1

42) Comment 70: Water heater Temp and Pressure Relief Valve is required to have a blow off leg, a piece of pipe to encapsulate the high temp/pressure water, and move it down toward the floor or exterior. It must terminate no more than 6" above the drain/floor. Not having a blow off leg is a safety hazard that could result in scalding during a pressure relief situation. Installing a blow off leg is recommended.

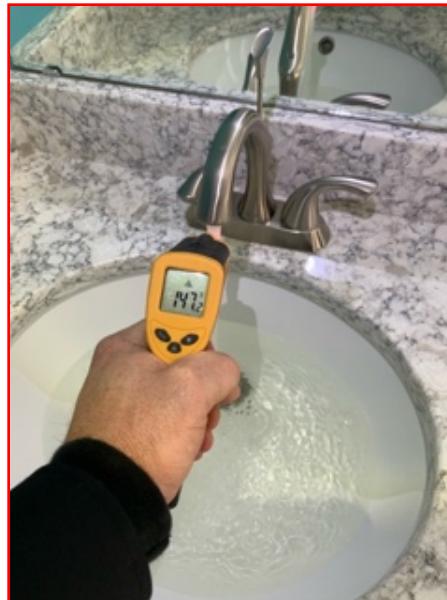
Figure 73-2

44) Comment 73: The hot water temperature measured above 147°. At this temperature, scalding of children or adults is possible. The recommended hot water temperature is 120°.

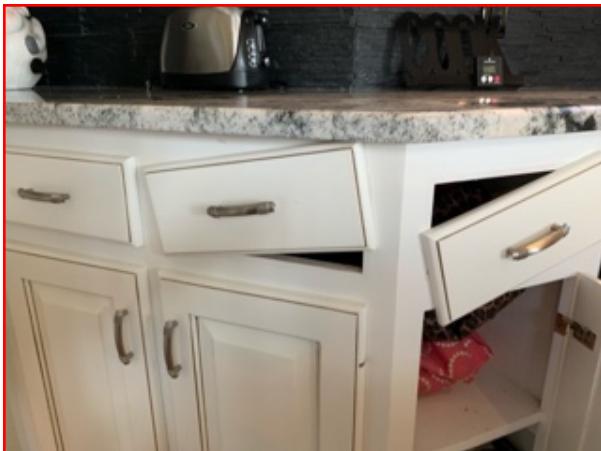
Figure 74-1

45) Comment 74: Several kitchen cabinet deadfront drawers and door hinges should be secured properly to prevent damage to the materials.

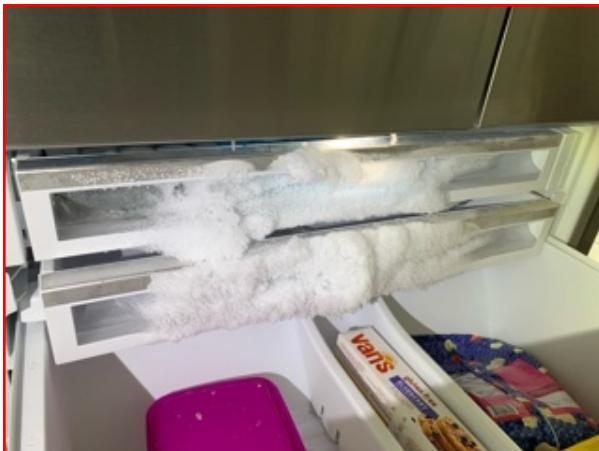
Figure 77-1

47) Comment 77: Excess moisture is entering the freezer drawer causing ice/frost to build up. Evaluation and repair by licensed appliance technician is recommended.

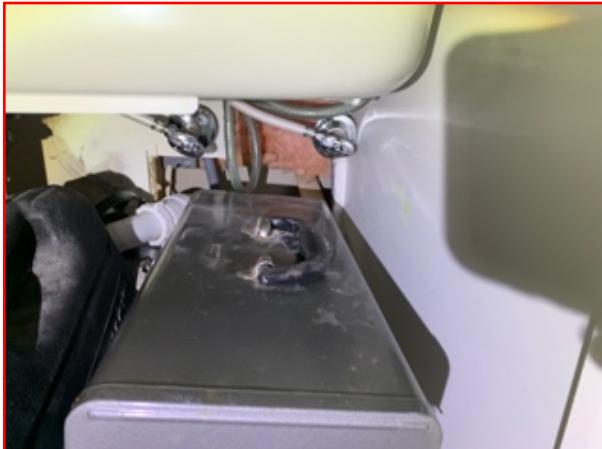
Figure 79-1

48) Comment 79: The laundry room sink base cabinet should be sealed to reduce moisture entry, conditioned air loss and pest entry.

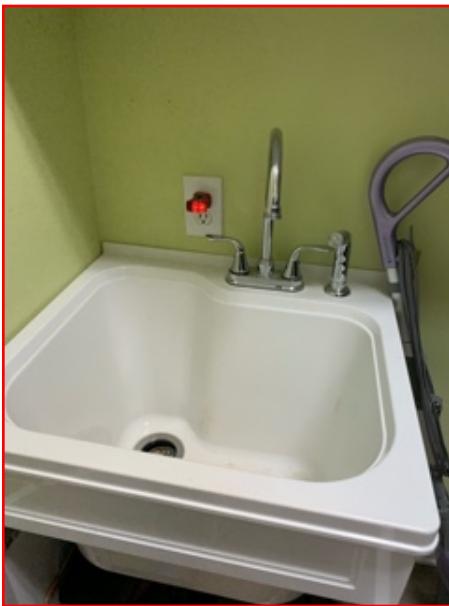
Figure 80-1

49) Comment 80: The laundry room sink receptacle is not GFCI protected. Repair by a licensed electrician is required to prevent accidental electrocution.

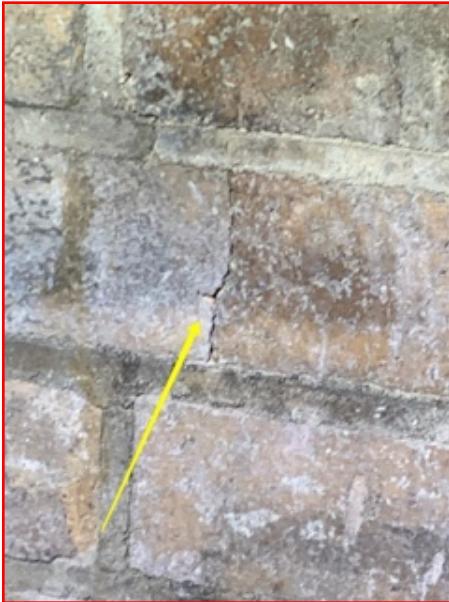
Figure 83-1

50) Comment 83: The first floor fireplace has a hairline crack in the masonry firebox wall. Evaluation and repair by a licensed fireplace technician is required before use to ensure safety of the fireplace.

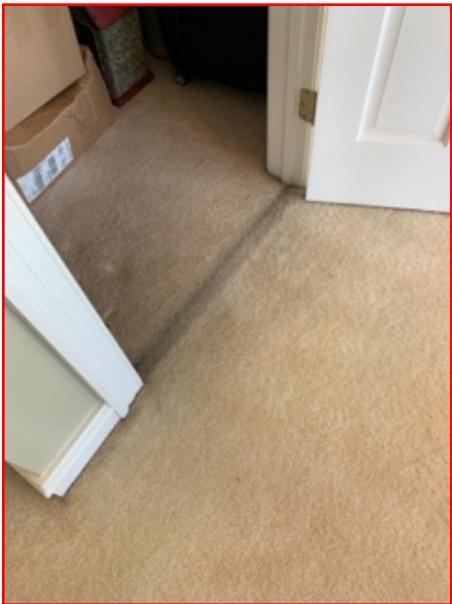
Figure 85-1

51) Comment 85: All interior doors should be cut 1/2" to 3/4" above the finish floor to allow the air to transfer between rooms. Doors without appropriate clearance results in staining of the carpets from dust/debris, as well as overworking of the HVAC system. Cut the bottoms of all doors as necessary to allow proper air circulation.

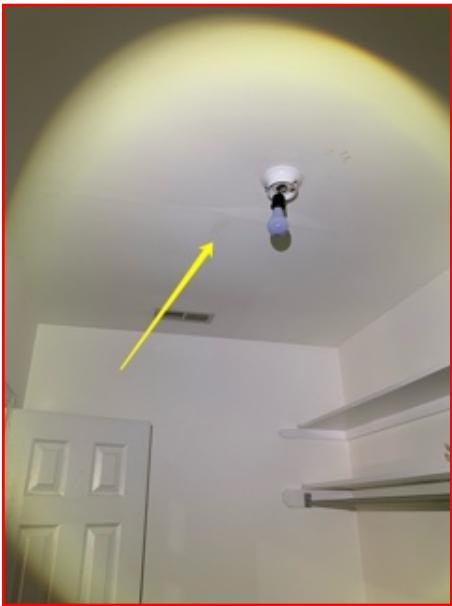
Figure 89-1

52) Comment 89: A section of the sheet rock ceiling in the tanning bed room is sagging and the raw seam is damaged. Further evaluation by a qualified professional is recommended.

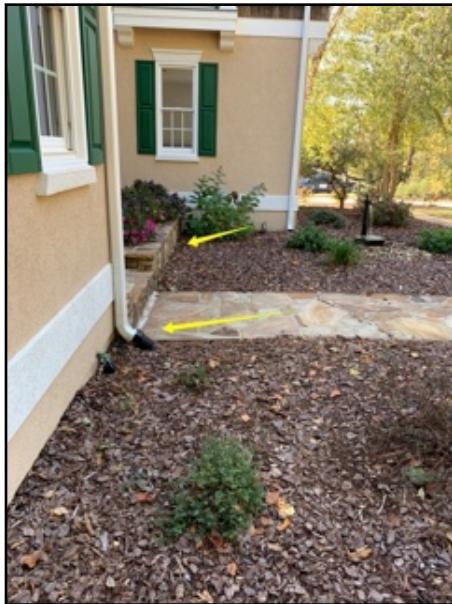
Figure 1-1

Site Grading:	Sloped Toward Structure Condition: Minor Defect
---------------	--

The site grading in multiple areas slopes toward the homes foundation. It is recommended that grading slopes away from the foundation 6 inches in the first 10 feet. This will prevent water intrusion into the foundation and deterioration of materials. Raising the grade or sloping these areas is recommended.

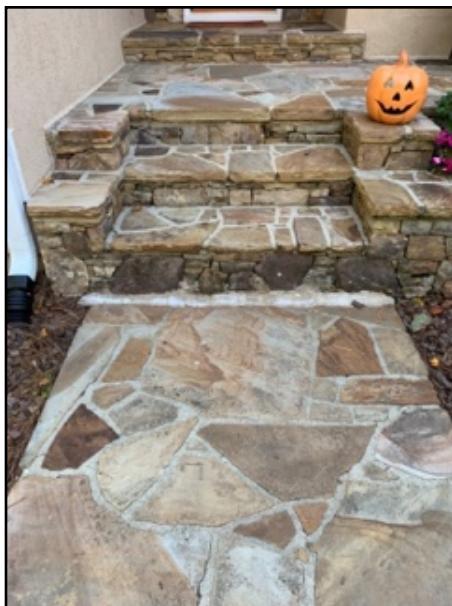
Figure 3-1

The front entry steps do not meet current building guidelines in regards to total riser height and riser height differential. It is considered a fall/trip hazard. 7 3/4" max height and no more than 3/8" difference in height or depth is allowed.

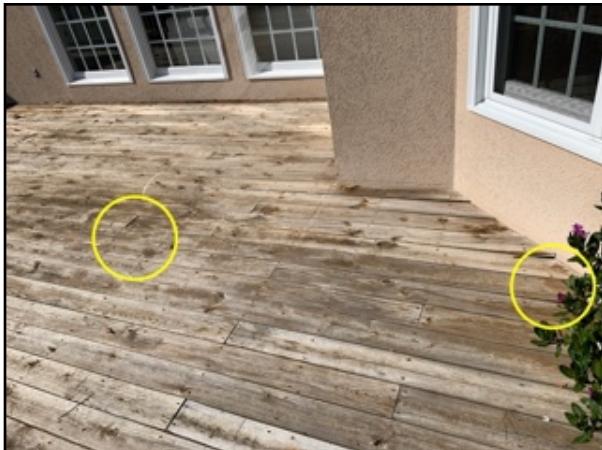
Figure 4-1

The back deck and back deck stairs have loose/damaged boards.
Replacement/repair of the boards is recommended to prevent failure.

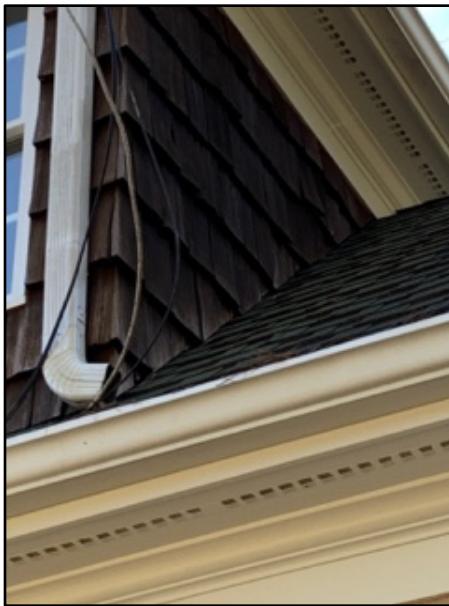
Figure 6-1

Siding and trim should not touch the roof's surface. A 1-2" air gap should be left between the siding/trim and roof is recommended to prevent water damage.

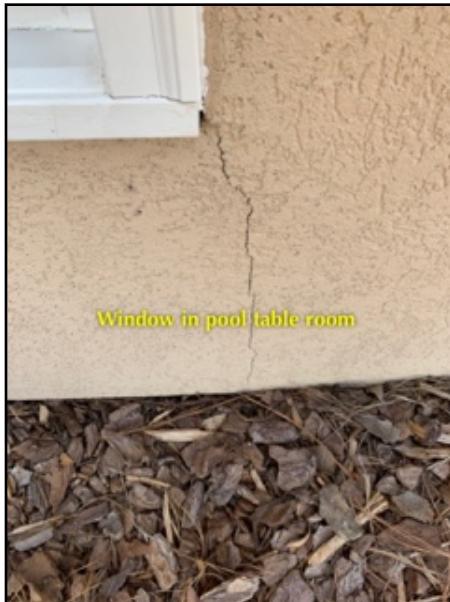
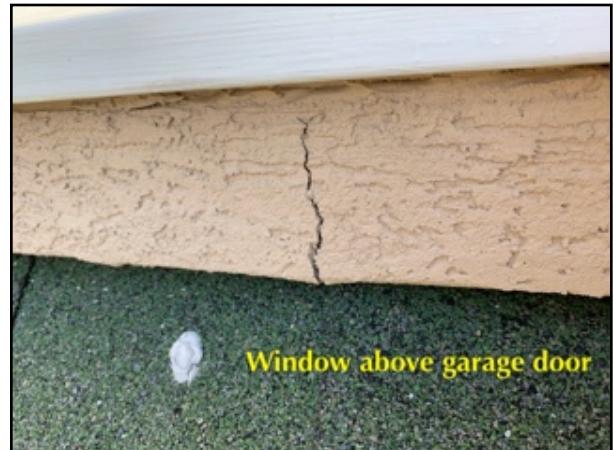
There are multiple hairline cracks in the exterior synthetic stucco. Evaluation, sealing and repairing the cracks by a qualified stucco professional is recommended to prevent water entry.

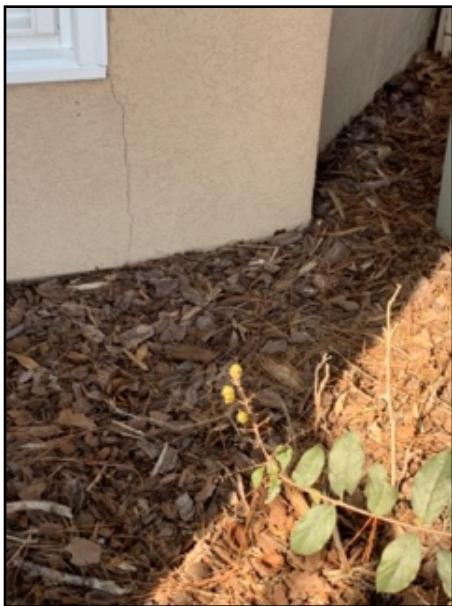
Figure 8-1

Synthetic stucco should not come into contact with the exterior grade. There should be approximately 6" between grade and the stucco to help prevent moisture related issues.

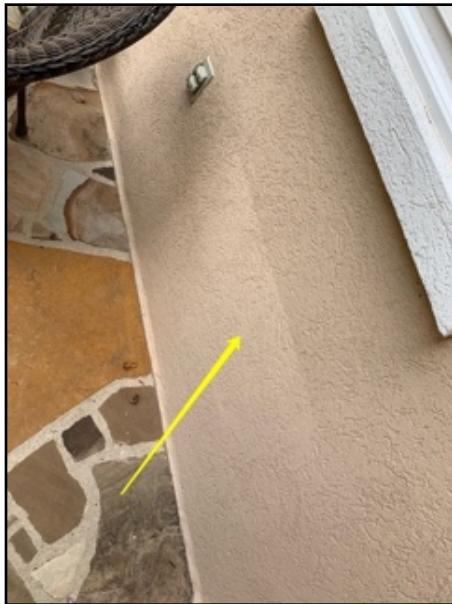
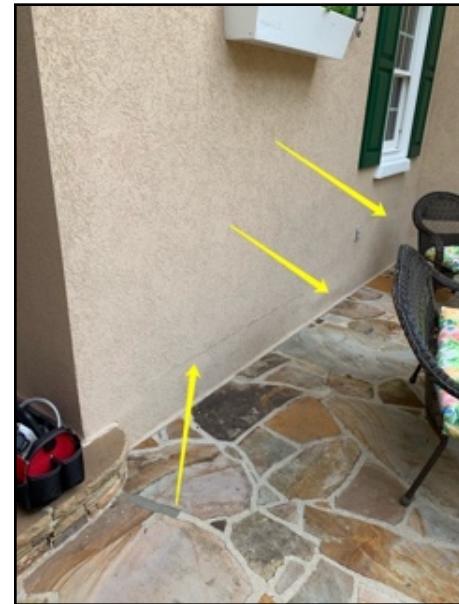
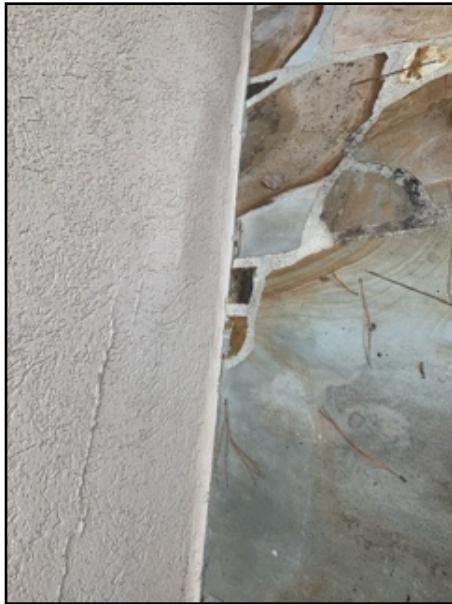
There is damage to the stucco on the lower wall of the front porch. There is a horizontal crack and the stucco is bowed out in multiple locations. Further evaluation and repair by a qualified stucco professional is recommended to prevent further damage.

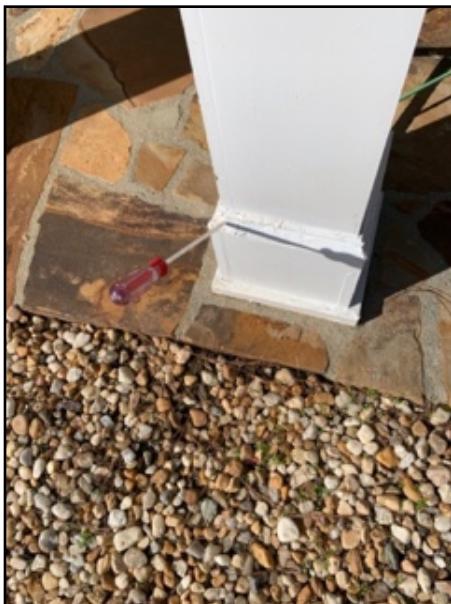
Figure 10-1

There is wood rot at multiple back porch columns. Repair by qualified carpenter is recommended to prevent further deterioration or damage to surrounding components.
