Pait Home Inspections of North Carolina, LLC

Home Inspection Report

Property Address:
123 Street Name
Louisburg, NC 27549

Inspected on Mon, Nov 4 2019 at 9:31 AM

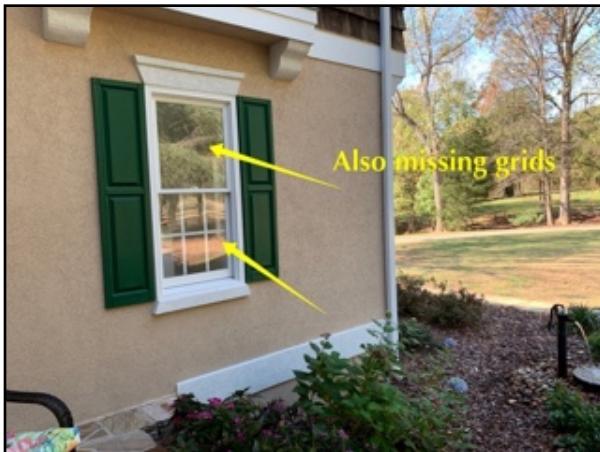
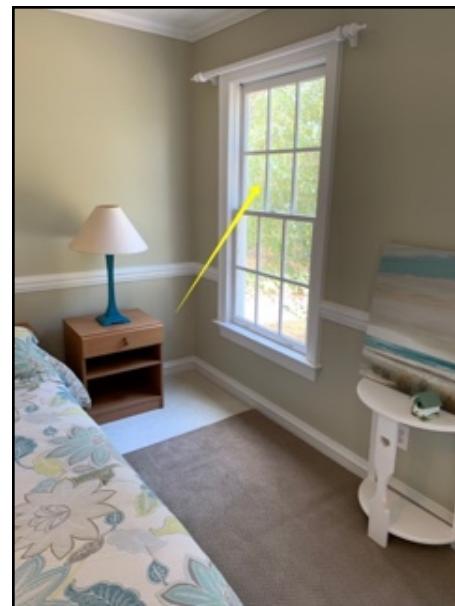
There are multiple windows whose hermetic seals are broken and moisture has entered between the two glass panes. This reduces the window's insulation ability. Evaluating all of the windows and replacing any failed windows is recommended.

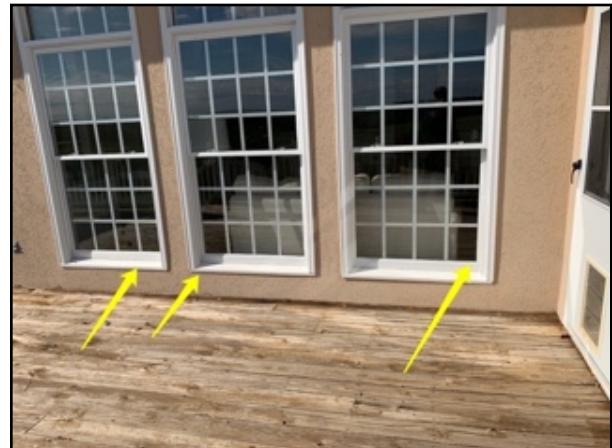
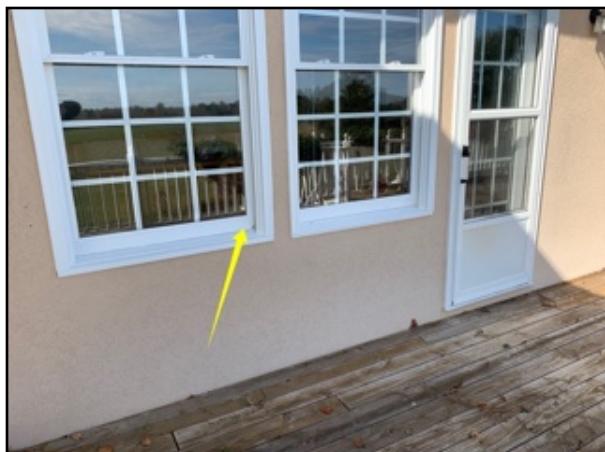
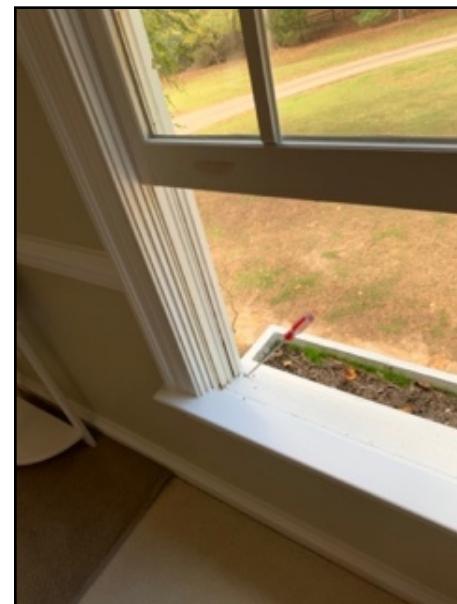
There are multiple windows that have water damage or show signs of beginning damage to rails or stiles of the window. Evaluation of all windows and repair or replacement by a licensed window contractor is required to prevent further damage.

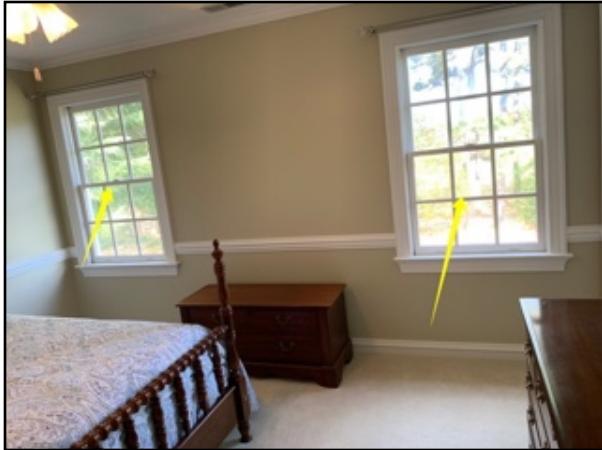
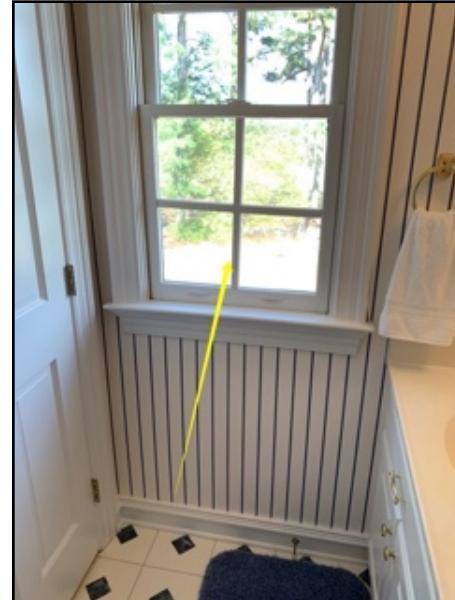
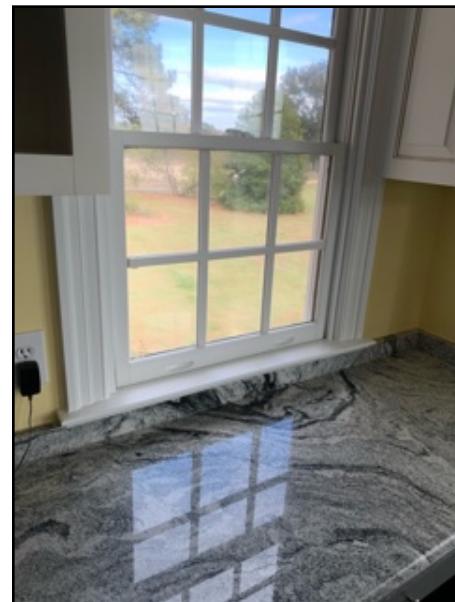
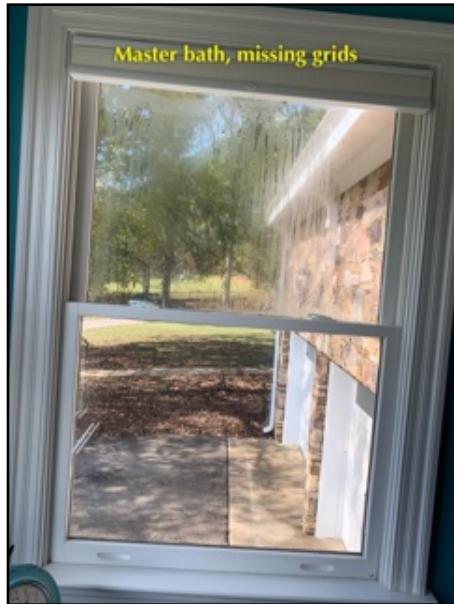
Comment 14:
More broken seal windows.

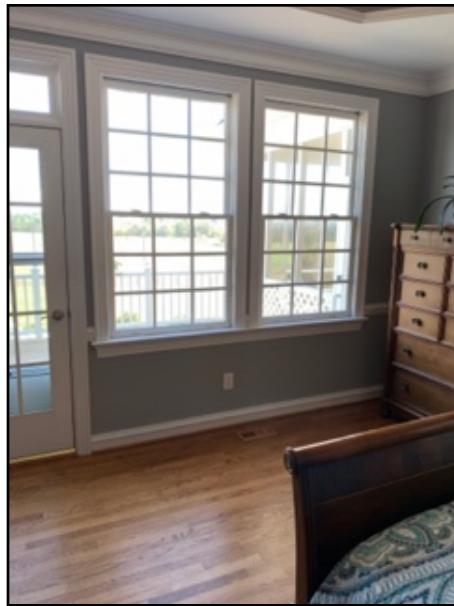
Figure 15-1

The windows in the master bedroom were difficult to open. The sash on the right wouldn't open (possible painted shut) and both windows are loose and came detached from the side channel when attempting to open them. Evaluation by a qualified professional is recommended.

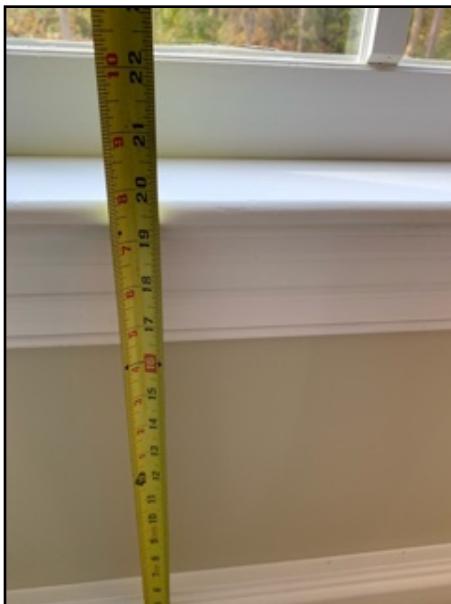
Figure 16-1

Current guidelines require any window whose sill is lower than 24" to the finish floor on the interior side but is greater than 6' feet above grade on exterior side to have sash limits installed. This is a safety device to prevent children from possibly opening and falling out of the window. While it was not a requirement at the time this home was built, it is a safety hazard and installing sash limits is recommended. (2nd floor)

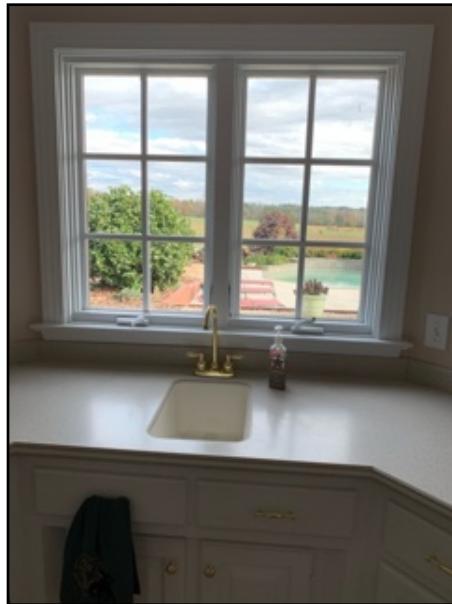
Figure 17-1

The casement windows in the basement kitchen were unable to be opened. Evaluation and repair by a qualified professional is recommended. (Possibly painted shut)

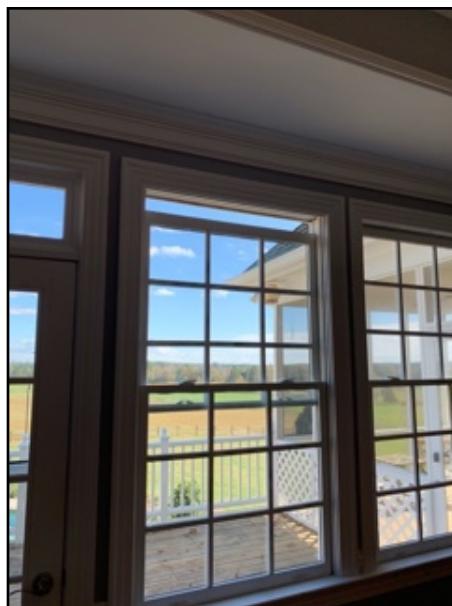
Figure 18-1

On several windows, the top sash drops several inches when the bottom sash is unlocked. Repair for proper function is recommended and to prevent further loosening of the top sash.

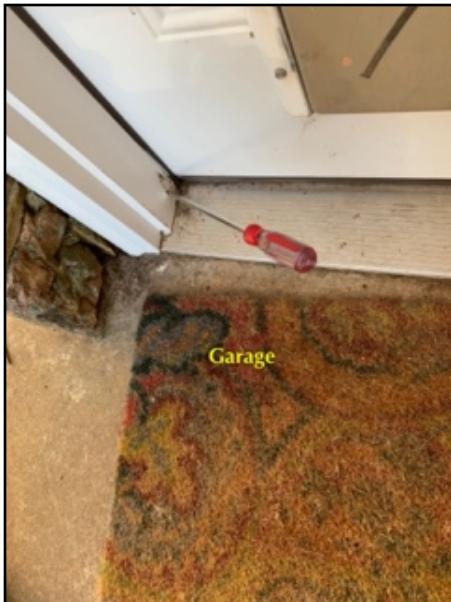
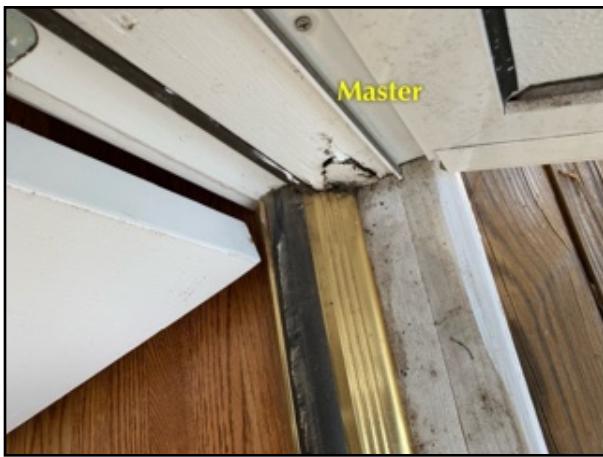
Multiple exterior doors have wood rot to the jamb. Repairing the affected area is recommended to prevent further damage.

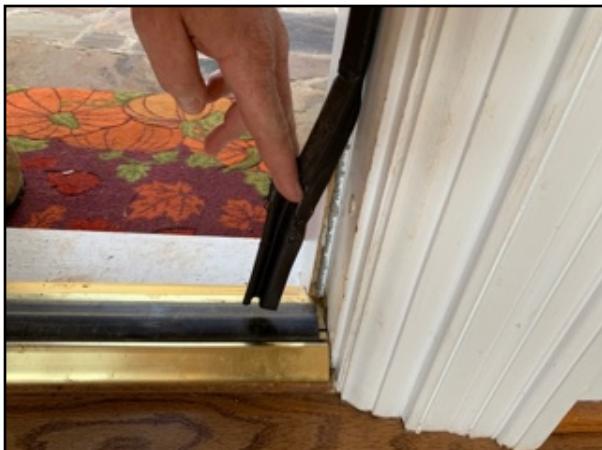
Figure 20-1

The front exterior door weatherstripping is torn. Replacing the weatherstripping is recommended.

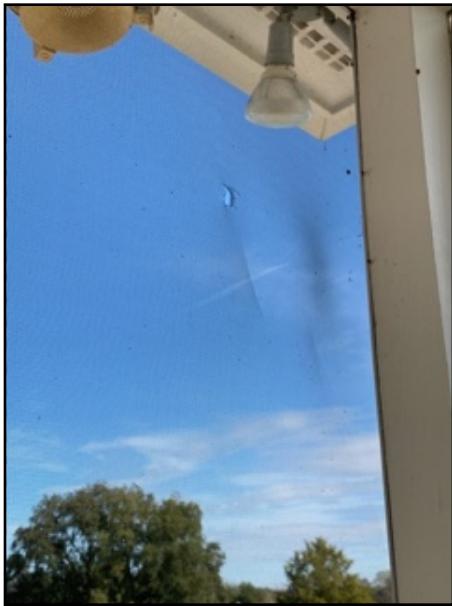
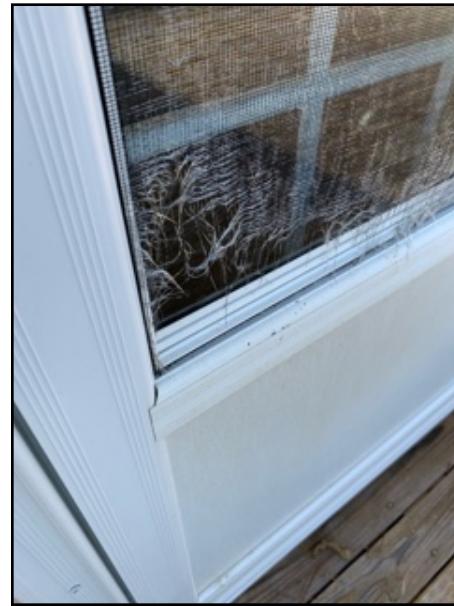
There are multiple screens damaged on windows, doors or porch enclosures. Repair as desired for proper function.

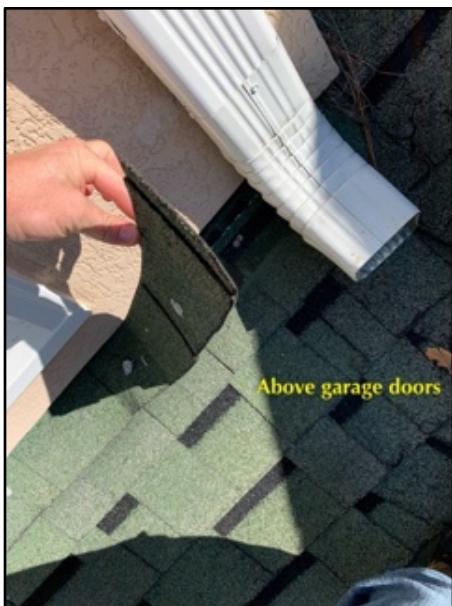
Figure 23-1

Due to the number of deficiencies with the roofing system, a complete evaluation by a licensed roofer is required. Some deficiencies include but are not limited to missing/detached shingle tabs, torn shingles, lifted flashing, signs of leaking and improper ridge cap repair.

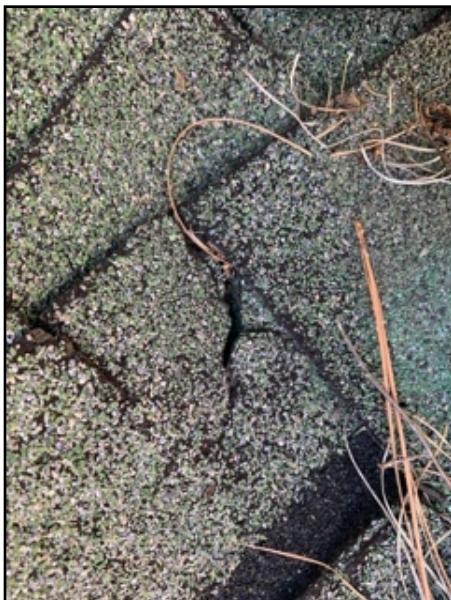
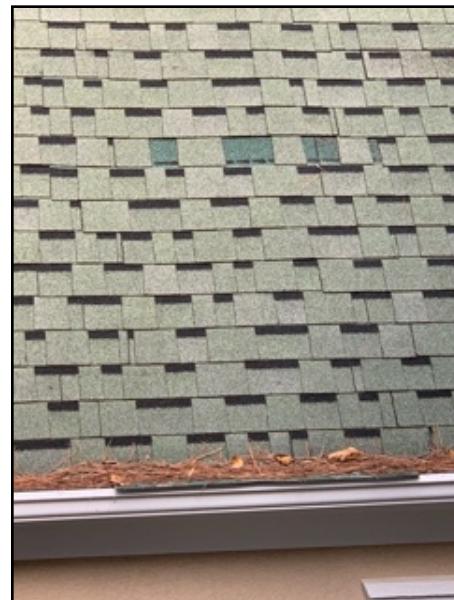
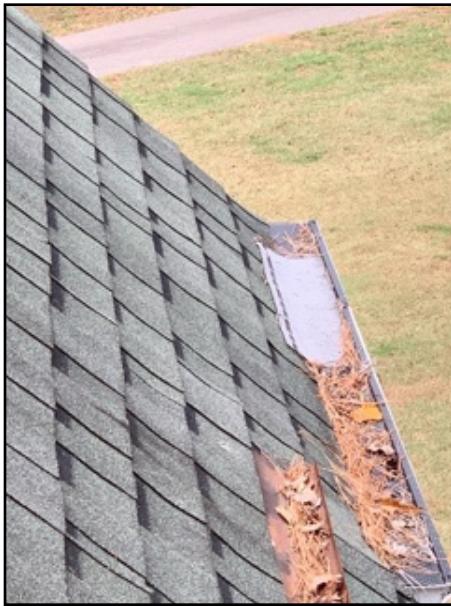
Comment 24:
Additional roof damage photos:

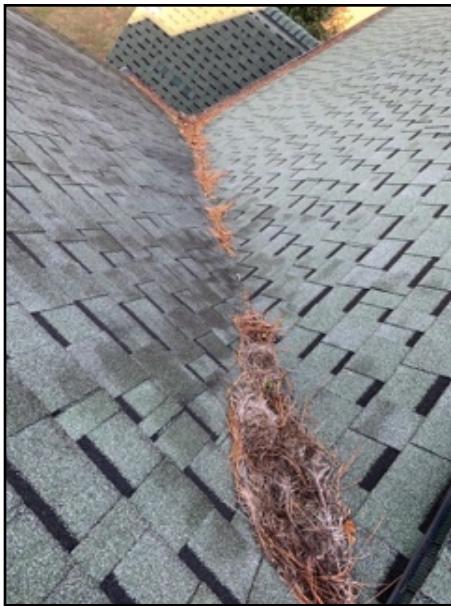
Figure 25-1

There is debris from trees and surrounding vegetation on the roof. This causes water to back up under the roofing materials and could lead to water leaking and damage to surrounding components. Periodic cleaning of the roof is required.

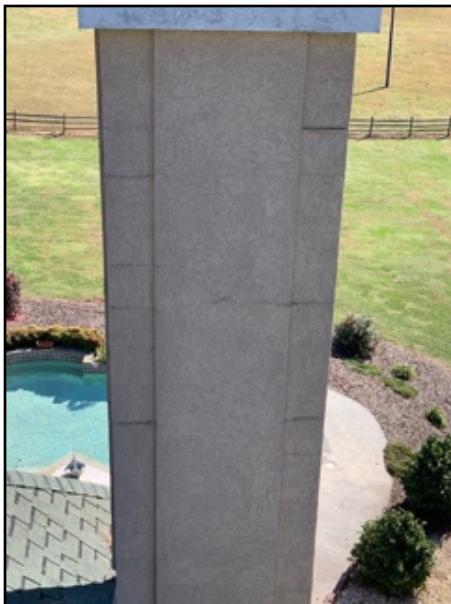
Figure 26-1

The stucco coat applied to the chimney block has come loose/been damaged. Evaluation and repair by a qualified contractor is recommended to prevent moisture entry.

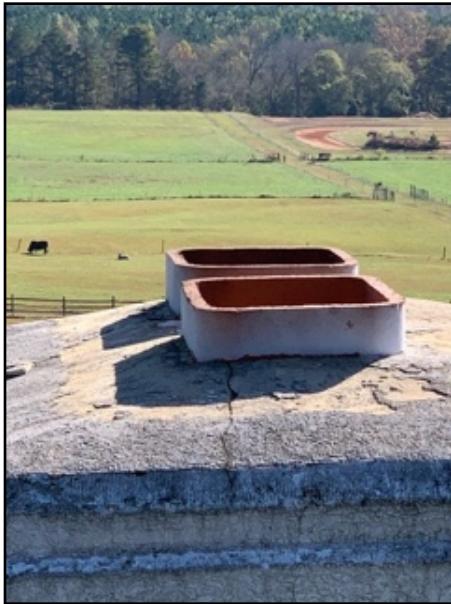
Figure 27-1

The mortar on the chimney cap has multiple cracks and is deteriorated. This could allow water to enter into the chimney chase. A qualified professional should repair the mortar chimney cap before using the fireplace. There is also no spark arrestor/rain cap.

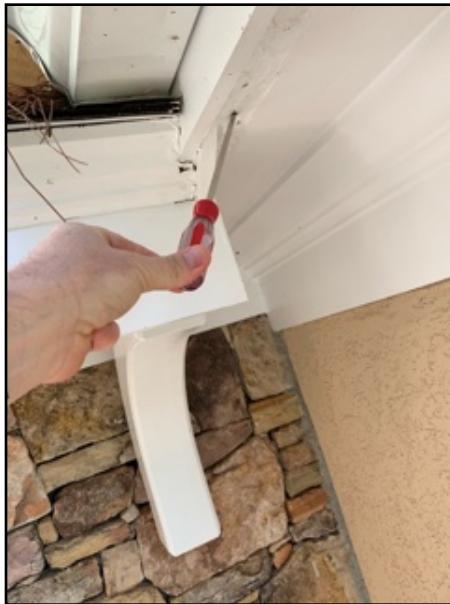
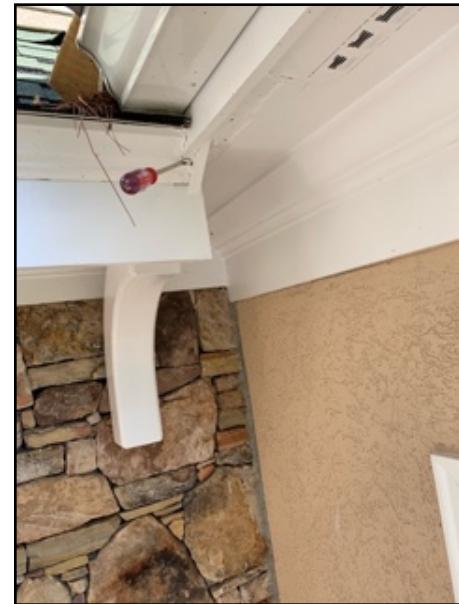
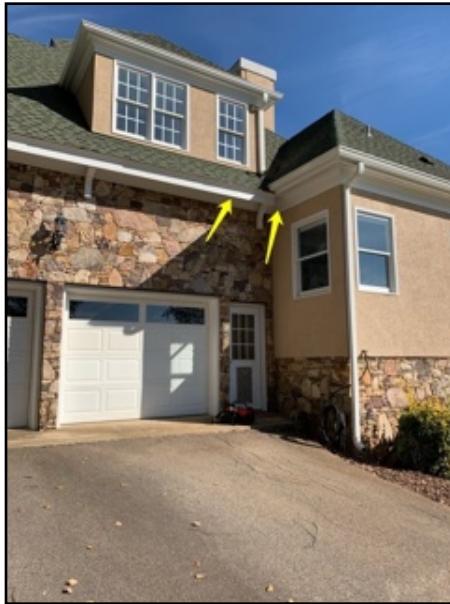
The soffits, facia and crown molding above the garage entry door have moisture damage and are deteriorated. Further evaluation of the cause of the leak and replacing any moisture damage wood is recommended.

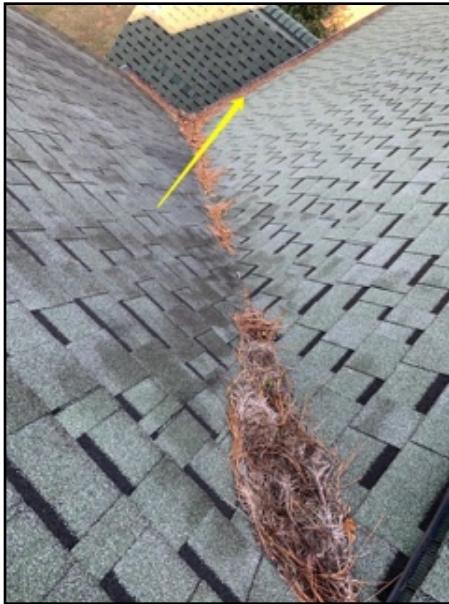
Figure 29-1

The gutters/gutter guards, in multiple locations, are filled with debris which will prevent water from exiting into the downspouts. This could cause water runoff in areas that could present moisture problems. Cleaning out the gutters and ensuring functional flow out of the downspouts is recommended.

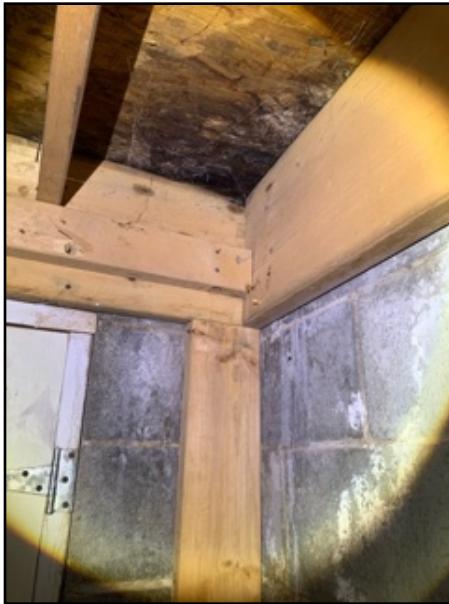
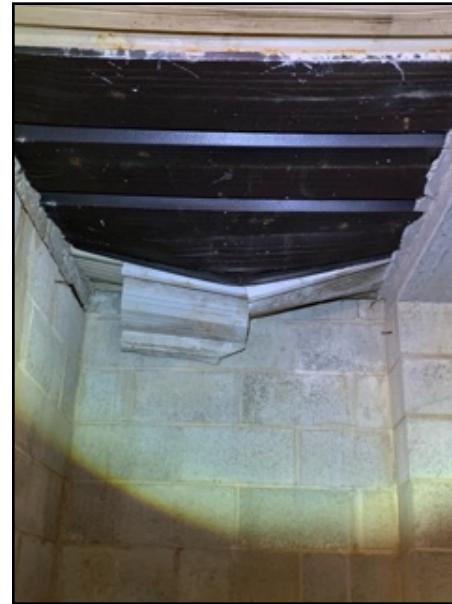
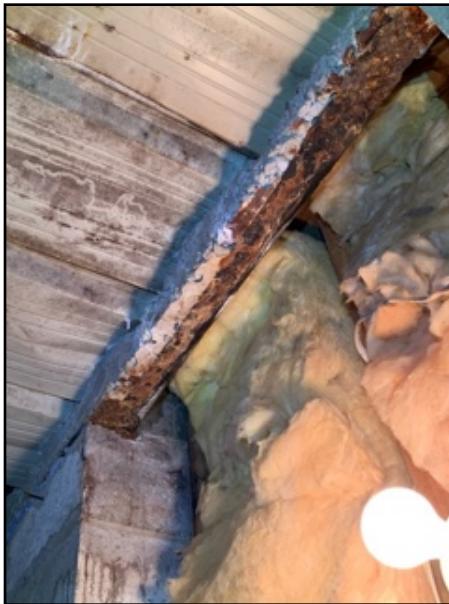
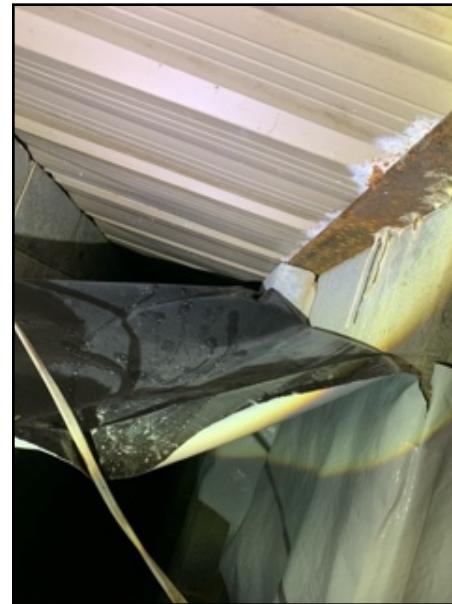
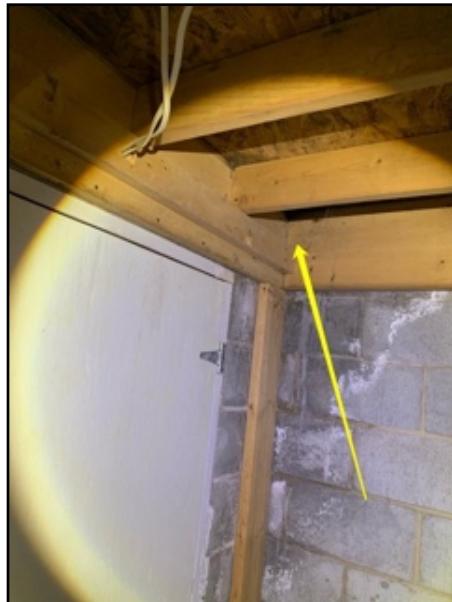
There are multiple indications of moisture/water entry into the foundation including but not limited to efflorescence, staining to masonry block and wood framing members, and rust to lentils. Further evaluation by a qualified professional is recommended.

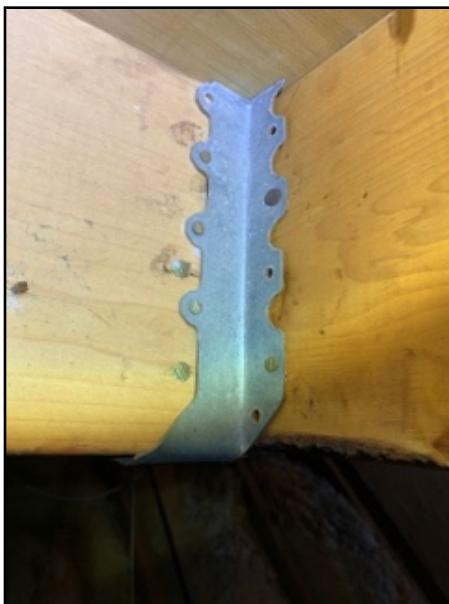
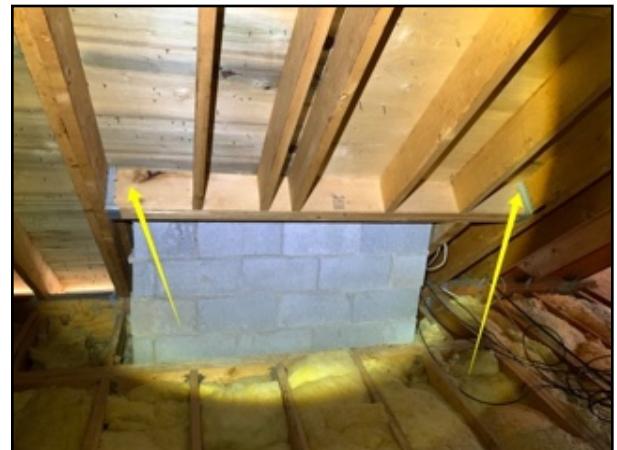
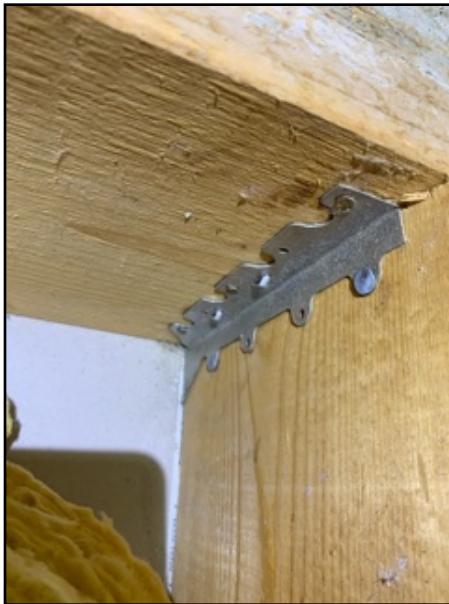
The attic joist hangers were not installed using the manufacturer's required fasteners. Galvanized common nails are required for installation of these hangers to ensure proper load support and to reduce galvanic corrosion between dissimilar metals. In addition, the manufacturers require all holes be filled with a fastened. Further evaluation by a licensed contractor is required.

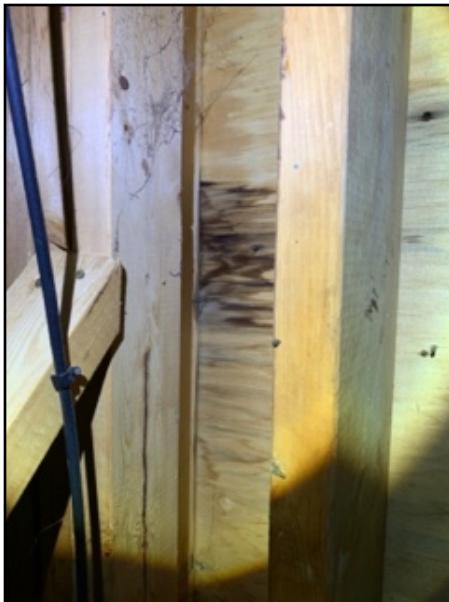
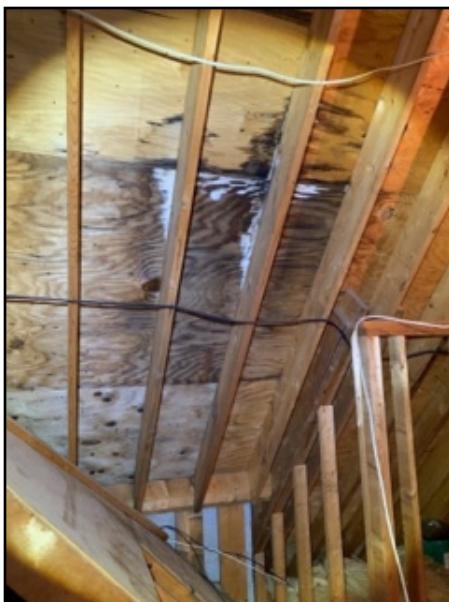
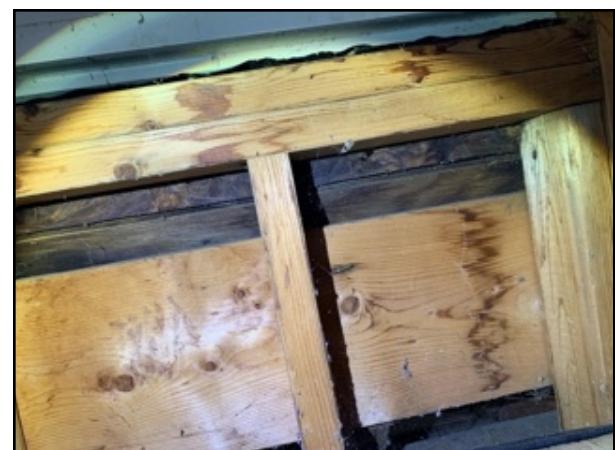
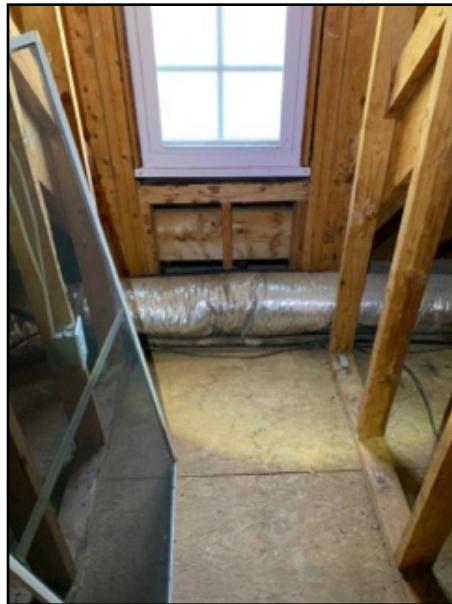
There are multiple areas of damaged roof decking due to roof leaks. Evaluation to determine if there are any active leaks and repair by a licensed contractor is recommended to prevent damage further damage.

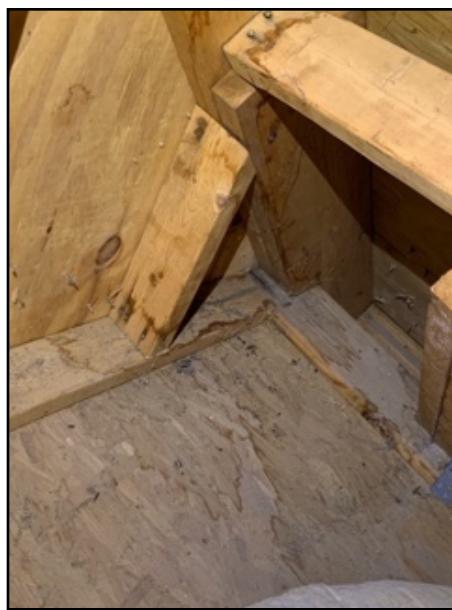
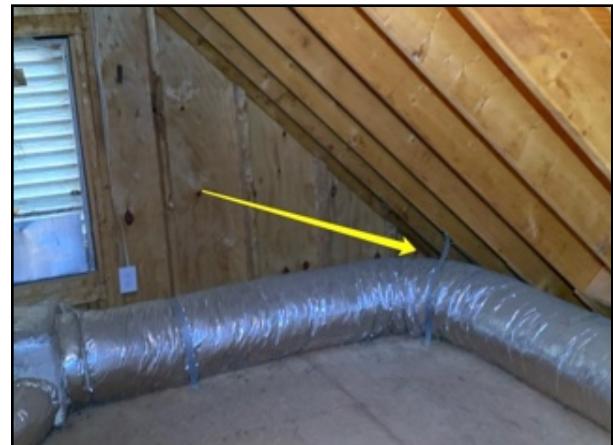
Comment 34:
Additional damaged areas:.

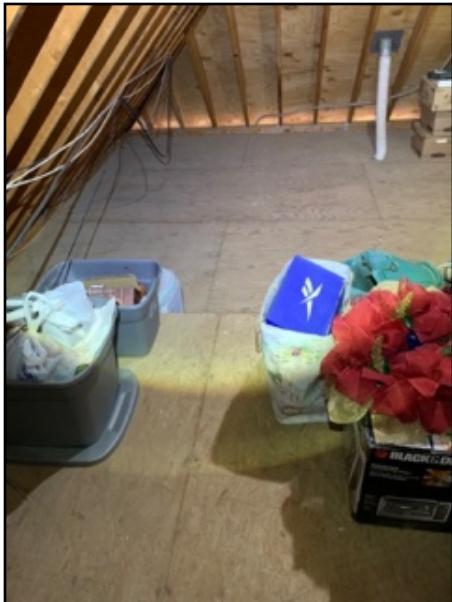
Figure 35-1

The insulation underneath the attic storage boards was unable to be inspected.

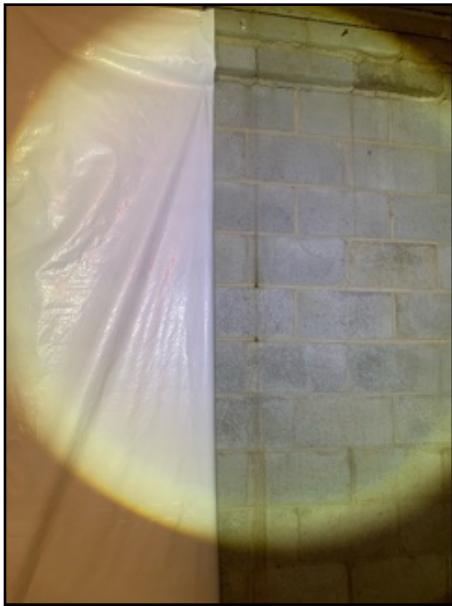
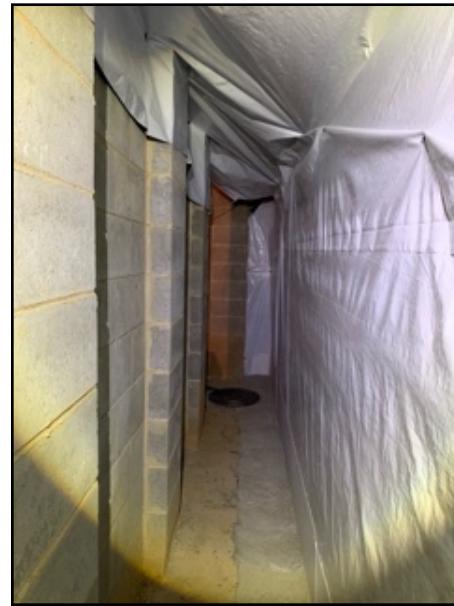
The entire condition of the unfinished basement was unable to be inspected due to visibility being limited by vapor barrier.

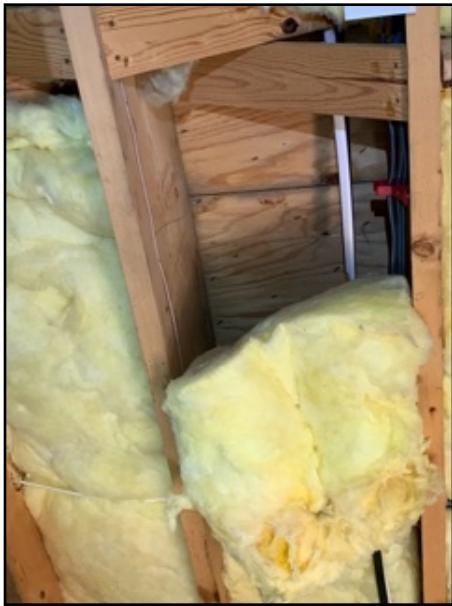
There are several areas of the utility room with missing or damaged insulation. This leads to excessive conditioned air exiting the livable space, as well as moisture intrusion. Having insulation installed/replaced in these areas is recommended.

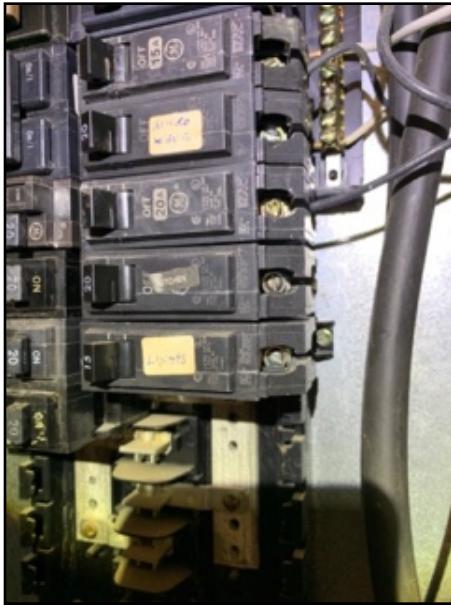
Figure 39-1

Unused breakers are required to be removed and replaced with a blank or they are required to be labeled "spare" on the breaker legend. There are multiple unused breaker in the utility room electrical panel that should be removed or labeled appropriately.

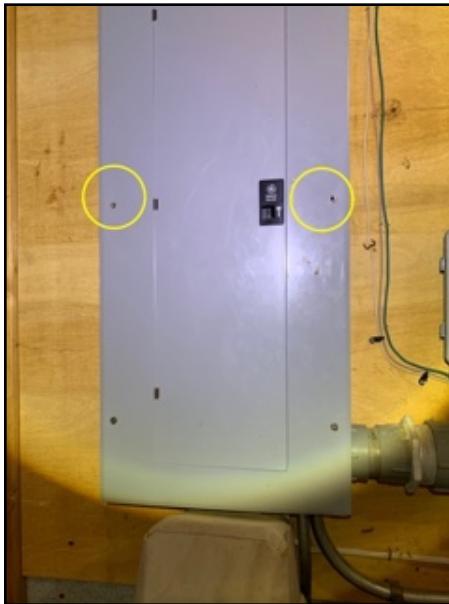
Figure 45-1

The dead front on the utility room electrical panel is missing multiple screws. Install the appropriate style screws securely secure the dead front to the panel.

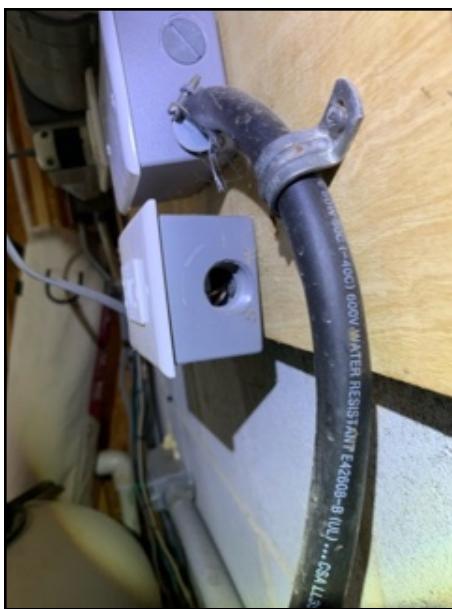
Figure 47-1

There is an open knockout to a receptacle in the utility room. This is a safety hazard and should be plugged to prevent accidental electrocution.

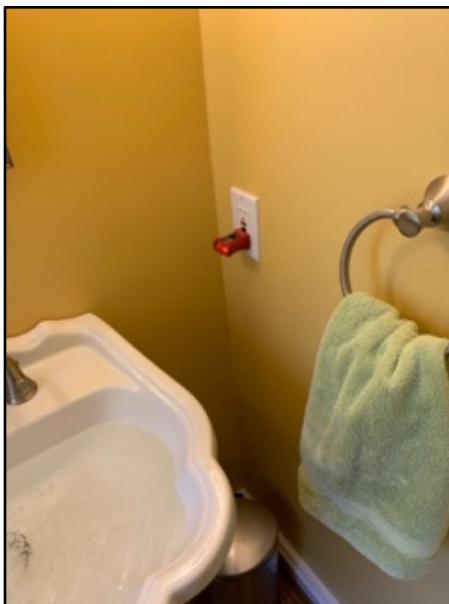
Figure 50-1

The GFCI receptacle in the front powder room of the first floor did not test properly. Evaluation and repair by licensed electrician is required.

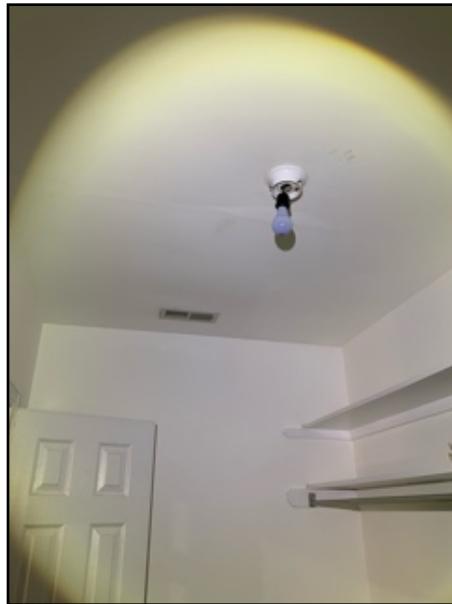
Figure 51-1

The ceiling fixture in the tanning bed room is broken. Replacement/repair is recommended by a licensed electrician.

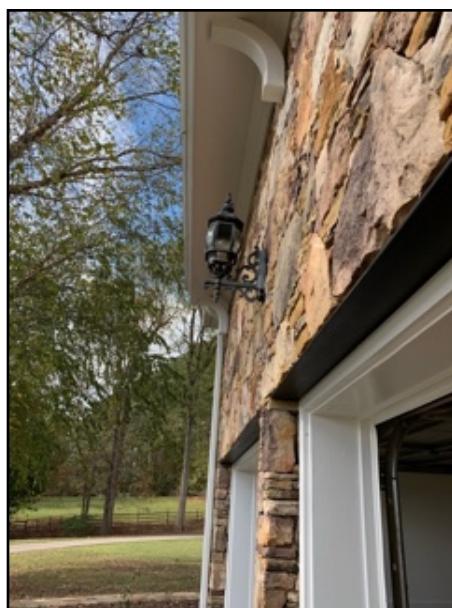
Figure 52-1

Unable to determine if the garage sconce functioned properly. Either the switch was not located or the bulb needs replacement. Consult the owners on the switch location and function.

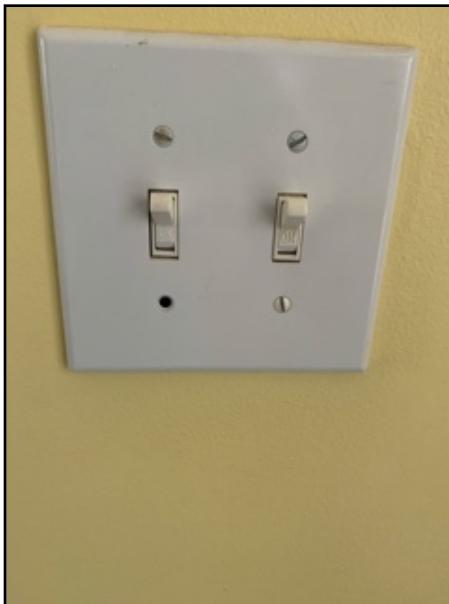
Figure 53-1

The kitchen light switch is missing/needs a longer faceplate screw.

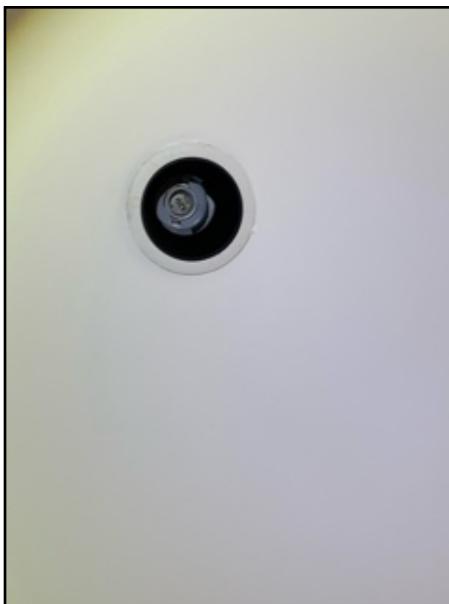
Figure 54-1

A bulb was missing from a kitchen can light. Proper function was unable to be determined .

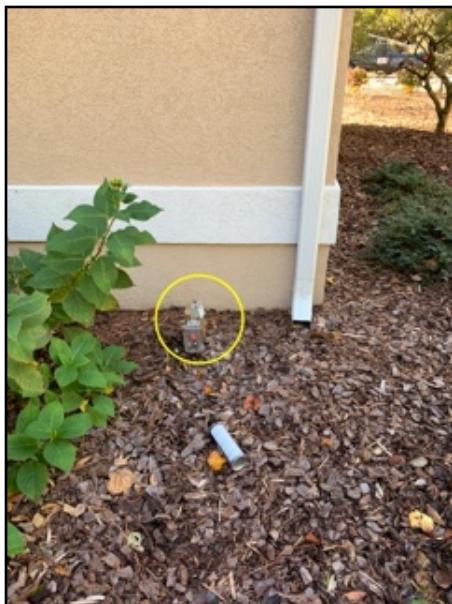
Figure 55-1

The exterior receptacles are not GFCI protected. A licensed electrician should replace all non-protected exterior circuits with a GFCI protected circuit.

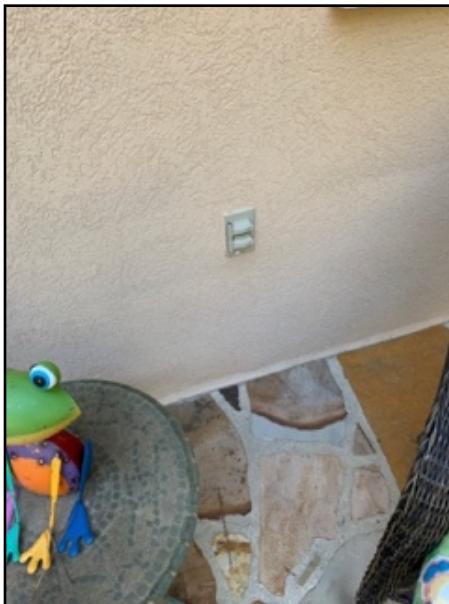
Figure 56-1

Installing in-use/bubble covers to the exterior outlets is recommended.

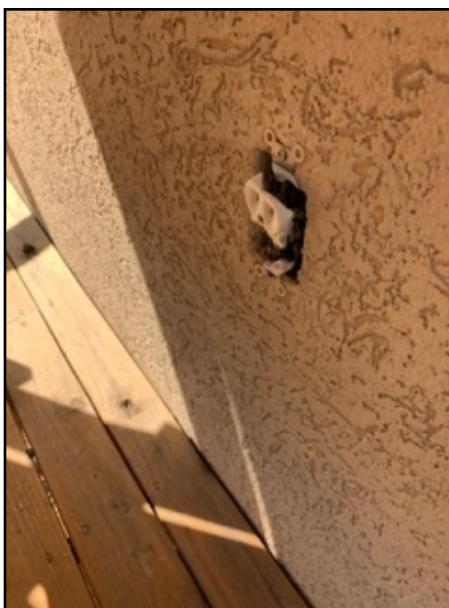
Figure 57-1

There is a broken receptacle located in the deck screened porch Replace this receptacle to prevent accidental electrocution and for proper function of all receptacles on this circuit.

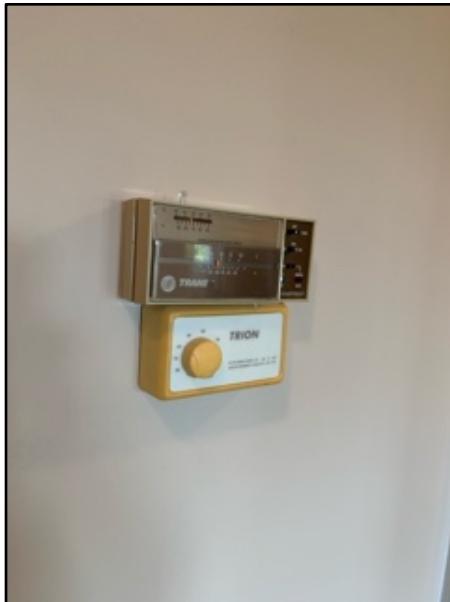
Figure 58-1

Installing a programmable digital thermostat is recommended for energy efficiency.

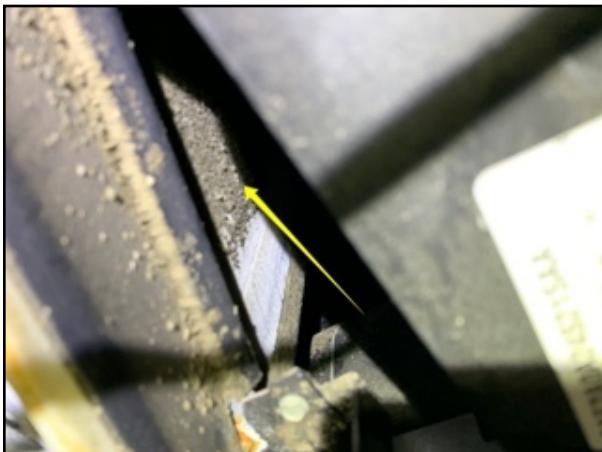
There is excess debris inside the utility room air handler unit. Evaluation and cleaning by a licensed HVAC technician is required.

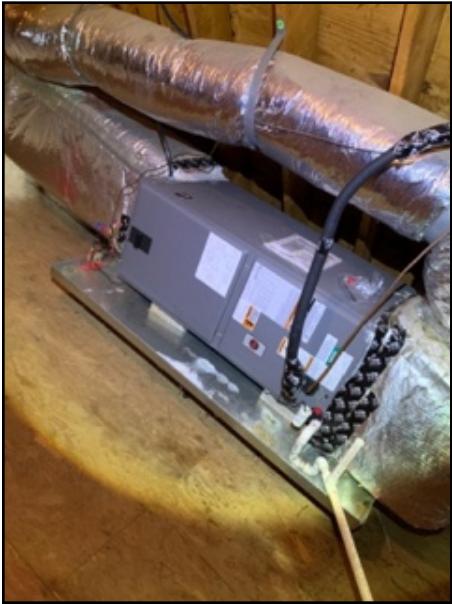
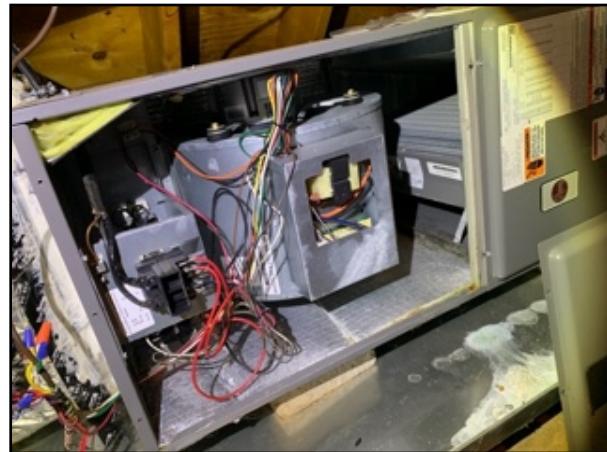
The heat pump air handler located in the attic of the second floor is not properly working. The intake and the output air were the exact same for over 15 min. Once the heat was produced, the output temp was only 11° differential. Further evaluation by licensed HVAC technician is required.

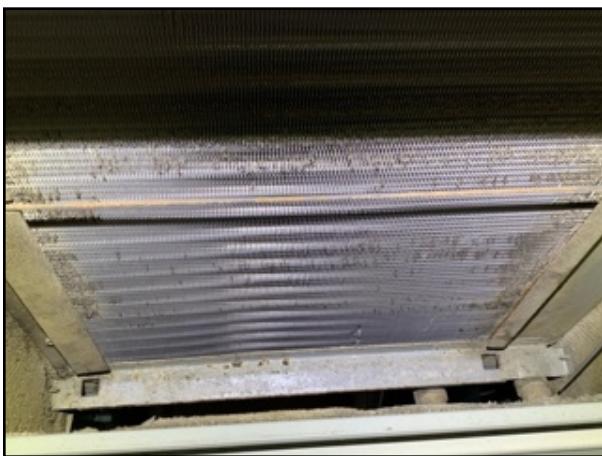
Figure 61-1

The basement HVAC is 24 years old. The average useful life of this type of equipment is 15 to 20 years. A complete evaluation by an HVAC technician is recommended.

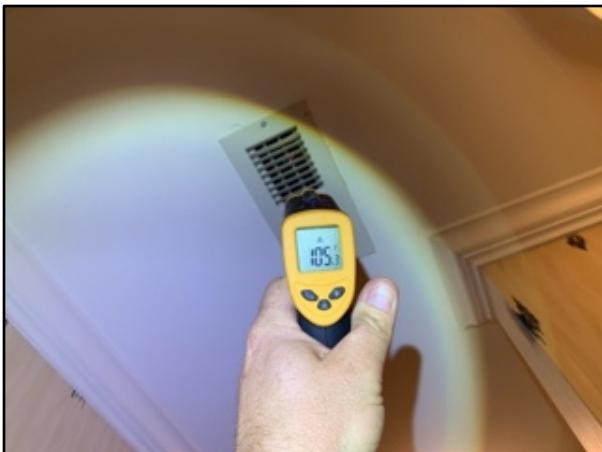
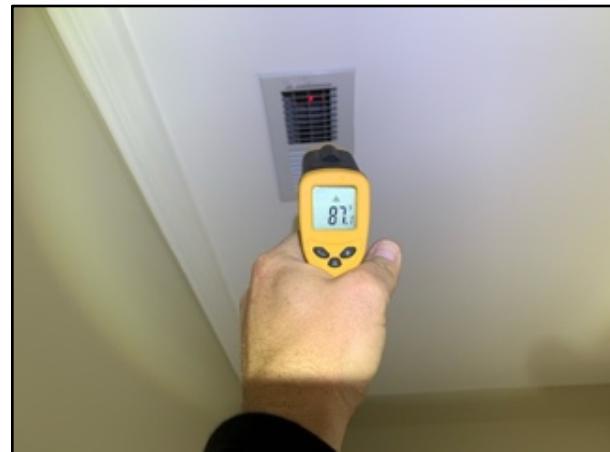
Comment 62:
Heat output temperature.

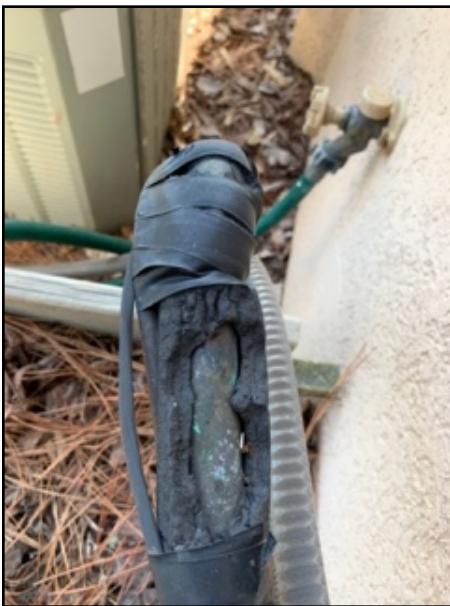
Figure 63-1

The insulation on the compression lines for the HVAC condenser unit is dry rotted and partially missing. This could allow inefficient heating and cooling, as well as damage to the condenser line. Install the appropriate condenser line insulation.

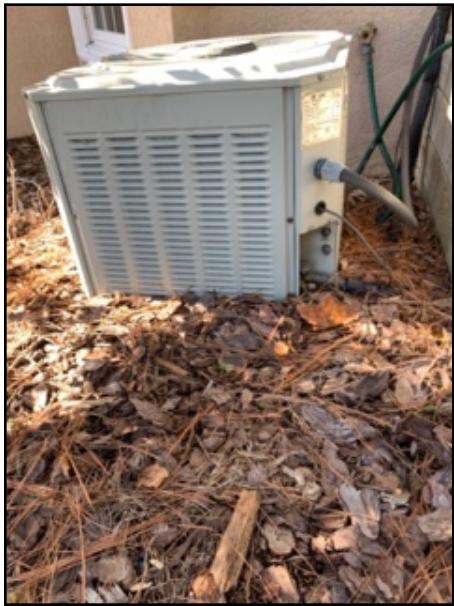
Figure 64-1

Exterior HVAC condenser units are required to have 3 inches of clearance to grade to prevent debris blocking coils and possibly causing damage to the condenser unit. A licensed HVAC technician is required to re-set the condensers with proper height clearance, as well as being plumb and level for proper efficiency.

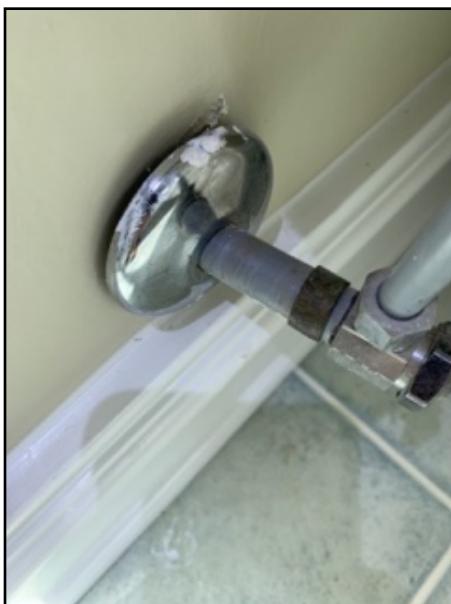
Figure 66-1

This home has a plumbing supply system that uses polybutylene plastic distribution lines and compression band fittings. Even though this plumbing system was installed in many homes from 1978 until the mid-1990s, it is no longer an approved plumbing system due to a history of material failures. The failures were related to improper installation, improper handling, improper storage, and plastic deterioration due to chemical reactions with the water supply. Due to the nature of this latent defect, it was not possible to adequately access the condition of the plumbing system during the home inspection. A licensed plumbing contractor should be consulted for a complete evaluation of the plumbing system to determine the significance of this concern.

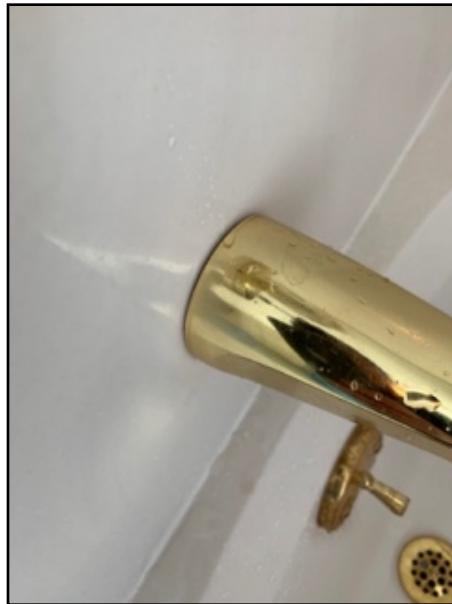
Figure 67-1

All tub spouts and valve escutcheons should be sealed where they contact the tub or shower surround to prevent water penetration through the plumbing supply opening. It is recommended to seal this gap with a 100% silicone sealant.

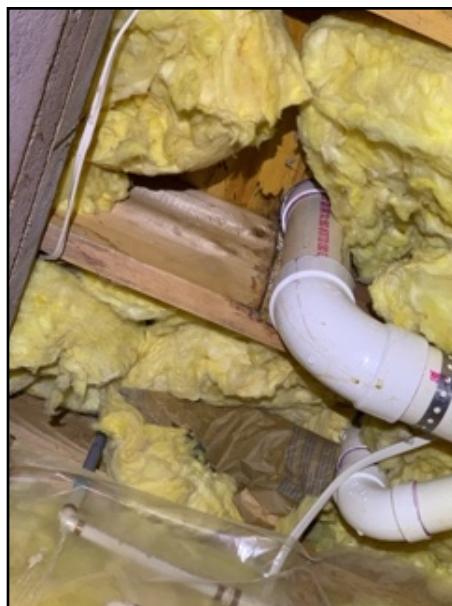
Figure 68-1

The subfloor and framing, located underneath the water closet in the first floor powder room, show signs of a possible leak. Further evaluation and repair by licensed plumber is recommended.

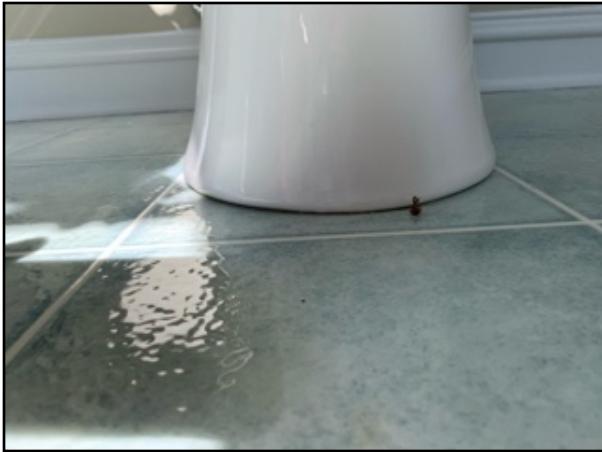
Figure 69-1

All toilet bases should be sealed to the floor to prevent excess movement as well as prevent sewer gases from entering the livable space. Sealing with grout or 100% silicone sealant is recommended.

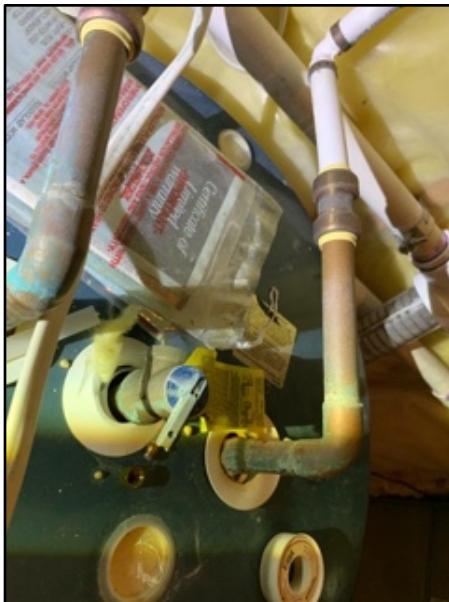
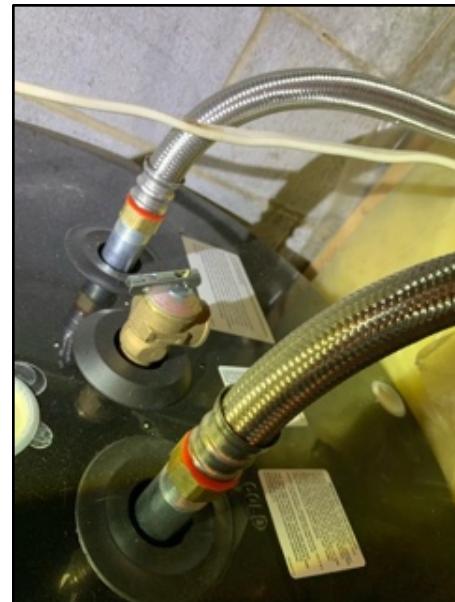
Water heater Temp and Pressure Relief Valve is required to have a blow off leg, a piece of pipe to encapsulate the high temp/pressure water, and move it down toward the floor or exterior. It must terminate no more than 6" above the drain/floor. Not having a blow off leg is a safety hazard that could result in scalding during a pressure relief situation. Installing a blow off leg is recommended.

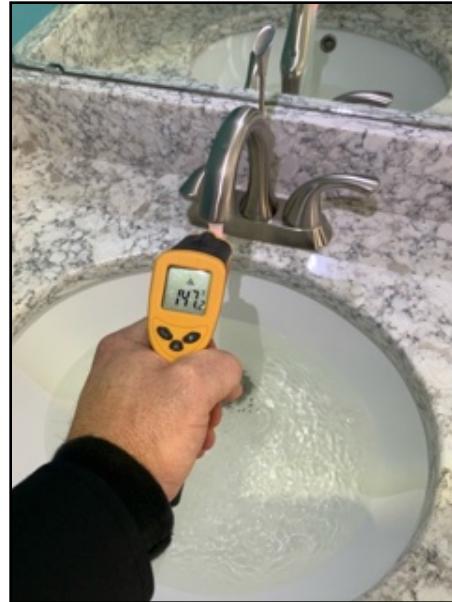
Figure 73-2

The hot water temperature measured above 147°. At this temperature, scalding of children or adults is possible. The recommended hot water temperature is 120°.
