Pait Home Inspections of North Carolina, LLC

Home Inspection Report

Property Address:
123 Street Name
Louisburg, NC 27549

Inspected on Mon, Nov 4 2019 at 9:31 AM

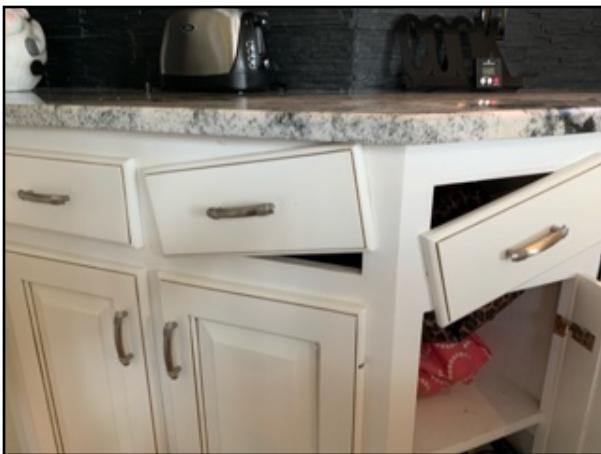
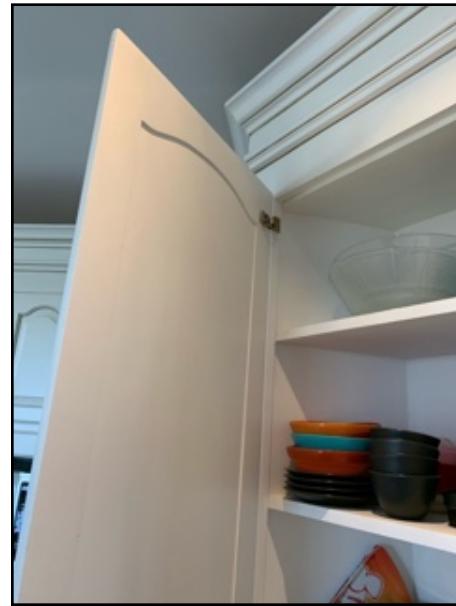
Several kitchen cabinet deadfront drawers and door hinges should be secured properly to prevent damage to the materials.

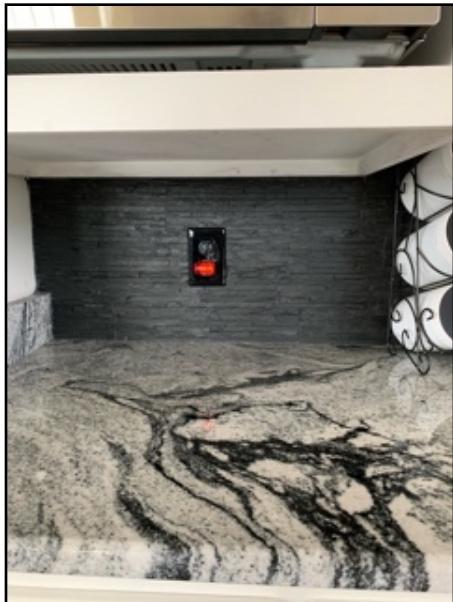
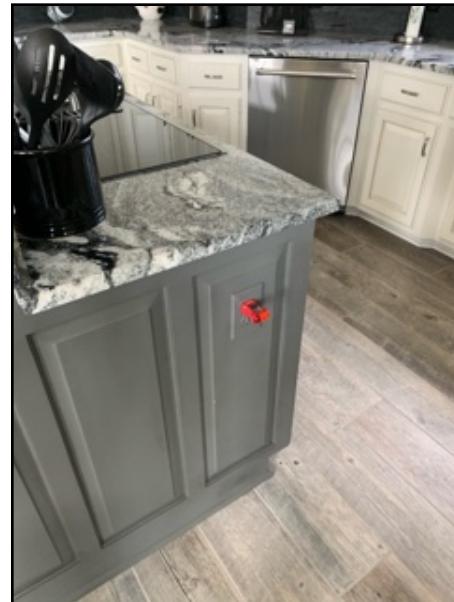
All kitchen receptacles are required to be protected by GFCI protected circuit. There are multiple receptacles in this kitchen unprotected. Install a GFCI outlet to protect any circuit in the kitchen to prevent accidental electrocution.

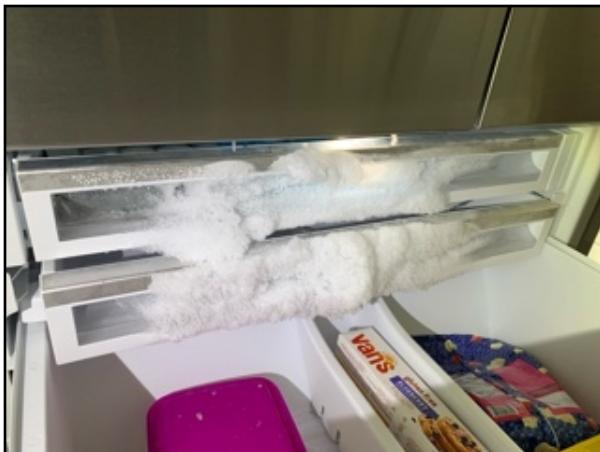
Figure 77-1

Excess moisture is entering the freezer drawer causing ice/frost to build up. Evaluation and repair by licensed appliance technician is recommended.

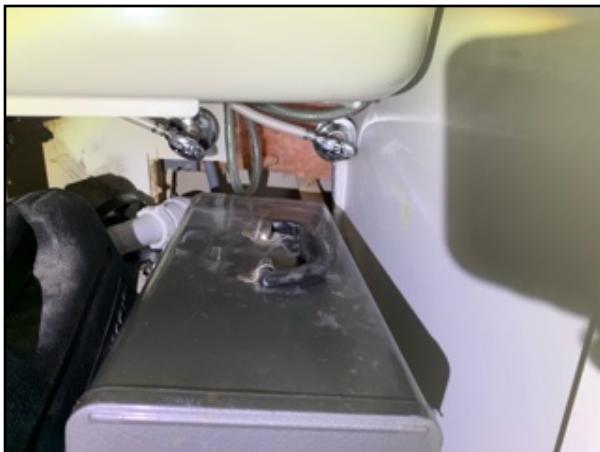
Figure 79-1

The laundry room sink base cabinet should be sealed to reduce moisture entry, conditioned air loss and pest entry.

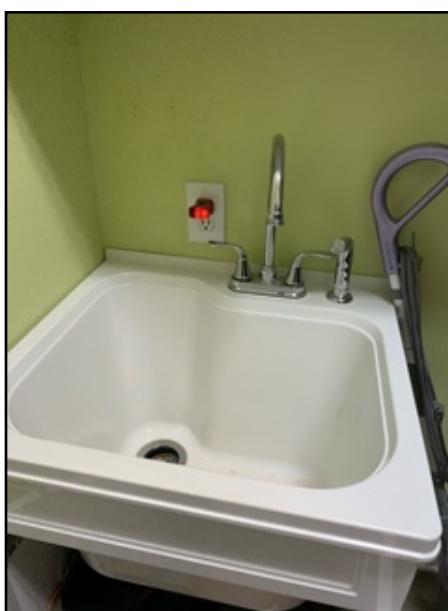
Figure 80-1

The laundry room sink receptacle is not GFCI protected. Repair by a licensed electrician is required to prevent accidental electrocution.

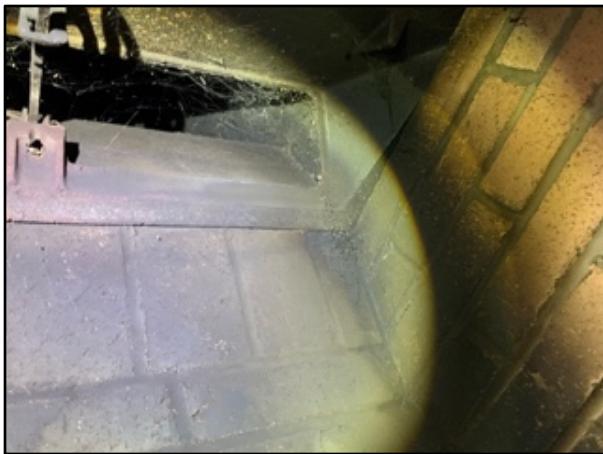
Figure 82-1

All fireplaces, chimneys and fuel burning stoves should be inspected by a certified technician before their first use and annually to ensure safety and proper function.

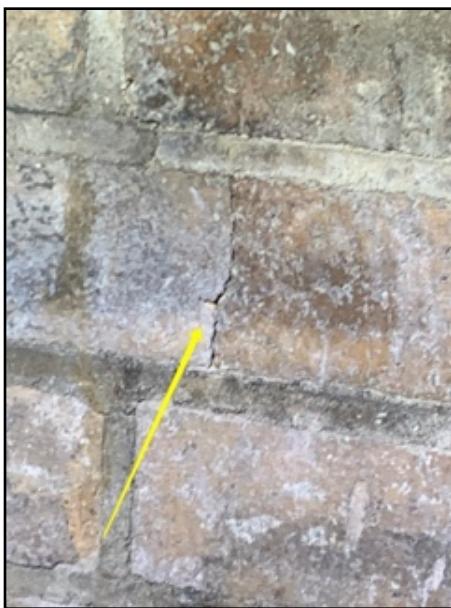
Figure 83-1

The first floor fireplace has a hairline crack in the masonry firebox wall. Evaluation and repair by a licensed fireplace technician is required before use to ensure safety of the fireplace.

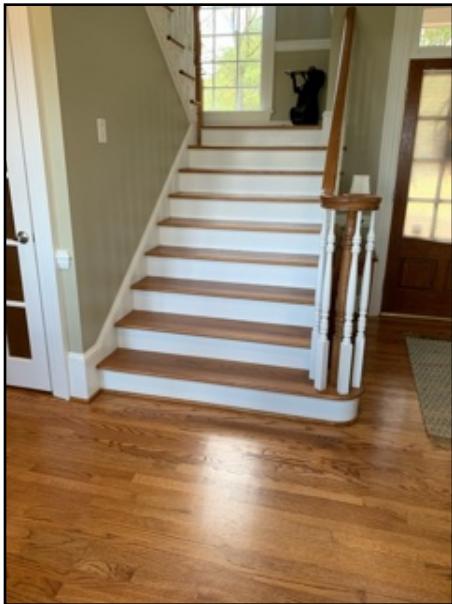
Figure 84-1

Any stairs greater than 44" in width are required to have a graspable handrail on each side of the stairway. Determine if this presents a safety issue for you and install a handrail if desired.

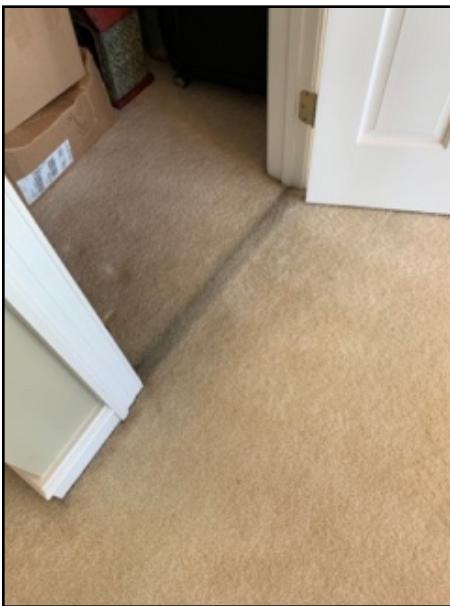
Figure 85-1

All interior doors should be cut 1/2" to 3/4" above the finish floor to allow the air to transfer between rooms. Doors without appropriate clearance results in staining of the carpets from dust/debris, as well as overworking of the HVAC system. Cut the bottoms of all doors as necessary to allow proper air circulation.

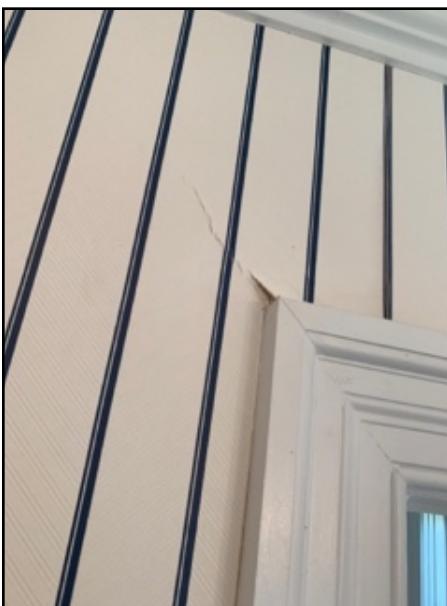
Figure 86-1

The ceiling/walls in several rooms have nail pops, corner bead or tape joint cracks, which over time could increase in size and/or become exposed. The wallpaper in the basement bathroom is coming loose at the seams. (cosmetic)

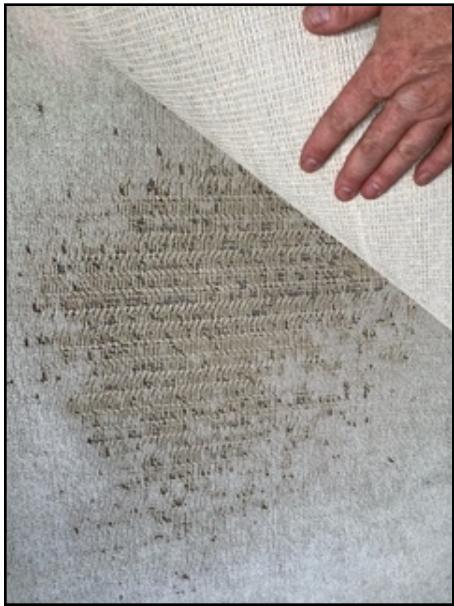
Figure 87-1

The upstairs carpet is damaged/stained in multiple areas. The evaluation of carpet and flooring is beyond the scope of a North Carolina home inspector and therefore any observations made or done so as a courtesy.

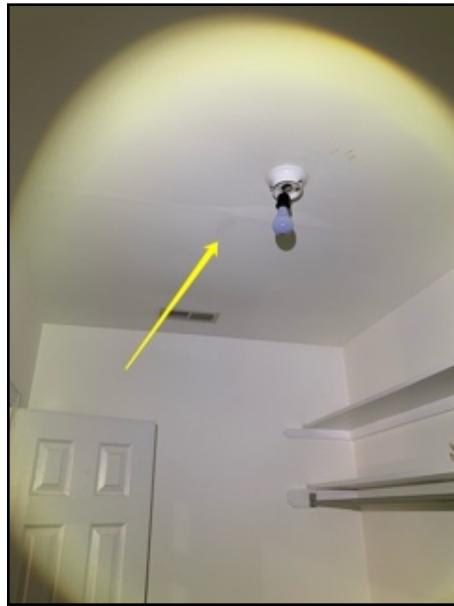
Figure 89-1

A section of the sheet rock ceiling in the tanning bed room is sagging and the raw seam is damaged. Further evaluation by a qualified professional is recommended.

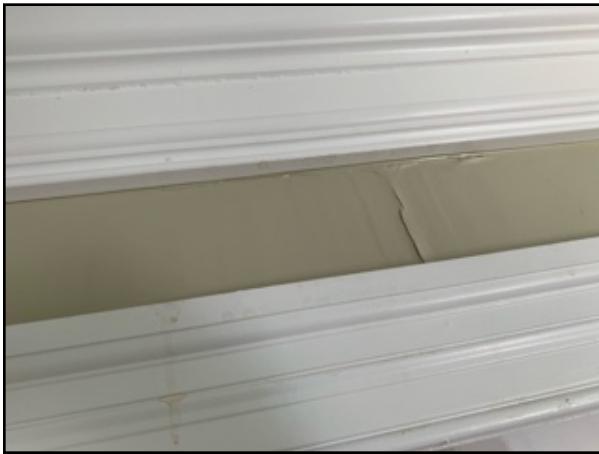
Figure 90-1

The wall/trim in the upstairs living room shows possible active water stains near the uphill side of the chimney. (To the right) Further evaluation and repair by a licensed contractor is recommended.

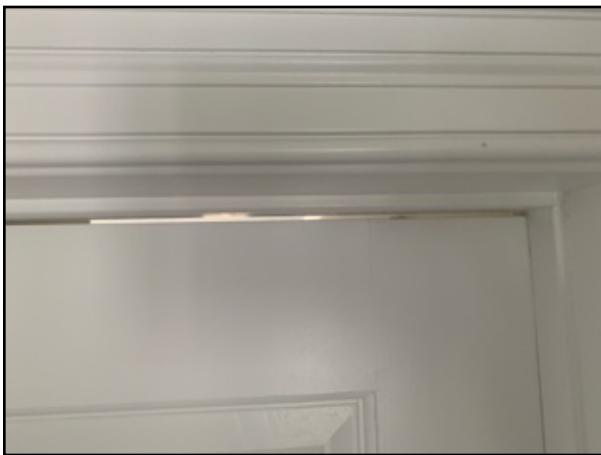
Figure 91-1

The door leading to the upstairs, front right bedroom has shifted and a gap has developed at the top of the door. The function of the door has not been compromised. Monitor the door and if further shifting develops, adjusting the door may be required.
