THE DWELLING INSPECTOR, LLC

## ARIZONA RESIDENTIAL HOME INSPECTION REPORT

1234 Main St.  
Tempe, Arizona 85282

Buyer Name  
07/28/2019 9:00AM

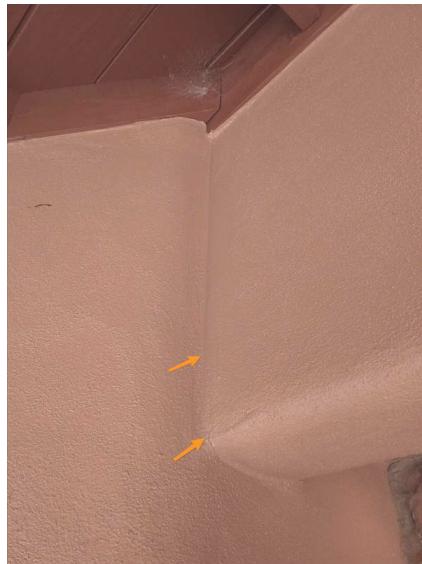
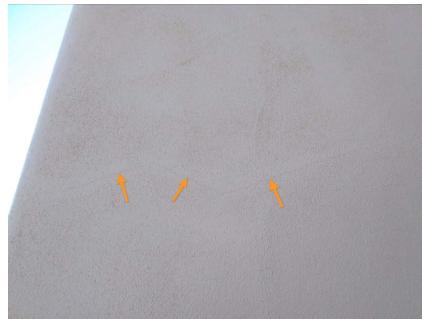
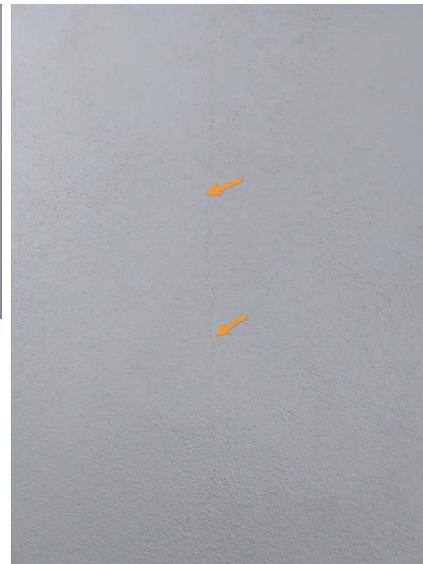
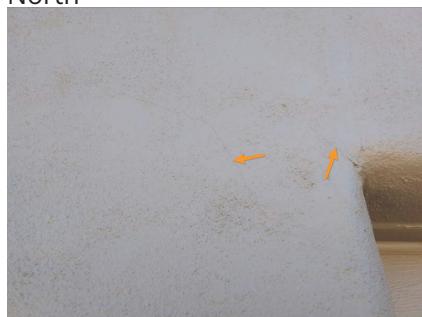
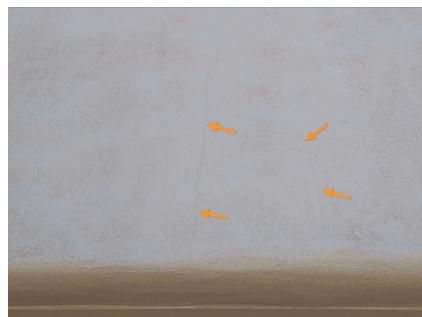
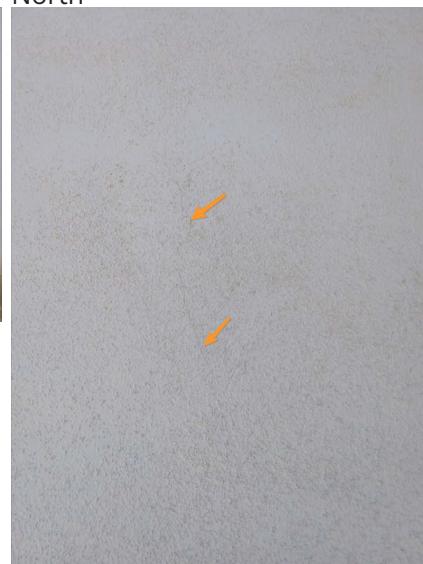
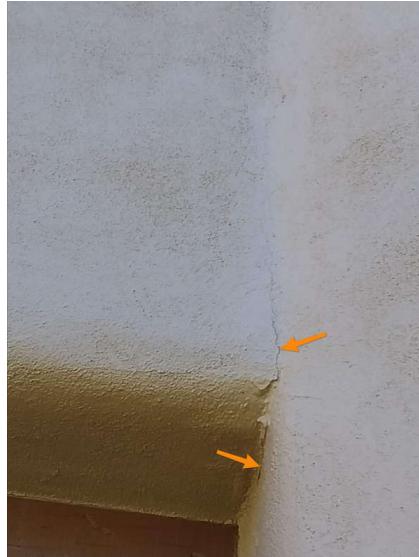
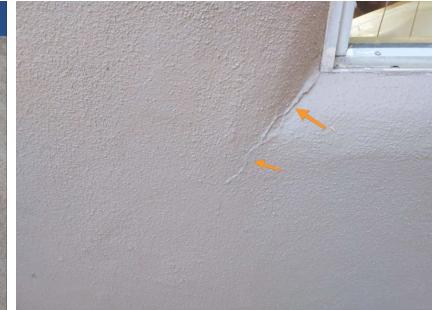
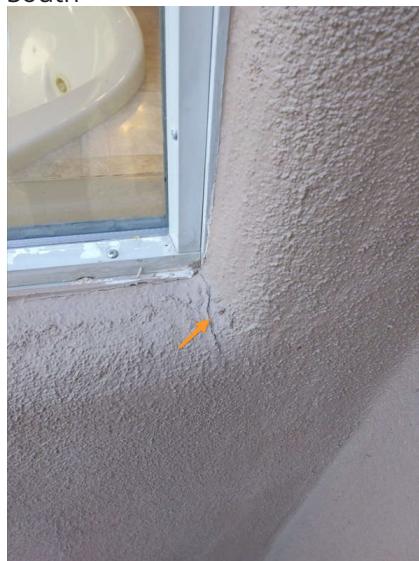
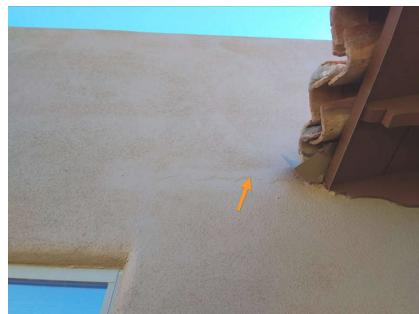
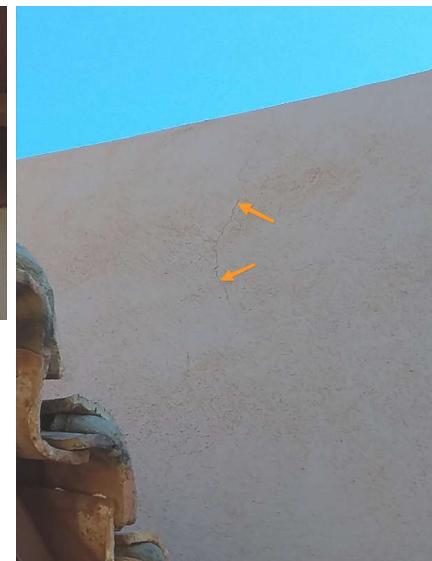
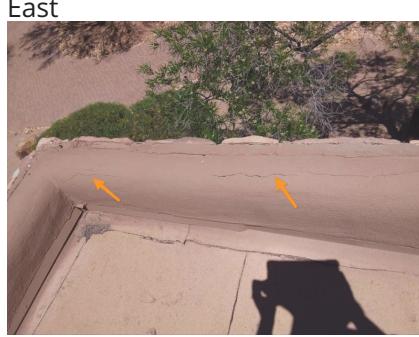
**MINOR CRACKS IN STUCCO**

Stucco showed cracking in one or more places. This could be a result of temperature changes or building settlement and is typical as homes with stucco age. Recommend a stucco repair contractor to seal and repaint to prevent water penetration.

The attached photos are a sampling of this condition. The contractor should evaluate all stucco areas for this condition.

Contact a stucco repair contractor

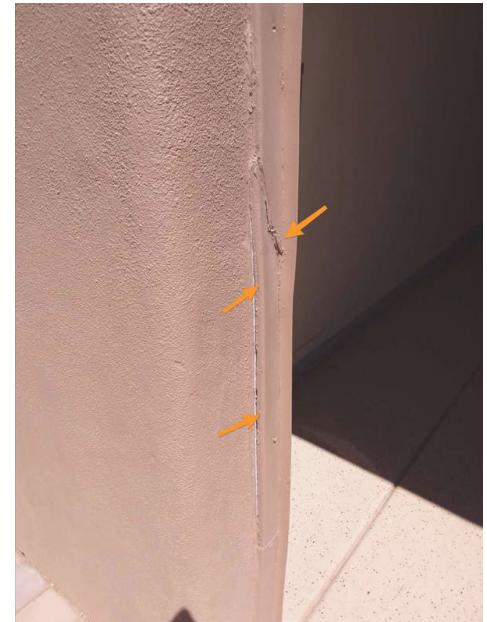
Garage

**DAMAGED EXTERIOR WOOD TRIM**

The exterior wood trim was observed to have some deterioration and/or damage. Damaged and deteriorated exterior wood trim should be repaired to prevent wall damage, moisture penetration and wood destroying insects.

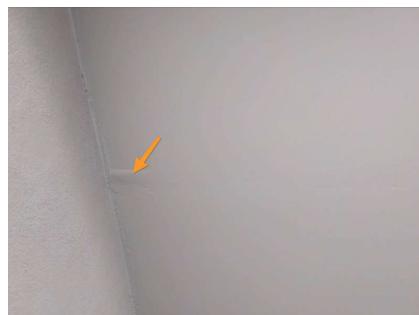
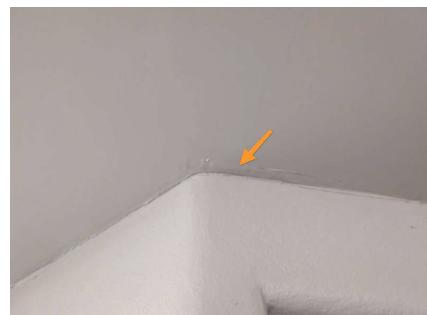
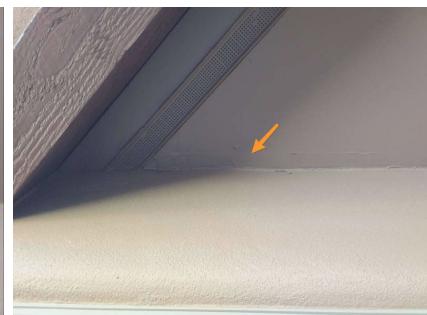
One or more cracks were observed in the exterior ceiling/soffit and appeared to be from poor drywall taping. Recommend correction by a professional drywall contractor.

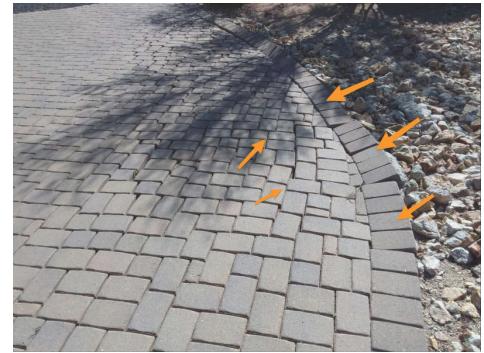
Differential movement of the driveway was observed. Differential movement in concrete pavers may be an indication of settlement, erosion or other defects and should be repaired as needed.

Contact a qualified driveway contractor.

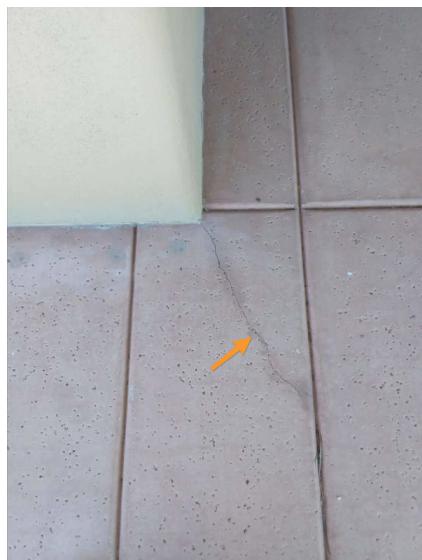
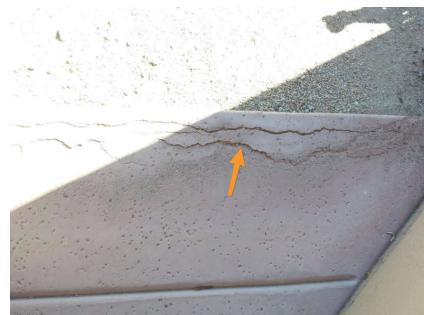
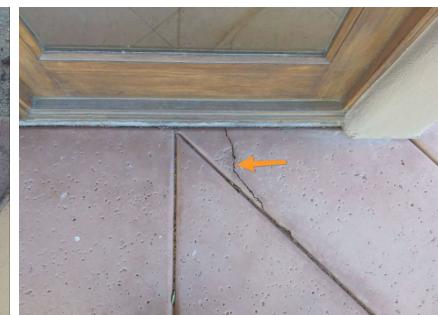
North

### REPAIR/RESEAL WALKWAY CRACKS

Cracks and/or deficiencies were observed in the poured concrete walkway. Cracks in poured concrete may be an indication of material defects, lack of maintenance, movement or settlement. Cracks and other defects in poured concrete should be repaired/resealed and monitored over time for movement, deflection and deterioration.

Contact a qualified grading contractor.

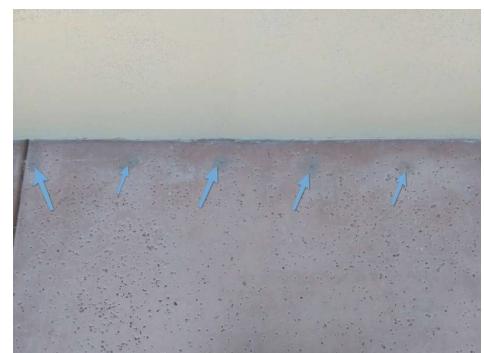
North

The walkway appeared to have holes drilled and refilled which is consistent with a previous termite treatment. The inspector recommends you ask the seller about this condition.

Recommend monitoring.

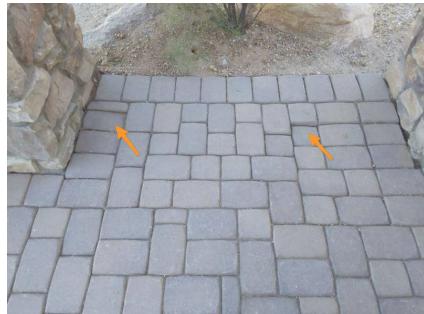
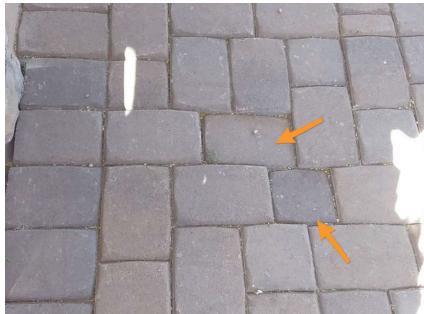
Differential movement of the patio(s) was observed. Differential movement in concrete pavers may be an indication of movement, settlement or other defects and should be repaired as needed.

Covered patio/cabana

Contact a qualified grading contractor.

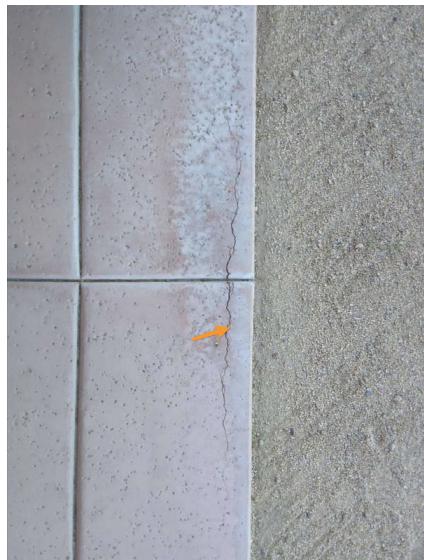
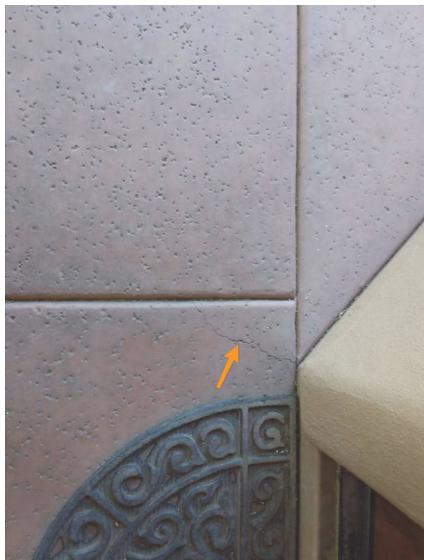
South

Cracks and/or deficiencies were observed in the poured concrete patio(s). Cracks in poured concrete may be an indication of material defects, lack of maintenance, movement or settlement and should be repaired/resealed and monitored over time for movement, deflection and deterioration.

Contact a qualified concrete contractor.

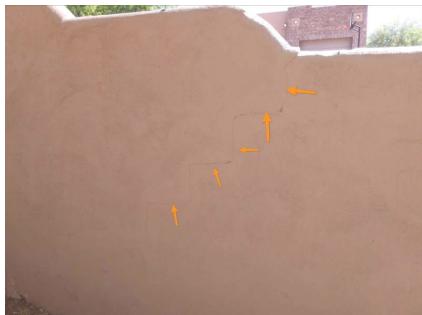
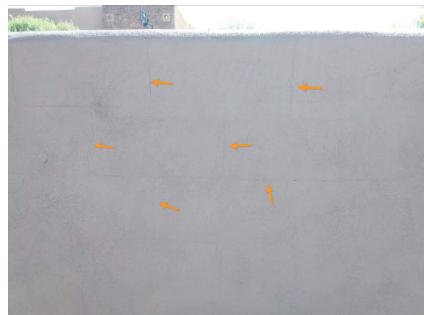
East

**CRACKS AT THE MORTAR SEAMS**

The perimeter concrete/masonry wall had step cracking at the mortar seams. This is an indication of settling, soil movement, or some other defect. Recommend repairs by a concrete/masonry fence contractor.

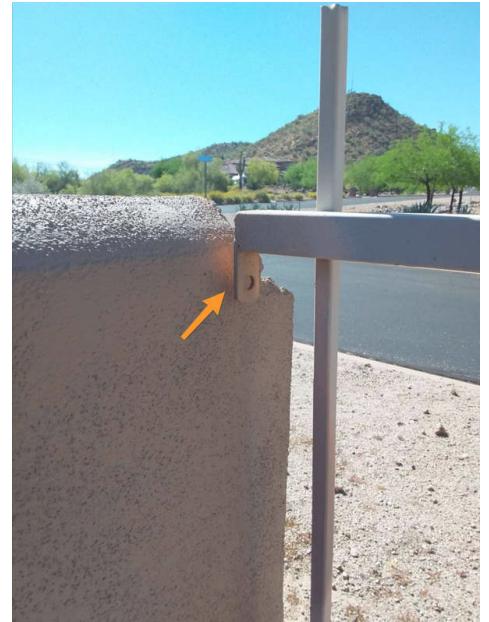
East

The metal fencing at the southeast corner was not securely attached to the wall. Recommend a qualified professional to securely fasten the fence

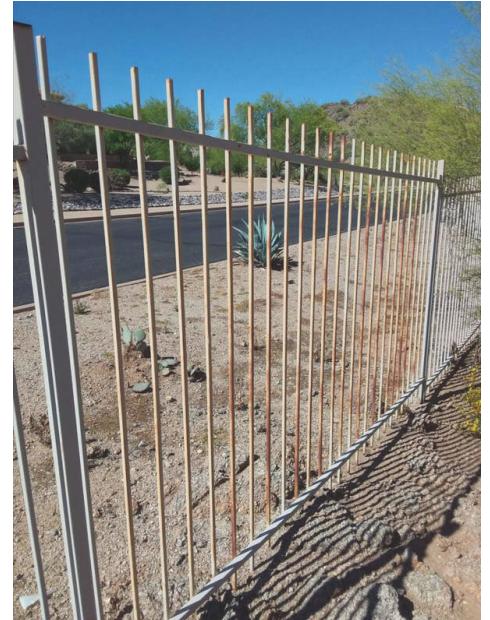
South

The metal fence at the south end of the property appeared to have surface rust. Recommend repainting the metal fence to prevent further deterioration.

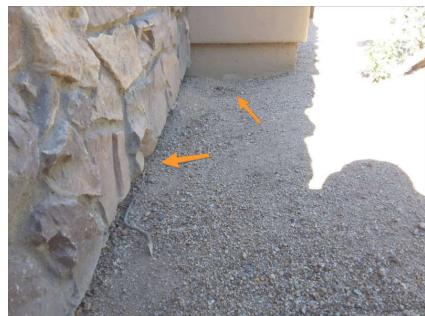
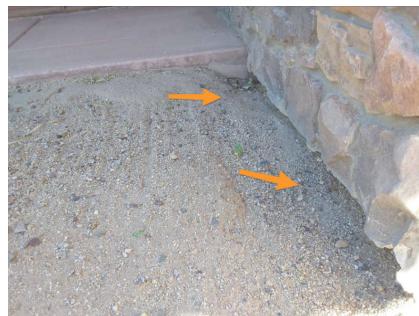
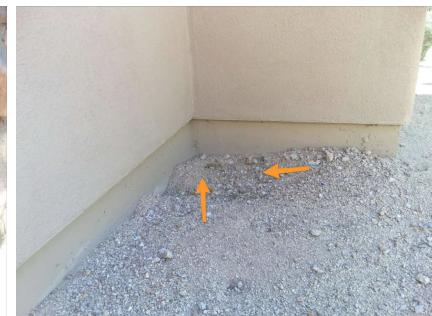
**NEGATIVE GRADE SLOPE TOWARDS THE FOUNDATION**

A negative grade slope towards the foundation was observed. Proper drainage is needed to help prevent water from standing and/or ponding next to the foundation. Grading improvements are needed to direct run off water away from the structure. Any area where the ground or grade does not slope away from the structure is to be considered an area of improper drainage. Recommended slope away from the foundation is 6 inches per 10 feet.

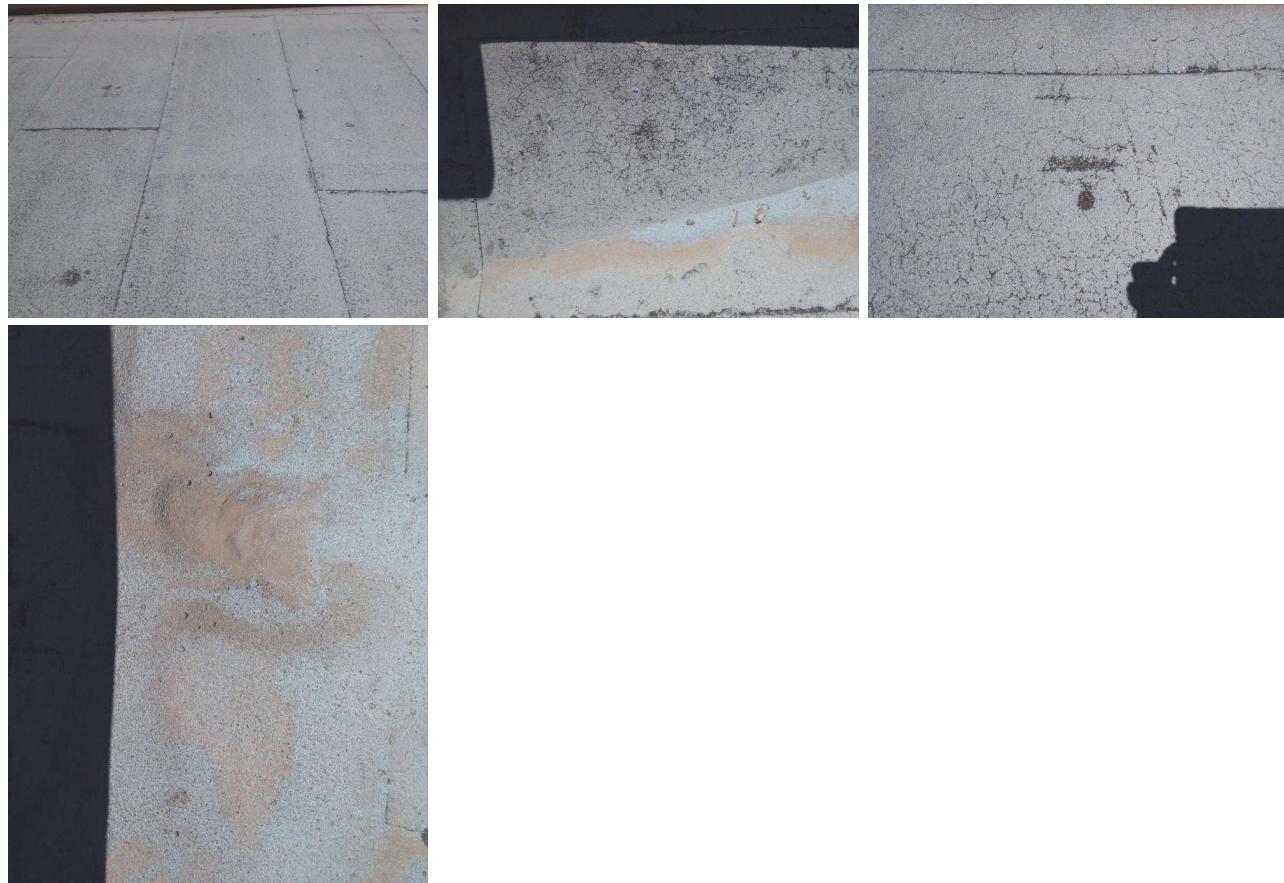
Roof coverings exhibited general wear and damage due to the age of the roof coverings that could affect ongoing performance. Recommend a qualified roofer to evaluate and repair.

The attached photos are a sampling of this condition.

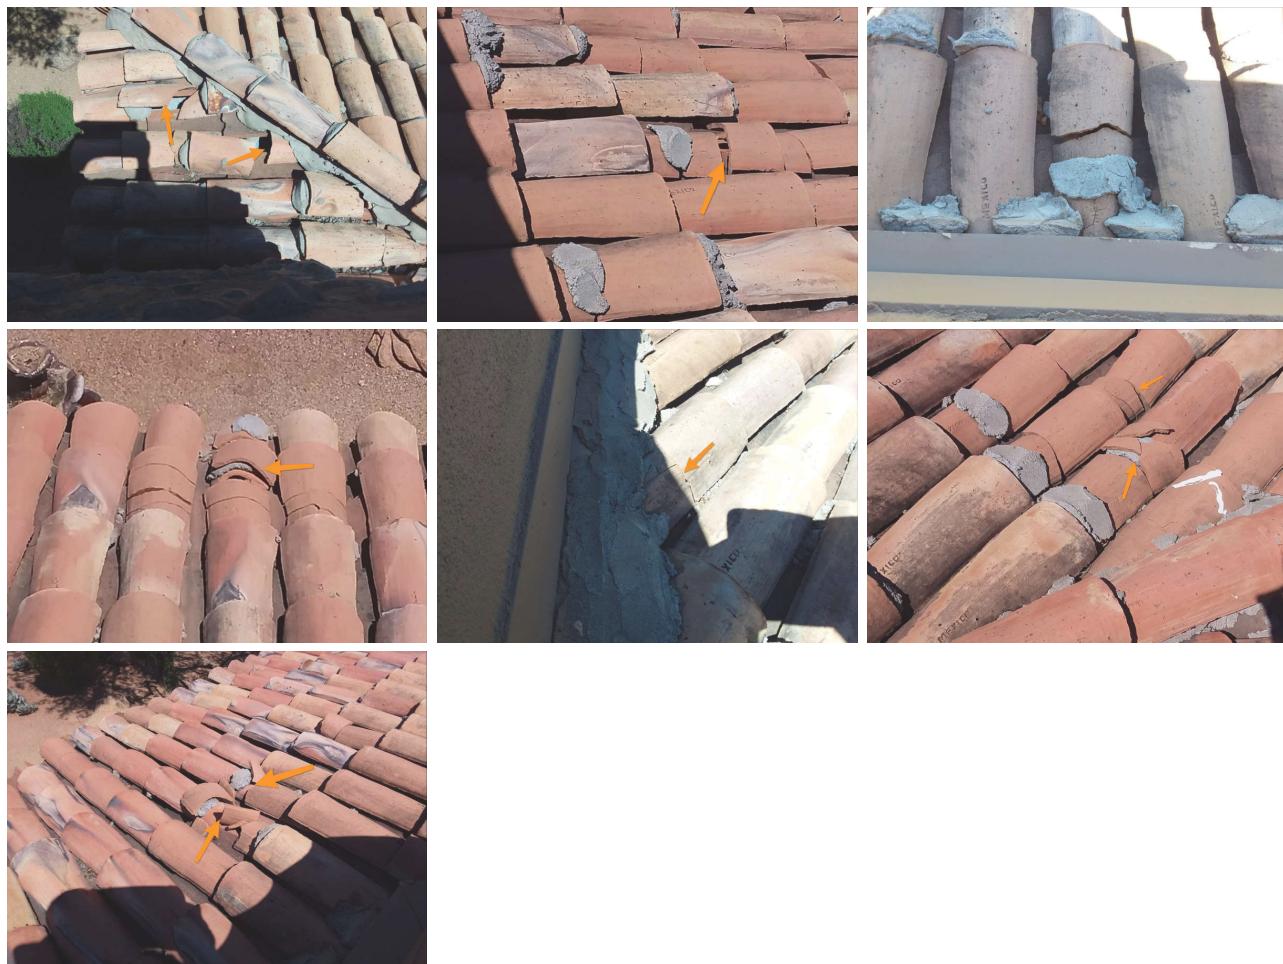
## 5.2.1 Second Roof

Contact a qualified roofing professional.

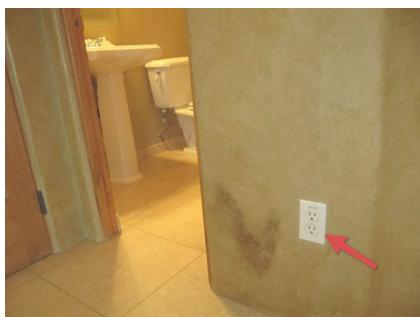
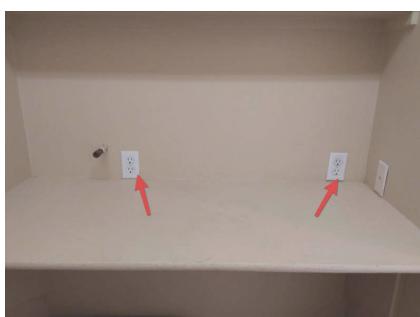
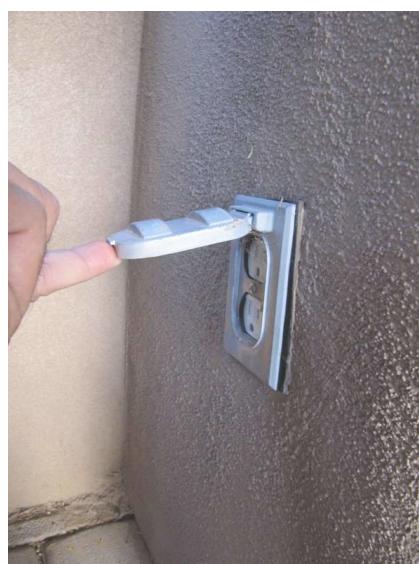
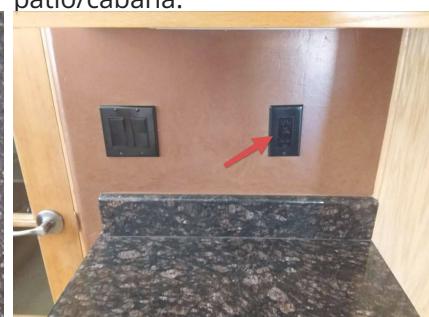
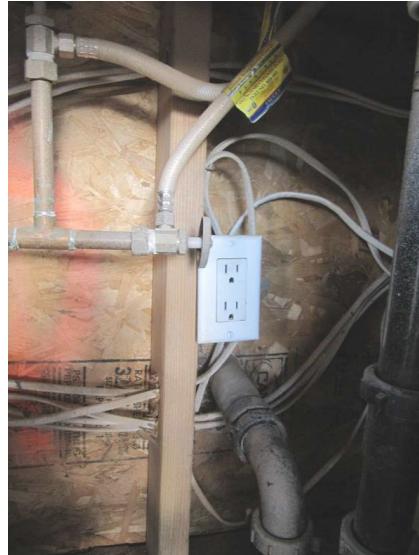
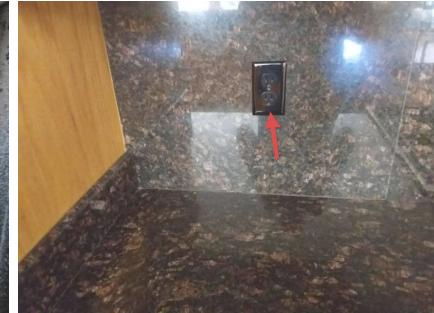
No ground fault circuit interrupter (GFCI) protection of home electrical receptacles was provided in the home at the time of inspection. Although GFCI protection may not have been required at the time the home was built, for safety reasons, the Inspector recommends that electrical receptacles located in basements, crawlspaces, garages, the home exterior, and interior receptacles located within 6 feet of a plumbing fixture be provided with ground fault circuit interrupter (GFCI) protection in good working order to avoid potential electric shock or electrocution hazards. This can be achieved relatively inexpensively by:

GFCI protected outlets were missing in the garage, the kitchen, outside the half bath, and at some exterior locations.

An outlet outside the half bath was labeled as a GFCI protected outlet, however it was not. The outlet was within 6 feet of the bathroom sink.

Contact a qualified electrical contractor.

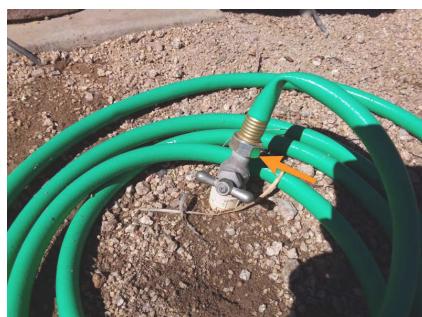
North

It is recommended to install an anti-siphon device at the exterior hose faucet for safety reasons. An anti-siphon device (or vacuum breaker) prevents unsanitary water from being pulled back through a garden hose and contaminating your water system, otherwise known as a "Cross Connection". These are fairly inexpensive and can be picked up at your local hardware store.

Contact a handyman or DIY project

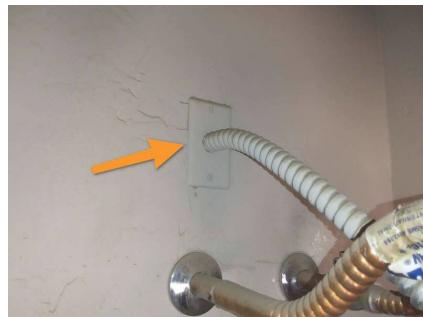
Recommend adding an electrical disconnect at the wall juncture as a safety upgrade for when maintenance and replacement of the water heater is needed. This condition is present for all the water heaters installed on the property.

Water heater on the south side of property.

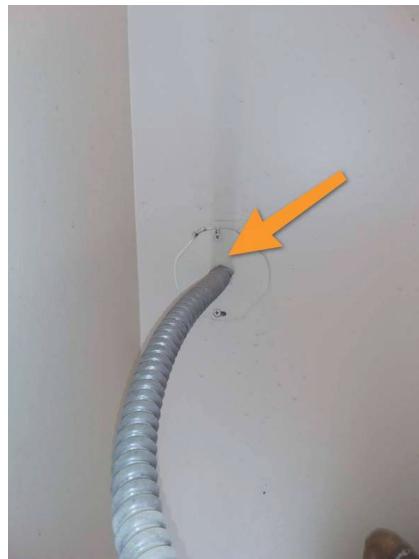
Water heater on the east side of the property.

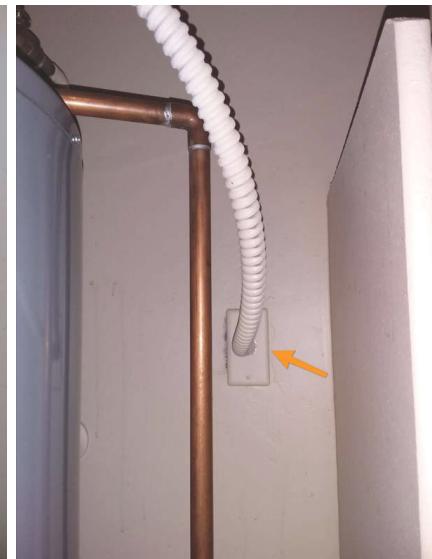
Water heater in the garage.

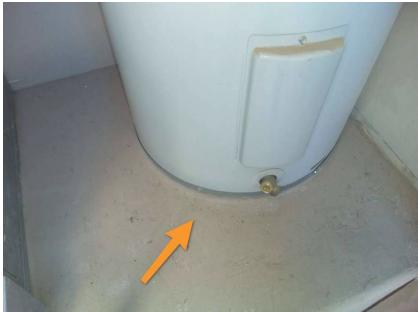
The water heating equipment was installed without an overflow pan. Current building standards state that all water heaters should be equipped with an overflow pan with a drain that drains to the exterior of the structure if leaks would cause damage.

This condition was present for all water heaters on the property.

Water heater located on the south side of the property.

Contact a qualified plumbing contractor.

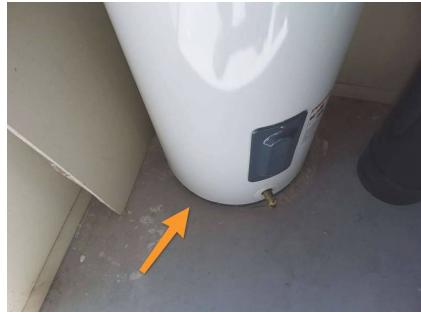
Water heater located on the east side of the property.

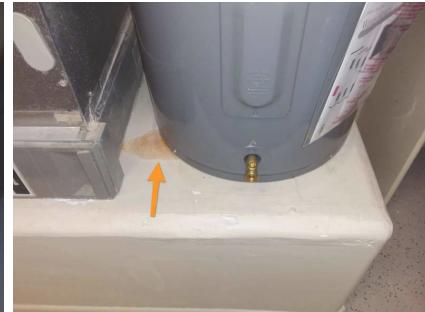
Water heater located in the garage.

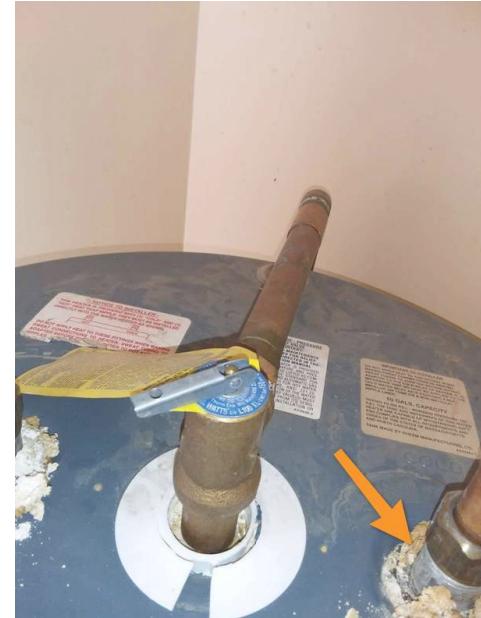
Water heater located on the east side of the property.

Contact a qualified plumbing contractor.

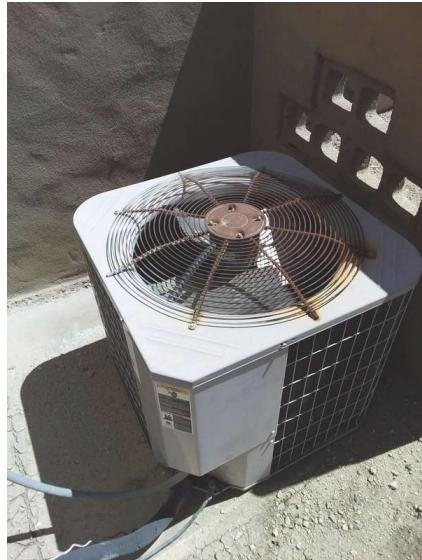
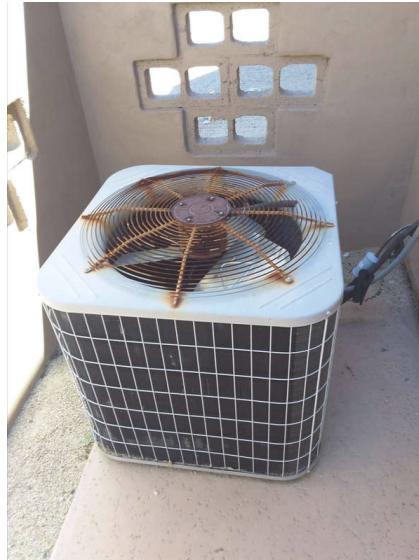
The heating equipment appeared to be old (year 2000), however it was working at the time of the inspection. Recommend service, maintenance and cleaning by a professional HVAC contractor.

Contact a qualified HVAC professional.

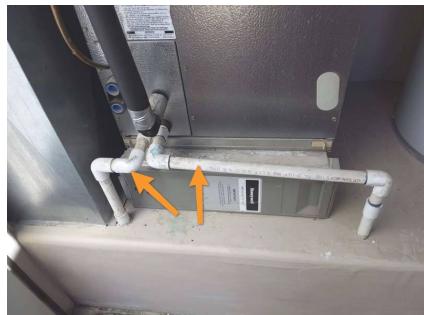
South

**CONDENSATE LINE(S) MISSING VENT AND P-TRAP**

The primary purpose of a condensate trap is to prevent air from moving in or out of the coil box or air handler during operation. Traps must be installed in a manner that will stop the air from passing through, but still allow the condensate to drain from the condensate pan. A standard residential system needs to have a trap of at least 1 1/2 inches to drain properly. There should not be an air vent between the drain and the trap. There should normally be a vent after the trap. Recommend correction by a professional HVAC contractor.

This condition was observed at all air handlers.

Contact a qualified HVAC professional.

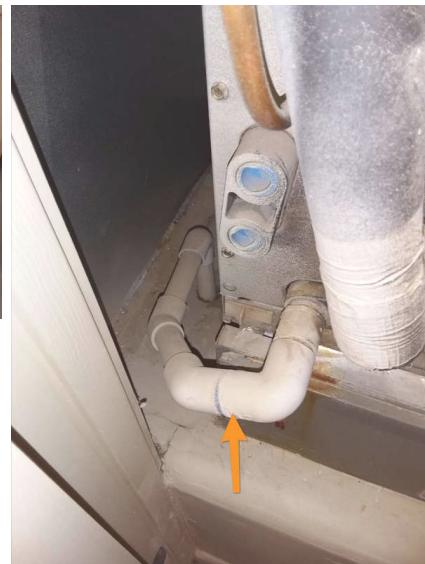
Air handler located in the garage.

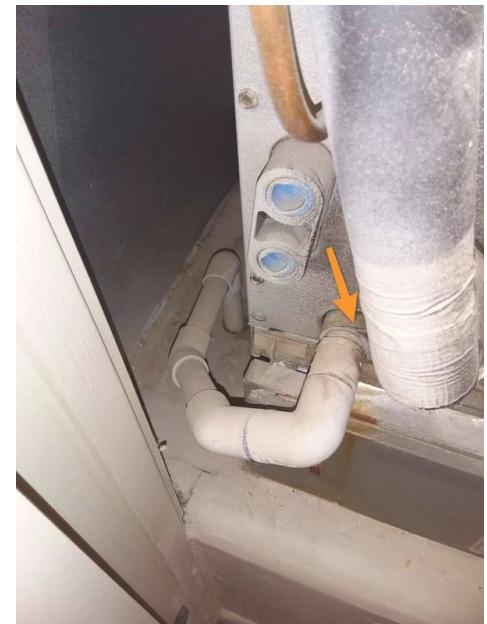
Garage

**MISSING SECONDARY DRAIN LINE  
OR SAFETY SWITCH**

The inspector recommends further evaluation of all installed air handlers.

Contact a qualified HVAC professional.

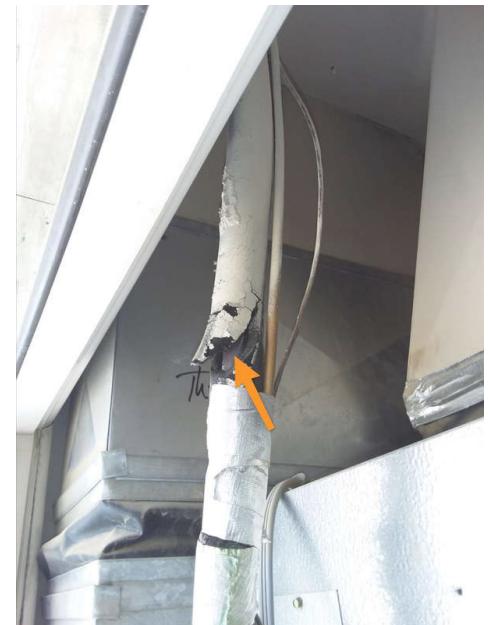
The HVAC refrigerant lines were not properly insulated. Inadequate cooling line insulation at the HVAC equipment may result in equipment damage, inadequate performance, reduced equipment life or other defects. Recommend service by a HVAC professional.

Contact a qualified HVAC professional.

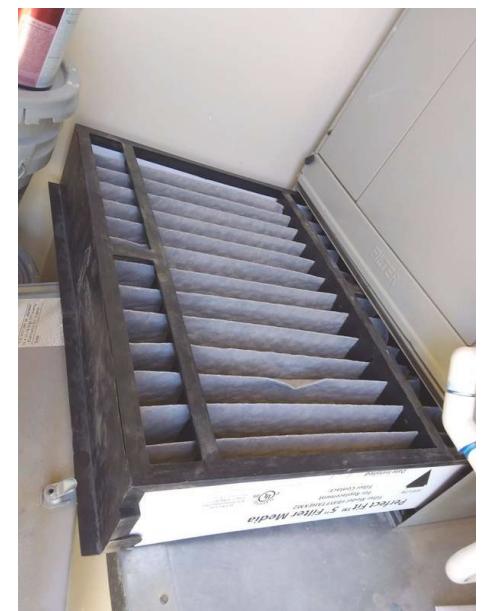
The air filter appeared to be dirty and should be replaced.

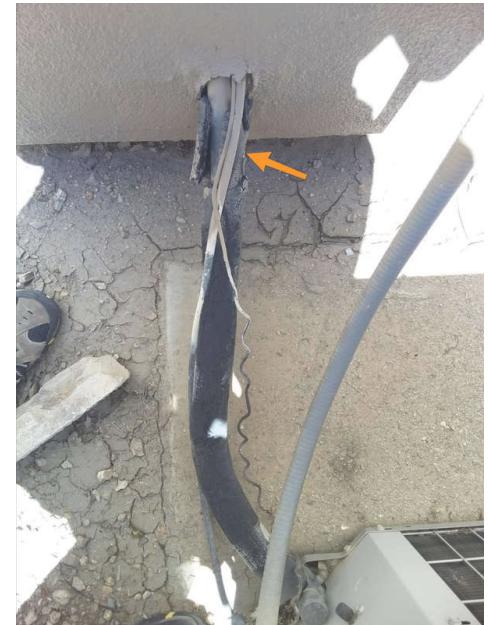
**INSULATION MISSING OR DAMAGED**

The HVAC refrigerant lines were not properly insulated or the insulation was damaged and in need of replacement at the exterior equipment. Inadequate cooling line insulation at the exterior HVAC equipment may result in equipment damage, inadequate performance, reduced equipment life or other defects.

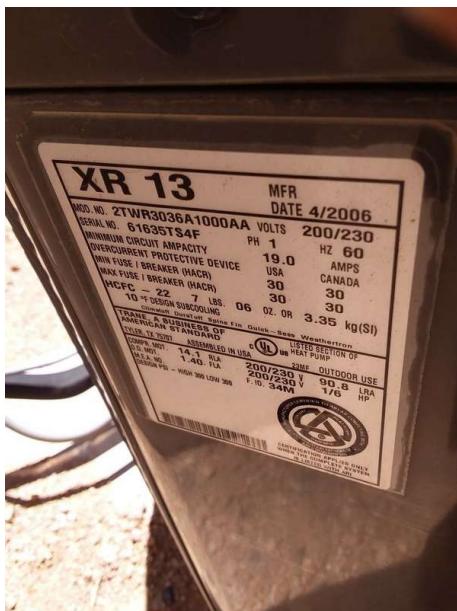
The data plate was present (see photo(s) for more information).

Manufacture Date: April 2006

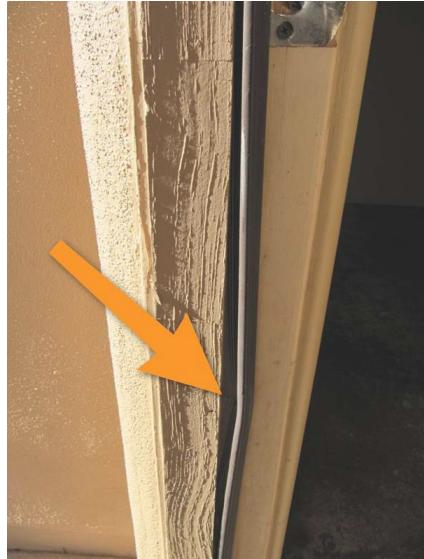
## 14.2.2 Entry/Exterior Door(s)

At the time of the inspection, weather-stripping at an exterior door was damaged or deteriorated. The Inspector recommends replacement/installation of effective weather-stripping components as necessary by a qualified contractor.

Contact a qualified professional.

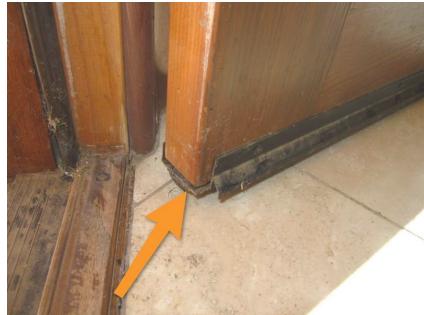
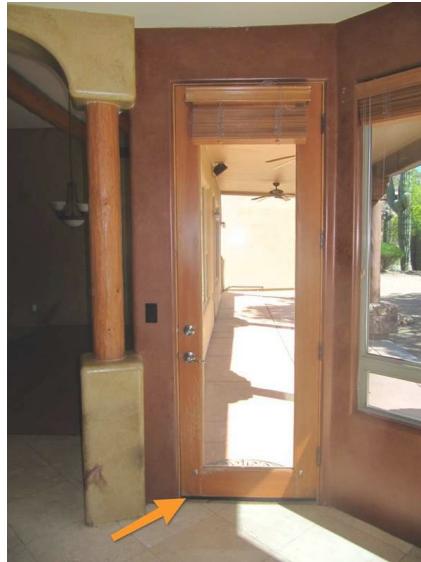
## 14.2.3 Entry/Exterior Door(s)

Recommendation**SWEET DAMAGED**

At the time of the inspection, the sweep was damaged or loose. A sweep is a rubber strip that attaches to the bottom of a door to seal the gap between the bottom of the door and the threshold. It should be repaired to help prevent moisture and pest intrusion and air/heat leakage that will increase heating/cooling costs and reduce home comfort. All work should be performed by a qualified contractor.

Contact a handyman or DIY project

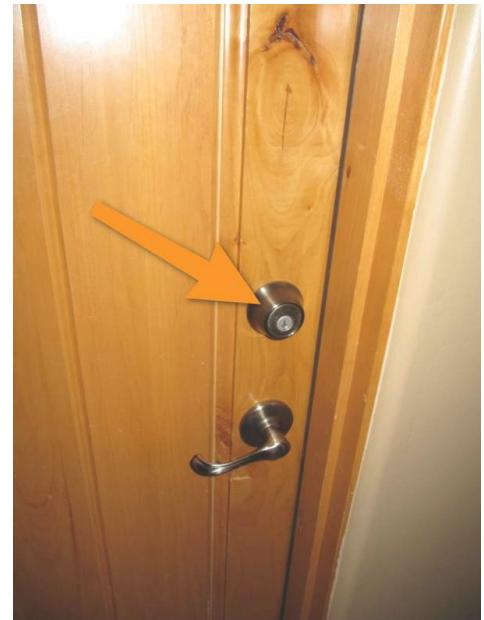
## 14.2.4 Entry/Exterior Door(s)

Recommendation**KEYED DEADBOLT**

A door that leads to the exterior had a deadbolt which required a key for operation from the inside. This condition is unsafe as it may slow or prevent exit during an emergency. Installation of these types of deadbolts is no longer allowed in new construction. The Inspector recommends that all deadbolts in the home that require a key for exit from the home interior be replaced with a deadbolt that operates from the inside with a lever. All work should be performed by a qualified contractor.

Contact a qualified door repair/installation contractor.

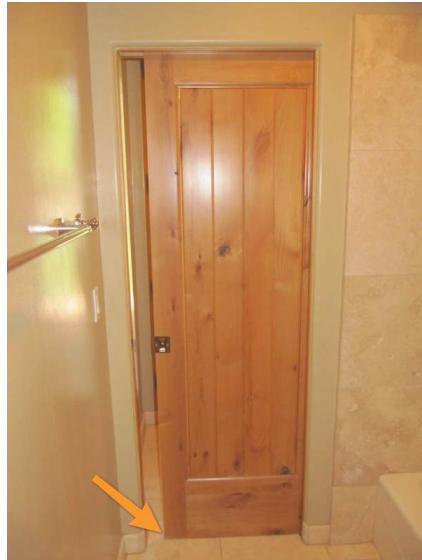
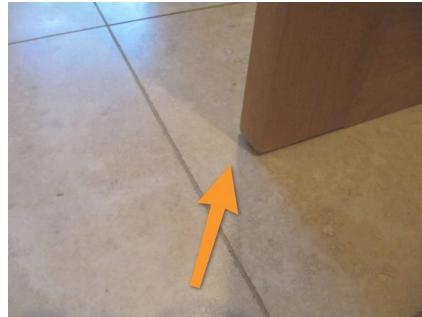
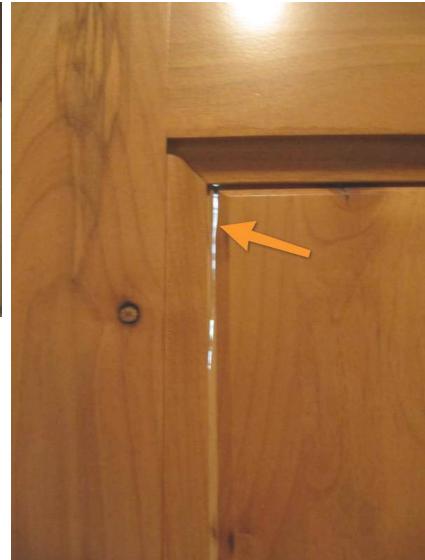
The pocket door in Bathroom 4 had a pocket door that rubbed the tile floor and made opening and closing of the door difficult. Recommend adjustment or repair by a qualified door contractor to ensure ease of operation.

This door also had a small crack or opening in one of the door panels which appeared to be a cosmetic defect.

Contact a qualified door repair/installation contractor.

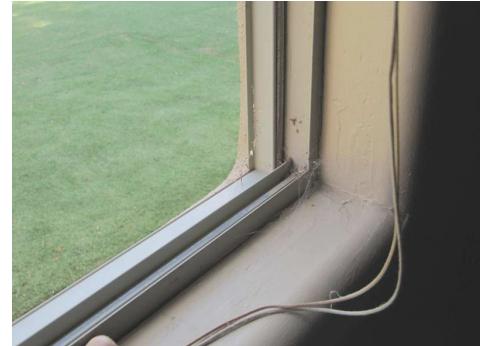
Exercise Room

**SCREEN(S) - MISSING**

One or more window screens were missing at the time of the inspection and should be replaced by a qualified professional.

Contact a qualified professional.

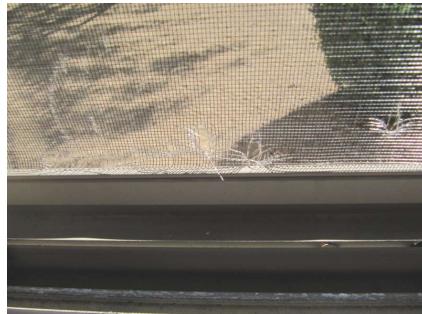
Bedroom 2

**SCREEN(S) - DAMAGED**

One or more screens were observed to be damaged and should be repaired or replaced by a qualified professional.

Contact a qualified professional.

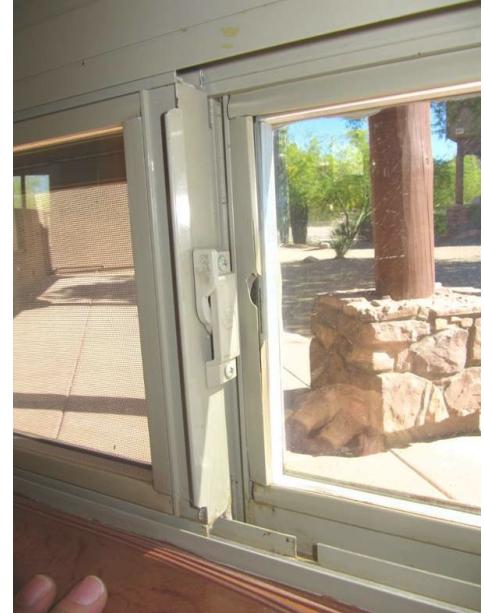
Kitchen Area

**VINYL WINDOW GLAZING - DAMAGED**

The vinyl window glazing at one or more windows were observed to be damaged and in need of replacement by a qualified window repair contractor.

Contact a qualified window repair/installation contractor.

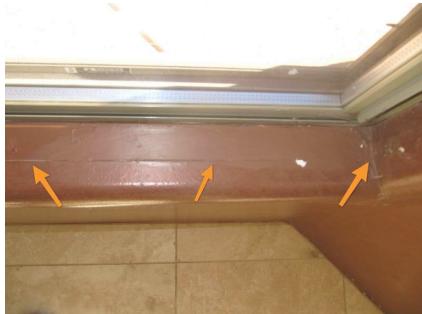
Kitchen

**DRYWALL - CRACKS AND/OR SEPARATION FROM WINDOW FRAMES**

The drywall at the corners of several windows were observed to be cracking and/or separating from the window frames. This is common as homes settle and materials shrink. Recommend repair, resealing, and repainting by a qualified drywall contractor.

Contact a qualified drywall contractor.

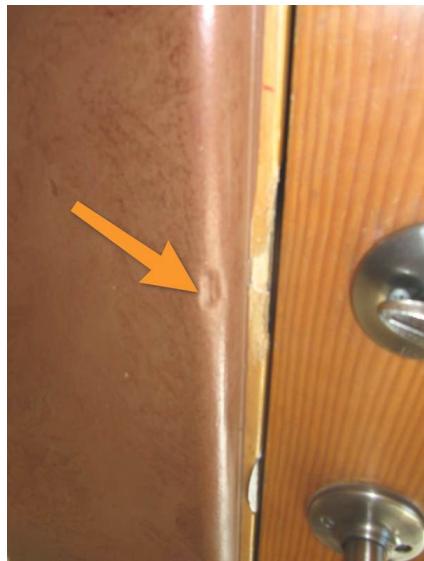
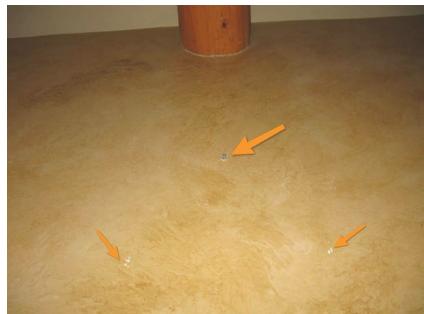
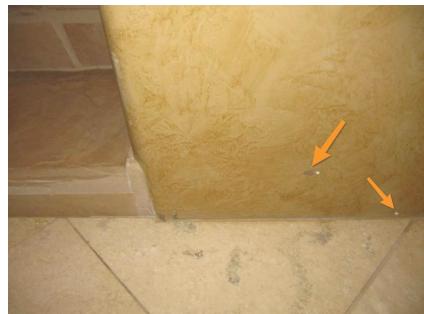
Kitchen

Recommendation**WALLS - GENERAL WEAR AND TEAR**

The walls of the house exhibited general signs of wear and tear. Scuff marks, furniture damage, small holes from nails and wall anchors, peeled or chipped paint and wall patching that does not match the texture of the walls was observed at the time of the inspection. This condition is common for a home of this age and you are recommended to contact a qualified professional to repair and repaint to restore the walls.

Contact a qualified painting contractor.

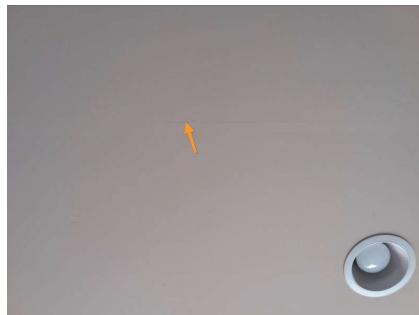
Kitchen

**CEILING CRACKS**

One or more cracks in the ceiling were observed at the time of the inspection. The cracks could be caused by settling of the roofing framework, poor tape joints, or some other defect. The cracks are not a structural concern. Recommend a professional drywall contractor to patch, re-texture and paint.

Contact a qualified drywall contractor.

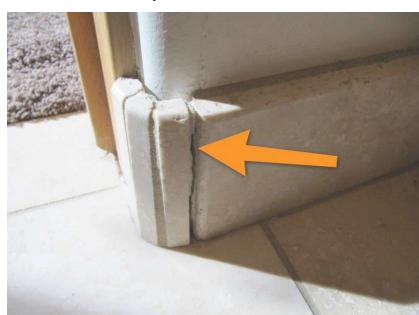
Bathroom 2

**TRIM DAMAGE/DETERIORATION- MINOR**

One or more areas of the tile trim exhibited minor cosmetic damage/deterioration. Recommend re-grouting by a qualified tile contractor.

Contact a qualified tile contractor

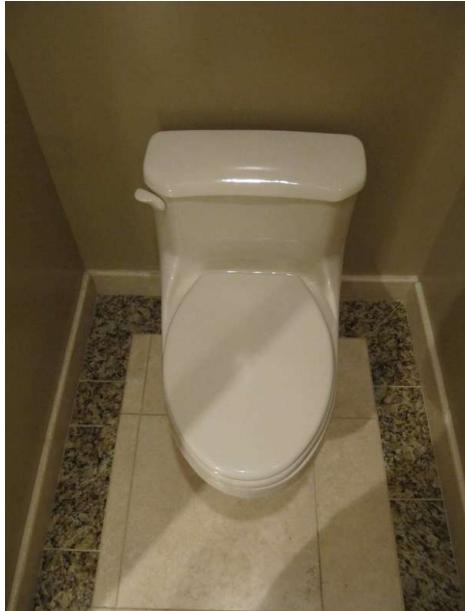
Master Bathroom

The toilet(s) appeared serviceable at the time of the inspection.

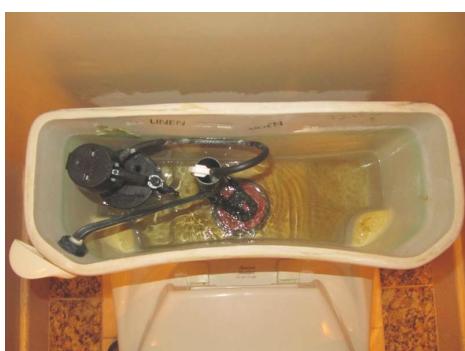
Master Bathroom

The water supply to the toilet(s) appeared to have functional flow at the time of the inspection., There were no water supply leaks observed at the time of the inspection.

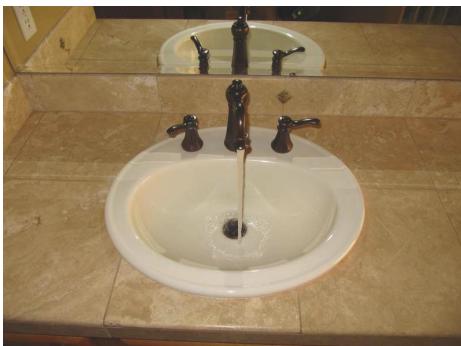
Master Bathroom

The sink(s) appeared serviceable except where noted (see Observations for more information).

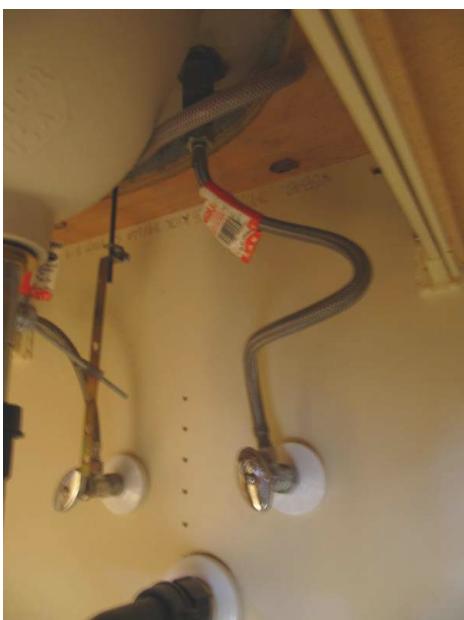
Master Bathroom

The water supply to the sink faucet(s) appeared to have functional flow at the time of the inspection,. There were no water supply leaks to the sink faucet(s) observed at the time of the inspection.

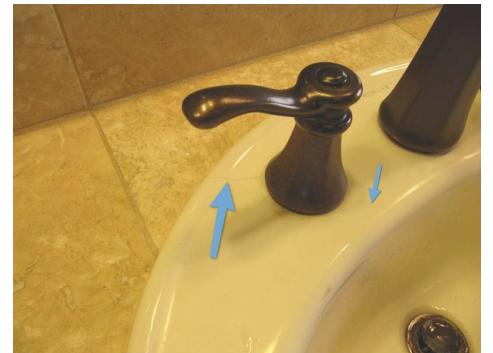
Master Bathroom

**15.2.1 Sink(s)****SINK - HAIRLINE CRACK**

The sink in the master bathroom had a hairline crack near the hot water faucet. This appeared to be cosmetic damage and did not affect the performance of the sink. Recommend continual use and monitoring until replacement is needed or desired.

Recommend monitoring.

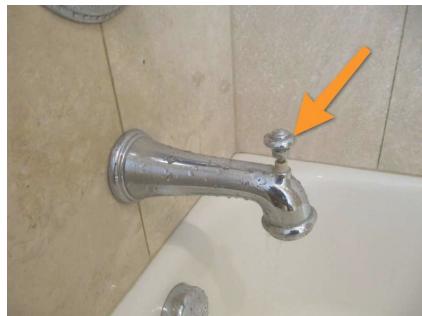
Bathroom 2

The diverter valve was inoperable or did not operate correctly (the diverter is the valve which diverts water from the tub faucet to the shower head). The diverter valve did not release when the water was turned off and held water in the supply line to the shower head. The Inspector recommends maintenance be performed by a qualified contractor.

Contact a qualified plumbing contractor.

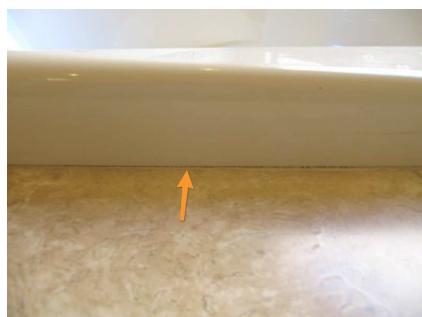
Master Bathroom

**CAULK LINE FAILED**

Sealant where the tub, tub faucet, and/or tub spout meet the tile was old and had sections of missing sealant that may allow damage from moisture intrusion of the wall assembly. The Inspector recommends maintenance by a qualified contractor.

Contact a handyman or DIY project

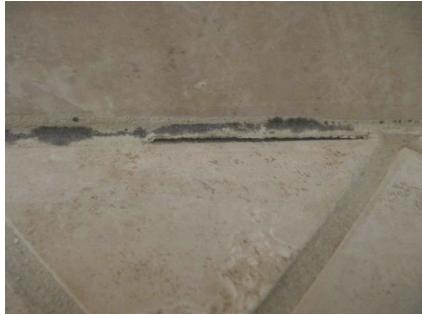
Master Bathroom

Recommendation**SEALANT AT SHOWER CORNERS**

Grout and/or caulk was needed at the tiled shower corners to prevent water intrusion and damage. Recommend a qualified professional to repair/reseal as necessary.

Contact a qualified professional.

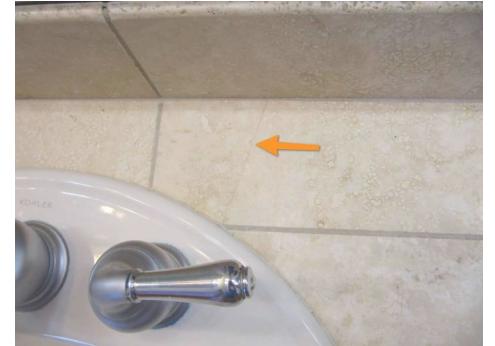
Bathroom 2

**COUNTERTOP CRACKED/CHIPPED**

Countertop had one or more cracks or chips. Recommend qualified countertop contractor evaluate and repair.

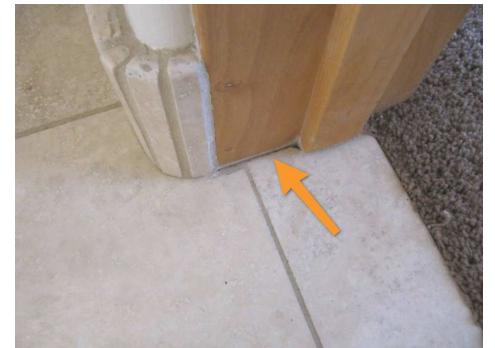
Bathroom 2

**GROUT DETERIORATING**

Grout lines were cracked or deteriorated, potentially allowing for moisture intrusion. Recommend a qualified contractor to repair or replace grout.

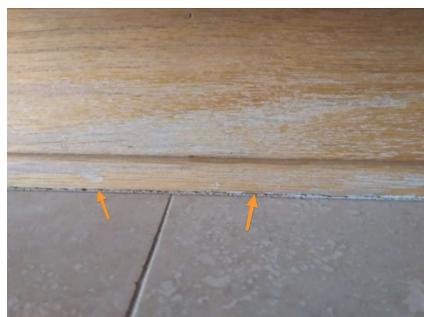
Kitchen

**GROUT DETERIORATING**

Grout lines were cracked or deteriorated, potentially allowing for moisture intrusion. Recommend a qualified contractor to repair or replace grout.

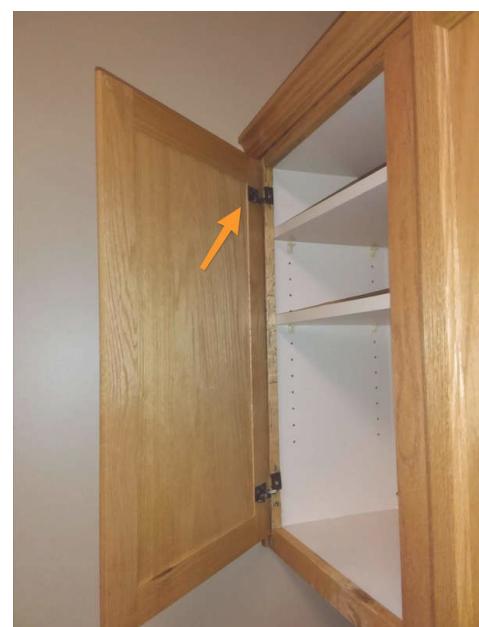
Laundry Room

**CABINET HINGE LOOSE**

One or more cabinet hinges were loose. Recommend a qualified handyman or cabinet contractor repair.

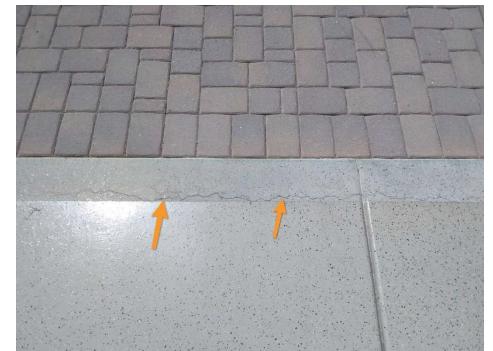
Garage

#### MINOR CRACKS IN CONCRETE

The garage floor had minor cracks in the concrete. These cracks are not a structural concern. Recommend sealing the cracks and monitoring over time for further cracking or deterioration.

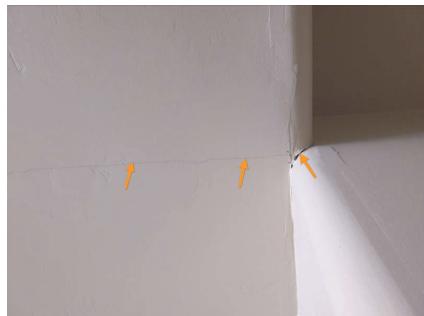
Garage

#### DRYWALL CEILING CRACKS

Interior ceiling cracks in one or more places were observed which is an indication of settling, movement or other defects. Ceiling drywall, texture and paint cracks should be repaired by a drywall professional and monitored over time for additional movement.

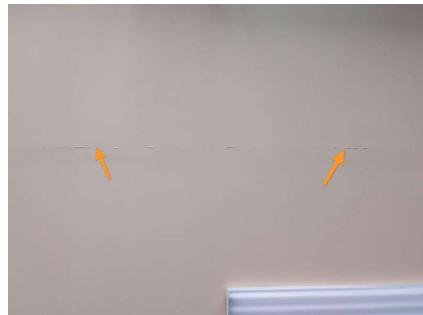
Garage 2

**DRYWALL CEILING CRACKS**

Interior ceiling cracks in one or more places were observed which is an indication of settling, movement or other defects. Ceiling drywall, texture and paint cracks should be repaired by a drywall professional and monitored over time for additional movement.

Contact a qualified professional.
