ON POINT HOME INSPECTIONS LLC

## INSPECTION REPORT

1234 Main St.  
Tucson, Az 85704

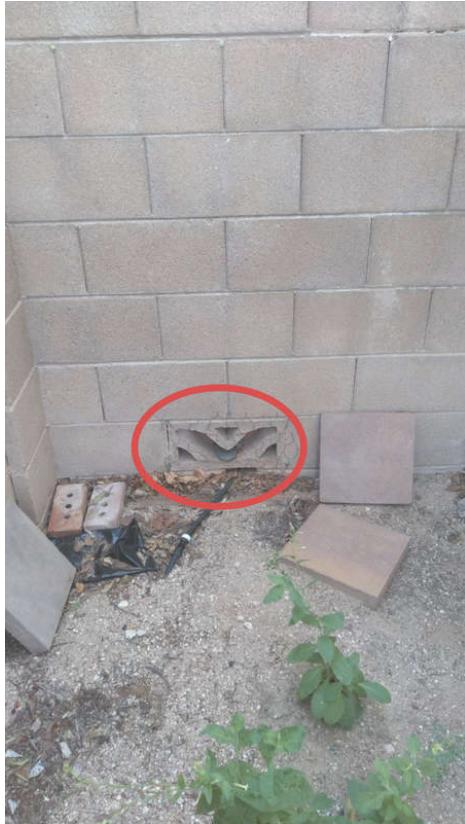
Keep dirt and debris clear of drainage ways. If these areas become blocked it can result in flooding of the surrounding area.

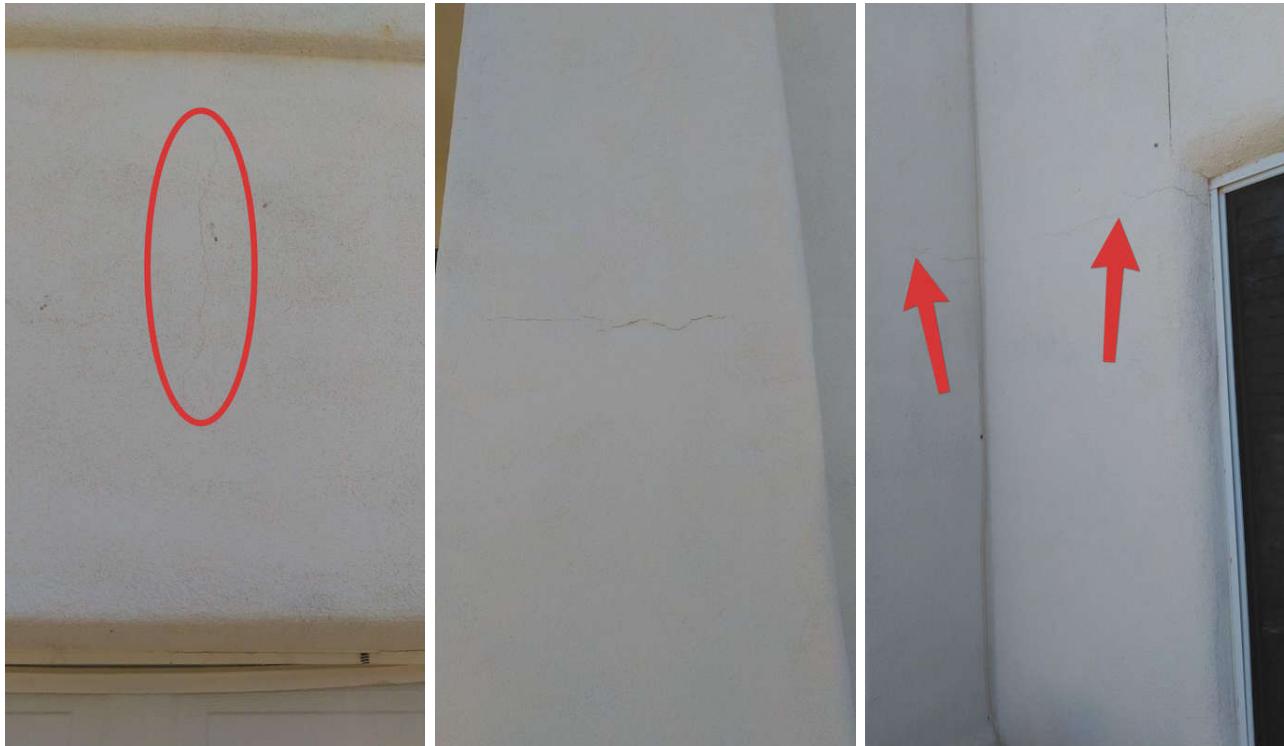
### 2.1.1 Siding, Flashing & Trim

#### CRACKING - MINOR

##### HOUSE EXTERIOR

The stucco siding had minor cracking in a few areas around the house. Minor/hairline cracks can be common and often are a result of temperature changes, expansion/contraction and typical as homes with stucco age. I recommend having a qualified professional seal these cracks as needed to prevent moisture intrusion.

Contact a qualified professional.

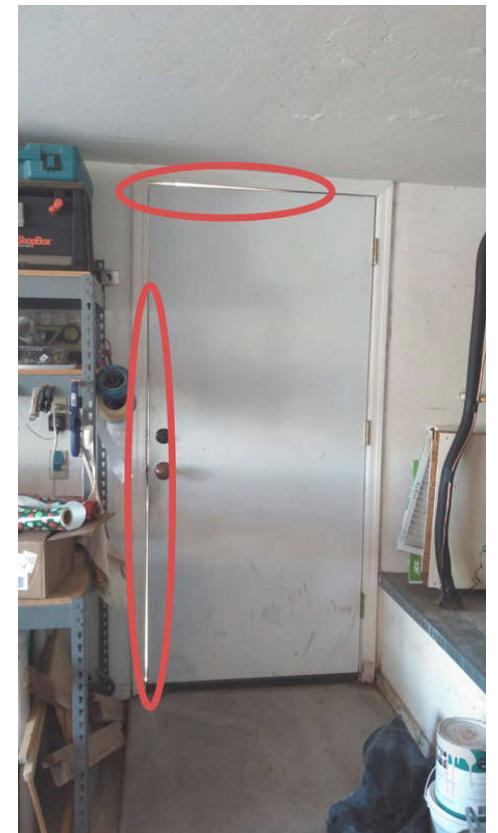
## 2.2.1 Exterior Doors

**WEATHER STRIPPING - GAPS**

## GARAGE SIDE EXIT DOOR

The garage side door had gaps in the weather stripping, this can allow moisture and pests to enter if not sealed. I recommend repairing, adjusting or replacing as needed to properly seal the door and prevent these issues.

Contact a qualified professional.

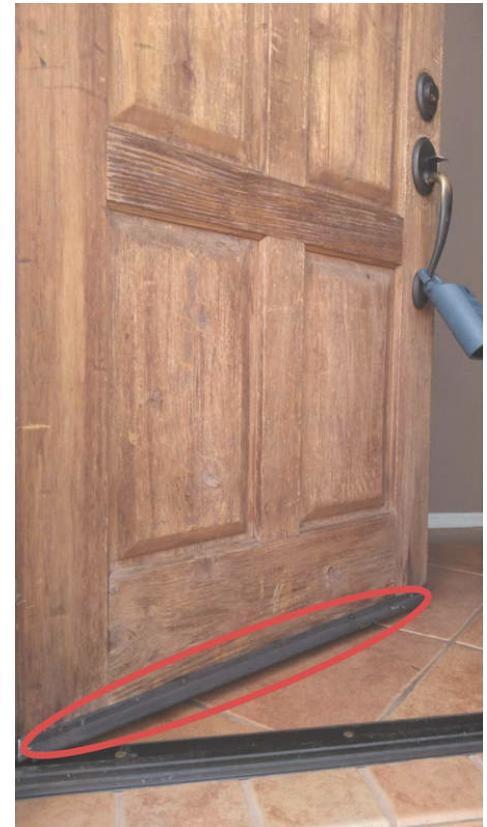
## 2.2.2 Exterior Doors

**WEATHER STRIPPING - LOOSE**

## FRONT DOOR

The door had loose weather stripping at the threshold which allows heating and cooling to escape lowering the homes efficiency, this can also allow pests to enter if not corrected. I recommend repairing or replacing loose sections of weather stripping to seal the door and prevent these issues.

Contact a qualified professional.

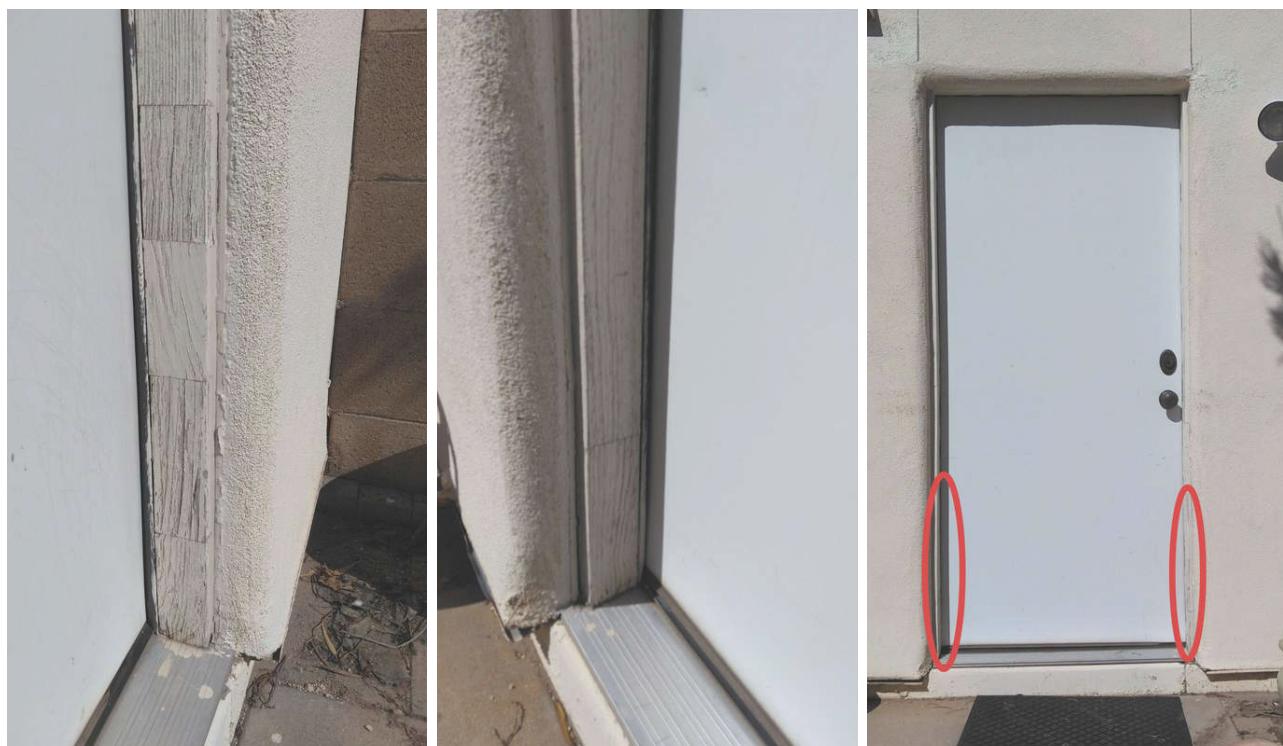
#### 2.2.3 Exterior Doors

#### DOOR FRAME/TRIM PAINT DETERIORATION

At the time of inspection the door frame/trim paint was peeling, cracking and deteriorating. The paint acts as a protective layer against wood rot, moisture intrusion, and deterioration. I recommend having a qualified professional repair or recoat as needed to properly seal and protect.

Contact a qualified professional.

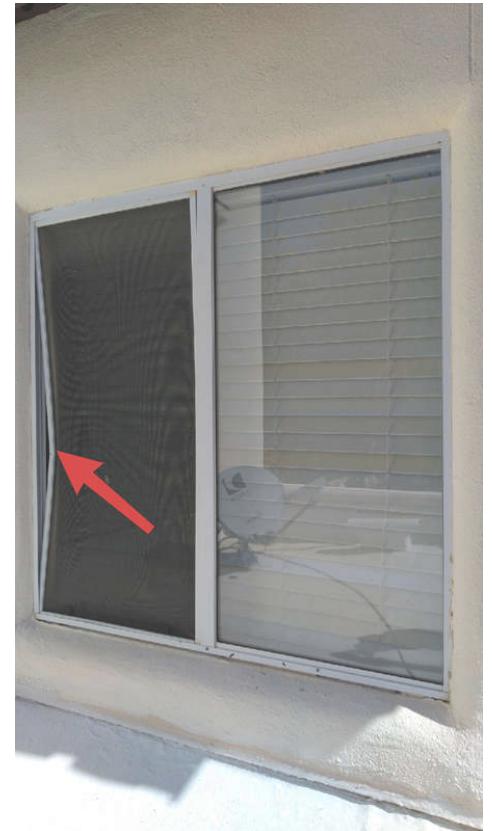
## 2.3.1 Windows

**WINDOW SCREEN DAMAGED**

## UPSTAIRS BEDROOM, KITCHEN EGRESS DOOR

At the time of inspection I observed a window screen damaged and a sliding glass door screen that had a damaged handle with tape on it. I recommend repairing or replacing the screens as needed to prevent birds, bugs, and pests from entering the home when the window/door is open.

Contact a qualified professional.

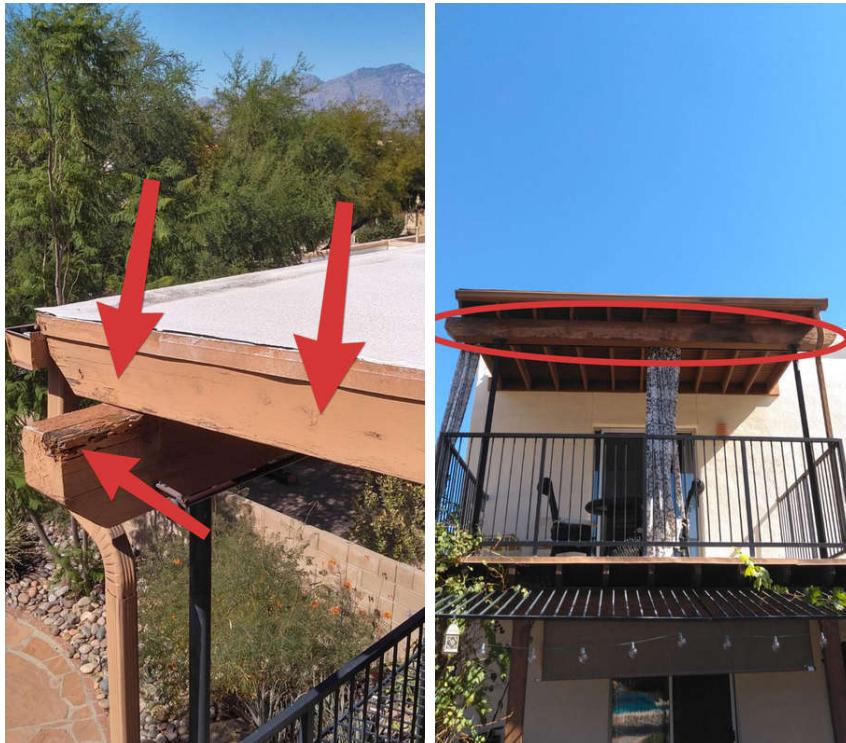
## 2.6.1 Eaves, Soffits &amp; Fascia

**BEAM AND/OR FASCIA DRY ROT AND PAINT DETERIORATION**

## BACK PORCH AND BALCONY

At the time of inspection I observed some wood rot as well as paint failing on the beam and/or fascia. The paint acts as a protective layer to prevent moisture intrusion, deterioration or rot of the wood material. I recommend having a qualified professional evaluate and repair the wood rot areas and restore the paint as needed to protect the wood from further deterioration/rot.

Contact a qualified professional.

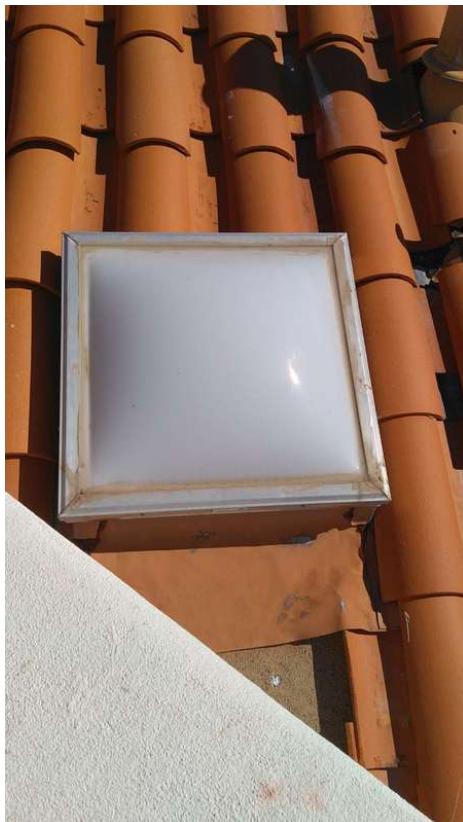
### **Roof Penetrations, Skylights, Chimneys: Skylights**

The skylight appeared to be sealed with no visible cracking on the dome or frame.

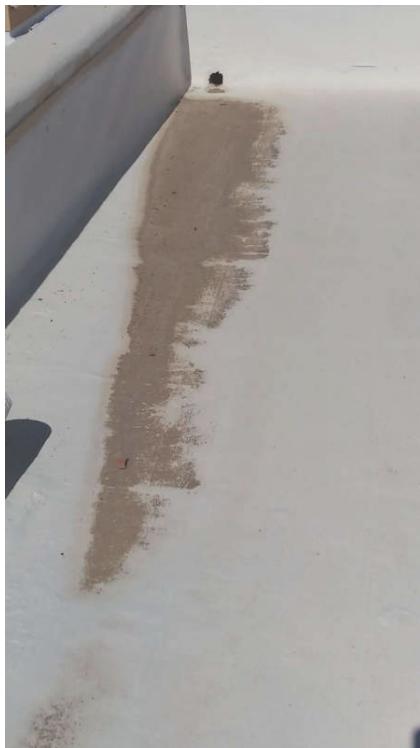
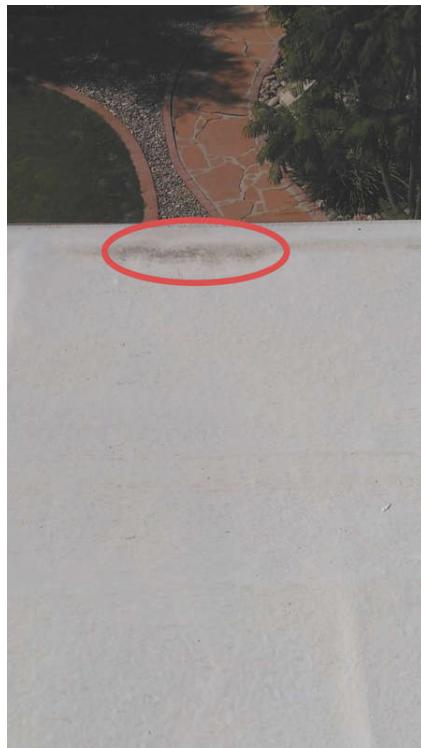
## 3.1.1 Coverings

**PONDING - MINOR**

I observed ponding in areas of the low pitched roof. Ponding can lead to accelerated erosion and deterioration of the roof covering materials. I recommend having a roofing contractor evaluate and repair as needed.

Contact a qualified roofing professional.

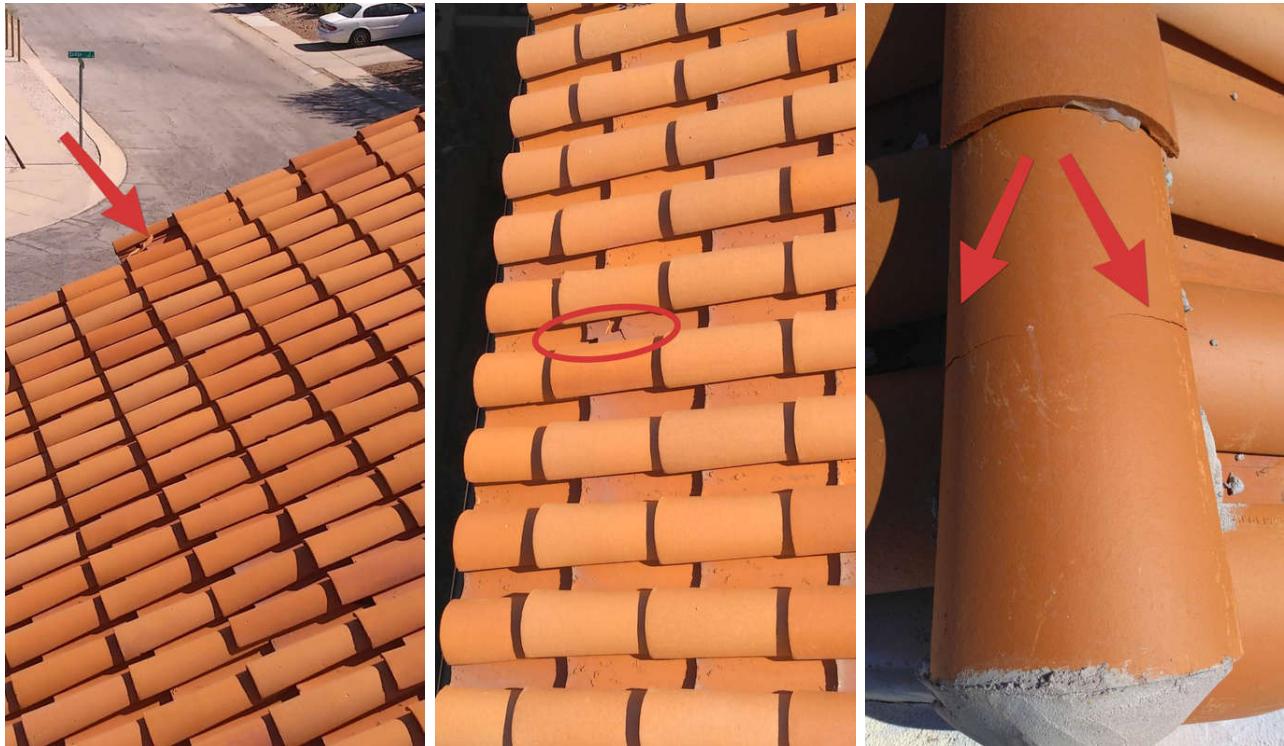
## 3.1.2 Coverings

**TILES CRACKED/BROKEN**

The roof had cracked/broken tiles at the time of inspection. Cracked tile can allow moisture to penetrate under the roof layers and into the house. I recommend having a roofing professional evaluate and repair or replace as needed prevent moisture intrusion.

Contact a qualified roofing professional.

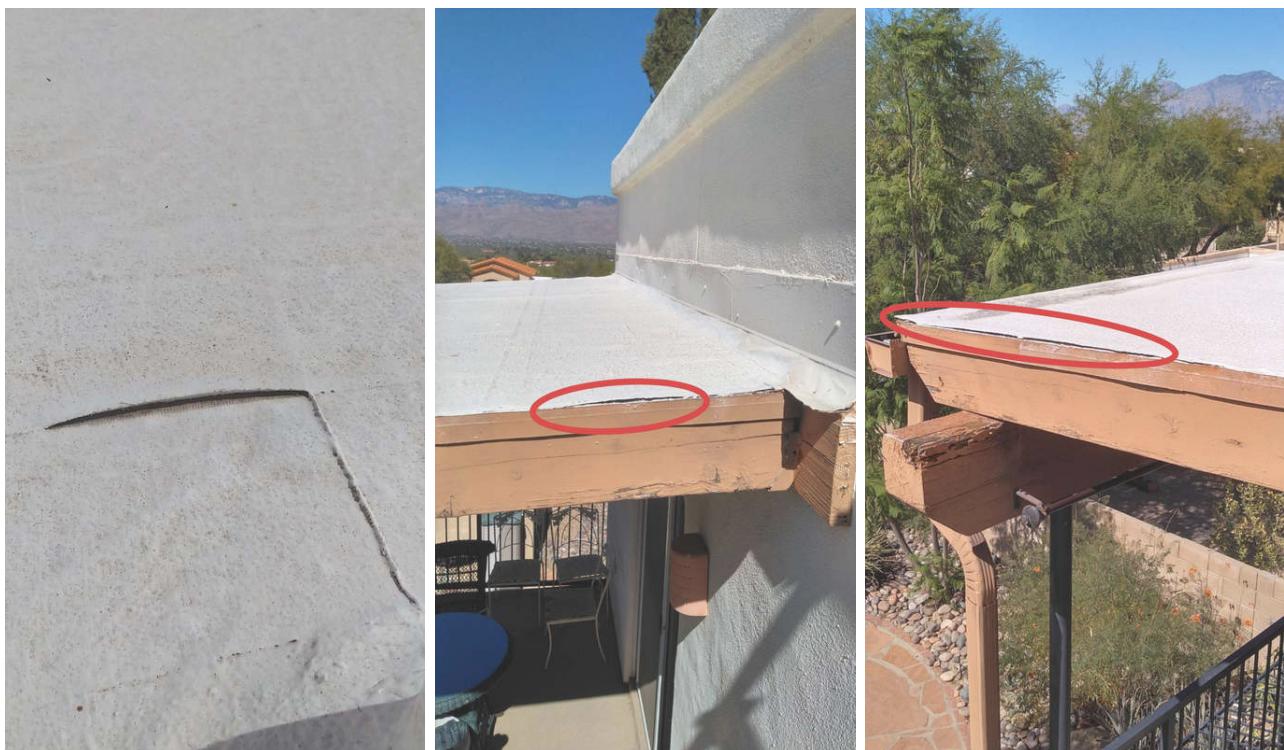
### 3.1.3 Coverings

#### PEELING ROOF COATING

The roof had some areas with peeling roof covering material at the time of inspection. This can allow water to penetrate under the roof layers and into the roof structure or house. I recommend having a roofing professional evaluate and repair as needed.

Contact a qualified roofing professional.

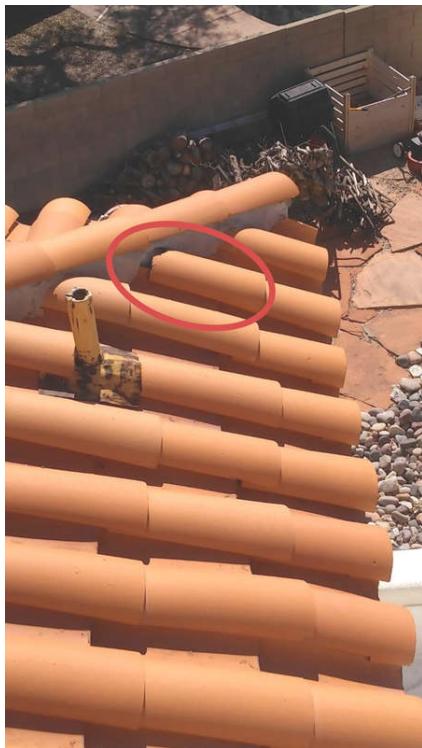
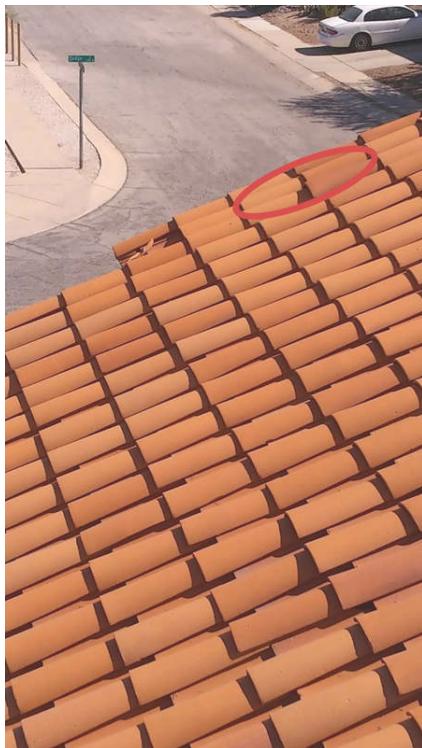
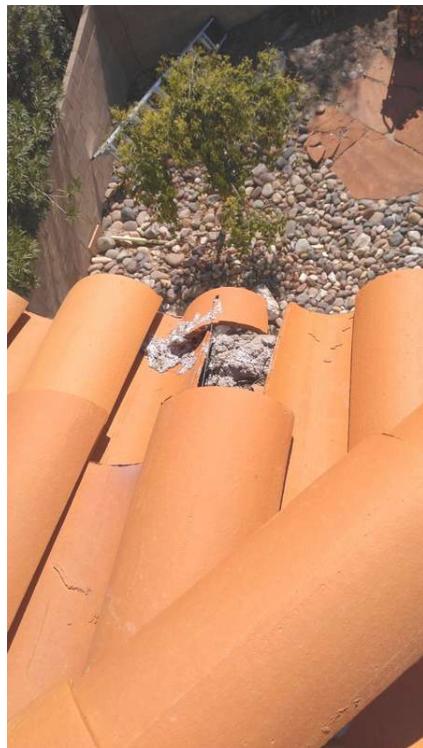
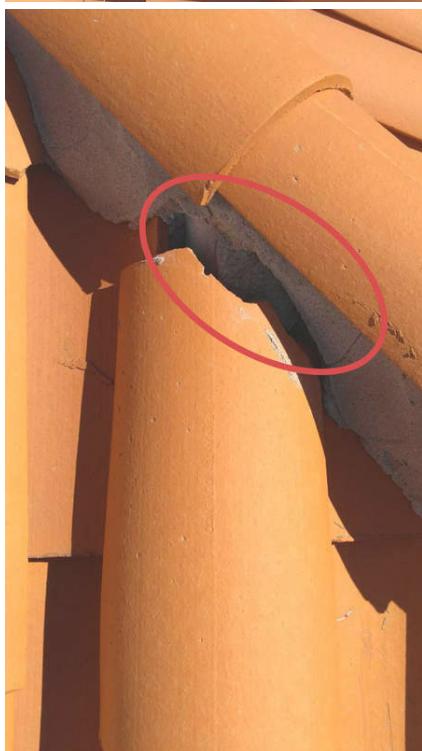
## 3.1.4 Coverings

**SLIPPED/SHIFTED TILES**

At the time of inspection I observed roof tiles that had slipped or shifted leaving the area exposed to moisture intrusion. I recommend having a roofing professional repair as needed to properly secure the tile.

Contact a qualified roofing professional.

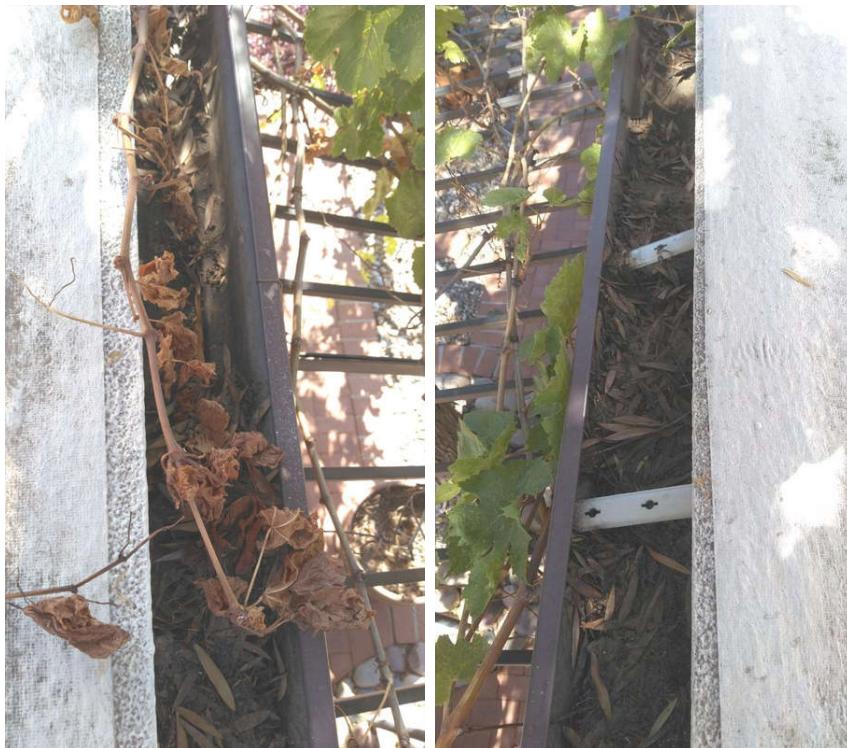
## 3.2.1 Roof Drainage Systems

**GUTTER - DEBRIS**

## BACK PORCH

At the time of inspection I observed tree/vine debris in the gutters. This can lead to improper drainage off the roof and cause moisture intrusion or deterioration of near by wood components if not corrected. I recommend having a qualified professional clean and maintain the roof drainage system to facilitate water flow.

Contact a qualified professional.

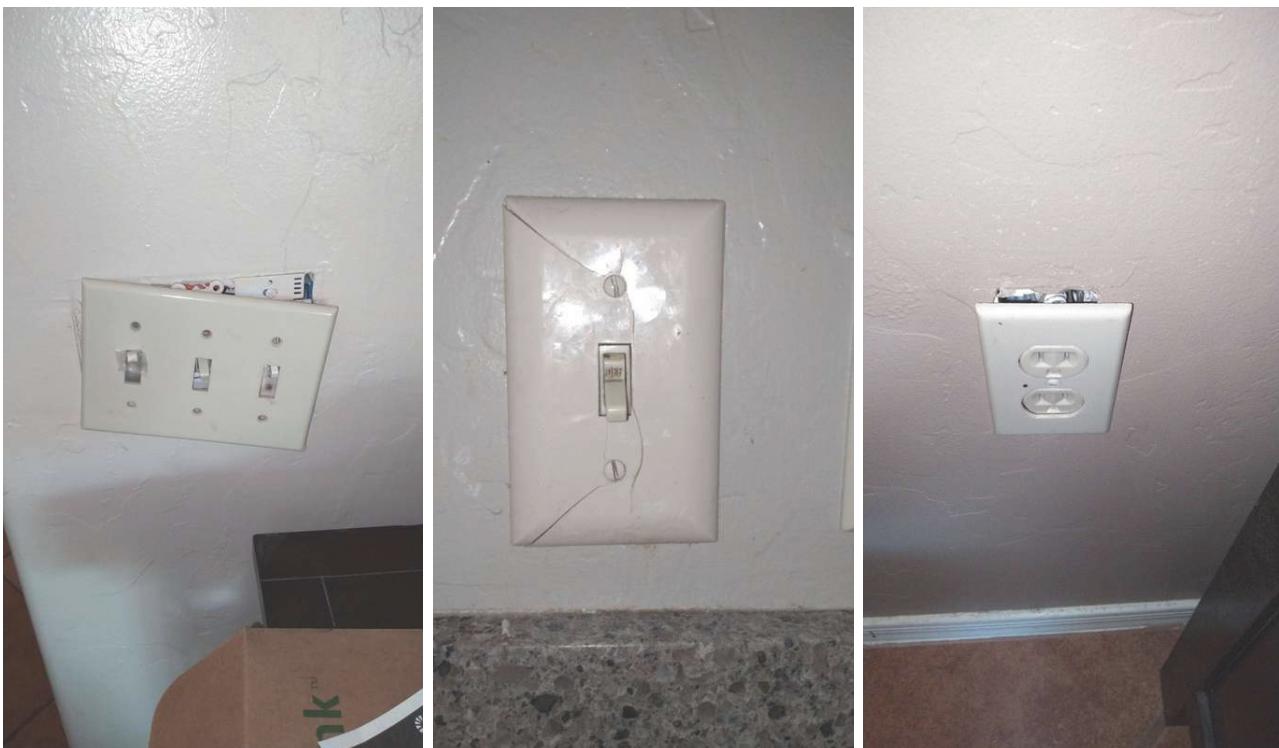
#### 4.4.1 Lighting Fixtures, Switches & Receptacles

#### **COVER PLATES DAMAGED OR LOOSE**

Receptacles and switches in the home had damaged and/or loose cover plates at the time of inspection. I Recommend repairing, replacing or tightening as needed.

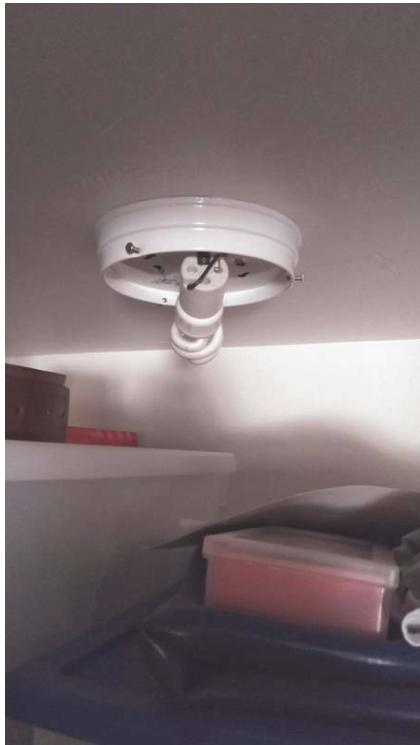
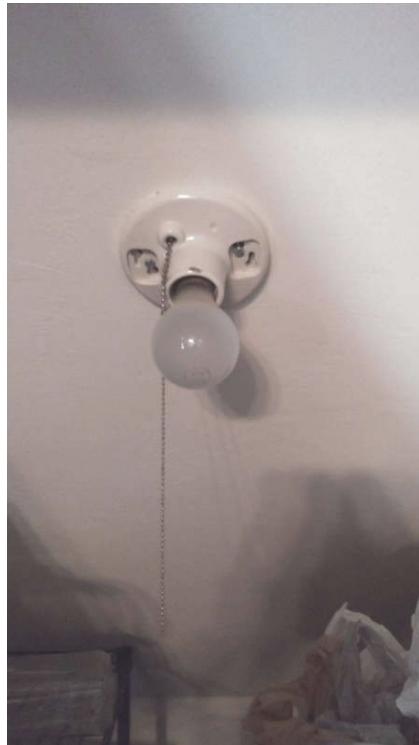
## 4.4.2 Lighting Fixtures, Switches &amp; Receptacles

Recommendation**LIGHT FIXTURES MISSING GLOBE**

At the time of inspection light fixtures were missing lenses, domes or globes. This leaves the bulb exposed to come in contact with items while it is hot and can also break if bumped resulting in bodily injury. I recommend installing the proper cover to protect the bulb from damage or the possibility of fire.

Contact a qualified professional.

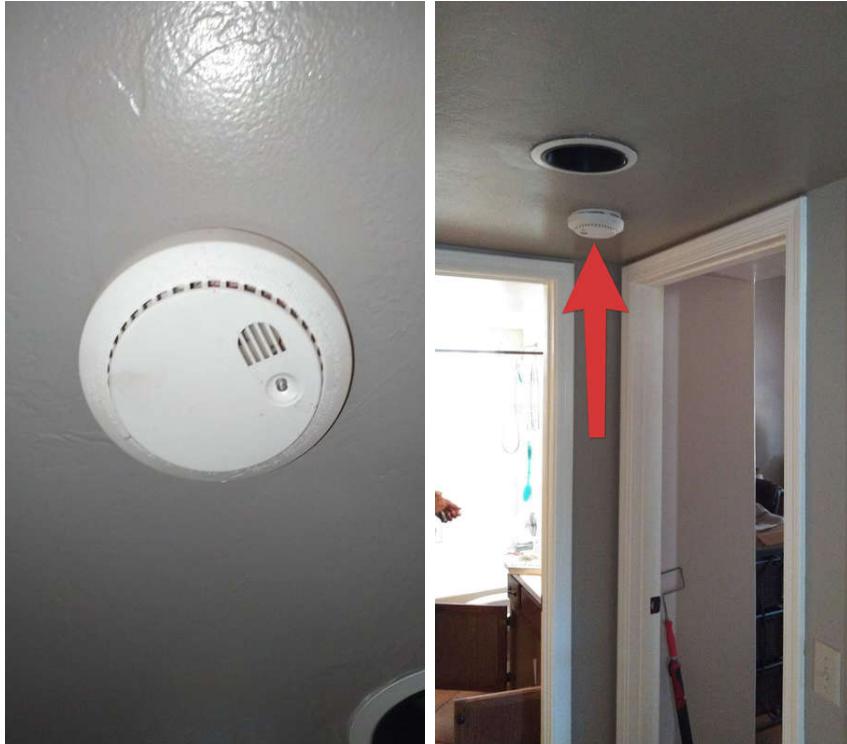
## 4.6.1 Smoke Detectors

Recommendation**SMOKE DETECTOR - DEFECTIVE**

At the time of inspection I observed a smoke detector that was connected, but did not respond when tested. I recommend replacing this detector as needed for proper function.

Recommended DIY Project

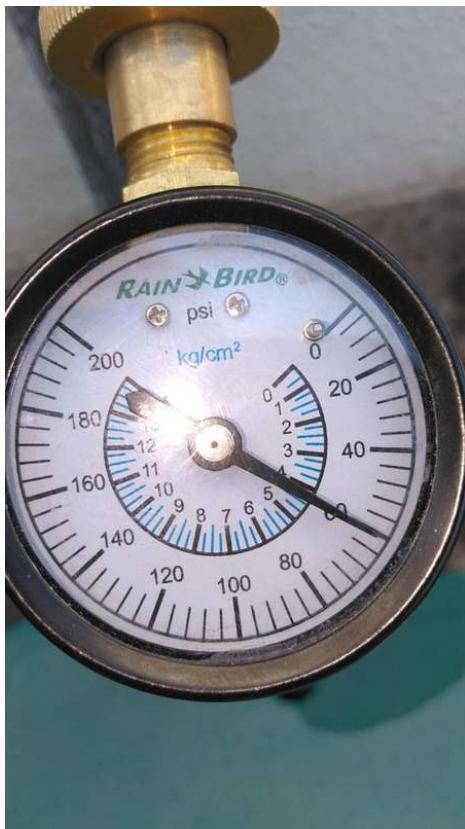
60 Psi

Recommended pressure is generally between 40 PSI and 80 PSI, anything below 40 PSI will have low flow from fixtures in the house and anything above 80 PSI can show accelerated deterioration of the seals in fixtures and faucets due to higher pressure.

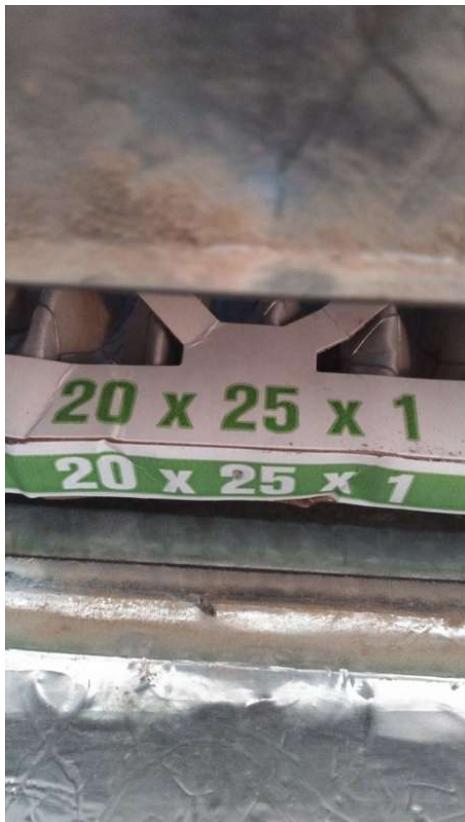
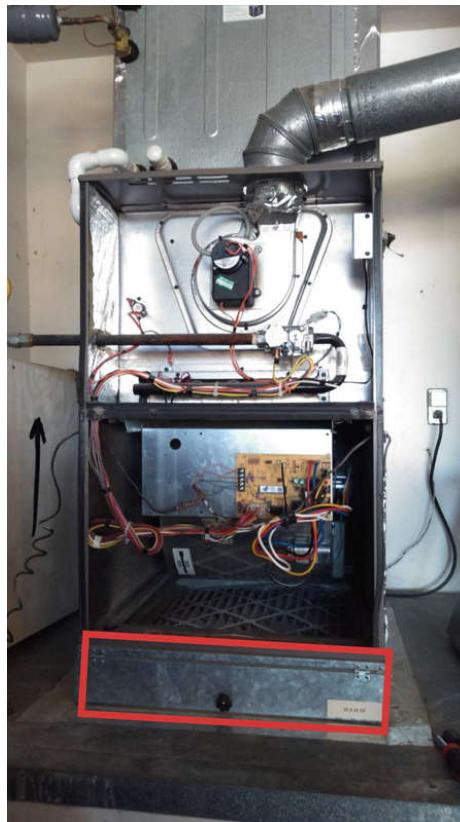
## Cooling Equipment: Air filter size and location

20X25X1, At the base of the heater/air handler unit

I recommend cleaning or changing the filter monthly for optimal performance.

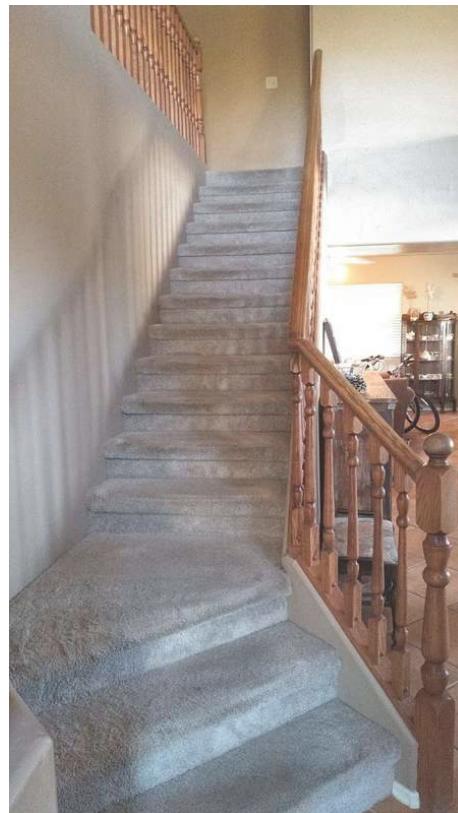
#### Steps, Stairs, Railing

Safe secure hand railing, Proper  
Tread height and depth

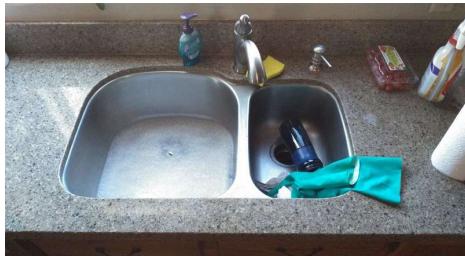
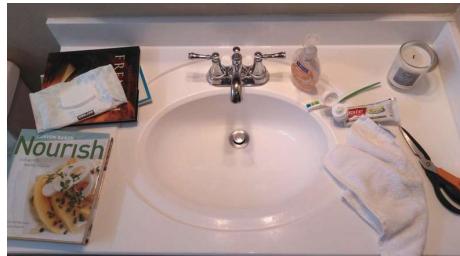
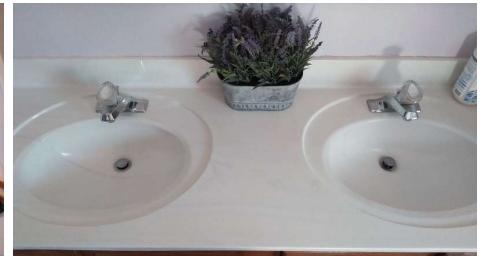
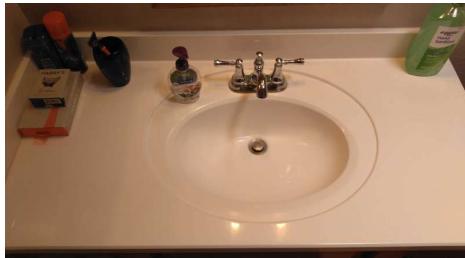
Minor cracking noted in the downstairs composite sink. No leaking underneath at the time of inspection.

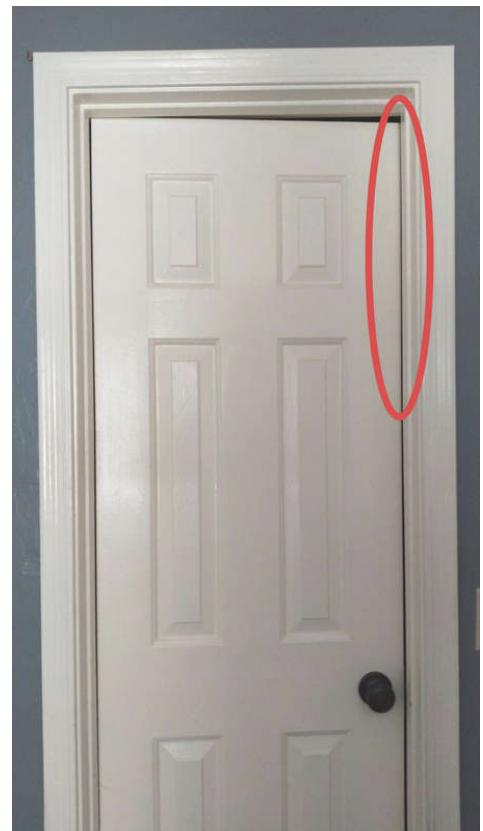
At the time of inspection I observed a closet door that did not open/close as it should and rubbed the frame. I recommend having a door installer evaluate and adjust or repair as needed to achieve proper operation.

Contact a qualified door repair/installation contractor.

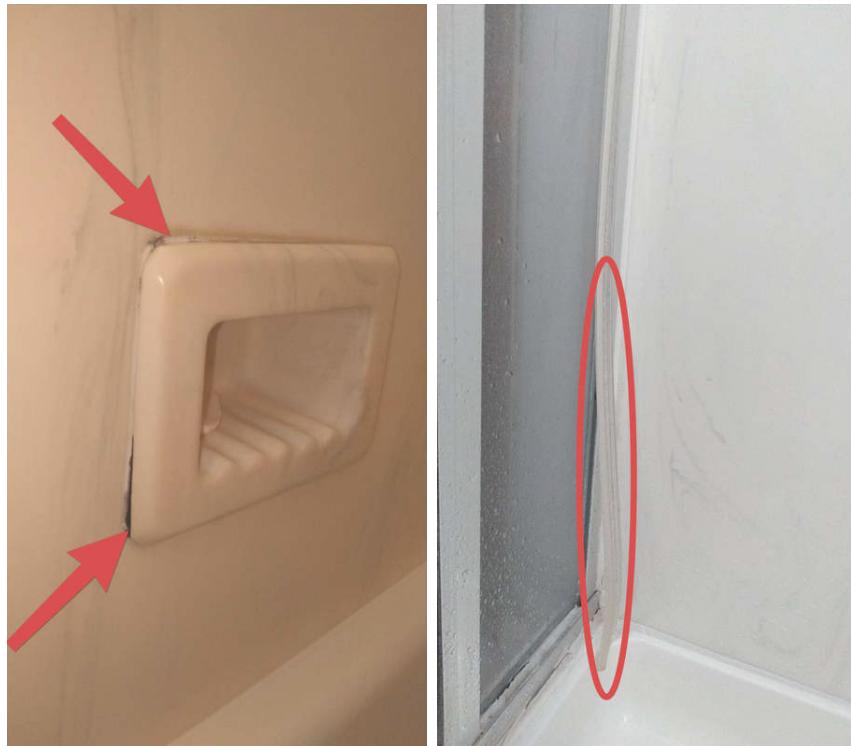
## 8.3.1 Walls

Recommendation**SHOWER ENCLOSURE SEALING RECOMMENDED**

At the time of inspection I observed sections of the shower enclosure that are in need of sealant and /or gasket repaired to prevent moisture leaking/intrusion. I recommend having a qualified professional evaluate and properly prep repair or seal these areas.

Contact a qualified professional.

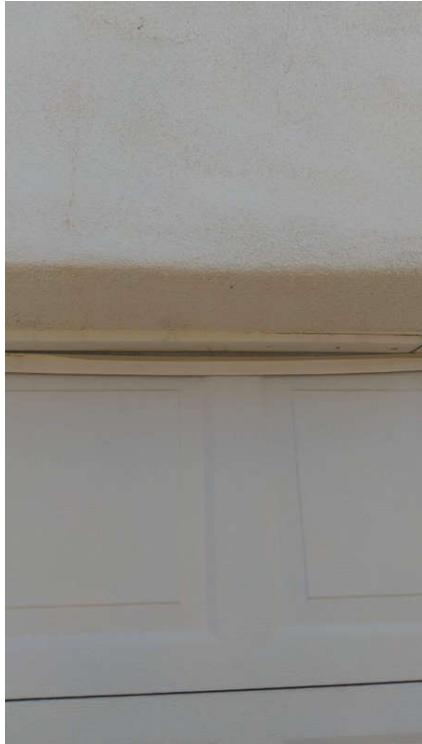
#### TRIM/WEATHER STRIP DAMAGE

At the time of inspection I observed damage to the trim/weather stripping against the garage door. I recommend having a qualified professional repair or replace to prevent pests from entering the garage.

Contact a qualified professional.

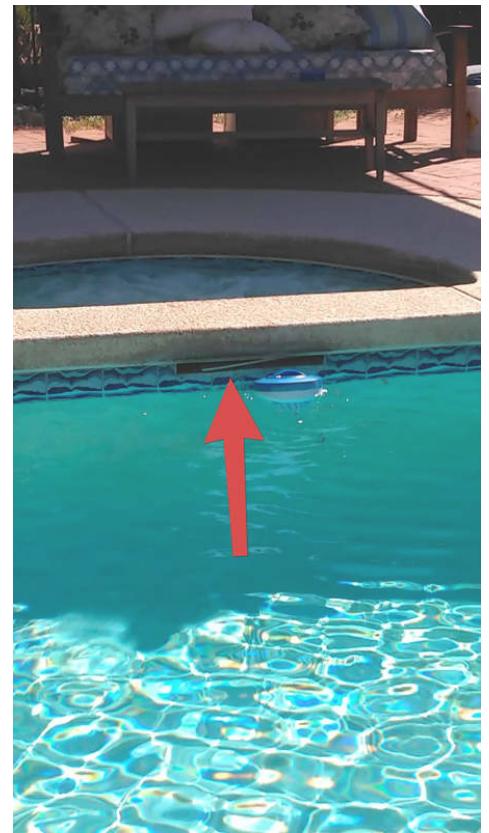
**LOOSE TILE**

At the time of inspection I observed a loose tile between the spa to pool spilway. I recommend having a pool professional repair or replace as needed.

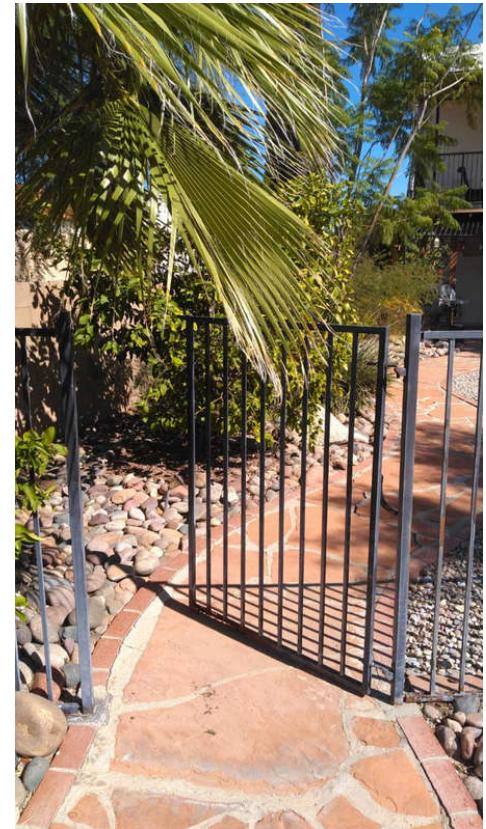
At the time of inspection the self-closing gate did not close on its own. The gate did have the proper self-closing hardware but may need to be adjusted. I recommend having a qualified professional evaluate and adjust or repair as needed to prevent unattended children from entering the pool area. (The fence and gate also had heavy rust on the lower tube)
