PGR HOME INSPECTIONS

RESIDENTIAL HOME INSPECTION REPORT

1234 Main St. Charleston SC 29414

11/27/2020 9:00AM

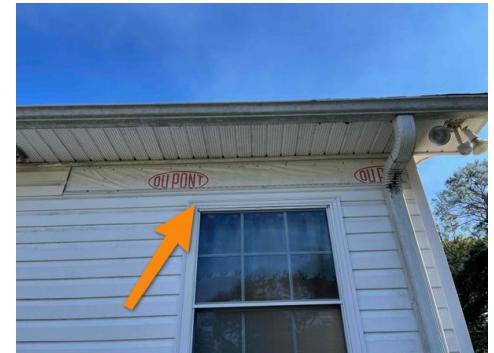
SIDING: MISSING

One small section of vinyl siding was found to be missing.
Recommend having a qualified siding contractor match to the existing siding and replace.

Contact a qualified siding specialist.

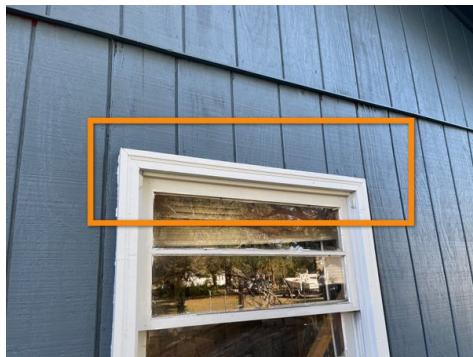
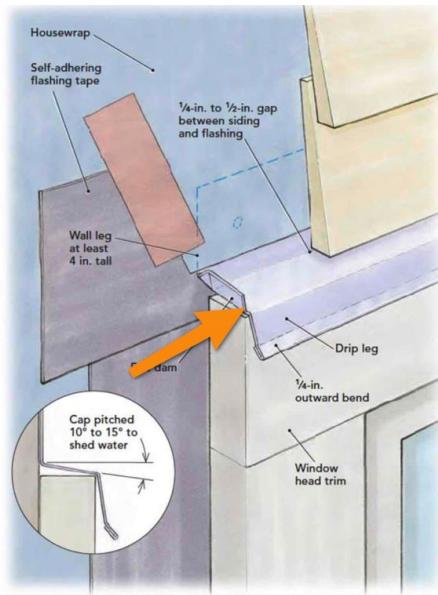
2.2.2 Exterior Components

WINDOW FLASHING: MISSING HEAD AND SILL FLASHING

Windows around the back shop had no "drip cap" or "head flashing" installed in the noted areas. All other windows had flashing installed. Better building practices call for such flashings, which reduce the chance of leaks above the windows. Without this flashing, caulk and paint must be maintained or water can enter the wall structure causing damage. Due to its location under the soffit and direction of prevailing rains this may or may not be an issue. It is recommended to monitor these areas in the future and maintain caulk and paint as needed or consult with a qualified professional about adding appropriate flashing.

Contact a qualified professional.

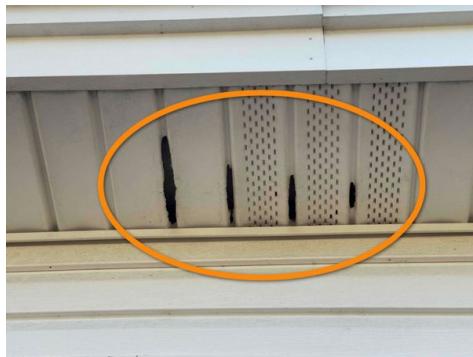
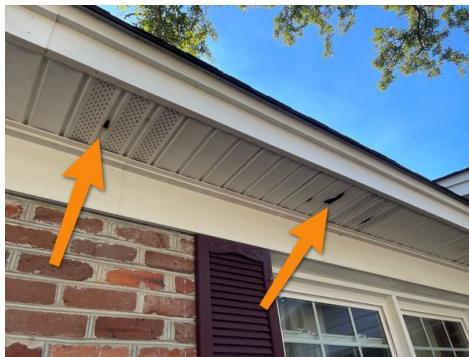
2.2.3 Exterior Components

SOFFIT: SQUIRREL DAMAGE

Squirrel damage noted in multiple areas of the soffit on the front of the home. Recommend repairing or replacing as needed to prevent unwanted pest entry.

Contact a qualified professional.

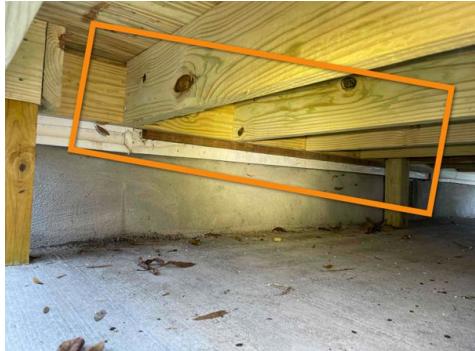
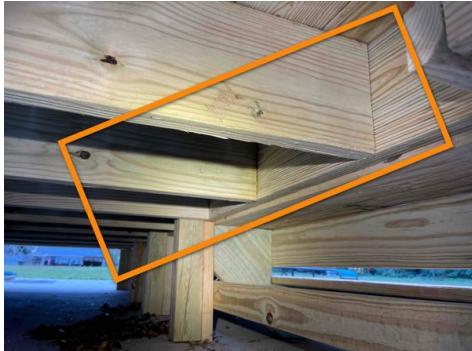
2.4.1 Decks, Porches, Steps

DECK: JOISTS HANGERS MISSING

Proper joists hangers or a ledger strip is missing on the back porch. Recommend a qualified professional evaluate install proper hangers or a ledger strip for added strength.

Contact a qualified professional.

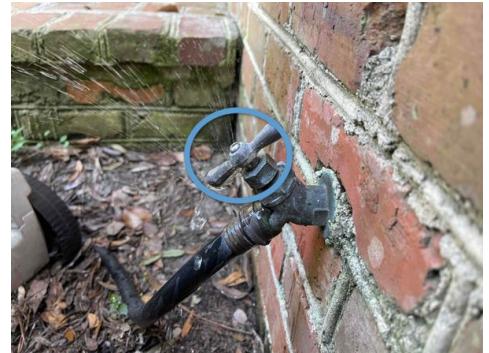
2.5.1 Hose Bibs

HOSE BIB: LEAKING

The hose bib on the front side of the house is leaking at the valve stem while in use. Recommend a qualified plumber repair or replace as needed before the defect possibly gets worse.

Contact a qualified plumbing contractor.

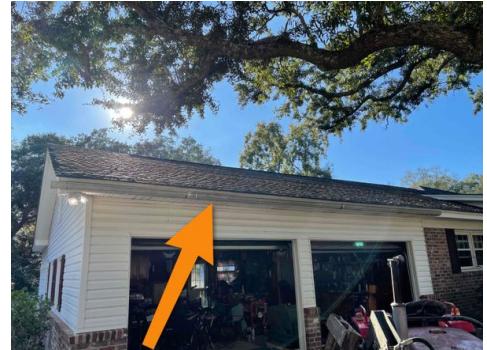
3.2.3 Gutters, Downspouts

GUTTERS: DEBRIS

Debris has accumulated in the gutters. Recommend cleaning to facilitate water flow.

Contact a handyman or DIY project

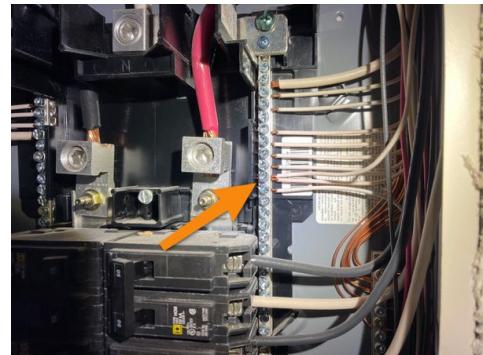
11.3.3 Branch Wiring Circuits, Breakers & Fuses

DOUBLE LUGGED NEUTRALS

Double lugged neutrals are present in the panel. There should not be more than one neutral under the same screw on the bus bar. This creates an issue if one of the circuits needs to be isolated. Also neutral conductors can be current-carrying and can become loose over time producing heat and a potential fire hazard. This was not added to the National Electric Code until 2002, however it is still recommended a licensed electrician repair.

Contact a qualified electrical contractor.

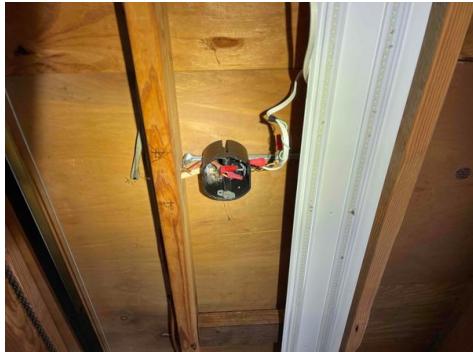
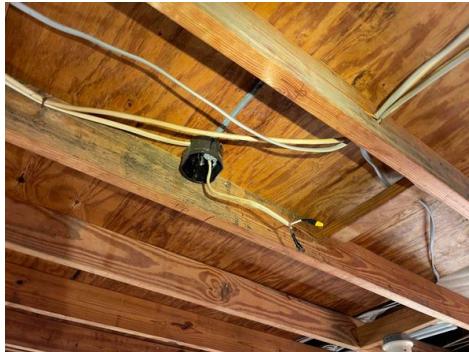
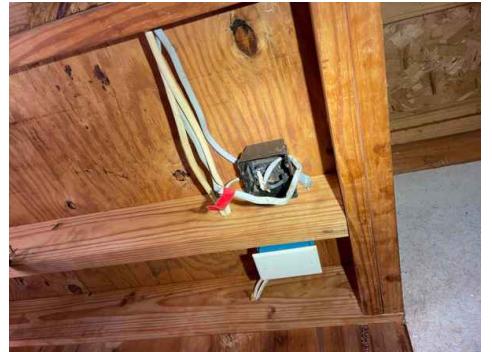
Multiple branch wiring/ lighting wire splices are exposed rather than being safely contained in a closed/ sealed junction box. This poses a possible hazard situation should the connection become loose and arc. Recommend a qualified professional repair as needed.

Contact a qualified professional.

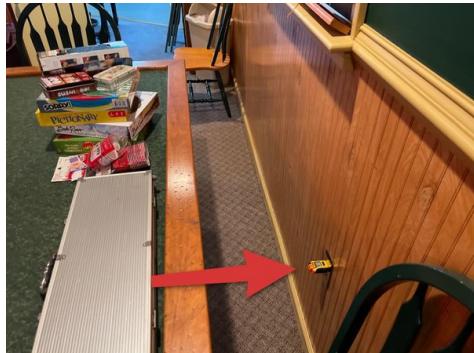
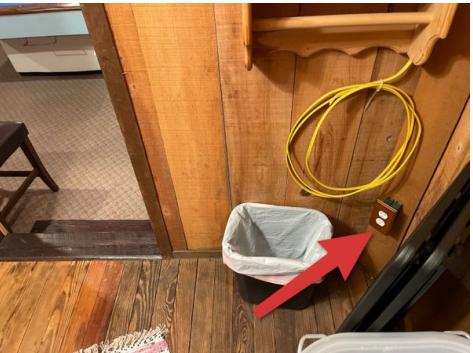
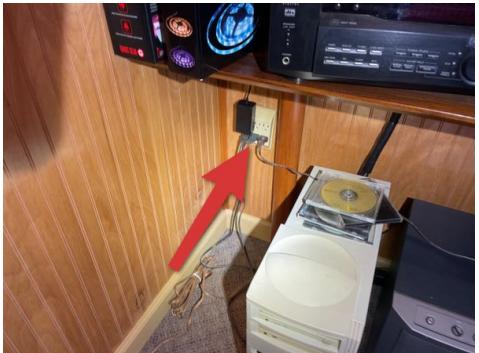
Game room

Multiple receptacles were showing to have an open ground. To prevent possibility of shock, injury and/or damage to equipment it is recommended that a qualified electrician evaluate and repair as needed.

Contact a qualified electrical contractor.

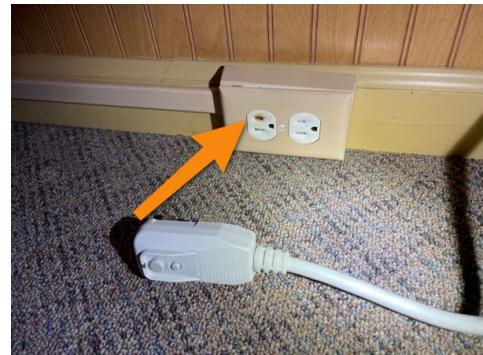
One of the receptacles in the game room had evidence of previous arcing. The receptacle was functional. Recommend a qualified electrician repair as needed to help prevent a future issue.

Contact a qualified professional.

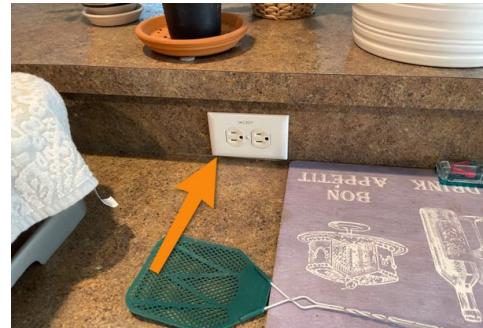
Kitchen

One of the kitchen receptacles was not functioning at time of inspection. Recommend a licensed electrician evaluate and repair as needed.

Contact a qualified electrical contractor.

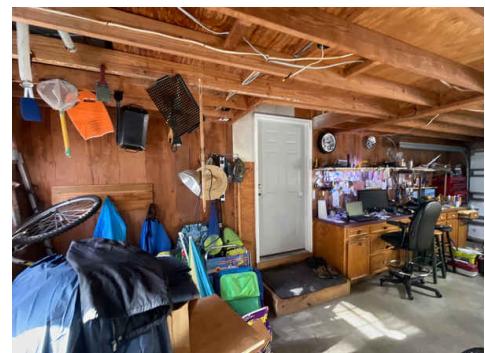
**WALL-TO-INTERIOR:
IMPROPER/INCOMPLETE FIRE SEPARATION**

The shared wall between the garage and interior space does not have the proper fire separation materials installed. Plywood does not provide adequate fire separation according to today's standards. Requirements may have been different at the time the home was built. Recommend consulting with a qualified professional regarding costs associated with installing Type X 1/2 inch drywall on the shared wall.

Contact a qualified professional.

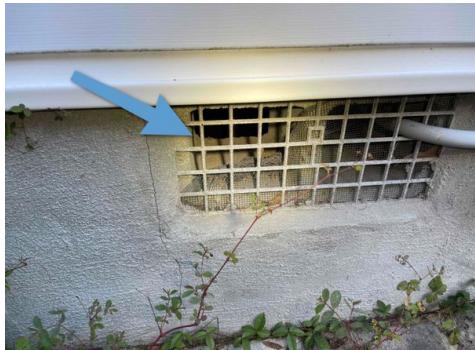
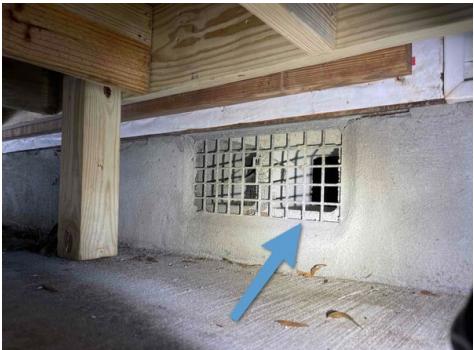
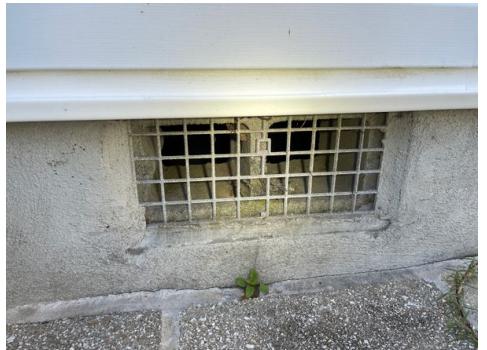
Back of the home

CRAWLSPACE VENTS: SCREENS MISSING OR DAMAGED

Multiple crawlspace vents have missing screens or are damaged which can allow for unwanted pests or animals to enter. Recommend installing screens on ALL vents where missing and repairing the ones that are damaged.

Contact a handyman or DIY project

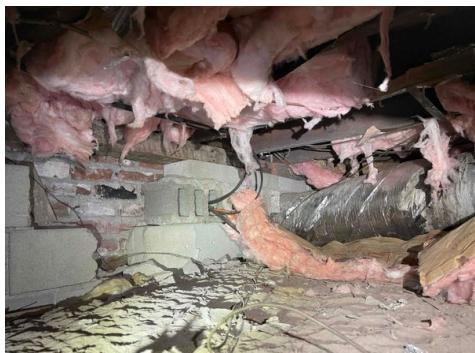
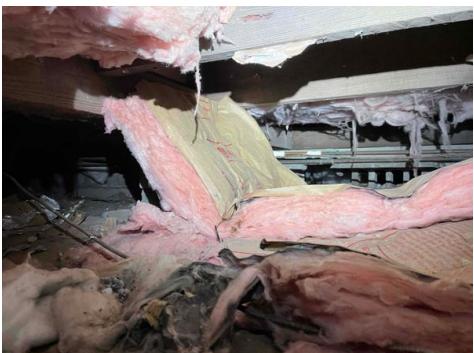
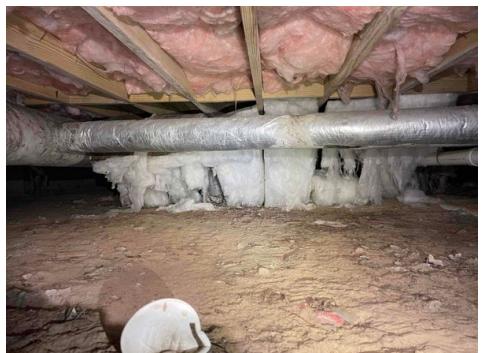
13.2.3 Crawlspaces

VAPOR BARRIER: NONE PRESENT/ MICROBIAL GROWTH

Contact a qualified professional.

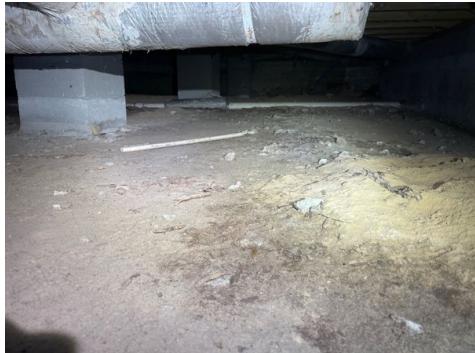
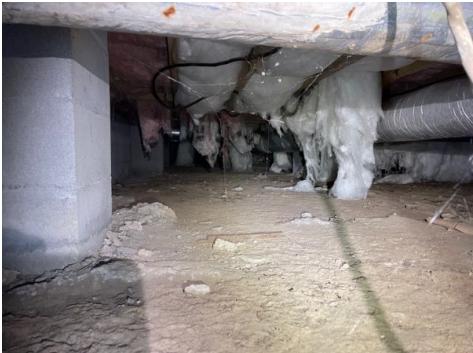
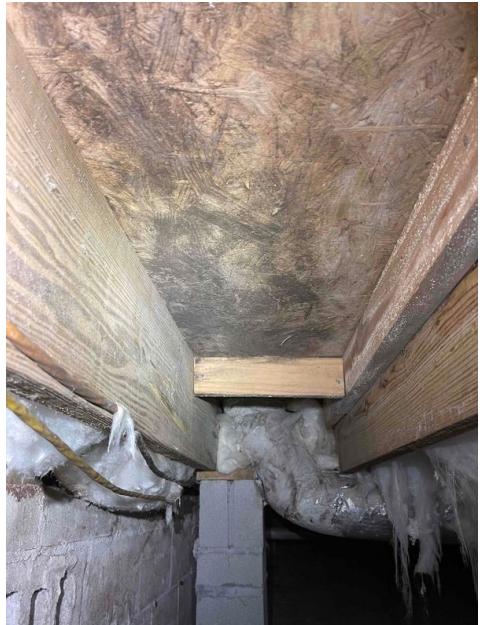
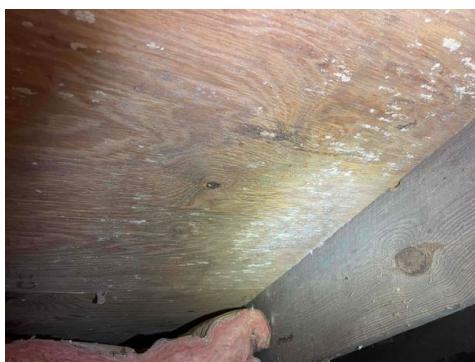
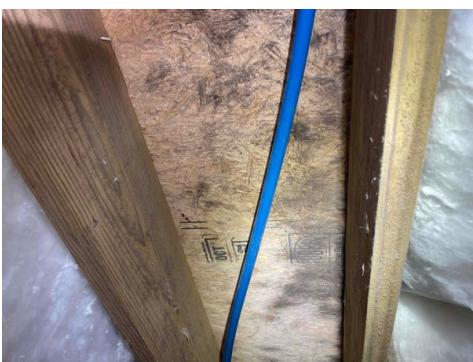
13.3.1 Floor Structure

JOISTS: WDI DAMAGE

Contact a qualified professional.

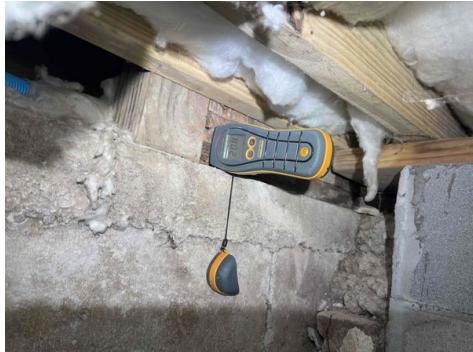
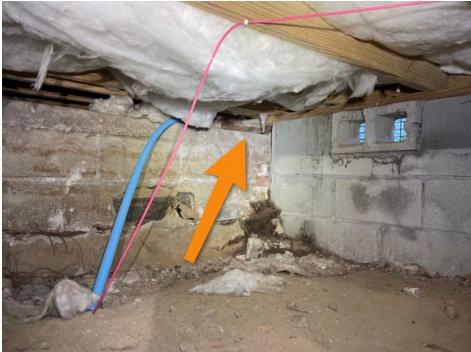
13.3.3 Floor Structure

ORIGINAL OUTER BEAM: MOISTURE DAMAGE/ ROT

Contact a qualified professional.

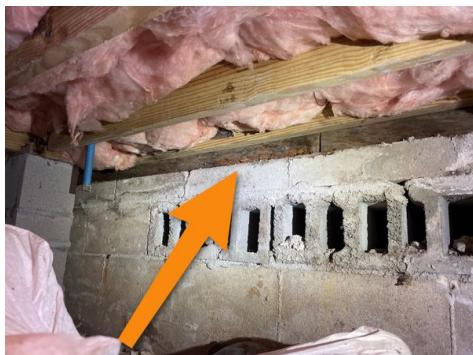
13.3.4 Floor Structure

BEAM: CRACKED/ DAMAGED

Contact a qualified general contractor.

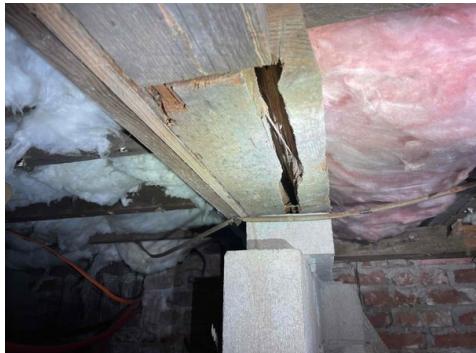
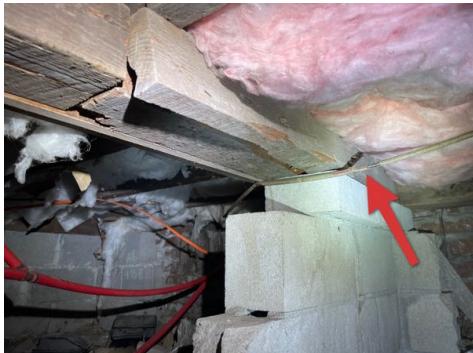
13.3.5 Floor Structure

**FLOOR STRUCTURE:
SUPPORT OUT OF PLUMB**

Contact a qualified professional.
